August 24, 2023

Marine Investigation Report MIR-23-18

Capsizing and Sinking of Crane Barge *Ambition*, Towed by *Karen Koby*

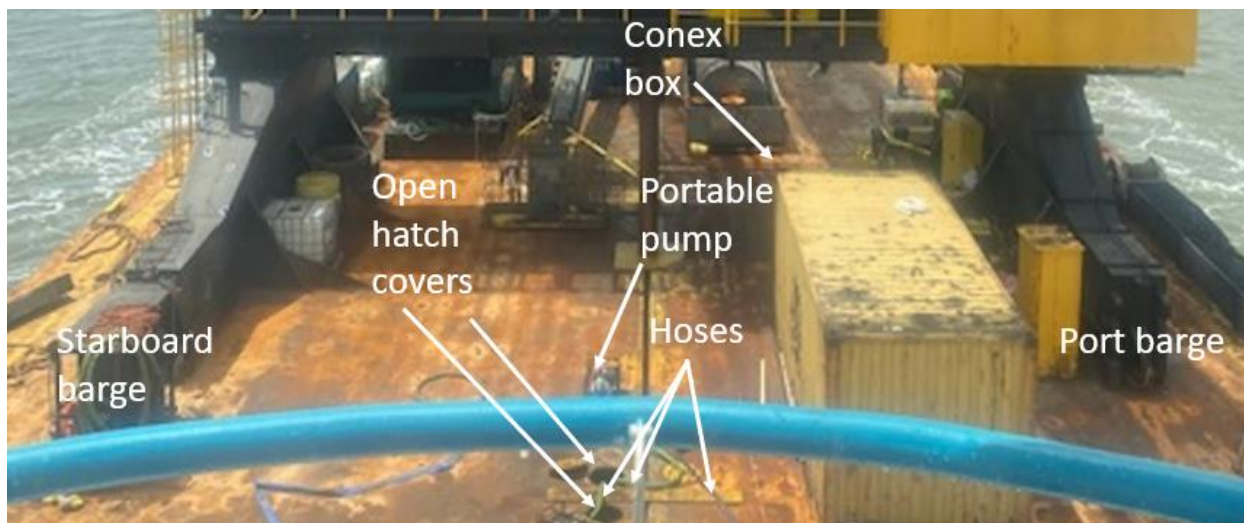
At least six hatches were not covered or secured. Two hatch covers were missing (Rigid crewmembers put a pump over one hatch and a steel plate over the other), two hatches had the covers laid over water suction hoses leading into the compartments below, and two hatch covers were not properly secured and fell off after the barge capsized. A deckhand from the *Karen Koby* told investigators that a Rigid crewmember told him that they had hoses in the compartments “all the time” in case they needed to pump water out.

Figure 5. The barge *Ambition* at 1200 on June 14 while being pushed southbound on the Calcasieu River en route to the fuel facility. A portable pump and hoses are visible leading into open hatches on the deck of the starboard barge near the bow on the inboard side, with a discharge hose leading out onto the main deck. (Source: *Karen Koby* mate)

There was evidence of past dewatering of two compartments (1P and 2P) on the starboard barge of the *Ambition*: a pump and hoses were rigged there, and a Rigid crewmember told a deckhand from the *Karen Koby* that they had the hoses in the compartments all the time in case they need to pump water out. This implies that water accumulation was a known issue with those compartments. However, none of the Rigid crewmembers were tasked with checking compartments and voids on the barge for water, even though it had been sitting idle in a fleet for 4 to 5 weeks. Thus, Rigid Constructors allowed for the *Ambition* to be taken under offshore tow without verifying the watertight integrity of the hull or any water quantities in the compartments or voids (except for the aft ones that were about half full).

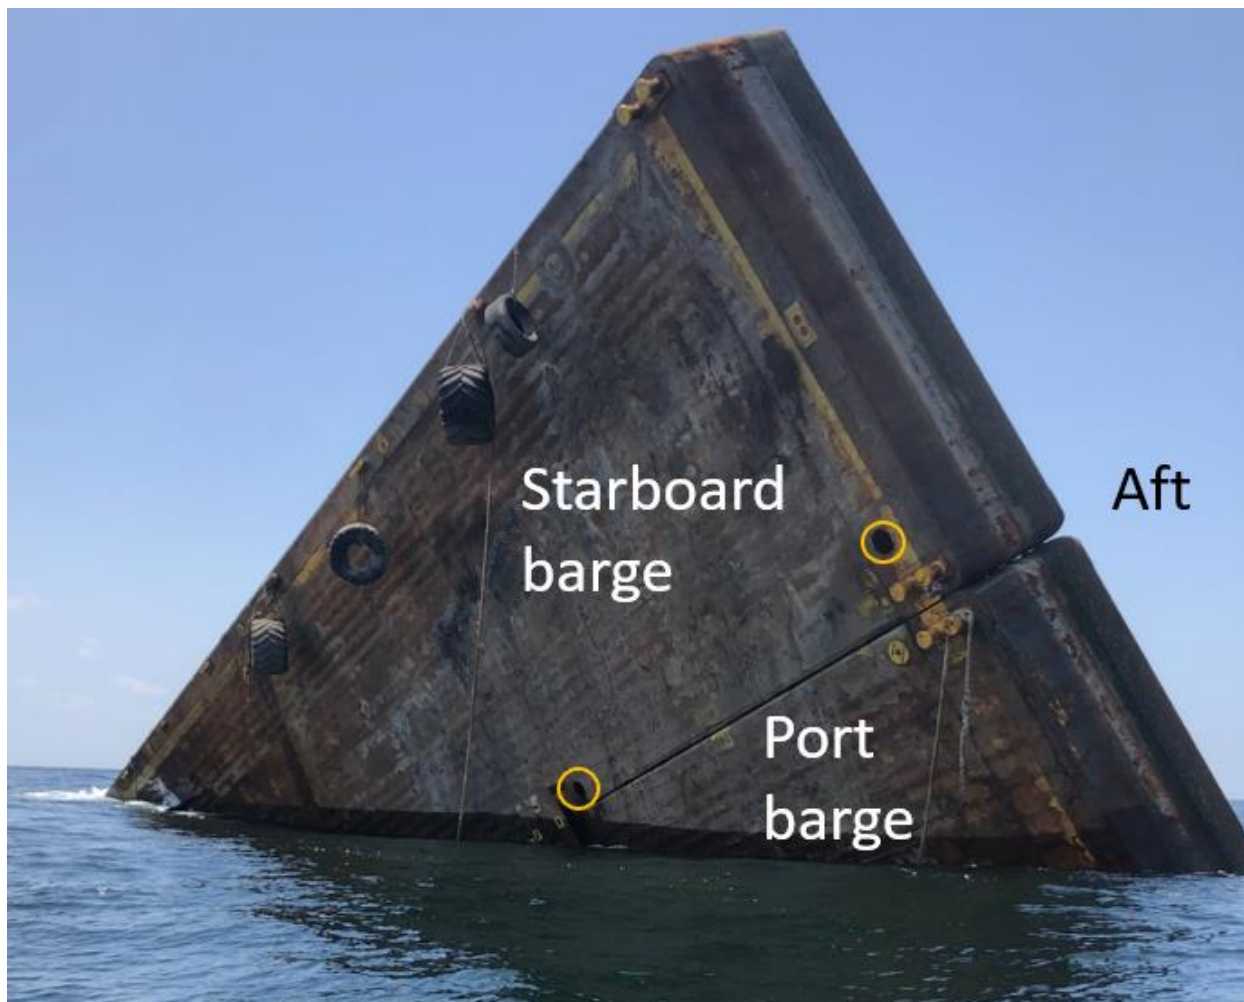
A postcasualty photo of the *Ambition* shows two missing hatch covers aft near the centerline of the starboard barge. According to the Rigid supervisor, these covers should have been secured. He told investigators that the tool used to tighten hatch covers was in the Conex box on the barge, but none of the Rigid crew were aware of the tool or its location.

Figure 6. The partially sunken barge *Ambition* the morning of the casualty with the starboard stern of the barge out of the water. The orange circles show hatch covers that had fallen off during the capsizing. (Background source: unknown)

During the tow in the Gulf of Mexico, the *Ambition* had at least six hatch covers that were either missing or not properly secured. Although a *Karen Koby* deckhand notified the captain of two missing covers, the captain did not notify the LA Carriers office (towing vessel operator) of any of the items noted in the barge inspection report. Rigid Constructor's (barge owner) crew returned to the barge but did not properly secure the missing covers (an iron sheet and a pump were used to cover the two hatches, but neither of those items made the compartments beneath watertight). As a result, the barge *Ambition* was towed offshore with open and unsecured compartments that were intended to be watertight.

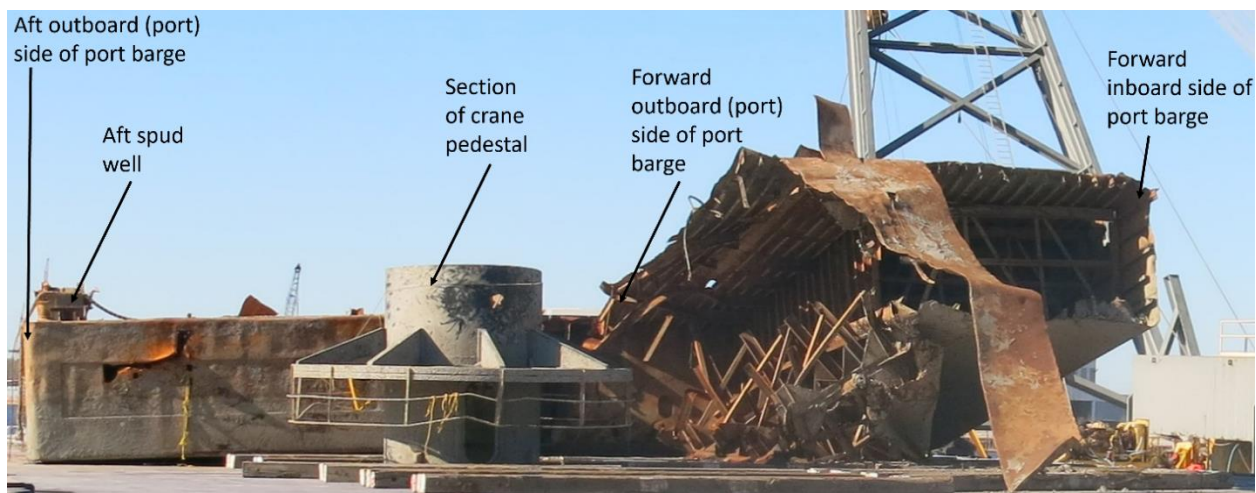
The port barge (*GD 962*) was recovered in two pieces. The area where the barge was separated was heavily damaged from salvage efforts. Investigators examined the exterior of the hull, which exhibited corrosion on all surfaces. There were numerous areas of corrosion, indentations, and deformations on all surfaces. Many sections of the hull and internal transverse frames and longitudinals exhibited poor material conditions such as severe steel corrosion. Investigators were unable to find any damage on the forward port side of the port barge from the reported contact with the channel marker since that section was destroyed.

Figure 7. The two sections of barge *GD 962* (the *Ambition's* port barge) after recovery from the Gulf of Mexico.

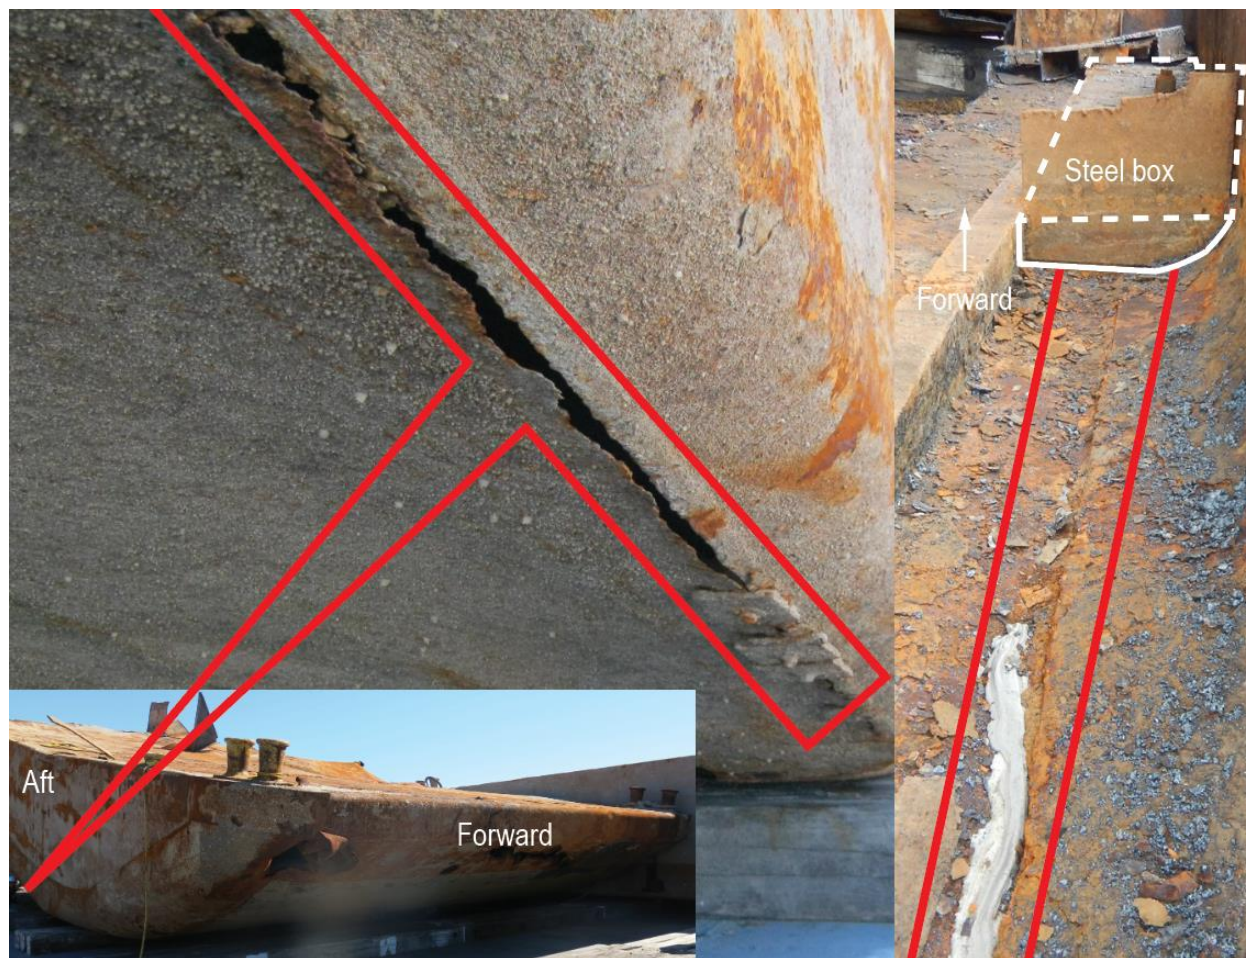
Investigators found a separation at the weld seam between the bottom plate and the bilge knuckle plate. The separation began in compartment no. 1S, where it was about 2 inches wide, with severely wasted (thin) steel on both plates. Three metal plates about 5 inches wide had been placed at the seam between the bottom plate and bilge knuckle plate; each of the three plates had a strongback-type bolt (a bar used with a soft patch to secure it when making temporary repairs) that passed into the hull at the center of each plate. Aft of the three plates, the separation between the bottom plate and bilge knuckle plate extended for about another 25 feet.

Figure 8. Left: The port barge's separation, at the weld seam, between the bottom plate and bilge knuckle plate, along with the metal plate repairs to the starboard bilge knuckle of the port barge (*GD 962*). Inset shows the location of the separation. Right: Aft (cutaway) section of the hull looking forward, showing the plate separation from the inside (between the red lines). The metal plate repairs to the separation are inside the steel box. (Sources: Coast Guard [left], K. Smith Marine Surveying [right])

This section of the hull was later cut away by parties representing Rigid Constructors and LA Carriers to examine compartment no. 1S. (Rigid Constructors retained this section of hull and a section of the transverse rake bulkhead forward of it, which exhibited severe corrosion with considerable metal loss and corrosion holes near the bottom.) The cutaway section revealed a steel box, about 13 feet long, created by welding plates, at the bottom and bilge knuckle plating at the forward portion of the separation between the bottom plate and bilge knuckle plate, encasing the endplates of the three strongback bolts that passed through the hull.

Per the Coast Guard Inland Tank Barge Inspection and Repair guidelines (03/09/94), "Bilge knuckles are highly stressed and critical to the longitudinal and overall strength of the barge." The guidance further stated, "Knuckles should be repaired as original; changes in dimensions or materials can create stress risers." Rigid Constructors did not provide any maintenance records related to their repair of the separation at the weld seam on the port barge.

Postcasualty examination of the port barge found a 25-foot-long separation along the weld seam between the bottom plate and bilge knuckle plate with both plates exhibiting severely wasted steel, which was not consistent with other damage related to the salvage and recovery. At some point, a temporary repair, which consisted of steel

plates welded to the floor and knuckle plating, forming a box inside compartment no. 1S, had been made to the area around the separation, to contain water ingress. Three soft patches with strongback-type bolts, typically used for temporary repairs, were found along the failed seam. However, the separation had grown aft, beyond the steel box, likely due to it being in an area known to be subject to longitudinal stress. The corrosive deterioration of the bottom and bilge knuckle plating and their separation along their weld seam would have allowed water to enter compartment no. 1S of the port barge, which was the likely origin of initial water ingress.

Rigid Constructors failed to conduct permanent repairs in an area critical to hull strength, and the separation between the bottom plating and the bilge knuckle plating progressed beyond the temporary repair. Rigid Constructors' lack of hull inspection, maintenance, and permanent repairs resulted in the poor hull condition that caused the failure of the hull.

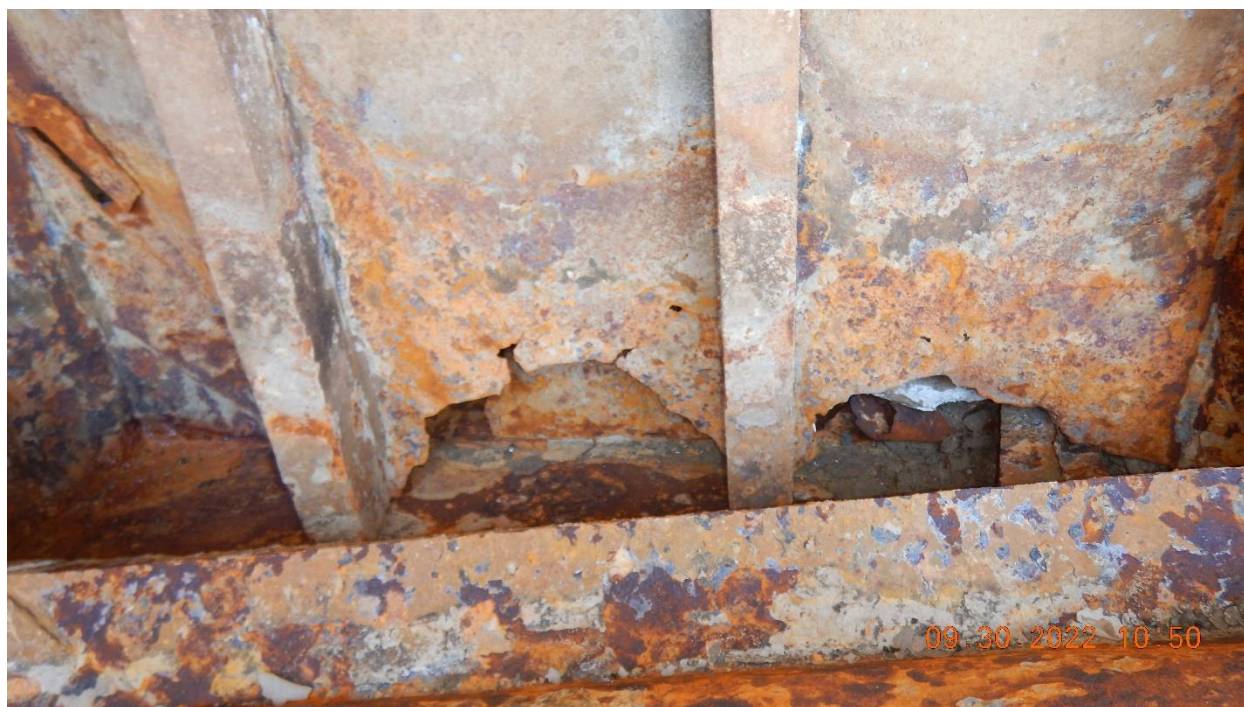
In addition to the hull damage, the bottom of the longitudinal centerline bulkhead separating the barge's nos. 1S and 1P compartments had severe corrosion. Investigators observed considerable metal loss along the bottom 2 feet of the bulkhead. Multiple

corrosion holes were found throughout the bottom section of the bulkhead. Moving up the longitudinal centerline bulkhead, toward the top of no. 1S compartment, there was surface corrosion but not at the severity observed at its bottom.

Figure 7. The bottom of the centerline longitudinal bulkhead between the no. 1S and no. 1P compartments of the port barge showing metal loss and corrosion holes. (Source: K. Smith Marine Surveying)

Investigators also found severe deterioration and steel wastage at the bottom of the centerline watertight longitudinal bulkhead (which segregated the no. 1S compartment from the no. 1P compartment of the port barge) and on the transverse bulkhead separating the rake void from the nos. 1S and 1P compartments. This allowed for the free communication of water from the compromised no. 1S compartment to the no. 1P compartment and rake void of the port barge. Based on the hull plating separation (which allowed water to enter the hull) and wastage on the interior bulkheads (which allowed water to spread across the full breadth of the port barge and to the rake void), the poor hull condition was the cause of the initial flooding.
