Issued September 7, 2023

MIR-23-19

Grounding of Tugboat *CC Portland*

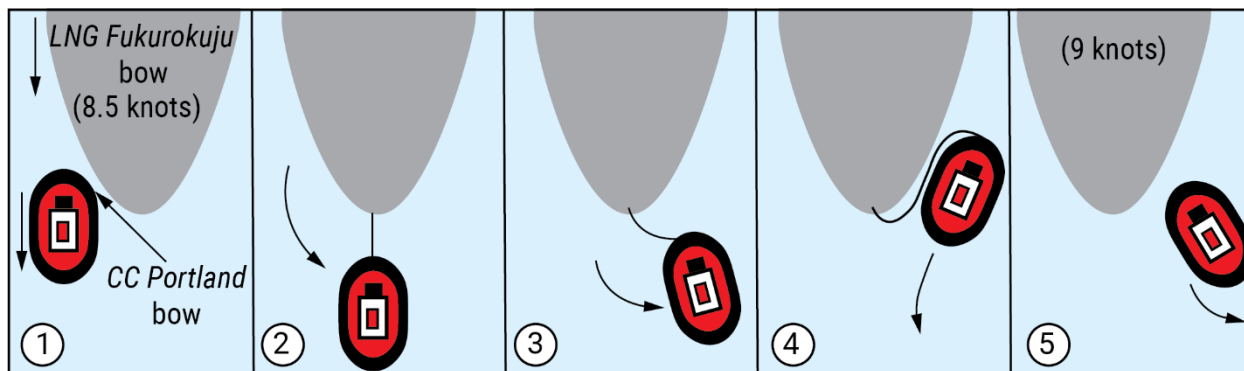
Figure 5. Sequence of events in the *CC Portland* grounding. 1) The *CC Portland* took a position underneath the starboard bow of *LNG Fukurokuju* (while moving astern with the ship) as the heaving line was lowered and the tow line was passed up. 2) As the tow line was pulled in by the crew on the *LNG Fukurokuju*, the *CC Portland* accelerated to reposition the tug ahead of the *LNG Fukurokuju* along the centerline. 3) While attempting to maneuver to the centerline, the *CC Portland* moved out of position to the port side of the *LNG Fukurokuju*. 4) As the mate attempted to correct the *CC Portland*’s position to the centerline of the LNG carrier, the tug lost speed and stabilized along the port bow of the *LNG Fukurokuju*. The position of the tug pulled the tow line to the stern and into the water as the heaving line parted. 5) As the *CC Portland* accelerated astern to regain position, the tug lost speed and directional control as it continued moving to starboard before leaving the channel and running aground. (Illustration not to scale.)

As the mate attempted to reposition the *CC Portland*, his inputs directed more thrust laterally, and the tugboat therefore lost speed astern. As the *CC Portland* lost speed, the tugboat began to move down the port bow of the LNG *Fukurokuju*. This movement pulled the tow line (attached at the bow), to the stern of the tugboat, causing the heaving line to snap and sending the tow line into the water. As the mate increased propulsion astern to regain position, the port Z-drive was fouled by the submerged tow line, thus significantly impacting the tugboat's maneuverability. At the time, the mate and training master were unaware that the port Z-drive was fouled as the mate continued to attempt to maneuver the tugboat back to the LNG carrier's centerline. With only the starboard Z-drive operational, the mate was unable to regain position, and as a result, the tug departed the ship channel and ran aground.
