Issued September 27, 2023

MIR-23-21

Contact of Passenger Vessel *Cathlamet* with Ferry Terminal Dolphin

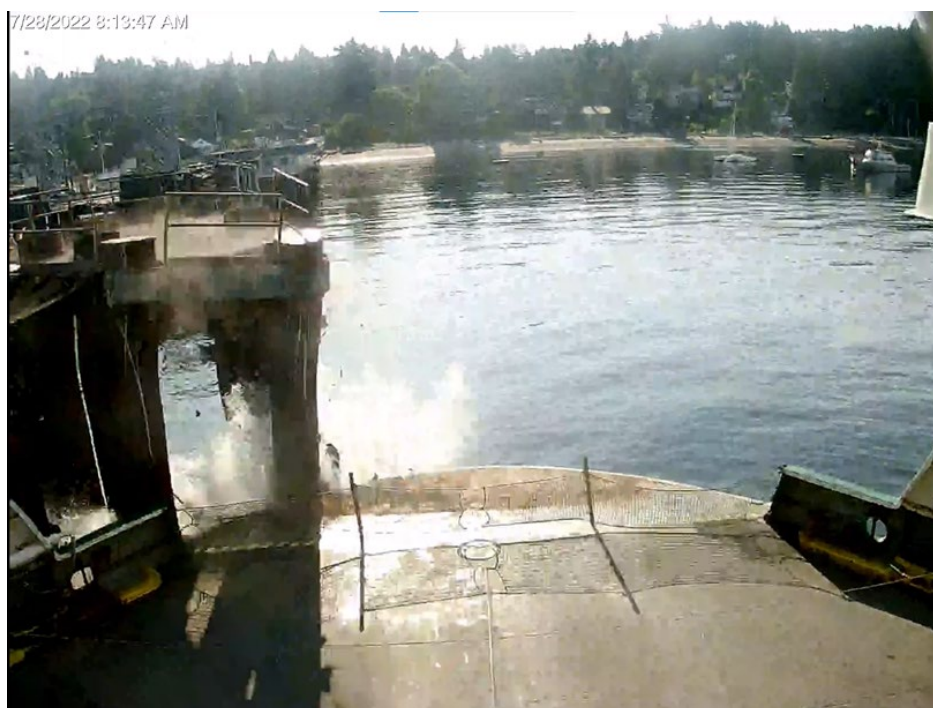
Figure 5. Still image from forward-looking camera footage on board the *Cathlamet* at the time the ferry's port bow struck the dolphin. (Source: Washington State Patrol)

At 0813:46, the Data Logger recorded a no. 1 (stern) rudder order of 35° to port, and the rudder angle reached 27° a few seconds later. The camera footage from on board the vessel and at the ferry terminal showed the vessel's port bow striking a ferry

terminal dolphin on the south side of the terminal at 0813:47.³ Coast Guard Vessel Traffic Service data showed the vessel was still at 15.7 knots at impact. The dolphin was about 190 feet west and about 35 feet south of the center of the ramp where the ferries docked.

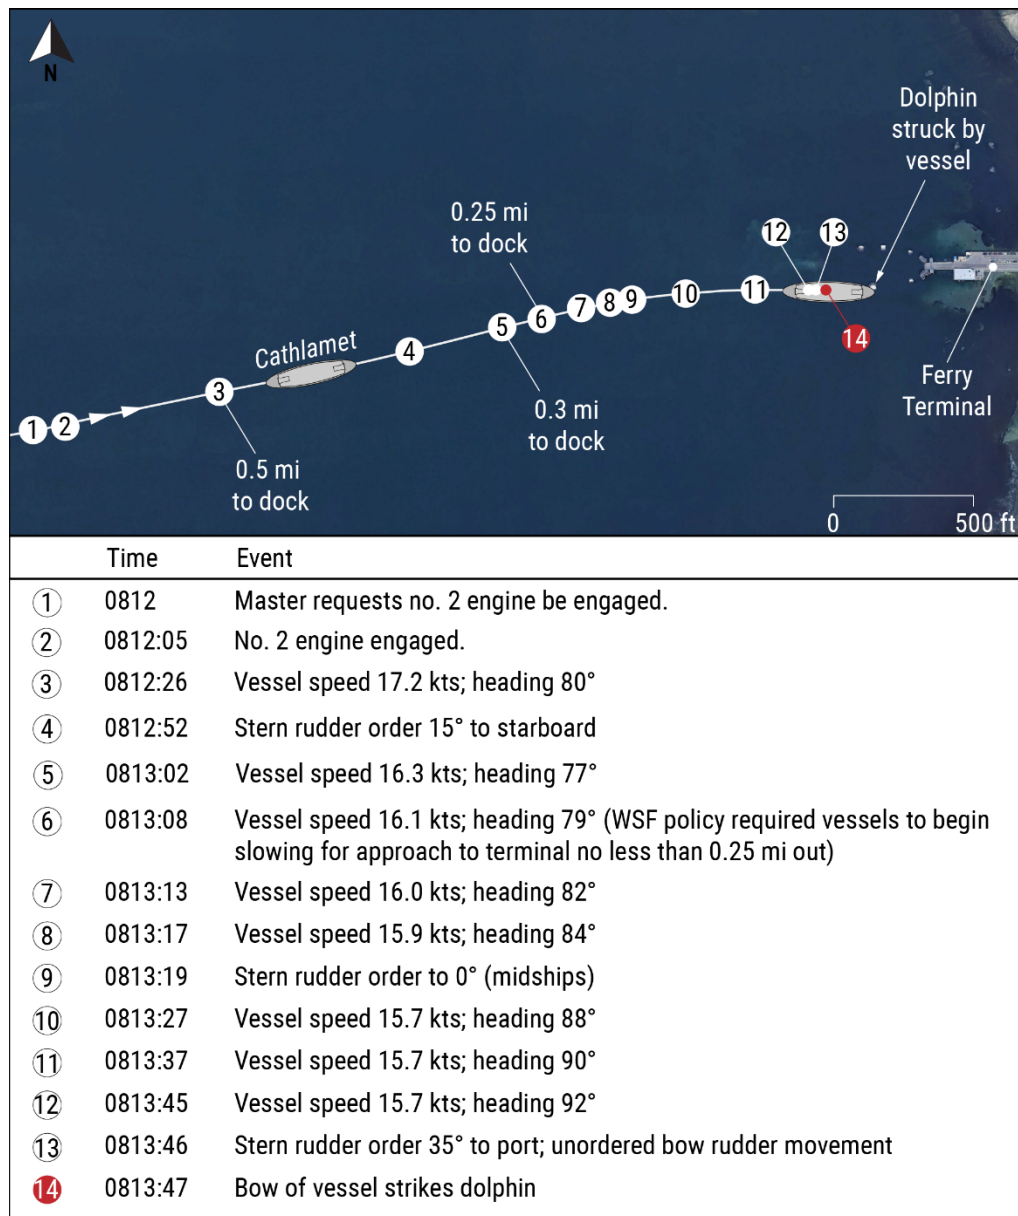
and reached midships at 0813:19, when the ferry was about a third of a mile from the terminal ramp. There were no other helm or throttle commands noted. The US Coast Guard Vessel Traffic Service radar showed the *Cathlamet* turning to starboard while slowing from 17.6 knots to about 15.7 knots. Over the next 28 seconds, the vessel's heading continued to move to starboard as the *Cathlamet* approached the dock. The vessel's Automatic Identification System (AIS) data showed the *Cathlamet* on an easterly heading of 88° at 0813:27, which was bringing the *Cathlamet* to the south of the terminal. At 0813:37 the vessel's heading was at 90°. At 0813:45, it had a heading of 92°, was still to the south of the terminal, and was proceeding at 15.7 knots.

Figure 6. Trackline of the *Cathlamet* from the time the master requested engine engagement to the time the vessel struck the dolphin. (Background source: Google Earth)

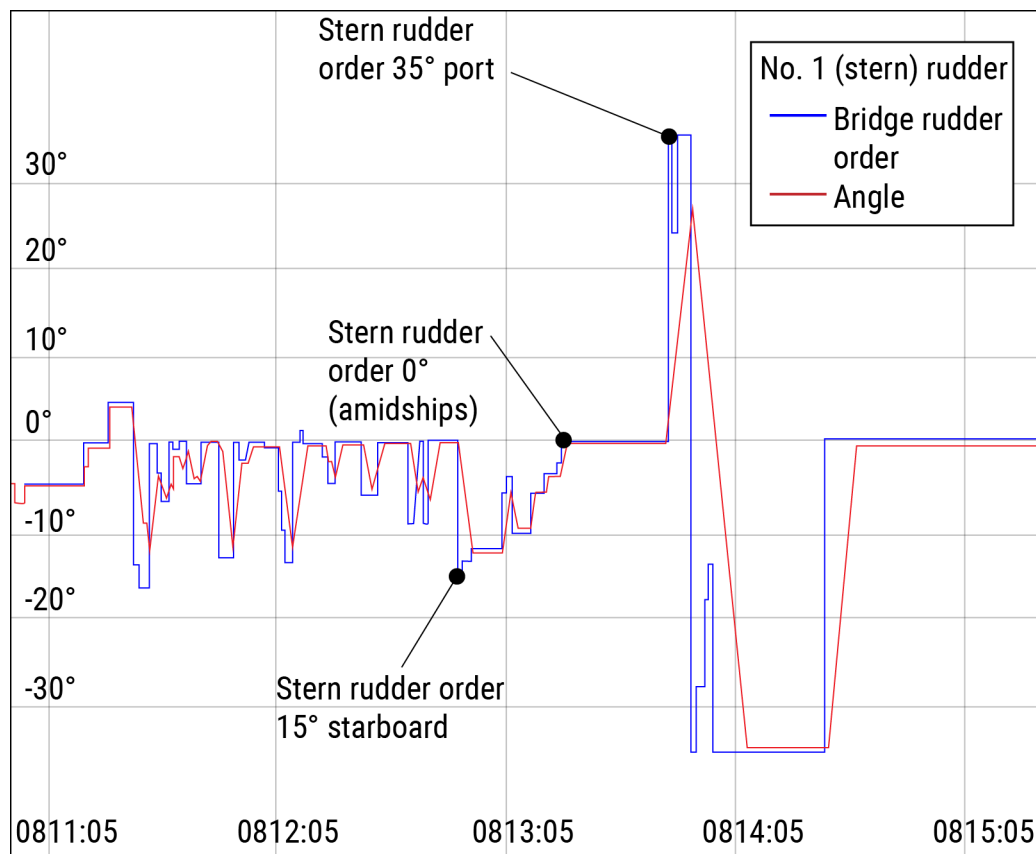
According to the vessel's Data Logger, which monitored the helm and throttle controls, over about the next minute, a series of rudder commands was given, generally from about midships up to 15° starboard. At 0812:52, a final 15° rudder command to starboard was made, followed by stepped adjustments, before the rudder was ordered

Figure 7. The no. 1 (stern) rudder order and rudder angle recorded by the vessel's Data Logger shortly after the captain took the helm (about 0810) to about a minute after the ferry's impact with the dolphin (0813:47). (Background source: WSF)

After the rudder was midships, the *Cathlamet* was on an easterly heading of 88°, which was moving the vessel south of the terminal ramp's centerline. As the vessel proceeded during the next 28 seconds, the heading continued to move to starboard—reaching 92° just before it struck the dolphin. As the vessel approached the dolphin, the master did not take any action to correct the ferry's course, slow down, or sound the alarm to alert the crewmembers and passengers that something was wrong. At 0813:46, the Data Logger recorded a helm input (rudder order) of 35° to port. Investigators were unable to determine if the master recognized the impending collision and attempted to turn the vessel or if the order occurred as a result of the contact (even though the time stamp is 1 second before impact). The vessel struck the dolphin at 0813:47. The master's statement to investigators following the contact showed that he seemed unaware of how the vessel had ended up striking the dolphin. The master also asked the quartermaster what had happened, further suggesting that the master was unaware of the events leading up to the dolphin strike. Additionally, the quartermaster had to prompt the master three times to maneuver the ferry astern to avoid running aground. These statements, combined with the master's actions and inactions, indicate that the master experienced a lapse in attention, likely due to some form of progressive incapacitation between when he engaged the bow engine and before the ferry was a quarter mile from the dock.

Our investigation found that rudder commands were insufficient to line up the vessel for docking, and the master did not properly slow the vessel. The master also did not radio the terminal or ensure an arrival announcement was made over the public address system. Additionally, there were no rudder commands for 28 seconds before the contact. Finally, the master did not recall what had occurred. These events are all consistent with incapacitation from a microsleep. Therefore, beginning sometime after the master called the engine room, the master likely experienced a microsleep due to fatigue.

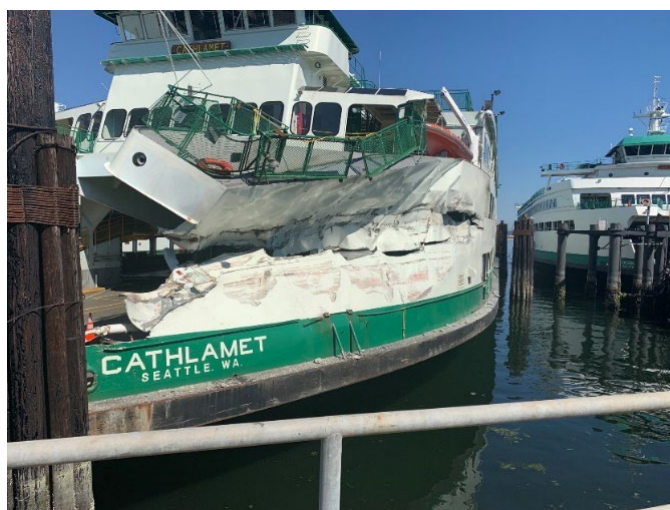
The impact with the dolphin caused extensive damage to the *Cathlamet's* structure at and above the portside main deck, causing about 30 feet of the forward port section of the passenger deck to collapse.

Figure 8. The damaged *Cathlamet* after the contact with the dolphin.

The *Cathlamet* was drydocked on August 29 to complete a damage survey. During the hull exam, inspectors discovered minor scraping damage at the bottom of the no. 2 rudder, which, according to Coast Guard investigators, indicated that the rudder may have touched bottom following the contact. There were also six insets along the hull's port side, just below the vehicle deck. This damage coincided with the area impacted by the dolphin.

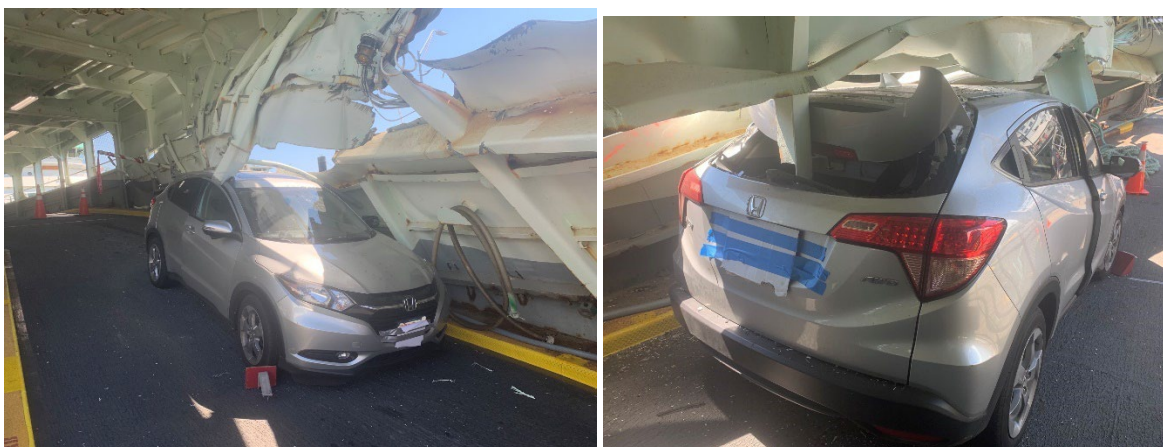
A passenger who had been standing on the portside passenger deck forward saw that the vessel was about to strike the dolphin and started to move aft toward the house. When the ferry struck the dolphin, the area where he had been standing collapsed from the impact. He hung onto a railing, which prevented him from falling onto the damaged deck below. When the deck collapsed, the port passenger deck structure also folded onto the car deck and penetrated the interior of a parked car, just missing the occupant who was sitting in the driver's seat.

Figure 9. Damage to the front (*left*) and back (*right*) of the vehicle impacted by the vessel structure.

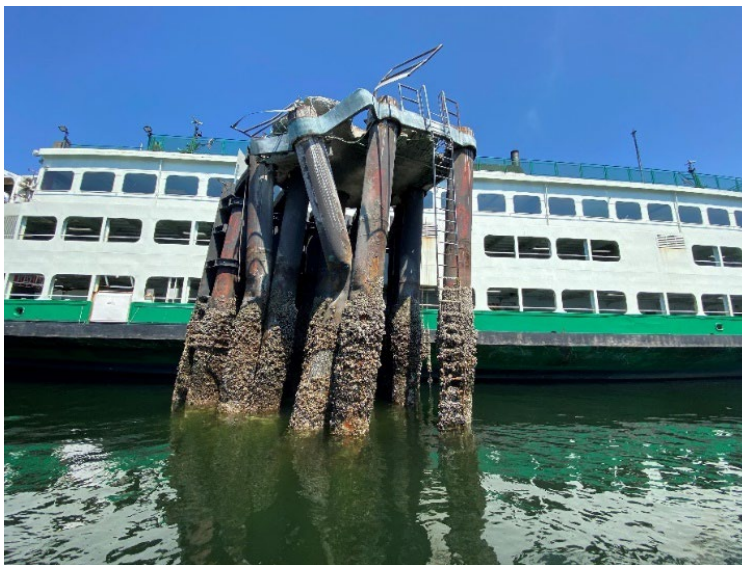
The dolphin sustained significant damage to several of its metal pilings, the metal framing, and to the cement cap, as well as to the rub rail.

Figure 10. The damaged dolphin. (Source: WSF)
