October 25, 2023

MIR-23-23

Fire aboard Tank Vessel *S-Trust*

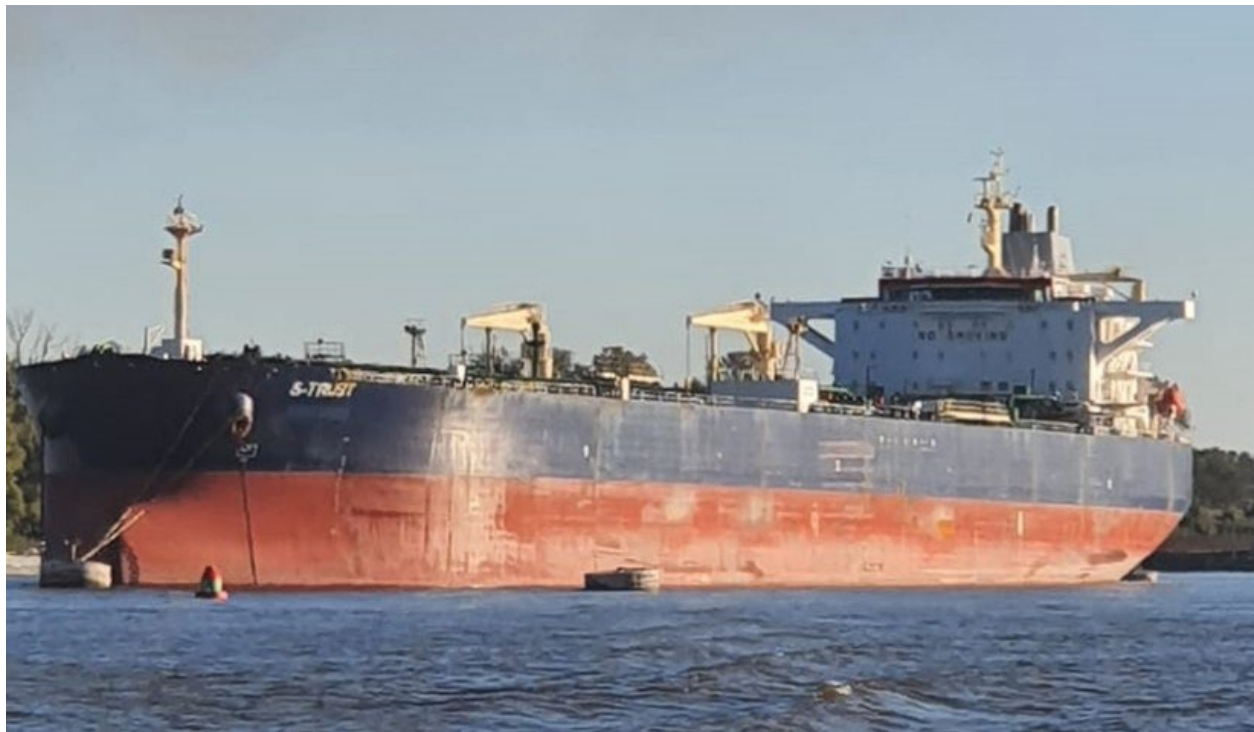
Figure 1. *S-Trust* at anchor following the casualty. (Source: US Coast Guard)

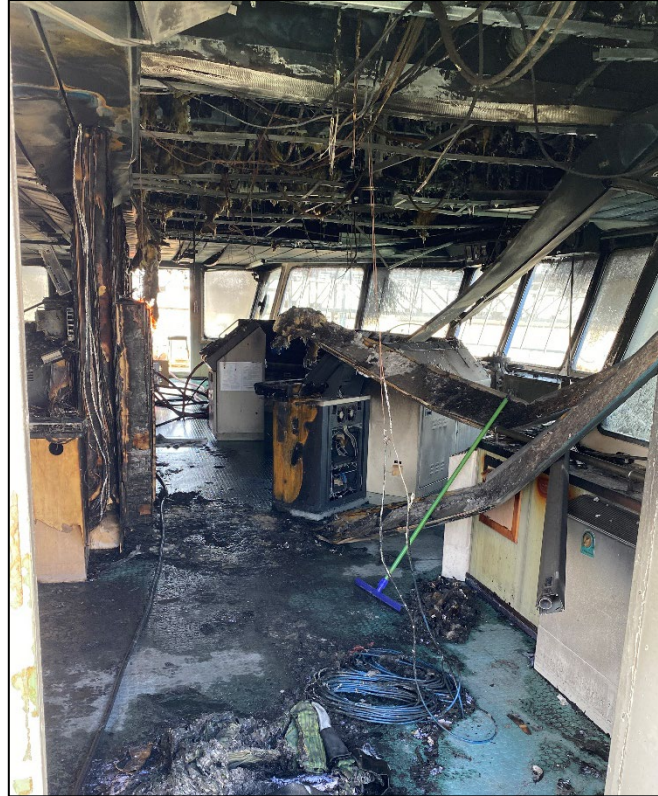
Investigators from the Coast Guard and the Bureau of Alcohol, Tobacco, Firearms and Explosives (ATF) discovered extensive damage throughout the bridge, including significant smoke and thermal damage. There was no damage noted to any of the lower decks in the superstructure. The navigation systems, communication systems, and alarm systems were damaged beyond repair.

Figure 3. The damage to the bridge. (Source: Coast Guard)

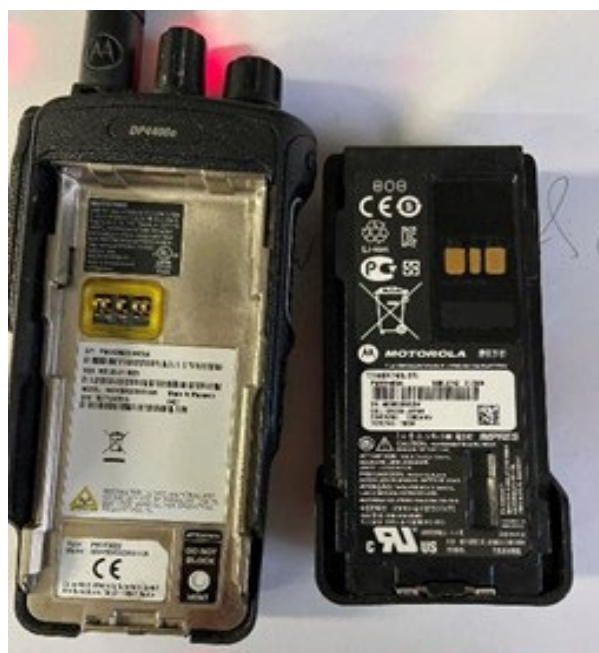
Figure 6. A Motorola DP4400e radio and lithium-ion battery used on the bridge of the *S-Trust*.

The two radios assigned to the bridge were a Motorola DP4400e radio, which used a lithium-ion battery, and a Motorola GP328 radio, which used a nickel-metal hydride battery. A crewmember informed investigators he believed that the batteries for those radios were not charging the day of the fire.
