Flooding and Sinking of Fishing Vessel *Captain Alex*

On November 25, 2022, about 0030 local time, the commercial fishing vessel *Captain Alex* was fishing in the Gulf of Mexico about 15 nautical miles south-southwest of Galveston, Texas, when the vessel began flooding.¹ The four crewmembers on board were unable to stem the flooding, and they abandoned the vessel to a responding US Coast Guard boat. The *Captain Alex* later sank, and an oil sheen and debris field were visible; a reported 17,000 gallons of diesel fuel were on board. There were no injuries. The *Captain Alex*, with a value of \$500,000, was a total loss.

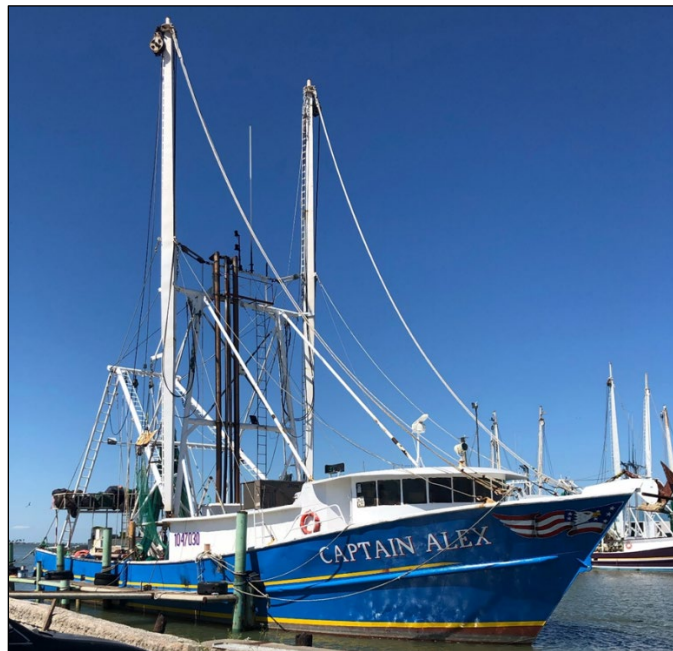
Figure 1. The *Captain Alex* precasualty. (Source: Coast Guard)

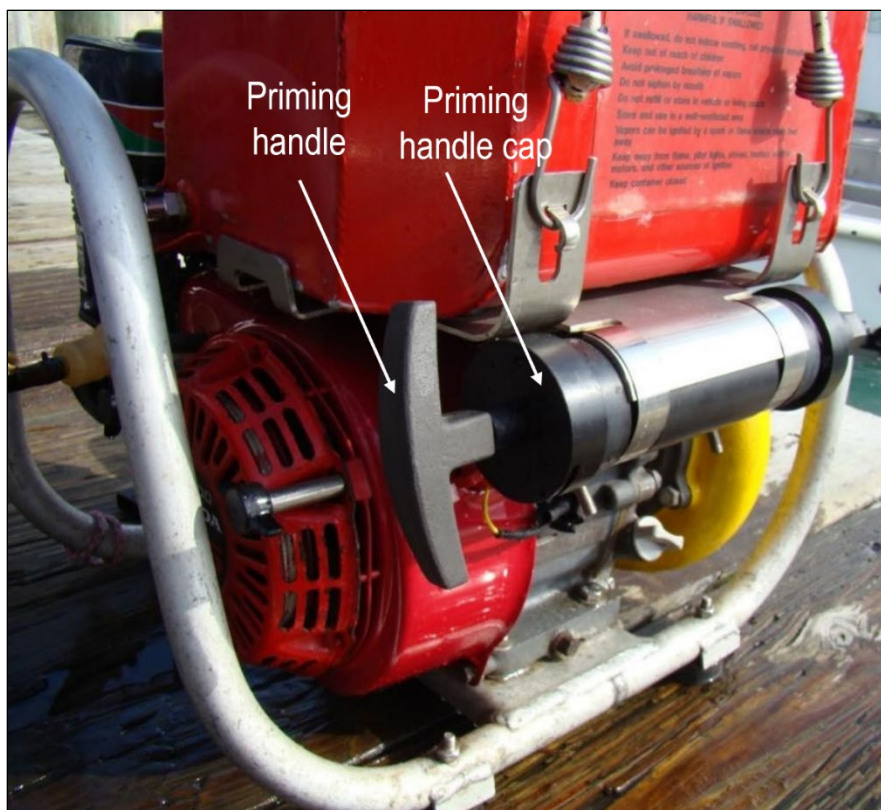
Figure 3. A P6 pump like the one sent to the *Captain Alex* showing the priming handle and cap. (Source: Coast Guard)

The responding Coast Guard boat crew, who arrived on scene about 3 hours after the captain first discovered the hole in the engine room, sent a P6 dewatering pump with instructions to the crew of the *Captain Alex*. However, while the *Captain Alex* crew was able to get the engine to start, they could not get the pump to pull water from the engine room below it to discharge overboard. The on-scene Coast Guard MK noted that the *Captain Alex* crew did not prime the pump, and when the MK tried to prime the pump, the priming handle broke. Since the pump was not recovered, investigators were unable to determine why the handle broke.

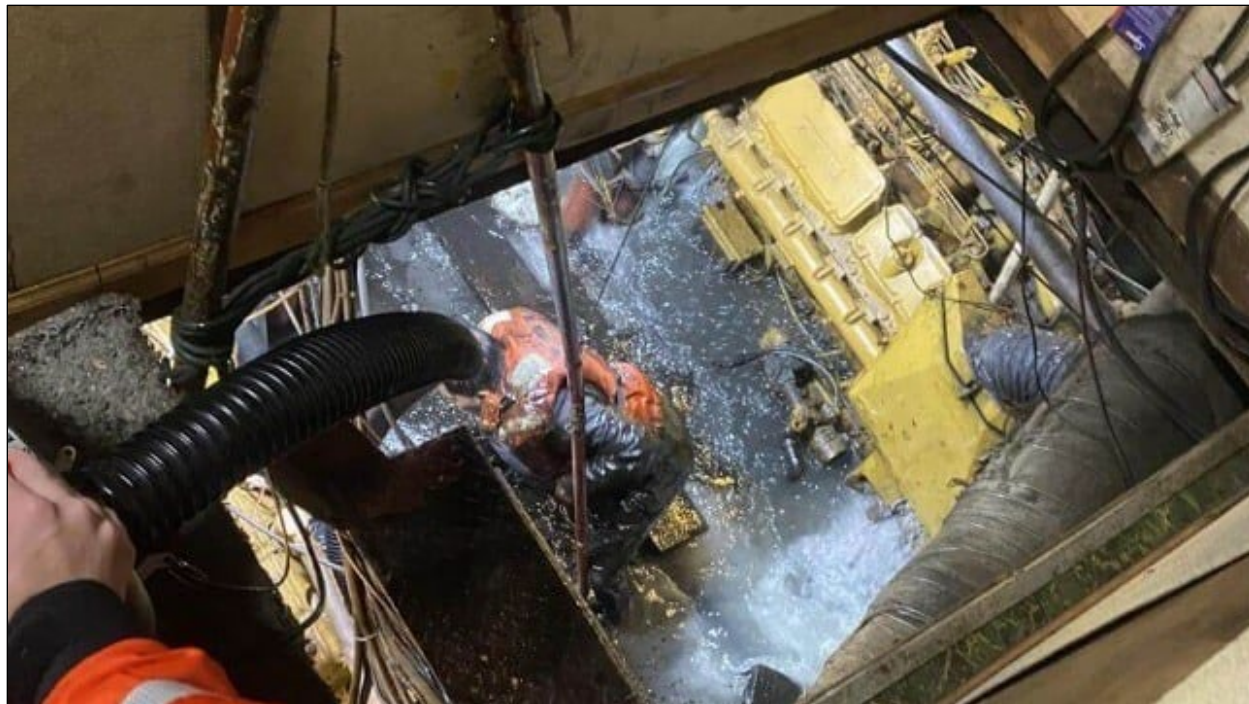
About 0325, the MK looked into the engine room from the main deck and saw the captain of the *Captain Alex* below. He instructed the captain to vacate the engine room. At the time he made this request, the MK saw that the water was up to the starboard main engine. (By the time the captain evacuated the vessel, the water was up to the top of the main engine.) The Coast Guard crew packed up the inoperable P6 pump. The crew of the *Captain Alex* dropped the vessel's anchor at the recommendation of the Coast Guard coxswain.

Figure 4. Looking down into the engine room of the *Captain Alex* at 0326, with the water midway up the starboard main engine and the captain of the vessel on the stairs. The suction hose to the portable dewatering pump (on deck) is on the left. (Source: Coast Guard)

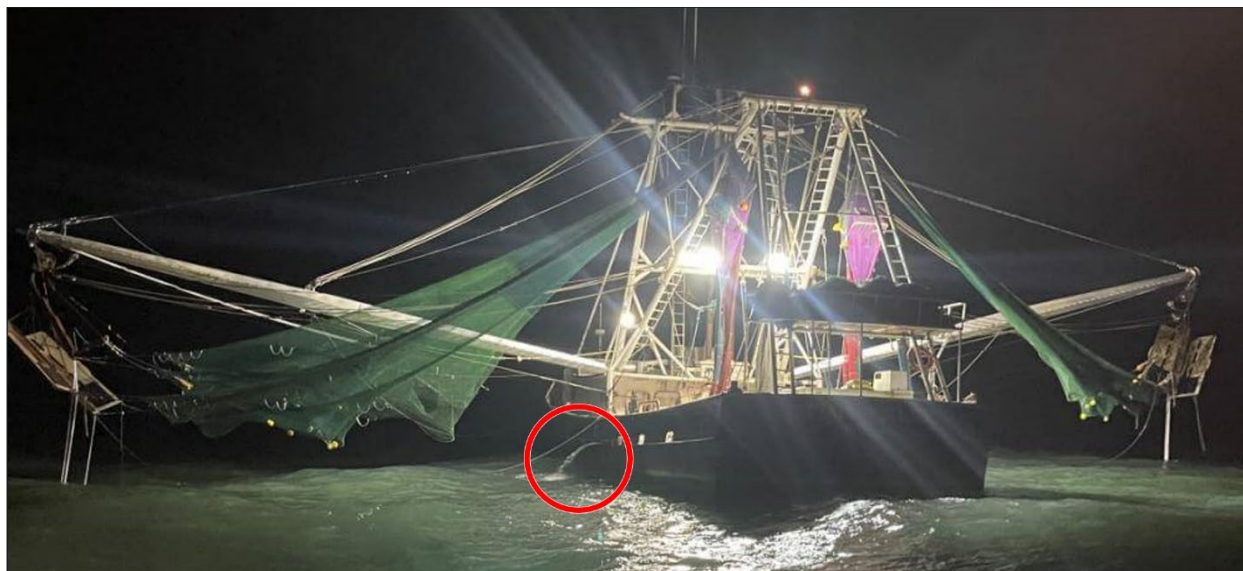
When CG 45630 arrived on scene, a stream of water could be seen coming from the port side of the *Captain Alex*; during his interview with investigators, the *Captain Alex* captain identified the stream as discharge from the bilge system (see Figure 5). The Coast Guard crew told investigators that, later, while the captain of the *Captain Alex* was on board CG 45630, he communicated that the vessel's bilge pumps were working intermittently.

Figure 5. The *Captain Alex* with discharge stream from bilge system (indicated by red circle) at 0317, just after CG 45630 arrived on scene. (Source: Coast Guard)

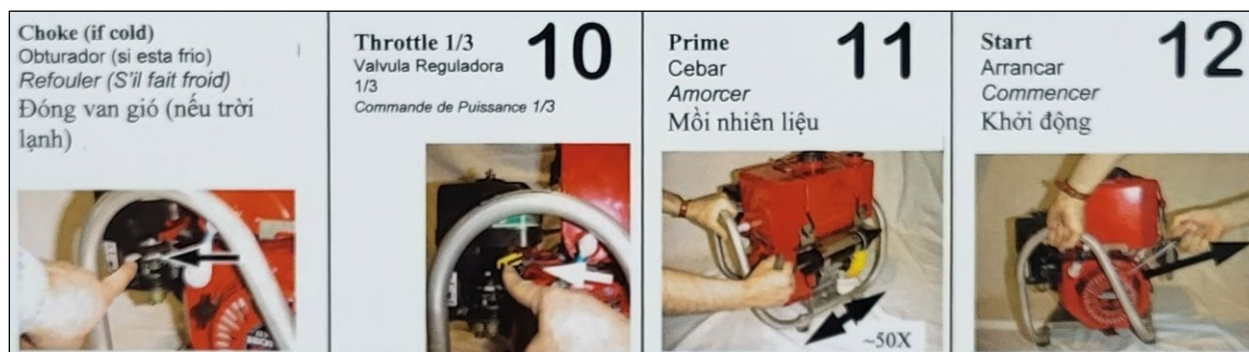
The Coast Guard’s P6 pump operation graphical instructions specified that, after setting up the suction and discharge hoses, the pump should be primed 50 times by moving a priming handle on the side of it before the engine is started. The P6 pump sank with the *Captain Alex* and was not recovered for examination.

Figure 6. An excerpt of the instructions included with the P6 pump like the one sent to the *Captain Alex*. The instructions show the priming sequence and include steps written in four languages: English, Spanish, French, and Vietnamese (the native language of the *Captain Alex* crew). (Source: Coast Guard)
