# Collision between *Big D* and *Carol McManus* Tows

On January 9, 2023, the towing vessel *Big D* was pushing 19 barges downbound on the Lower Mississippi River, and the towing vessel *Carol McManus* was pushing 42 barges upbound on the river. At 0152 local time, the two tows collided at mile 312 near Fort Adams, Mississippi, causing the barges in both tows to break free.<sup>1</sup> Several barges were damaged in the collision, and about 1,380 gallons of ethanol spilled into the waterway. Two minor injuries were reported. Damages to the barges were estimated at \$1.36 million.

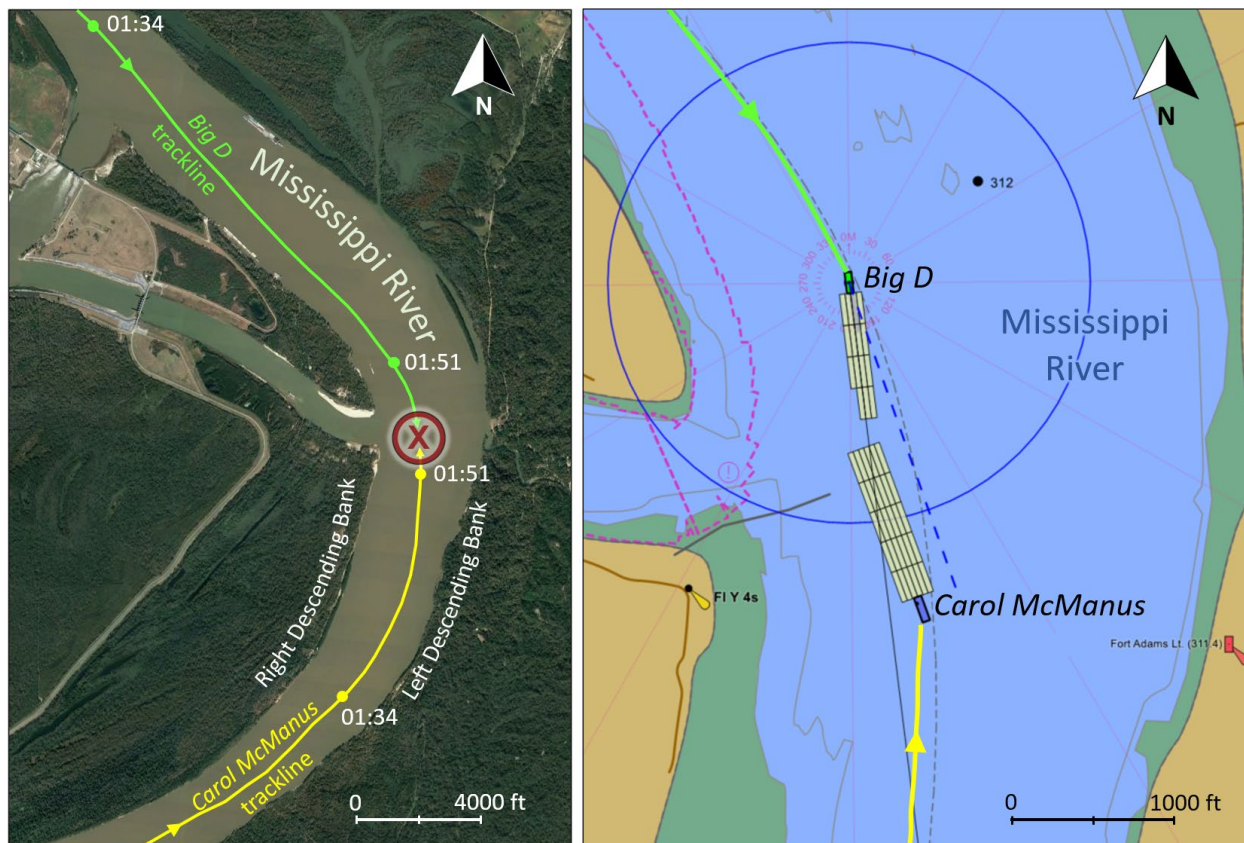
**Figure 5.** AIS tracklines of the *Big D* and *Carol McManus*, with a red X marking the location where the tows collided (*left*), and the positions of the tows just before the collision at 0152 (*right*). (Background sources: Google Earth [*left*]; US Army Corps of Engineers ENC U37LM236, as presented on Rose Point electronic chart system [*right*])

astern. Despite the pilots' efforts, at 0152, the raked bow of the empty hopper barge *IN065432*, at the head of the *Carol McManus* tow, struck and ran up on the loaded tank barge *FMT1052*, at the head of the *Big D* tow. Several other barges made contact, and the tows broke apart.

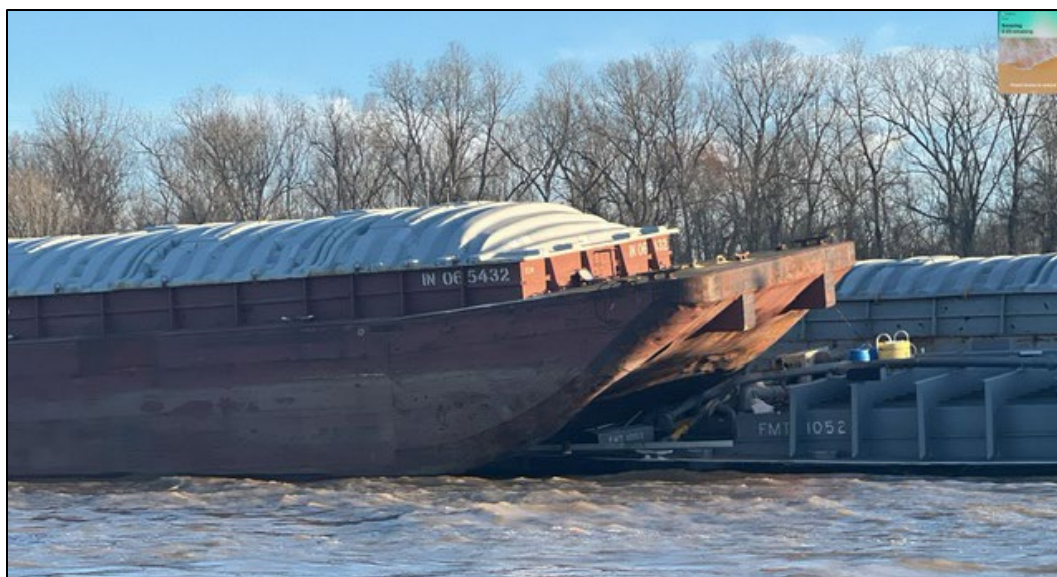
Six barges in the *Big D* tow sustained damage as a result of the casualty, including indentations of deck and hull plating, distorted framing, and damage to deck machinery and piping systems. Estimated costs to repair the damage totaled \$877,000. A breach to an expansion tank and piping systems on barge *FMT1052* resulted in the release of about 1,380 gallons of ethanol into the river.

**Figure 6.** Hopper barge *IN065432* (left) from the *Carol McManus* tow, and tank barge *FMT1052* (right) from the *Big D* tow, postcasualty. (Source: Ingram Barge Company)

Eight barges in the *Carol McManus* tow sustained damage during the collision, including indentation of deck and hull plating and damage to deck fittings and piping systems. Estimated costs to repair damages totaled \$479,977. There was no reported pollution from the barges damaged in the *Carol McManus* tow.
