MIR-24-01

Anchor Strike of Underwater Pipeline and Eventual Crude Oil Release

San Pedro Bay

Near Huntington Beach, California

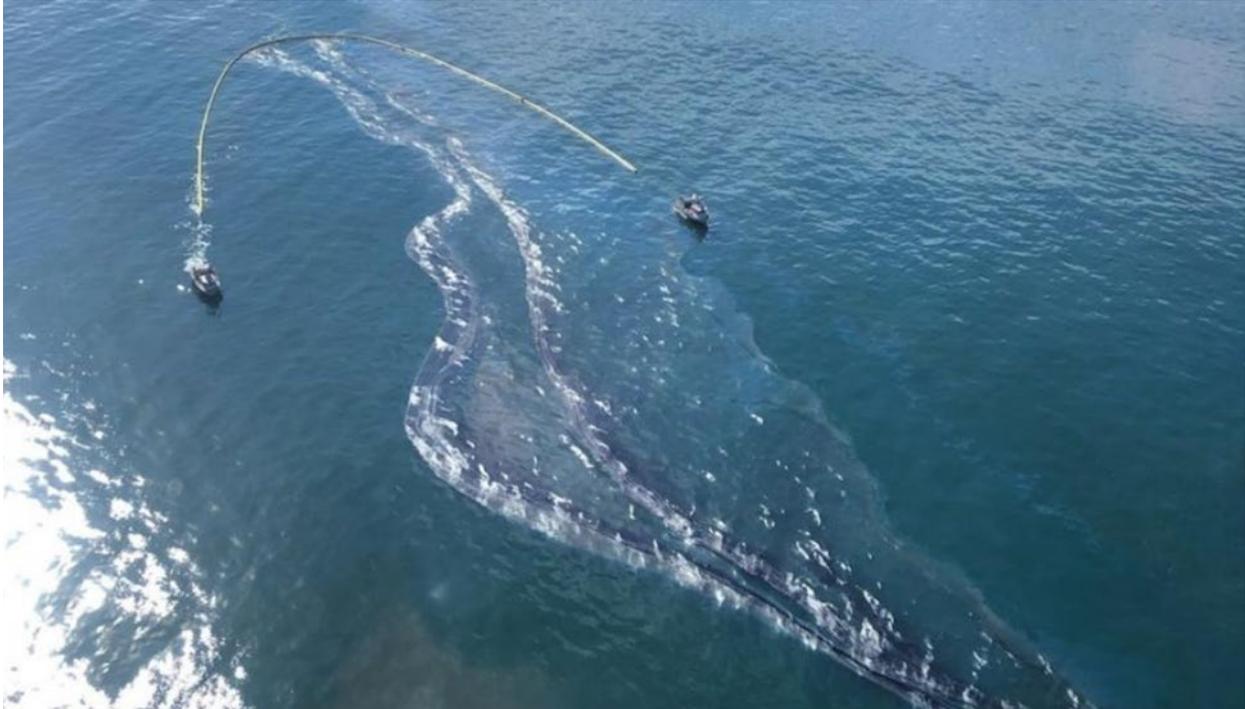
Figure 1. Crude oil in the Pacific Ocean off the California coast on October 3, 2021. Oil spill removal organization vessels are towing a skirted oil boom to contain the oil spill. (Source: US Coast Guard)

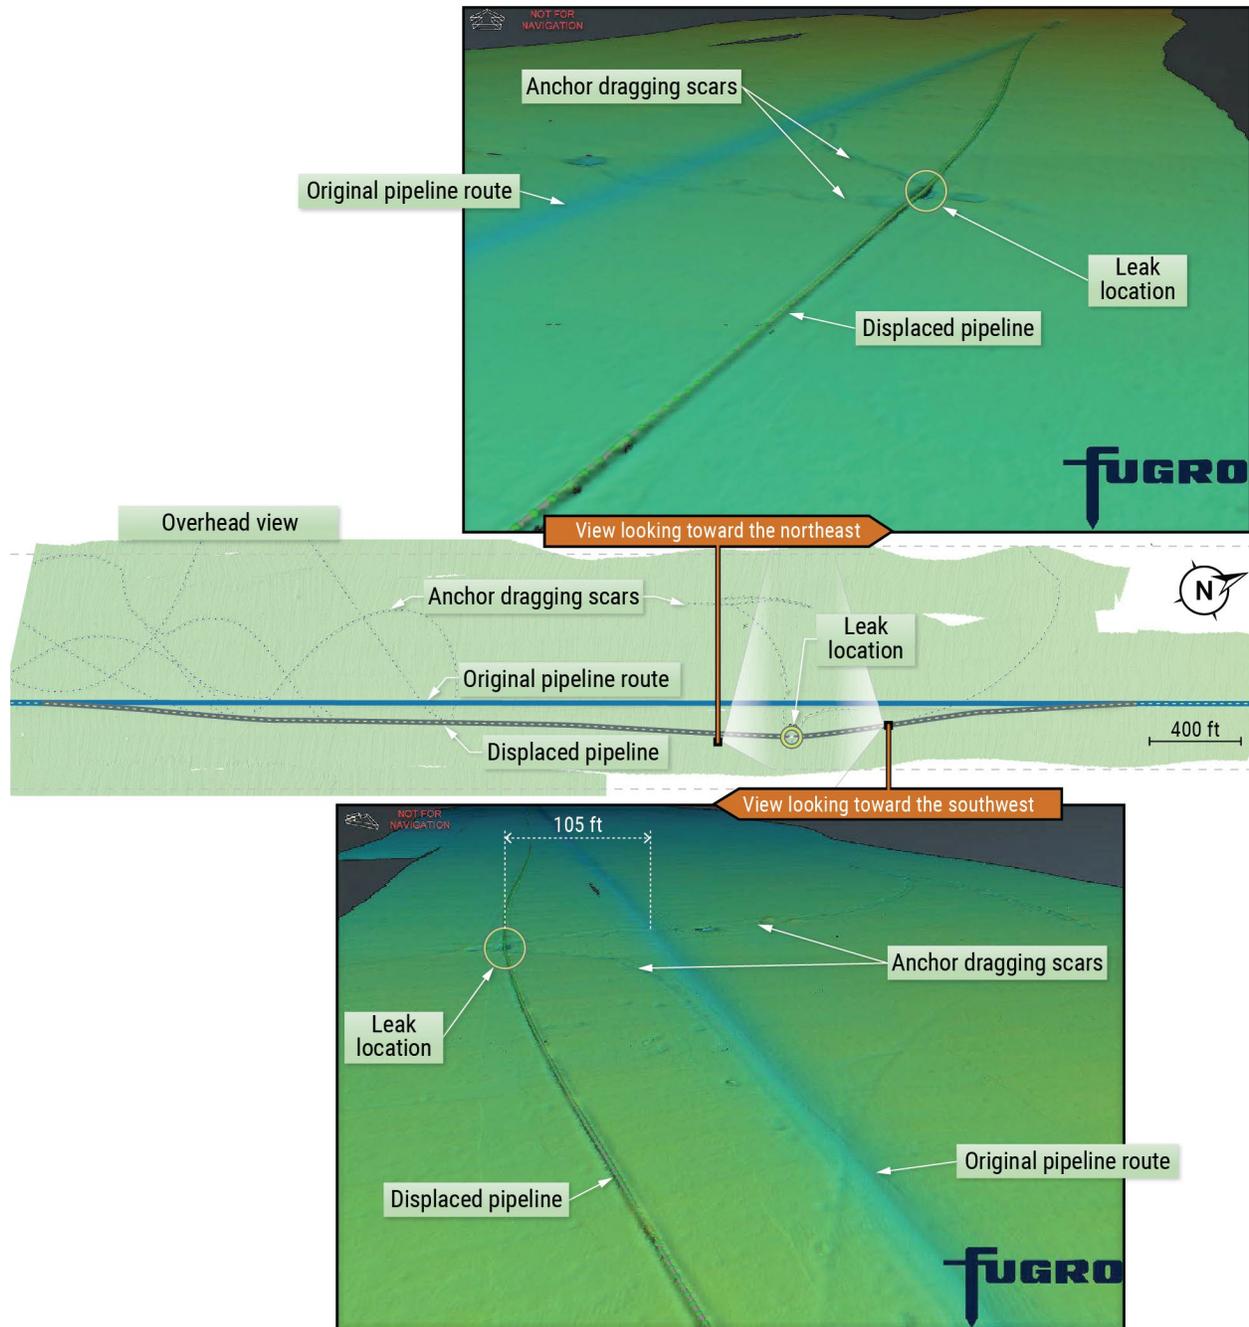
Following the oil release and pipeline shutdown, Beta's contractor completed a detailed underwater pipeline survey on October 22, 2021. The purpose of the survey was to identify and map any displacement of the pipeline and search for any indication of how the pipeline was damaged. The survey showed that a 4,025-foot section of pipeline was displaced, with a maximum displacement point 105 feet from the original pipeline location, and there was evidence of seabed scars/scouring adjacent to and near the damage (see figure 5). The pipeline's concrete coating was also damaged. (In the most recent remotely operated vehicle [ROV] survey contracted by Beta, conducted in 2020, the pipeline was positioned in the original pipeline location.)

Figure 5. Results of the survey showing the San Pedro Bay Pipeline original location, leak location, pipeline displacement, and anchor dragging scars, viewed looking toward the northeast (*top*), from overhead (*middle*), and looking toward the southwest (*bottom*). (Background sources: Amplify, Aqueos, Fugro)

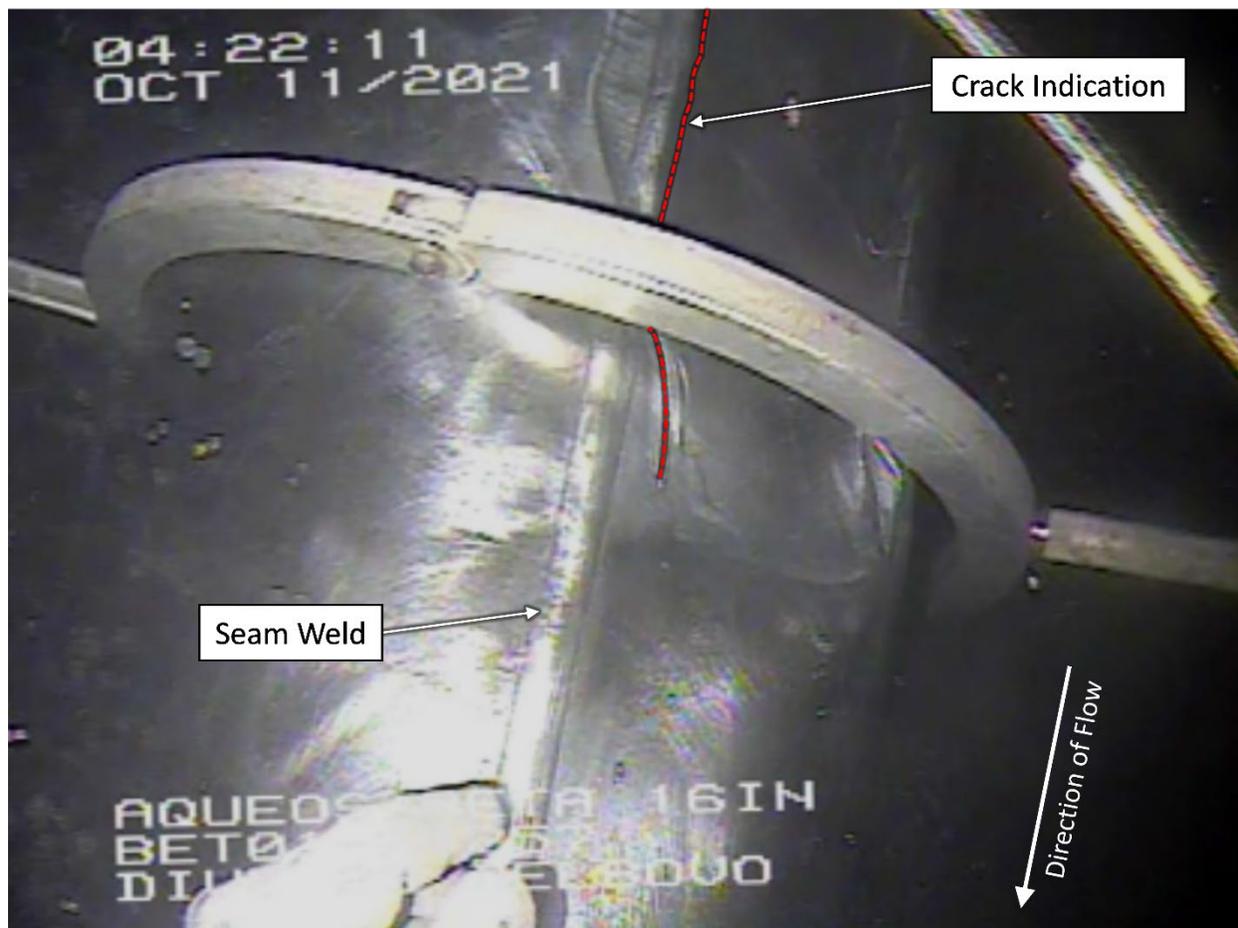
Crews conducted underwater nondestructive testing of the failed section of pipeline. The surveyors also found indications of a longitudinal crack with an overall measured length of 21¾ inches on the outer surface. The circumferential profile showed the pipeline was out of round with a convex (dented) segment at the crack

location. The crack was at the 10:30 through 11:00 o'clock position relative to the pipe facing north and below the weld seam (see figure 6).⁹

Figure 6. San Pedro Bay Pipeline underwater nondestructive testing showing a portion of the crack indication, highlighted in red, on the pipe on October 11, 2021. (Background source: Aqueos)

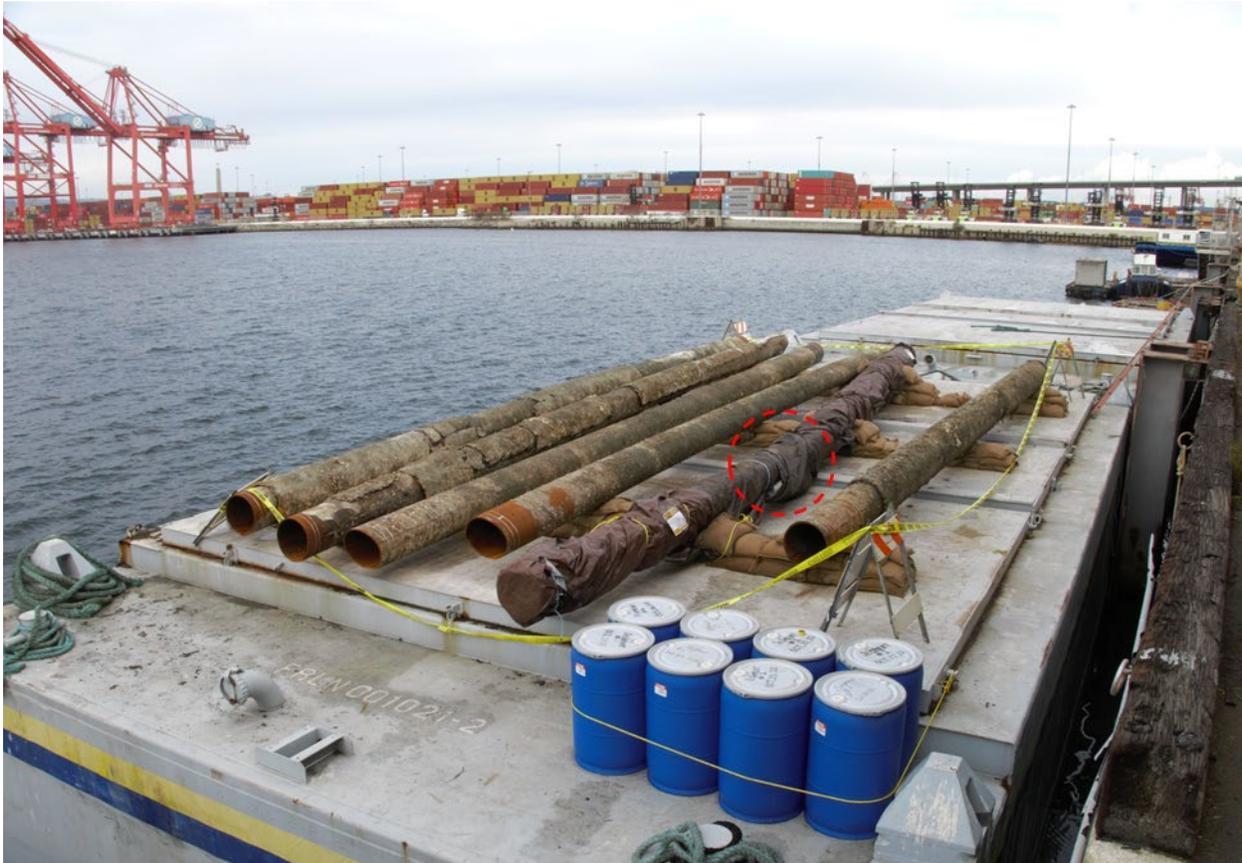
Figure 16. Six segments of damaged pipeline removed for replacement. The leak site, circled in red, was observed on the segment shown wrapped in a tarp.

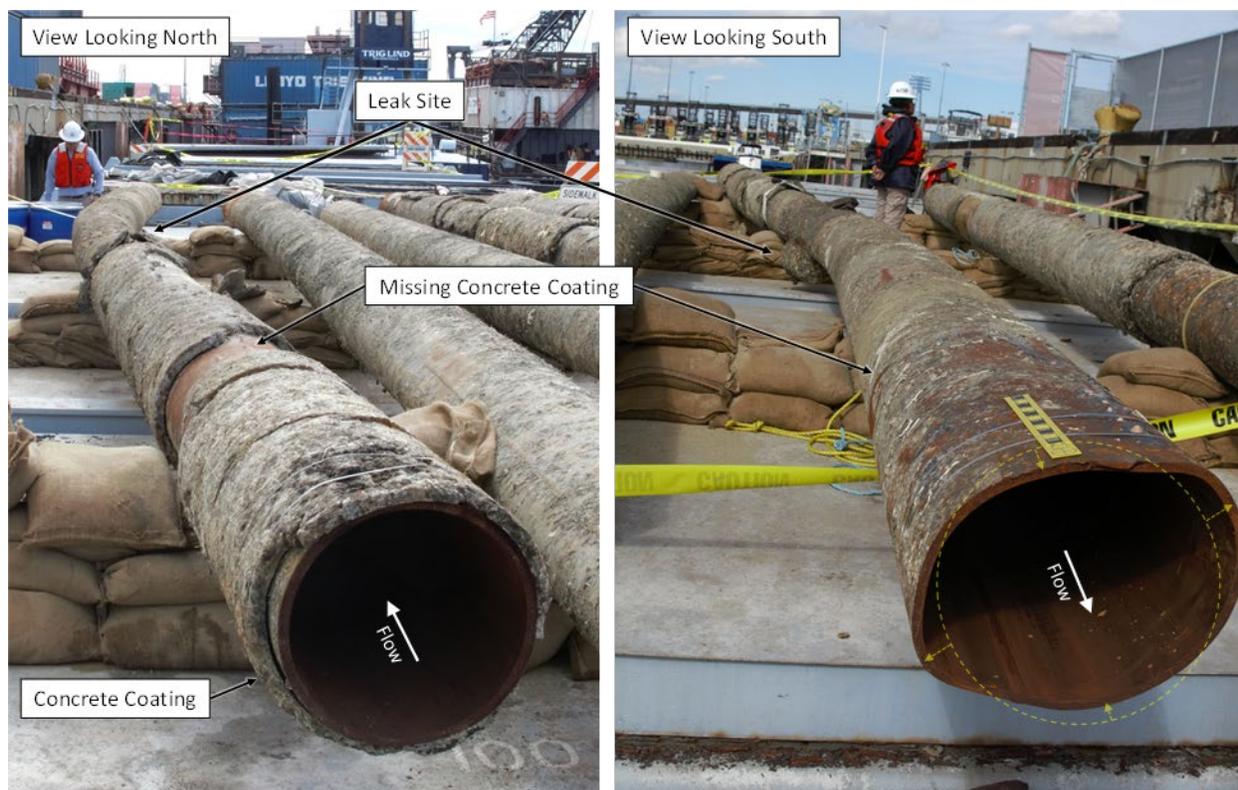
The segment contained the site of the crack where the leak occurred, which had been temporarily repaired with a welded patch so remaining crude oil could be flushed from the line (see figure 17).

Figure 17. Opposite ends of the pipe segment that contained the leak site, which had been temporarily repaired with a welded repair patch, visible in the right image. Damage signatures observed included lateral deformation, out-of-roundness deformation (a typical example indicated at the end of the segment in the right image), and missing concrete coating, especially north of the leak site.

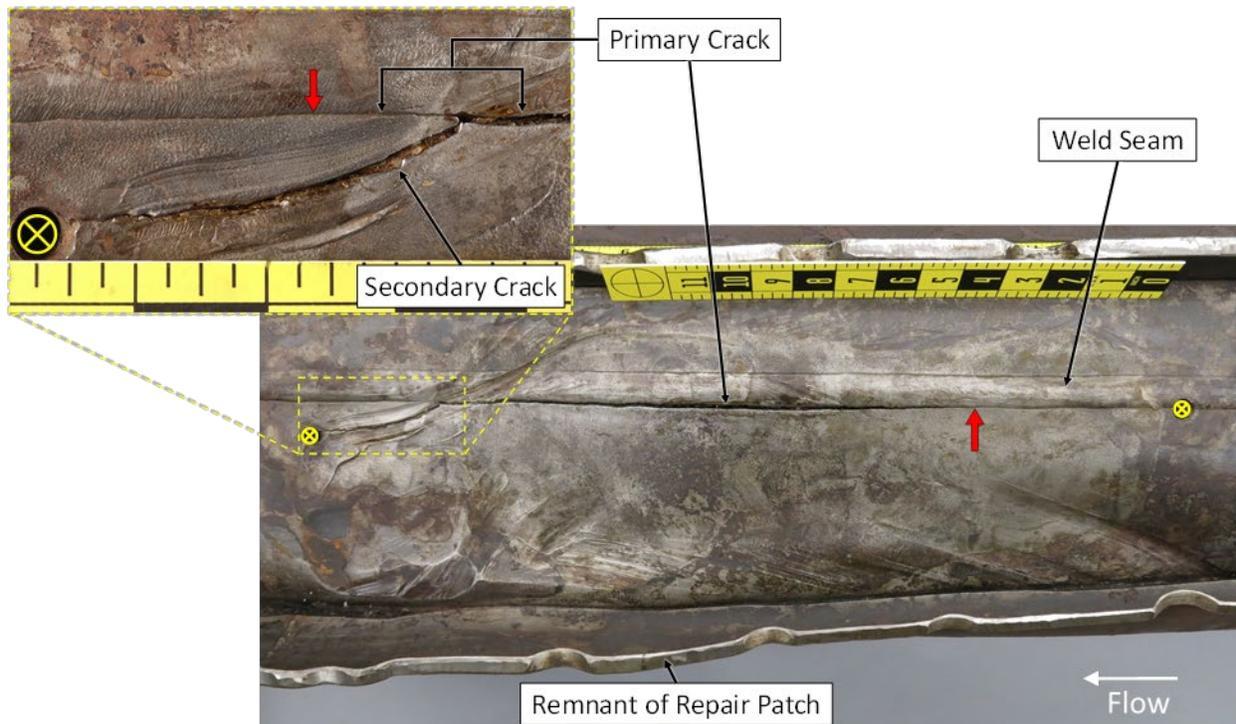
Figure 18. A closer view of the leak site from the outer surface after removal of the repair patch showing general inward deformation, localized gouges, parallel scratches, and smeared metal. The red arrows mark the ends of a visible primary crack along the seam weld toe. The two holes denoted by a yellow circled X were introduced following underwater nondestructive testing to prevent further cracking. Inset scale markings are 0.25 inches.

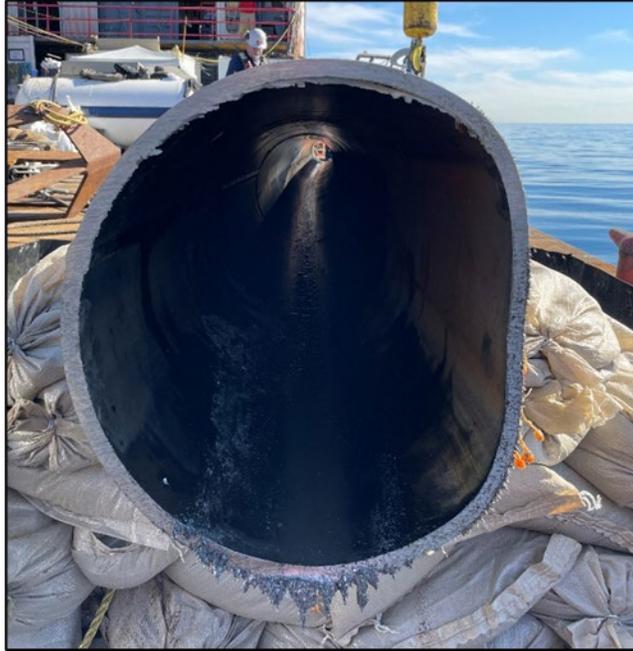
On November 25, 2022, an additional two segments of pipeline that had been located along the displaced length of pipeline to the south of the leak location were brought to the surface. The NTSB examined photographs of these pipeline segments, which totaled about 75 feet in length (see figure 19). The concrete coating was damaged or missing along parts of the segments, and a portion of the pipe was deformed (out-of-round).

Figure 19. End of segment that had been located along the displaced length of pipeline to the south of the leak locations, showing out-of-roundness deformation. (Source: PHMSA)

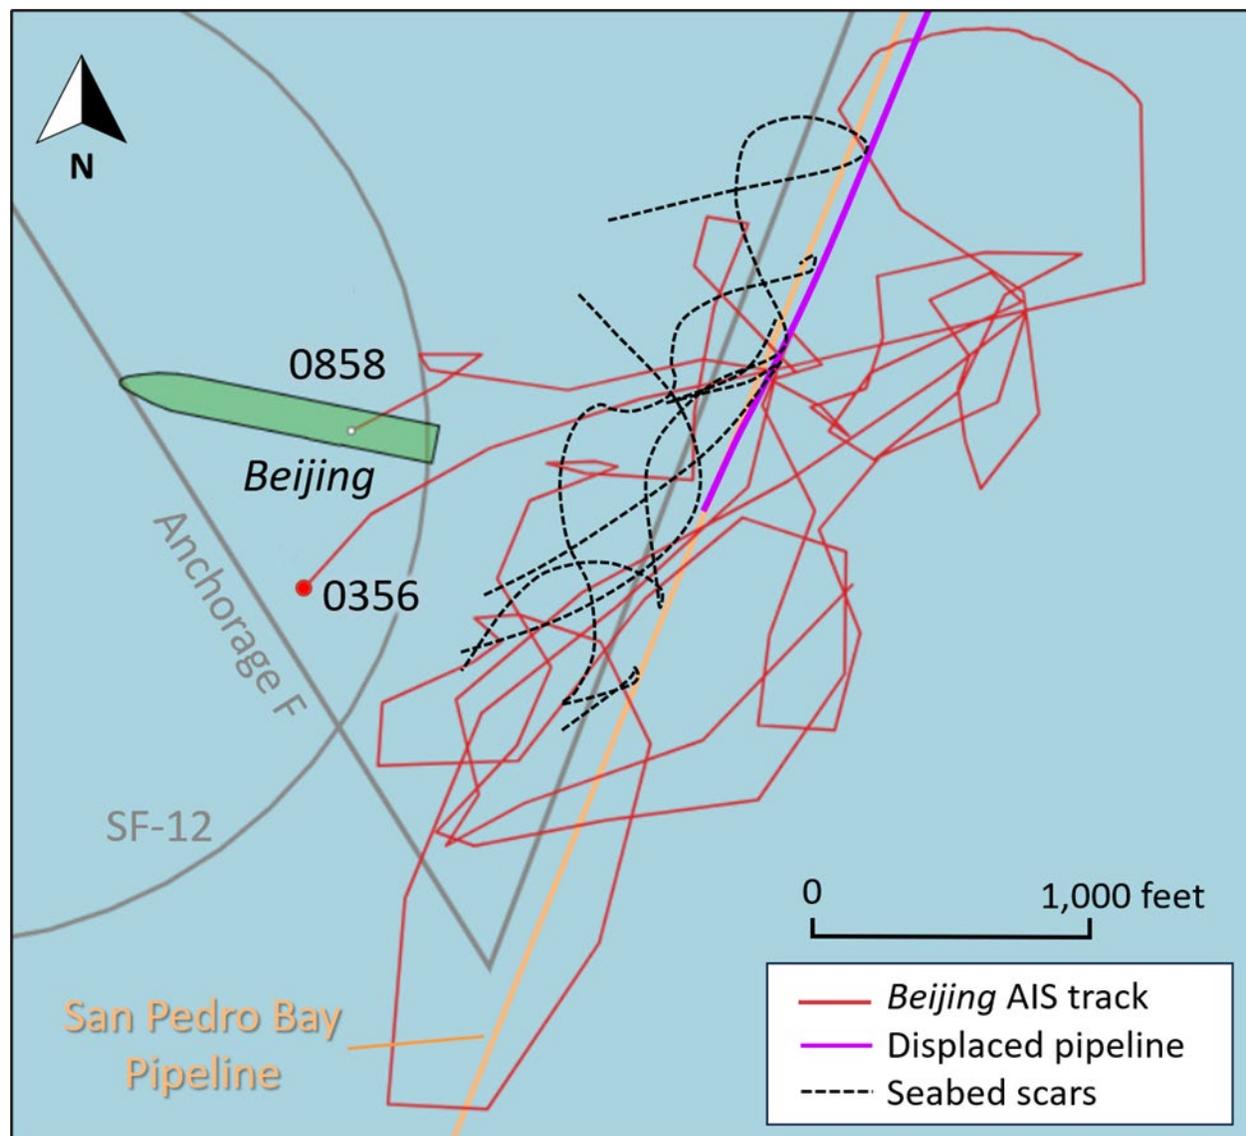
Figure 22. Location data from anchor dragging scars on the seabed, when overlaid with the *Beijing's* AIS data, indicate that the *Beijing* anchor likely struck the pipeline multiple times.

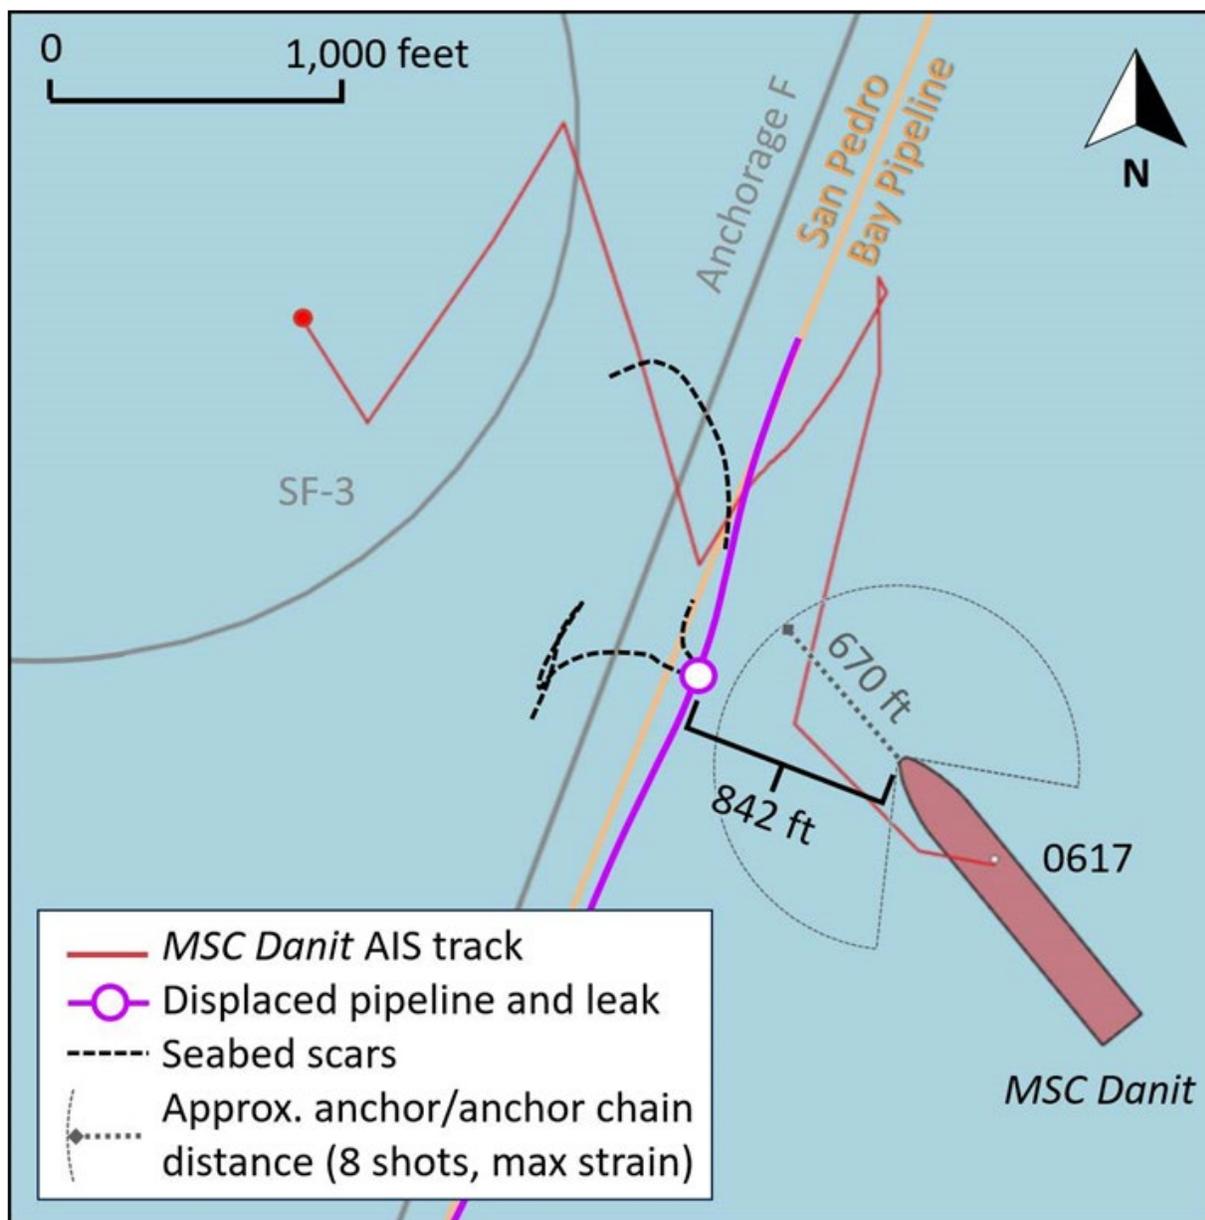
0617, *MSC Danit's* eastward progress stopped when its bow was about 842 feet southeast of where the pipeline leak would eventually be found (see figure 24). Based on the NTSB's modeling of the *MSC Danit's* anchor position (maximum of 670 feet forward of the ship's bow), the anchor would have struck the pipeline as the ship drifted past it (842 feet east of the leak location).

Figure 24. The *MSC Danit's* position as the vessel dragged anchor over the San Pedro Bay Pipeline, the approximate distance of the anchor from the vessel, and location data from anchor dragging scars on the seabed.

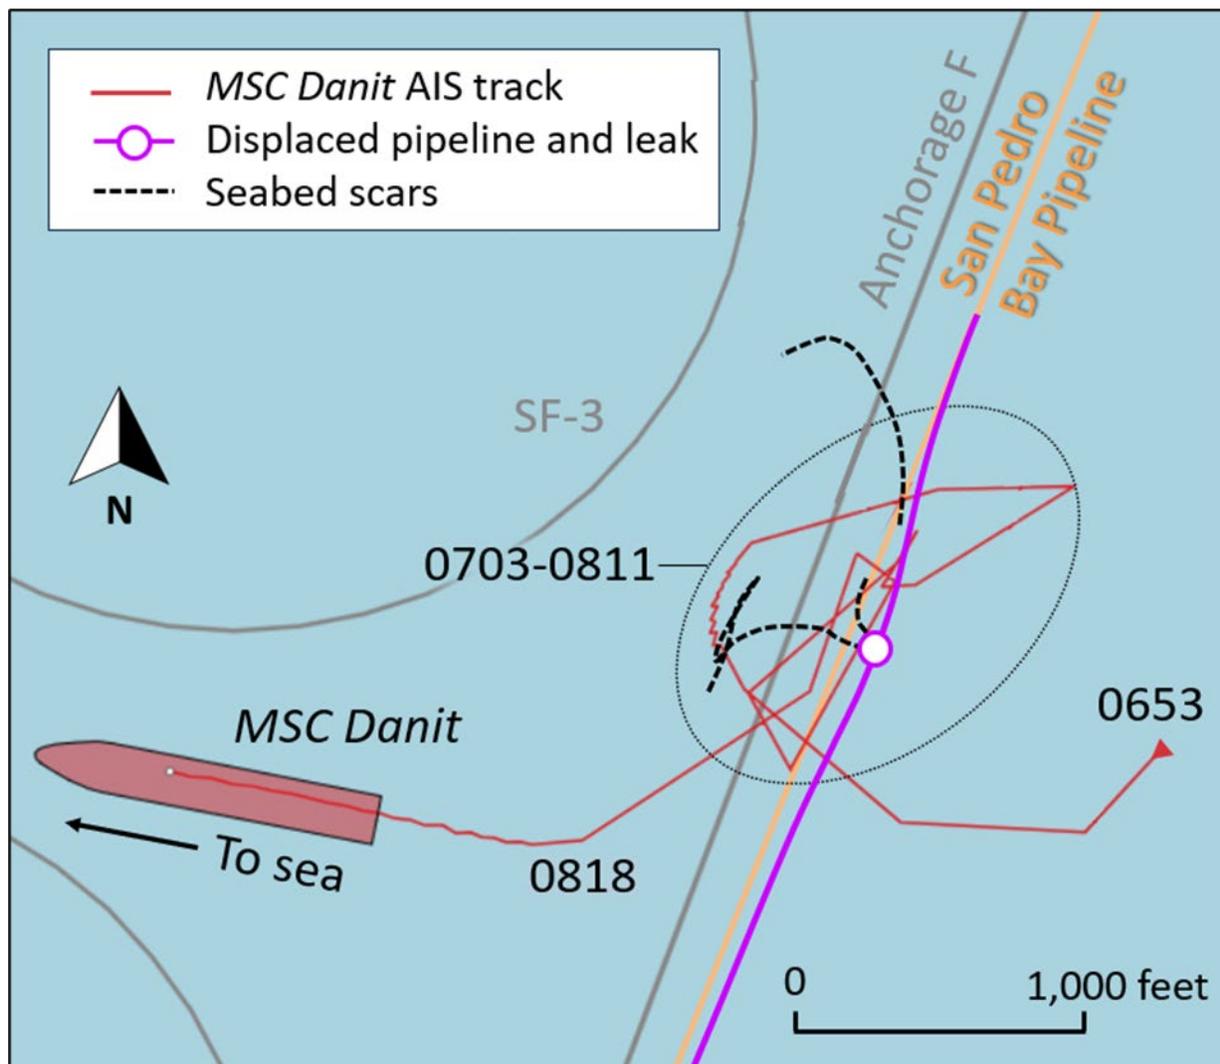
the *MSC Danit* again started heaving in its anchor and moved in a westerly direction. The vessel maneuvered directly over the pipeline—close to the apex of the pipeline’s eastward displacement and the location where the leak was eventually found—and remained there for over an hour (see figure 25). Scars on the seabed indicated anchor dragging marks in the immediate area of the eventual leak location.

Figure 25. The *MSC Danit*'s AIS data indicated that the vessel maneuvered directly over the pipeline and remained there for over an hour.
