April 8, 2024

MIR-24-07

Flooding and Partial Sinking of Towing Vessel *Joanne Marie*

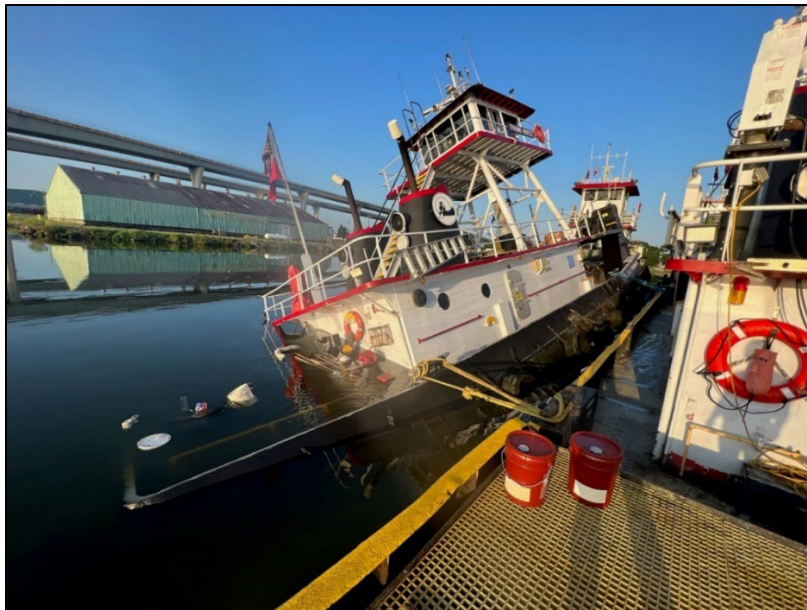
On June 25, about 0530, the on-duty port captain (a different port captain than had secured the vessel) received a phone call from company personnel notifying him that a vessel was listing at the shipyard (see figure 4). The on-duty port captain then notified the off-duty port captain (who had secured the vessel and was responsible for managing it), who headed to the shipyard, arriving about 0600. The off-duty port captain found the *Joanne Marie* partially submerged at the stern and listing to port, with the port quarter resting on the bottom of the canal at a depth of 15 feet. The mooring lines remained secured on the *Joanne Marie*’s starboard side to the towboat *Nativity*. About 0630, the port captain notified other company personnel.

Figure 4. *Joanne Marie* listing at the shipyard on the morning of June 25. (Source: US Coast Guard)

About a day and a half after being moored and deactivated at a shipyard on the Harvey Canal, the unattended *Joanne Marie* was found listing and partially submerged with its port quarter resting on the bottom of the canal.

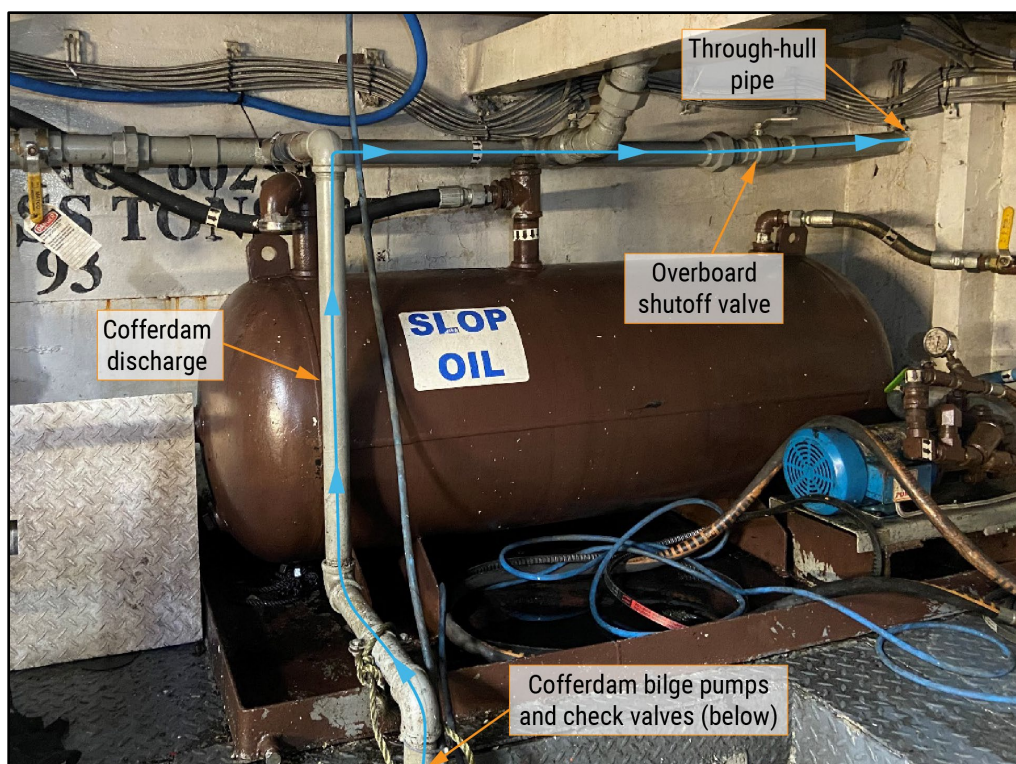
Two dedicated bilge pumps inside the cofferdam discharged any water that entered through the shaft seals. These pumps were electrically powered either through the onboard generators or shore power (the *Joanne Marie* was not typically connected to shore power when it was deactivated). Both pumps were float-activated and automatically engaged once water inside the cofferdam reached a set level. When activated, each pump routed the water through a short hose connected to a check valve that was connected to 1.5-inch Schedule 40 steel piping that discharged overboard via a through-hull pipe (see figure 5 and figure 6).

Figure 5. *Joanne Marie* cofferdam discharge system (facing aft). (Background source: Coast Guard)

The shaft seal cofferdam discharge system had two bilge pumps whose discharges combined into a single overboard line. The discharge lines had valves installed to prevent water ingress. First, there was an overboard shutoff valve installed just before the through-hull pipe (combined overboard discharge) to prevent the accidental admission of water from moving through the discharge system into the engine room. However, company personnel stated that the overboard shutoff valve was left open when the *Joanne Marie* was secured on June 23 and this was typical for deactivated vessels.

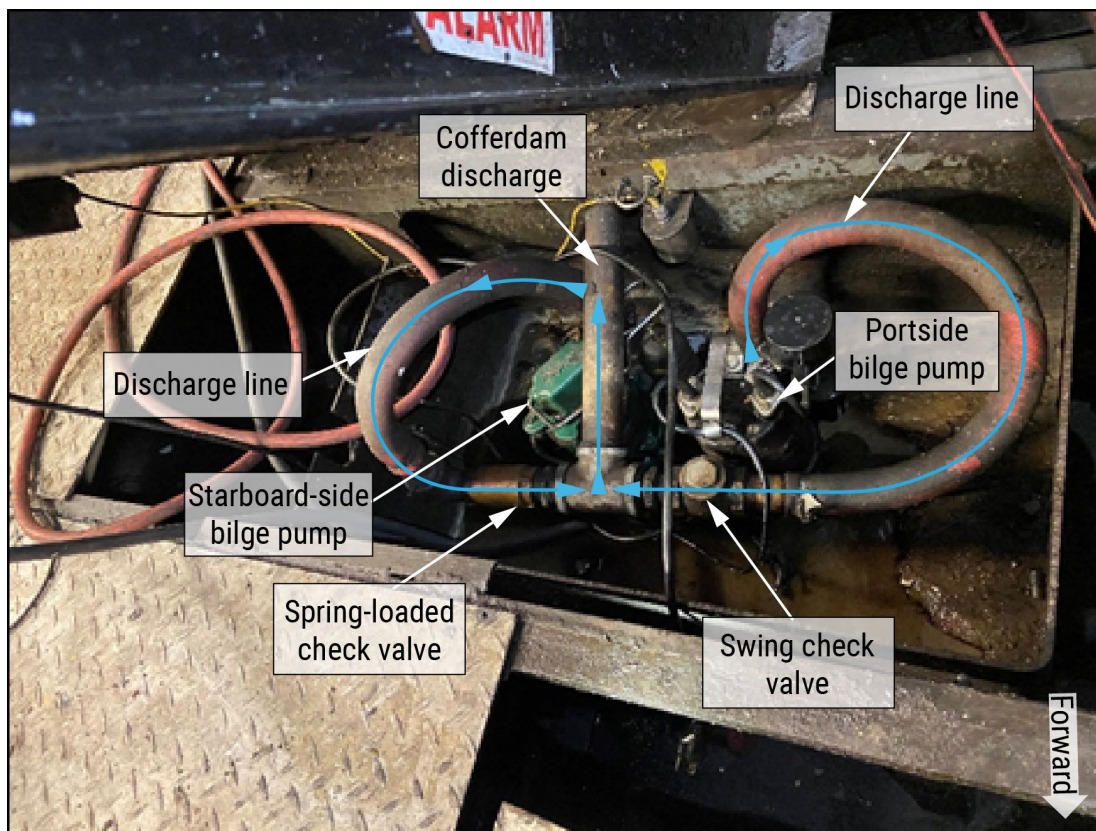
Figure 6. *Joanne Marie* cofferdam (looking down) with deck plate removed postcasualty, showing bilge pumps, pump discharge lines, and associated check valves. (Background source: Coast Guard)

As required by Title 46 *Code of Federal Regulations (CFR)* Subchapter M, each cofferdam bilge pump was protected by a check valve, which prevented water from backflowing into the cofferdam either from outside water entering through the through-hull pipe, or from water that remained in the system when the pumps turned off.³ The starboard-side pump was protected by a spring-loaded check valve, and the portside pump was protected by a swing check valve.

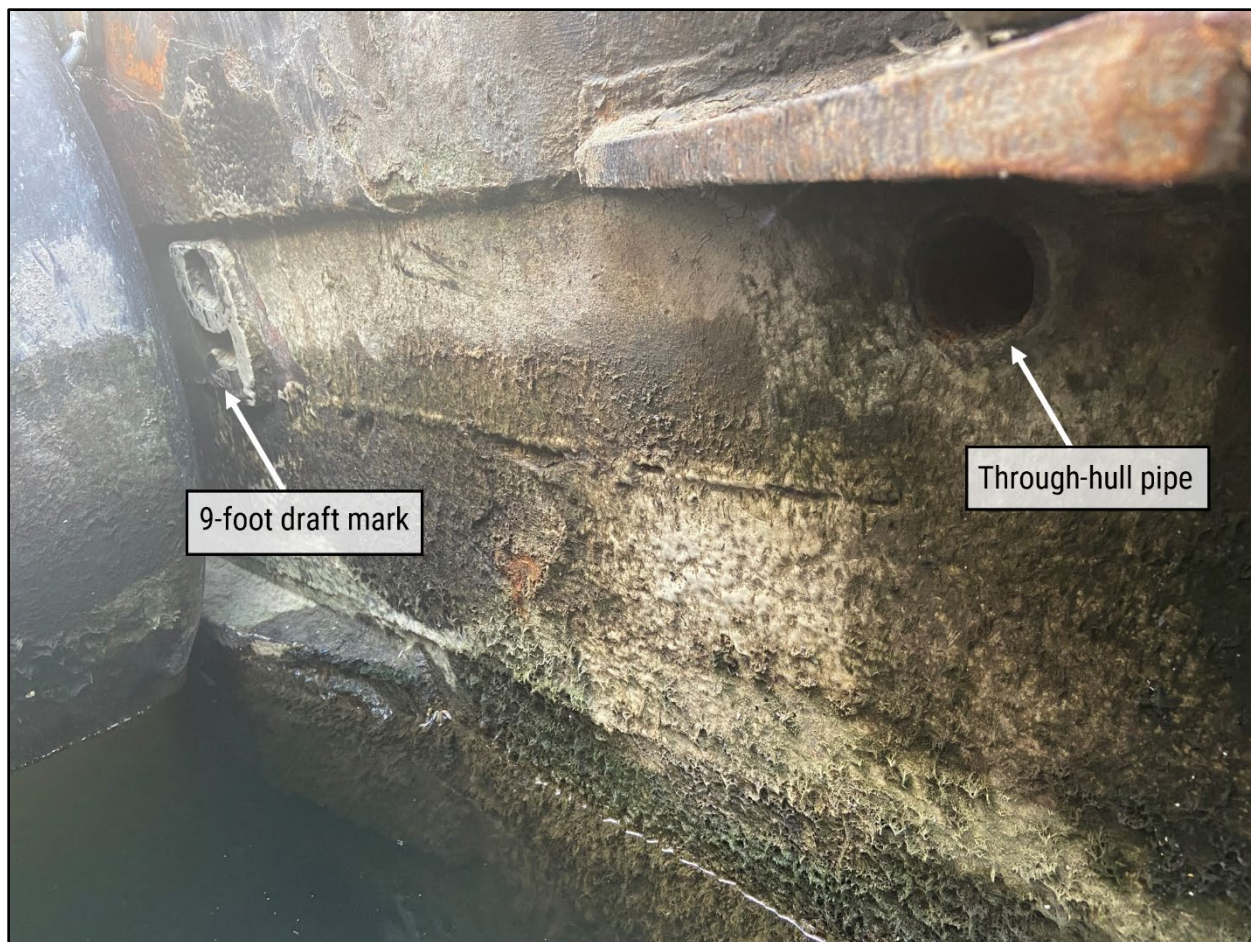
The through-hull pipe for the cofferdam overboard discharge was located on the port quarter of the vessel above the 9-foot draft marking on the hull (see figure 7). As required by Subchapter M, the discharge system was equipped with an overboard

shutoff valve immediately before the through-hull pipe.⁴ The port captain stated the valve was typically kept in the open position when the *Joanne Marie* was moored; the valve was open when the vessel was deactivated before the sinking.

Figure 7. *Joanne Marie* through-hull pipe for the cofferdam pumps' overboard discharge on the port quarter with 9-foot draft mark shown postcasualty. (Background source: Coast Guard)

After the vessel was refloated, no water ingress into any vessel spaces was found, indicating the hull condition did not contribute to the flooding. Postcasualty testing found that, when water was pumped into the through-hull pipe for the propulsion shaft seals' cofferdam overboard discharge, it entered the cofferdam (open to the engine room).

The vessel's typical operating draft was estimated to be about 9 feet 2 inches. The port captain did not note the *Joanne Marie*'s draft during his rounds of the vessel on June 23 or June 24, and there were no records of the vessel's draft at the time it was deactivated on June 23. Therefore, investigators were unable to definitively determine the vessel's draft and, subsequently, the exact height of the through-hull pipe for the cofferdam overboard discharge above the waterline when the vessel was deactivated. A company representative stated that the draft of the *Joanne Marie* was 8 feet when the fuel tanks were 62% full. However, on the day the vessel was deactivated, the daily boat log showed that the fuel tanks were 75% full—which equated to over 18,000 additional pounds of fuel. Given the weight from the additional fuel, the vessel's draft on the day it was deactivated was likely greater than 8 feet and closer to the estimated normal operating draft of 9 feet 2 inches. This draft placed the through-hull pipe—which was located about 9 feet above the keel—near or potentially below the waterline. Therefore, because the opening of the through-hull pipe was so close to the waterline, water would have been able to enter the discharge line from a variety of sources, including the wake from passing vessels or a small list.

The port captain completed the deactivation tasks with the crew in accordance with the TSMS. However, the tasks were limited to housekeeping items and did not address the configuration of onboard systems to prevent a casualty (the port captain did tighten the shaft seals; however, this task was not captured in the company's TSMS for vessel deactivation). The deactivation procedures in the operating company's TSMS did not direct the crew to close the overboard shutoff valve. Had the TSMS deactivation procedures accounted for the configuration of vessel systems, such as closing the overboard shutoff valve, the procedures would have accounted for the possibility of the spring-loaded check valve becoming stuck and resulting in flooding. Following the casualty, the operating company replaced the spring-loaded check valve with a swing check valve (like the check valve on the other cofferdam bilge pump); the company also modified their checklist for vessels entering deactivation to include closing the overboard shutoff valve for vessels without shore power.

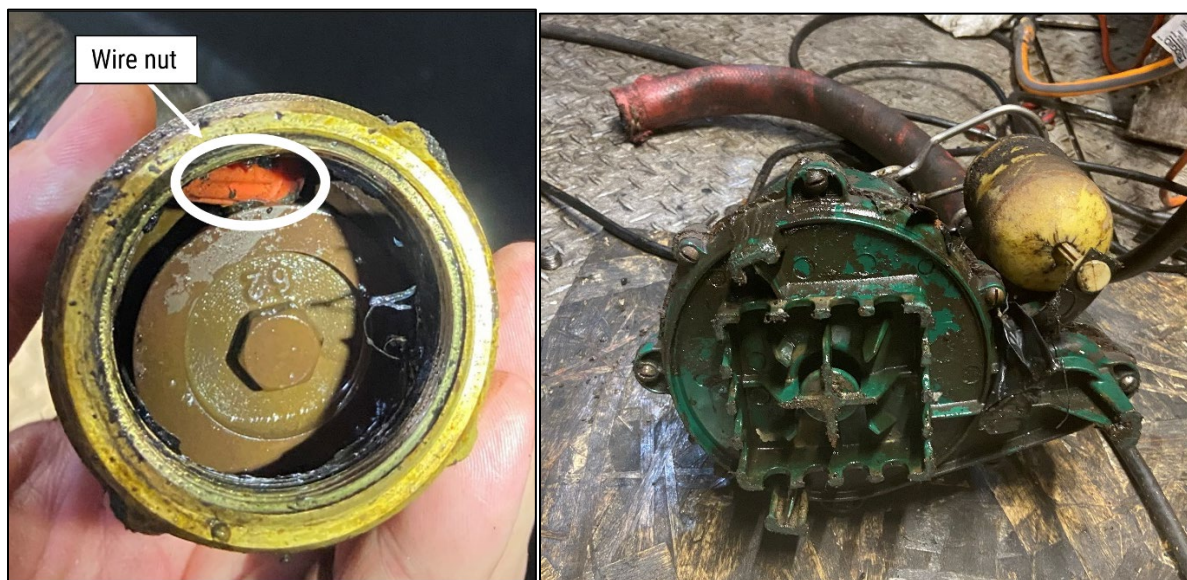
Following the casualty, the Coast Guard and company personnel removed the bilge pump discharge check valves and the starboard bilge pump protected by the spring-loaded check valve. They found that the spring-loaded check valve was stuck in a partially open position due to a lodged twist-on electrical wire connector, commonly called a wire nut (see figure 8). The wire nut was about 0.5 inches wide and 0.88 inches in height. The Coast Guard retained the bilge pump and check valves for further examination.

Figure 8. Spring-loaded check valve shown with lodged wire nut (*left*) and associated cofferdam bilge pump with inlet shown with strainer removed (*right*). (Source: Coast Guard)

On July 14, Coast Guard investigators and representatives from the vessel's operating company examined the removed check valves and starboard bilge pump. The bilge pump functioned normally when connected to a power source, and there were no issues identified with the internal components. After the wire nut was removed from the spring-loaded check valve, the check valve functioned normally. The swing check valve from the other bilge pump was not obstructed and functioned normally.

With the wire nut removed, the Coast Guard and company representatives evaluated the fittings on the bilge pump, including the strainer and pump mechanism, to determine if the wire nut could have passed through the bilge pump and into the spring-loaded check valve. The Coast Guard and company representatives found that the wire nut was sufficiently small to pass through the pump inlet strainer, pump impeller, and the discharge line into the check valve. The

Each pump also had a check valve on its individual discharge line before the lines combined. After the casualty, investigators found that a wire nut had lodged in a spring-loaded check valve on the starboard-side bilge pump discharge line,

obstructing the valve and forcing it to remain partially open (the swing-type check valve on the portside bilge pump worked properly). Investigators could not determine how the wire nut had entered the cofferdam. The wire nut may have been inadvertently dropped or fallen into the cofferdam when the deck plate covering the cofferdam was removed for regular maintenance. The Coast Guard and company representatives found that the wire nut was small enough to pass through the cofferdam bilge pump inlet strainer, so when the cofferdam bilge pump activated, the wire nut was pulled through the strainer and subsequently the pump impeller and discharge line before reaching the spring-loaded check valve. The spring-loaded design of the check valve held the wire nut in place, leaving the valve in a partially open position and susceptible to backflow.

The National Transportation Safety Board determines that the probable cause of the flooding and partial sinking of the *Joanne Marie* was the ingress of water into the engine room through a through-hull pipe located near the waterline due to an obstructed spring-loaded check valve on a cofferdam bilge pump discharge. Contributing to the sinking were inadequate procedures for securing unattended vessels.

Following the casualty, the operating company of the *Joanne Marie* investigated the sinking and determined that the partially open spring-loaded check valve, open overboard shutoff valve, and open fuel tank crossover valve (which allowed “fuel to gravitate from one side to the other”) all contributed to the water ingress and subsequent sinking. As a result of the casualty, the company modified their checklist for vessels entering deactivation to include closing the overboard shutoff valve when a vessel was not connected to shore power. The company also replaced the spring-loaded check valve on the cofferdam discharge line before the through-hull pipe with a swing check valve—they believed a swing check valve would be less likely to become “jammed.”
