April 15, 2024

MIR-24-09

Contact of Tank Vessel *Bow Triumph* with Pier

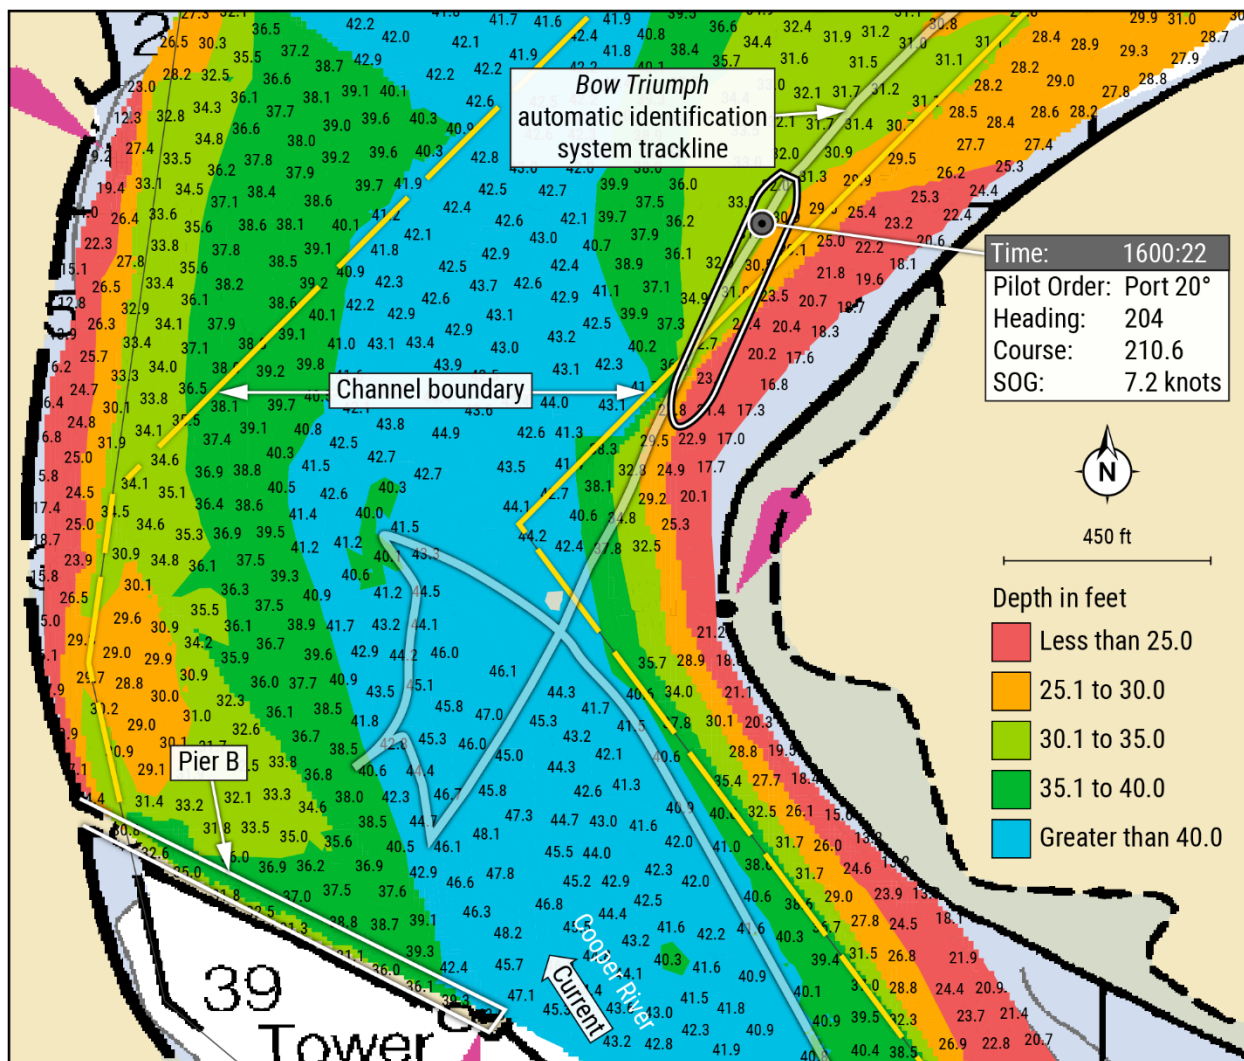
The pilot ordered full ahead at 1600:11, increasing the propeller rpm, and rudder midships at 1600:14. After ordering the rudder to port 20° at 1600:22, he noticed that the “rate of turn was not increasing” (see figure 4). The pilot ordered increased port rudder orders at 1600:31 and 1600:58, and then a full Becker rudder (the main rudder was at 45°, and the flap was at an angle of 90° to the ship’s centerline), at 1601:08.⁴

Figure 4. Position of the *Bow Triumph* (approximate scale) at 1600:22, based on automatic identification system (AIS) data, about the time the pilot noticed that the rate of turn was not increasing. Pilot order is from the vessel’s voyage data recorder (VDR). Soundings (in feet) were recorded during the September 6, 2022, Corps of Engineers survey.

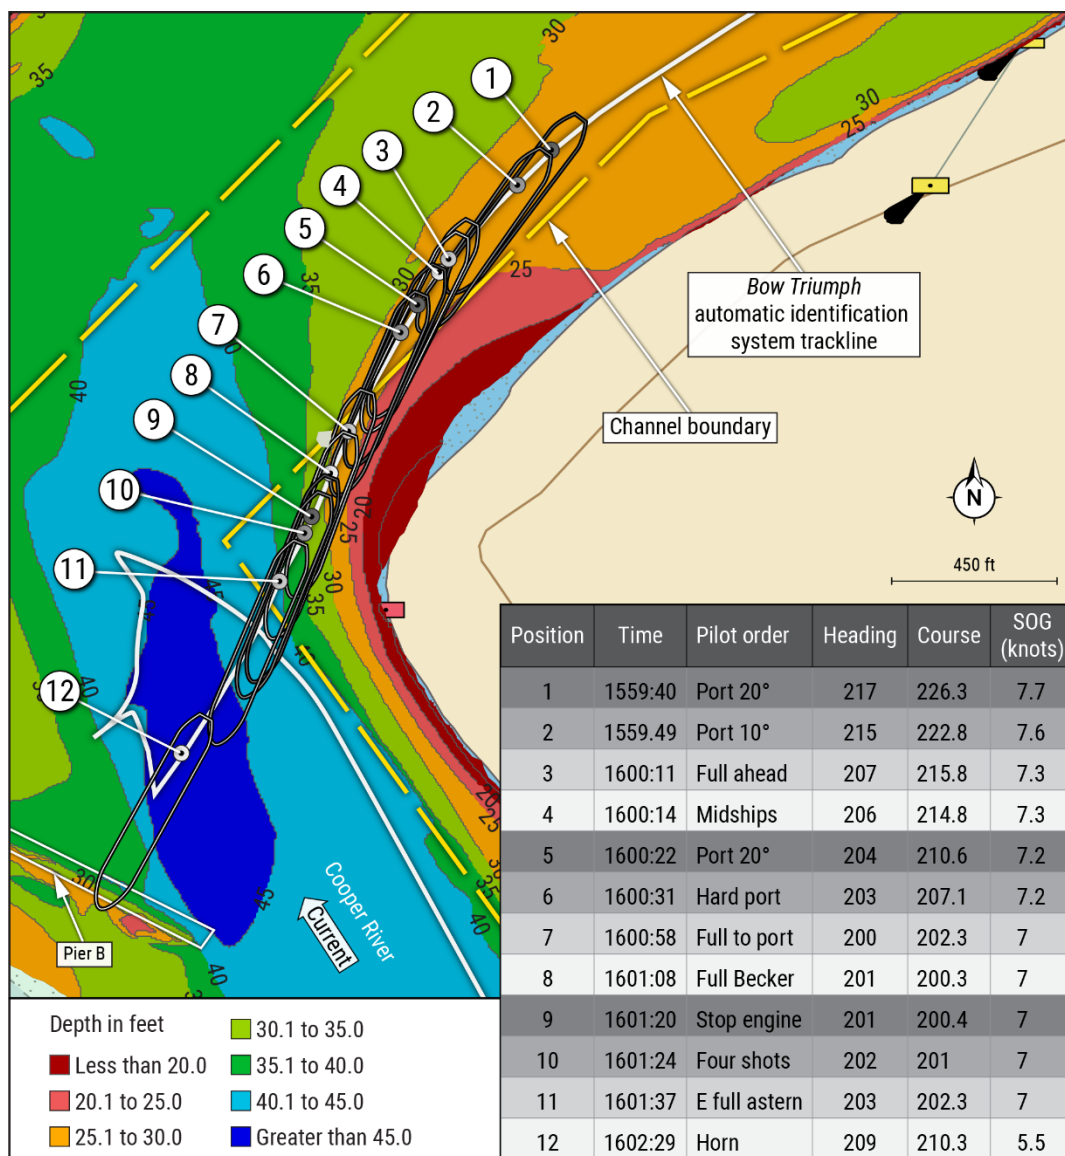
Between 1600:22 and 1601:24, as the vessel drew nearer the left bend, its heading had only changed 2° to port and the vessel’s course over the ground showed an increase of about 10° to port as it drew closer to the left bank. At 1601:24, as the vessel was not turning as he expected it to, the pilot gave the order to drop anchor. Less than 1 minute later, at 1602:20, the *Bow Triumph*’s bow struck Pier B at a 90° angle (see figure 5).

Figure 5. Positions of the *Bow Triumph* (approximate scale) approaching Pier B at Naval Weapons Station Charleston in the minutes leading up to the casualty, based on AIS data. Pilot orders are from the vessel’s VDR. Soundings (in feet) were recorded during the September 6, 2022, Corps of Engineers survey.

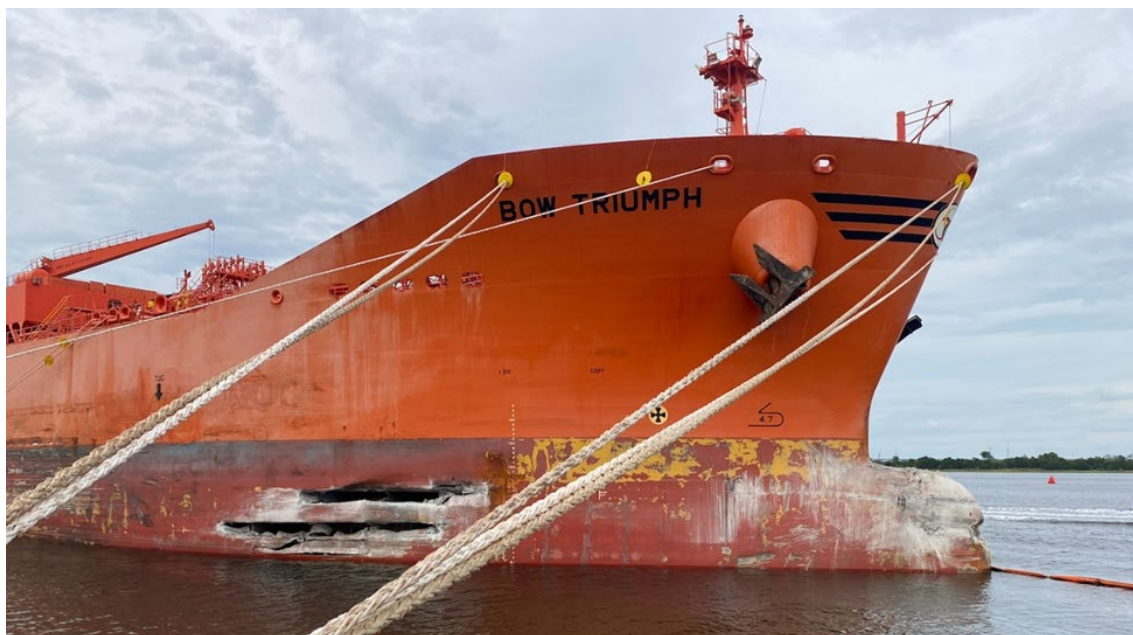
Damage to the *Bow Triumph* included a punctured bulbous bow and damage to side shell, frames, and stringers in way of the forepeak ballast tank and the no.1 starboard ballast tank, which compromised the watertight integrity of the hull (see figure 6). A September 7, 2022, diver survey report noted small areas on the keel, port of the centerline, where there was no marine growth and the hull plate coating (paint) was missing. The total cost of repairs was estimated at \$2,459,570. The cost to demolish and reconstruct the damaged portion of Pier B was estimated at more than \$27 million (see figure 7).

Figure 6. *Bow Triumph* at the Odfjell Terminal in Charleston on September 8, 2022, showing damage to the vessel's starboard side. (Source: US Coast Guard)

The vessel's classification society allowed the *Bow Triumph* to proceed directly to a shipyard in Florida for permanent repairs after temporary repairs were made in Charleston.

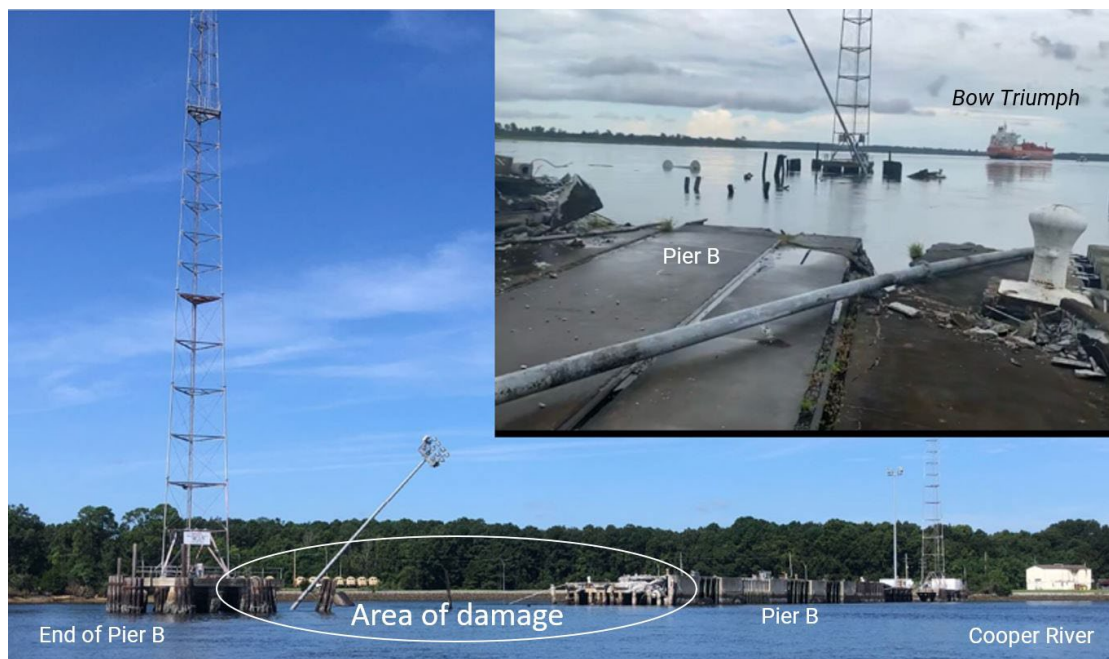
A 300-foot section of the pier collapsed after it was struck by the *Bow Triumph*. The pilot backed the *Bow Triumph* out from the debris with the assistance of the tugs *Capt. Jim McAllister* and *Jefferey McAllister* and ordered the anchor hauled in (1 shot of anchor chain).⁵ At 1616, the pilot began conning the ship downriver without tug assistance. The vessel arrived at the Odfjell Terminal on the Cooper River at 1703.

Figure 7. Pier B damage. Inset: Witness photograph taken shortly after the contact. (Sources: Corps of Engineers, Jacob Wall [inset])

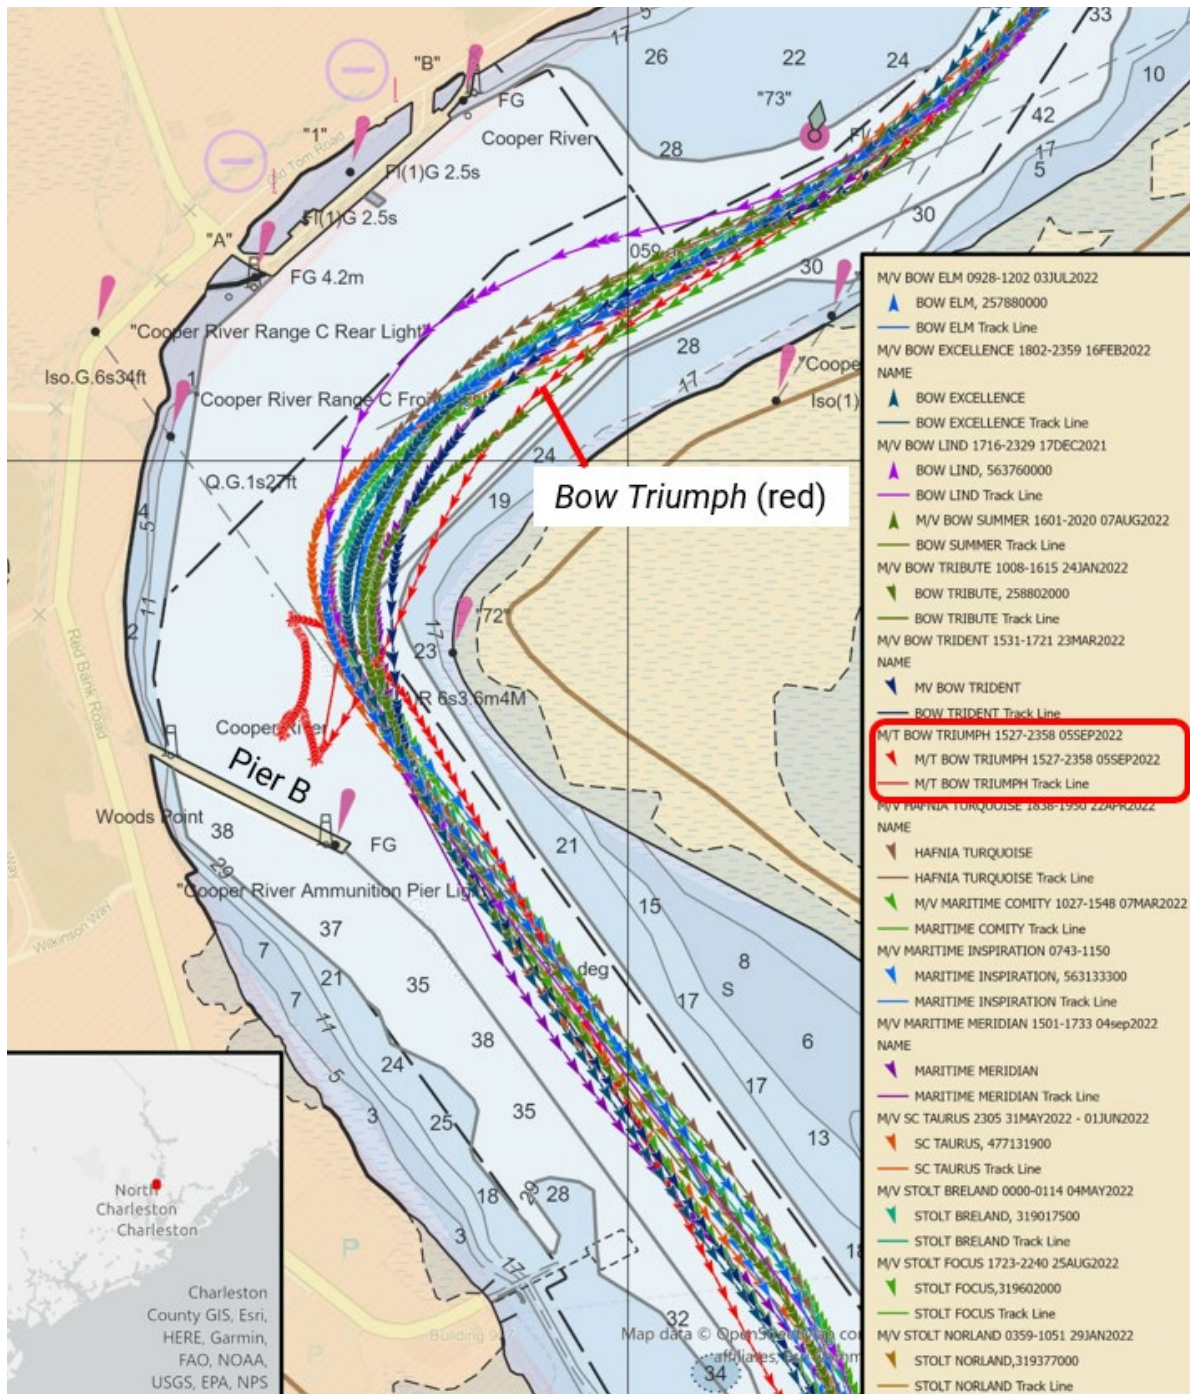
AIS data of the *Bow Triumph* and 14 other vessels of similar size and draft that departed from the INEOS Aromatics Terminal in the 12 months before the casualty show that the *Bow Triumph* pilot attempted to pass the closest to the bend (see figure 8).⁸ When asked about his trackline, the pilot told investigators that he did not intend to cut the corner. He envisioned a gradual turn through the bend with the flood tide pushing him toward the west bank as the bow entered Range C.

Figure 8. Tracklines of vessels of similar size to the *Bow Triumph* that departed from the INEOS Aromatics Terminal within the 12 months before and including September 5, 2022, plotted in the Cooper River near Joint Base Charleston. (Source: Coast Guard)

All the other vessels of similar size and draft departing the INEOS Aromatics Terminal in the previous 12 months approached the bend nearer the center of the channel than the *Bow Triumph* did on its casualty transit, and all were able to safely navigate the bend (see figure 8). Transiting in the center of the channel is prudent to avoid the risks associated with bank effect.

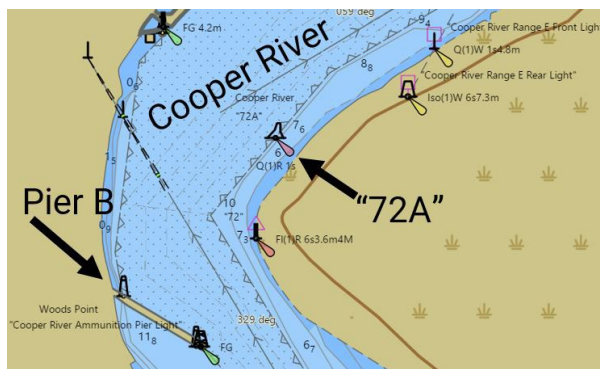
Figure 9. Excerpt from NOAA chart US5SC1LO, annotated by NTSB.

On January 17, 2024, at the request of the CBPA, the Coast Guard permanently established Cooper River lighted buoy 72A in the position where the temporary buoy had been (see figure 9). The January 17, 2024, Notice to Mariners stated, "This additional aid to navigation will ensure commercial vessels can routinely transit this area in a safe manner."
