MIR-24-10

Fire aboard Commercial Fishing Vessel

Kodiak Enterprise

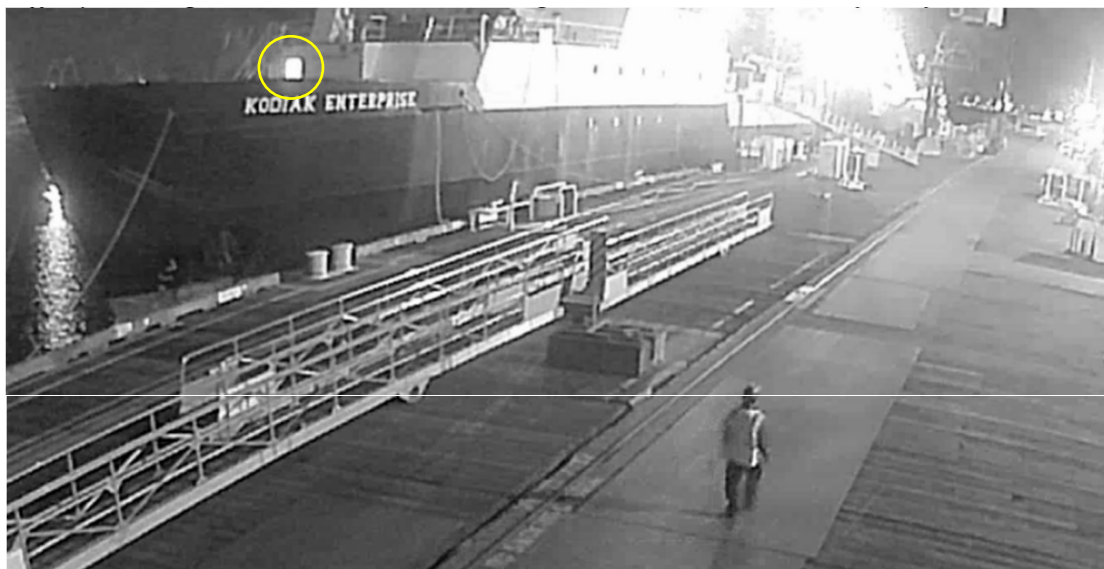
About 0300, the deckhand on board the passenger vessel *American Constellation*, which was docked about 200 yards away from the *Kodiak Enterprise*, was out on deck and saw smoke rising from the bow of the *Kodiak Enterprise* near an opening that was later identified as the deck locker door. When he approached the vessel to investigate, he smelled what he described as burning wood. At 0306, facility security camera footage of the *Kodiak Enterprise*'s bow and port side showed light smoke coming from the vessel. By 0308, the smoke was heavier, and, at 0310, the deckhand could be seen running to inform the Trident

Figure 4. Security camera footage of the *Kodiak Enterprise* with fire visible in the open watertight deck locker door (circled in yellow) on the foredeck and the deckhand from the *American Constellation* heading toward the guard shack at 0310. (Source: Trident Seafoods)

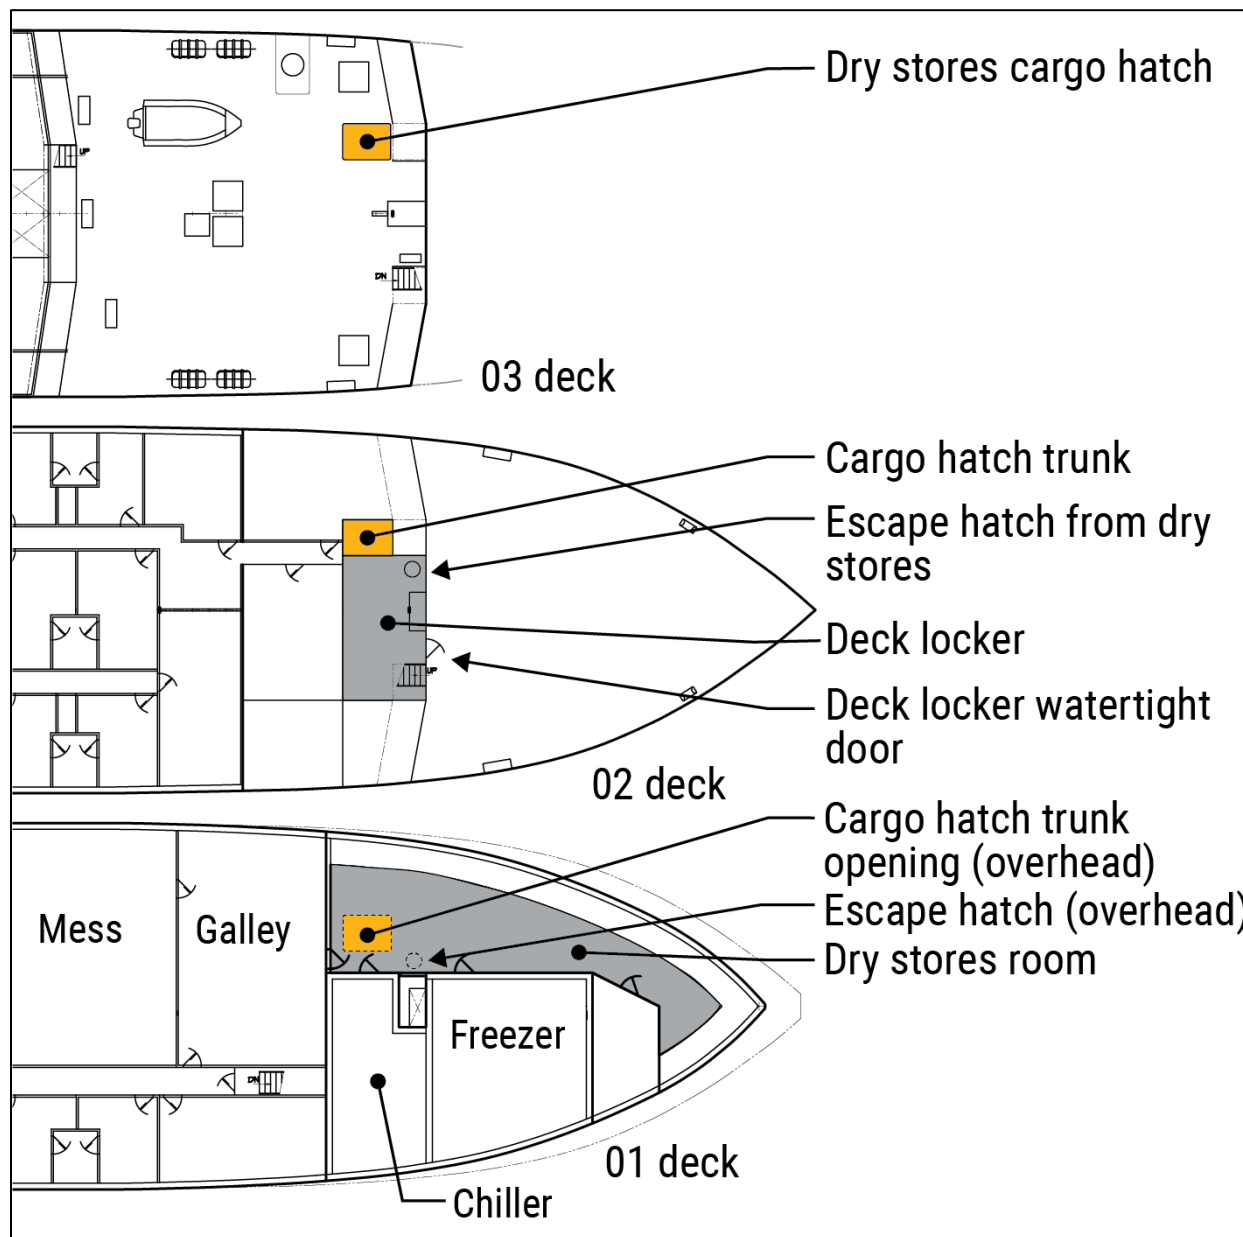
Figure 5. Plan view of the vessel decks showing the dry stores room and the trunk leading from the cargo hatch in the dry stores room to the 03 deck.

By 0321, flames could be seen coming from the dry stores room cargo hatch on the 03 deck (see figure 5). At 0327, shoreside firefighters arrived; the crewmembers provided them with information on where they thought the fire was located (see figure 6). The firefighting teams entered the 01 deck of the vessel and proceeded through thick black smoke toward the galley. The chief engineer and the assistant chief engineer went back on board to start one of the generators to power the ballast pumps and transfer ballast within the hull to help prevent the vessel from heeling as water from the firefighting efforts accumulated within the vessel. At some point, the ballast pumps stopped working, so both crewmembers secured the generators and departed the vessel.

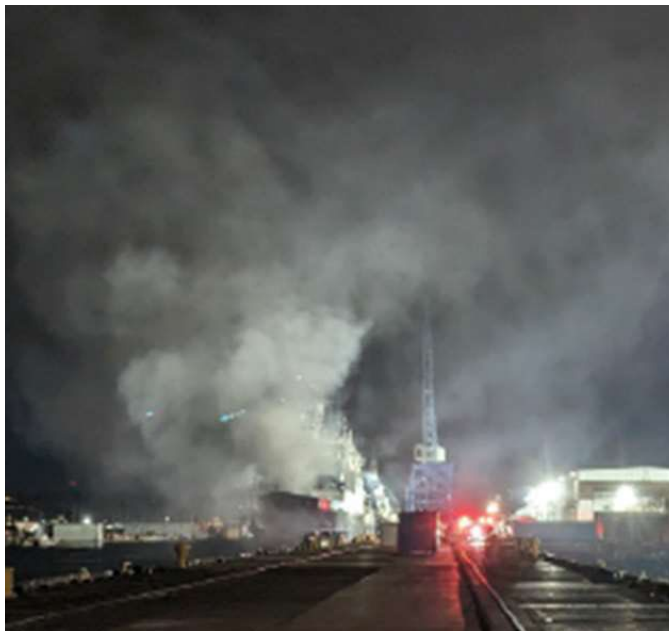
Figure 6. The *Kodiak Enterprise* on fire at 0328. (Source: J. Loring)

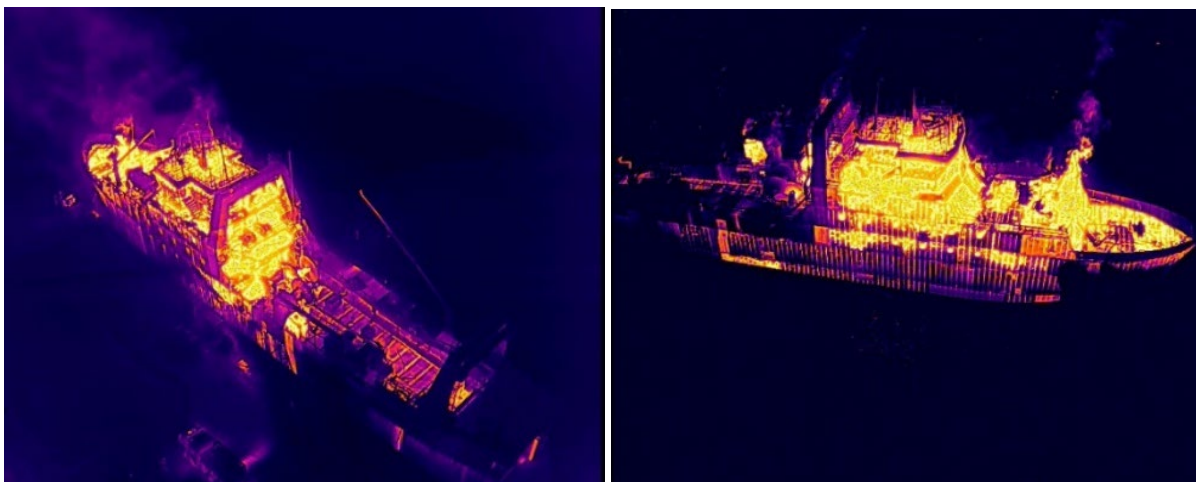
Due to the smoke, firefighters used a thermal imaging camera to find their way within the vessel and to identify hot spots and cool them down (see figure 7). The fire team got about 6 feet into the galley and was able to cool and extinguish the fire in that space, but the fire reignited, primarily on the starboard side of the bulkhead separating the galley from the dry stores room. The fire teams noted that there was no fire on the deck located below the 01 deck; however, a firefighter on the 01 deck noted that the 02 deck of the vessel above the mess was fully involved with fire, and he closed the fire door on the ladder well to prevent it from spreading down to their location.

Figure 7. Thermal images of the fire within the *Kodiak Enterprise* on April 11, taken from a drone. (Source: Resolve Marine)

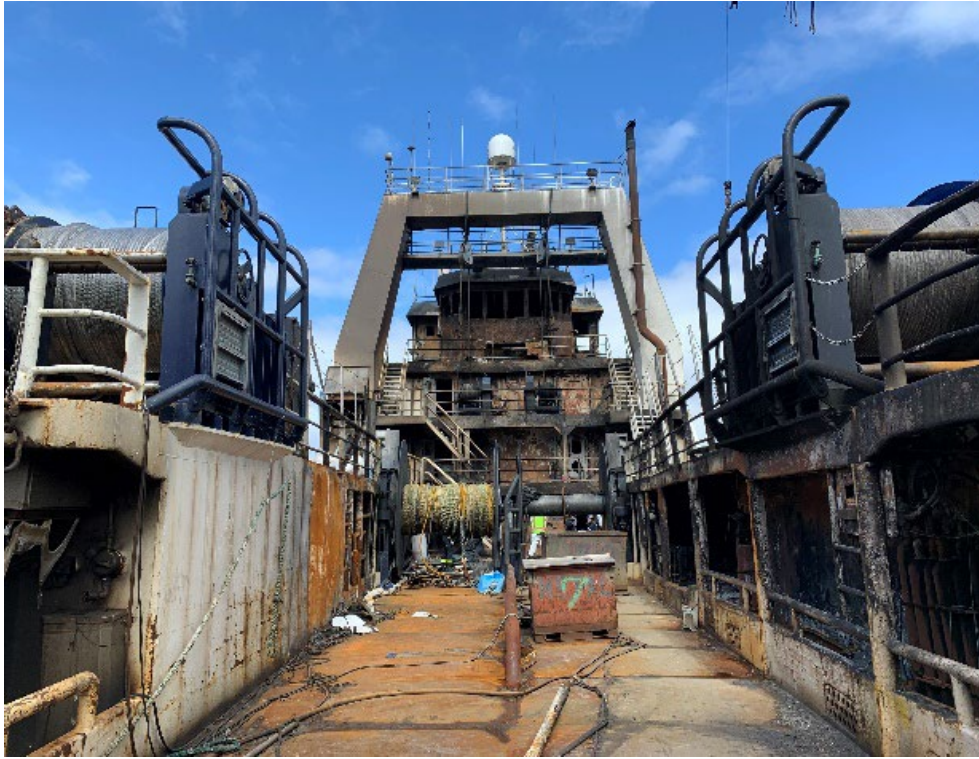
There was extensive smoke and thermal damage throughout the entire vessel due to the 6-day duration of the fire (figure 8). All of the equipment within the vessel were severely damaged, and significant sections of the overhead and bulkhead panels had collapsed due to the fire.

Figure 8. The *Kodiak Enterprise* stern after the fire.

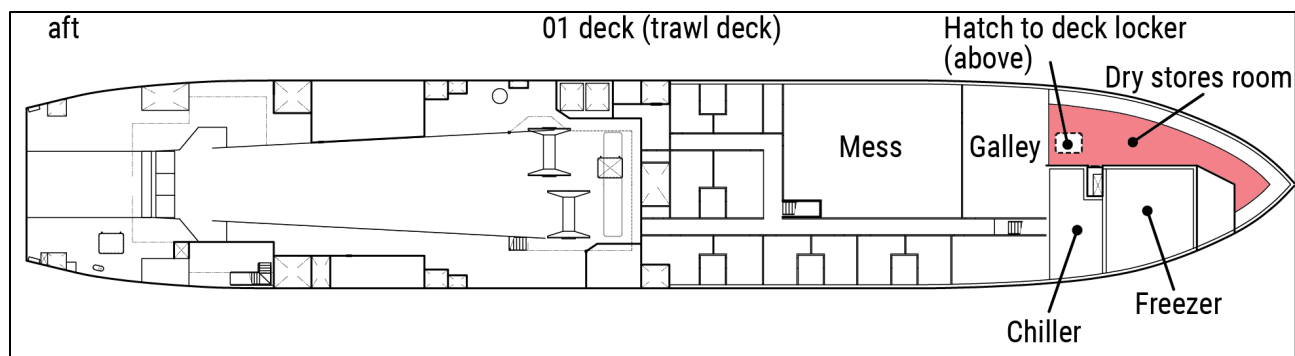
Investigators examined the deck locker on the bow of the 02 deck, where the first sign of smoke was observed. At the time of the fire, the deck locker contained mooring lines. It also contained an emergency escape hatch from the dry stores room located directly below on the 01 deck (the hatch was found closed). The dry stores room was extensively damaged. The mess and the galley, aft of the dry stores room, were also extensively damaged (see figure 9).

Figure 9. Plan view of the *Kodiak Enterprise* 01 deck showing the dry stores room, where the fire most likely originated. (Background source: Trident Seafoods)

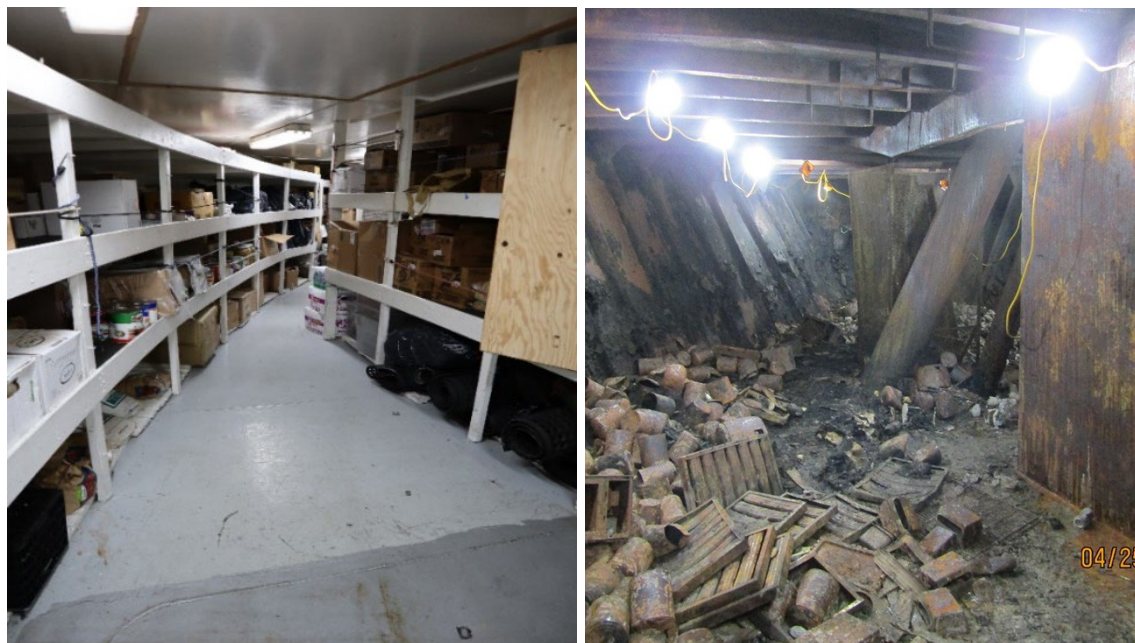
The ATF fire investigator's origin and cause report noted that, although there was widespread damage throughout the vessel, the dry stores area had "specific and more isolated damage which could not be explained by ventilation, construction, fuel load, or uniform heat exposure." Photos of the dry stores room from before the fire showed wooden shelves holding cardboard boxes. The shelves and boxes were completely destroyed by the fire (see figure 10).

Figure 10. Left to right: The dry stores room, looking forward, before and after the fire. (Sources: Trident Seafoods, Coast Guard)

Investigators examined potential sources of the fire, such as the hot work to remove a section of the deck near the open hatch on the 03 deck, or a possible electrical failure. The origin and cause report for the fire stated that "the cause of this fire was determined to be an unknown electrical failure within the dry stores room."

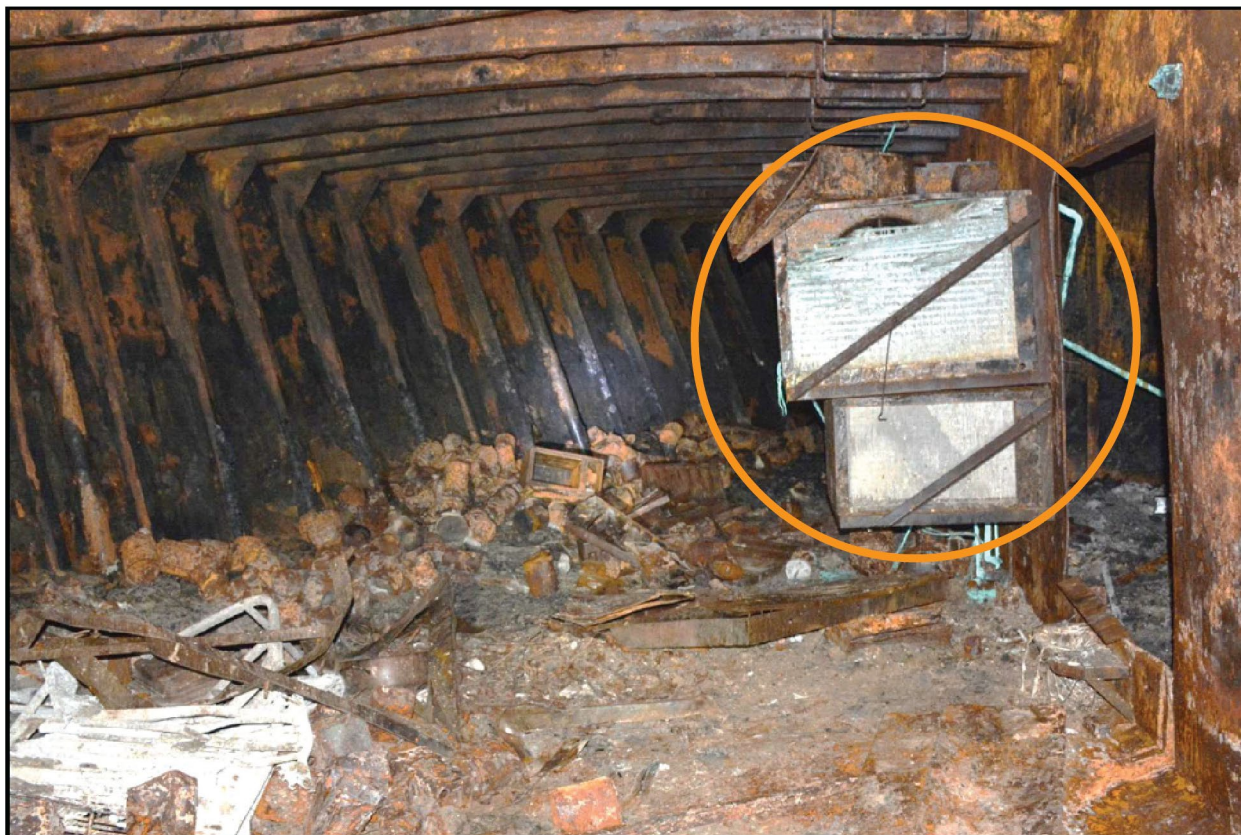
The report detailed other potential ignition sources, including the hot work, the chiller compressors, light fixtures, the clothing washer and dryer, and all electrical outlets in the space (see figure 11).

Figure 11. The two compressors (circled in orange) in the dry stores room. The one for the freezer is on top; the one for the chiller is on the bottom . (Background source: ATF)

The origin and cause report ruled out hot work as the cause of the fire due to safety procedures that were used, including procedures for using fire blankets and implementing a fire watch, as well as an inspection of the project areas by the assistant chief engineer. Before the fire, there was no indication of a problem with any of the electrical equipment or systems, but since all of the electronic devices and the outlets sustained extensive fire damage, the report could not rule them out as potential sources of the fire.
