# Loss of Propulsion aboard Containership *Maunalei*

On August 11, 2022, about 1834 local time, the containership *Maunalei* was transiting the North Pacific Ocean, about 245 miles northwest of the entrance to the Columbia River, en route to Portland, Oregon, when the crew intentionally shut down the main engine due to problems in the controllable pitch propeller system, resulting in a loss of propulsion.<sup>1</sup> The vessel's controllable pitch propeller system may have lost up to 1,632 gallons of hydraulic oil. There were no injuries reported. Damage to the vessel was estimated at \$3.03 million.

<b>Casualty type</b>	Machinery Damage
<b>Location</b>	North Pacific Ocean, 245 miles from Columbia River entrance, Oregon 47°35.31' N, 132°01.49' W
<b>Date</b>	August 11, 2022
<b>Time</b>	1834 Pacific daylight time (coordinated universal time -7 hrs)
<b>Persons on board</b>	23
<b>Injuries</b>	None
<b>Property damage</b>	\$3.03 million
<b>Environmental damage</b>	Up to 1,632 gal hydraulic oil lost from controllable pitch propeller system
<b>Weather</b>	Visibility 10 mi, winds south-southwest at 5 kts, seas 2-3 ft, air temperature 64°F, water temperature 66°F
<b>Waterway information</

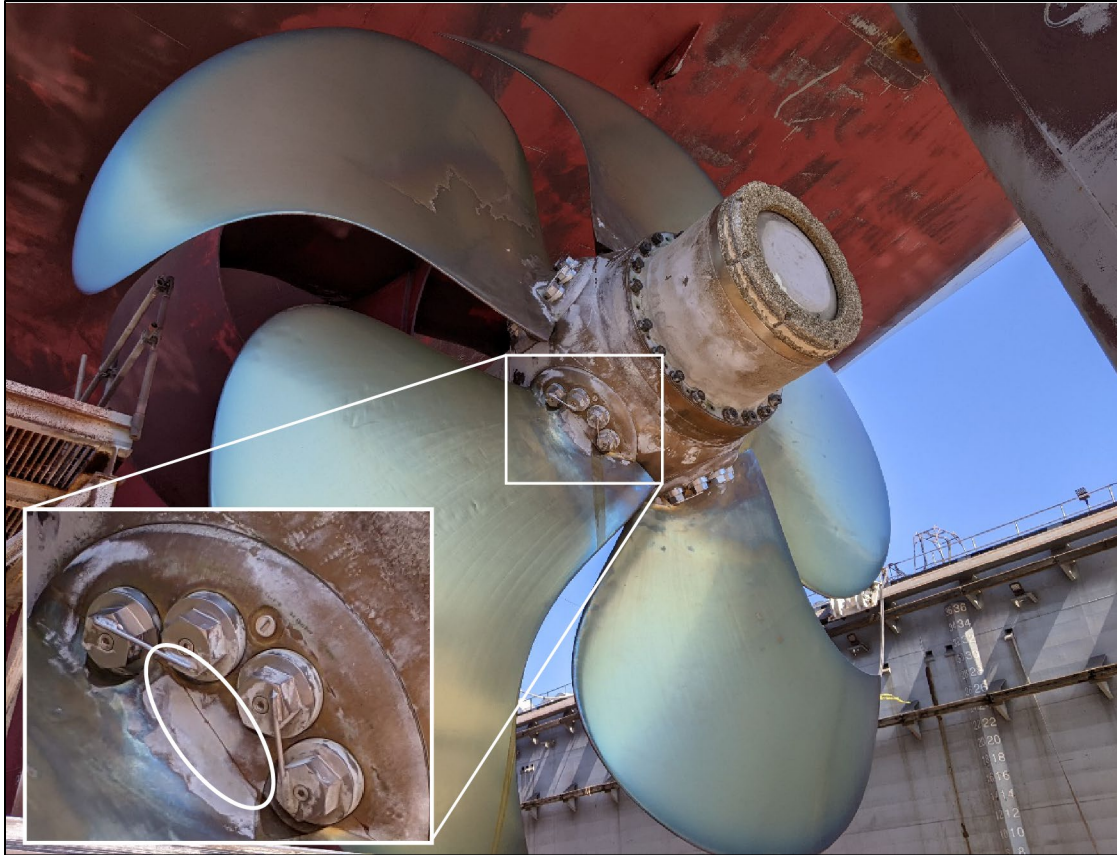
On August 15, a diver performed an underwater survey of the CPP blades and hub. The diver discovered that two of the propeller blades, nos. 2 and 4, had fractures at the base (hub) of the blades (see figure 5).

**Figure 5.** The CPP on the *Maunalei* after the casualty, showing a fracture (*inset*) at the base of the no. 4 blade. (Background source: Coast Guard)

On August 18, shipyard personnel removed both the no. 2 and 4 blades from the CPP hub, and temporary repairs began the following day. The no. 4 fractured blade was replaced with a new spare blade that the owner/operator provided, and the fractured blade was sent off for further examination and testing by the vessel's marine underwriters. Shipyard personnel grinded out the fractures and performed a weld specification procedure—approved by both the CPP manufacturer and classification society—on the no. 2 blade to return the material to its original thickness.<sup>4</sup>

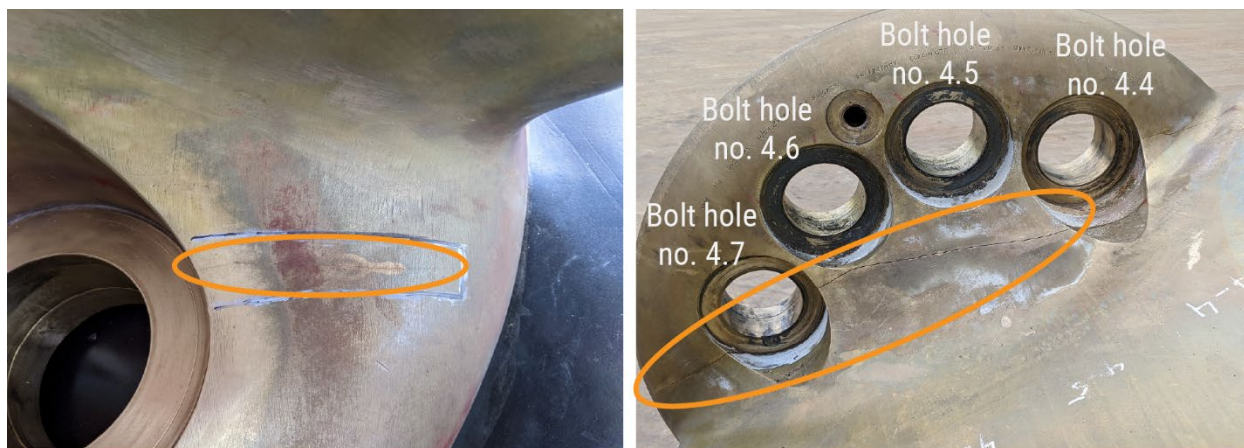
After the underwater survey, the vessel was drydocked on August 17 at Vigor Shipyard. The no. 2 blade base (foot) had free surface cracks in the way of the nos. 2.6 and 2.7 bolt holes and between the no. 2.1 bolt recess hole to the blade's leading edge (suction side) (see figure 6). The no. 4 propeller blade base had a fracture at the hub in the way of the leading edge, extending through the bolts, approaching the trailing edge. This fracture was determined to extend through the thickness of the base of the blade.

**Figure 6.** Fractures (circled in orange) on propeller blade no. 2, suction side (*left*) and no. 4, pressure side (*right*). (Background source: Coast Guard)

Coast Guard marine inspectors, a surveyor from DNV (the vessel's classification society), representatives for the propeller manufacturer, and port engineers from the owner/operating company examined the *Maunalei* while it was drydocked. The propeller blades were pressure washed, inspected, and dye-penetrant tested. Oily water from the CPP hub system was observed seeping from the no. 4 blade base fracture near blade bolt hole nos. 4.6 and 4.7.

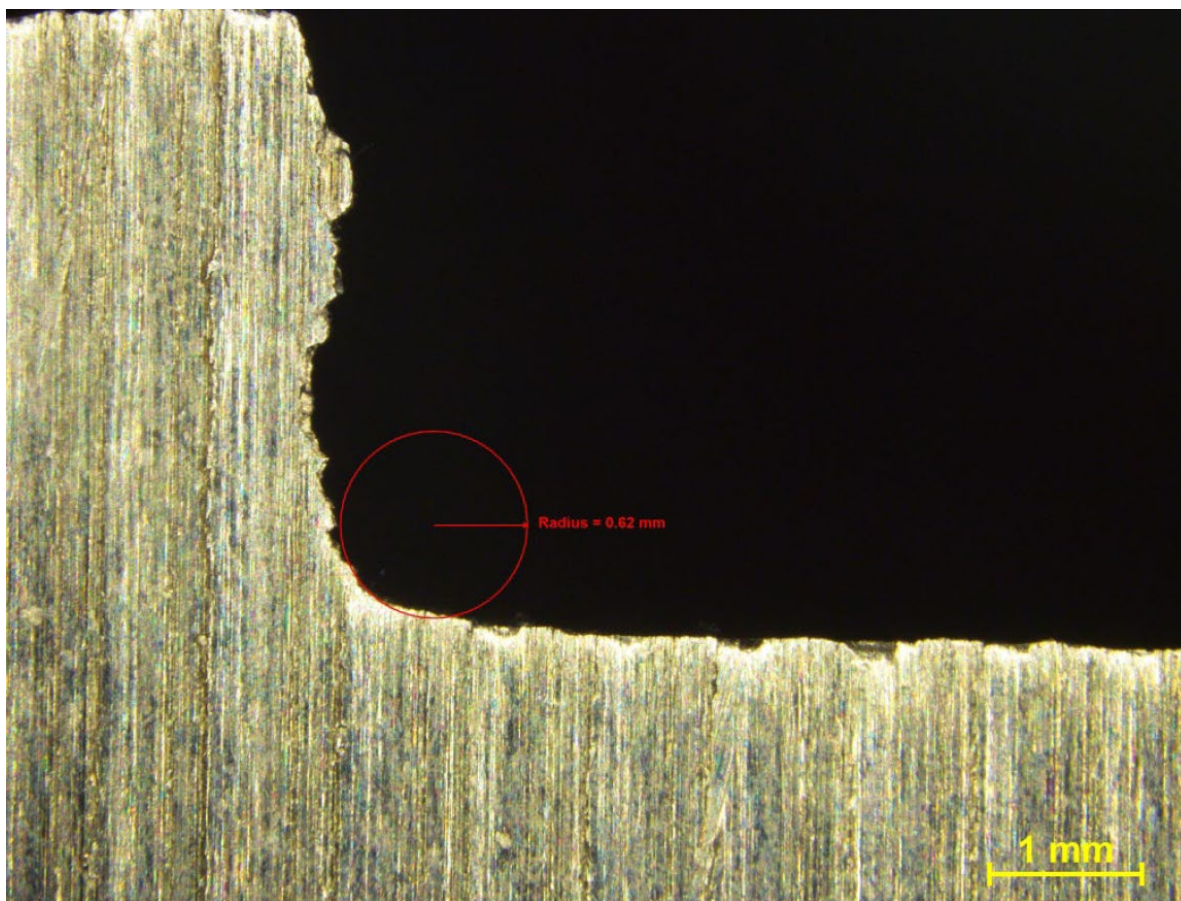
appearance of the crack fracture surfaces and the ratchet marks observed at the bolt hole counterbore edges were visually consistent with progressive cracking [caused by] high-cycle fatigue that initiated at the bolt hole counterbore edges.

The report also stated that a cross-section of one of the bolt hole counterbores measured a radius of about 0.62 millimeters, which, according to the report, did not meet the original manufacturer's designed machining radius of 0.8 millimeters (see figure 7).

**Figure 7.** The optical stereomicroscopic examination of the no. 4 blade bolt hole counterbore cross-section measured a radius of 0.62 millimeters. (Source: SOCOTEC)

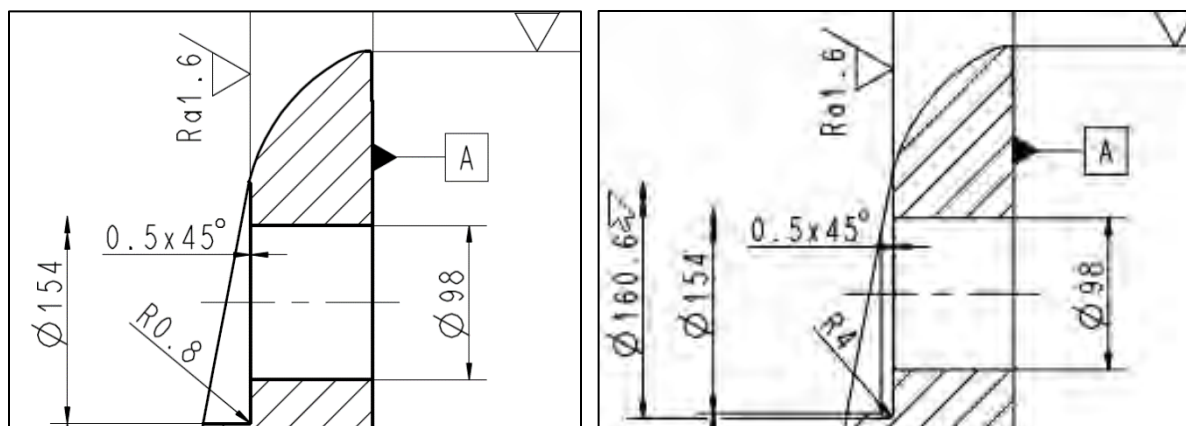
**Figure 9.** CPP blade original (*above*) and revised (*below*) machining drawings reflecting the increased internal radius required for the bolt holes. (Source: MAN Energy Solutions)

In September 2022, the CPP system manufacturer completed a review of their propeller blade foot (blade base) machining drawings. They revised the spotface machining of the internal radius for all seven bolt hole counterbores on the *Maunalei* CPP system from 0.8 millimeters to 4.0 millimeters.<sup>7</sup> The manufacturer's revised blade foot machining drawings were finalized on September 15 (see figure 9).
