Grounding of the Bulk Carrier *American Mariner*

On January 7, 2023, about 0734 local time, the bulk carrier *American Mariner* had begun transiting outbound in the Vidal Shoals Channel, near Sault Ste. Marie, Ontario, en route to Superior, Wisconsin, when the vessel grounded and sustained damage to three ballast water tanks (see figure 1 and figure 2).¹ No pollution or injuries were reported. Damage to the vessel was \$600,000.

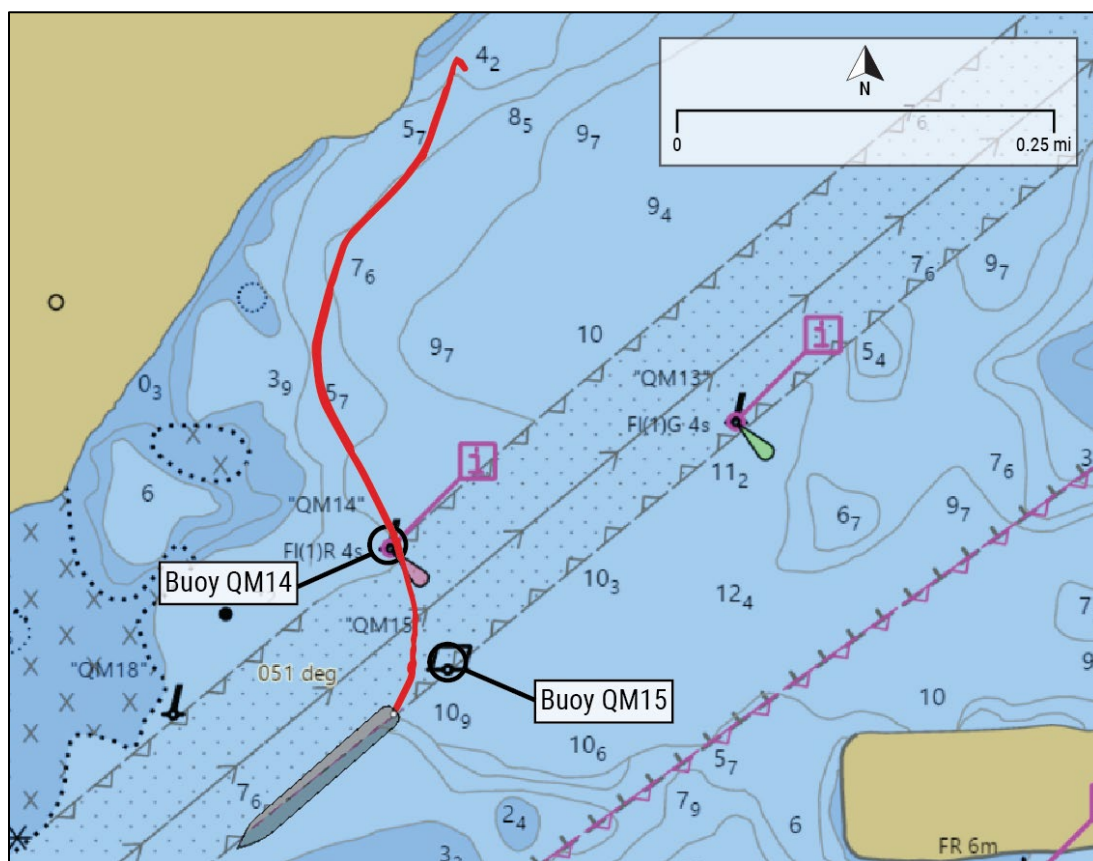
Figure 3. *American Mariner's* AIS path after it left the facility, in relation to the buoys, channel, and shoal water (final vessel position shown is at 0730:55). Soundings are in meters; shoal water is indicated with darker blue. (Background sources: Made Smart and NOAA)

Crewmembers reported a sound and “shudder” while the master was maneuvering the vessel into the Vidal Shoals Channel; they then discovered that one of the vessel’s ballast tanks appeared to be communicating with the lake, and therefore was likely damaged. Although the master stated the ship was in the channel, the shoals were located immediately outside the buoyed channel and the AIS data from that time showed the vessel on the far (southeast) side of the channel. After the vessel was drydocked, damage to three ballast tanks at the bilge chine along the port side was found—including breaches of the hull to hold no. 6. Given the crew reports, damage to the port chine and bottom plating, and the vessel’s position at the southeast edge of the channel, the *American Mariner* grounded on Vidal Shoals at the edge of the channel.

When departing the Algoma Sawmill Bay Dock, the ship had to avoid shoal water south of the dock (marked by buoy QM14). The NTSB reviewed data for two years of port calls at the dock. Four of the seven times *American Mariner* left the facility, including all three times after the grounding, the vessel moved astern about a ship’s length, where there was more room to maneuver, before coming ahead and entering the channel at a shallow angle and lining up on the centerline. On the casualty voyage, the master did not leave enough room between the ship and this shoal water, forcing a hard port turn once underway. The heading and position from that turn resulted in the ship entering the channel at a steep angle, which required a sharp turn to starboard to stay within the channel and avoid the shoals at the opposite side of the channel. Therefore, the master’s initial angle of departure from the dock and close approach to the shoal water by buoy QM14 positioned the vessel at a poor angle to successfully maneuver into the channel, which resulted in the vessel overshooting the turn and grounding on the shoals on the opposite side of the channel.

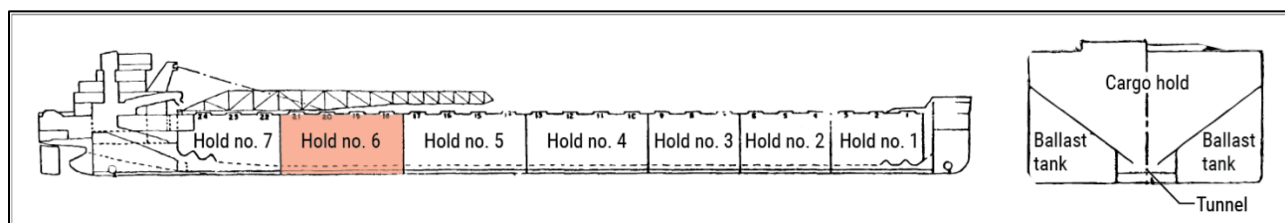
Meanwhile, the second assistant engineer was close to finishing ballasting the ship, loading nos. 7 and 8. At 0730, the first assistant relieved the second assistant engineer and noticed that tank no. 6S had 25 feet, but tank no. 6P only had 20 feet of water. The engineers attempted pumping water into no. 6P, but the water level did not increase. They then attempted to pump out tank no. 6P but could not drop the water level past 16 feet. They told investigators that they believed this indicated that the no. 6P tank was damaged (in effect, the tank was breached and communicating freely with the lake water).

Figure 4. (Left to right) Inboard profile drawing of *American Mariner*. Section drawing of *American Mariner* showing the ballast tanks in relation to the cargo tanks, void, and fore and aft tunnel. The no. 6P tank, where the engineers detected flooding, is highlighted. (Background source: Grand River Navigation)

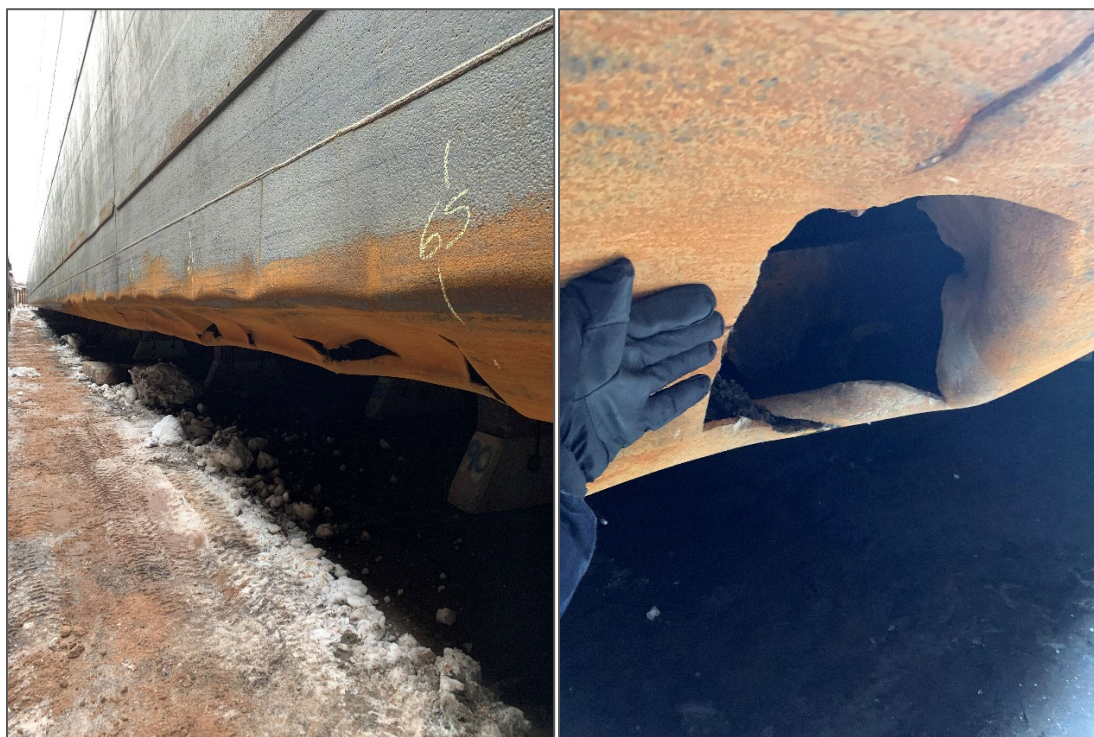
The *American Mariner* had an 80-foot-long hull indentation and holes in ballast tanks nos. 5P, 6P, and 7P at the bilge chine and in the outboard bottom plating (see figure 5). Repairs were completed during the winter lay-up and cost \$600,000.

Figure 5. Damage to the port water ballast tanks. (Source: Coast Guard)

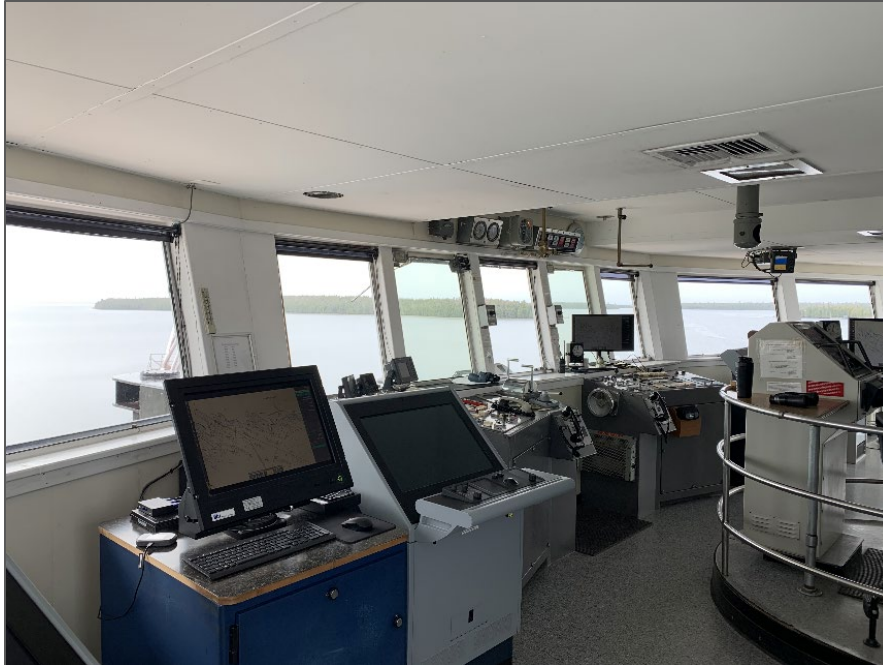
American Mariner was outfitted with a RosePoint electronic chart system (ECS) (see figure 6). The ECS was not configured to display the footprint of the vessel, according to the master, and safety depths were not programmed into the ECS.

Figure 6. *American Mariner's* bridge and centerline conning station. (Source: Coast Guard)

At the time of the grounding, it was dark and the seasonal channel buoys were unlit, which would have made it more difficult for the master to see the channel. Rose Point ECS software, which the master was using to navigate, allows users to overlay the footprint of the vessel on the chart display. (Without this, the ship appears as a dot or small icon at the position of the GPS antenna or at an offset reference point.) According to the master, this vessel footprint overlay feature was not used. Additionally, the captain was alone on the bridge (there was no regulatory or

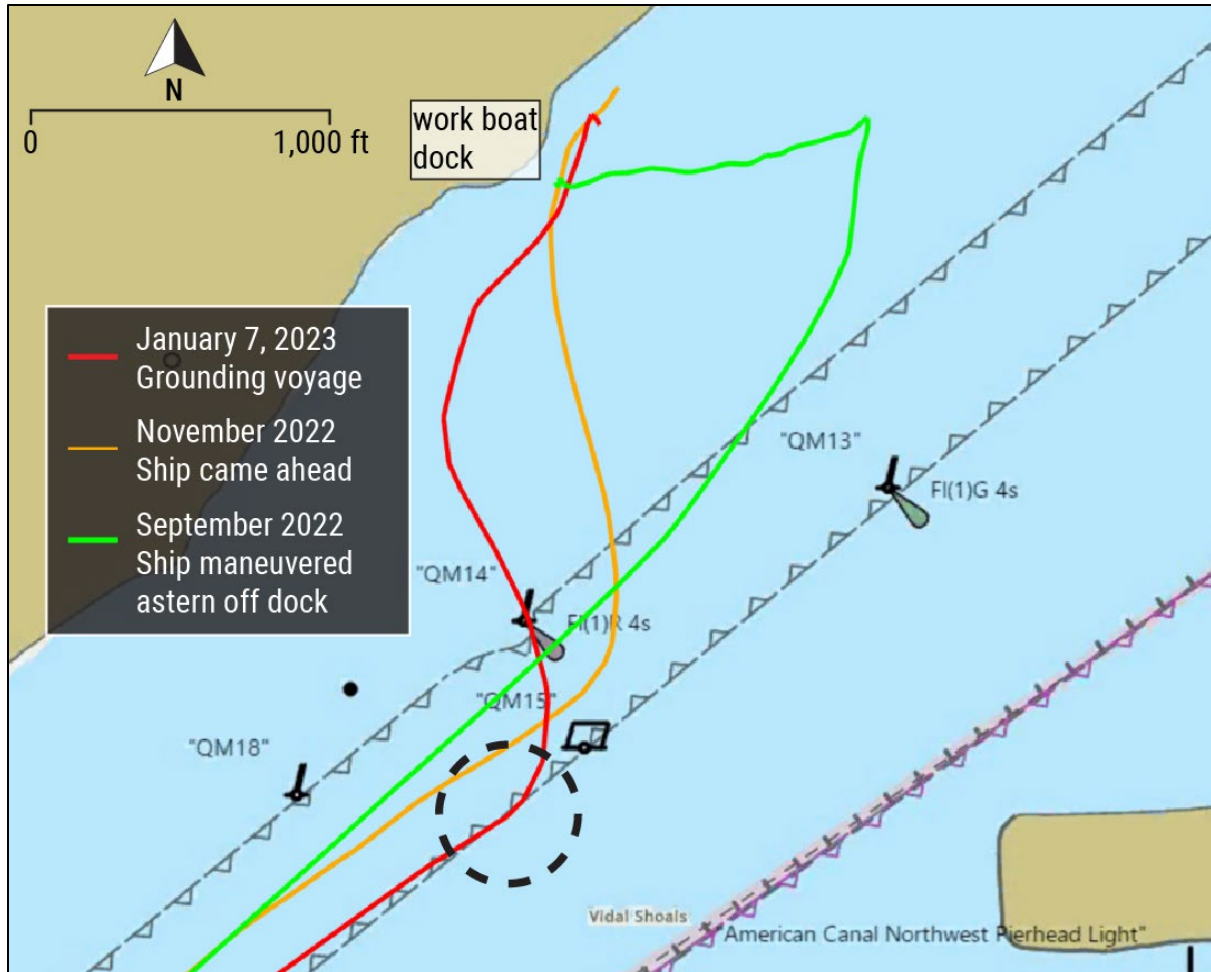
The NTSB reviewed the *American Mariner's* other port calls at Algoma in 2022 and 2023. In 2022, the *American Mariner* called on the Sawmill Bay Dock three times. In January 2022, the ship turned around and proceeded farther up the channel to the Algoma Steel dock. In September 2022, the ship moved astern about a ship's length when leaving the berth, giving the ship room to enter the channel outbound at a shallow angle and allowing for a safe passage in the center of the channel. In November 2022, *American Mariner* came ahead from the berth, turned to port, and entered the channel at a steep angle but clear and north of the red QM14 buoy, leaving room to straighten out and navigate the center of the channel (see figure 7).

Figure 7. AIS tracklines of the *American Mariner* navigating into the channel from the facility. The area where the vessel's course took it near the edge of the channel is circled with dashes. (Source: Made Smart)
