Grounding of Bulk Carrier *John J Boland*

Casualty Summary

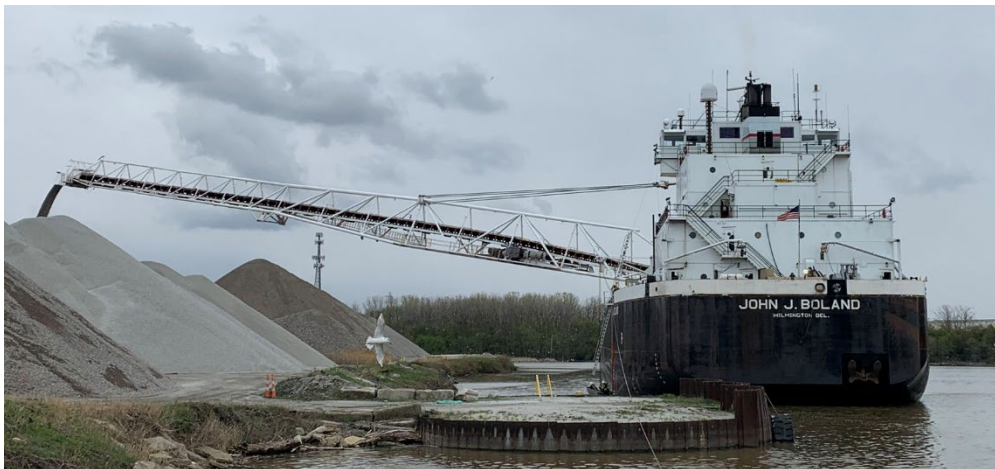
Figure 1. *John J Boland* discharging cargo from its port side using its self-unloading boom in Lorain, Ohio, after the grounding.

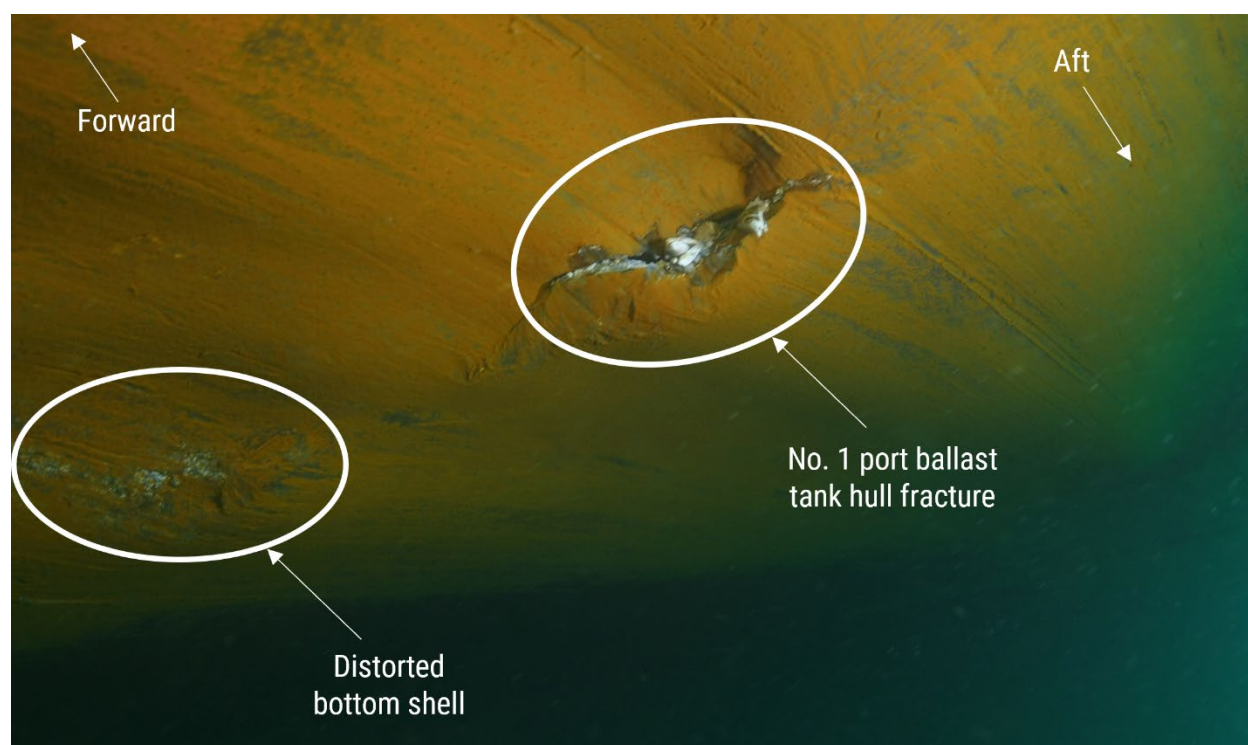
On April 22, an American Bureau of Shipping surveyor boarded the *John J Boland* and examined the damage. The surveyor found that both the nos. 1 and 2 port ballast tanks had sustained four hull fractures (all about 6 inches in length), all on the portside bottom plating at or near the turn of the bilge (near hatch nos. 3 and 4), which allowed for flooding into these spaces. Additionally, the no. 1 port tank had distorted bottom shell longitudinals and transverse web frames, and the no. 2 port tank had distorted longitudinals for the full length of the tank (all about 7 to

10 feet from the portside shell). The nos. 3 and 4 port ballast tanks sustained inset damage to the bottom plates of the tanks with longitudinals distorted and upset for the full length of no. 3 tank and about a quarter of the length of no. 4 tank (but no fractures).

The survey report noted there was lengthy but shallow inset damage from frames 7 to 29 on the port side bottom (generally coinciding with hatch no. 1 back to hatch no. 8). Photos taken by a contracted diving company showed bottom debris and mussel shells in the largest of the fractures (see figure 5). Insets and scrapes that led in a forward and aft direction were found on the hull in this location. The operating company attributed the damage to the vessel being “loaded down onto a shoal located at the forward end of the slip bed.”

Figure 5. No. 1 port ballast tank hull fracture and distorted bottom shell (both circled). (Background source: Beneath the Surface)

Based on the surveyor’s assessment of the damage, and with approval of the US Coast Guard, the *John J Boland* was granted passage to its discharge port (in Lorain, Ohio) where the vessel could be unloaded before transiting to drydock (in Sturgeon Bay, Wisconsin) for permanent repairs. The cost of repairs was \$776,125.

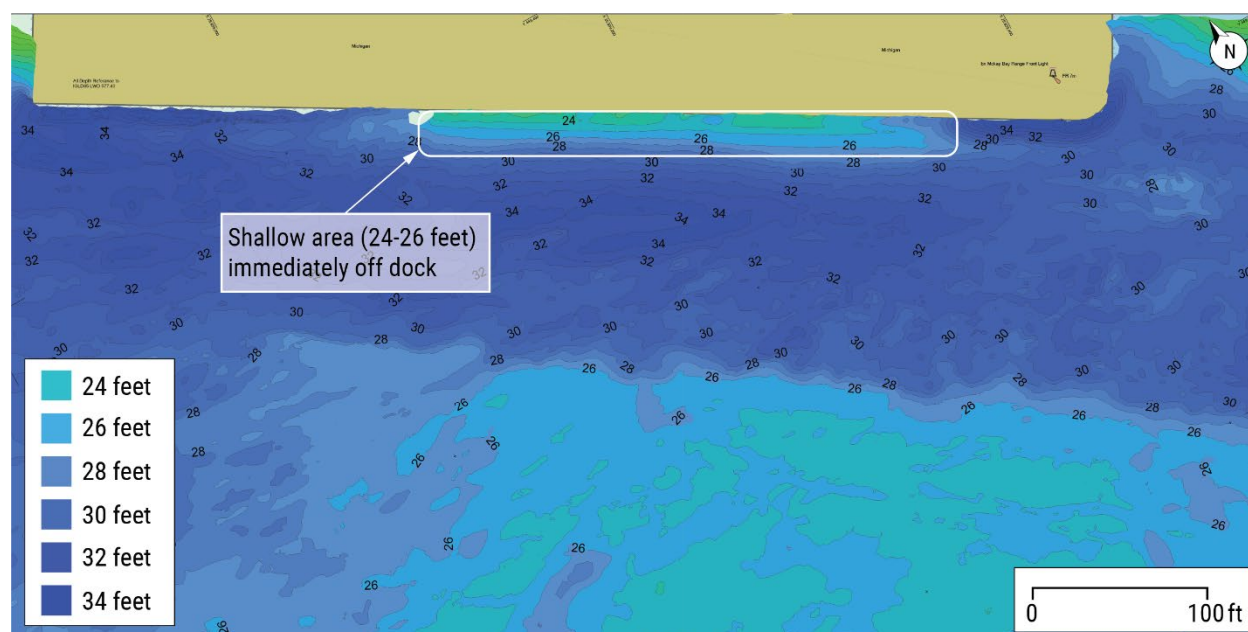
After the *John J Boland* grounded, Carmeuse Americas contracted a marine construction company to conduct a bathymetric condition survey of the area around the Cedarville dock. The resulting May 8, 2023, survey recorded that the shallowest areas were immediately off the dock, measuring 24 to 26 feet (at International Great Lakes Datum) and extending about 15 feet away from the dock (see figure 6).

Figure 6. May 8, 2023 (16 days after grounding) bathymetric survey of Cedarville dock (at International Great Lakes Datum). (Background source: Ryba Marine Construction Co.)

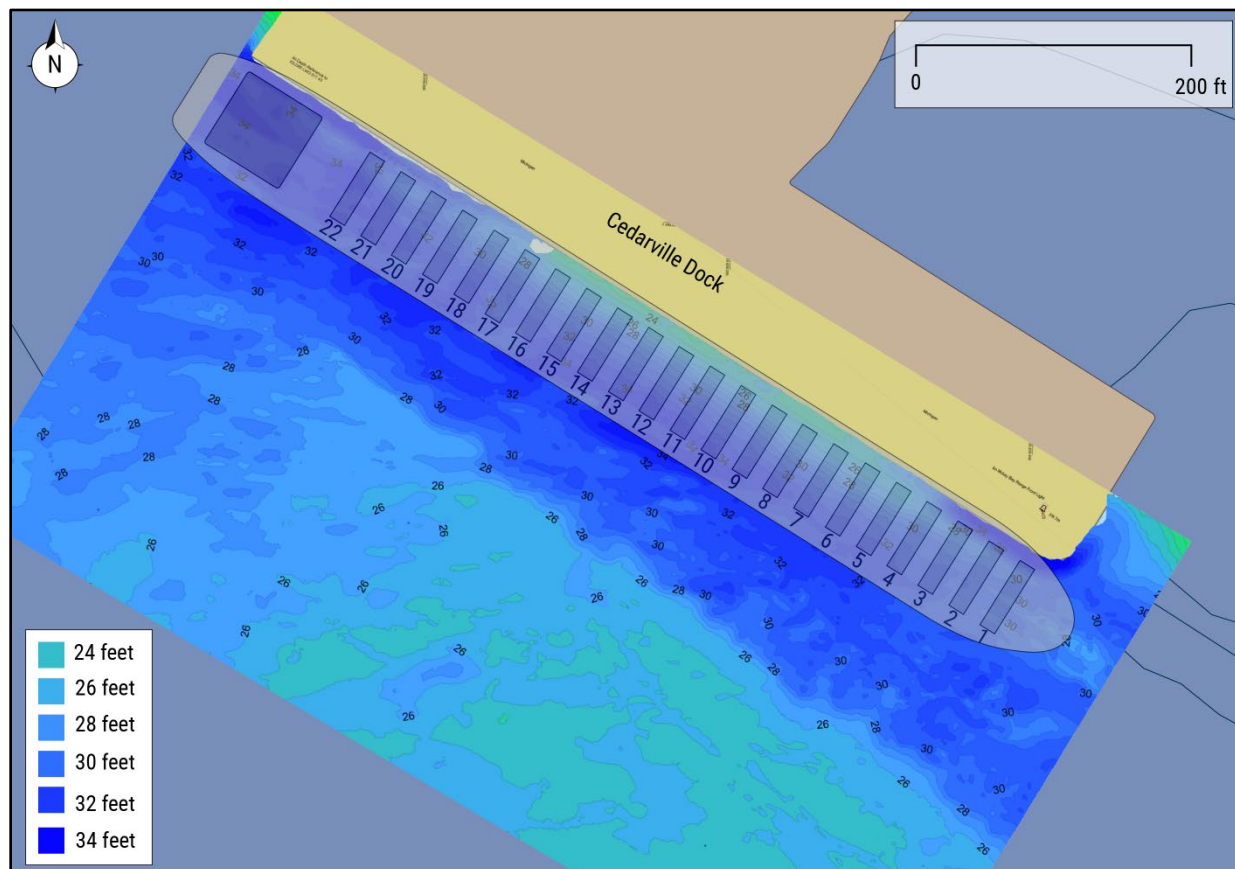
However, when the forward draft reached 26 feet 7 or 8 inches, the draft stopped increasing while product was still being added to the hatch, indicating the vessel had touched bottom. Although the forward draft that it stopped at was still within the limits of the load plan, it exceeded the depth of the shoal by 2 to 3 inches. Therefore, the load plan for the *John J Boland* was inadequate because it did not take into account the shoaling at the Cedarville Dock.

Figure 7. Overlay of *John J Boland*'s position at 0946 after the vessel initially grounded over the 2019 bathymetric survey of the Cedarville dock, which was based on International Great Lakes Datum at Low Water Datum. (Background sources: NOAA Electronic Navigation Chart US5MI53M, Ryba Marine Construction Co.)

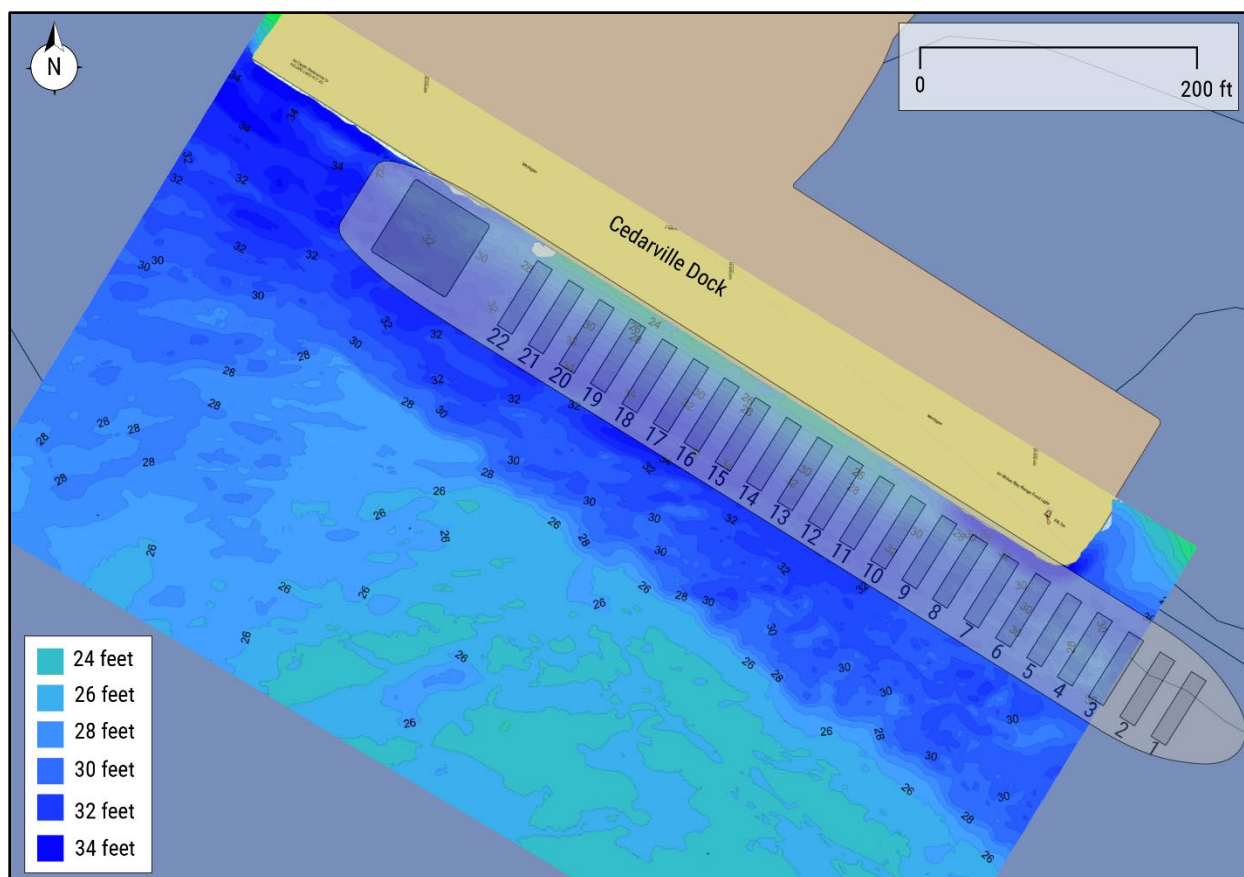
After the first grounding, the crew freed the vessel by using mooring lines to move it ahead (see figure 8). The oncoming first mate then began trim loading through the aft hatches. However, when the vessel's aft draft reached 26 feet 3 inches, the aft draft stopped increasing, indicating the vessel had grounded a second time. The oncoming first mate estimated that, at that time, the vessel's draft forward was 26 feet 10 or 11 inches, exceeding the limiting draft according to the load plan, exceeding the depth of the shoal by 5 to 6 inches, and again leaving the vessel with no underkeel clearance near the bow. About the same time the aft draft

stopped increasing, the ship listed to starboard. Although the crew loaded product through the port side of the hatches, intending to correct the list to starboard, their continued loading likely placed the vessel harder onto the shoal. Unlike in the first grounding, when the crew used the mooring lines and the self-unloading boom to free the *John J Boland*, the master decided to use the vessel's main engine (propulsion) to free it and back off the dock after the second grounding because the vessel was ready to depart. The vessel's hull, which was already grounded on the shoal, would have scraped along the bottom as the master backed the vessel off the dock, likely causing the hull damage.

Figure 8. Overlay of *John J Boland*'s position at 0957 after the vessel grounded a second time over the 2019 bathymetric survey of the Cedarville dock, which was based on International Great Lakes Datum at Low Water Datum. (Background sources: NOAA Electronic Navigation Chart US5MI53M, Ryba Marine Construction Co.)
