MIR-24-37

Fire aboard Passenger Vessel *Spirit of Boston*

Commonwealth Pier, Boston Harbor

March 24, 2023

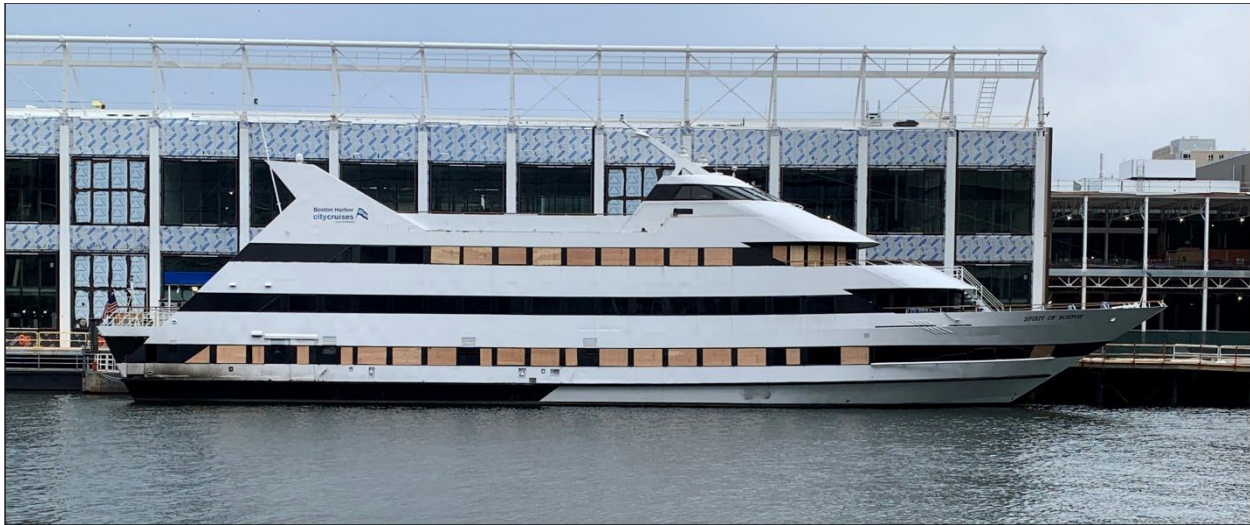
Figure 1. Passenger vessel *Spirit of Boston* after the fire.

Most of the fire damage was concentrated in the wait station and the adjacent spaces on deck 1.

About 70 windows on both sides of the vessel on all passenger decks were broken. Two vertical stanchions between deck 3 and the bridge deck were distorted,

and there was heat and smoke damage throughout the vessel on all passenger decks.

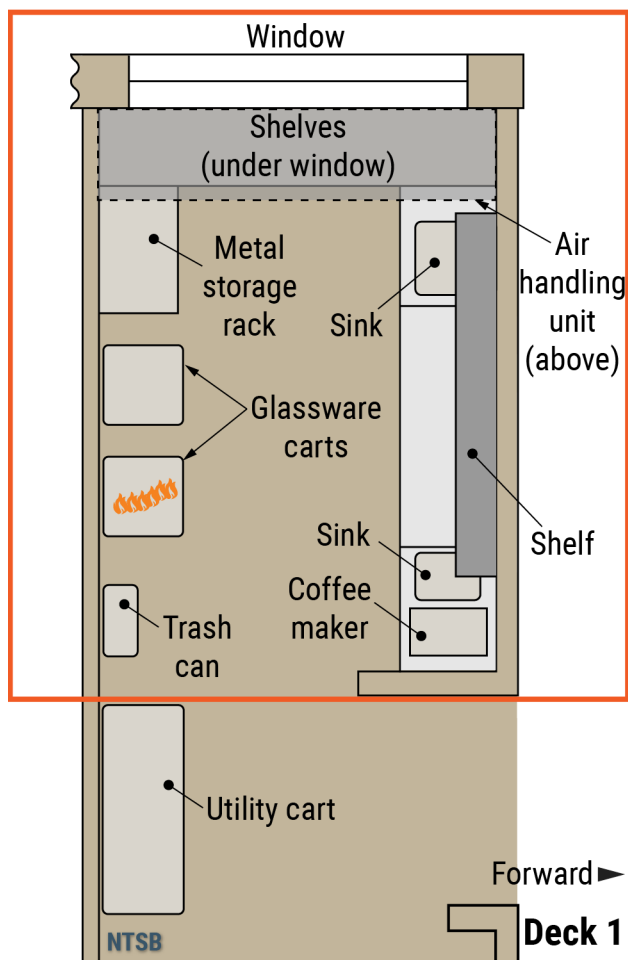
The restaurant manager stated that the color of the fire was “yellowish/orange” and was contained to the deck; he said that nothing else was burning at the time. He also heard “a very high-pressure noise” that “sounded like basically an air compressor like when you press it, and it shoots out pressurized air.” He did not know what

Figure 8. *Spirit of Boston* deck 1 wait station area layout (outlined), including approximate location of fire, indicated by a fire symbol, as reported by the restaurant manager.

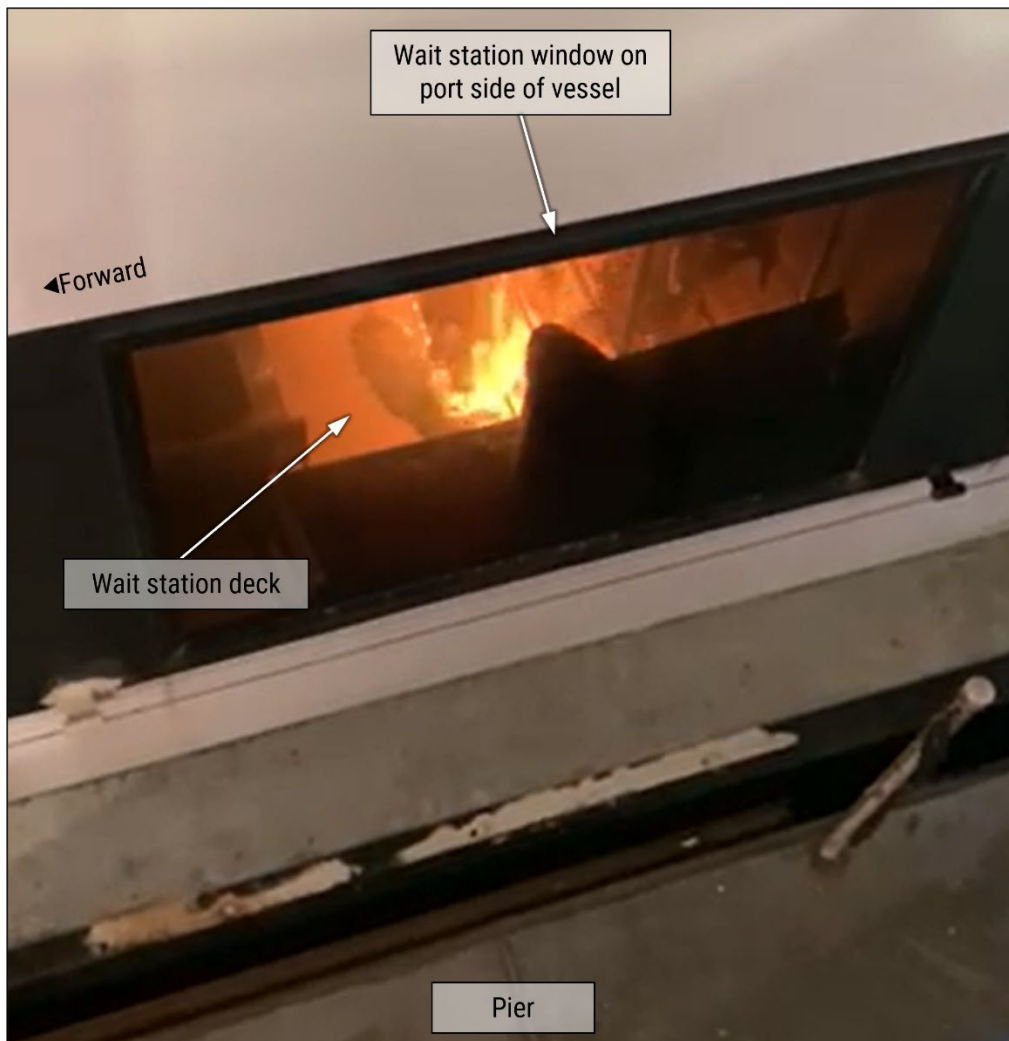
About 2 minutes after the vessel was evacuated, the restaurant manager observed from the pier that the “entire vessel was filled with black smoke, and then it started seeping out of the windows and the door.” He stated, “[The fire] broke through that [wait station] window. And out of that window the flames started following it” (see figure 9).

Figure 9. Screenshot from video taken on the pier at 2307, after hospitality staff evacuated the vessel, showing fire in the *Spirit of Boston* wait station as seen through the wait station window. (Source: *Spirit of Boston* hospitality staff member)

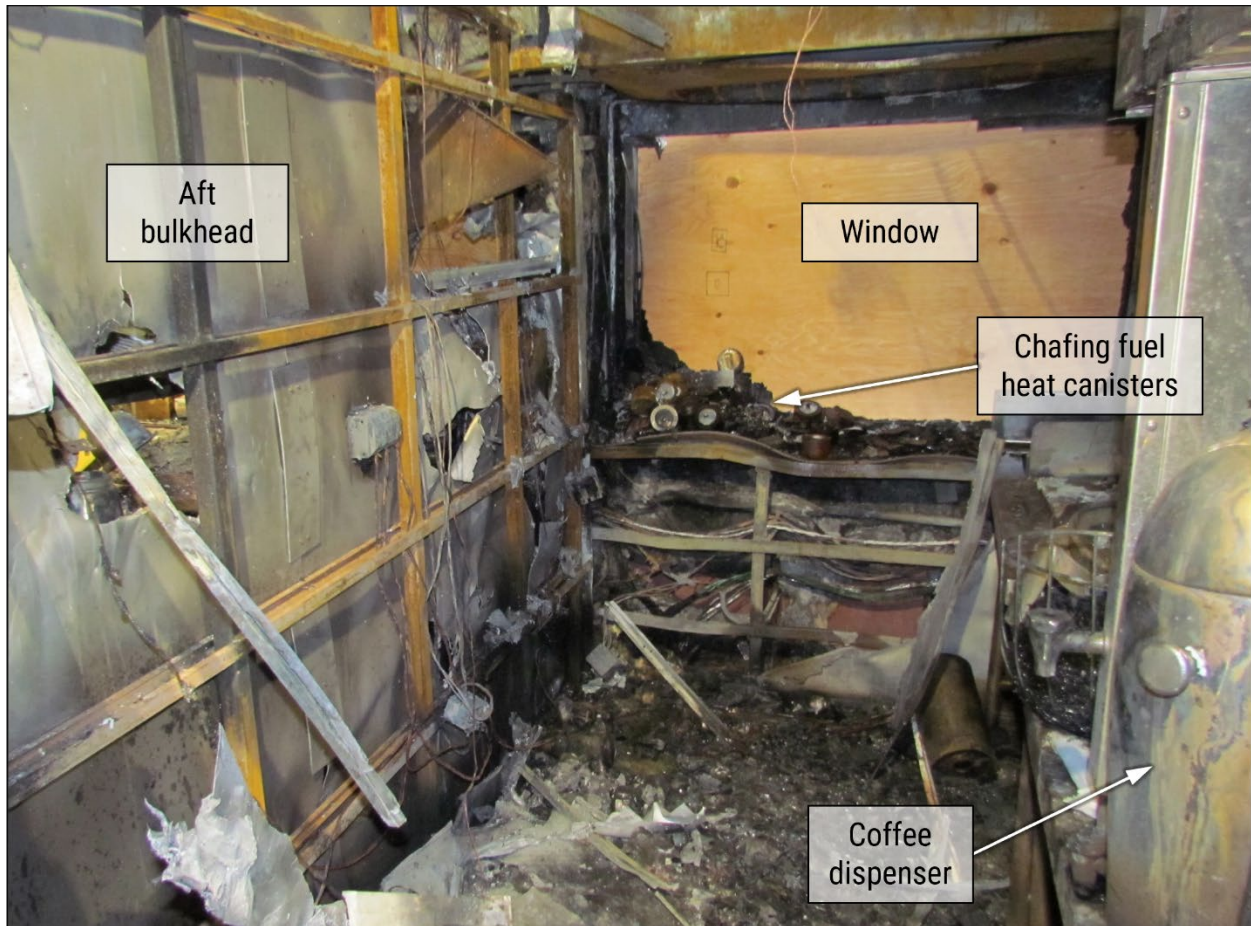
The bulkheads of the 6.5-foot-wide-by-9-foot-long wait station on deck 1 of the *Spirit of Boston* were made up of steel framing covered by metal joiner panels. The overhead had a drop ceiling made of metal panels that were hung from the framing of the deck above. The aft bulkhead joiner panels melted away during the fire, and the steel framing was exposed. Several electrical cables that ran through the bulkhead cavity and in the space above the drop ceiling sustained fire damage. Steel beams in the overhead area were warped and distorted from the heat of the fire, and the steel deck above the wait station warped and buckled the tiled deck above the steel deck.

... were in a cardboard box that was burned on the top with the bottom of the box remaining. The chafing fuel heating canisters had exterior heat damage but none of the cans were split open or showed signs of boiling liquid expanding vapor explosion.⁴ [See figure 10.]

Figure 10. *Spirit of Boston* deck 1 wait station, looking outboard, after the fire. (Source: ATF)

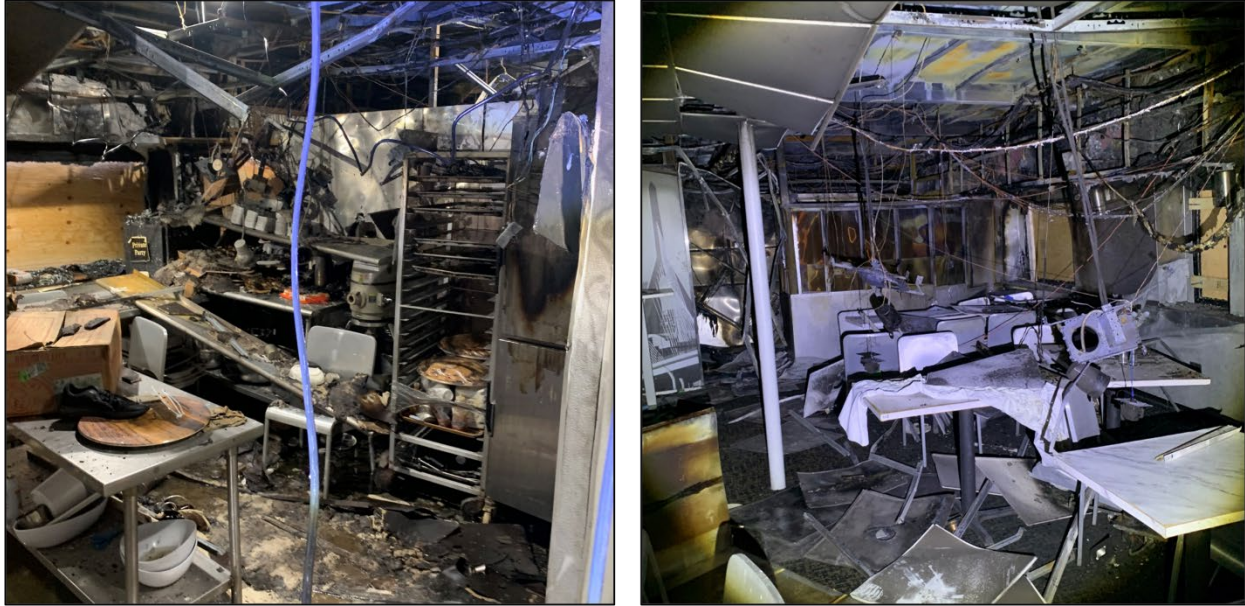
In the cold prep room aft of the wait station, the galley equipment, electrical cables, and some combustible materials on the forward side of the room (adjacent to the deck 1 wait station) sustained fire damage (see figure 11). Several drop ceiling panels in the cold prep room were consumed by fire.

Figure 11. Left to right: Port side of the *Spirit of Boston* cold prep room, aft of the deck 1 wait station, after the fire, looking forward. Port aft corner of the passenger area on deck 1, forward of the wait station, after the fire.

In the passenger area on deck 1, forward of the wait station, in the port aft corner of the space, the drop ceiling panels had been consumed by fire, the electrical cables in the exposed overhead space were damaged, and bulkhead joiner panels were burned (see figure 11). Numerous lifejackets with fire damage were found in the storage bin, which ran along the upper section of the port outboard bulkhead above the windows. Several lifejackets were completely consumed, with only the buckles remaining.

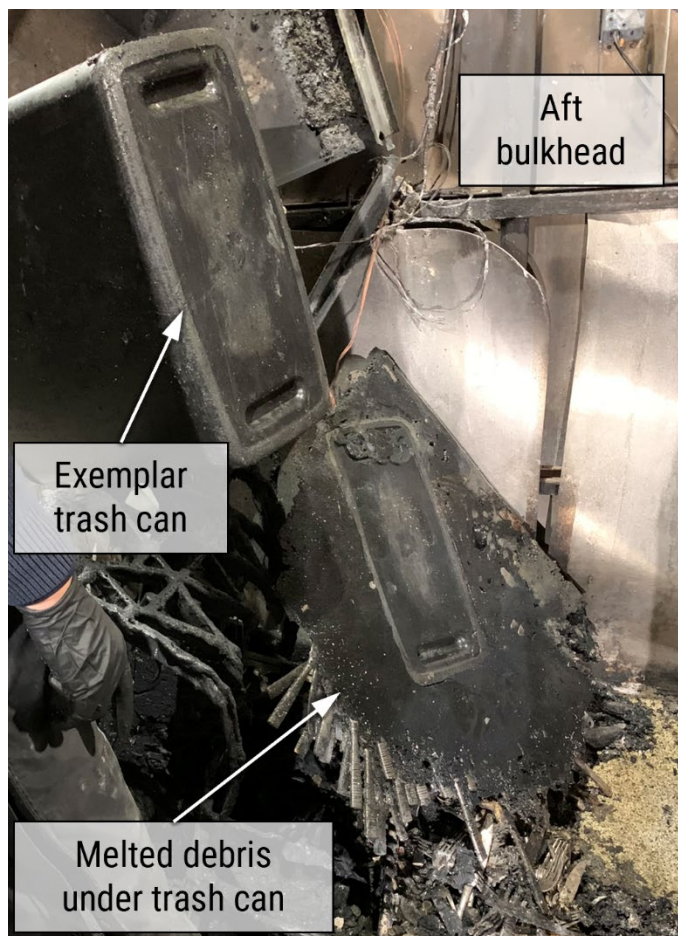
the wait station. Several utensils and unburned combustible items—including a coffee filter, a sugar packet, and straws—were found at the base of the melted trash can. The plastic trash bag that had been at the bottom of the trash can was still intact. Investigators did not find a chafing fuel heating canister nor a liquid wax candle in the remains of the trash can. The trash can melted, turning into a mass of debris directly below where it had been located. The melted mass had an outline of the base of the trash can—visible when the mass was inverted—enabling investigators to determine the trash can’s exact location in the deck 1 wait station during the fire (see figure 14).

Figure 14. Underside of melted mass of debris (remains of trash can) in the deck 1 wait station on the *Spirit of Boston* after the fire, showing imprint of the trash can’s base compared to an exemplar trash can.

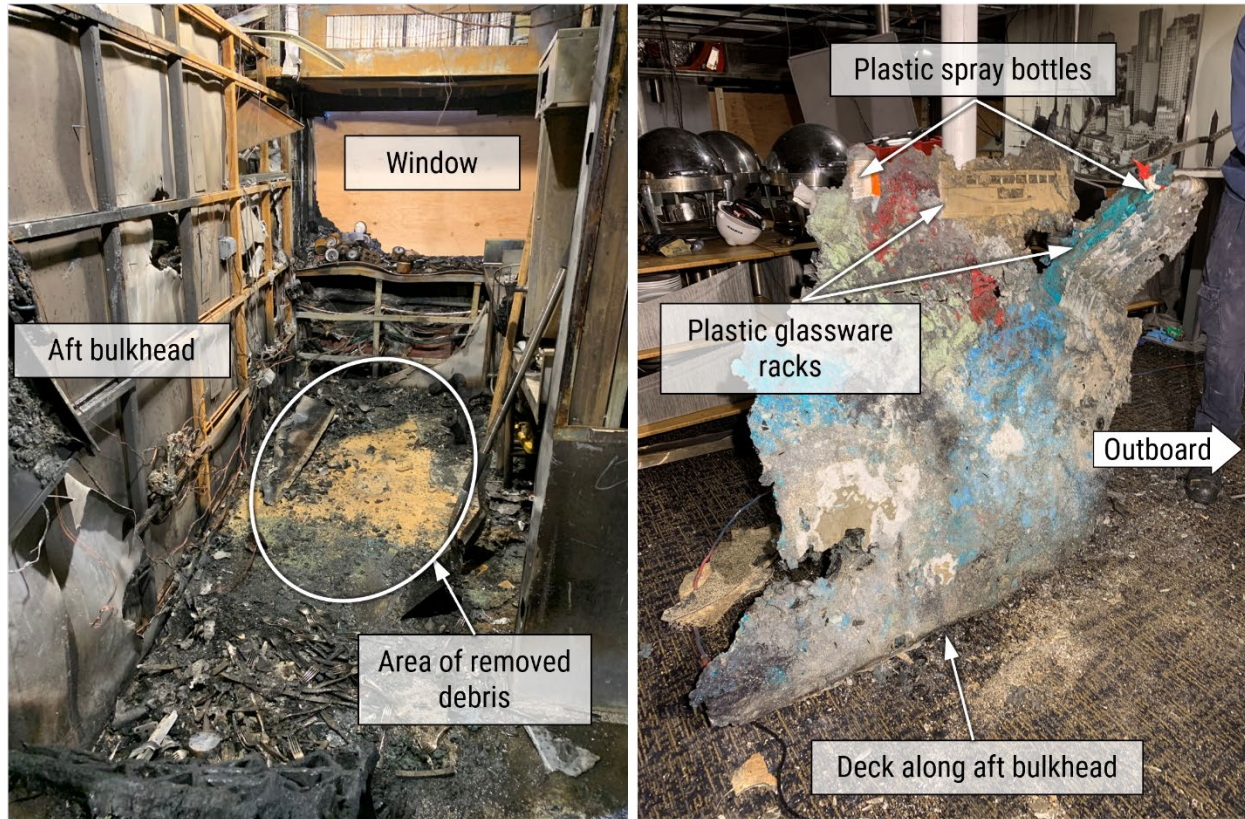
Investigators pried another melted single piece of debris from the steel deck of the wait station where the plastic glassware rolling carts had been located outboard of the trash can in the deck 1 wait station (see figure 15). A visual examination of the bottom of the removed mass of debris revealed melted plastic glassware rolling carts, drinking glasses, coffee cups, plastic spray bottles, and other debris.

Figure 15. *Left to right:* Location of the melted mass of debris—comprising the remains of the plastic glassware rolling carts—removed from the deck 1 wait station on *Spirit of Boston* after the fire. Bottom of the melted mass of debris from the wait station after flooring material was removed. (Figure 8 shows the deck 1 wait station layout before the fire.)

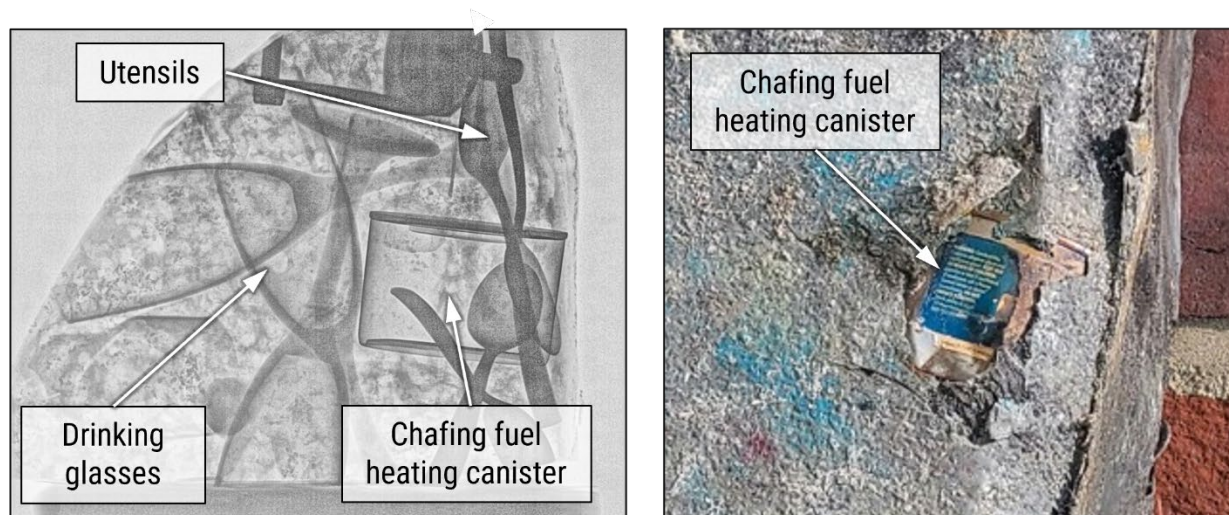
On May 11, 2023, ATF fire investigators X-rayed the second melted mass of debris that was removed from the area where the plastic glassware rolling carts had been. They found several metal utensils, such as knives and spoons, throughout the mass. They also found a chafing fuel heating canister; they determined the canister was located on its side, up against the aft bulkhead, under the plastic glassware cart nearest to the trash can (see figure 16).

Figure 16. Left to right: X-ray image of debris removed from the *Spirit of Boston* deck 1 wait station showing chafing fuel heating canister. Closeup of chafing fuel heating canister found in the same debris. (Background sources: ATF, Coast Guard)

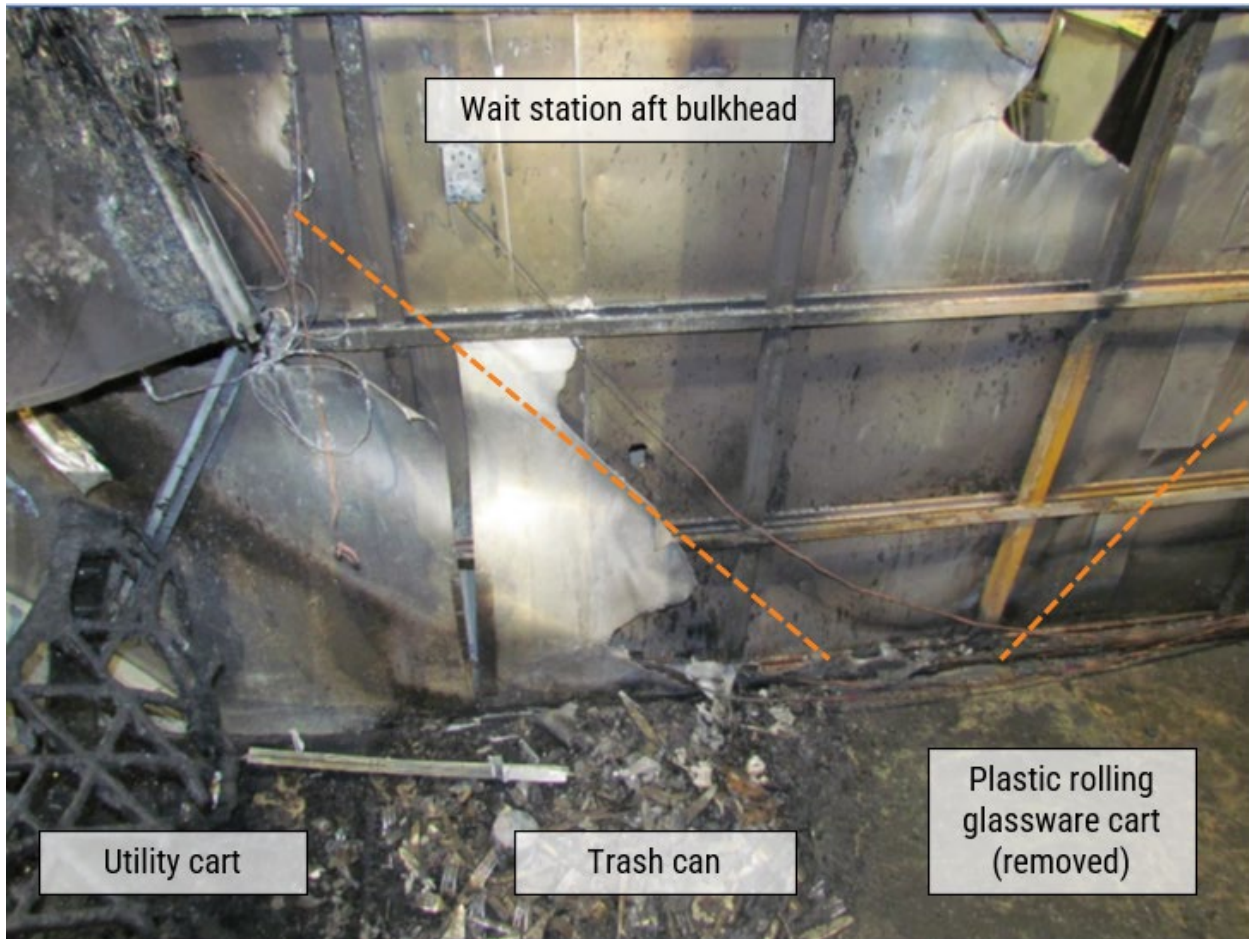
During the postcasualty examination of the vessel, ATF fire investigators observed an oxidation pattern on the aft bulkhead of the deck 1 wait station's sheet metal bulkhead covering—aft of the plastic glassware rolling carts and trash can. Additionally, they found that a two-level utility cart located in the outboard corner of the deck 1 wait station was directionally damaged, meaning the damage increased on the inboard side of the cart and decreased on the outboard side of the cart. Together, the directionally damaged cart and oxidation pattern created a "V" fire pattern on the aft bulkhead of the deck 1 wait station (see figure 17).¹⁷ Aft of the deck 1 wait station, in the cold prep room, there was a "V" fire pattern on the forward portside bulkhead that abutted the wait station. On both sides of the bulkhead, the

“V” pattern rose upward and outward from the deck from the area behind the inboard plastic glassware rolling cart in the deck 1 wait station.

Figure 17. “V” pattern (shown as orange lines) as observed by ATF on aft bulkhead of deck 1 wait station near utility cart, waste trash can, and plastic rolling glassware carts. (Background source: ATF)

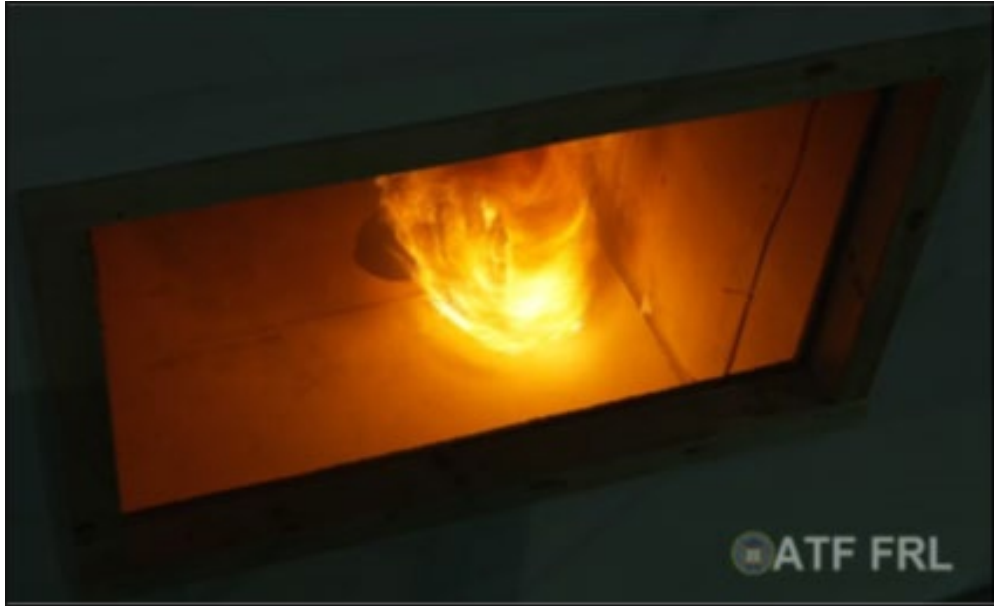
Several tests were conducted within the test structure by placing a lit chafing fuel canister on its side under the inboard plastic glassware rolling cart, as found in the X-ray of the melted mass of debris. About 8 minutes after ignition of the plastic glassware rolling cart, visible or “light” smoke emanating from behind/underneath the plastic glassware rolling cart in the test structure was observed for about 14 minutes, and about 9 minutes after ignition of the plastic glassware rolling cart, “heavy” smoke was reported for about 14 minutes.¹⁸ About a minute after heavy smoke was observed, the smoke began to turn dark, and intermittent flames could be seen between the vertical gap in the forward bulkhead and the drop ceiling.

Throughout the test scenarios, a video camera was placed outside the window of the test structure to simulate the position of the witness recording the fire aboard the *Spirit of Boston* (see figure 9 for a screenshot of the witness video taken at 2307 on March 24, 2023). According to the ATF, video taken during testing showed a “snake’ of fire, determined to be flaming dripping plastic from the rolling cart and/or glassware racks,” that was “consistent with witness observations and descriptions.” The ATF determined that the video taken during testing demonstrated a “fire consistent with the observed fire event” due to the “consistent flame vectoring and liquified plastic pool to the left of the flames” (see figure 18).

Figure 18. Screenshot of video looking through window of ATF test structure in replicated deck 1 wait station showing flame vectoring and liquified plastic pool (to left of flames) in the area where the plastic glassware rolling cart was located. (Source: ATF)
