January 14, 2025

MIR-25-01

## Contact of *Kitty* Tow with Algiers Lock Gate

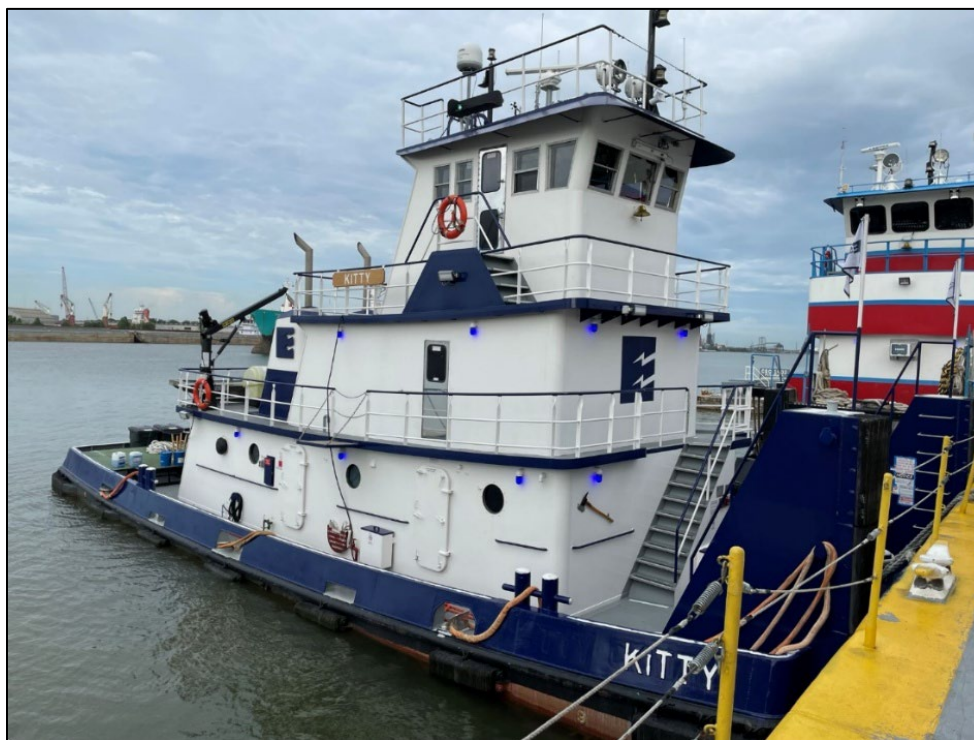
**Figure 1.** The *Kitty* after the casualty.

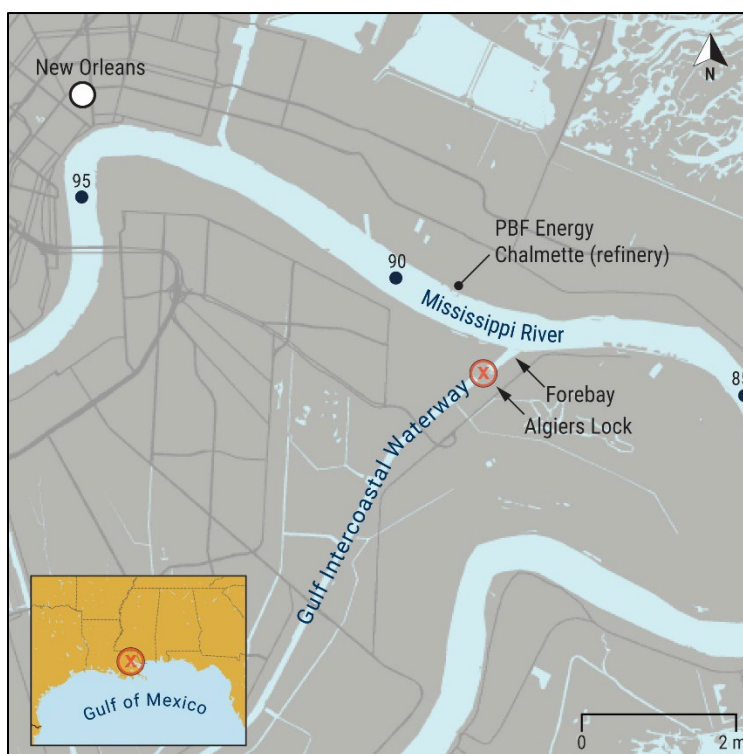
**Figure 2.** Area where the *Kitty* tow contacted Algiers Lock Gate D as indicated by a circled X. (Background source: Google Maps)

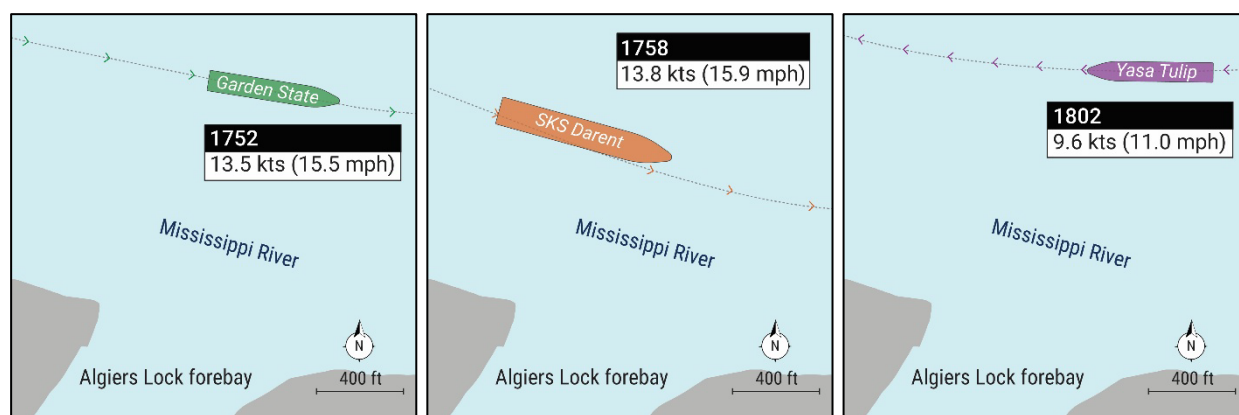
**Figure 6.** Left to right: Positions, tracks, times, and speeds of the *Garden State*, *SKS Darent*, and *Yasa Tulip* (approximate scale) while transiting the Mississippi River, near the Algiers Lock forebay, in the minutes leading up to the casualty (based on automatic identification system data).

The size of a wake caused by a vessel and the volume of water displaced is proportional to the vessel's speed, displacement, draft, trim, beam, and hull form, as well as the water's depth and the width of area the vessel is moving through. Prior to the casualty, three loaded ships (587 feet long and 820 feet long, moving southbound at about 13-14 knots; and 580 feet long, moving northbound at about 10 knots) had transited near the lock within about 10 minutes' time. The size, speed, and frequency (each within about 5 minutes of each other) of the three loaded ships transiting near the lock would have produced wakes that affected the forebay and lock chamber.

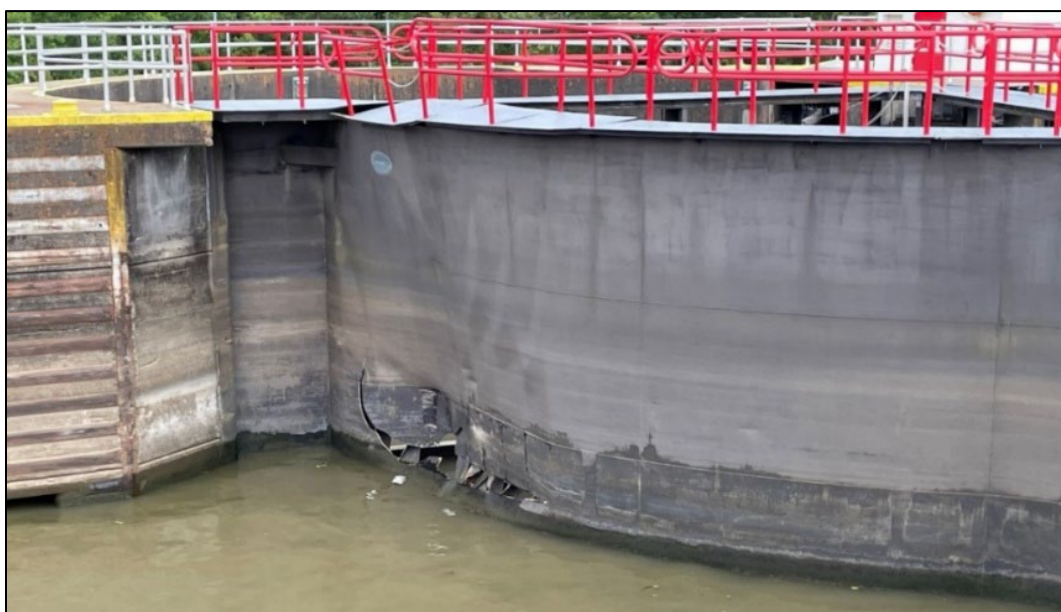
Algiers Lock Gate D sustained an approximately 16-20-foot gash and a large inset in the steel plating (see figure 8). The steel support members were also damaged, and the gate walkway was bent. The Corps of Engineers reported the cost of repairs was \$2,082,677. The Algiers Lock was reopened approximately 3.5 hours after the strike and remained functional.

**Figure 8.** Damage to Gate D as viewed from the north wall of the lock chamber.
