January 17, 2025

MIR-25-03

Grounding of Cargo Vessel *Bonnie G*

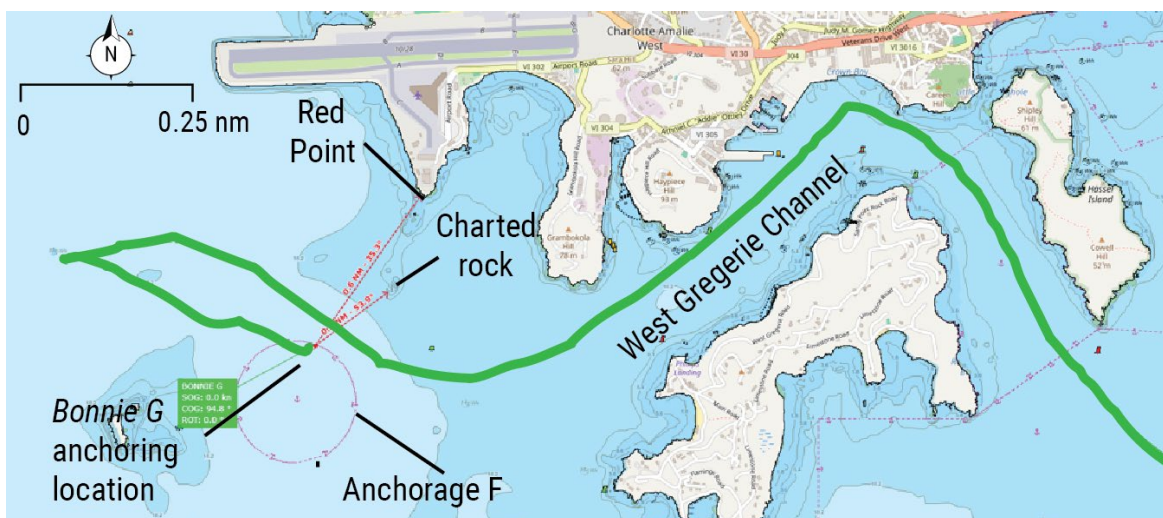
At 0020, on October 4, the *Bonnie G* was about 0.6 miles south-southwest of Red Point. According to the captain, the winds were out of the south-southeast and gusting up to 25 knots. The captain was unsure of the water depth at the anchorage, telling investigators following the casualty that the water depth was "maybe 7 to 8 meters" (23-26 feet). The navigation chart for the location indicated the water depth was 68 feet. The captain ordered the port anchor, a 2,000-pound Danforth-type with 1-3/8-inch chain, let go, and 1.5 shots (about 135 feet) of chain paid out. After several minutes, the anchor fetched up, and the vessel held position (see figure 3).

Figure 3. The *Bonnie G*'s trackline leading up to the approximate time the vessel anchored on October 4, 2023. Red bearings indicate distances to the closest point of land and to a nearby charted rock. (Background source: NOAA electronic navigation chart 25649 as viewed on Made Smart AIS)

Once the decision was made to anchor the *Bonnie G* and the captain navigated the vessel into position, the port anchor was deployed with 1.5 shots (135 feet) of chain. He likely based his decision to pay out 135 feet of chain on his erroneous assessment that the water depth in the area was only “around 7 to 8 meters” (23-26 feet). In actuality, the navigation chart for the location indicated the water depth was 68 feet. When anchoring a vessel, a length of anchor chain that is five to seven times the water depth (scope, or ratio of anchor chain to water depth) should be used; even more anchor chain should be used in adverse weather.⁷ About 340-475 feet (3.7-5.3 shots) of chain should have been let out—about 2.5-3.5 times more chain than was let out—and potentially more could have been let go, considering the windy conditions. Therefore, considering the water depth and weather conditions at the time of anchoring, the *Bonnie G* captain did not deploy enough anchor chain for a secure anchorage (inadequate scope).

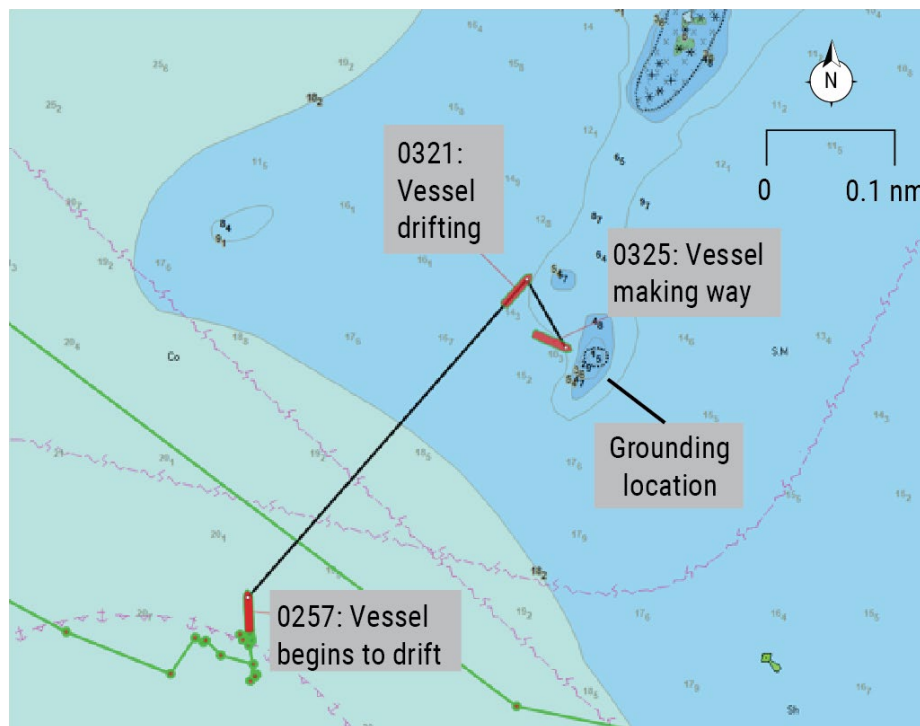
Figure 4. The *Bonnie G*'s trackline after the captain began navigating the vessel toward the green buoy and the West Gregerie Channel, just before the vessel grounded. (Background source: NOAA electronic navigation chart 25649 as viewed on Made Smart AIS)

At 0328, only minutes after beginning to make way and traveling at 0.8 knots, the *Bonnie G* ran aground on a rock. The tide at the time was running near low, and the vessel's draft was about 10 feet. According to the *United States Coast Pilot*, "a rocky ledge extends 0.4 mile south of Red Point. A steep-to rock at the outer end has a least depth of 5 feet over it."⁶ Investigators confirmed that the rock was depicted on NOAA chart 25649 and British Admiralty chart 2183.

When anchoring the vessel, the captain relied on satellite imagery screen shots sent to him by the vessel owner to find the anchorage rather than using onboard charts and navigational equipment. Additionally, after anchoring the vessel, the captain did not look at the chart and identify the charted rock just 0.3 miles northeast of the vessel's position (the direction the wind would set the vessel when drifting). The captain of the *Bonnie G* was attempting to keep his vessel and crew safe after encountering heavy weather at night, experiencing a broken anchor chain, and then observing his vessel drifting toward shore. However, because the captain did not use the available onboard navigational chart to identify a rock nearby, when maneuvering after the anchor chain failed, he inadvertently steered directly onto the rock and grounded the vessel.

When anchoring, mariners should review navigational charts and other sources of local information, such as the *US Coast Pilot*, to become familiar with nearby hazards. It is important to have this information available in heavy weather conditions, when there is heightened risk of drifting and crews may need to get a vessel underway on short notice.

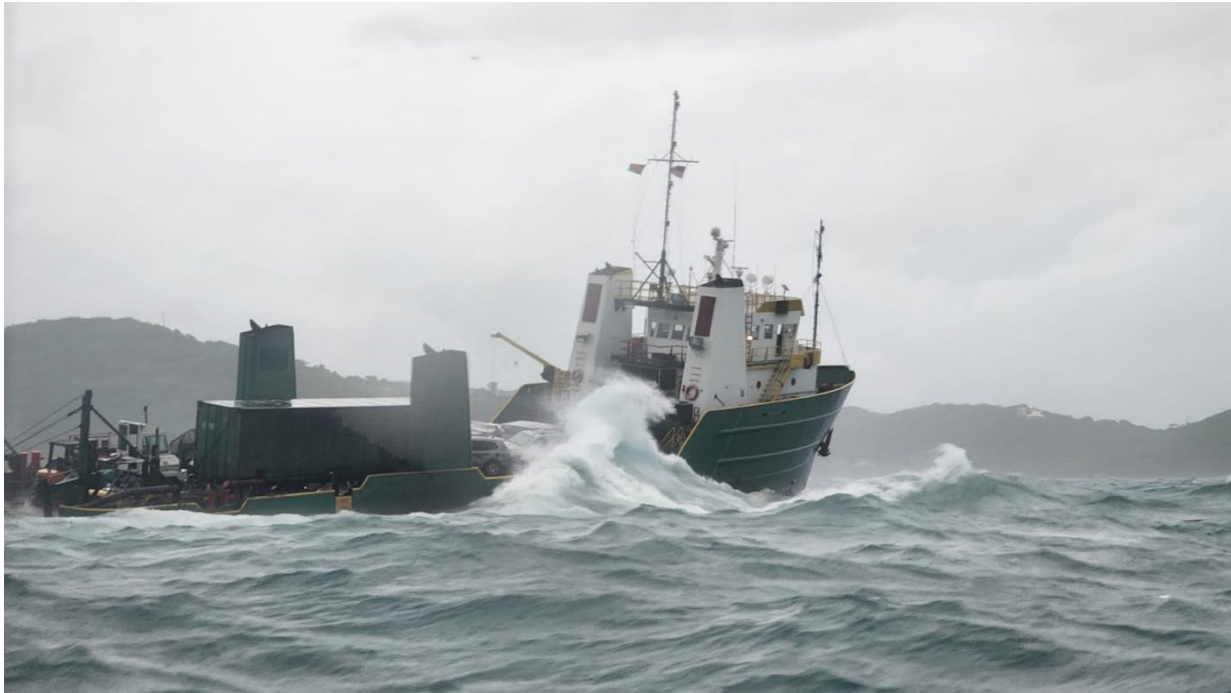
Over the next several weeks, the vessel remained stranded, in the same position where it had grounded (see figure 5). Surveyors and salvors worked to ascertain the extent of the damage to the vessel and to mitigate the potential for pollution. On October 30, following the completion of temporary repairs to the breaches in the hull (using underwater epoxy) and the removal of most of the floodwater from the engine room and hold deck (the lowermost deck of the vessel in which the engine room was located), the vessel was successfully refloated and towed to the dock in Crown Bay.

Figure 5. The *Bonnie G* stranded on the rocks following the grounding. (Source: Coast Guard)

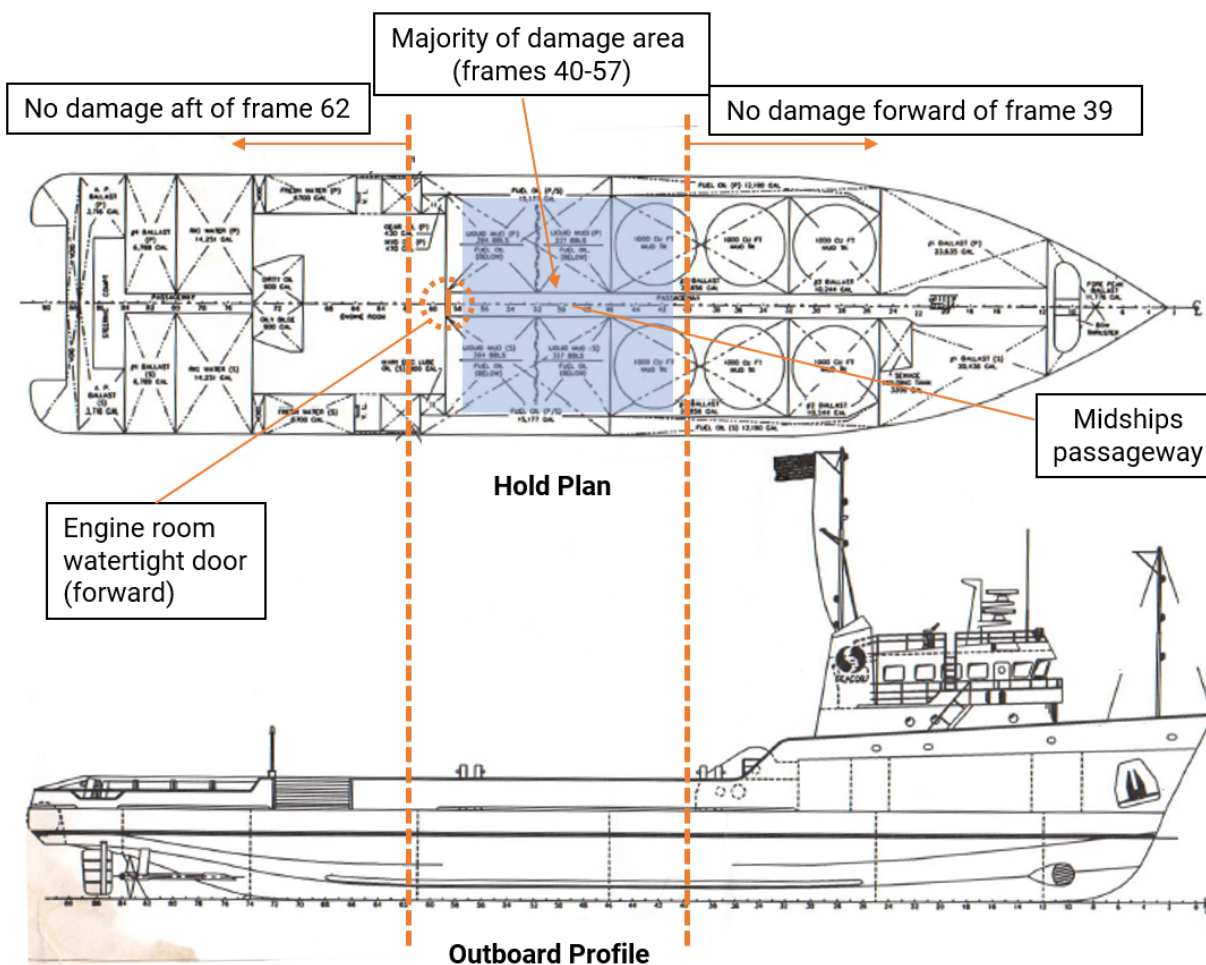
In the days following the grounding of the *Bonnie G*, a dive survey was conducted to determine and document the damaged underwater portions of the vessel (see figure 6 and figure 7). The survey determined that the bottom of the vessel had minor to serious indentation up to 1 foot in depth, pushed up into the vessel. Although there was damage to the hull noted between frames 39 and 62, most hull indentations were between frames 40 and 57. Most hull breaches were along bottom plating welds in the area of the midships passageway.

Figure 6. A plan and profile view drawing of the *Bonnie G* with annotations noting areas of damaged sustained during the grounding. Additionally, the engine room watertight door through which floodwater entered the engine room from the midships passageway is identified. (Source: Third Lady, LLC)

There was significant flooding inside the vessel. A hull breach in the midships passageway caused flooding into the passageway space. The watertight door located at frame 59 segregated the midships passageway from the engine room. This door was open during the grounding and subsequent flooding, and thus allowed water to progressively flood from the midships passageway into the engine room. In total, about 6-7 feet of water flooded the engine room, submerging all engine room equipment, including the electrical generators and main engines, in salt water.

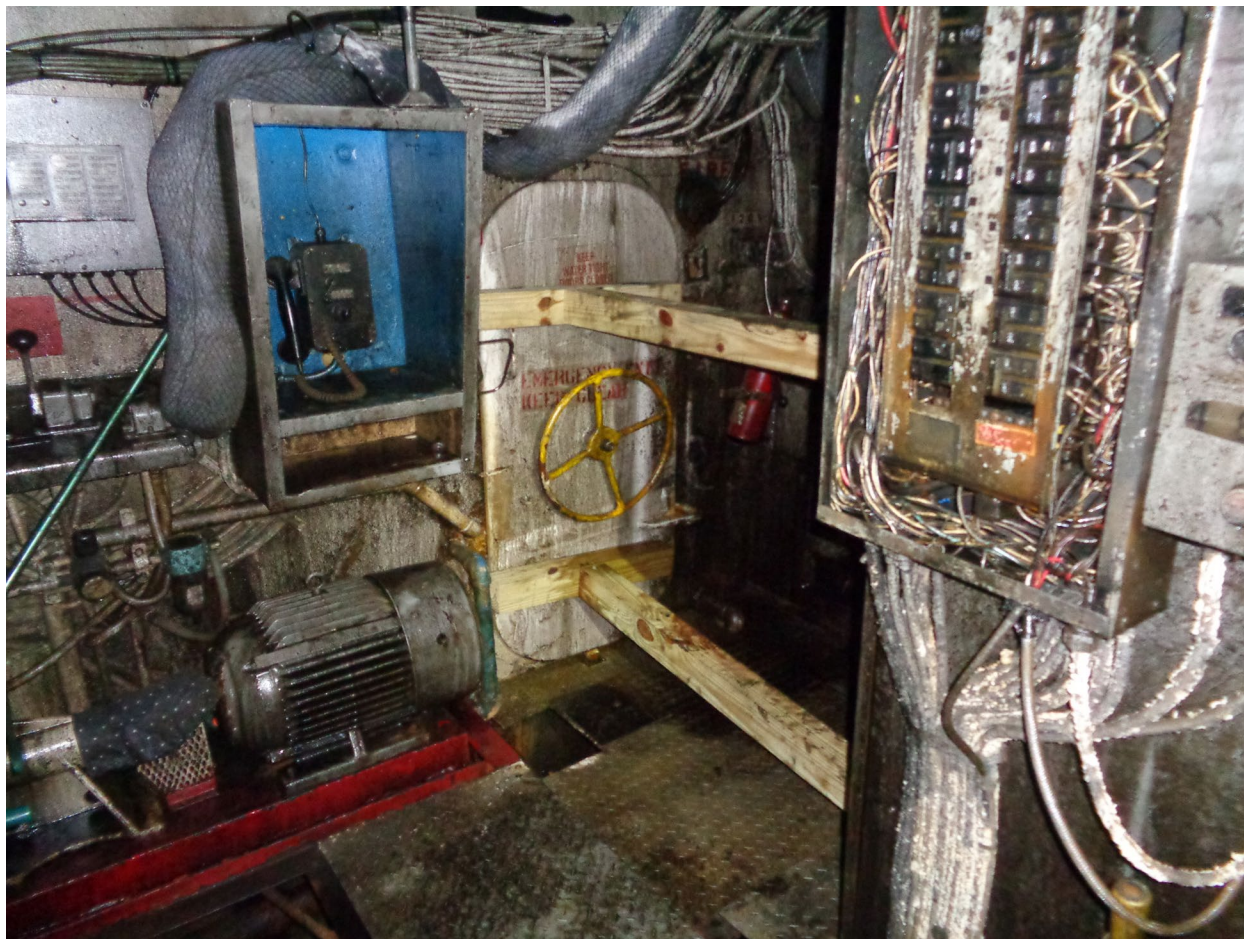
Figure 7. Forward engine room watertight door shown closed and secured with timber bracing that was installed after the grounding to facilitate salvage. (Source: Third Lady, LLC)

As a result of the vessel grounding, the hull was breached just forward of the engine room. Floodwater filled the midships passageway and then poured into the engine room through the open watertight door. Watertight doors are required to remain closed while not being traversed and while a vessel is underway so as to maintain watertight bulkhead subdivision and prevent progressive flooding (from a flooded space to another space).⁸ The forward watertight door in the engine room of the *Bonnie G* was open during the casualty events, and it was not secured before the crew abandoned the vessel. Had the watertight door been shut as required, it is likely that progressive flooding of the engine room and aft spaces would not have occurred, limiting vessel damage.
