# NTSB MEMORANDUM FOR RECORD

**Date: 7/10/2020**  
**Summary of airplane examination**  
**NTSB Accident Number: ERA20LA237**

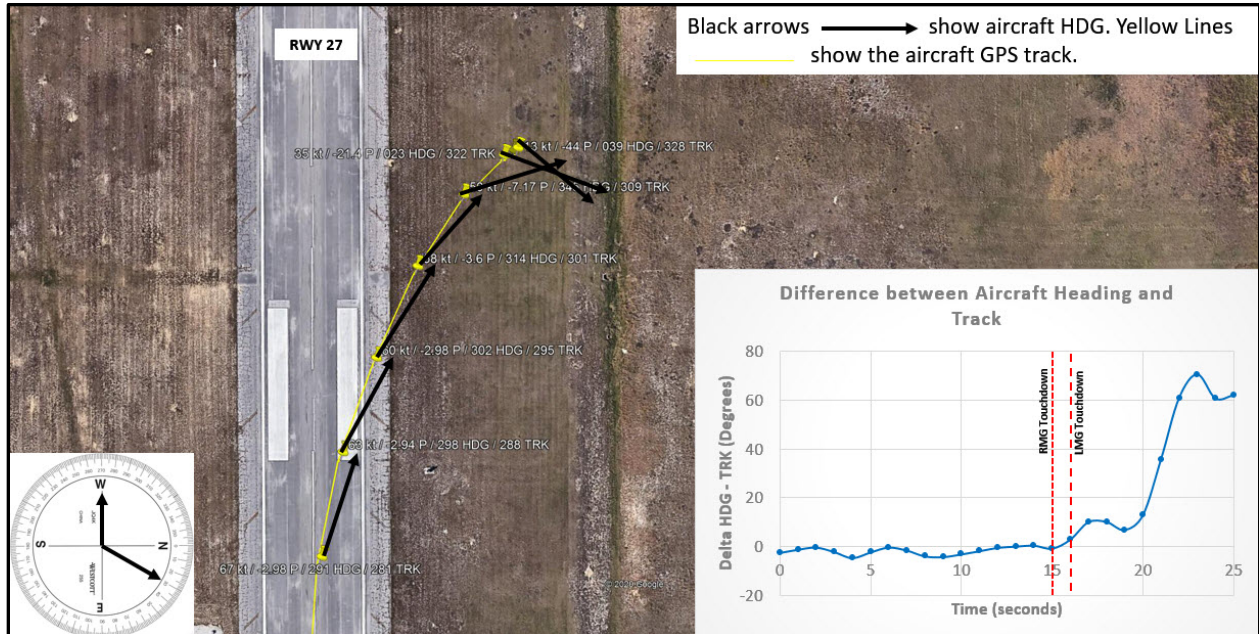
Figure 2: Landing Heading and Track Information Showing Skid

- Runway: FAA reported that runway markings indicate that the pilot landed short at the intersecting runway, just left of center. Markings showed that the airplane travelled “straight” until the hold short line then started to veer 10-15° right, crossed over centerline right about at the threshold. There was no evidence that the LMLG was tracking anything but forward. The skid mark from NLG started about 30 ft beyond the MLG main gear.
