From: Wiseman, Kyle L CIV USARMY CEMVS (USA) [REDACTED]
Sent: Wednesday, April 7, 2021 9:16 AM
To: Broadstock, Keli N CIV USARMY CEMVS (USA) [REDACTED] >; [REDACTED]
MSSE4 <[REDACTED]@uscg.mil>
Cc: Adden, James F CIV CEMVS CEMVD (USA) <[REDACTED]>; Griffith, Bradley M CIV
USARMY CEMVS (USA) <[REDACTED]>
Subject: RE: Kevin Michael Incident

Initial Incident Email Notification

Incident Summary: Approach The main chamber, collided
with lock wall

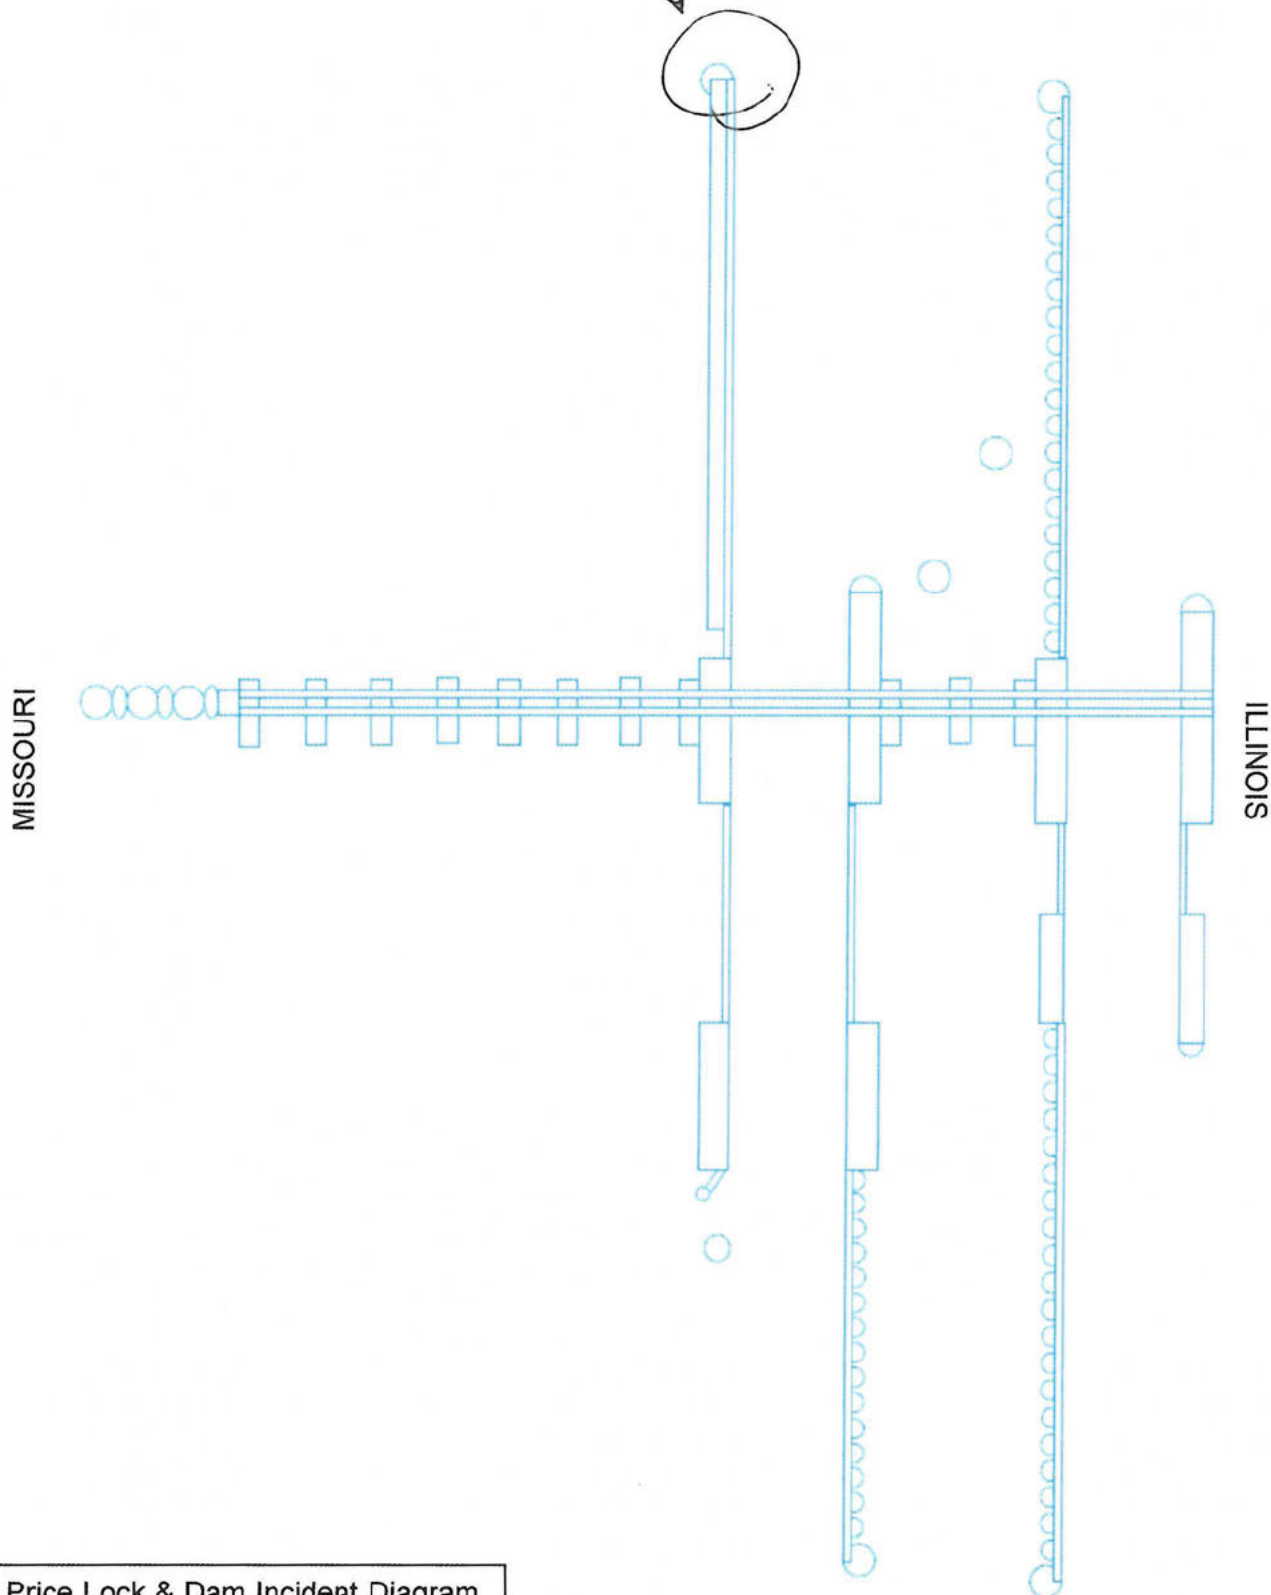
Melvin Price Lock & Dam Incident Diagram

Point of Impact Below Top of Wall: Hit bullnose on ~~bottom~~ the side of second strand of barges. Then head on w/ 3rd strand of barges

Comments: the boxes with an "X" indicate where barges were struck
where

barge ~~struck~~ struck
long wall bullnose
