MEMO: MPS-21-015

SUBJECT: Teardown Inspection of Propellers from:  
Cessna 421, N731PF,  
File #:(MPS: 2019-09, NTSB: ERA19FA283)

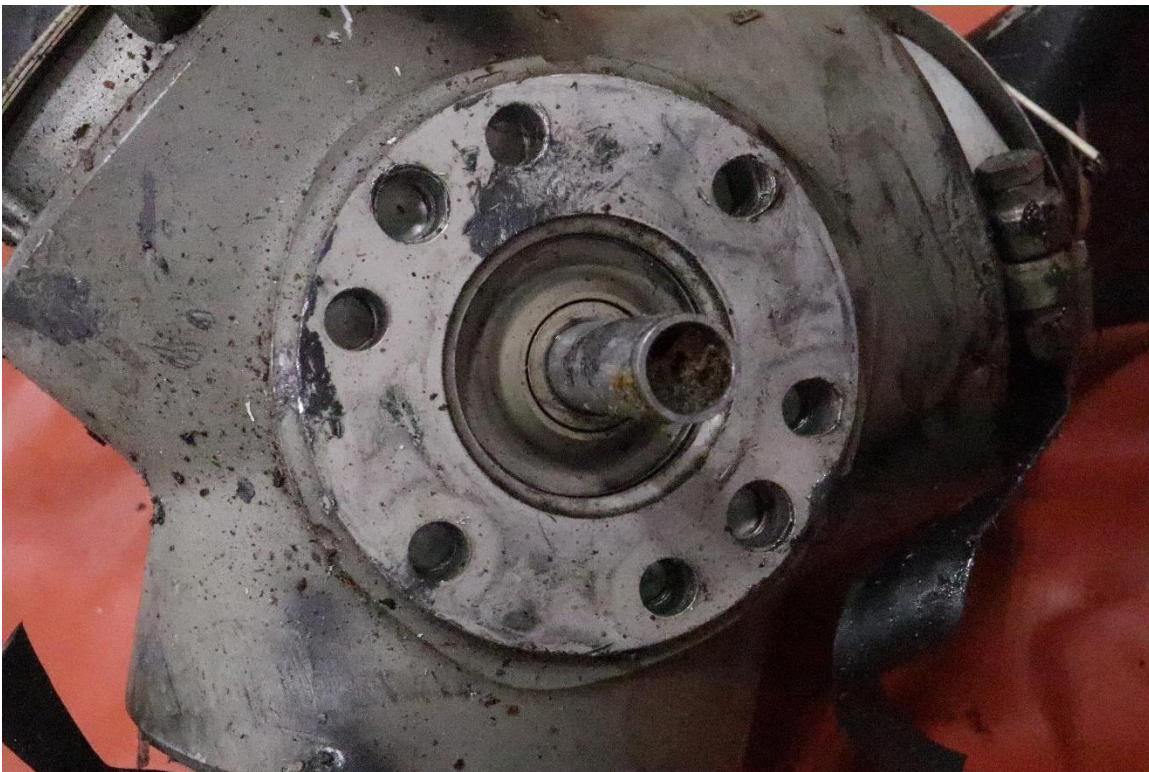
4. Both propellers had all six attach stud threaded holes stripped and the studs were not present in the hub for the tear down. Both propellers had stud attach holes that were elongated during the impact sequence. The direction of the elongated holes is consistent with low amounts of rotational energy during the impact sequence.
5. Both LH and RH propellers had intact latch screw arrowheads.
6. Both propellers had evidence of field service events including hub and cylinder paint.
7. The RH propeller had unknown counterweight cheek weight attach bolts used on all three blades. The bolts found on the propeller were silver-grey in color and had a shorter length than the correct A-2513-45 counterweight cheek weight attach bolt. No attempt was made to identify the unknown bolts.

**Figure 1: Left Hand Propeller Engine Flange**

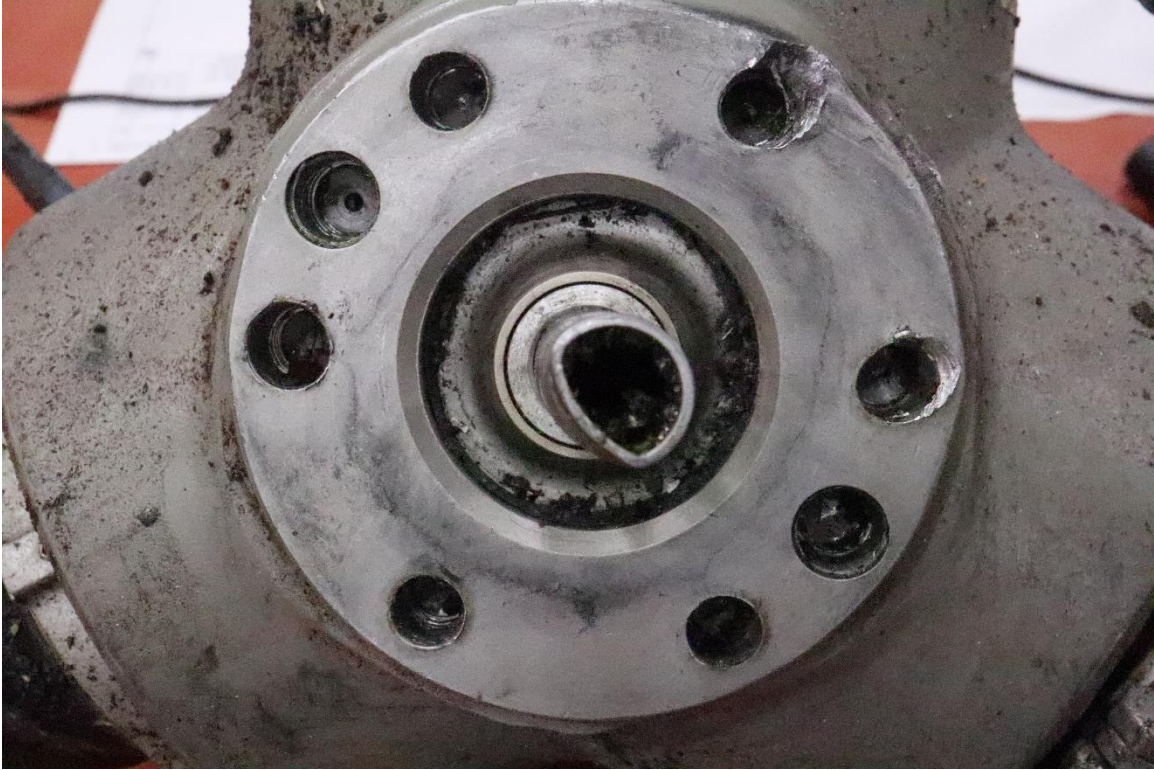
**Figure 2: Right Hand Propeller Engine Flange**

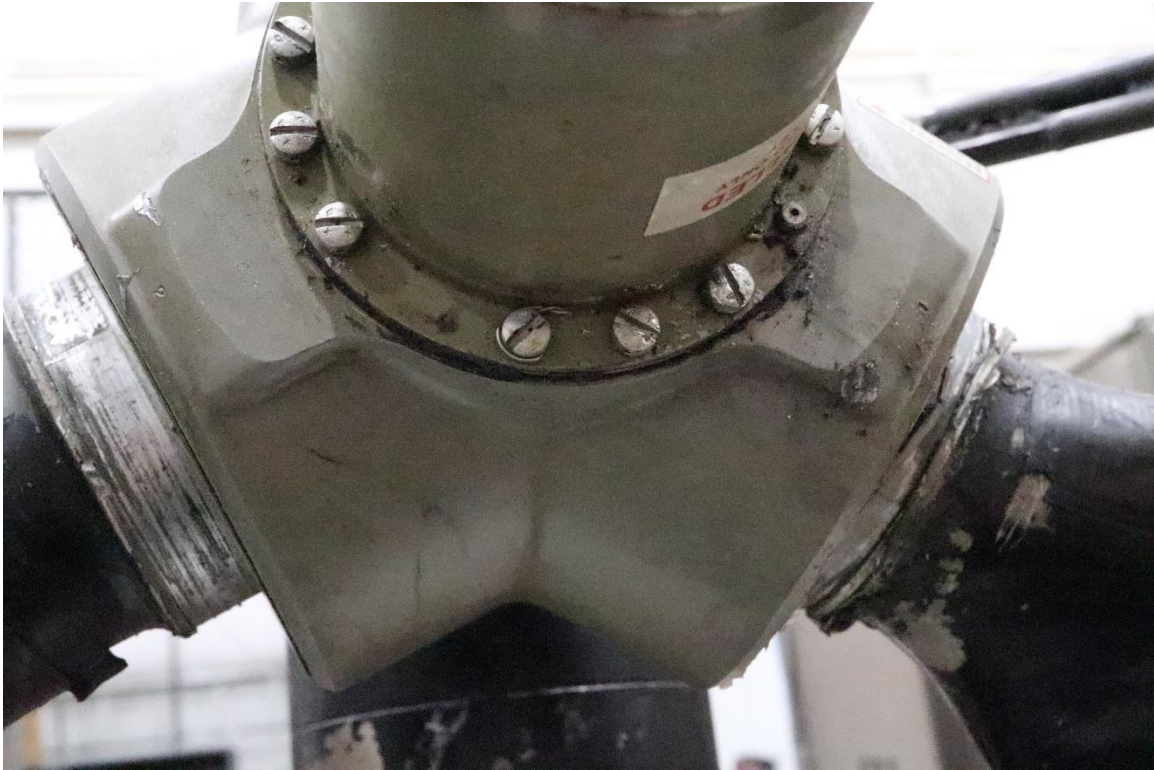
1. Both LH and RH propellers had sudden-failure type damage that is typically associated with impact forces; and gross part deflections. The investigation found no evidence of any type of fatigue failure.
2. Both LH and RH propellers had witness marks from contact between the blade counterweights and the propeller hub during the impact sequence. The position of all these marks indicates an approximate propeller blade angle of low pitch position at impact.
3. The propeller blade bending, twisting, paint scuffing, and overall propeller assembly damage is typical of that associated with low amounts rotational energy absorption during the impact sequence.

**Figure 3: Left Hand Propeller Counterweight Witness Marks**

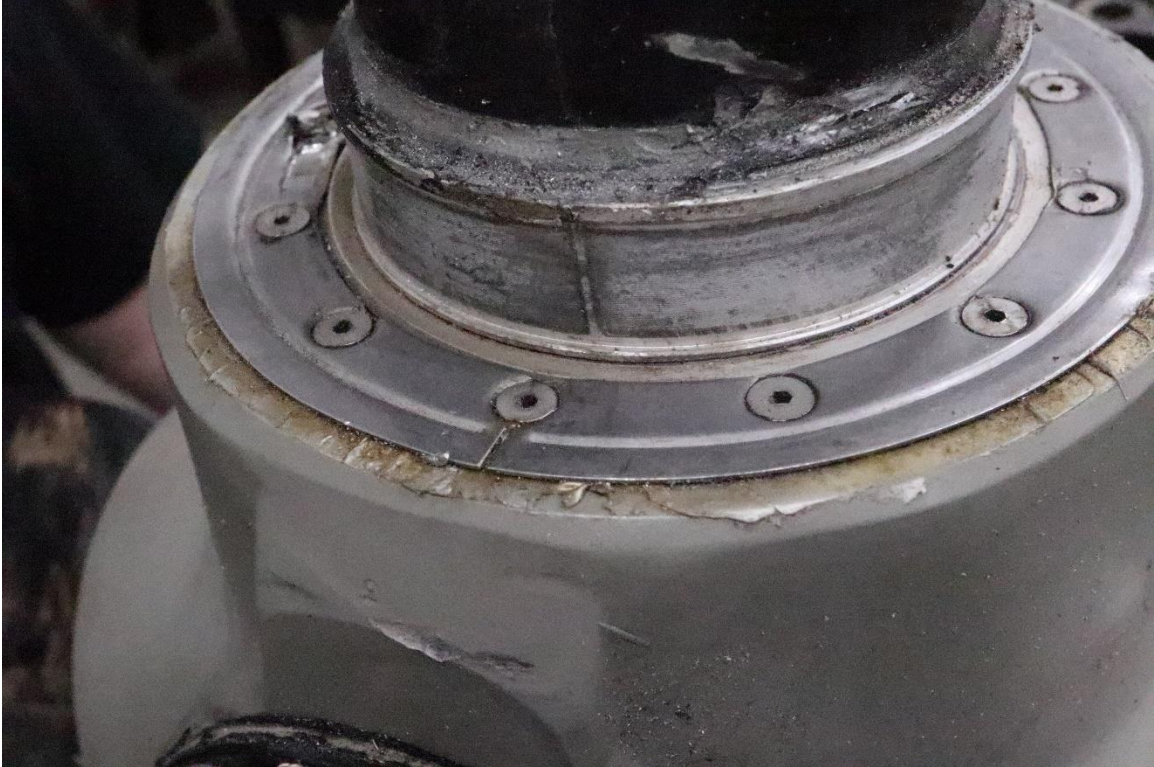
**Figure 4: Right Hand Propeller Counterweight Witness Mark**

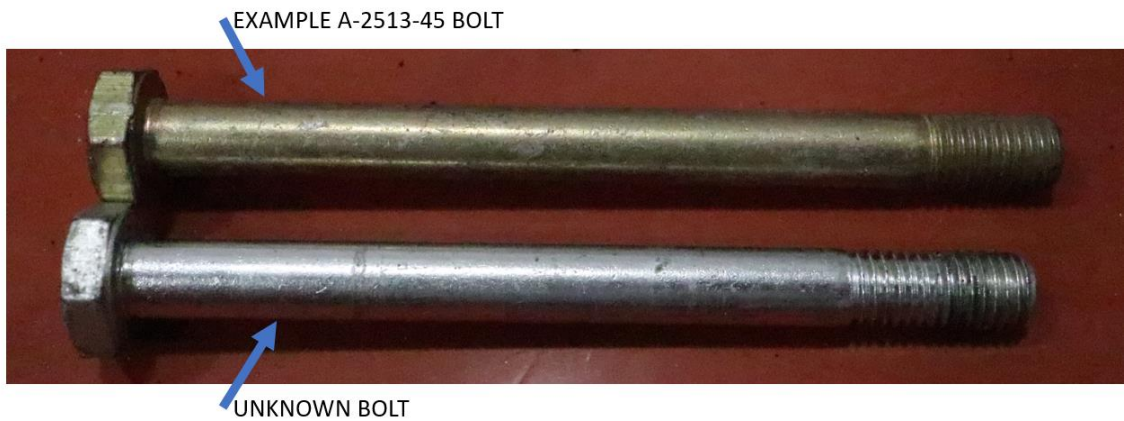
**Figure 5: Right Hand Propeller Counterweight Cheek Weight Attach Bolt Comparison**
