Marathon Pipe Line LLC
Operational Records
Title & Contract Transmittal Form

Roxana - Patoka Woodpat 22"

The triggering event for this Risk Assessment was an ILI tool run in March of 2017.

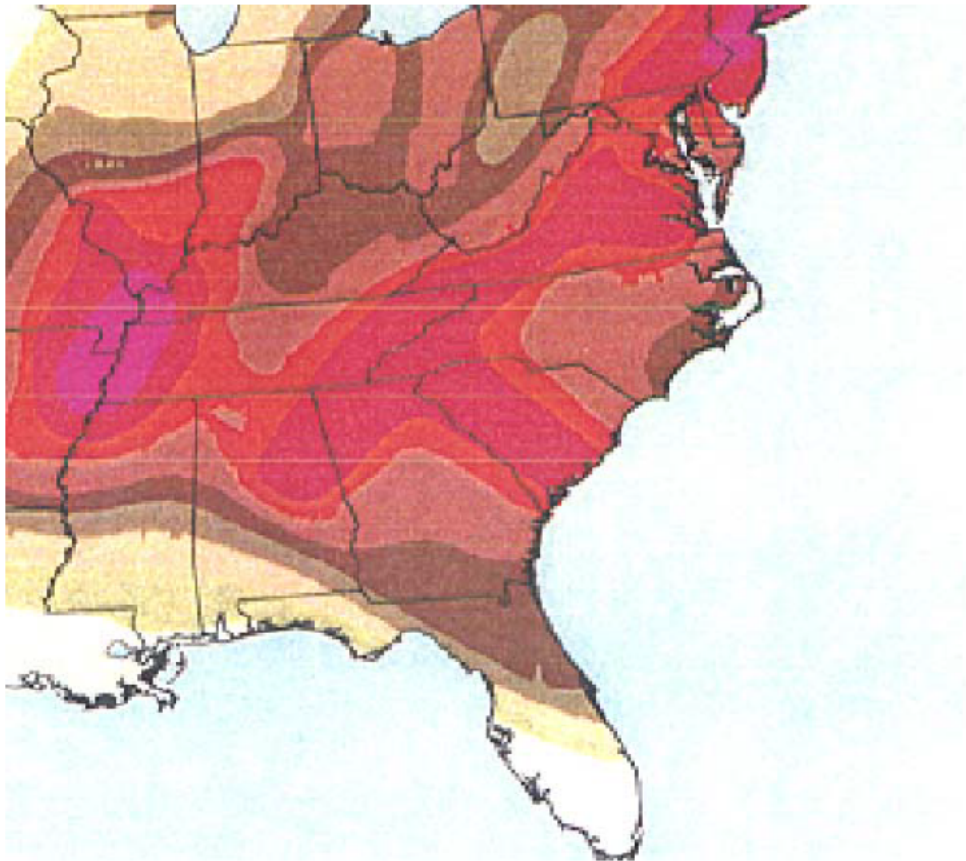
Earthquake Hazard Rank

FEMA Earthquake hazard map. The part of the line closer to Wood River is in a higher Earthquake rank zone.

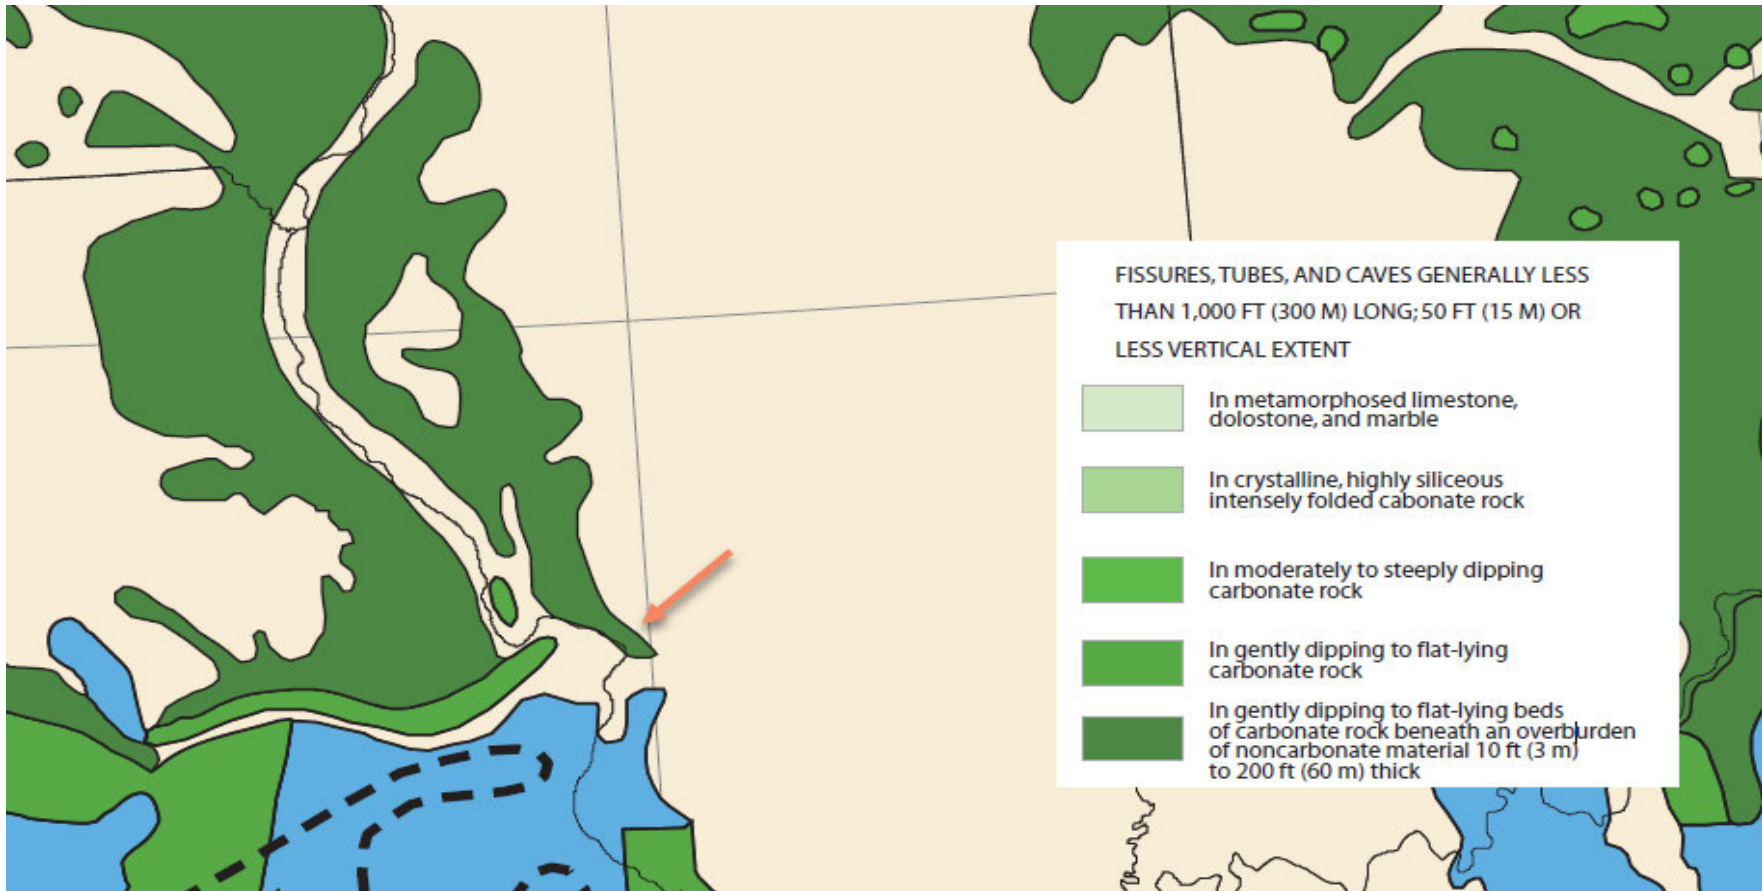
Karst USA map. The part of the line very close to Wood River is in a zone indicated to be at risk of caverns.

There are some caves along the river to the North West of Wood River.

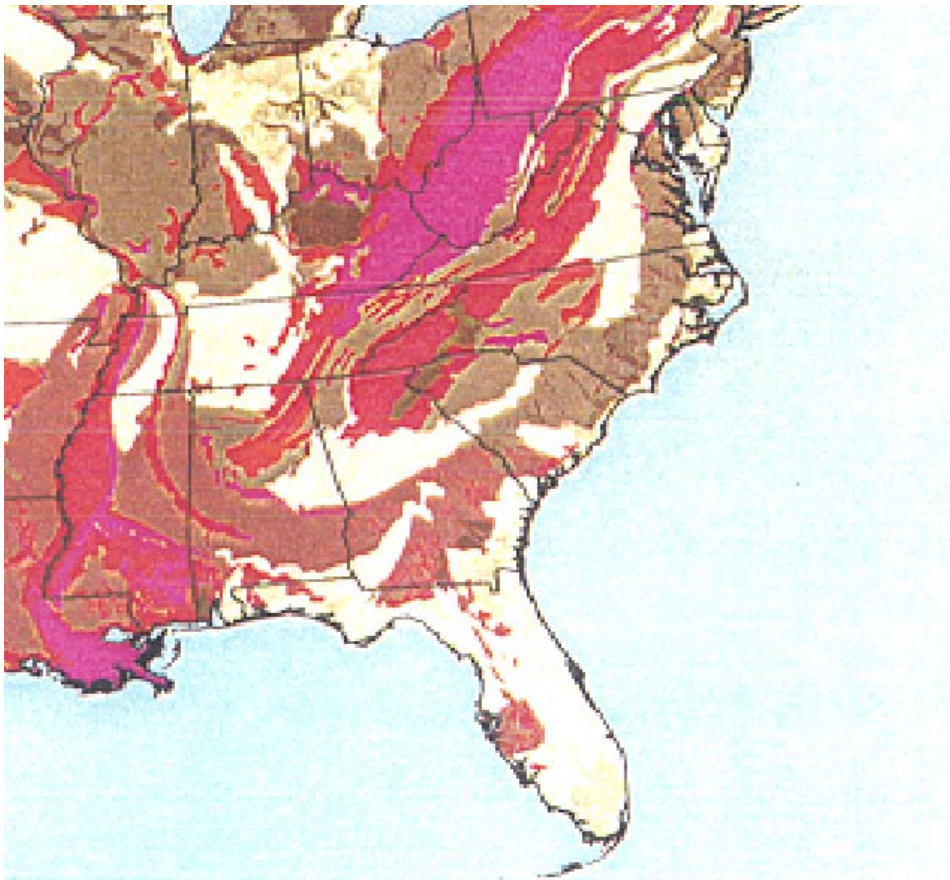
Landslide Hazard Rank

FEMA Landslide hazard map. The part of the line in Wood River is in a higher Landslide rank zone.

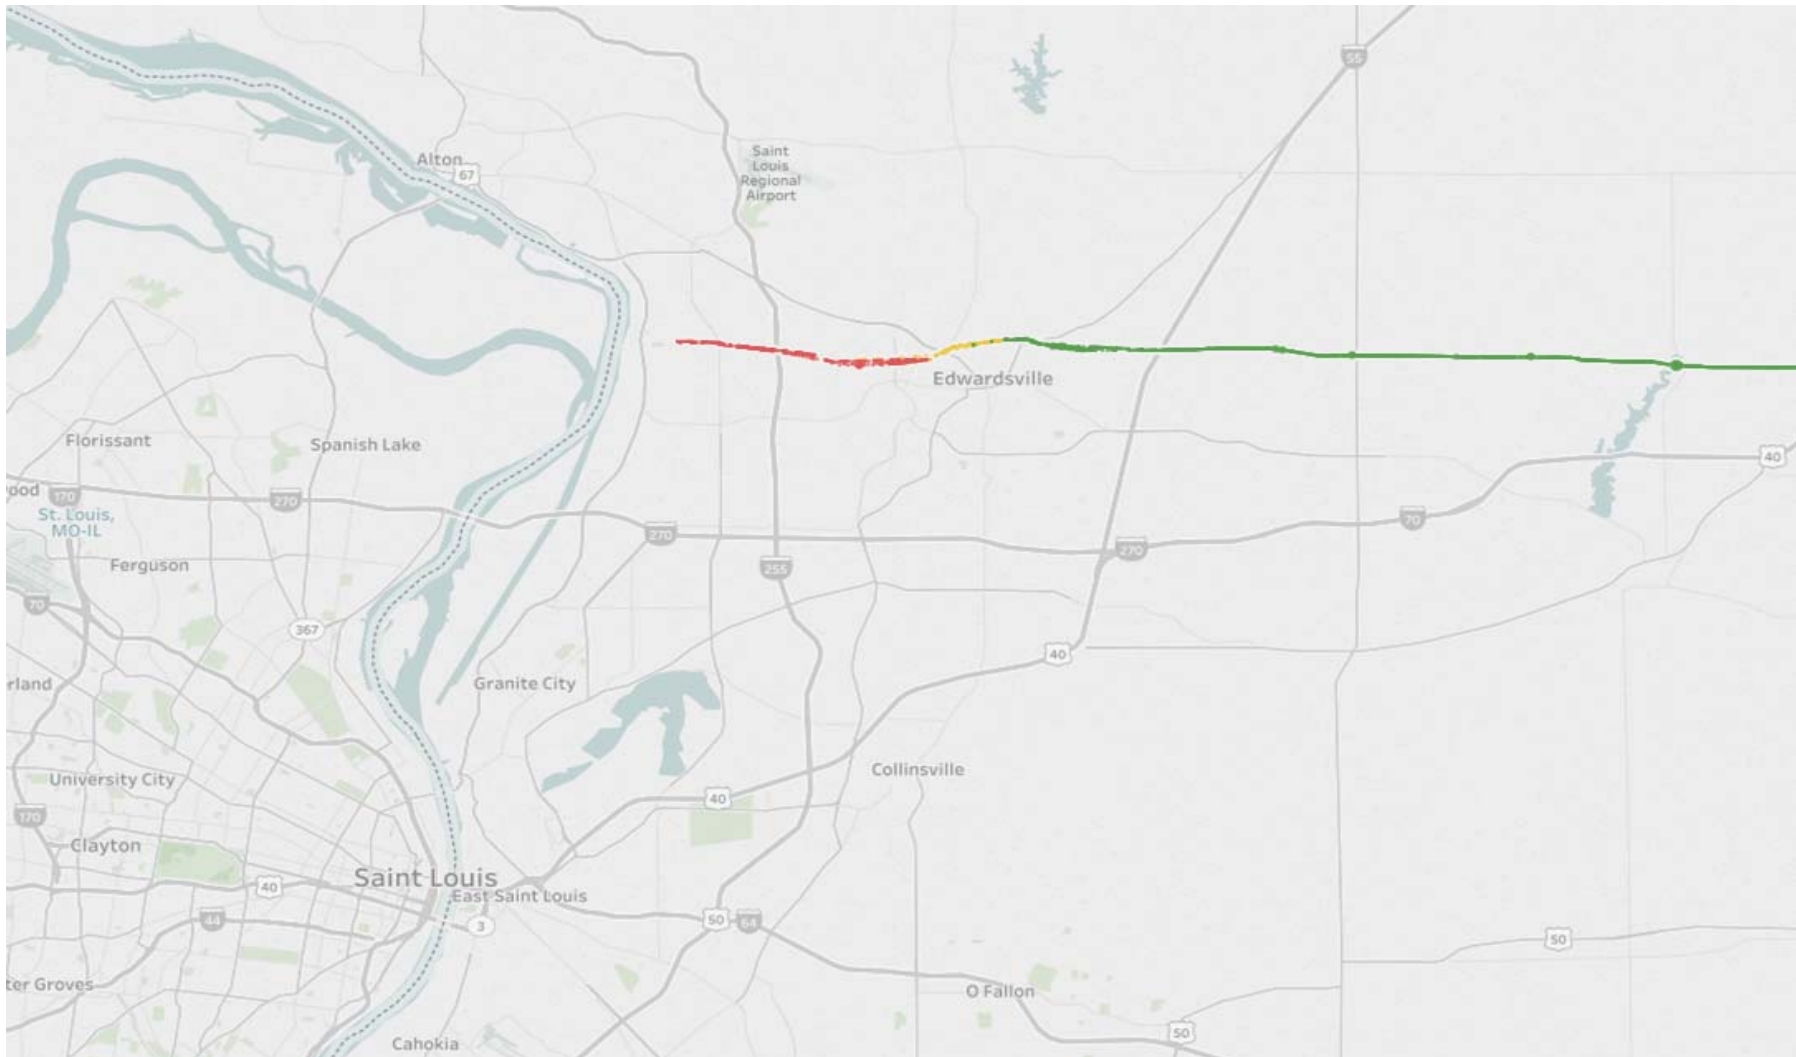
High score of 7.26 and Moderate score of 5.52: This is located at the Wood River end of the line, and goes through Wood River and South Roxana. Medium Earthquake rank and Karst present, also high Flood rank (close to the Mississippi River) and high Landslide rank.

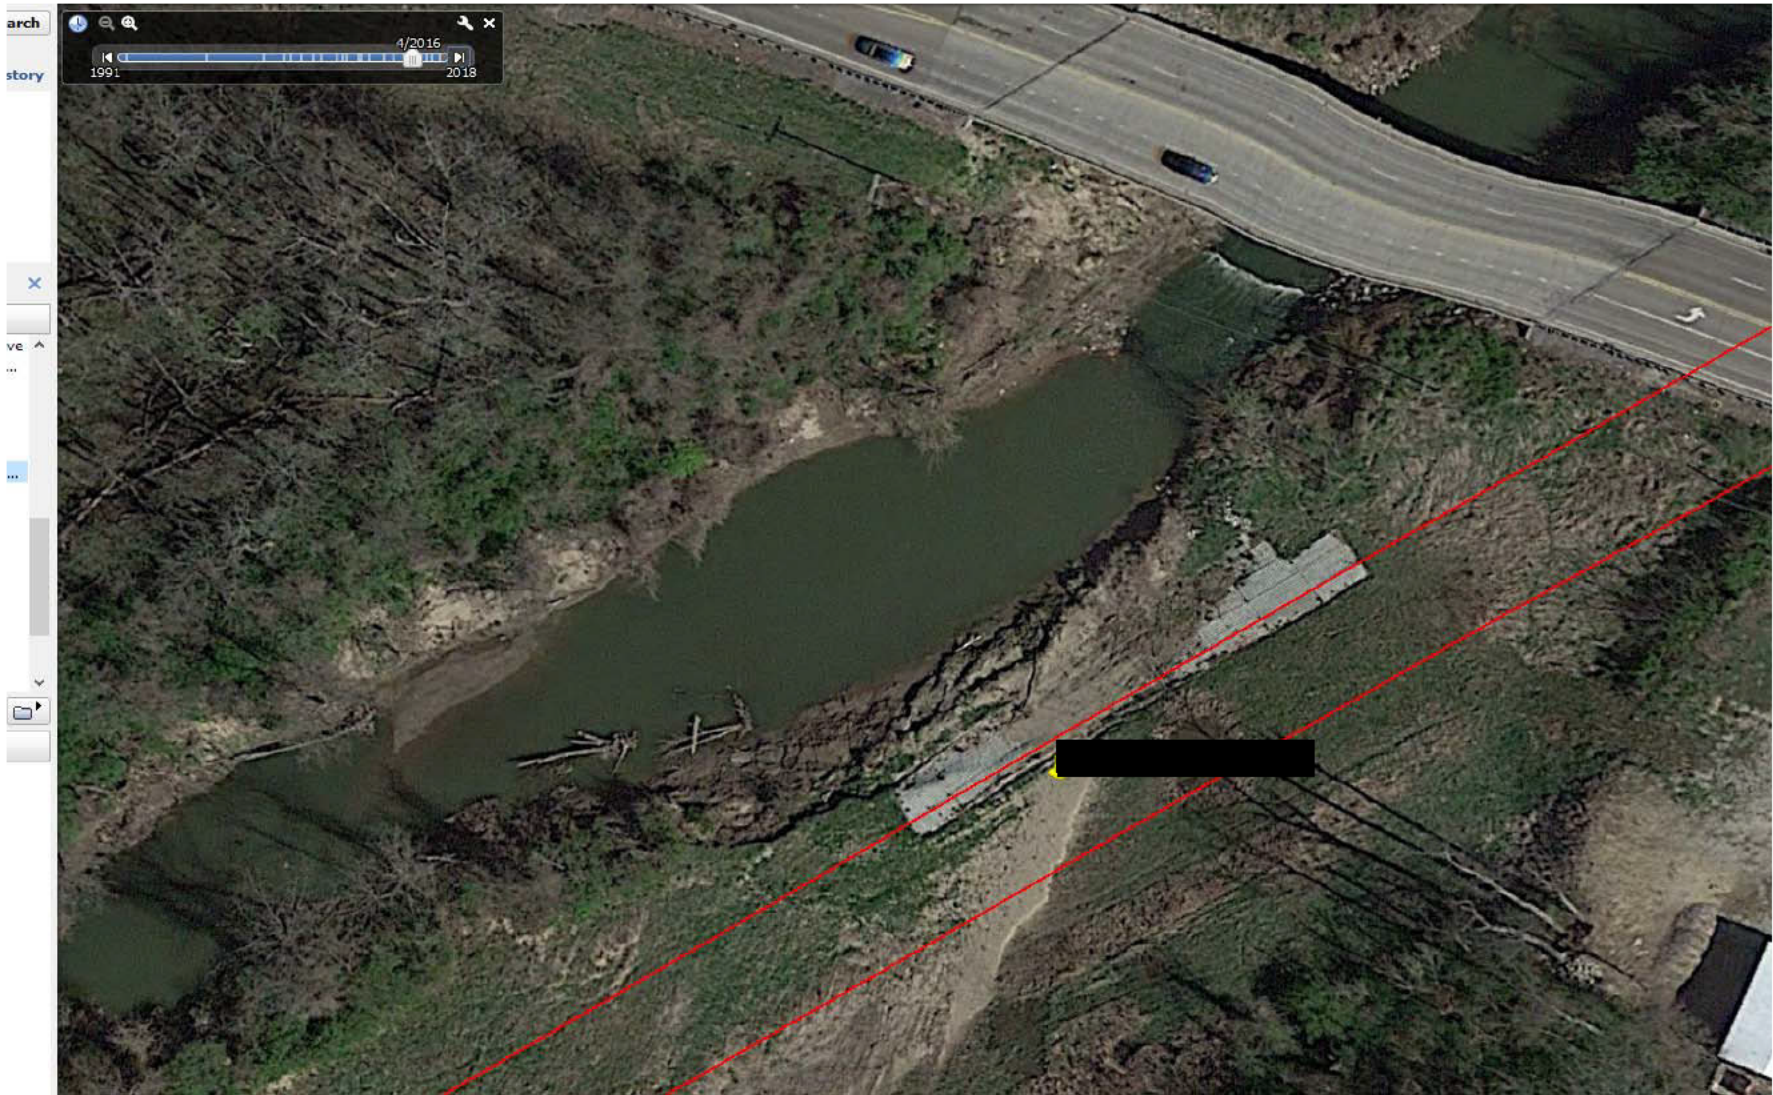
-Ops asked about the WWX at HWY 143 near Edwardsville - there's submar matting over the creek. We visually inspect them after flooding events. These were installed in 2015 due to the waterway encroaching on our pipe ROW. The matts are considered stable.

Mats were installed at this waterway encroachment in 2015 as a P&MM.
