NATIONAL TRANSPORTATION SAFETY BOARD

<u>Maintenance Factual – Federal Express</u>

A. <u>ACCIDENT</u> DCA17MA022

Aircraft: FedEx Flight 910, Boeing MD-10, Registration N370FE

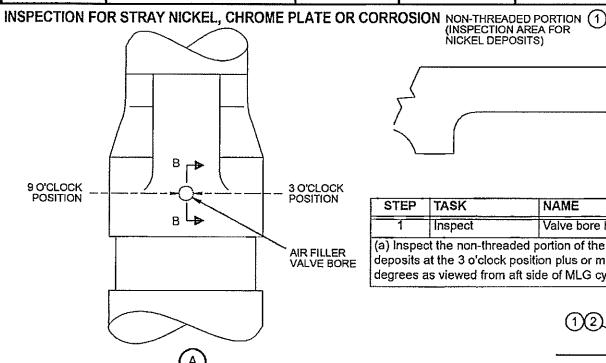
THREADED PORTION (NOT INSPECTED) AIR FILLER VALVE BORE B-B ROTATED 90° CCW

RECORD VALVE BORE FINDINGS DESIGN DIA: 0.4460-0.4537 RECORD DIA: 0.453 STRAY NICKEL: (Y) (N) CHROME PLATING: (Y) (N) CORROSION: (Y) (N)

- (a) Inspect valve hole bore interior for evidence of corrosion.
- (b) Remove all corrosion from non-threaded surfaces of hole using abrasive nylon web (Scotch-Brite) pad installed in drill motor at 4,200 RPM maximum speed. Stop and allow metal to cool after 2 minutes. Repeat process until all corrosion is removed.
- (c) Scotch-Brite debris resulting from clean-up is likely. Debris entering strut is acceptable, but attempt to minimize.
