Edwardsville Supplemental Response

Marathon Pipe Line LLC

October 2023

Edwardsville Failure Analysis

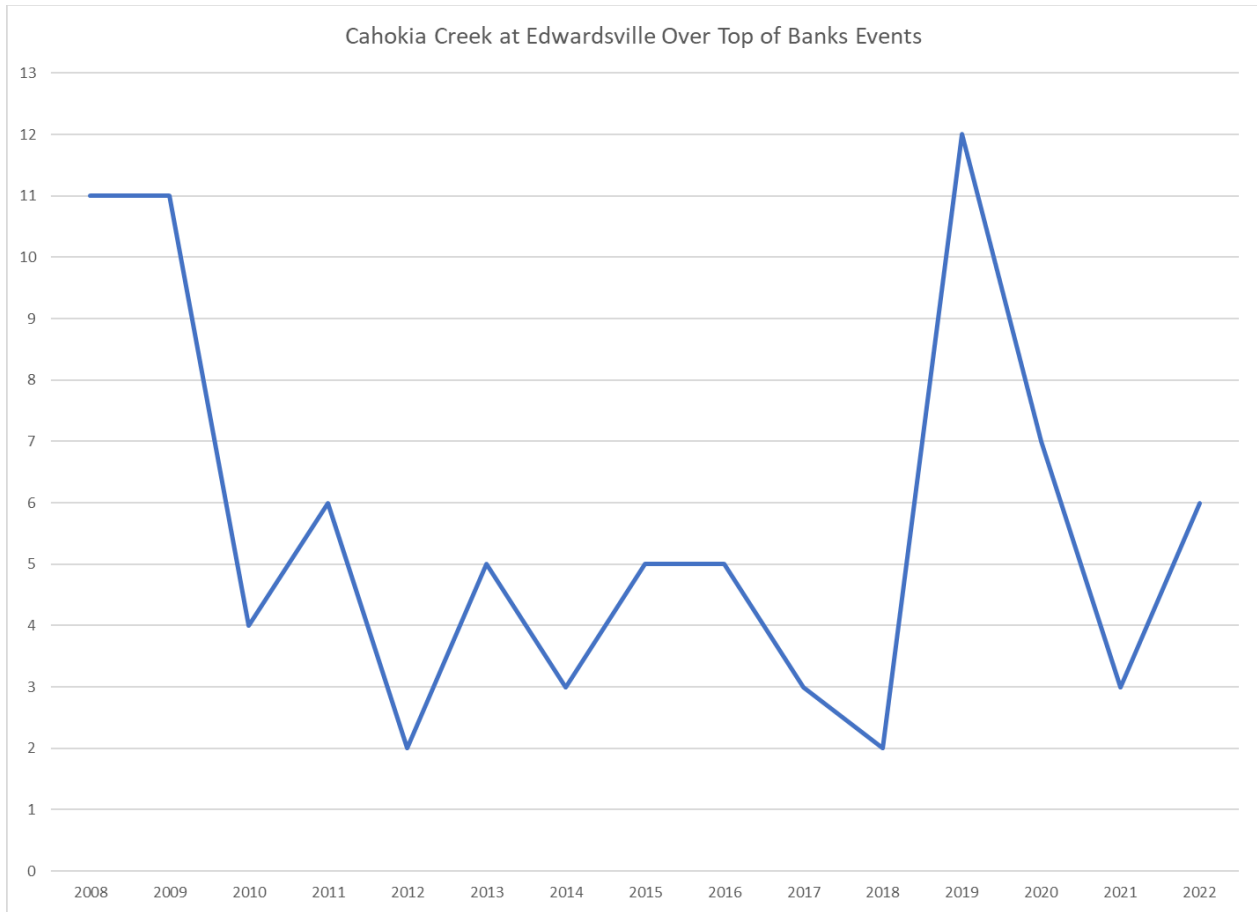
Figure 2: Significant Rain Events at the Incident Site

Water in Cahokia Creek passes underneath the bridge east of the incident site, and flows directly toward the south stream bank, towards the location of the failure. Sandy flood deposits were observed along the streambank more than 15 feet above the observed water elevation, suggesting that episodic high-flow and associated erosional events occur within Cahokia Creek. Streambank deposits along Cahokia Creek are alluvial deposits susceptible to scour. It is suspected that a single flood event is not responsible for the scour that led to the conditions at the incident site, but rather a series of several small events.

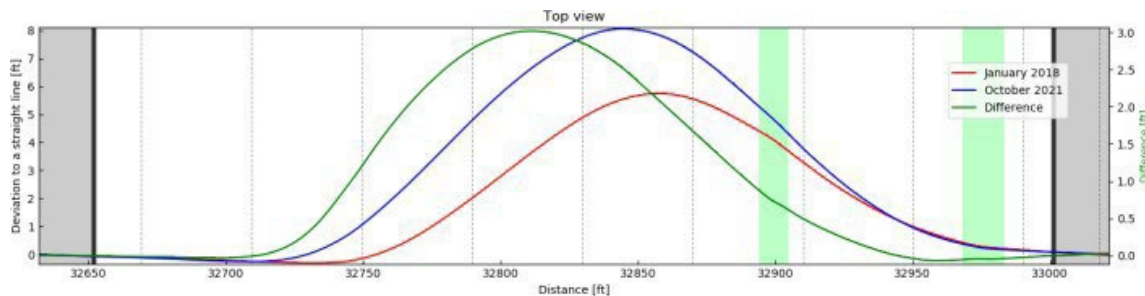
Figure 5: 2018 and 2021 Deviation to a Straight Line

Figure 5 below shows the eight-foot deflection of the pipeline from deviation to a straight line just prior to the accident on March 11, 2022.

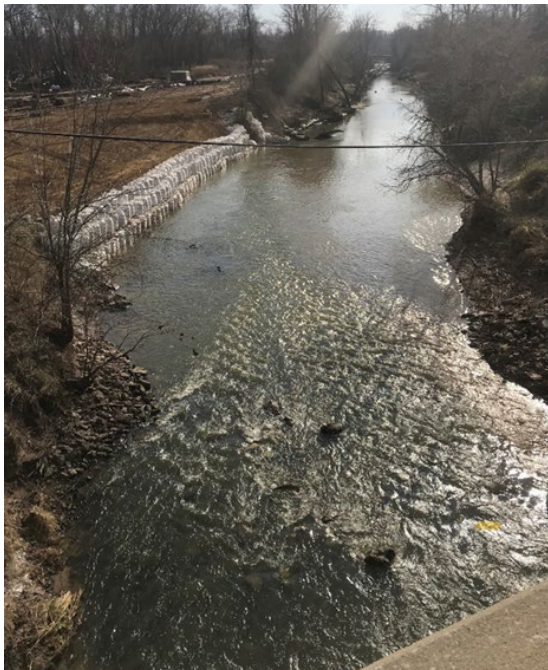
Figure 7: Cahokia Creek Flow without Peninsula

The figure below shows the water flow after the rip rap peninsula was removed. Notice the turbulent flow of the creek staying in the center of the creek as opposed to being diverted towards the south bank. Also note the lack of turbulence around the edge of the creek bank, indicative of slower-moving water velocities.

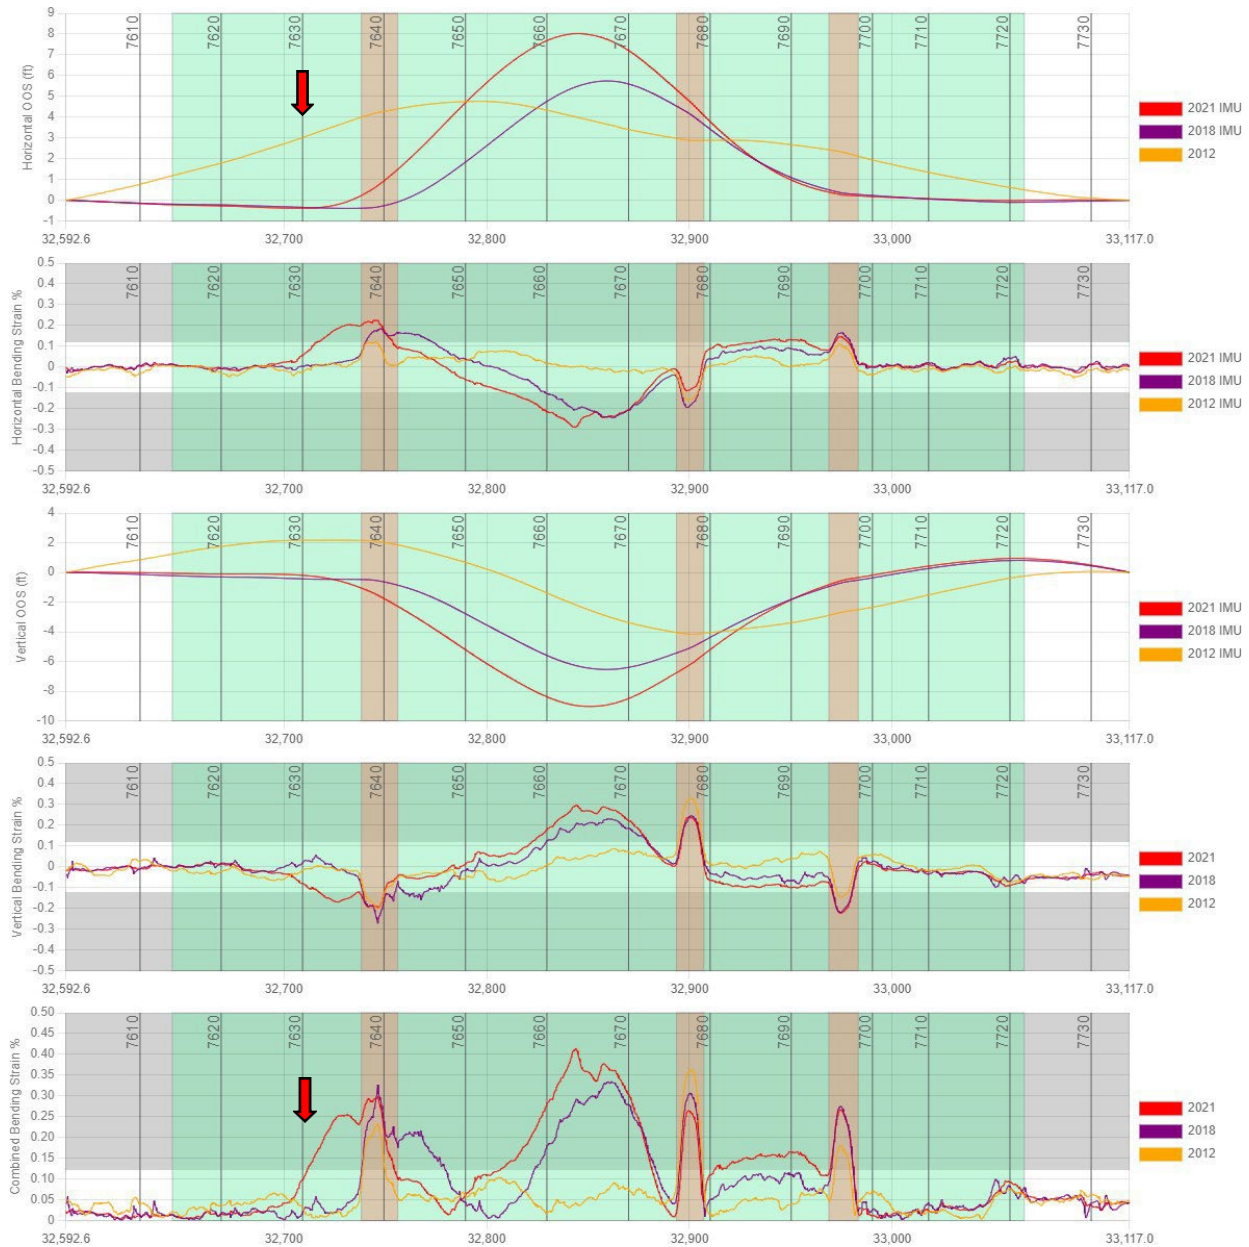
Figure 3.2: IMU Comparison for 2012, 2018, and 2021

When comparing the strains in Figure 3.2, a clear progression in the horizontal, vertical, and combined strains is evident from 2012 to 2018 and from 2018 to 2021. This data confirms that the pipeline was experiencing external loads and being subjected to both horizontal and vertical movement in the time between 2012 and 2021.

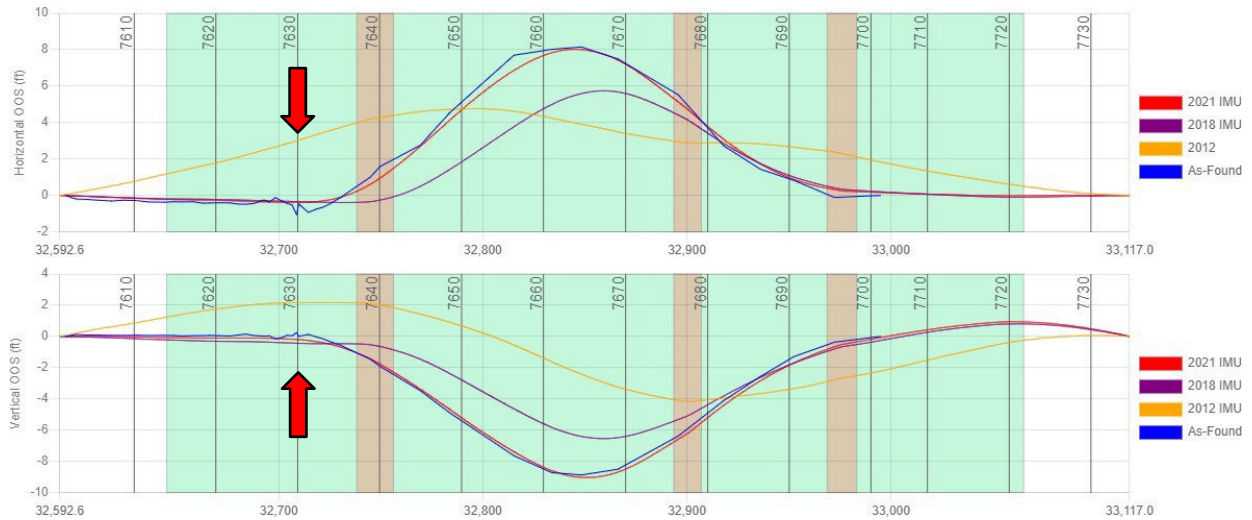
Figure 3.7: As-Found Survey

The information from the as-found survey was aligned and overlaid with the available IMU data sets. The comparison for the horizontal and vertical out-of-straightness profiles are shown in Figure 3.7. The survey information shows that the Woodpat pipeline exhibited slight additional movement after the 2021 survey with a total horizontal out-of-straightness of 8.2 feet. The vertical out-of-straightness did not show a measurable difference when compared to the 2021 IMU data set with a total vertical deviation of 9-feet.

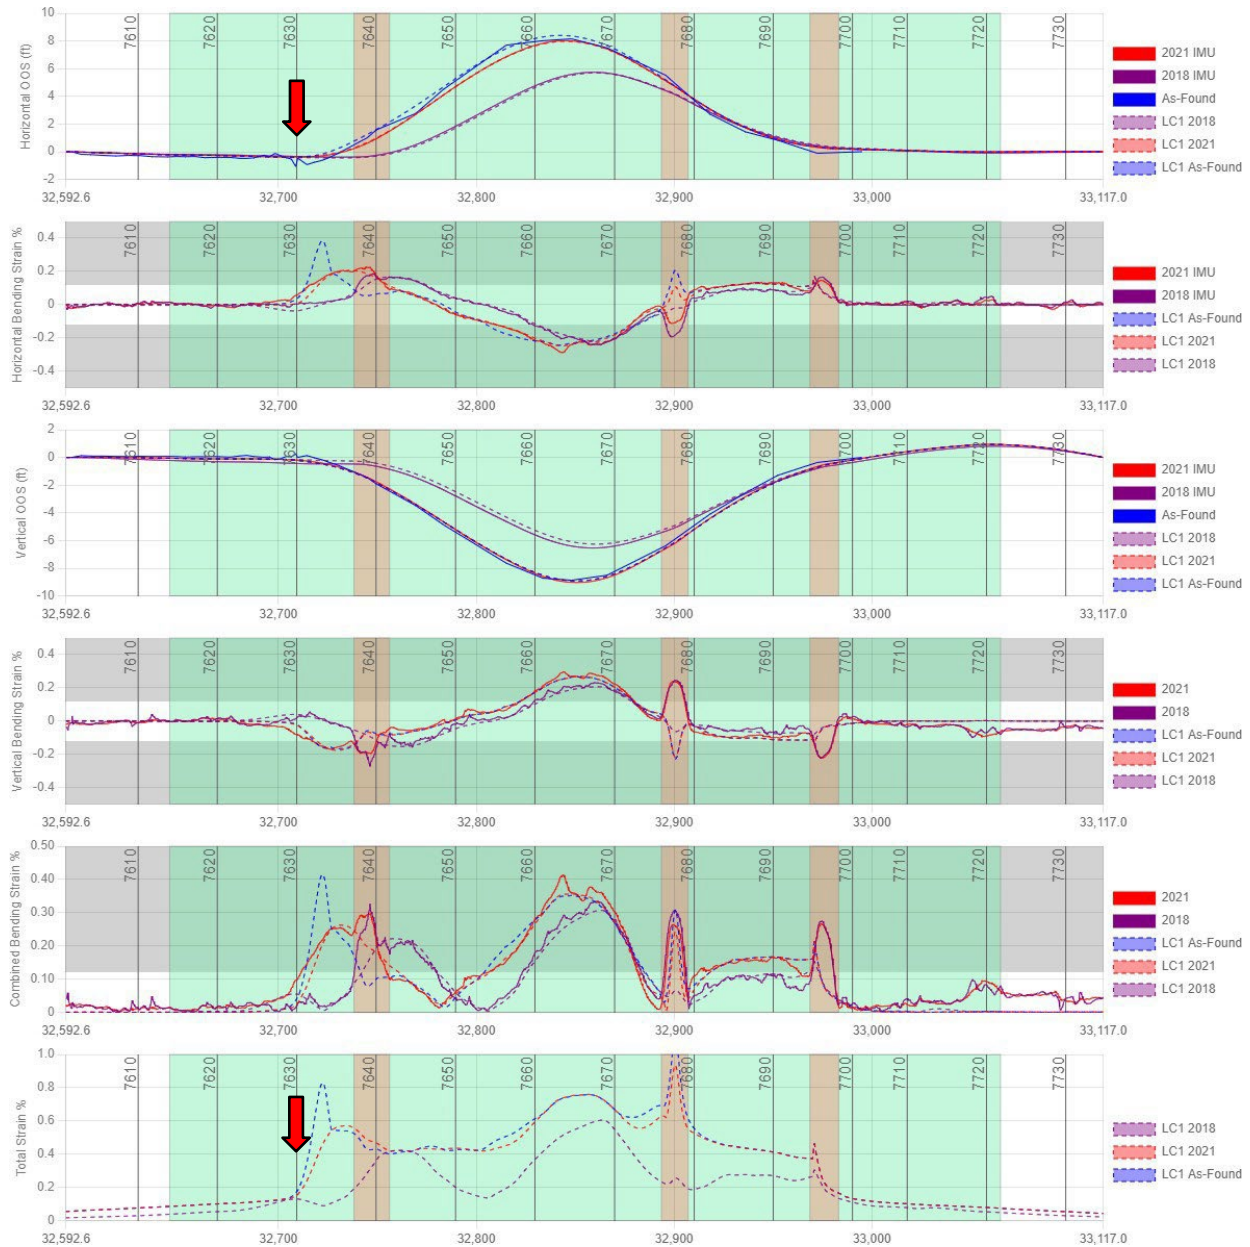
Figure 5.2: Load Case 1, Upper Bound Undrained, Results Comparison

In summary, the comparison for Load Case 1 shows that the horizontal bending and total strains changed rapidly near the upstream flank of the landslide adjacent to the location of the failed girth weld. While the actual total strains are 0.18% at the location of the failed girth weld, the peak total strain occurs less than 10-feet away from the girth weld. Given the uncertainties with the precise position of the WoodPat pipeline prior to failure with respect to the landslide extents, it is possible that the strains were as high as 0.83% in the weld if the upstream flank of the landslide is shifted slightly upstream from where it is located based on the 2021 IMU data.

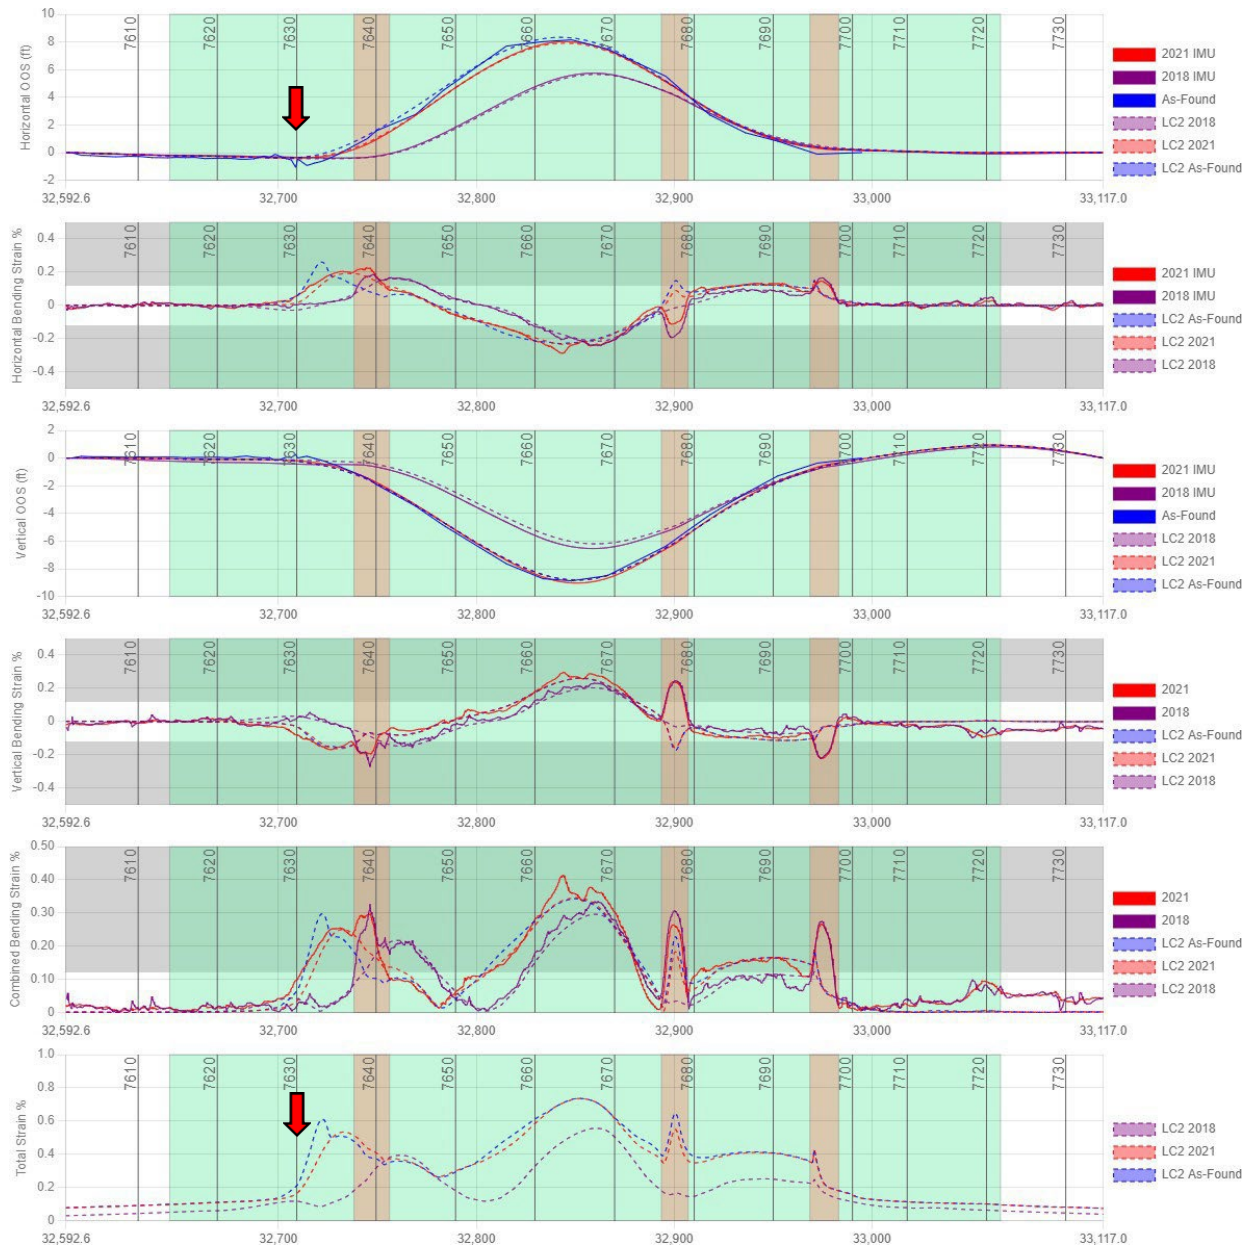
Figure 5.3: Load Case 2, Lower Bound Undrained, Results Comparison

With respect to the out-of-straightness plots, the results from Load Case 2 are nearly identical to the results from Load Case 1. Both the horizontal and vertical out-of-straightness plots show excellent agreement with the 2018, 2021, and as-found data sets. However, the results do show differences in the horizontal, combined, and total strains. The sharp peak observed in Load Case 1 is more muted for Load Case 2 with lower overall strains near the upstream flank of the landslide. The horizontal bending strain near the upstream flank is 0.26% while the total strain is 0.61%. The strains are lower for Load Case 2 because the axial and bending resistance of the soil is weaker for the lower-bound load properties. The weaker properties delay the formation of the plastic hinge, but do not prevent its formation.

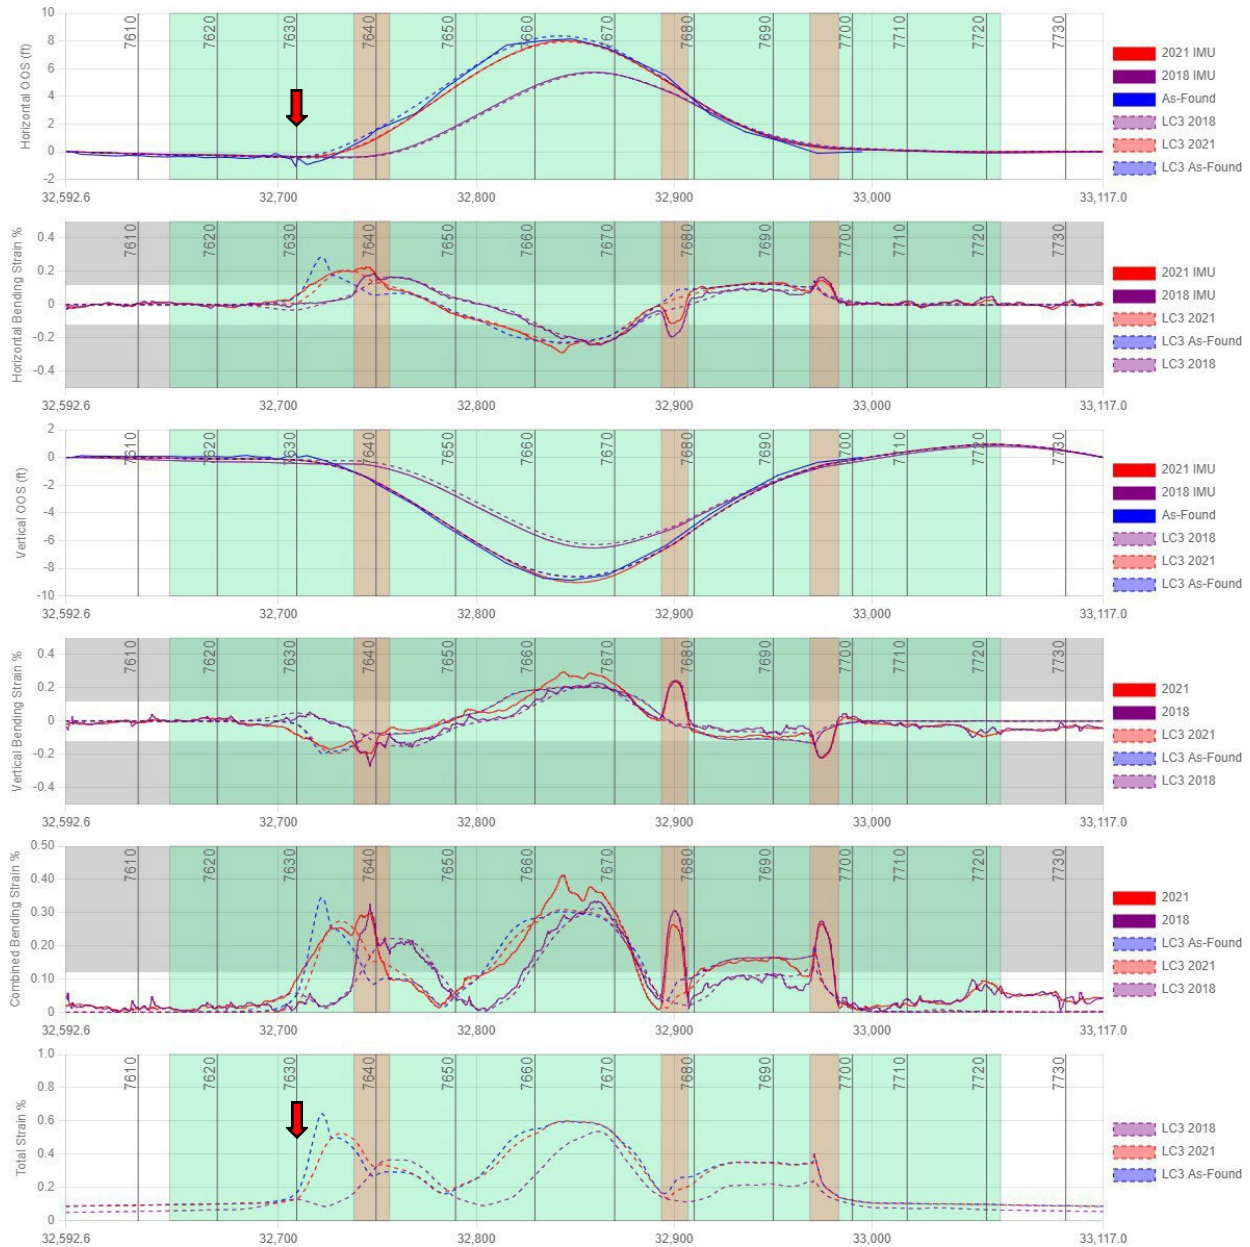
Figure 5.4: Load Case 3, Upper Bound Drained, Results Comparison

Regarding the strains, the results from Load Case 3 show similar results to Load Case 1. A localized peak in the strains is evident near the upstream flank of the landslide. The horizontal bending strain near the upstream flank is 0.29% while the total strain is 0.64%. These strains are slightly lower than the results for the upper bound undrained properties in Load Case 1.

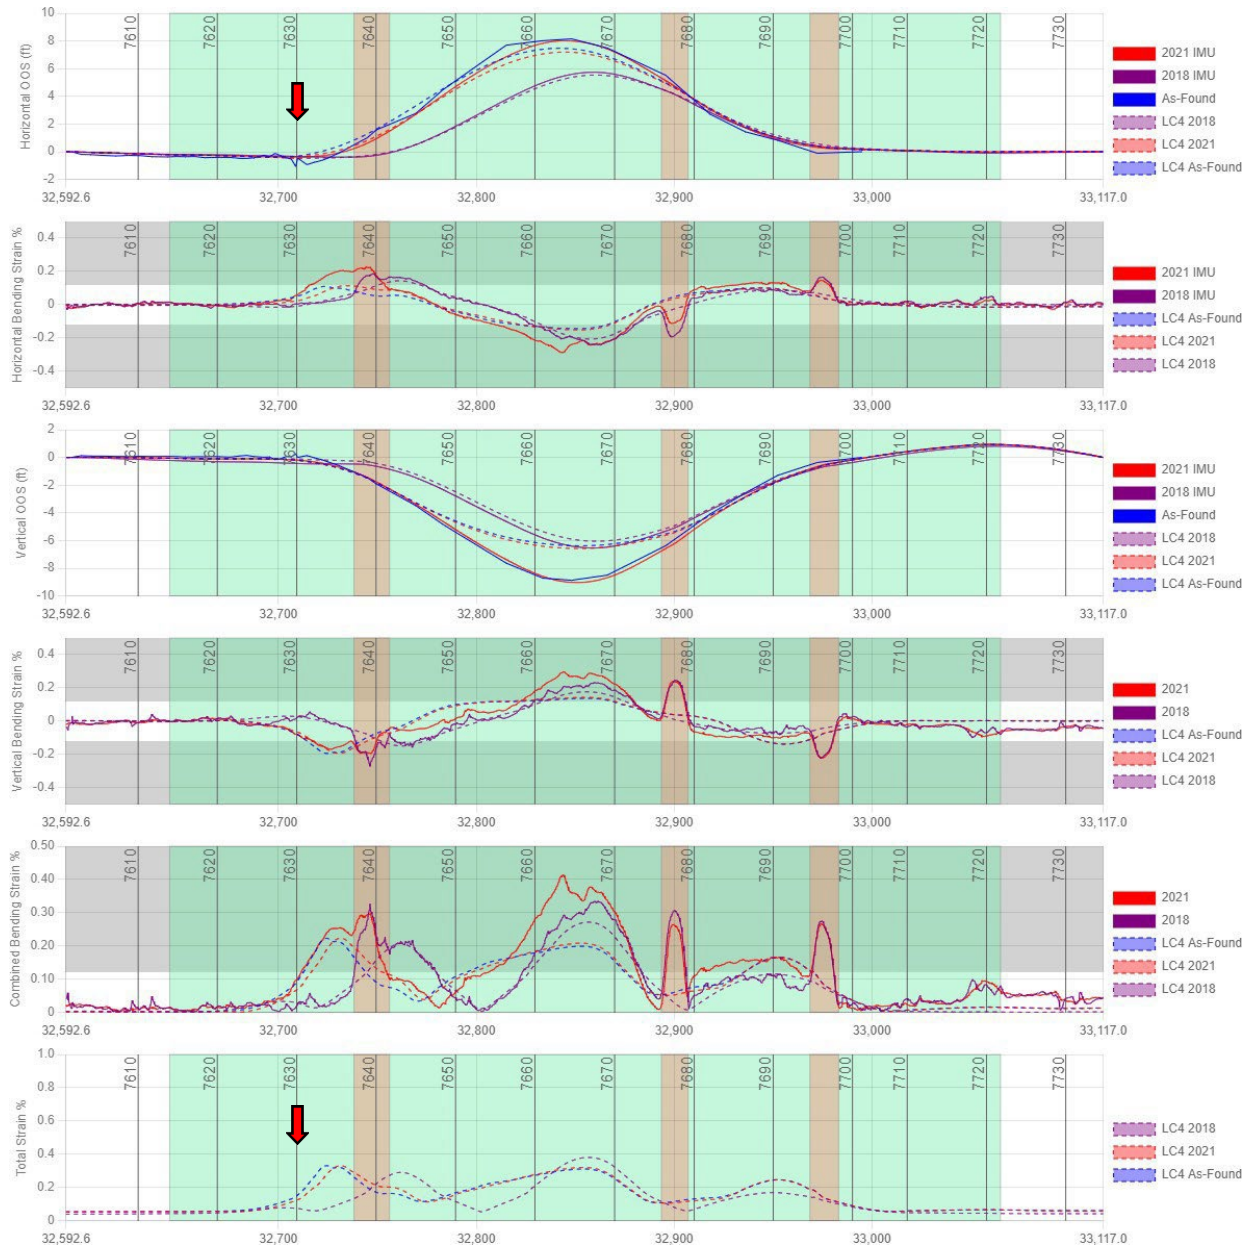
Figure 5.5: Load Case 4, Lower Bound Drained, Results Comparison

Regarding the strains, the results for Load Case 4 show significantly lower strains than the other load cases. The vertical and horizontal strains for the 2021 condition show poor agreement with the IMU data. While additional modifications to the soil properties may provide improvements to the comparison, it is unlikely that the vertical displacements will be able to be calibrated. These results indicate that the lower bound drained properties are not an accurate representation of the conditions observed at the failure location based on the 2021 IMU data and information collected at the time of failure. Therefore, the results from Load Case 4 were disregarded for future use.

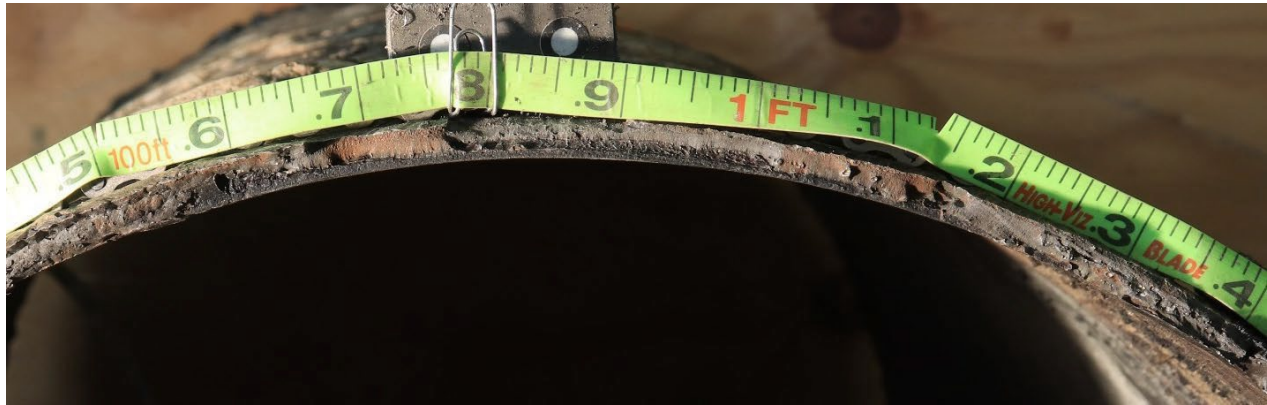
- Incomplete Penetration, 0.5-inch long, 4:15 to 4:21 o'clock orientation (24.5 inch to 25 inch)
 - Metallurgical depth 1.3 mm
- Incomplete Fusion, 0.5-inch long, 6:54 to 7:00 o'clock orientation (39.75 inch to 40.25 inch)
- Burn through, 0.25 inch long, 9:20 to 9:23 o'clock orientation (53.75 inch to 54 inch)

Figure 1: Photograph of fracture surface. Numbered scale divisions are inches.

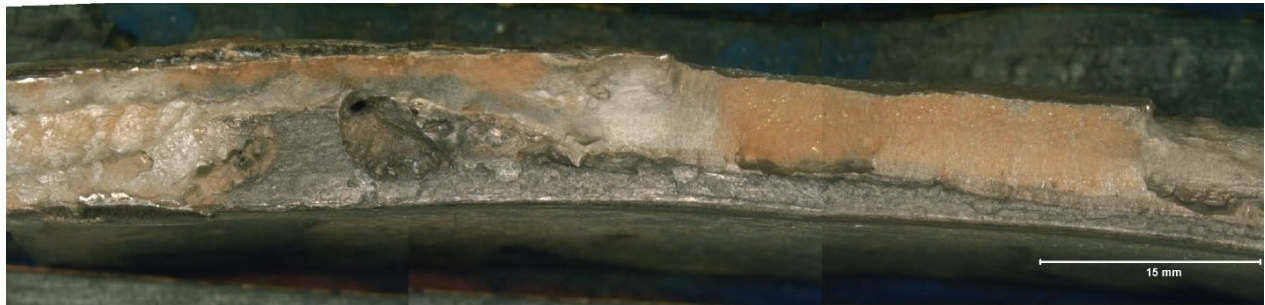
Figure 2: Photograph of fracture surface.

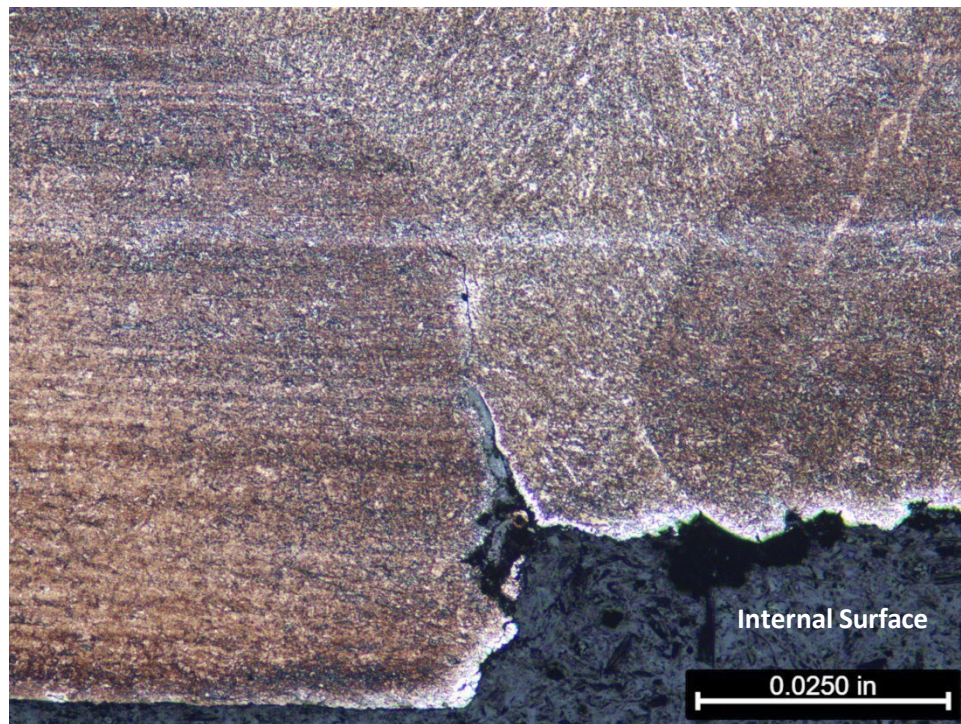
Figure 11: Photomicrograph of girth weld feature present along the internal surface of the 3:00 o'clock cross section. Etchant is 2% Nital; original mangification is 50x.

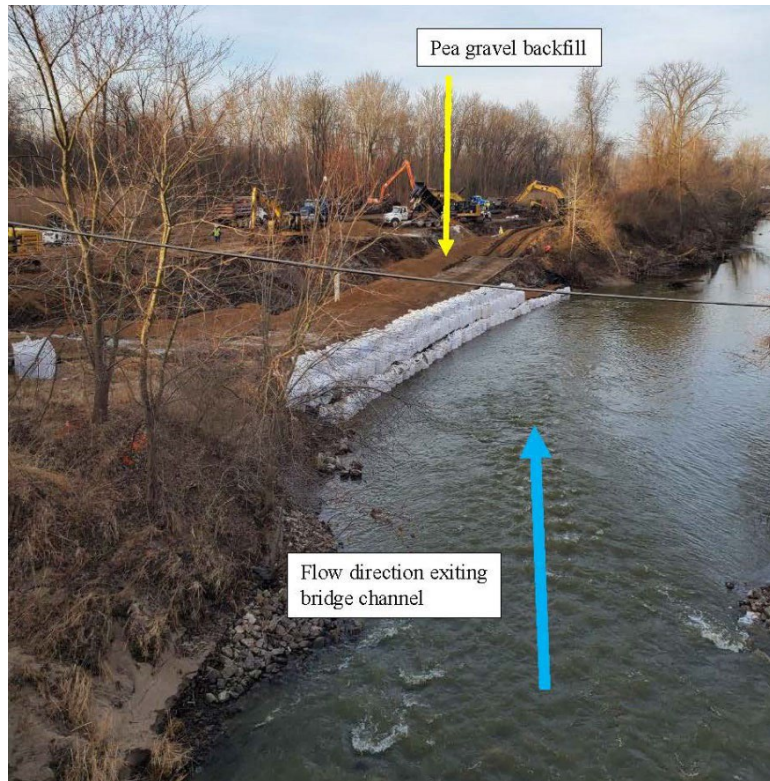
- Water in the Creek, as it passes underneath the bridge north of the Site, flows directly toward the south stream bank (left bank looking downstream) near the southwestern extent of the ground movement, as shown in Figure 1.
- Sandy flood deposits were observed along the streambank more than 15-feet above the observed water elevation, suggesting episodic high-flow and associated erosional events occur within the Creek.
- Streambank deposits along the Creek are alluvial deposits which are susceptible to scour.

Figure 1 - View Looking Southwest from Edwardsville Road Bridge (Photo Taken 17 March 2022)

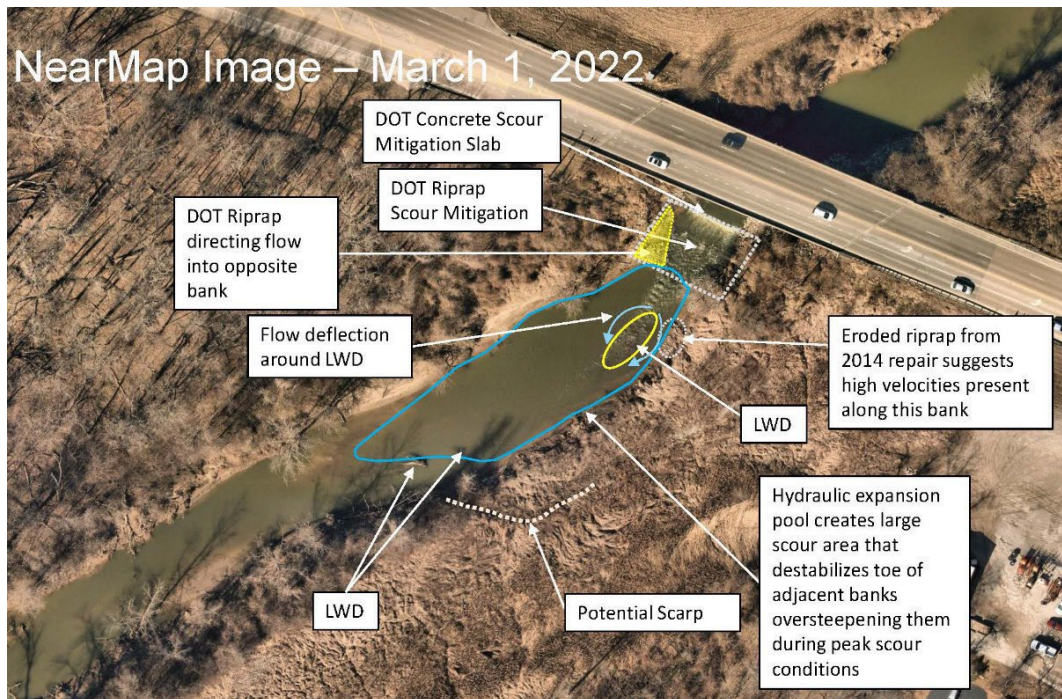
- The image from 1 March 2022 (Figure 5) shows flow through the Illinois Department of Transportation (IDOT) installed scour mitigation riprap directed towards the left bank and accumulations of LWD.

Figure 5 - Aerial Image Dated 1 March 2022 (from NearMap)

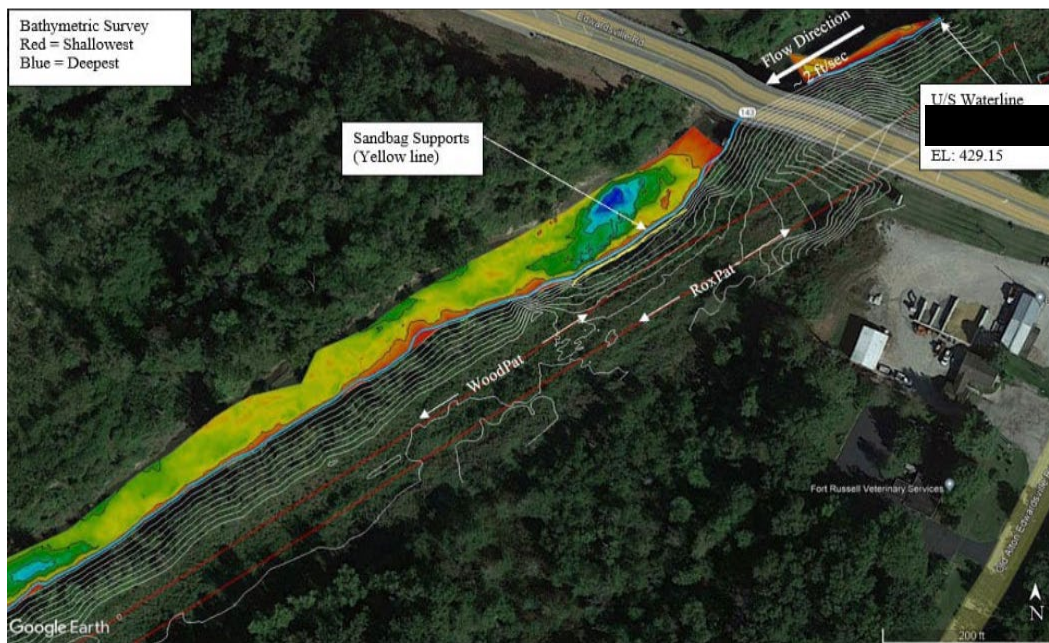
The creek bathymetry and bank topography collected by DoC Mapping LLC after the 11 March 2022 ground movement is shown in Figure 6. These contours, along with the cross sections in Figure 8, illustrate topographically the impact of scour and ground movement on the left bank relative to the forested upstream and downstream streambanks. The instabilities along the left bank are coincident with deeper creek bed depths (i.e., resulting from bed scour), lateral bank position, and altered bank slope inclination. As shown in Figure 8, in the area of the ground instability, the creek bed depth is about five feet deeper and the bank is recessed laterally about 15 feet, compared to the upstream and downstream streambanks.

Figure 6 - Site Plan with Bathymetric and Ground Contours Obtained April 2022 (from DoC Mapping LLC)

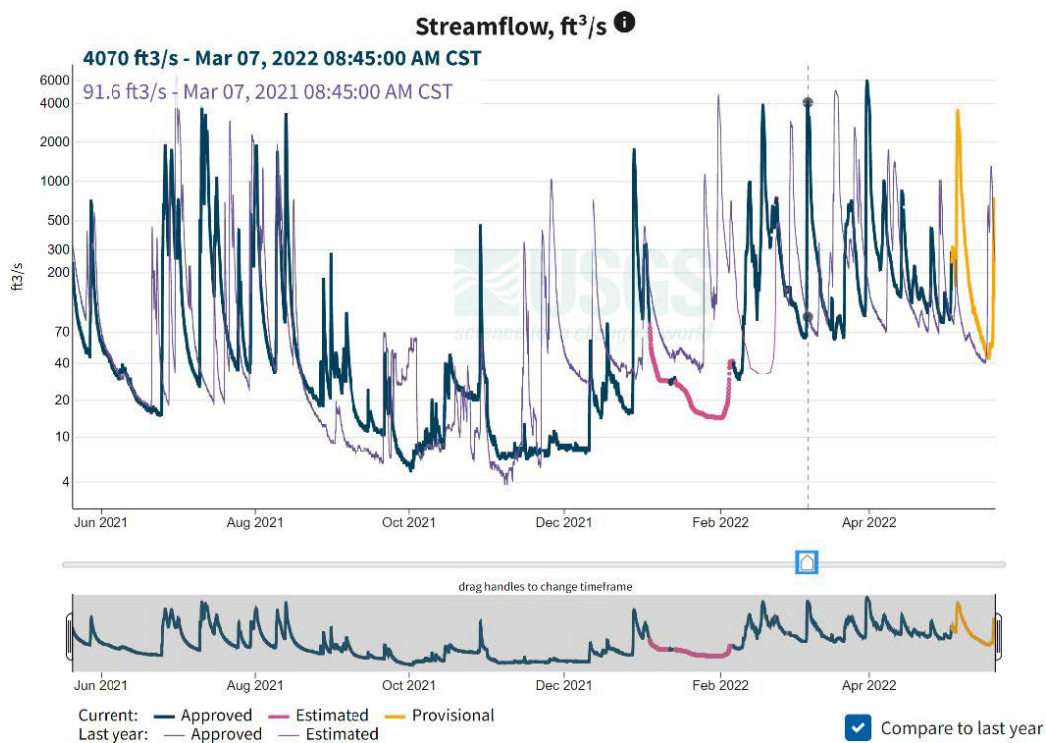
The flood event which occurred on 7 March 2022, preceding the Pipeline rupture by several days, is reported to have had a stream flow magnitude of 4,070 cubic feet per second (cfs), which corresponds to approximately a 1.5-year return period event. This is equivalent to a “bankfull” event responsible for the dominant sediment transport annually. It is suspected that a single flood event is not responsible for the scour which led to the conditions at the Site, but rather a series of multiple smaller events, such as the 7 March 2022 flood event. Figure 9 contains a hydrograph with stream flow data for the Creek showing the relatively frequency of flood events with stream flows in the range of 4,000 cfs from May 2021 to April 2022.

Figure 9 - 1-yr Cahokia Creek Hydrograph (from USGS)

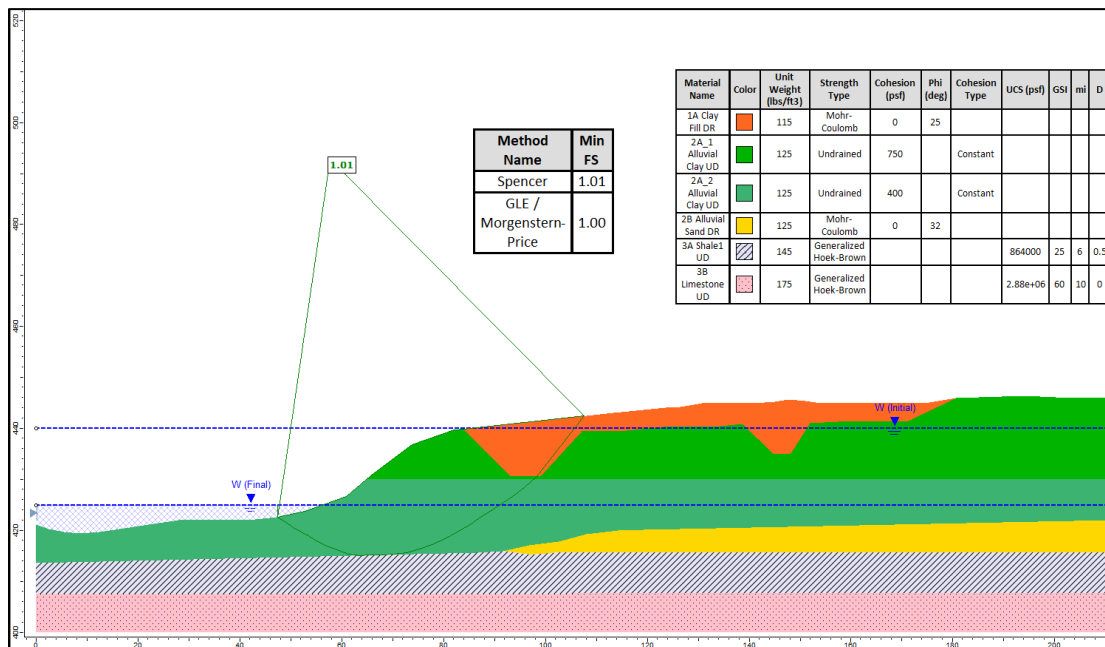
The slope stability analysis results for Section A-A' under the assumed conditions at the time of instability are shown in Figure 10. This scenario considers a streambank slope of approximately 1.2H to 1V with material removed at the slope toe from riverine scour. Groundwater is modeled as a rapid drawdown condition with initial and final water elevations changing from EL. 440 feet¹ to EL. 425 feet within the model to match flooding conditions observed prior to the event on 11 March 2022. The undrained shear strength of the alluvial clay (Unit 2A) below EL. 430 feet was adjusted until a factor of safety equal to 1.0 was achieved. The resulting undrained shear strength is 400 pounds per square foot (lbs/ft²), a value that is consistent with the range of shear strengths for this material measured from laboratory testing.

Figure 10 - Limit Equilibrium Slope Stability Analysis at Section A-A'
