MARiTECH COMMERCIAL, INC.

Report No.: 185286

SURVEY REPORT

M/V "SIROCCO" (Voy.32L)

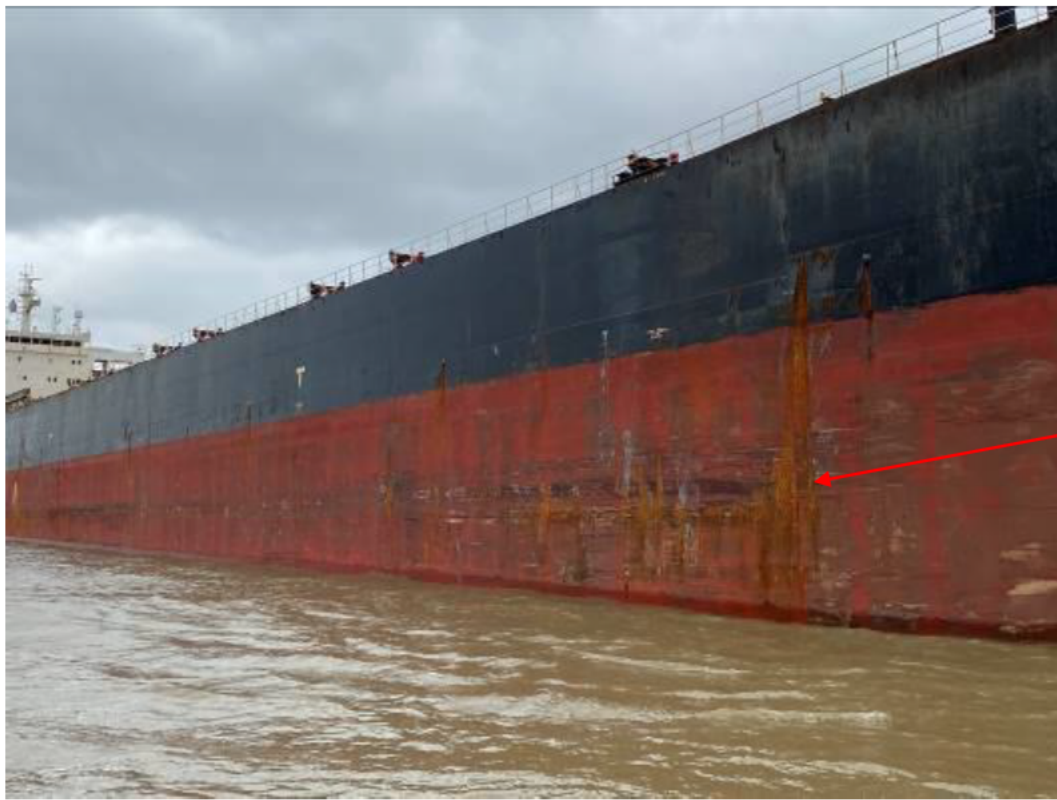
3. Viewing
Starboard
side hull
mid to fwd
section.

Note: Rust
scaling and
paint fowling
present.

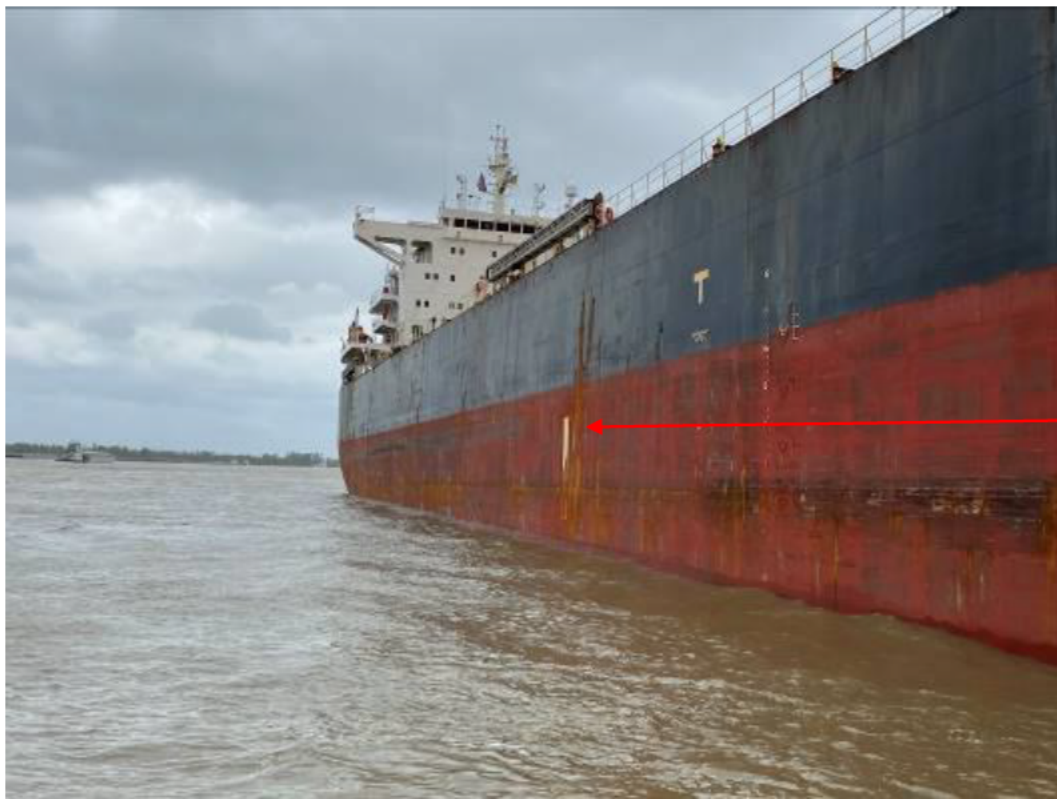
4. Viewing
Starboard
side hull
mid to aft
section.

Note: Rust
scaling and
paint
fowling
present.

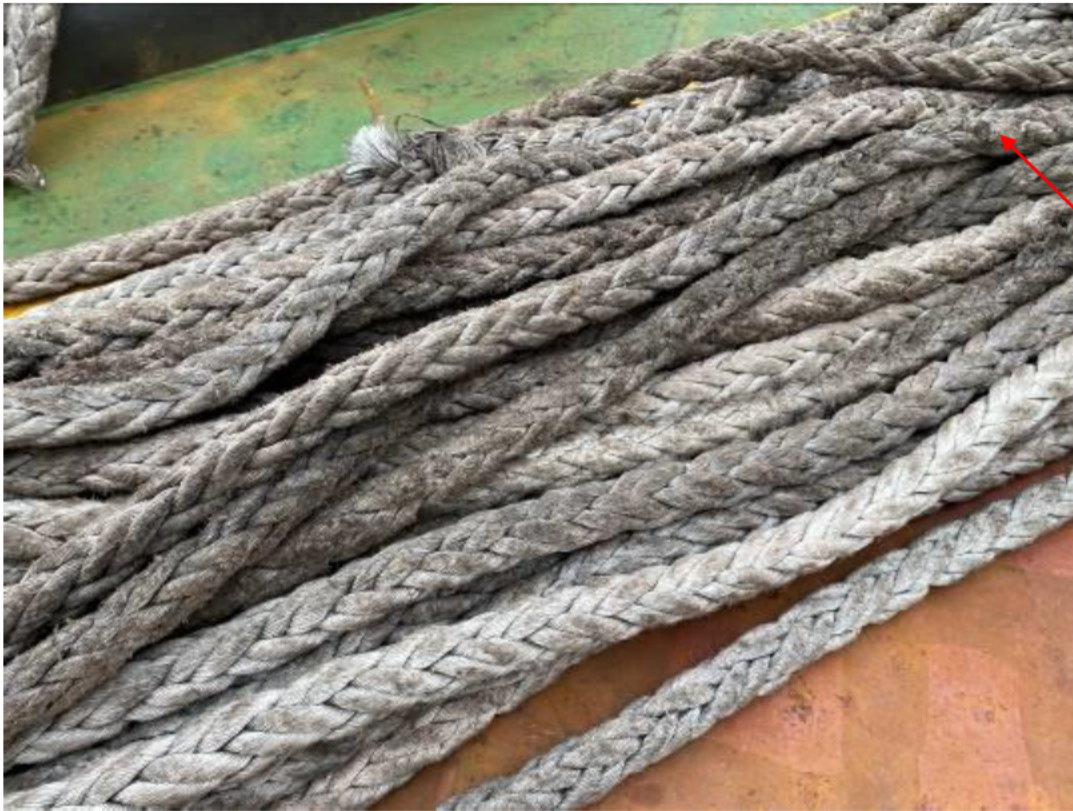
13. Port side mooring windlass spare rope.

Note: Polyester-Polypropylene Mooring ropes were in poor condition, with heavy wear at the time of survey. Please find attached Photos #9-#27 of the photo report for close view of ropes and all equipment. Mooring gear and rope certificates are attached.

1 Polyester-Polypropylene moderate wear and tear present.

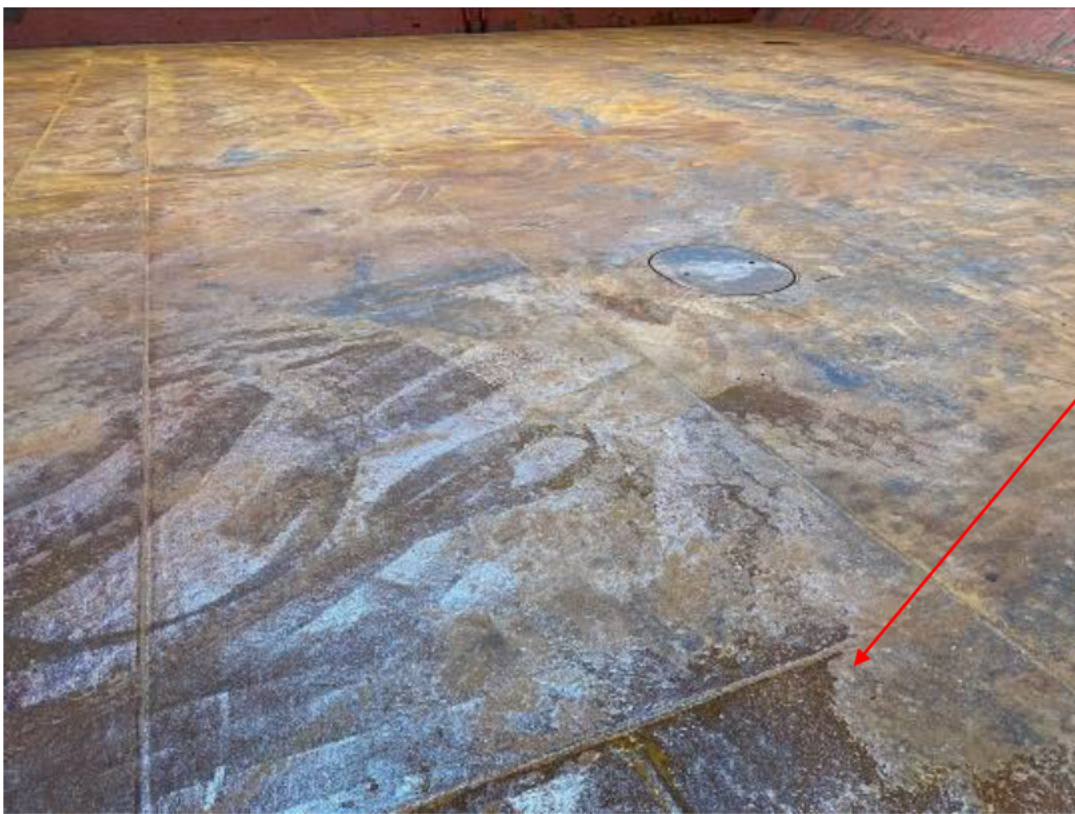
52. Hold #1 -
Tank top

- **Rust browning present. (Photo #52)**
-

Note: Rust
browning on
tank top.

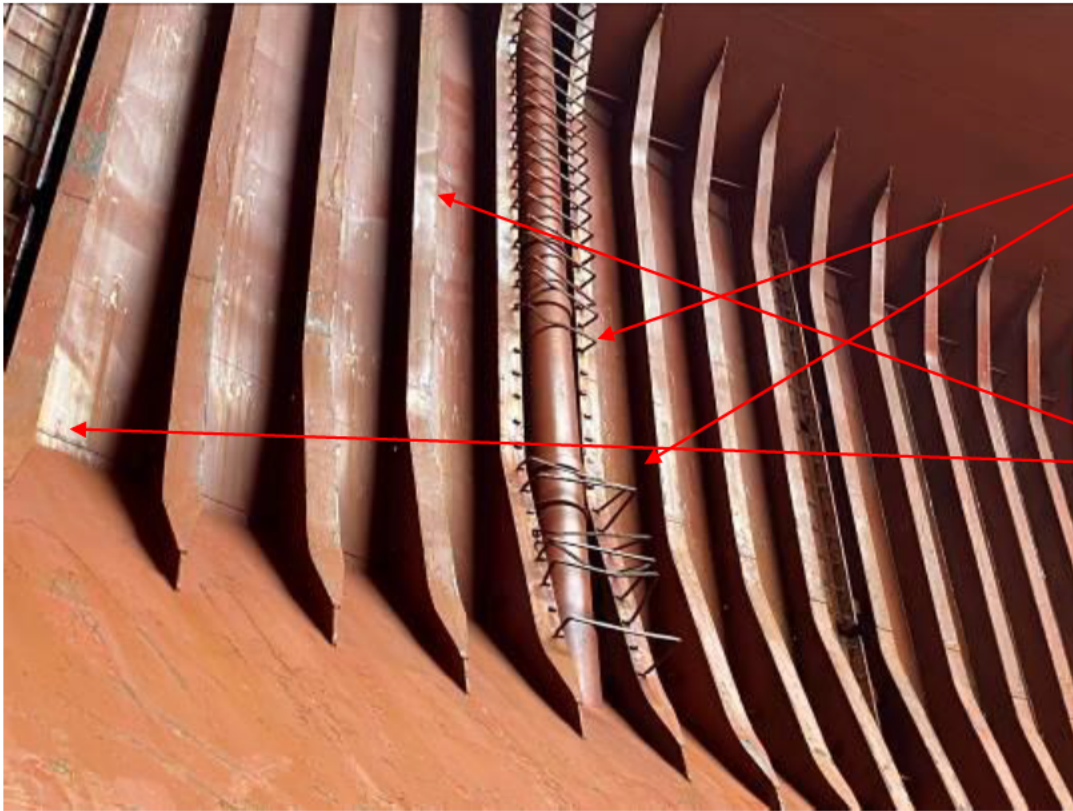
- **Portside bulkhead pipe guards bent and missing also white stains present on upper section. (Photo #53)**
- **Paint fowling and exposed metal on lower hopper slope. (Photo #46)**

53. Hold #1
-
Portside
bulkhead
pipe guards
bent and
missing.

Note: White
stains present
on upper
section.

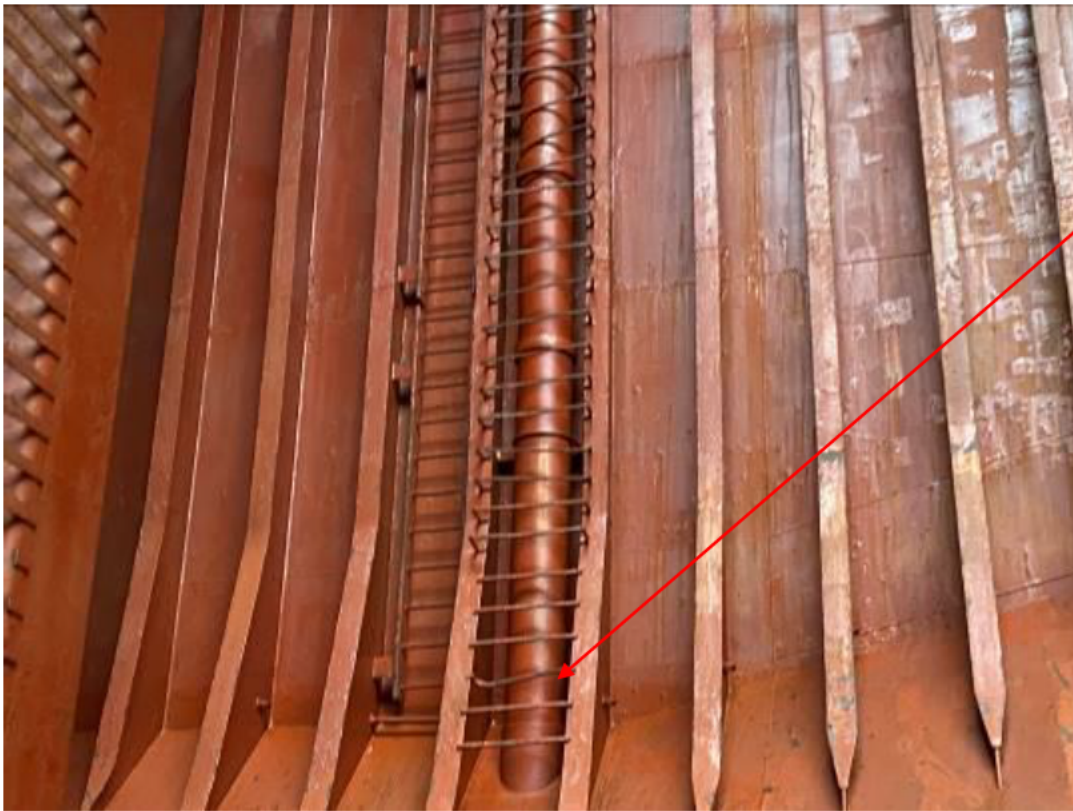
- **Starboard side bulkhead pipe guards bent. (Photo #54)**

54. Hold #1
-
Starboard
side
bulkhead
pipe guards
bent.

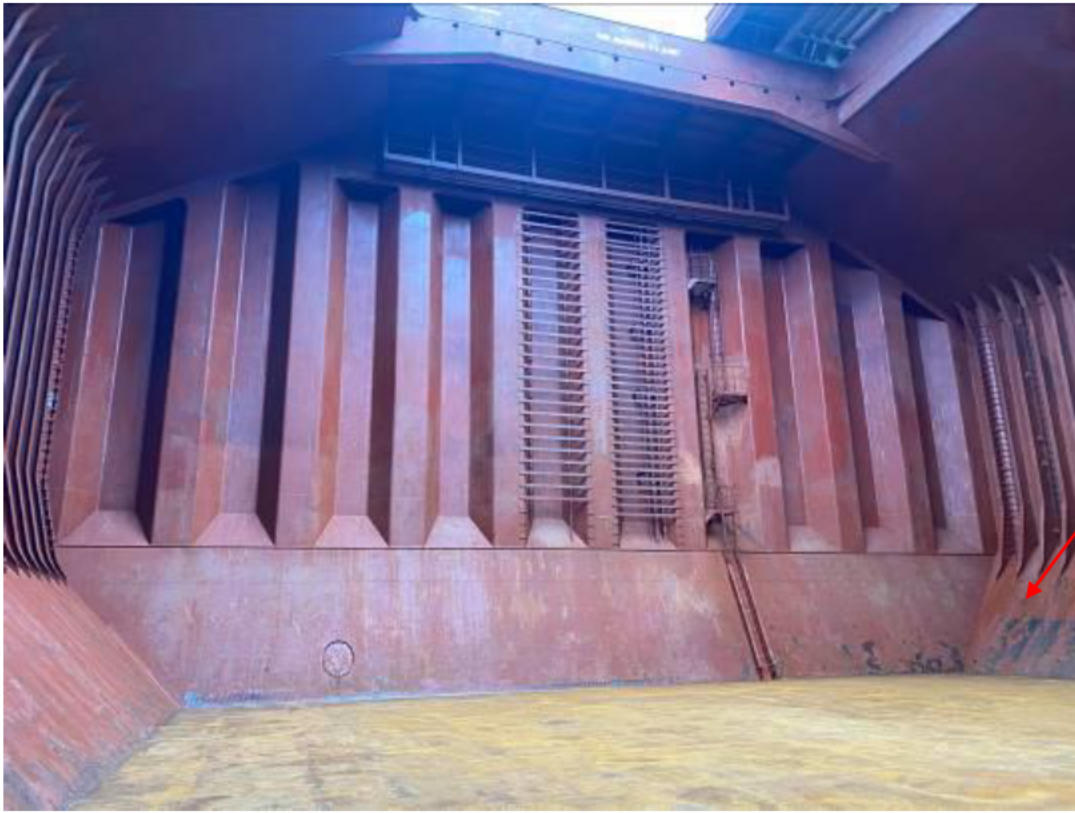
55. Hold #2 - Forward vertically corrugated transverse bulkhead.

- **Paint fowling and exposed metal on lower hopper slope. (Photo #55)**

Note: Paint missing on lower hopper slope.

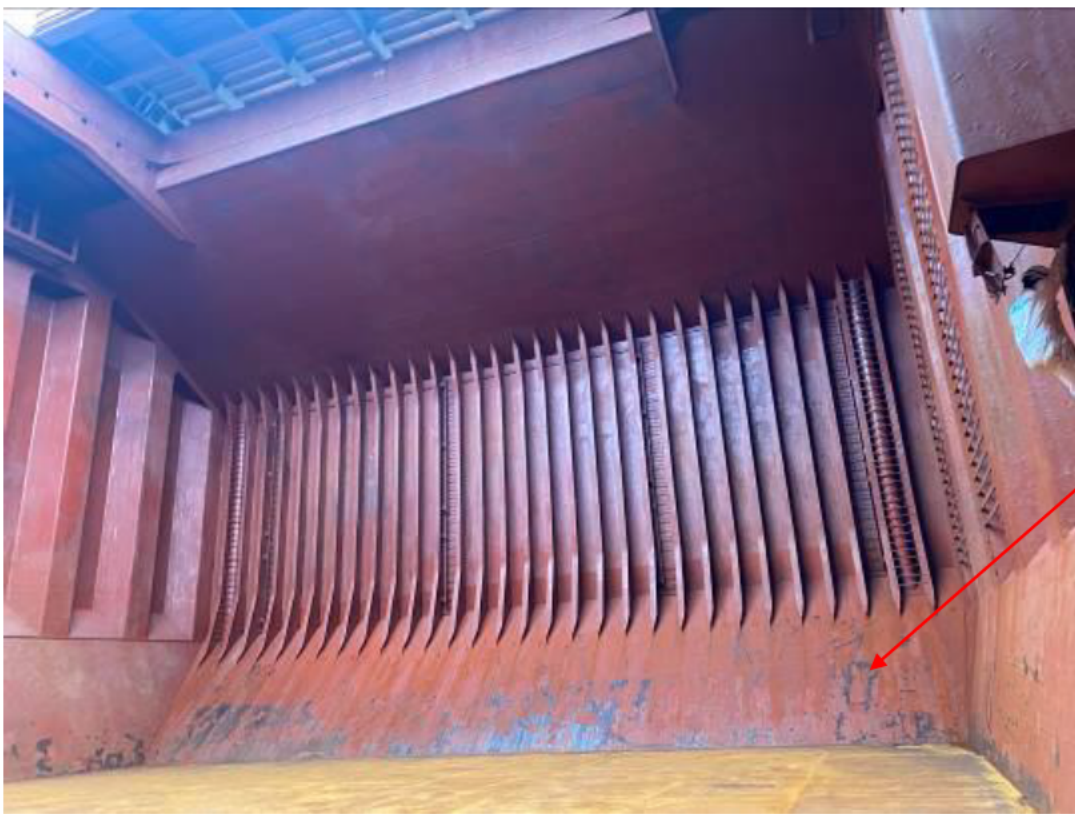
56. Hold #2 - Full viewing of starboard side bulkhead.

- **Paint fowling and exposed metal on lower hopper slope. (Photo #56)**

Note: Paint missing along lower hopper slope.

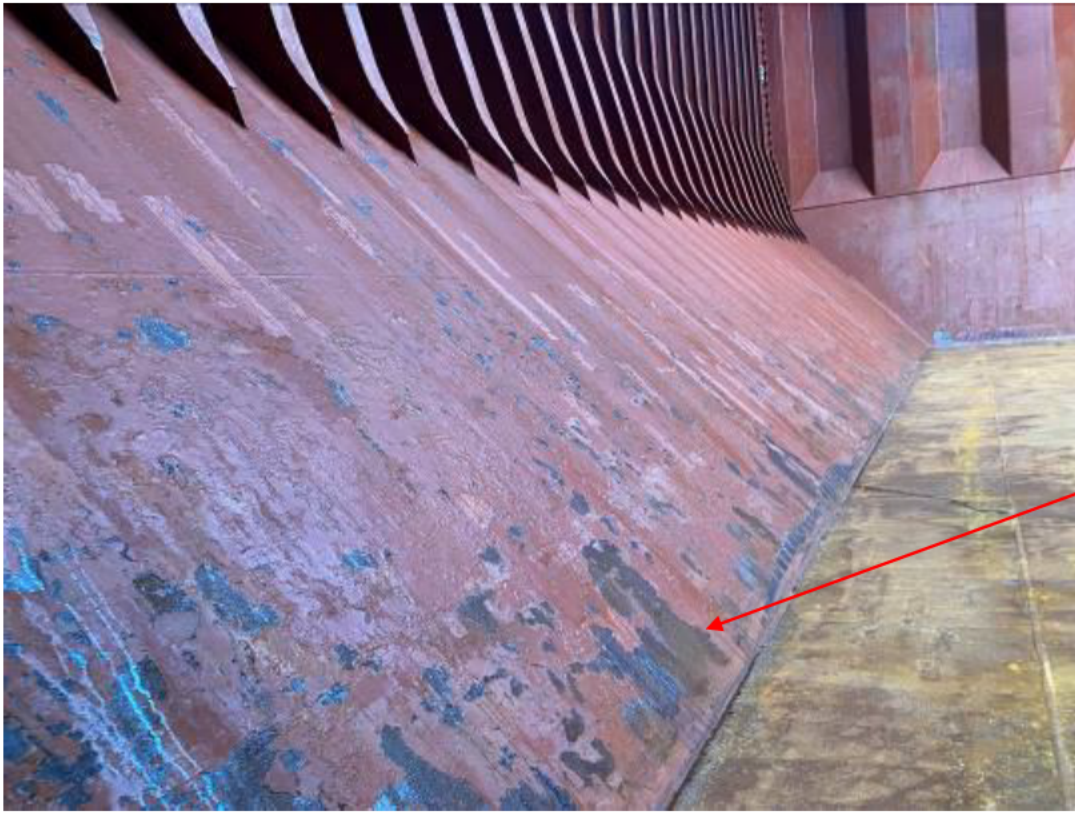
57. Hold #2 -
Port side
lower
hopper
slop.

- **Paint fowling and exposed metal on lower hopper slope. (Photo #57)**
-

Note: Paint
missing along
lower hopper
slope and rust
present.

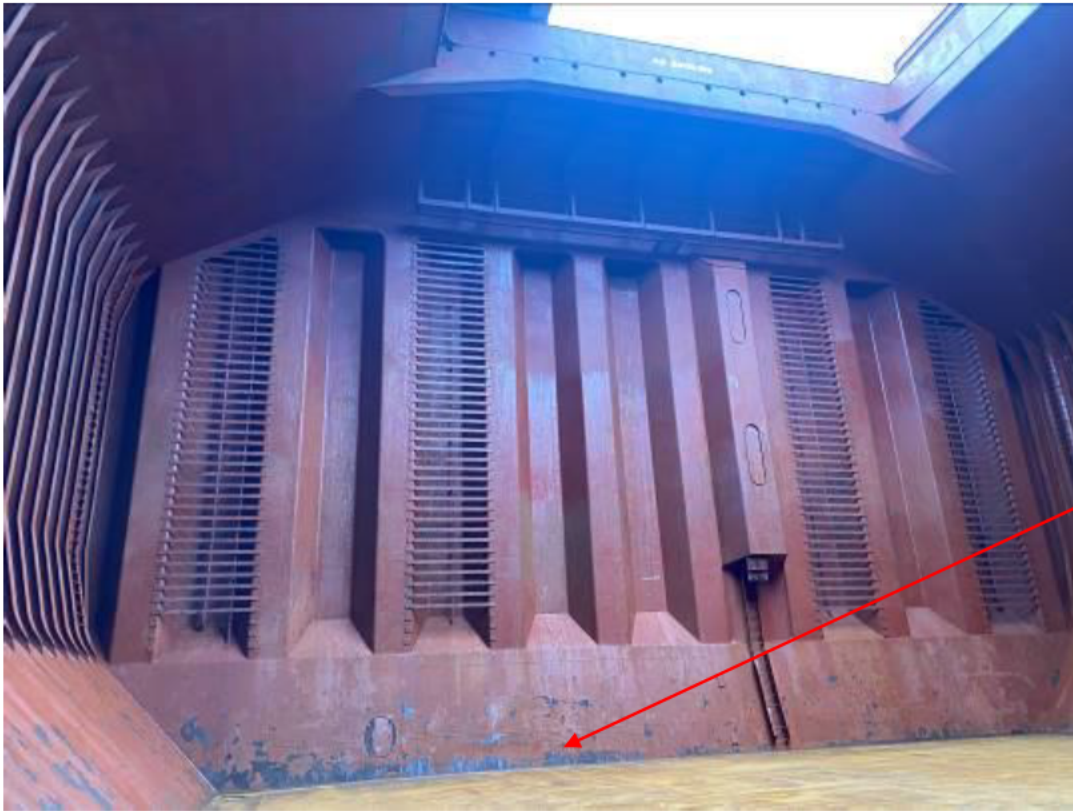
59. Hold #2 -
After
vertically
corrugated
transverse
bulkhead.

- **Lower access ladder frame bent on after bulkhead and paint fowling present. (Photo #64)**
- **Paint missing and flaking on lower section of bulkhead. (Photo #59)**

Note: Paint
missing along
lower hopper
slope.

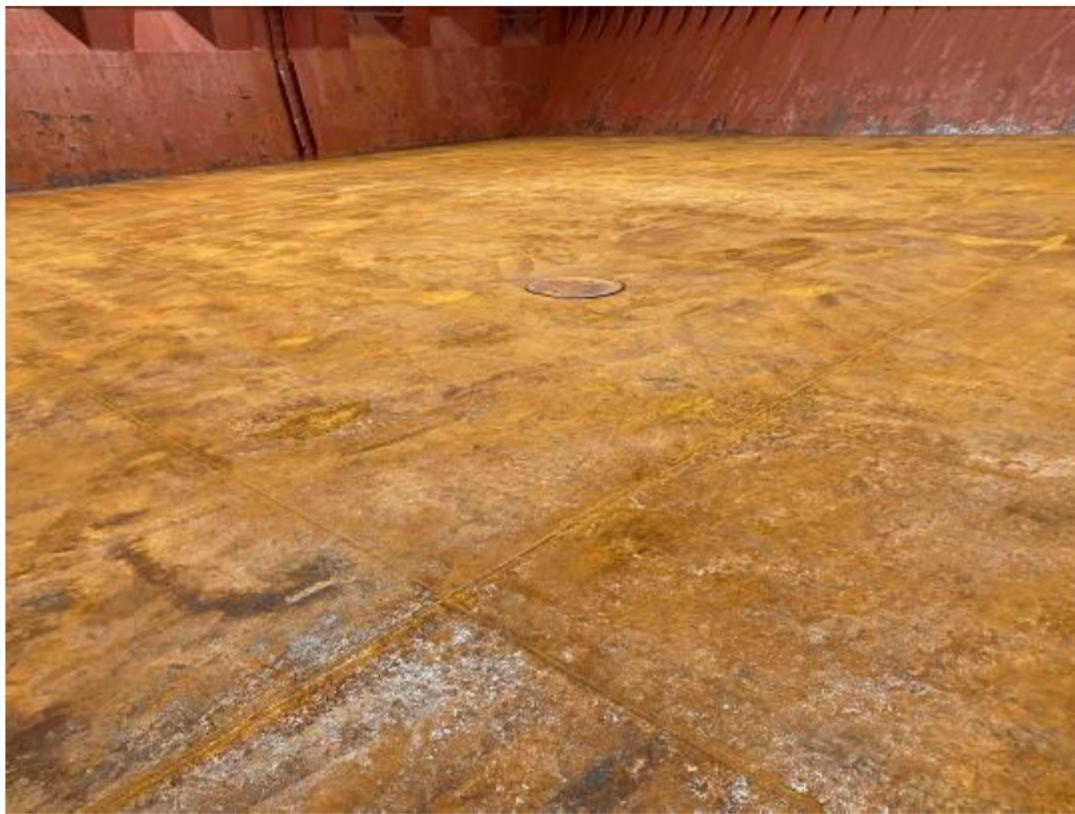
63. Hold #2 -
Tank Top.

- **Heavy rust present throughout the tank top. (Photo #63)**

Note: Heavy
Rust present
on tank top.

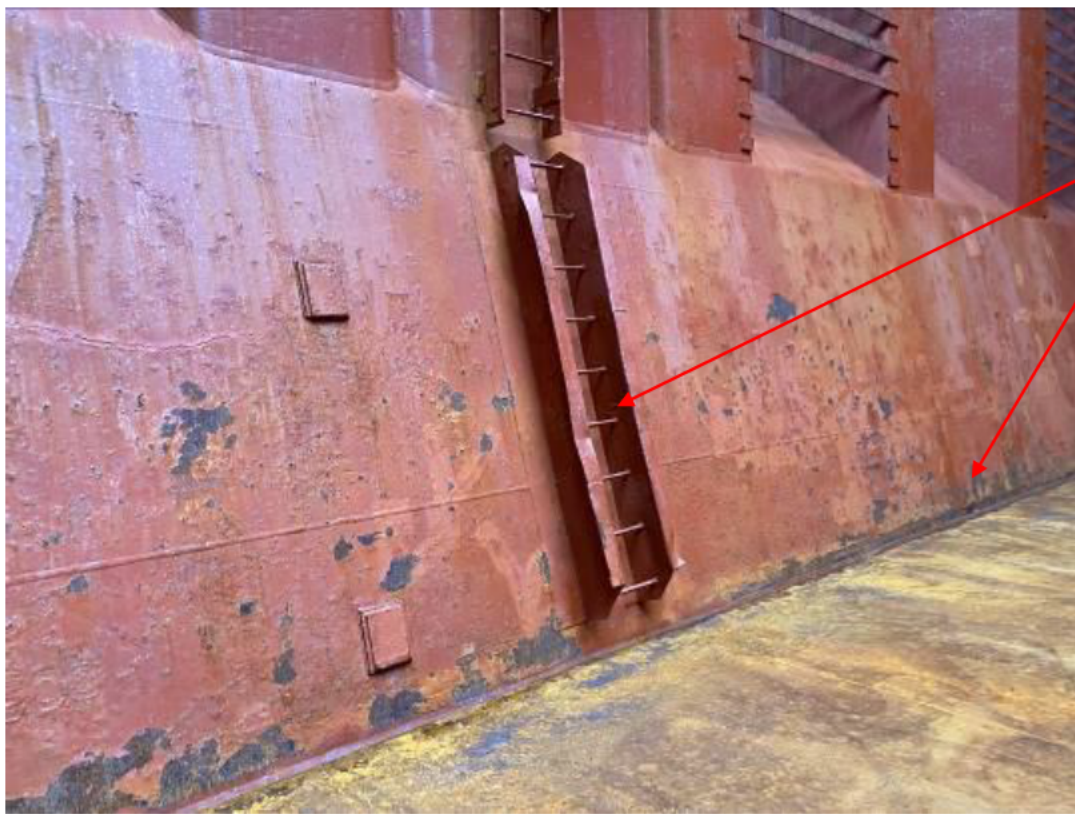
64. Hold #2 -
Lower
access
ladder
frame bent
and paint
fowling
present
throughout
the after
bulkhead.

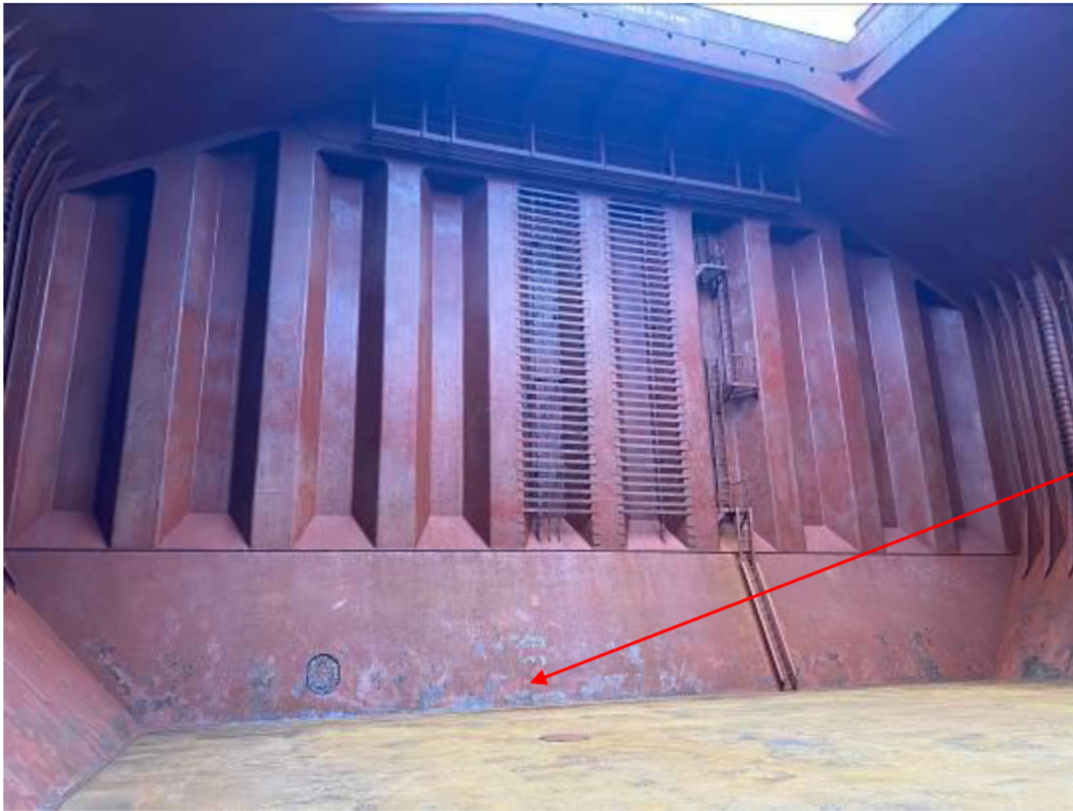
65. Hold #3-
Forward
vertically
corrugated
transverse
Bulkhead.

- **Paint missing and flaking along lower hopper slope. (Photo #65)**

Note: Paint
missing and
flaking along
lower hopper
slope.

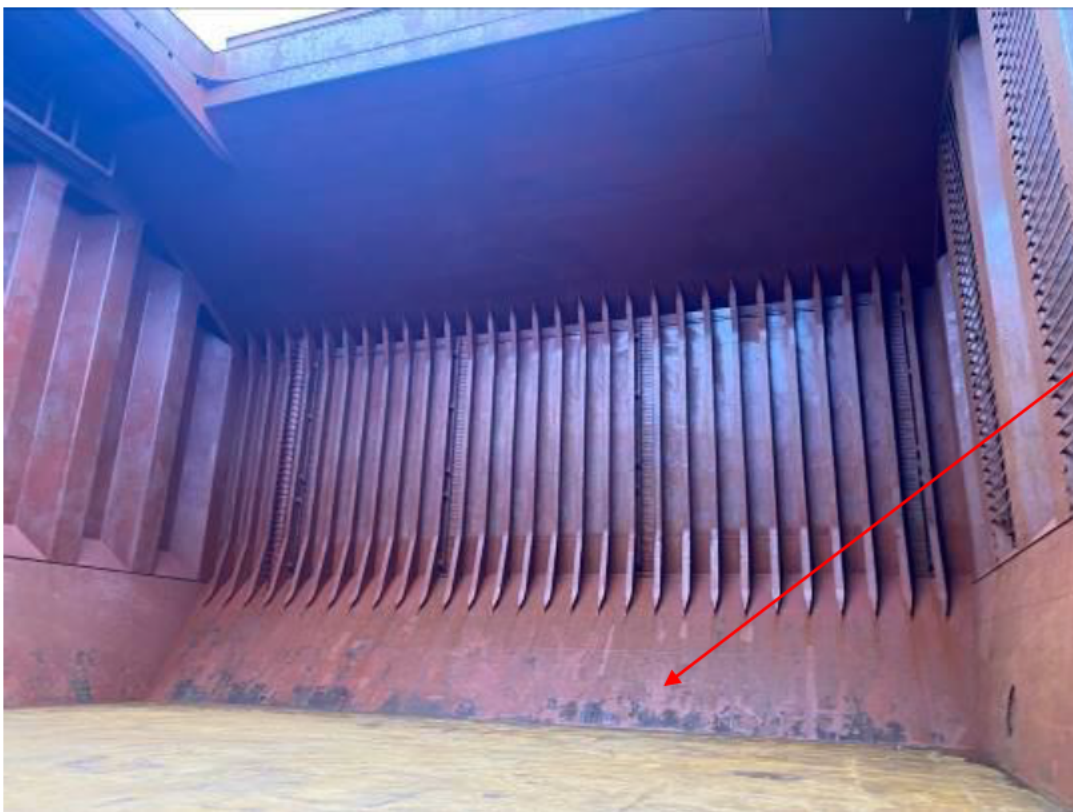
66. Hold #3 -
Starboard
side
bulkhead.

- **Paint missing and flaking along lower hopper slope. (Photo #66)**

Note: Paint
missing and
flaking along
lower hopper
slope.

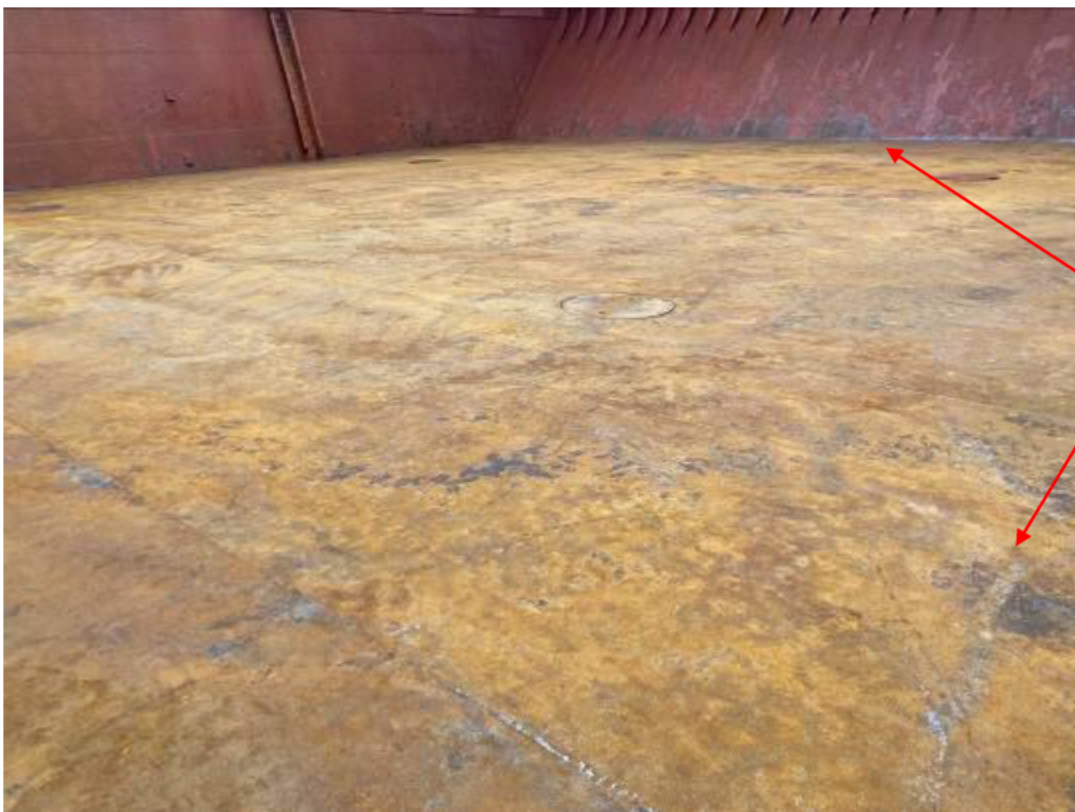
72. Hold #3 -
Tank top.

- **Rust present on tank top and exposed metal along lower sections of slopes. (Photo #72)**

Note: Rust
present on
tank top and
exposed metal
along lower
sections of
slopes.

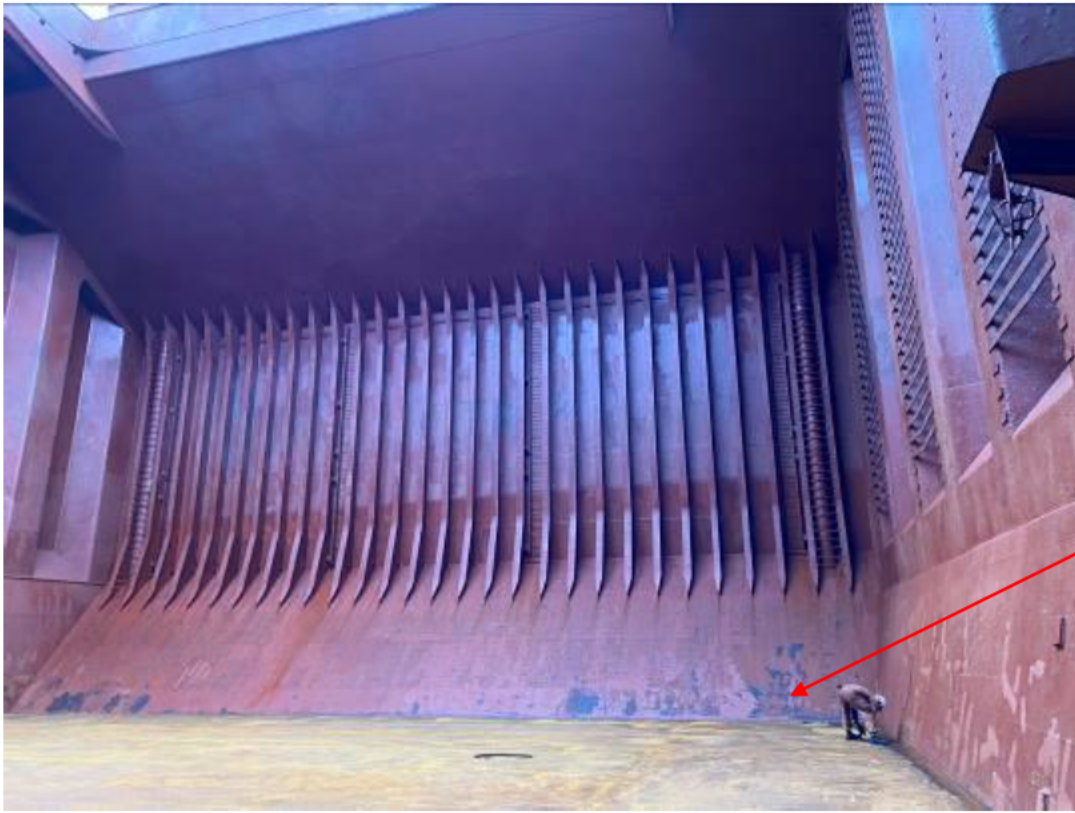
75. Hold #5 - Full viewing of starboard side bulkhead.

- **Paint missing along lower hopper slope. (Photo #75)**

Note: Paint missing along lower hopper slope.

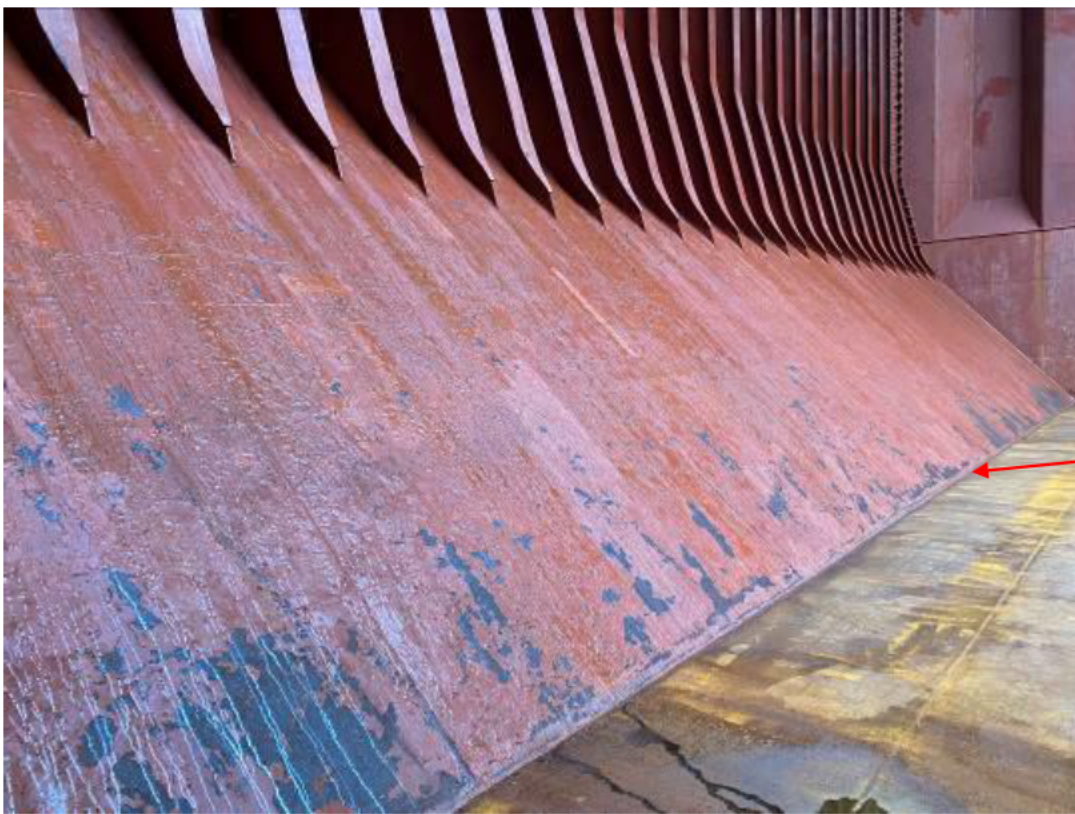
76. Hold #5 - Port side lower hopper slope.

- **Paint missing along lower hopper slope. (Photo #76)**

Note: Paint missing along lower hopper slope.

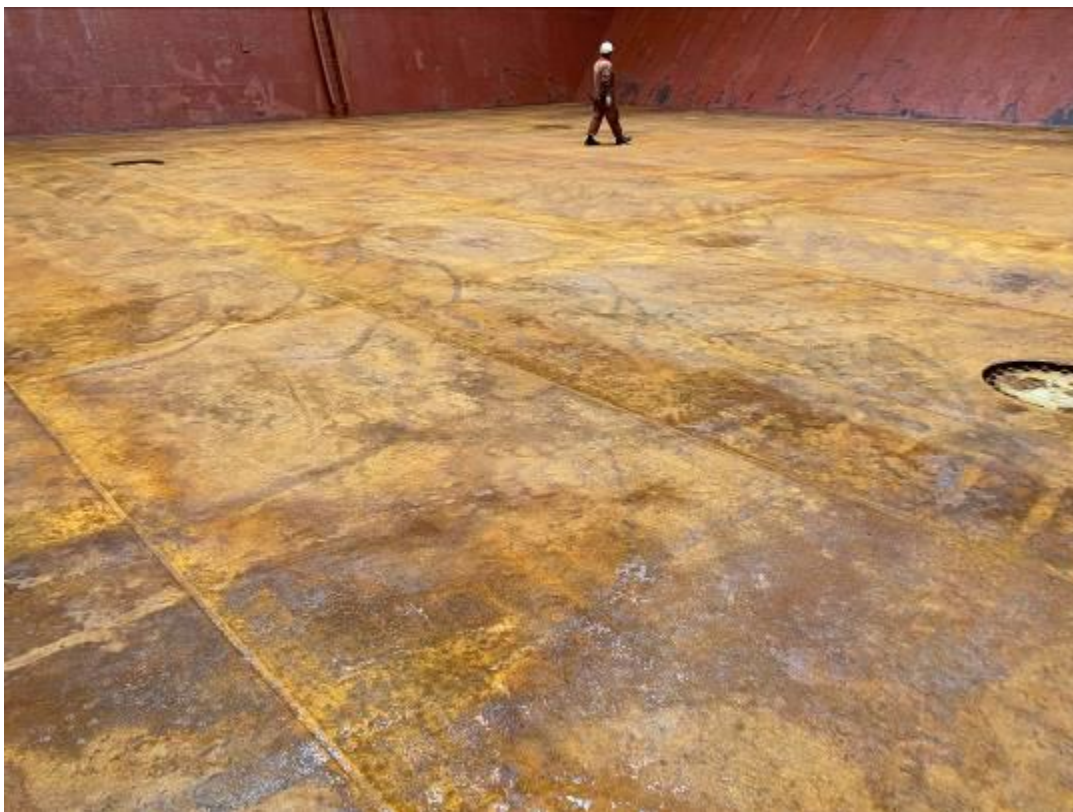
84. Hold #5 -
Tank top.

- **Rust present on tank top. (Photo #84)**

Note: Heavy
rust present
along tank
top.

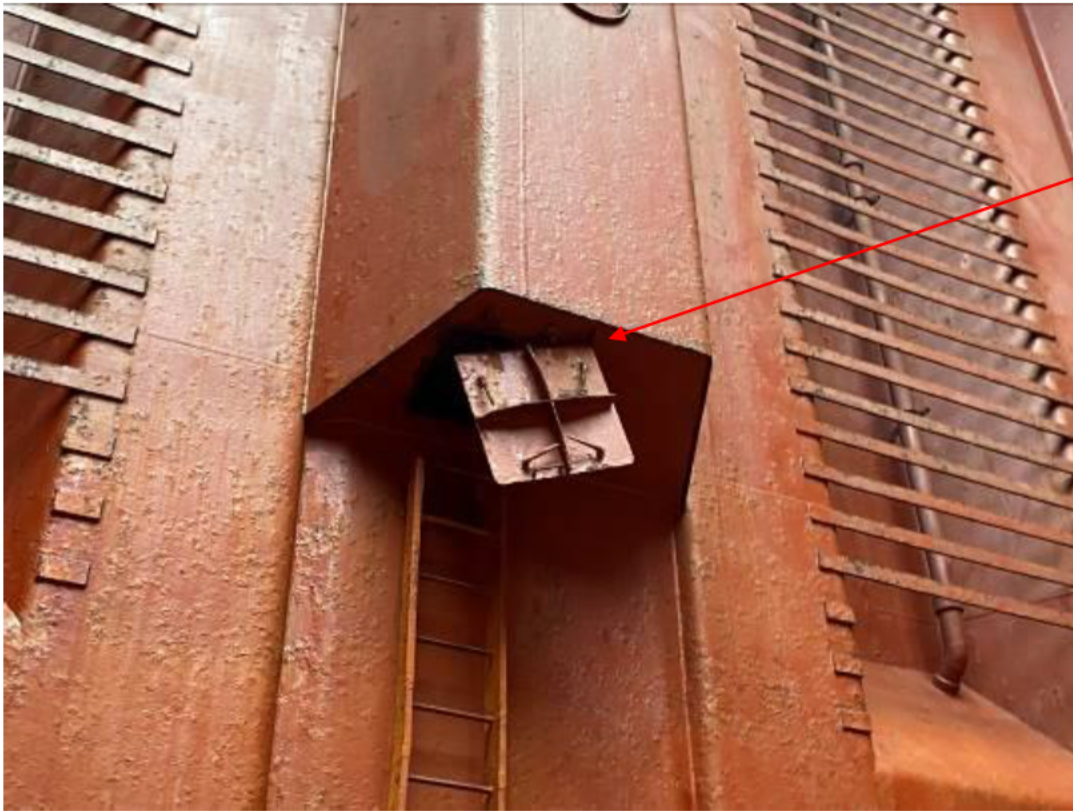
- **Lower access ladder door broken and hanging. (Photo #85)**
- **Rust spots are present throughout bulkhead. (Photo #85)**

85. Hold #5 - Lower access ladder door broken and hanging.

Note: Rust spots present throughout Bulkhead.

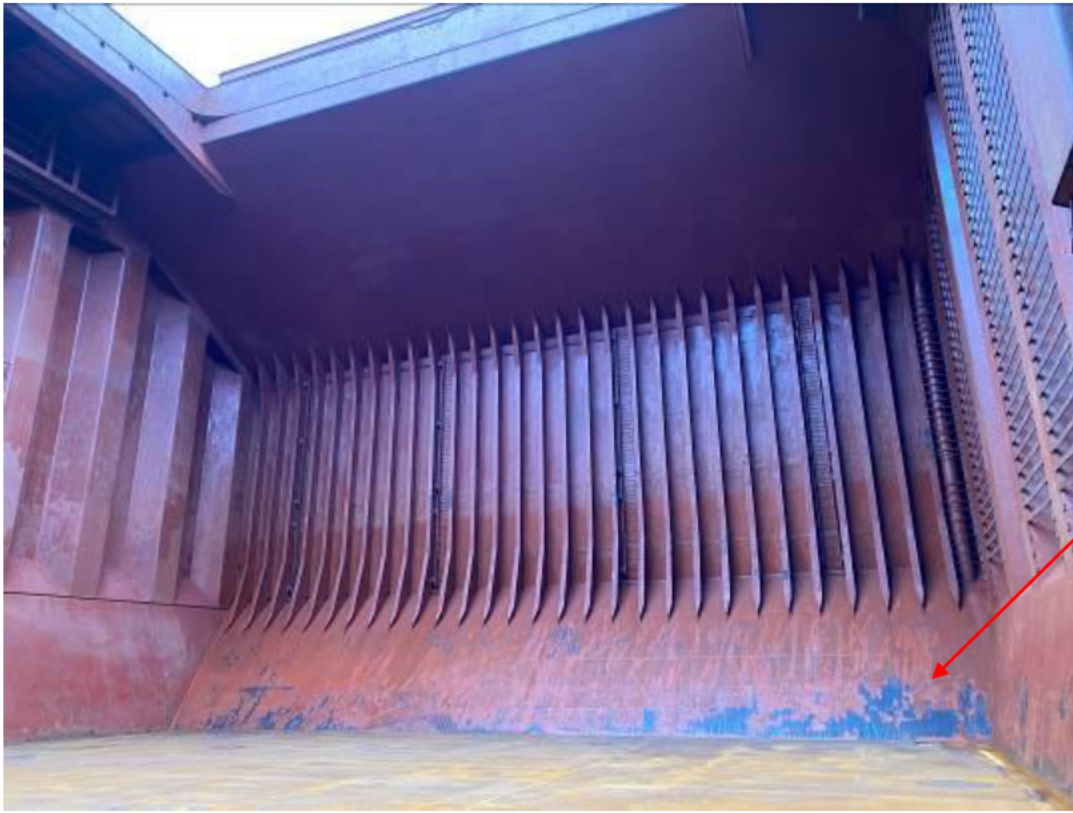
87. Hold #6 - Full viewing of starboard side bulkhead.

- **Paint missing and flaking along lower hopper slope. (Photo #87)**

Note: Paint missing and flaking along lower hopper slope.

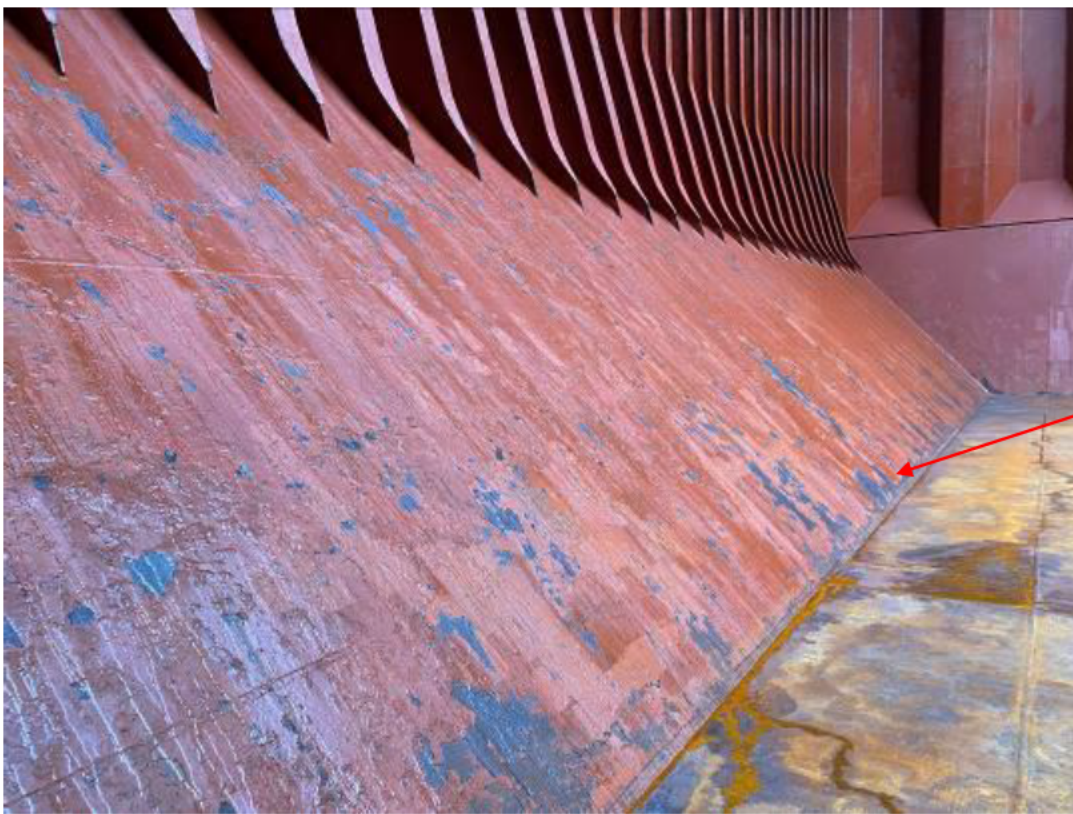
88. Hold #6 - Port side lower hopper slope.

- **Paint missing and flaking along lower hopper slope. (Photo #88)**

Note: Paint missing along lower hopper slope.

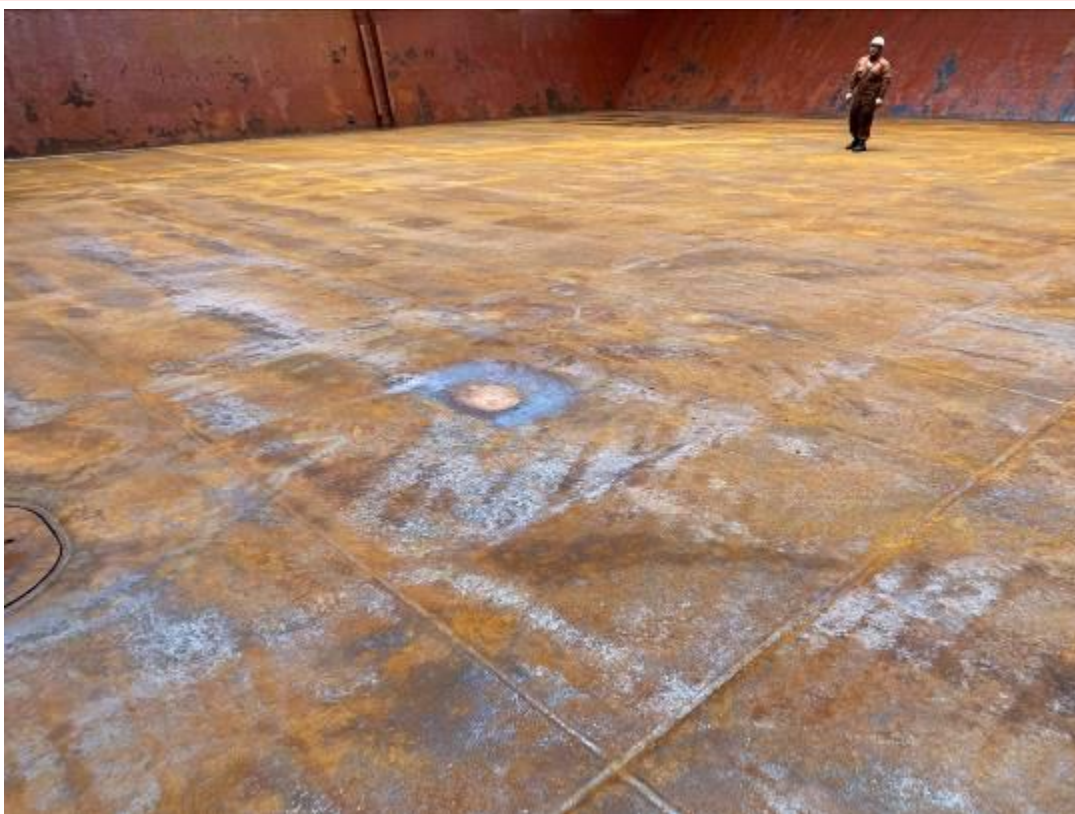
96. Hold #6 - Tank top.

Note: Heavy rust throughout tank top.

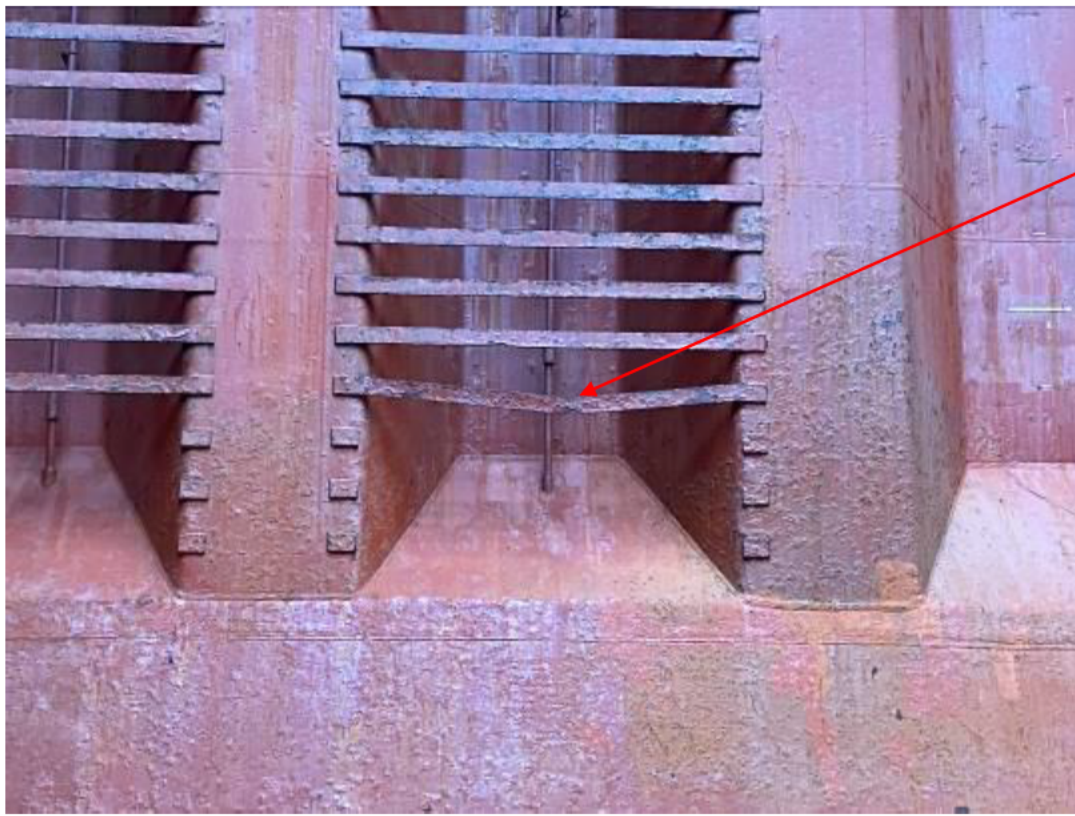
97. Hold #6 -
Pipe guard
bent.

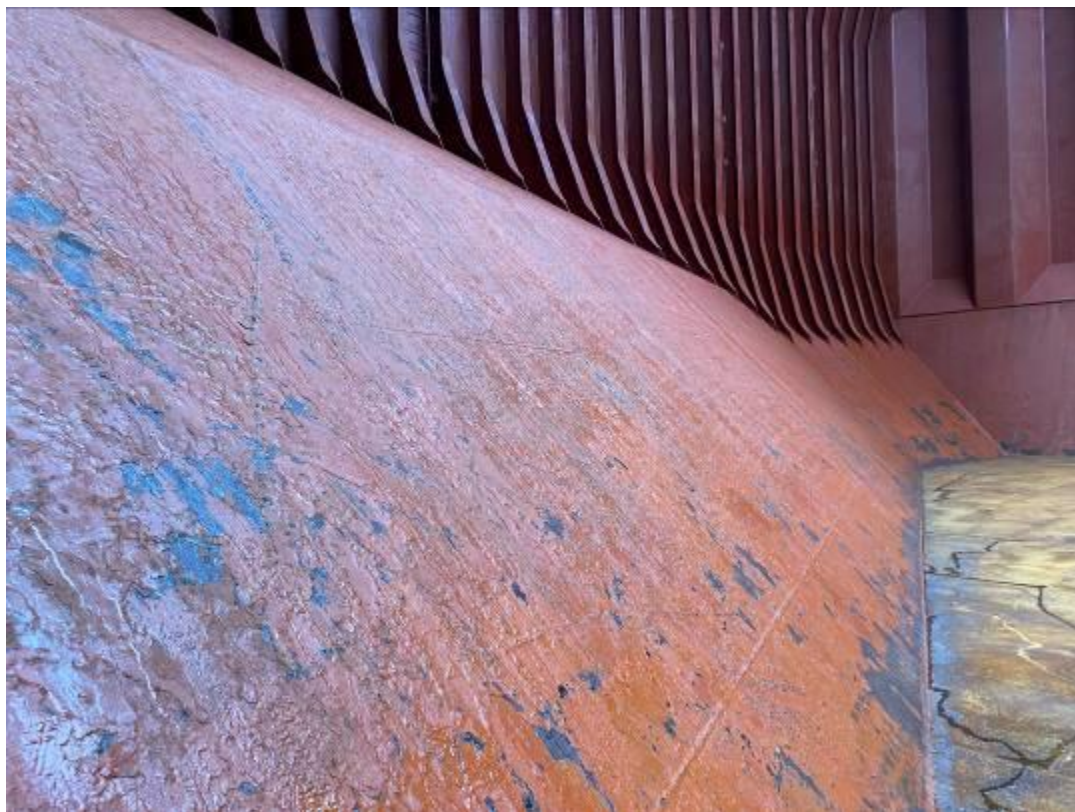
100. Hold #7 - Port Side Lower hopper slope.

Note: Paint missing along lower hopper slope.
