# NATIONAL TRANSPORTATION SAFETY BOARD

MATERIALS LABORATORY FACTUAL REPORT

Report No. 10-005

Place : Butte, Montana  
Date : March 22, 2009  
Vehicle : Pilatus PC-12/45, N128CM  
NTSB No. : WPR09MA159  
Investigator : Dennis Diaz

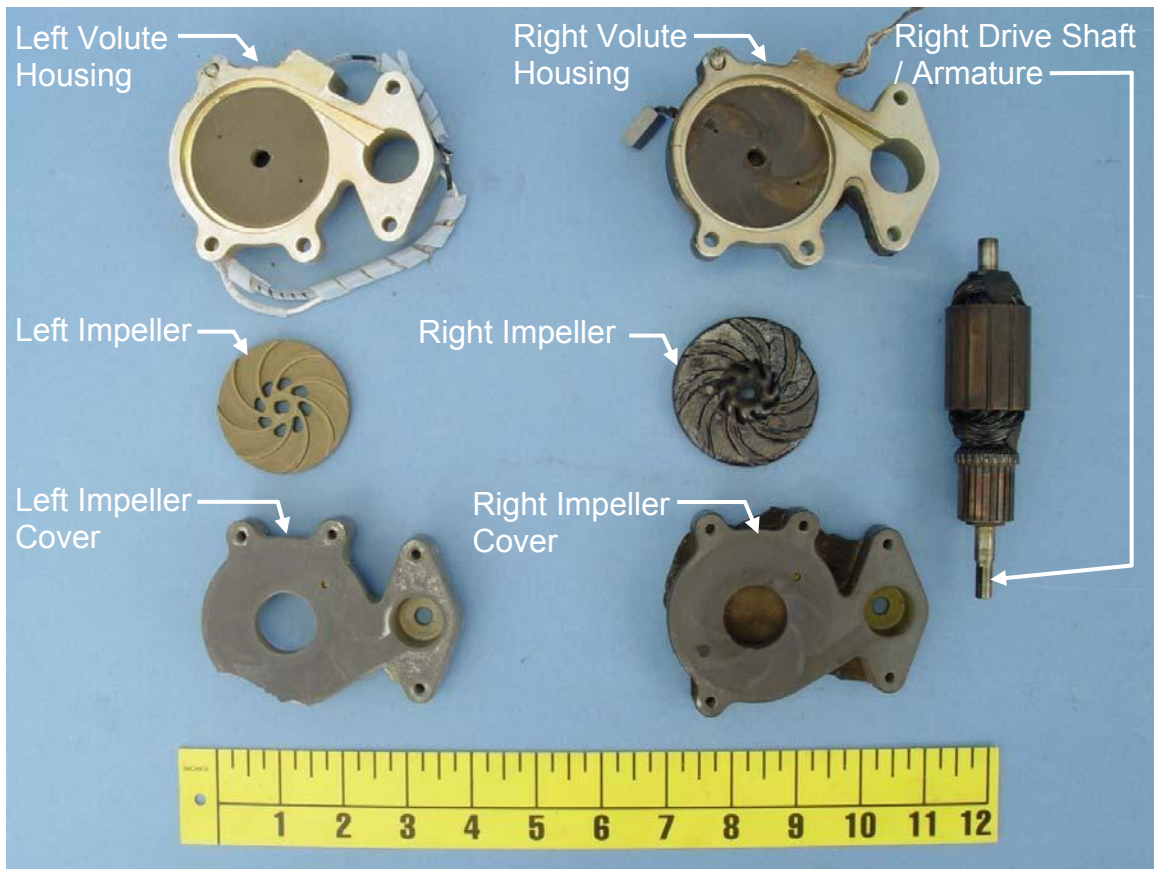
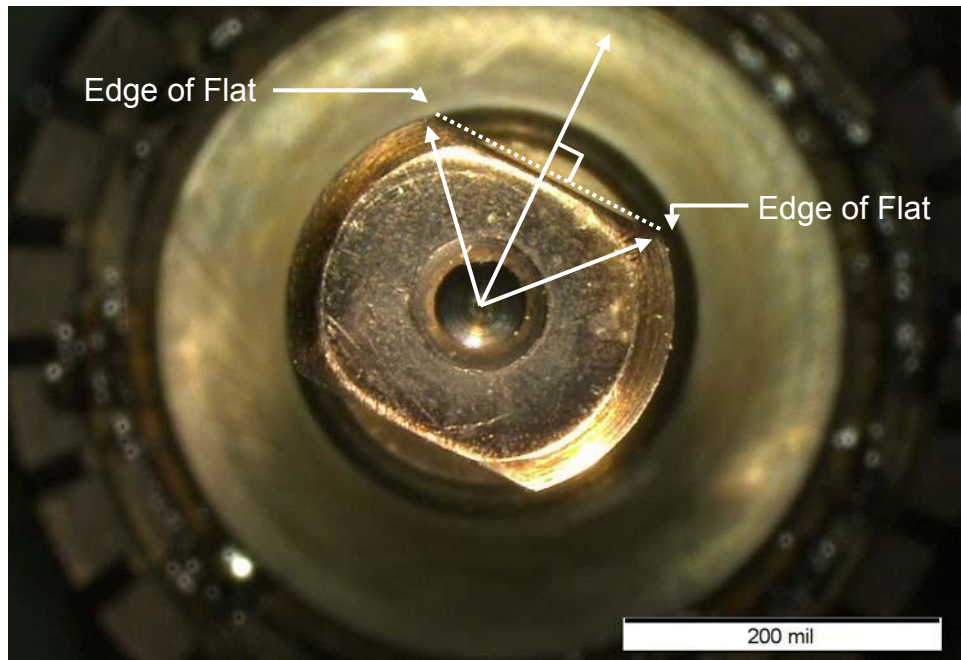
The fuel boost pumps were received in a disassembled state by the Materials Laboratory as shown in figure 1a. The pumps were centrifugal volute pumps (model #: RR35710K) that operated at 7,900 RPM<sup>1</sup>. The left drive shaft / armature assembly was not recovered. The end of the right drive shaft indicated by the arrow had two parallel flats on opposing sides forming a "Double-D" shown in figure 1b. The width of each flat was 0.170 inch as measured by calipers. As situated on the aircraft the armature sat above the volute housing. The shaft passed through a through-hole in the volute housing and emerged into the volute chamber that housed the impeller. Figure 2 shows the left volute housing as viewed from underneath. The drive shaft emerges out of the page into the volute chamber in this view. The appearance of the right fuel boost pump was consistent with exposure to fire. The right pump housing, impeller cover, and armature assembly were brown/black. The right impeller was black and had expanded to fill the volute chamber. The center of the impeller had expanded into the suction side inlet hole and the edge of the impeller had expanded into the pressure side outlet. The lower left corner of the left impeller cover (see figure 1) was fractured. The appearance of the fracture surface was consistent with an overstress fracture.

**Figure 1:** a) Left and right boost pump components as received; b) Double-D drive shaft at end of armature. The Dashed line is parallel to the flat.

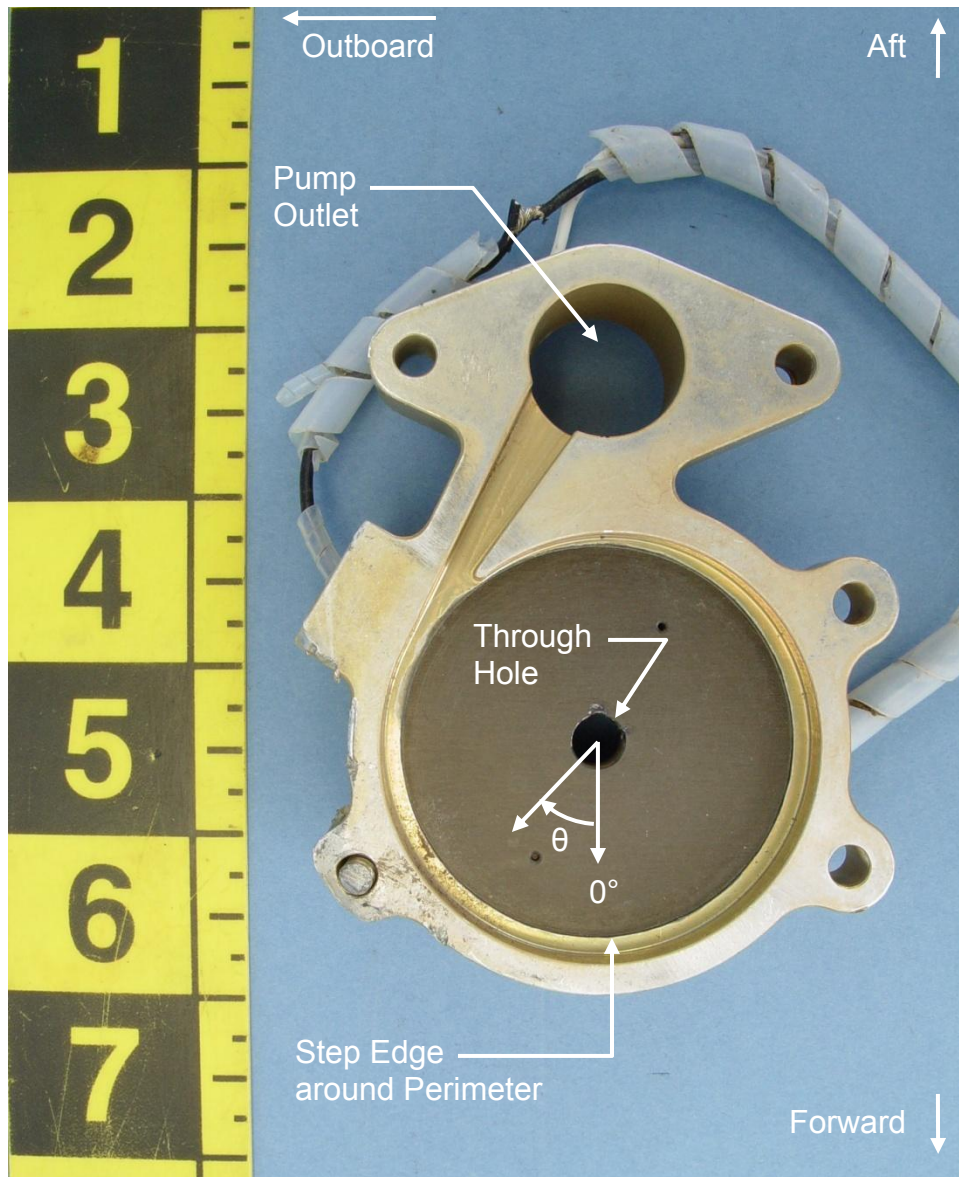
Deformation marks on the volute housings and metal transfer on the right drive shaft were consistent with contact between the drive shaft and through-hole. Deformation marks were observed on the through-holes of the left and right pump housings. The through-hole is identified on the pump housing in figure 2. An angular reference system was used to identify the location of the deformation marks on the walls of the through-holes. The angle was defined starting in the forward direction along the line intersecting the center of the through-hole and the pressure-side outlet of the boost pump and progressing clockwise. The angles were measured on digital macrophotographs. The locations of the deformation marks are shown in figures 3a and 4a for the left and right housings, respectively. The left pump housing had deformation marks that extended the entire length of the through-hole at  $186^\circ$  and  $253^\circ$  as shown in figure 3b. The right pump housing had marks that extended approximately half the length of the through-hole at similar angles of  $189^\circ$  and  $258^\circ$  as shown in figure 4b. Between these marks were two additional smaller contact marks. The linear distance between the deformation marks was 0.171 inch and 0.166 inch on the left and right housings, respectively as measured on calibrated digital images. This length was consistent with the 0.170 inch width of the flat on the drive shaft. The right armature drive shaft was examined by scanning electron microscope (SEM) in backscatter mode. Aluminum metal transfer from the housing to the drive shaft was observed on a flat face of the drive shaft and an adjacent curved surface. Figure 5a shows the region of aluminum transfer, identified as a dark strip near the edge of the flat face, and figure 5b shows an energy dispersive spectroscopy (EDS) spectrum within the strip confirming the presence of aluminum.

**Figure 2:** Left boost pump volute housing viewed from the underside as oriented on the aircraft.

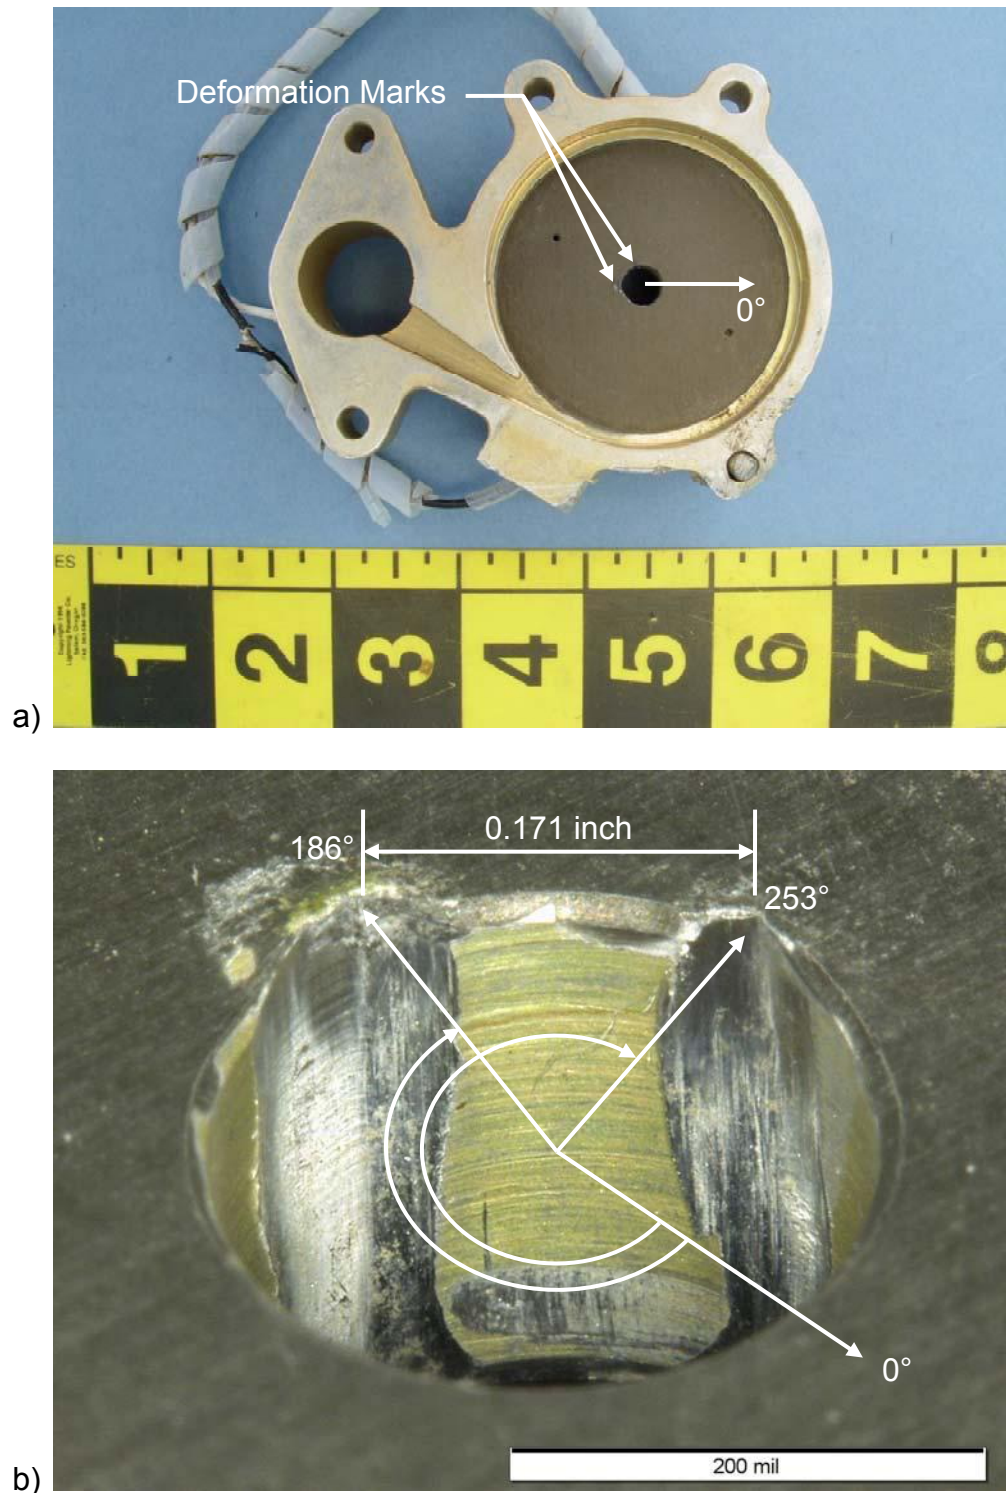
**Figure 3:** a) Photograph of the left volute housing. The location of deformation marks are indicated on the through-hole; b) photomicrograph of the through-hole from part a) at an oblique angle.

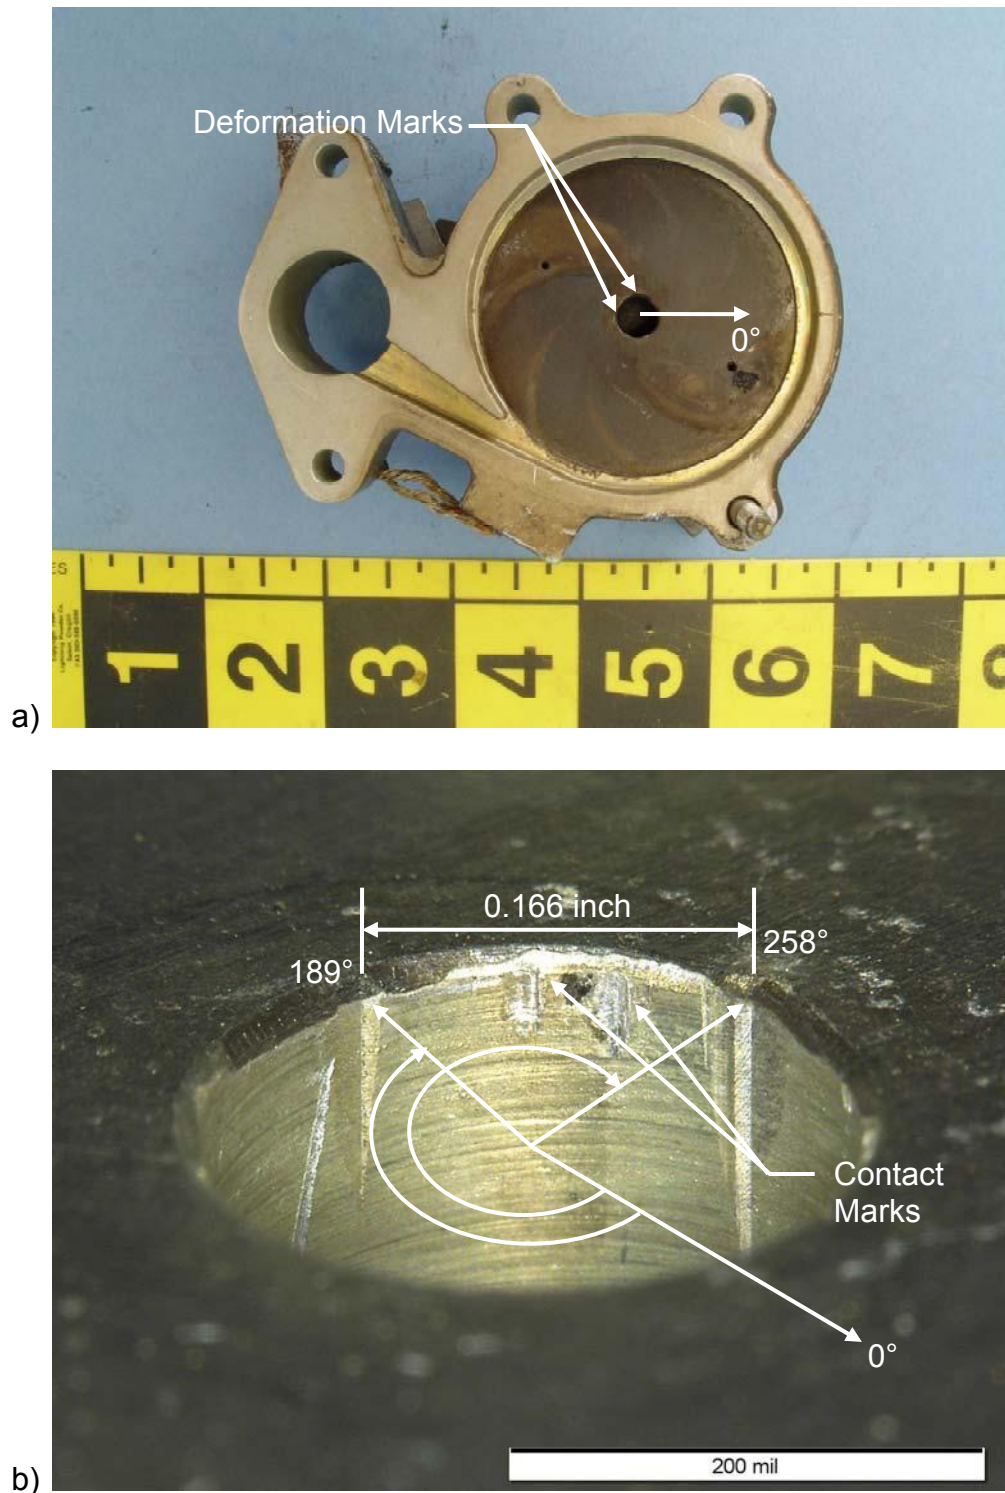
**Figure 4:** a) Photograph of the right volute housing. The location of deformation marks are indicated on the through-hole; b) photomicrograph of the through-hole from part a) at an oblique angle.

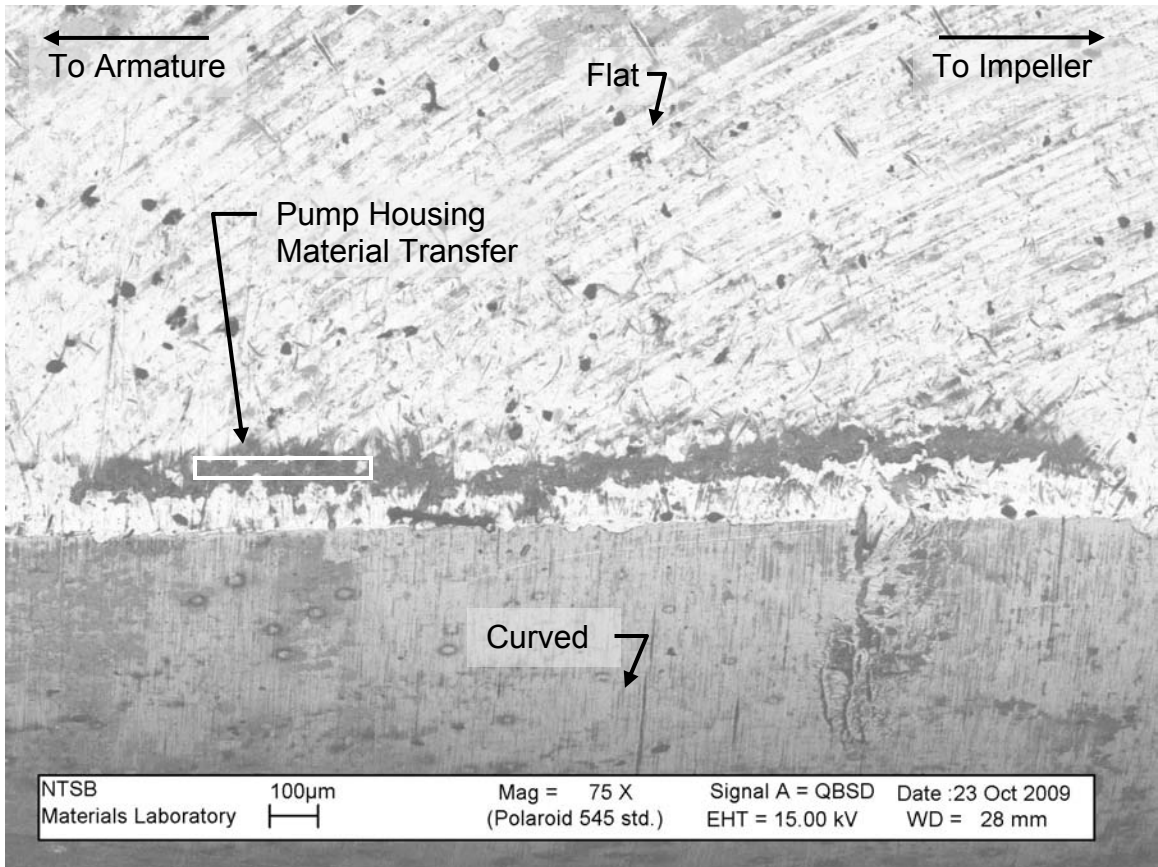
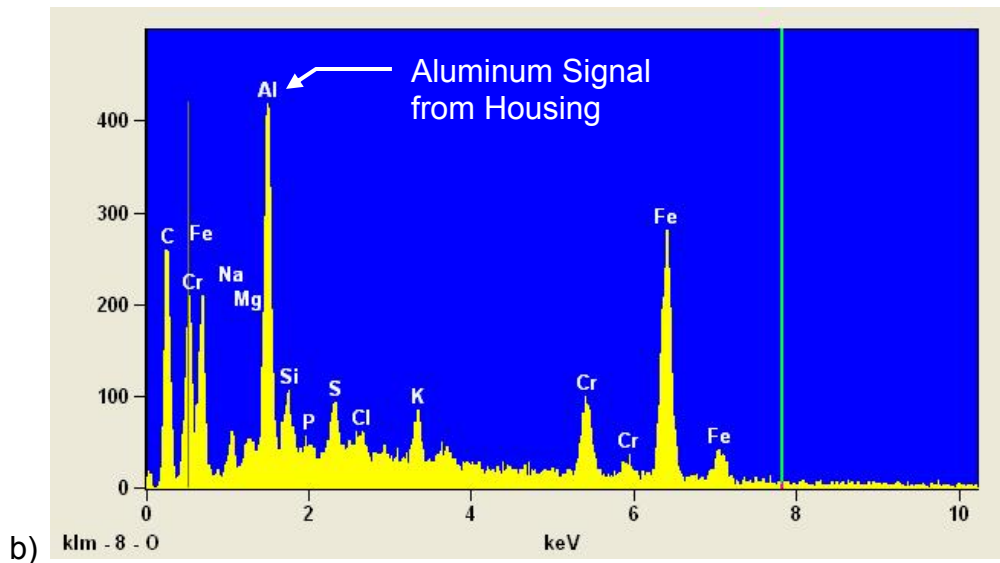
**Figure 5:** a) Backscatter SEM image of the right boost pump double-D drive shaft showing material transfer on a flat face; b) EDS spectrum from the region indicated by the box in part a) showing aluminum material transfer from the volute housing.

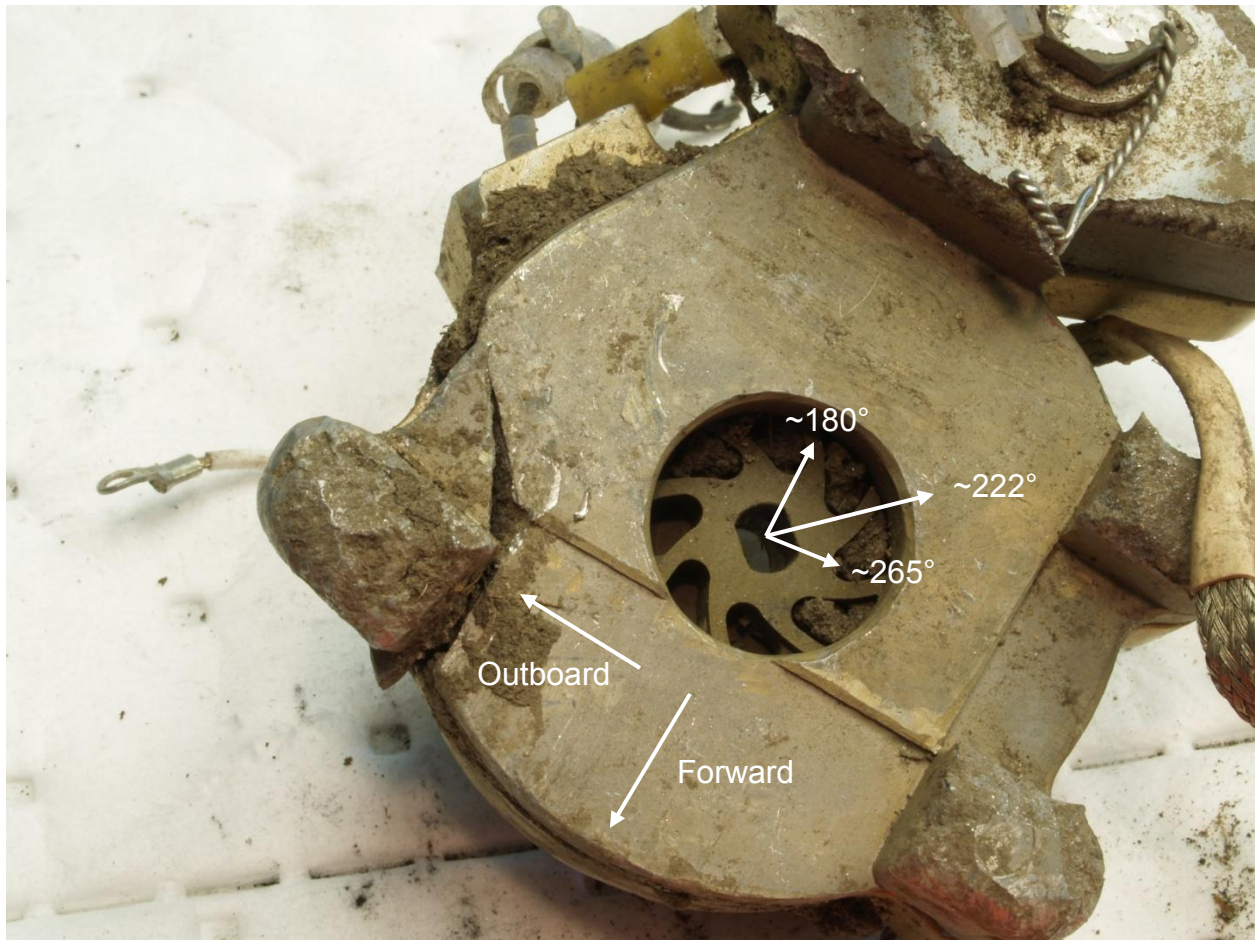
The post-crash orientation of the left and right boost pump impellers and armatures was estimated from photographs of the recovered wreckage shown in figures 6 and 7 for the left and right boost pumps, respectively. The photographs were taken at an off-normal angle so that the angles were approximate. Using the angular reference system described above, the orientation of each impeller (and driveshaft) was defined by a line perpendicular to the flat on the driveshaft as shown in figure 1b. It was determined by measuring angles from the center of the shaft to both edges of the flat and averaging the values (see figure 1b). Using this definition, the post-crash orientations of the left and right drive shafts were  $222^\circ \pm 3^\circ$  and  $268^\circ \pm 3^\circ$ , respectively. The same technique was used on the deformation marks left by the drive shaft flat on the volute housing to determine the orientation of the drive shaft as it made contact with the through-hole. The orientation of the deformation marks on the left and right through-holes was  $220^\circ$  and  $224^\circ$ , respectively. For the left pump, the orientation of the contact marks and the post-crash orientation of the impeller / drive shaft were the same. For the right pump, they differed by approximately  $44^\circ$ .

**Figure 6:** Photograph of the left boost pump prior to teardown (Photo by D. Diaz). The view is of the suction side from underneath the pump as situation on the aircraft.

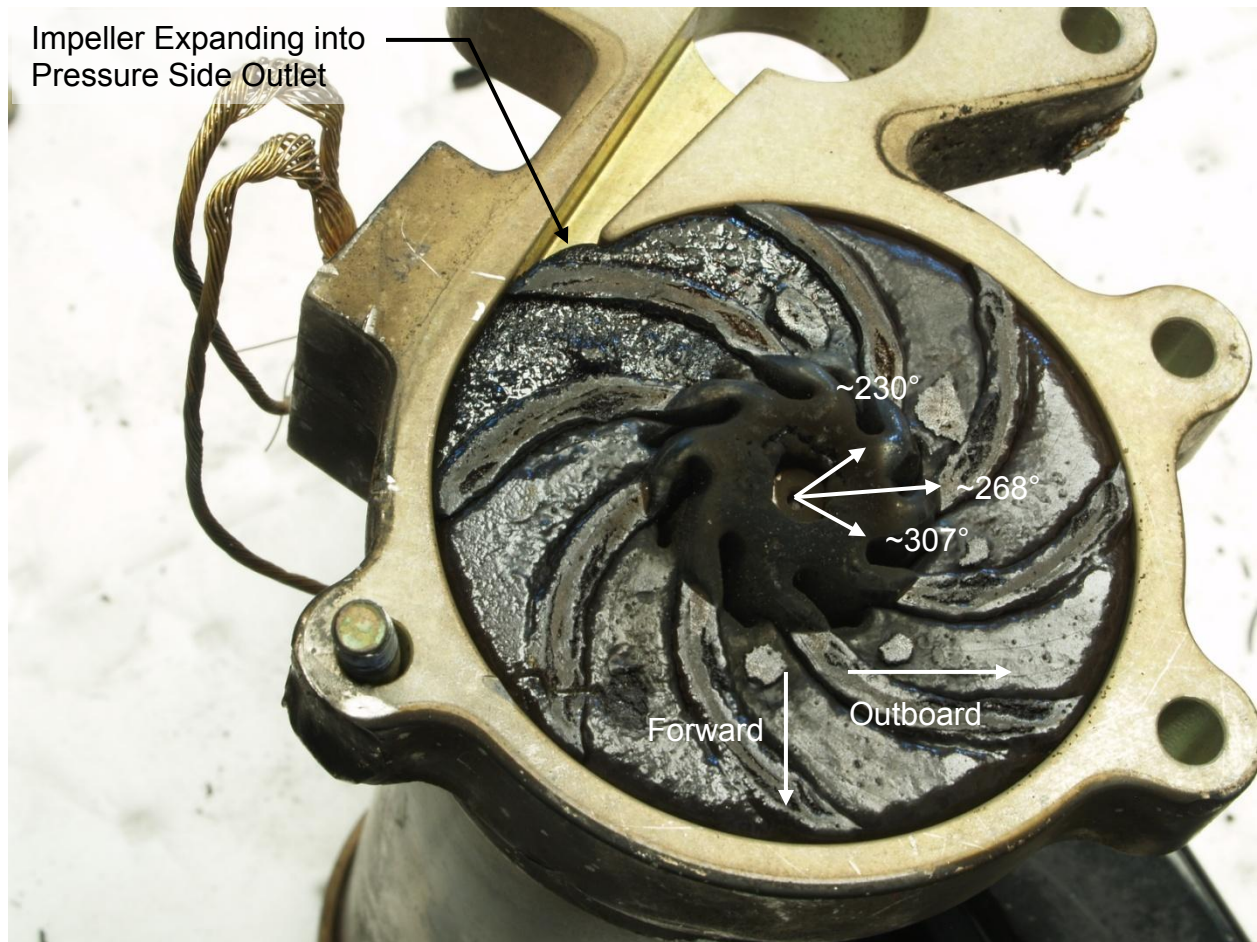
**Figure 7:** Photograph of the right volute housing and impeller during teardown (Photo by D. Diaz). The view is from underneath as situated on the aircraft.

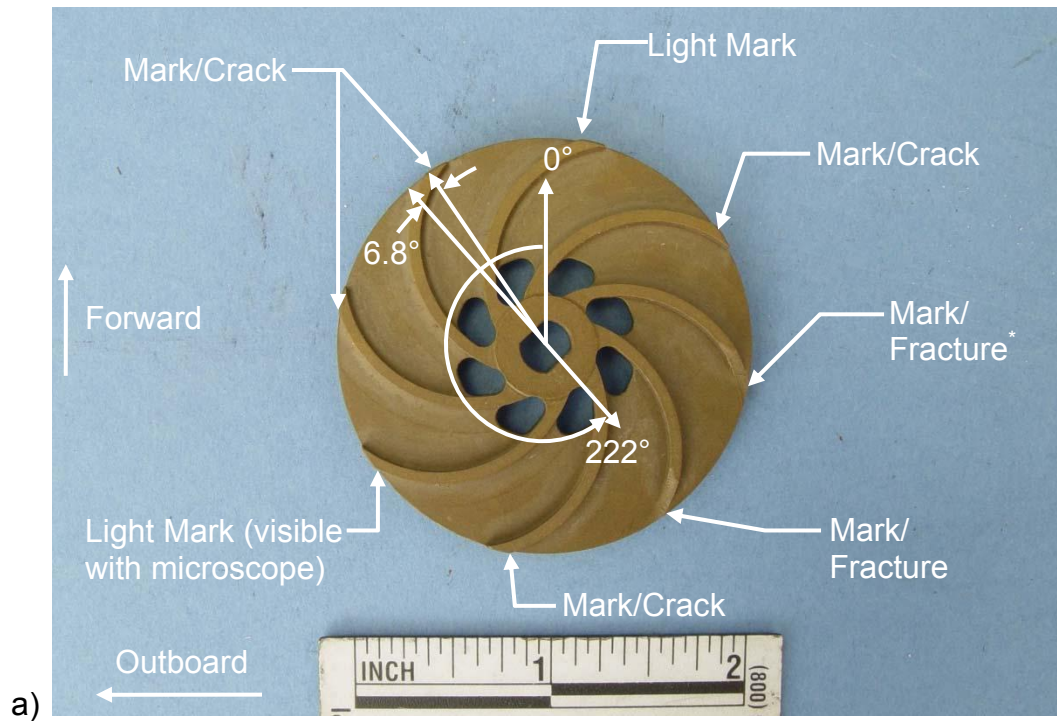
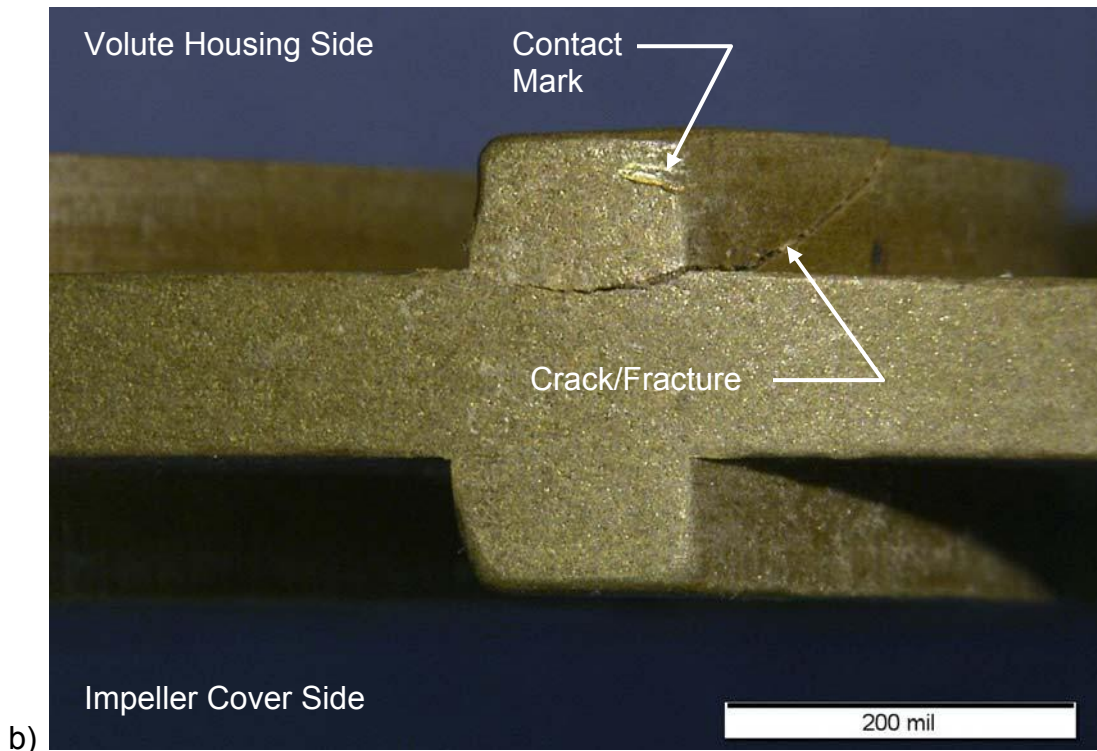
The angular orientation of the left pump impeller vane tips relative to the drive shaft was measured on a digital image. One vane tip lagged the drive shaft by  $6.8^\circ$  as defined in figure 8a. The other vane tips were spaced at  $45^\circ$  around the impeller. The left pump impeller vanes were fractured, cracked, and/or exhibited deformation marks. The impeller is shown in figure 8a as it appeared oriented post-crash in the volute chamber. The view is from above as situated on the aircraft so that the face in contact with the volute housing is

face up. All eight vanes facing the housing had deformation marks at the tip as shown in figure 8b. Some of the marks were at a slight angle to the direction of rotation. Two of the marks were comparatively light with one only visible with a microscope (indicated in figure 8a). The height of the marks was consistent with a 0.030 inch step edge around the perimeter of the volute housing as indicated in figure 2. Six of eight vanes had cracked or fractured tips similar to that shown in figure 8b. Two of the vane tips had fractured completely (see figure 8a). One of the two fractured vane tips was still attached by a fine ligament to the body of the impeller when received by the lab but detached shortly thereafter. The remaining four cracks were shorter and the vane tips remained attached. The fracture surfaces were consistent with an overstress event. The presence or absence of contact marks or cracks on the right pump impeller could not be determined due to its exposure to heat.

**Figure 8:** a) Photograph of left boost pump impeller viewed from above in its post-crash orientation. \*Tip originally attached by small ligament; b) side view of an impeller vane tip showing a typical contact mark and cracked vane tip.

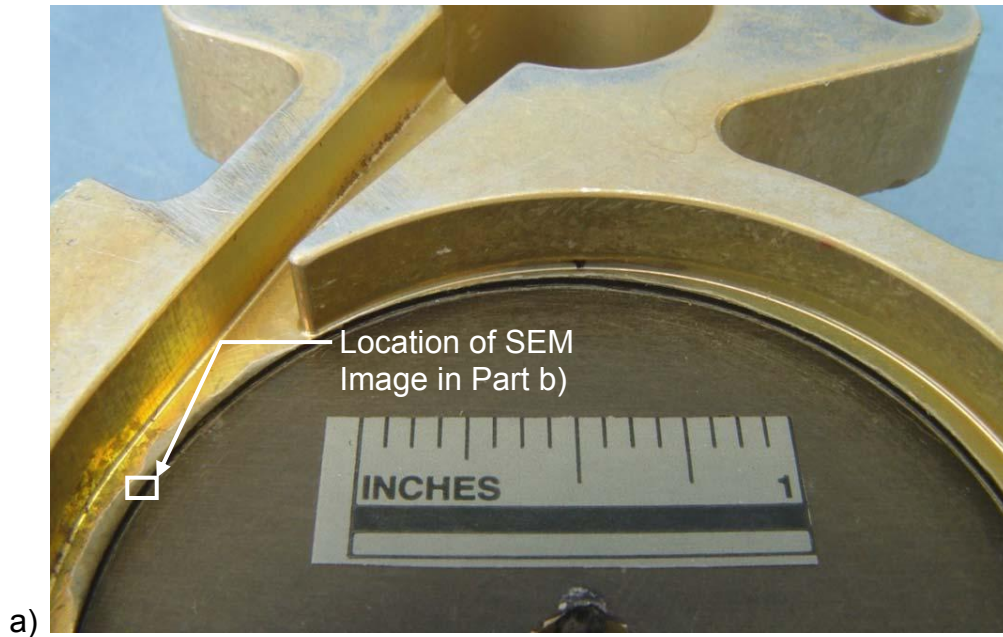
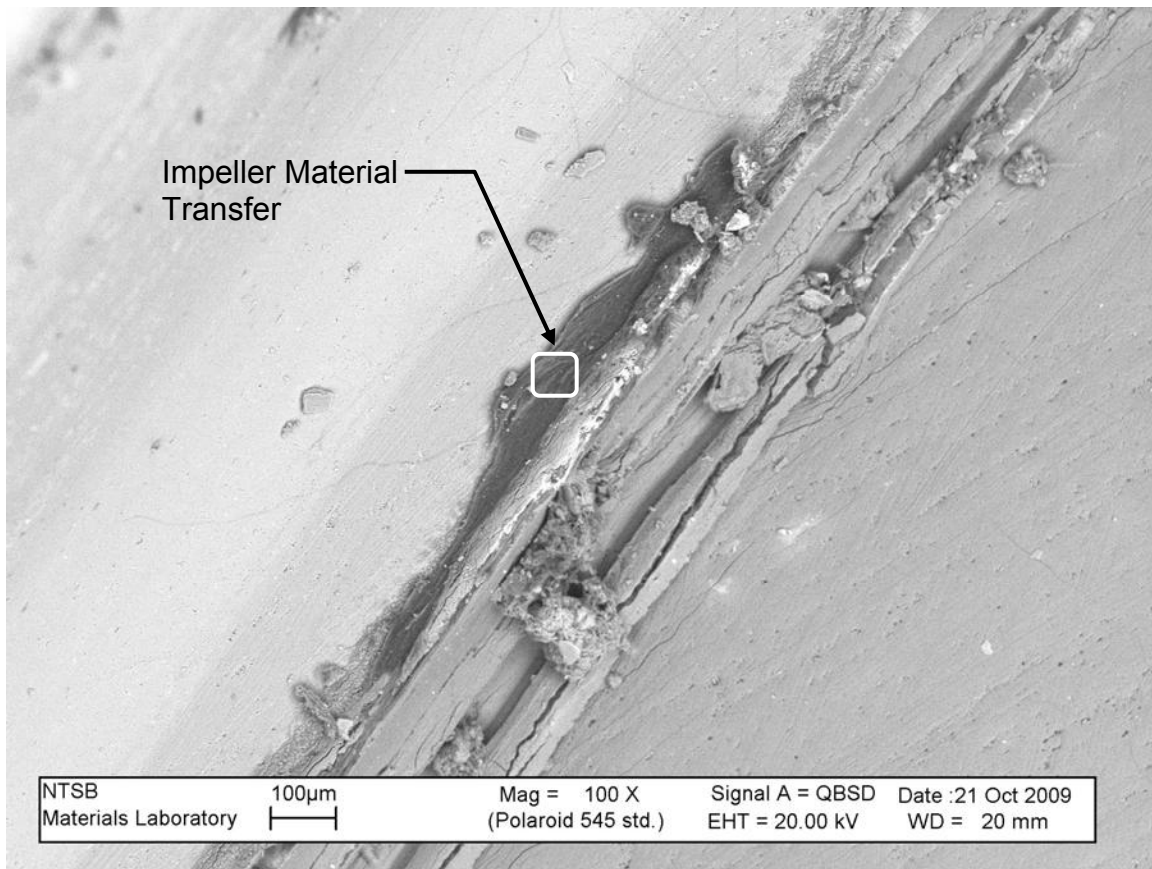
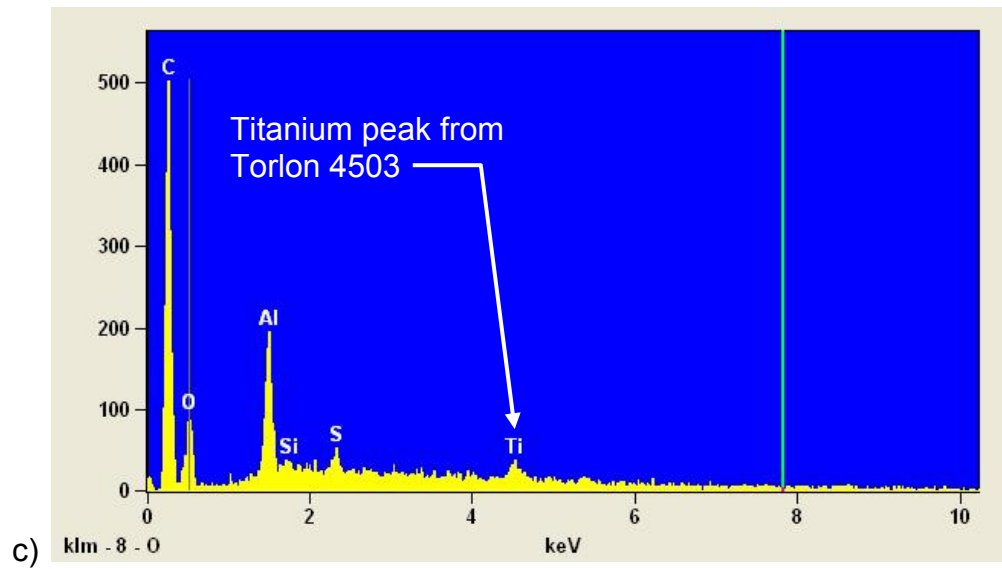
Polymer transfer marks from the impeller were detected along the raised edge that ran around the perimeter of the left volute chamber. The raised edge was examined by backscatter SEM. Occasional transfer marks were observed as dark spots along the raised edge. A typical example is shown in figure 9. Figure 9a shows a photograph of the left volute housing. While examining the raised edge by backscatter SEM, a transfer mark was observed at the location indicated by the white box. Figure 9b shows the backscatter SEM image from that location. In the image, the transfer mark, consisting of low atomic mass elements such as carbon, nitrogen, and oxygen, appeared as a dark region against the bright background of the aluminum housing. To confirm that the material was from the impeller, the composition of the impeller was first determined by EDS (not shown). The detected peaks included carbon, oxygen, and titanium, consistent with Torlon® 4203/4503, a titanium dioxide-filled polyamide-imide (the two grades are of similar composition)<sup>2</sup>. Fabrication of the impeller from Torlon 4503 was allowed according to RG57169<sup>1</sup>. The EDS spectrum taken in the region inside the square in figure 9b is shown in figure 9c. The titanium peak on the transfer mark was consistent with the impeller material. A graph depicting the location of transfer marks on the impeller housing is shown in figure 10. The view of the graph is from the top of the volute housing as situated on the aircraft. Transfer marks were found around the perimeter of the housing but were heaviest between 165° and 225°. There were no detected marks between 50° and 120°.

**Figure 9:** a) Photograph showing the location of the SEM image in part b); b) Backscatter SEM of a material transfer mark left by the impeller on the raised edge of the volute housing.

**Figure 9 (cont.):** c) EDS spectrum of the material transfer mark with the same titanium signature as the impeller material.

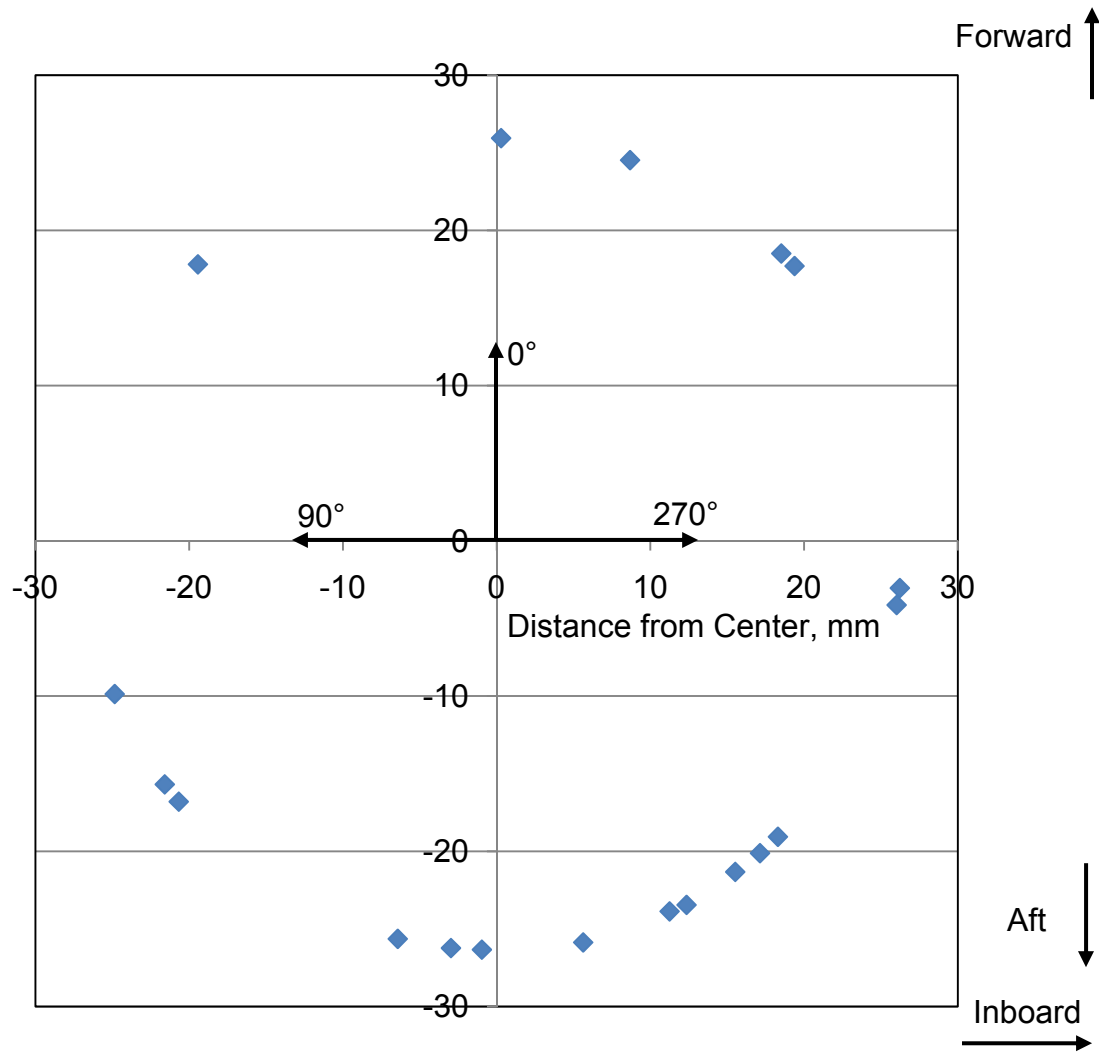
**Figure 10:** Graph of the location of material transfer marks on the left boost pump volute housing. The view of the housing is from the top as oriented on the aircraft.

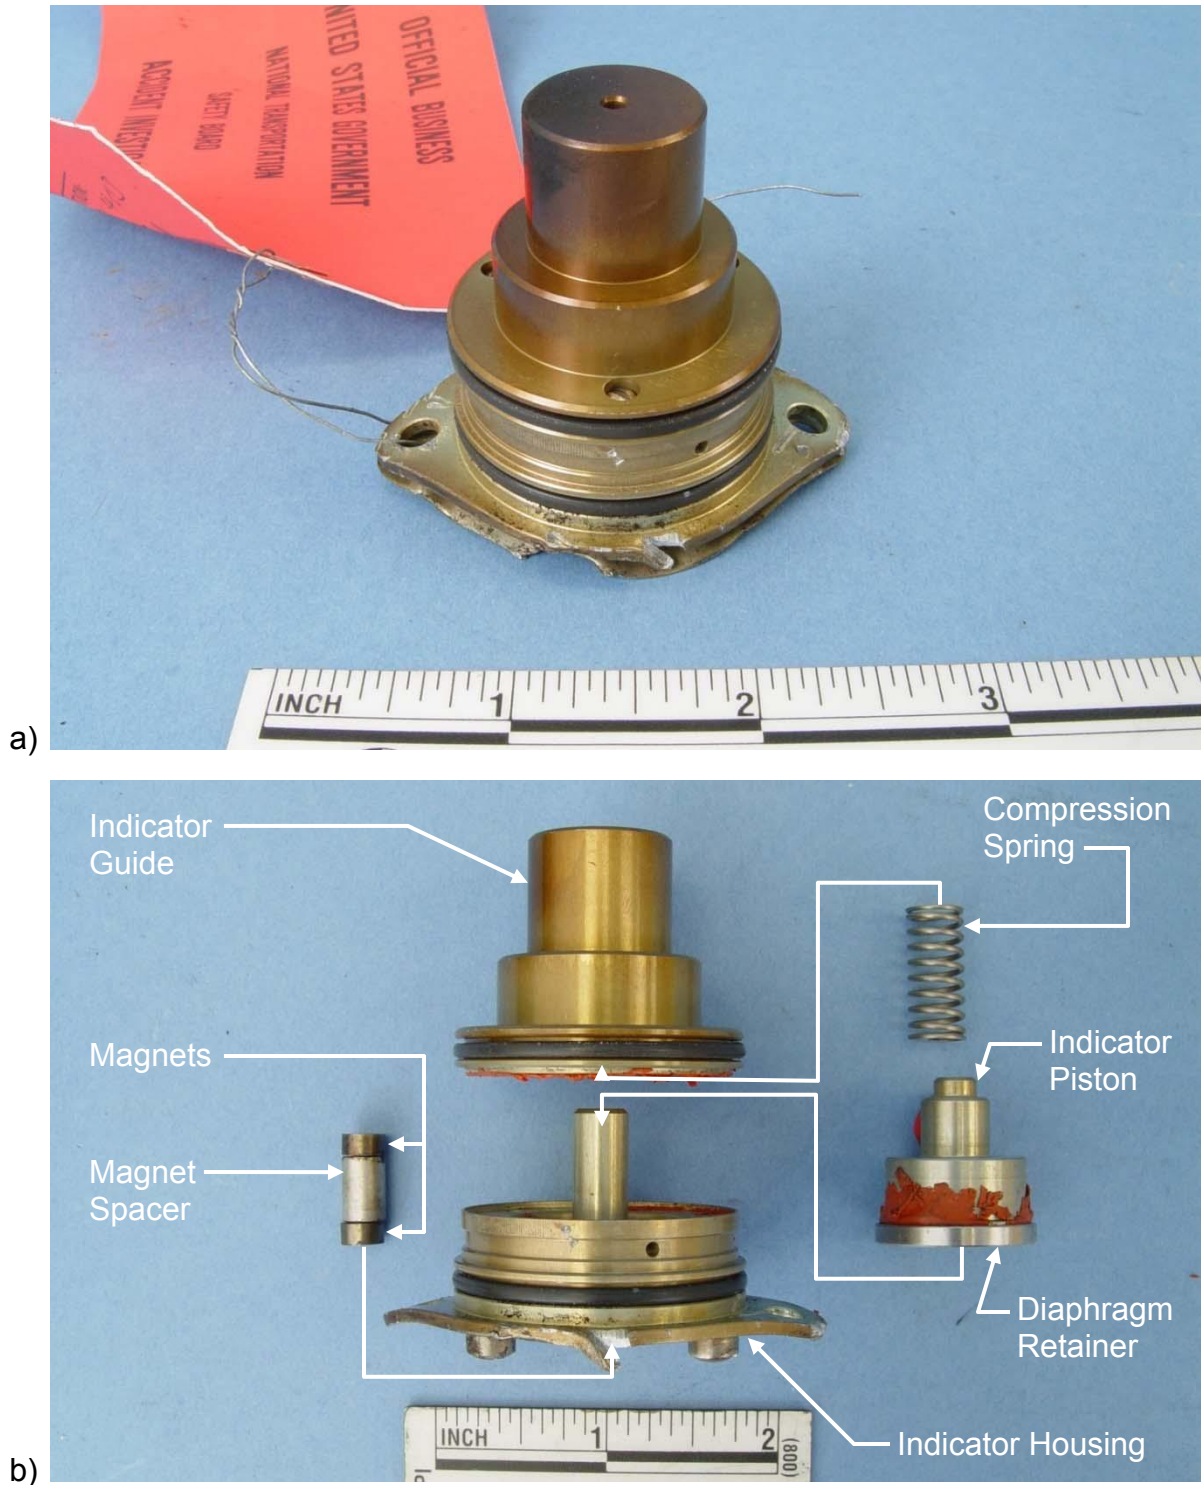
The fuel filter bypass indicator was received by the Materials Laboratory as shown in figure 11a. The red indicator stem was missing. The base of the indicator housing and the identification plate were deformed. Figure 11b shows the indicator after disassembly with arrows indicating the position of the pieces with respect to one another. The compression spring was housed inside the indicator guide. The bottom of the spring made contact with the top of the indicator piston which, along with the diaphragm retainer, slipped over the hollow post on the indicator housing. The magnet/spacer assembly was inserted through a hole in the bottom of the indicator housing into the hollow post. A ring-shaped magnet at the bottom of the indicator piston actuated the magnet/spacer assembly. If the red indicator

**Figure 11:** a) Fuel filter bypass indicator as received; b) exploded view of bypass indicator. Disassembly was done after radiography.

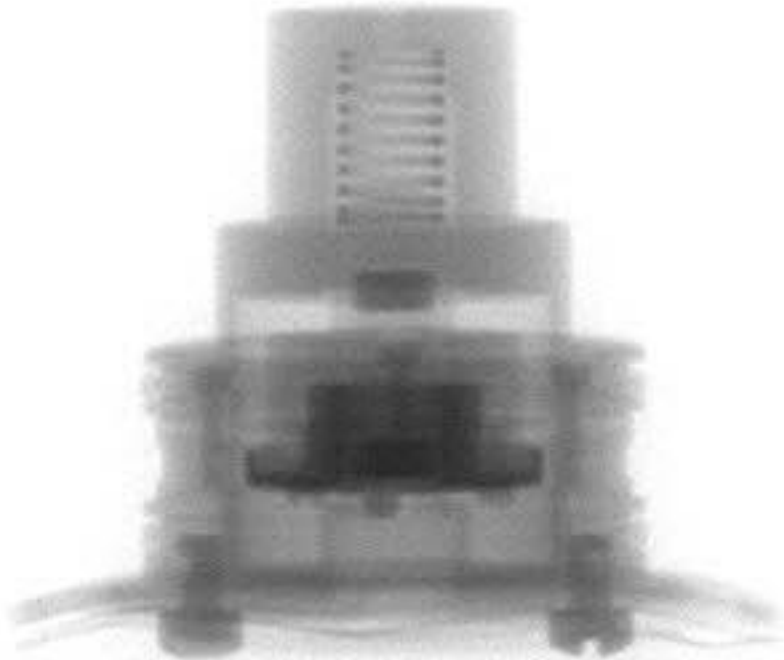
Prior to disassembly, the fuel filter was examined by X-ray radiography at the FBI Materials Laboratory, Quantico, Virginia. A side view of the indicator is shown in figure 12. A gap was observed between the top of the indicator piston and the upper interior surface of the indicator guide. The magnet/spacer assembly was near the top of the cavity inside the hollow post. The post was examined by stereomicroscope and by backscatter SEM for signs of impact marks or material transfer, but none were found. The elastomer rolling diaphragm was soft, cracked, and torn apart as shown in figure 13.

**Figure 12:** Radiograph of the fuel filter bypass indicator.

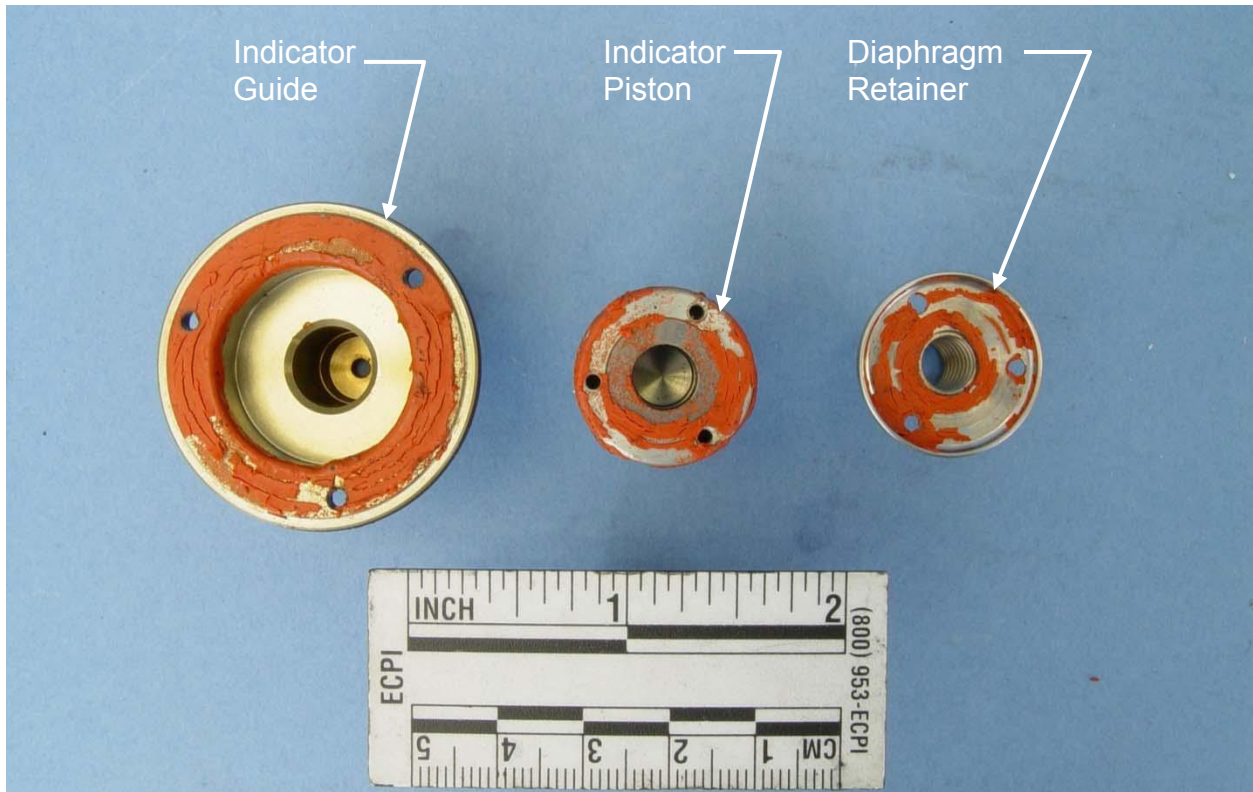
**Figure 13:** Photograph showing the condition of the elastomer rolling diaphragm.

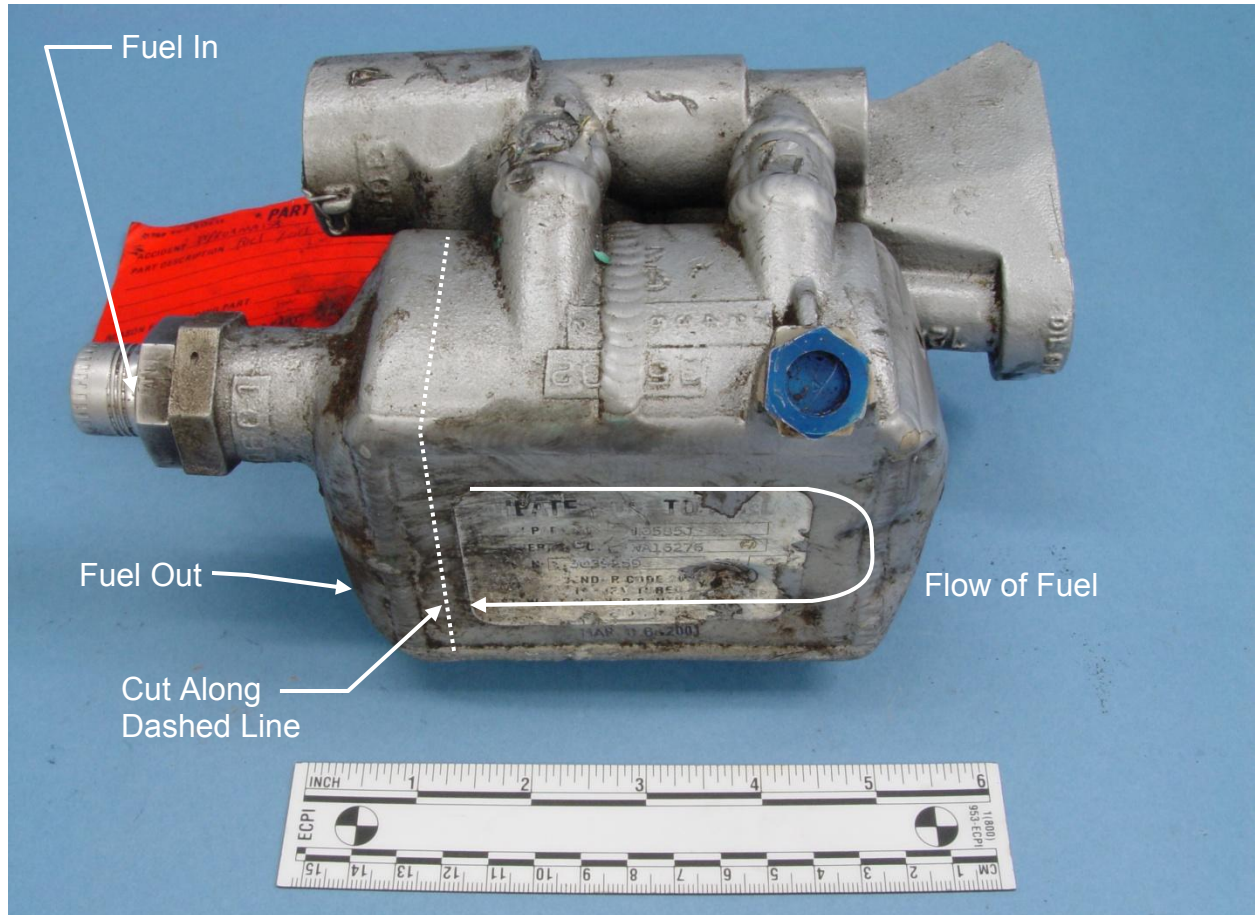
The fuel/oil heat exchanger was received by the Materials Laboratory as shown in figure 14. The fuel entered the heat exchanger through the in-port, travelled to the opposite end, and back as indicated in the figure. The heat exchanger was cut by a band saw along the dashed line approximately 0.5 inch inside the weld line. There were a few drops of fuel in the heat exchanger; otherwise it was empty. The cut section looking back at the fuel in and out ports is shown in figure 15. There were no observable obstructions on either the fuel in or fuel out sides.

**Figure 14:** Fuel oil heat exchanger as received.
