# NATIONAL TRANSPORTATION SAFETY BOARD

MATERIALS LABORATORY FACTUAL REPORT

Report No. 10-005

Place : Butte, Montana  
Date : March 22, 2009  
Vehicle : Pilatus PC-12/45, N128CM  
NTSB No. : WPR09MA159  
Investigator : Dennis Diaz

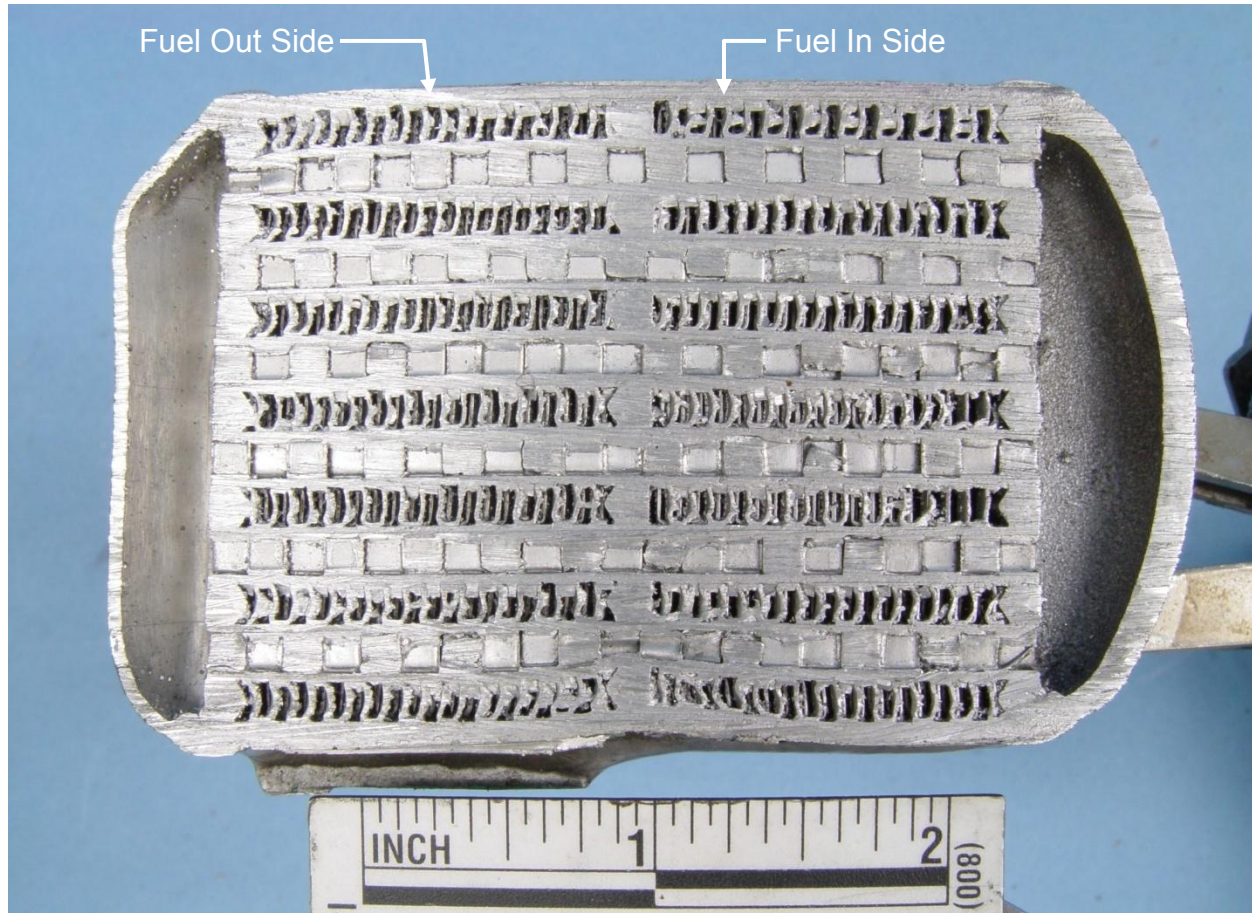
The fuel/oil heat exchanger was received by the Materials Laboratory as shown in figure 14. The fuel entered the heat exchanger through the in-port, travelled to the opposite end, and back as indicated in the figure. The heat exchanger was cut by a band saw along the dashed line approximately 0.5 inch inside the weld line. There were a few drops of fuel in the heat exchanger; otherwise it was empty. The cut section looking back at the fuel in and out ports is shown in figure 15. There were no observable obstructions on either the fuel in or fuel out sides.

**Figure 15:** Cross section of the fuel oil heat exchanger approximately 0.5 inch inside the welded seam looking back at the fuel and out ports. Fuel flows out of the page on the fuel in side and into the page on the fuel out side.

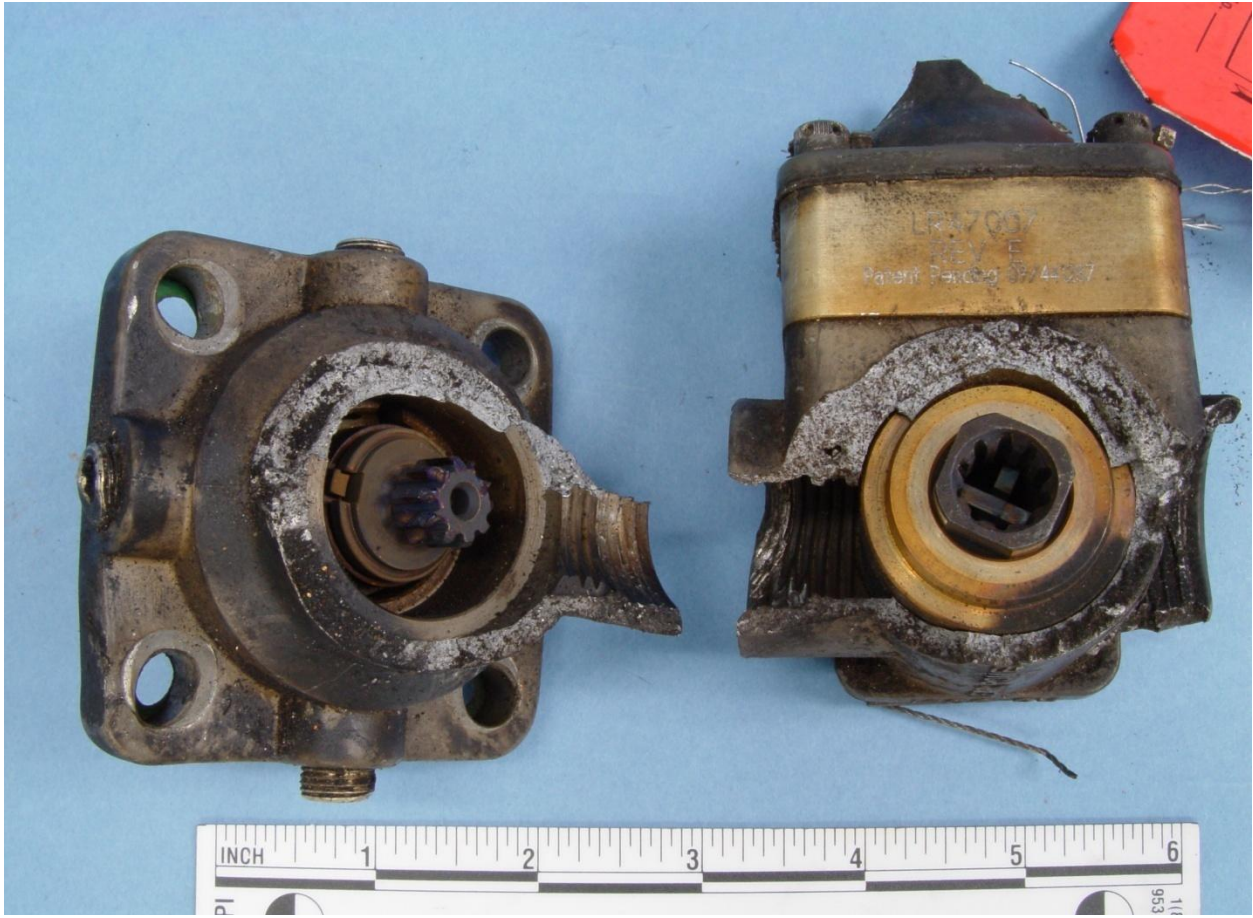
The low-pressure engine-driven fuel pump was received by the Materials Laboratory as shown in figure 16. The pump housing was fractured in the vicinity of where the gear engaged the impeller drive shaft. The fracture surfaces were consistent with overstress fractures. The vanes and offset cylinder were removed from the housing and examined by eye. The cylinder and vanes are shown in figures 17a and b, respectively. The components were discolored across a range of brown, blue, and purple, consistent with exposure to fire. The contact surfaces between the cylinder and vanes had wear marks consistent with routine use. There were no gouges or plow marks on any contact surfaces.

**Figure 16:** Low-pressure engine-driven fuel pump as received.

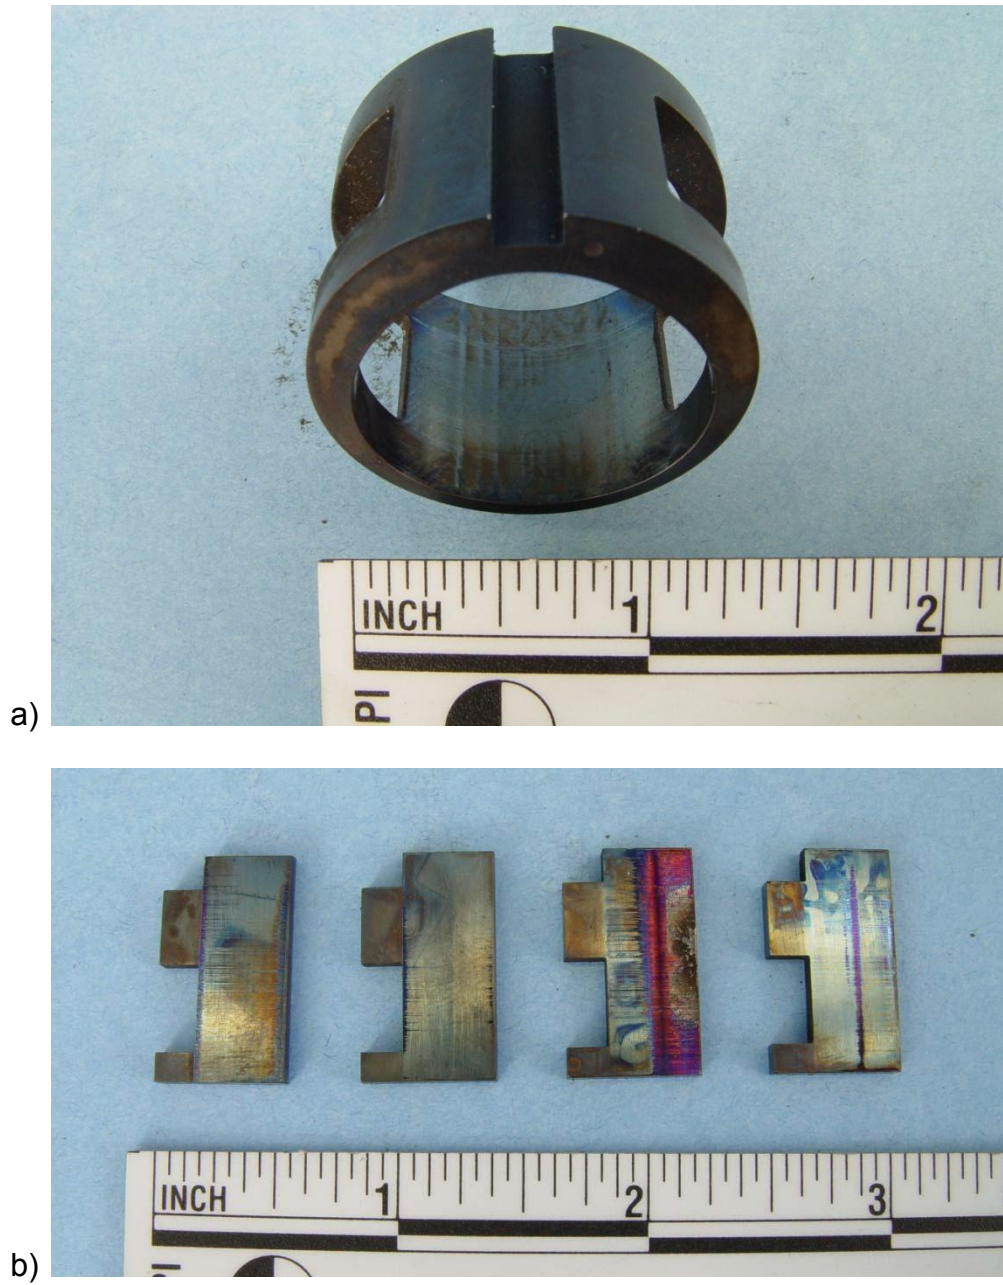
**Figure 17:** Low-pressure fuel pump components showed typical wear marks and exposure to heat; a) pump offset cylinder, and b) vanes.
