NATIONAL TRANSPORTATION SAFETY BOARD

MATERIALS LABORATORY FACTUAL REPORT

Report No. 00-157

Place : Bellingham, Washington
Date : June 10, 1999
Vehicle : Olympic Pipe Line Company, 16-inch diameter gasoline pipeline
NTSB No. : DCA99-M-P008
Investigator : Allan Beshore

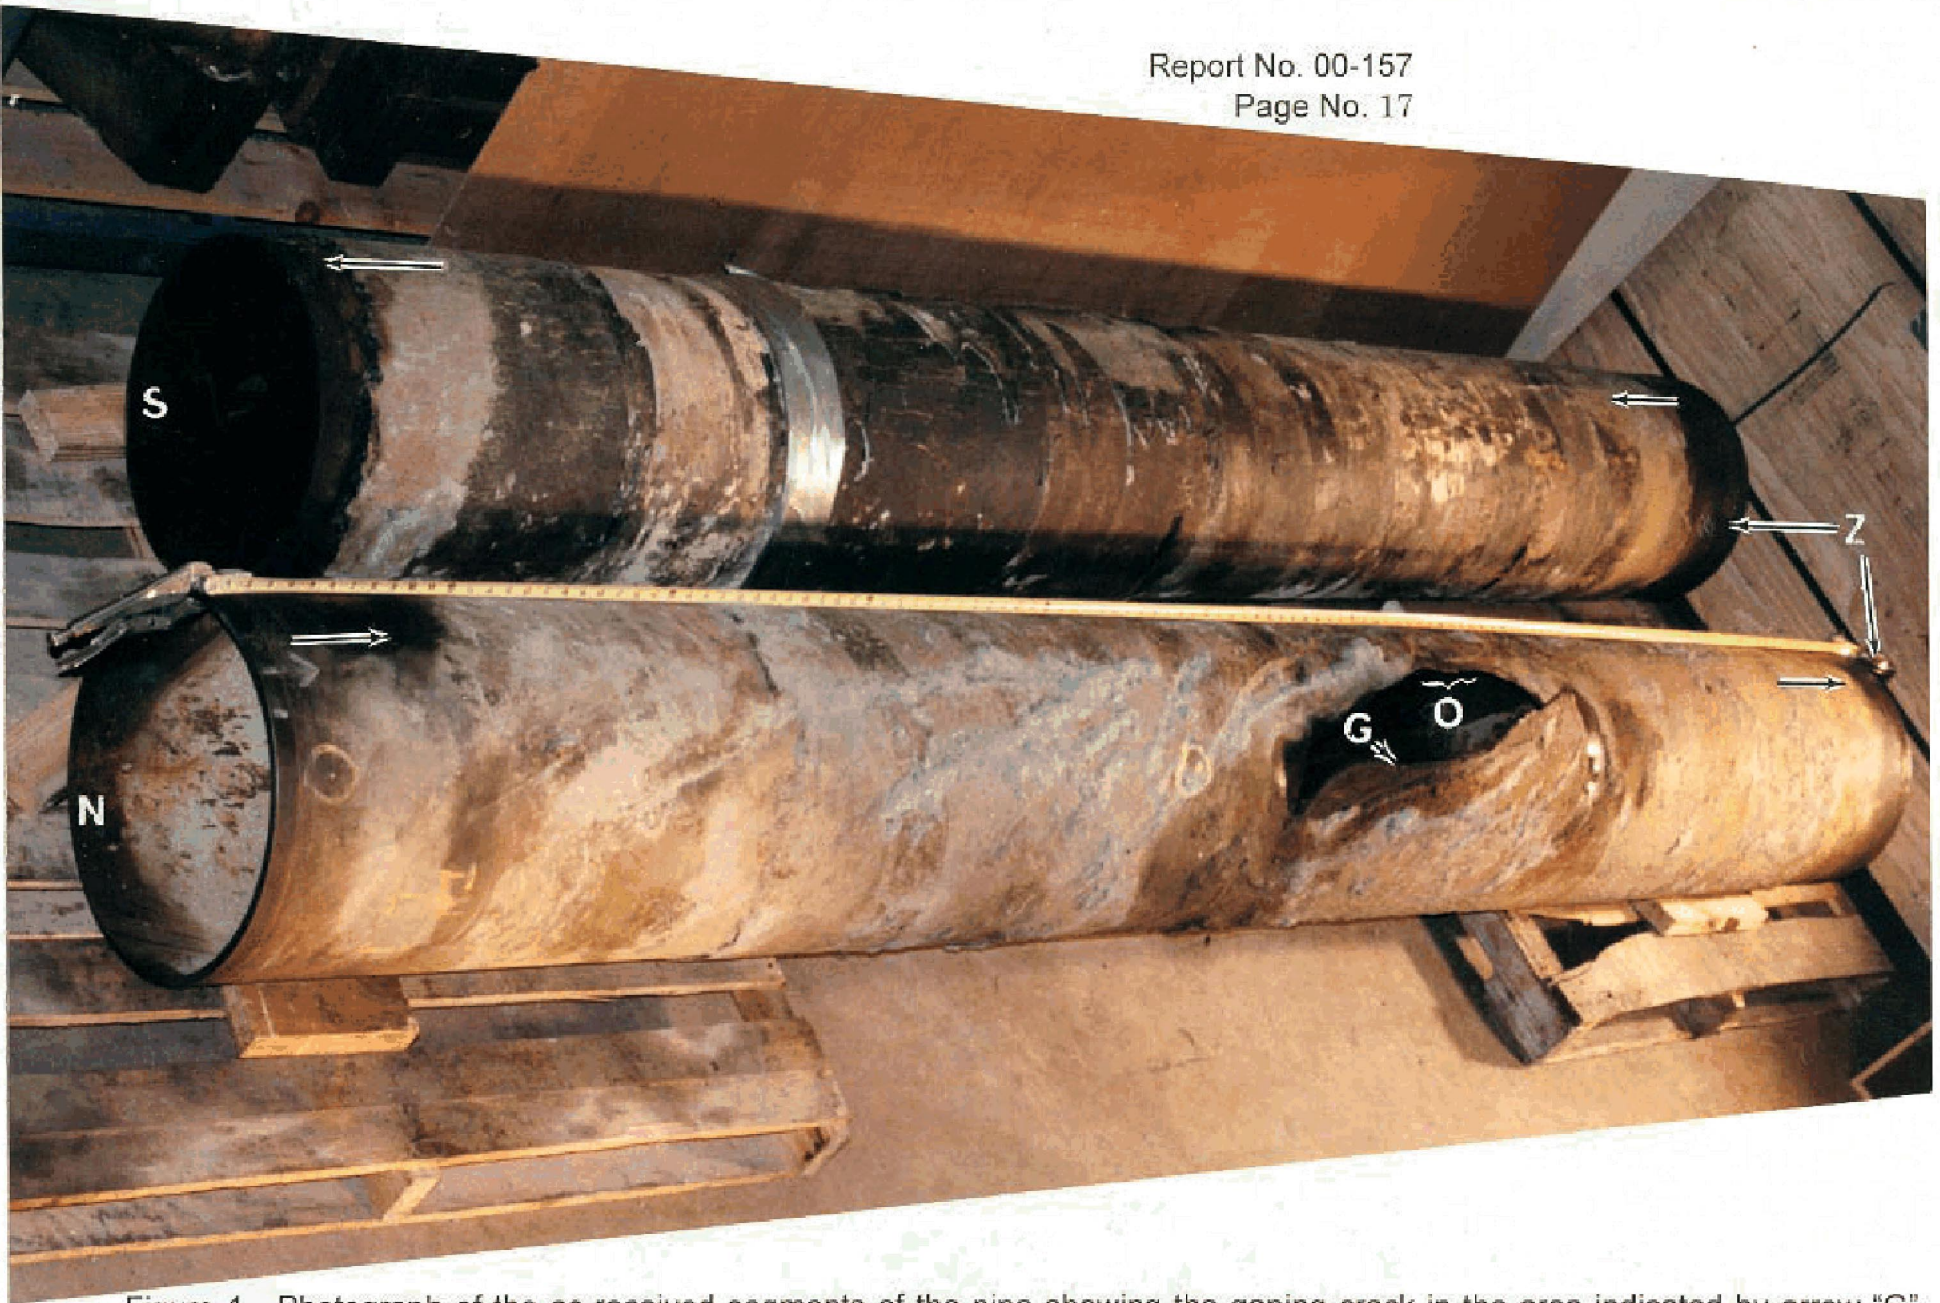
On July 20, 1999, two pipe segments were submitted to the Safety Board Materials Laboratory. A photograph of the as-received pipe segments is shown in figure 1. The pipe segments were cut from the remainder of the pipeline in the field to facilitate shipping and handling. For the purpose of this report, the segments of the pipe will be referred to as the north and south segments. The north segment of the pipe contained a gaping crack (referred as "the fracture" in the remainder of this report) in the area indicated by arrow "G". This fracture extended over a longitudinal distance of approximately 27 inches and had a maximum separation of 7 inches.

Figure 1. Photograph of the as-received segments of the pipe showing the gaping crack in the area indicated by arrow "G". The north end is indicated by "N" and the south end is indicated by "S". Gasoline reportedly was flowing south (downstream) in the direction indicated by unmarked arrows. The mating ends of a cut in the pipe are indicated by arrows "Z".

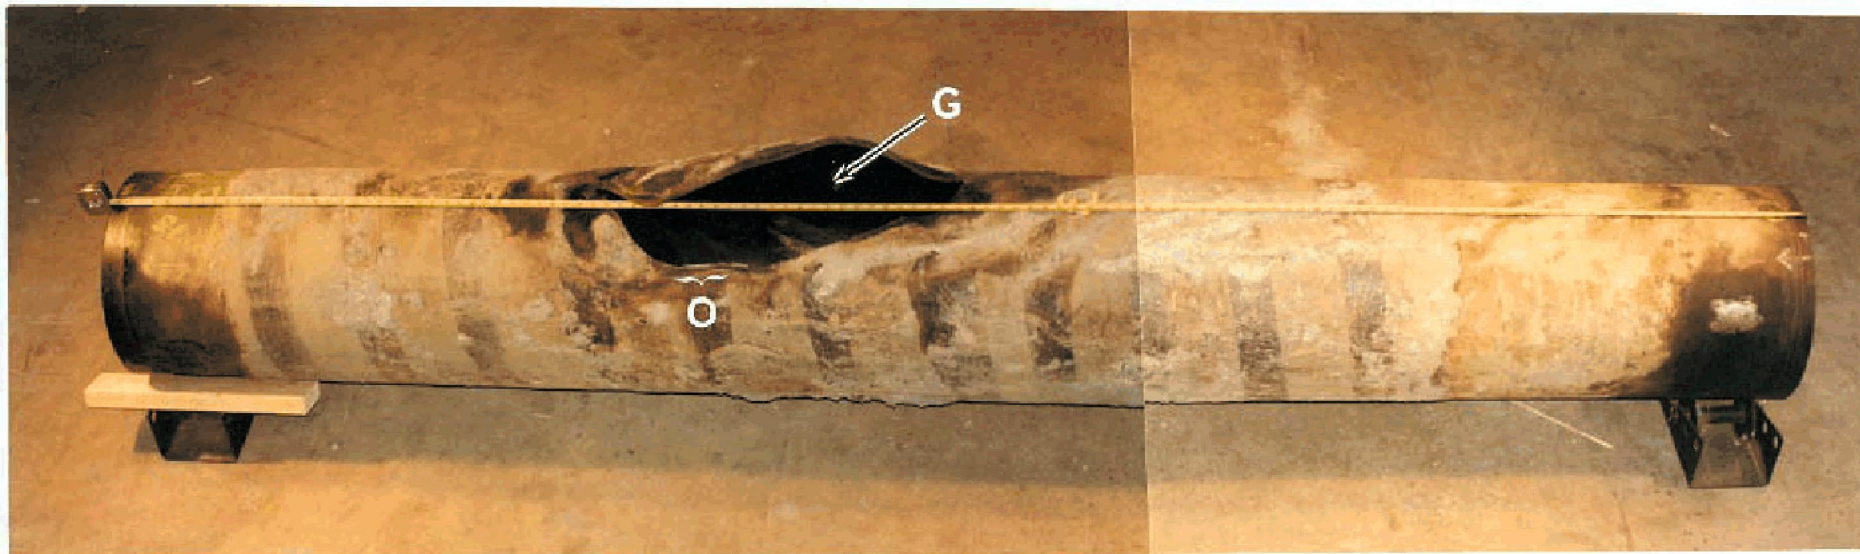
Figure 4. Composite photograph looking down at the north segment of the pipe showing the gaping crack indicated by arrow "G". Downstream (south) is located on the left side of the photograph.

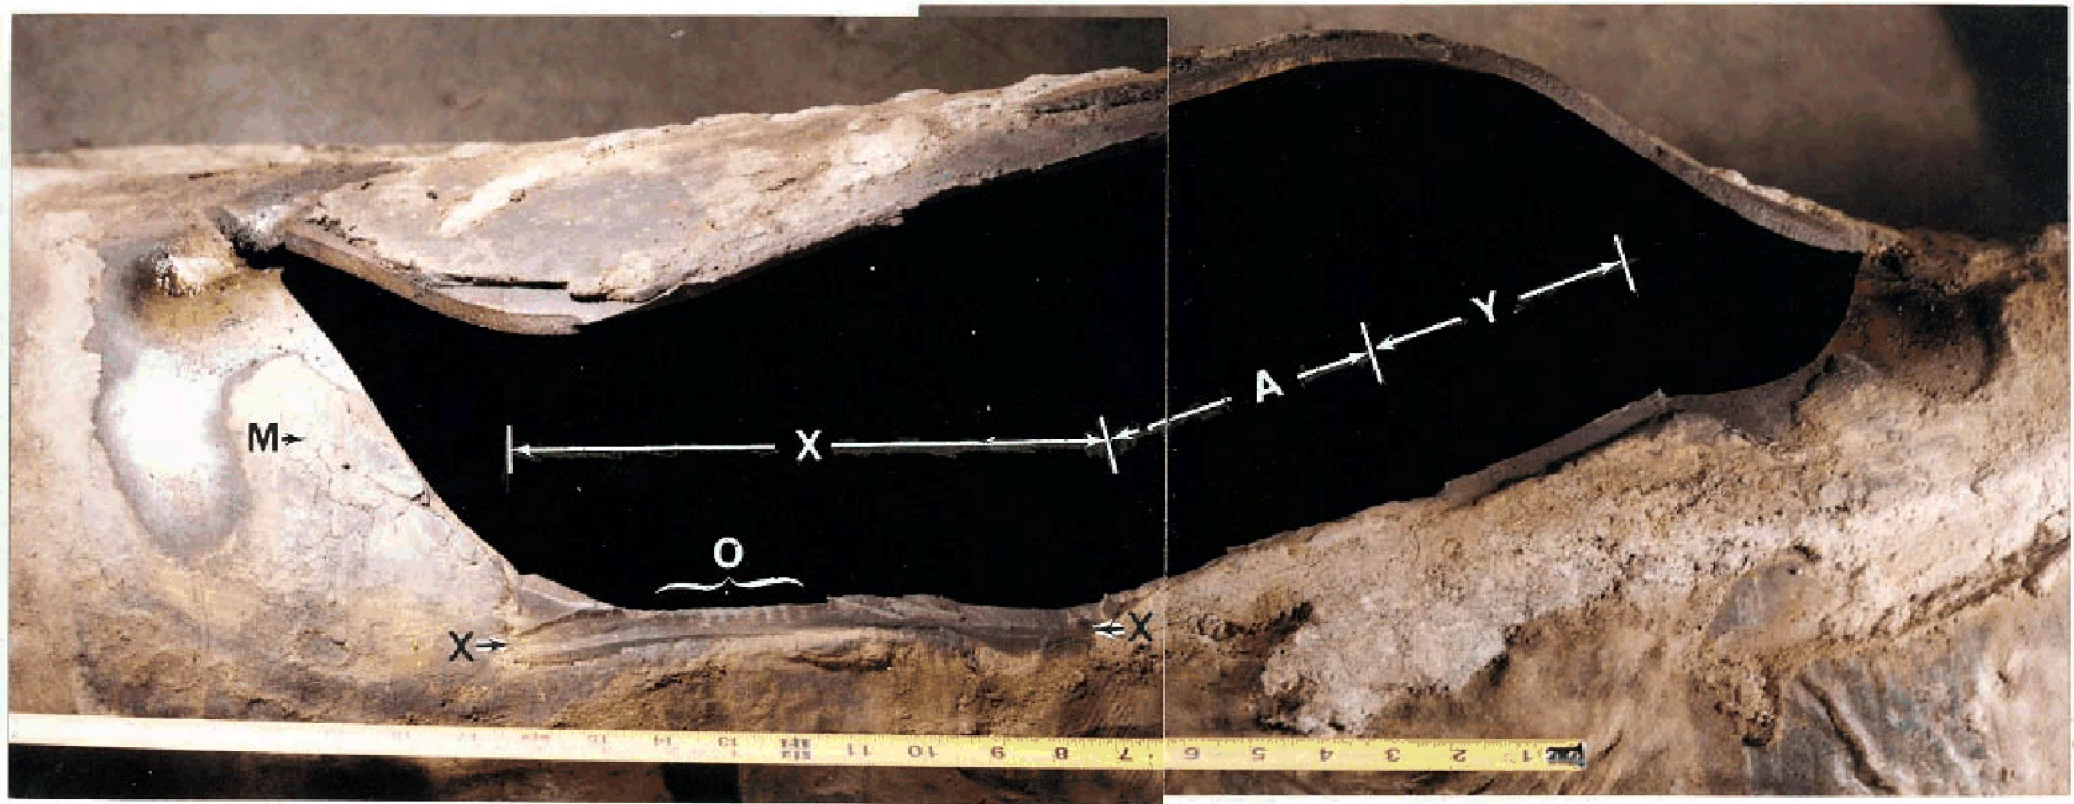
The 27-inch gaping fracture intersected two other gouge marks that are indicated by brackets "A" and "Y" in figure 5. These two gouge marks extended upstream from the upstream end of the gouge mark "X" and were distinguished from each other and gouge mark "X" by slight changes in angle and surface metal flow characteristics.

Figure 5 Composite photograph of the gaping crack. Downstream (south) is located on the left side of the photograph. The gouge mark located adjacent to the fracture in the area indicated by "A" was covered with soil deposit, whereas gouge marks in the areas indicated by "X" and "Y" were relatively clean. (3.5X)

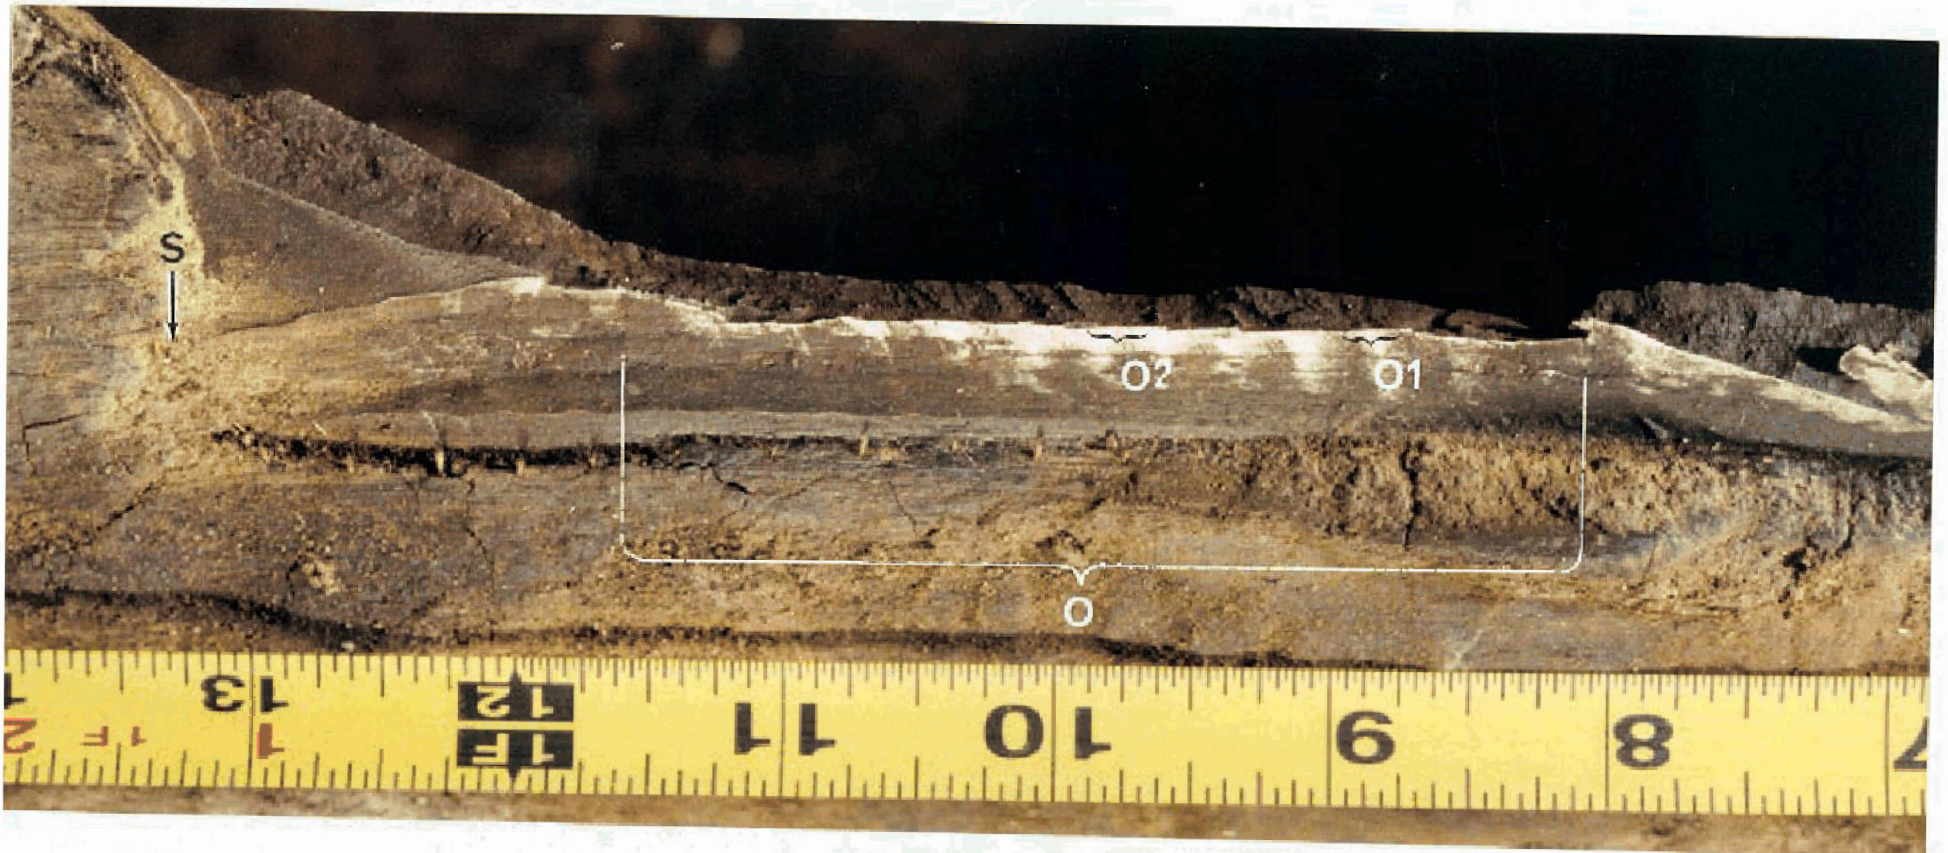
cleaner areas revealed metal flow consistent with an object moving upstream relative to the pipe. This indicated that the starting end of the gouge mark was the downstream end of the gouge mark in the area indicated by arrow "S" in figure 6. The surface of the gouge mark exhibited multiple longitudinally oriented cracks (see figure 7). These cracks were generally oriented parallel to each other and in the general orientation of the gouge mark. The length of the relatively clean portion of the gouge mark measured approximately 8.5 inches.

Figure 6. Close-up photograph of the fracture origin area indicated by bracket "O". This fracture origin was located at the base of gouge mark "X", whose downstream end is indicated arrow "S". Downstream (south) is located on the left side of the photograph.

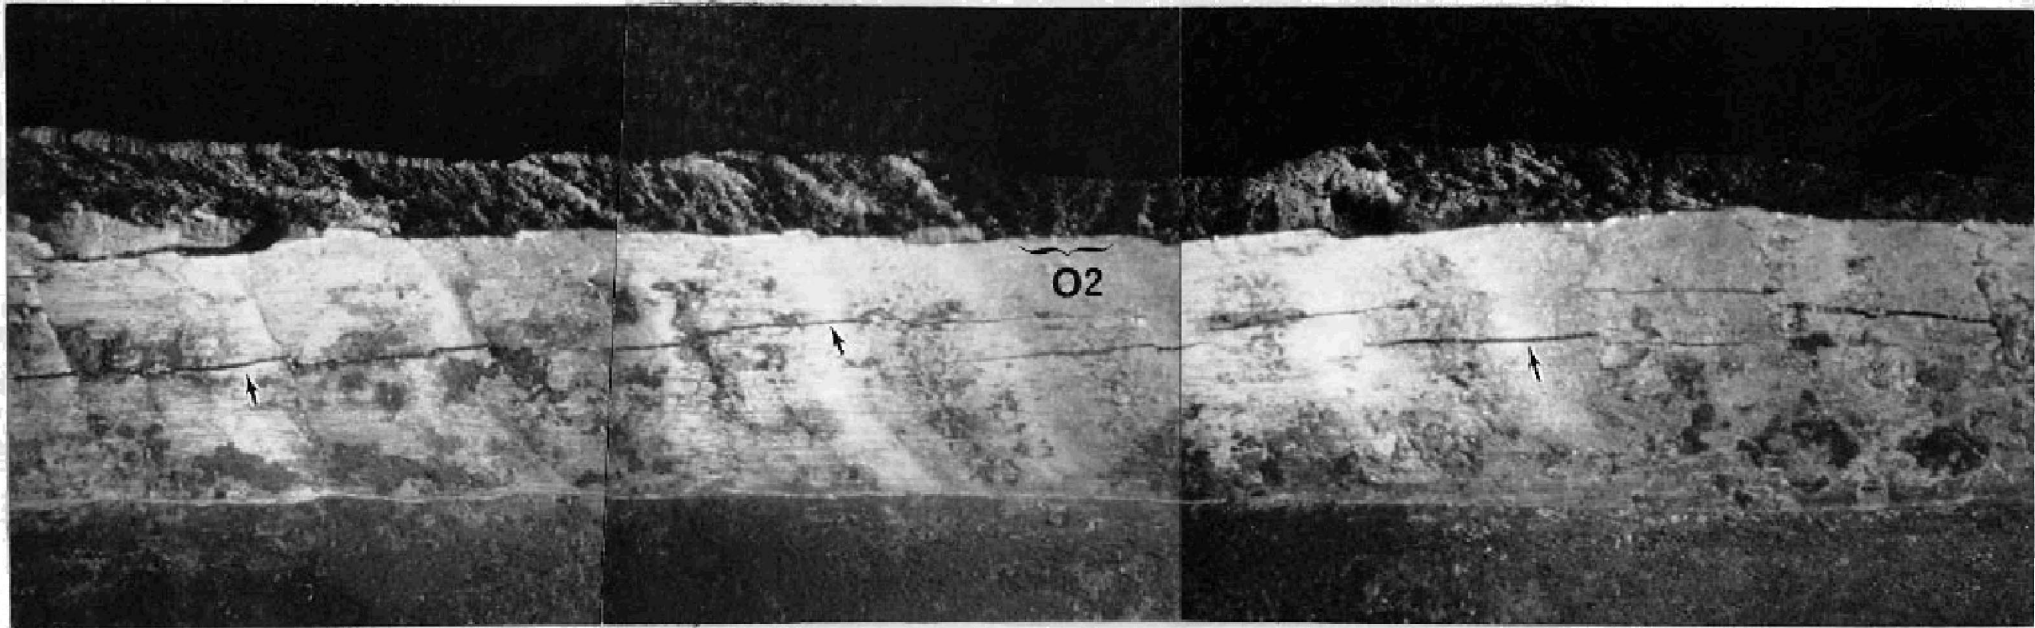
Figure 7. View looking down at the surface of gouge mark "X" in the area of the fracture origin area showing nearly longitudinal cracks. Unmarked arrows indicate typical cracks. (3.5X)

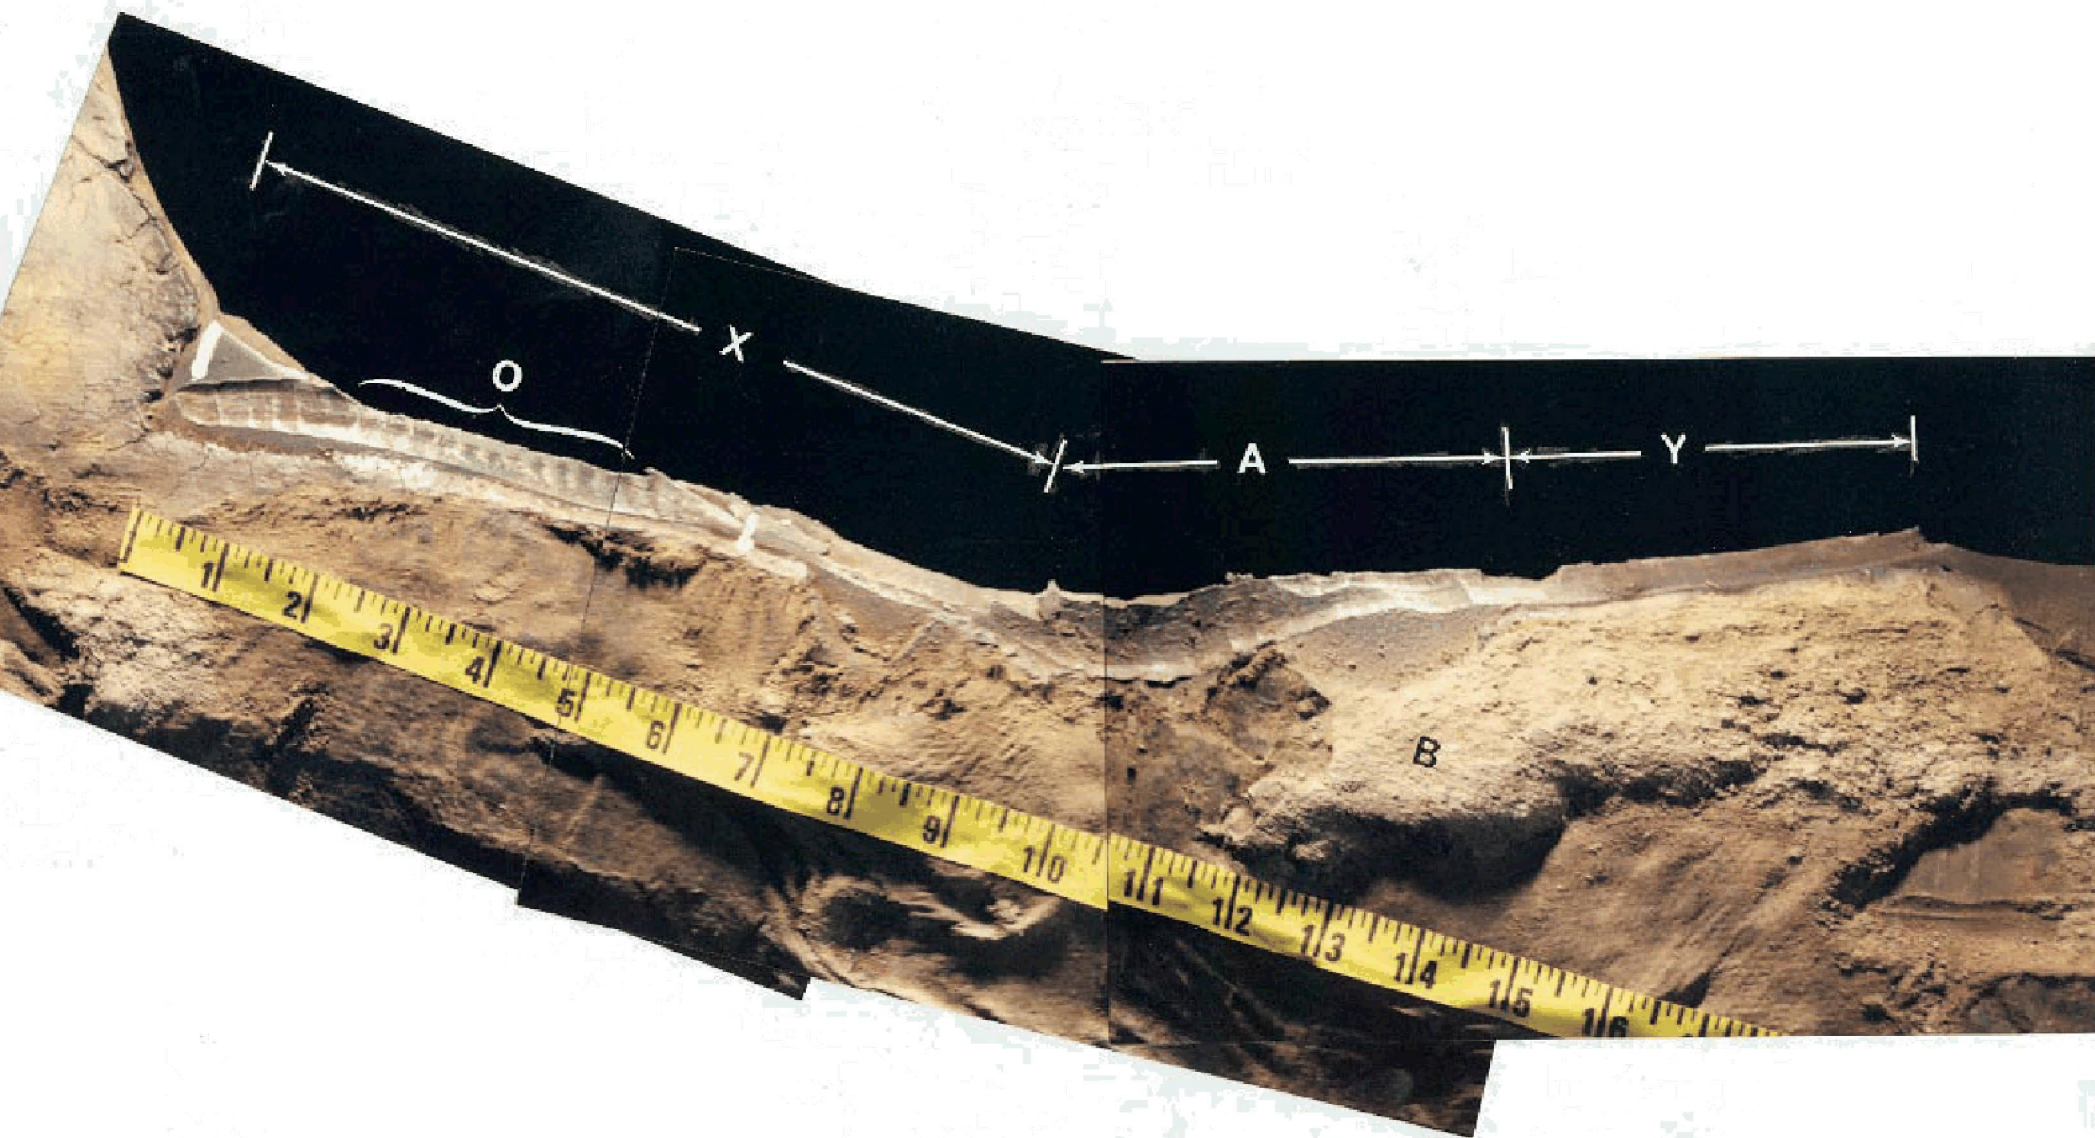
Figure 8. Close-up photograph of the outside diameter in the area of the east fracture in figure 5, showing gouge marks "X", "A", and "Y". This photograph was taken after soil was removed from gouge mark "A".

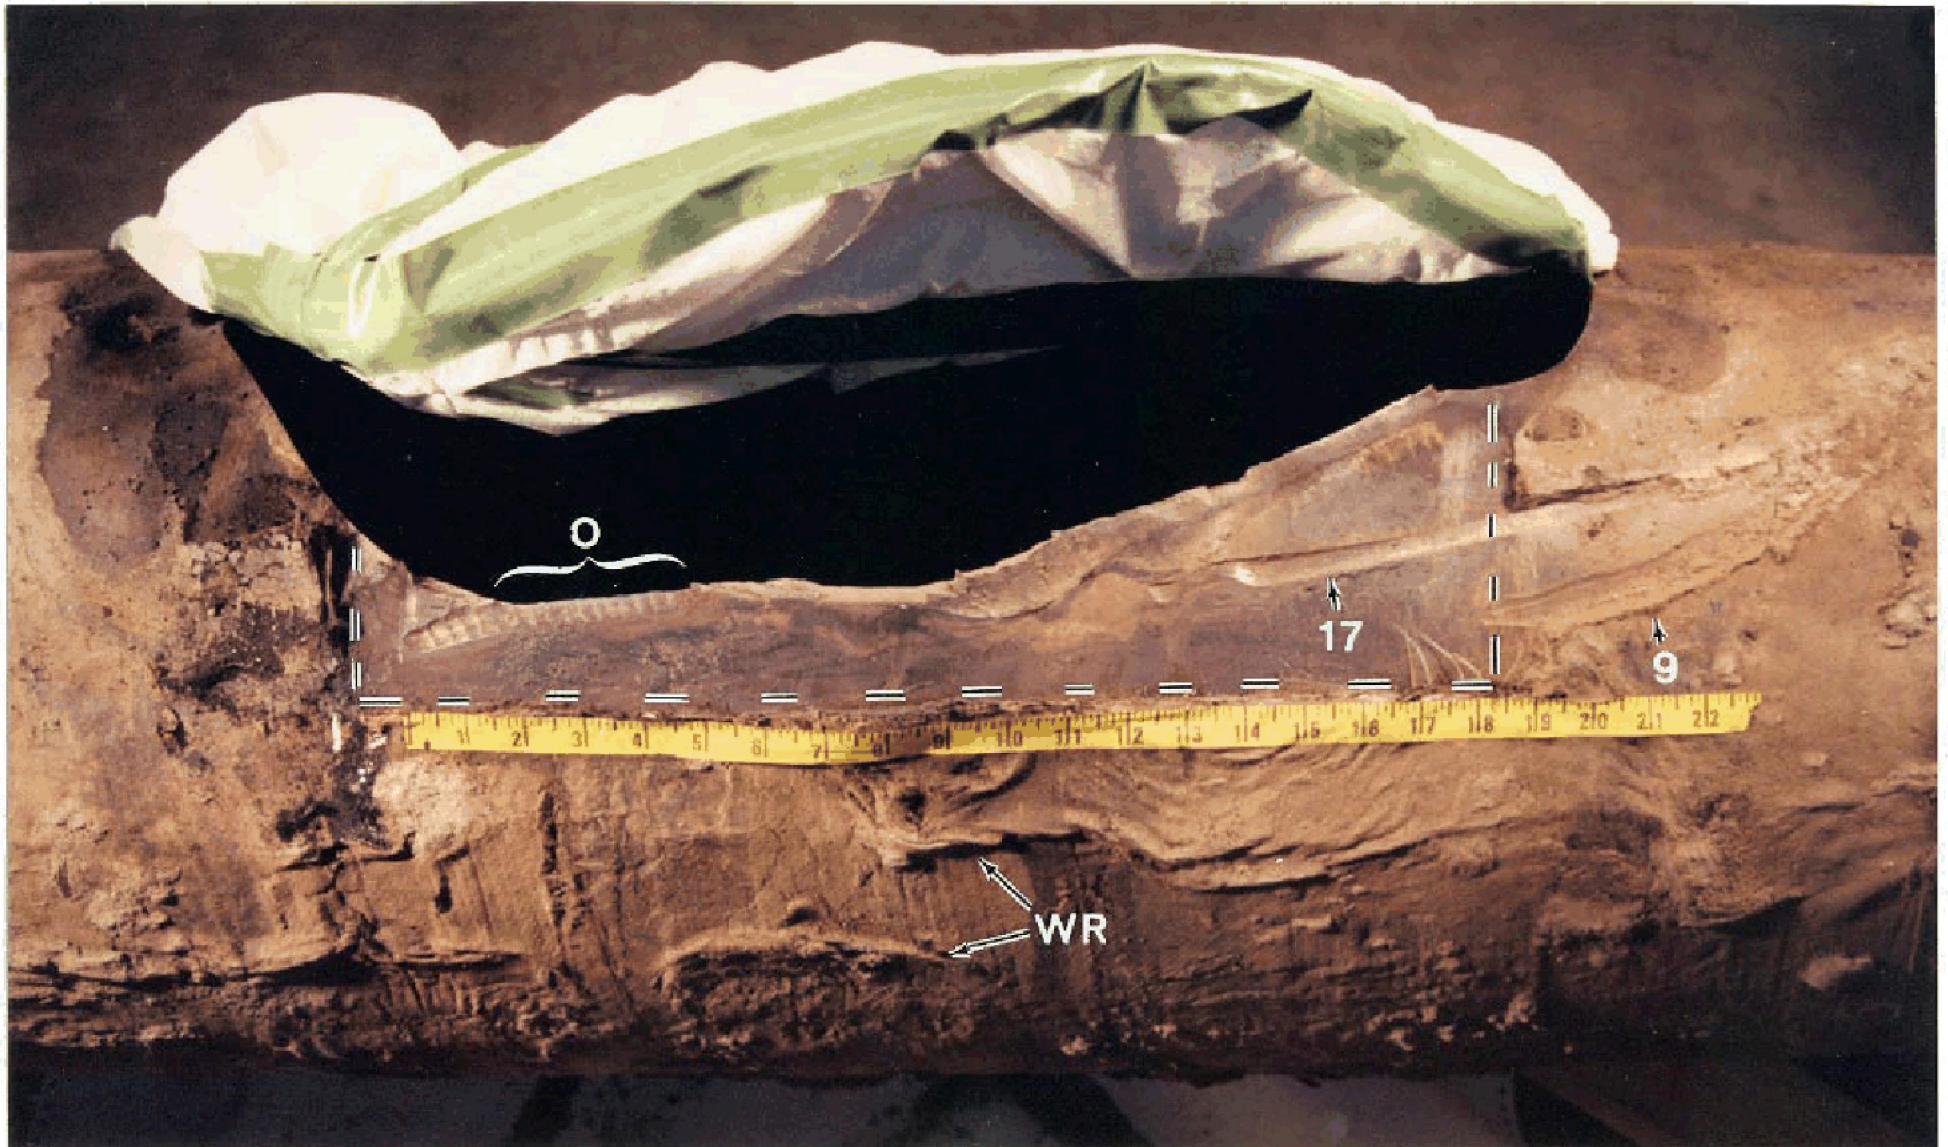
The tar coating was peeled away from the outside diameter between the east face of the fracture and the dashed line position in figure 9. A putty knife was forced between the pipe and coating to assist removal. The excised tar coating in this area had strongly adhered to the pipe. One continuous layer of tar coating was peeled away from this area. This process exposed an additional gouge mark that is indicated by arrow "17" in figure 9. Gouge mark "17" did not intersect the other gouge marks. The area from which the coating was removed intersected the fracture over a distance of 19 inches, extending beyond the ends of the combined gouge marks "X", "A", and "Y". This portion of the east fracture face will be referred to as the 19-inch fracture.

Figure 9. Overall view of the outside diameter in the area of the gaping crack after the coating was removed from the region inside the dashed line.

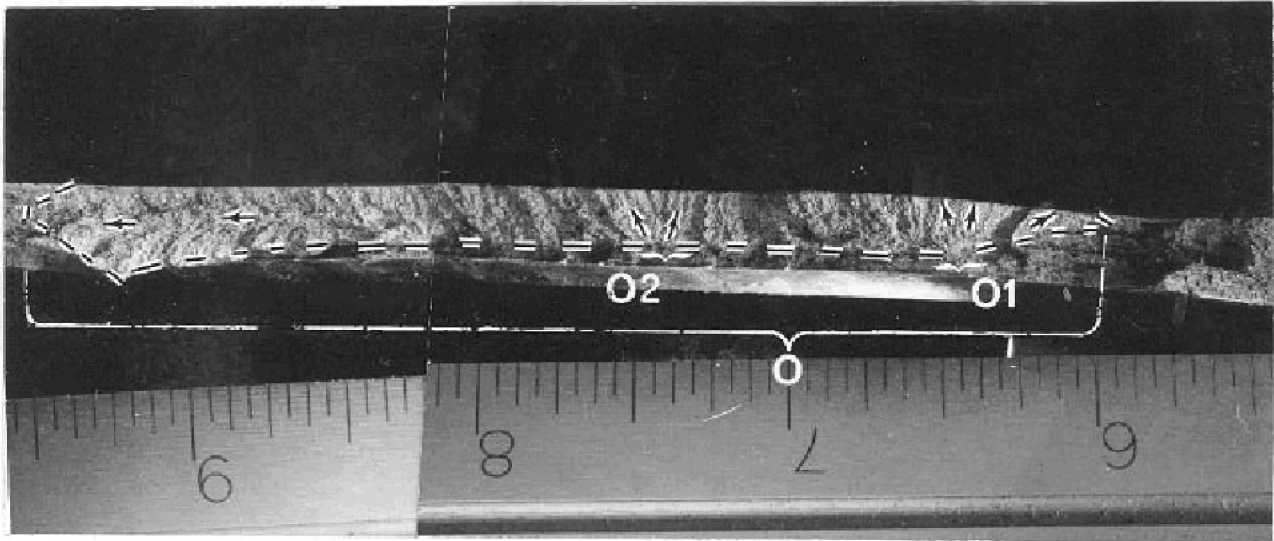
flat region extended from the bottom of the shear region to the inside diameter of the pipe. This extent of the flat region is indicated by the dashed line positions in figure 10. As indicated earlier, the maximum longitudinal extent of the flat region was 3.5 inches. Detailed visual examination of the flat region showed that it contained radial marks that emanated from two origin areas located at the boundary between the shear region and the flat region. The two fracture origin areas are indicated by brackets "O1" and "O2" in figures 10 and 11. In the area of origin "O2", the distance between the shear region and the inside diameter (inside pipe surface) measured approximately 0.17 inch. Unmarked arrows in figures 10 and 11 indicate general directions of fracture propagation in the flat region away from origin areas "O1" and "O2". Furthermore, the downstream end of the flat region contained chevron marks¹³. The orientation of these chevron marks indicated that the fracture in the area of the chevron marks propagated downstream and away from the origin "O2".

Figure 10. A close-up photograph of the fracture origin area, indicated by bracket O". The flat region is bound by the dashed line and the inside diameter. Gouge mark "X" is at the bottom side of the photograph and down stream is located to the left side of the photograph.

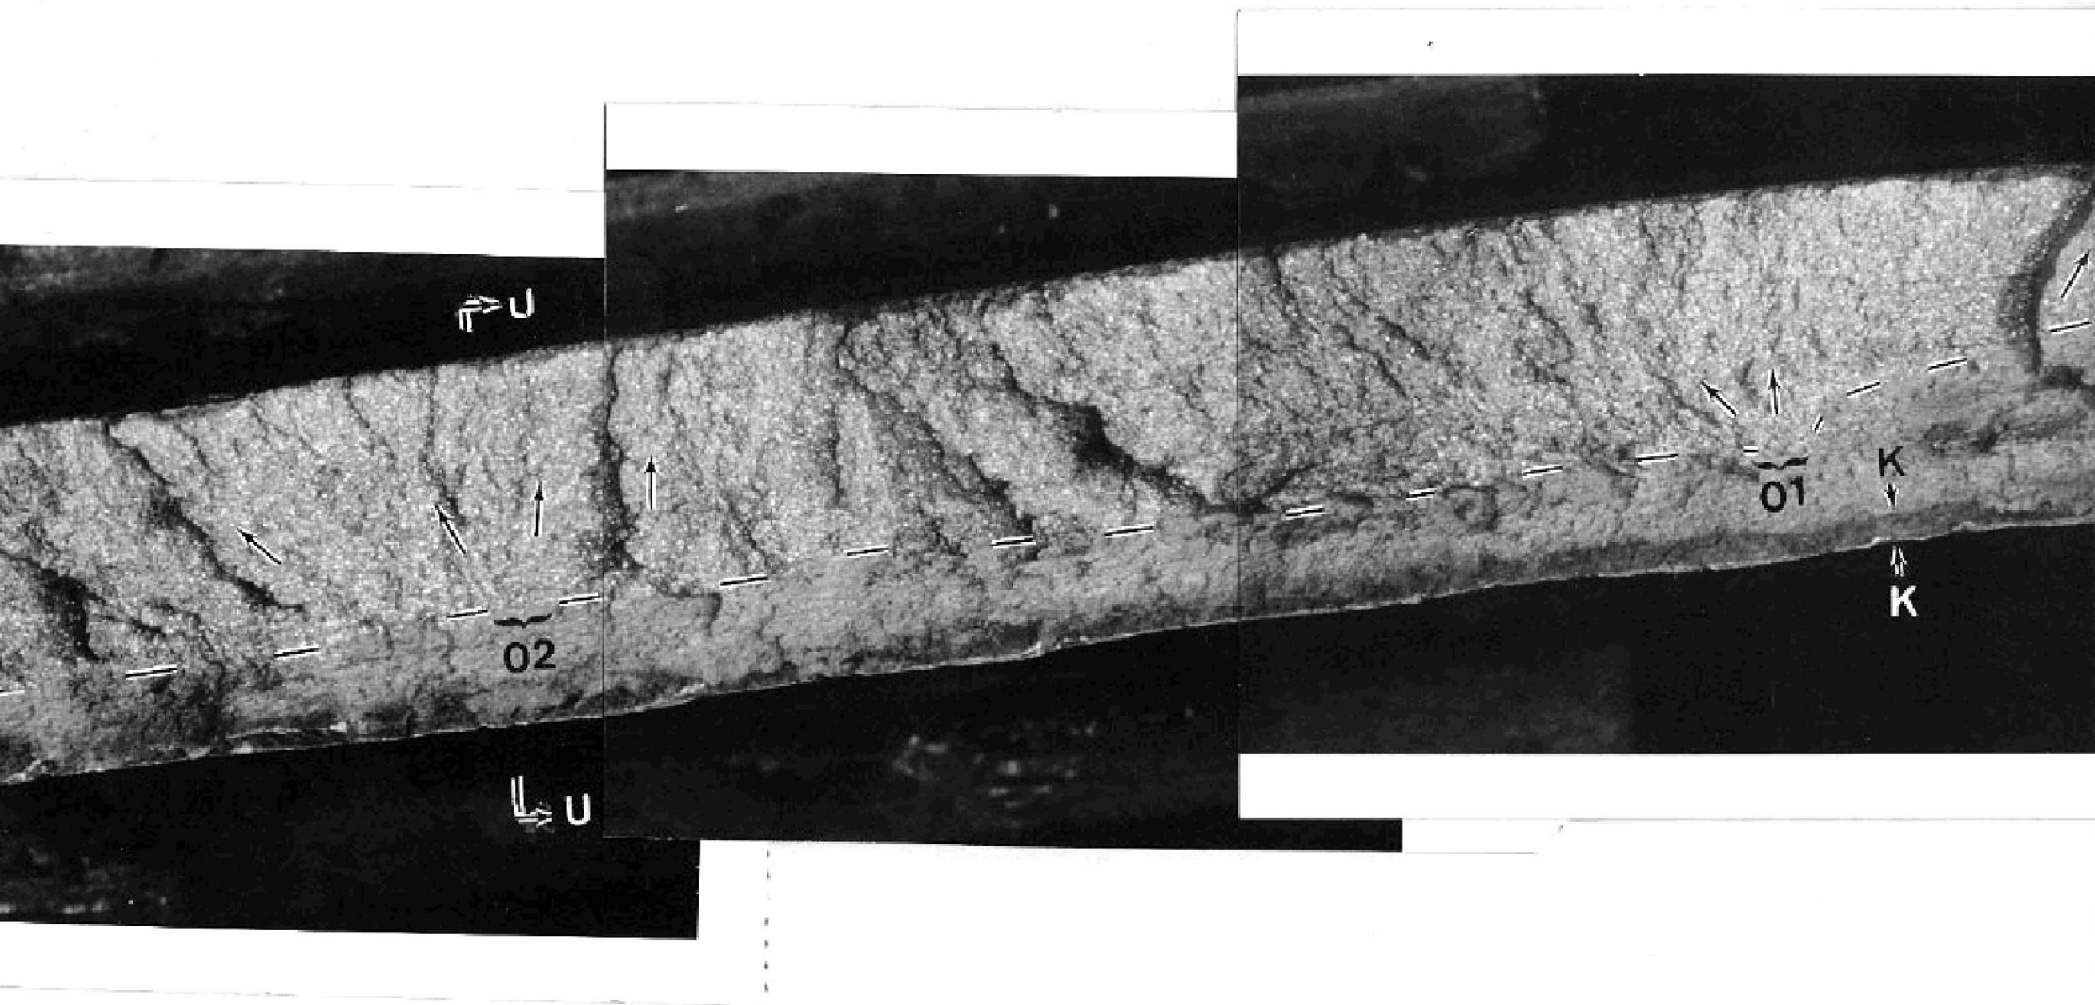
A metallurgical section was made at the edge of the fracture origin "O2" in the orientation indicated by section line "U-U" in figure 11. This excised section measured approximately 0.3 inch longitudinally and 0.9 inch circumferentially. The section was polished and etched with 2% nital reagent. Figure 18 shows a photograph of the fracture profile. Metallographic examination of this section revealed the fracture contained a gradual transition between the shear region and flat region. The profile of the fracture was rough for the most part of the fracture length. The surface adjacent to the gouge mark contained a white layer, in the area between unmarked arrows in figure 19. The thickness of this layer measured approximately 0.001 inch. This white layer exhibited barely visible deformation lines. The wall of the pipe exhibited severe deformation lines in areas below the white layer. Figures 19 and 20 show close-up photographs of the deformation lines in the area adjacent to the white layer. The severity of the deformation lines gradually decreased as the distance increased away from the gouge mark.

Figure 11. Close-up photograph of a portion of the fracture origin area showing a brown deposit layer (in the area between arrows "K") adjacent to gouge mark "X". Outside diameter is located on the bottom side of photograph. (7.5X)

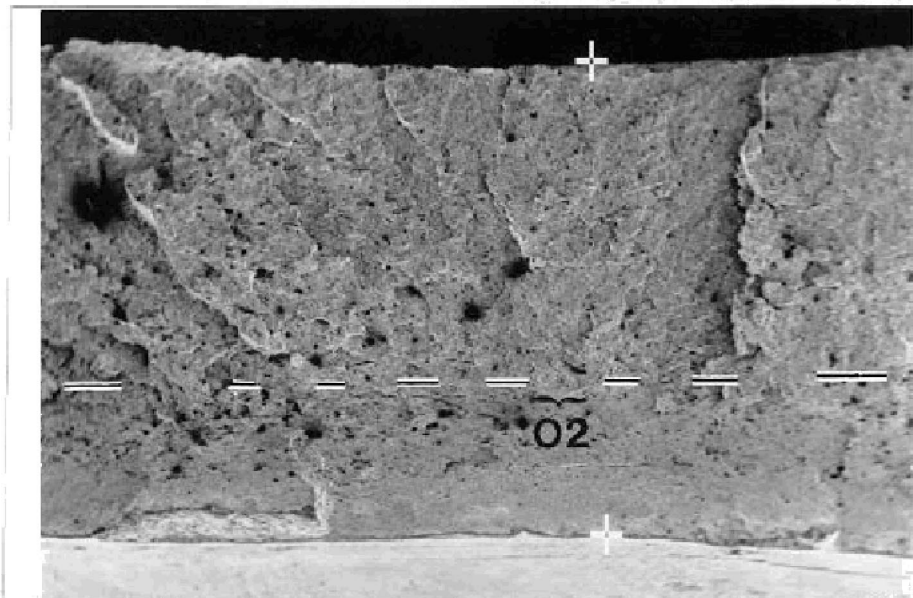
Figure 12. Scanning electron microscope (SEM) photograph of a portion of the flat region on the fracture showing radial marks that emanated from the bottom of the shear region in the area indicated by bracket "O2". The dash line indicates the transition area between the shear and flat regions. Inside diameter is located at the top side of the photograph. (10.6X)

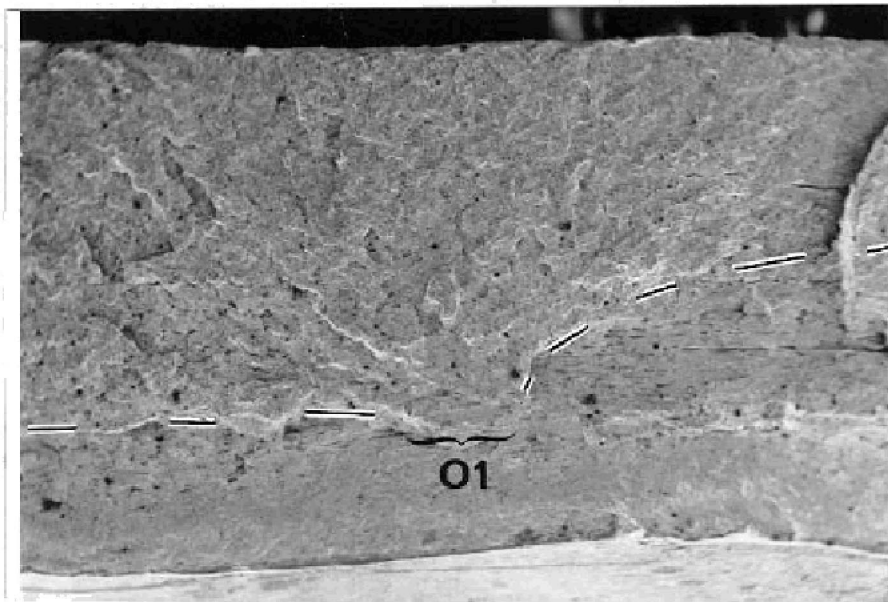
Figure 13. SEM photograph of a portion of the flat fracture region showing radial marks that emanated from another area at the bottom of the shear fracture region in the area indicated by bracket "O1". The dash line indicates the transition area between the shear and flat regions of the fracture. Inside diameter is located at the top side of the photograph. (10.6X)

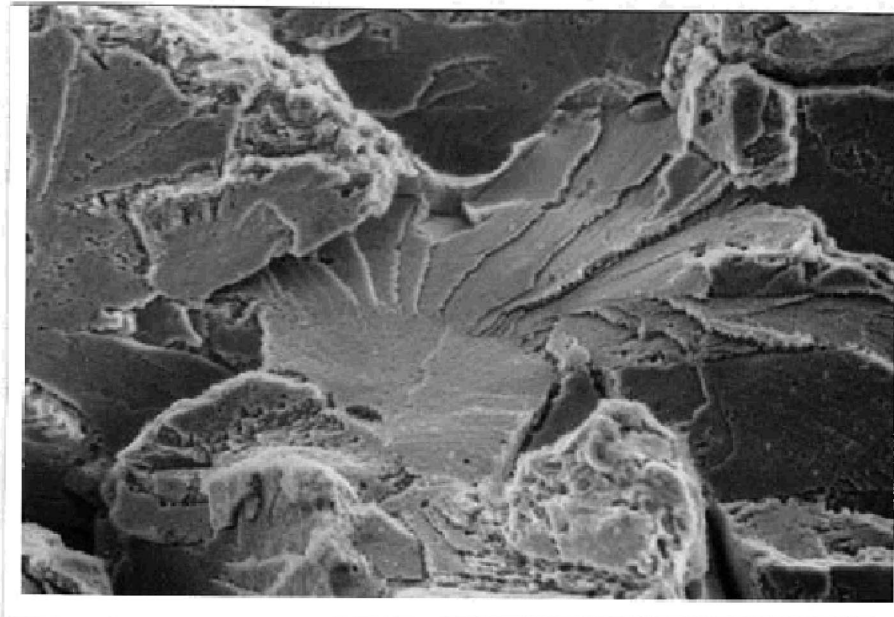
Figure 14. SEM photograph of a typical cleavage fracture region. (1,050X)

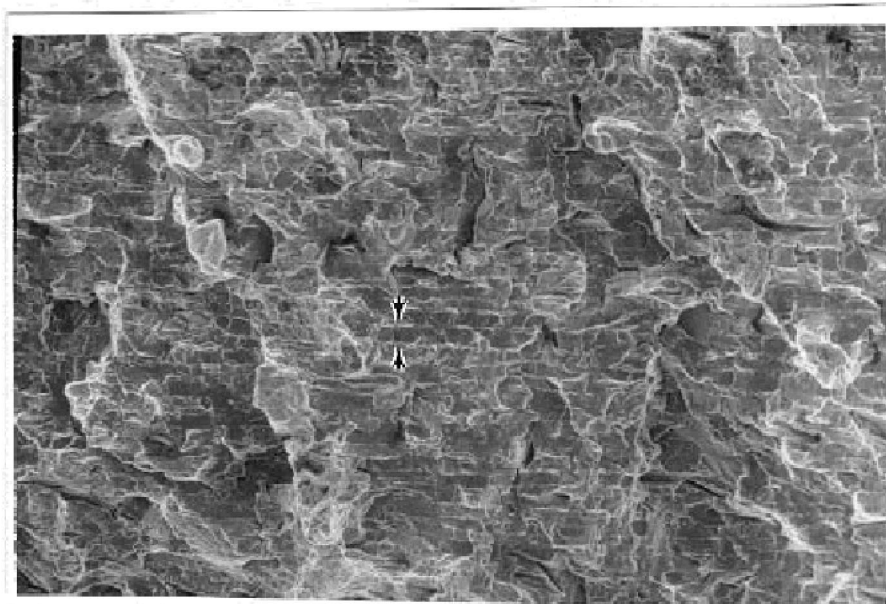
Figure 15. Lower magnification SEM photograph of a portion of the flat region showing typical longitudinal band-like features. A typical band is located between unmarked arrows. (161X)

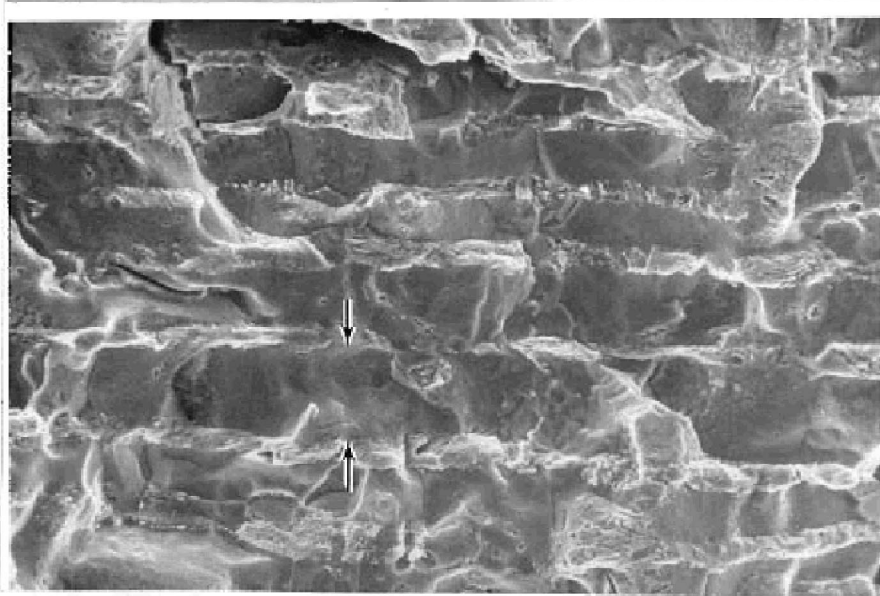
Figure 16. Higher magnification SEM photograph of the band-like feature between unmarked arrow. (867X)

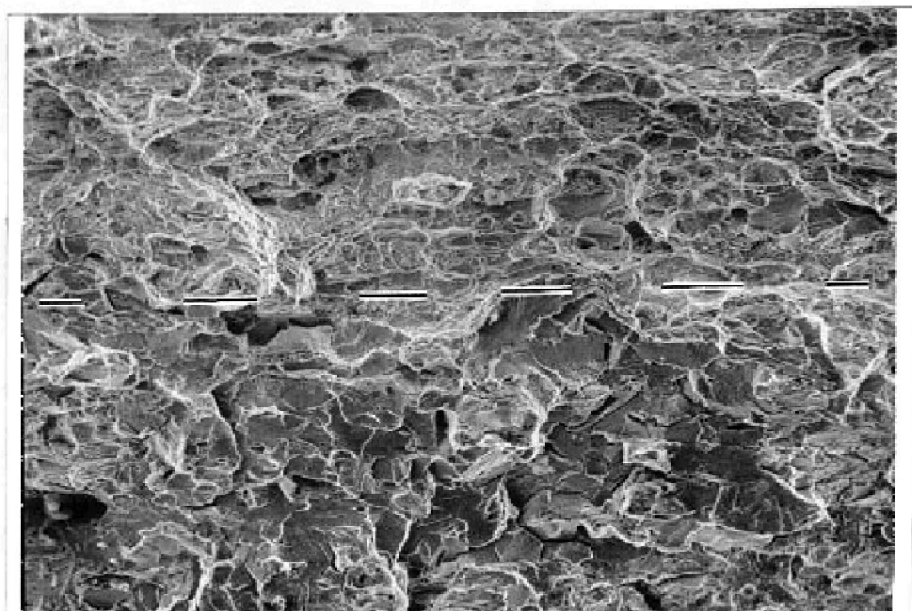
The SEM examination showed that the flat region did not extend all of the way to the inside diameter of the pipe. A shallow shear lip, with a minimum width of approximately 0.003 inch, was found between the bottom of the flat region and the inside diameter. The SEM examination also showed that all fracture areas outside the flat fracture region, including the shear region adjacent to gouge "X" and shear lips adjacent to the inside diameter surface, contained ductile dimple features. No evidence of a crack arrest mark or marks¹⁵ were found on the flat fracture area or elsewhere on the fracture. At the interface between the shear region at the exterior surface and the flat region, the transition from ductile dimple overstress to predominantly cleavage was gradual. Figure 17 shows a close-up photograph of a typical transition area between the flat and shear region.

Figure 17. SEM photograph of the transition area, indicated by a dash line, between the shear region (upper) and the flat region (lower) of the fracture. Note that the flat fracture region contains cleavage features and the shear fracture region contains ductile dimple features. (204X)

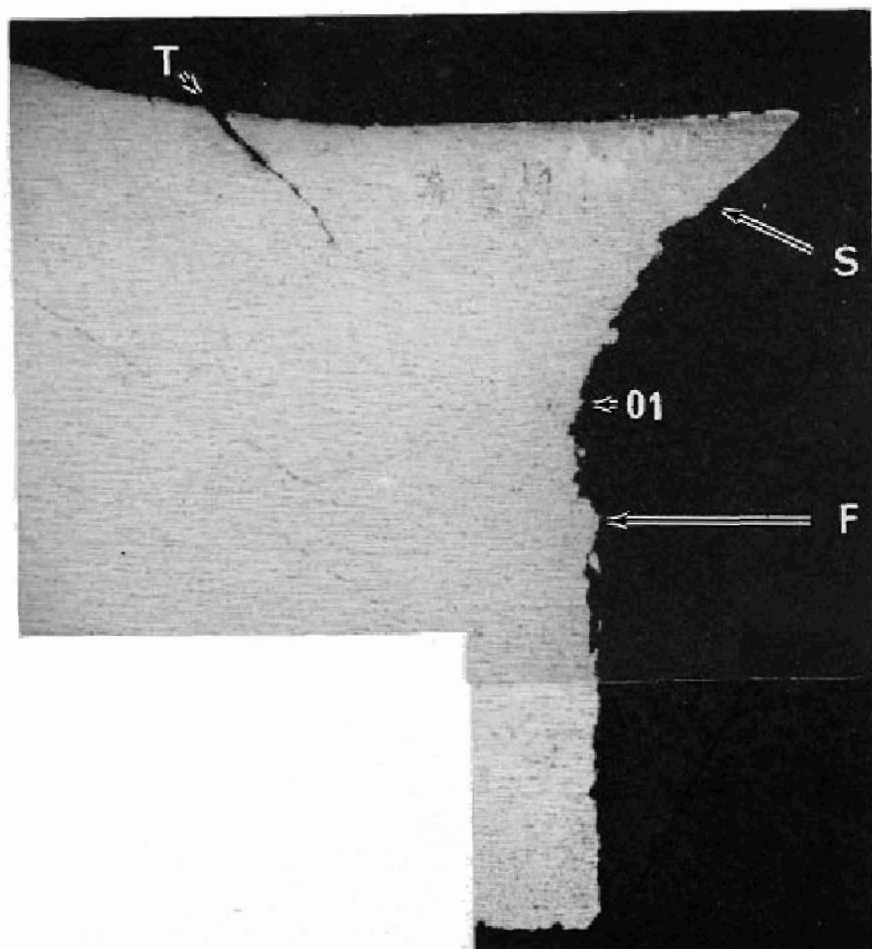
Examination of section "U-U" through origin area "O2" also revealed the presence of a secondary gaping crack that is indicated by arrow "T" in figure 18. This crack was on the opposite shear plane to the plane of the shear region associated with the fracture and was found on the surface of the gouge mark in the proximity of the fracture. The crack extended to a radial depth of 0.04 inch from the gouged surface. However, the length of the crack was approximately 0.06 inch, measured along its length. A portion of the crack that extended between surface of the gouge mark and approximately 0.02-inch radial from the surface of the gouge mark was filled with a deposit. EDS analysis of this deposit produced a spectrum that contained peaks of iron and oxygen, consistent with iron oxide.

Figure 18. Composite photograph of a portion of metallurgical section "U-U" showing the fracture profile and fracture origin indicated by arrow "O1". Gouge mark "X" is located on the top side of the photograph. The shear region indicated by arrow "S" is located above the fracture origin area and the flat region indicated by arrow "F" is located below the fracture origin. Etched with 2% nital reagent. (16X).
