NATIONAL TRANSPORTATION SAFETY BOARD

MATERIALS LABORATORY FACTUAL REPORT

Report No. 00-157

Place : Bellingham, Washington
Date : June 10, 1999
Vehicle : Olympic Pipe Line Company, 16-inch diameter gasoline pipeline
NTSB No. : DCA99-M-P008
Investigator : Allan Beshore

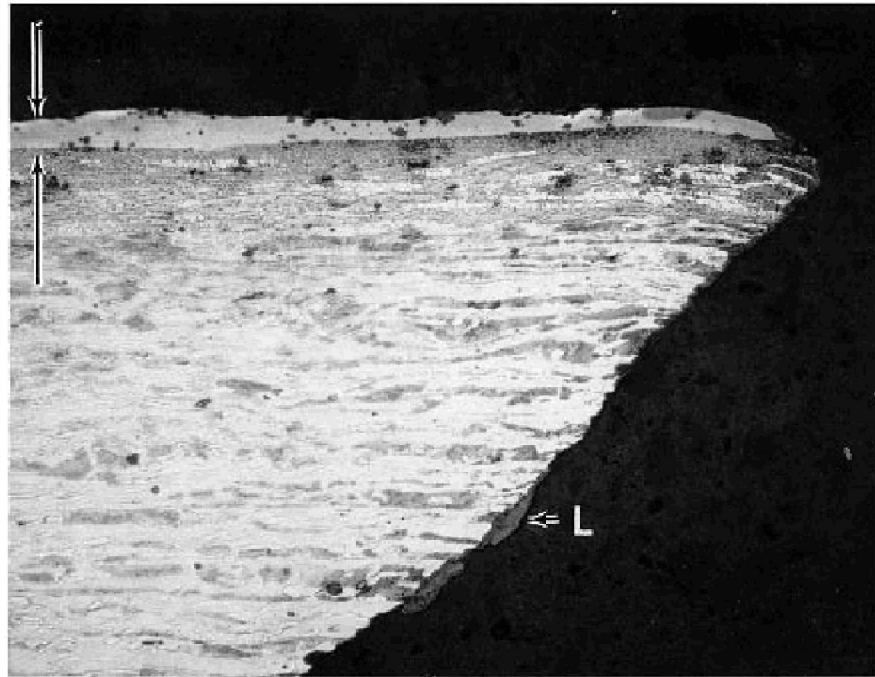
The fracture surface adjacent to the gouge mark also contained a layer of iron oxide (verified by EDS analysis). The location of the thickest portion of the iron oxide layer is indicated by arrow "L" in figure 19. The iron oxide layer on the fracture surface extended from the surface of the gouge mark to a distance located approximately 0.016 inch radial from the surface of the gouge mark, slightly less than the depth of the iron oxide deposit

Figure 19. Close-up photograph of a portion of the section showing a white layer that was located at the surface of gouge mark "X" in the area between unmarked arrows. (160X)

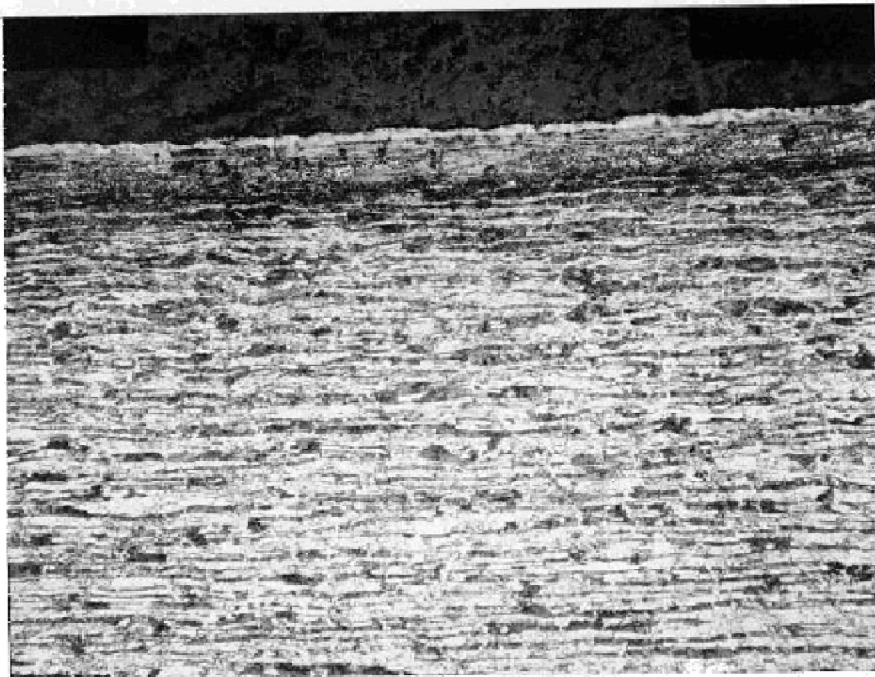
Figure 20. Another view of the section in the area adjacent to gouge mark "X" showing the white layer (at top of photograph). Note the deformed grains adjacent to the white layer. (100X)

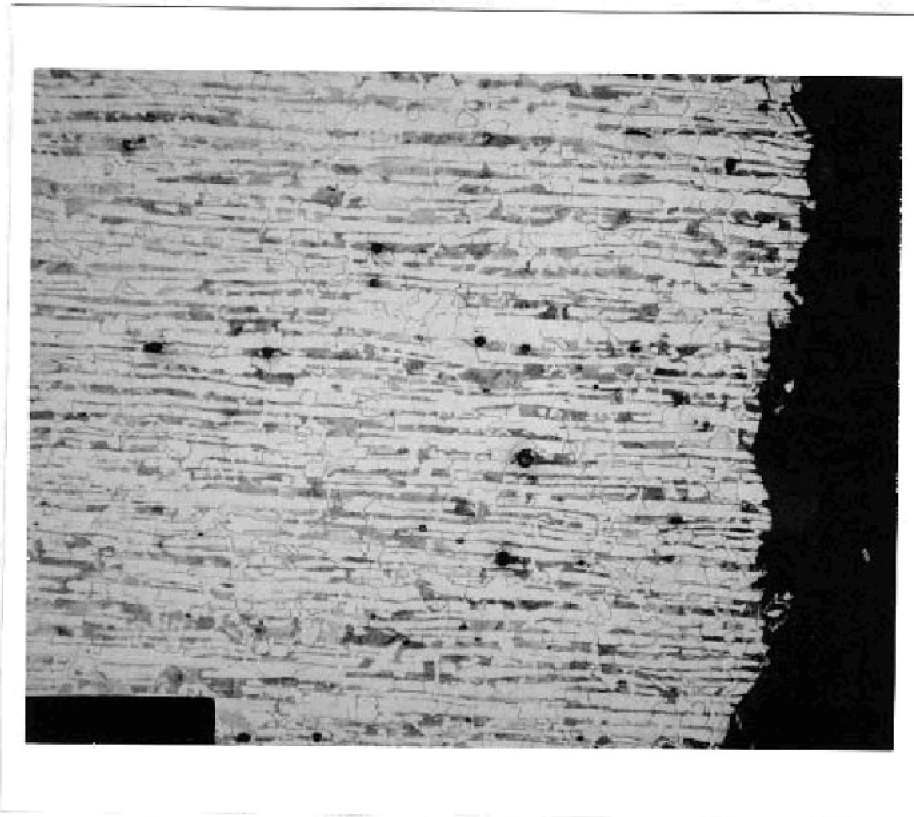
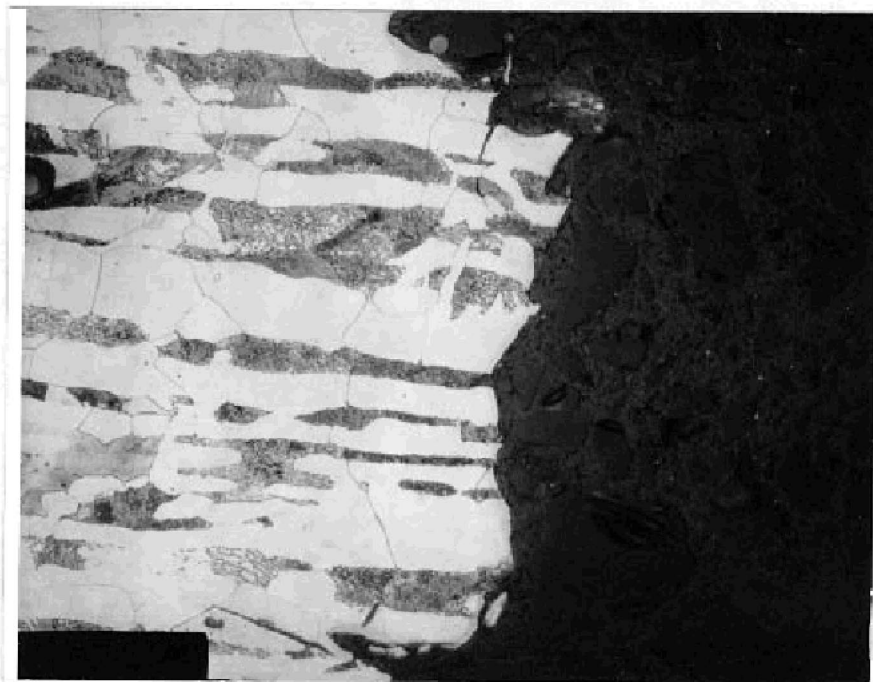
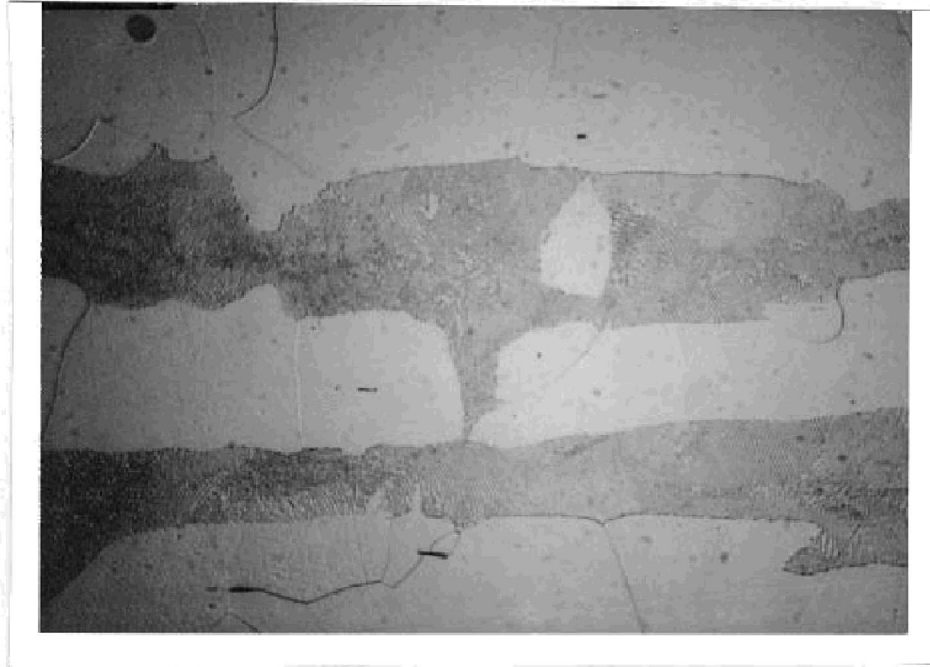
The wall of the pipe in areas outside the white layer contained a microstructure of pearlite and ferrite grains, normal for a low alloy steel. Figures 21A through 21C show typical microstructure of ferrite and pearlite. The ferrite and pearlite grains exhibited alternating band-like layers that were oriented in the longitudinal direction. The pearlite grains were discontinuous and interrupted the band-like layers in the microstructure. The size of the ferrite and pearlite grains in the microstructure appeared similar to the size of

Figure 21A. Photomicrograph of typical microstructure found in the area adjacent to the flat region of the fracture. The microstructure exhibited ferrite grains (light areas) and pearlite grains (dark areas). 100X

Figure 21B. Higher magnification photomicrograph of the microstructure in the area adjacent to the flat region of the fracture. (500X)

Figure 21C. Higher magnification photograph of the microstructure found at the wall of the pipe showing ferrite (light) and pearlite (dark zebra-like pattern) grains. This area was located at the inside diameter in an area that contained no evidence of deformation. (1,000X)

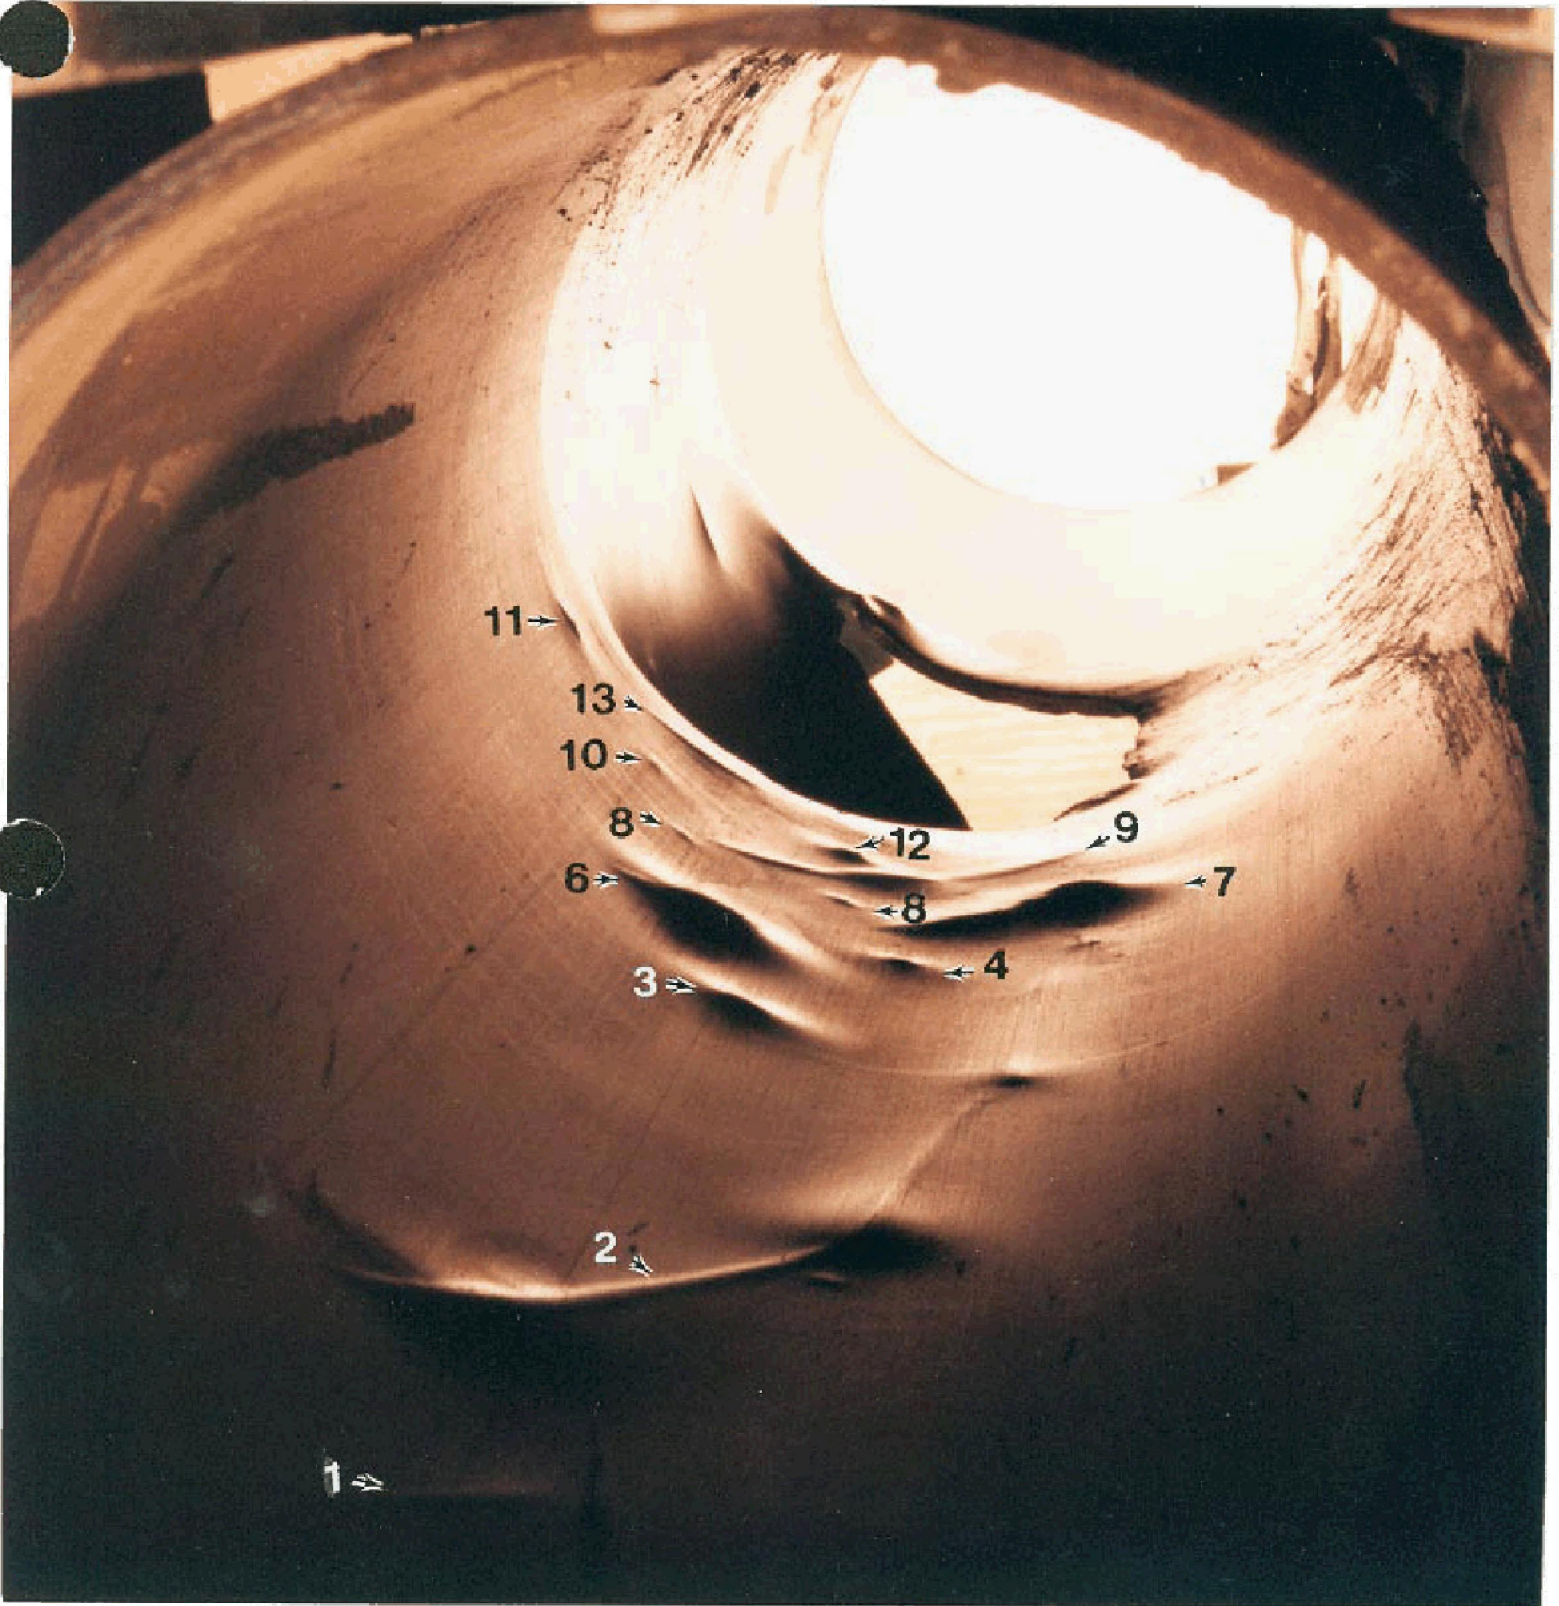
Figure 28. View looking downstream at the inside diameter of the north segment of the pipe. The number next to each arrow identifies the gouge mark associated with the indicated dent.

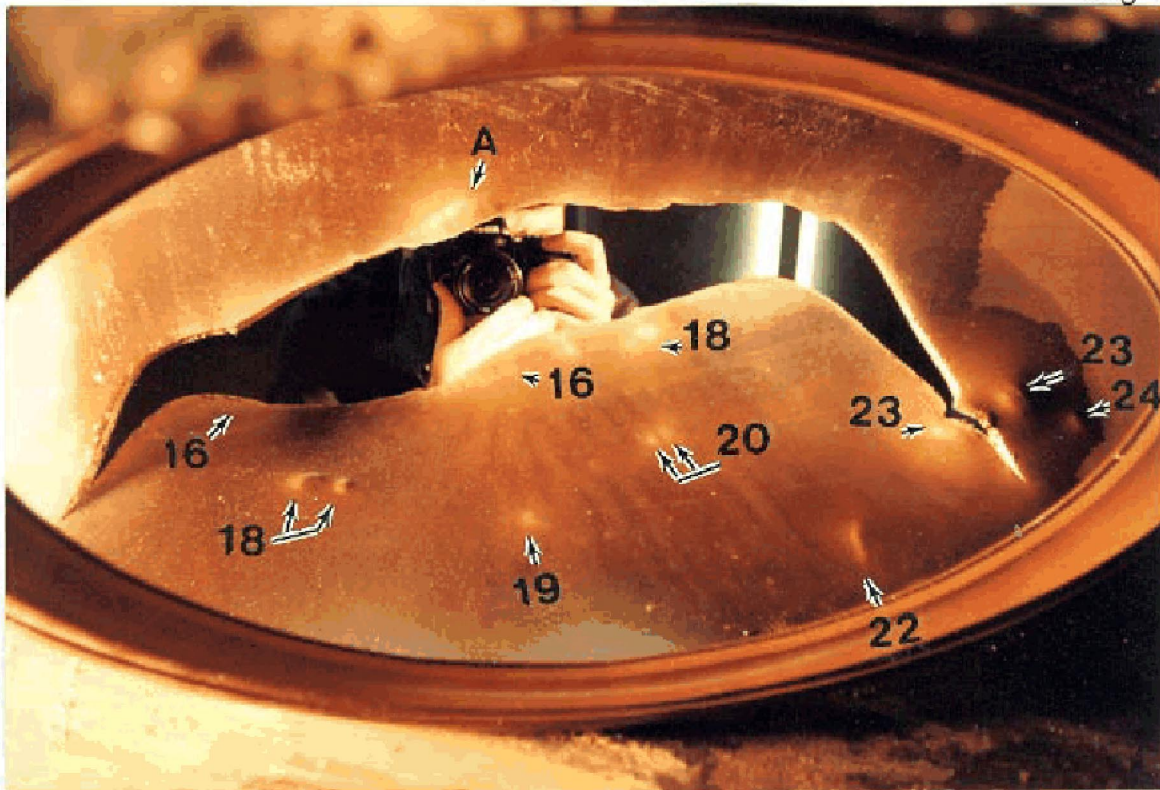
Figure 29. Photograph through a mirror of the inside diameter wall showing the full length of the gaping crack. Photograph was taken through the gaping crack from outside the pipe and with an oval mirror positioned inside the pipe. East face of the fracture is located on the top side of the photograph, and the downstream end is located at the right side.

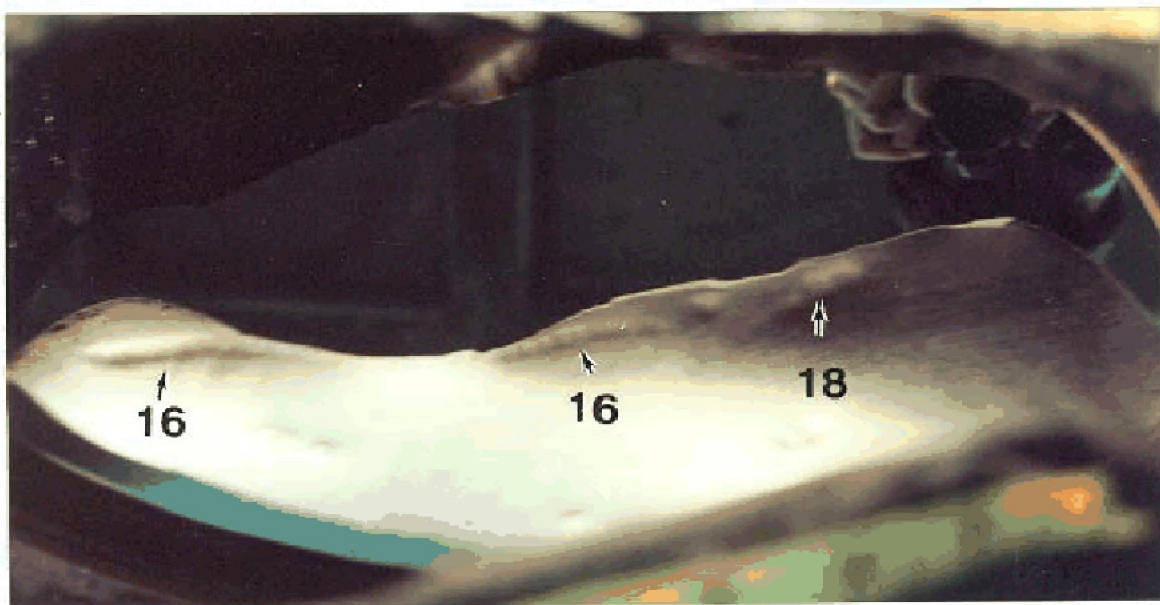
Figure 30. Photograph through a mirror of the inside diameter wall showing a close-up view of a portion of west face of the fracture. Downstream end is located at the right side.

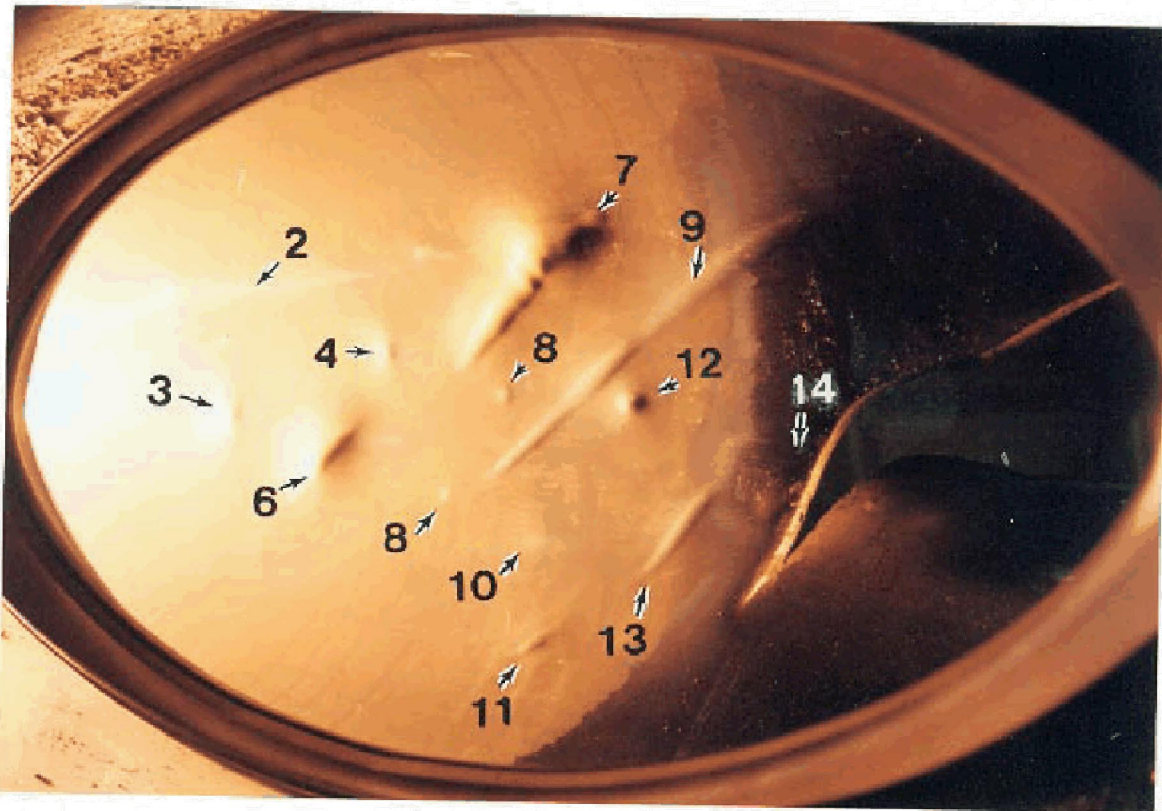
Figure 31. Photograph through a mirror of the inside diameter wall in the area located adjacent to the upstream end of the gaping crack. Photograph taken through the gaping crack from outside the pipe with a mirror positioned inside the pipe.

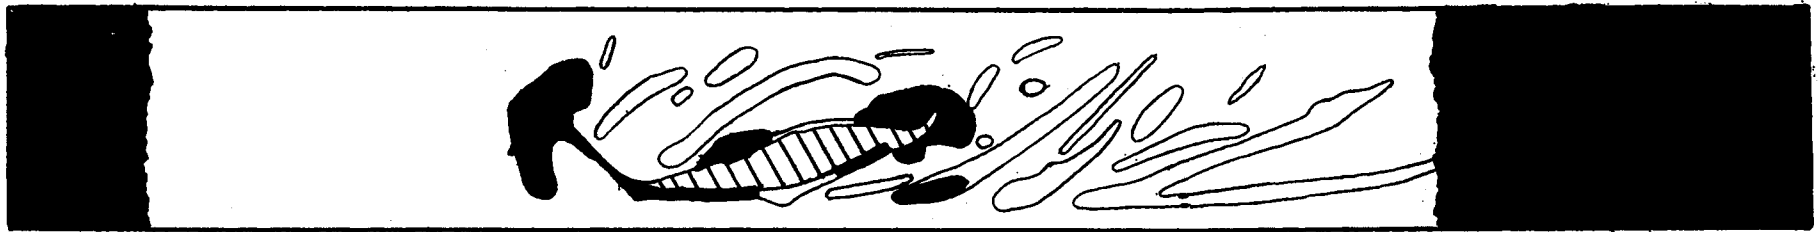
Figure 32. Sketch of the as-received north segment of the pipe showing the locations (black regions) where coating was either missing or had been removed from the exterior surface of the pipe. Note that areas without coating overlap portions of several gouge marks. Diagonal lines indicate gapping crack. The north (upstream) end is located on the right side of the sketch. Compare to figure 27.

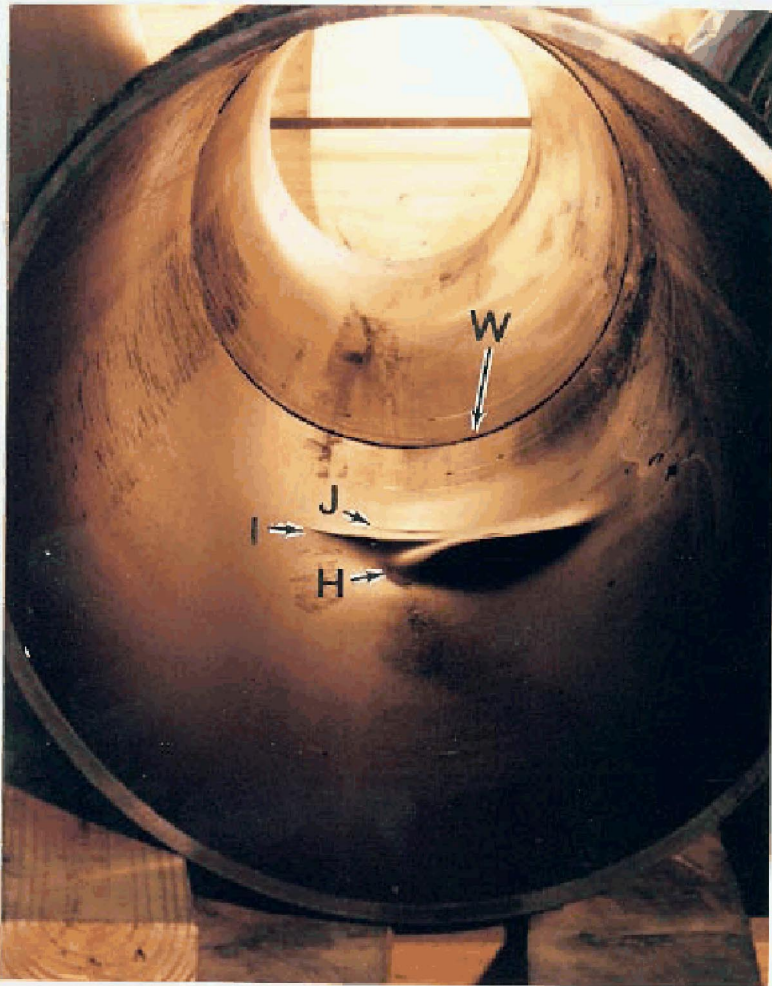
Figure 33. Photograph of the inside diameter of the south segment looking upstream showing the girth weld, indicated by arrow "W", and three gouge marks, indicated by arrows "H", "I", and "J".

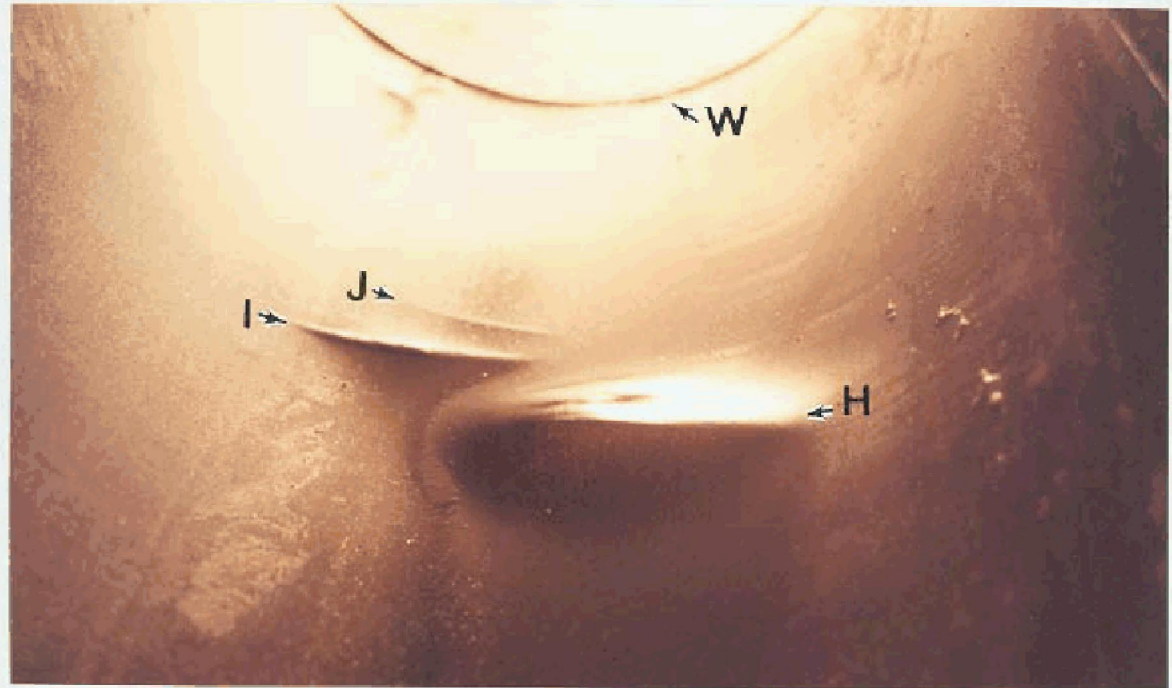
Figure 34. Close-up view of gouge marks "H", "I", and "J".

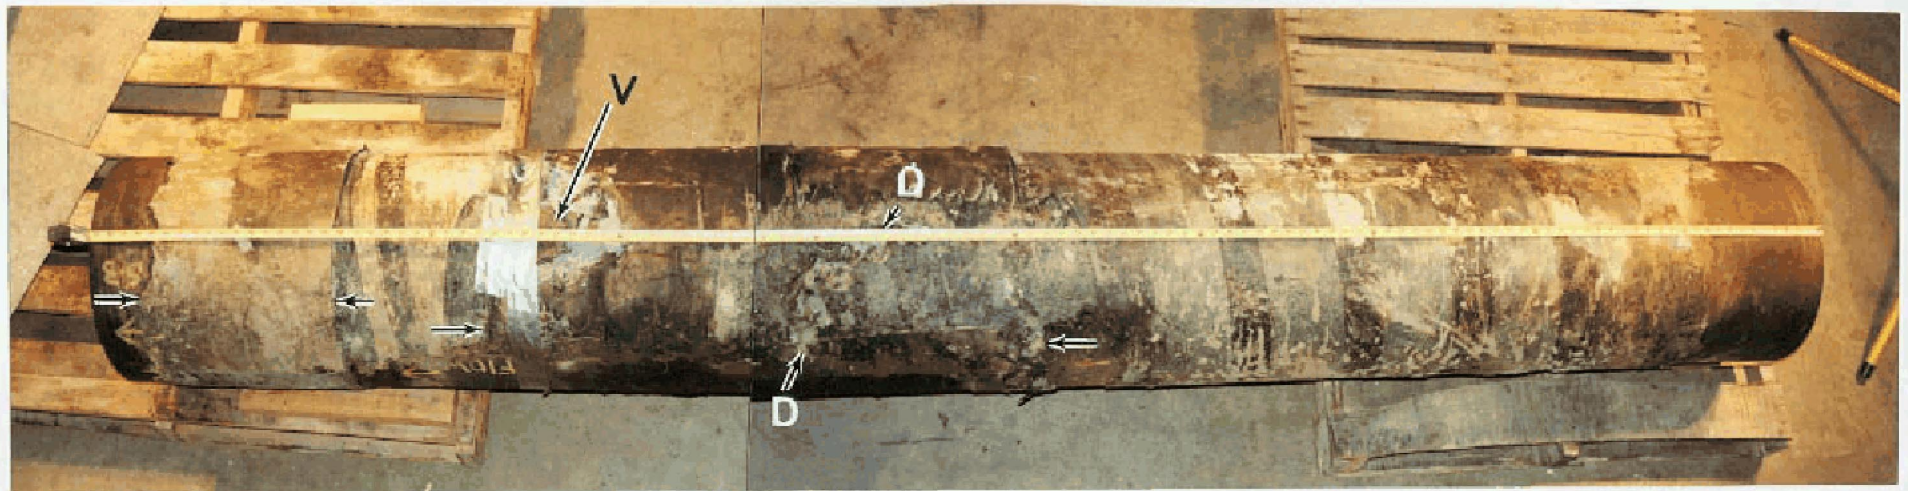
Figure 35A. Composite photograph of the as-received south segment of the pipe showing a ruler that was placed longitudinally at 3:30 o'clock. Two dislodged pieces of the coating, arrowed "V", are held in place by duct tape. The patches are located between unmarked arrows. Refer to figure 3 for the length of each patch.

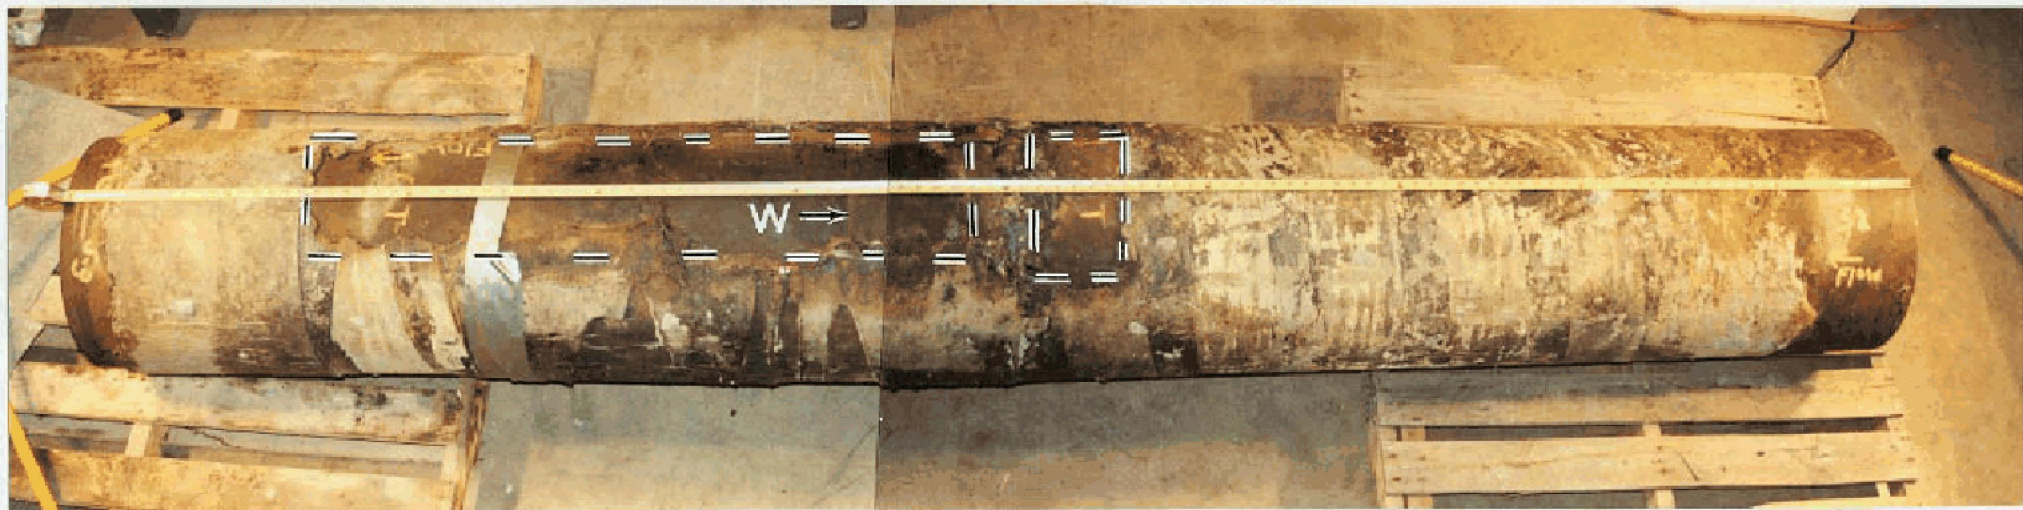
Figure 35B. Composite photograph of the as-received south segment of the pipe showing a ruler that was placed longitudinally at 12:00 o'clock. Coating reportedly was removed in the areas bound by a dashed line, to expose the girth weld arrowed "W".

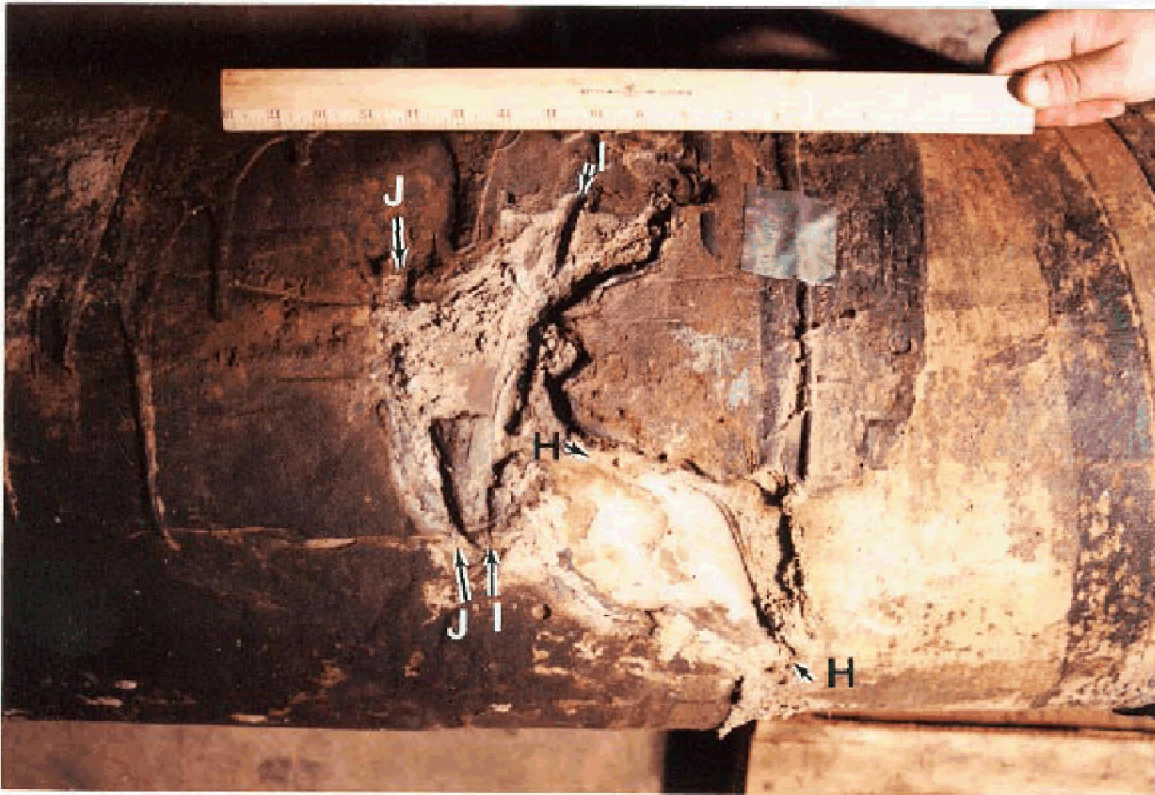
Figure 36. Photograph of the outside diameter showing gouge marks "H", "I", and "J". These gouge marks correspond to those shown in figure 3.

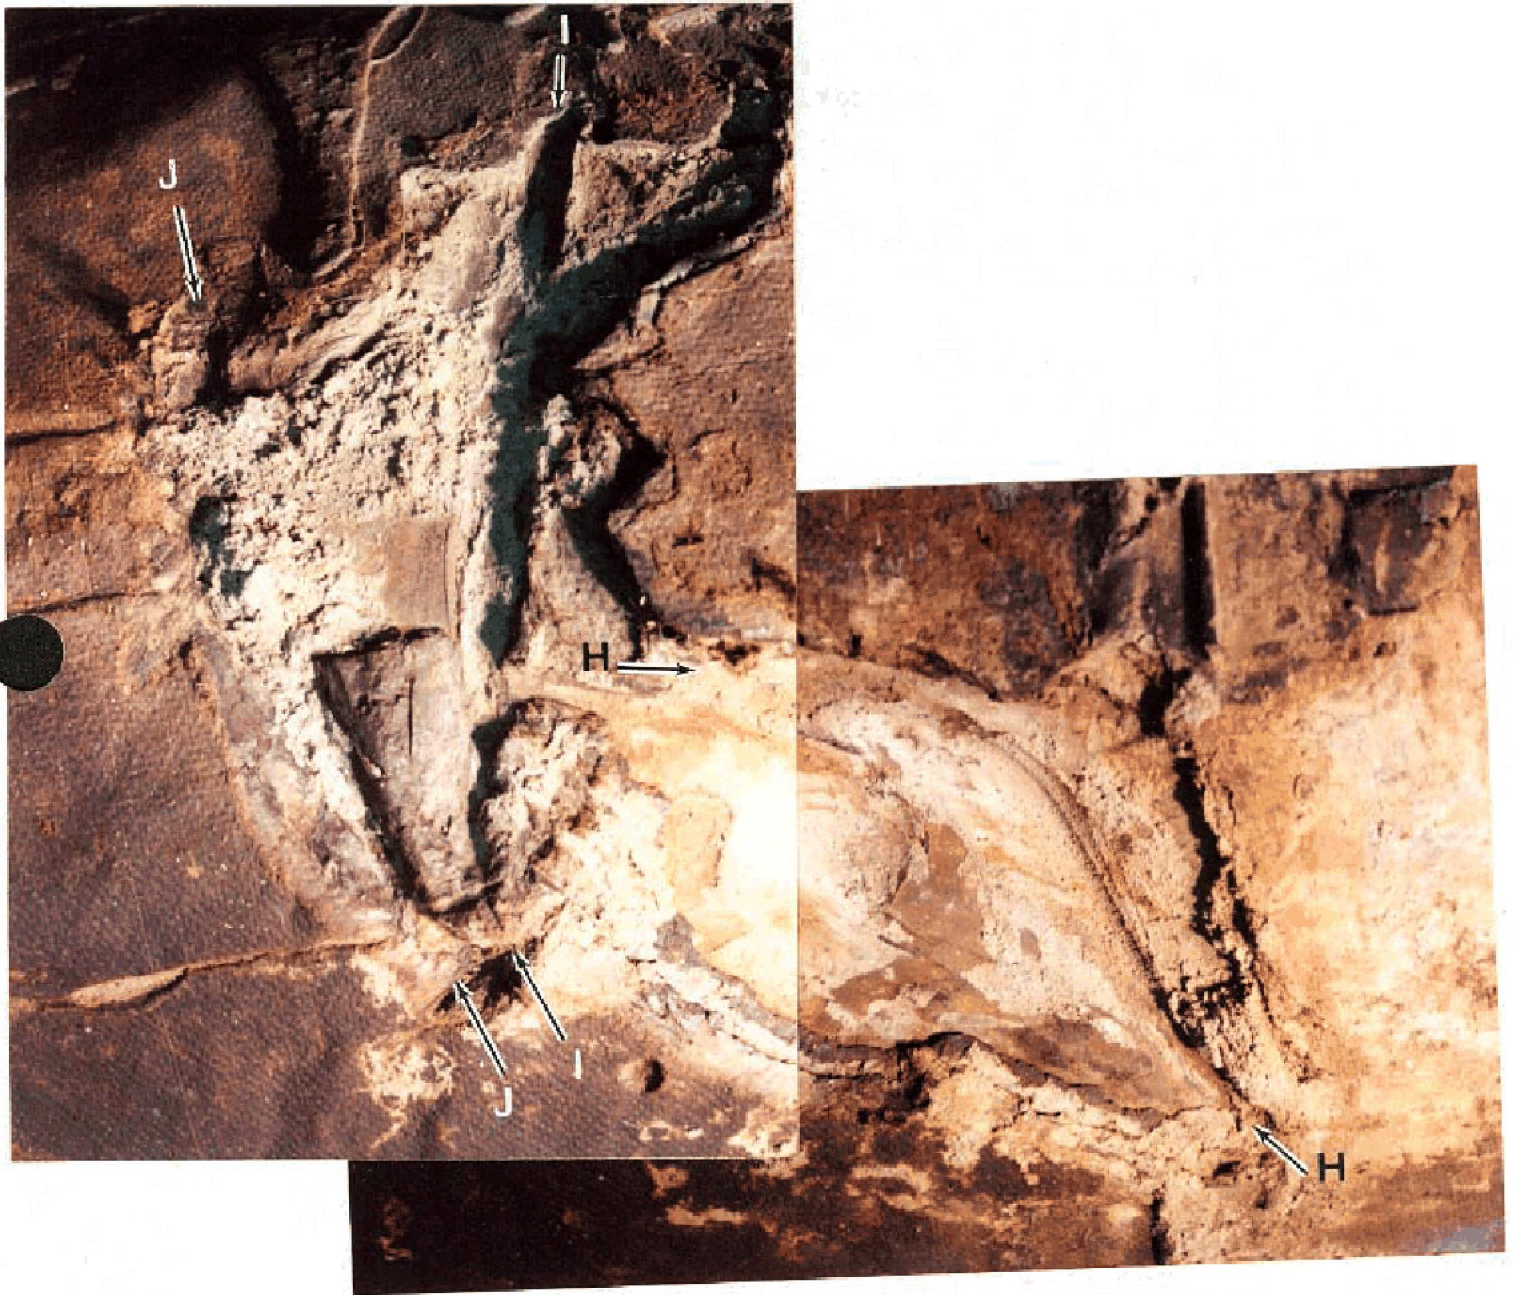
Figure 37. Close-up photograph the gouge marks "H", "I", and "J". Length of each gouge mark is located between arrows. Letters correspond to those in figure 36.
