NATIONAL TRANSPORTATION SAFETY BOARD

MATERIALS LABORATORY FACTUAL REPORT

Report No. 20-050

Place : Scottsbluff, Nebraska
Date : December 18, 2019
Vehicle : Cessna 525A, C-GOJG
NTSB No. : CEN20LA041
Investigator : Mitchell Gallo, ASI-CEN

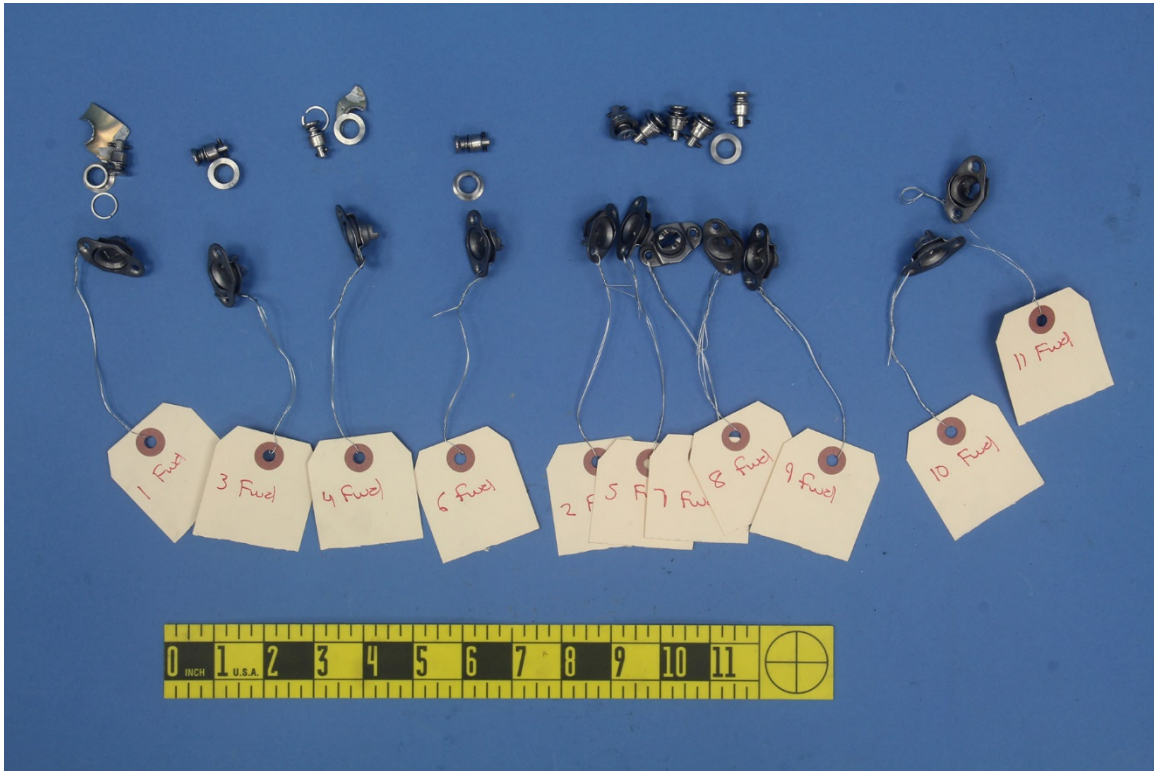
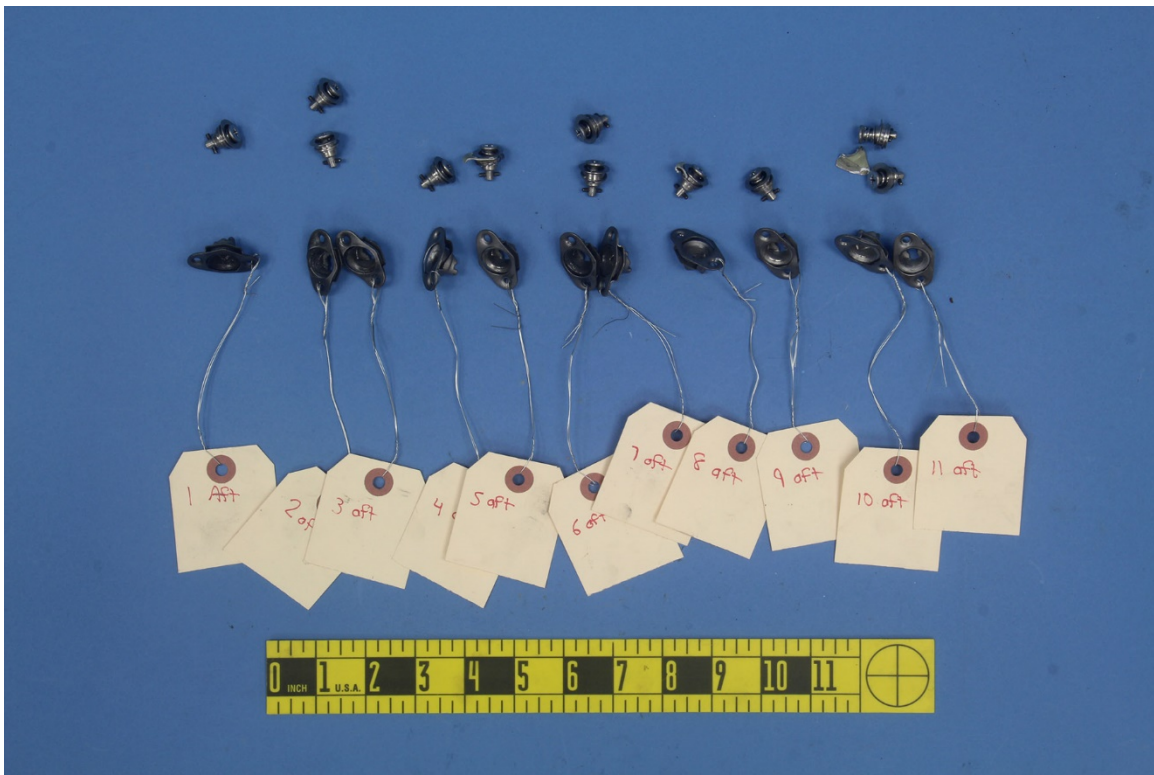
The lower cowl door fastener assemblies from the forward and aft attachment flanges were received by the Materials Laboratory as shown in figures 1a and 1b, respectively. There were eleven receptacles but only nine stud assemblies, grommets, and snap rings. On-scene examination of the right engine revealed that the missing hardware originated from the inboard side of the engine as shown in figure 3. When viewed from the aft position looking forward, the fasteners were between the 8:00 and 9:00 positions. On scene, the fasteners were given numbers starting at the 3:00 position and proceeding clockwise, so that the missing hardware was located at positions 10 and 11, as indicated in figure 3. Of the remaining nine studs, studs 1, 3, 4, and 6 were matched

Figure 1: Images of the as-received quarter-turn fastener assemblies: a) hardware from the forward attachment flange and b) hardware from the aft attachment flange.

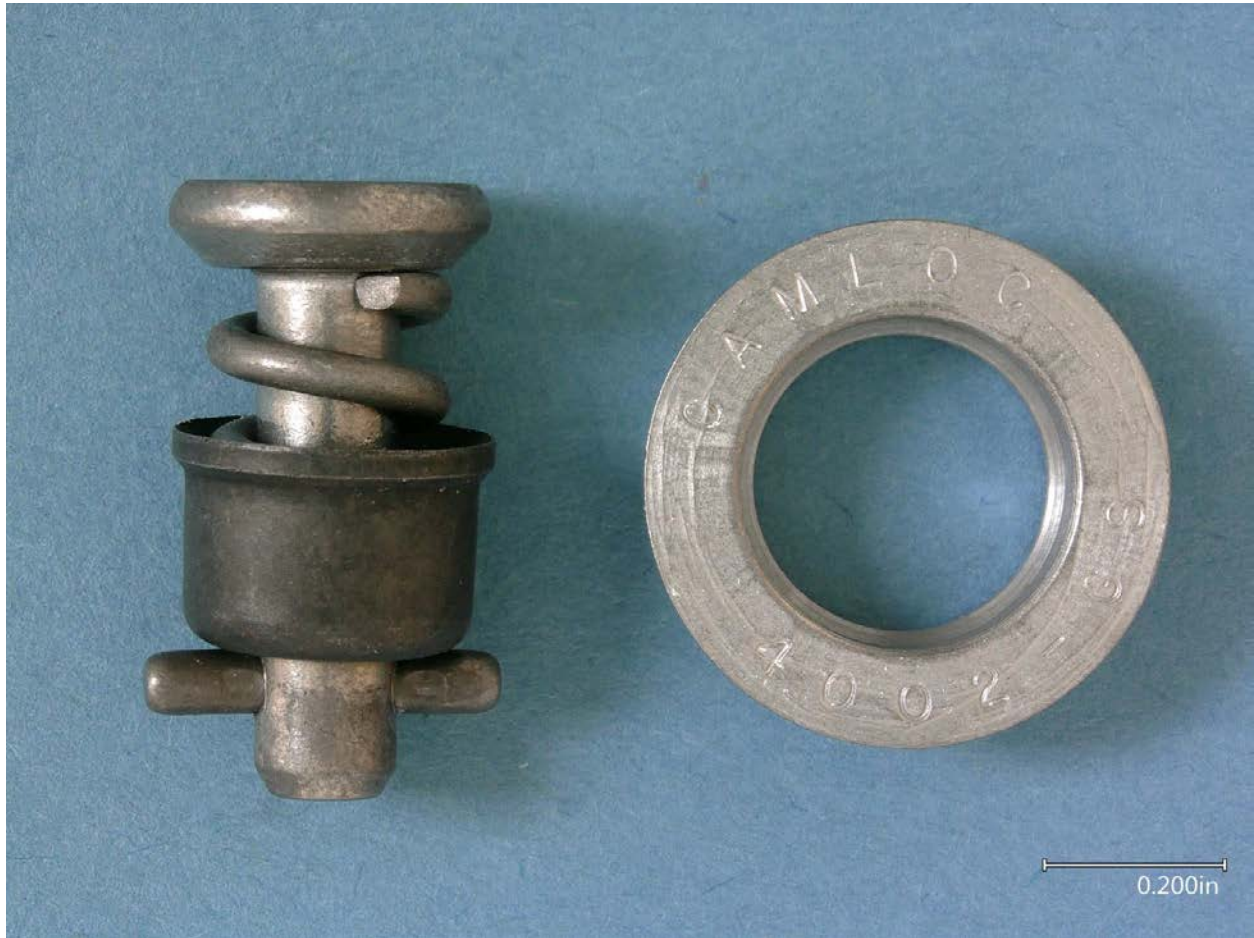
Figure 2: Image of an exemplar stud assembly and grommet.

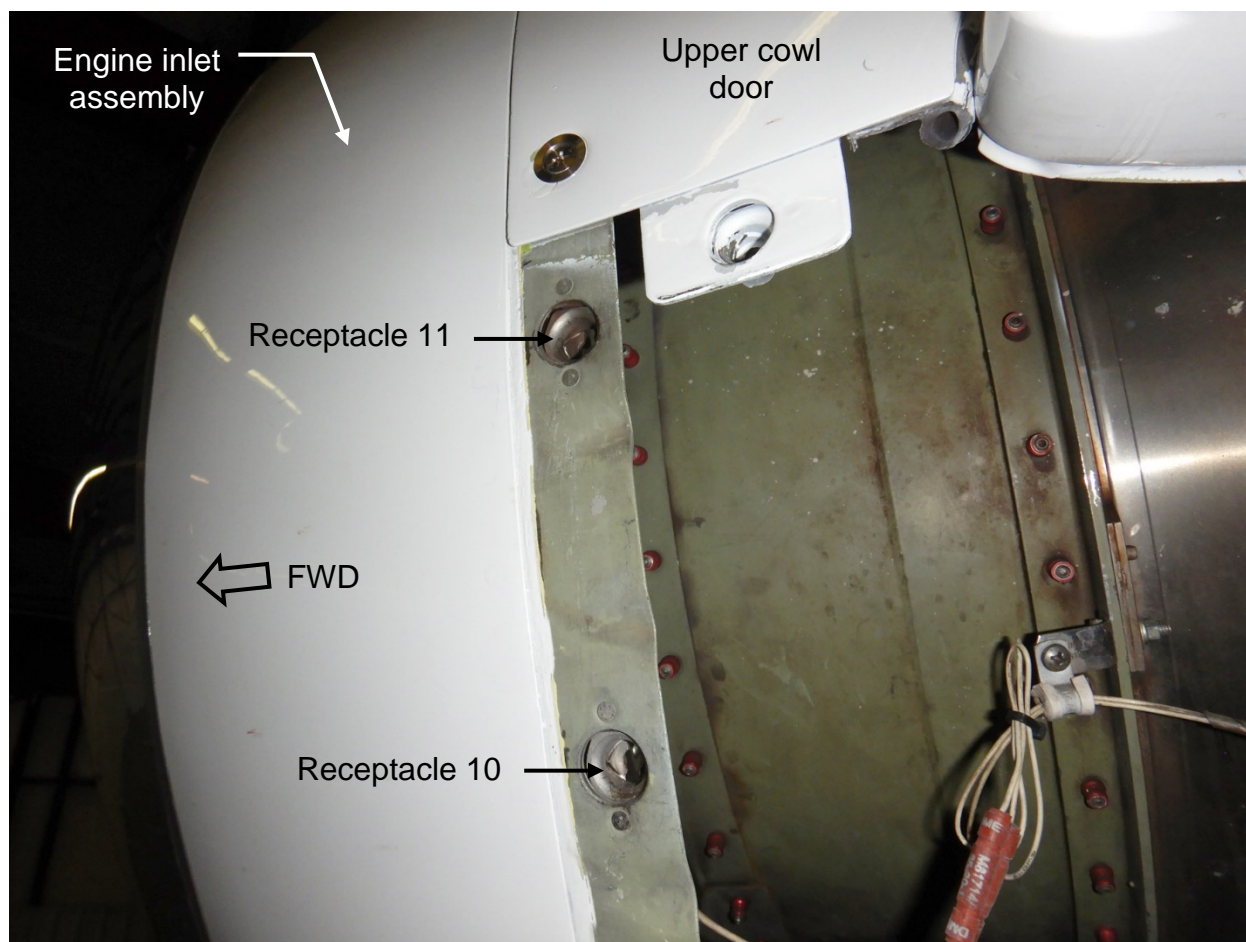
Figure 3: Image of the right engine inboard side showing the missing lower cowl door and the missing studs two of which were in the inlet flange and were numbered 10 and 11.

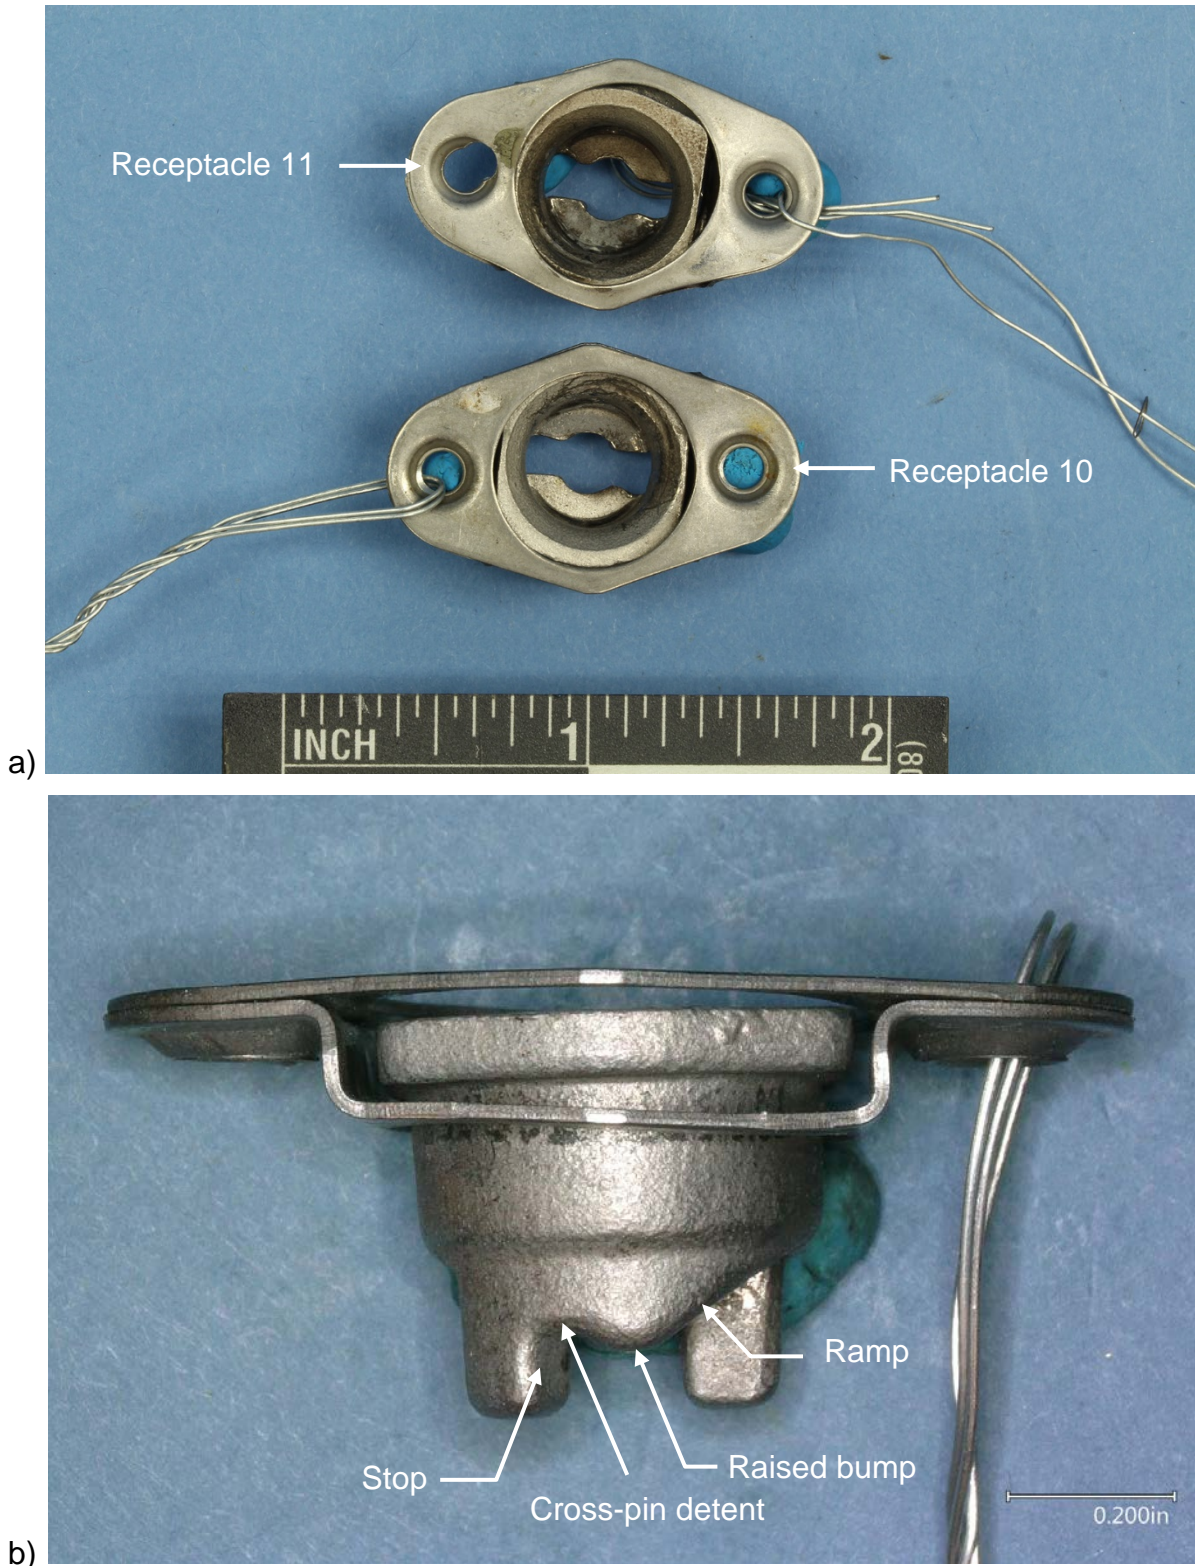
The numbers 10 and 11 receptacles were examined for any notable features, but none were found. An overview image of the two receptacles is shown in figure 4a and a side view of receptacle 10 is shown in figure 4b. The interior of the number 10 receptacle cup is shown in figure 6a and the backside of the cup is shown in figure 6b. Deformation and wear of material was observed at the edge of the slot where the cross-pin passed through the base of the cup and the ramps on the backside of the cup exhibited a rubbed appearance consistent with sliding contact. The detent regions exhibited regions with a rubbed appearance interspersed with the matte appearance of the as-manufactured cup. The vertical walls of the slotted hole adjacent to the detent were examined for any deformation or contact damage as shown in figures 7 and 8 for receptacles 10 and 11, respectively. The areas directly adjacent to the detent exhibited a matte appearance consistent with the surface finish of the as-manufactured cup. One area on each receptacle, adjacent to the cup interior, exhibited a rubbed appearance as indicated in figures 7b and 8a.

Figure 4: a) Image of receptacles 10 and 11, each showing the cup into which the stud and spring cup are inserted and b) side view image of receptacle 10 showing the raised bump, cross-pin detent, and stop.

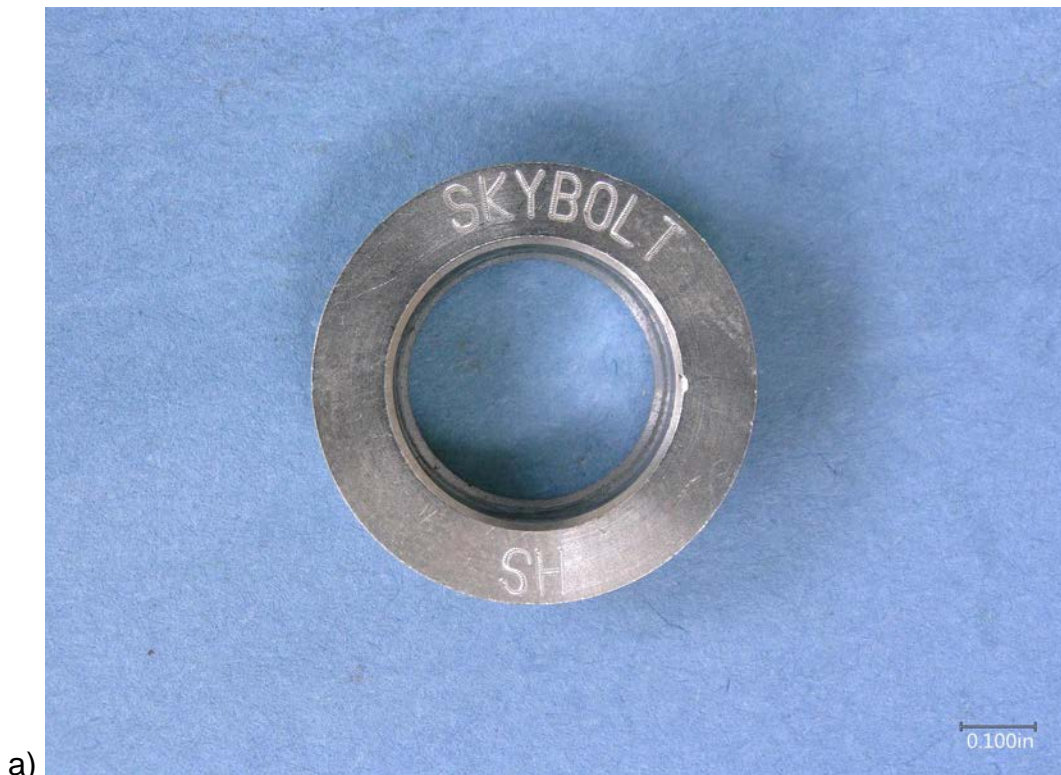
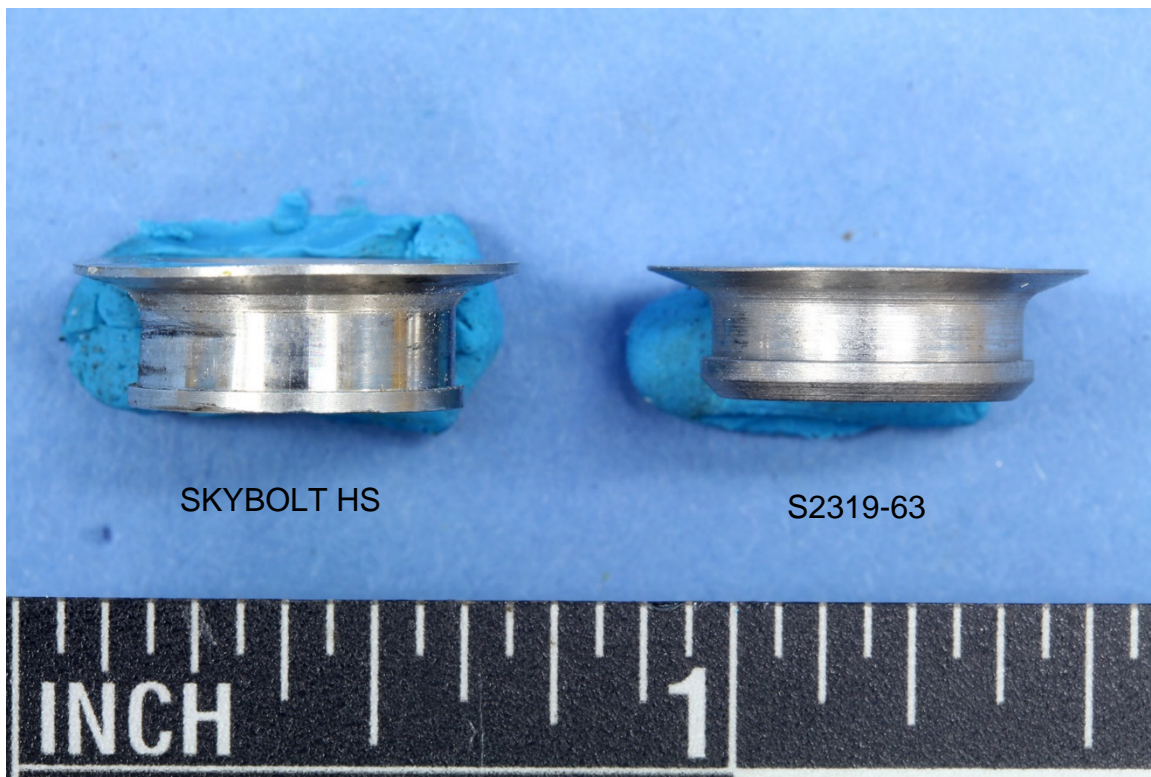
The hardware was examined for part numbers or other identifying marks. None were found on the receptacles. The stud heads were labelled with dash numbers and all studs were “-3” except for the studs at receptacle location 4 on both the forward and aft attachment flanges, which were “-4” studs. The length of a “-3” and “-4” stud was measured with a micrometer and each corresponded to the length given in table 1 above. According to a Textron Air Safety Investigator, the number 4 receptacles are located at a splice plate. The grommets were all labelled as “SKYBOLT HS”. According to Skybolt product information, HS-type grommets are nominally 0.197 inch in height. The height of one of the grommets was measured with a micrometer and measured 0.204 inch in height. A top-down view of a HS grommet from the accident aircraft is shown in figure 5a and a side view comparing the height with that of a S2319-63 (from the part catalog) is shown in figure 5b.

Figure 5: a) Top-down image of a SKYBOLT HS grommet from the accident aircraft and b) side view image of the HS grommet along with a S2319-63 grommet as called out by the parts catalog.

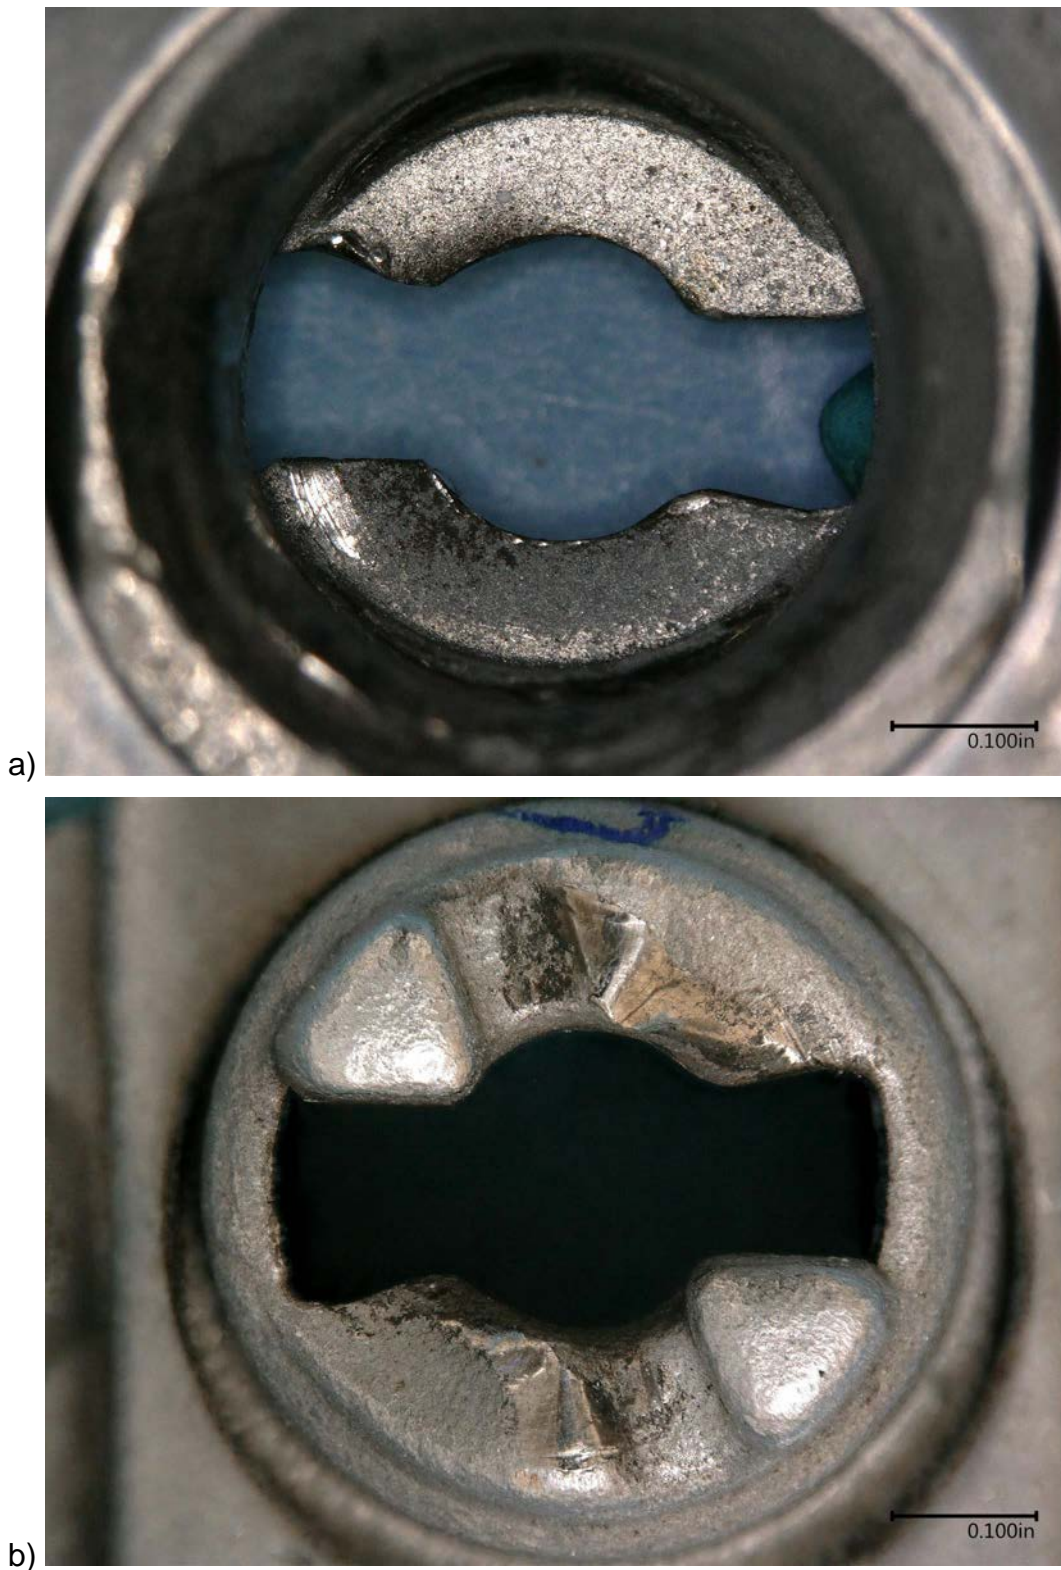
Figure 6: Higher magnification views of the receptacle cup for receptacle 10: a) cup side into which the stud and spring cup are inserted and b) backside with the ramp, raised bump, and detent that engage the cross-pin on the stud.

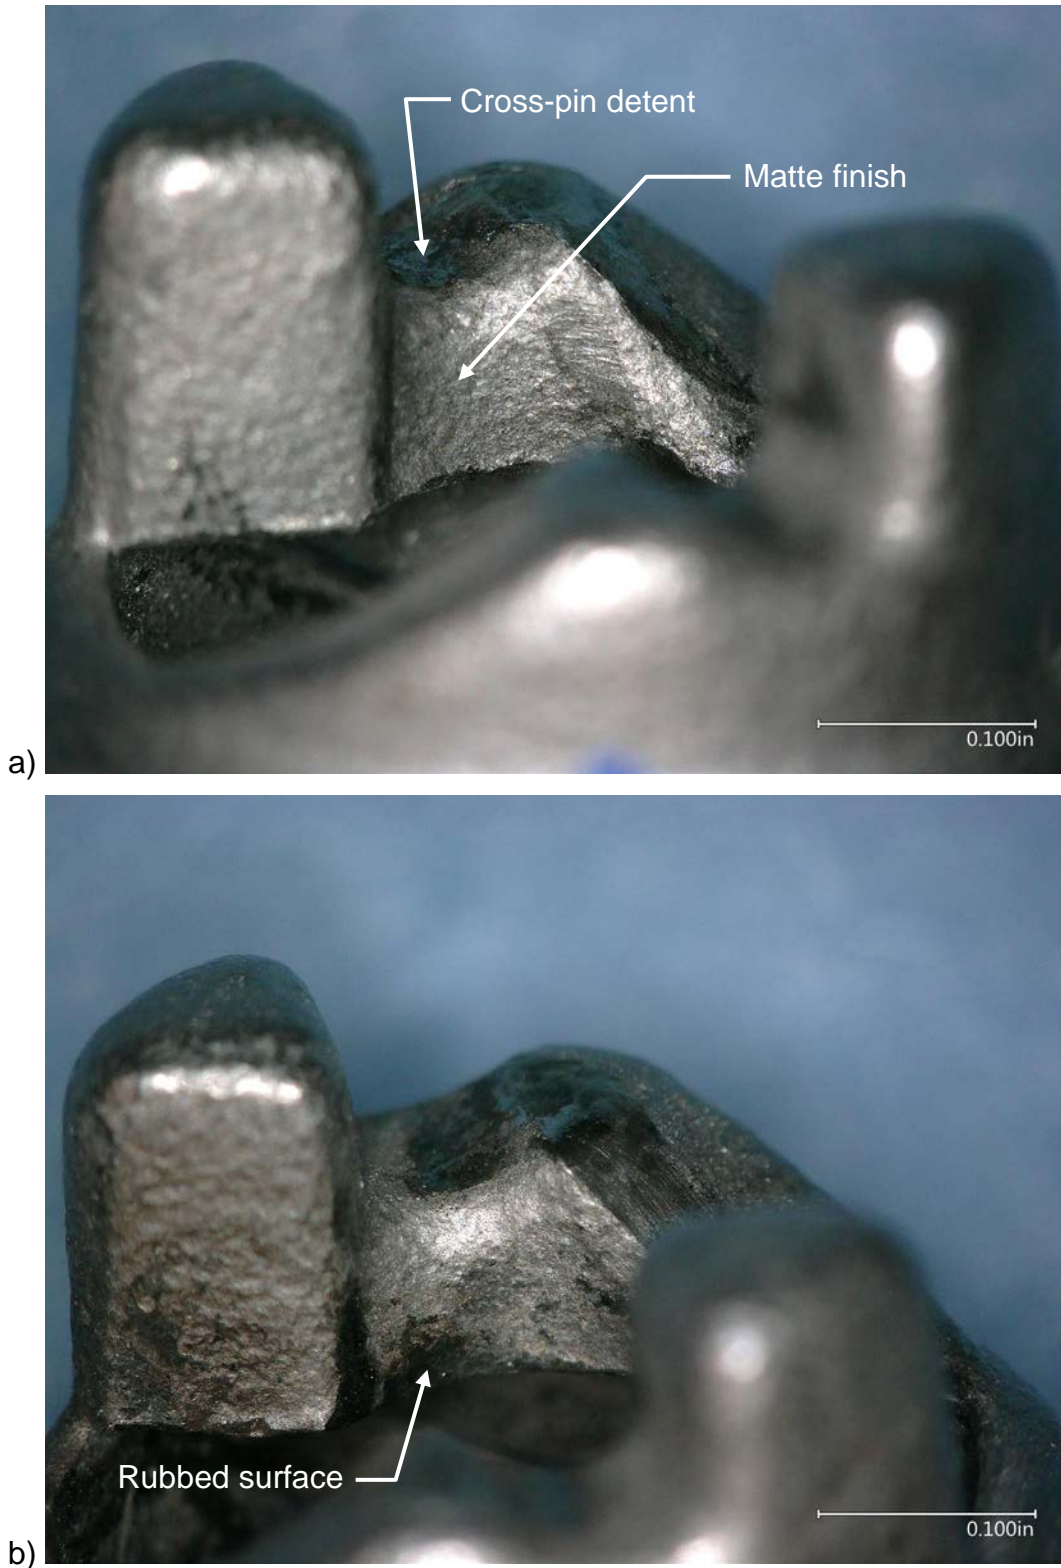
Figure 7: Images of the slotted hole on receptacle: a) one detent region and b) the second detent region.

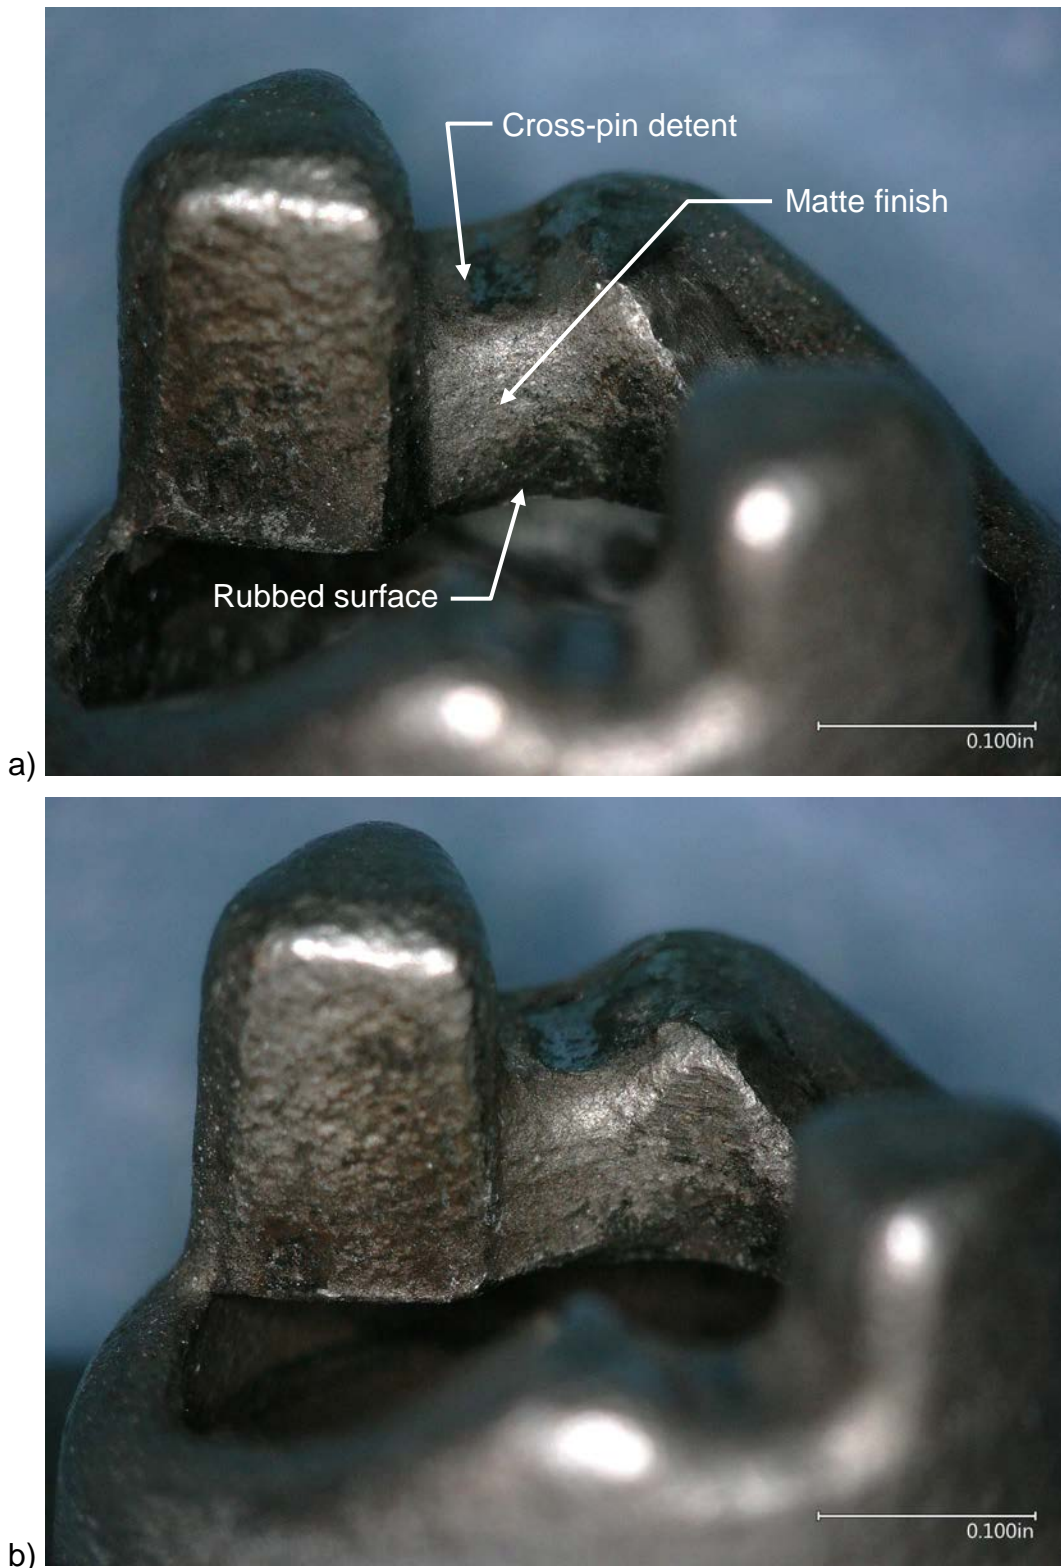
Figure 8: Images of the slotted hole on receptacle 11: a) one detent region and b) the second detent region.

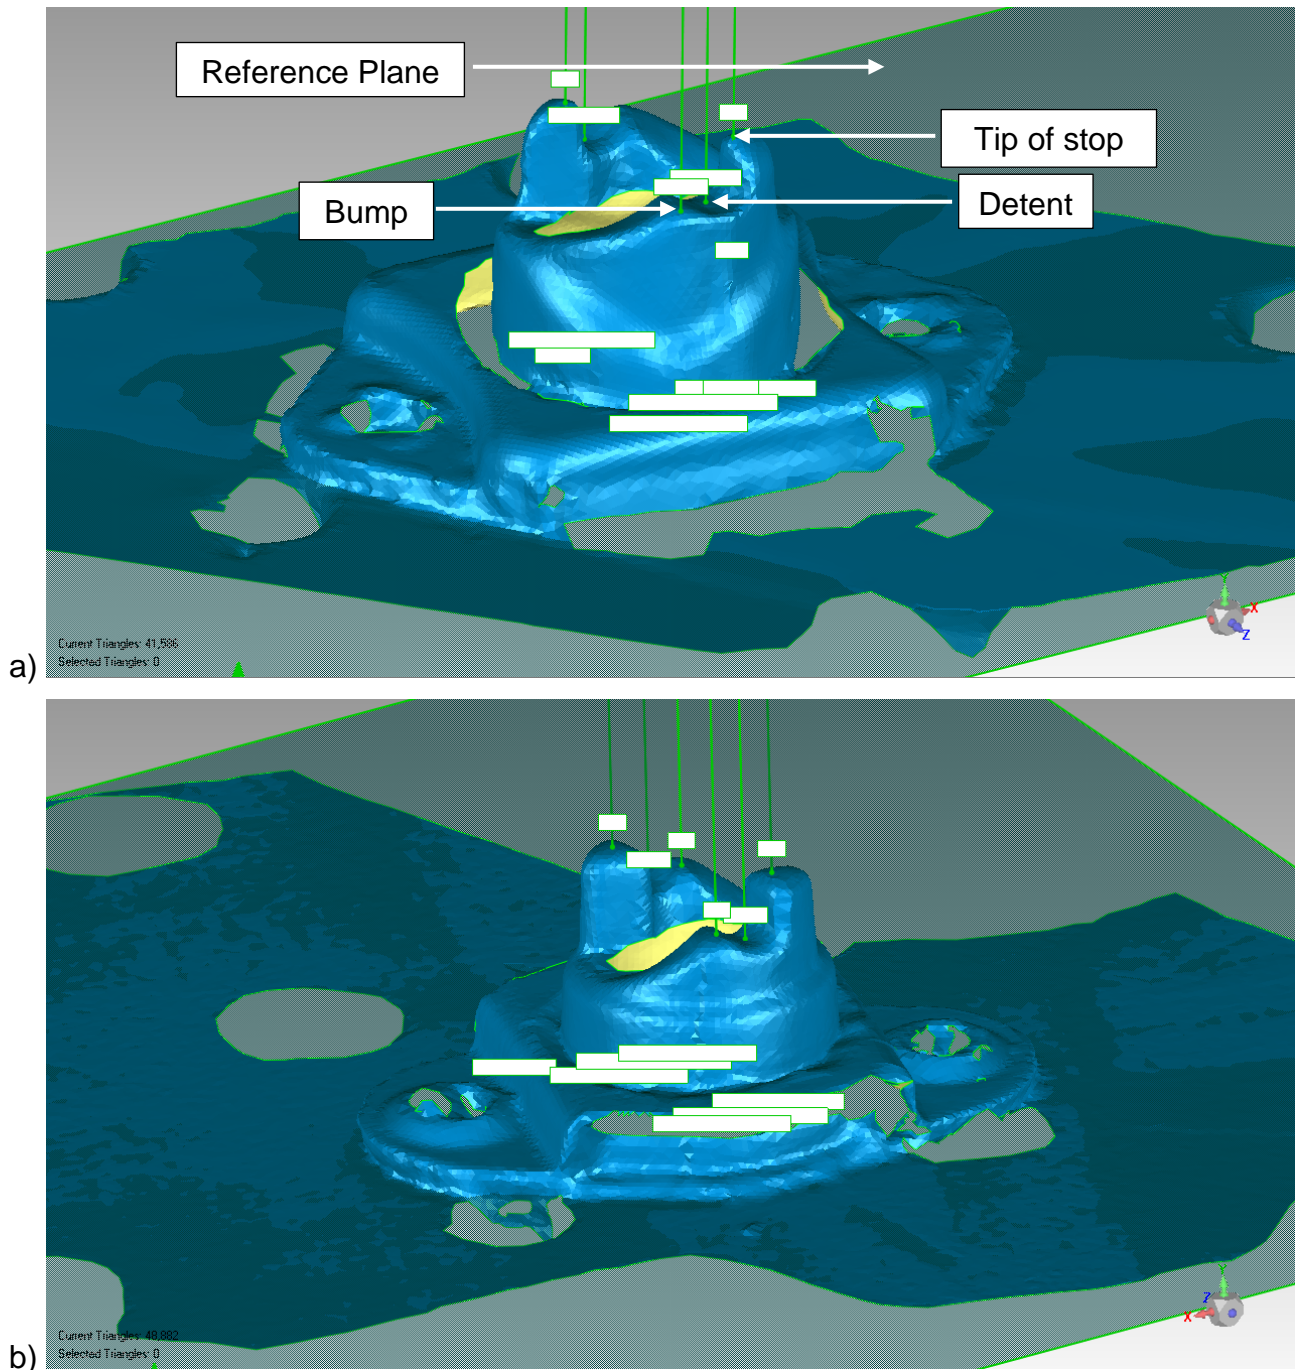
the vertical distance from the reference plane to the tip of each stop, detent, and raised bump, as indicated in figure 9a. The tip/detent and bump/detent vertical distances were then calculated. The results are shown in table 2 below and are for information purposes only. The two sides of each receptacle were arbitrarily labelled 1 and 2.

The maximum and minimum distances from the tip of the stop to base of the detent were 0.112 inch and 0.104 inch, respectively; a difference of 0.008 inch. The vertical distance from the tip of the raised bump to the base of the detent measured 0.025 inch for four of the six measurements, while one side on the exemplar measured 0.027 inch and one side on receptacle 10 measured 0.022 inch.

Figure 9: 3D laser scan surface meshes used to measure the vertical distance from the flat face of the receptacle (coincident with the reference plane) to the tip end of the stop, the detent, and the tip of the raised bump: a) scan of an exemplar receptacle and b) scan of receptacle 10.

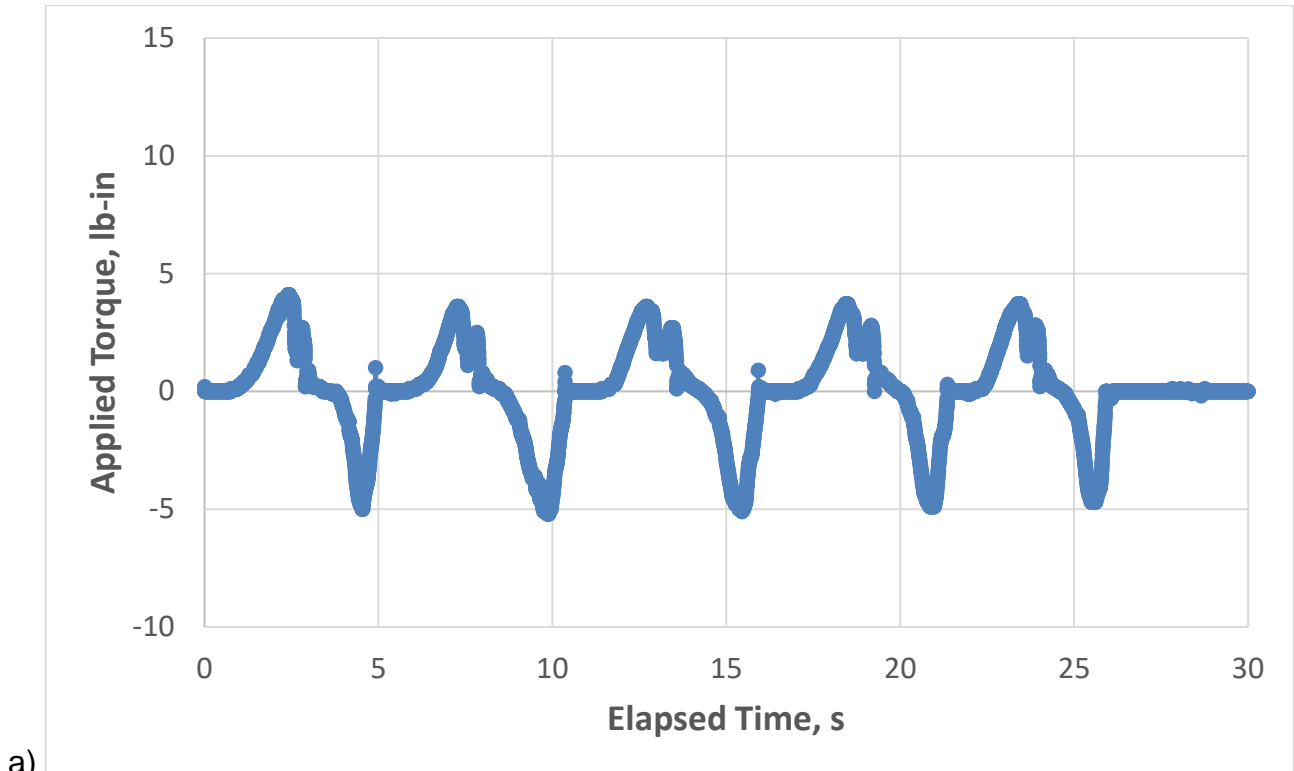
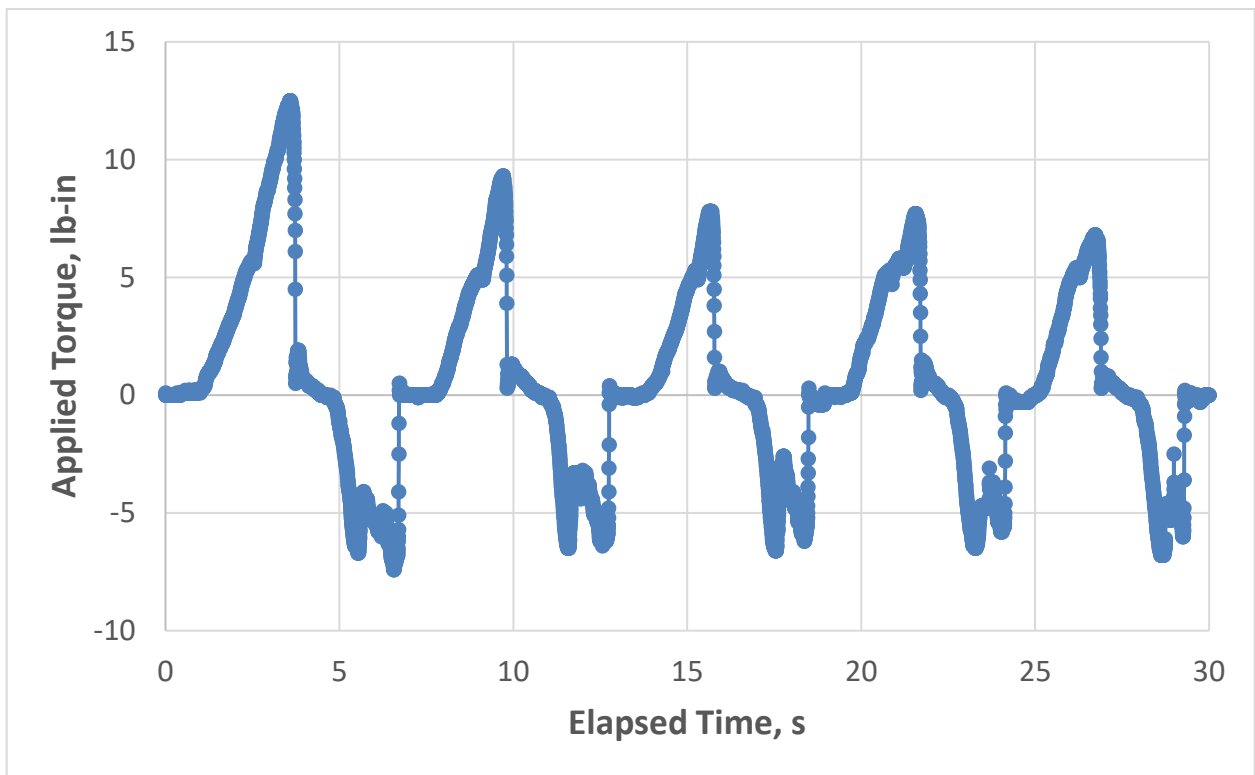
Figure 10a shows the locking and unlocking torque data for an exemplar S3412-103 stud and exemplar S2319-63 grommet. Over five cycles, the applied torque increased from 0 lb-in to a peak between 3.5 lb-in – 4.1 lb-in at which point the cross-pin crossed over the bumps into the detents and the applied torque was removed. During the unlocking phase, counterclockwise torque was applied and the torque decreased to a minimum that ranged between -4.7 lb-in to -5.2 lb-in, at which point the cross-pins popped out of the detents and the applied torque was removed. The height of the exemplar grommet was 0.186 inch, as measured with a micrometer. Figure 10b shows data from a similar test but with a 0.204-inch height “HS” grommet taken from the accident aircraft. In contrast to the GS grommet, the peak locking torques for the HS grommet were higher, starting at 12.5 lb-in and decreasing with subsequent cycles to 6.7 lb-in. The peak unlocking torques were comparatively constant after the first cycle, ranging from -6.5 lb-in to -6.8 lb-in.

Figure 10: Locking and unlocking torque curves for an exemplar "-3" stud (0.72 inch in length) and exemplar receptacle mounted to a plate with an effective thickness of 0.085 inch: a) locking and unlocking torque with a "GS"-type grommet and b) locking and unlocking with a "HS"-type grommet.

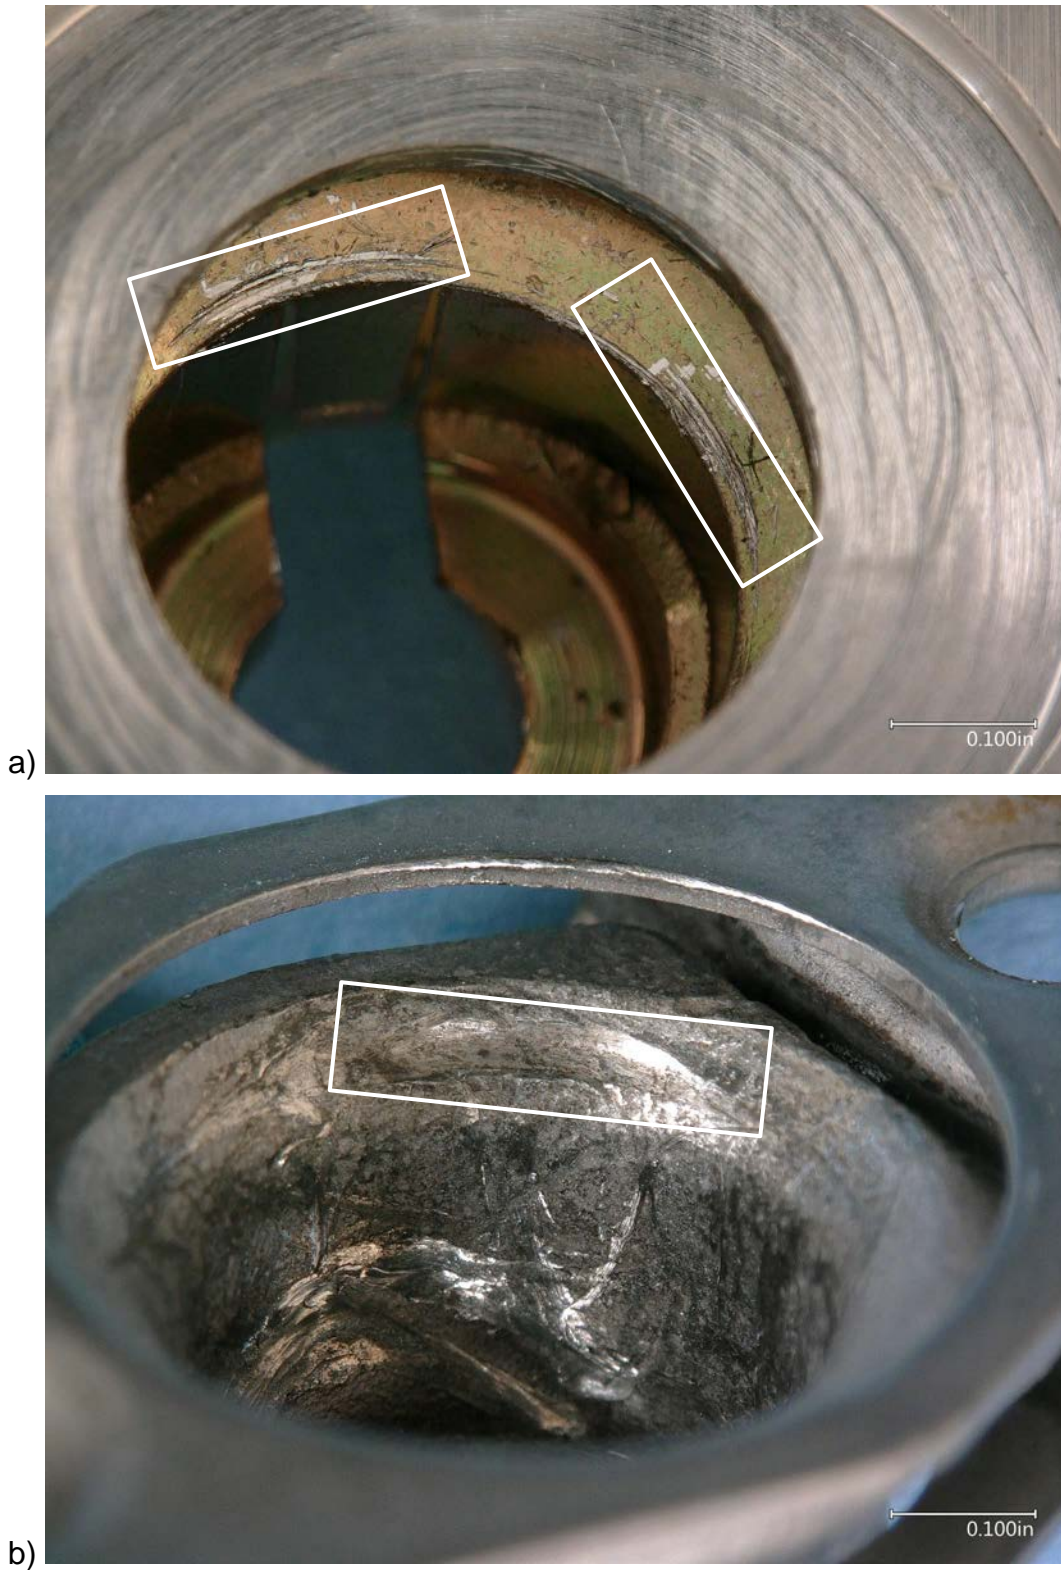
Visual examination of the exemplar receptacle revealed that the HS grommet had impinged on the rim of the receptacle cup causing plastic deformation as indicated in figure 11a. Similar features were observed on the rim of receptacles 10 and 11, as shown for receptacle 10 in figure 11b.

Figure 11: Images of receptacle cups showing contact damage on the cup: a) exemplar receptacle after locking and unlocking with an “HS”-type grommet and b) receptacle 10 as received.

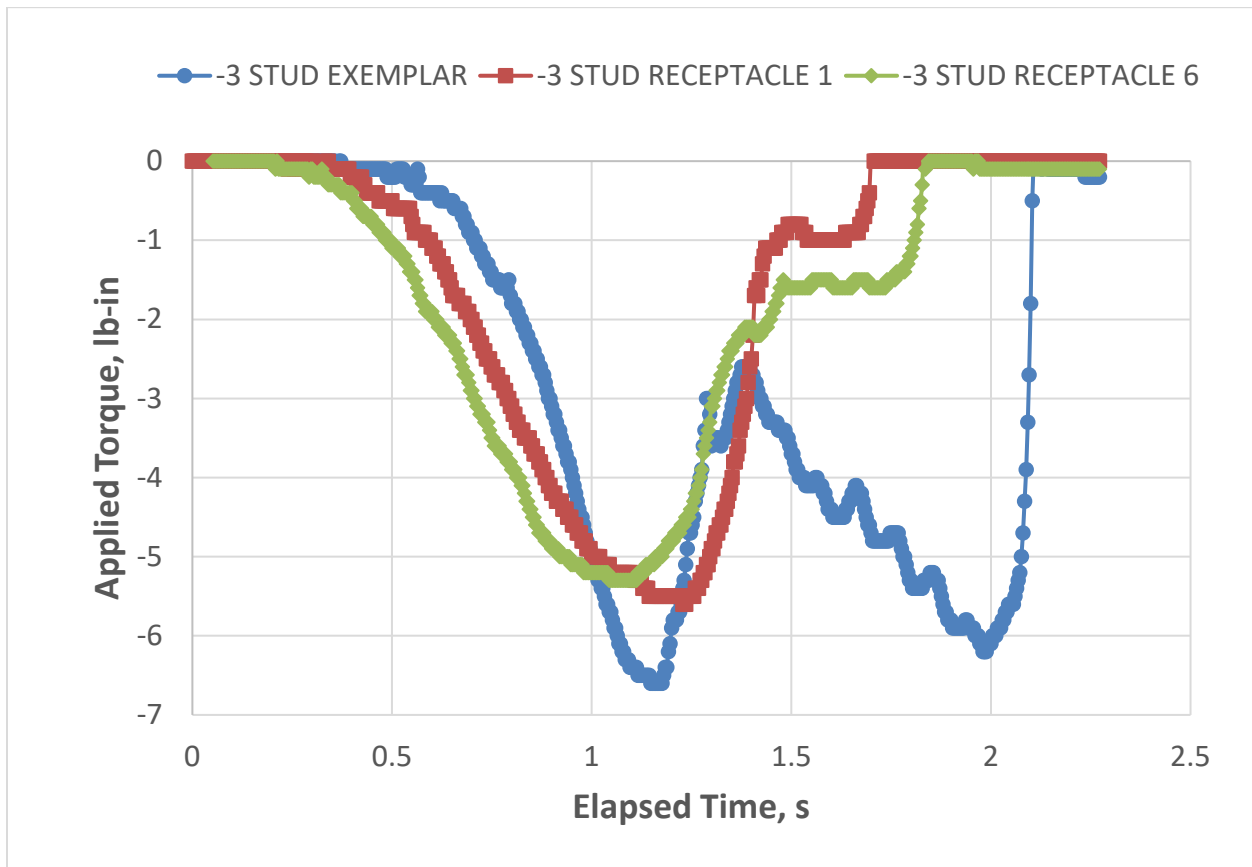
Two “-3” studs from the accident aircraft, taken from receptacles 1 and 6 were inserted through an HS grommet and similar locking and unlocking torque measurements were taken.¹ For comparison, the data from one unlocking sequence for receptacles 1 and 6 have been extracted and time-aligned with one unlocking sequence for the exemplar stud, as shown in figure 12. Over five cycles, the peak unlocking torques for the stud from receptacle 1 ranged from -5.7 lb-in to -5.2 lb-in. Similarly, the peak unlocking torques for the stud from receptacle 6 ranged from -5.5 lb-in -5.0 lb-in. As stated above, peak unlocking torque for the exemplar stud after the first cycle ranged from -6.5 lb-in to -6.8 lb-in.

Figure 12: Single unlocking curves extracted from the locking/unlocking data and time aligned for the exemplar stud and studs from forward attachment flange receptacles 1 and 6.
