NATIONAL TRANSPORTATION SAFETY BOARD

MATERIALS LABORATORY FACTUAL REPORT

Report No. 22-007

Place : Lewiston, Idaho
Date : July 24, 2021
Vehicle : SIAI-Marchetti SM-1019B, N28U
NTSB No. : WPR21FA283
Investigator : Andrew Swick, ASI-WPR

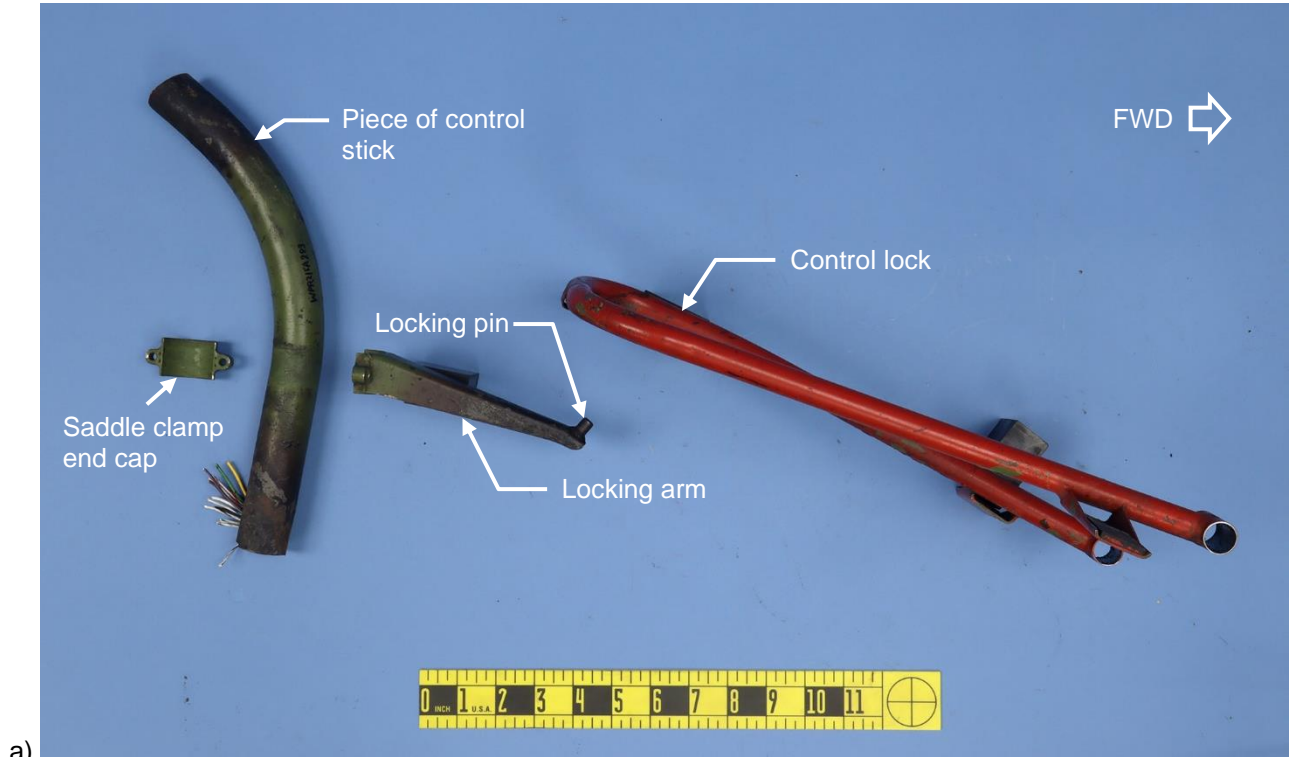
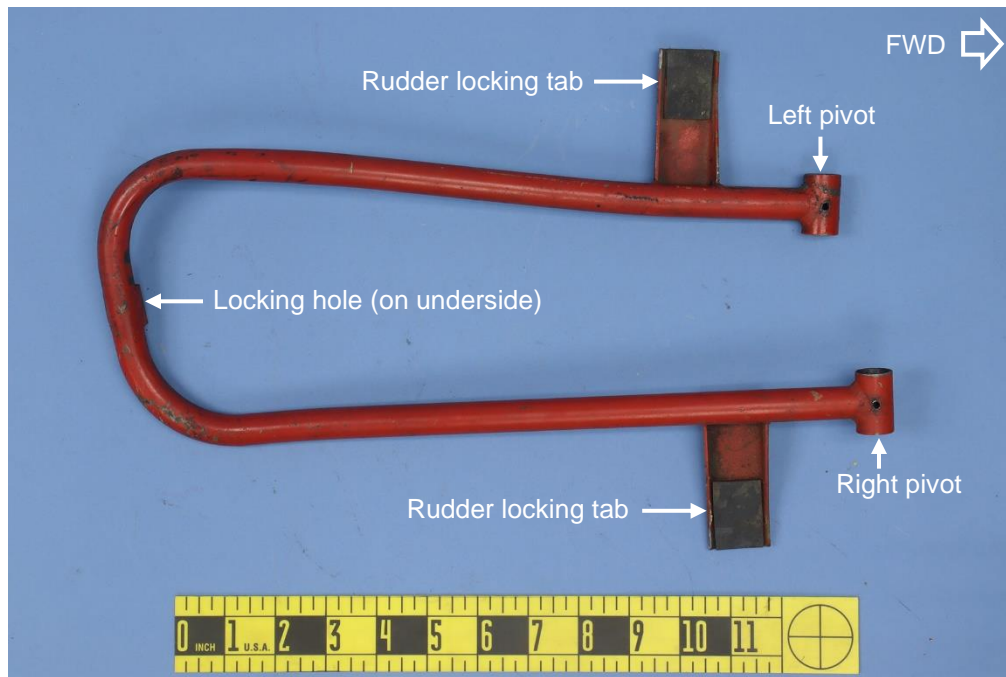
The control lock was deformed but there was no apparent deformation to the locking arm or the piece of control stick. The deformation had displaced the left pivot aft, inward, and downward relative to the right pivot, as seen in figures 1a and 1b. The paint on transverse arm of the lock exhibited wear at the spot that engaged with the retention clip as well as other sporadic chips and scratches, as shown in figures 2a – d. The locking arm, shown in figures 3a and 3b, was examined for any bending or buckling features, but none were observed. Similarly, there was no apparent deformation to the piece of the control stick. A stripe of red paint was observed along the edge where top and left sides of the locking arm met, as indicated in figure 3a and shown at higher magnification in figure 3c. Visual examination indicated that the red paint was conformal to the underlying surface, did not appear to have disturbed the underlying paint, exhibited a slightly raised lower stripe edge, and exhibited transverse scratch features that had removed the red paint in select areas. The features were consistent with wet application of the paint.

Figure 1: a) Image of the flight control locking components, as received; b) top down view of the the control lock; and

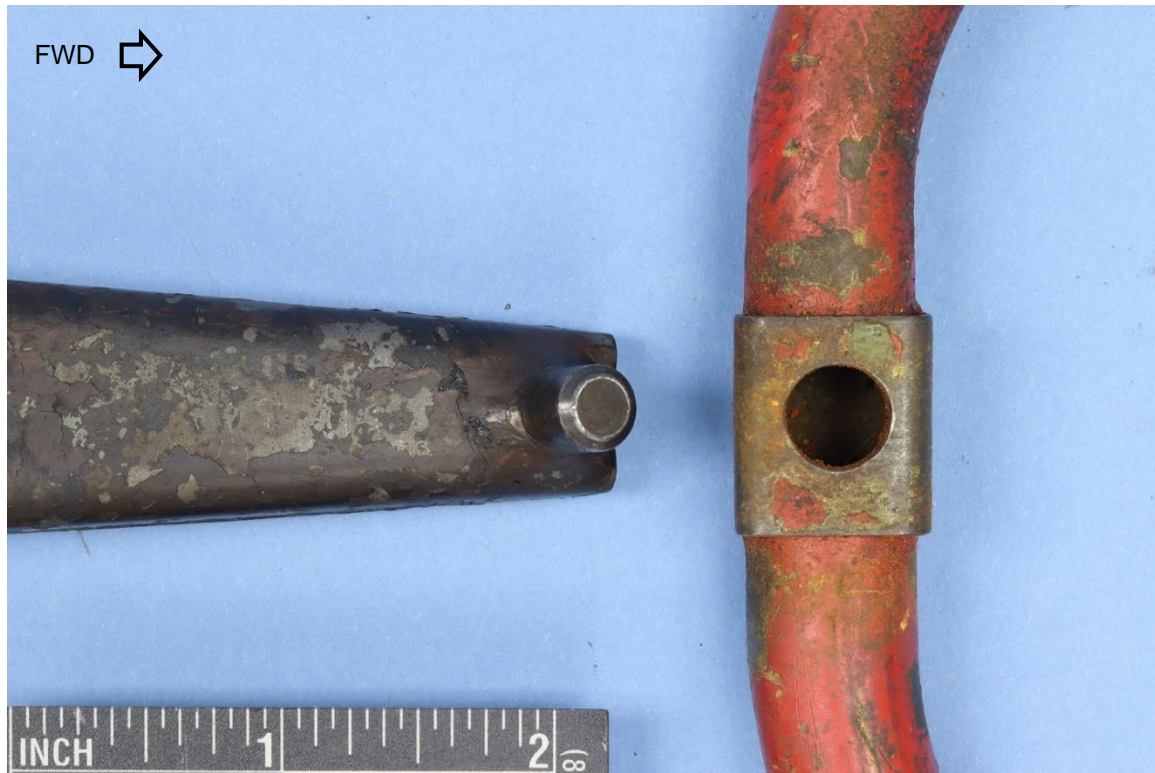
Figure 1 (cont.): c) Image showing the pin on the top side of the locking arm and the hole that receives the pin, located on the underside of the control lock.

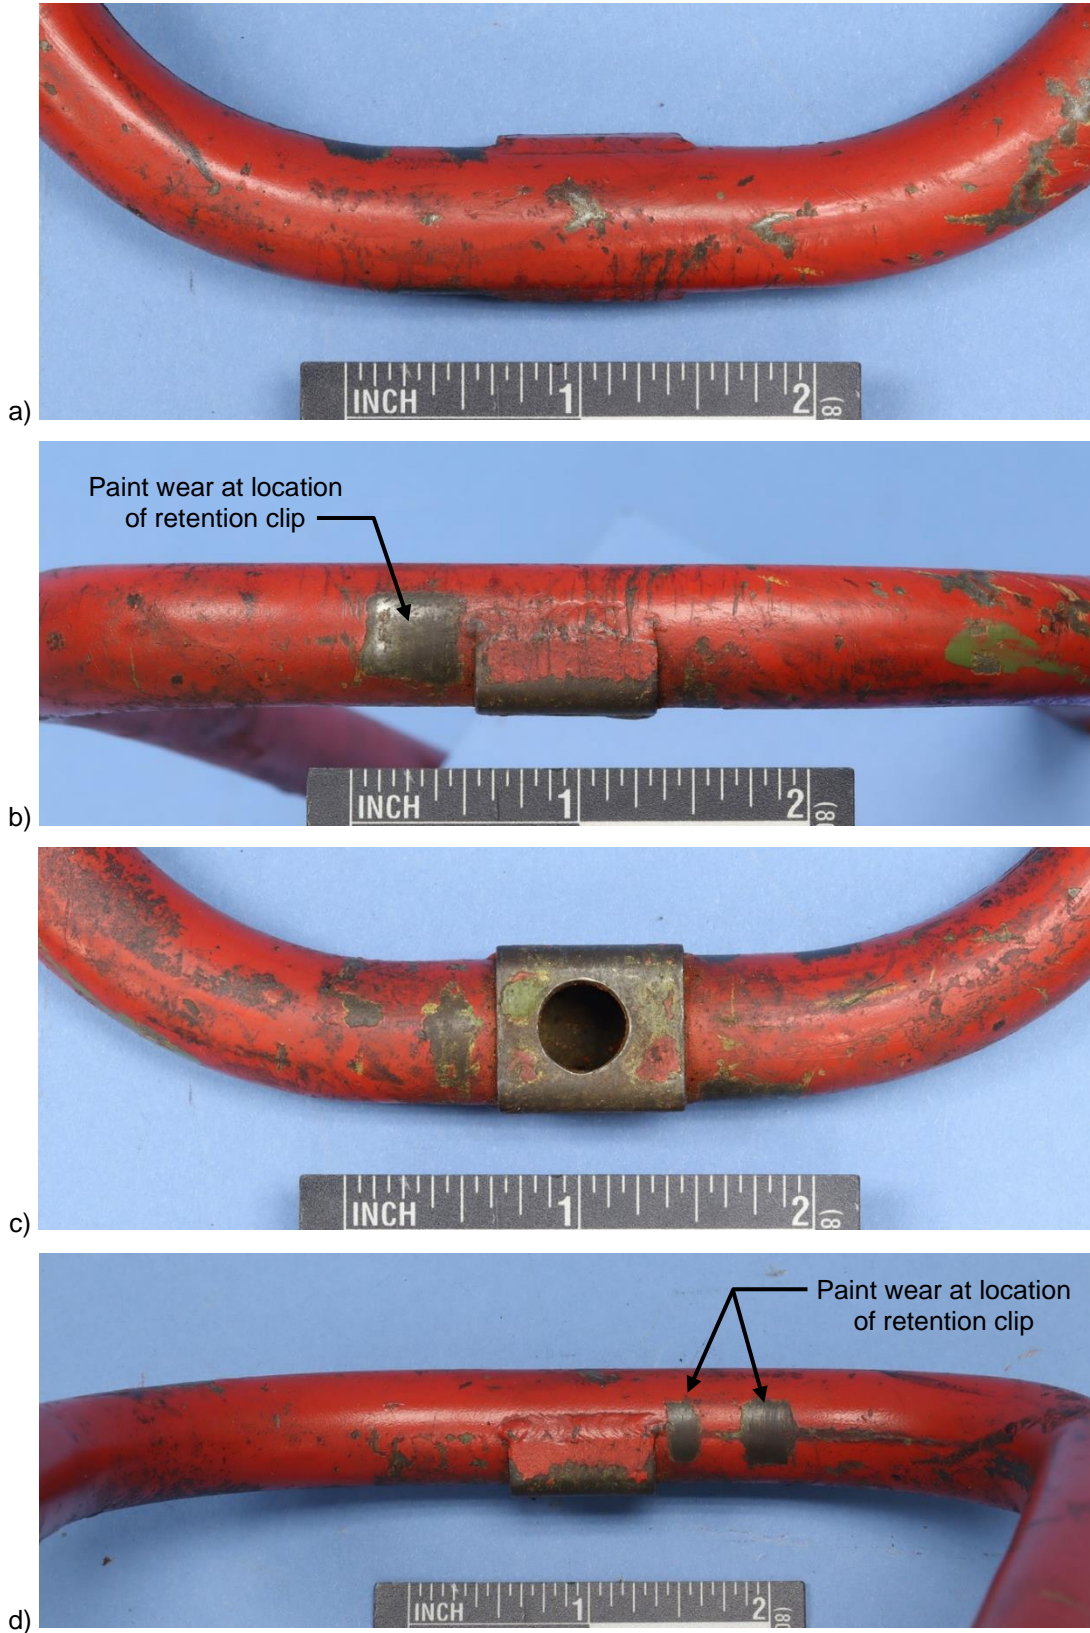
Figure 2: Images of the control lock's transverse arm; a) top side viewed top down; b) aft side viewed looking forward; c) bottom side viewed looking up; and d) forward side viewed aft.

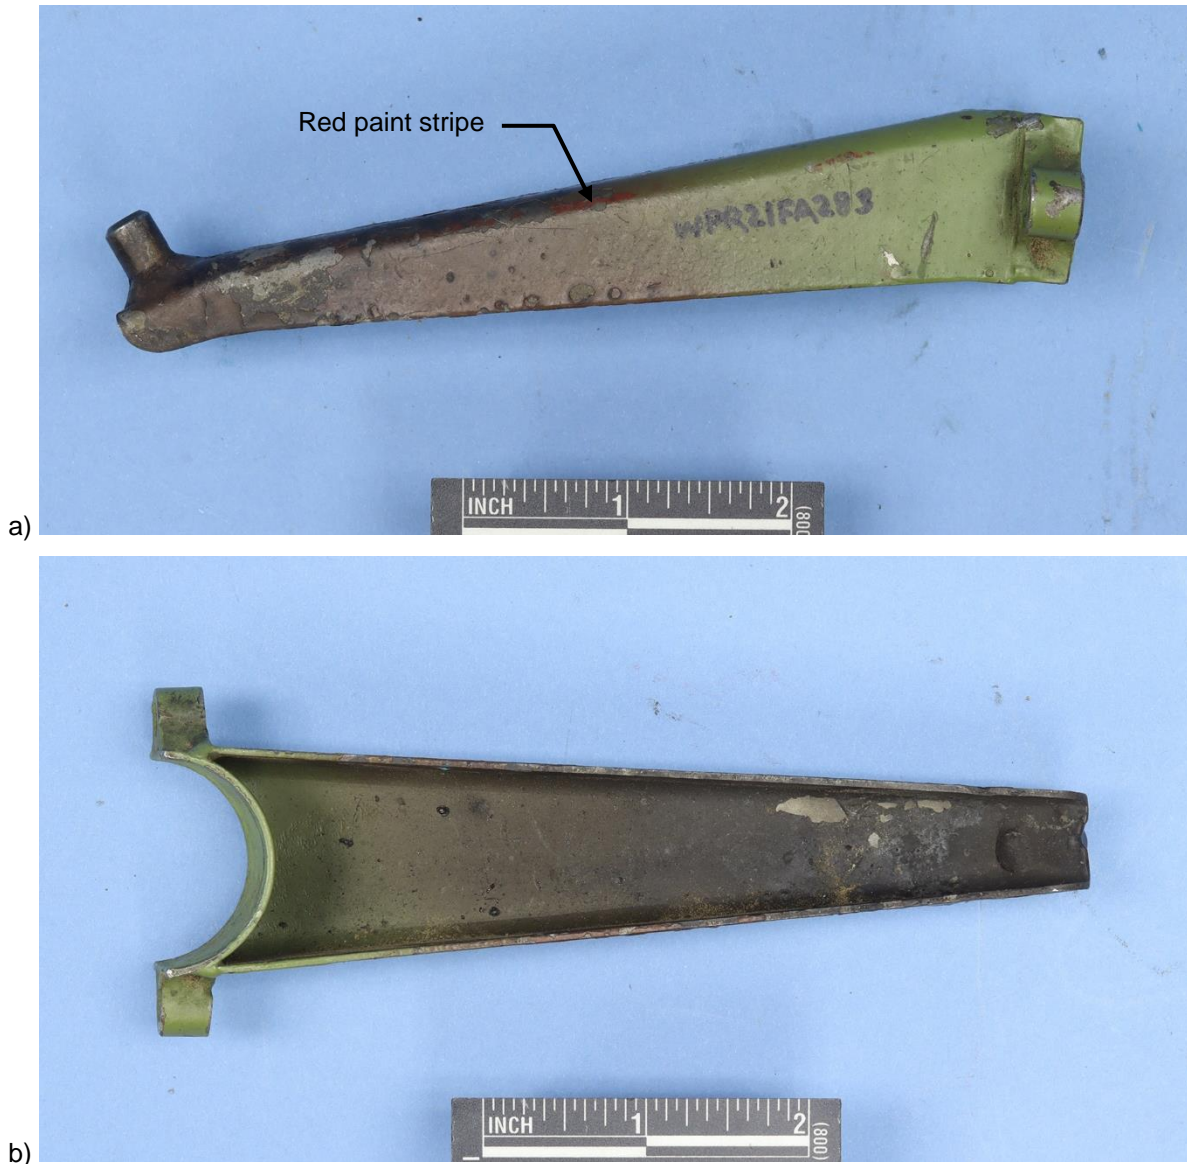
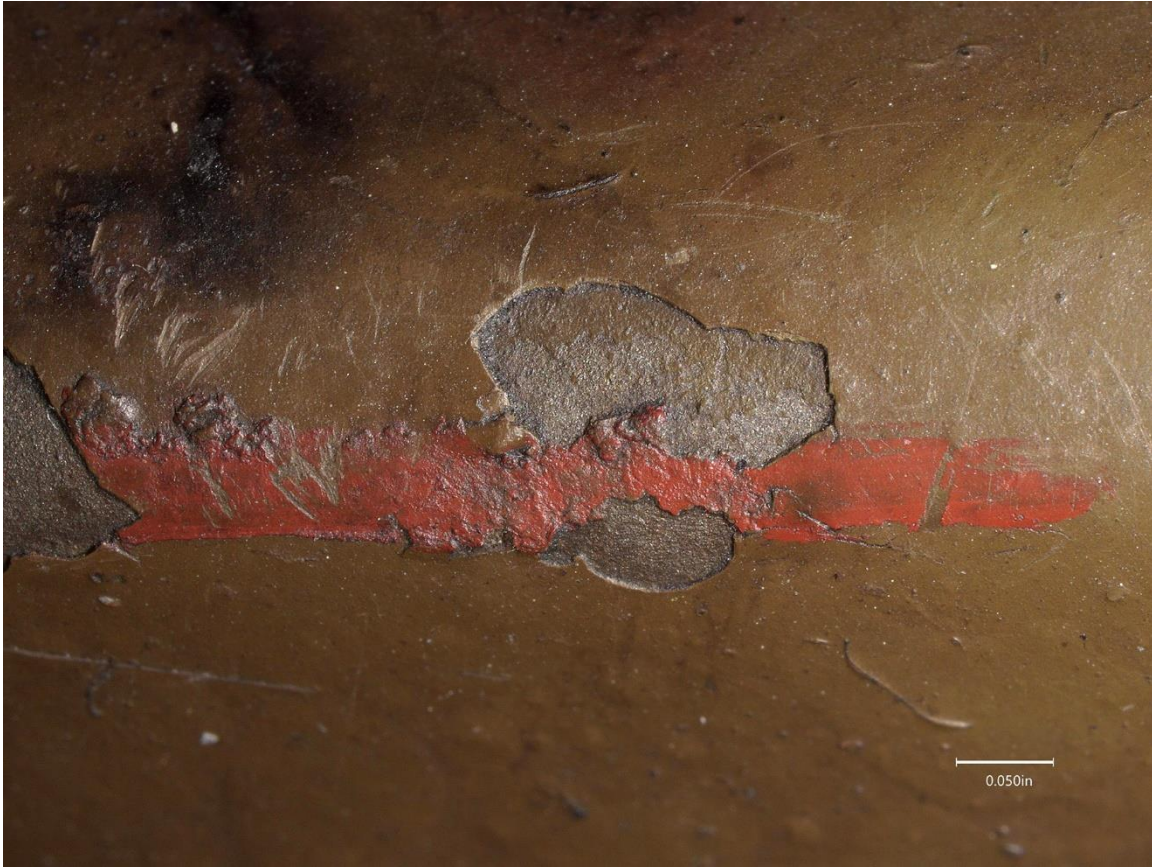
Figure 3: Images of the locking arm; a) view of the left side; b) view from underneath looking up; and

Figure 3 (cont.): c) image of a paint stripe located along the top left edge.

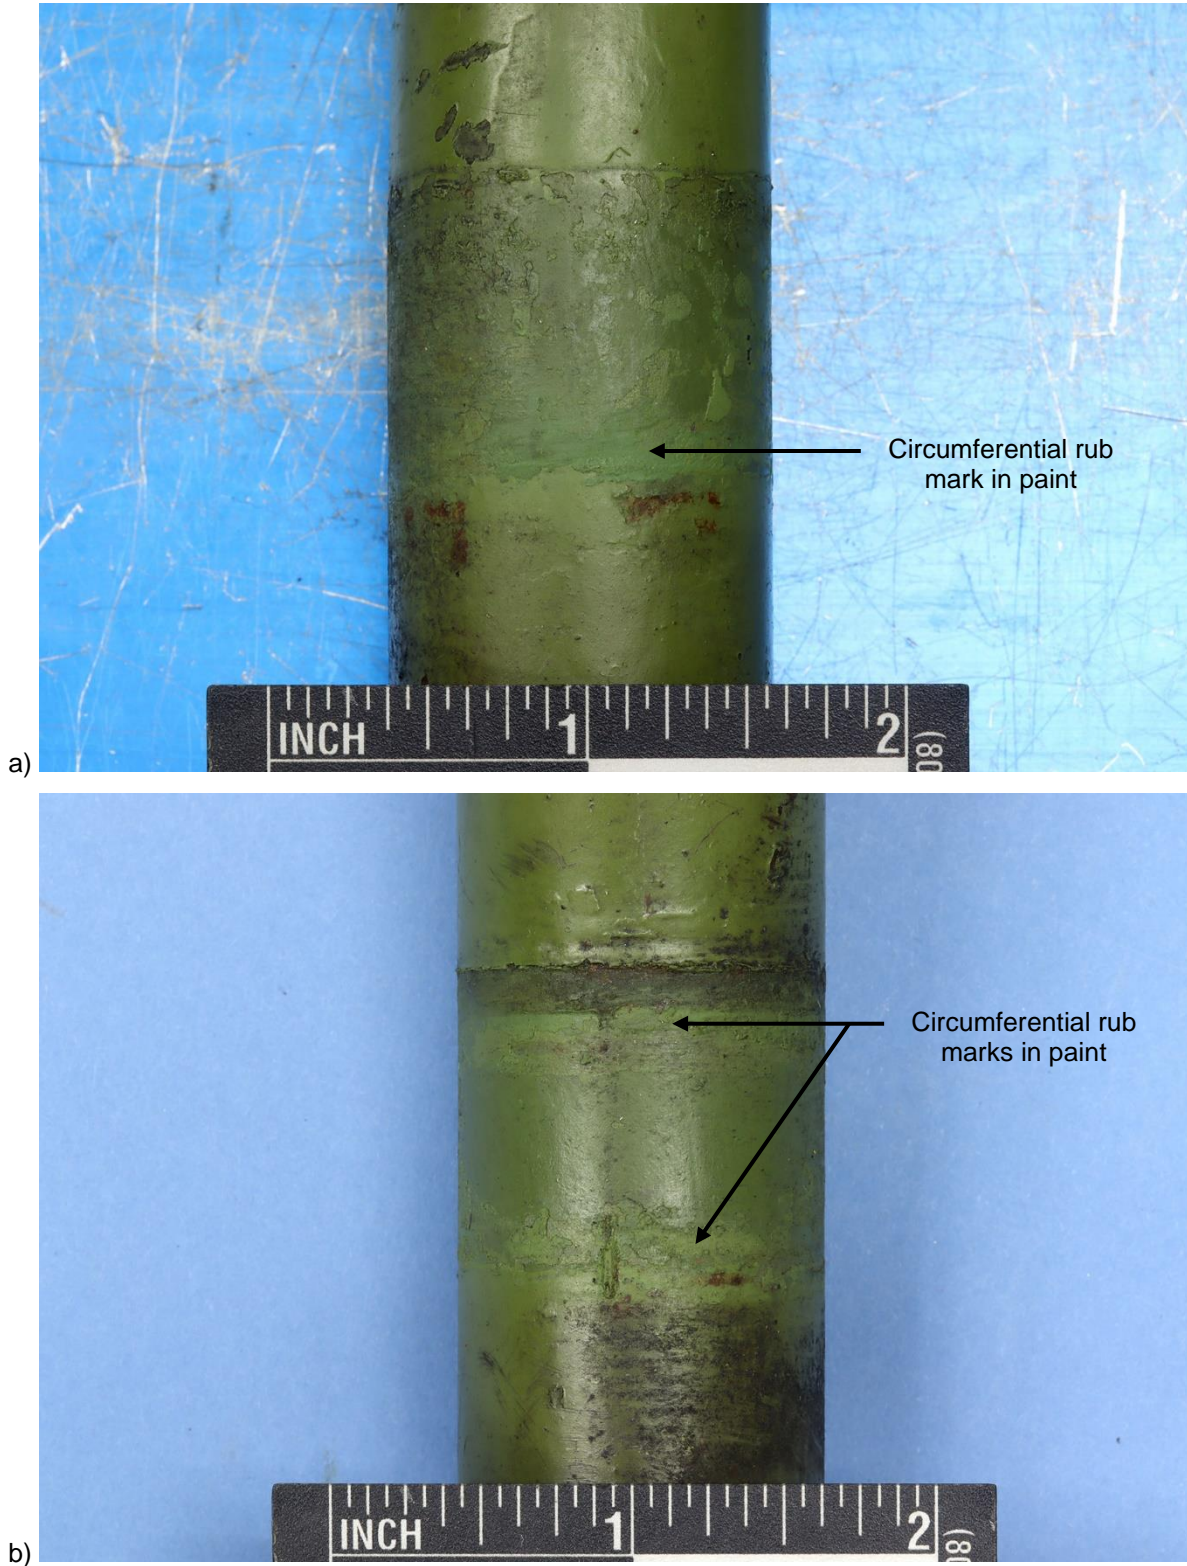
There were circumferential rub marks in the paint at the point where the locking arm was clamped to the control stick. Images of the control stick's forward-facing and aft-facing sides are shown in figures 4a and 4b, respectively, and images of the locking arm's saddle clamp are shown in figures 5a and 5b. Most of the paint on these two components exhibited a heat-damage, debris-covered, and/or glossy appearance, but on the control stick, at the locking arm's clamping point, there were circumferentially aligned bands of

paint, free of dirt, that exhibited a matte appearance as indicated in the images. The control stick's saddle clamp exhibited a combination of banding and discreet patches where paint exhibited a rubbed appearance.

Figure 4: Images of the control stick at the spot where the locking arm was clamped to the stick. Circumferential rub marks were observed in the paint; a) forward side of the stick and b) aft side of the stick.

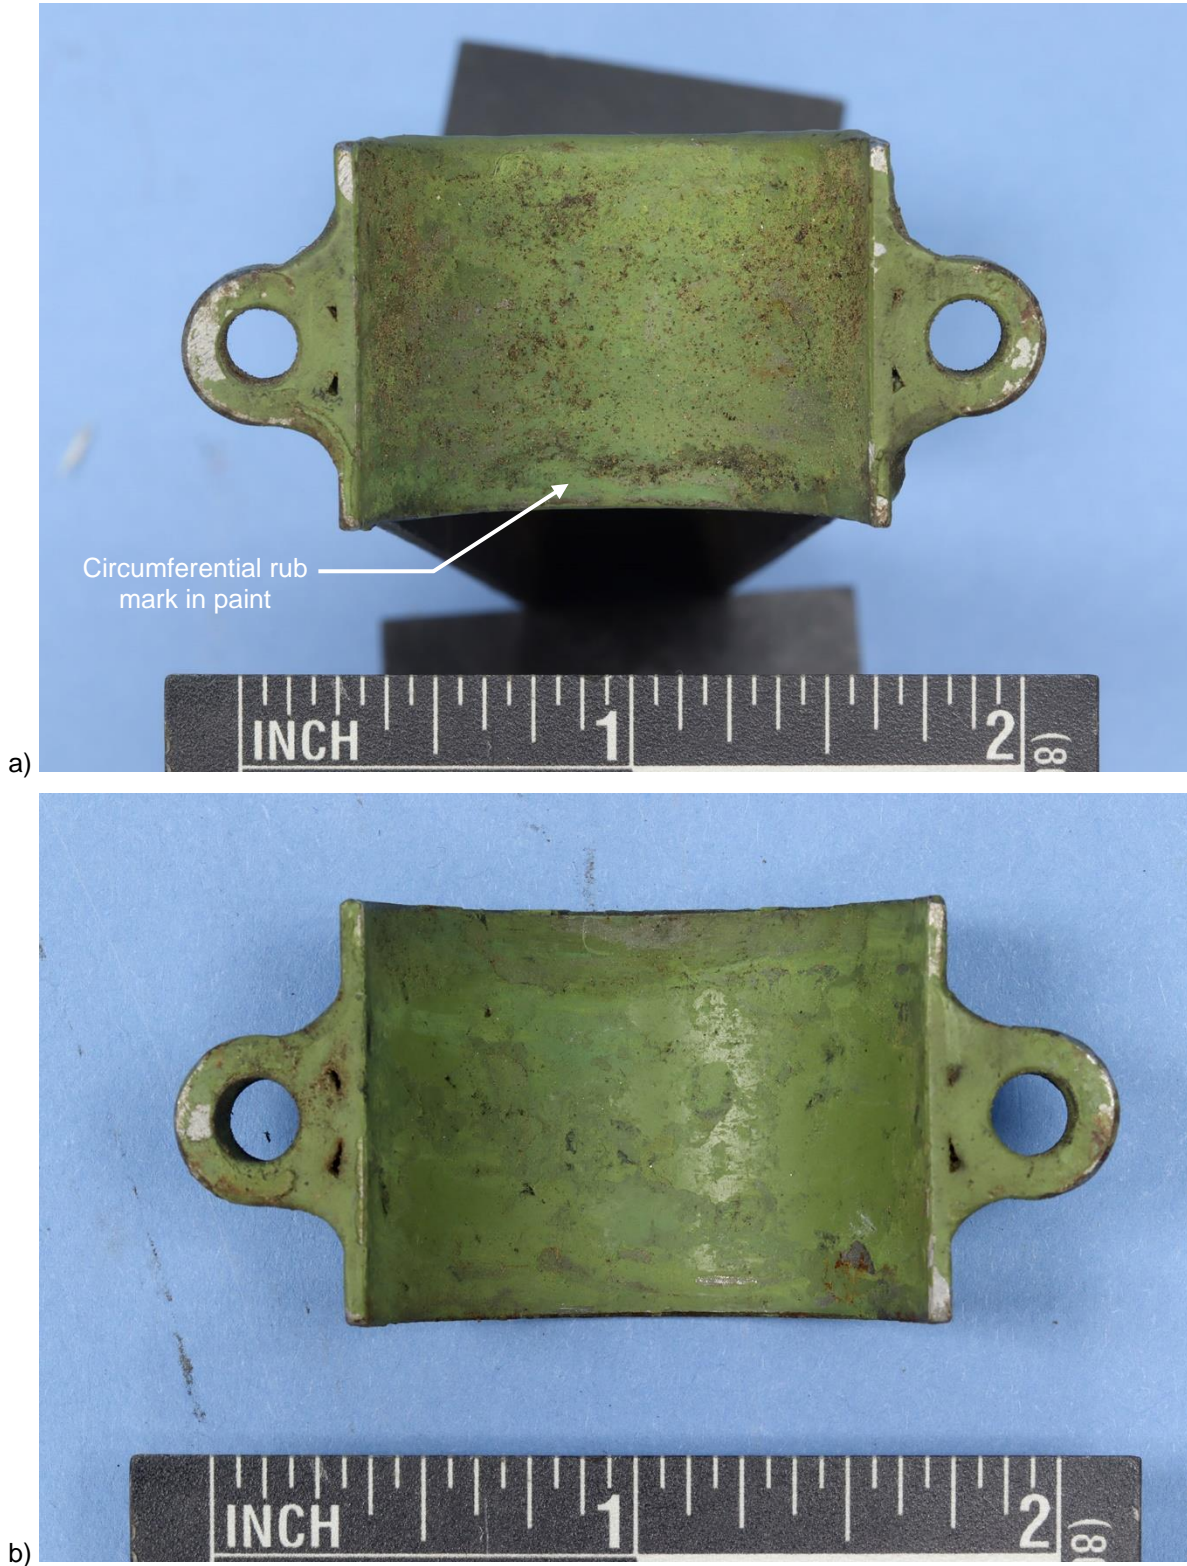
Figure 5: Images of the locking arm's control stick clamping surfaces; a) clamping surface on the aft end of the locking arm and b) the locking arm's saddle clamp end cap.

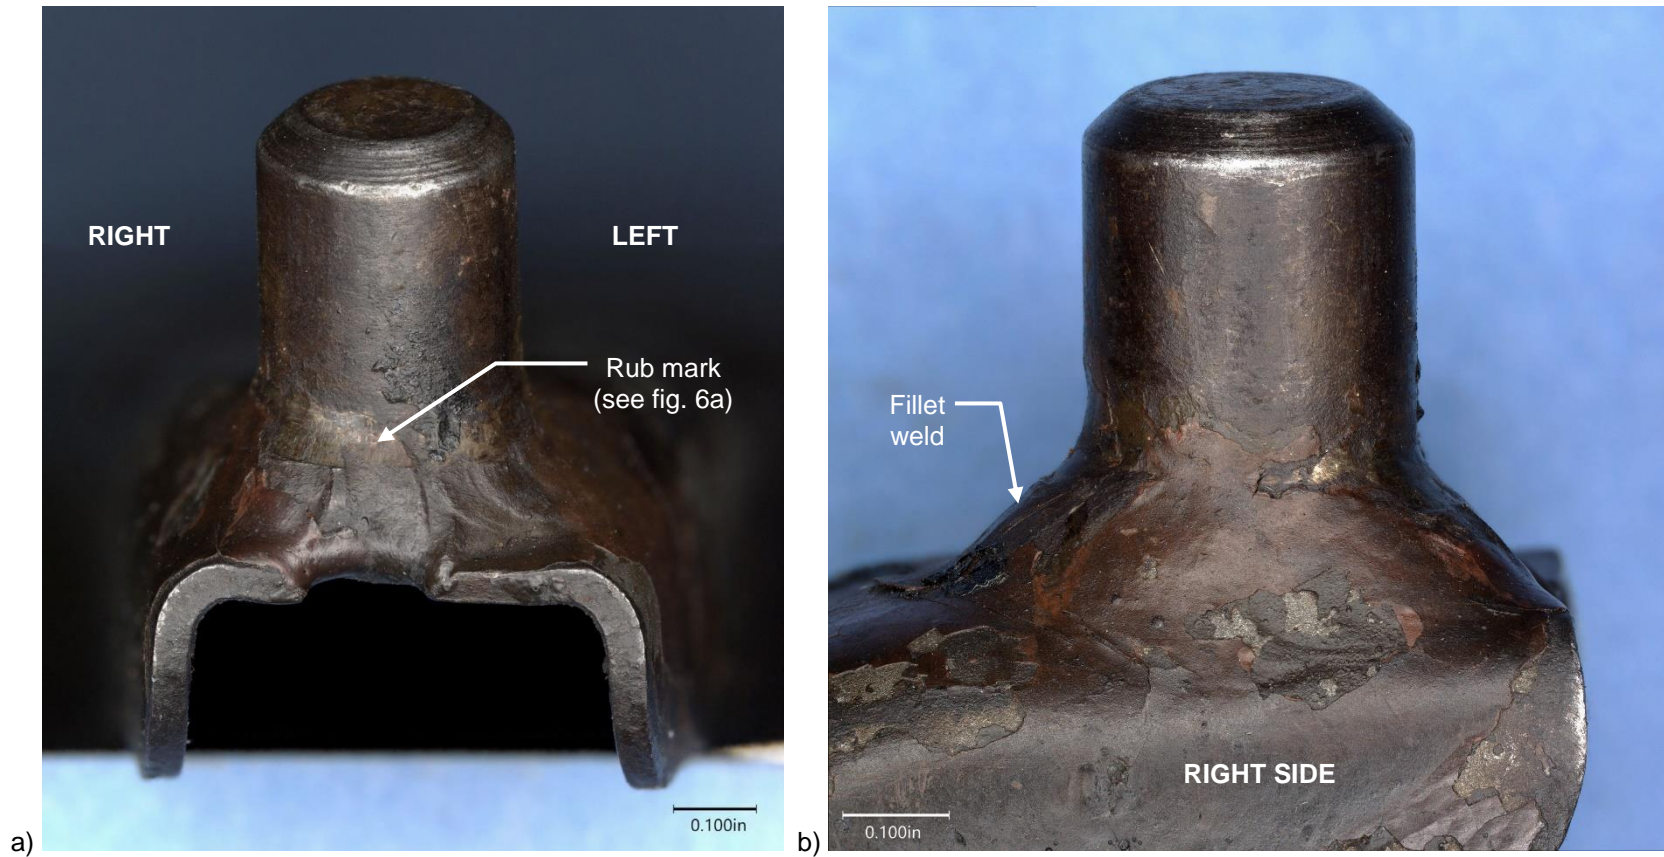
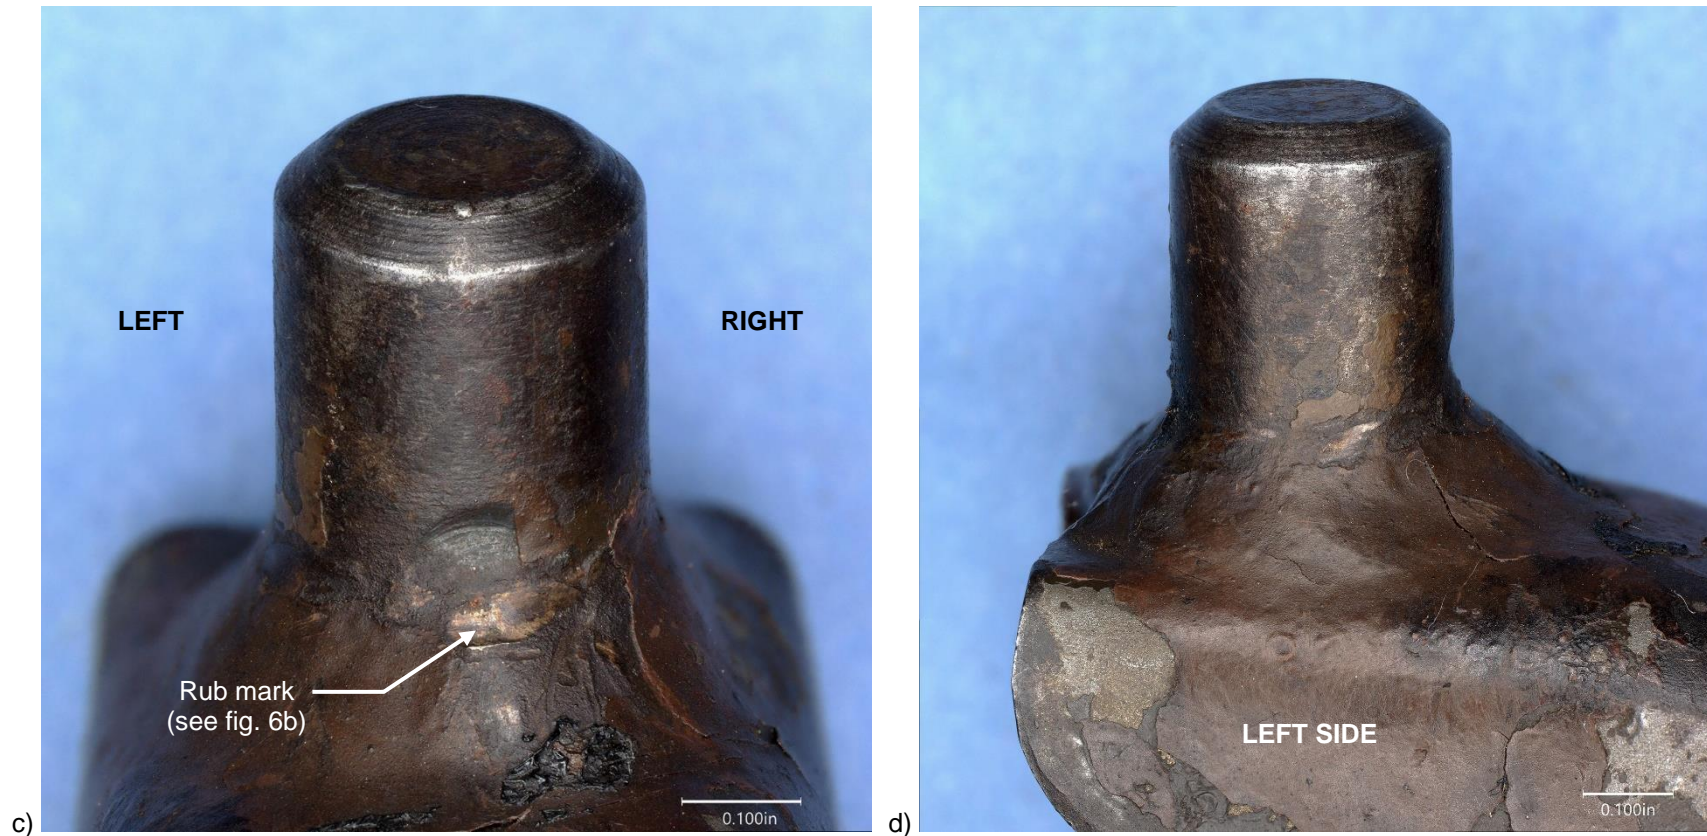
The forward portion of the locking arm and the fillet weld at the base of the pin were coated with paint that had chipped and flaked, as shown in figures 6a – d. The pin surface itself consisted of bare metal. The pin and much of the surrounding surface, painted or not, had a dark oxidized appearance that was consistent with exposure to fire. Some areas, where the paint had chipped and exposed the underlying metal, had a lighter gray appearance.

Figure 6: Images of the pin at the forward end of the locking arm; a) forward view; b) right side view;

Figure 6 (cont.): c) aft side view; and d) left side view.

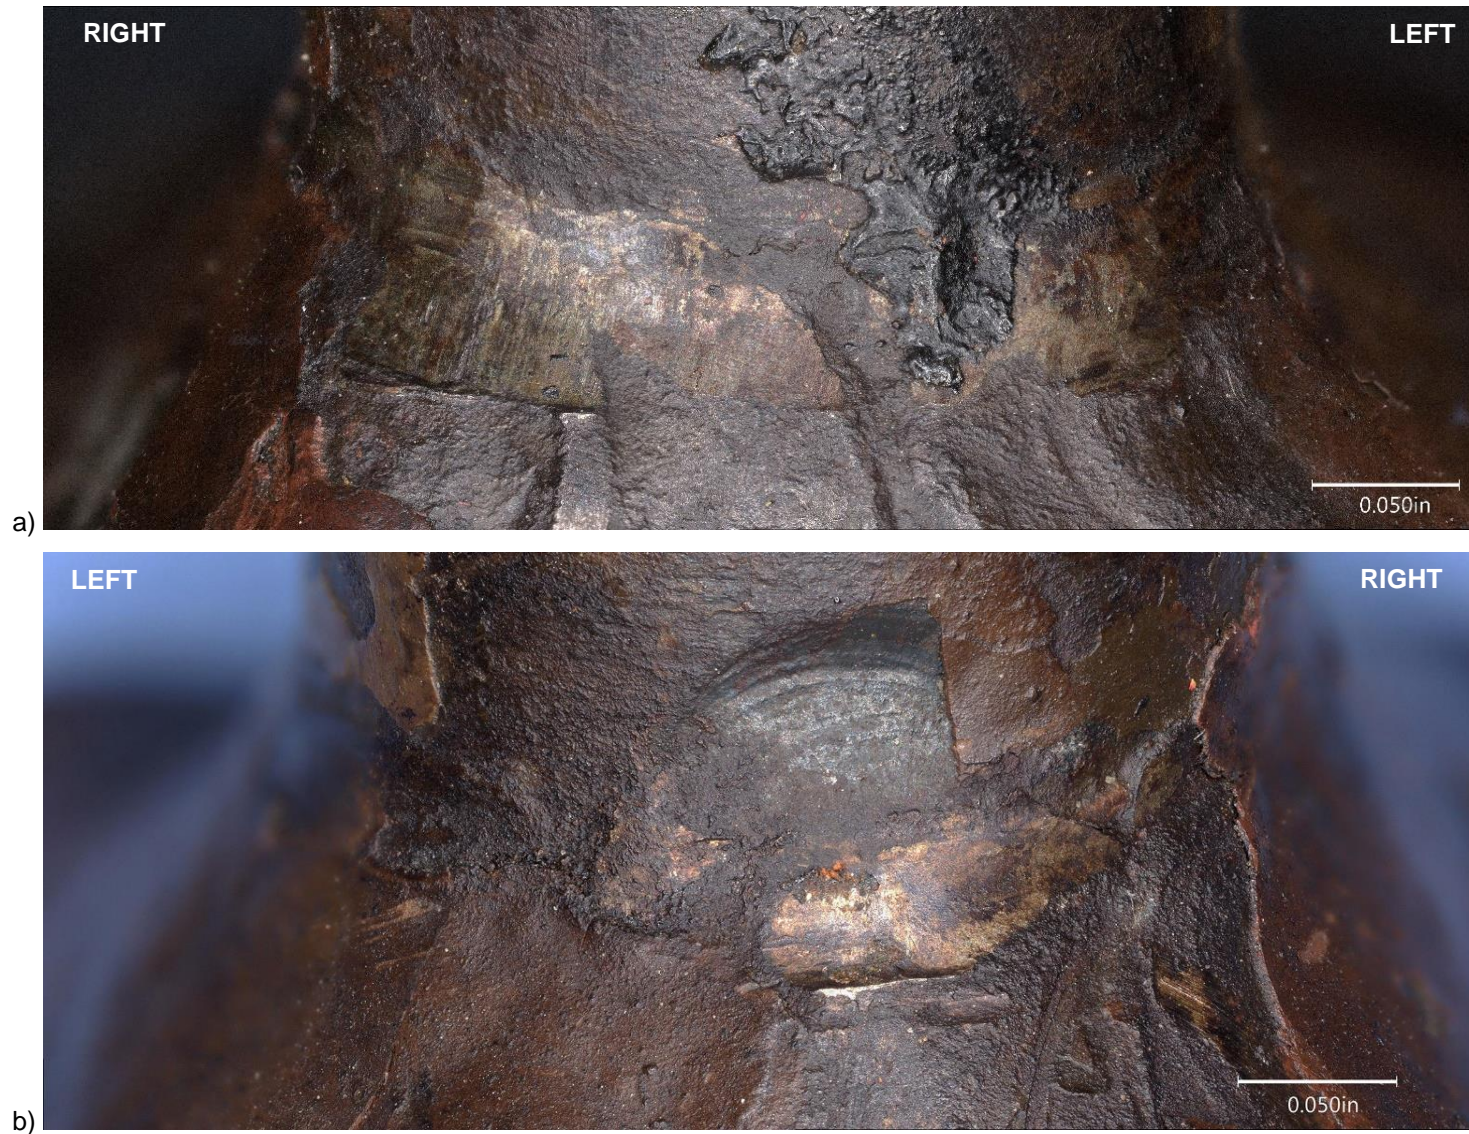
The locking arm's pin and control lock's pin hole exhibited features consistent with rubbing against one another. Two bands were observed at the base of the pin where it met the toe of the weld. Those two regions are shown in figures 7a and 7b for the forward-facing and aft-facing sides of the pin, respectively. The two bands also exhibited a heat tint that was consistent with exposure to fire. The pin was examined for similarly tinted gouges or impact marks, but none were found. The inner diameter surface of the locking hole was initially covered in debris and oily residue, as shown for the forward region in figure 8. The debris and residues were removed using standard laboratory cleaning protocols and the resulting inner surface is shown in figures 9a – d. The hole exhibited wear along the forward and aft edges, consistent with contact with the fillet weld at the base of the locking arm pin. Elsewhere the hole was either coated with paint, exhibited a smooth rubbed appearance, or exhibited machining / grinding marks.

Figure 7: Higher magnification images of rub marks at the toe of the weld located at the base of the pin; a) Rub mark on the forward-facing portion of the pin and b) rub mark on the aft-facing portion of the pin.

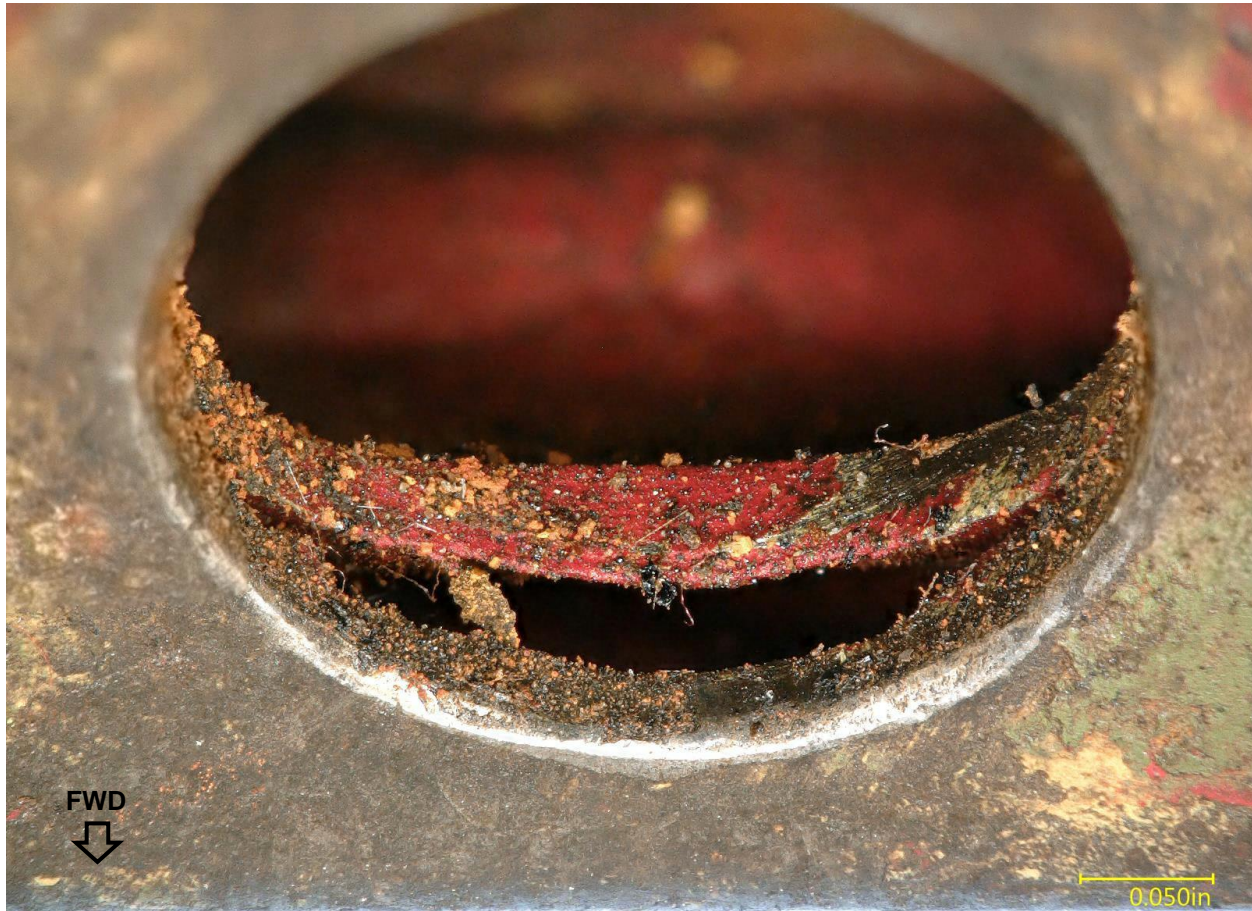
Figure 8: Image of the locking hole's inner diameter surface showing accumulated debris and oily residues. The edge of the hole was rounded/chamfered, consistent with rubbing against the locking pin's weld toe.

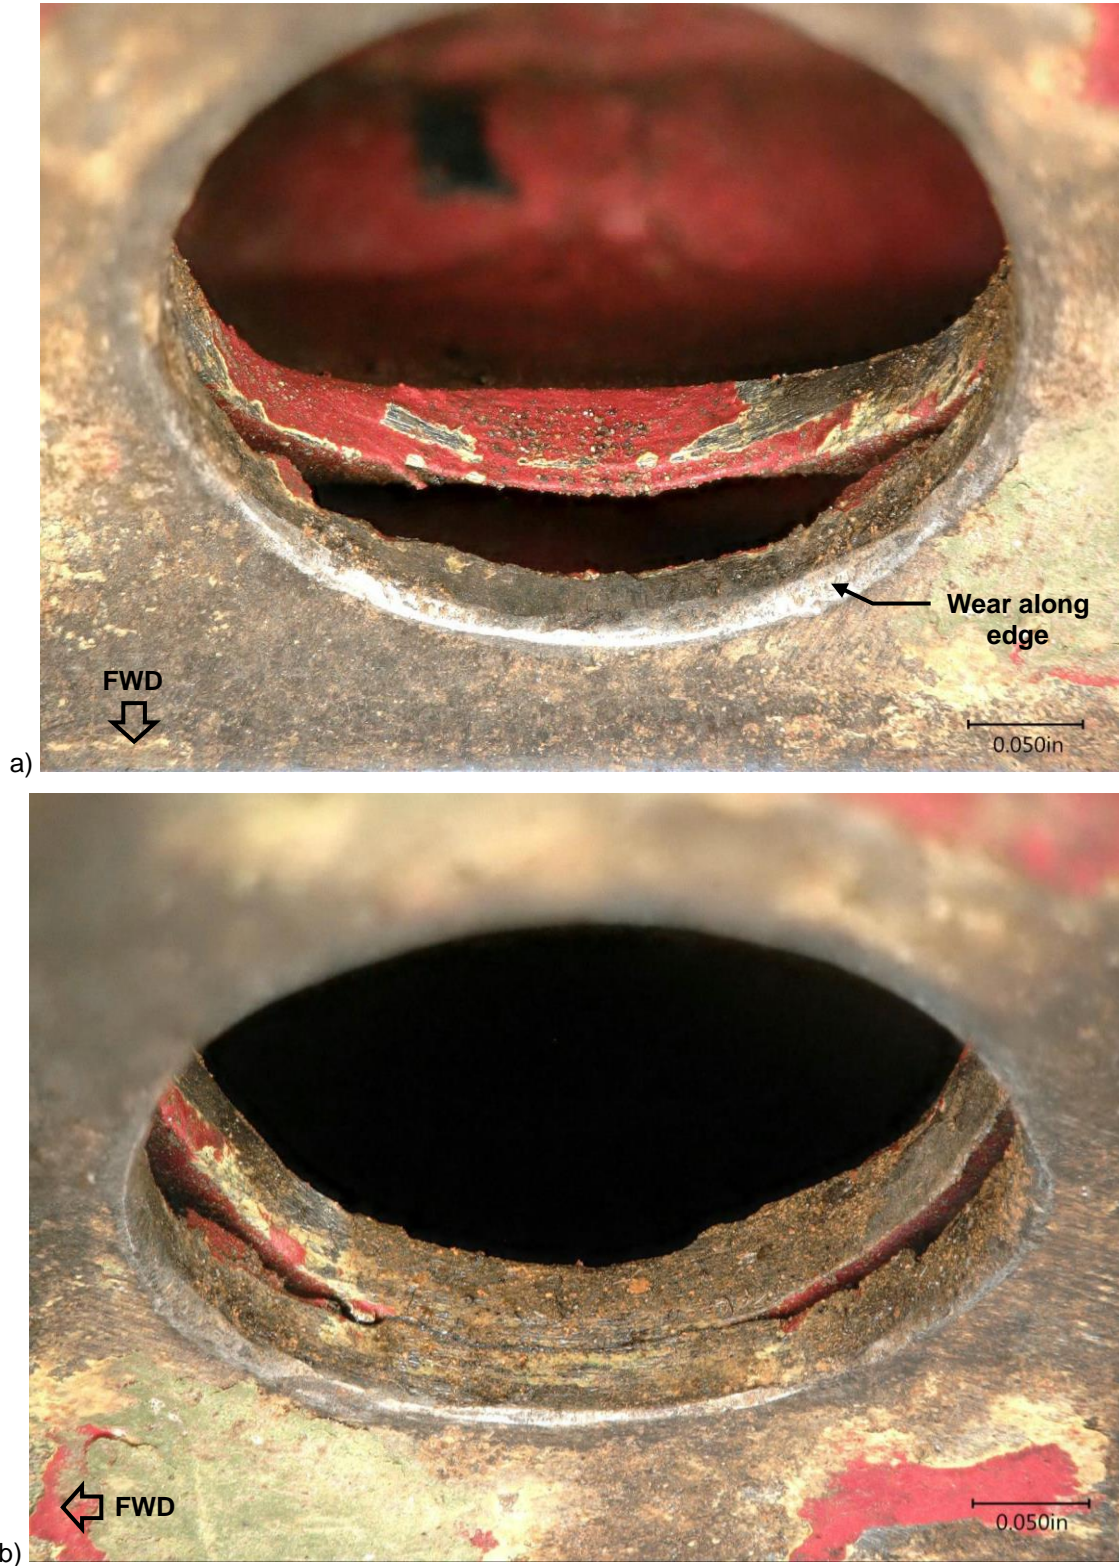
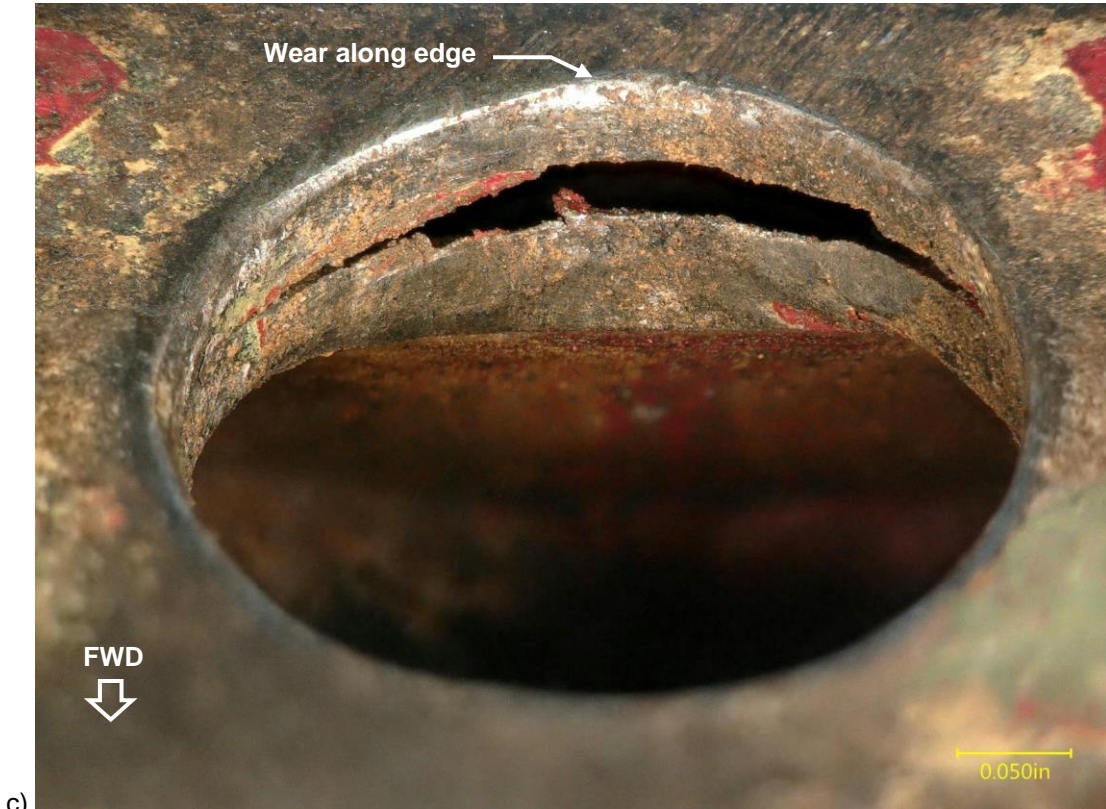
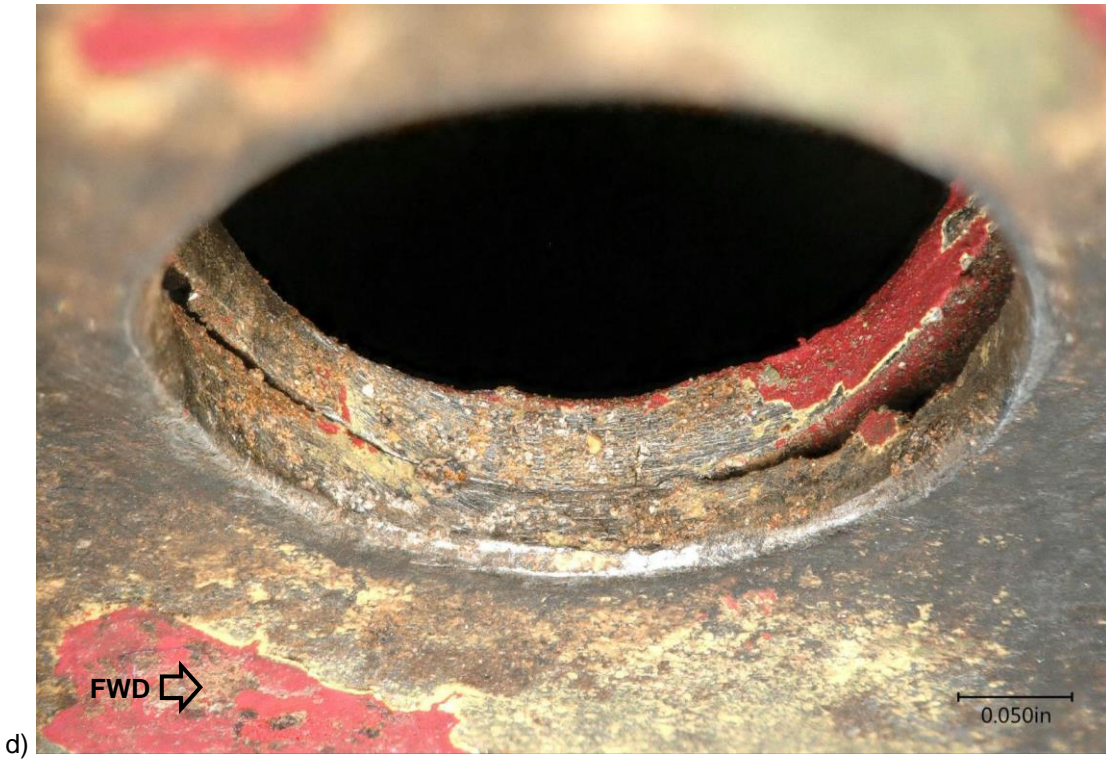
Figure 9: Images of the locking hole's inner diameter surface after cleaning; a) forward; b) right side;

Figure 9 (cont.): c) aft; and d) left side.
