# National Transportation Safety Board

ERA23FA046

## **MATERIALS LABORATORY**

Location: Southington, Ohio  
Date: October 28, 2022  
Vehicle: Zenith CH 750 Cruiser (N820RC)  
Investigator: Heidi Kemner

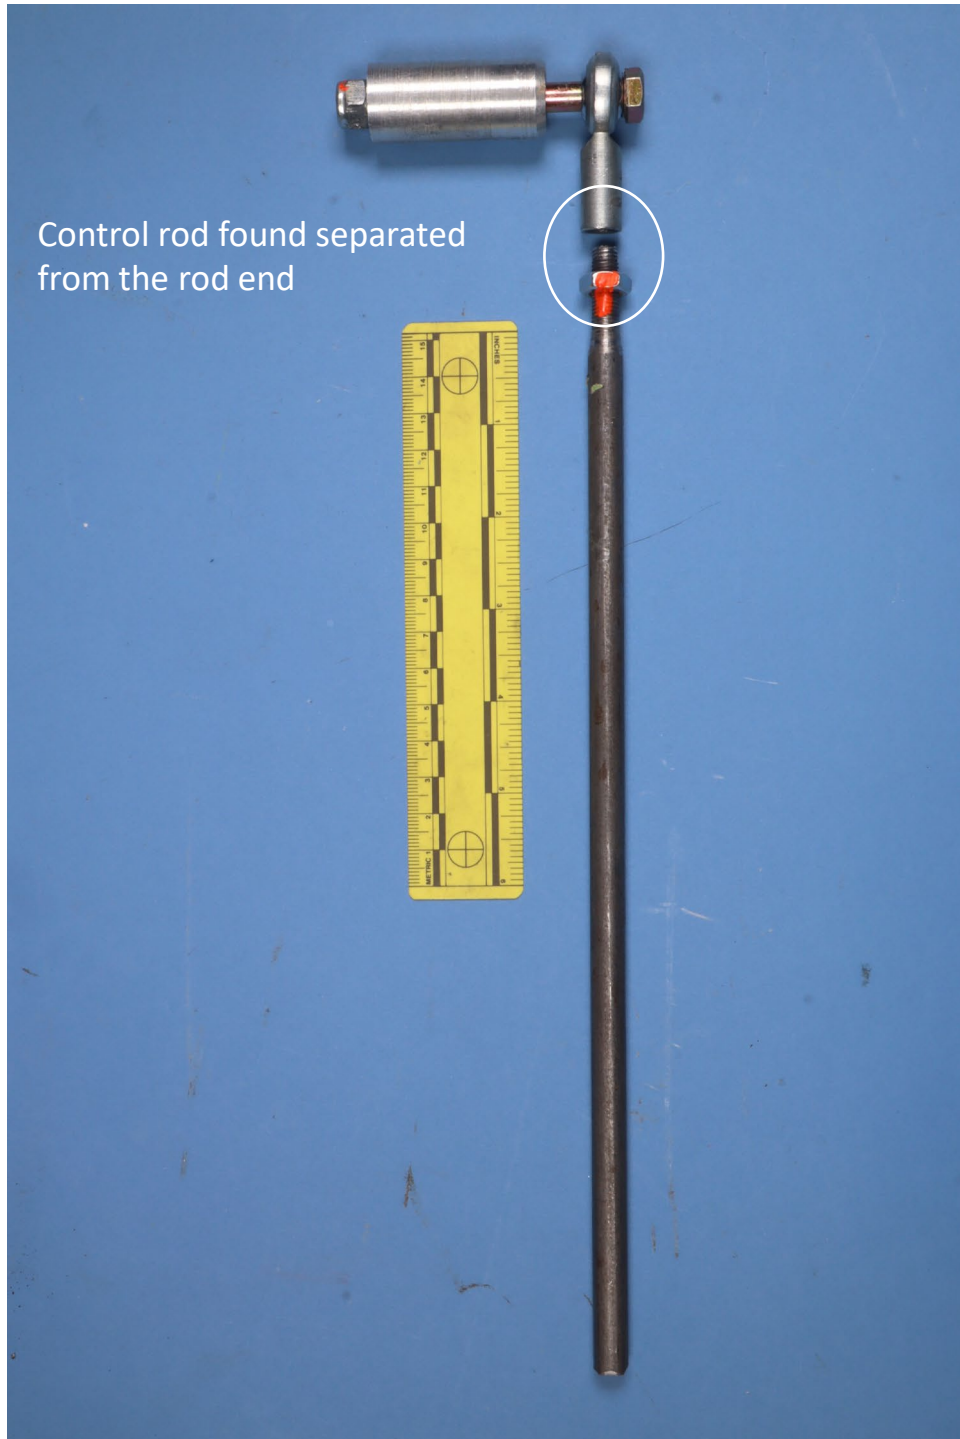
**Figure 1.** Image of the submitted items.

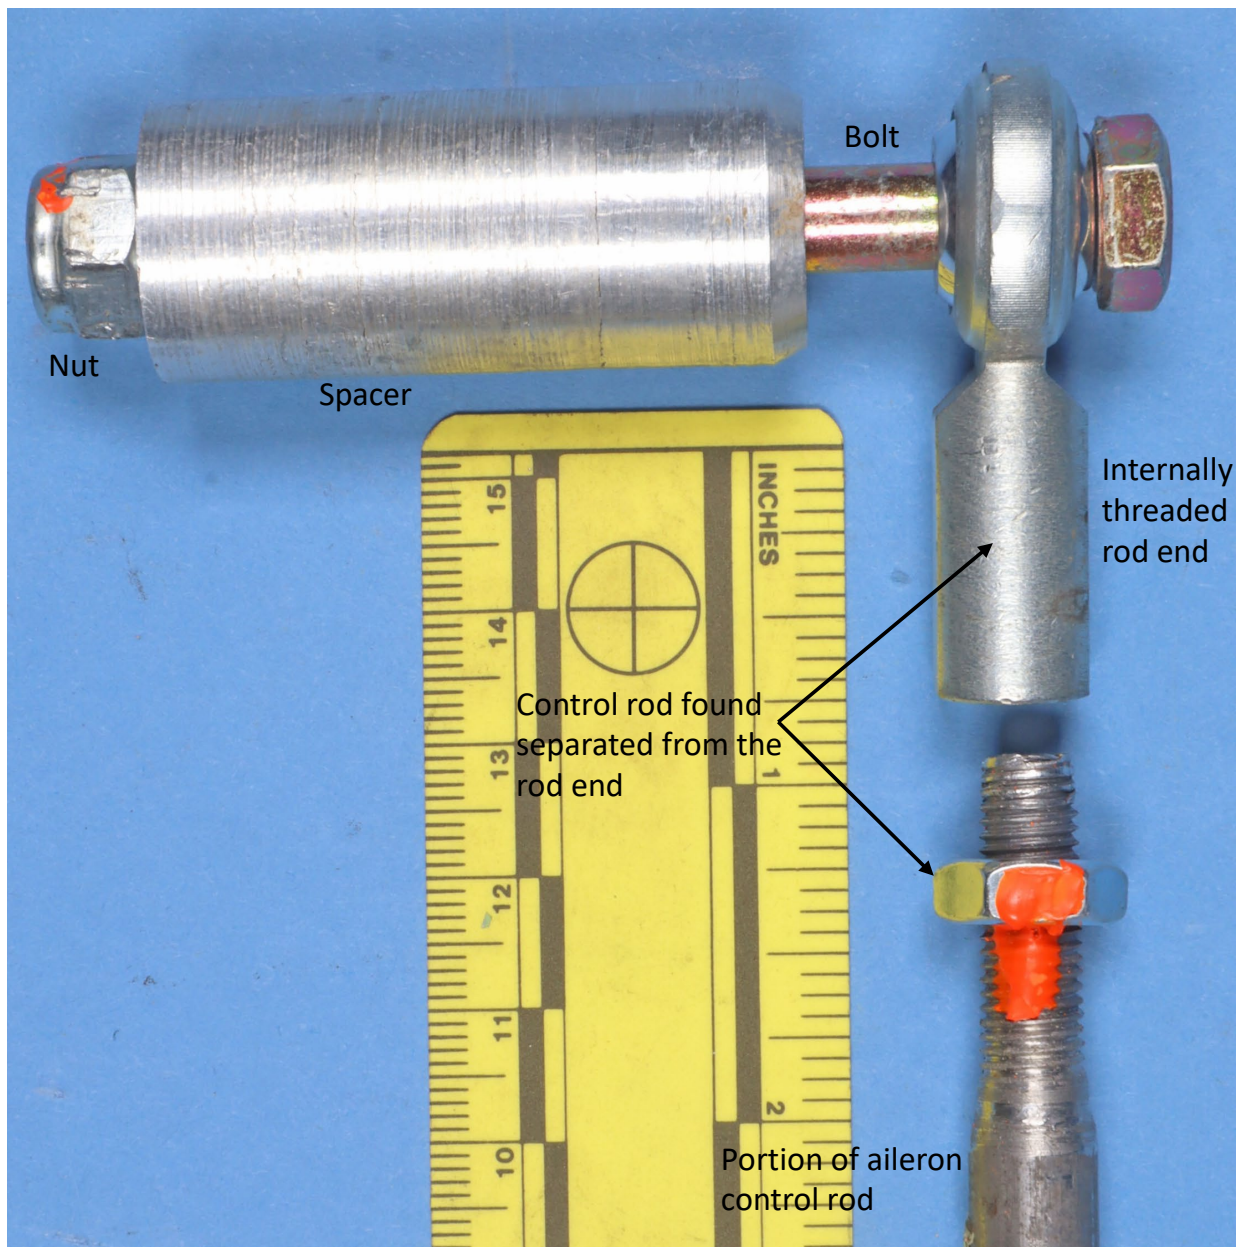
**Figure 2.** Image showing a close view of the aileron control rod separated from the rod end at the threaded joint.

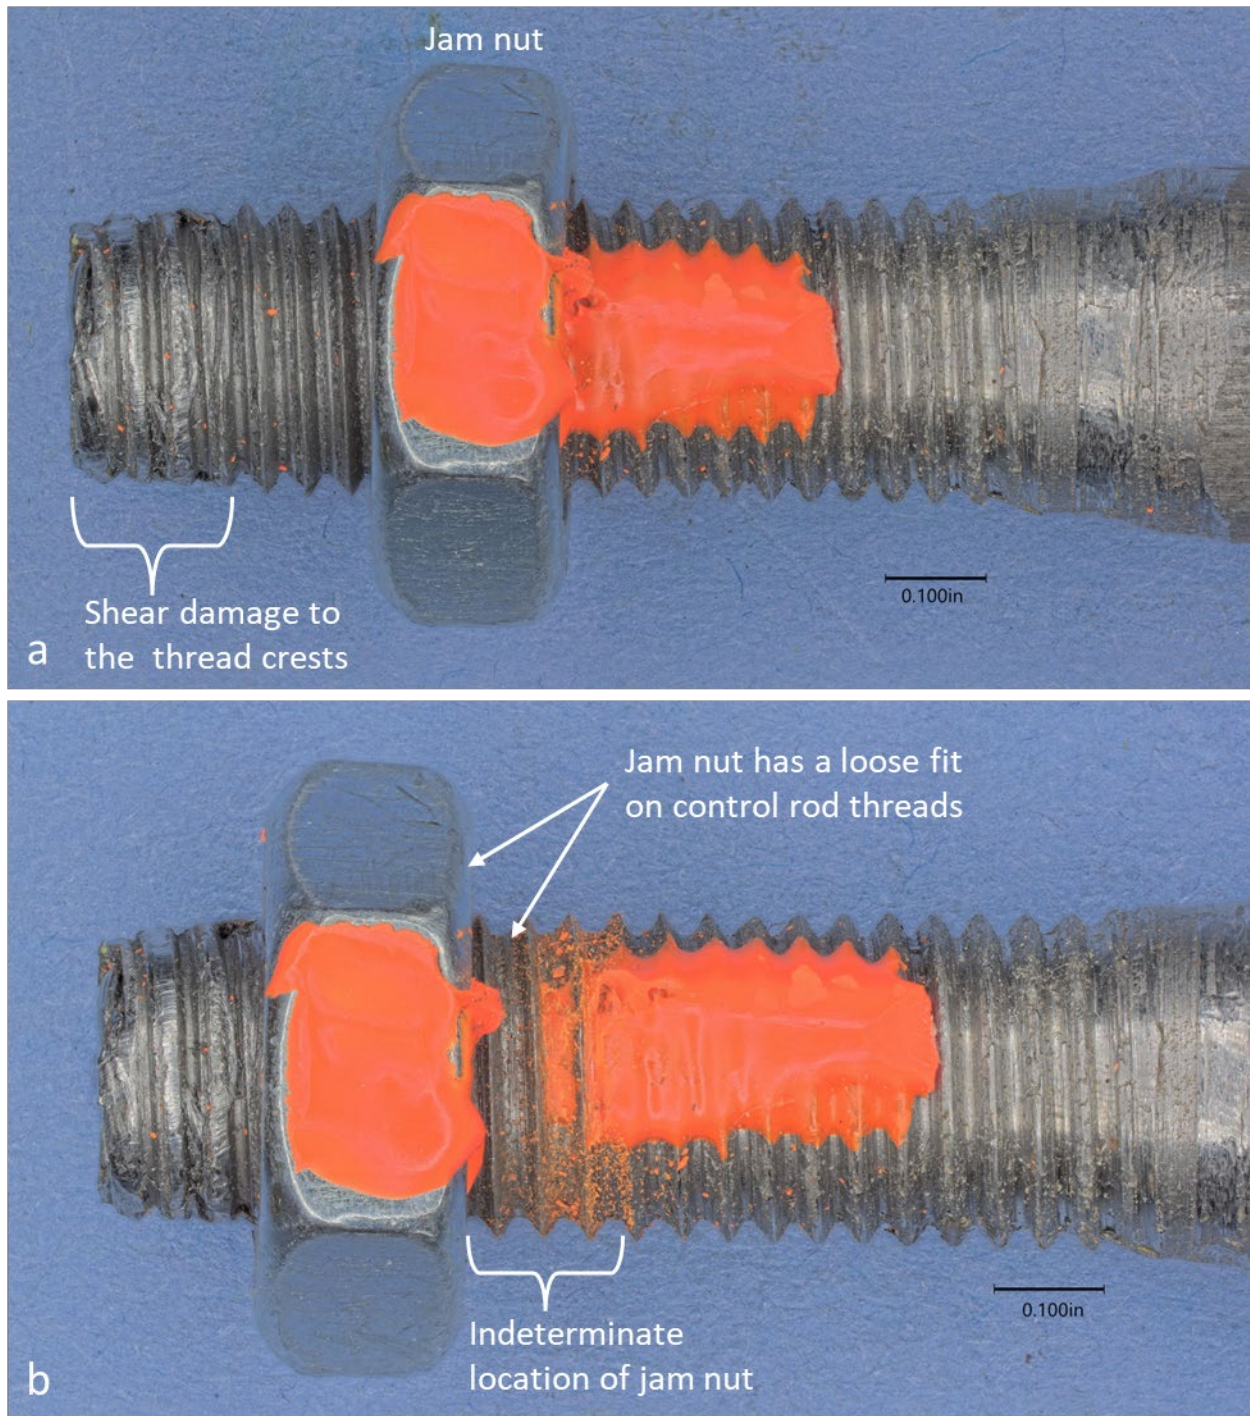
Examination under a 5X to 50X stereo zoom microscope and digital microscope revealed that the male control rod threads, where they engaged with the rod end, exhibited shearing damage of the thread crests (see Figure 3a). The jam nut was found (by hand feel) to have a loose fit on the external threads. In Figure 3b, the jam nut was found to be loose and had been threaded or turned over the torque stripe on the external threads. Given the indeterminate position of the jam nut on the external threads of the control rod, it could not be determined if it loosened or backed-off during flight.

The major diameter of the external threads on the aileron control rod piece, measured with a micrometer, was approximately 0.303 inch. Using a thread gage, the thread teeth per inch was confirmed to be 24 tpi. The thread minor diameter, measured using a digital microscope, was approximately 0.258 inch. Typically, a UNC 5/16 x 24 external thread, Class 2A, would have a 0.2603 inch maximum minor diameter and a 0.3042 inch to 0.3114 inch major diameter<sup>1</sup>.

**Figure 3.** Images of the external threads on the aileron control rod. View a identified shear damage to the thread crests where they mate with the rod end internal threads. View b shows the indeterminate location of the jam nut.

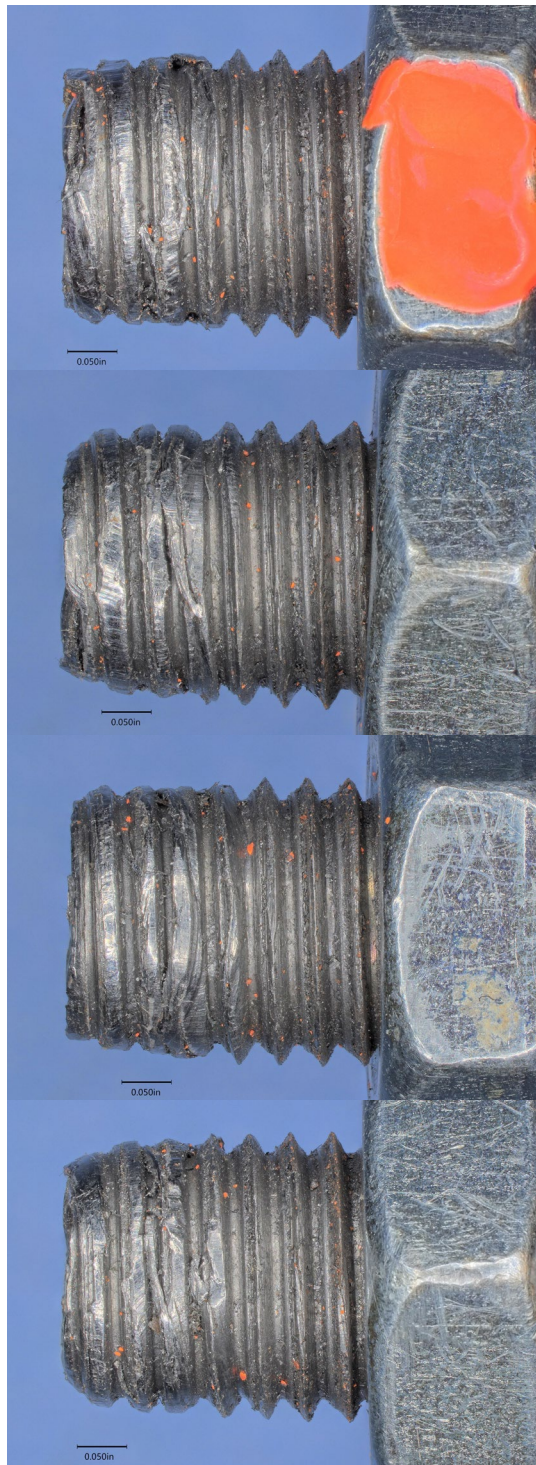
Closer digital microscope images of the external threads on the aileron control rod piece where they engaged with the internal rod end threads are shown in Figure 4. The threads crests on the last two full threads exhibit damage consistent with shearing.

**Figure 4.** Images of the external threads on the aileron control rod at 90° intervals about the axis of the control rod. Shear damage to the thread crests where they mate with the rod end internal threads is observed.

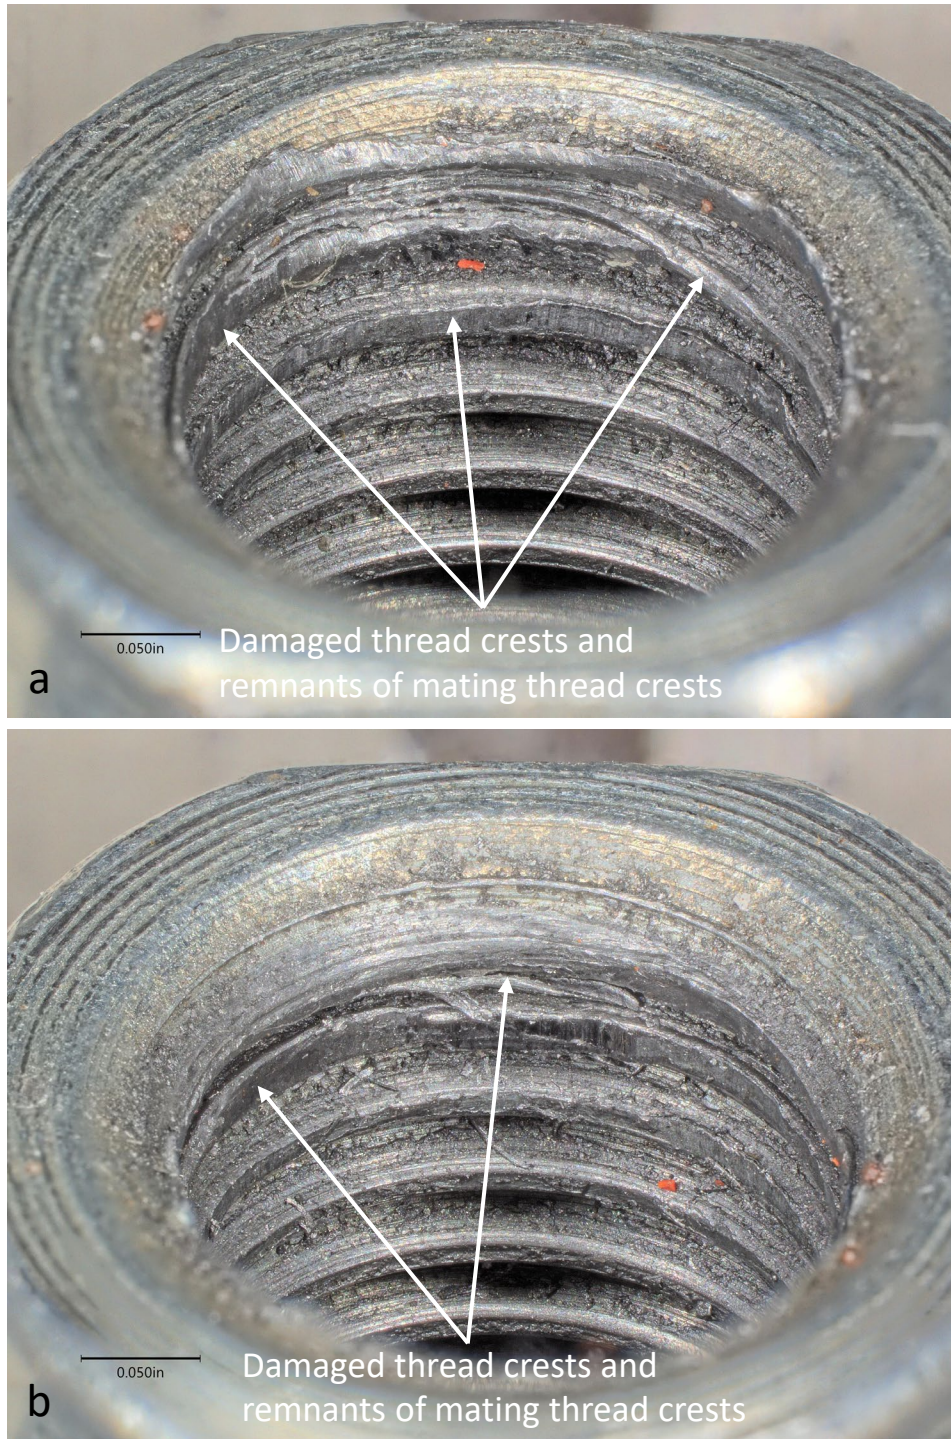
Digital microscope images of the internal threads on the rod end piece where they engaged with the external control rod threads are shown in Figure 5. The threads crests on the last two full threads exhibit damage consistent with shearing.

The major diameter of the internal threads on the rod end piece, measured using a digital microscope on a silicone replica, was approximately 0.318 inch. Using a thread gage on a silicone replica, the thread teeth per inch was confirmed to be 24 tpi. The thread minor diameter, measured using a digital microscope on a silicone replica, was approximately 0.273 inch. Typically, a UNC 5/16 x 24 internal thread, Class 2B, would have a 0.3125 inch minimum major diameter and a 0.2670 inch to 0.2770 inch minor diameter.

**Figure 5.** Oblique images of the internal threads in the rod end, 180° apart. Shear damage on the thread crests is noted and remnants of mating thread crest pieces are present.
