National Transportation Safety Board

ERA23FA174

MATERIALS LABORATORY

Factual Report 23-051

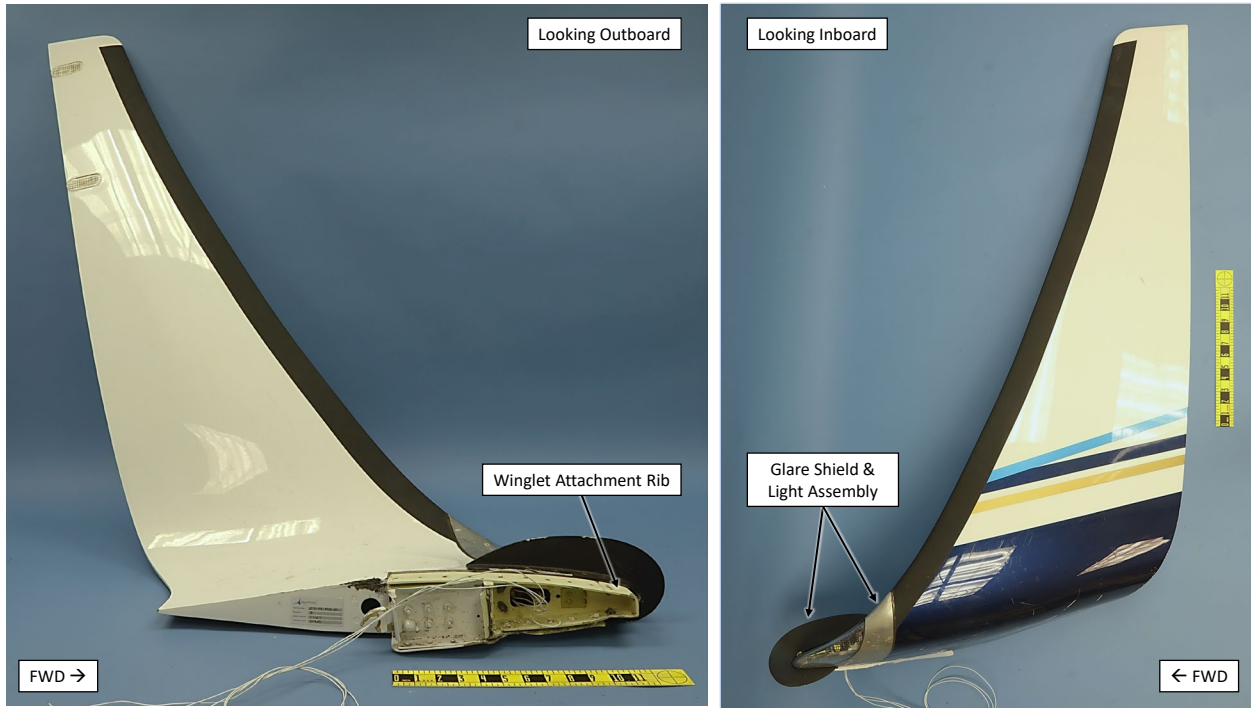
Figure 2 shows inboard and outboard views of the winglet, an assembled fiber reinforced polymer matrix composite structure, which was still attached to the winglet attachment rib component of the wing extension assembly. The wingtip light assembly and glare shield components were still attached, and the static wicks and their associated bases had separated from the inboard skin surface. The outboard TACS hinge support brackets and portions of the outboard TACS hinge brackets (fractured), upper and lower main spar caps (fractured), main spar web (fractured), forward spar web (fractured), and lower skin (fractured) were still attached to the winglet attachment rib. The winglet assembly ID placard contained the following part identification information:

Figure 2. Photographs of the left winglet as received.

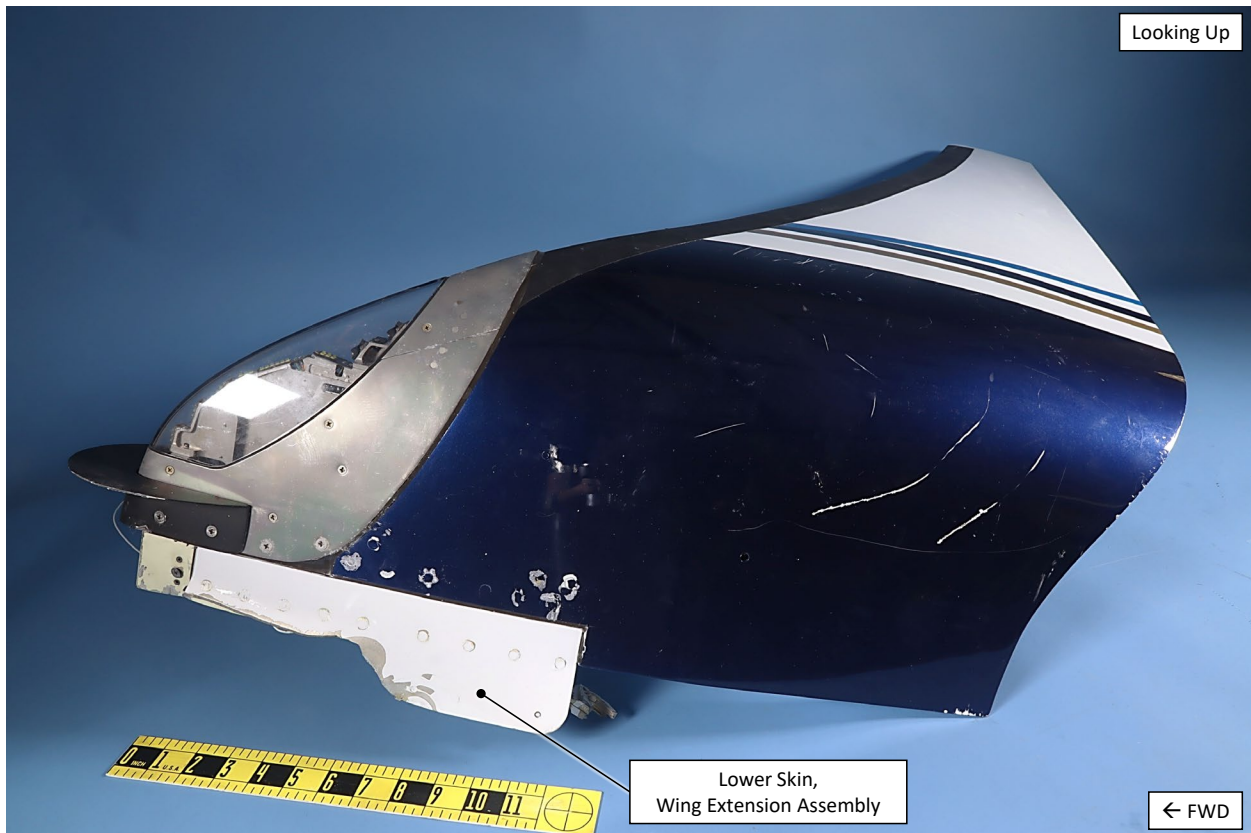
Figure 3 shows a view of the lower surface of the winglet. Several white scratches were observed on the blue painted area of the lower surface. White powdery deposits were observed around some of the fasteners and metallic surfaces, consistent with corrosion and deposits from exposure to a marine environment. A portion of the lower skin from the wing extension assembly remained attached to the winglet attachment rib.

Figure 3. Photograph of the left winglet lower surface as received.

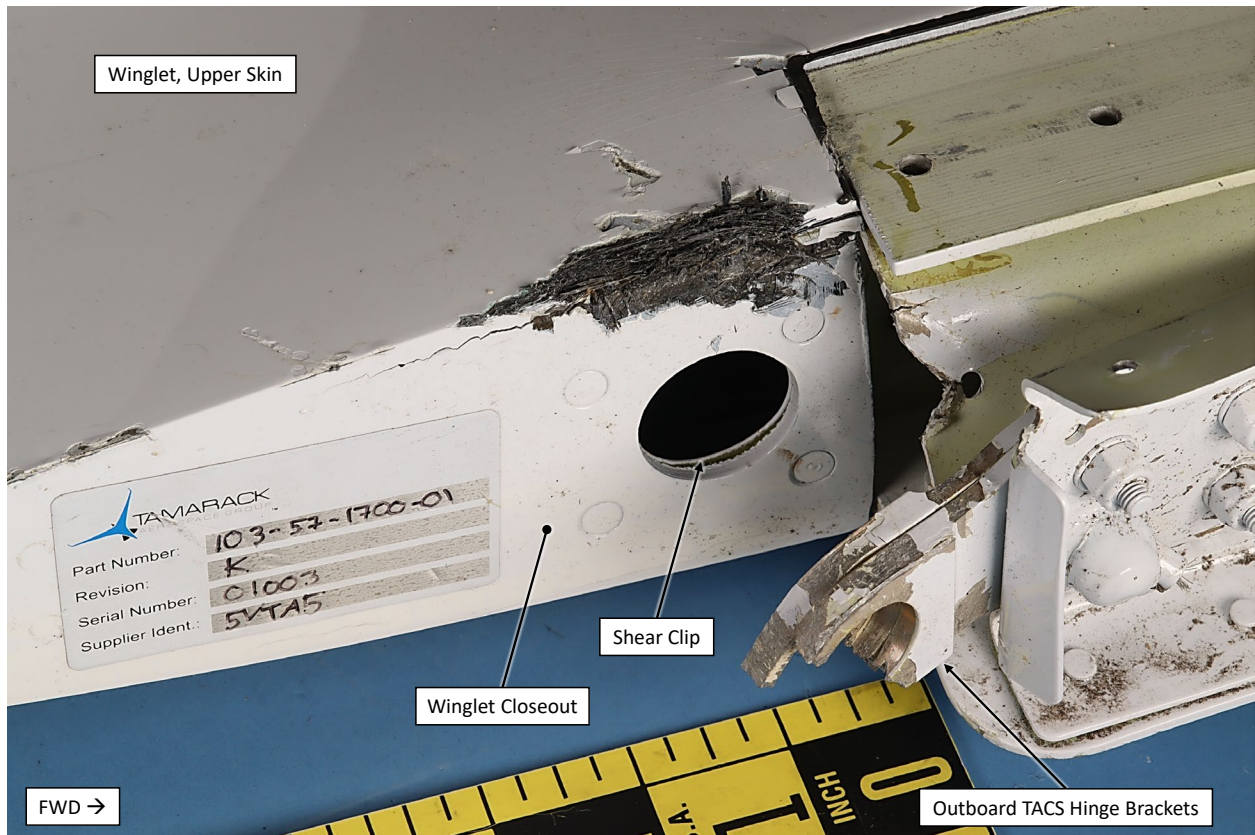
Figure 4 shows an area of localized damage to the upper inboard corner of the winglet, located just aft of the winglet attachment rib and just outboard of the outboard TACS hinge brackets. Damage signatures consisted of chipped paint, crushed carbon fibers, and interlaminar separation. A crack, approximately 3.7 inches long, was observed extending between the forward end of the winglet closeout and upper skin. Similar cracks were observed in the paint layer extending approximately 4.7 inches from the forward end of the winglet closeout at the lower skin joint. A Z-shaped shear clip which connected to the inner surface of the winglet closeout and the winglet attachment rib was partially separated from the closeout, as indicated in figure 4. A mirror was used to visually examine the forward face of the shear clip leg which spanned between the attachment flanges as shown in figure 5. This leg exhibited outboard deformation and buckling. The damage to the winglet closeout, upper skin, and shear clip was consistent with localized impact or mechanical contact damage to the closeout near the upper skin edge.

An orange grease like substance was observed on the outboard side of the outboard TACS hinge and support brackets and winglet closeout where local impact damage on the winglet was observed (see figures 4 and 13). This material was analyzed using FTIR spectroscopy and the chemistry was consistent with typical lubricants used in bearing applications such as MIL-G-81322.

Figure 4. Photograph showing localized damage to the composite construction of the left winglet, aft of the winglet attachment rib and outboard of the TACS hinge brackets.

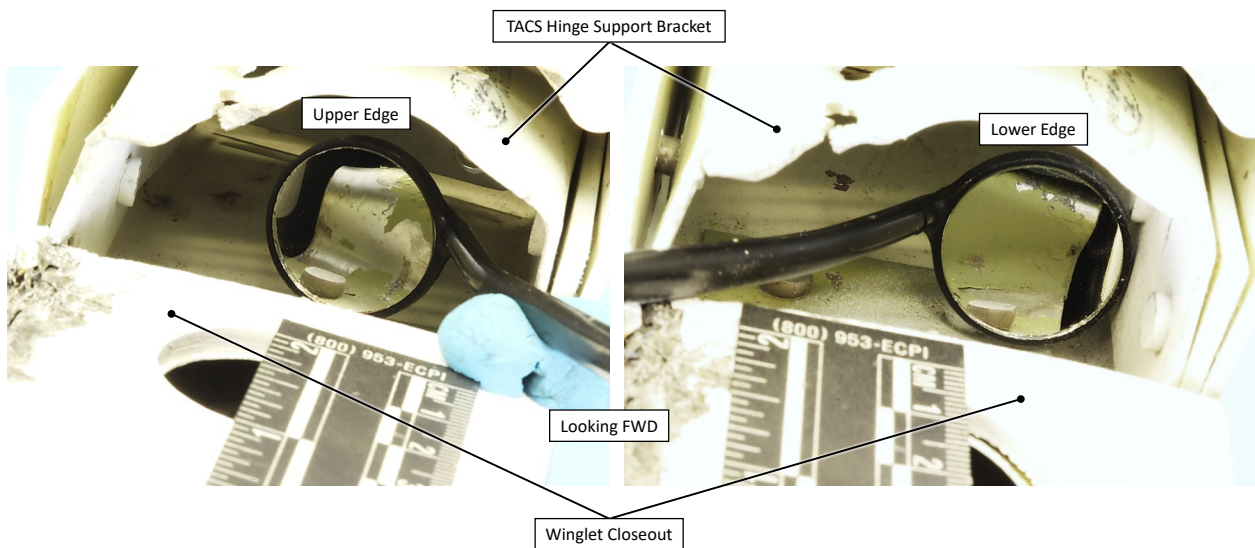
Figure 5. Photographs showing deformation to the forward-facing surface of the shear clip component as viewed in an inspection mirror.

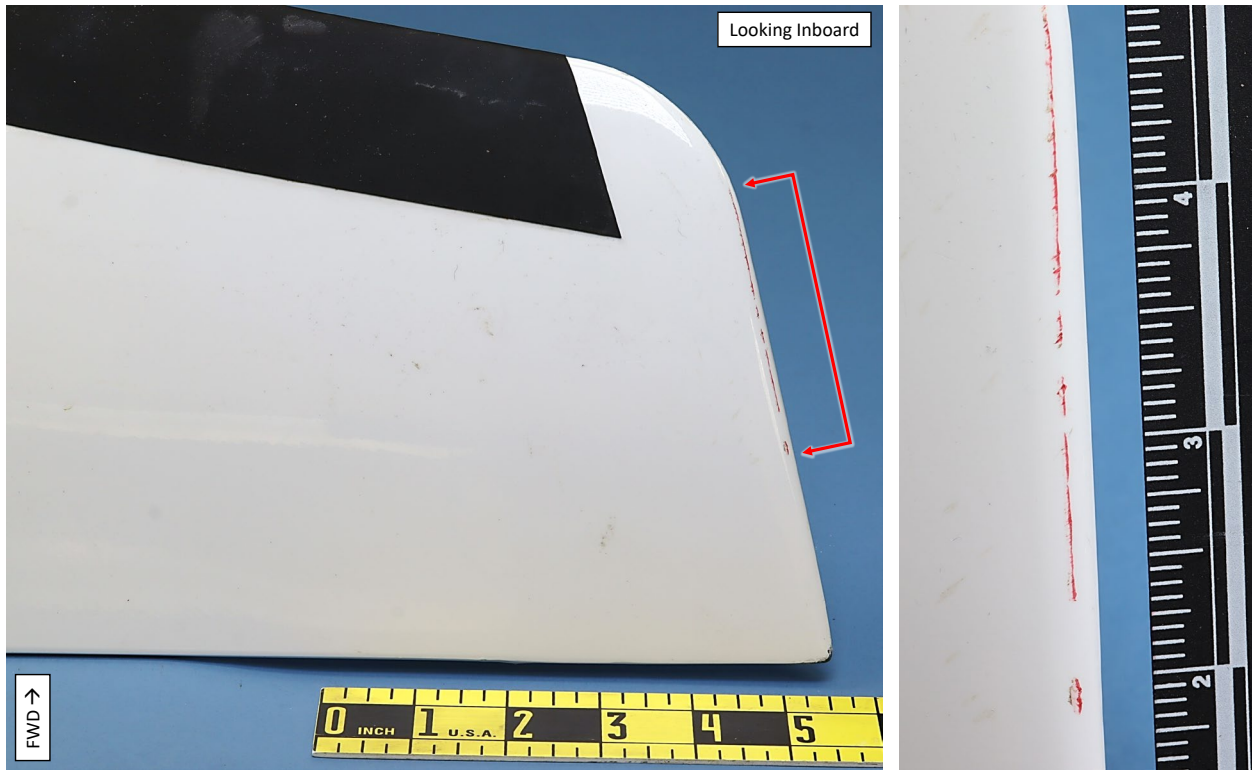
Figure 6 shows a photo of the outboard side of the winglet tip where an area of red material transfer, inconsistent with the aircraft exterior livery, was observed. The transfer mark was approximately 3 inches in length and was located along the outboard tangent of the rounded winglet tip as indicated by the red bracket and shown more closely in the right image. The overall appearance was a series of colinear streaks with smaller smeared streaks emanating downward and slightly aft. A specimen of the red material was extracted for chemical analysis using Fourier transform infrared (FTIR) spectroscopy and the spectrum was consistent with a polyurethane chemistry typically found in aircraft topcoats and industrial paints and was indistinguishable from the white topcoat material.

Figure 6. Photograph of an area of red material transfer observed on the outboard side of the winglet tip indicated by the red bracket. A closer view of this area is shown on the right.

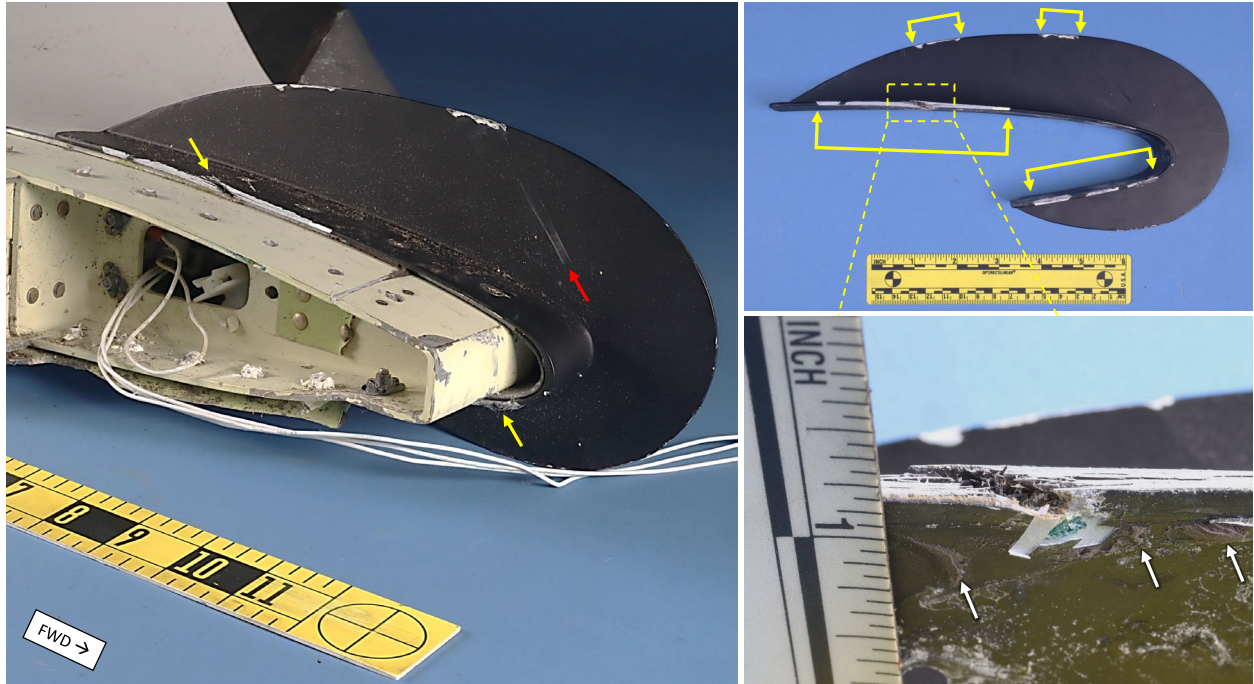
The glare shield, a fiber reinforced polymer composite component, remained attached to the winglet and exhibited localized damage signatures as shown in the left image of figure 7. Two areas of crushed fibers were observed on the inboard edge of the glare shield as indicated by yellow arrows, with the area on the upper surface located approximately 5.5 inches aft of the apex of the leading edge, and the

area on the lower surface located approximately 0.9 inch aft of the apex of the leading edge, near the lower tip of the winglet rib fitting. A witness mark, indicated by a red arrow, was observed on the inboard vertical surface of the glare shield which emanated towards an area of chipped paint on the upper edge. The upper right image of figure 7 shows the inboard side of the glare shield after disassembly and yellow brackets indicate areas of chipped paint near the crushed fibers along the inboard edge and areas of chipped paint on the upper edge. The lower right image of figure 7 shows a closer view of the boxed area along the upper inboard edge and adjacent faying surface where crushed fibers were observed. Interlaminar cracks emanated from the crushed fibers and residual fractured sealant was observed on the adjacent surface, as indicated by white arrows.

Figure 7. Photograph of the glare shield looking outboard (left) as received with crushed fiber damage indicated by yellow arrows and a witness mark indicated by a red arrow. The upper right image shows the glare shield disassembled with areas of chipped paint indicated by yellow brackets. A closer view of the boxed area is shown in the lower right image where crushed fibers and interlaminar cracks were observed at the inboard edge of the glare shield, and fractured sealant material (white arrows) was observed on the adjacent faying surface.

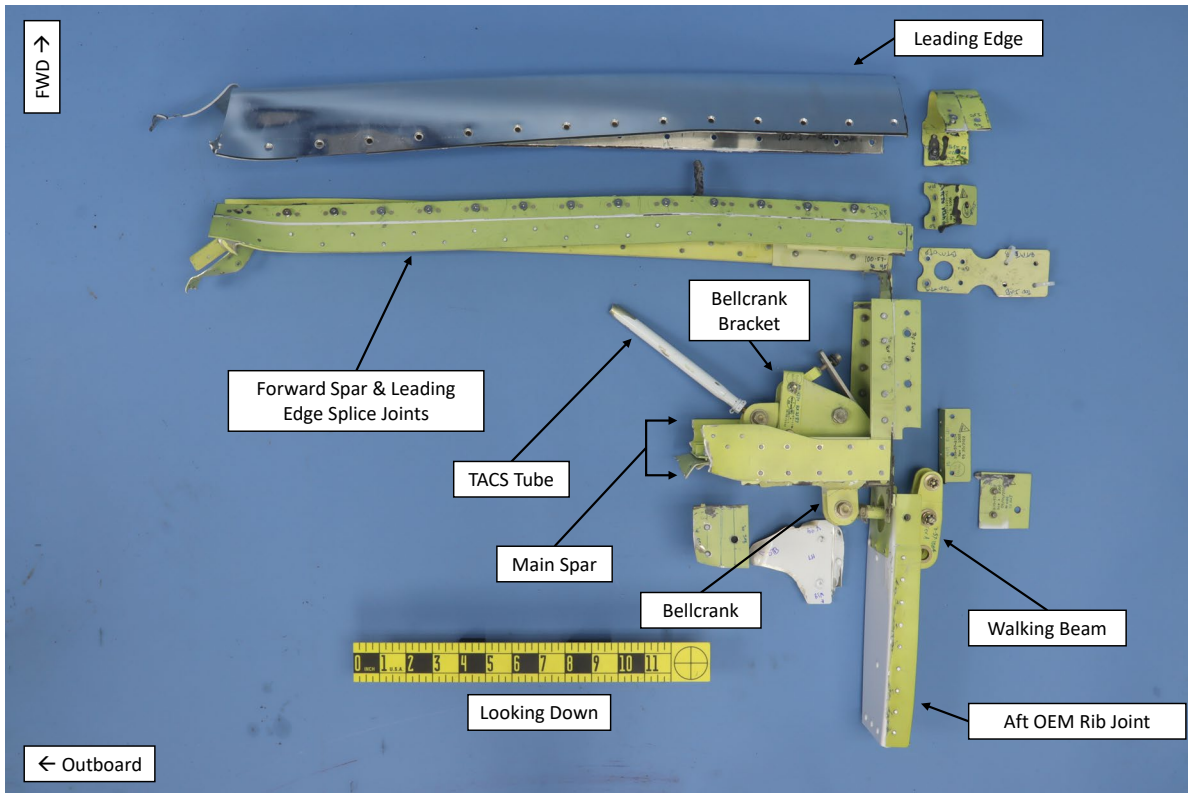
Figure 8 shows a view of the portion of the wing extension assembly that was received. The leading edge had been disassembled from the forward spar and splice joints. The upper skin and a majority of the lower skin were not received. The fractured TACS tube (long pushrod) was reportedly disassembled from the bellcrank to facilitate removal from the OEM wing and was received installed forward of the main spar, as pictured, rather than through the main spar as specified in installation drawings. On scene photos, prior to removal from the accident airplane, showed the tube oriented aft through the main spar pass-through as intended by design and as shown in the following figure.

Figure 8. A photograph showing the pieces received from the wing extension assembly.

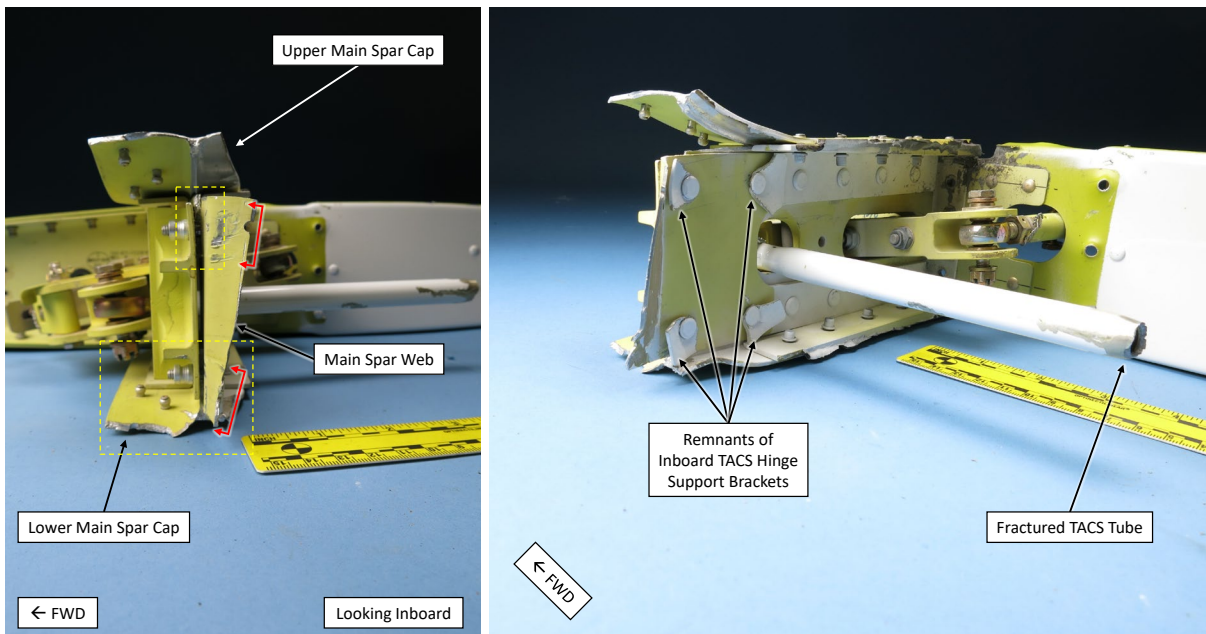
Figure 9 shows views looking inboard along the fractured main spar of the wing extension assembly, just outboard of the bellcrank mechanism. The main spar, which consisted of upper and lower T-shaped caps fastened to a vertical web, was fractured transversely just outboard of the attached bellcrank fitting. The upper and lower main spar caps were fractured through the stem at the outboard fasteners where the bellcrank bracket attached. Closer views of these areas within the yellow boxes are shown in figure 10. The lower spar cap flange was fractured slightly outboard from the stem through a fastener hole where the lower skin attached, approximately 7 inches from the inboard end of the wing extension assembly. The top flange of the upper main spar cap was fractured approximately 7.1 inches from the inboard end of the wing extension assembly, between upper skin fastener locations, and exhibited deformation and shear lip features consistent with overstress separation. The top flange of the upper main spar cap was partially separated and deformed upward away from the stem with shear lip features across the fracture surface, consistent with overstress separation under peel loading. The main spar web extended approximately 1 inch outboard from the spar cap stem fractures where it was fractured through the next set of fastener holes and bent aft. The fracture surface of the main spar web exhibited shear lip features, consistent with tensile overstress separation. Witness marks in the form of scraped primer and parallel scratches/gouges, consistent with mechanical contact damage, were observed on the

forward side of the main spar web extending from the cap stem fractures to the web fracture. The witness marks were contained within regions approximately 0.75 inch from the upper and lower edges of the web as indicated by red brackets, consistent with contact with the upper and lower spar cap stems. The inboard main spar cap fracture surfaces were sectioned from the assembly to facilitate closer examination, and observations are detailed later in this report.

Figure 9. Photographs of the wing extension main spar fracture (inboard location) showing witness marks highlighted by red brackets in the left image. Areas within the yellow boxes are shown more closely in the following figure. The right image indicates portions of the retained TACS hinge support brackets on the aft side of the main spar web and the fractured end of the TACS tube.

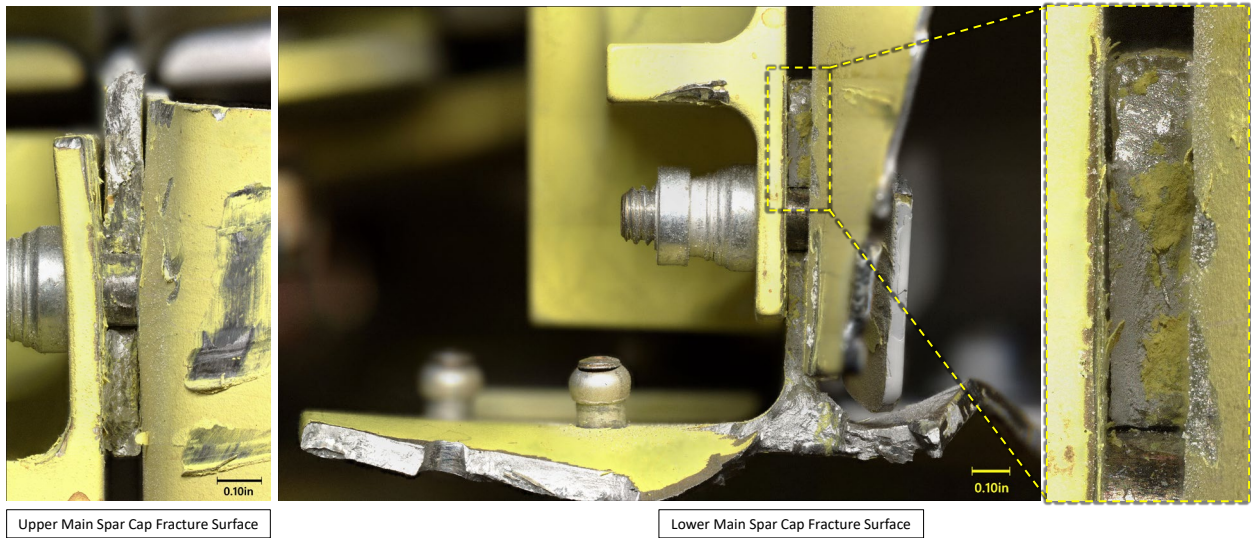
Figure 10. Digital microscope images of the upper (left) and lower (right) fractured main spar caps (inboard location).

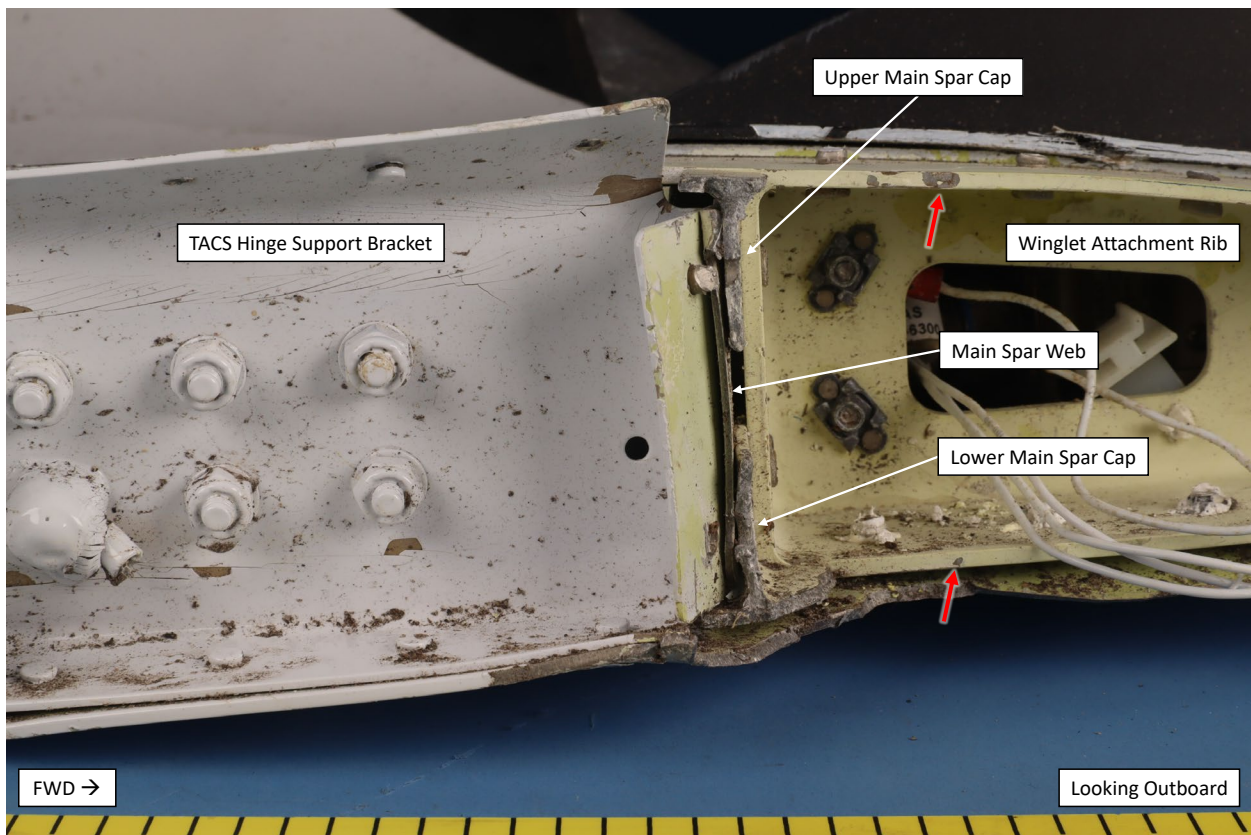
The main spar caps (upper and lower) were fractured transversely through the T-shaped cross section through the fastener holes approximately 1 inch inboard of the edge of the winglet attachment rib as shown in figure 11. The transverse fractures turned outboard along the forward side of both flanges and continued to the outboard edges of the caps. The main spar web was fractured along the same plane through the same fastener holes and exhibited shear lip features, consistent with tensile overstress separation. Contact marks, indicated by red arrows, were observed on the upper and lower inboard edges of the winglet attachment rib approximately 1.4 inches forward of the main spar. The outboard main spar cap fracture surfaces were sectioned from the assembly to facilitate closer examination, and observations are detailed later in this report.

Figure 11. Photograph of the wing extension main spar fracture (outboard location) in the as received condition. Red arrows indicate contact marks on the inboard edges of the winglet attachment rib, forward of the main spar.

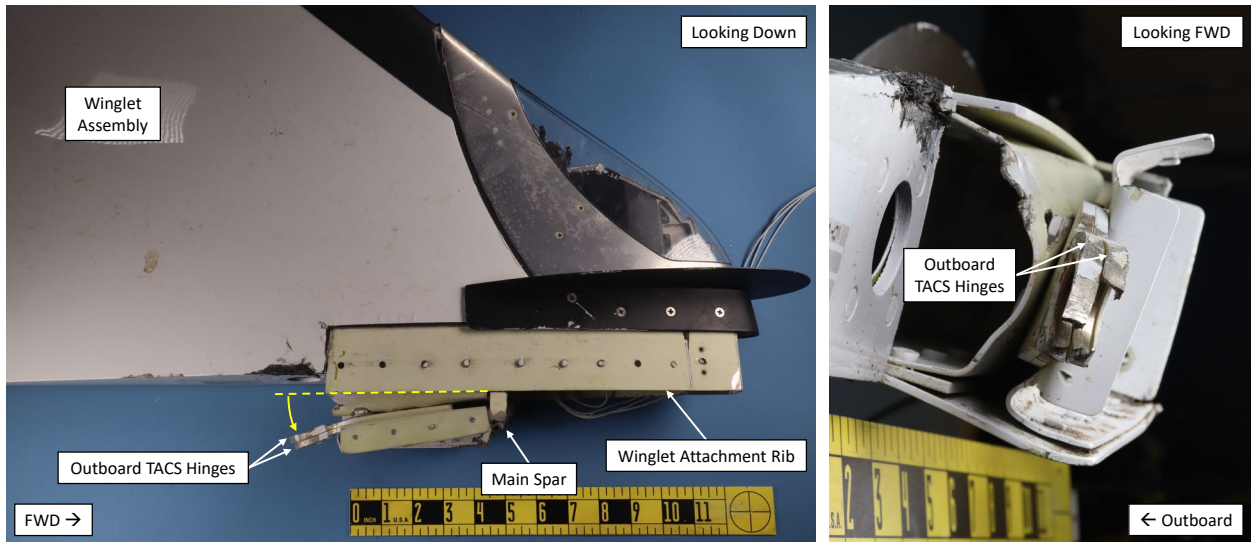
Figure 13. Photographs showing deformation of the outboard TACS hinge brackets as indicated by the yellow dashed line and arrow in the left image.

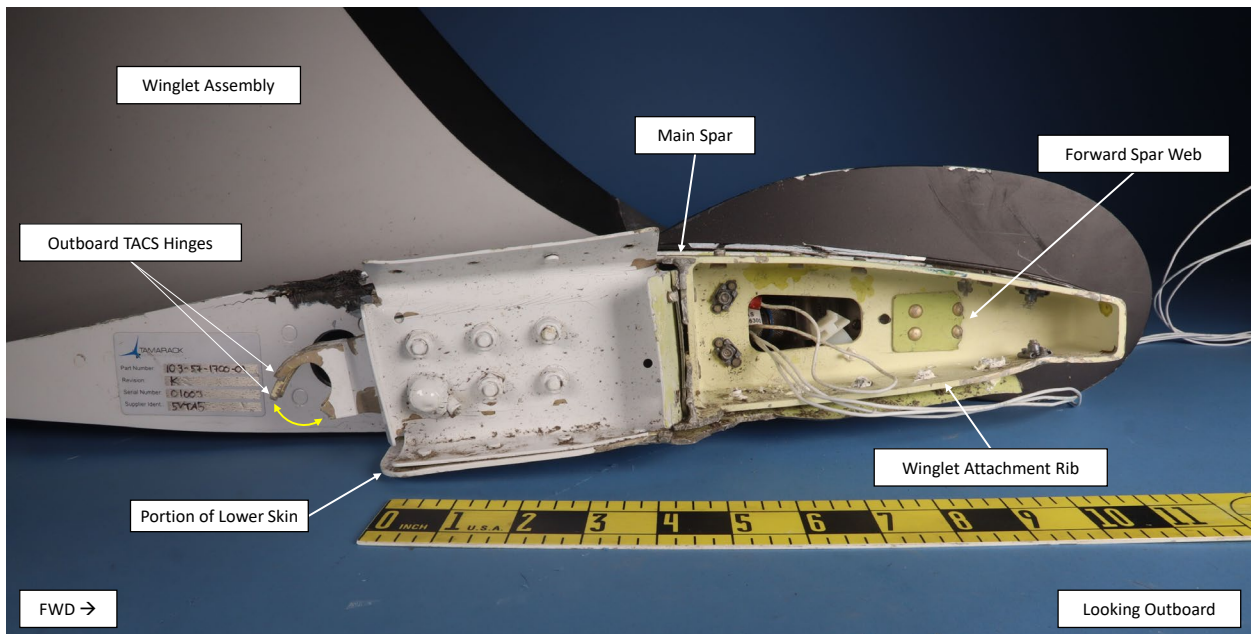
The forward spar web was fractured through the forward set of fastener holes which attached to the winglet attachment rib as indicated in figure 14. The portion of the forward spar web still attached to the accident airplane was plastically deformed and bent aft and downward with the 20 outboard-most fasteners separated from the lower forward spar cap as shown in figure 15, indicated by a yellow bracket. The four circled holes at the inboard spar cap-to-web joints contained fasteners that were removed to aid with disassembly from the accident airplane and no appreciable separation of the web-to-spar cap faying surfaces was observed. The 2 outboard most fasteners and the 2 fasteners just outboard of the weight reduction holes where the forward spar web attached to the upper forward spar cap were separated. The web was partially fractured from the lower surface to the bottom of the outboard weight reduction hole and deformed aft above the outboard weight reduction hole at the location indicated by the red arrow in figure 15, consistent with compressive buckling or torsion loading. The upper and lower forward spar caps were splayed open and partially separated from the leading edge splice joints at the outboard end, consistent with aft bending and/or outward loading on the upper and lower surfaces.

Figure 14. Photograph of the fractured forward spar, main spar (outboard location) and TACS hinge brackets (indicated by the yellow arrow) of the wing extension assembly as viewed looking outboard.

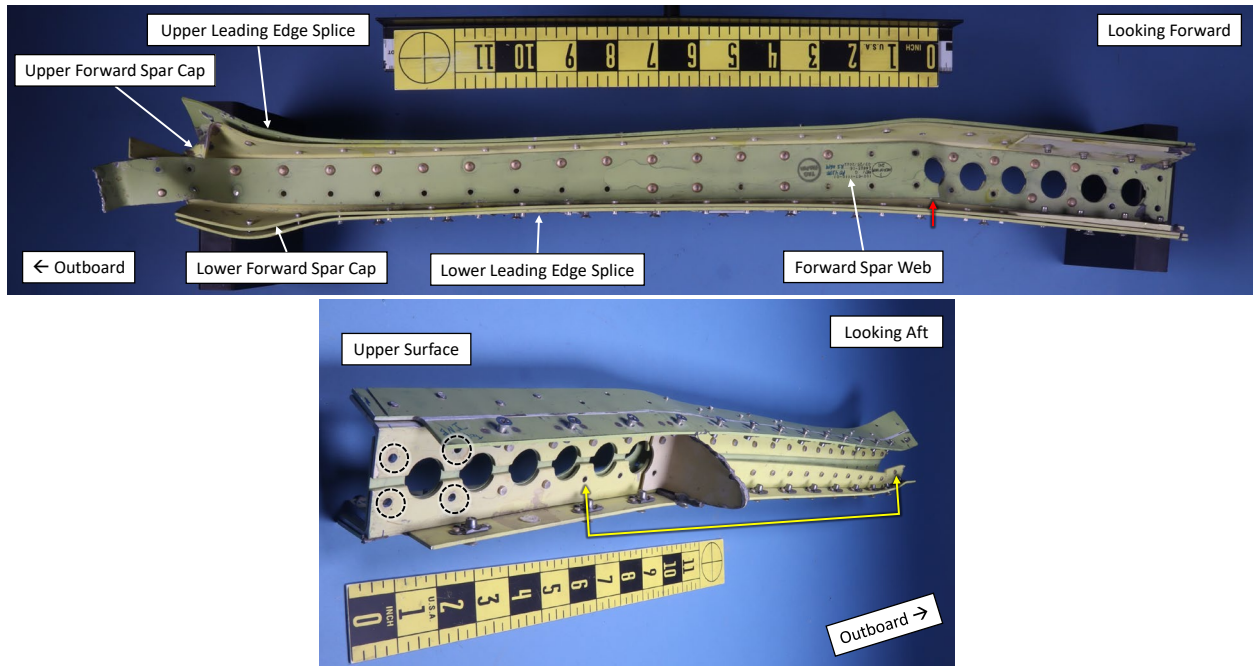
Figure 15. Photographs of the aft side (upper) and forward side (lower) of the wing extension forward spar and leading edge splice joints with the leading edge component removed. The red arrow in the upper image indicates a fracture on the lower side of the forward spar web where localized buckling of the web and upper cap/leading edge splice was observed. The lower image shows fastener separation of the outboard end of the lower forward spar cap from the web indicated by a yellow bracket. The circled locations indicated fasteners removed to aid with disassembly.

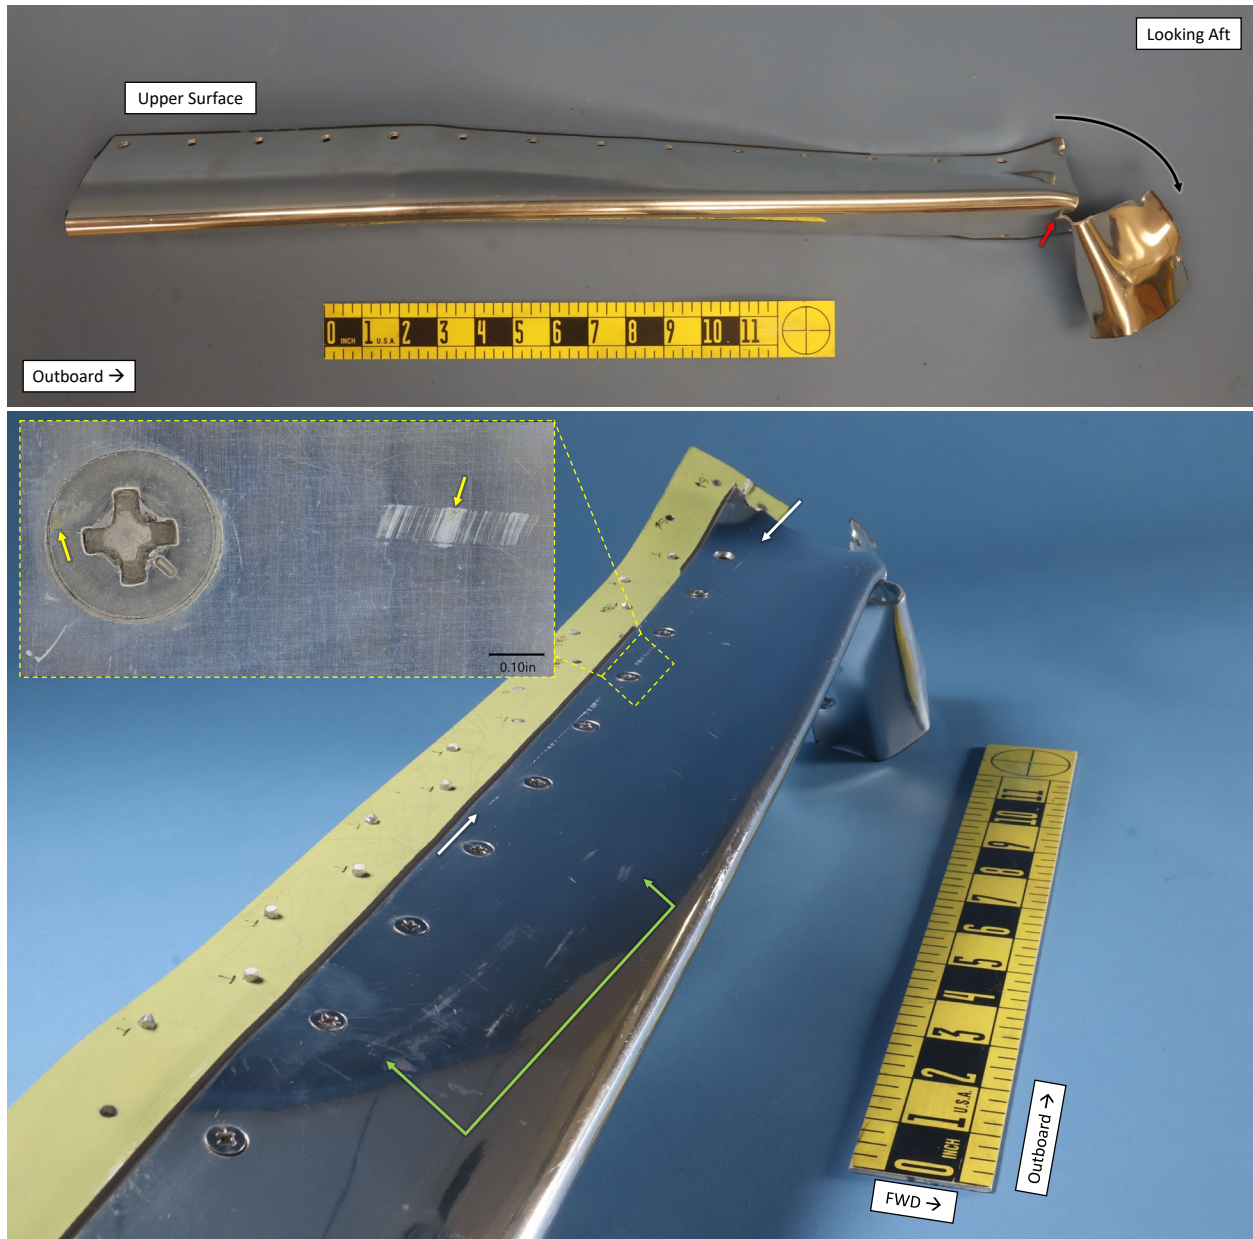
The C-shaped leading edge component was received disassembled from the wing extension assembly as shown in the upper image of figure 16. The chemical composition of the leading edge component was consistent with a 6XXX series aluminum alloy as identified using x-ray fluorescence (XRF) spectroscopy. The leading edge was partially fractured chordwise along the upper surface through the second

fastener hole, approximately 3 inches from the outboard edge. The fracture terminated at the lower surface near the apex of the leading edge as indicated by a red arrow, and the outboard section was bent downward and plastically deformed. The deformed shape of the outboard end of the leading edge matched the profile of the forward end of the winglet attachment rib and witness marks on the inner surface of the leading edge were consistent with contact with the forward end of the winglet attachment rib. A linear streak was observed at the outboard end of the leading edge upper surface which spanned between the white arrows in the lower image of figure 16. The streak consisted of parallel scratches oriented slightly off axis from the chordwise direction as shown in the inset image in figure 16. Two areas of yellow material transfer were observed within the parallel scratches as indicated by yellow arrows. Elevated levels of strontium were detected at these regions using XRF spectroscopy, consistent with a common constituent of chromated primer coatings. Abrasions and scratches were also observed on the upper surface of the leading edge in the area indicated by a green bracket. The outboard fastener holes on the leading edge were enlarged as shown in figure 17, and the lower hole was torn inward consistent with the countersink fastener head pulling through during separation from the winglet attachment rib. The upper fastener hole was elongated between approximately 0.20 - 0.65 inch from the aft edge and deformed forward and slightly outboard relative to the original fastener hole. The lower fastener hole was elongated to approximately 0.60 inch from the aft edge. All other intact leading edge fastener hole locations measured approximately 0.26 and 0.55 inch from the aft edge of the leading edge to the aft and forward edges of the countersunk fastener heads, respectively. The lower outboard leading edge fastener remained secured by the respective nutplate on the winglet attachment rib. The upper outboard leading edge fastener head was fractured and not recovered.

Figure 16. Upper: Photograph of the leading edge component as disassembled from the wing extension assembly showing downward bending (black arrow) near the outboard end from the fracture which arrested on the lower surface near the apex of the leading edge as indicated by the red arrow. Lower: Photograph looking outboard along the leading edge assembled to the forward spar components. A linear streak observed on the upper surface spanned between the two white arrows. A closer view of the boxed area, shown in the inset image shows parallel chordwise scratches and two areas of yellow material transfer indicated by yellow arrows. Abrasions and scratches were also observed in the area indicated by a green bracket.

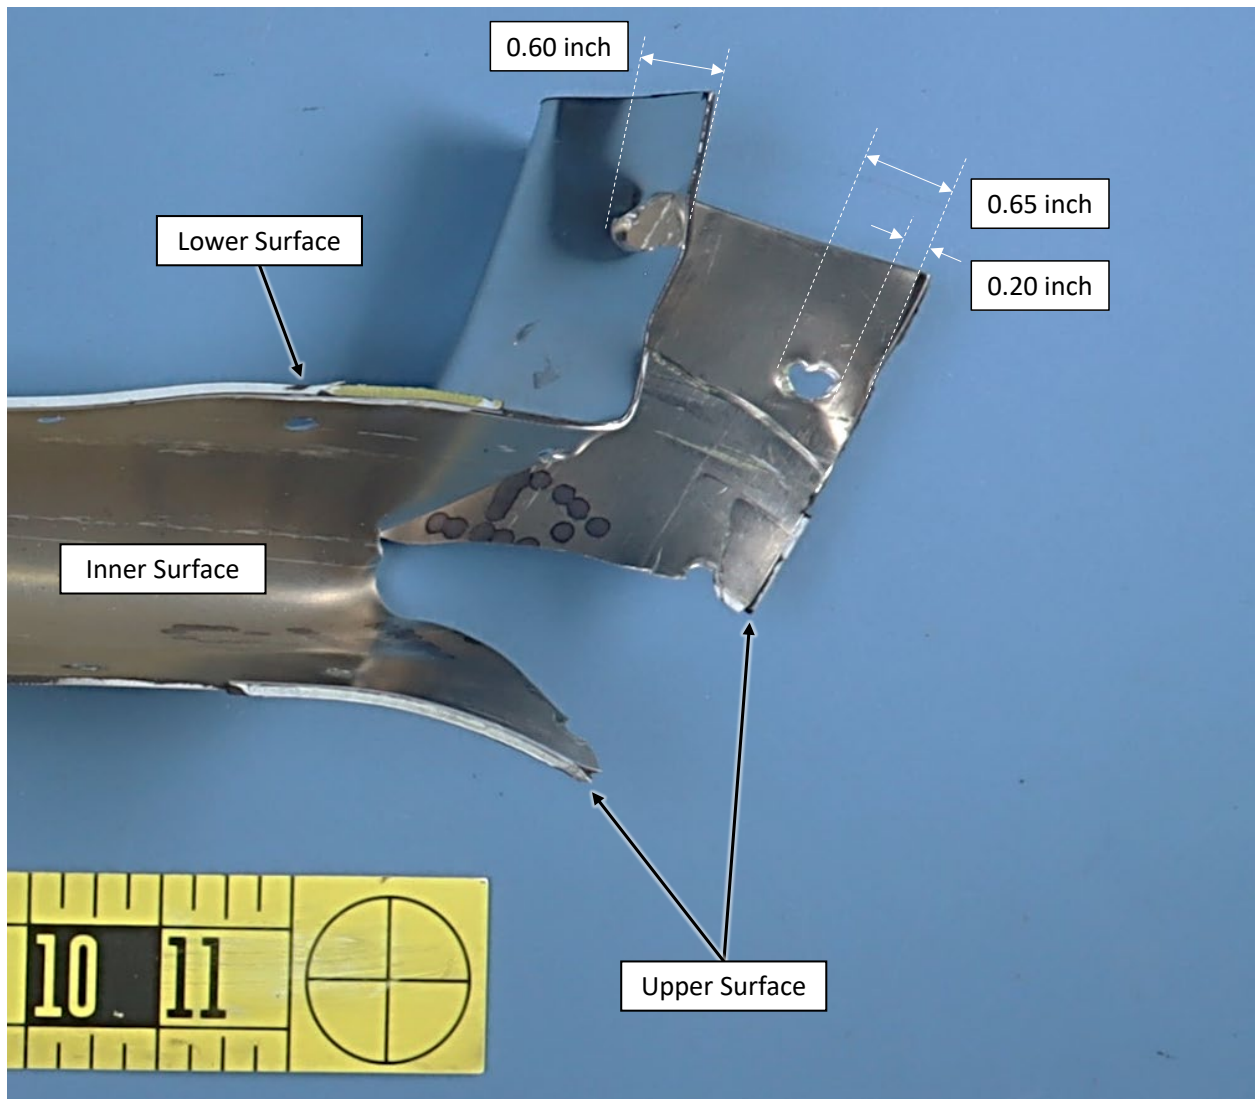
Figure 17. Photograph of the inner surface of the leading edge component showing the elongated outboard fastener hole locations as measured from the aft edge of the part.

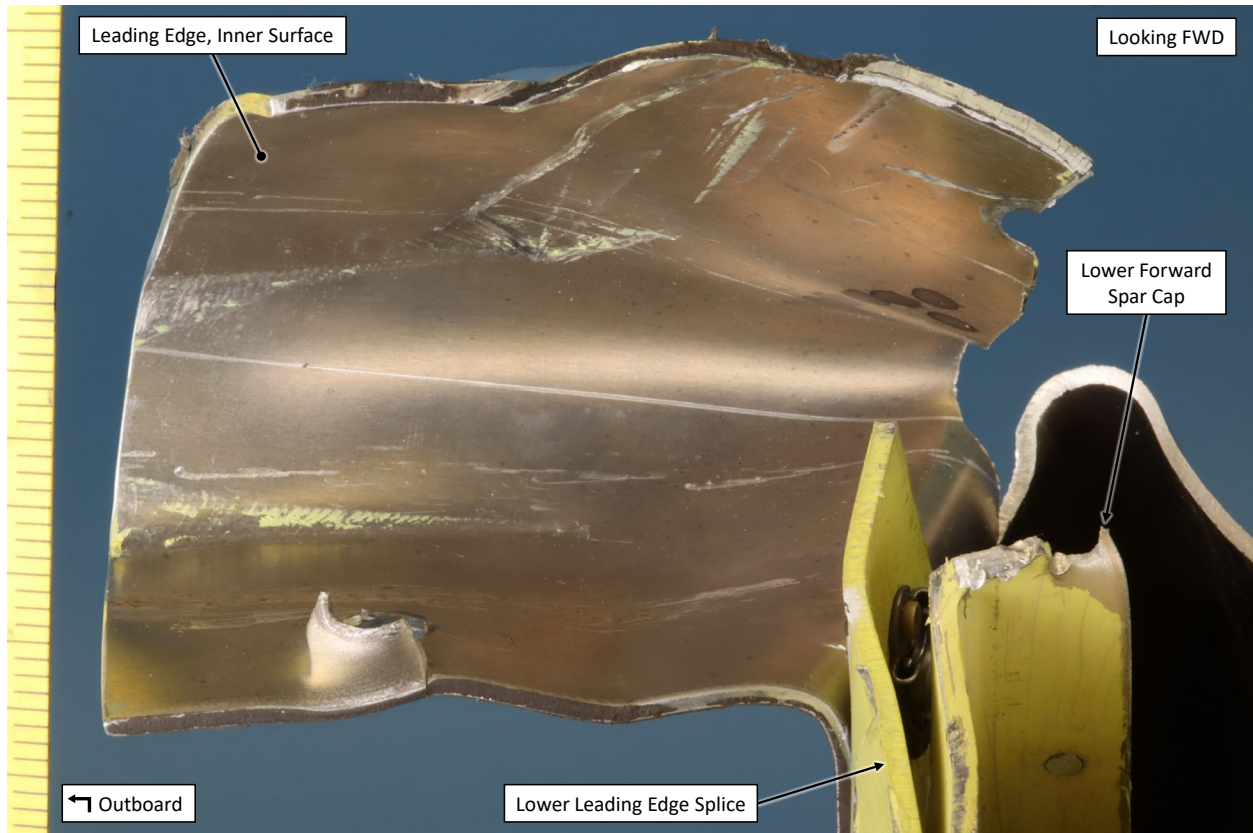
Figure 18. Photograph of the inner surface of the leading edge component after it was reassembled to the leading edge splices. Witness marks such as gouges, dark gray contact marks, and white/yellow paint/primer material transfer was apparent, consistent with contact with the forward end of the wingleet attachment rib shown in the following figure.

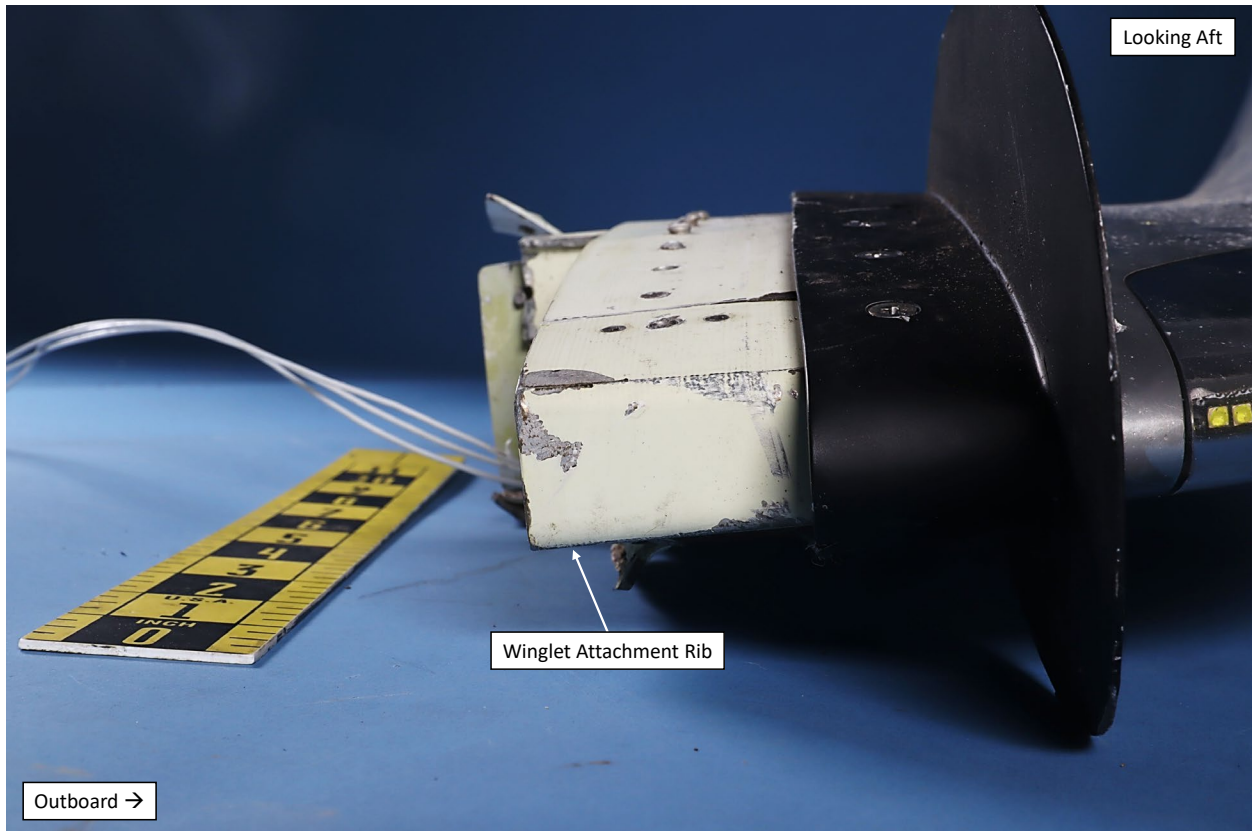
Figure 19. Photograph of the forward end of the winglet attachment rib showing corresponding witness marks (chipped/scraped primer and dark gray contact marks) to the inner surface of the leading edge component.

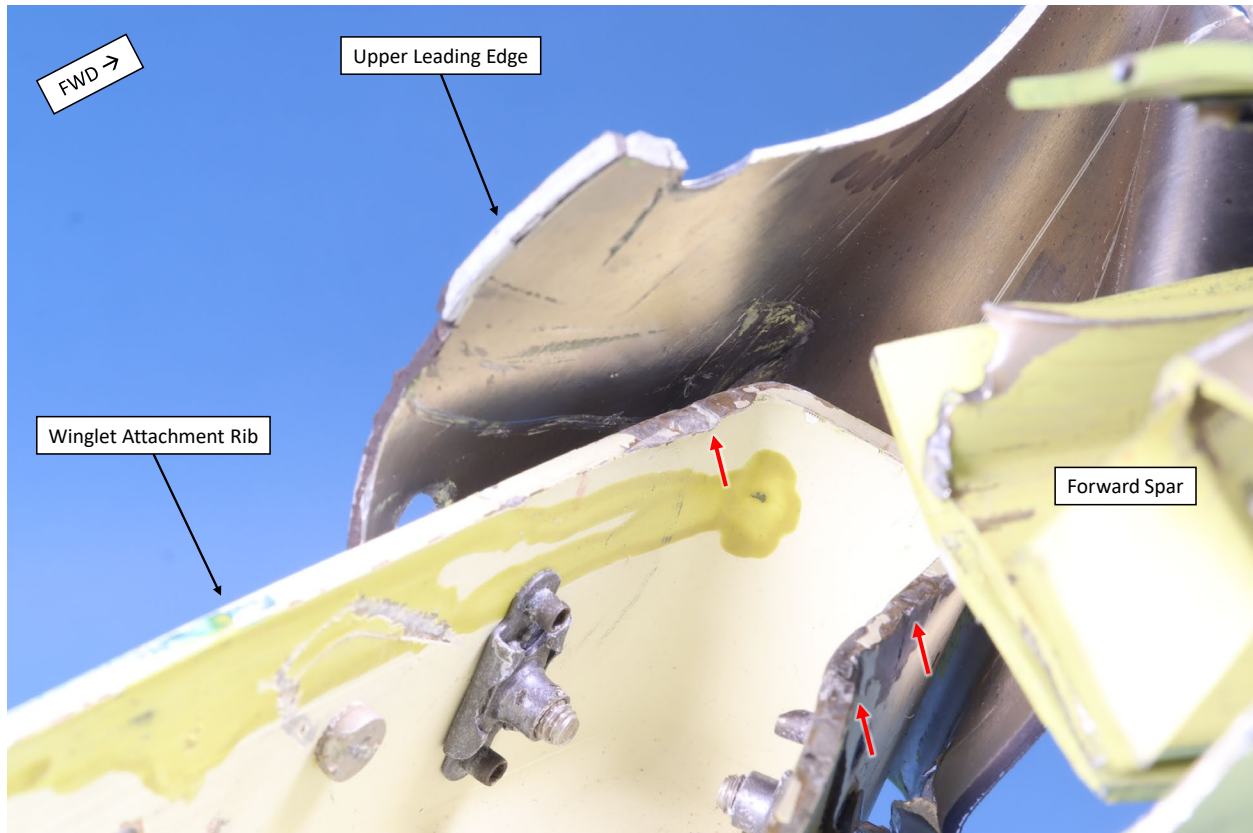
Figure 20. Photograph of the winglet attachment rib placed in close proximity to the connection points on the leading edge component to show the proximity to the witness marks observed on the inner surface of the leading edge. Contact marks on the inboard edge of the winglet attachment rib are indicated by red arrows.
