National Transportation Safety Board

ERA23FA174

MATERIALS LABORATORY

Factual Report 23-051

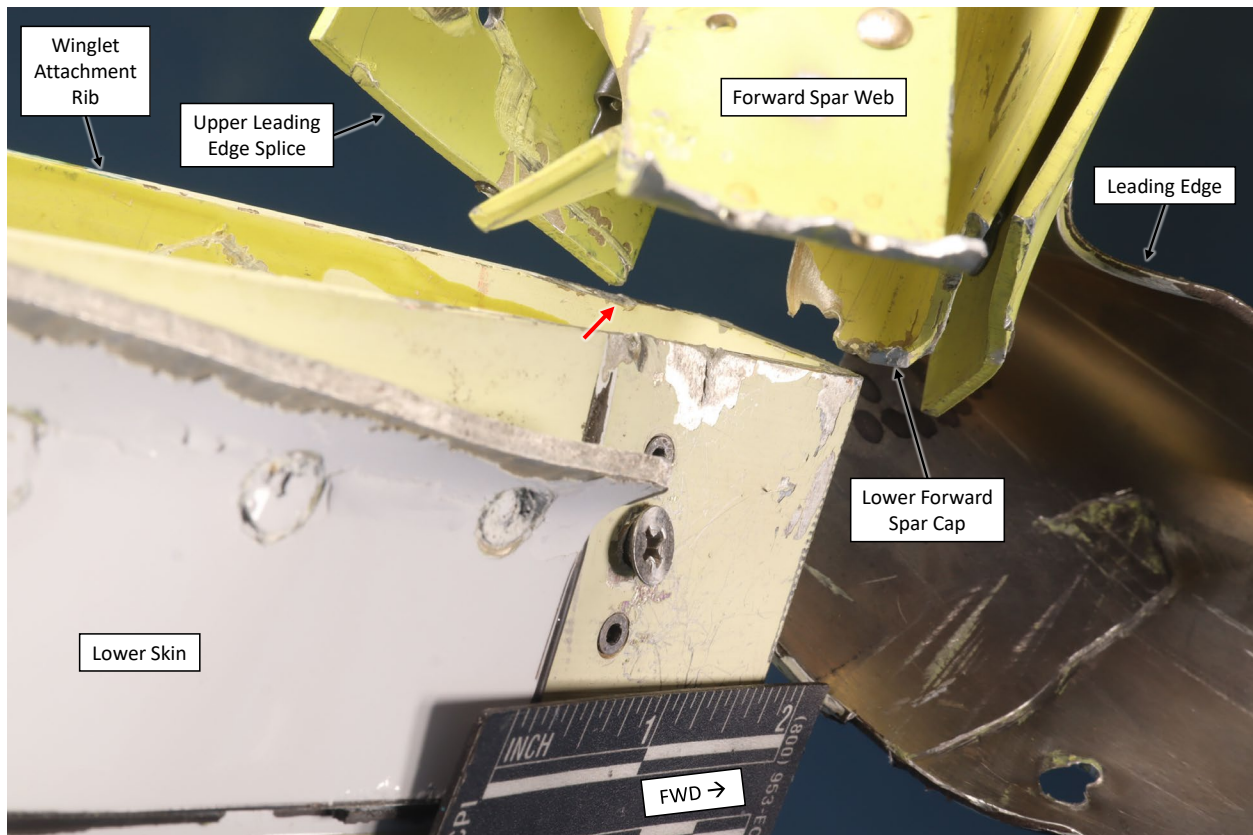
Figure 21. Photograph of the outboard end of the upper leading edge splice aligned with the contact mark on the winglet attachment rib identified in the previous figure (red arrow). The fractured end of the lower forward spar cap closely matches the position of the lower edge of the winglet attachment rib. Scraped and chipped primer was also observed on the lower surface of the upper leading edge splice.

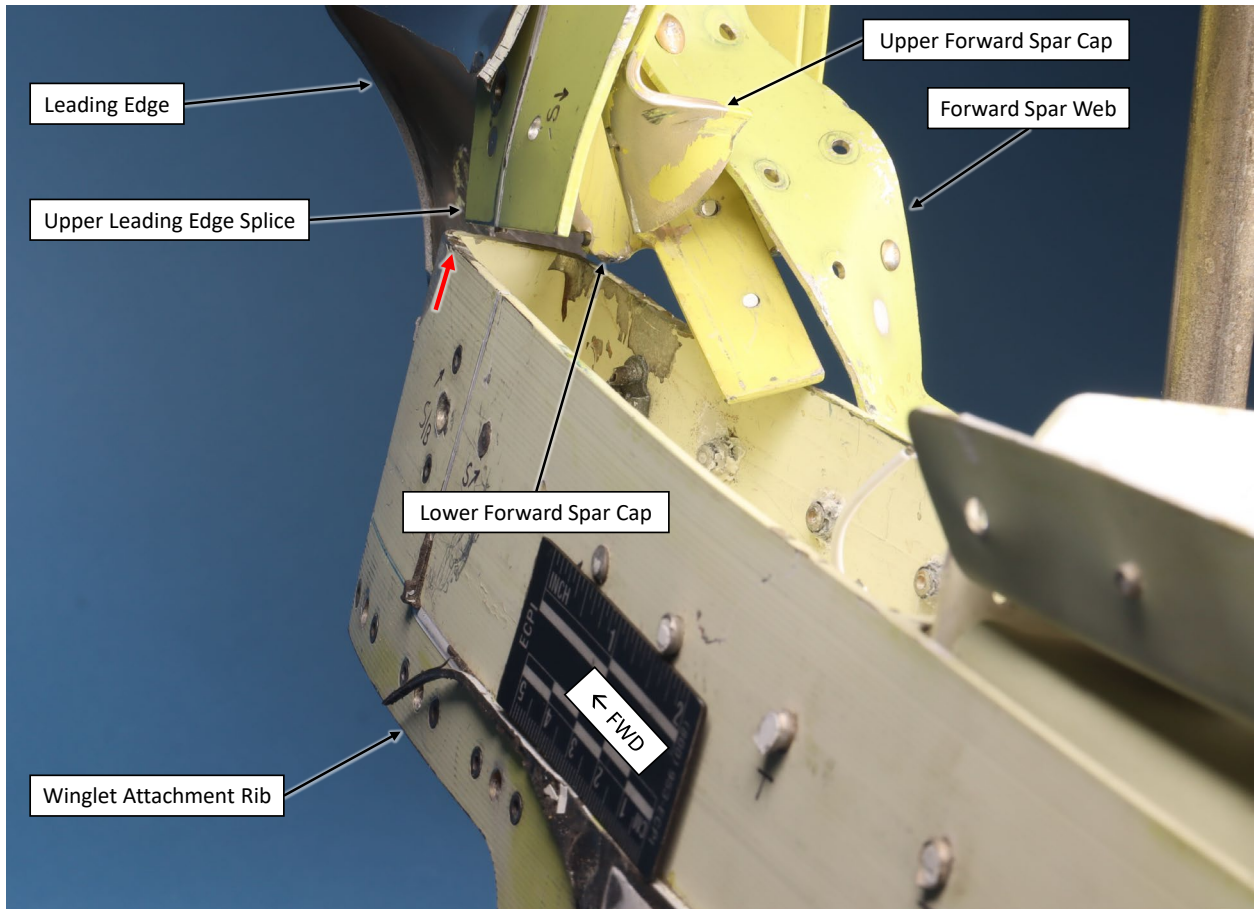
Figure 22. Photograph similar to the previous figure taken from the upper surface. Contact marks and deformation were observed on the upper surface of the upper forward spar cap.

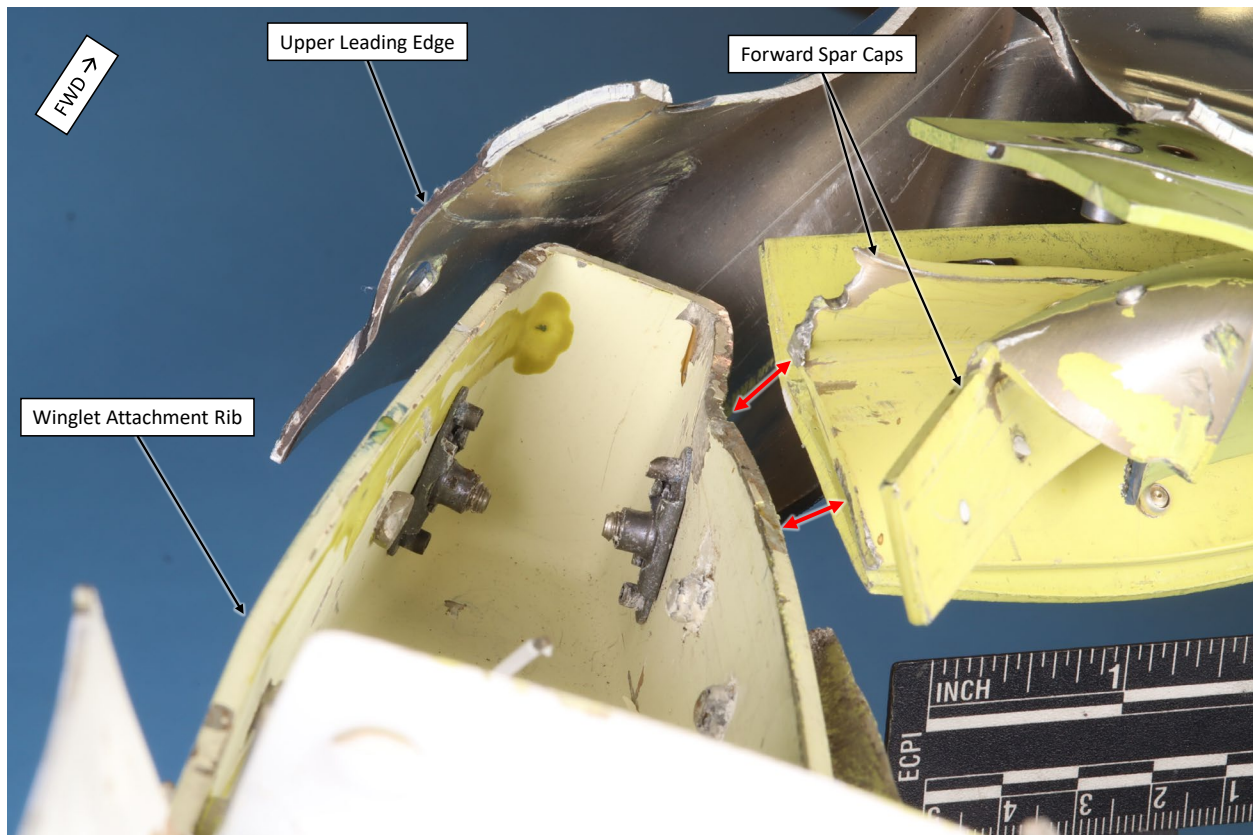
Witness marks, consistent with mechanical contact damage, were observed at the outboard end of the leading edge (inner surface), forward spar, and winglet attachment rib as detailed in figures 17 - 24. The inner surface of the leading edge exhibited white, yellow, and dark gray material transfer marks, consistent with contact with the forward end of the winglet attachment rib, shown in figure 19. Corresponding areas of disturbed and chipped primer were observed on the forward end of the winglet attachment rib. Contact marks were observed on the inboard edge of the winglet attachment rib, indicated by red arrows in figure 20, which shows the upper forward edge of the attachment rib aligned with the inboard contact mark observed on the inner surface of the leading edge. The lower inboard edge of the rib exhibited upward deformation near the contact marks. The mark observed at the upper inboard edge of the rib was consistent with contact with the outboard end of the upper leading edge splice joint. When these features were aligned, as shown from below and above in figures 21 and 22, respectively, the fractured lower forward spar cap interfered with the lower surface of the winglet attachment rib. When the upper forward edge of the attachment rib was aligned with the outboard contact mark observed on the inner surface of the leading edge, as shown in figure 23 (the

outboard portion of the deformed forward spar was removed for clarity), locations of contact marks and deformation observed on the lower inboard edge of the attachment rib corresponded with contact marks observed on the outboard end of the lower forward spar cap as indicated by red arrows. Additional contact marks were observed on the lower side of the upper leading edge splice and the forward side of the upper forward spar cap, which was bent back and downward as shown in figures 21 and 24 (red arrows). A gouge was observed on the forward side of the forward spar web, as indicated by a red arrow, which corresponded to dragging contact with the outboard end of the upper forward spar cap, which was bent aft and upward.

Figure 23. Photograph of the winglet attachment rib aligned with the outboard contact mark on the inner upper surface of the leading edge. Contact marks and deformation observed on the lower inboard edge of the attachment rib corresponded with contact marks observed on the outboard end of the lower forward spar cap as indicated by red arrows. Note the outboard section of the deformed forward spar has been removed for clarity.

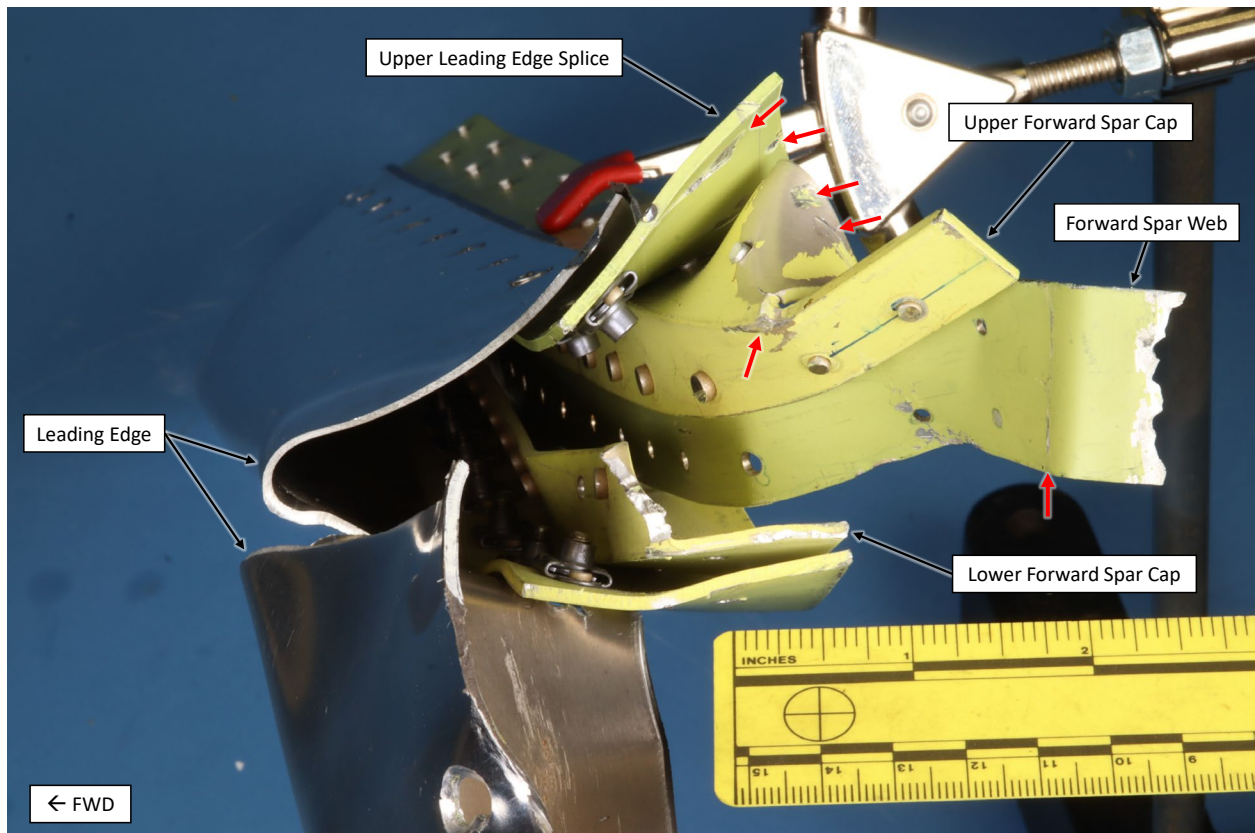
Figure 24. Photograph looking inboard along the forward spar assembled to the leading edge component showing deformation and witness marks (red arrows) near the outboard end. The lower spar cap was separated along the fastener row which connected to the web.

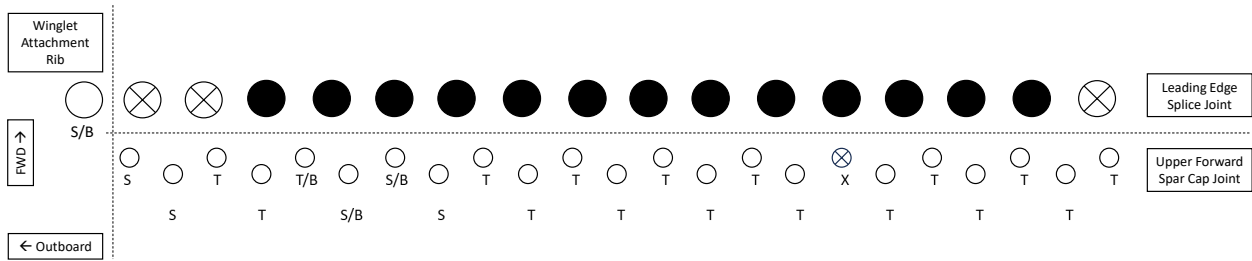
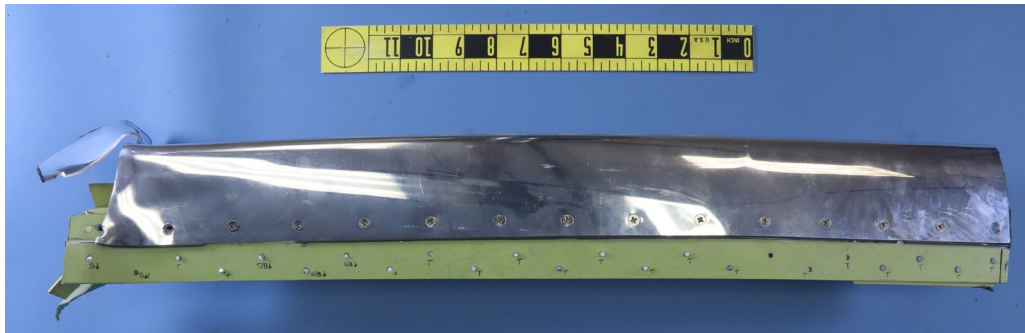
Figure 25. Schematic of the upper leading edge splice joint and upper skin-to-forward spar fastener conditions along the wing extension. Fractured fasteners are identified by an open circle, missing fasteners by a circle with an "X" and intact fasteners by a filled circle. Fracture designations are T = tensile fracture mode, S = shear fracture mode, B = mixed mode bending fracture used in conjunction with T or S as applicable.

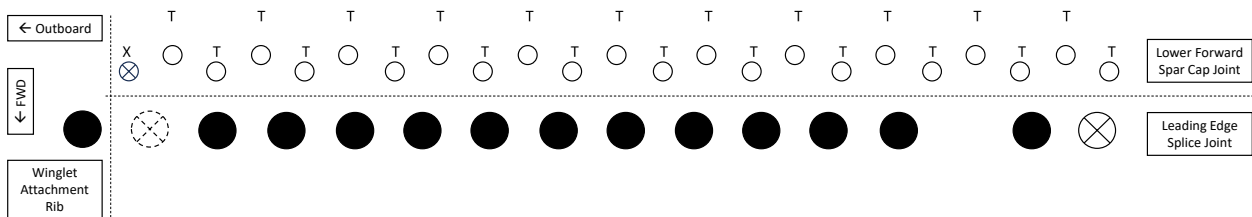
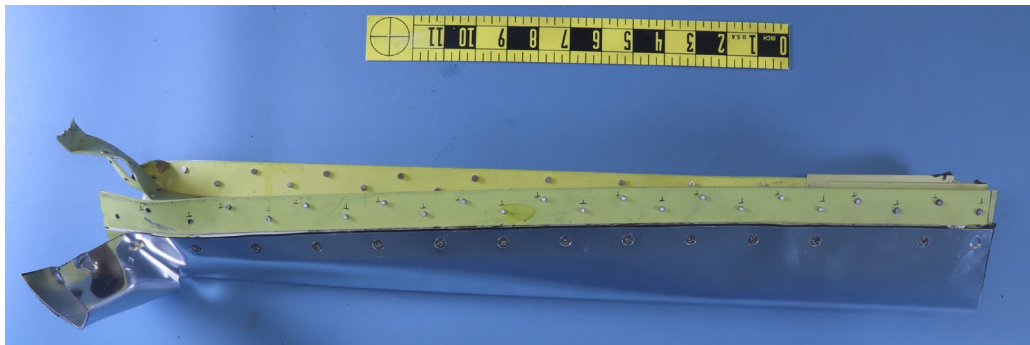
Along the leading edge splice joint, all fasteners were present and intact with the exception of the three outboard most fasteners on the upper surface and the second outboard most fastener on the lower surface (dashed circle in figure 26), which had been drilled out for disassembly prior to receipt by NTSB. The outboard lower leading edge fastener was still retained in the nutplate on the winglet attachment fitting. The upper and lower inboard most fasteners were also not present but the countersunk holes in the leading edge component did not appear damaged or deformed. A total of 23 fastener locations were observed where the upper skin attached to the upper leading edge splice and forward spar cap. Of these locations, 16 fasteners exhibited tensile overstress fracture features, 3 fasteners exhibited shear overstress fracture features, 3 exhibited mixed tensile/shear and bending fractures, and 1 fastener was missing. A total of 23 fastener locations were observed where the lower skin attached to the lower leading edge splice and forward spar cap. All of these fasteners exhibited tensile overstress fractures except the outboard most fastener, which was missing.

Figure 26. Schematic of the lower leading edge splice joint and lower skin-to-forward spar fastener conditions along the wing extension. Fractured fasteners are identified by an open circle, missing fasteners by a circle with an "X" and intact fasteners by a filled circle. Fracture designations are T = tensile fracture mode, S = shear fracture mode, B = mixed mode bending fracture used in conjunction with T or S as applicable. The fastener represented by a dashed "X" circle was drilled out to aid with disassembly.

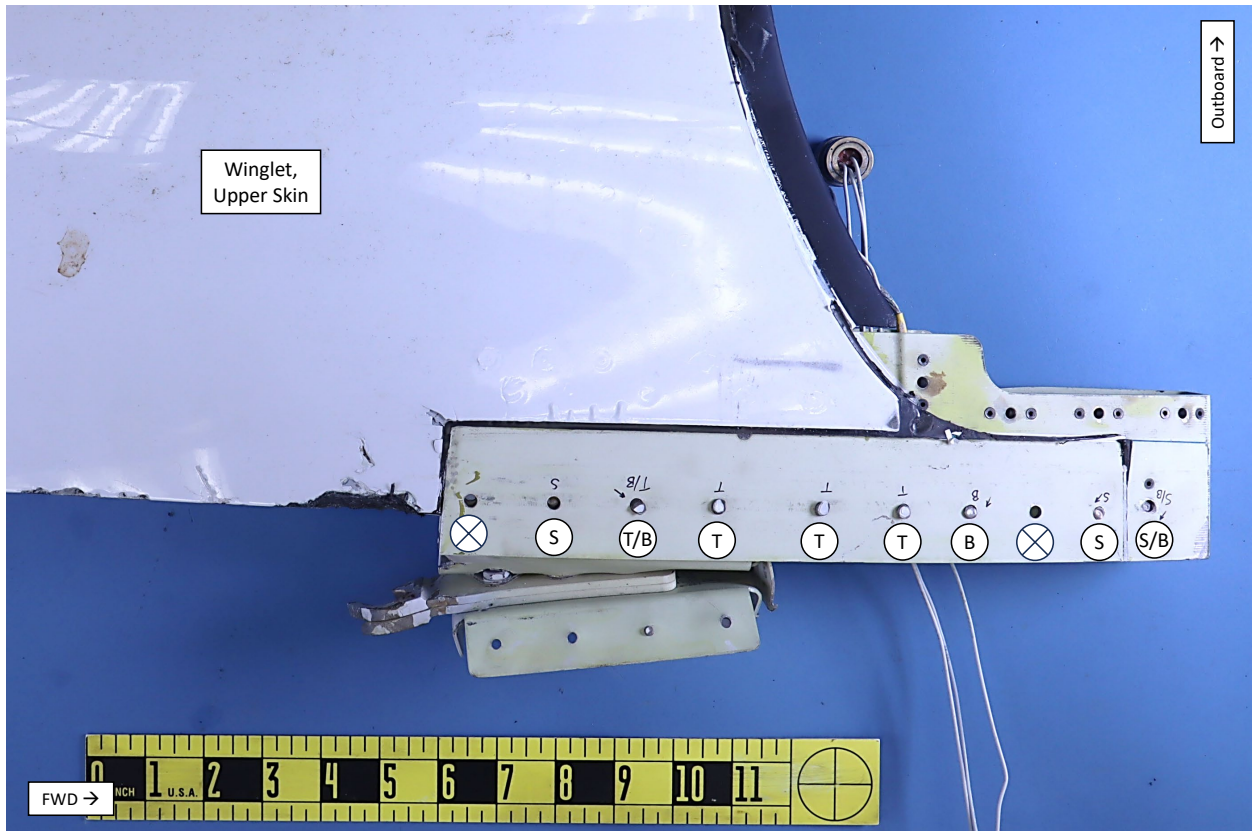
There were 10 fastener locations along the upper surface of the winglet attachment rib where the upper skin and leading edge attached. Of these locations, 3 fasteners exhibited tensile fractures, 2 exhibited shear fractures, 3 exhibited bending or mixed bending shear/tensile fractures, and 2 were missing as indicated in figure 27. The fasteners along the lower surface of the winglet attachment rib, where the lower skin attached, were still intact with a portion of the lower skin retained. The forward fastener where the leading edge attached was bent but still intact and

Figure 27. Schematic of the wing extension upper skin-to-winglet attachment rib fastener conditions. Fractured fasteners are identified by an open circle, missing fasteners by a circle with an "X" and intact fasteners by a filled circle. Fracture designations are T = tensile fracture mode, S = shear fracture mode, B = mixed mode bending fracture used in conjunction with T or S as applicable.

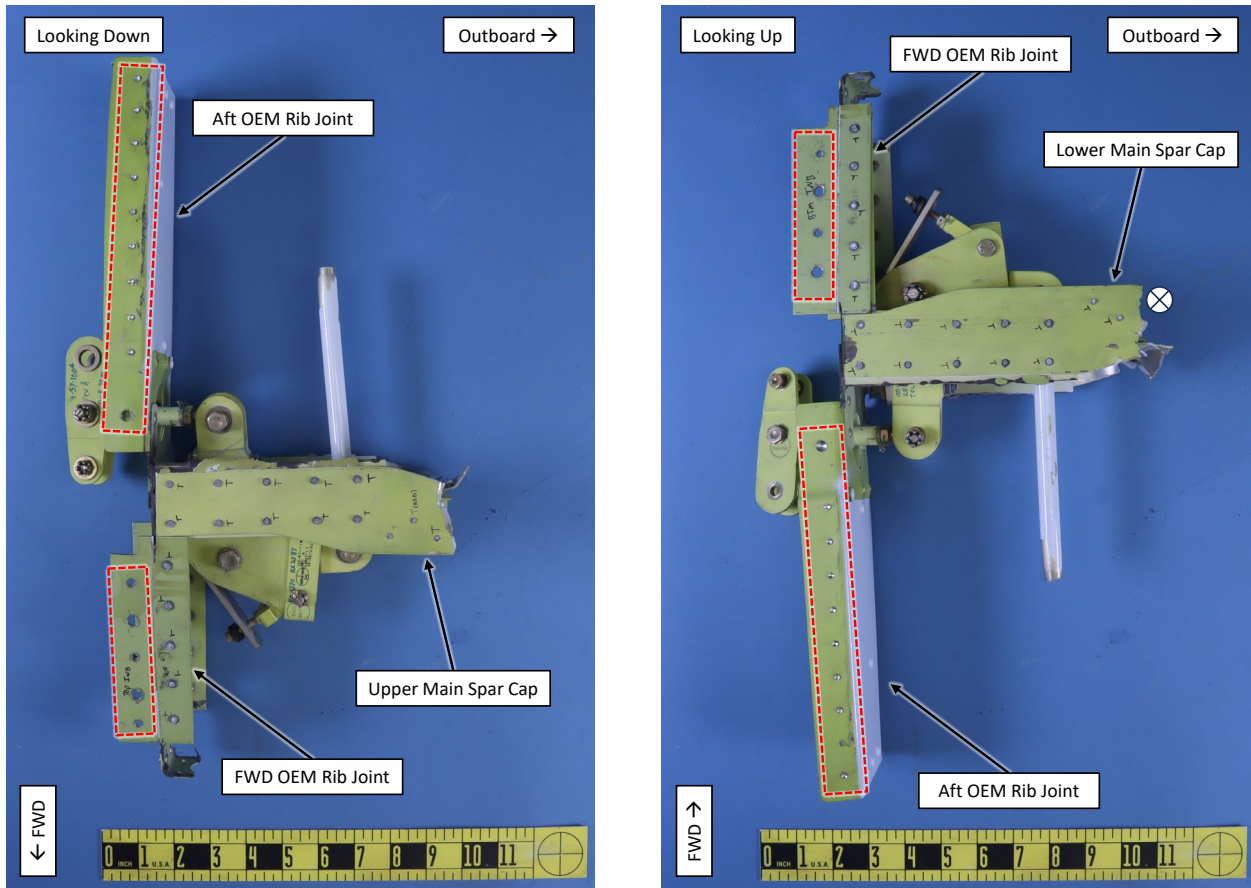
The inboard portion of the wing extension assembly contained 18 fastener locations on the upper and lower sides where the upper and lower skins were attached as shown in figure 28. All of these fasteners exhibited tensile overstress fractures except the outboard most fastener on the lower surface which was missing, and also coincided with the inboard lower main spar cap fracture as shown in the right image of figure 28. The fastener locations bounded by red boxes were drilled out prior to the NTSB Materials Laboratory examination to aid with disassembly from the accident airplane.

Figure 28. Schematic of the inboard wing extension upper skin (left) and lower skin (right) fastener conditions. All fractured fasteners exhibited tensile fracture modes. Fastener locations within the red boxes were drilled out to aid with disassembly from the accident airplane.

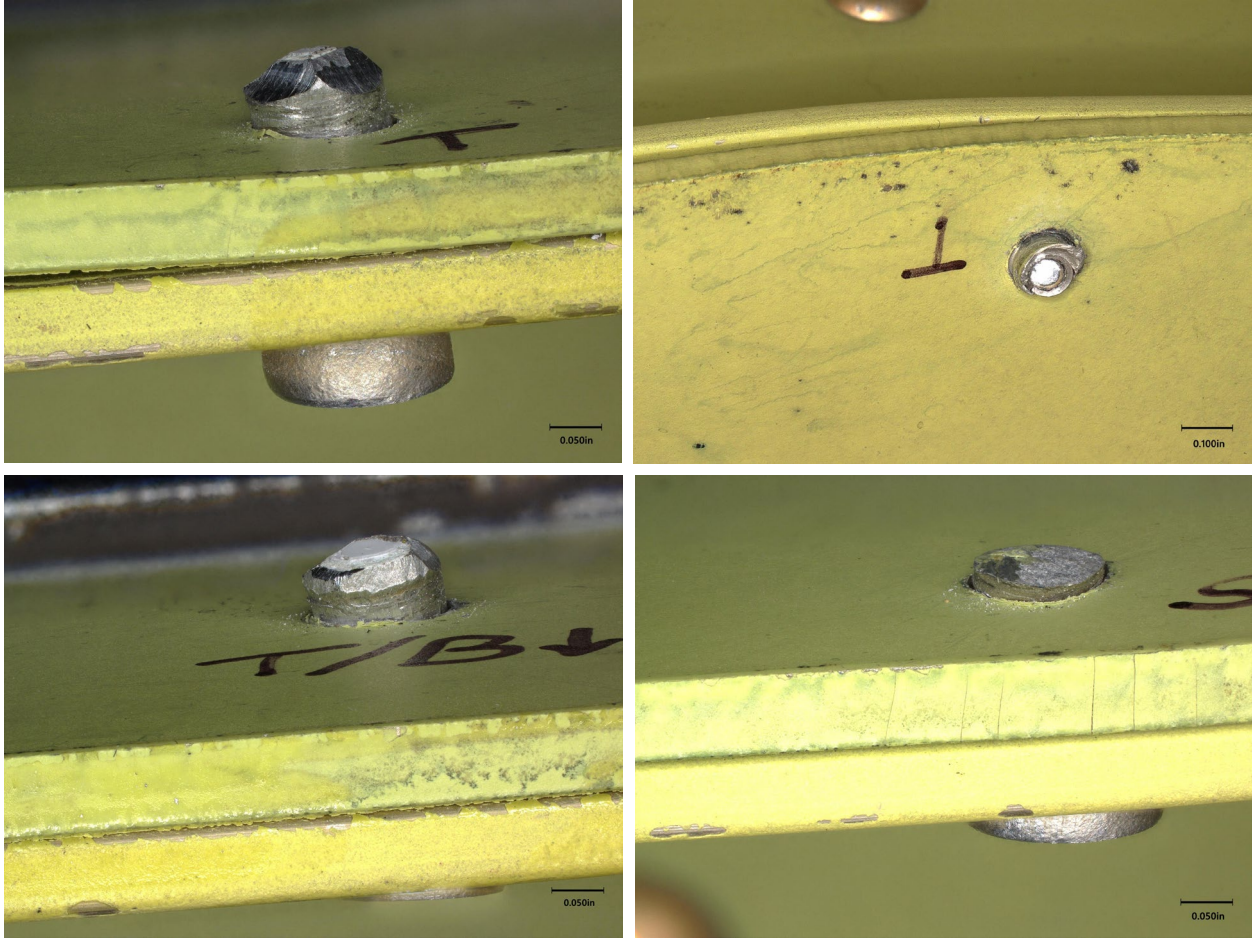
Examples of typical rivet fractures are shown in figure 29 with solid rivet tensile/bending fractures shown on the left, a blind rivet tensile fracture shown in the upper right, and a solid rivet shear fracture shown in the lower right.

Figure 29. Digital microscope images showing typical fractured fastener characteristics for solid rivet tensile fracture mode (upper left), solid rivet tensile/bending fracture mode (lower left), blind rivet tensile fracture mode (upper right), and solid rivet shear fracture mode (lower right).

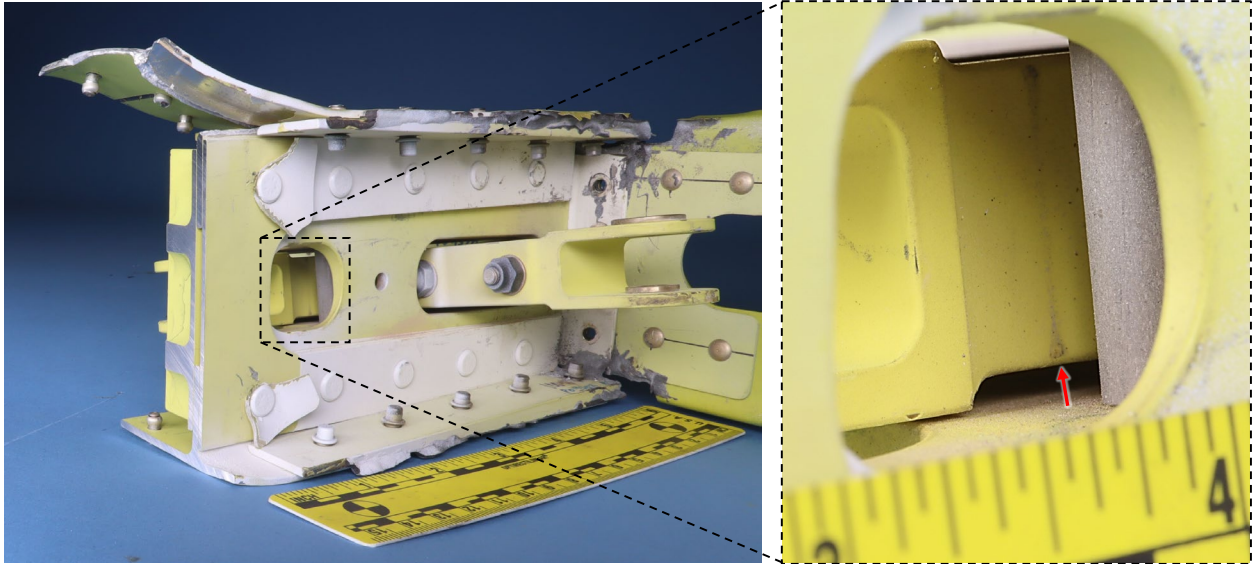
The bellcrank mechanism and connections were visually examined from the walking beam component to the fractured TACS tube component as identified in figure 8. Flanged bushings were observed installed in all walking beam holes. The walking tube (short pushrod) assembly was installed to the walking beam fitting at the pivot point and the installed cotter pin was intact. The lock wires at the inboard and outboard jam nuts on the short pushrod assembly were intact. The short pushrod assembly was connected to the bellcrank. The bellcrank and spring assembly was attached to the bellcrank bracket about the pivot point and via the TACS return bracket with lockwire about the jam nut and TACS return bracket still intact. As received, the bellcrank had approximately 0.23 inch range of motion between aft contact with the bushing installed through the bellcrank bracket and forward movement restricted by the spring when engaged with the screw and spherical washers attached to the TACS return bracket. Range of motion was measured along the TACS return bracket fail stop edge, indicated by two horizontal black lines in the right image of figure 31. Light vertical contact marks were observed on the bellcrank which closely matched the position of the forward side of the bushing and the aft side of the TACS return bracket as indicated by a red arrow in figures 30 and 31.

Figure 30. Photograph of the aft side of the bellcrank mechanism showing a light contact mark indicated by a red arrow in the right image which closely matched the position of the forward side of a bushing on the bellcrank bracket.

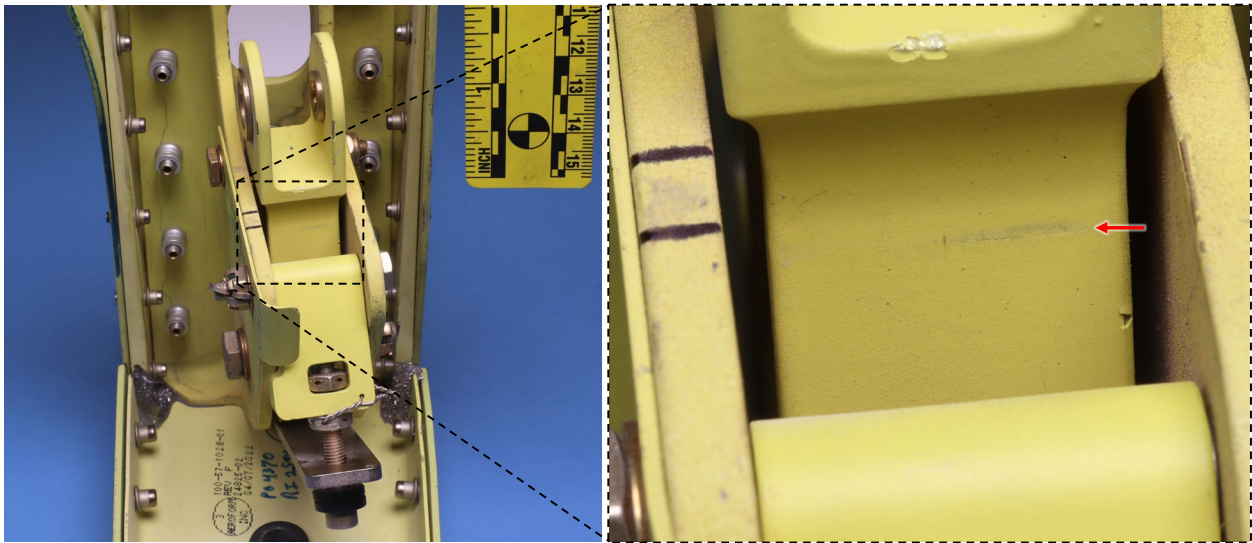
Figure 31. Photograph of the forward side of the bellcrank mechanism showing a light contact mark indicated by a red arrow in the right image which closely matched the position of the TACS return bracket.

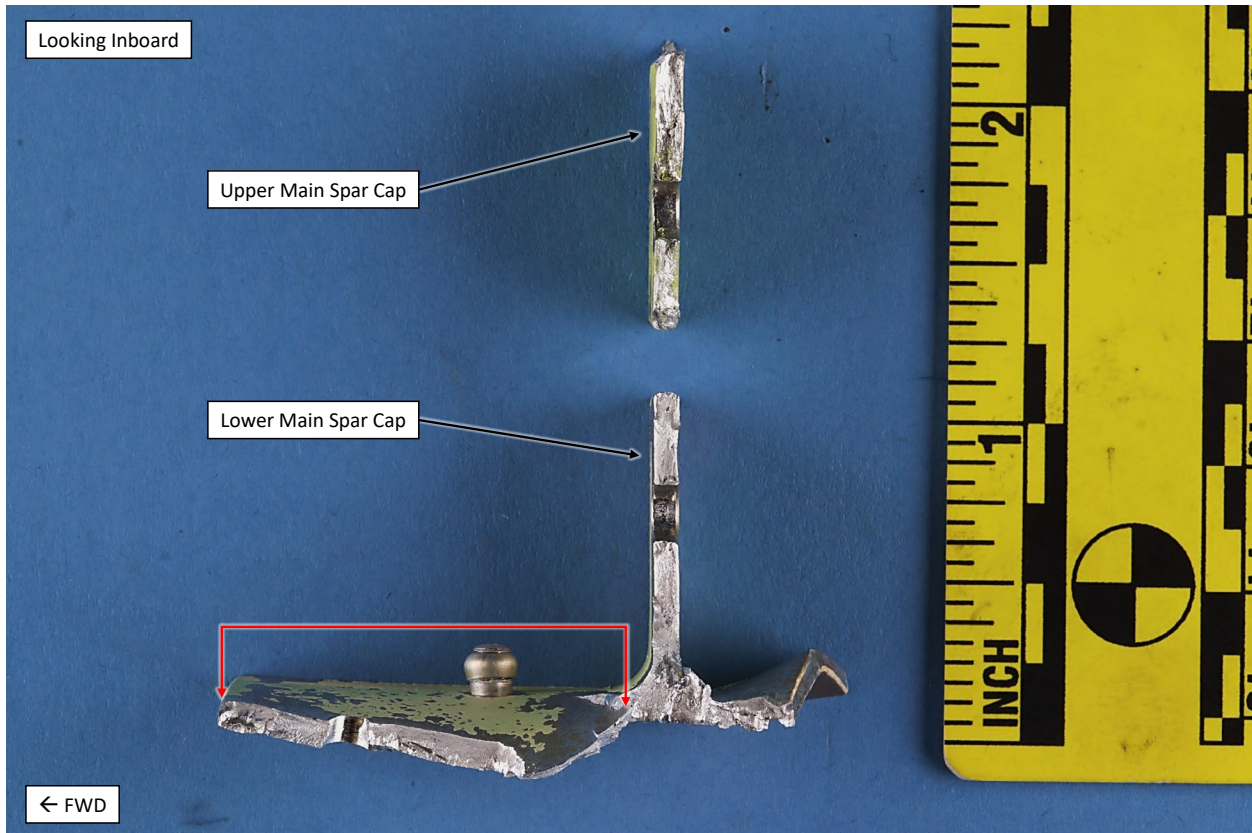
assembly and disassembled from the bellcrank bracket and main spar web for closer examination of the fracture surfaces as shown in figure 32. The upper main spar cap fracture surface was smeared, with a greater degree of smearing on the upper side of the fastener hole.

A secondary crack was observed along the forward flange of the lower main spar cap at the inboard fracture location through the next outboard lower skin fastener location as indicated by a red bracket in figure 32. The flange was deformed downward, and the fracture surface exhibited shear lip features consistent with overstress separation. The aft flange of the lower main spar cap exhibited smearing damage and shear lip features on the fracture surface and was buckled, consistent with compressive loading and overstress separation. The upper part of the lower main spar cap stem fracture surface above the fastener hole exhibited a smeared and battered appearance consistent with post separation contact damage as shown more closely in figure 35.

Figure 32. Photograph of the main spar cap fracture surfaces (inboard fracture location) showing a secondary crack along the forward flange of the lower main spar cap indicated by the red bracket. Bending and buckling deformation was observed along the lower flanges. Smearing and contact damage was observed on the upper spar cap fracture surface, around the fastener holes, and along the aft flange fracture surface.

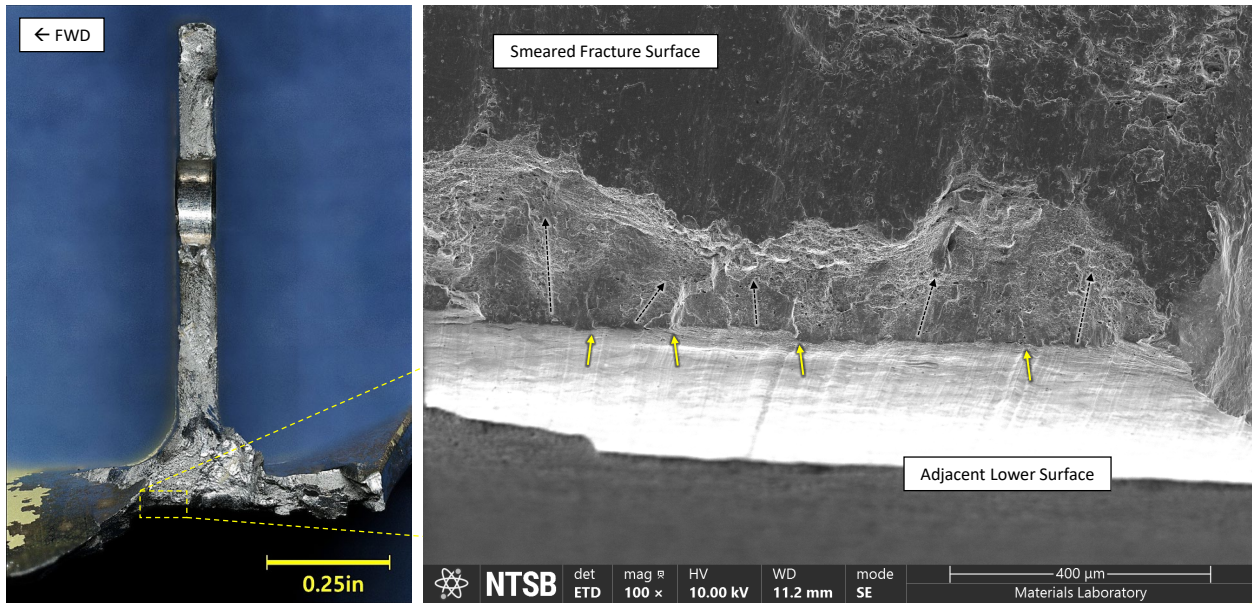
A scanning electron microscope (SEM) was used to examine fracture features on the spar caps more closely. The lower main spar cap exhibited fracture initiation sites at the lower surface, opposite of the stem-to-flange junction as indicated by yellow arrows in figure 33. These radial marks emanated from an area of parallel streaks on the adjacent lower surface over a region which extended upward into the part approximately 0.01 inch as indicated by black dashed arrows, over a relatively flat plane before transitioning to rougher fracture features and smearing damage. The streaks observed on the adjacent lower surface were consistent with machining marks or surface patterns generated during an extrusion process. Figure 34 shows a typical example of the fracture initiation area at higher magnification using a secondary electron detector. Dimpled features were observed interspersed with islands of linear striated features, oriented horizontally in these images, and the fracture mode was consistent with overstress dominated tensile or upward bending fracture.

Figure 33. Secondary electron fractograph (right) of the lower main spar cap fracture and adjacent lower surface in the area indicated by the yellow box in the left image. Fracture initiation sites (yellow arrows) were observed emanating from the lower surface from parallel features consistent with machining marks or extrusion lines observed on the lower surface. The fracture progressed over a relatively flat plane as indicated by black arrows before transitioning to rougher fracture features that were obscured by smearing damage.

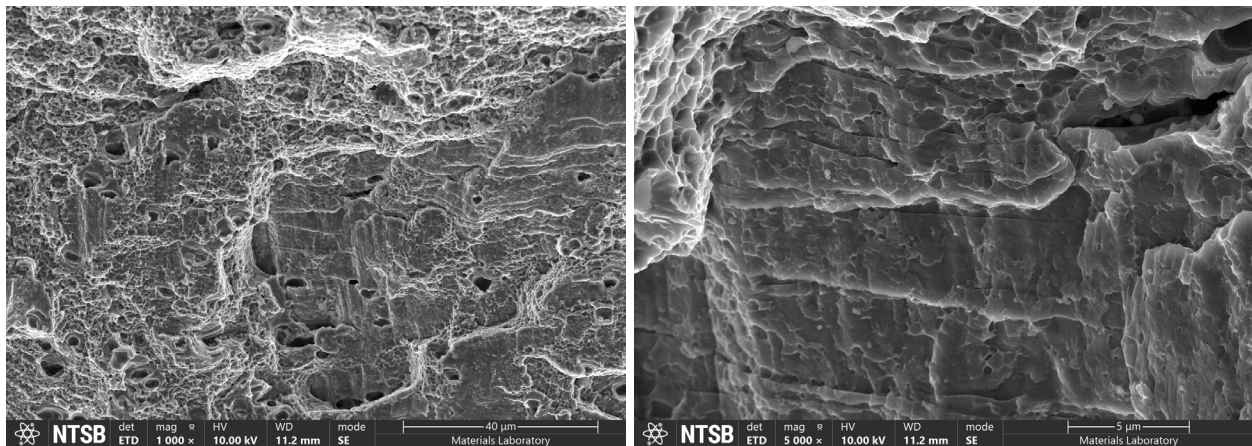
Figure 34. Secondary electron fractographs of the previous figure at higher magnifications showing dimpled features interspersed with islands of striated features oriented horizontally in these images.

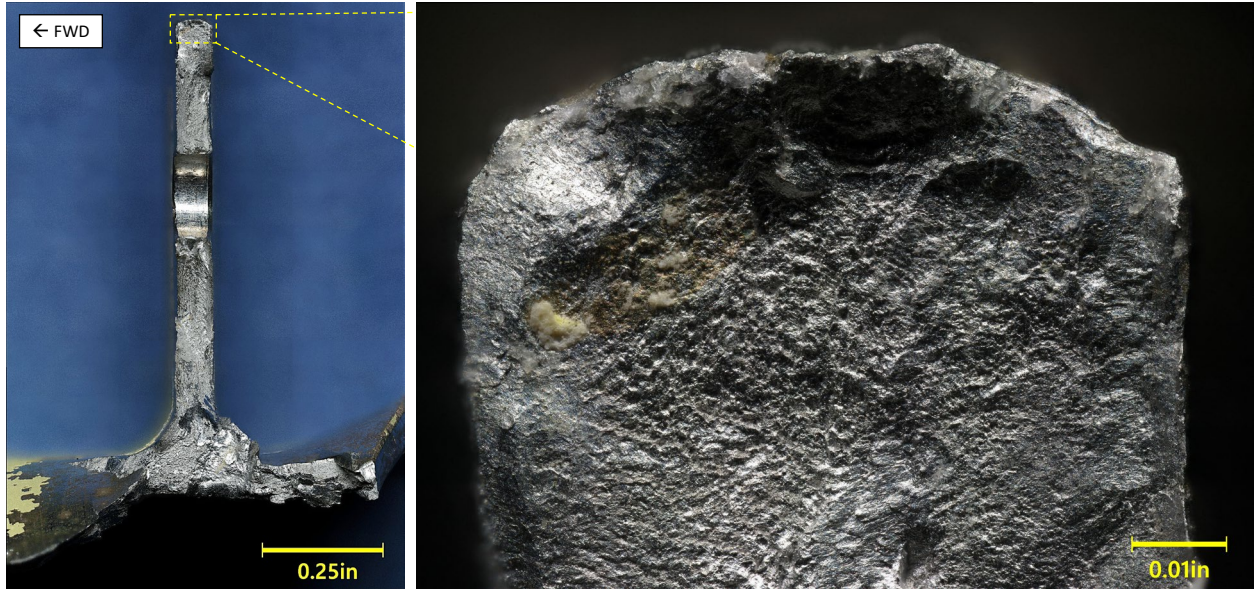
Figure 35. Digital microscope images of the fracture surface near the upper edge of the lower main spar cap (inboard fracture location) showing a smeared and battered appearance consistent with post separation contact damage.

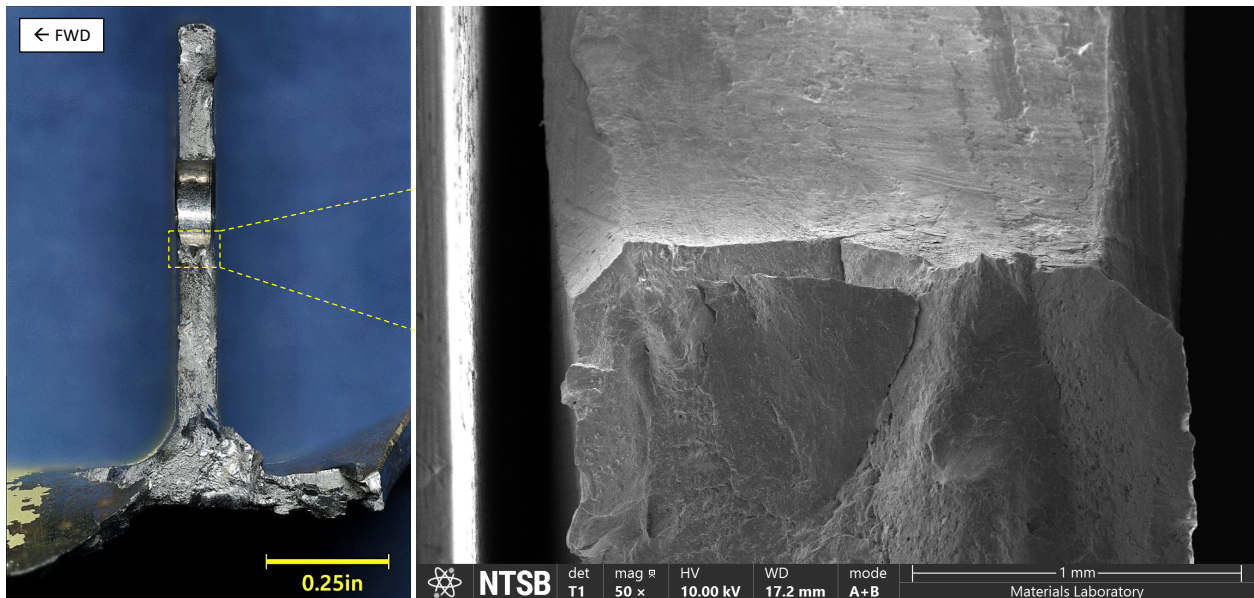
The appearance of the lower main spar fracture surface at the inboard location around the main spar web/bellcrank fitting fastener hole location were examined more closely as shown in figures 36 - 40. These areas were smeared and exhibited mechanical contact damage. Just below the fastener hole (figures 36 and 37), dimpled fracture features were observed at higher magnification where smearing was less prevalent, as shown in the scanning electron microscope image in figure 37, consistent with overstress fracture. Just above the fastener hole, as shown in figure 38, smearing and contact damage was observed adjacent to the hole. The central fractured region as shown in the SEM image exhibited a rough dimpled appearance with shear lip features and necking deformation observed on the right and left side of the spar cap stem, consistent with overstress separation. Closer views of the boxed area in the SEM image are shown in figures 39 and 40, which was above an area where mechanical contact/smearing damage was observed. This area exhibited

Figure 36. Secondary electron fractograph (right) of the lower main spar cap fracture surface (inboard fracture location) below the fastener hole showing mechanical contact damage.

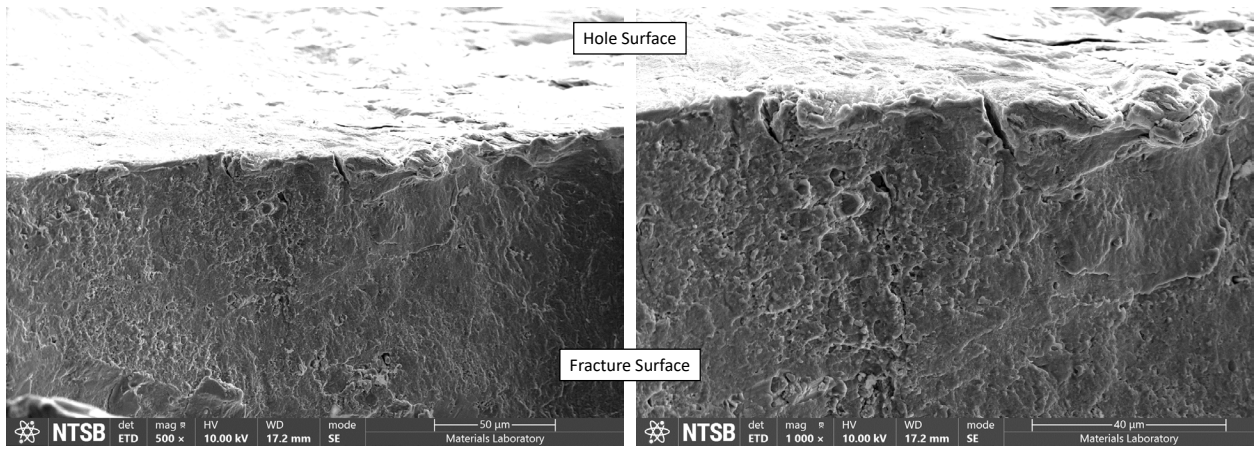
Figure 37. Secondary electron fractographs of the previous figure at higher magnifications showing dimpled fracture features where smearing damage was less pronounced.

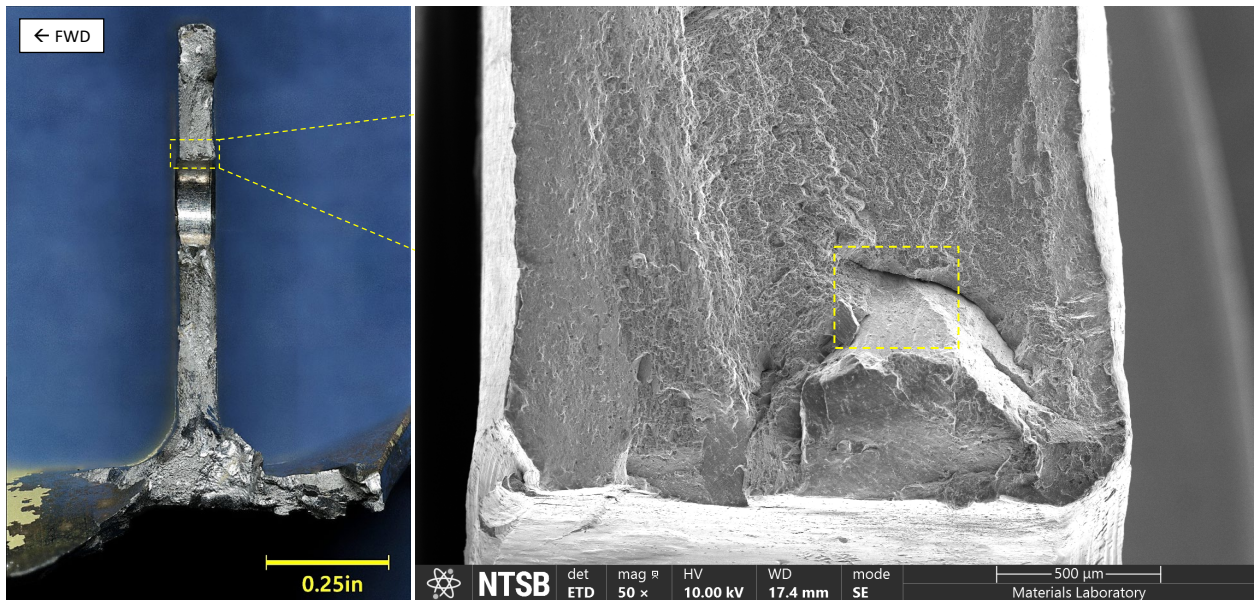
Figure 38. Secondary electron fractograph (right) of the lower main spar cap fracture surface (inboard fracture location) above the fastener hole showing mechanical contact damage. Shear lip features and necking deformation were observed along the forward and aft edges of the stem with a rougher central region between. The area highlighted by a yellow box in the right image was observed more closely as detailed in the following figures.

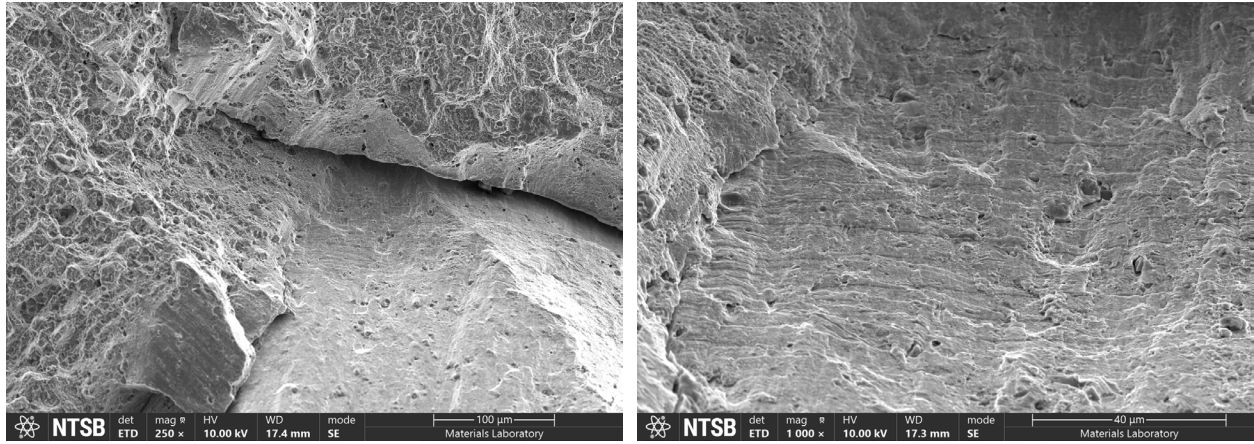
Figure 39. Secondary electron fractographs of the previous figure at higher magnification showing horizontally oriented striated features interspersed with dimpled fracture features.

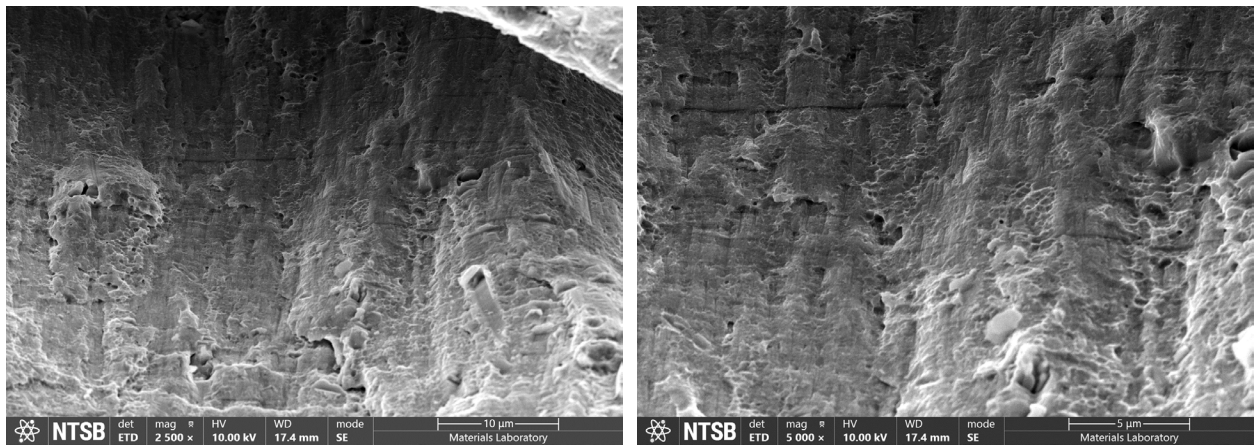
Figure 40. Secondary electron fractographs of the previous figure at higher magnifications.

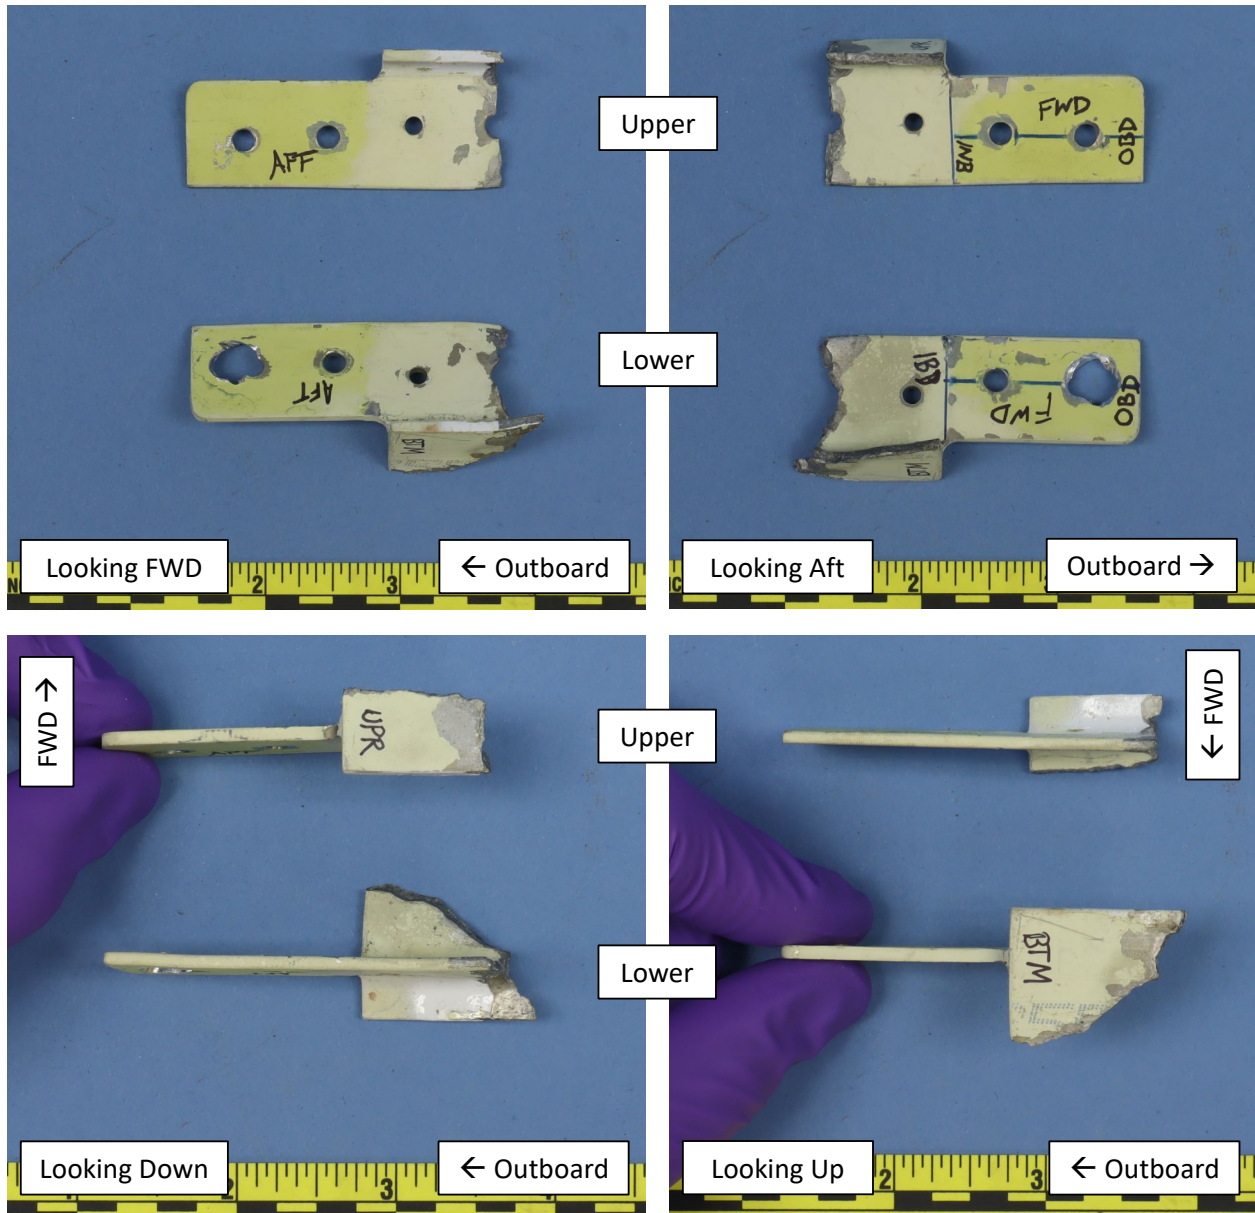
The fractured main spar caps at the inboard end of the winglet attachment rib (outboard main spar fracture location) were disassembled from the attachment rib, main spar web, and outboard TACS hinge bracket supports for closer examination. Views of the spar caps as disassembled are shown in figure 41. Figure 42 shows a view of the fracture surfaces tilted slightly aft. The fracture path along the spar cap stems was oriented along a chordwise plane transverse to the wing axis. The fracture surface in the vicinity of the fastener holes was smeared, consistent with mechanical contact damage. The aft flanges exhibited smeared shear lip features, consistent with overstress separation. The forward flanges of both main spar caps were fractured from the stem fracture surface to the outboard end of the part. The lower spar cap forward flange fracture surface extended along a forward angled path and exhibited a shear lip, consistent with overstress separation. The upper spar cap forward flange fracture surface extended along the wing axis and was relatively rough in appearance.

Figure 41. Photographs of the fractured main spar caps (outboard fracture location) after disassembly from the winglet attachment rib, main spar web, and TACS hinge support brackets.
