National Transportation Safety Board

ERA23FA174

MATERIALS LABORATORY

Factual Report 23-051

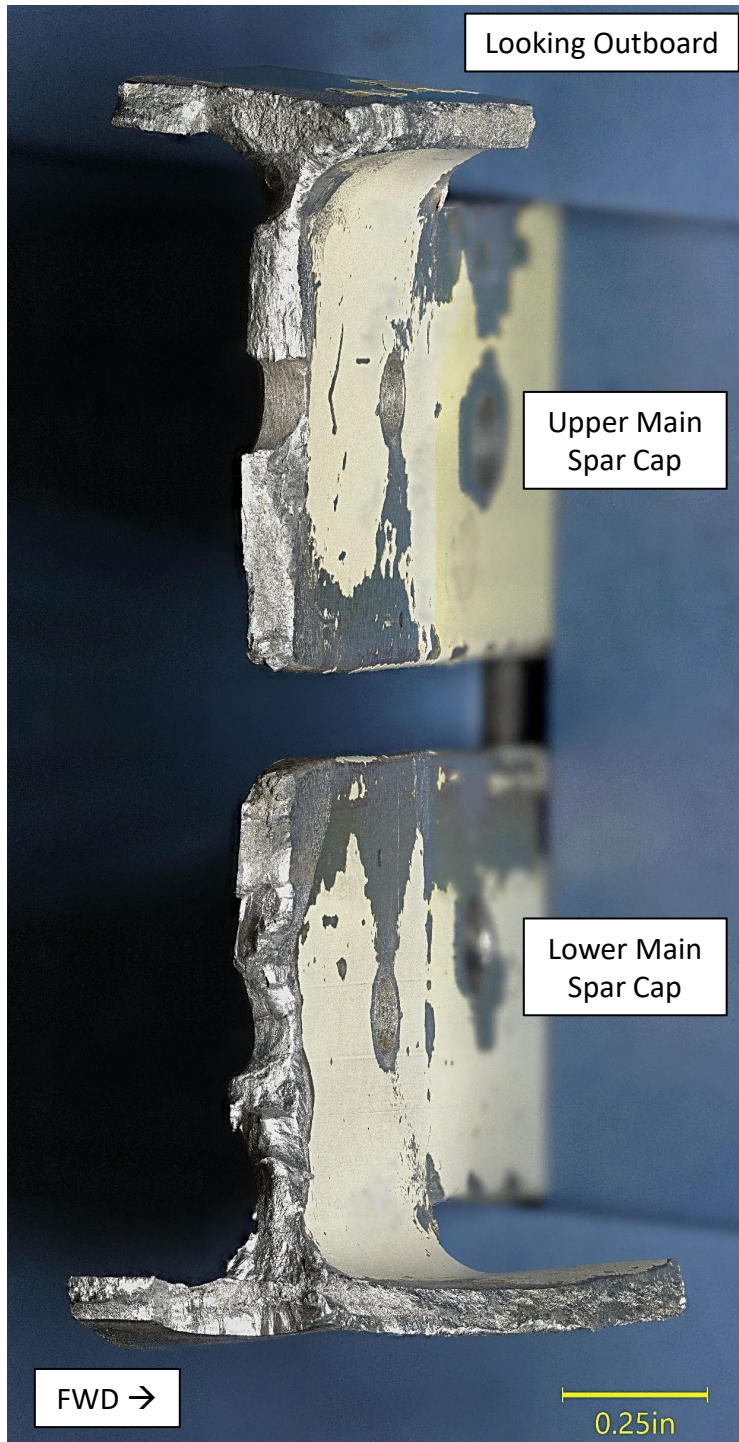
Figure 42. Digital microscope image of the upper and lower main spar cap fracture surfaces (outboard fracture location) viewed tilted slightly aft.

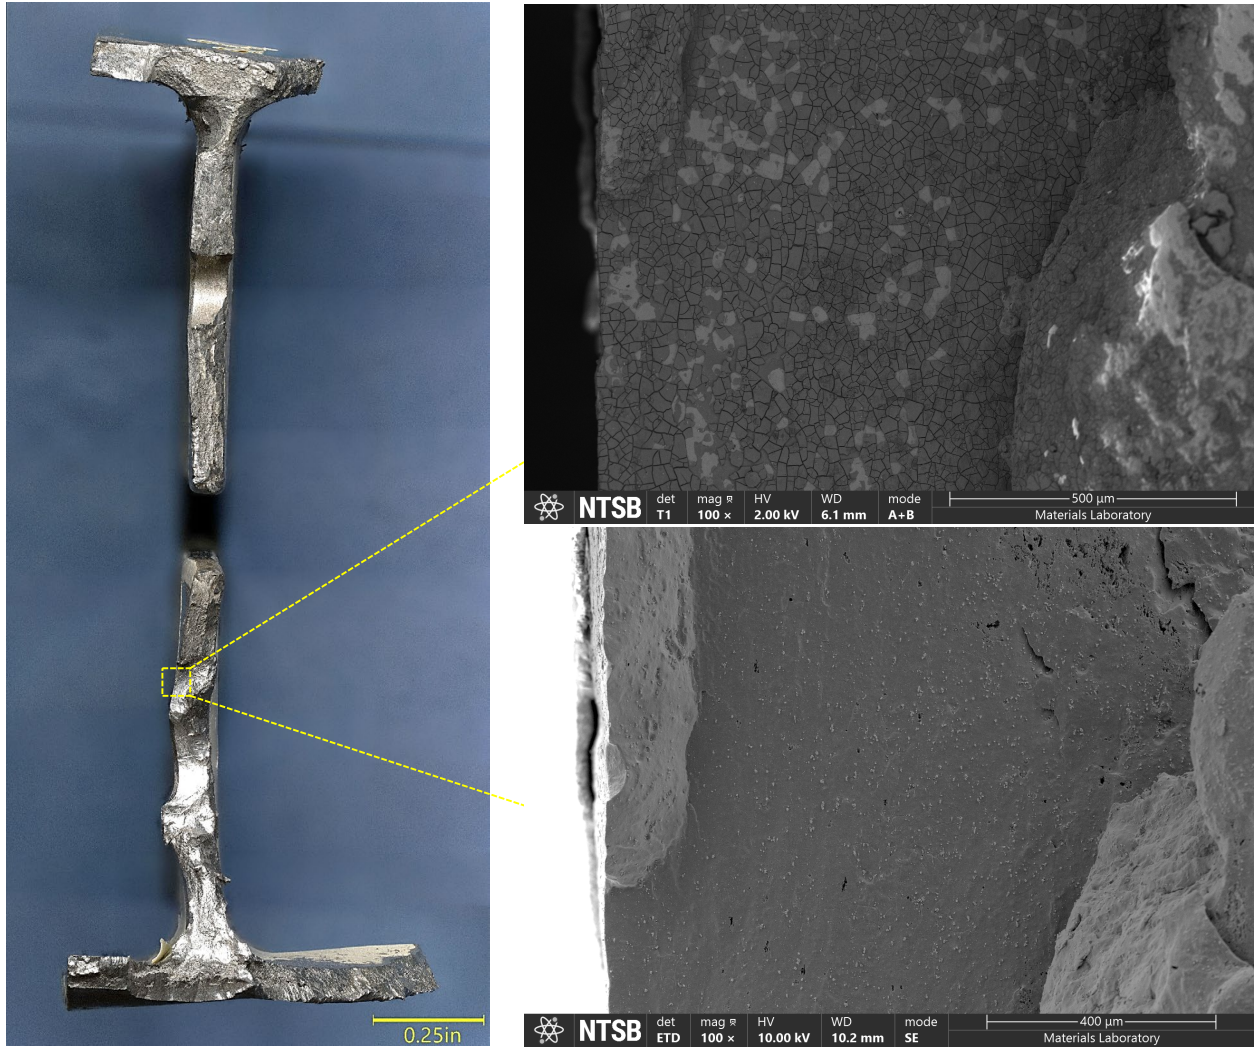
Figure 43 shows scanning electron microscope images (right) of a region of flat fracture on the lower main spar cap stem in the area highlighted by the yellow box in the left image. The upper right image was taken after ultrasonic cleaning the fracture surface using a mild detergent followed by acetone. The surface exhibited a mudcracked appearance consistent with oxide layer buildup from extended exposure to a marine environment which obscured any visible fracture features. Progressive cleaning techniques including acetate tape replicas and additional ultrasonic solvent cleanings did not sufficiently remove the oxide layer, so a heated chromic-phosphoric acid cleaning procedure was then used to remove the oxide layer. The lower right image shows the same area following the heated acid cleaning procedure. After acid cleaning, the surface was relatively smooth and featureless and fracture features were not observable, consistent with smearing from mechanical contact damage or fracture features being consumed by the built up oxide layer.

Figure 43. Scanning electron microscope images of a flatter region on the fracture surface of the lower main spar cap (outboard fracture location) before heated acid cleaning (upper right) showing a mudcracked surface consistent with a built up oxide layer from extended exposure to a marine environment. The lower right image shows the same area after heated acid cleaning and a relatively smooth and featureless appearance was observed on the fracture surface.

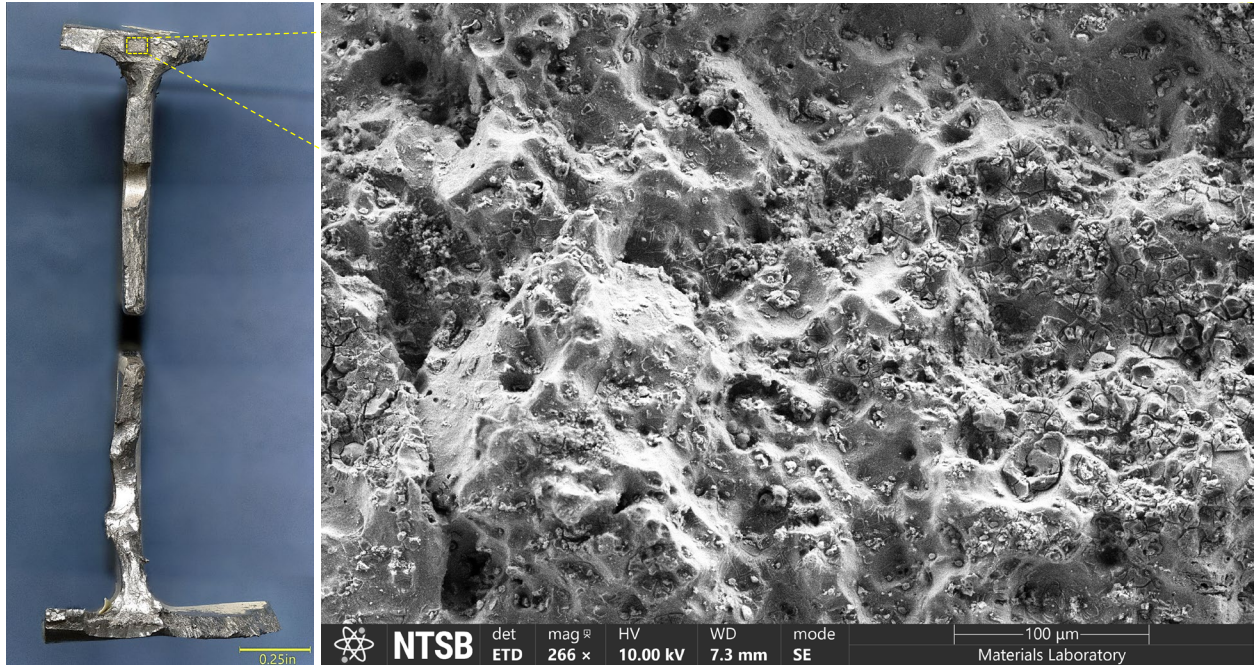
Figure 44 shows a secondary electron image (right), following the heated acid cleaning procedure, of a region of flat fracture on the upper main spar cap in the area highlighted by the yellow box in the left image. Remnants of the oxide layer were observed over a dimpled subsurface, consistent with microvoid coalescence and overstress separation.

Figure 44. Secondary electron fractograph of a flatter region on the fracture surface of the upper main spar cap (outboard fracture location) showing some residual oxide layer (mudcracked appearance) over a dimpled subsurface, consistent with overstress fracture.

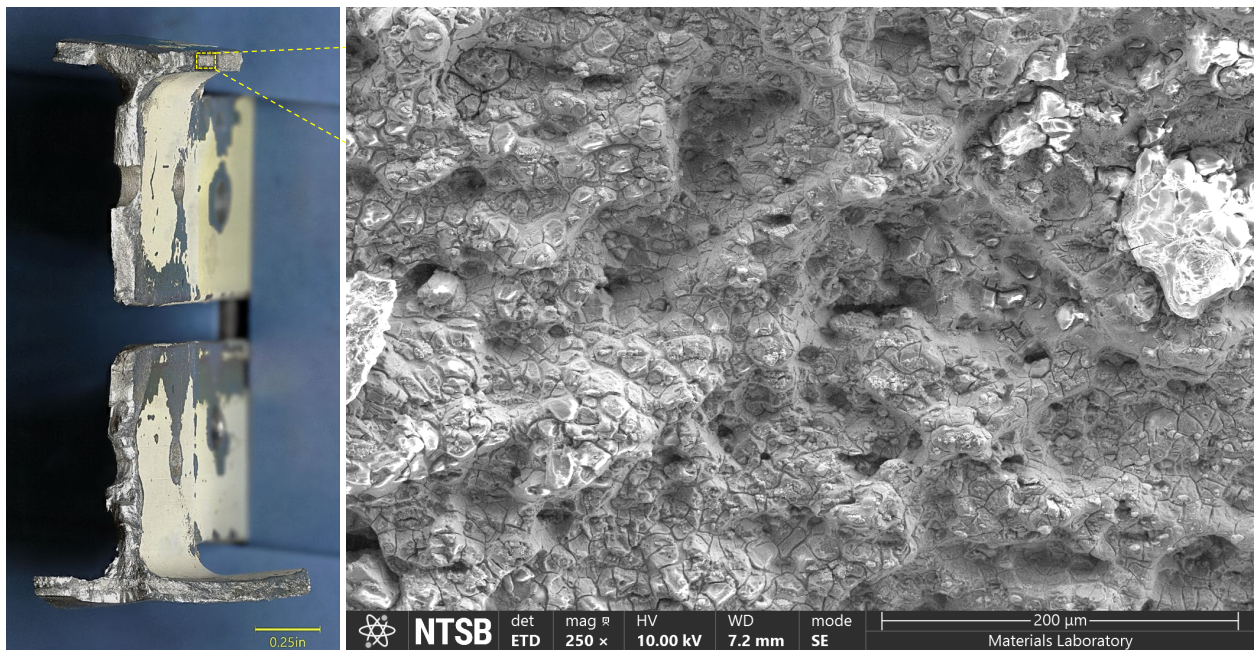
Figure 45 shows a secondary electron image of the fracture surface of the forward flange of the upper main spar cap after ultrasonic cleaning using a mild detergent followed by acetone (prior to the heated acid etch). A similar mudcracked oxide layer appearance was observed, however a dimpled appearance was observed beneath the oxide layer, consistent with overstress separation.

Figure 45. Secondary electron fractograph of the forward flange fracture surface of the upper main spar cap (outboard fracture location) showing an oxide layer (mudcracked appearance) over a dimpled subsurface, consistent with overstress fracture.
