National Transportation Safety Board

WPR23LA130

MATERIALS LABORATORY

Factual Report 23-053

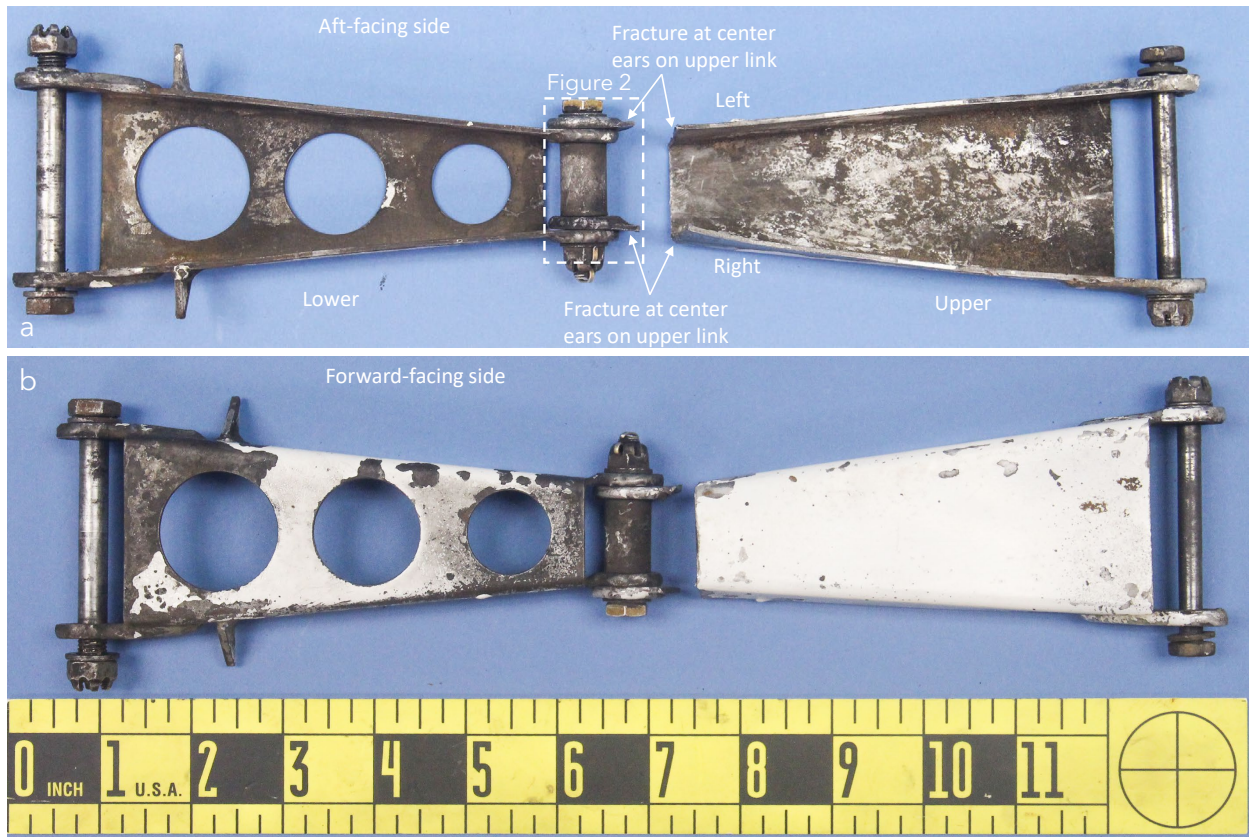
Images of the submitted pieces of the nose landing gear scissors link assembly are shown in Figure 1. The center ears on the upper link are separated by fracture as annotated in Figure 1a. A close view of the fractured ears still assembled to the lower link is shown in Figure 2. A fatigue fracture origin is identified on the fracture surface of the left ear from the upper link.

Figure 1. Images of the upper and lower scissors link with orientations annotated.

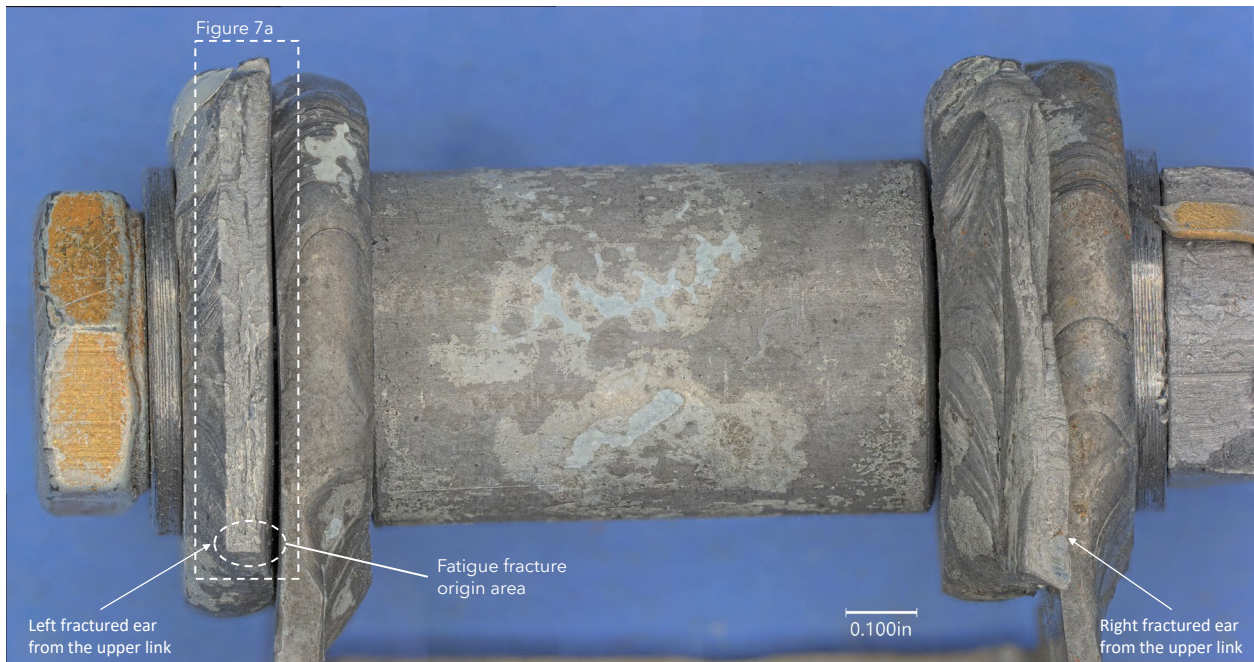
Figure 2. Close view digital microscope image of the fractured ears still assembled to the lower link.

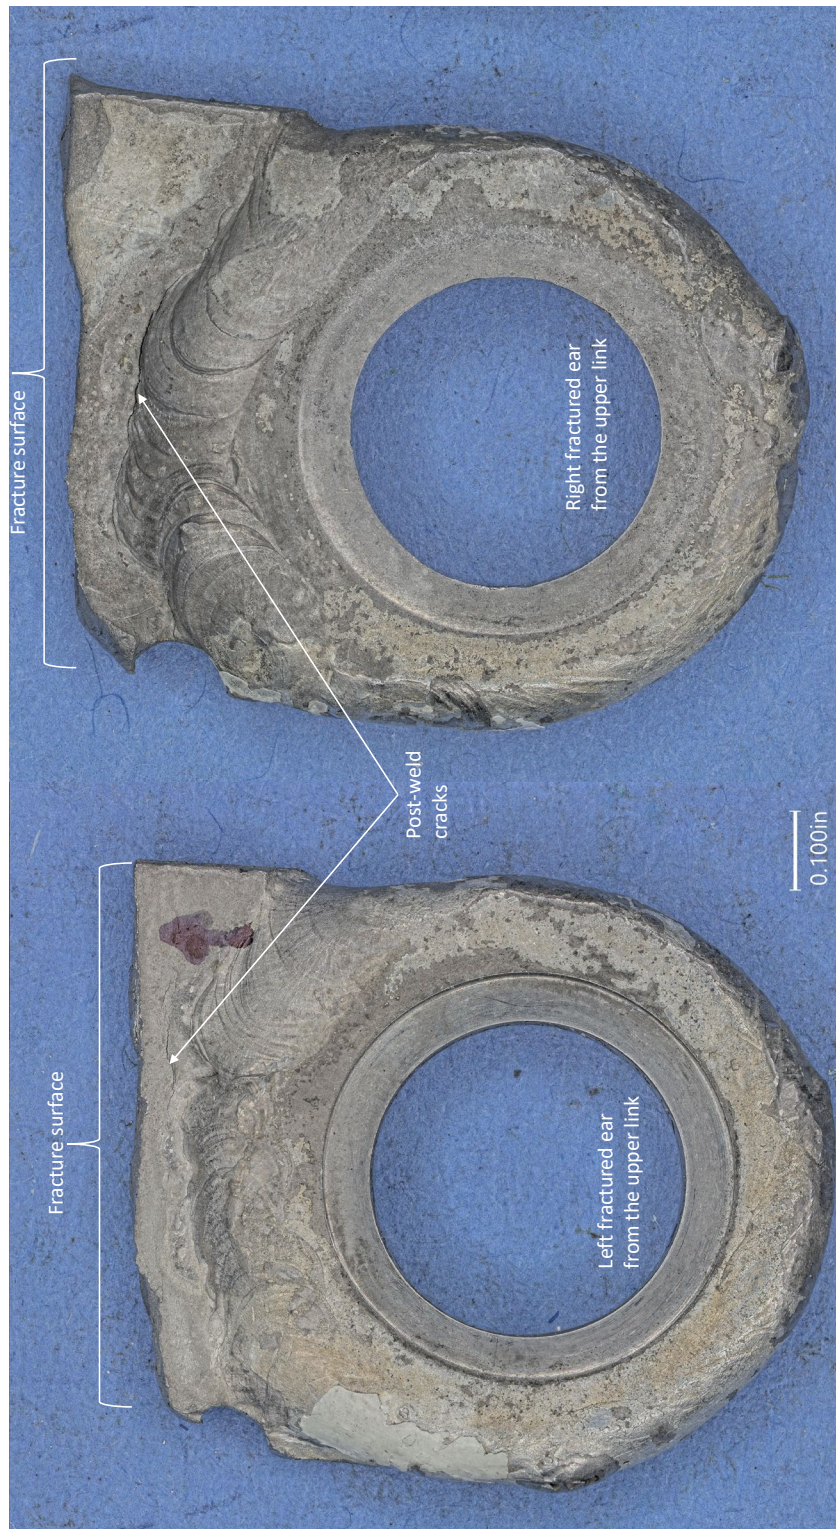
As depicted in Figure 3, the left and right ear fragments from the upper link were removed for closer examination. As fabricated, the ears are integral to the rest of the upper link via a single piece of steel sheet. Weld overlay is applied to the ears, increasing their thickness. As noted in the figure, post-weld cracks occurred adjacent to the weld or in the heat affected zone. Closer views of the fracture surfaces in profile are shown in Figures 4 and 5.

Figure 3. Digital microscope images of the left and right ear fragments from the upper link were removed for closer examination. The fracture surfaces are annotated and post-weld cracks are identified.

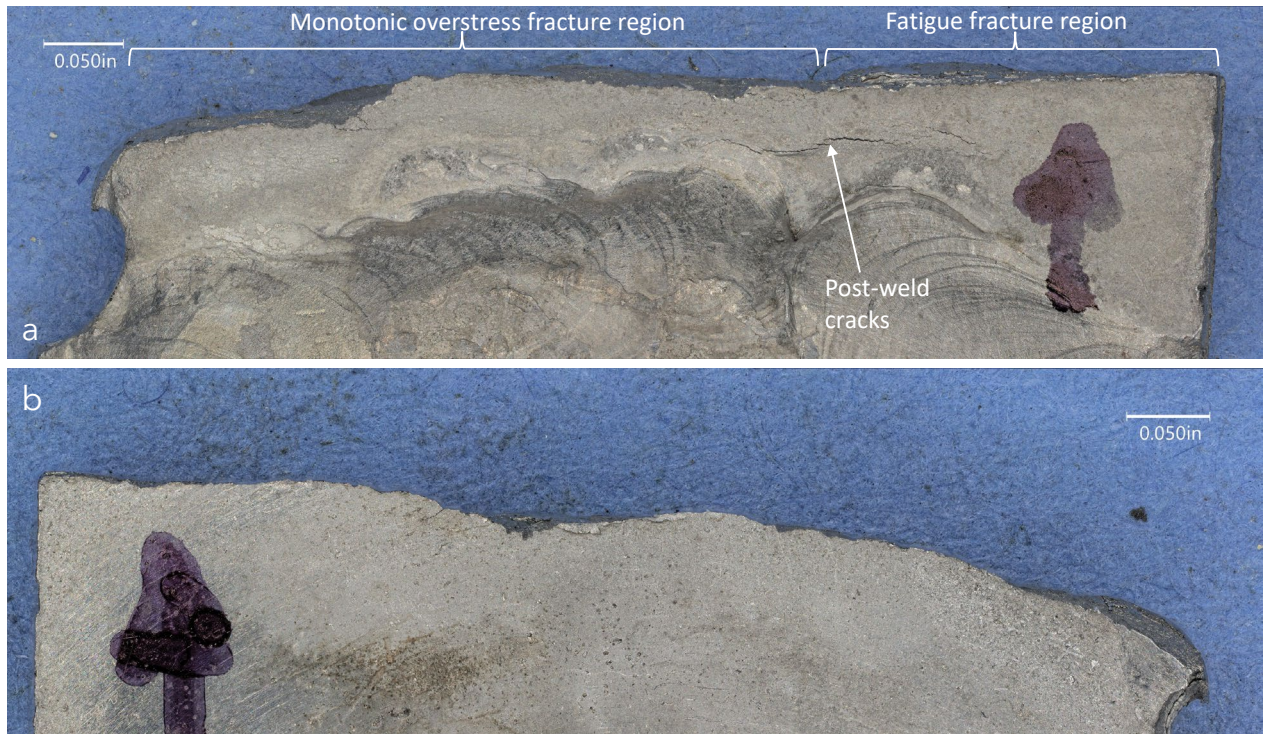
Figure 4. Closer digital microscope images of the left ear fracture surface in profile.

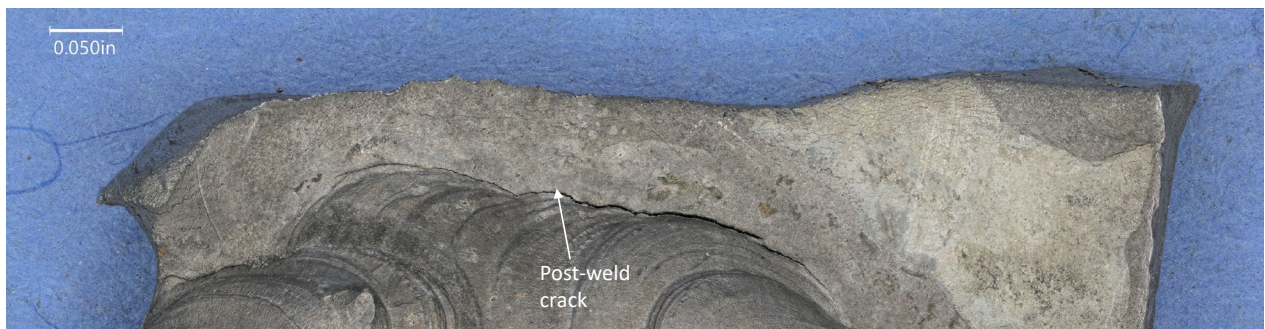
Figure 5. Closer digital microscope images of the right ear fracture surface in profile.

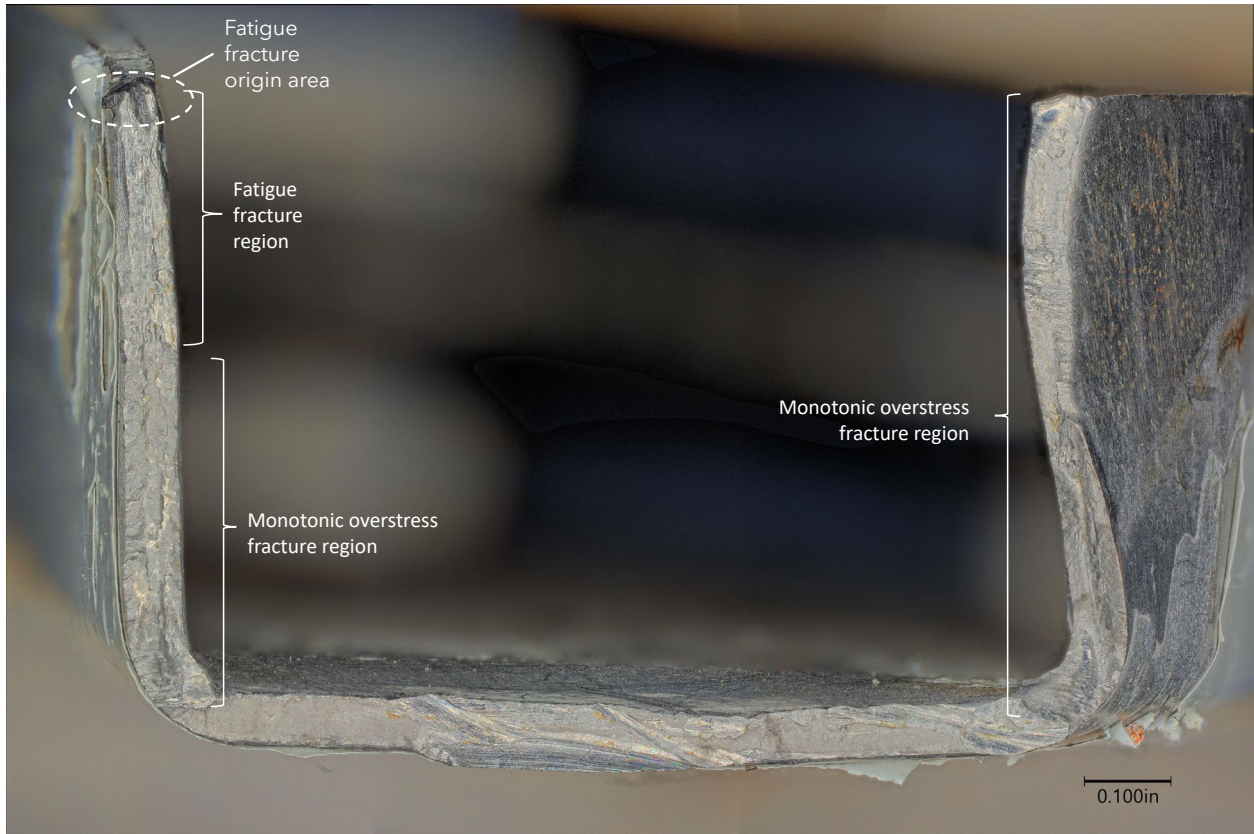
The mating fracture surfaces on the upper link piece are shown in Figure 6. Key features are annotated in the figure including a region of fatigue cracking.

Figure 6. Digital microscope image showing the mating fracture surfaces on the upper link piece. Key features are annotated in the figure including a region of fatigue cracking.

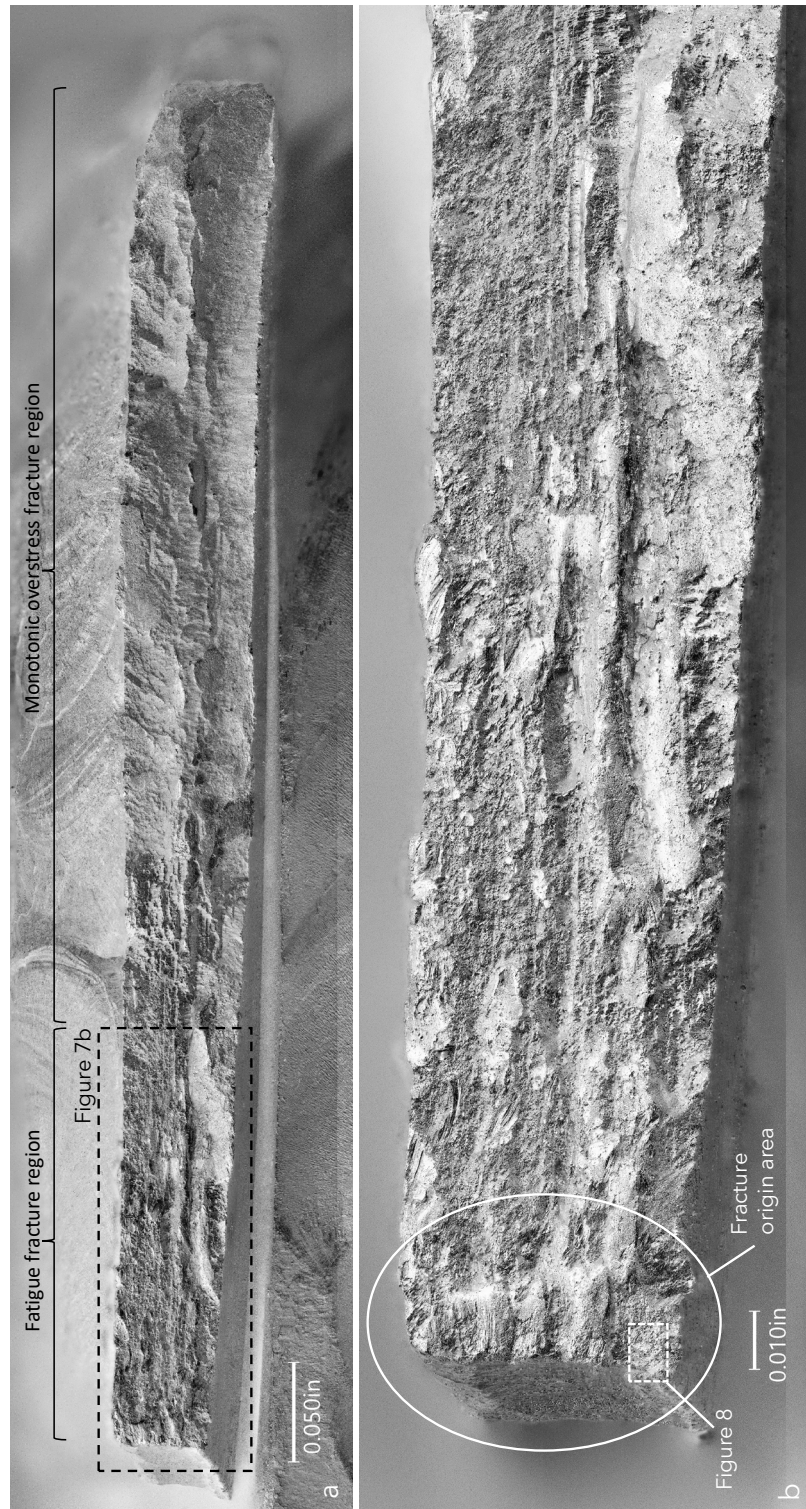
Figure 7 shows higher magnification digital microscope images of the fracture surface of the left fractured ear from the upper link. A fatigue fracture region is identified in Figure 7a. A closer view of the fatigue fracture region is shown in Figure 7b. Significant mechanical batter is present on the fracture face in the fatigue fracture region. A scanning electron microscope was used to image the fatigue fracture

Figure 7. Digital microscope images of the fracture surface of the left fractured ear from the upper link. A fatigue fracture region is identified in Figure 7a. A closer view of the fatigue fracture region is shown in Figure 7b. Significant mechanical batter is present on the fracture face in the fatigue fracture region.

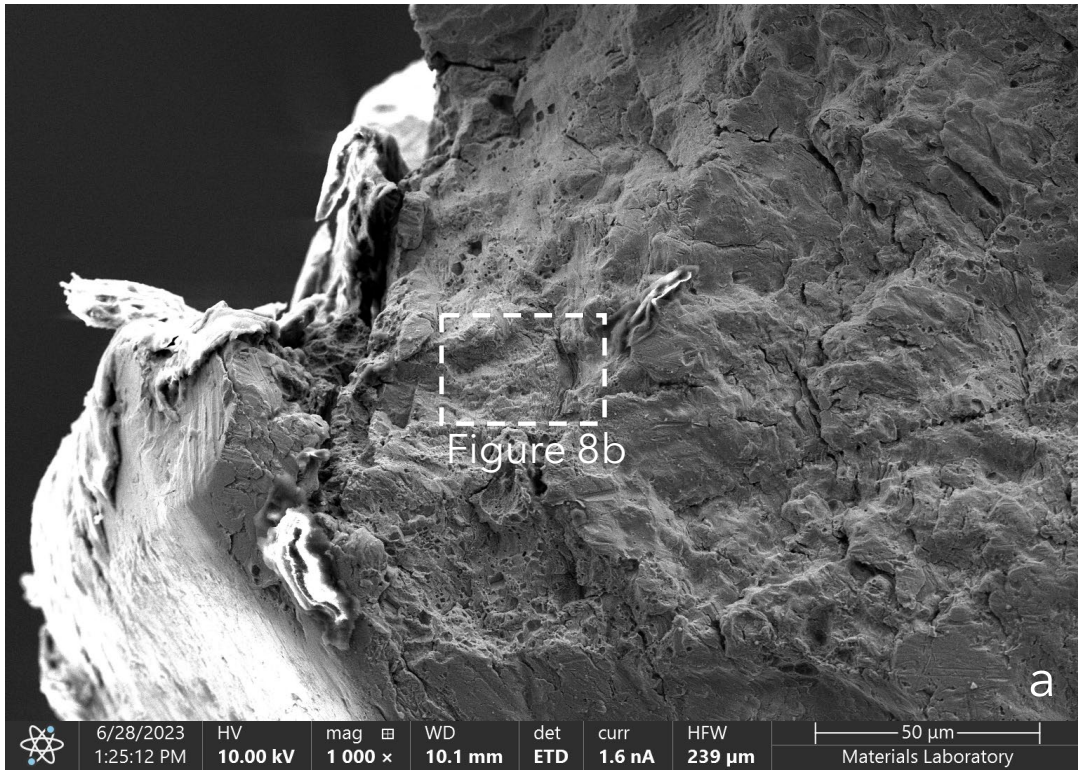
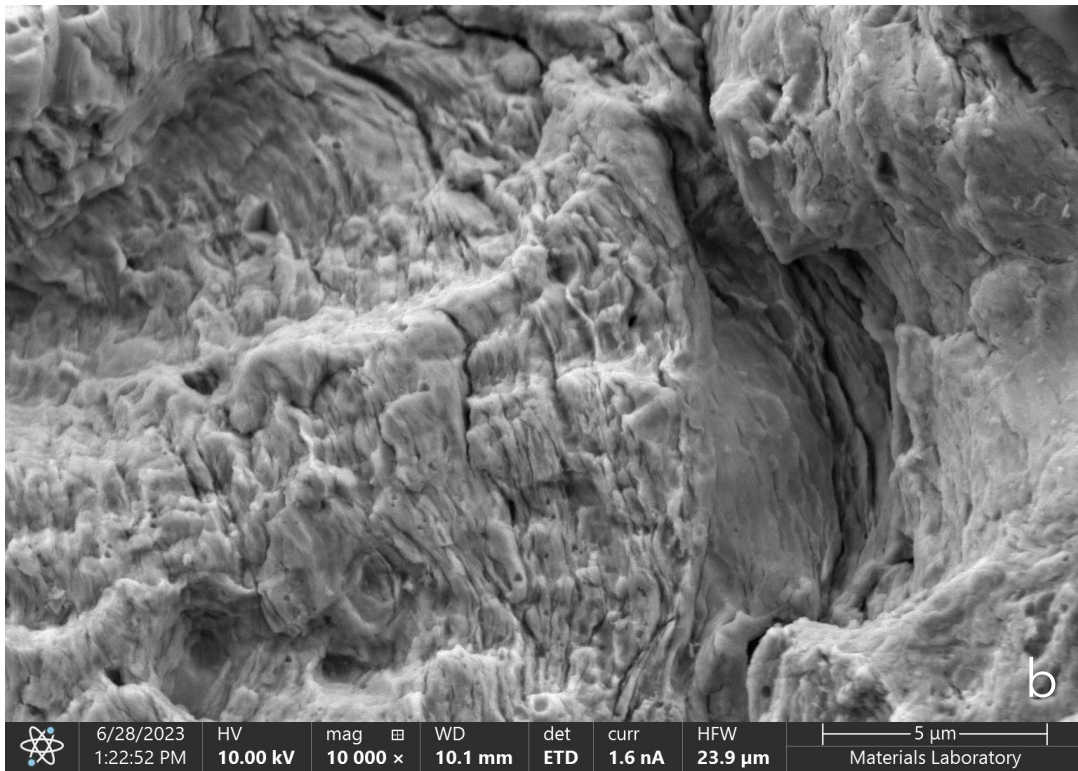
region close to the origin. Fine striation features were observed in this region as shown in Figure 8 (see Figure 7b for the specific location).

Figure 8. Secondary electron scanning electron fractograph of the fatigue fracture region close to the origin on the left ear piece. Fine striation features were observed in this region as shown in view b (see Figure 7b for the specific location).
