# National Transportation Safety Board

DCA22FA082

## **MATERIALS LABORATORY**

Factual Report 23-056

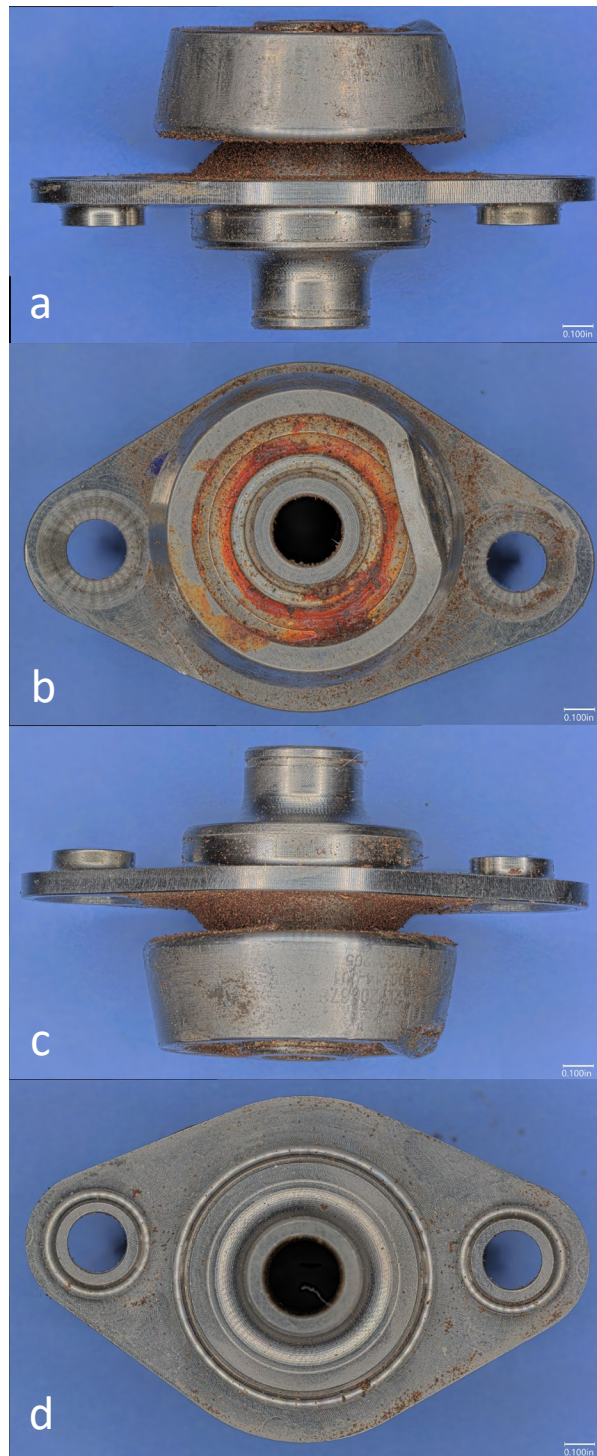
Figure 2 shows multiple views of the Station 2 tilt slide anti sag roller bearing and mount. The tapered ring pressed onto the outer bearing race exhibited a dent as revealed in Figure 2b. The bearing assembly was removed from the mount using a plate-type bearing puller and an arbor press. A high force was required to remove the bearing indicating that the inner bearing race was assembled on the mount shaft with a tight interference fit. The Station 2 mount with the bearing assembly removed is shown in Figure 3.

**Figure 2.** Digital microscope images of the Station 2 tilt slide anti sag roller bearing and mount, as-received.

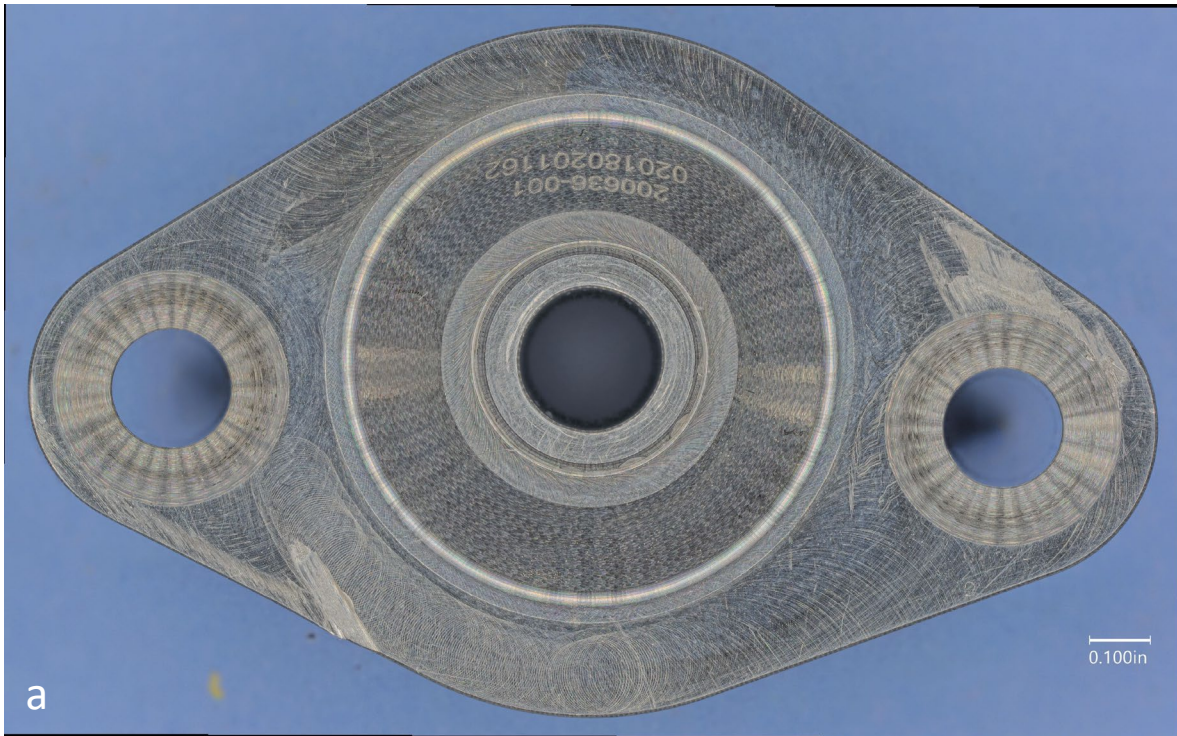
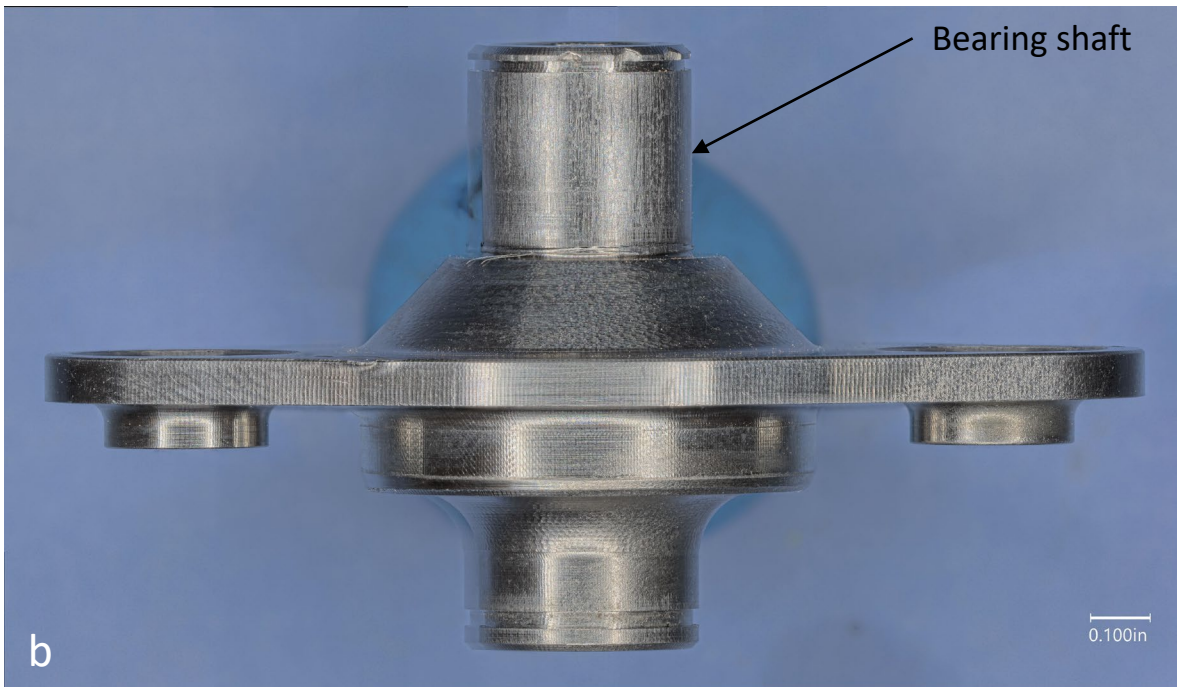
**Figure 3.** Digital microscope images of the Station 2 tilt slide anti sag roller bearing mount, with the bearing removed.

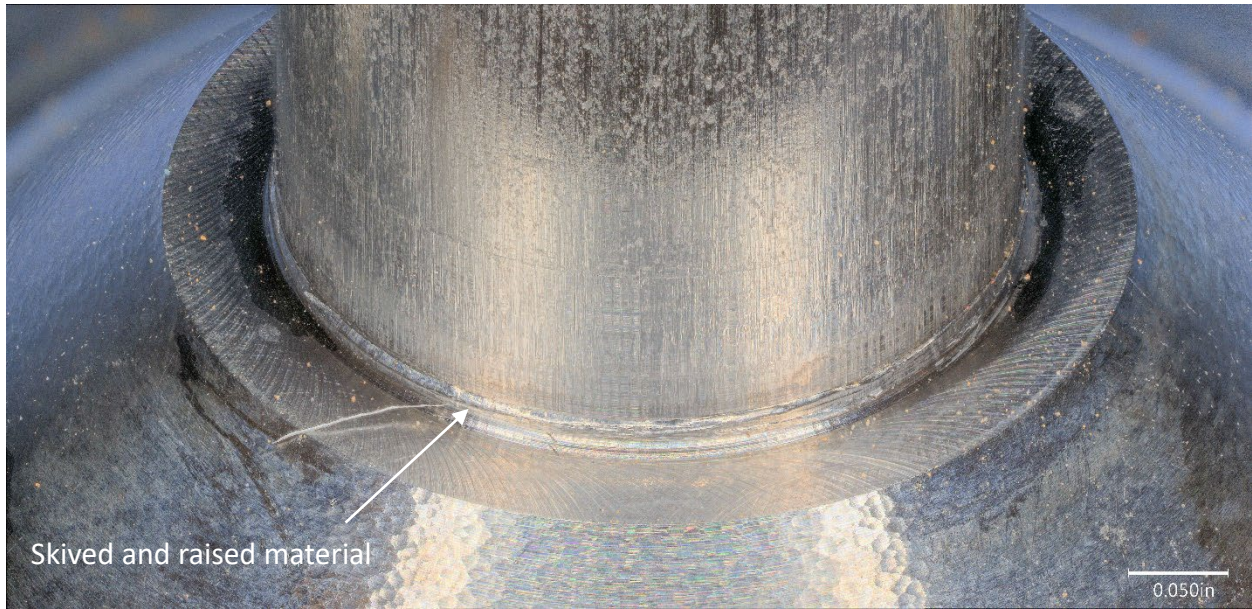
Close digital microscope images of the transition from the bearing shaft to the mount body on the Station 2 mount are shown in Figures 4 and 5. The transition area was visually inspected with a 5x to 50x stereozoom microscope for the presence of any cracks. As indicated in the figures, skived and raised material is present near the

shaft base consistent with deformation associated with press-fitting the bearing onto the shaft. No preexisting cracks were observed.

**Figure 4.** Close view digital microscope image of the base of the bearing shaft where it meets the mount body for the Station 2 tilt slide anti sag roller bearing mount. Note the raised material and skived filament associated with the pressing of the bearing onto the shaft.

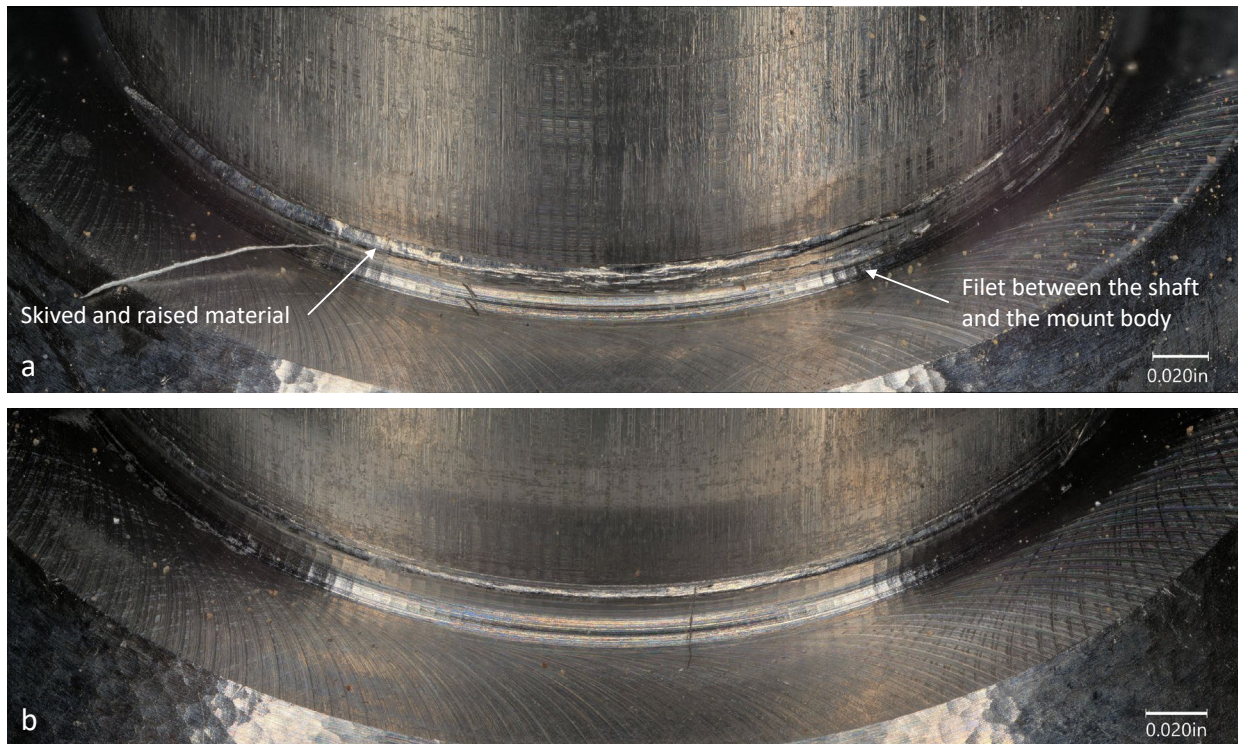
**Figure 5.** Higher magnification digital microscope images of the base of the bearing shaft where it meets the mount body for the Station 2 tilt slide anti sag roller bearing mount. Note the raised material and skived filament associated with the pressing of the bearing onto the shaft. Views a and b are 180° apart. No preexisting cracks were observed.

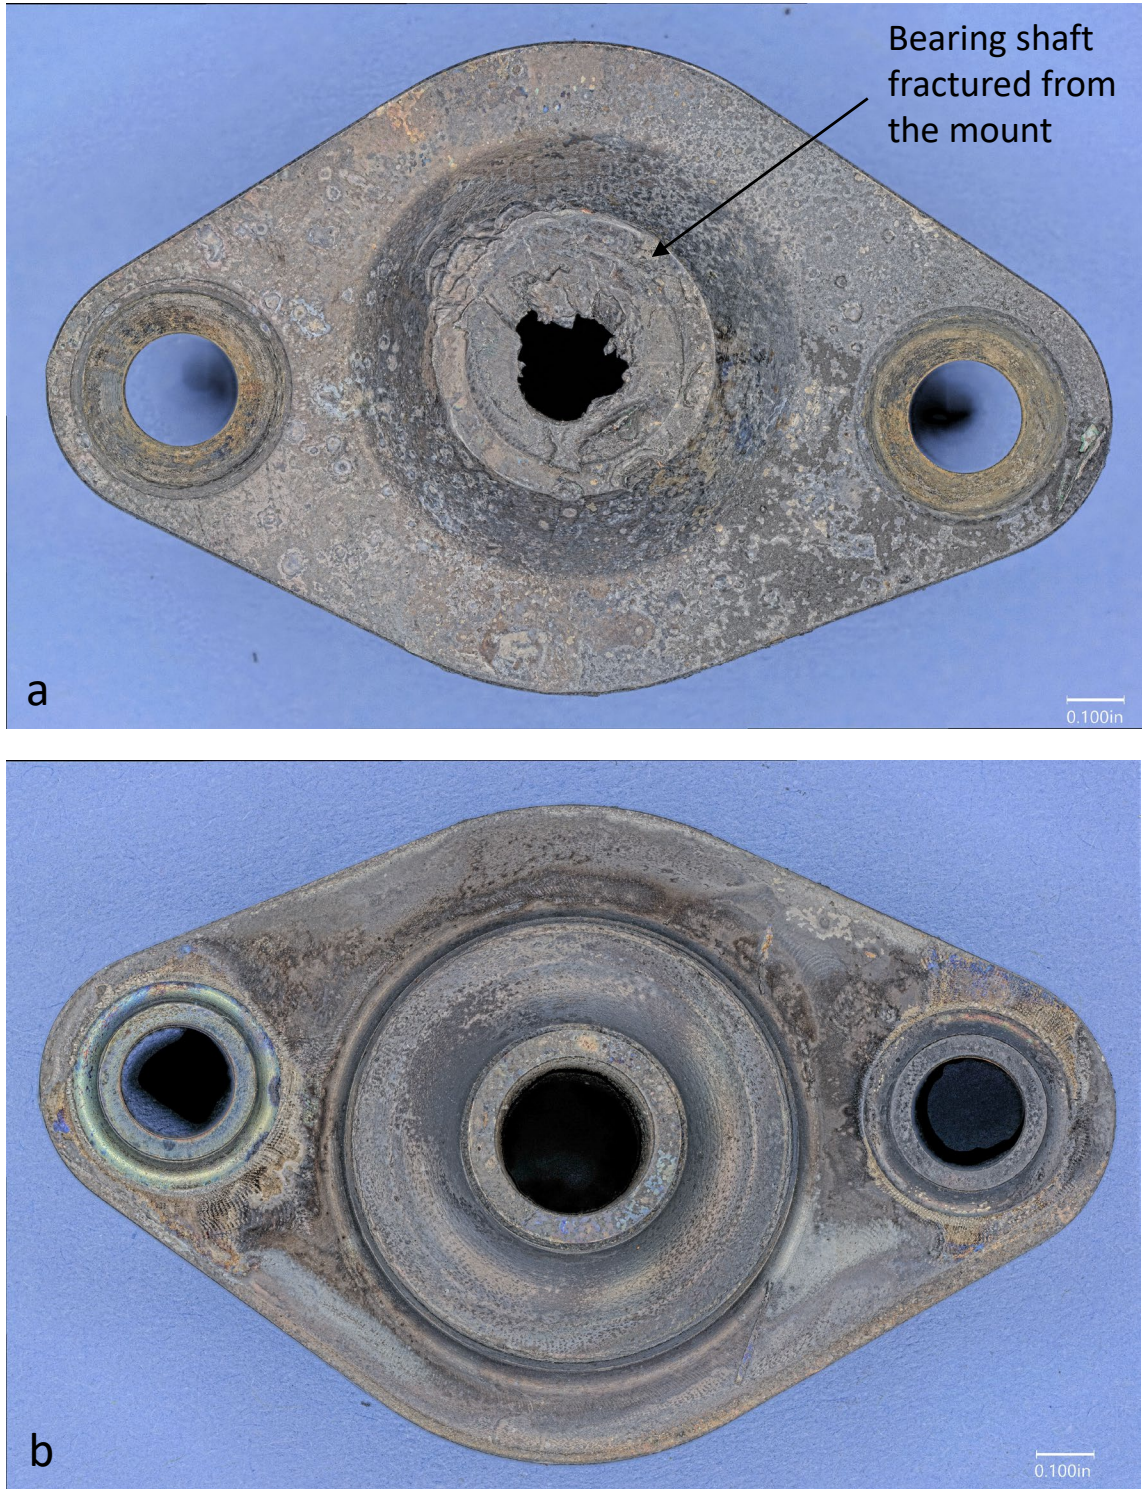
Images of the Station 3 mount are shown in Figure 6. The bearing shaft has been fractured from the mount (bearing and shaft portion were not recovered from the accident scene). Figures 7 and 8 show the overall fracture surface at the base of the bearing shaft using digital and scanning electron (SEM) microscopy, respectively. Approximately 90% of the fracture surface is mechanically damaged and precluded fractographic examination. The undamaged areas of the fracture surface exhibited fracture features consistent with monotonic overload (detail images are shown in Figures 9 and 10).

**Figure 6.** Digital microscope images of the Station 3 portion of tilt slide anti sag roller bearing mount, the separated shaft and bearing were not submitted.

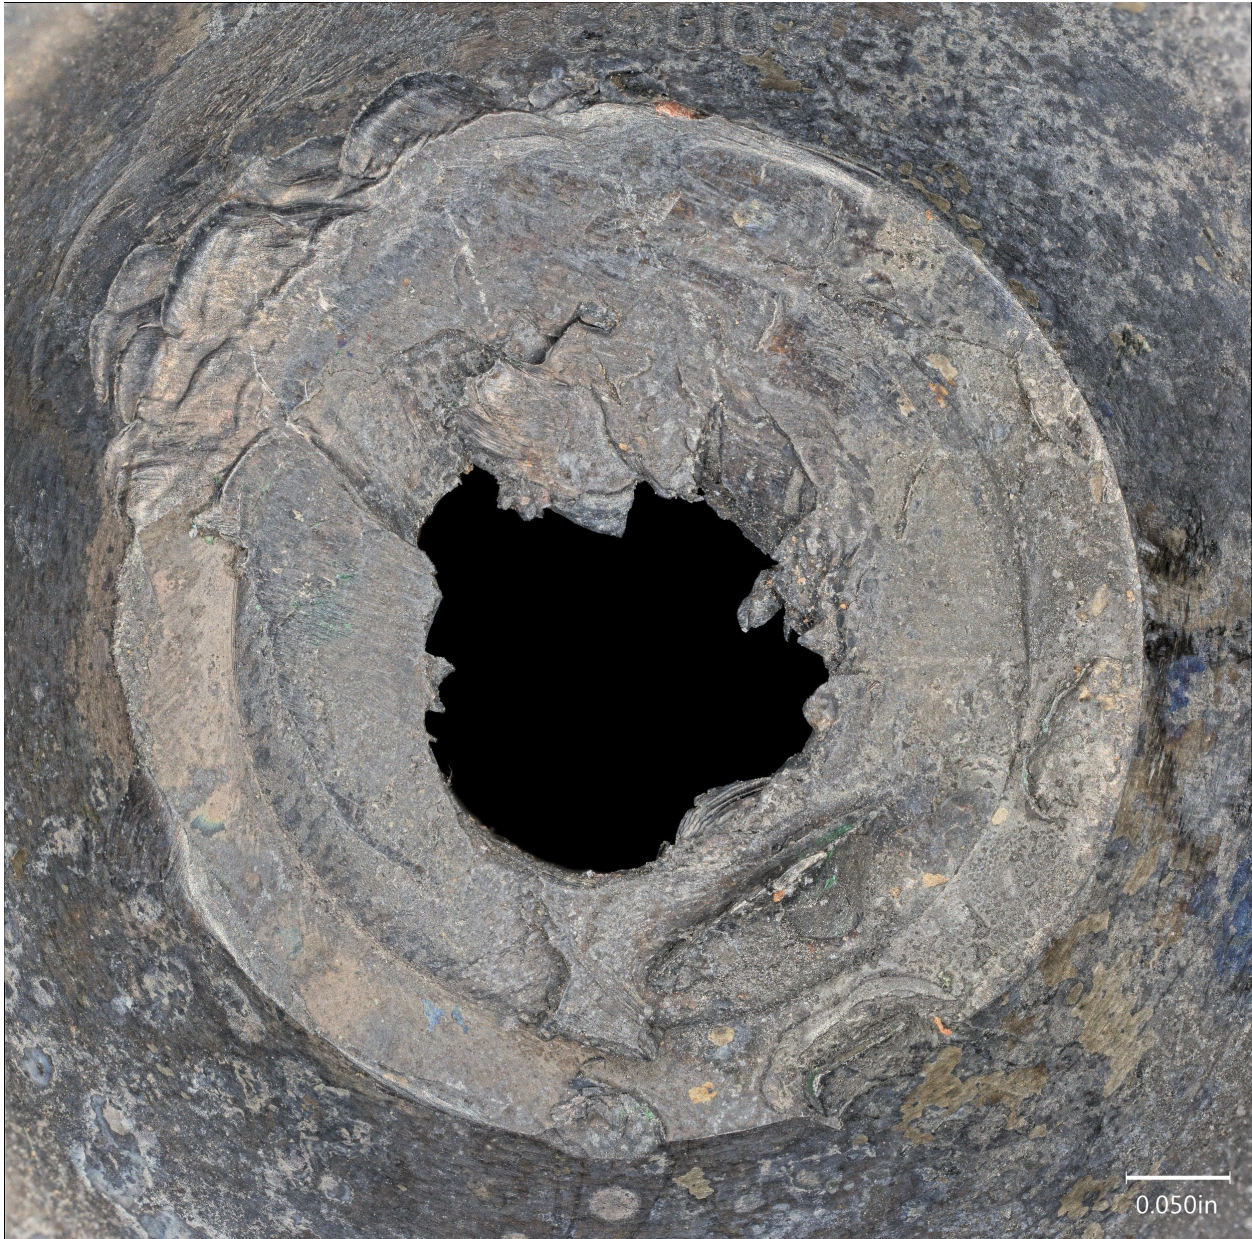
**Figure 7.** Digital microscope image of the bearing shaft fracture surface from the Station 3 portion of tilt slide anti sag roller bearing mount.

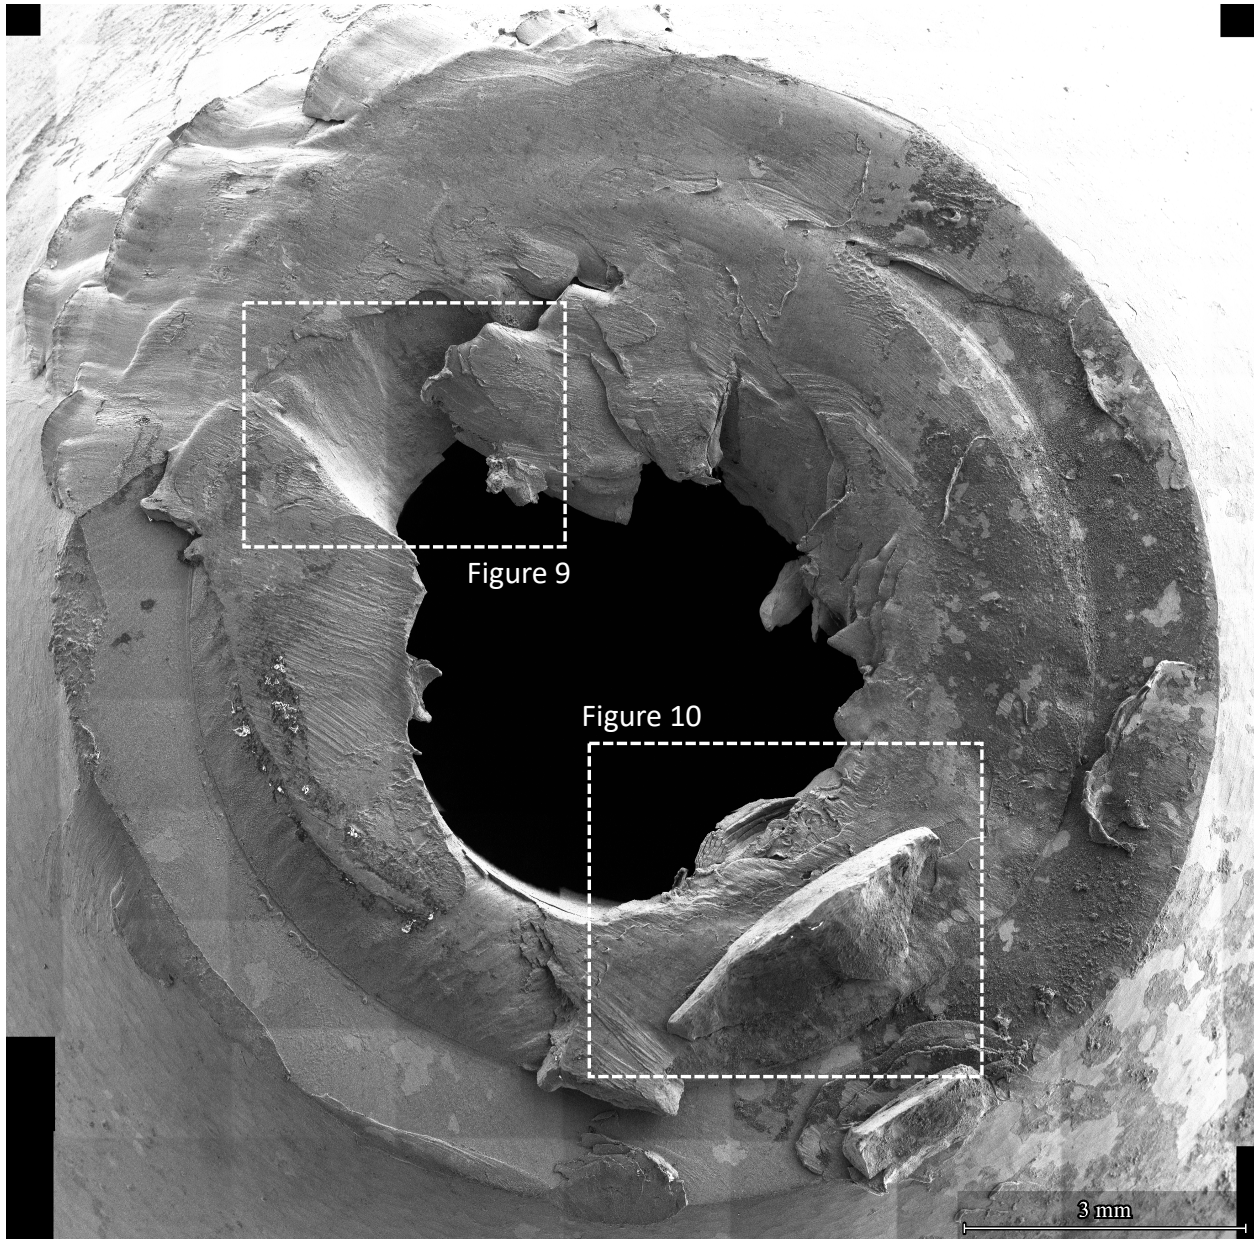
**Figure 8.** Scanning electron microscope image of the bearing shaft fracture surface from the Station 3 portion of tilt slide anti sag roller bearing mount.

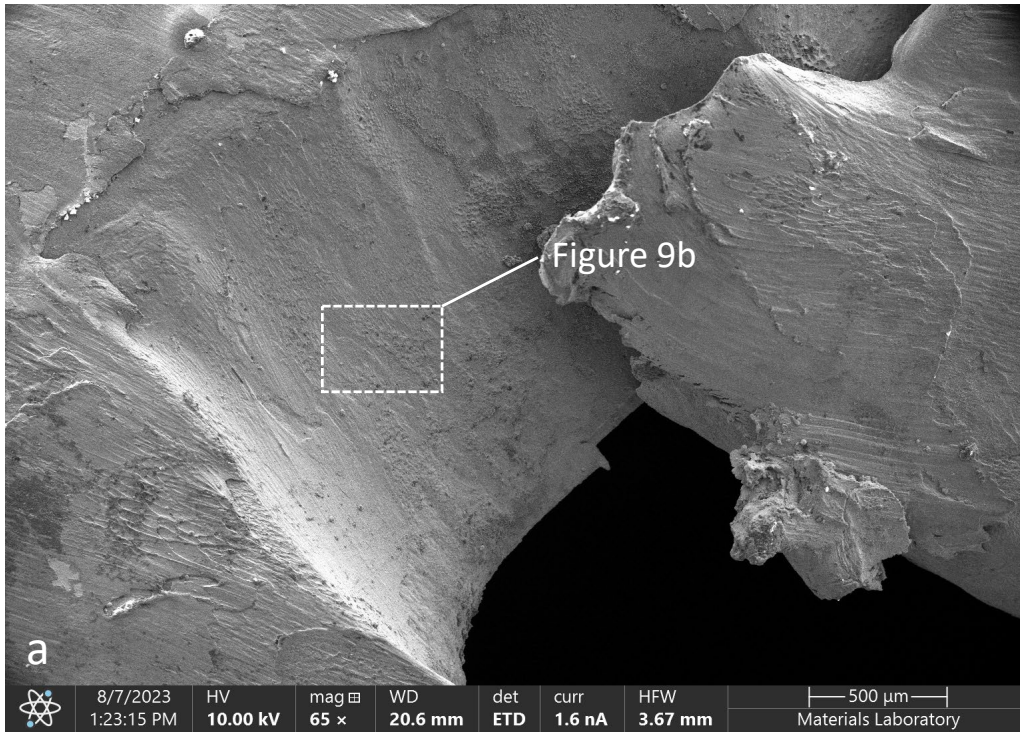
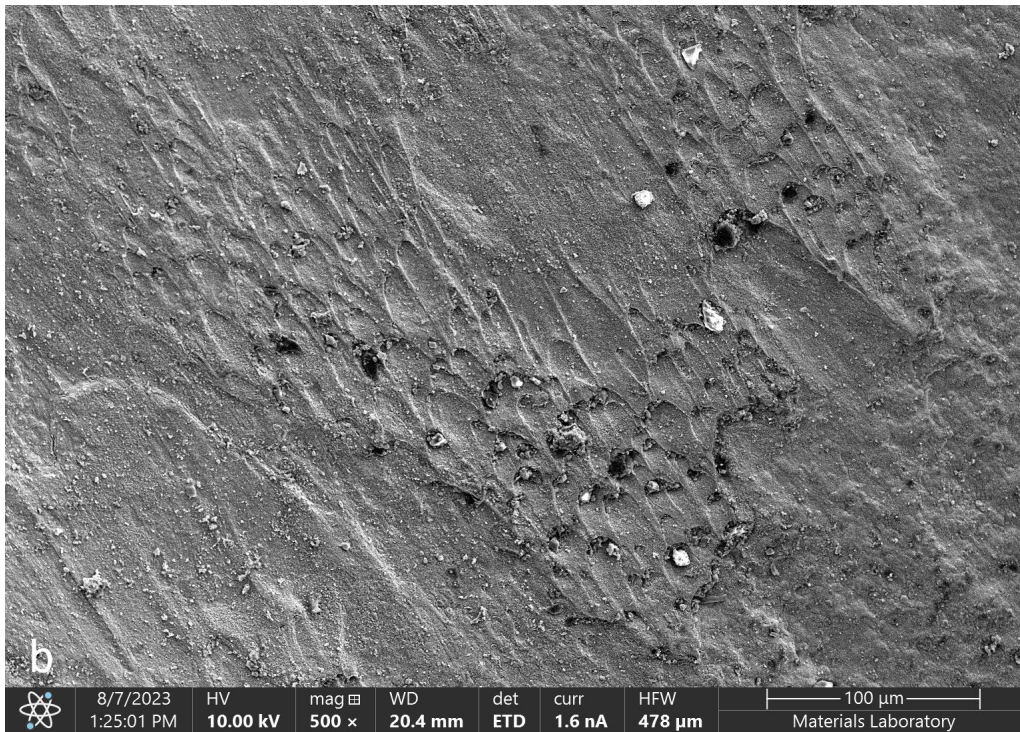
**Figure 9.** Close scanning electron microscope images of the bearing shaft fracture surface from the Station 3 portion of tilt slide anti sag roller bearing mount (see figure 9 for the specific location). The fracture features are consistent with monotonic overload.

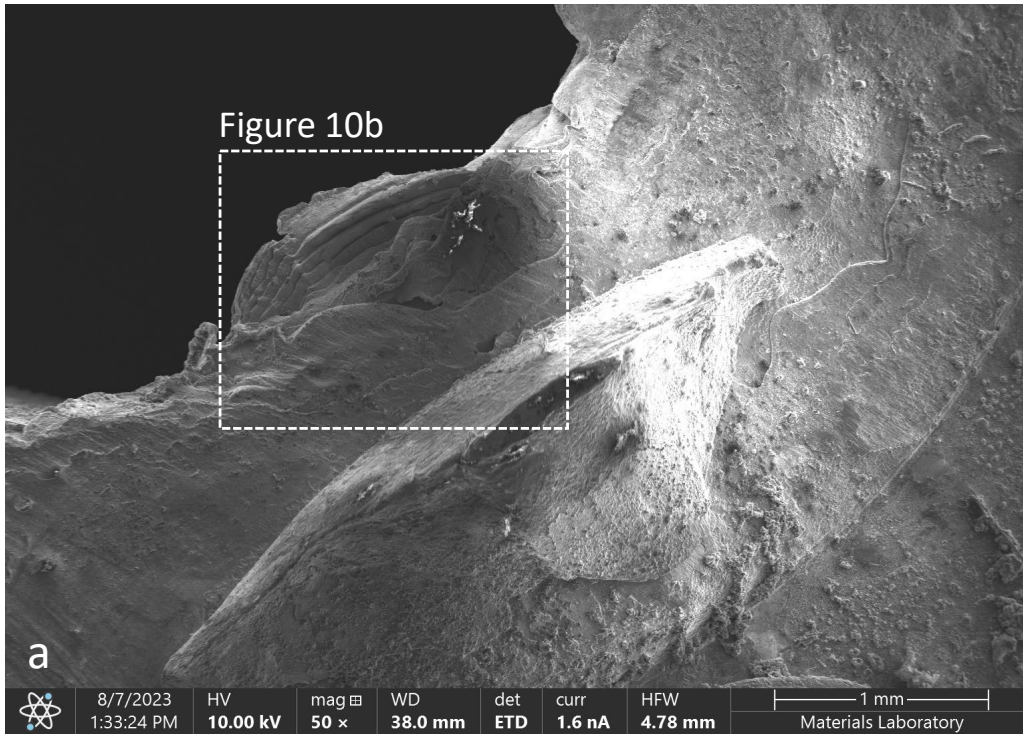
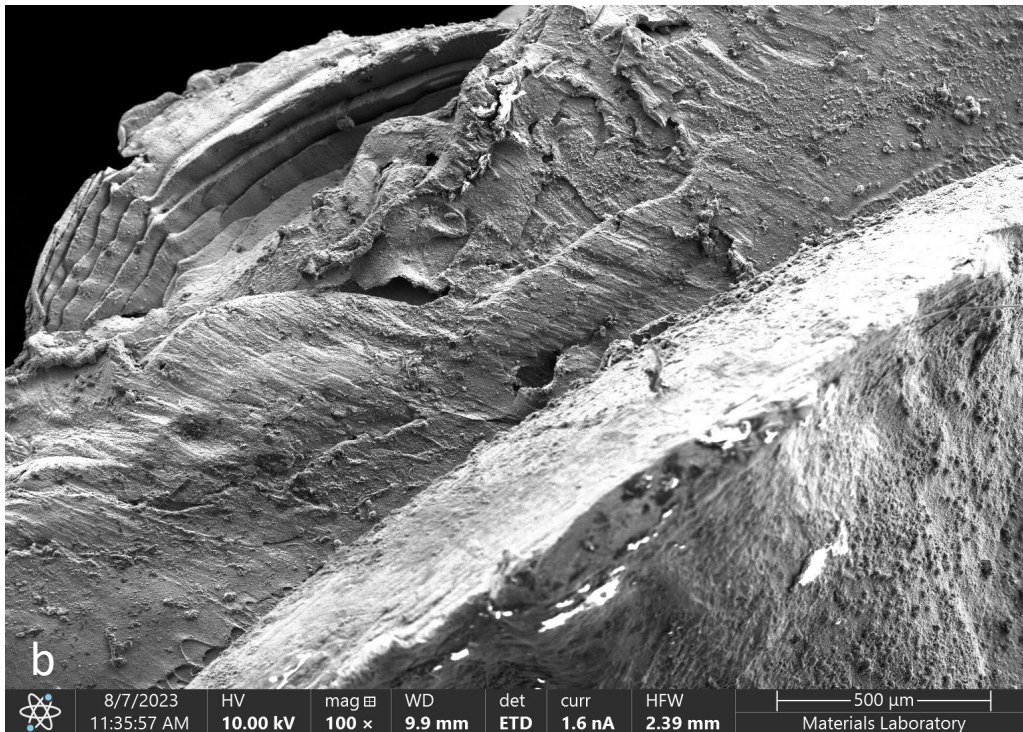
**Figure 10.** Close scanning electron microscope images of the bearing shaft fracture surface from the Station 3 portion of tilt slide anti sag roller bearing mount (see figure 9 for the specific location). The fracture features are consistent with monotonic overload.
