# National Transportation Safety Board

## **MATERIALS LABORATORY**

Factual Report 23-072

Location: West Reading, Pennsylvania  
Date: March 24, 2023  
Vehicle: UGI Gas Distribution Pipeline System  
Investigator: Kim West, RPH-20

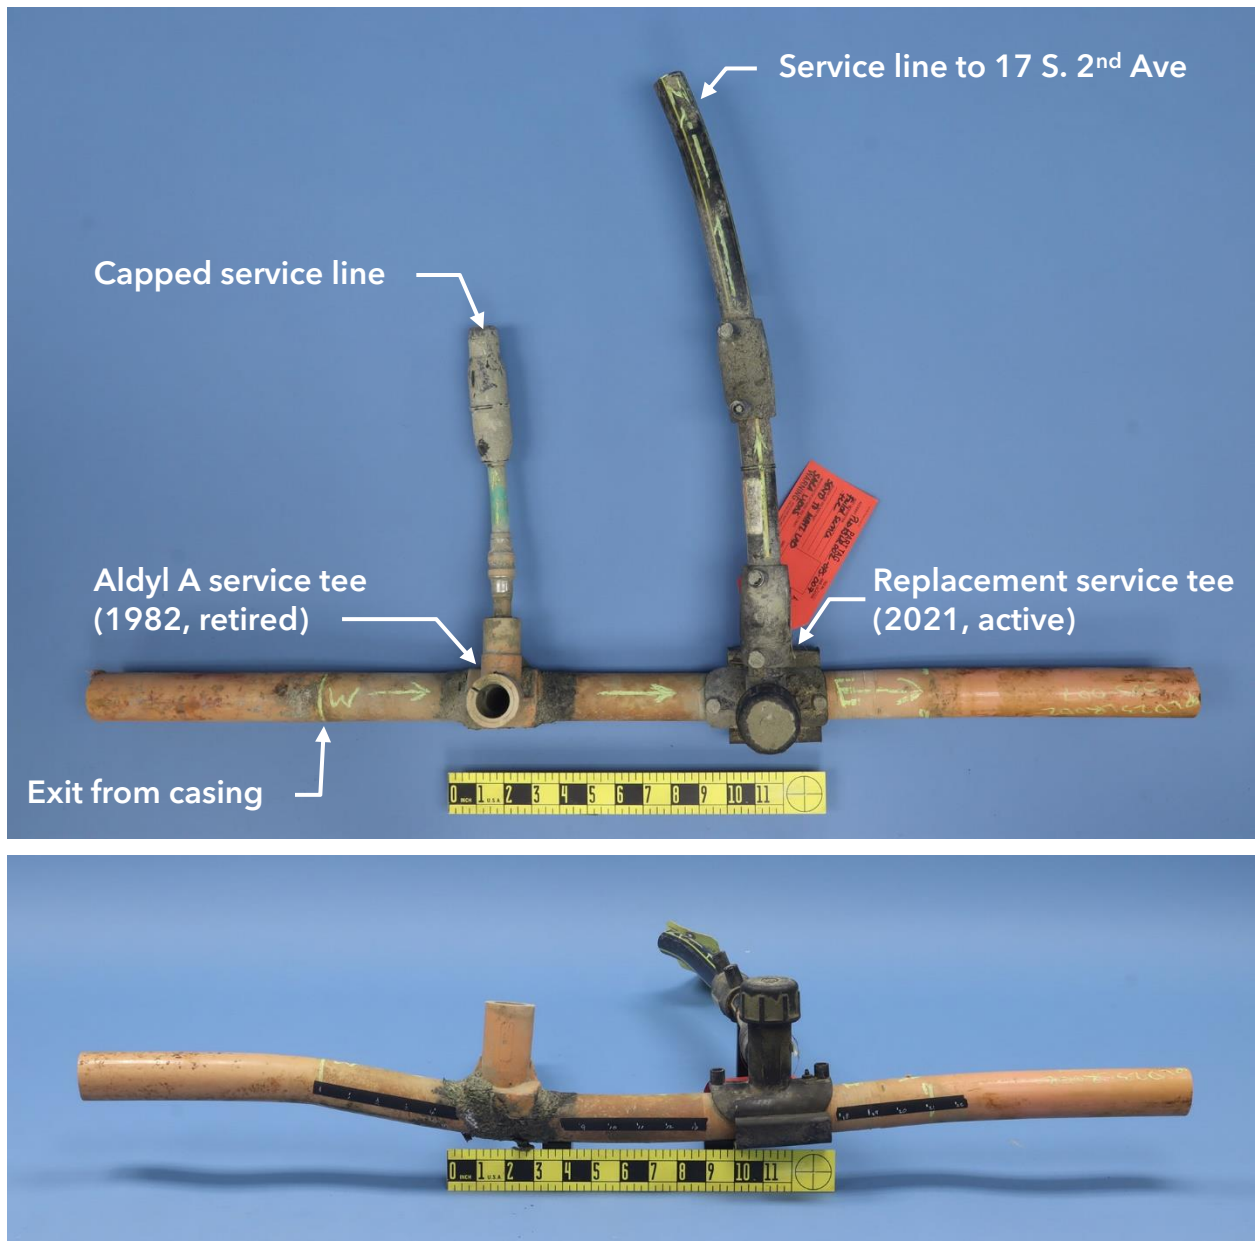
Gas service to 17 S. 2<sup>nd</sup> Ave was originally supplied through an Aldyl A service tee, as indicated in figure 1. The Aldyl A tee was retired from service in March 2021 and a replacement service tee was installed on the main located approximately 9.45 inch downstream.

**Figure 1.** Aldyl A gas main with retired service tee and adjacent active service tee, installed in 2021 and providing gas service to 17 S. 2<sup>nd</sup> Ave at the time of the accident.

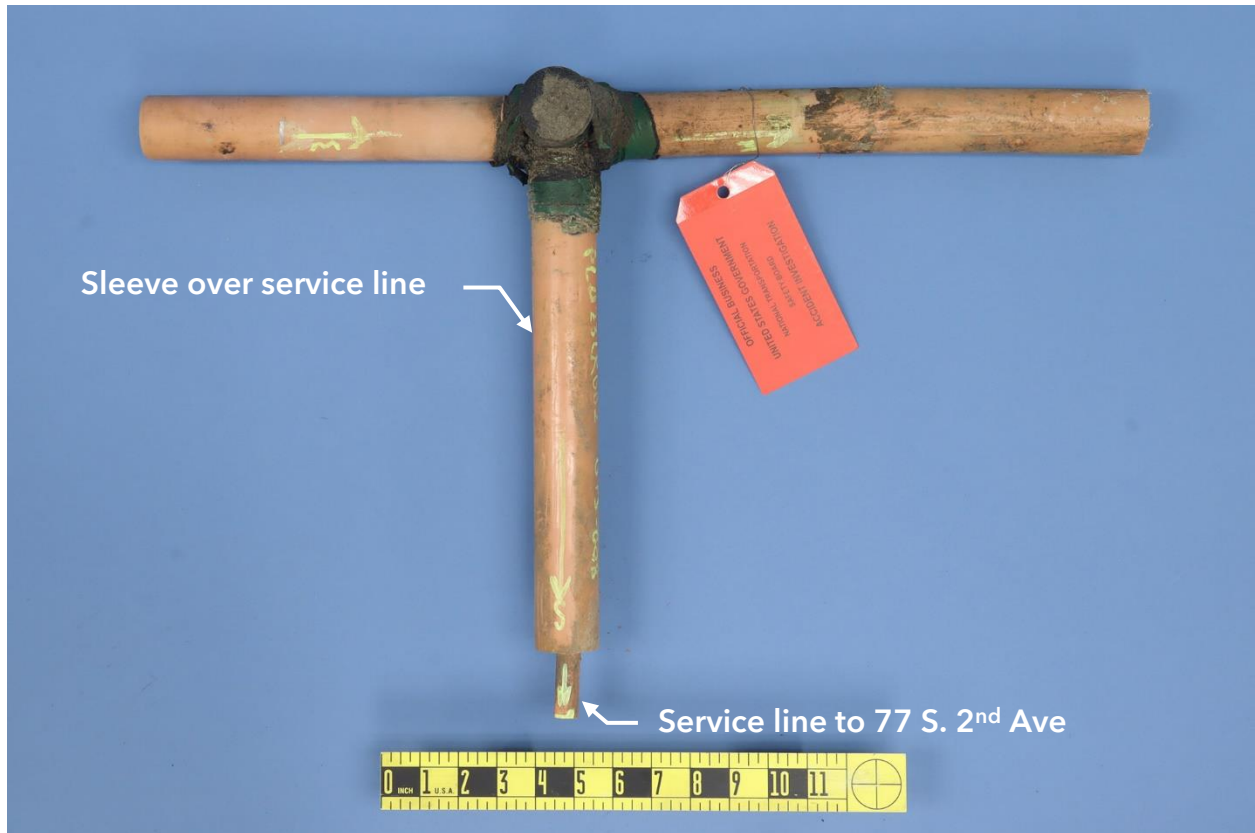
At the time of the accident, gas service to 77 S. 2<sup>nd</sup> Ave was supplied through the Aldyl A service tee originally installed in 1982, shown in figure 2. The tee was recovered intact with tape around the fitting (for holding in place a protective sleeve on the tee outlet) and without any apparent damage or discrepancies. As seen in figure 1, there was no sleeve on the 17 S. 2<sup>nd</sup> Ave retired tee outlet.

**Figure 2.** Aldyl A gas main segment, service tee, and service line segment for 77 S. 2<sup>nd</sup> Ave.

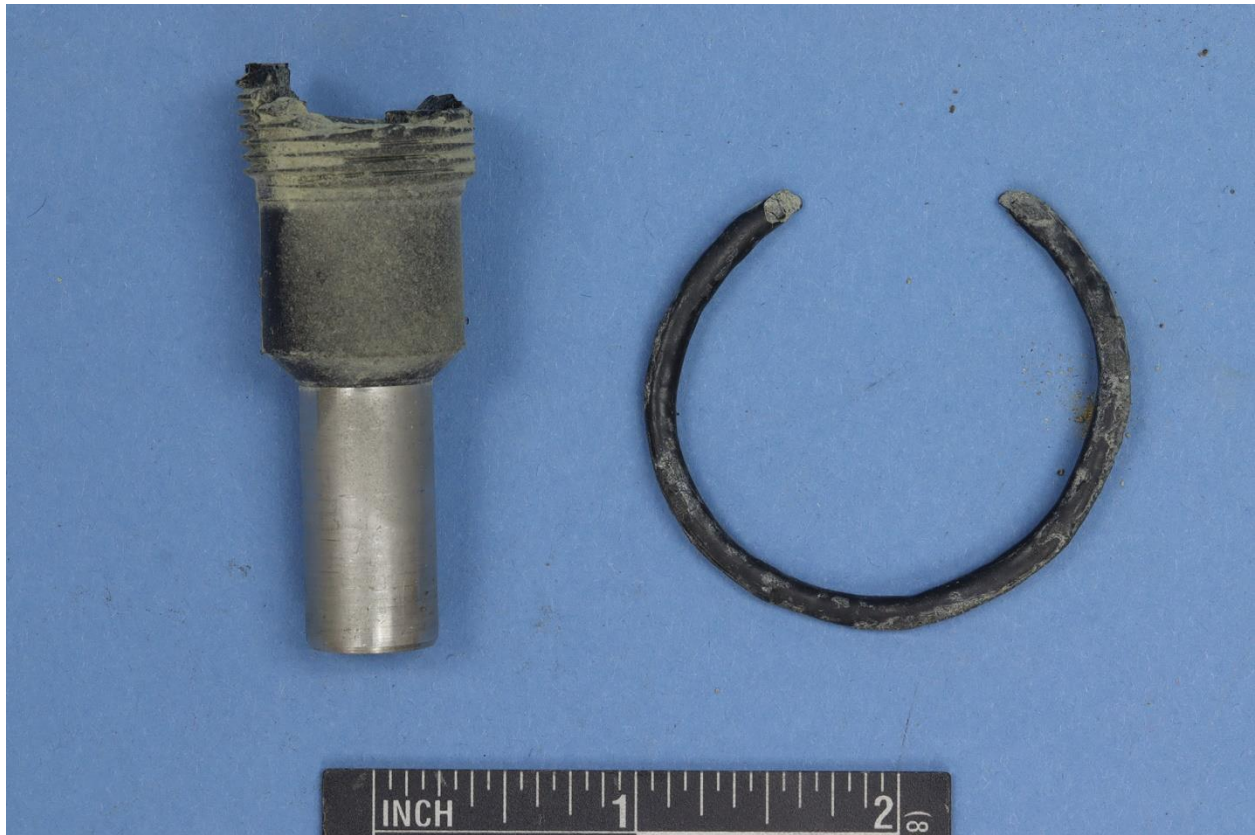
**Figure 3.** The cutter and O-ring, recovered from the excavation site for the active and retired service tees that provided gas service to 17 S. 2<sup>nd</sup> Ave (Palmer building #2).

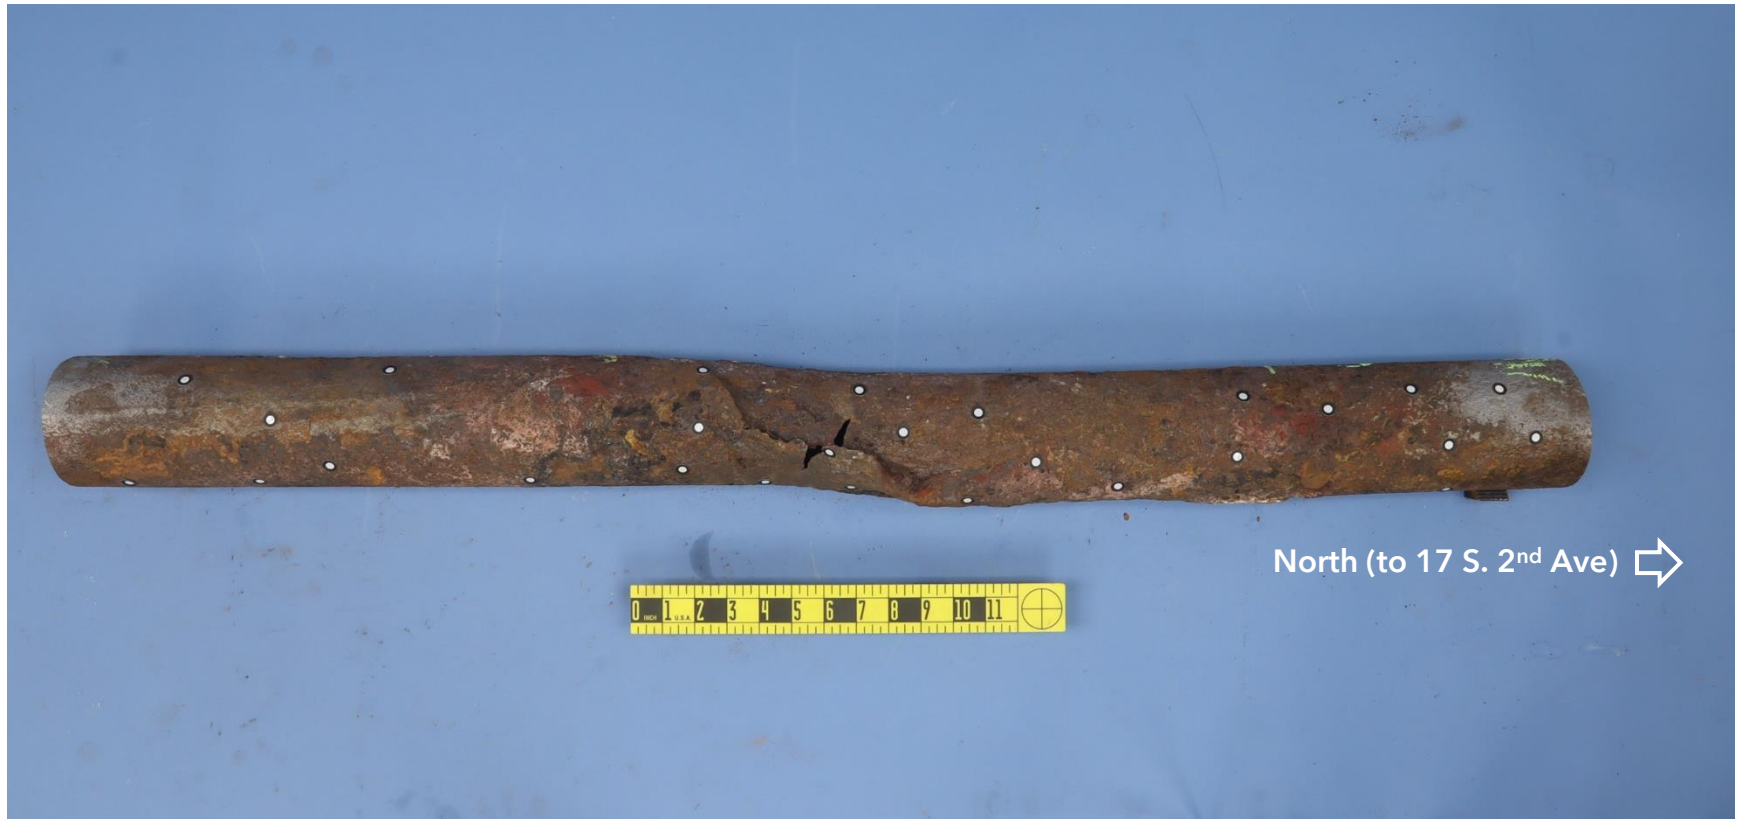
A section of a nearby buried steam pipe, used to provide radiant heat to parts of 17 S. 2<sup>nd</sup> Ave., was submitted to the lab as well (figure 5). The pipe was deformed, corroded, and cracked along its east side as discussed below. A white powder surrounded the pipe at the accident site. The material was identified as predominantly calcium carbonate by an external laboratory at a later date. See the Operations Group Chairman Factual Report for additional details on the identification of the calcium carbonate and for photos and illustrations of the excavation site showing the relative locations of the 17 S. 2<sup>nd</sup> Ave service tees, the steam pipe, and other assets.

**Figure 5.** East side of buried steam pipe segment.

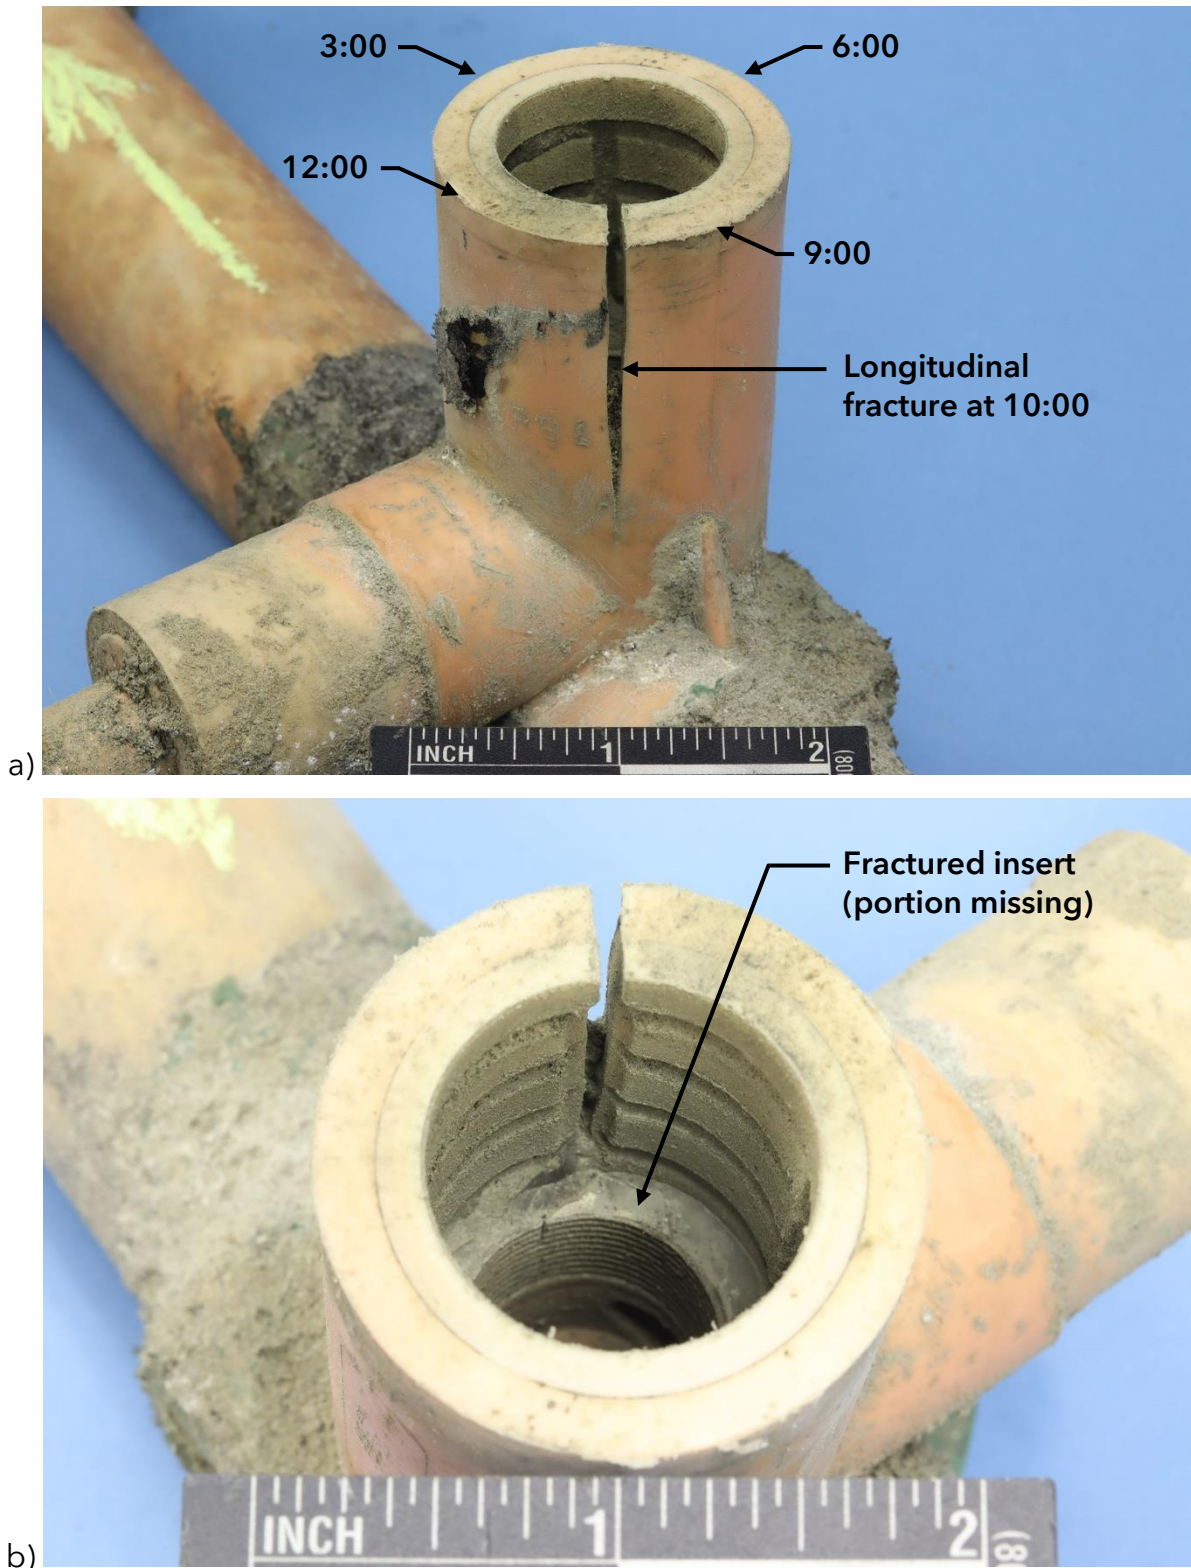
The retired tee was recovered with its cap missing, a portion of its insert missing, and a longitudinal fracture in the tower shell (figures 6a and 6b; also see Section 1.0 and figure 7 below for a depiction of the service tee components and definitions). The cap and the upper portion of the insert were not recovered. For convenience clock positions were assigned to the perimeter of the tower, with 12 o'clock assigned to the tee outlet and other clock positions assigned when viewing the tee from top down. Using this nomenclature, the longitudinal fracture was located at approximately 10 o'clock. A cutter and O-ring, shown in figure 3, were recovered separately.

**Figure 6.** Images of the retired service tee from 17 S. 2<sup>nd</sup> Ave: a) image showing clock position nomenclature and the longitudinal fracture in the shell at 10:00; b) image inside the tower showing the fractured insert;

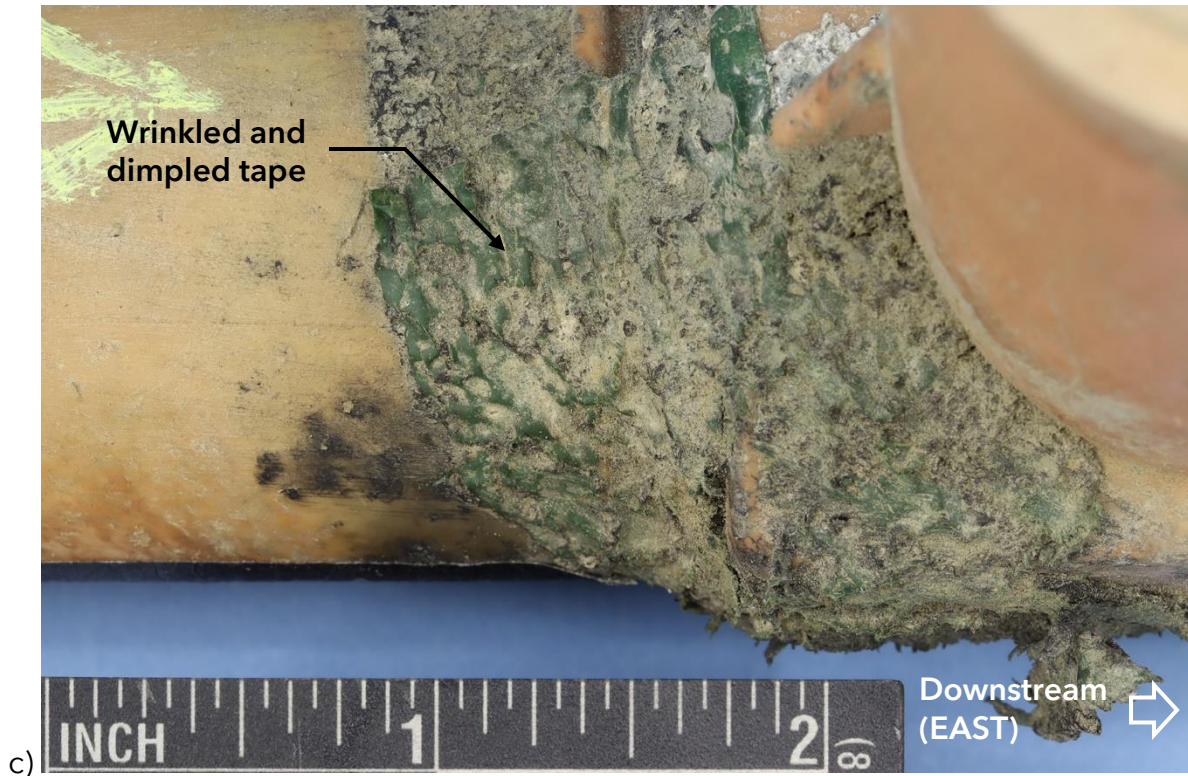
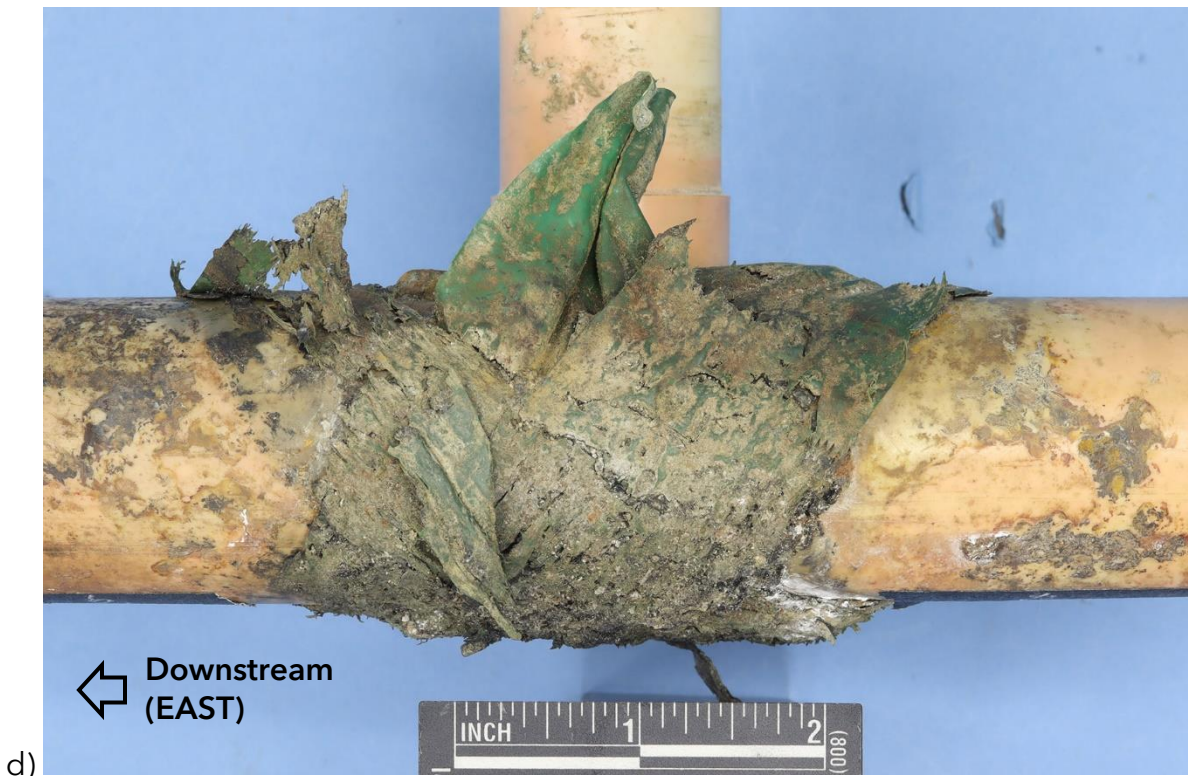
As shown in figures 6c and 6d, respectively, the tape around the retired tire exhibited a wrinkled and dimpled appearance on the top/south side of the gas main and a cracked and split appearance on the bottom/south side of the main. The tape on the north-facing side of the main, by contrast, did not exhibit any noteworthy features, nor did the tape on the tee for 77 S. 2<sup>nd</sup> Ave (see figure 7).

**Figure 6 (cont.).** c) image showing the appearance of the green tape on the top west side of the tower; and d) image showing the appearance of the tape on the underside of the tower.

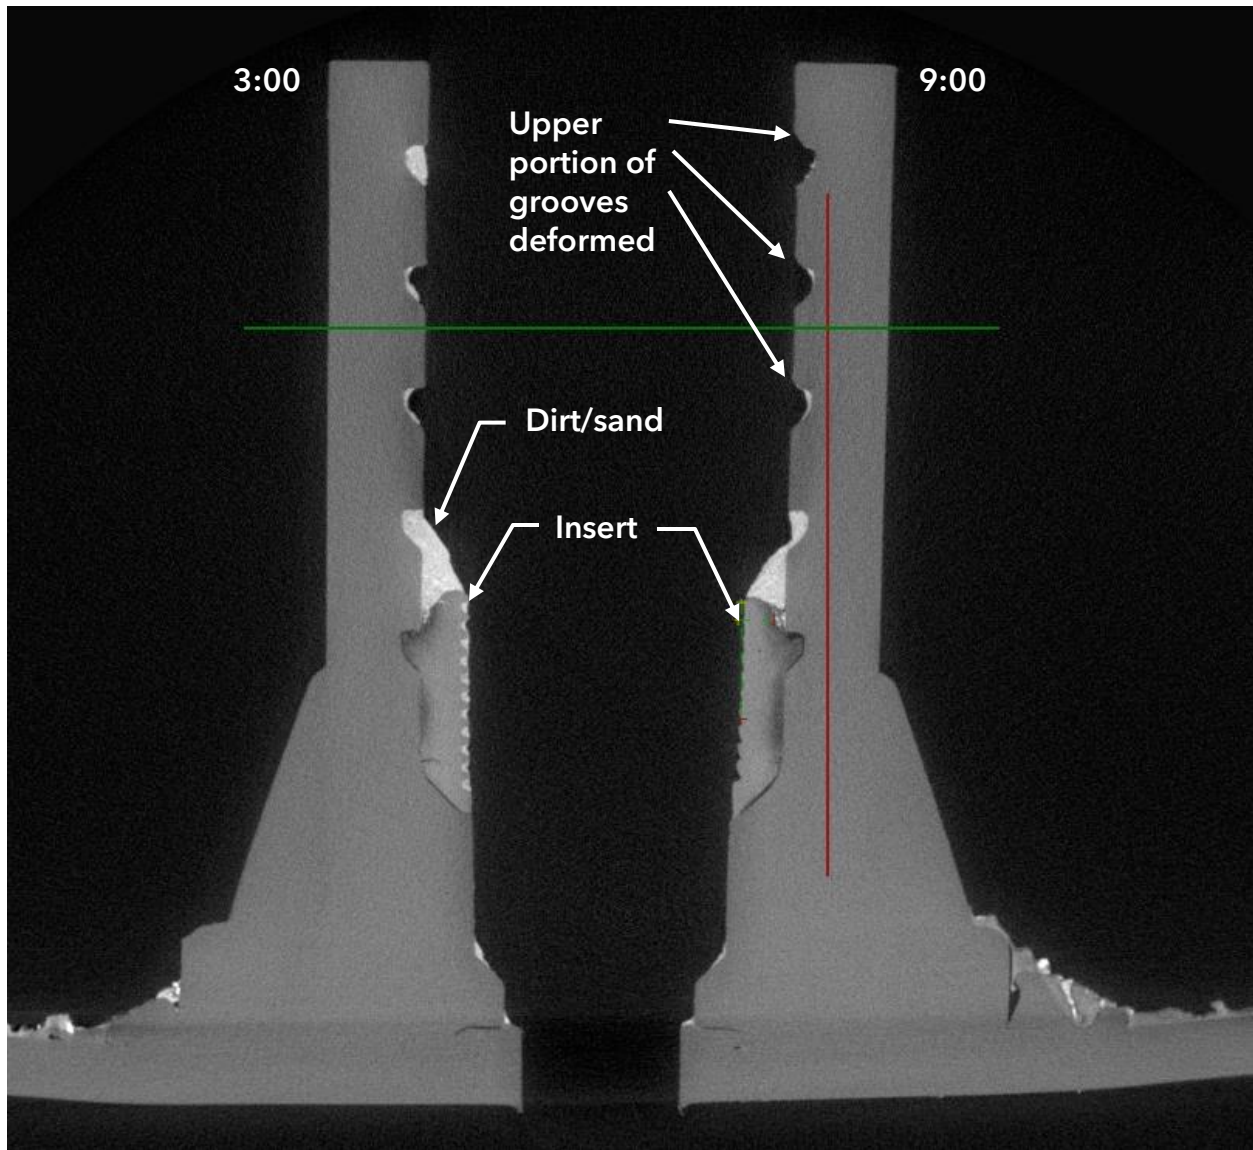
**Figure 9.** X-ray CT cross section of retired tee from 17 S. 2<sup>nd</sup> Ave through the 3:00 and 9:00 positions. The circumferential grooves on the 9:00 side of the shell were deformed upward/outward.

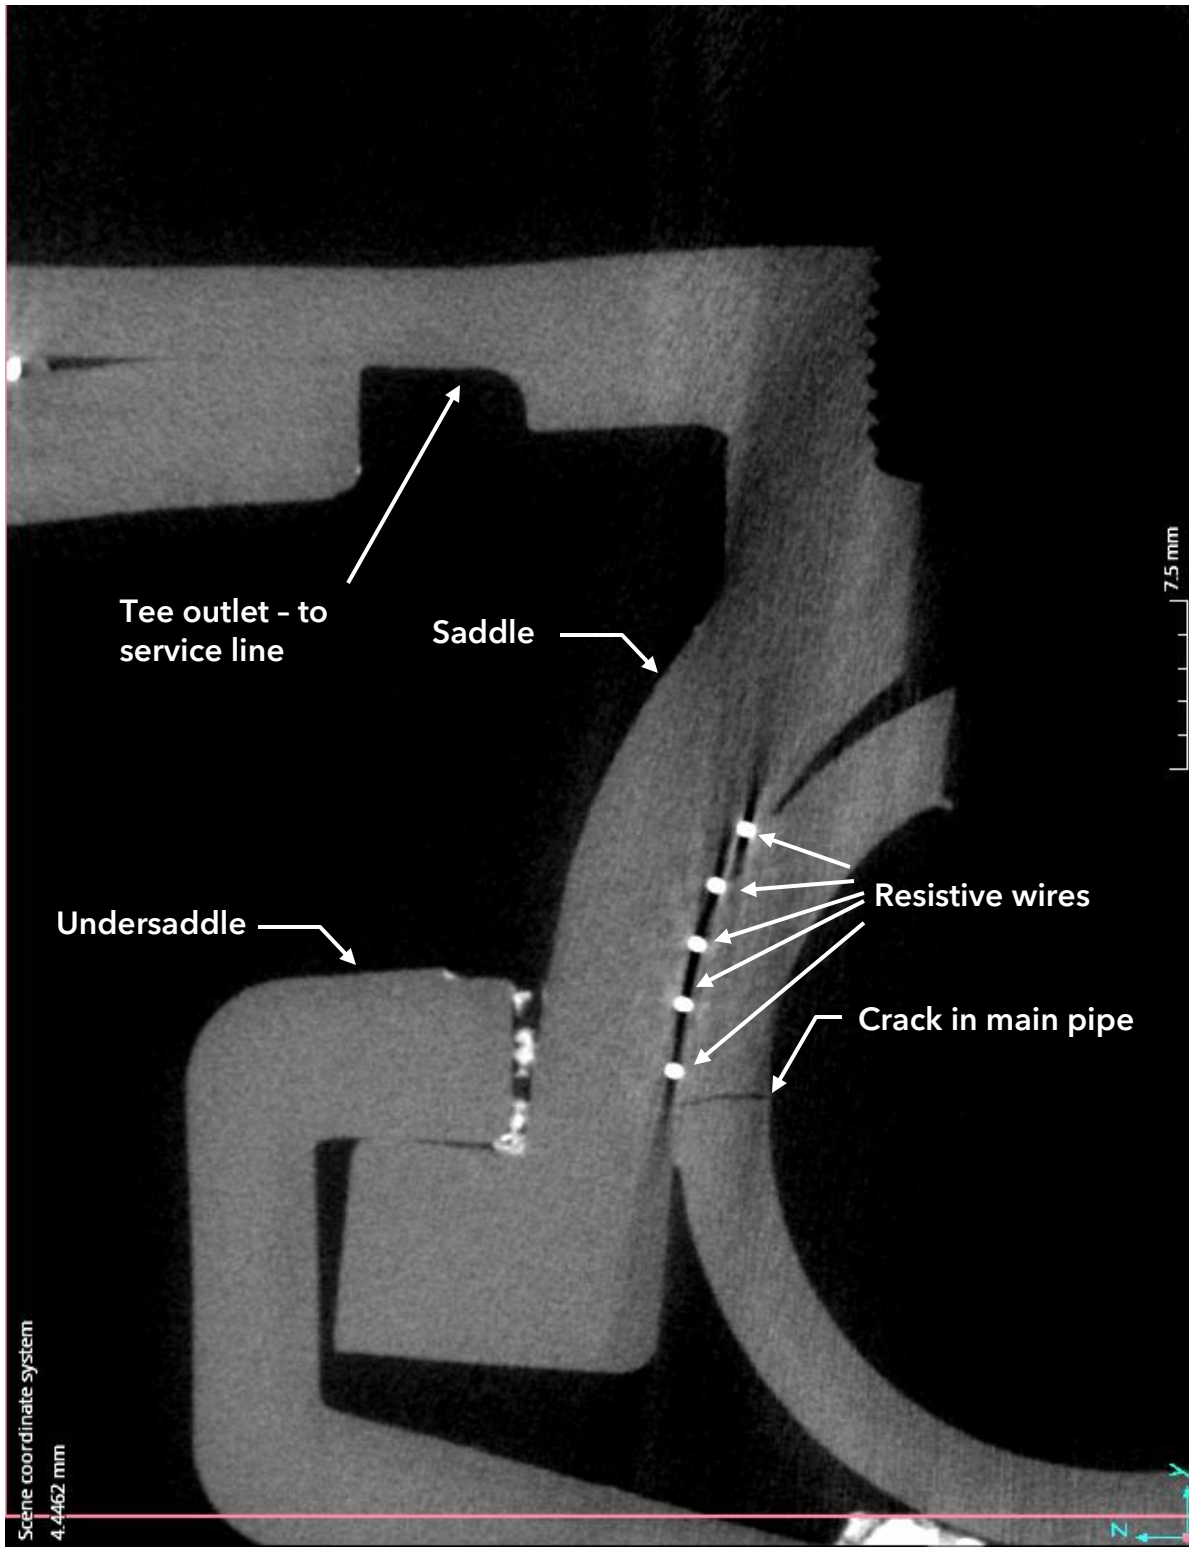
- 4) A crack was observed in the main Aldyl A gas pipe underneath the saddle of the 2021 replacement tee as shown in figure 10. As described below, the crack was near the midline of the tee (centered approximately 0.085 inch upstream of the midline), underneath the tee's outlet, just outside the resistive fusing wires, and approximately 90° from top dead center.

**Figure 10.** X-ray CT cross section through the 2021 replacement tee, viewed looking in the downstream direction. A crack was observed in the main pipe, close to the midline of the tee.

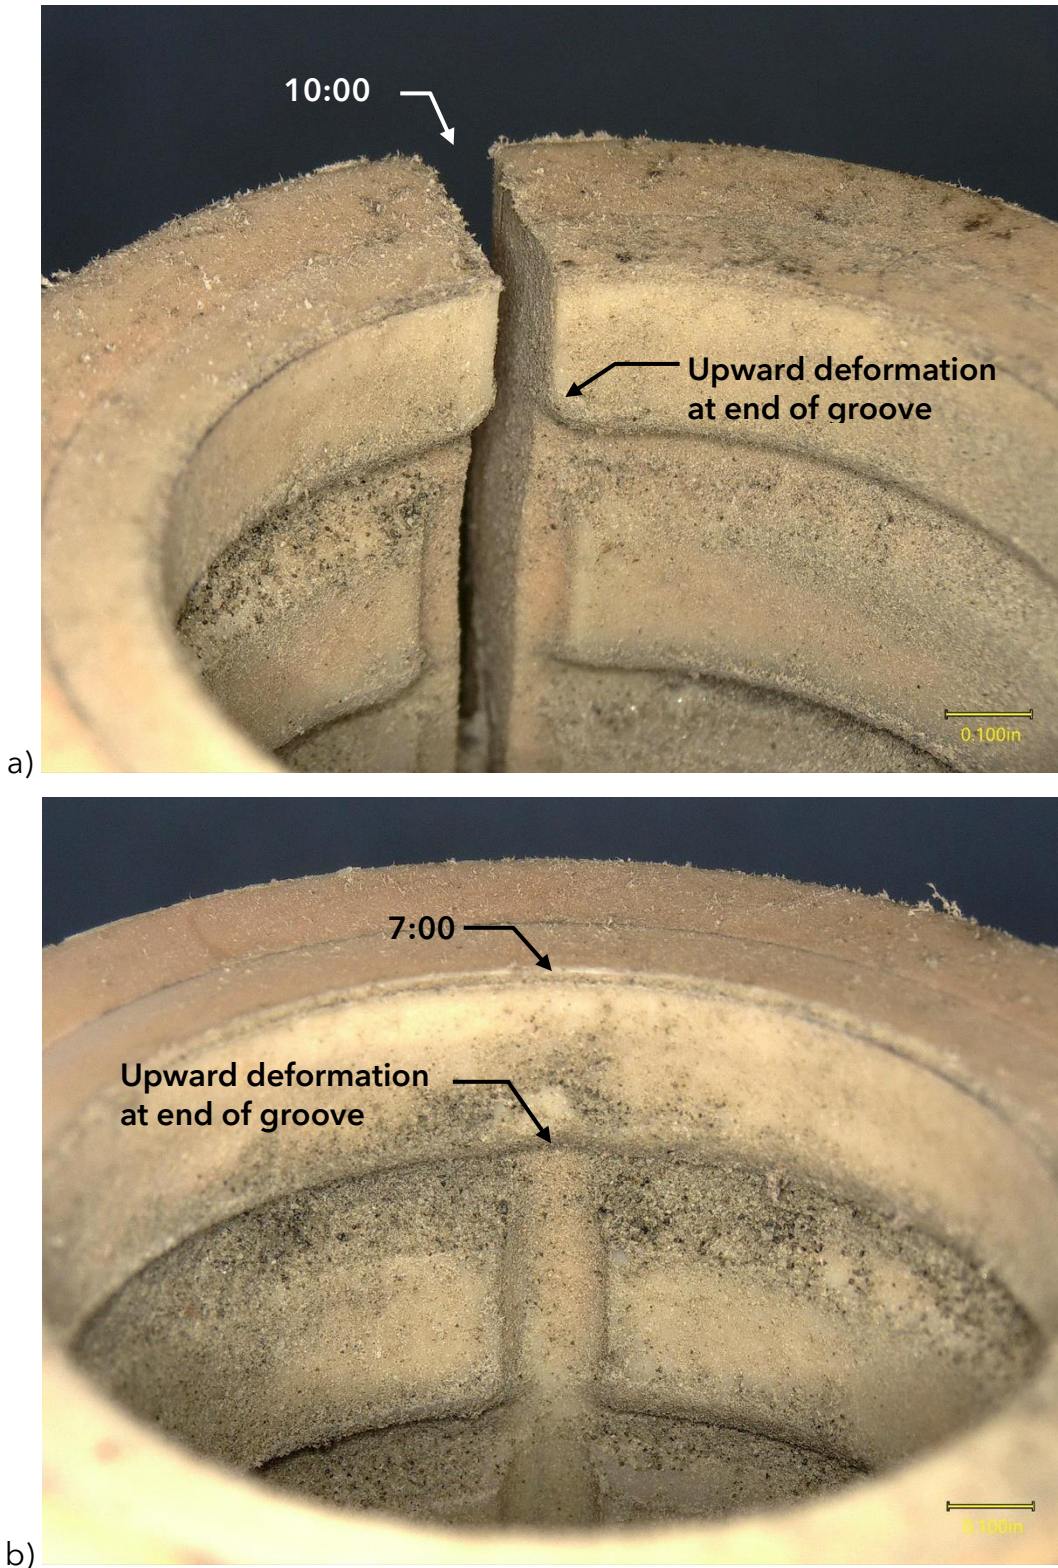
The retired tee was visually examined and then cut into pieces in order to examine the insert and the longitudinal fracture through the tower shell. The longitudinal grooves in the shell were positioned at 1:00, 4:00, 7:00, and 10:00. As shown in figures 11a and 11b, the upper groove ends at the 10 o'clock and 7 o'clock positions were deformed upward and the longitudinal fracture in the shell was centered within the groove at 10 o'clock.

**Figure 11.** Images showing upward deformation at the ends of two longitudinal grooves in the retired tee polyethylene shell: a) groove at 10:00 and b) groove at 7:00.

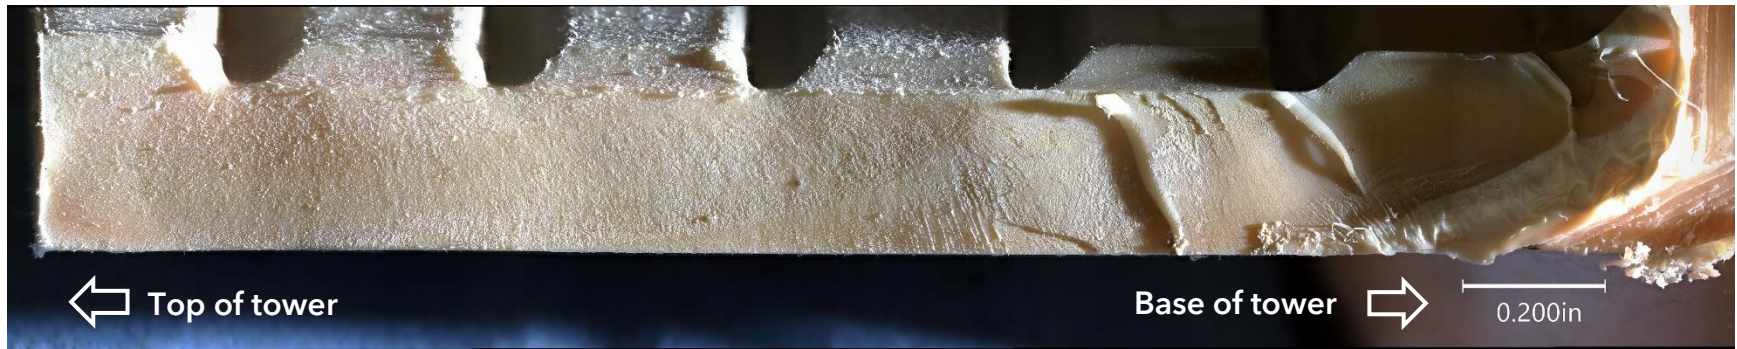
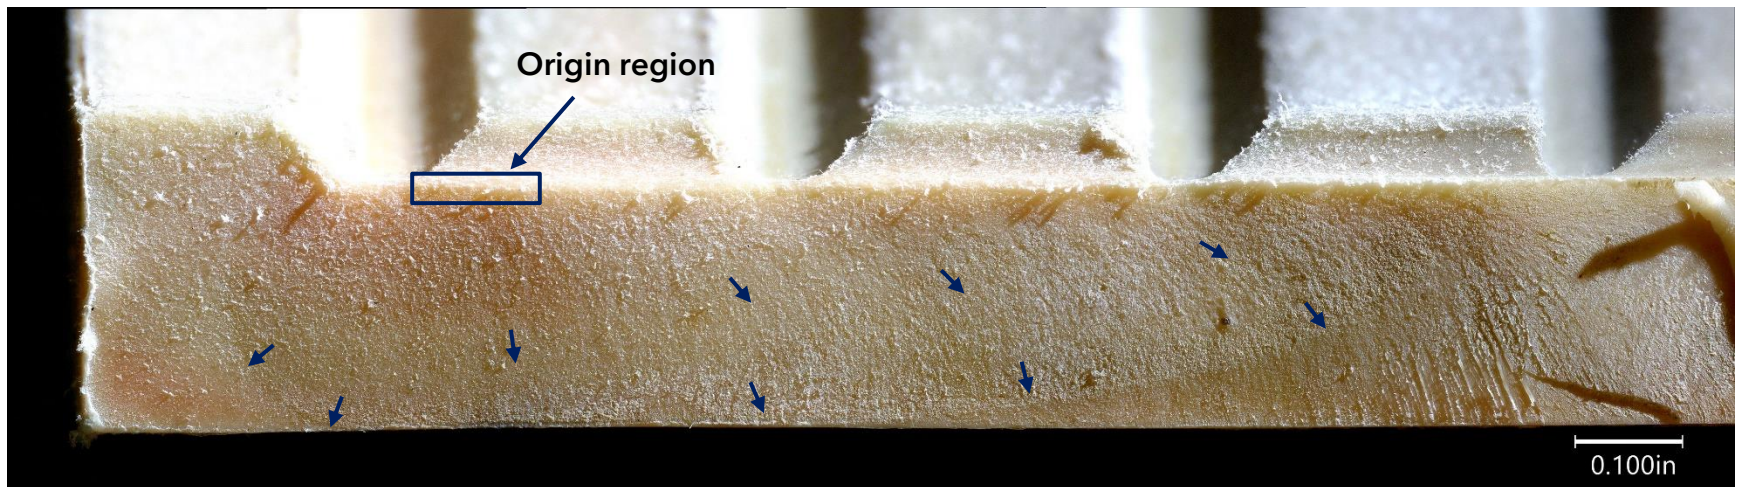
The fracture surface exhibited features consistent with initiation due to slow crack growth. The upper portion of the fracture (left side in figure 13) was flat and comparatively featureless, with fibrils observed across the region, consistent with slow crack growth. This region extended through the shell wall near the top of the tower, approximately 0.233 inch across, and extended further down the tower along the inner diameter (ID) surface than along the outer diameter (OD) surface. Along the ID surface, the slow crack growth region extended approximately 1.320 inch from the top of the tower and along the OD surface, it extended approximately 0.715 inch from the top of the tower. When viewed under a stereomicroscope and oblique lighting, fine radiating crack growth features were observed on the fracture, progressing away from the inner diameter surface (see blue arrows in the lower image in figure 13). The features were traced back toward a region, indicated in figure 13, extending from 0.325 inch to 0.430 inch from the top of the tower. As shown in figure 14 (Note: photo taken after the group exam), the crack origin occurred along an impression in the shell wall created by the mold line on the

polyoxymethylene insert. Further toward the base of the tower, the fracture surface exhibited flat featureless regions transitioning to hackle consistent with a transition to fast fracture. In total, the longitudinal fracture extended approximately 2.300 inch from the top of the tower on the ID and 1.860 inch on the OD. Other than the mold line impression, there were no other apparent anomalies in the vicinity of the crack origin.

**Figure 13.** Upper image: Longitudinal fracture from top of tower to base of tower. Lower image: Detailed image of slow crack growth region with blue arrows indicating the local direction of crack propagation.

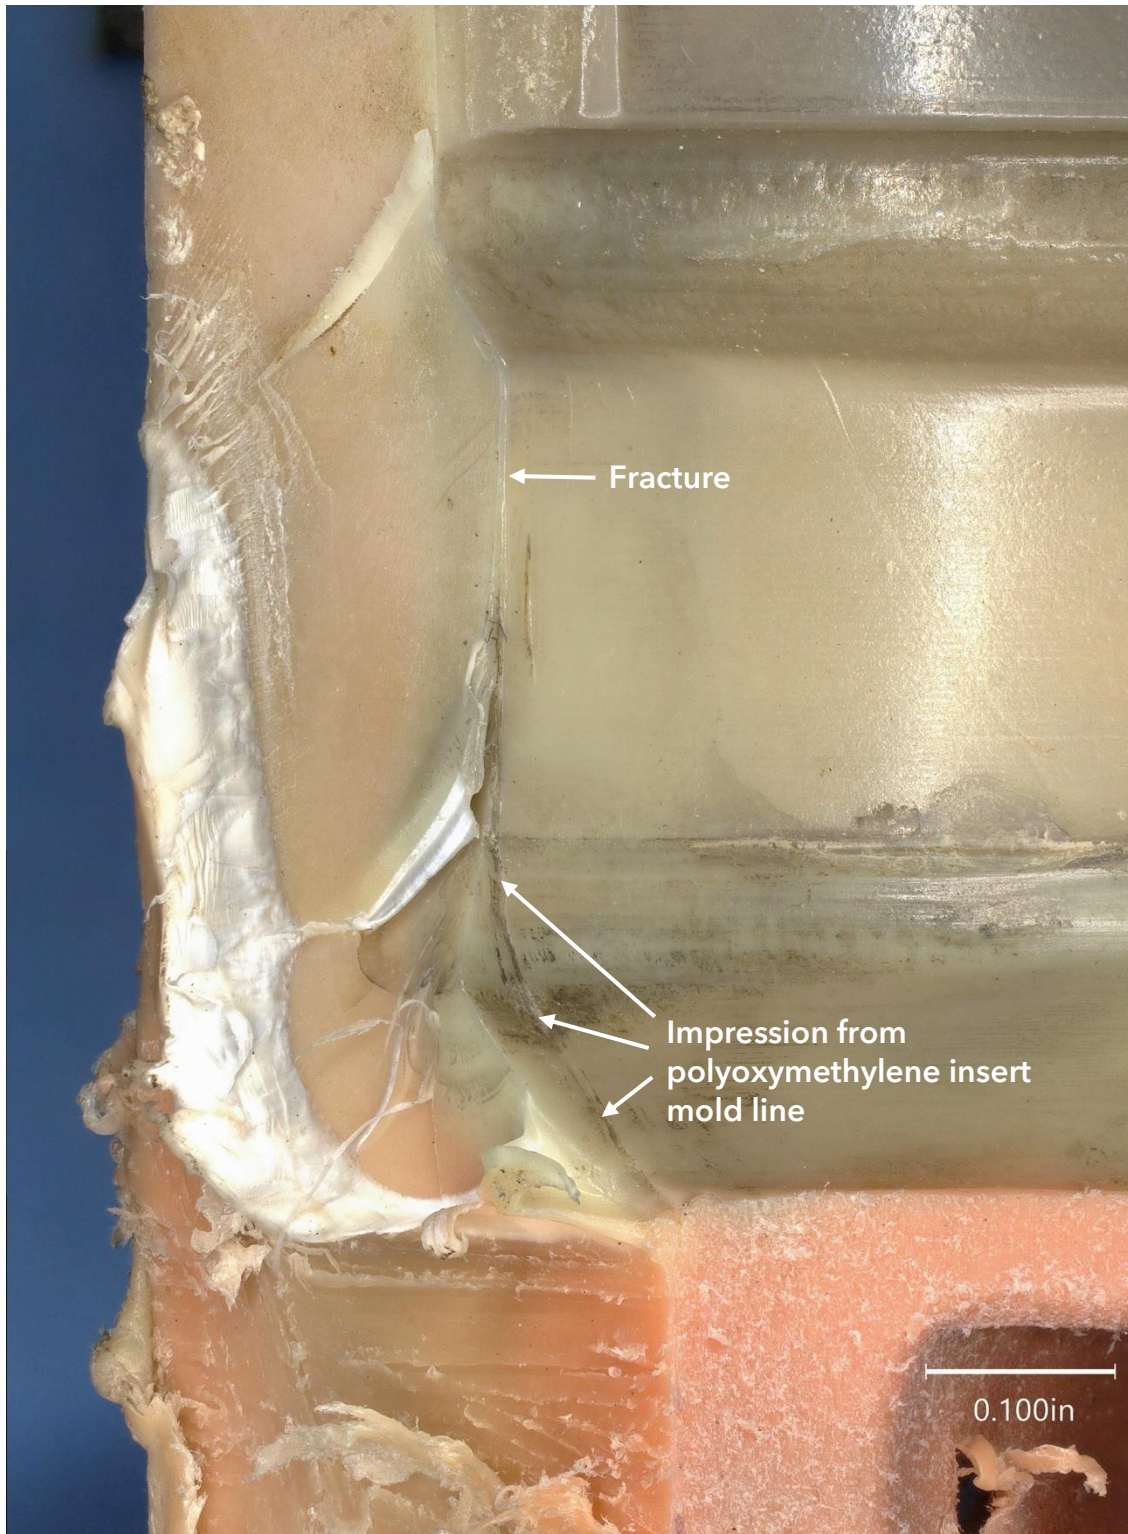
**Figure 14.** Image from the retired tee tower shell near the base of the tower. The longitudinal fracture coincided with an impression in the shell created by the mold line on the polyoxymethylene insert.

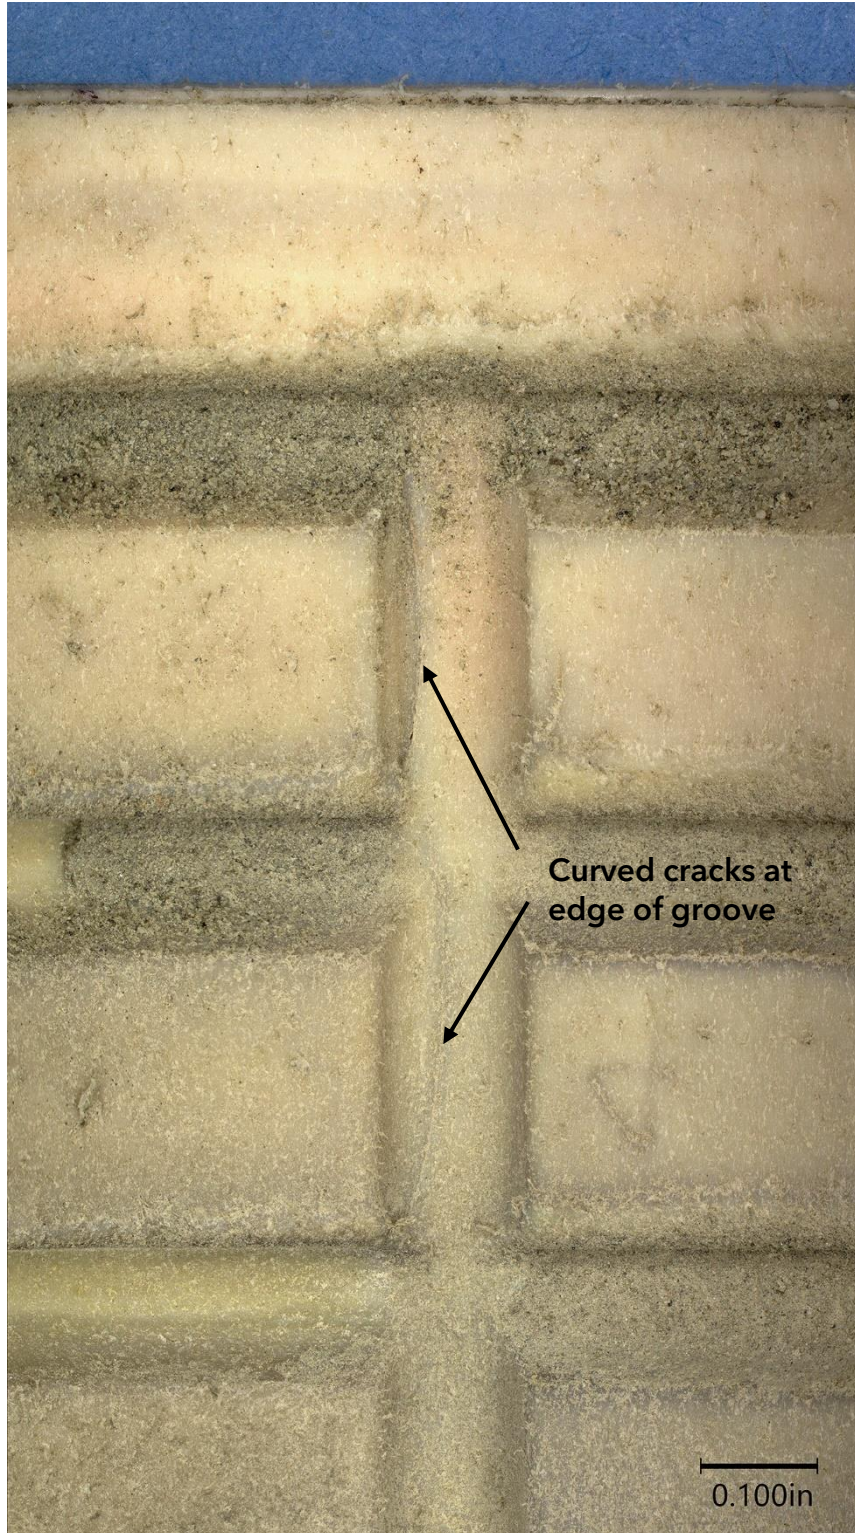
After the group activity, but included in this section for completeness, additional cracks were observed in the tower shell, as shown in figures 15 and 16. Figure 15 shows the longitudinal groove in the shell at 7 o'clock. Two curved cracks were observed in the groove near the top of the shell between the top and third from the top circumferential grooves. An incipient crack was also found near the origin of the longitudinal crack, shown in figures 16a and b.

**Figure 15.** Image of the longitudinal groove at 7:00 in the retired tee highlighting two additional cracks.

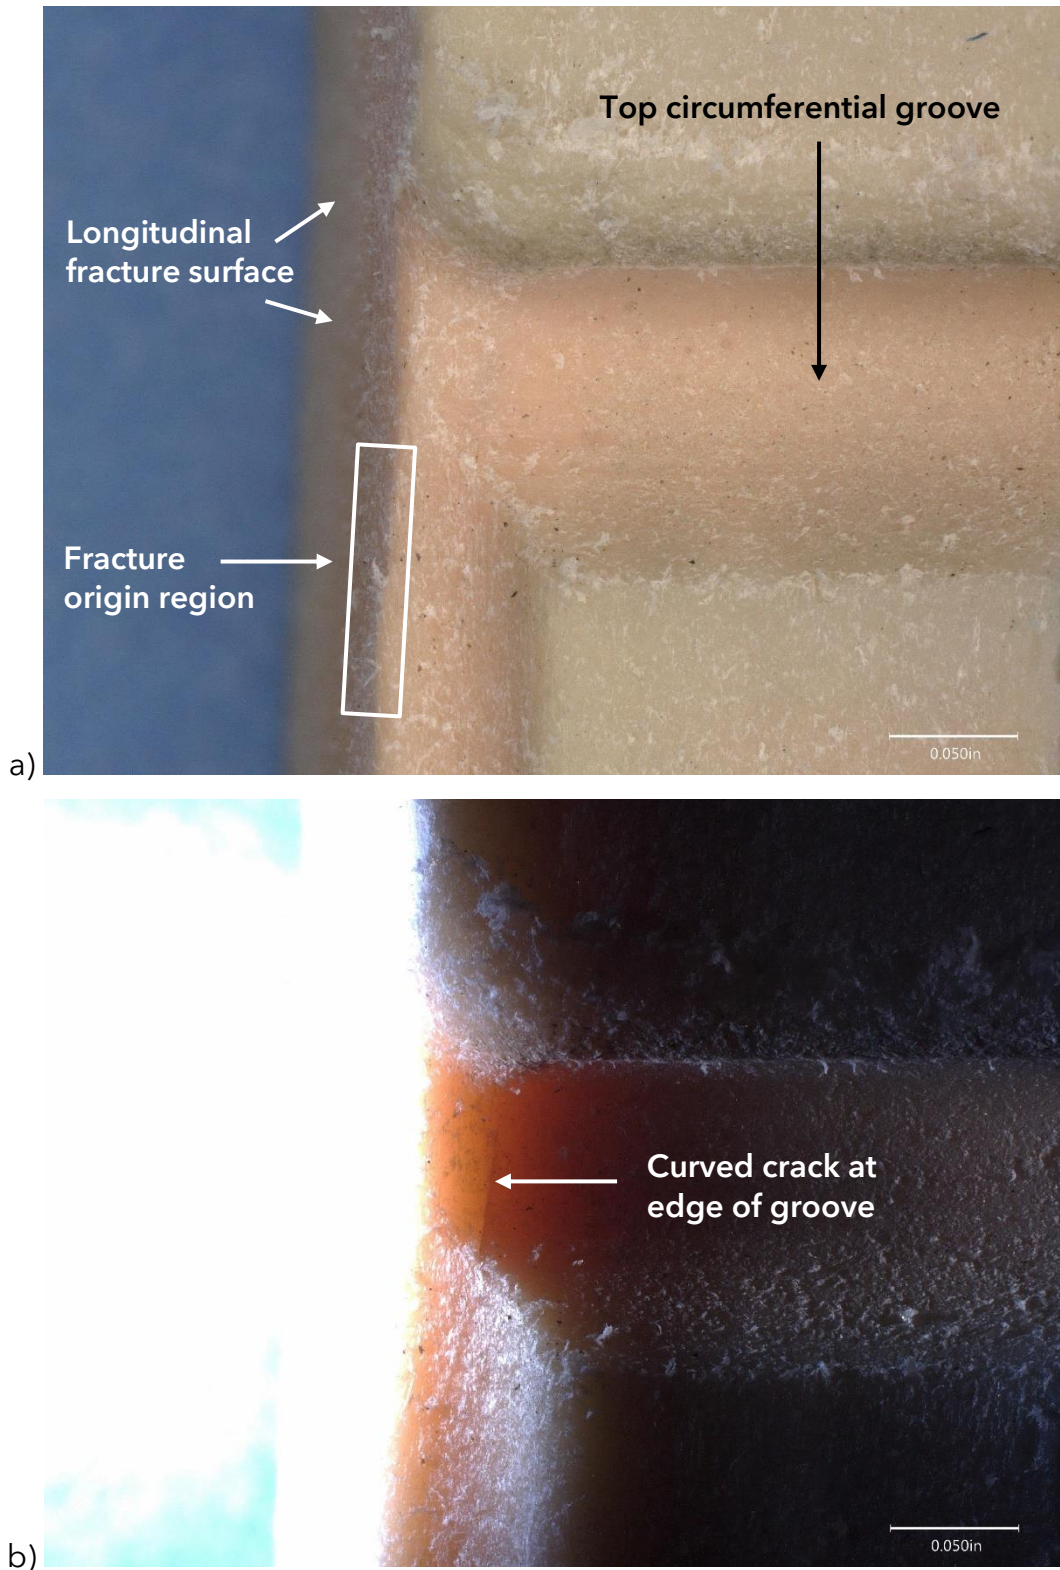
**Figure 16.** Shallow crack observed in the retired tee near the origin of the longitudinal fracture: a) reference image under normal lighting and b) image under penetrating oblique lighting with crack indicated.
