# National Transportation Safety Board

## **MATERIALS LABORATORY**

Factual Report 23-072

Location: West Reading, Pennsylvania  
Date: March 24, 2023  
Vehicle: UGI Gas Distribution Pipeline System  
Investigator: Kim West, RPH-20

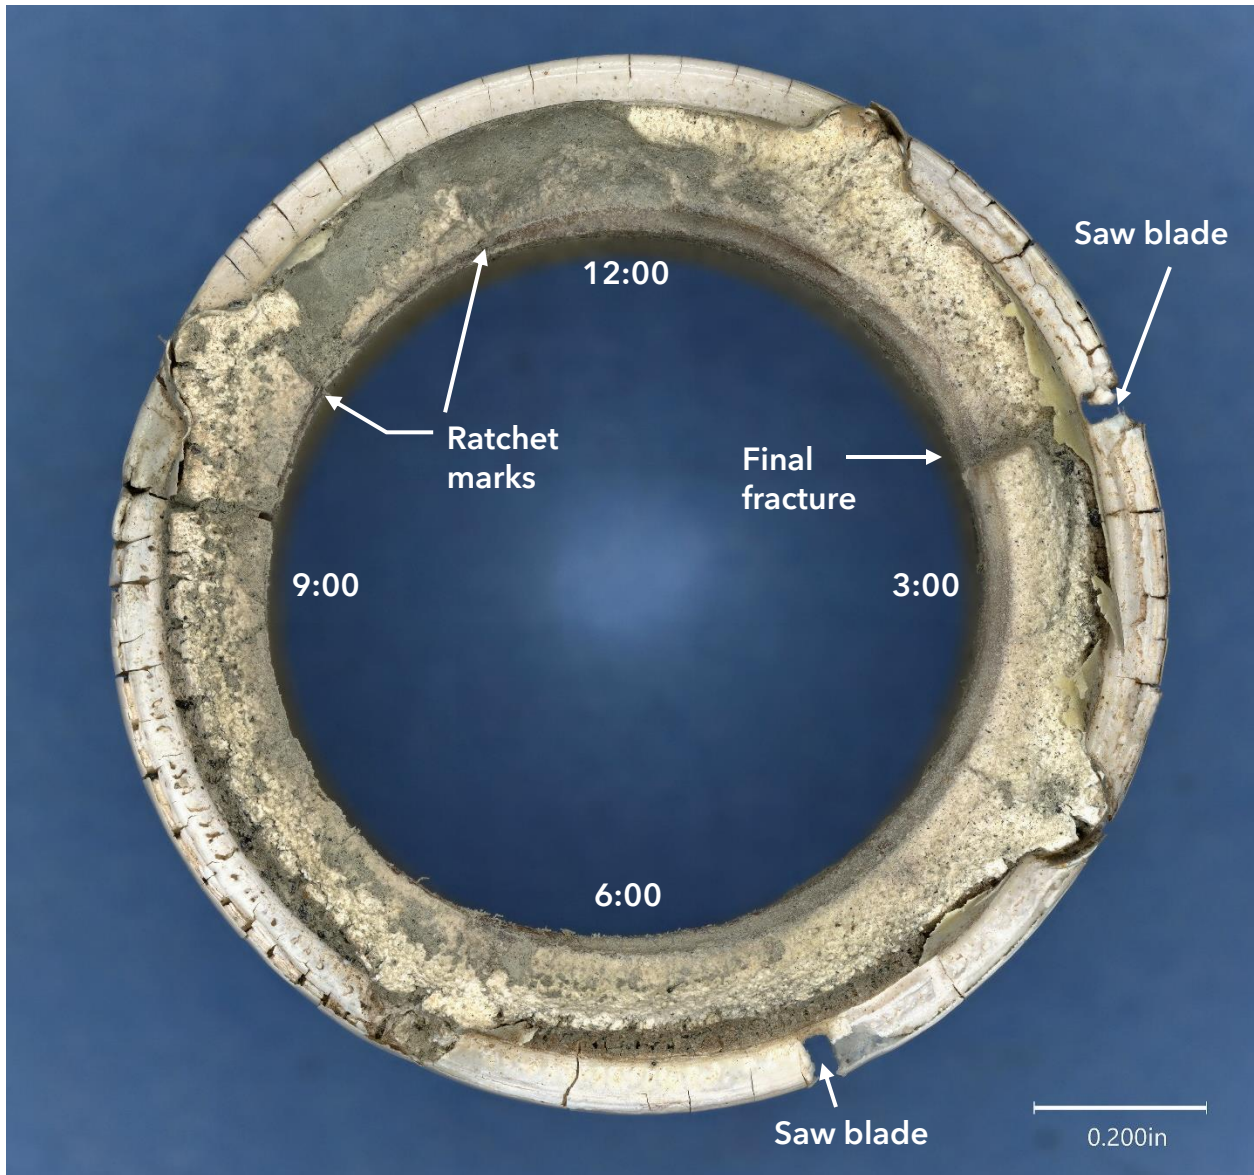
The tower insert was fractured in the transverse plane above the lowest circumferential rib. The height of the remaining piece was approximately 0.720 inch. The insert from the sister tee measured 2.318 inch by micrometer, resulting in an approximate remaining length fraction for the fractured insert of 0.31. An image of the transverse fracture is shown in figure 17 and side views at 90° rotation intervals are shown in figures 18a - d. The insert was not cleaned and some regions of the fracture surface were covered by dirt/debris. Two ratchet marks were observed originating from the ID surface, near the 10 o'clock and 11 o'clock positions, and from 6 o'clock to 12 o'clock by way of 9 o'clock, the inner half of the through-wall fracture exhibited a crazed and fibrous appearance. By contrast, the outer half, where visible, exhibited a granular and porous appearance. From 6 o'clock to 12 o'clock by way of 3 o'clock, the entire through-wall fracture exhibited a granular and porous appearance. The fracture intersected and followed a thread root on the ID surface, progressing along clockwise and counterclockwise paths until meeting at a point of final fracture between 2 o'clock and 3 o'clock, where the two paths intersected, by jumping across a thread crest. The features were consistent with fracture initiation on the 9 o'clock side of the insert.

The insert exhibited features consistent with material degradation and volume loss. As seen in figures 17 and 18, portions of the fracture surface exhibited a granular porous appearance. Mud cracking features were observed adjacent to the fracture in some regions, as shown between 9 o'clock and 6 o'clock in figure 18a. Multiple cracks and porosity were observed in the circumferential rib and additional cracks were observed on the barrel's outer diameter surface. As shown in figure 19, the thread profile was diminished on a region of the ID surface between 6 o'clock and 9 o'clock. At a later date (not part of the group activity) the insert was sectioned for external lab testing. As part of sample acquisition, longitudinal breaks were made at 6 o'clock and 4 o'clock. The broken faces, as shown for the 6 o'clock face in figure 20, revealed that the outer portion of the insert body exhibited a granular and friable appearance. By contrast, the inner half of the wall exhibited a comparatively smooth fracture typical of fully consolidated material.

**Figure 17.** Image of insert fracture surface from the retired tee.

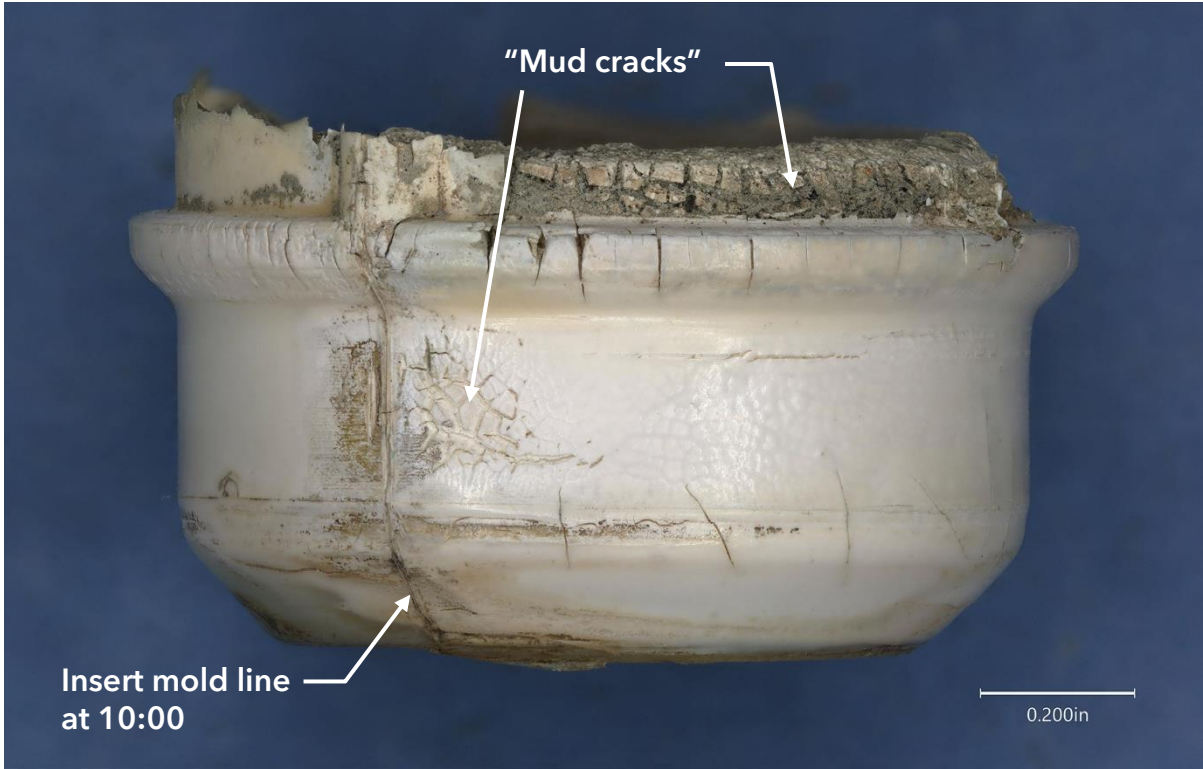
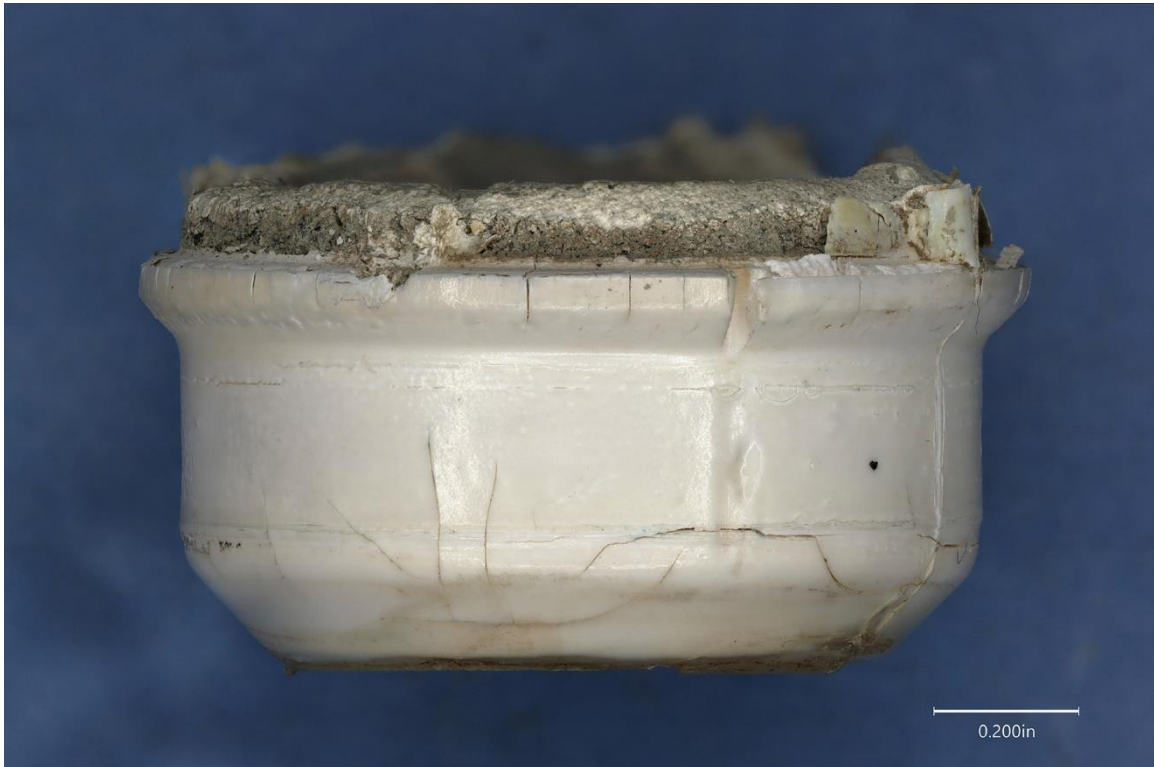
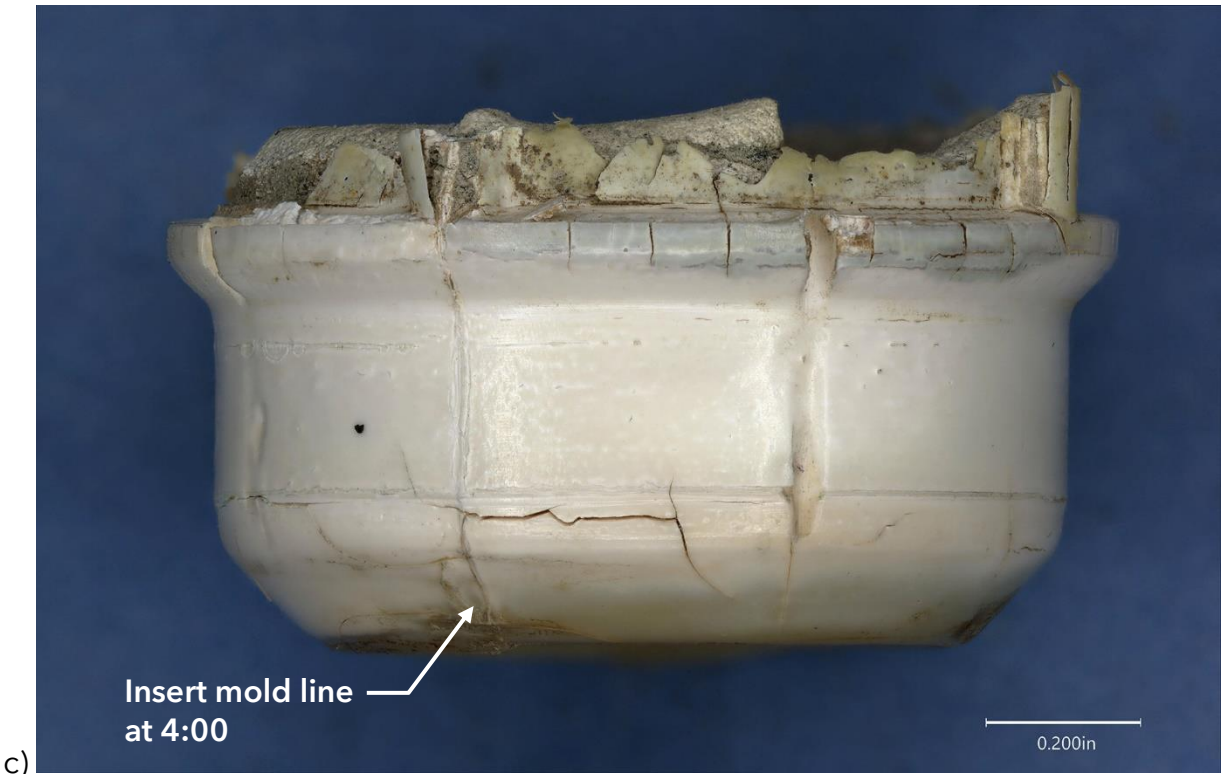
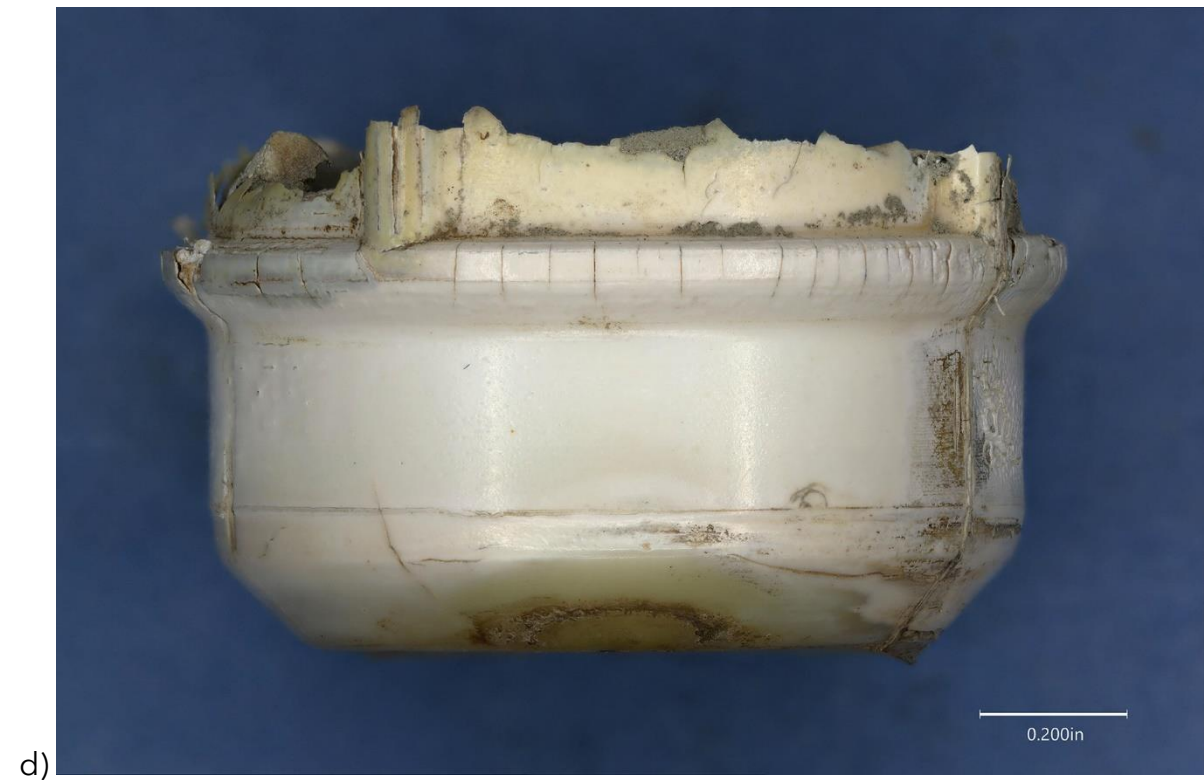
**Figure 18.** Side views of the insert from the retired tee: a) 9:00; b) 6:00;

**Figure 18 (cont.).** c) 3:00; and d) 12:00.

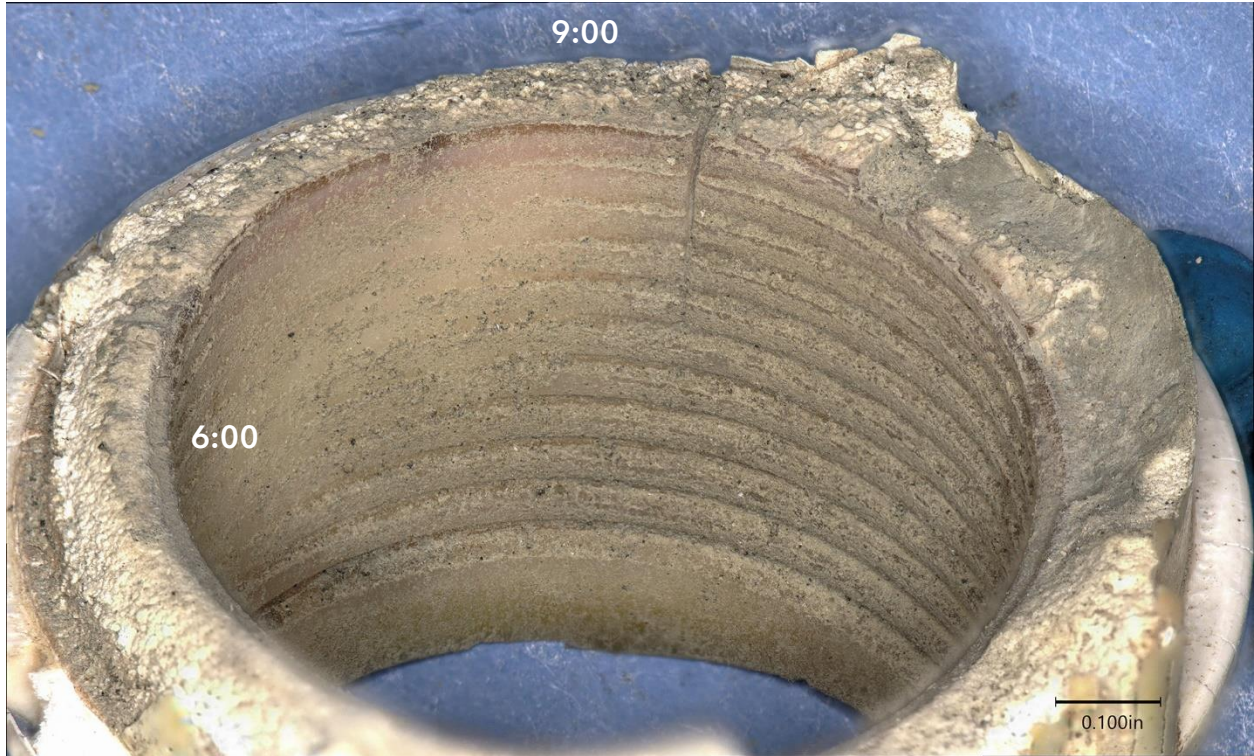
**Figure 19.** Image of the insert inner diameter showing loss of thread profile between 6:00 and 9:00.

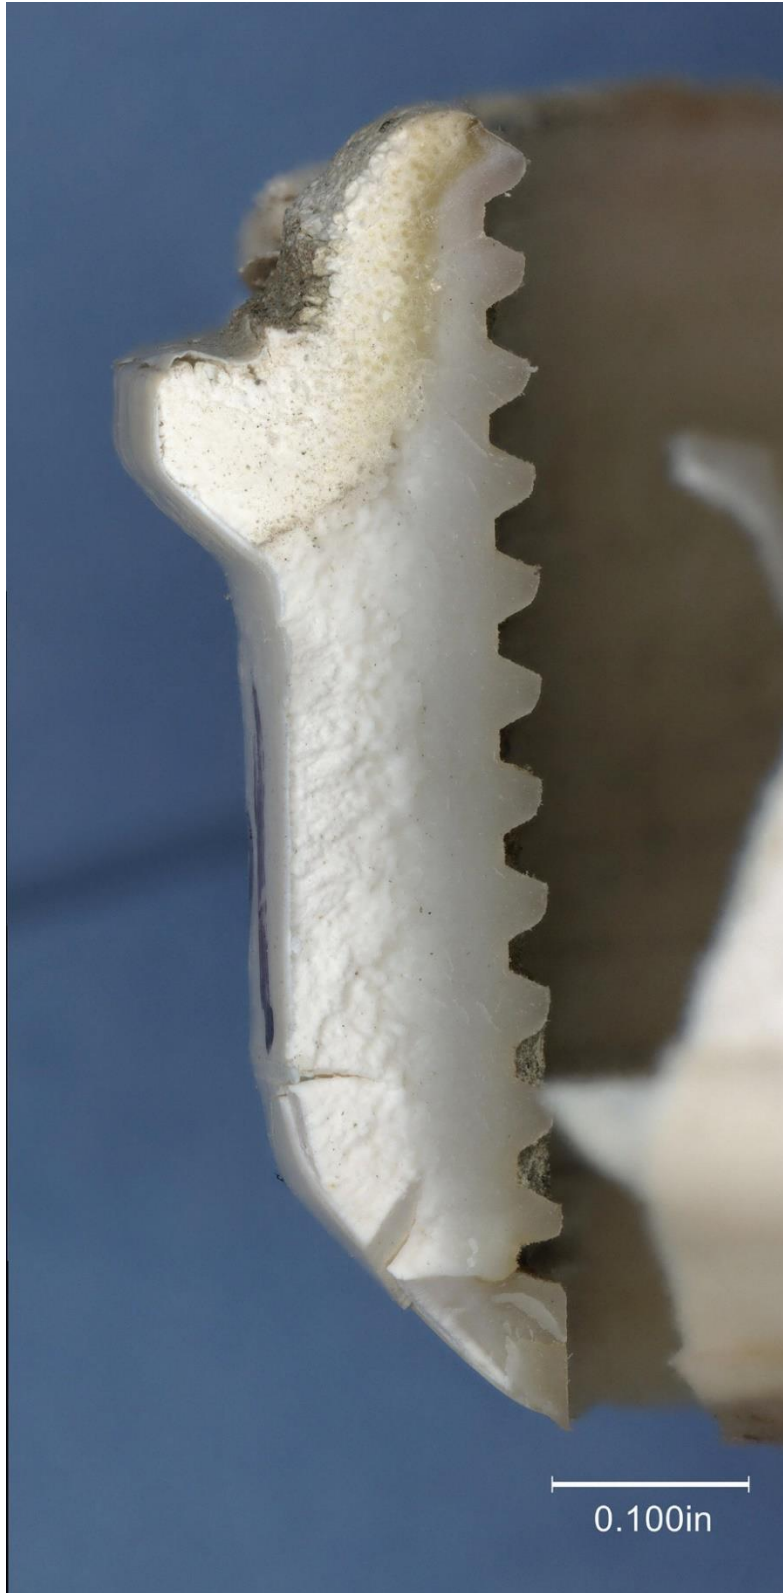
**Figure 20.** Longitudinal cross section of retired tee insert at 6:00 showing granular friable material on the outer half of the wall and fully consolidated material on the inner half of the wall.

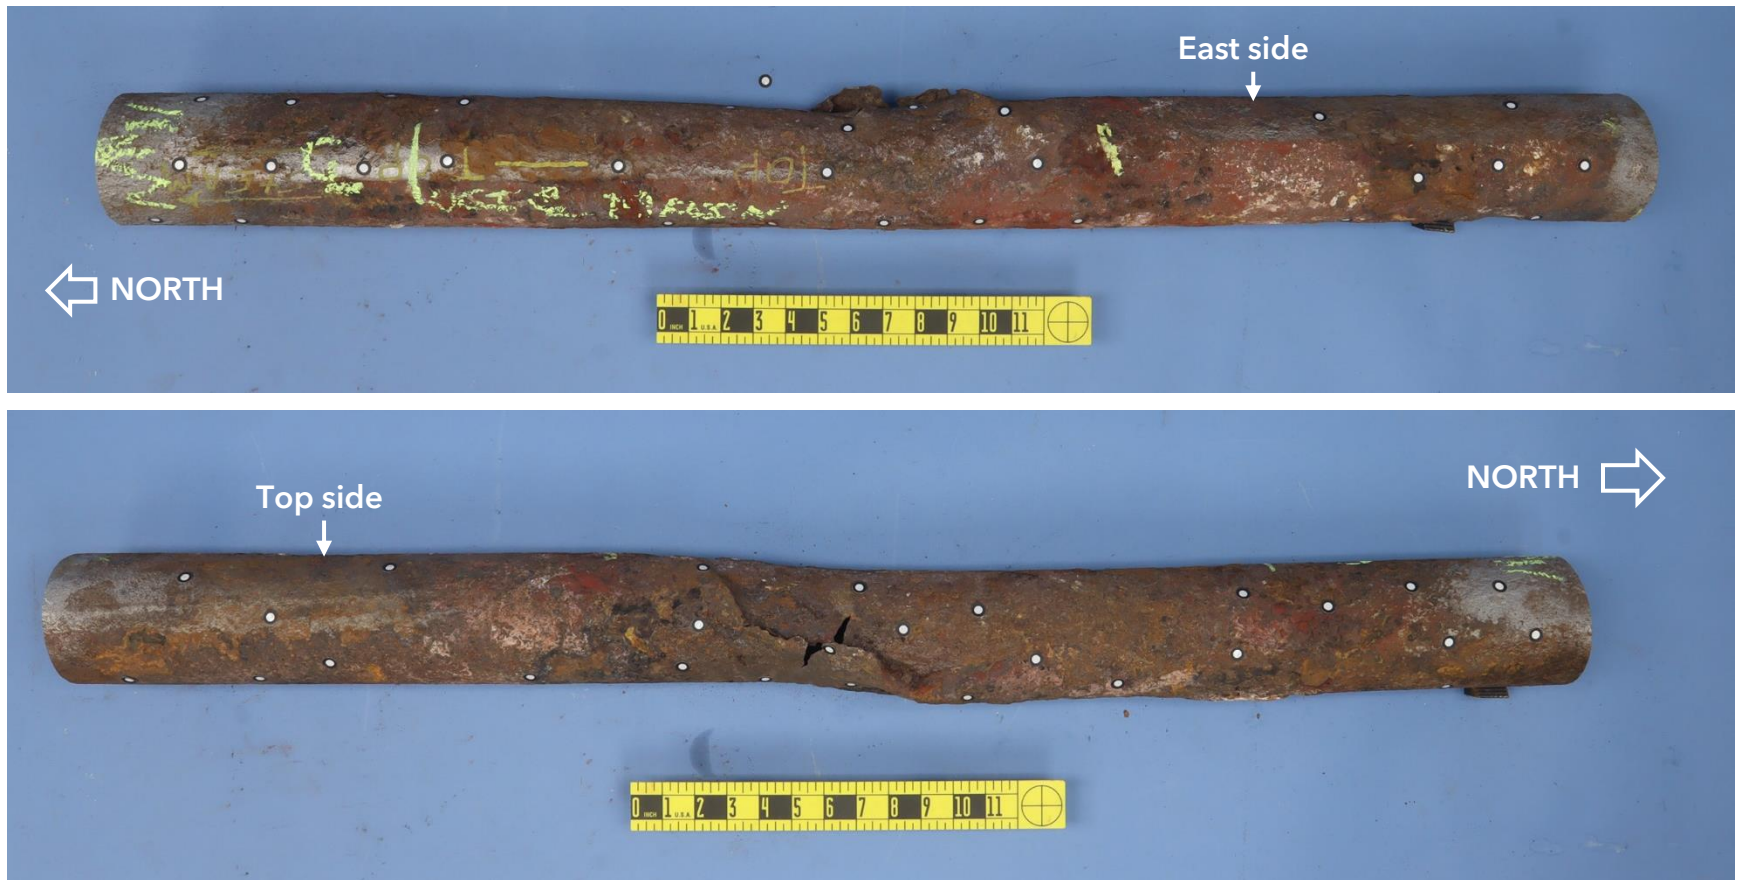
A segment of the steam pipe, approximately 46 inch in length, is shown in figures 21 and 22. The pipe had a nominal outer diameter of 4.00 inch and a wall thickness between 0.20 inch and 0.22 inch, consistent with NPS 3-1/2-inch Schedule 40 pipe. The pipe was located approximately 23.4 inch to the west and 15.5 inch above the retired tee (center of pipe to top of tee). The steam pipe laid perpendicular to the gas main, with steam flowing from 77 S. 2<sup>nd</sup> Ave to 17 S. 2<sup>nd</sup> Ave (from south to north). In the middle of the segment, the pipe was corroded around its outer diameter surface. Little to no corrosion was apparent on the inner diameter surface. In the corroded region, the pipe was deformed and cracked. Viewed from the side, the pipe lengths upstream and downstream of the corroded region exhibited a vertical shear displacement relative to one another. The steam pipe segment was marked with the approximate location of the Aldyl A gas main centerline near its downstream end. See section 3.4 for distance measurements of various features along the length of the pipe.

The pipe was cracked on its east side. Assigning clock positions to the pipe, viewed from the south looking north and with top dead center as 12 o'clock. The center of the cracked region was located at 3 o'clock. The east side was deformed inward downstream of the sheared and cracked region. The cracks in the pipe ran at inclined angles to the longitudinal axis of the pipe. One crack was associated with an outward compressive bulge/buckle (figure 22b) that measured approximately 4.05 inch in length. Two transverse cracks branched off this crack, one measuring approximately 1.14 inch (toward the pipe top) and the other measuring 1.26 inch (toward the pipe bottom), respectively. The fracture faces associated with the buckle overlapped. In total, the features were consistent with initial localized shear deformation of the pipe in the corroded region followed by cracking of the pipe wall and additional torsion deformation.

**Figure 21.** Images of the segment of steam pipe: Top: Top down view; Bottom: East side view.

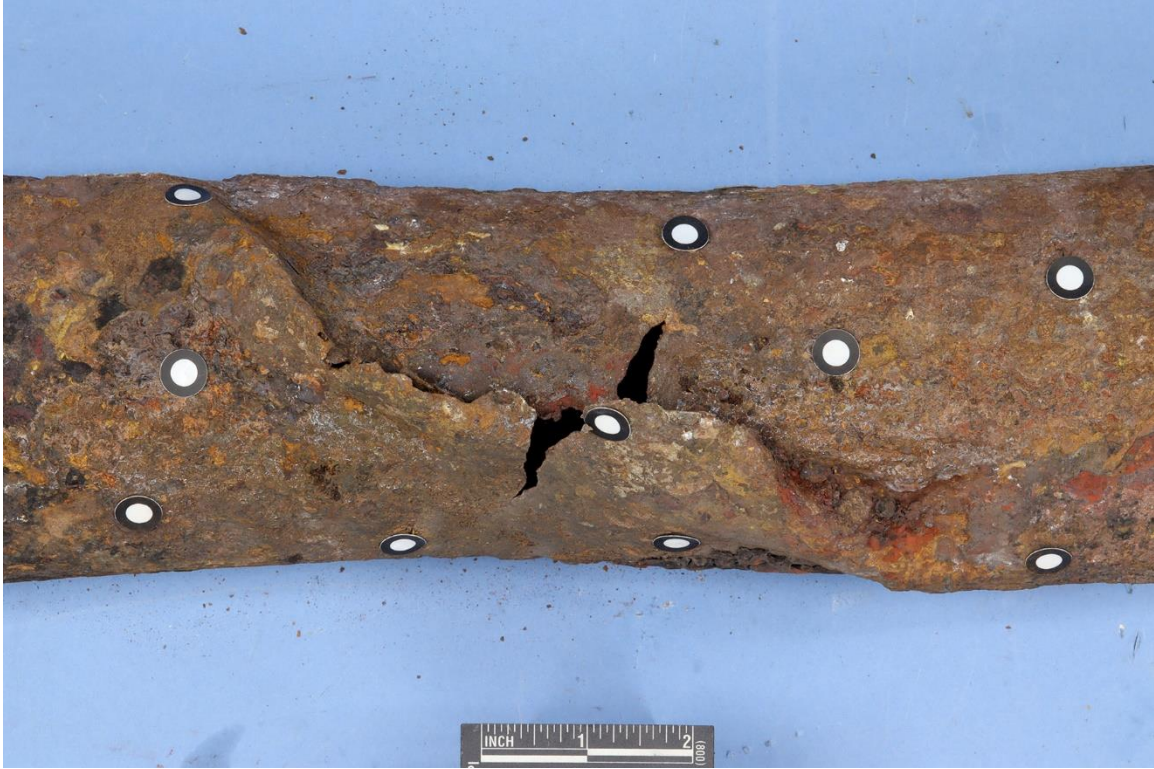
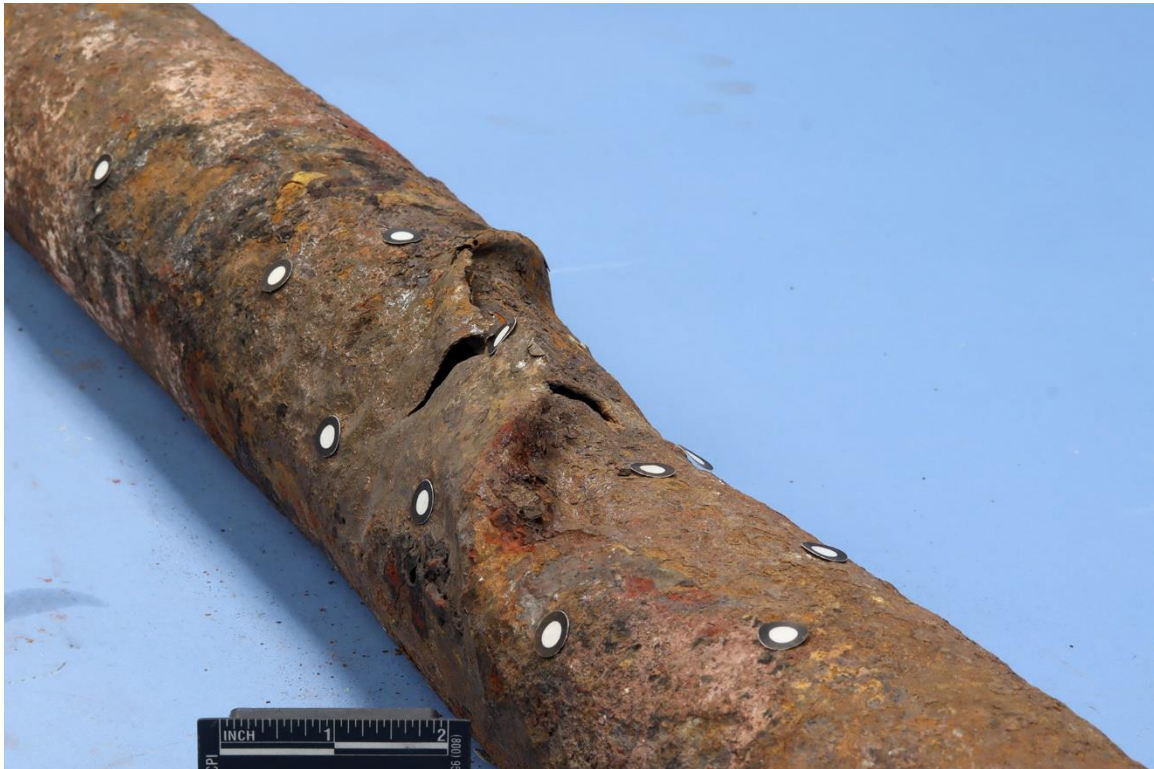
**Figure 22.** Images of the breach in the steam pipe: a) viewed from the side and b) viewed down the axis of the outward buckle in the pipe wall.

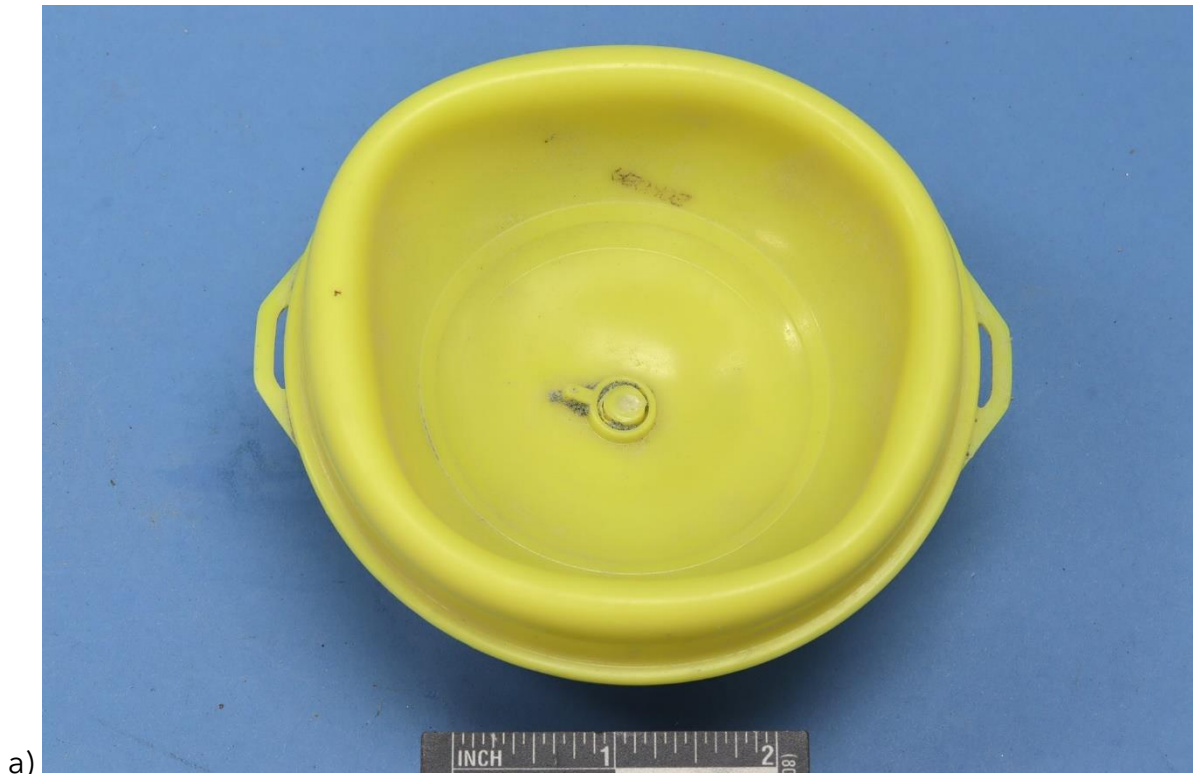
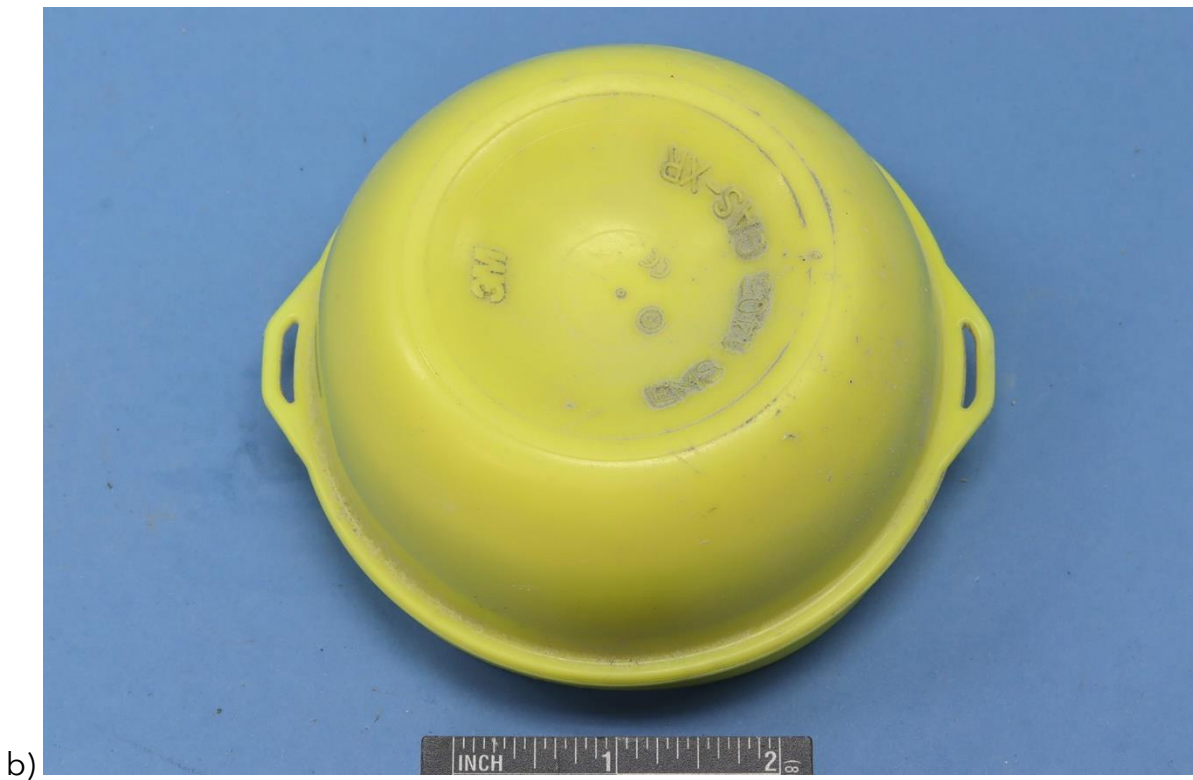
in-service marker ball was recovered from the excavation site for the 17 S. 2<sup>nd</sup> Ave active and retired service tees. It was found south of and above the retired tee. See the Operations Group Chairman Factual Report for additional details. As seen in figures 23a and b, both half-domes of the in-service marker ball had collapsed inward, with one dome collapsing inward more than the other. The seam joining the half domes is shown for the in-service and exemplar marker balls in figures 24a and b, respectively. For the in-service ball, a gap was observed at the seam between the two half-domes. By contrast, for the exemplar ball, the seam was sealed by a plastic bead.

**Figure 23.** Images of the collapsed in-service marker ball: a) first side and b) opposite side.

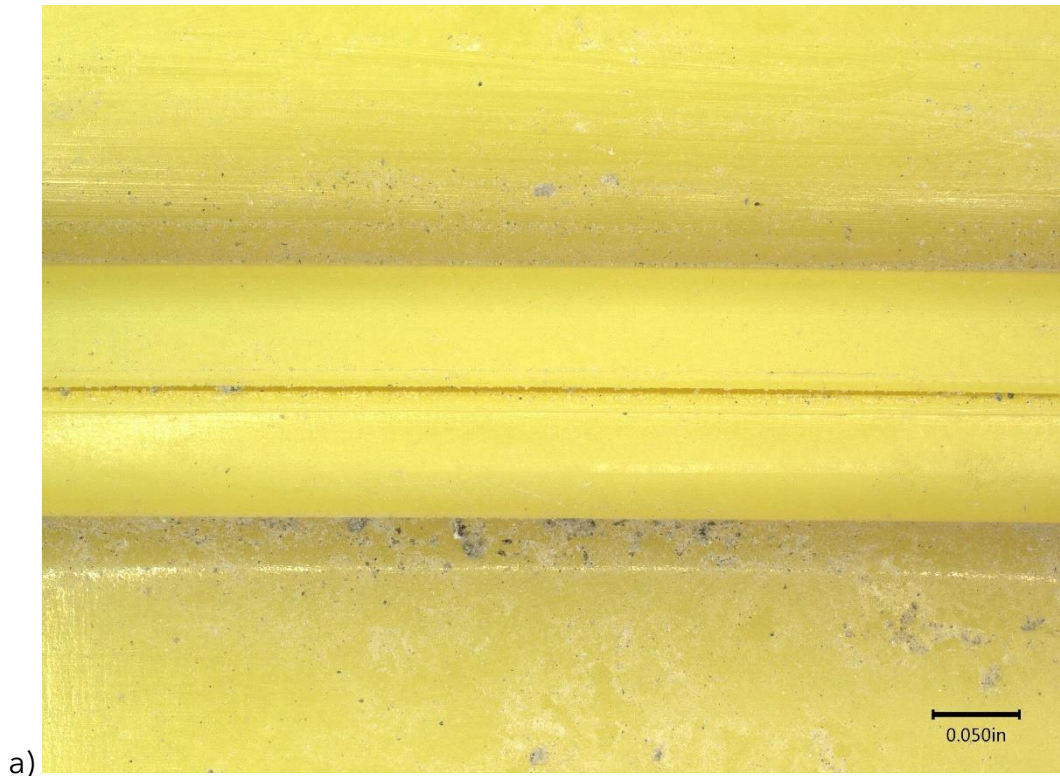
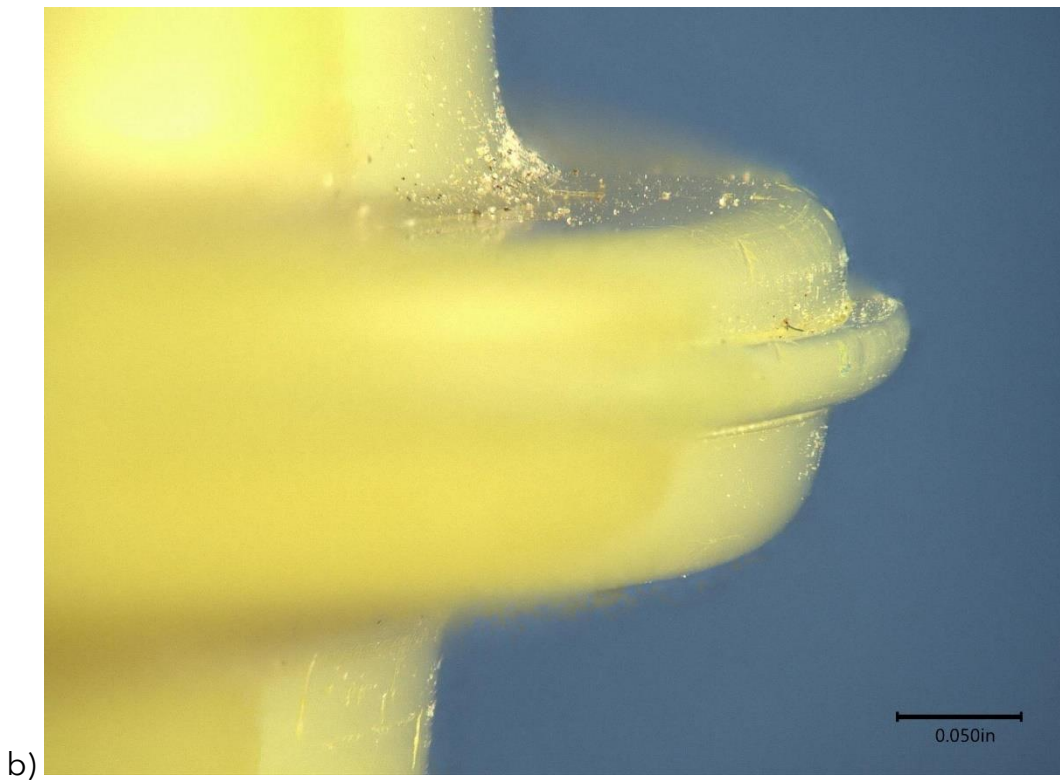
**Figure 24.** a) Seam of in-service marker ball with missing weld bead and b) exemplar marker ball with intact weld bead.

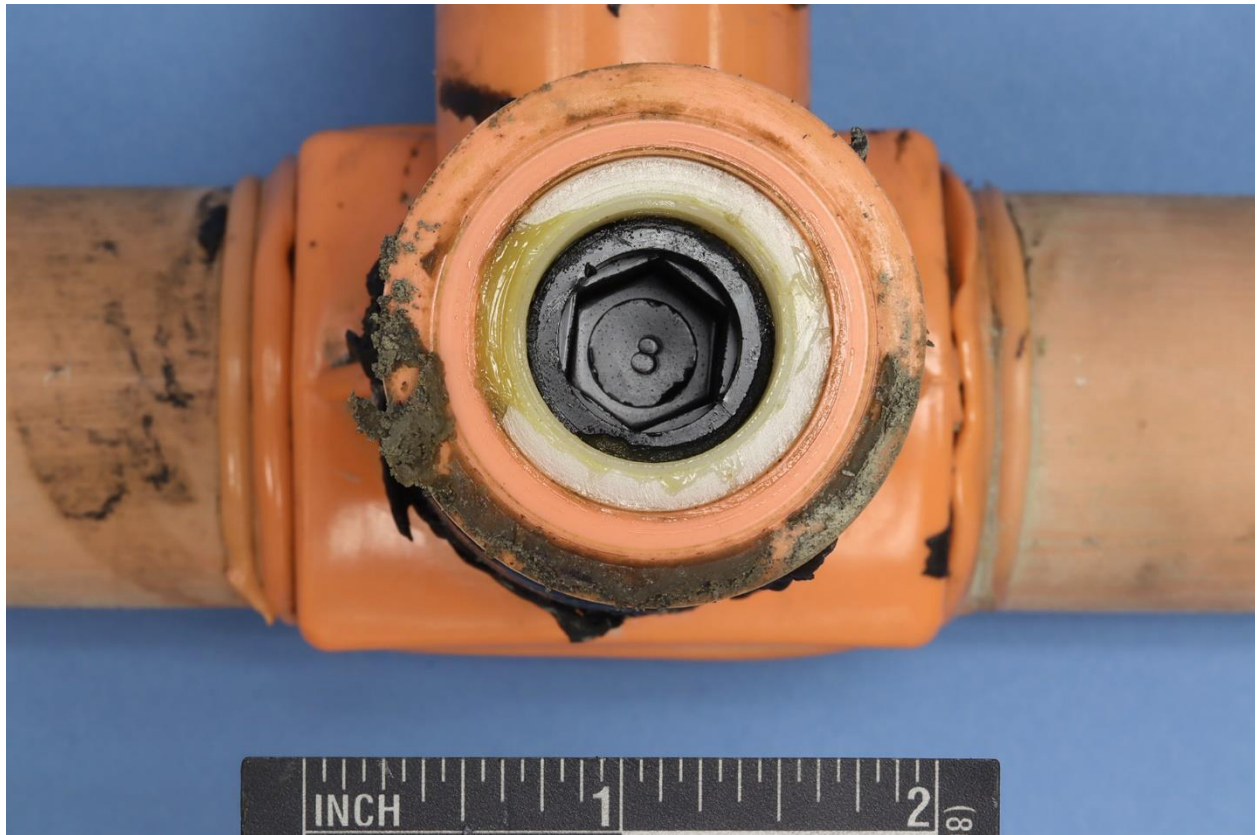
**Figure 25.** Sister tee from 77 S. 2<sup>nd</sup> Ave after removal of the cap showing grease on the insert and cutter.

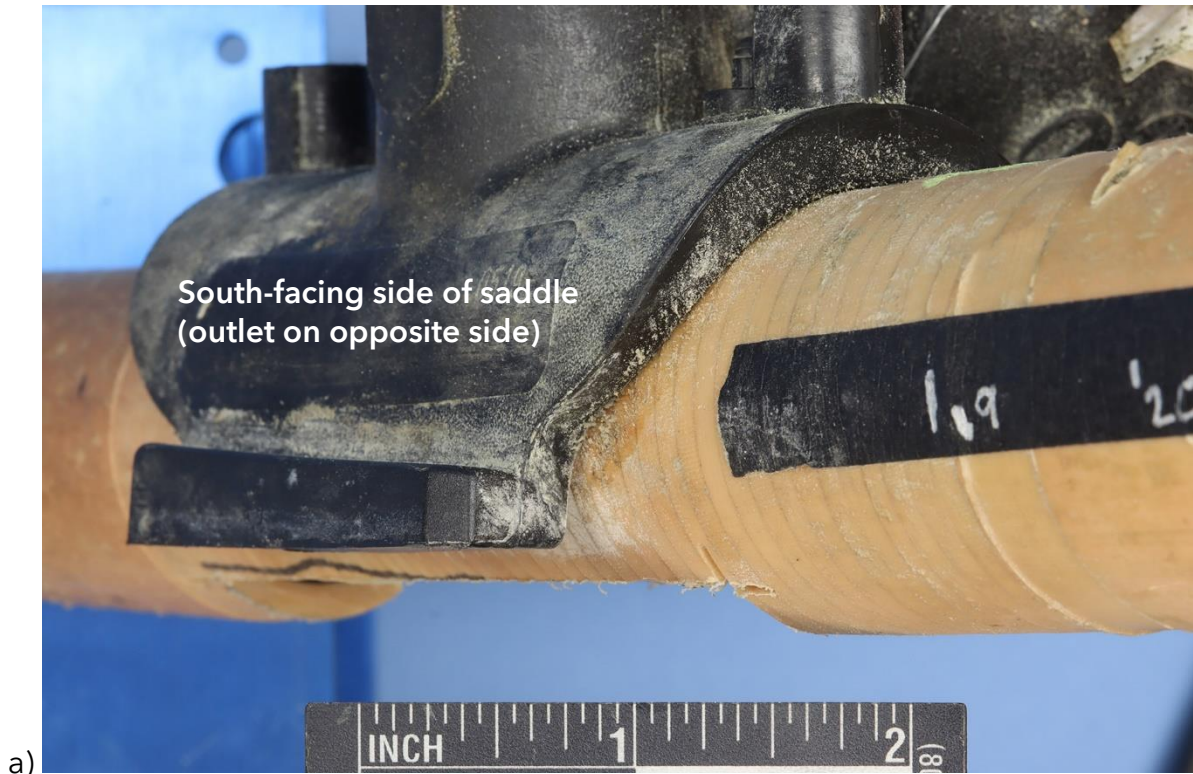
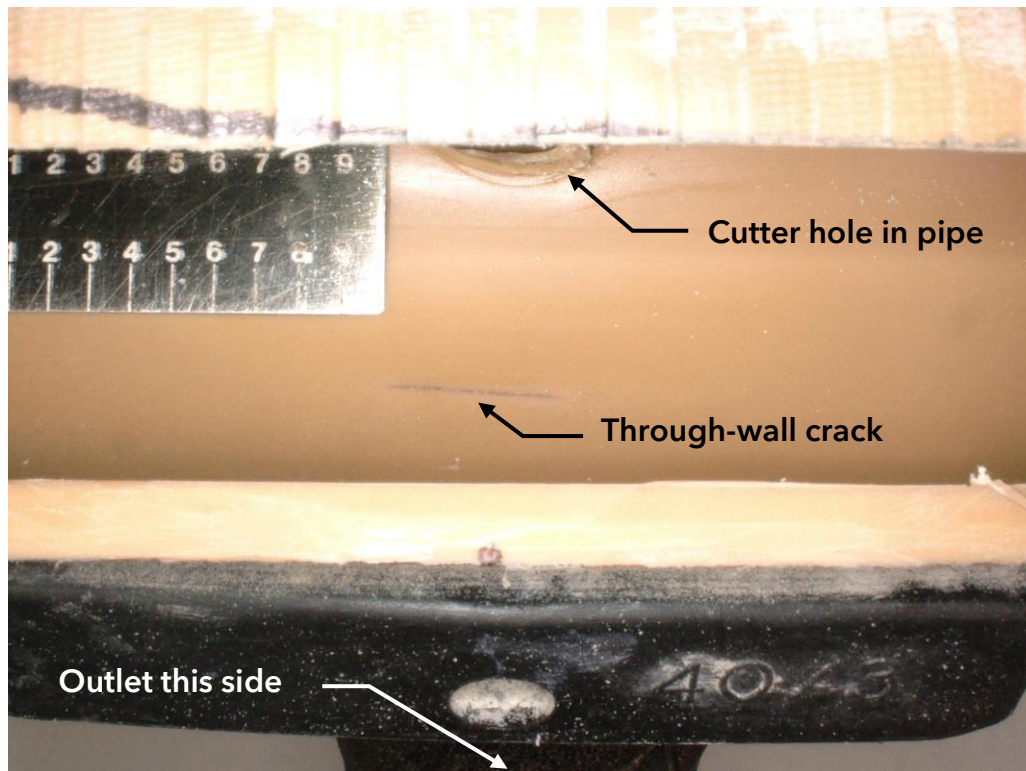
**Figure 27.** a) Image of 2021 replacement tee with undersaddle and pipe section removed and b) image of the pipe ID surface showing the through-wall crack.

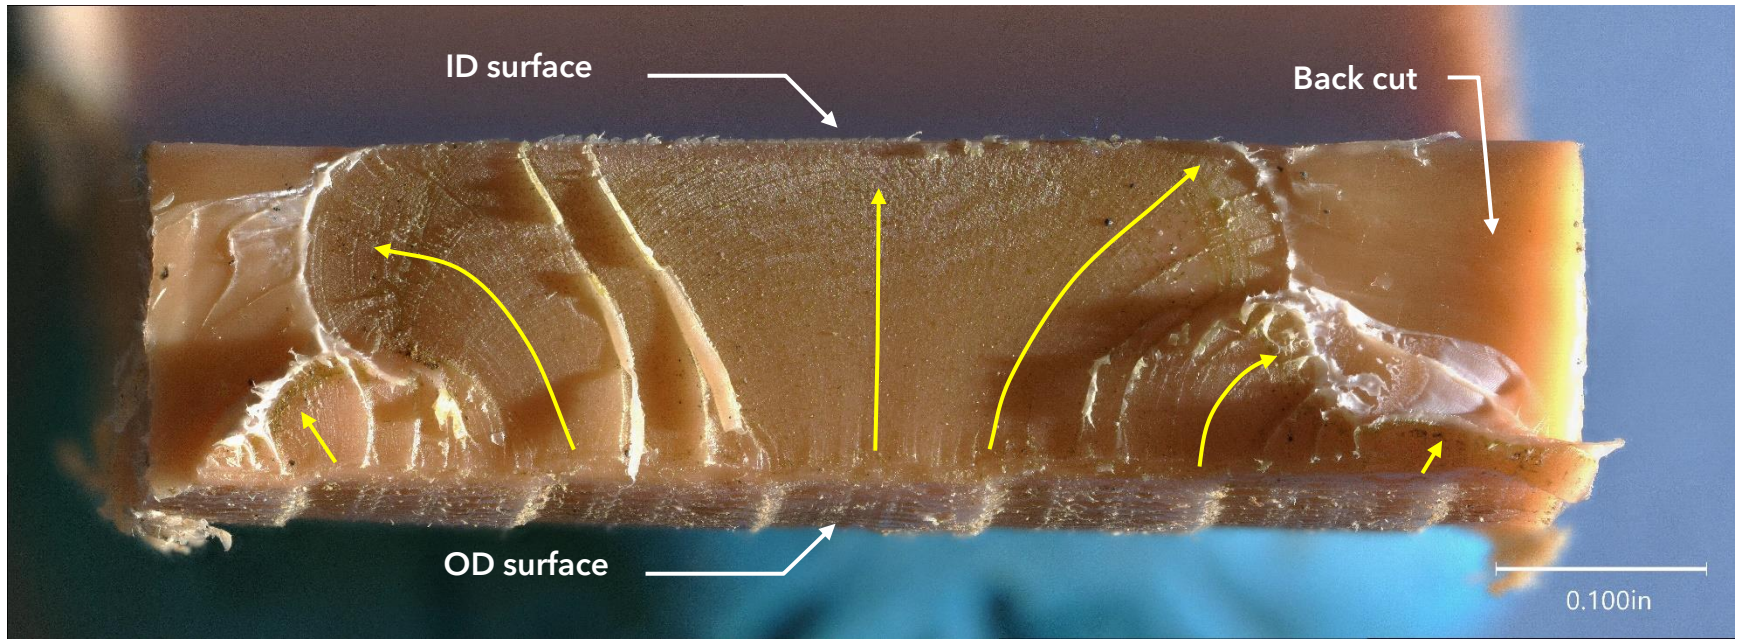
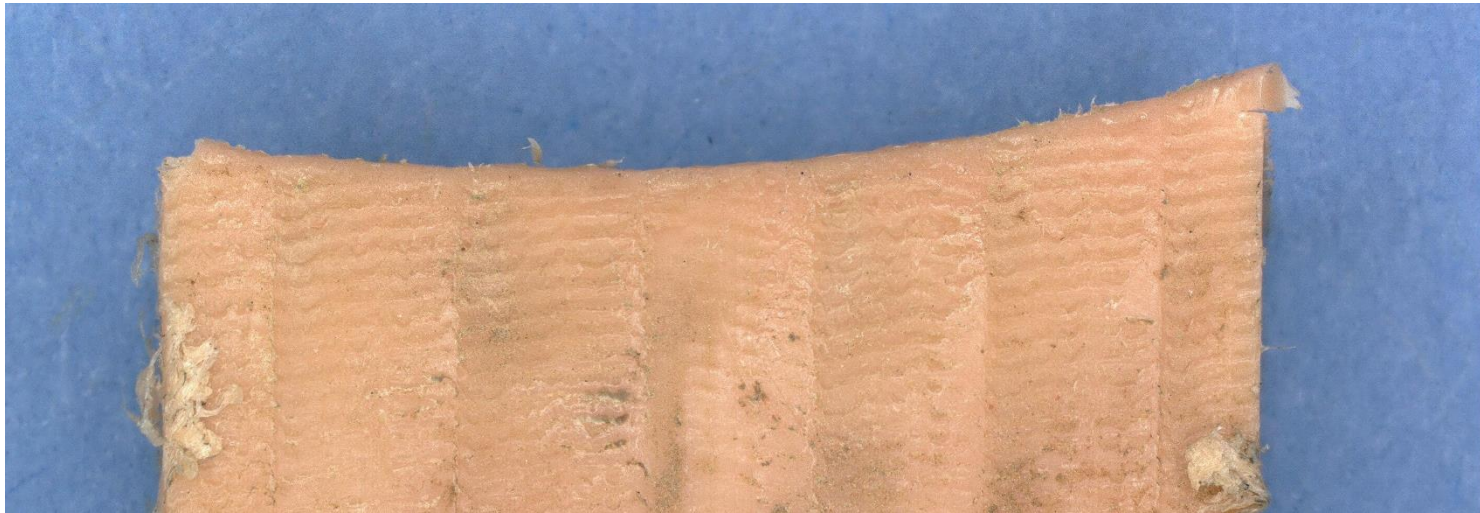
**Figure 30.** Top: Fracture through the wall of pipe associated with the 2021 replacement teel. Bottom: side view of fracture on OD surface.

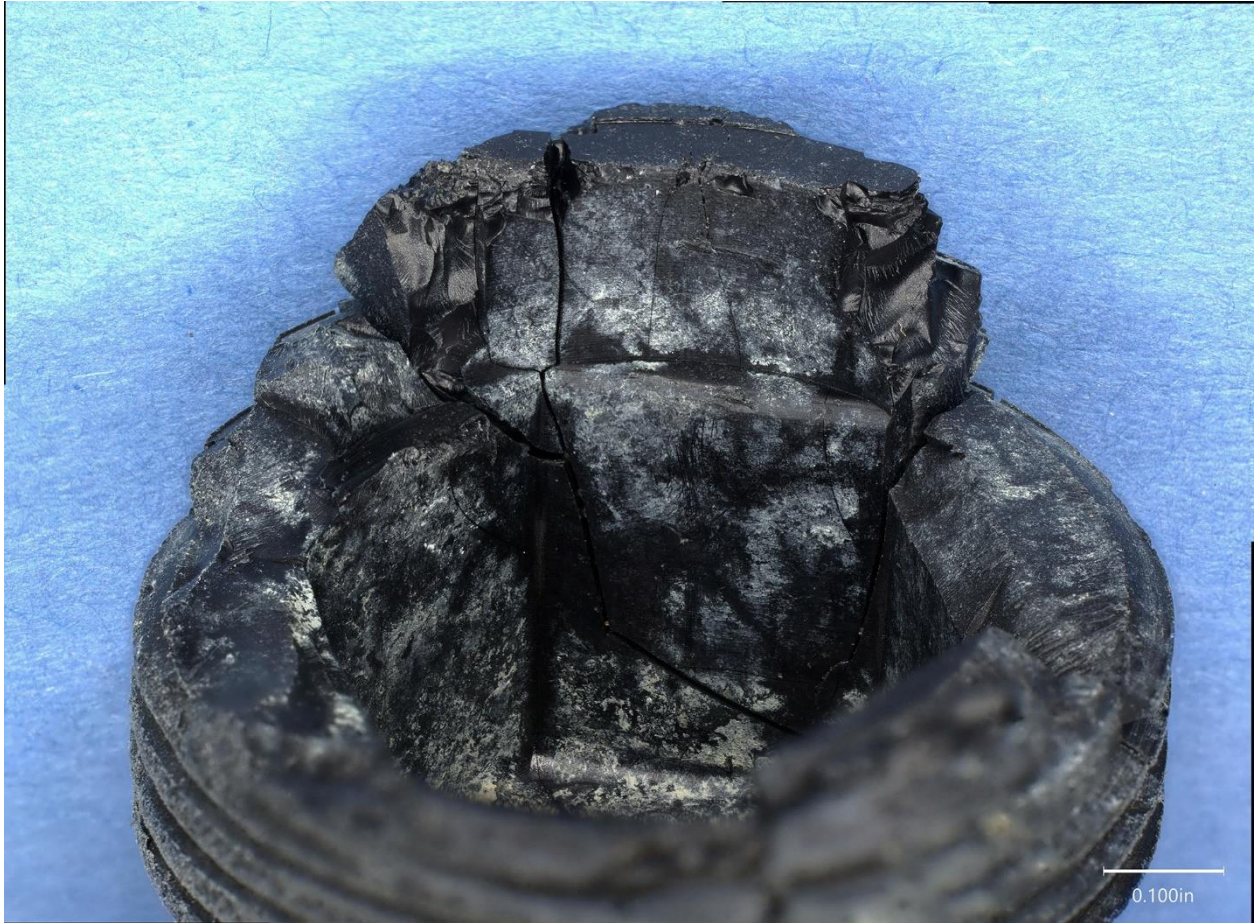
**Figure 32.** Image showing multiple cracks in the retired tee cutter head.

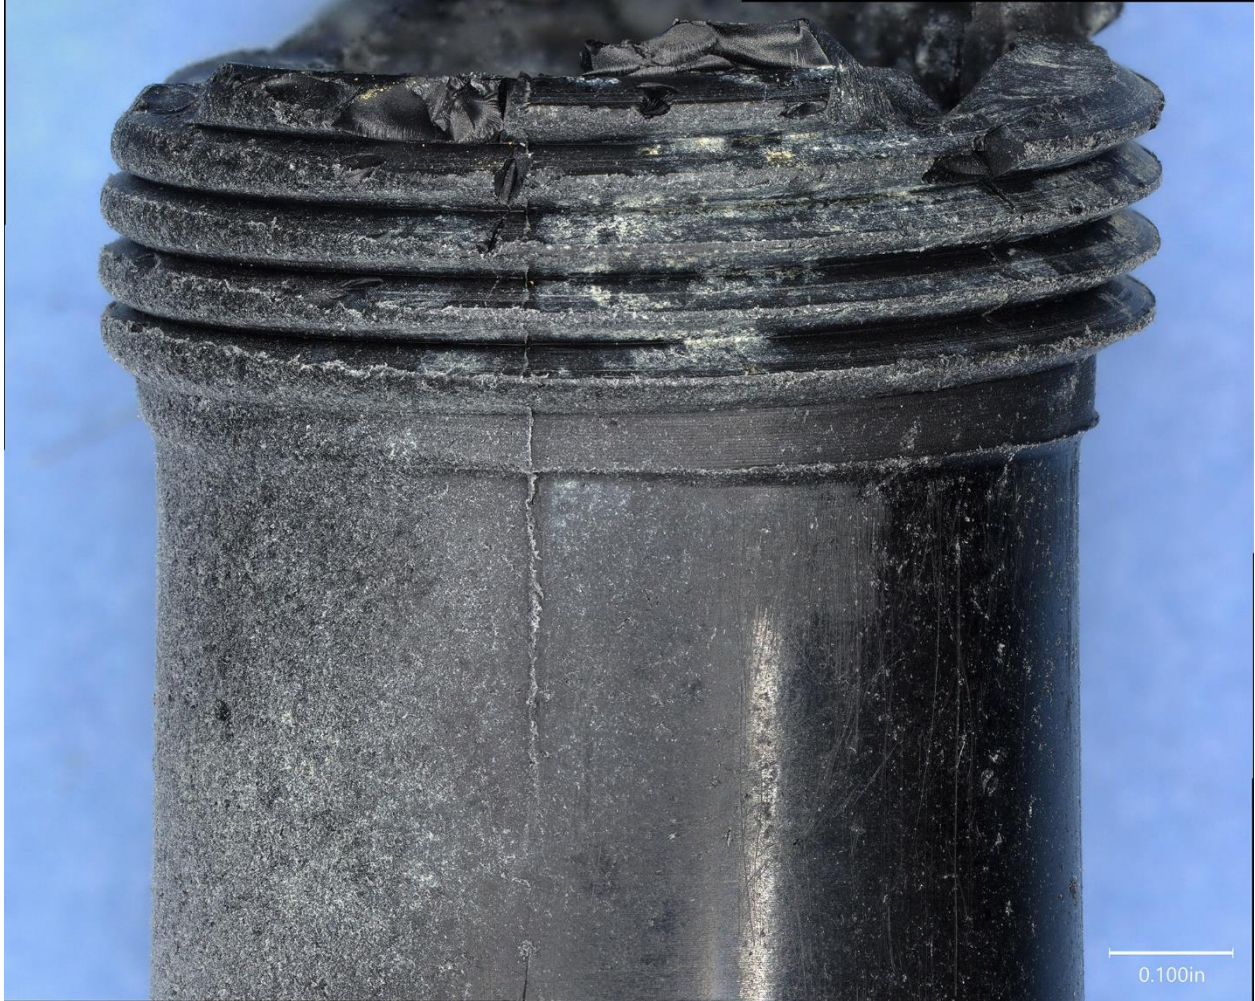
**Figure 33.** Image of cutter barrel and threads showing roughening of the surface and rounding of the edge profile.
