# National Transportation Safety Board

## **MATERIALS LABORATORY**

Factual Report 23-072

Location: West Reading, Pennsylvania  
Date: March 24, 2023  
Vehicle: UGI Gas Distribution Pipeline System  
Investigator: Kim West, RPH-20

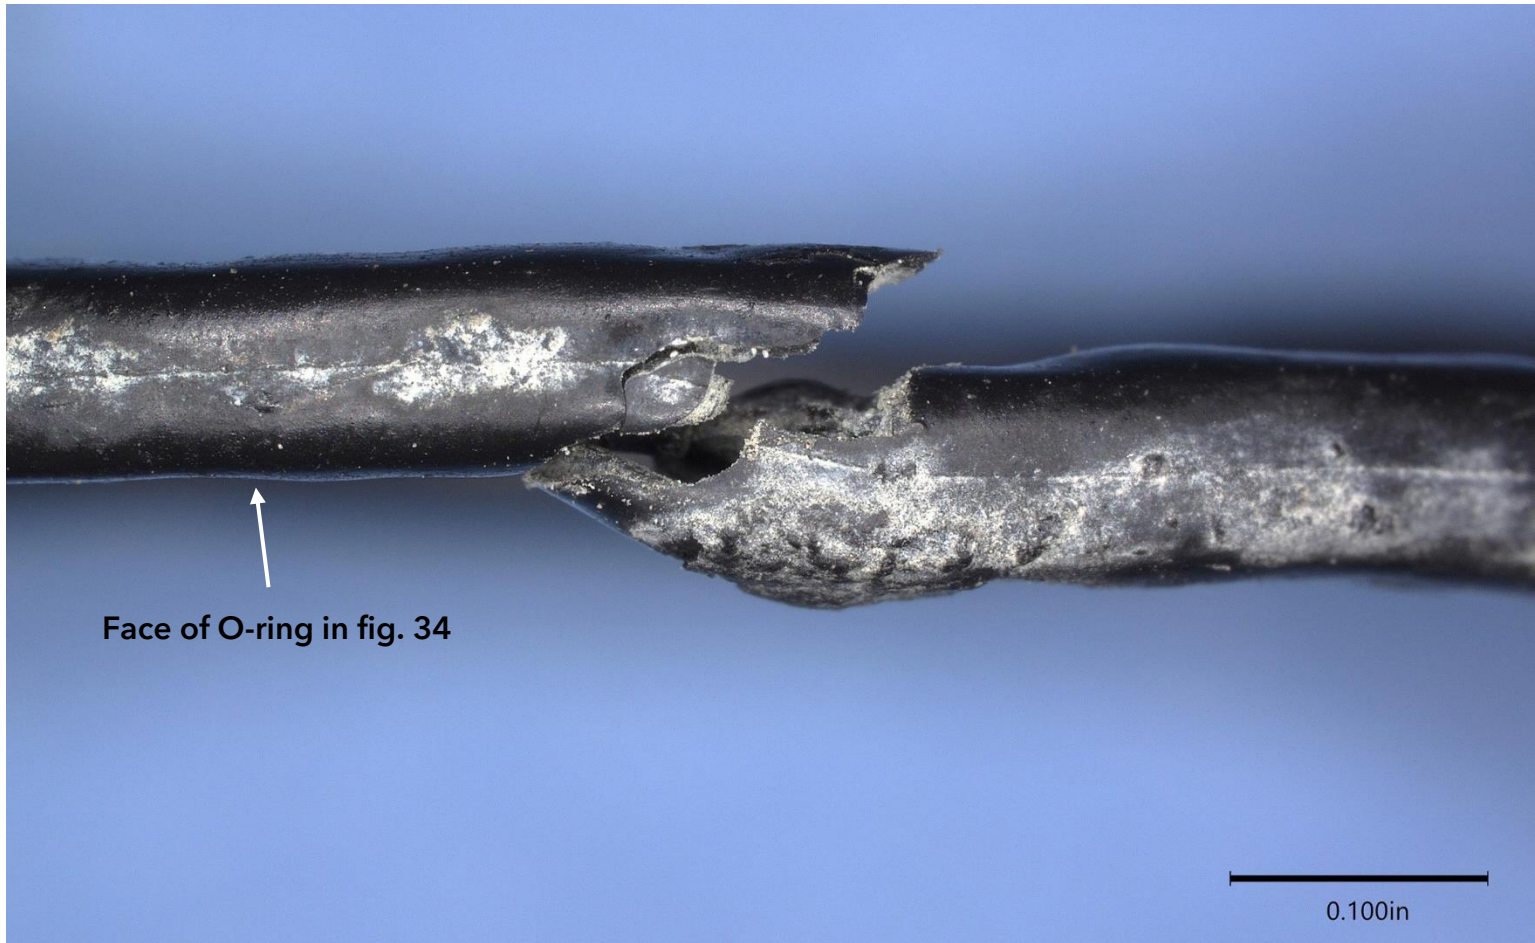
**Figure 35.** Image of the split in the recovered O-ring. The ring was fractured at an oblique angle. There was a bulge/extrusion on one side of the ring at the fracture location.

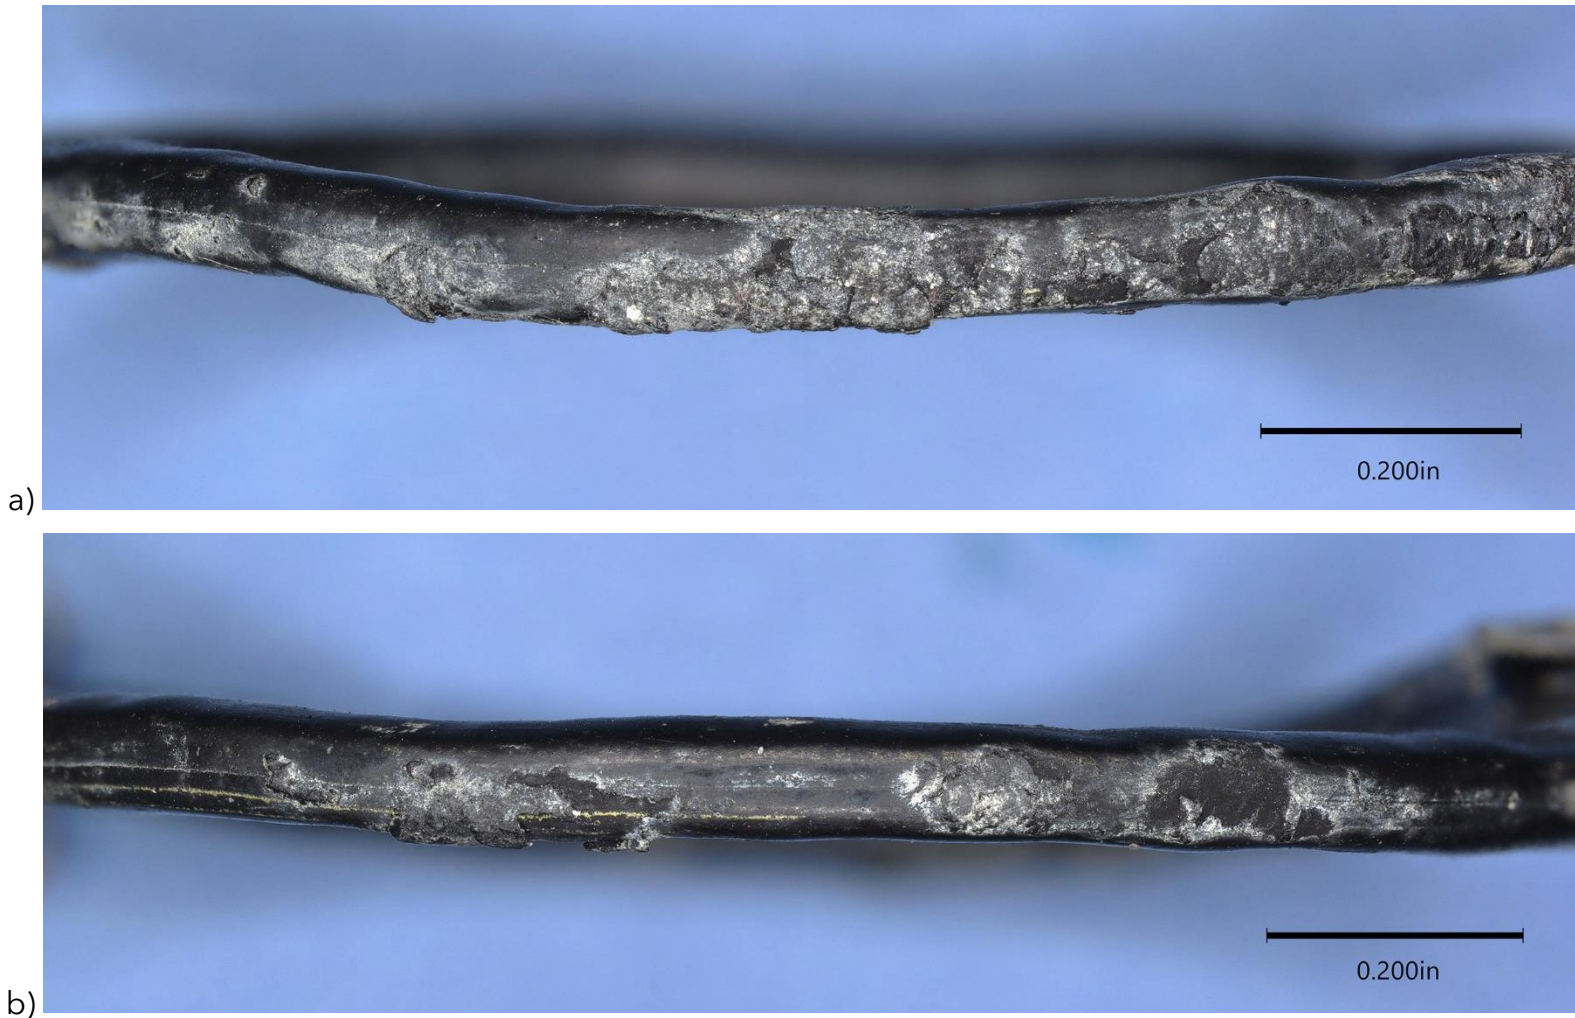
**Figure 36.** Images showing degradation of the recovered O-ring material: a) location 90° clockwise from the split as shown in figure 34 and b) location 90° counterclockwise from the split as shown in figure 34.

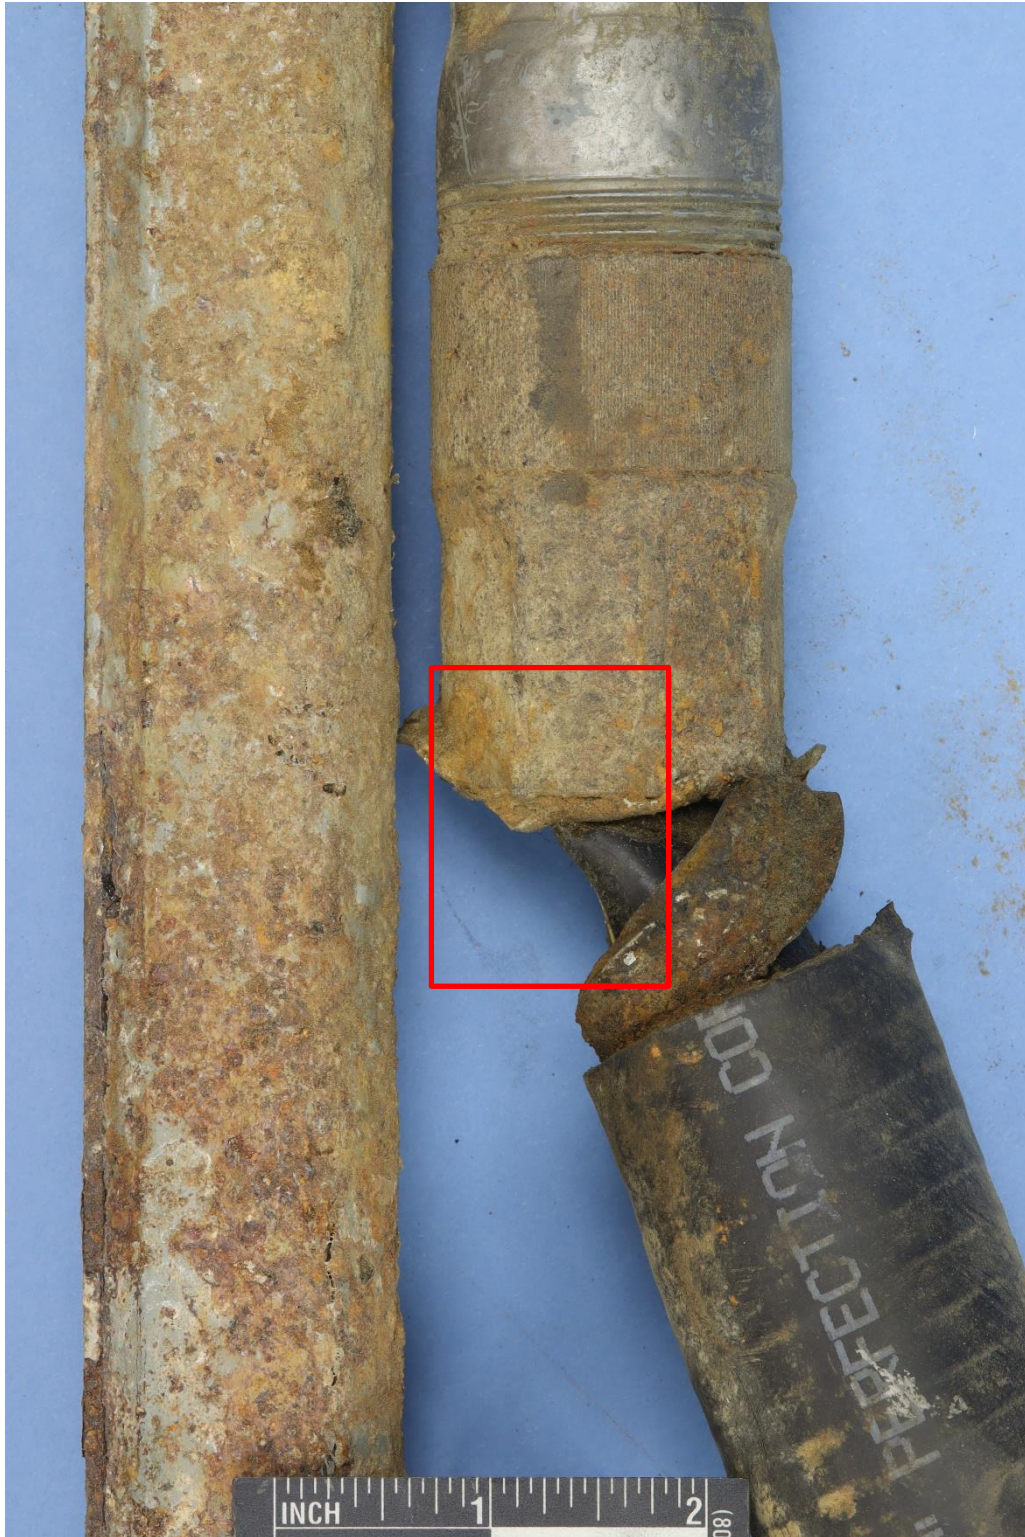
During pressure testing on scene, the 17 S. 2<sup>nd</sup> Ave service line did not hold pressure. The service line and riser were submitted to the laboratory for examination as shown above in figure 4a. The 1" CTS service line entered a Perfection Corp. 1-1/4" flexible riser. The downstream end of the riser was connected to a rigid steel tube riser that led to the meter. The main body of the flexible riser was composed of a coiled steel strip covered by a rubber sleeve. A moisture seal covered the upstream end where the service line entered the riser, and a steel fitting connected the downstream end of the flexible riser to the rigid riser tube. The coiled steel strip and rubber sleeve had pulled away from the downstream fitting exposing the 1" service line, as shown in figures A1 and A2. The fitting at the downstream end exhibited signs of plastic deformation. The exposed 1" service line was deformed and partially flattened/ovalized. At one spot, the service line had impinged on the deformed end of the fitting and the wall of the service line had been breached, as indicated in figures A2 and A3 (Note: The fitting on the flexible riser was unthreaded from its downstream connection to the rigid pipe, causing rotational scoring to the service line in the process). The features were consistent with a breach of the service line due to mechanical damage by and to the flexible riser.

**Figure A1.** Closer view of flexible riser downstream end showing separation of coiled winding and deformation to end fitting.

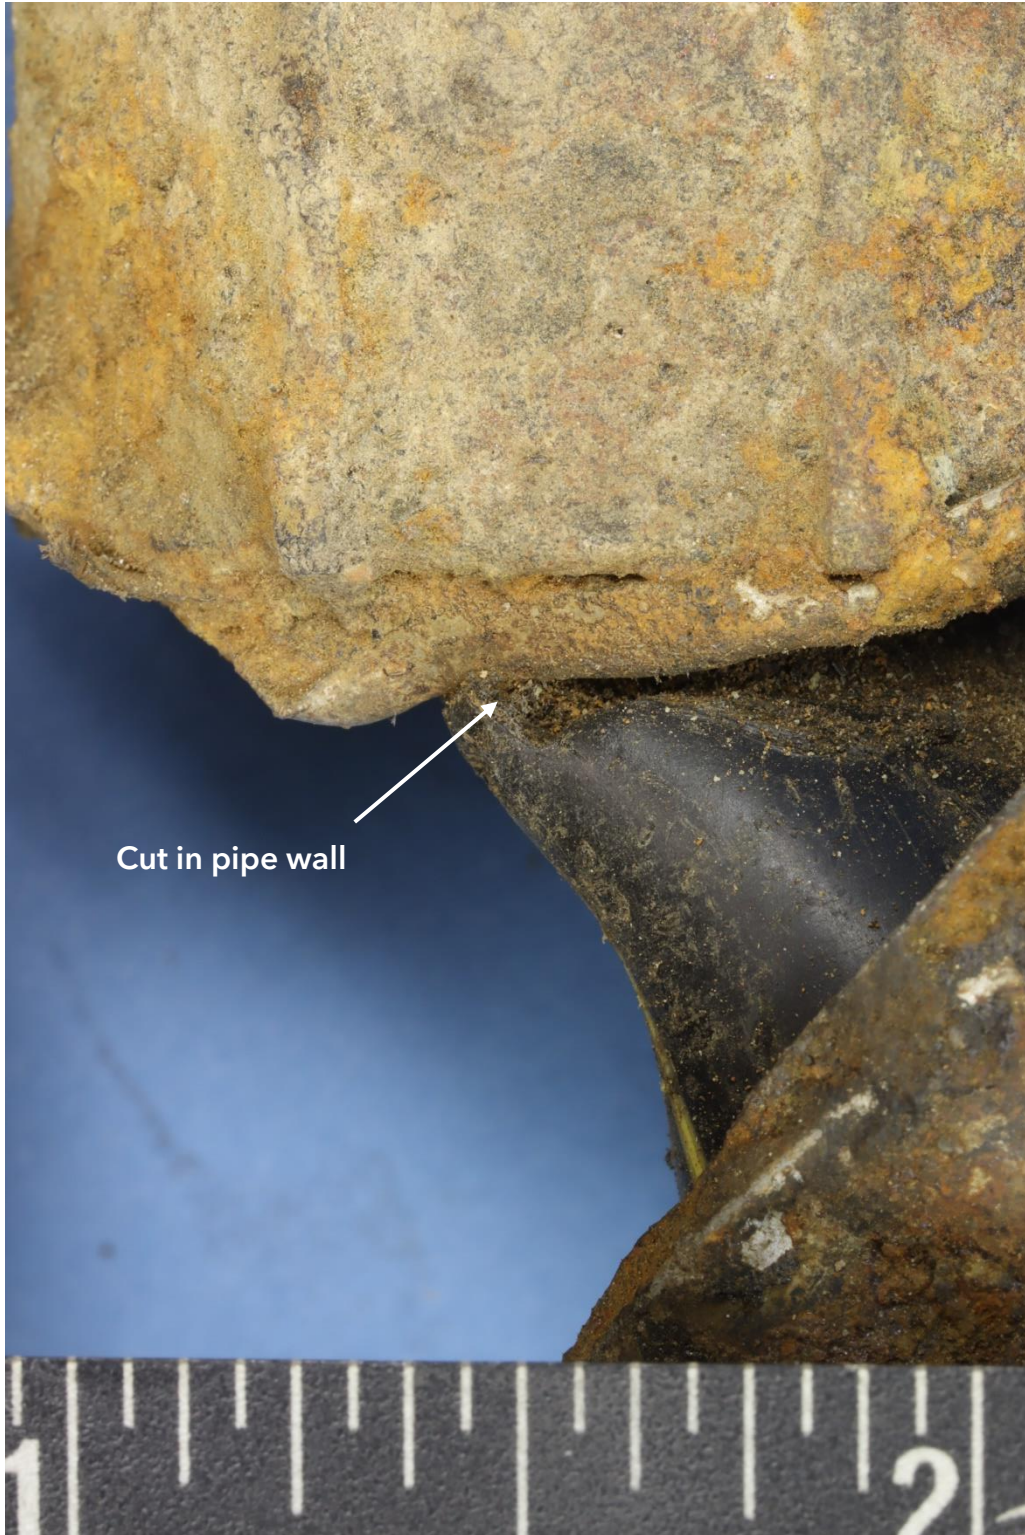
Cut in pipe wall

**Figure A2.** Image of the breach in the 1-inch plastic pipe, cut by the exposed end of the downstream end fitting.

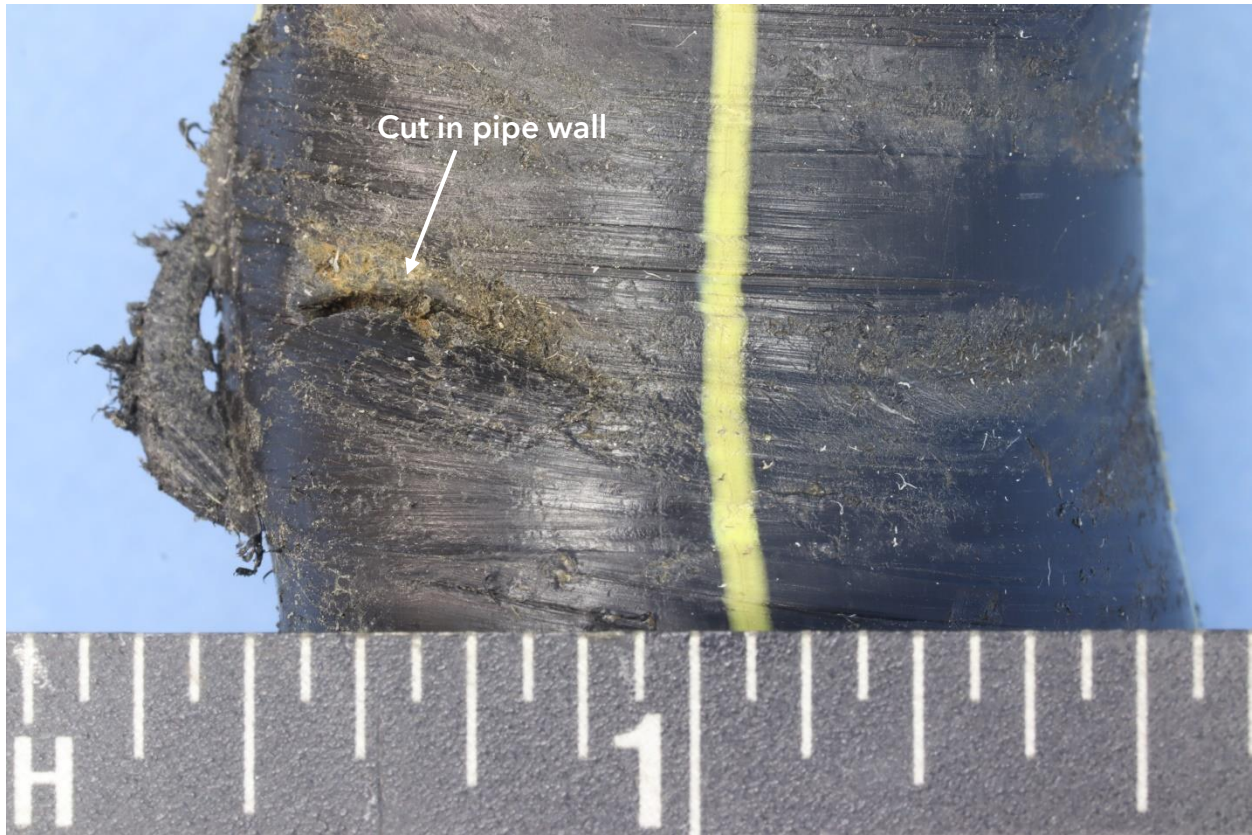
**Figure A3.** Image showing cut in 1 inch service line.
