National Transportation Safety Board

ERA23FA137

MATERIALS LABORATORY

Factual Report 23-083

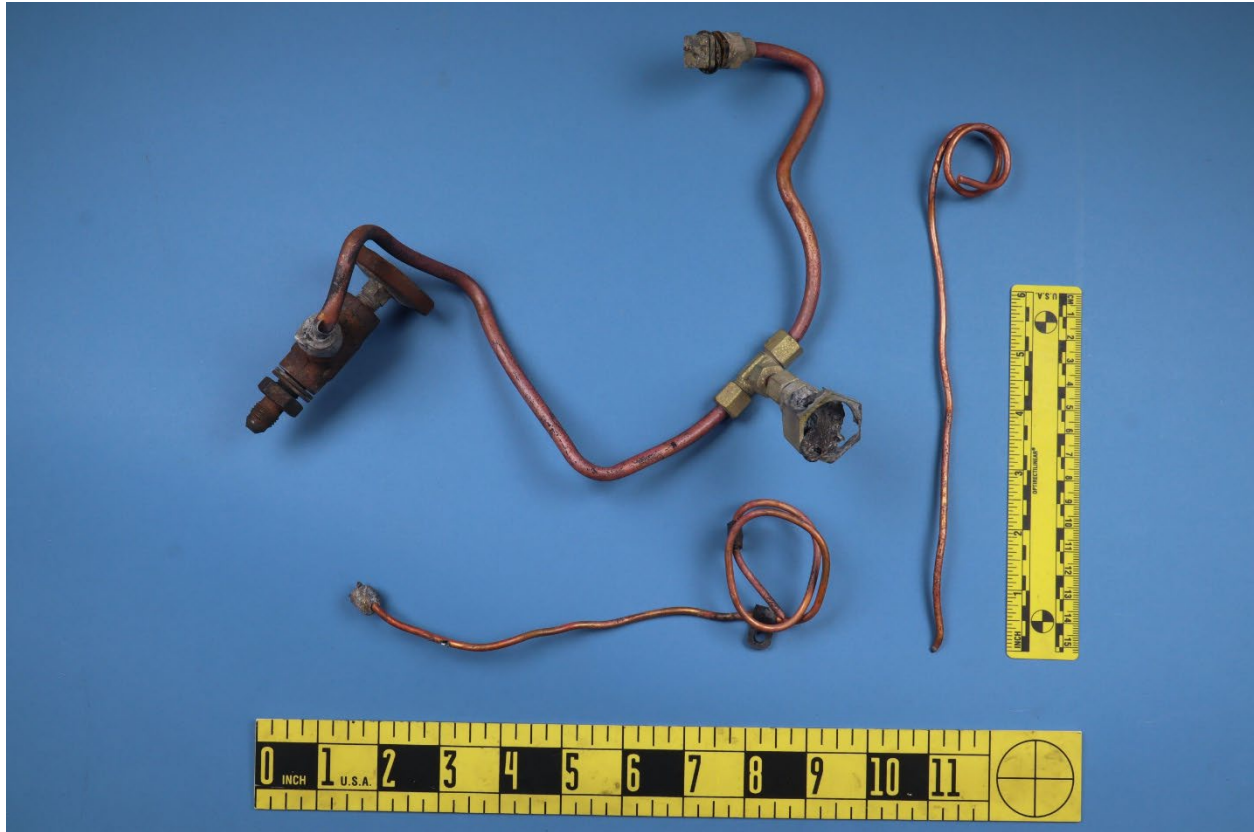
Two fuel priming lines and one oil pressure line with fittings (Figure 1).

Figure 1. Two fuel priming lines and one oil pressure line with fittings as received.

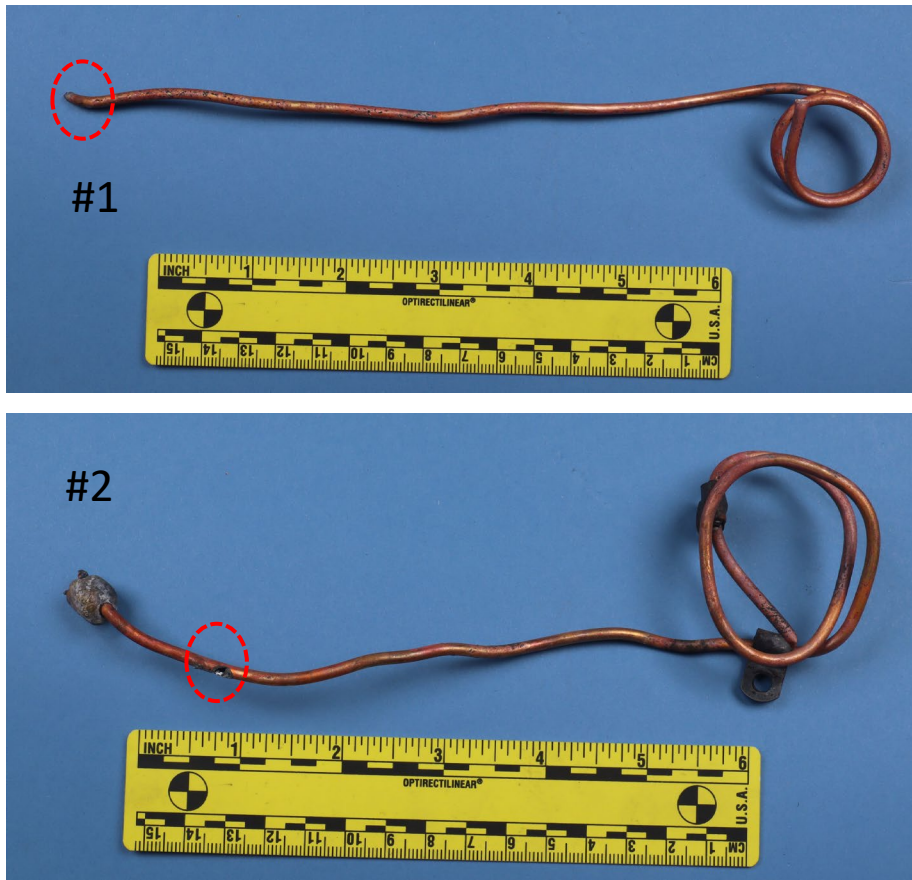
The two fuel priming lines (Figure 2) would have been attached to a manually operated fuel priming pump in the cockpit. The two lines have been arbitrarily labeled #1 and #2 as it is not known which one was attached to the suction and which one was attached to the pressure side of the manual pump. Both lines were copper and approximately 0.125 inch outside diameter. Examination of the copper tube by X-Ray fluorescence spectroscopy¹ found the alloy to contain approximately 99.6% Cu. Fuel priming line #1 exhibited a melted and tapered end (Figure 3). Fuel priming line #2 exhibited an area along the tube exterior with localized melting and foreign material adhering to the tube's exterior surface (Figure 4).

Figure 2. Fuel primer lines with areas of damage indicated by red circles.

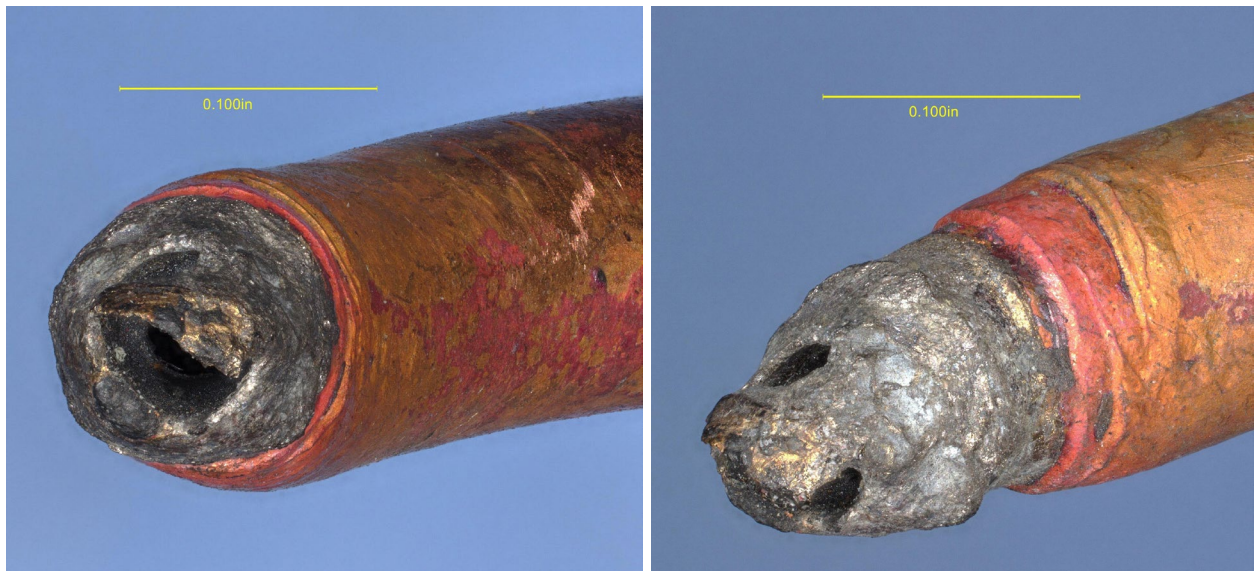
Figure 3. Melting on the end of primer line #1.

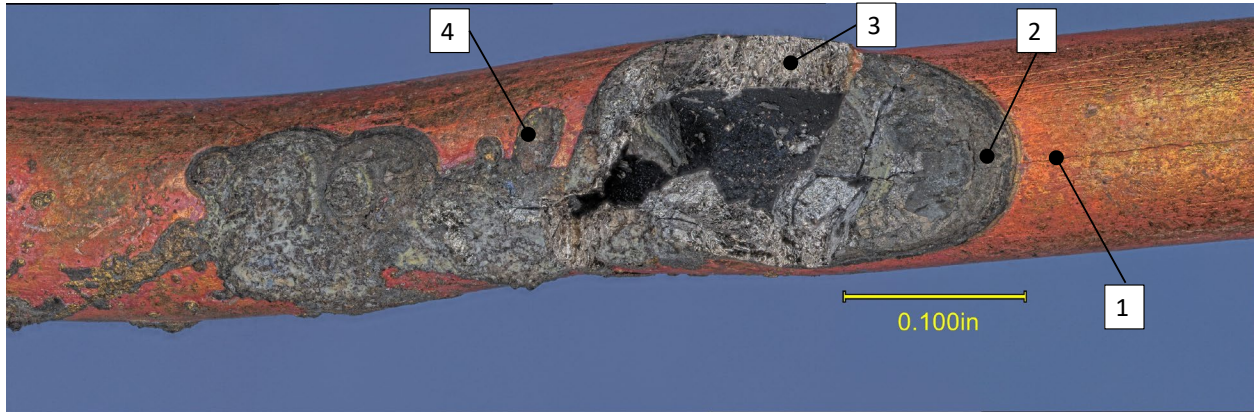
Figure 4. Damage on the surface of primer line #2.

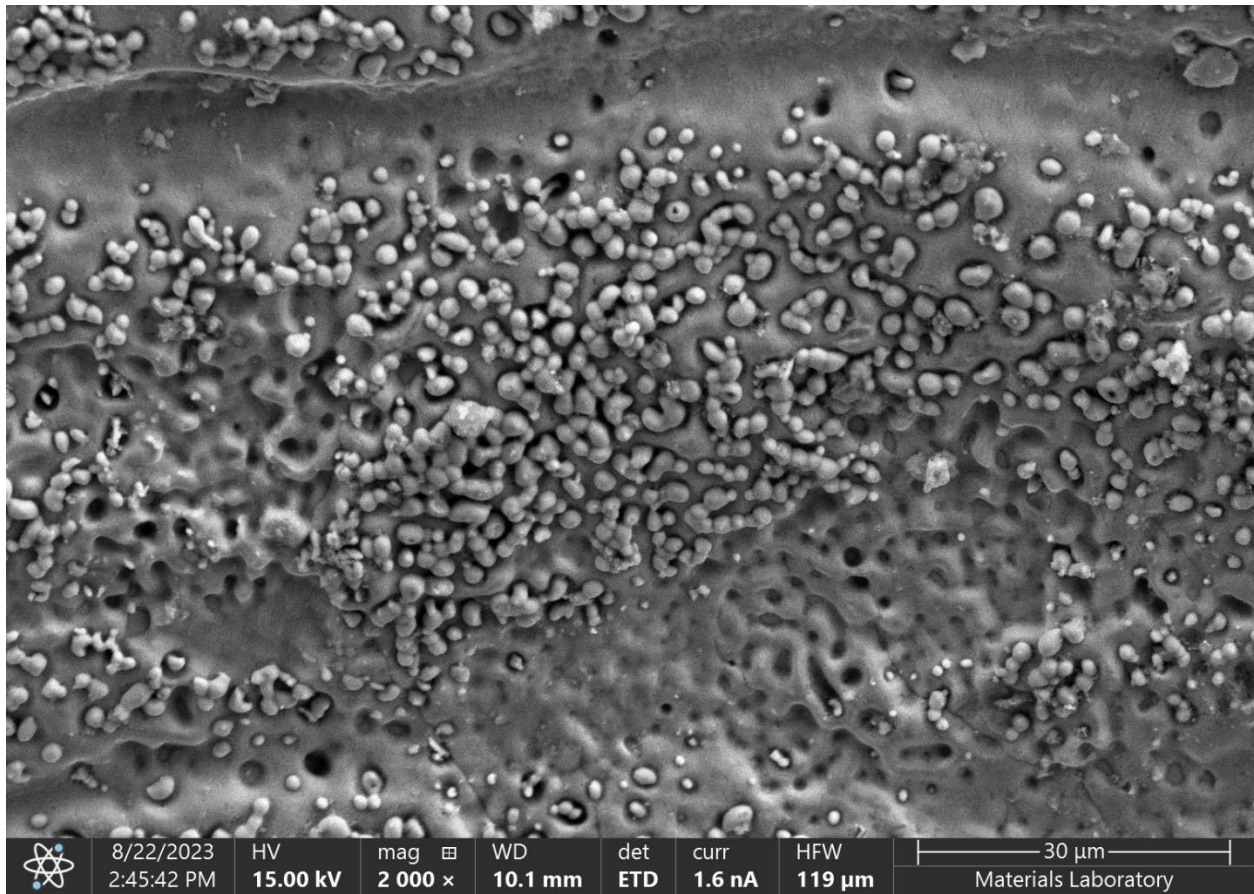
Priming tube #2 was examined using a scanning electron microscope (SEM). The areas examined were labeled 1 - 4 as designated in figure 4. Area #1 was outside the area of apparent damage and exhibited small voids on the surface as well as spherical globules adhering to the surface (Figure 5). Area #2 was within a region that appeared to have had melted and resolidified exhibiting a rippled surface morphology (Figure 6). Area #3 was in the area where the tube wall had been penetrated through its full thickness. This area #3 exhibited a cleaved surface morphology (Figure 7). Area #4 was on the tube's exterior where it appeared that

Figure 5. SEM micrograph from area #1.

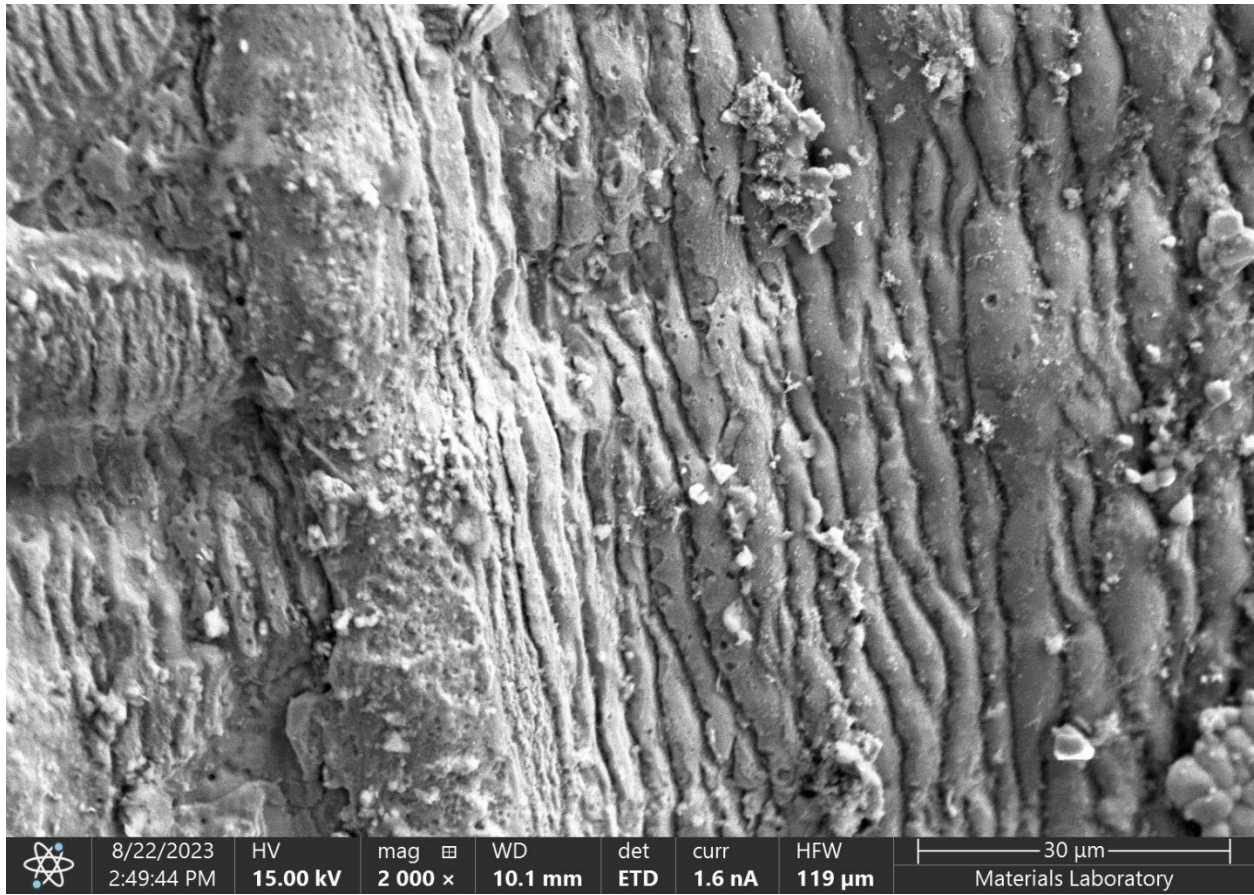
Figure 6. SEM micrograph from area #2.

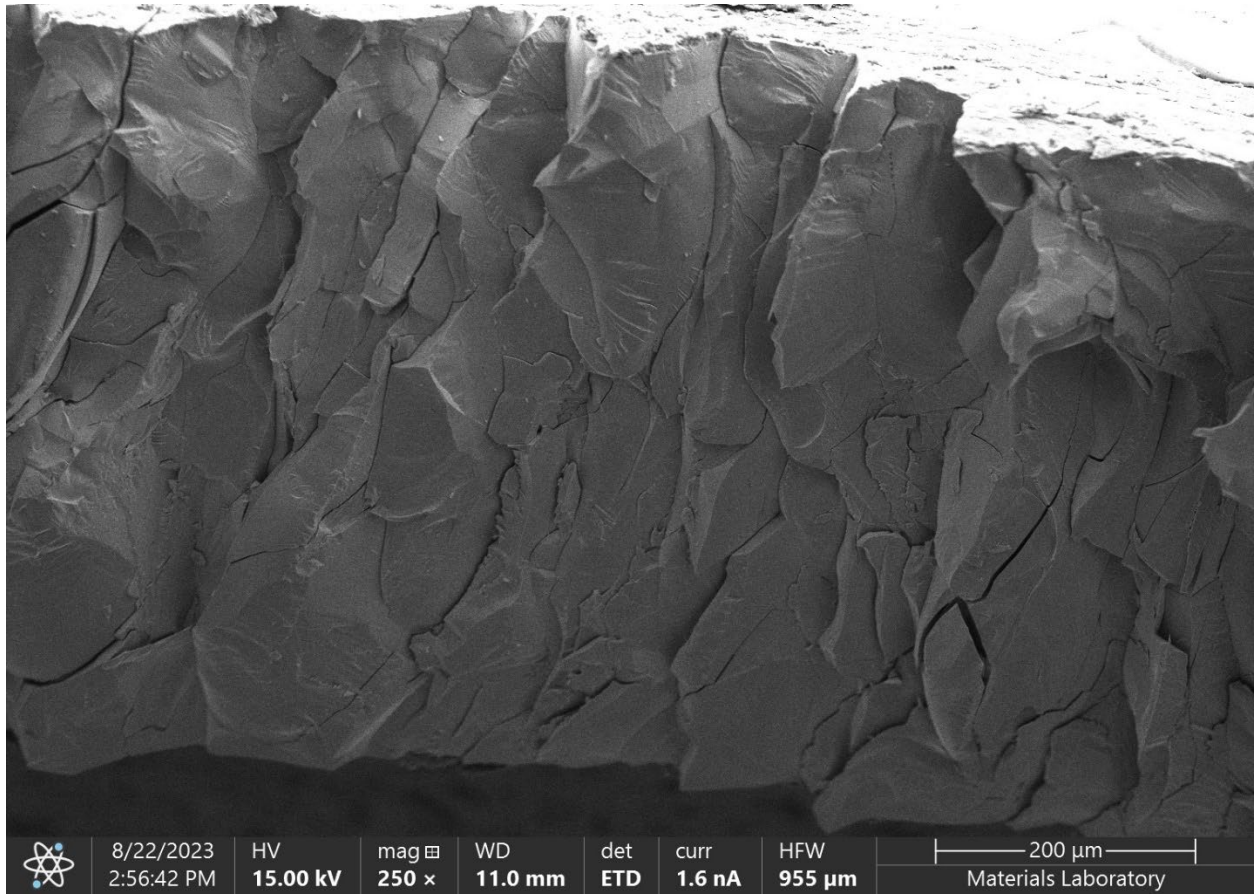
Figure 7. SEM micrograph from area #3.

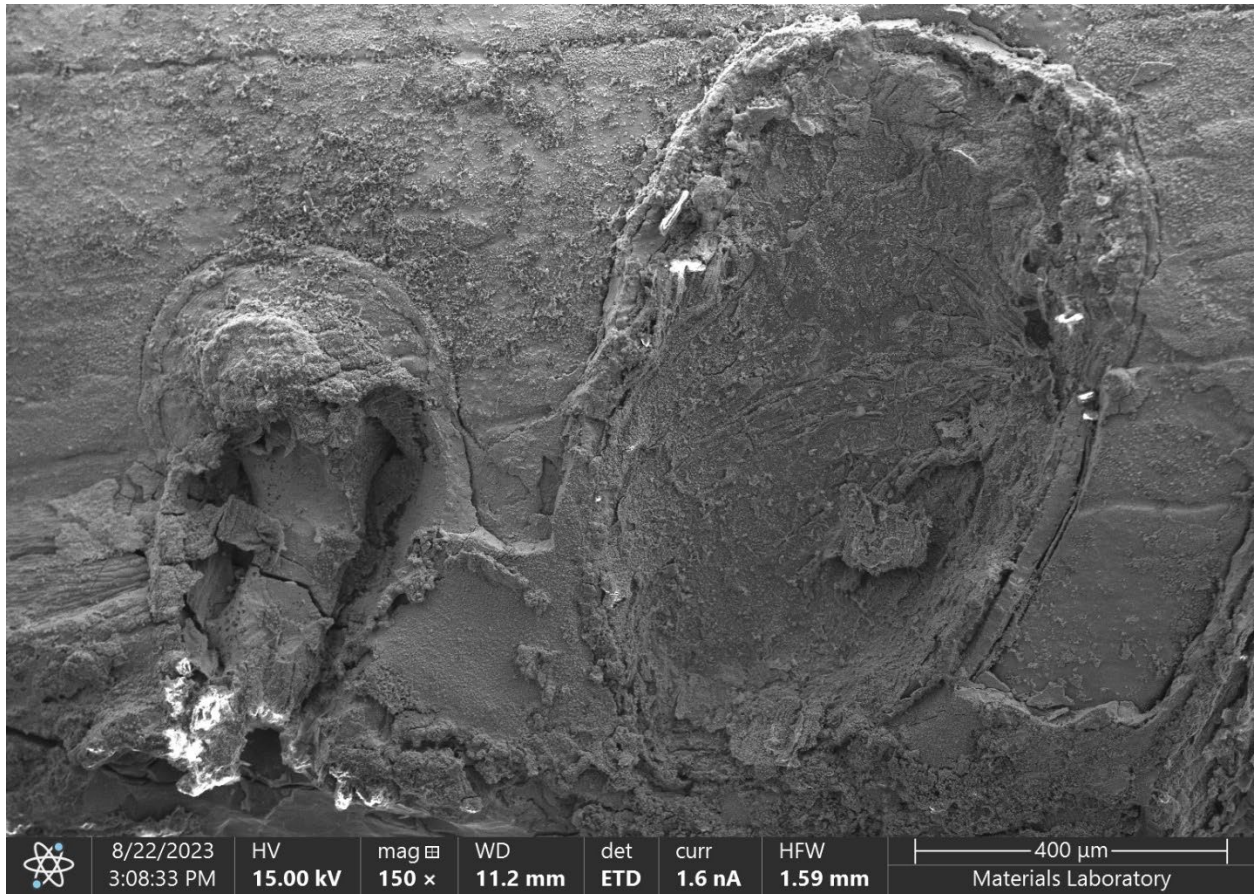
foreign material was adhering to the surface (Figure 8). An Energy Dispersive Spectroscopy (EDS) map of the region in area #4 with Cu and Al overlay is shown in Figure 9.

Figure 8. SEM micrograph from area #4.

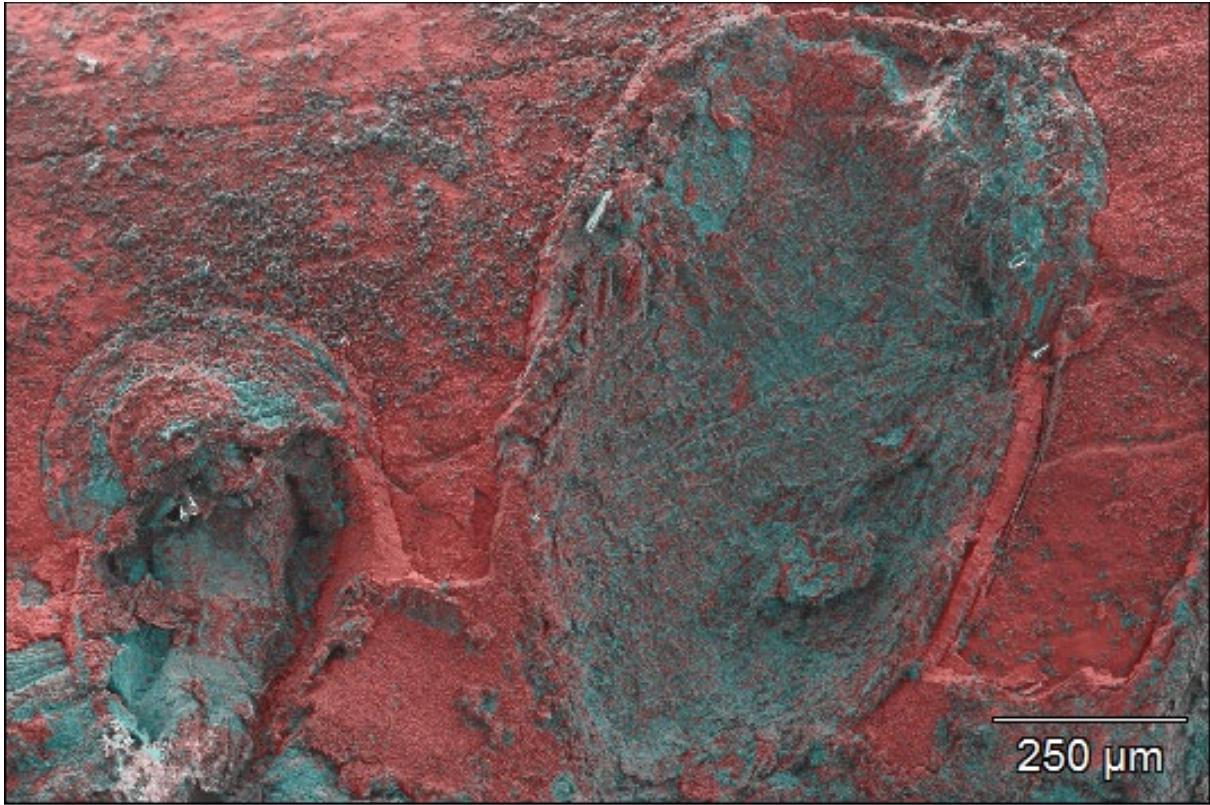
Figure 9. EDS Map of area #4 showing overlaid elements Cu (red) and Al (green).

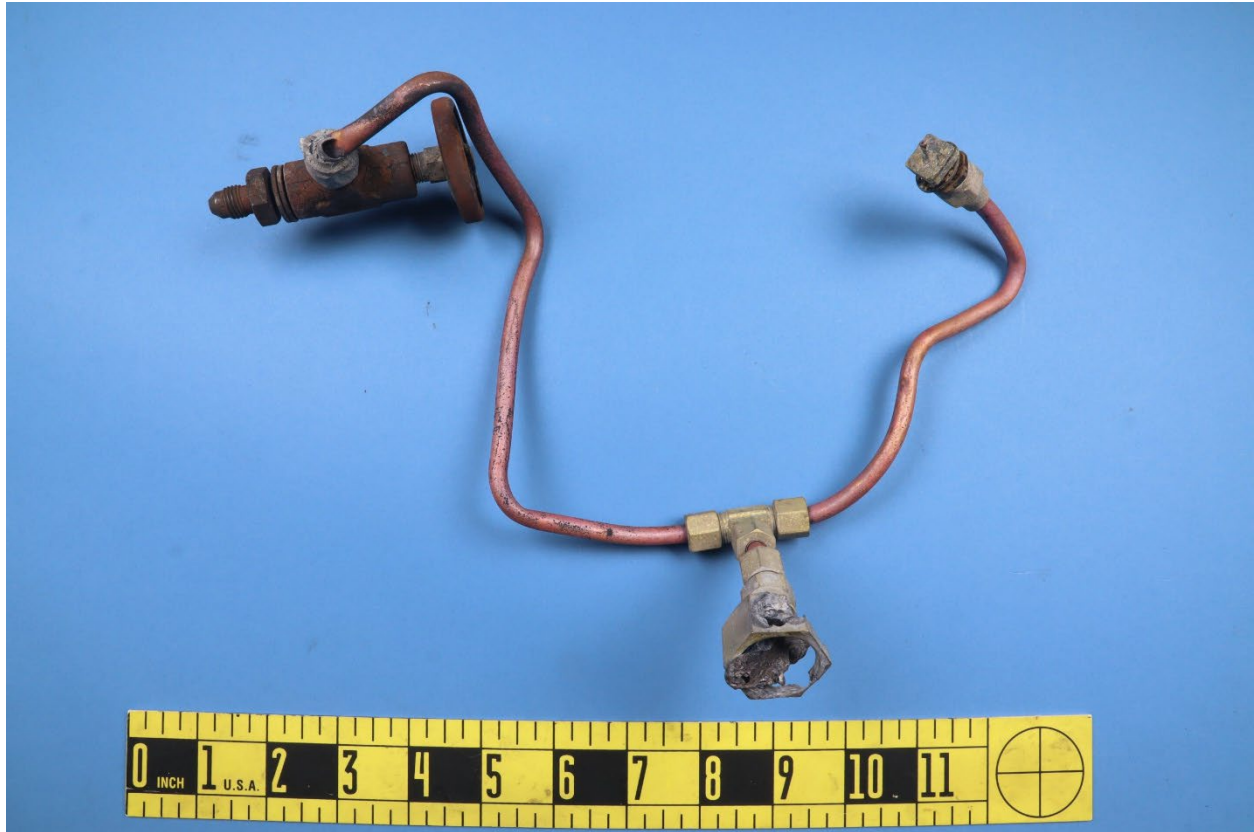
The oil pressure line consisted of an approximately 0.250 inch copper tube that would have extended from the firewall to an oil pressure gauge on the instrument panel. The oil pressure line had a Tee fitting approximately midspan along its length (Figure 10). This Tee fitting created a branch line that terminated at a partially melted fitting (Figure 11). The Tee fitting, branch line and melted end fitting were not part of the original oil pressure line design. It is unknown what had been connected to the melted fitting. The melted fitting was examined using a digital microscope (Figure 12). The fitting exhibited a concentrated region of melted and missing material. In some areas the melted region was flanked by intact material on either side. Some of the margins between the melted and intact material exhibited a scalloped like appearance. The morphology of the melting exhibited by the fitting is consistent with localized extreme temperature such as that generated by electrical arcing. Examination of the fitting by X-Ray fluorescence spectroscopy found the alloy to be consistent with a 360 series free machining brass.

Figure 10. Oil pressure line with Tee fitting mid span.

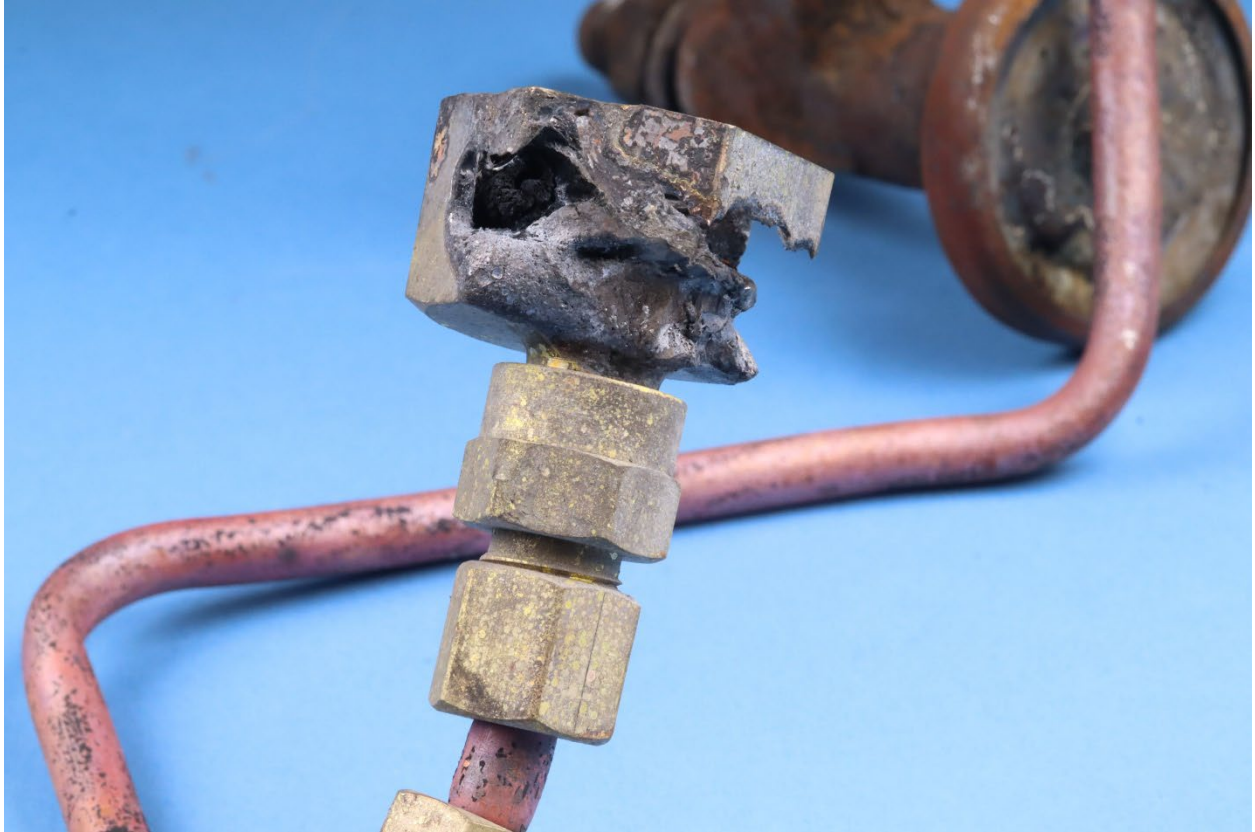
Figure 11. Branch line with damaged fitting on the end.

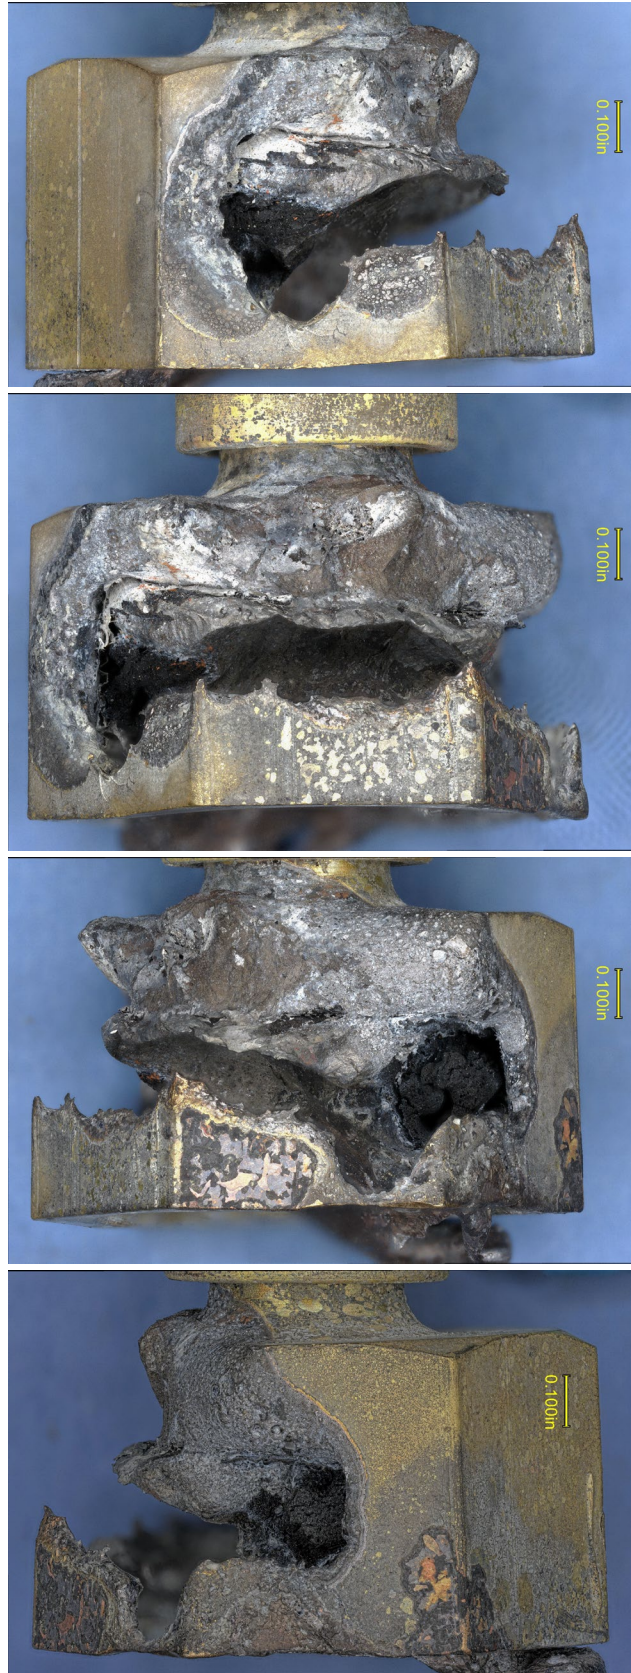
Figure 12. Multiple views of melting on oil line fitting.
