National Transportation Safety Board

HWY23MH017

MATERIALS LABORATORY

Factual Report 23-084

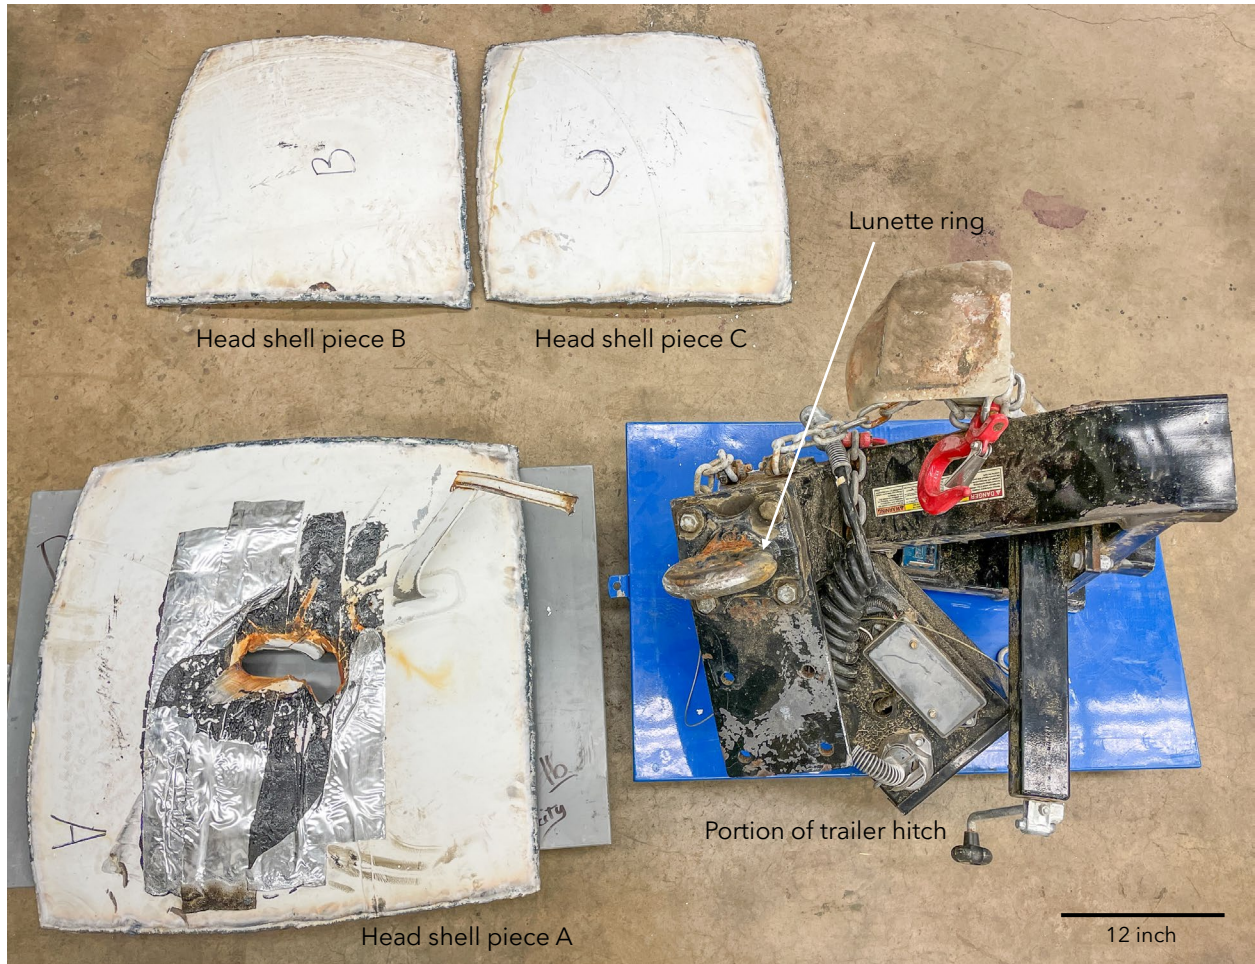
Figure 1. As-received evidence: three head shell pieces labelled A, B, and C; portion of trailer hitch with lunette ring.

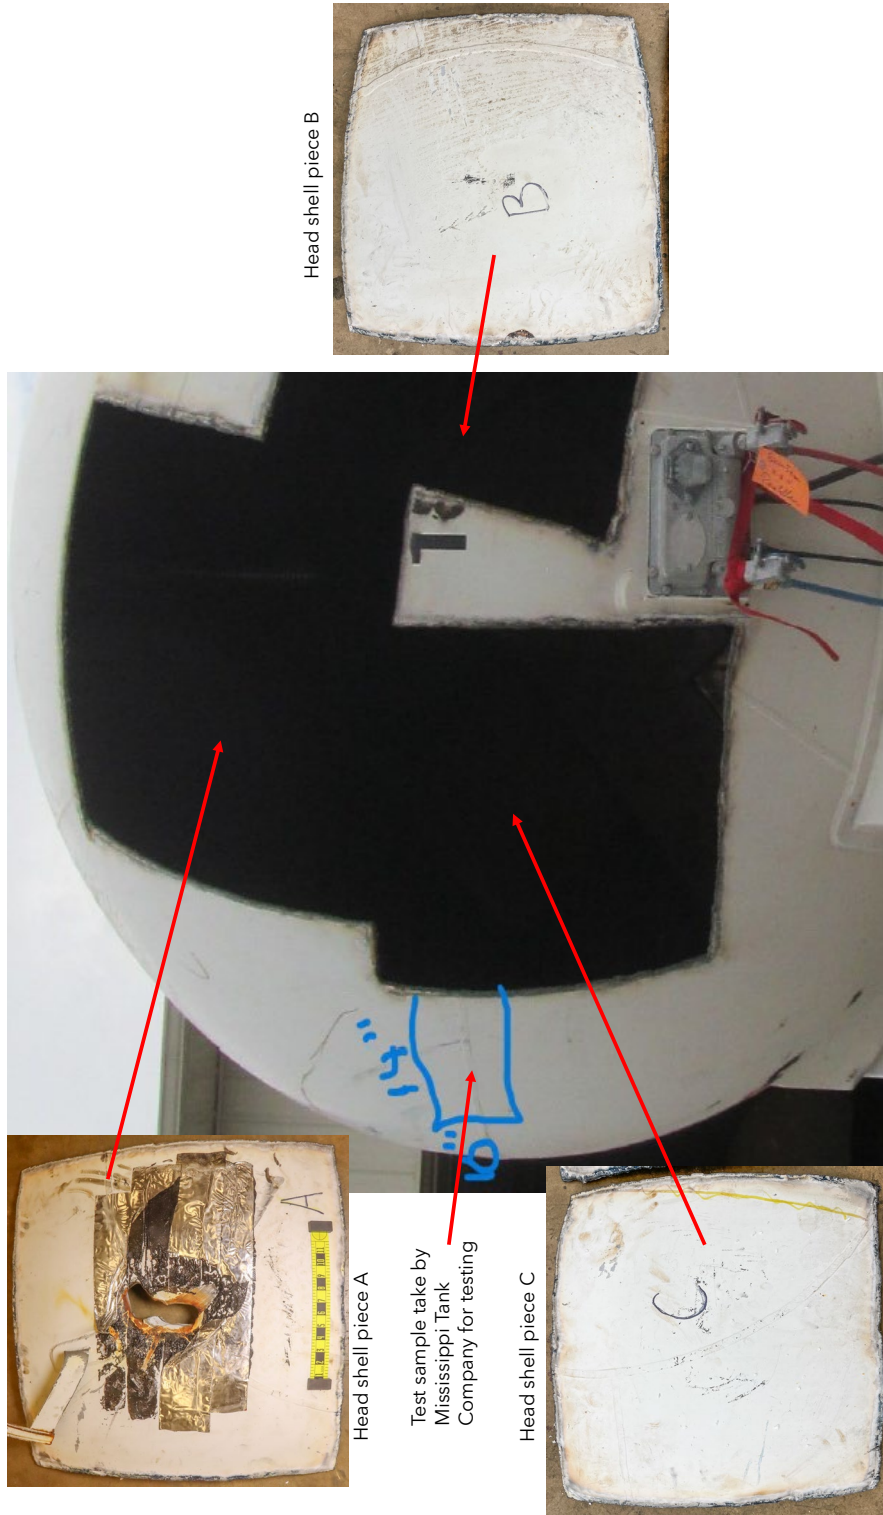
Figure 2. Image of the front of the cargo tank semitrailer showing the location of head shell pieces A, B, and C.

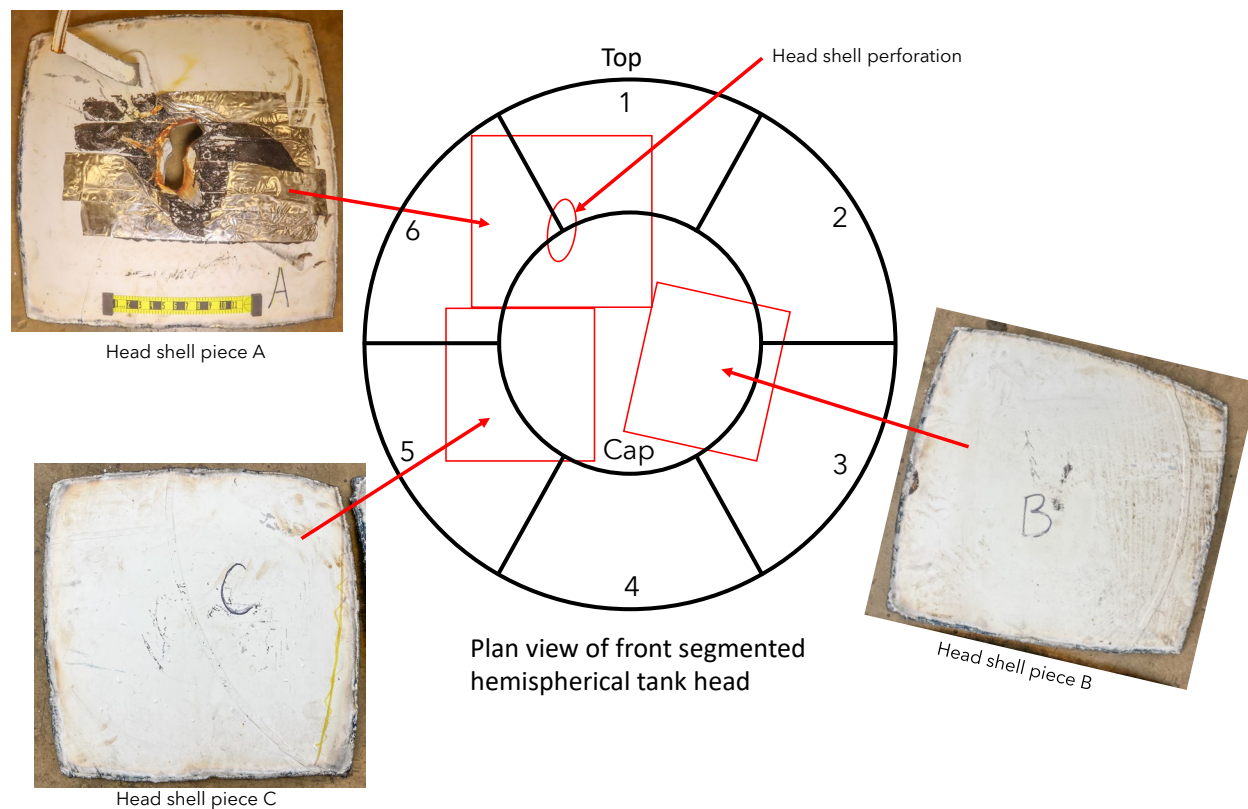
Figure 3. Plan view of the front of the cargo tank semitrailer showing the location of the butt-welded panels. The panels have been arbitrarily numbered for reference purposes. The locations of the removed head shell pieces A, B and C are also shown for reference (external side shown). The location of the perforation in the head is shown; it occurred where the segment 1-6 butt weld met the cap butt weld.

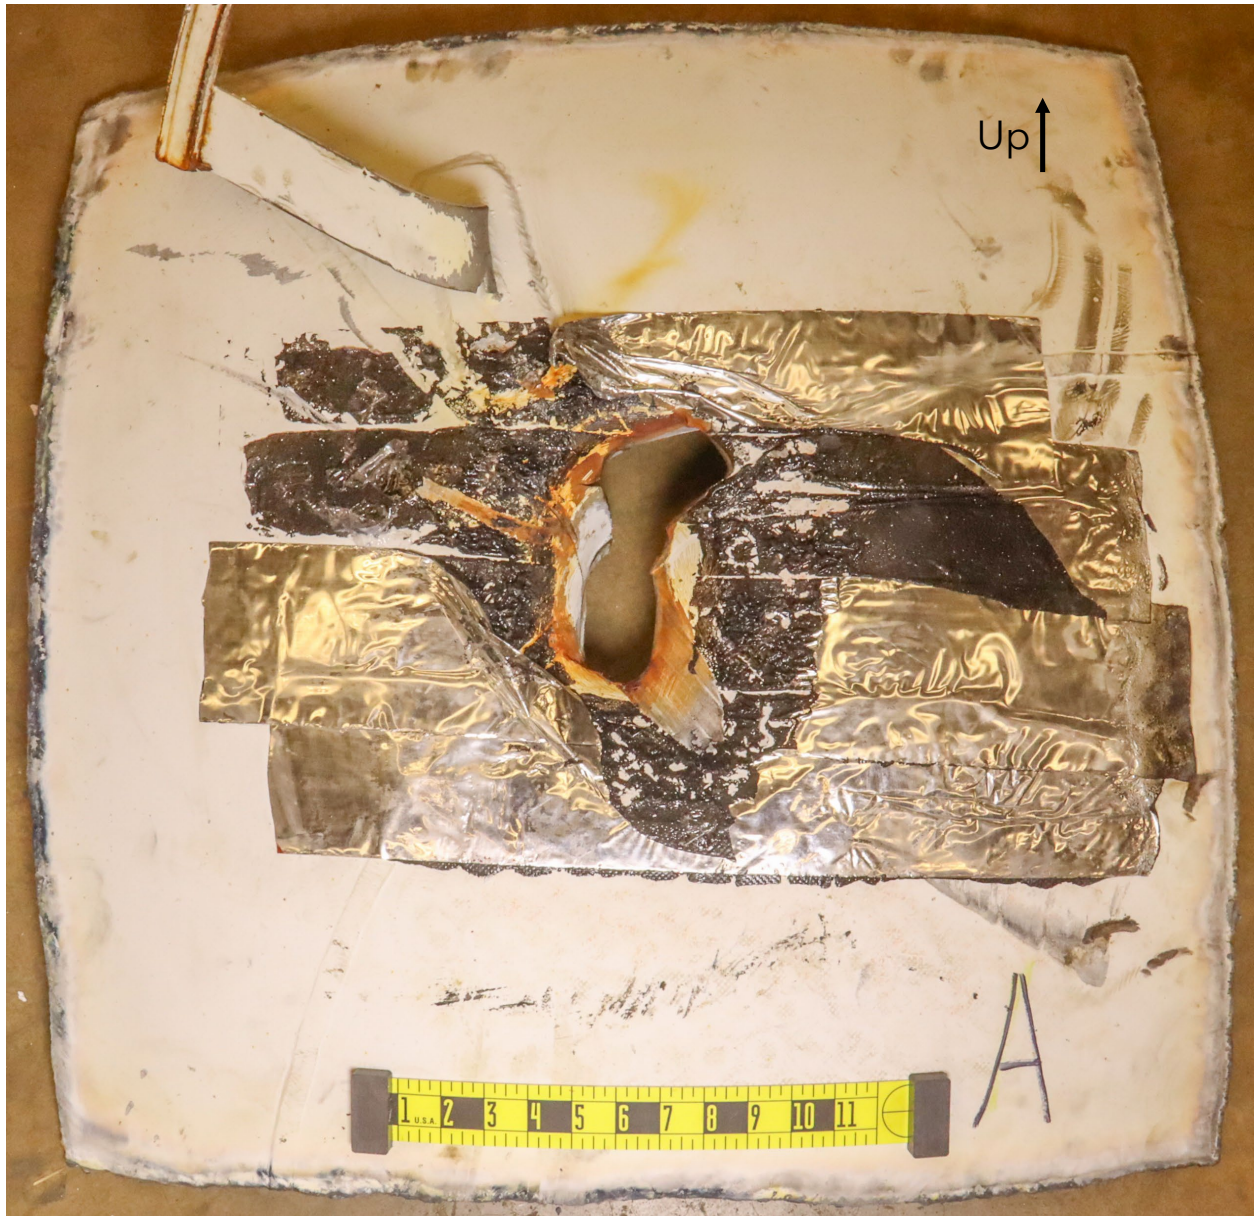
Figure 4 shows the external side of head shell piece A. A perforation approximately 6.3 inch wide and 2 inch long is approximately located in the geometric center of the piece. Remnants of a temporary tape patch are present around the perforation. The mechanical deformation associated with the perforation reveals that the shell piece was perforated from the outside towards the inside of the tank. In Figure 5, yellow dashed lines overlaid on the image show the approximate locations of the segment and cap butt welds.

Figure 4. View of the external side of head shell piece A, which contains a perforation. The upward direction of the shell piece is labelled. Remnants of a foil tape are present around the perforation.

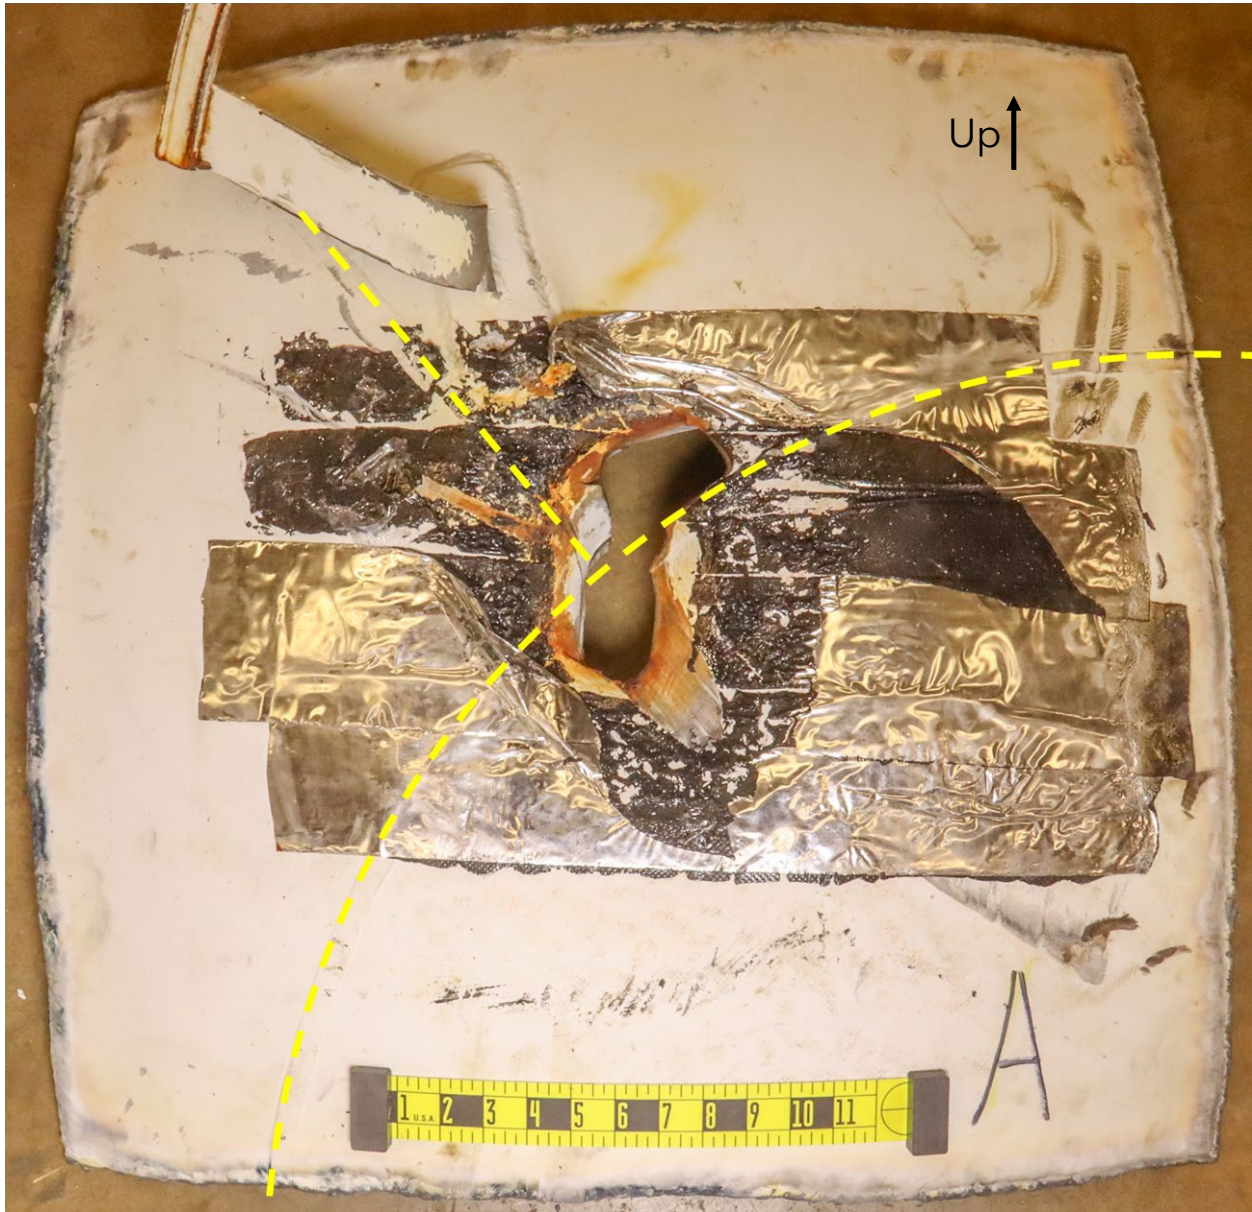
Figure 5. View of the external side of head shell piece A, which contains the perforation. The dashed yellow lines show the approximate paths of the butt weld deposits. Segments 1, 6, and the cap are identified. The perforation occurred where the segment 1-6 and cap butt welds meet.

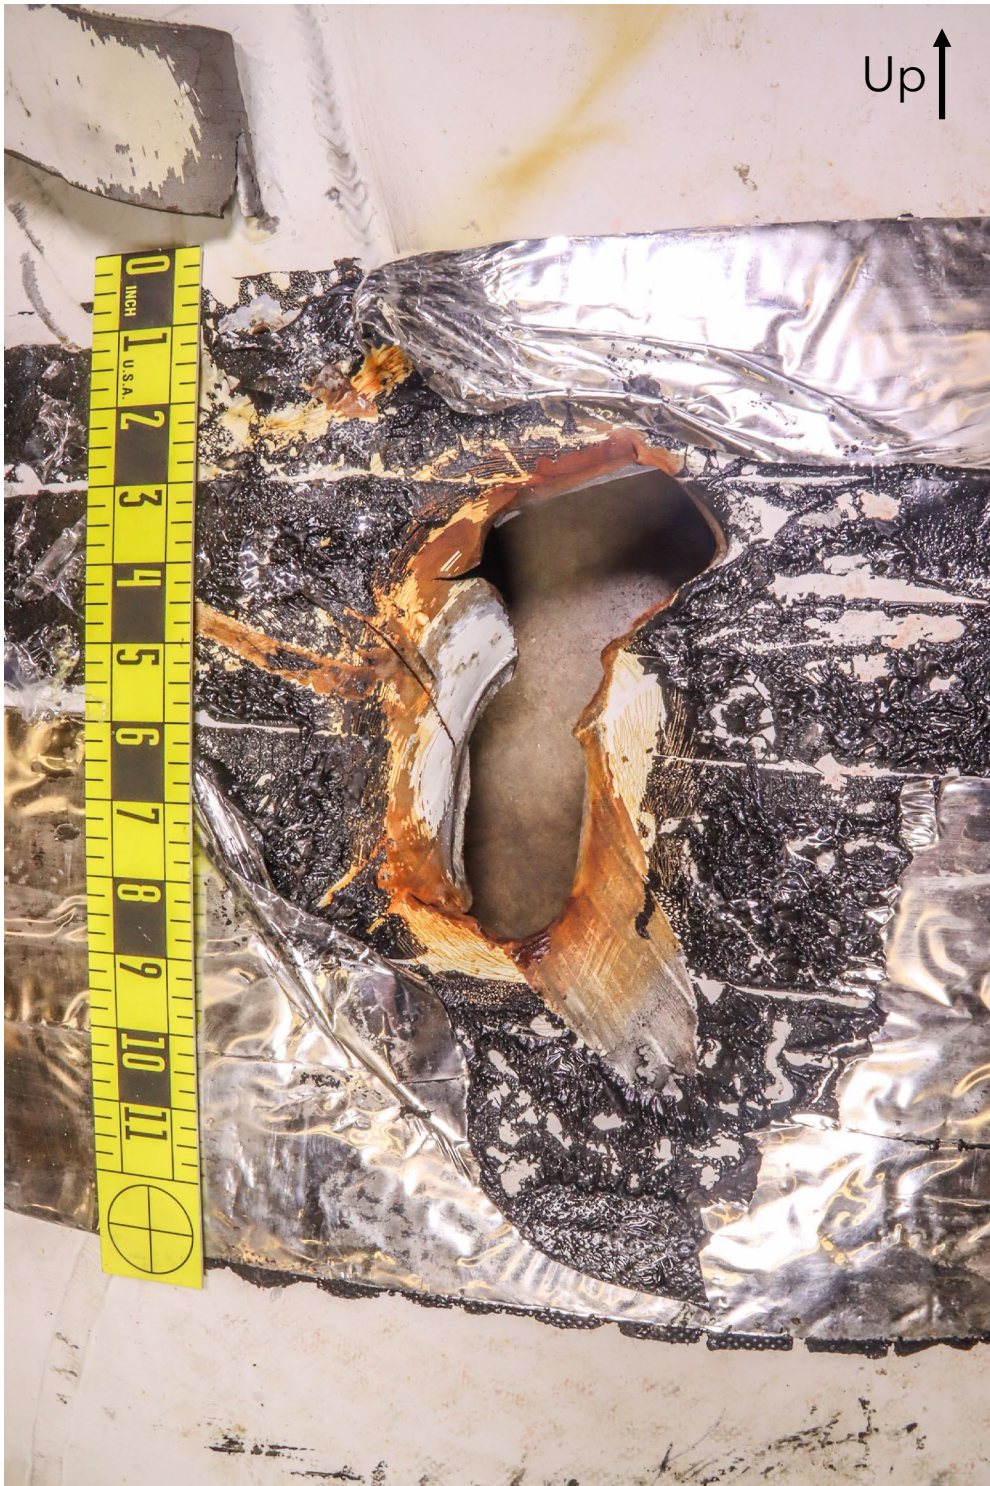
Closer views of the perforation in shell piece A are shown in Figures 6-8. The perforation occurred close to the meeting point of the welds for segments 1, 6, and the cap. Due to the mechanical deformation from the perforation, a crack developed on the external surface along the crown of the butt weld deposit between segments 1 and 6 (see Figure 8 for close detail).

Figure 6. Closer view of the external side of head shell piece A, which contains a perforation.

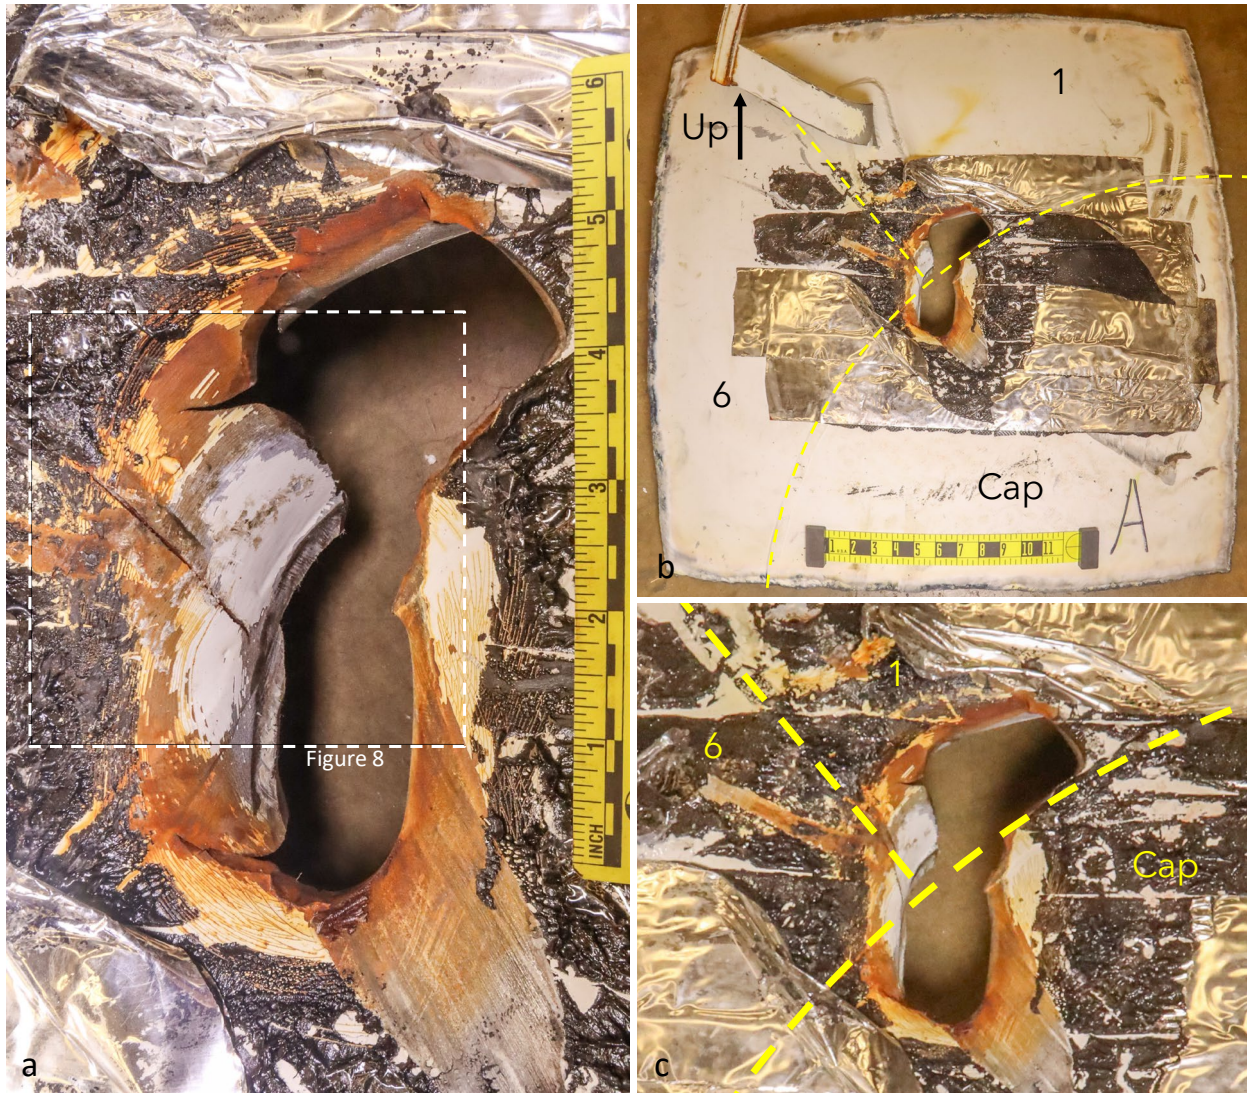
Figure 7. Close and detailed view of the external side of the perforation in head shell piece A (view a). Views b and c show the butt weld deposits in relation to the perforation.

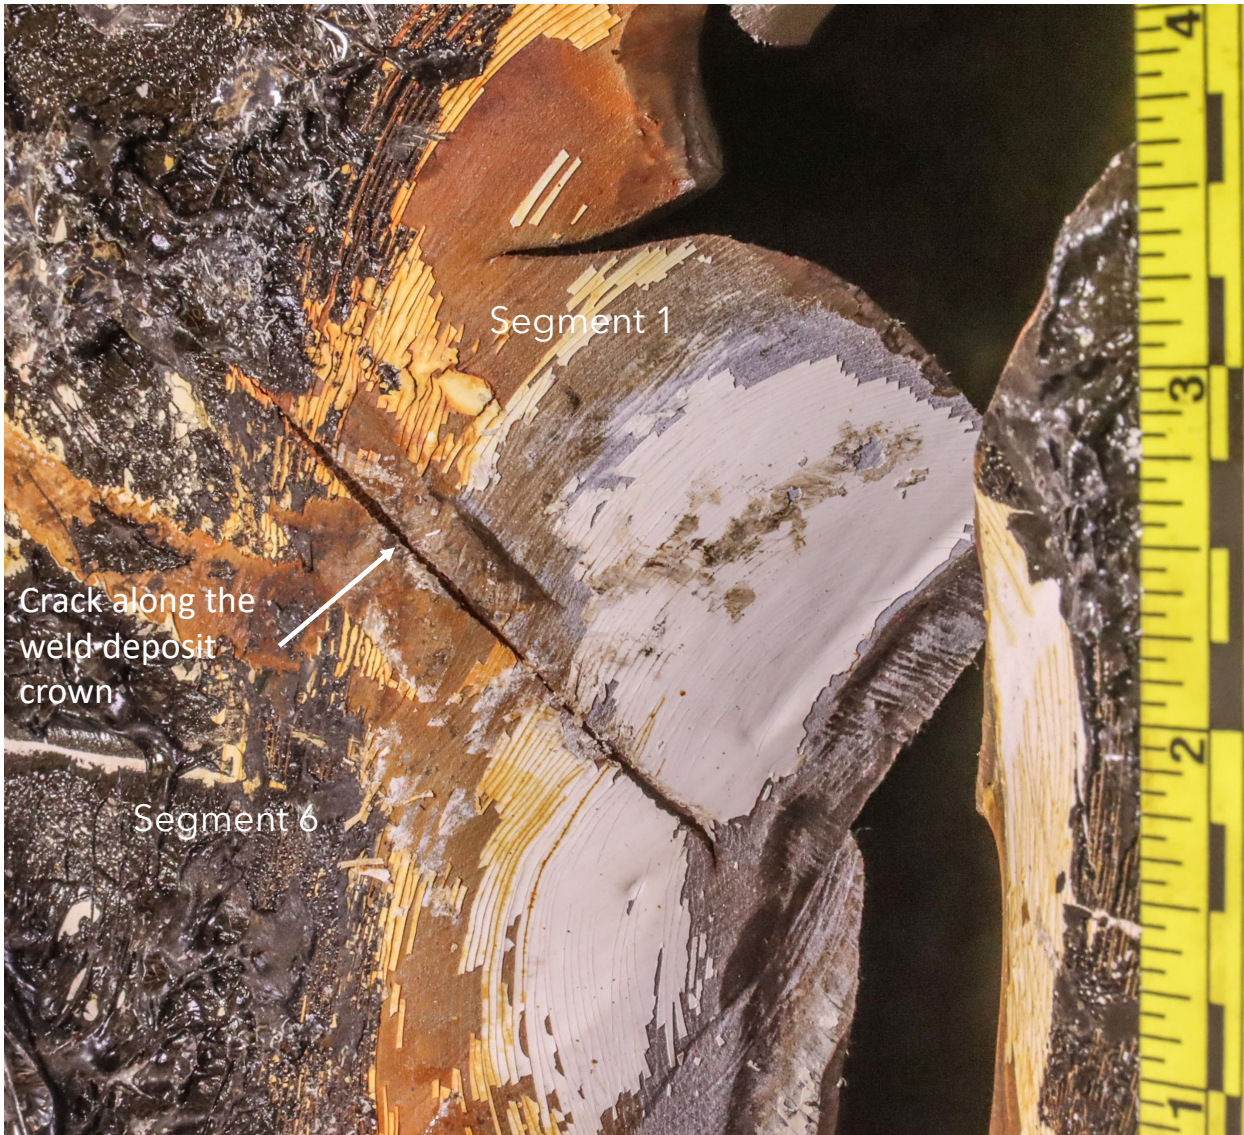
Figure 8. Close view of the butt weld between segment 1 and 6 revealing a crack in the crown of the weld deposit in the deformed area of the perforation.

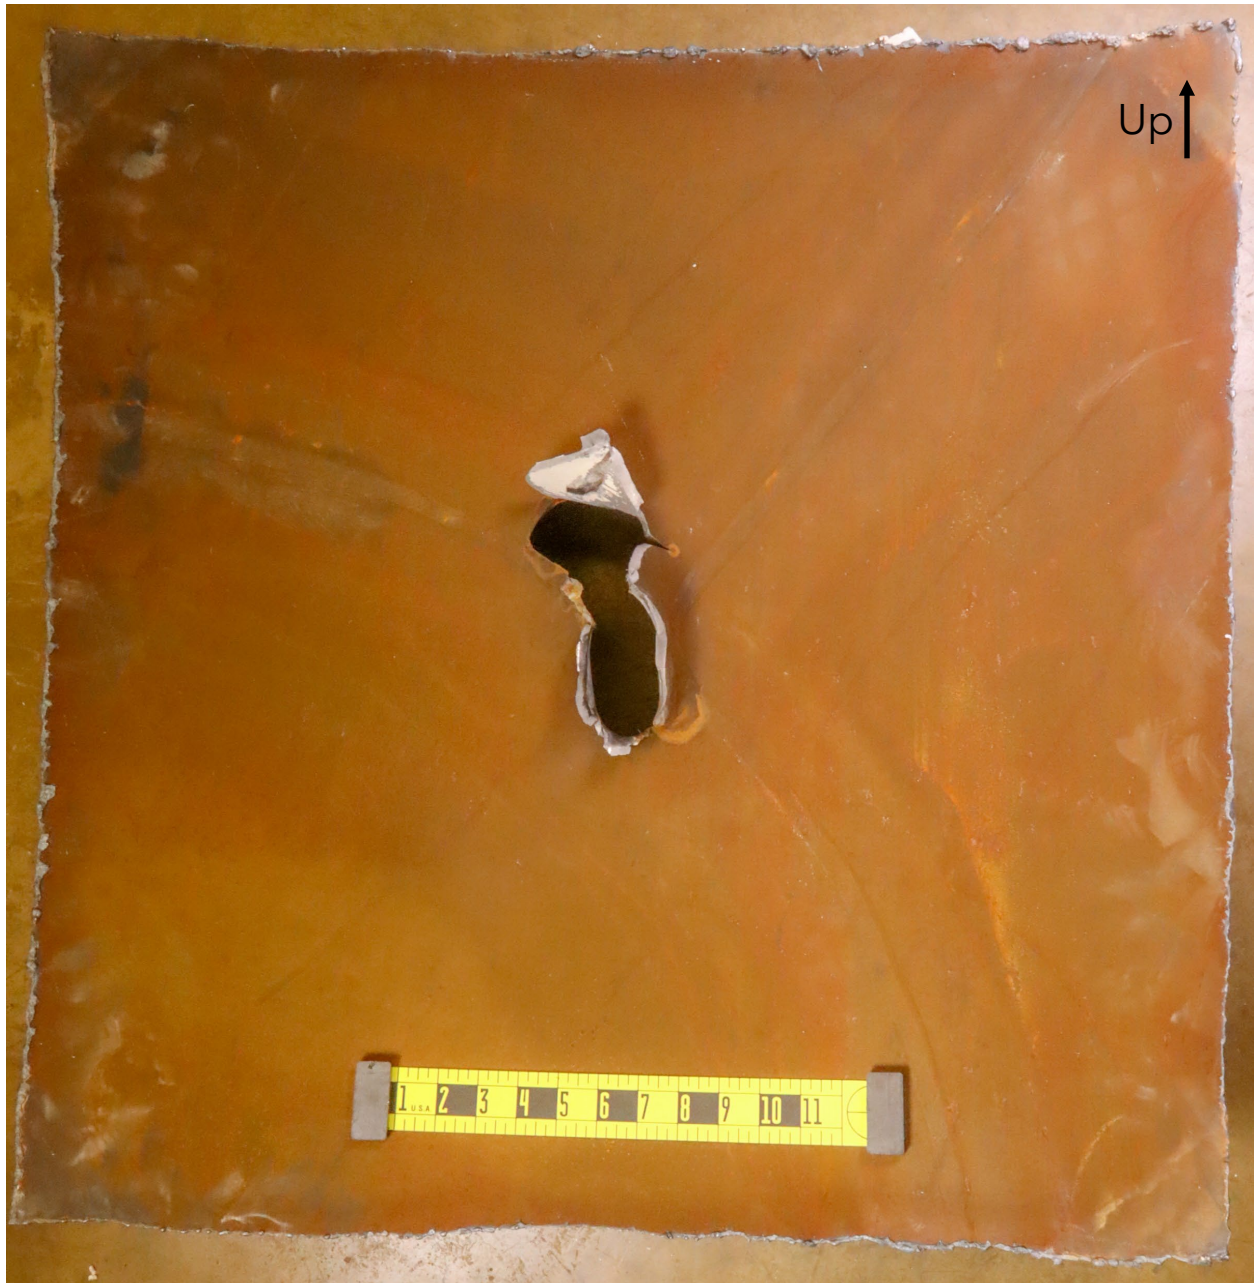
Images showing the inside surface of shell piece A are shown in Figures 9-11. In Figure 10, the approximate locations of the butt welds are projected onto the image. The perforation coincides with the meeting of the segment 1 to segment 6 weld at the cap. The image in Figure 11 shows close details of the mechanical deformation associated with the perforation. The shell piece is petaled inward around the perforation, consistent with inward perforation from an external source.

Figure 9. View of the internal surface of the front head shell piece A revealing a perforation with deformed material petaled inward from the exterior. The internal shell surface, which is untreated steel, exhibited a uniformly-colored layer of ferrous corrosion product.

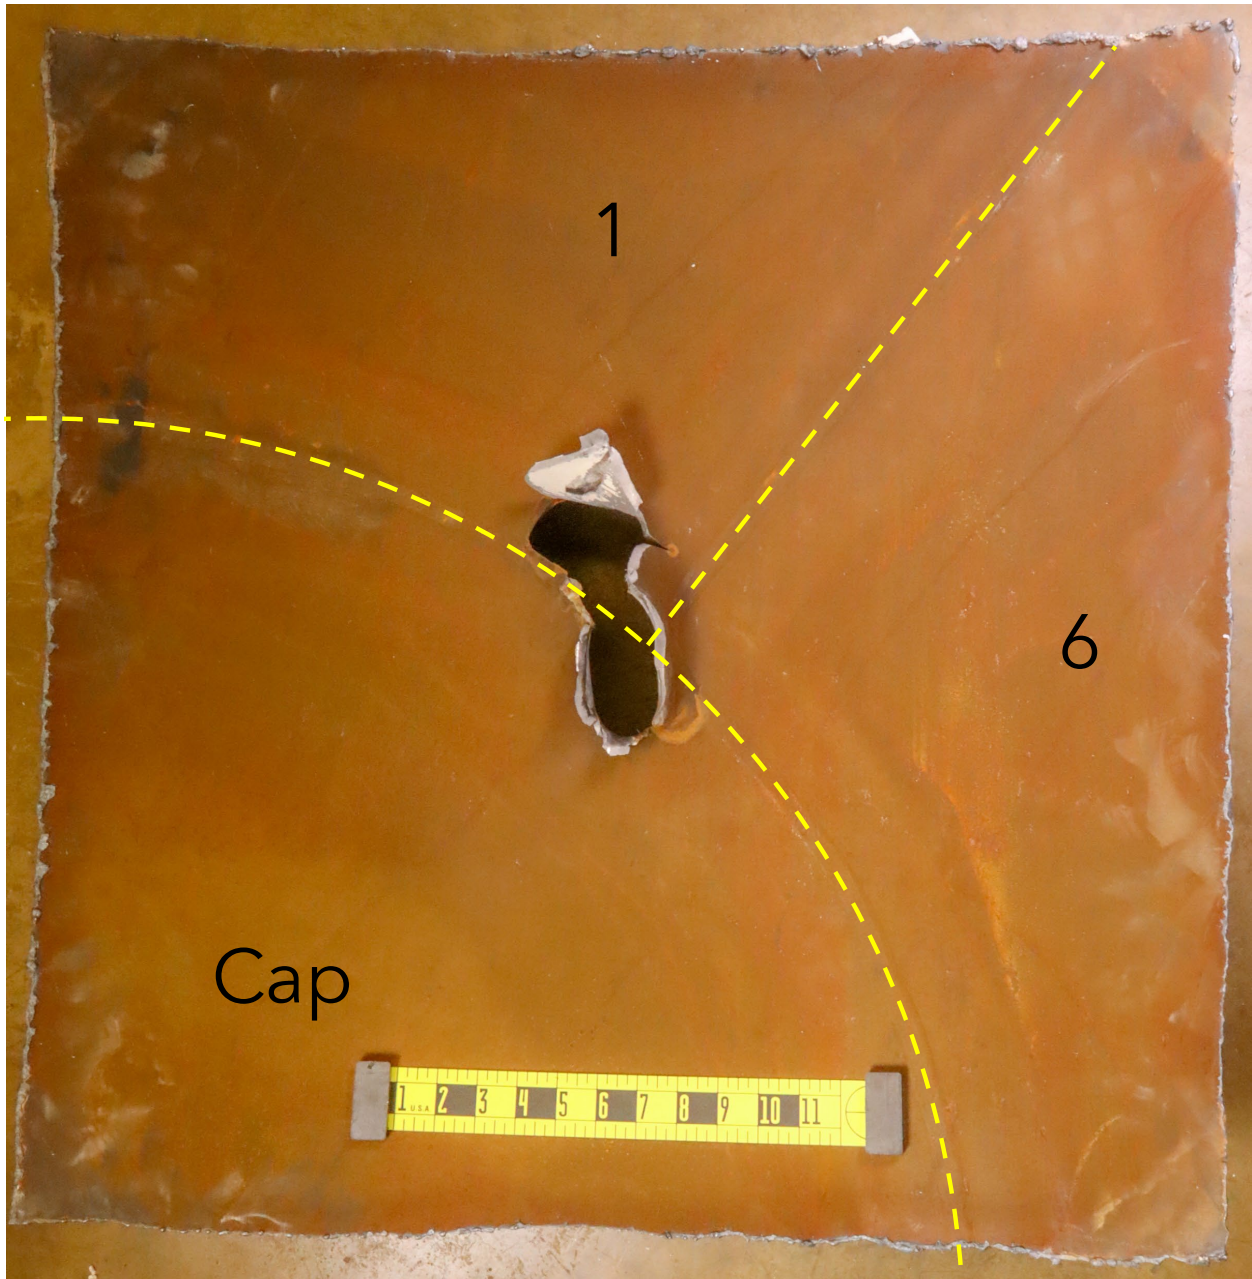
Figure 10. Similar view to Figure 9 with yellow dashed lines showing the approximate location of the butt weld deposits joining segments 1, 6, and the cap.

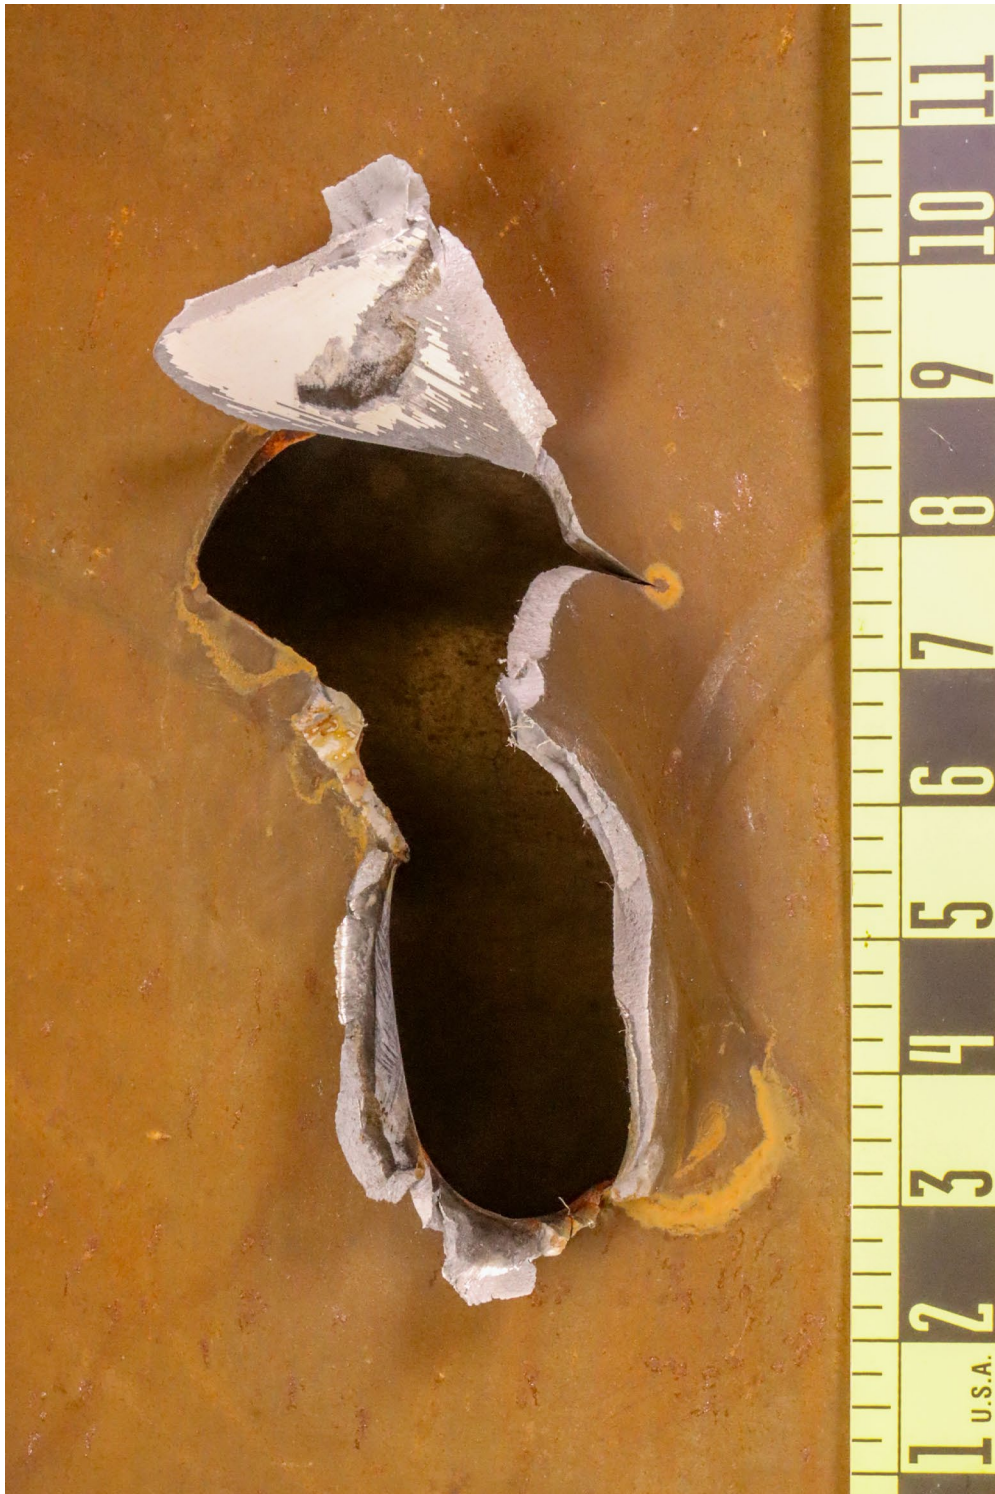
Figure 11. Close view of the internal surface of front head shell piece A revealing a perforation with deformed material petaled inward from the exterior.

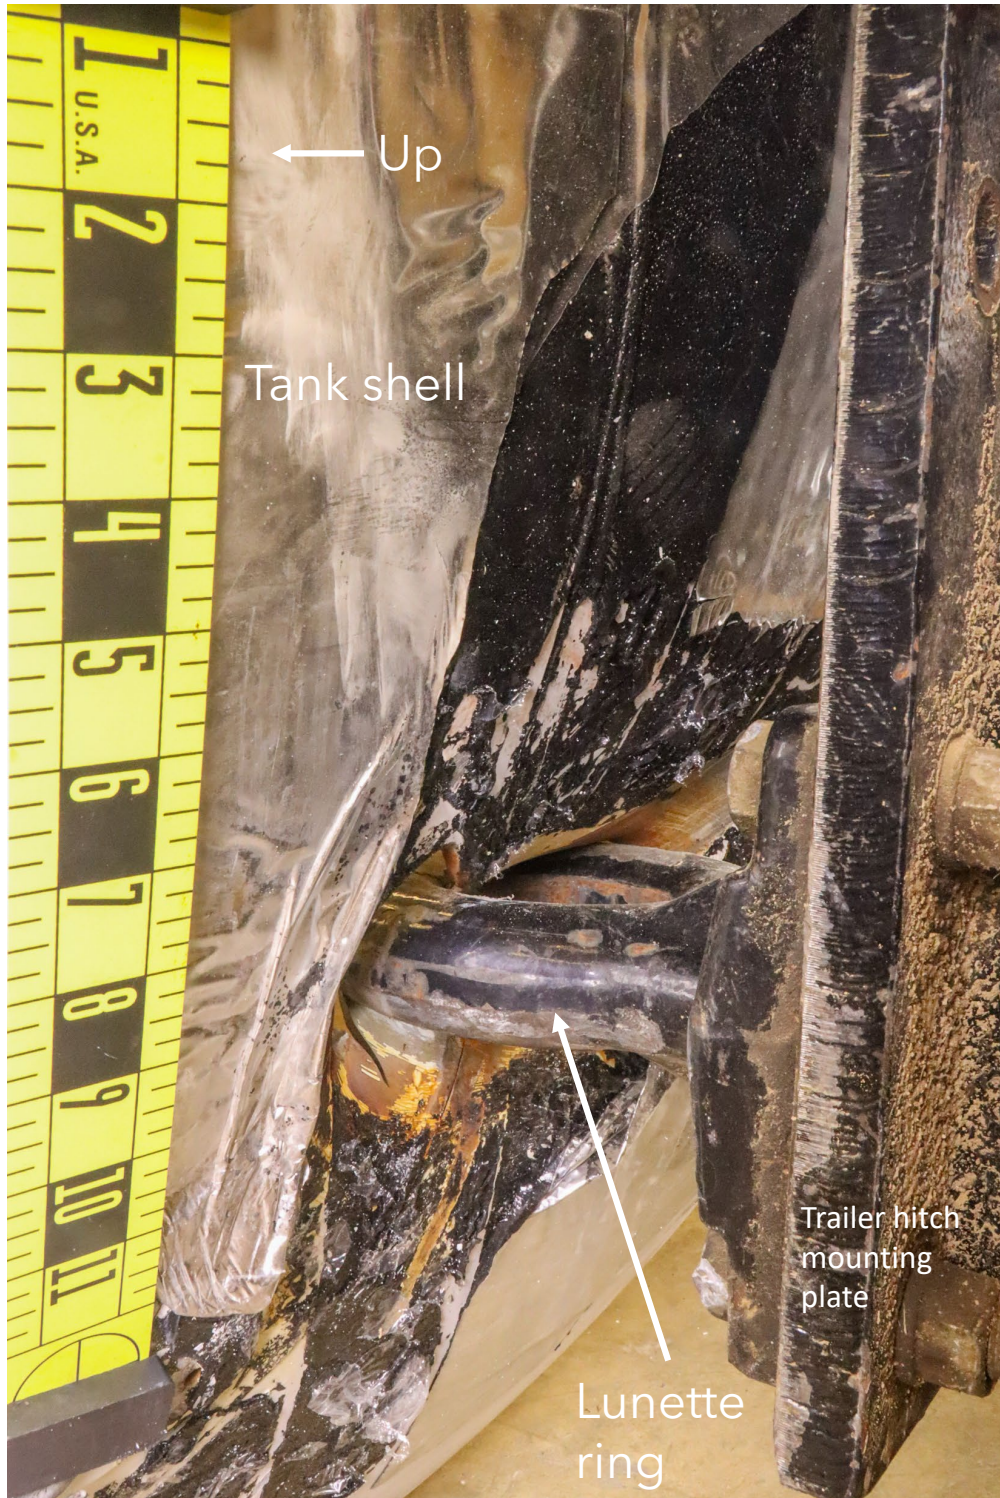
To simulate the perforation event, the trailer hitch with lunette ring was placed in close proximity to the perforation as shown in Figures 12-14. The size and shape of the perforation is consistent partial penetration by the lunette ring (about 5.8 inch wide x 1.5 inch thick). The dimensions of the perforation were consistent with the dimensions and shape of (e.g. thickness and outside diameter) of the lunette ring. During the fit-up of the lunette ring in the head shell perforation, the back side of the trailer hitch was photographed to document witness marks. Figure 15 shows the back side of the trailer hitch mounting plate and the front (exterior surface) of head shell piece A

Figure 12. View of the perforation in the exterior side of the front head shell piece A with the trail hitch lunette ring placed close to the perforation.

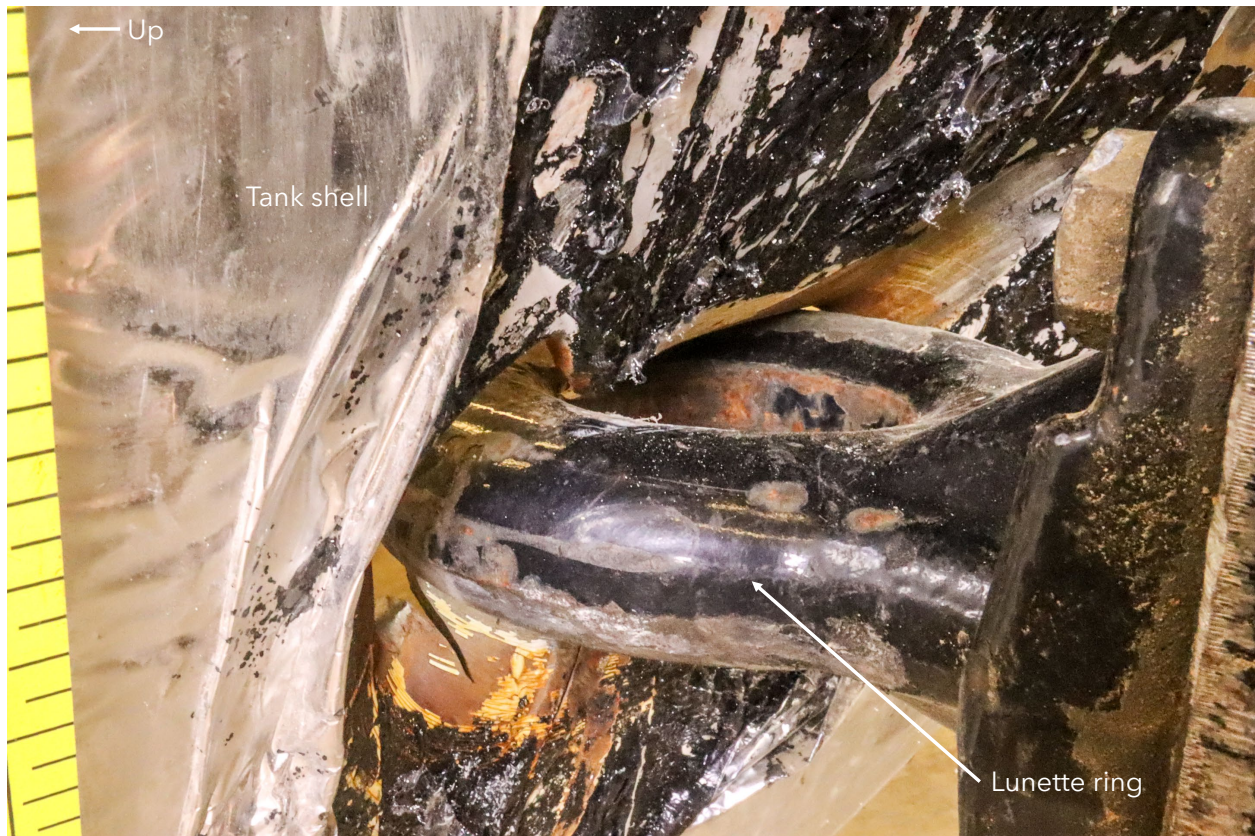
Figure 13. Closer view of the perforation in the exterior side of the front head shell piece with the trail hitch lunette ring placed close to the perforation.

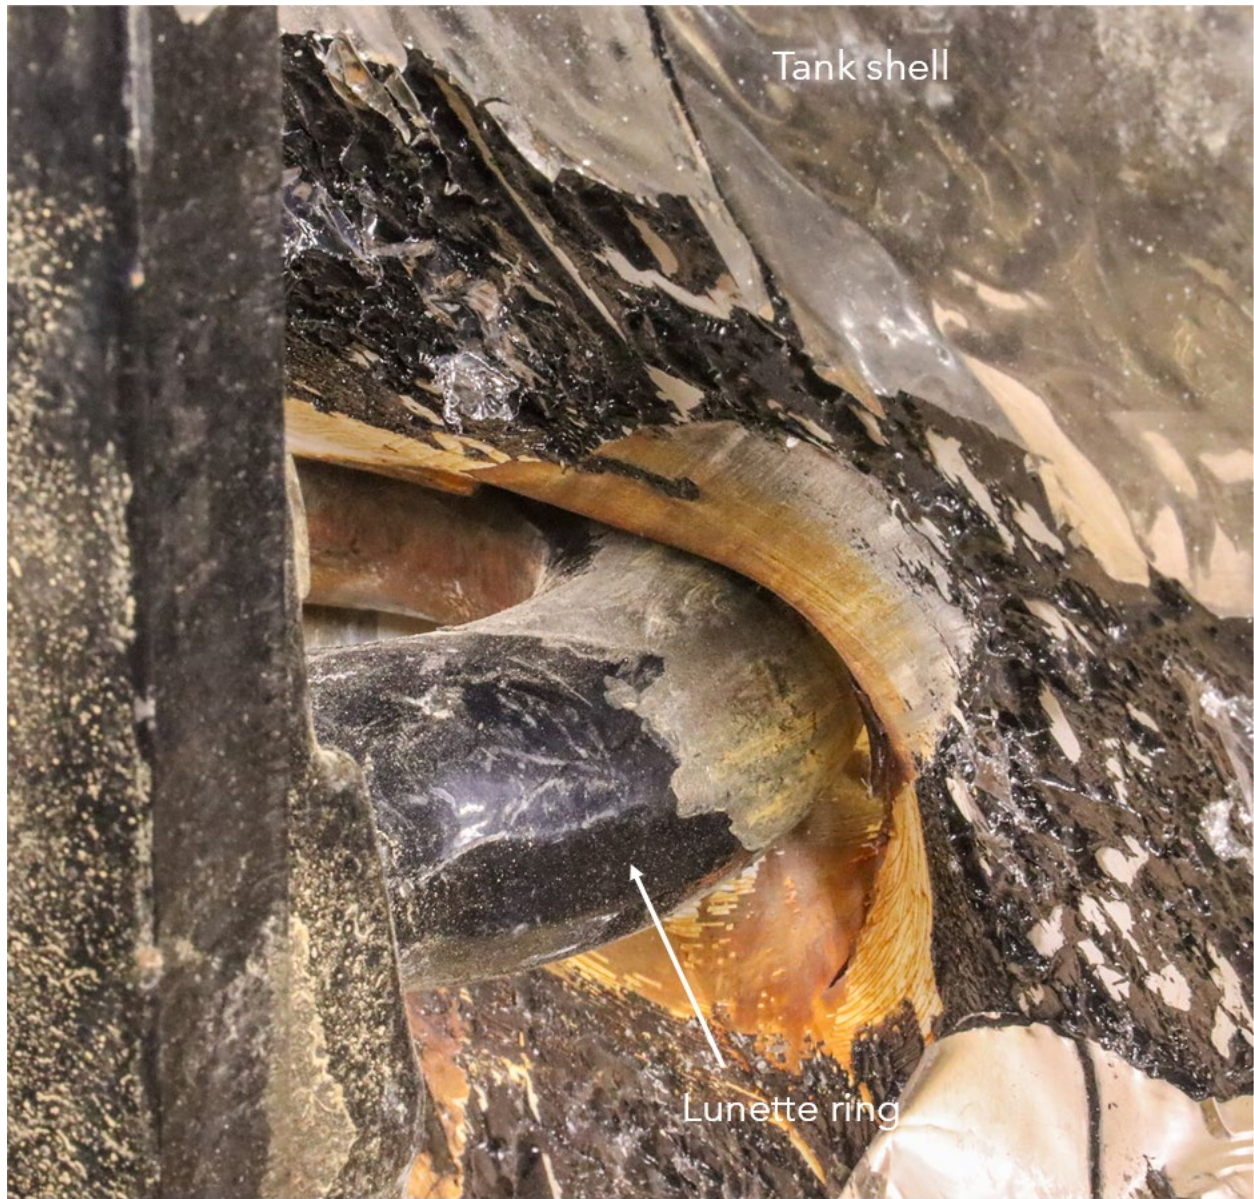
Figure 14. Closer view of the perforation in the exterior side of the front head shell piece with the trail hitch lunette ring placed close to the perforation.

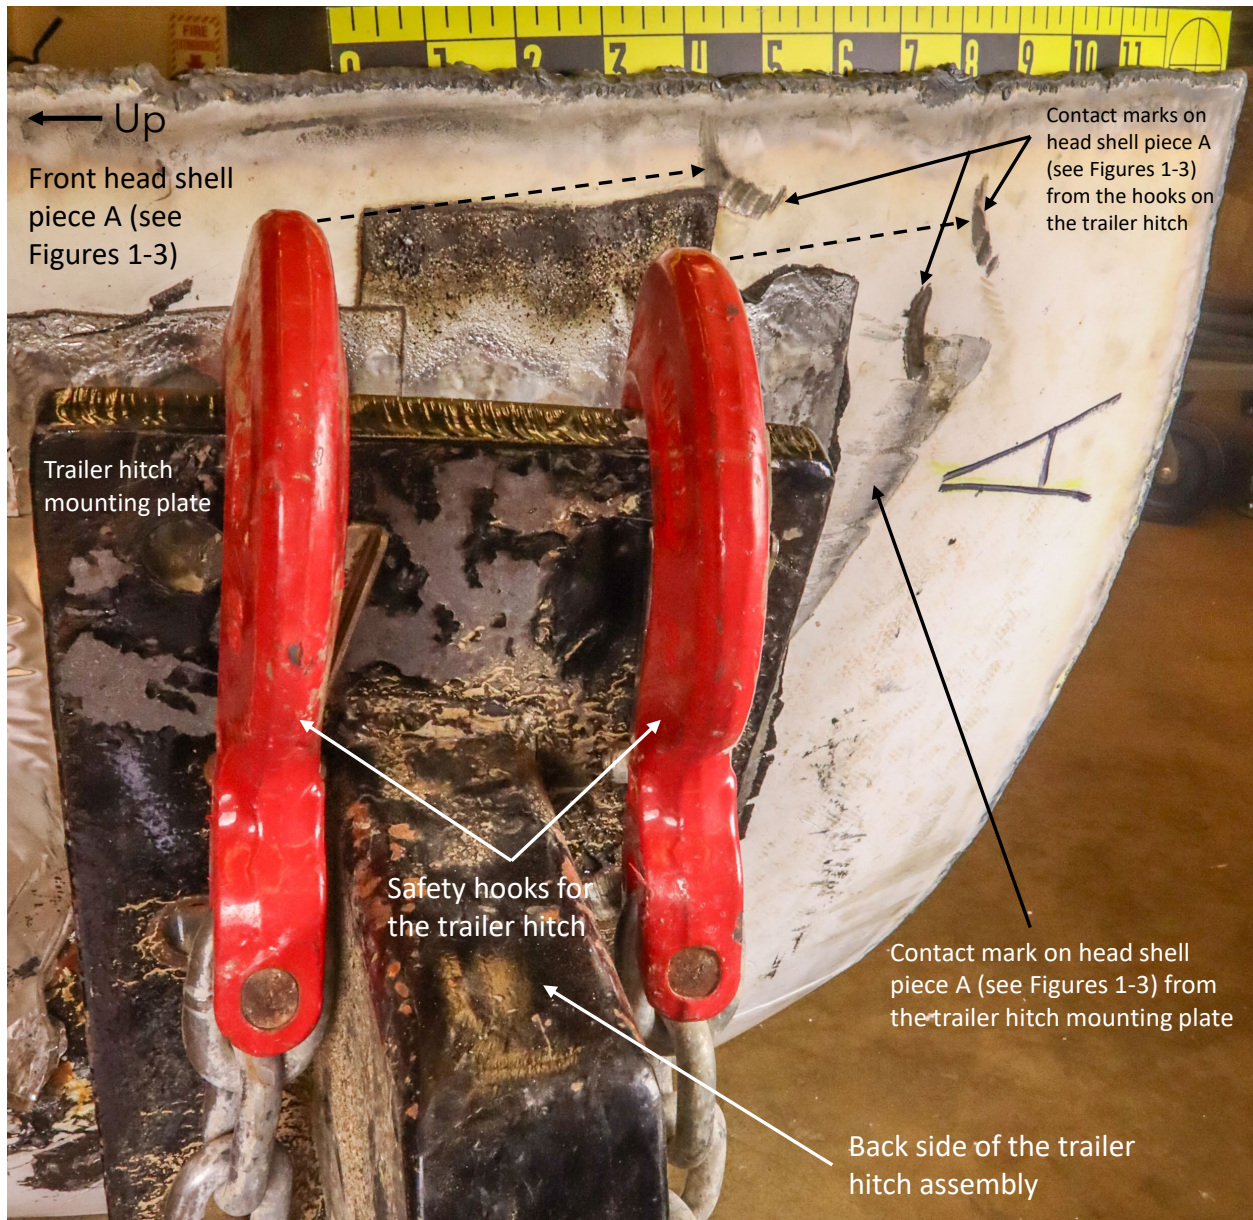
Figure 15 View of the exterior side of the front head shell piece with the trail hitch placed in close proximity. Several contact or witness marks are identified consistent with the trailer hitch mounting plate and hooks contacting the exterior side of the front head shell.
