National Transportation Safety Board

HWY23MH017

MATERIALS LABORATORY

Factual Report 23-084

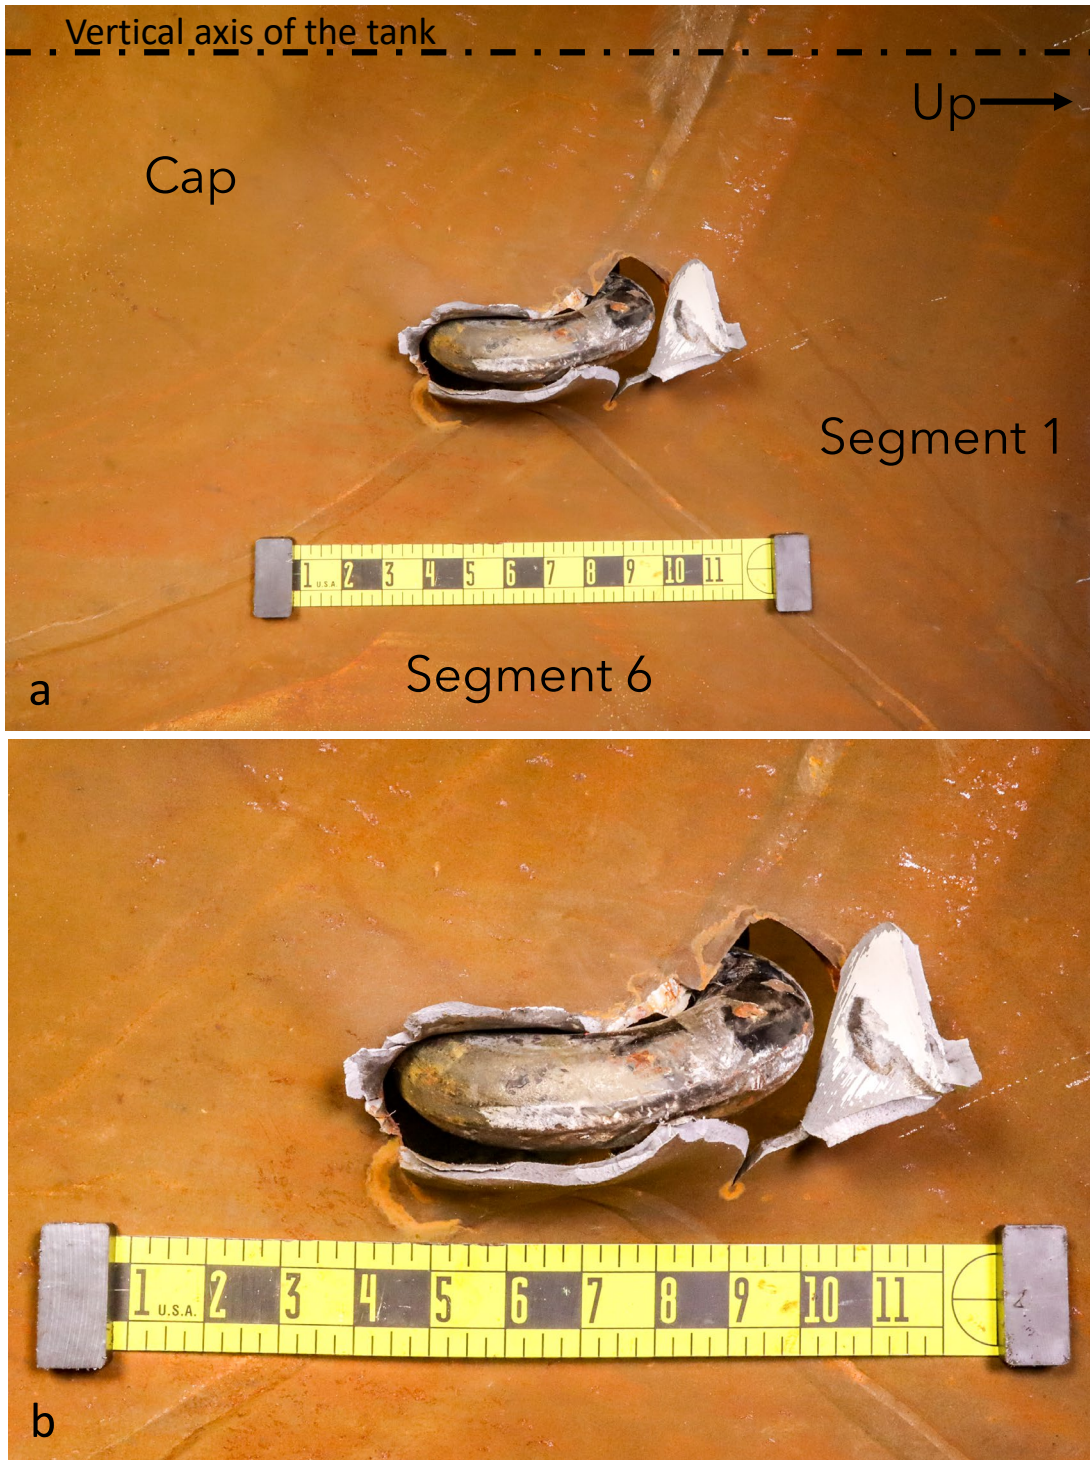
Figures 16-18 show views of the internal side of shell piece A with the lunette ring placed in close proximity to the perforation. The size and shape of the perforation is consistent partial penetration by the lunette ring.

Figure 16. Views of the internal surface of front head shell piece A with the trailer hitch lunette ring in close proximity to the perforation. Deformed material petaled inward from the exterior. View a shows the location of segment 1, 6, and the cap.

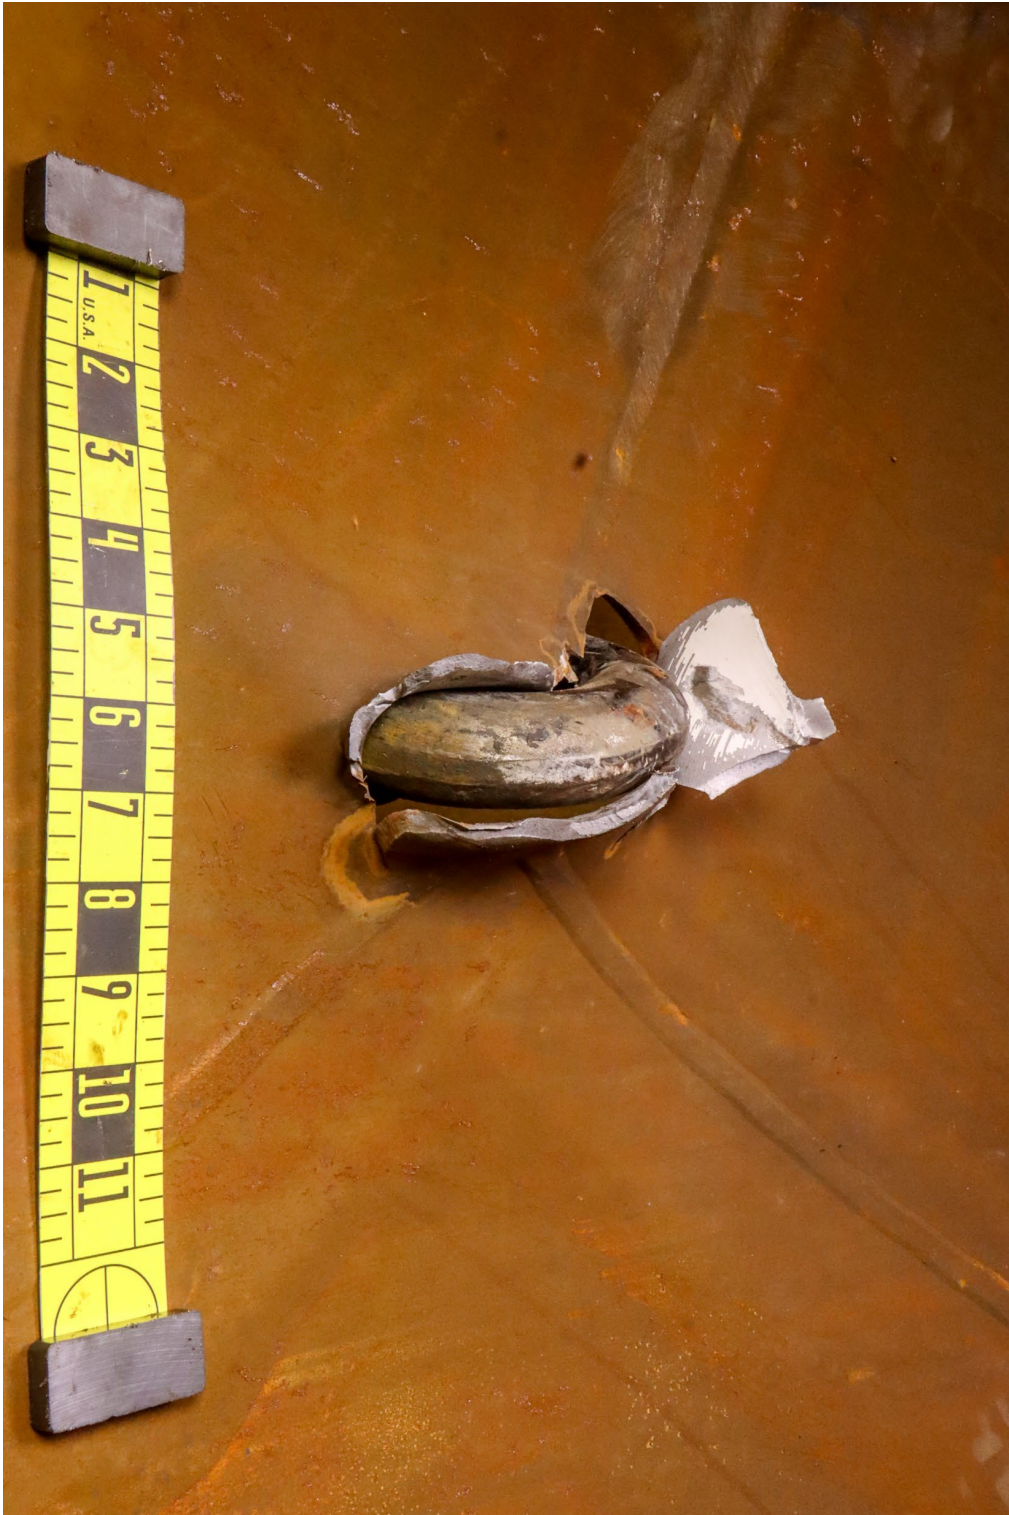
Figure 17. Oblique side view of the internal surface of front head shell piece A with the trailer hitch lunette ring in close proximity to the perforation. Deformed material petaled inward from the exterior.

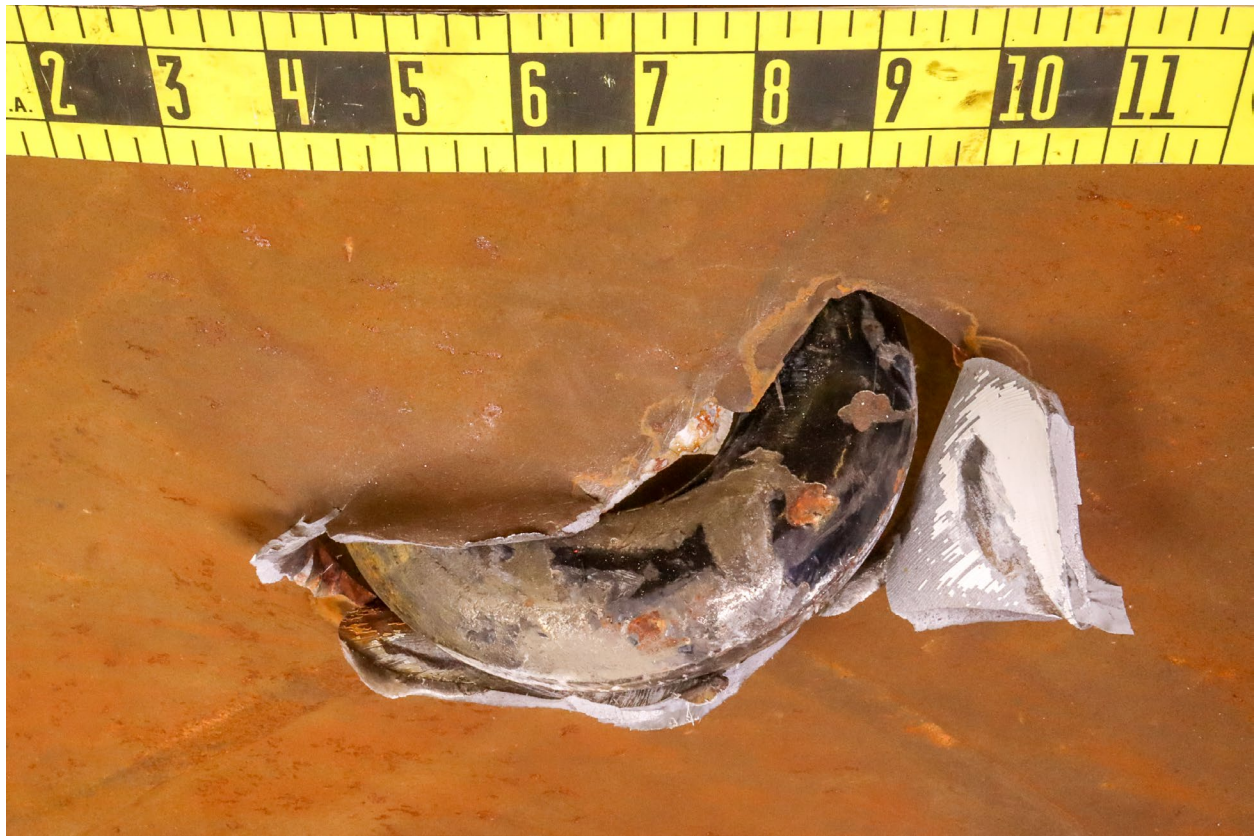
Figure 18. Oblique top-down view of the internal surface of front head shell piece A with the trailer hitch lunette ring in close proximity to the perforation. Deformed material petaled inward from the exterior.
