# National Transportation Safety Board

DCA23FM036

Factual Report 24-011

Location: Atlantic Ocean  
Date: June 18, 2023  
Vehicle: OceanGate Experimental Submersible Titan  
Investigator: Marcel Muise, MS-10

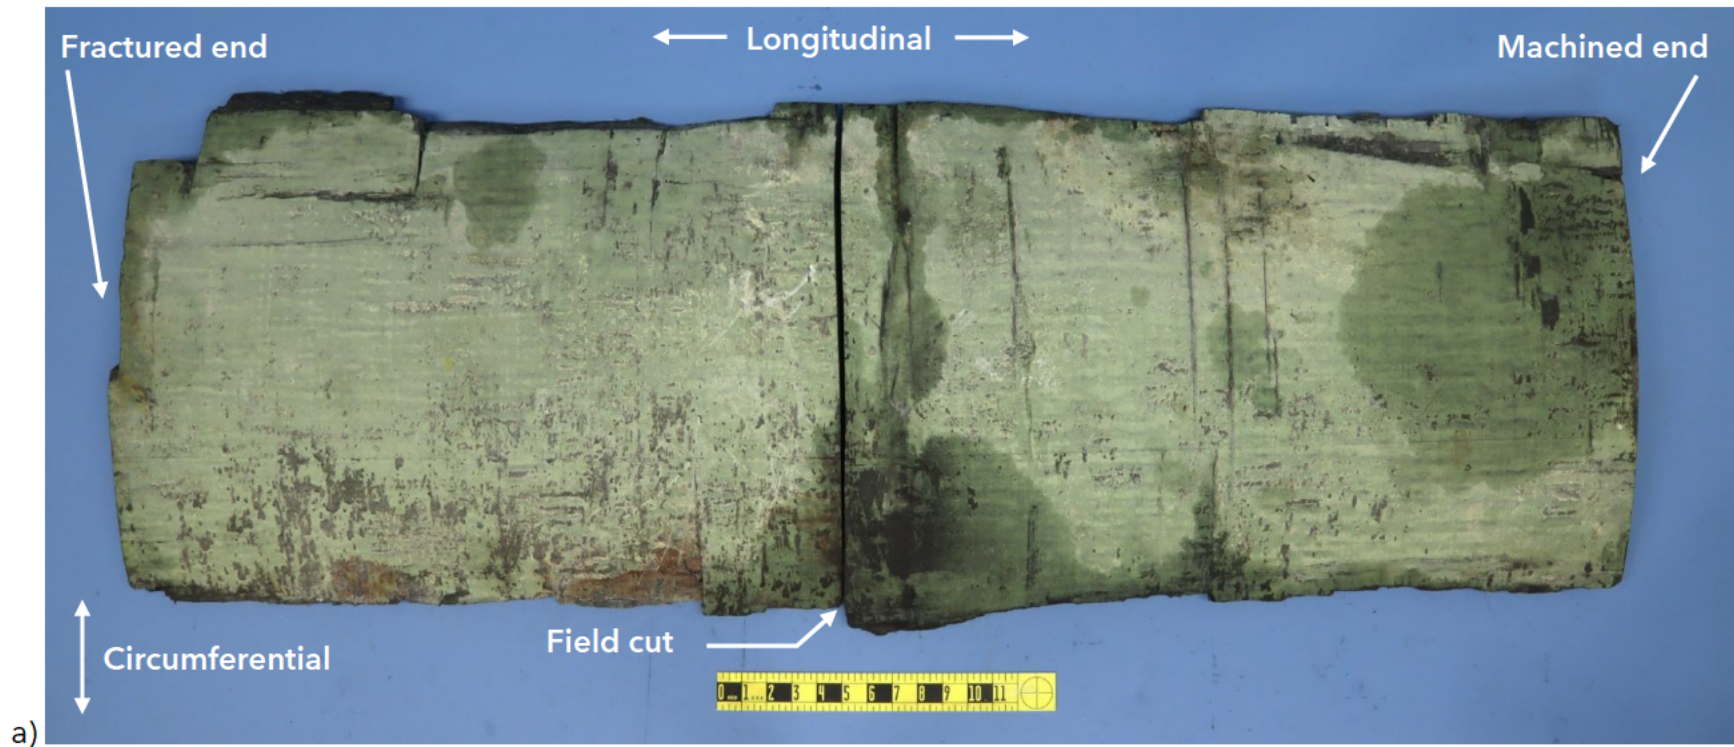
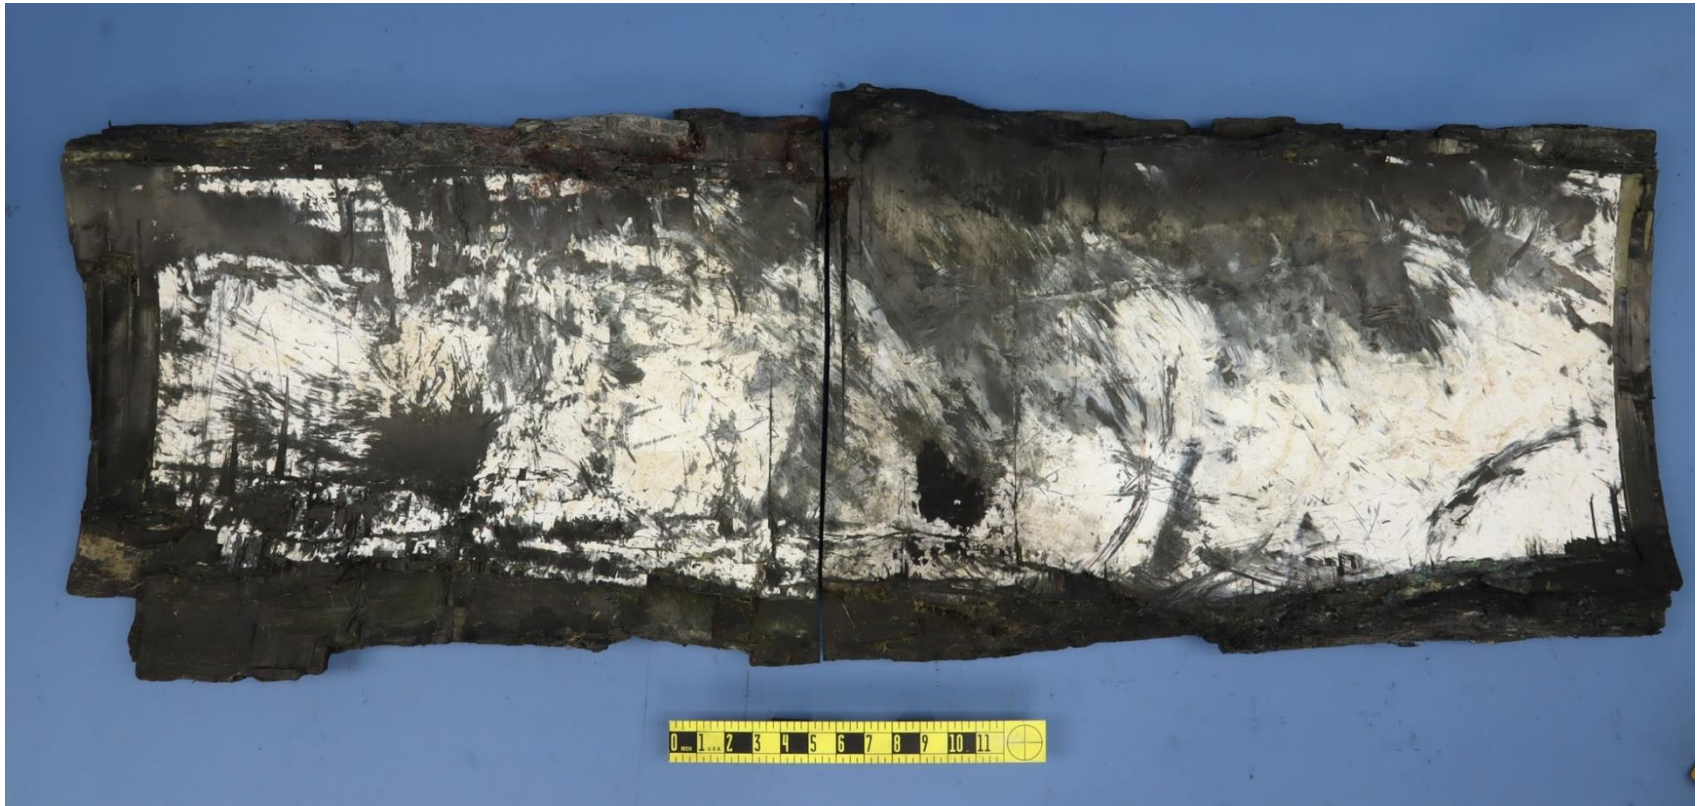
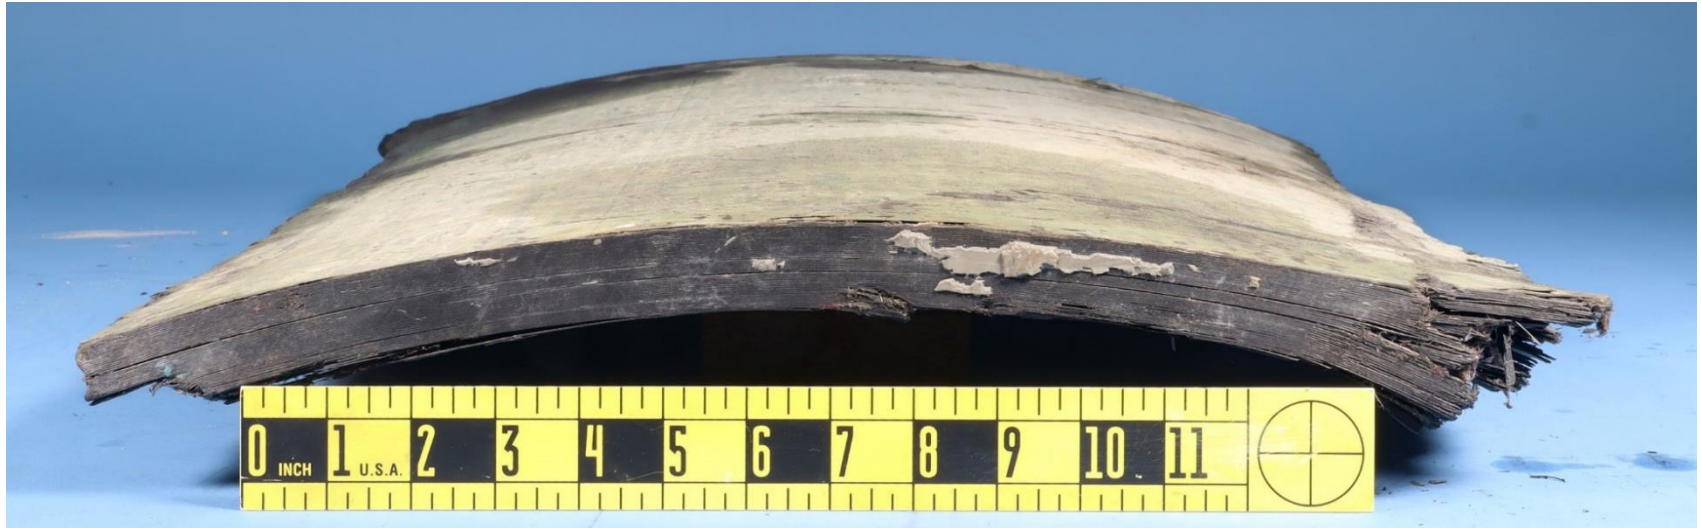
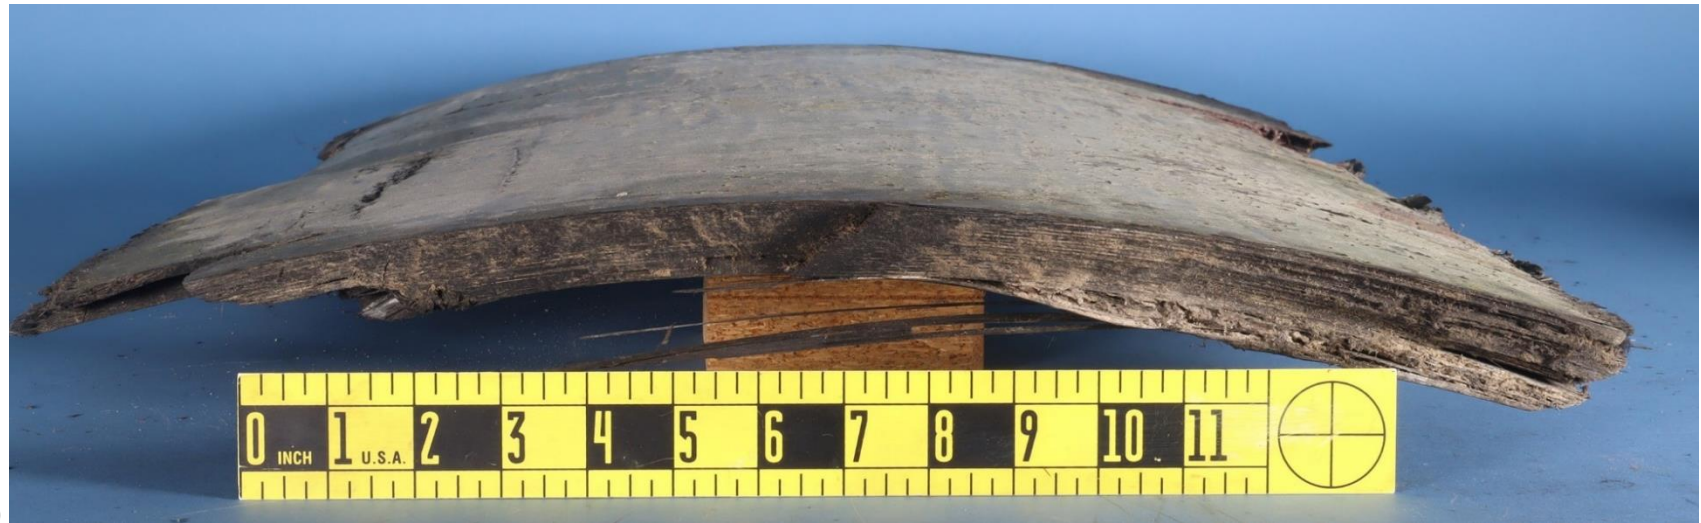
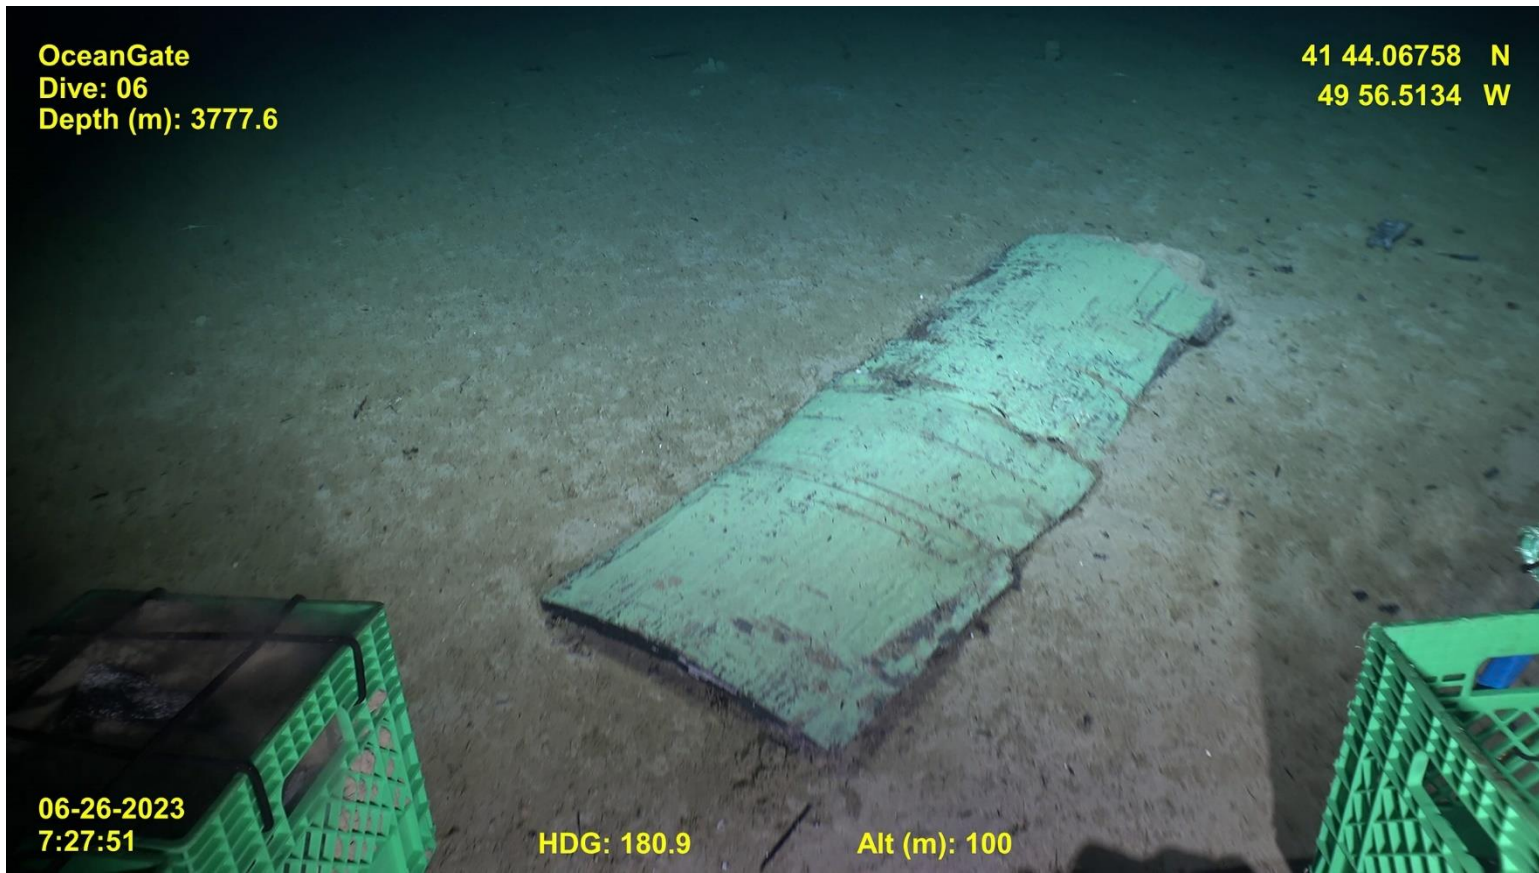
**Figure 1.** Images of recovered carbon fiber composite hull piece: a) Outer surface;

**Figure 1 (cont.).** b) inner surface;

**Figure 1 (cont.).** c) machined end face; d) mid-span fractured face; and

**Figure 1 (cont.).** e) hull piece as found on the ocean floor.

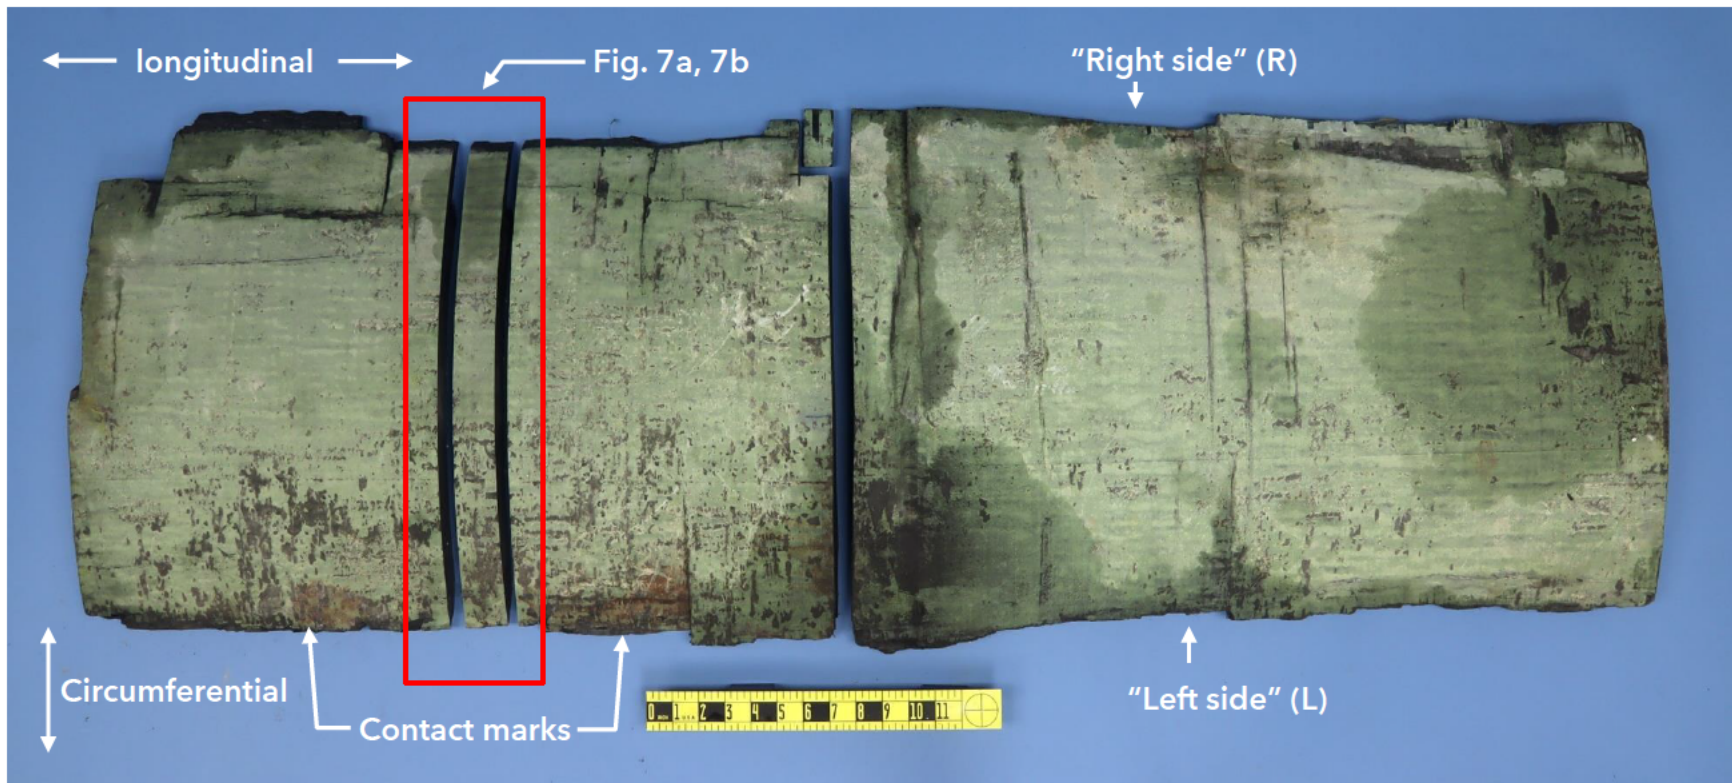
There were two impact / contact marks on the “left” side of the hull piece, as shown in figures 6 and 24a. One mark was approximately 6 inch long and centered 39 inch from the machined end. The second mark was approximately 8 inch long and 49 inch from the end. A piece of metal mesh/rope was wedged in the hull piece at the edge of the 6-inch impact mark as shown in figure 24b. The material was extracted and identified as predominantly lead (Pb) using an SEM equipped with an energy dispersive X-ray spectrometer (EDS), consistent with material from a drop weight.

**Figure 6.** Strip of hull piece cut for closer examination.

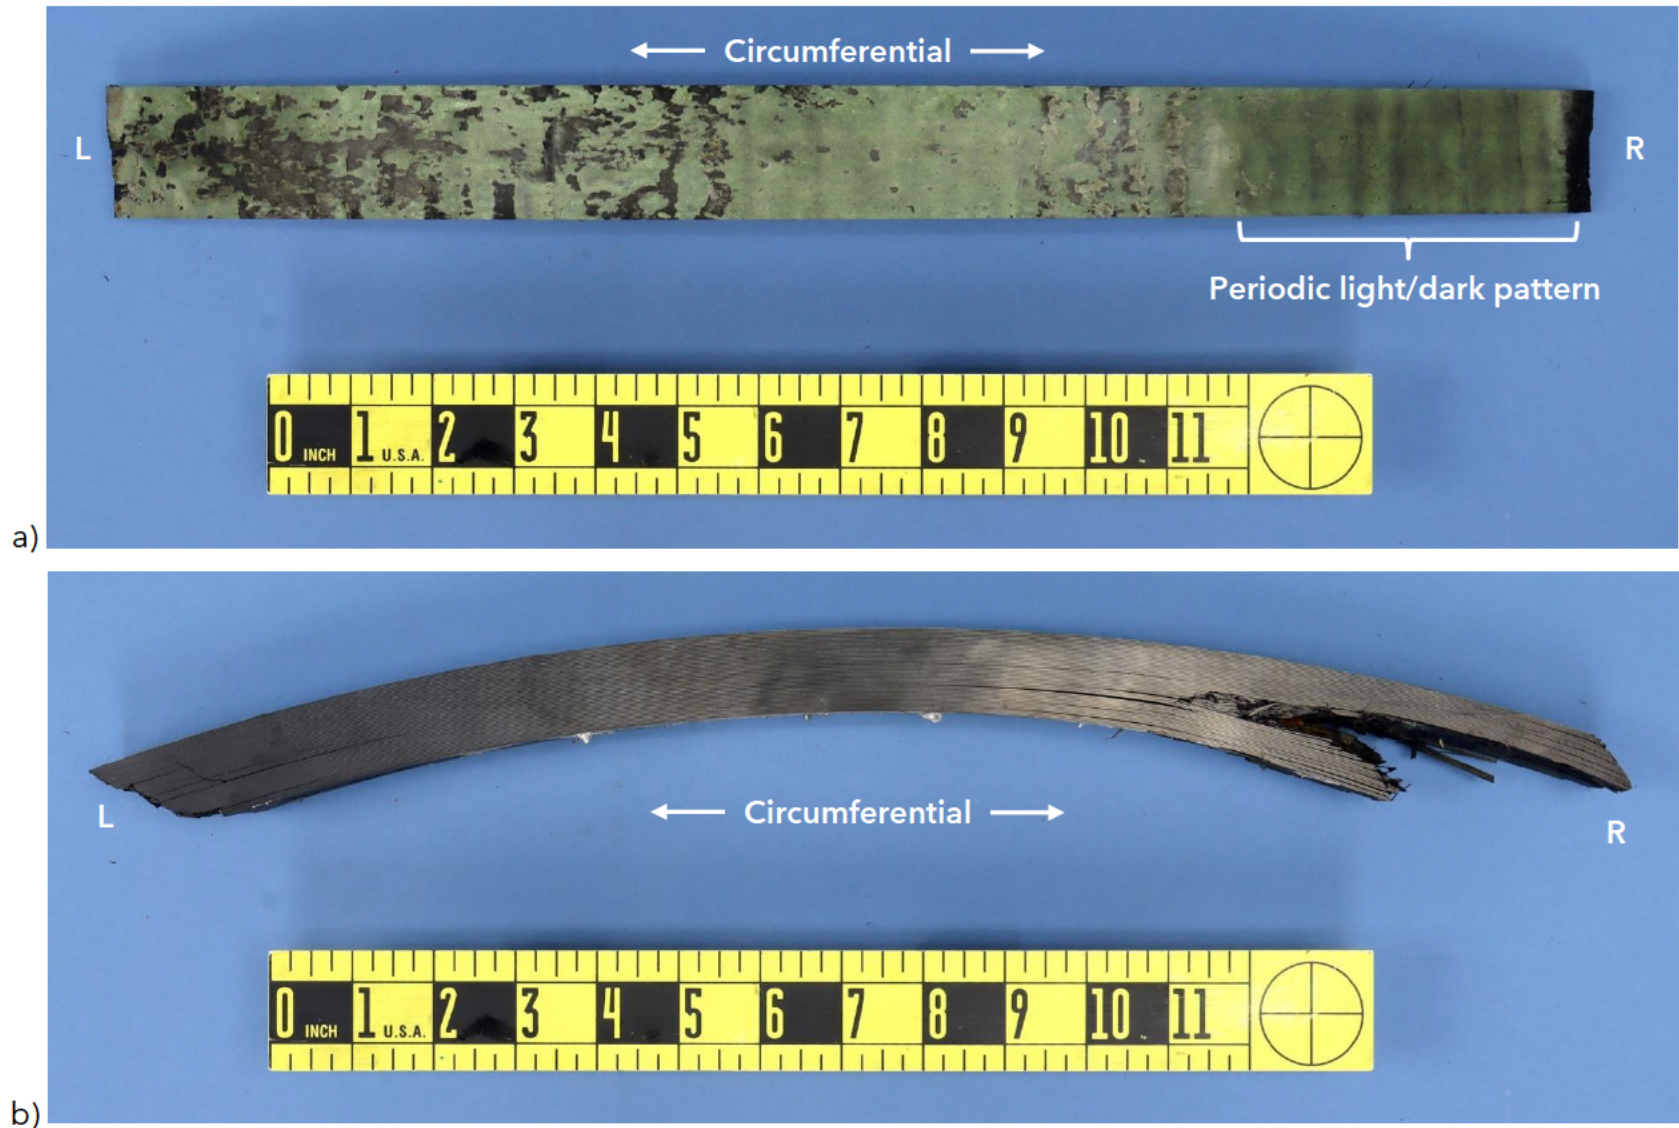
Visual examination of the adhesive surface revealed a periodic light/dark pattern progressing along the circumferential direction, as indicated in figure 7a. As indicated in figures 8a and 8b, the color variation coincided with variations in the adhesive film thickness. The lighter/greener regions coincided with thicker regions of adhesive while the darker regions coincided with thinner regions of adhesive. The variation in adhesive color and thickness was correlated with waviness of the underlying composite layer.

**Figure 7.** Images of hull piece cut for closer examination: a) plan view and b) cross section view.

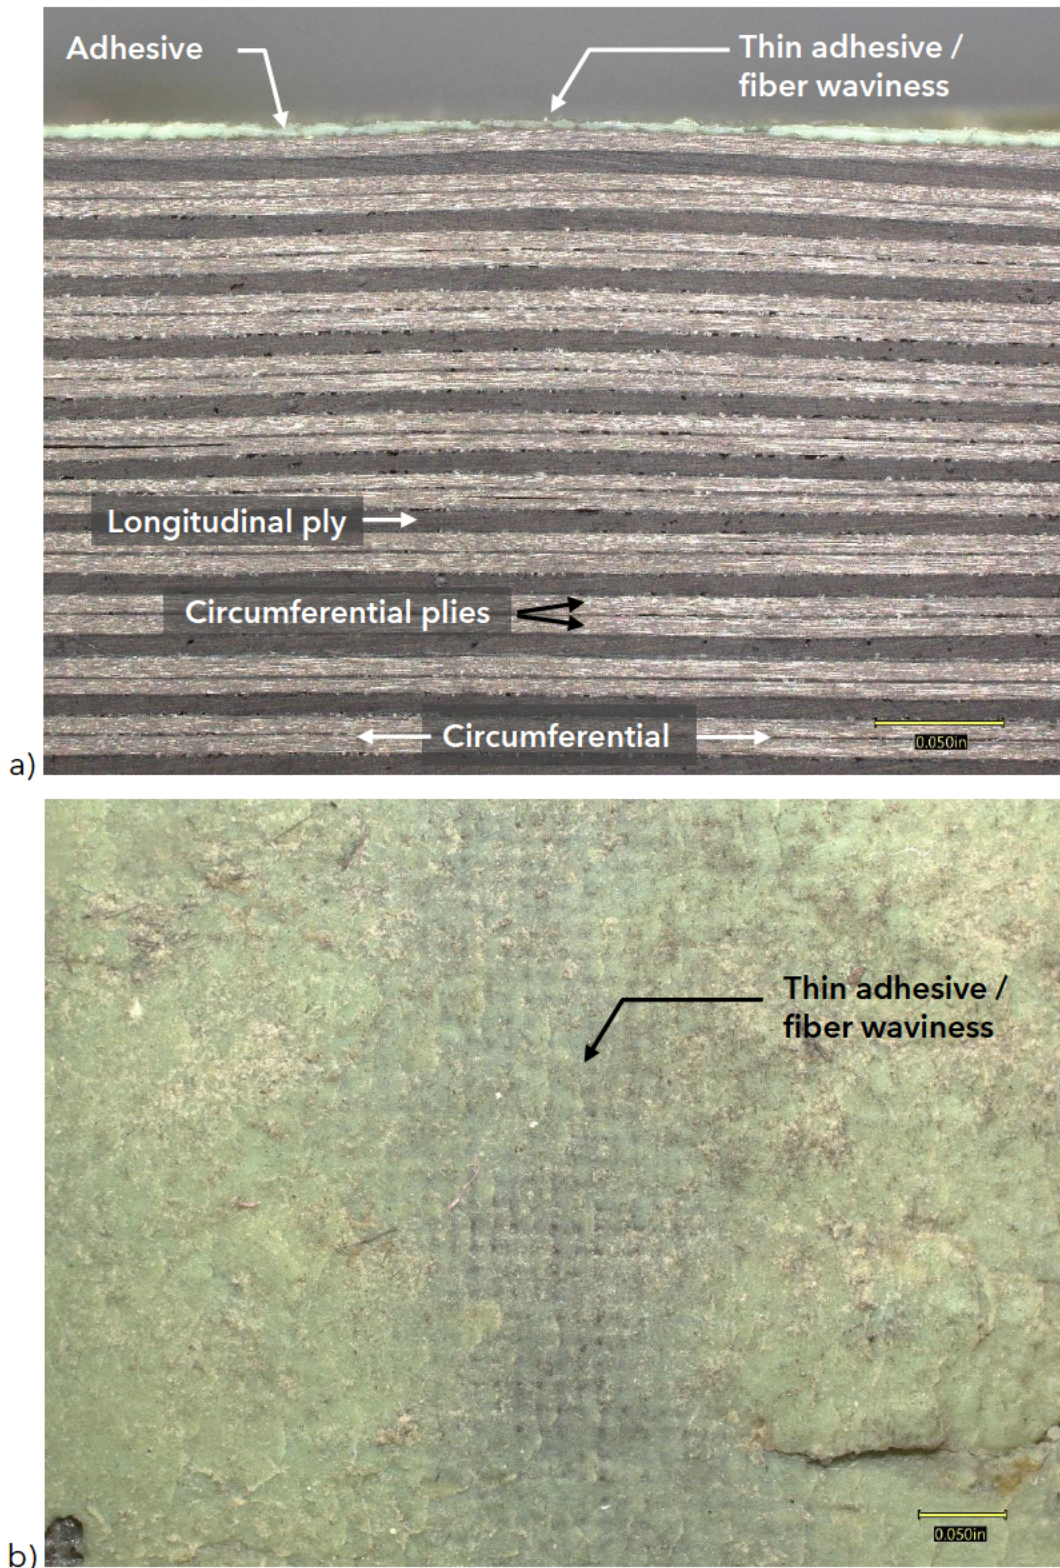
**Figure 8.** a) Cross section image showing waviness of composite plies and variation in adhesive thickness and b) plan view image showing variation in adhesive color.

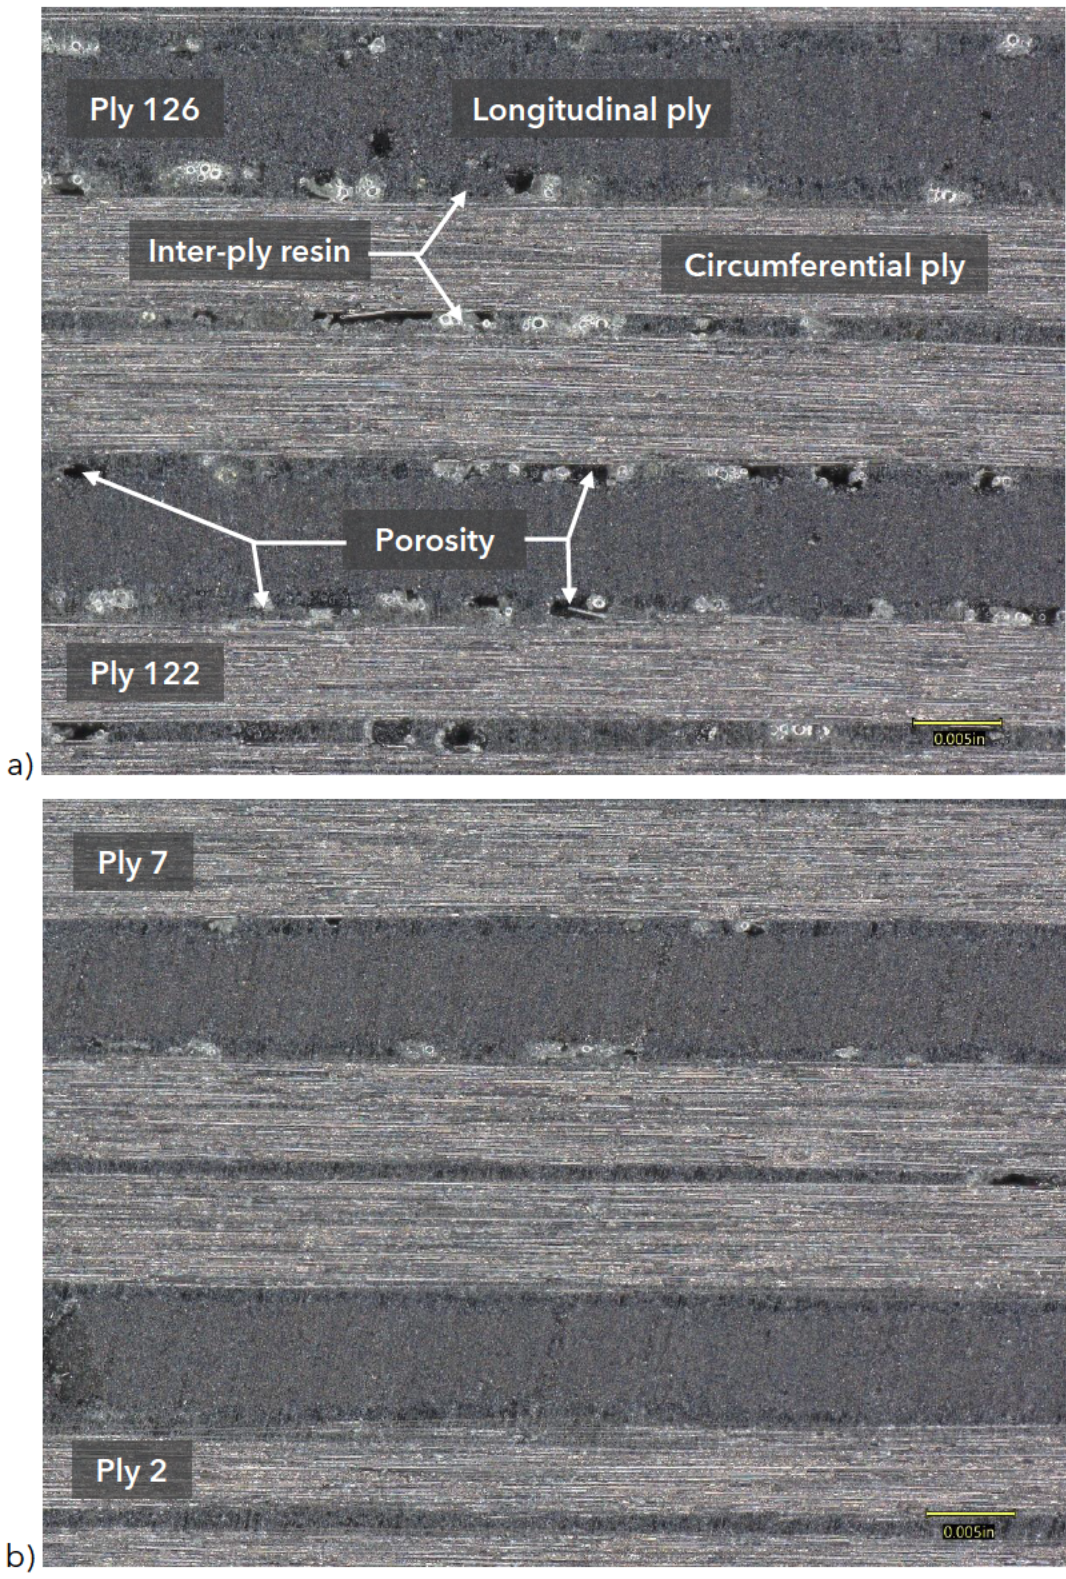
The increase in stack height was due in large part to porosity within the inter-ply resin. Higher magnification images from porous and non-porous regions are shown in figures 11a and b, respectively. Figure 11a shows plies 122 - 126 and figure 11b shows plies 2 - 7. In figure 11a, porosity was visible within the inter-ply resin and the stack height was visibly greater. A tangential cross section through the hull piece was prepared, as shown in figure 12. The cut made a glancing pass through the inter-ply resin in the region shown in figure 13. The area fraction of the porosity was measured for several regions (see for example figures 14a and b) and

**Figure 11.** Higher magnification cross section images showing the variation in porosity in the inter-ply resin layers: a) plies 122 - 126 and b) plies 2 - 7.

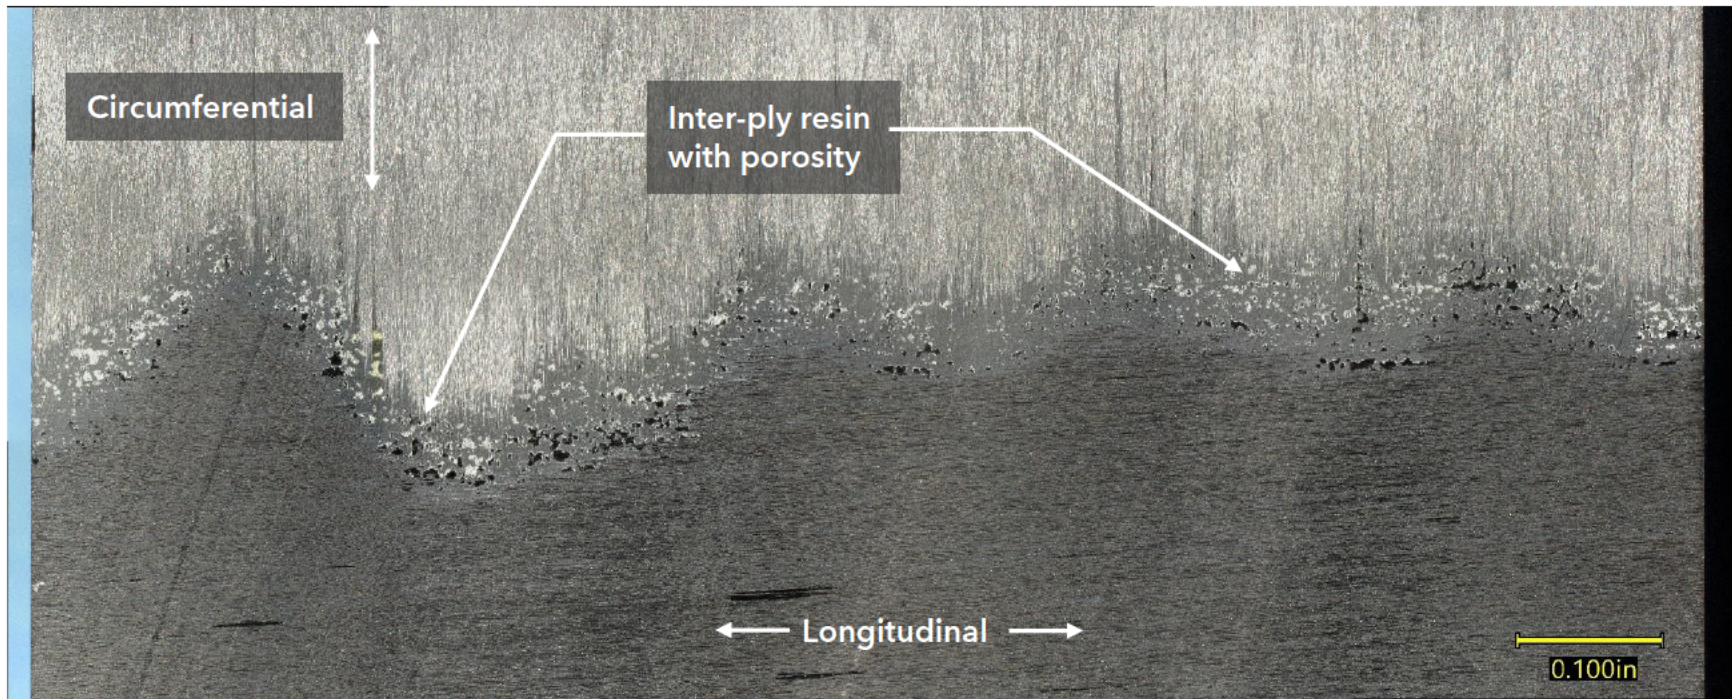
**Figure 13.** Oblique cut through inter-ply resin layer showing porosity within the layer.

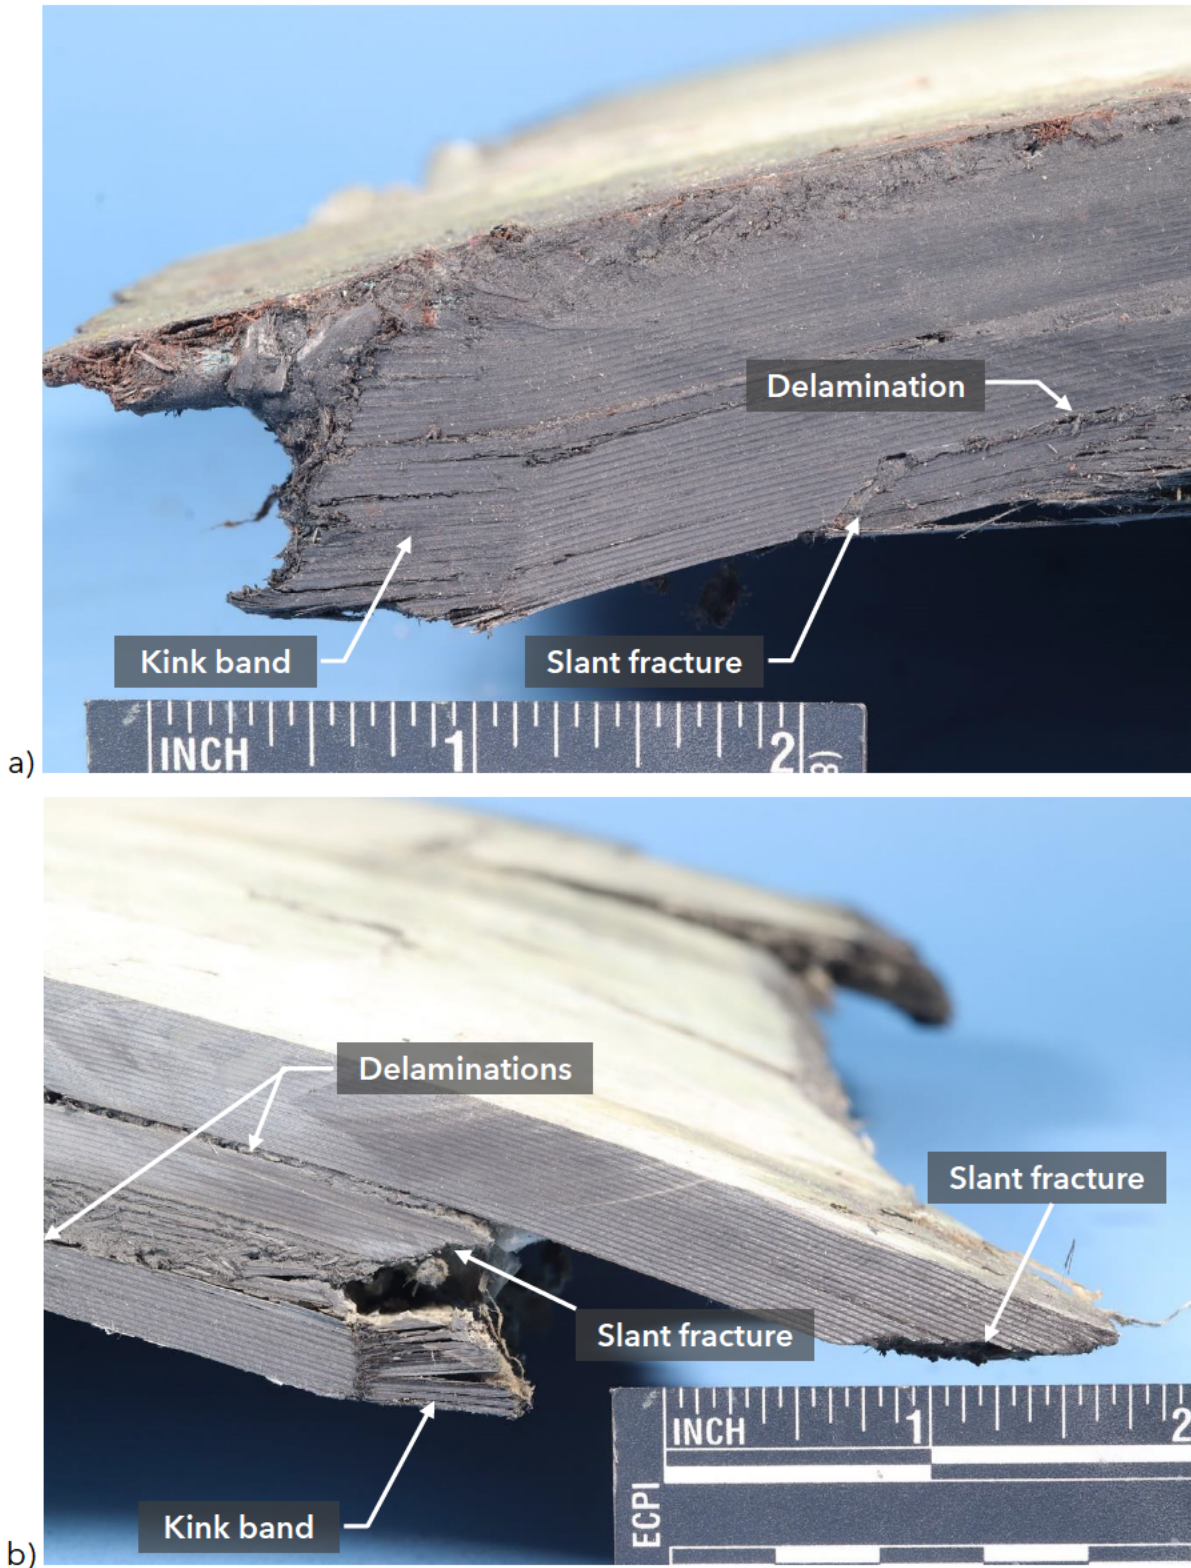
The longitudinal fractures through the hull piece exhibited slant fractures and kink bands, consistent with failure under compression and bending loads. A cross section through the hull piece is shown in figure 16. Close-up images of the left and right fractured sides are shown in figures 17a and b, respectively, as indicated by the red rectangles in figure 16. In figure 17a, a nearly full-thickness kink band was observed, and a slant fracture was observed starting on the inner surface, which transitioned to a circumferential delamination. In figure 17b, a kink band was observed near the inner surface and two slant fractures were observed that transitioned to delaminations, one spanning approximately the outer third of the layer and one in the middle third of the layer.

**Figure 17.** a) Fracture along left side and b) fracture along right side.

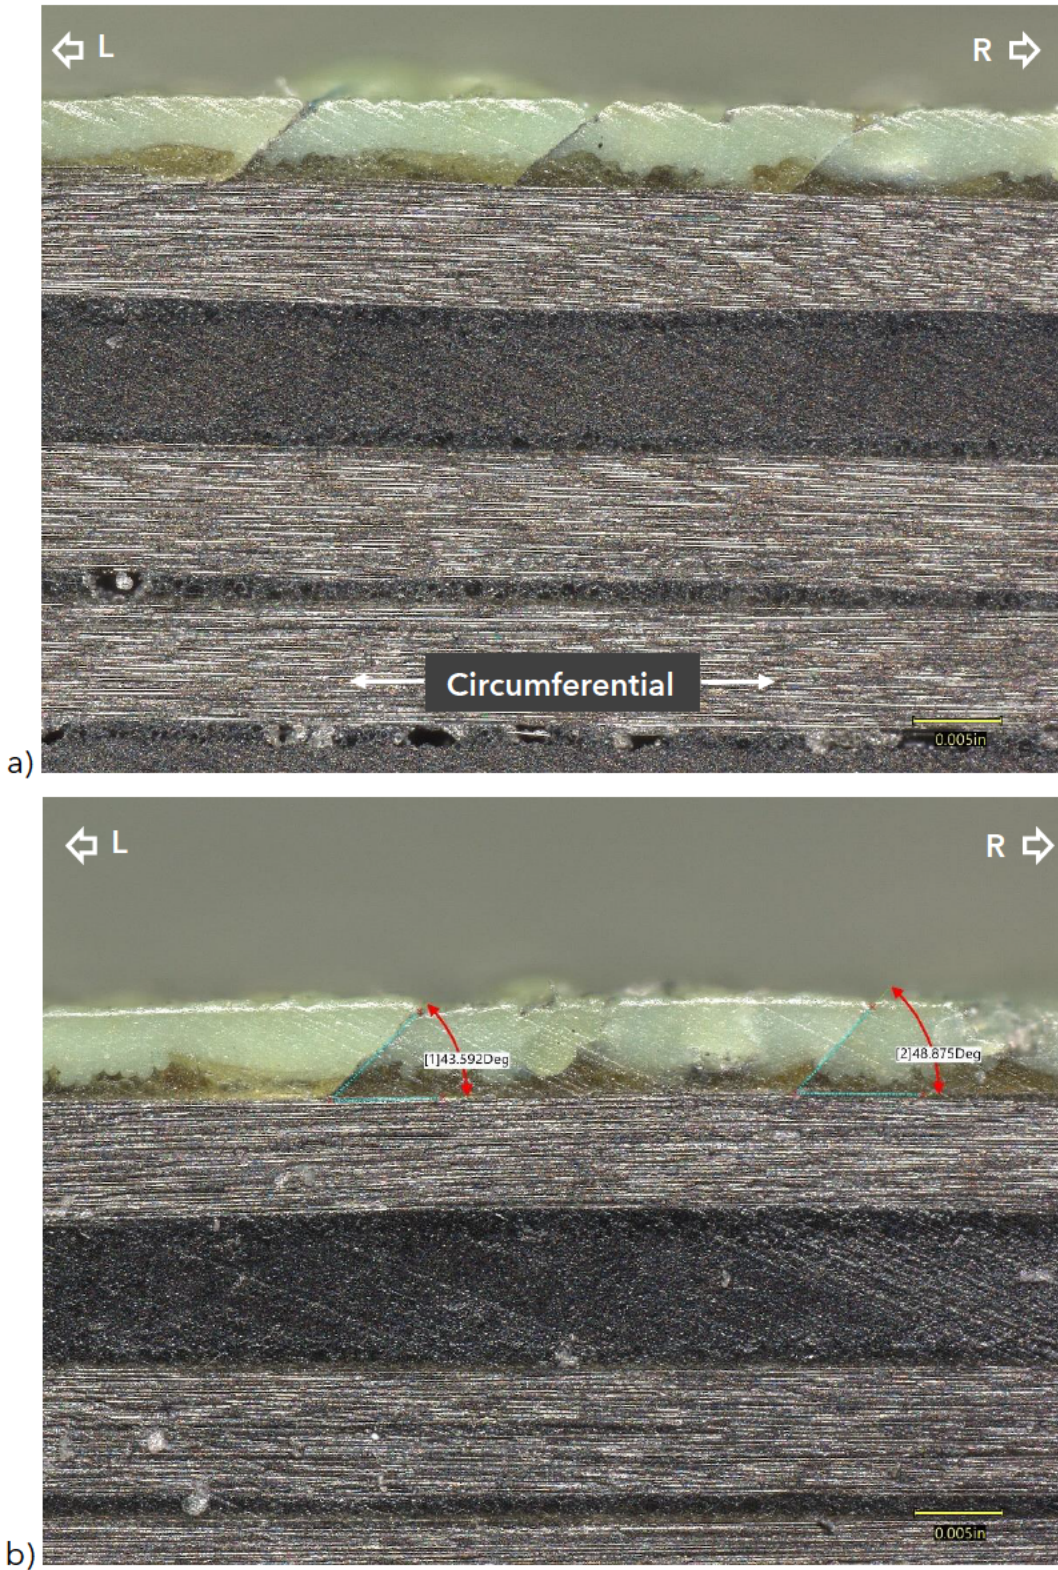
The adhesive surface exhibited features consistent with shear sliding between the first and second layers. Inclined cracks were visible in the adhesive layer on circumferential cross section images (figures 18a and b), but not on longitudinal cross sections. The measured angles of two cracks shown in figure 18b were  $43.6^\circ$  and  $48.9^\circ$ , both close to a  $45^\circ$  inclination angle. Patches of the adhesive had spalled (figures 19a and b). The edges of the spalled regions formed a "C"-shape with the spall progressing from right to left. A region where the top composite ply was exposed is shown in figure 20 on a piece examined using a scanning electron microscope (SEM). Hackles, consistent with shear fracture of the epoxy matrix from right to left, were observed in multiple locations. Taken together the fracture features were consistent with shear sliding between the first and second hull layers, with layer 2 shearing from "right" to "left" with respect to layer 1.

**Figure 18.** a) and b) 45° slant cracks in the adhesive atop layer 1.

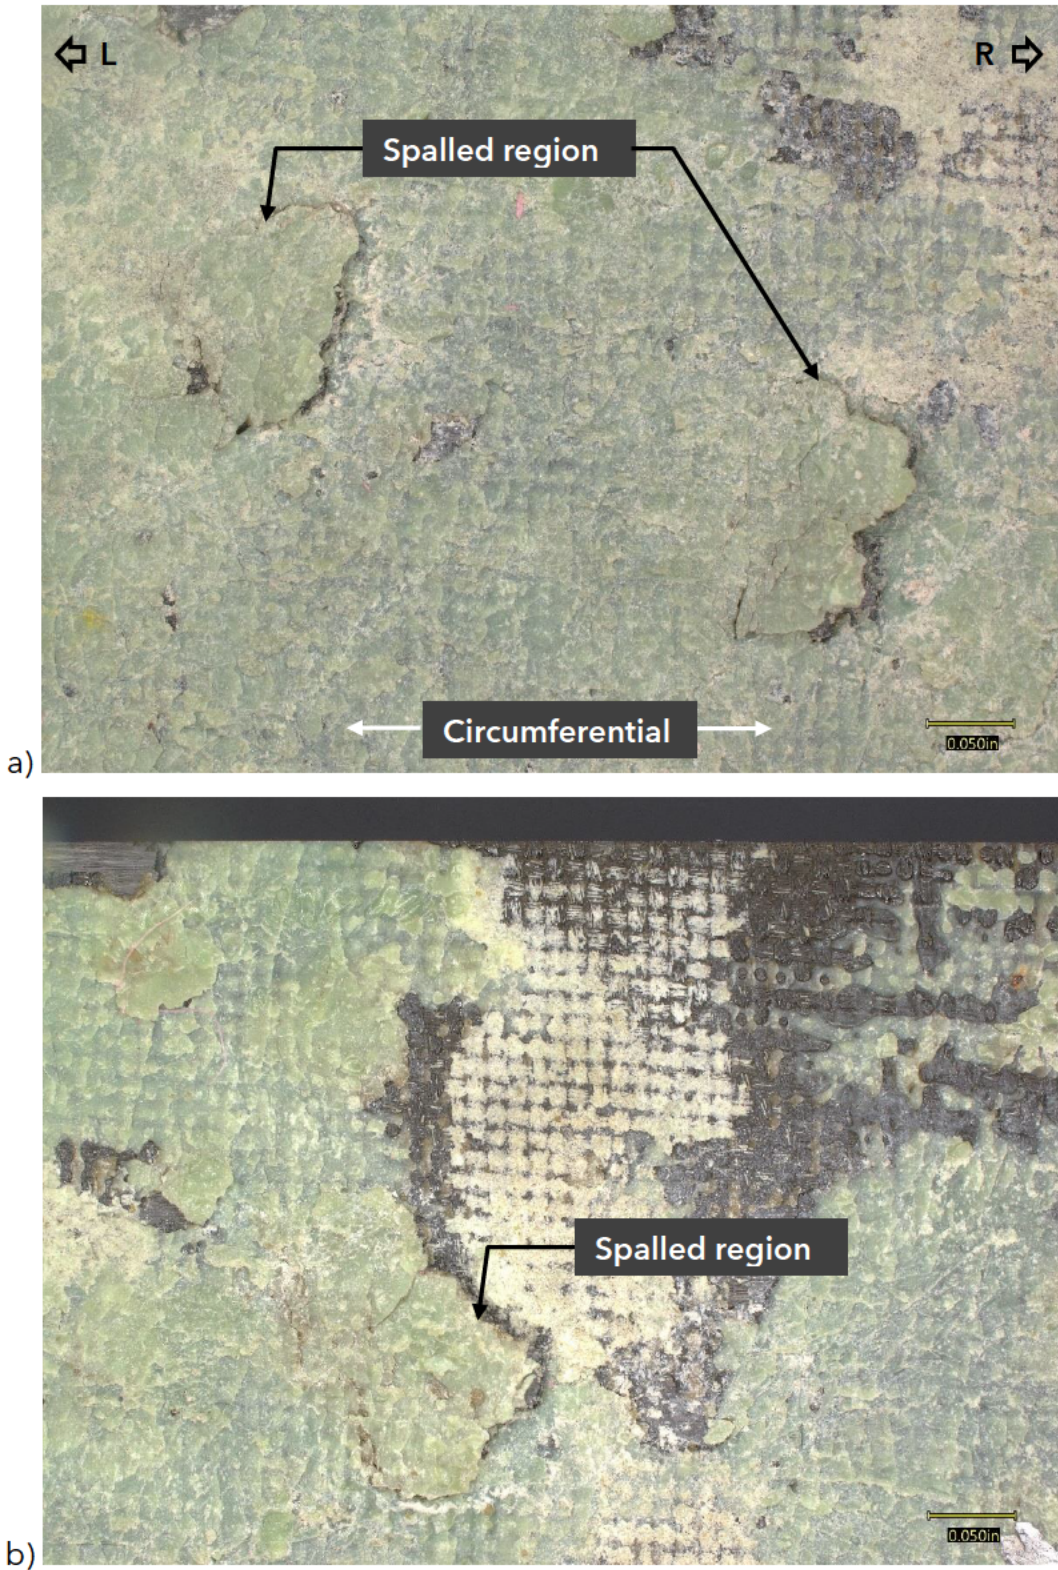
**Figure 19.** a) and b) regions with spalled adhesive layer.

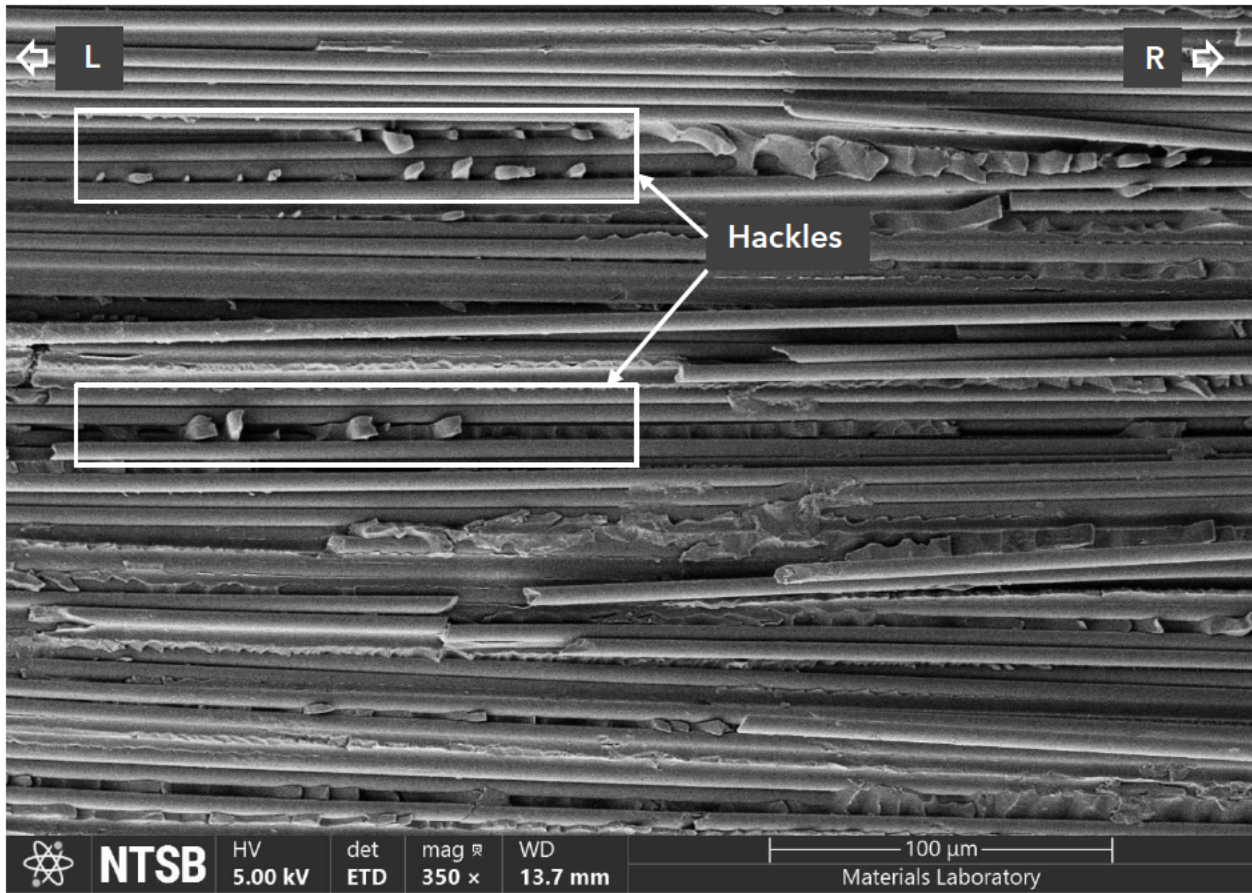
**Figure 20.** Hackle marks in the epoxy matrix consistent with shear separation.

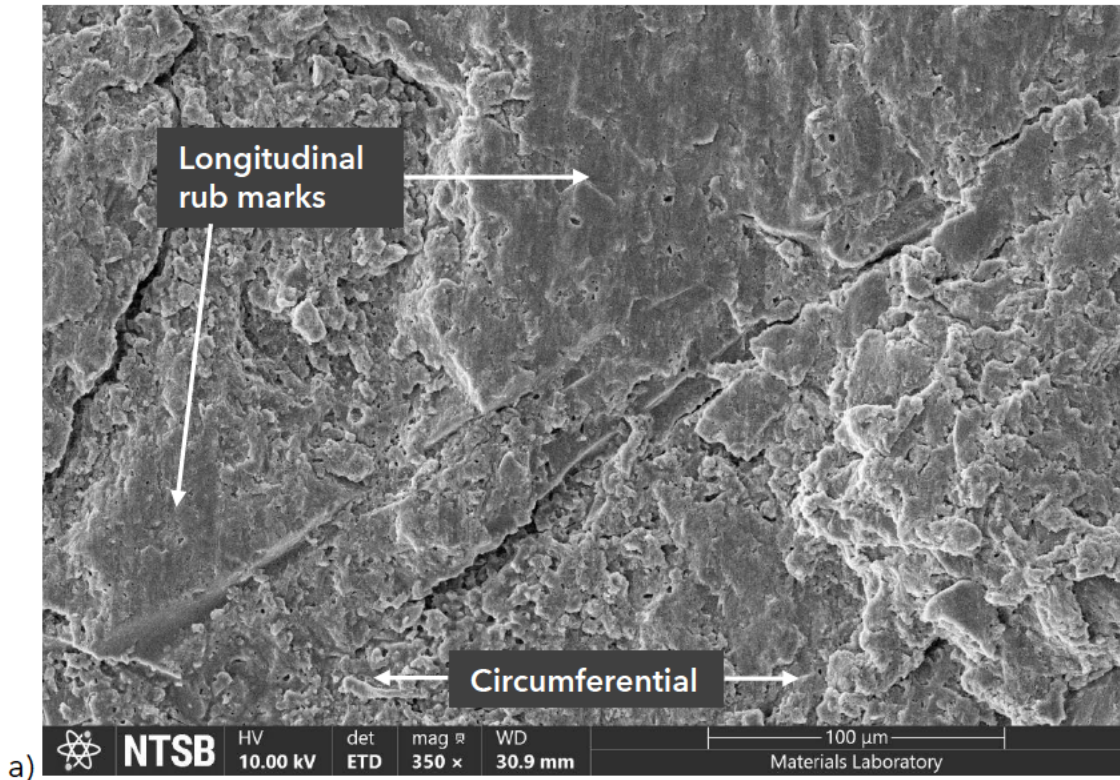
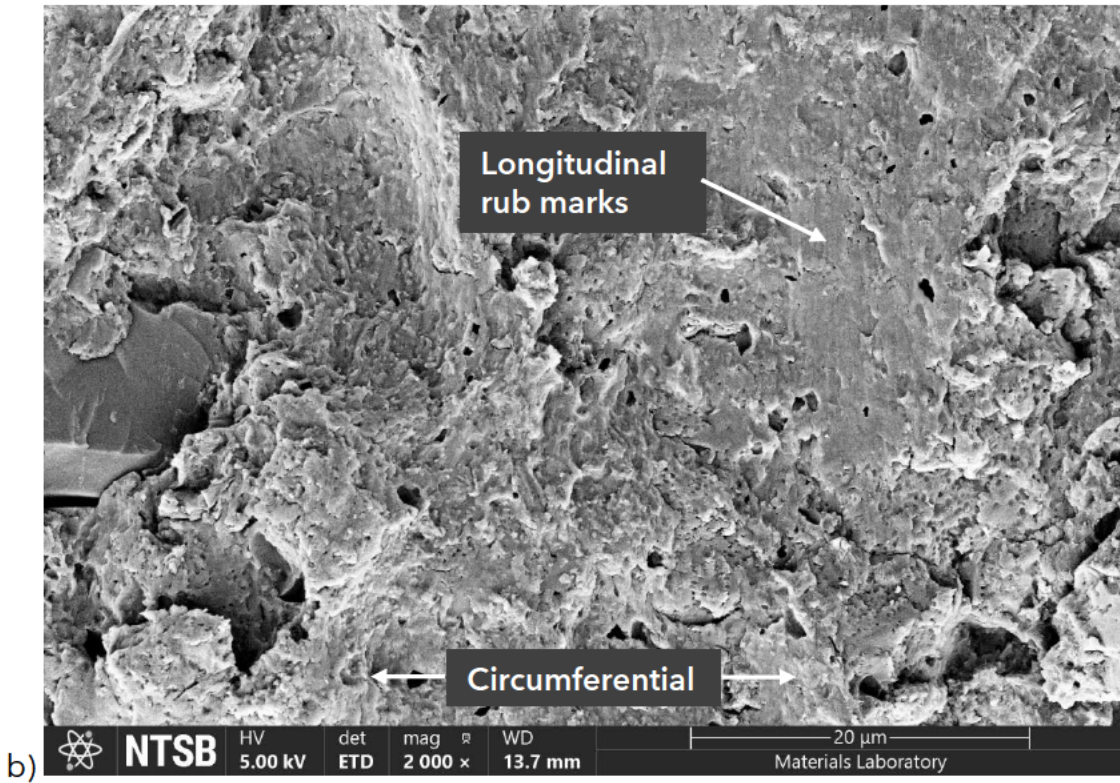
The adhesive surface showed features consistent with rubbing damage. Three SEM images, from the piece shown in the lower image of figure 12, are shown in figures 21a - c. Rub marks were observed in the longitudinal direction in multiple locations. Wear debris had filled some of the adhesive voids, such as the void shown in figure 22a. A scalpel and flux brush were used to remove the debris. The same region post-removal is shown in figure 22b. Some of the debris was collected (figure 23a) and its chemical composition was examined using a Fourier-transform

**Figure 21.** a) and b) longitudinal rub marks on the adhesive surface.
