# National Transportation Safety Board

DCA23FM036

Factual Report 24-011

Location: Atlantic Ocean  
Date: June 18, 2023  
Vehicle: OceanGate Experimental Submersible Titan  
Investigator: Marcel Muise, MS-10

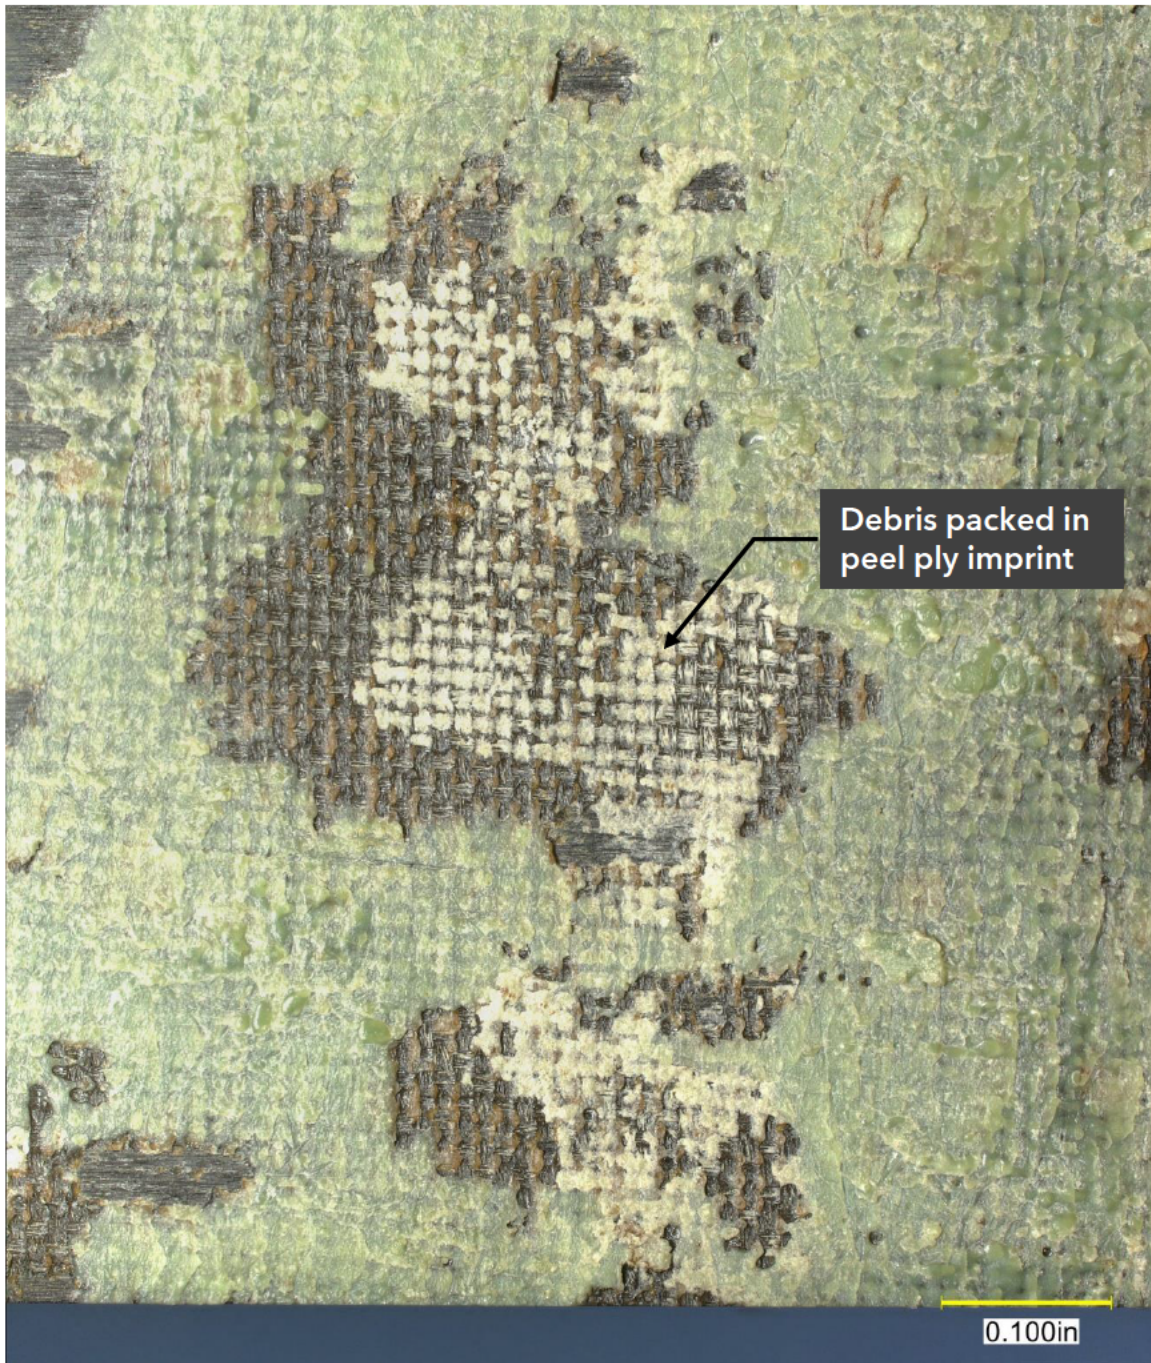
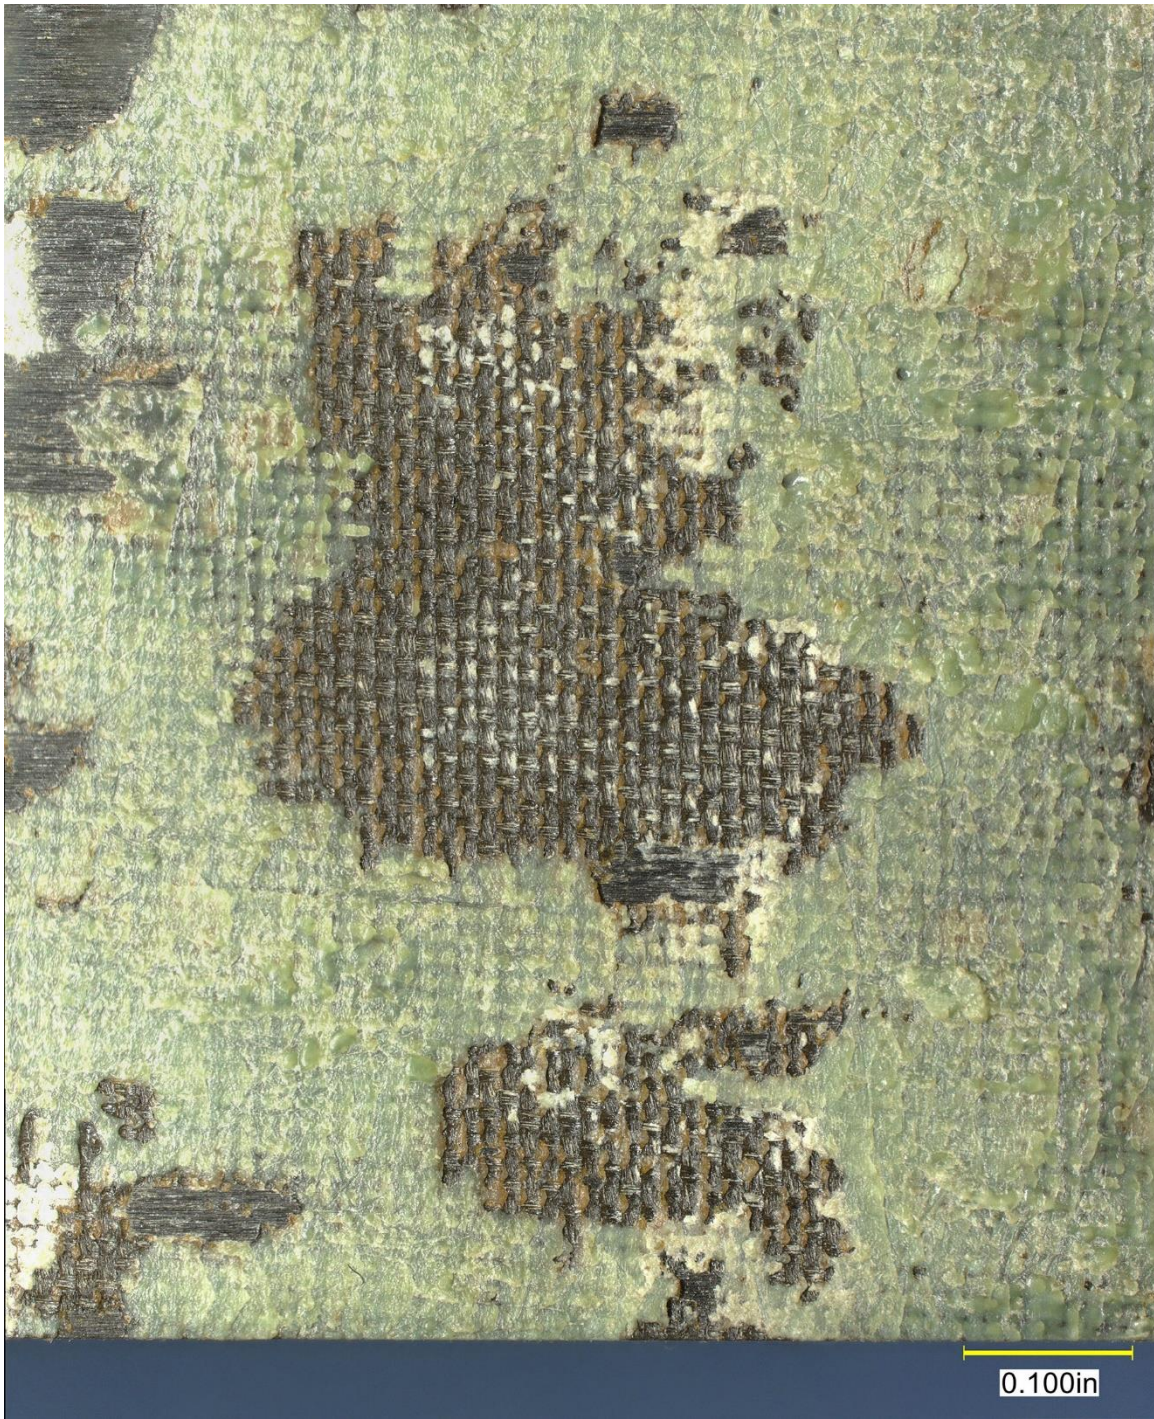
a)  
**Figure 22.** a) Void in adhesive layer prior to cleaning with debris packed into the peel ply imprint and

**Figure 22 (cont.).** b) same void after cleaning and removal of the debris.

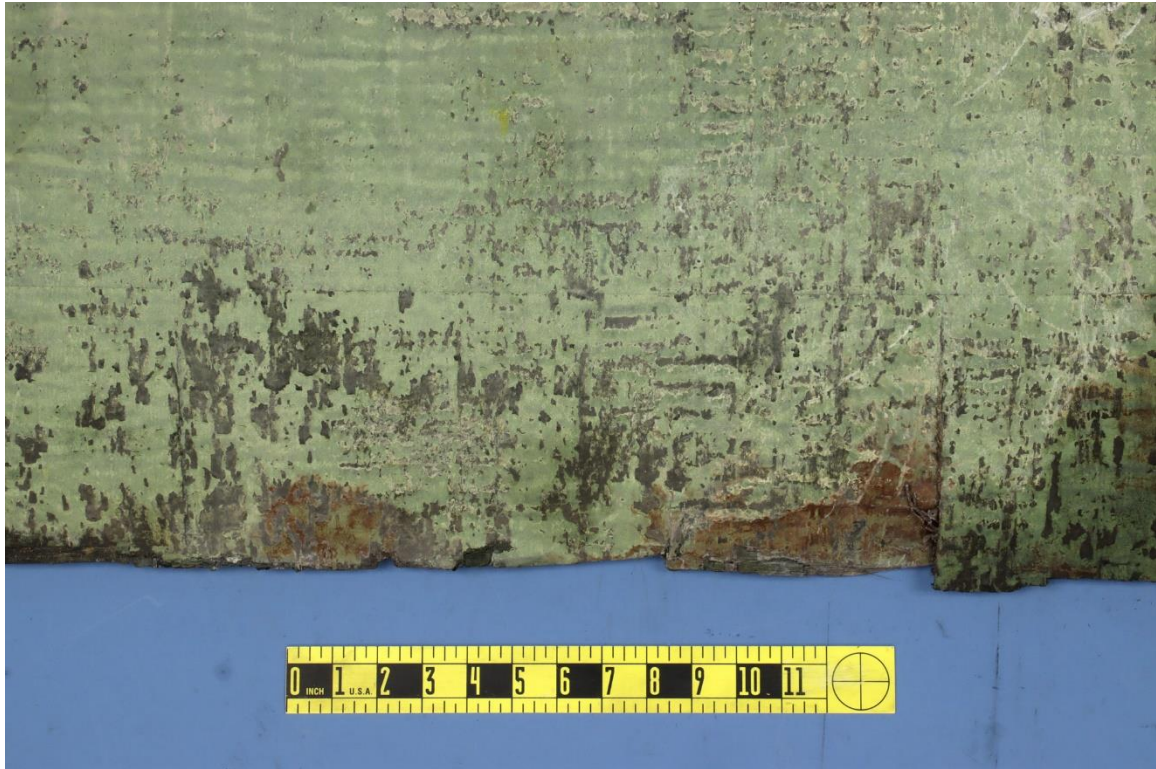
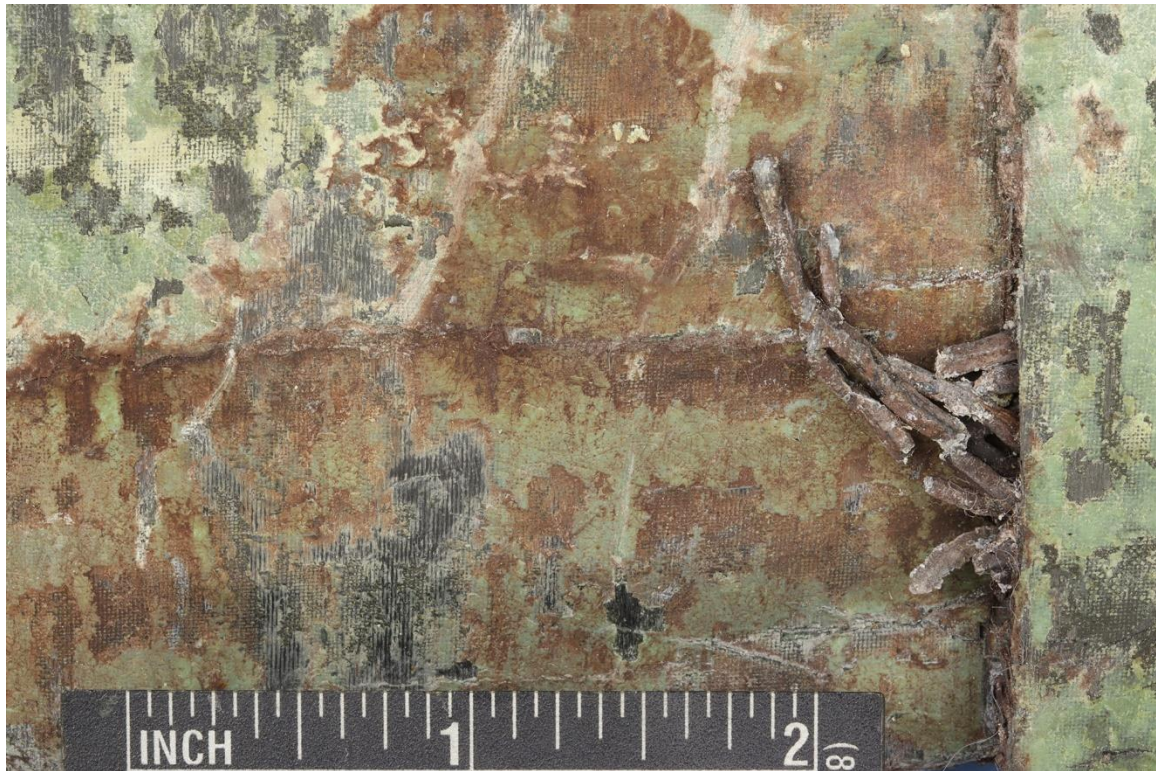
There were two impact / contact marks on the “left” side of the hull piece, as shown in figures 6 and 24a. One mark was approximately 6 inch long and centered 39 inch from the machined end. The second mark was approximately 8 inch long and 49 inch from the end. A piece of metal mesh/rope was wedged in the hull piece at the edge of the 6-inch impact mark as shown in figure 24b. The material was extracted and identified as predominantly lead (Pb) using an SEM equipped with an energy dispersive X-ray spectrometer (EDS), consistent with material from a drop weight.

**Figure 24.** Contact marks on the left side: a) image showing both contact marks and b) higher magnification image of the forward mark showing the embedded object, identified as lead.

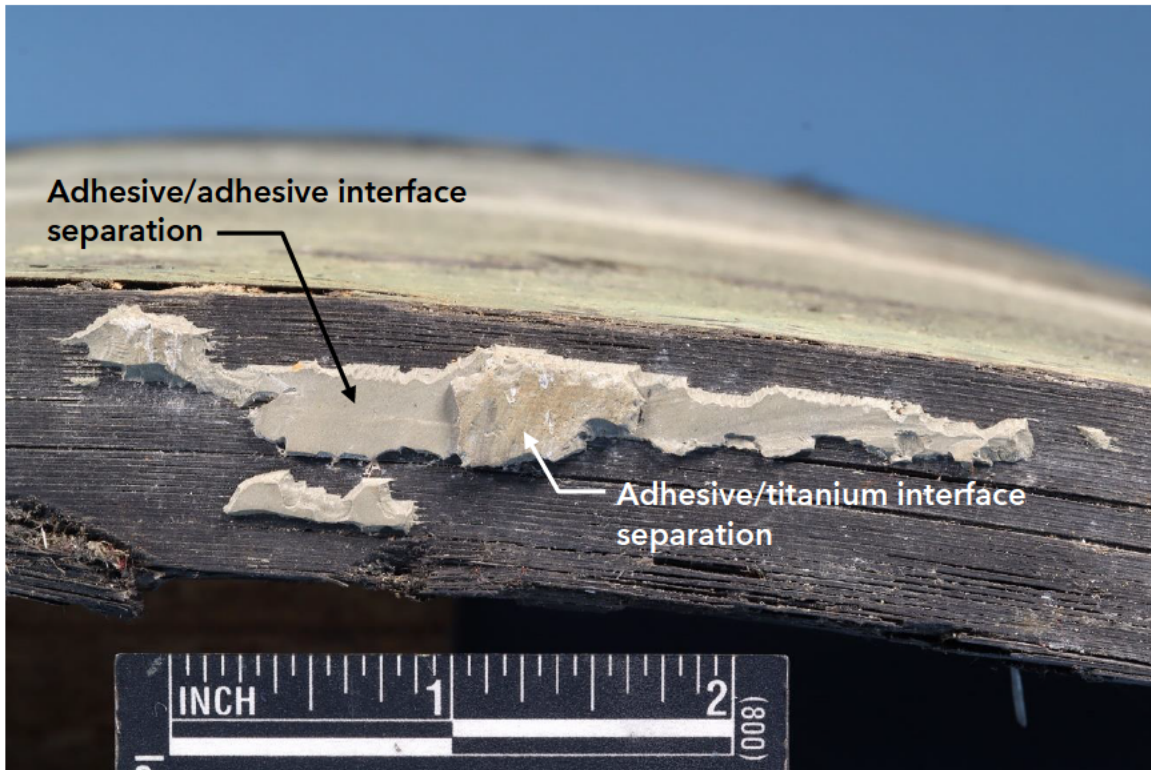
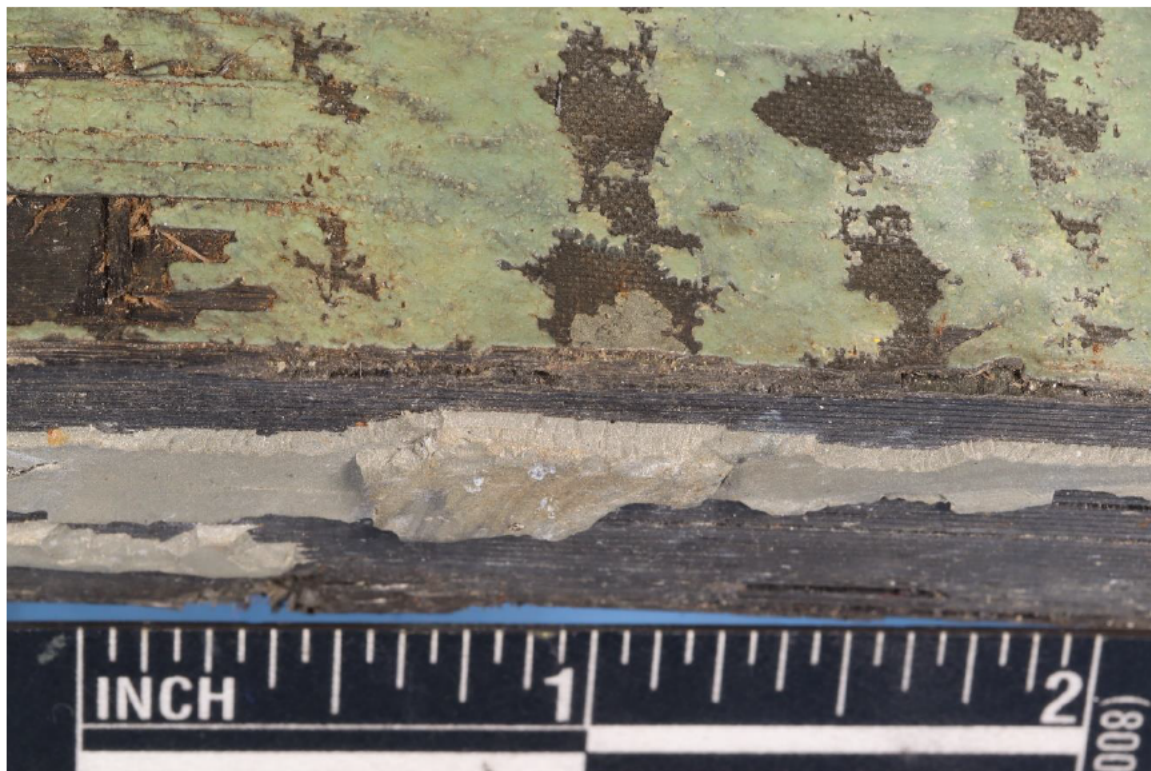
Most of the adhesive originally used to bond the hull to the titanium segment had disbonded from the machined end of the hull piece, but there was an approximately 3.5-inch-long patch where some adhesive bits were still attached, shown in figures 25a and b. Most of the patch was between 0.030 inch and 0.034 inch thick. In a smaller region, the adhesive measured between 0.055 inch and 0.064 inch thick, all measurements performed by caliper. As previously described, the process for bonding the hull to the segments involved applying excess epoxy adhesive to both the end of the carbon fiber hull and the flat face of the titanium segment’s C-channel. The appearance and thickness of the thinner adhesive region was consistent with a separation at the interface between the adhesive applied to the hull and the adhesive applied the titanium. The appearance of the thicker patch was consistent with a separation at the interface between the adhesive and the titanium.

**Figure 25.** a) and b) Images of the machined end of the hull piece showing the size and thickness of the remaining adhesive bits.

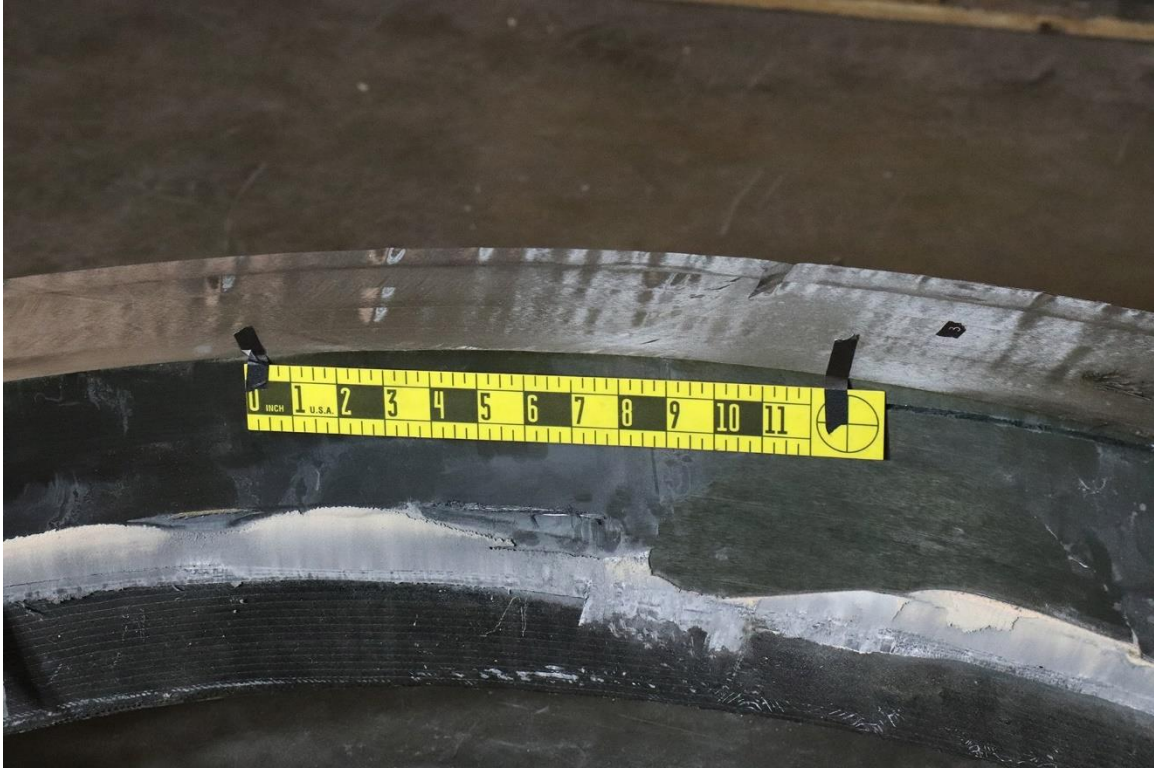
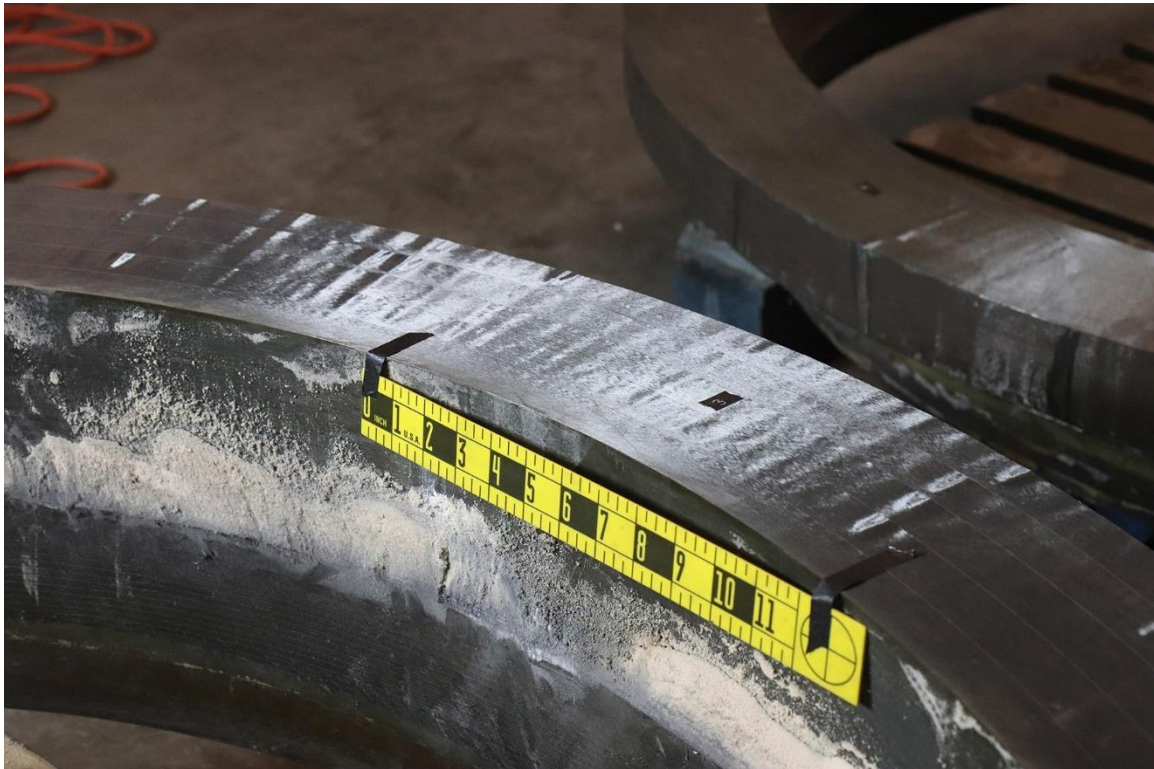
The scrap ends exhibited a notable amount of waviness and wrinkles of the composite plies, particularly for layers 2 through 5. Figures 28a and b show images of the trimmed end faces under oblique lighting conditions for ends 'A' and 'B', respectively. The oblique lighting combined with the variation in fiber ply orientation resulted in light/dark brightness variations across the surface. Waviness features were seen around the entire circumference on both ends. The end faces were examined with a handheld stereo binocular magnifier and anomalies were observed associated with some wrinkles. Voids were observed in the adhesive from fiber bridging / tenting on one or both sides of some smaller amplitude wrinkles (figure 29a). Other wrinkles showed signs of grinding to bring protruding regions flush with the outer surface (figure 29b). Using oblique lighting and the magnifier, end 'B' was examined in its entirety to count the number of fiber bridging / tenting features and grinding features associated with each layer. The results are shown in table 1 and a markup of the trimmed end is shown in figure 30a. In the photo, fiber bridging locations are

**Figure 28.** Images of the trimmed end faces under oblique lighting showing wrinkles and waviness in the carbon fiber orientation. Local variations in fiber orientation result in the observed light/dark brightness variations; a) trimmed end 'A' and b) trimmed end 'B'.

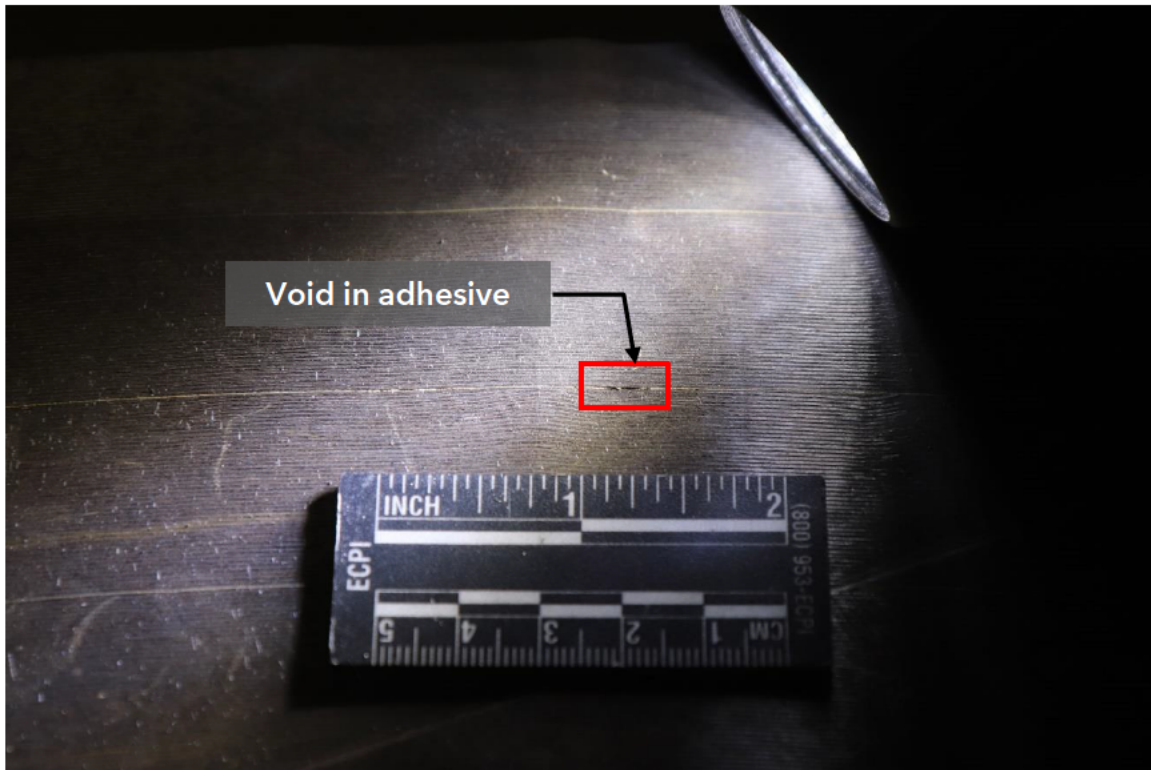
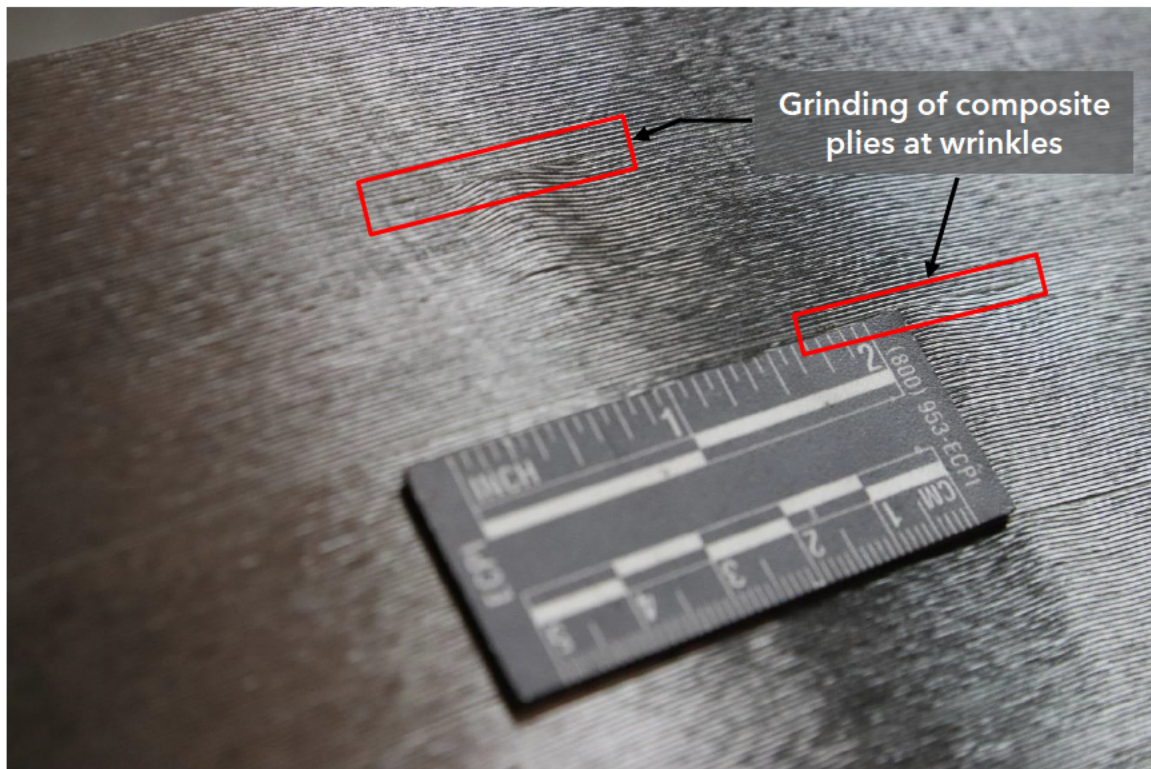
**Figure 29.** a) Image showing a void in the adhesive layer associated with fiber bridging / tenting around a wrinkle and b) image showing grinding of outer carbon fiber plies at a wrinkle.

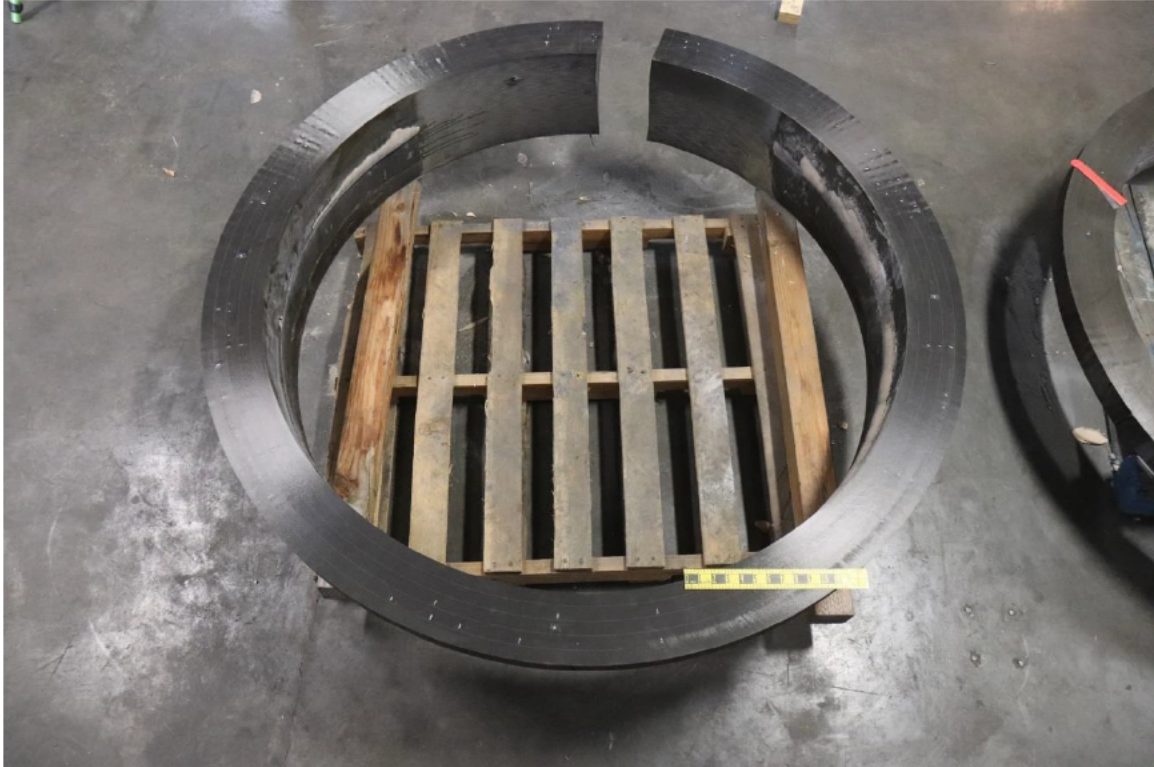
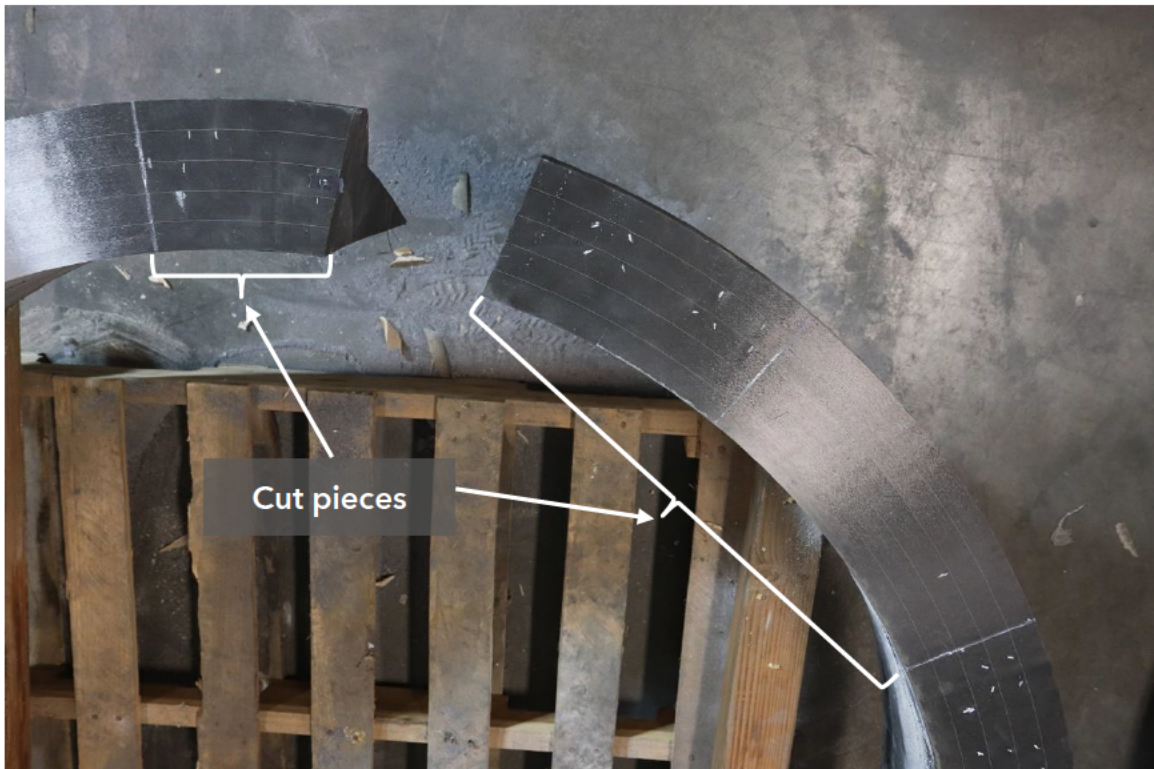
**Figure 30.** Image of end 'B' after grease pen markup: a) overview image showing distribution of fiber bridges with voids (marked with ' / \') and ground wrinkles (marked with '|') and b) closer image showing the location of samples cut for laboratory examination and testing.

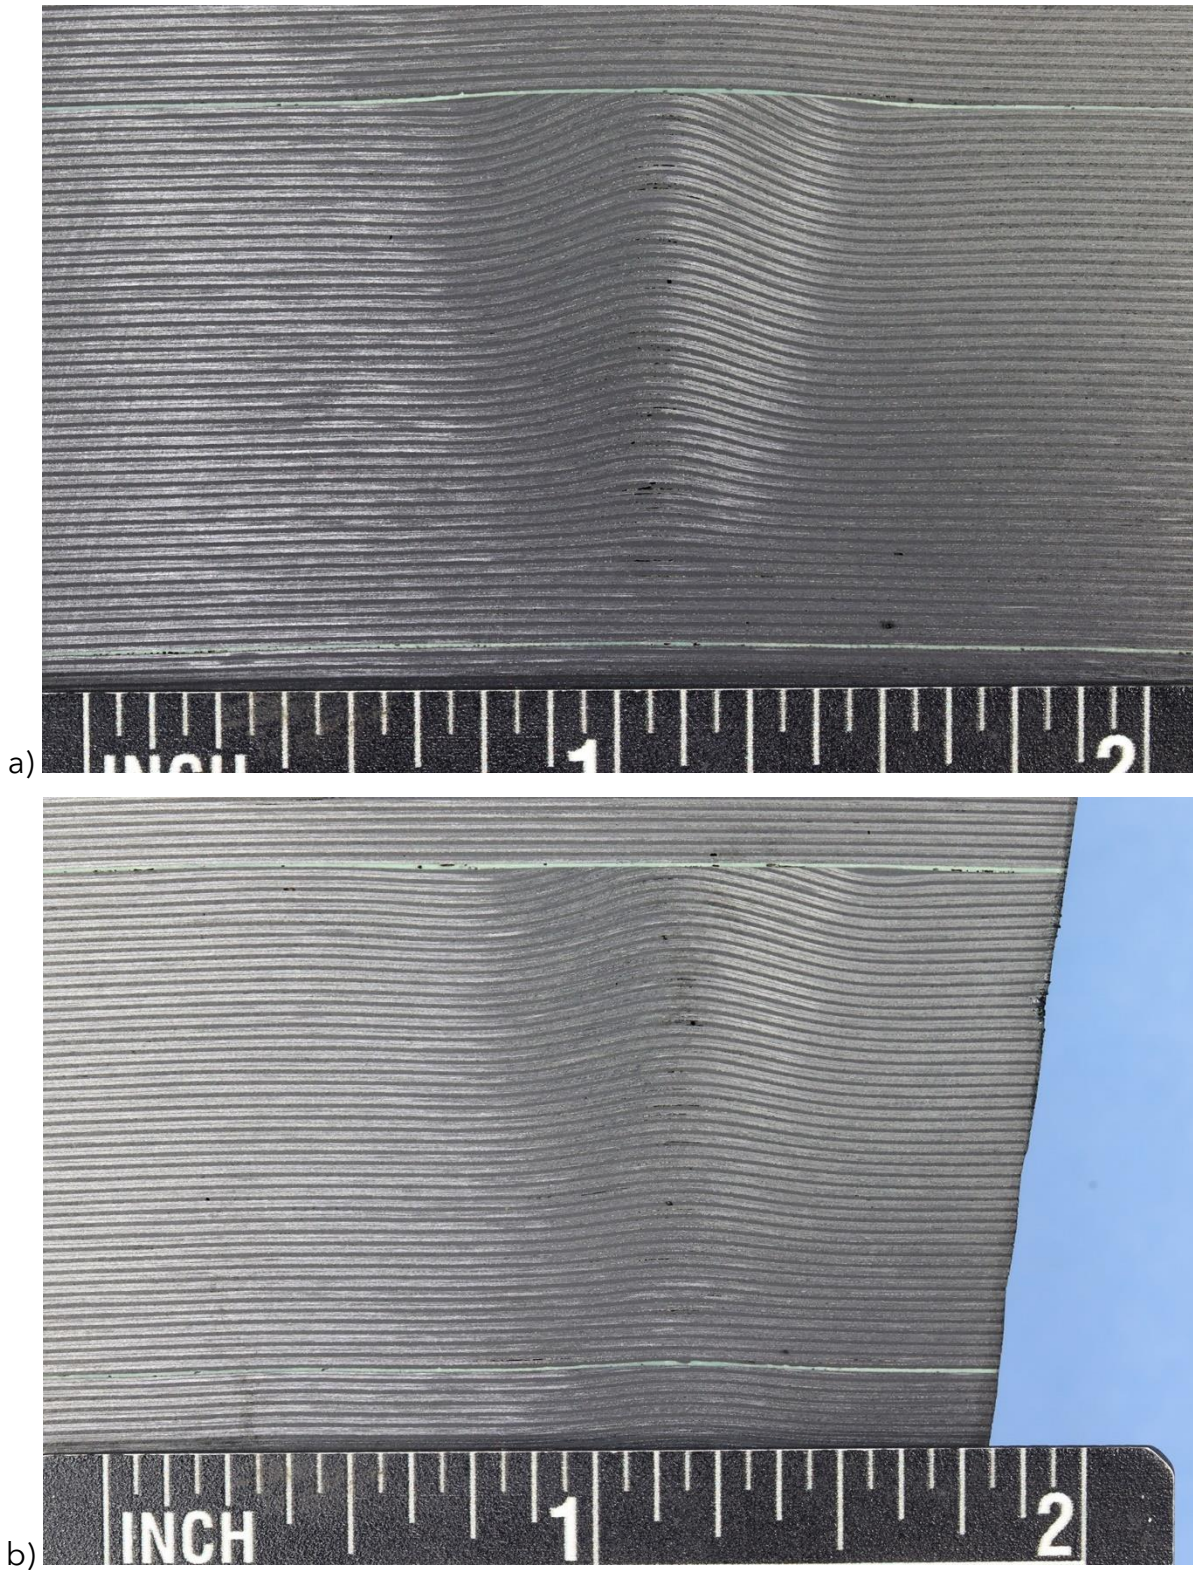
The locations of two notable wrinkle grinding features on the smaller end piece are indicated in figure 31a and shown in greater detail in figures 33a and b. A fiber bridging feature with voids in the adhesive on either side of the incipient wrinkle is indicated in figure 32 and shown in greater detail in figure 34. For the piece in figure 31, a total of 6 grinding features were observed. The number of ground plies for each of the features (from most to least) was 12, 10, 6, 5, 5, and 1.

**Figure 33.** Two images of ground wrinkles on the smaller piece from trimmed end 'B'.

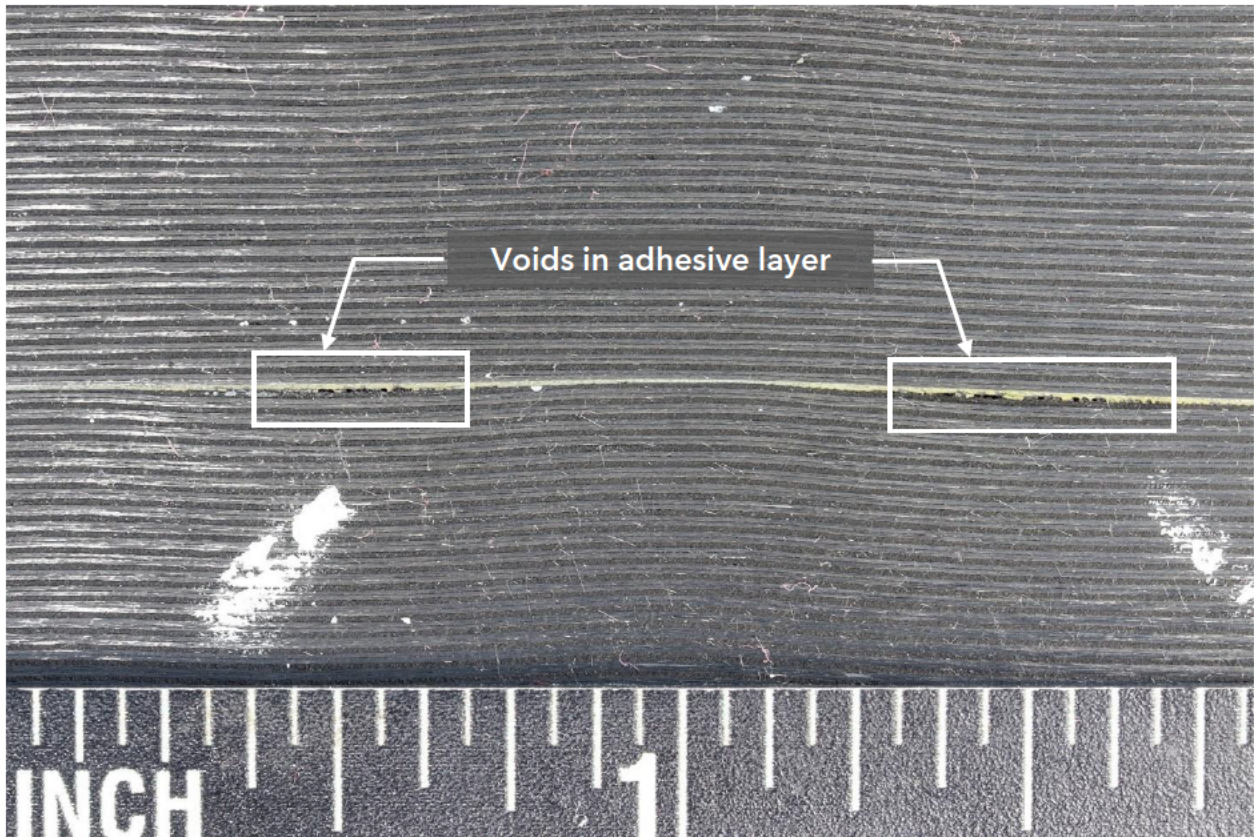
**Figure 34.** Image of the layer 3/4 interface showing voids / porosity on either side of a waviness-induced fiber bridging feature.

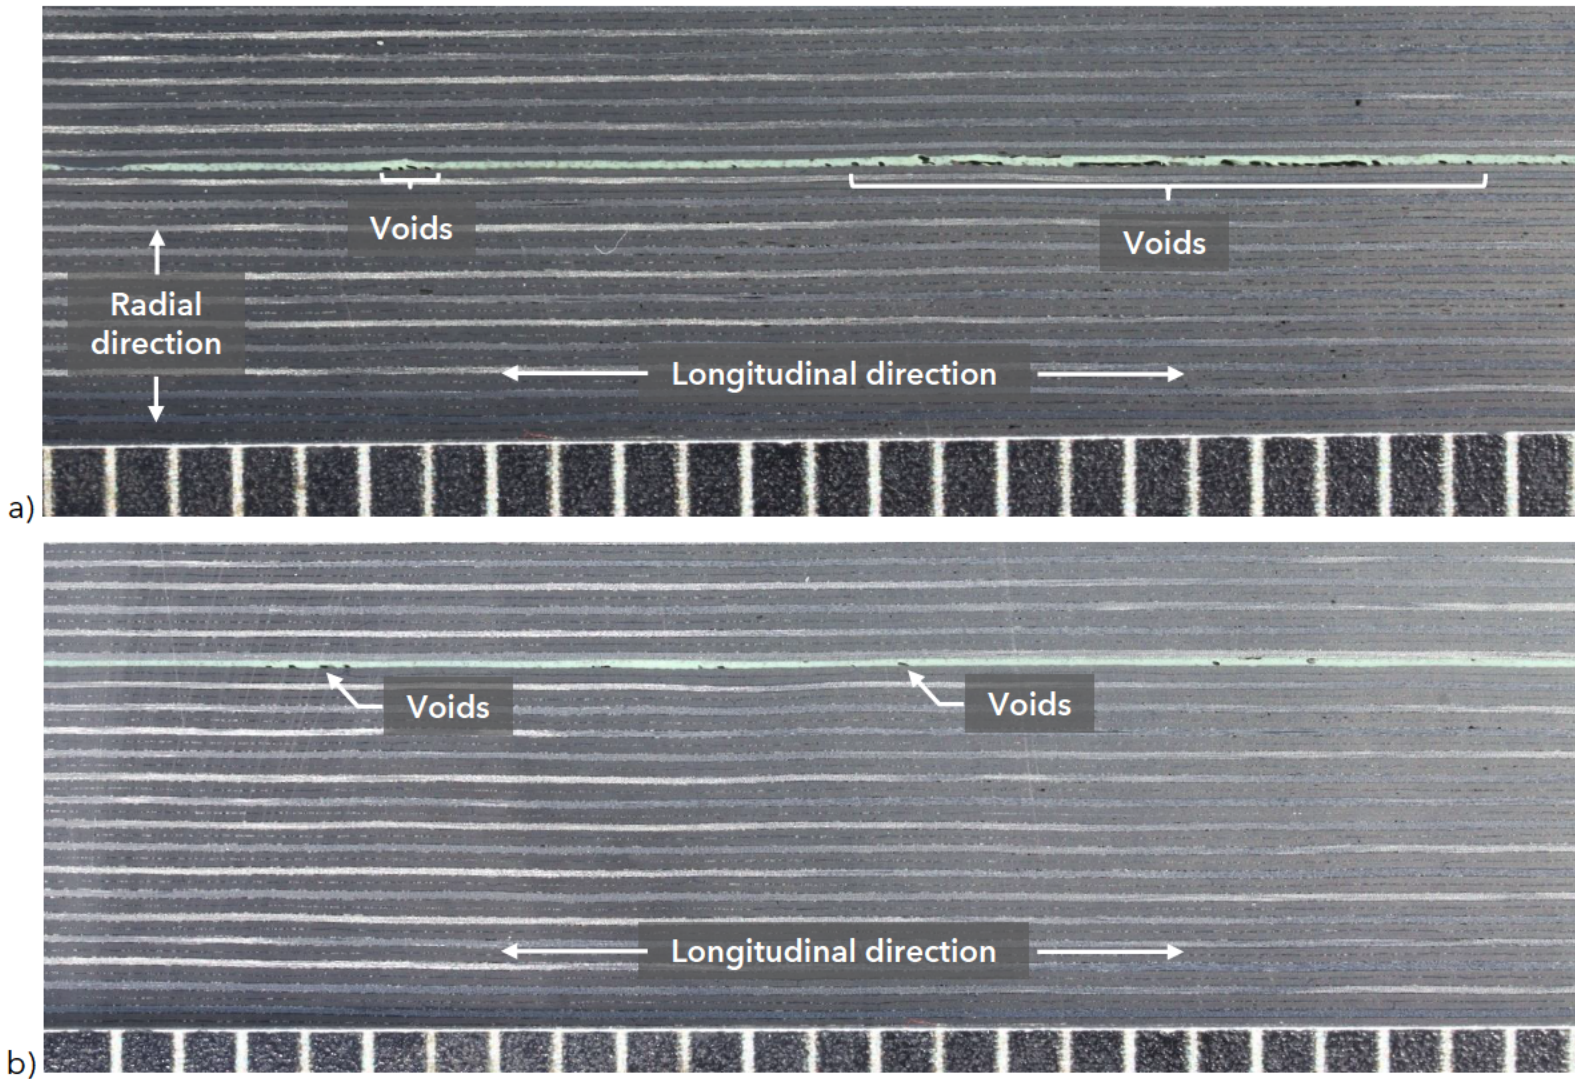
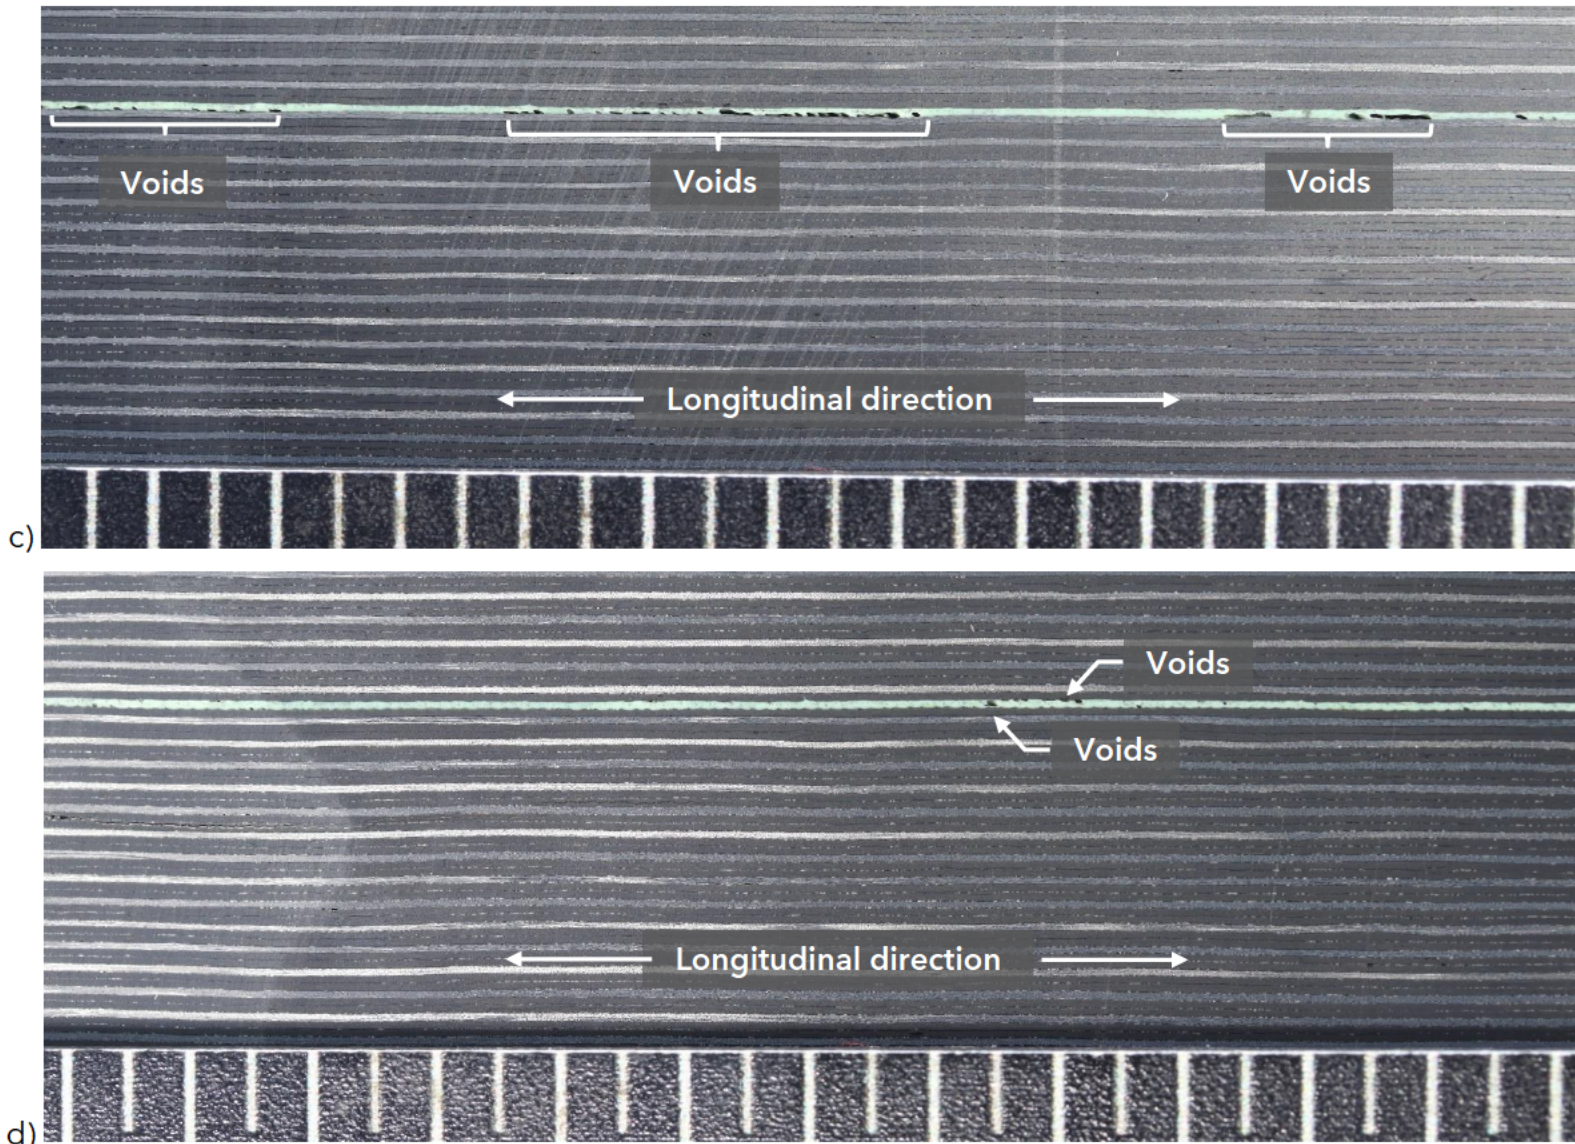
Voids were observed in the adhesive used to join the co-bonded layers. The voids were most prominent on longitudinal cross-sections at the layer 1/2 interface and the layer 3/4 interface. As shown in figures 35a - d, some voids were observed in the adhesive at every co-bonded interface. However, the voids at the layer 2/3 and layer 4/5 interfaces were fewer in number and typically discrete, nominally spherical voids. By contrast, the voids at the layer 1/2 and layer 3/4 interfaces formed elongated features along the interface with the lower layer. For example, one void along the layer 1/2 interface, in figure 35a, was approximately 0.6 inch long and one void along the layer 3/4 interface was approximately 0.4 inch long. These larger voids constituted a gap between the adhesive and the supporting layer beneath it. Figure 36 shows a higher magnification image at another spot along the layer 3/4 interface where gaps between the top of layer 3 and the adhesive were present. Figure 37 shows the results of a lab fracture of a strip of hull material at the layer 1/2 interface. The upper image shows a cross-section view, similar to those shown in figures 35 and 36. The lower image shows a plan view of the fractured strip. In areas where the adhesive joint was sound, either the adhesive fractured in a cohesive manner, or an adjoining composite ply fractured. The regions that contained voids showed the peel ply imprint pattern in resin, left over from curing layer 1, as indicated in the lower image of figure 37. The feature was identical to that seen periodically on the layer 1 piece from the accident hull, shown previously in figures 6 and 22 and discussed in Section 2.0.

**Figure 35.** Adhesive layers between co-bonded carbon fiber composite layers, viewed on longitudinal cross sections: a) joint between layers 1 and 2; b) joint between layers 2 and 3;

**Figure 35 (cont.).** c) joint between layers 3 and 4; and d) joint between layers 4 and 5.

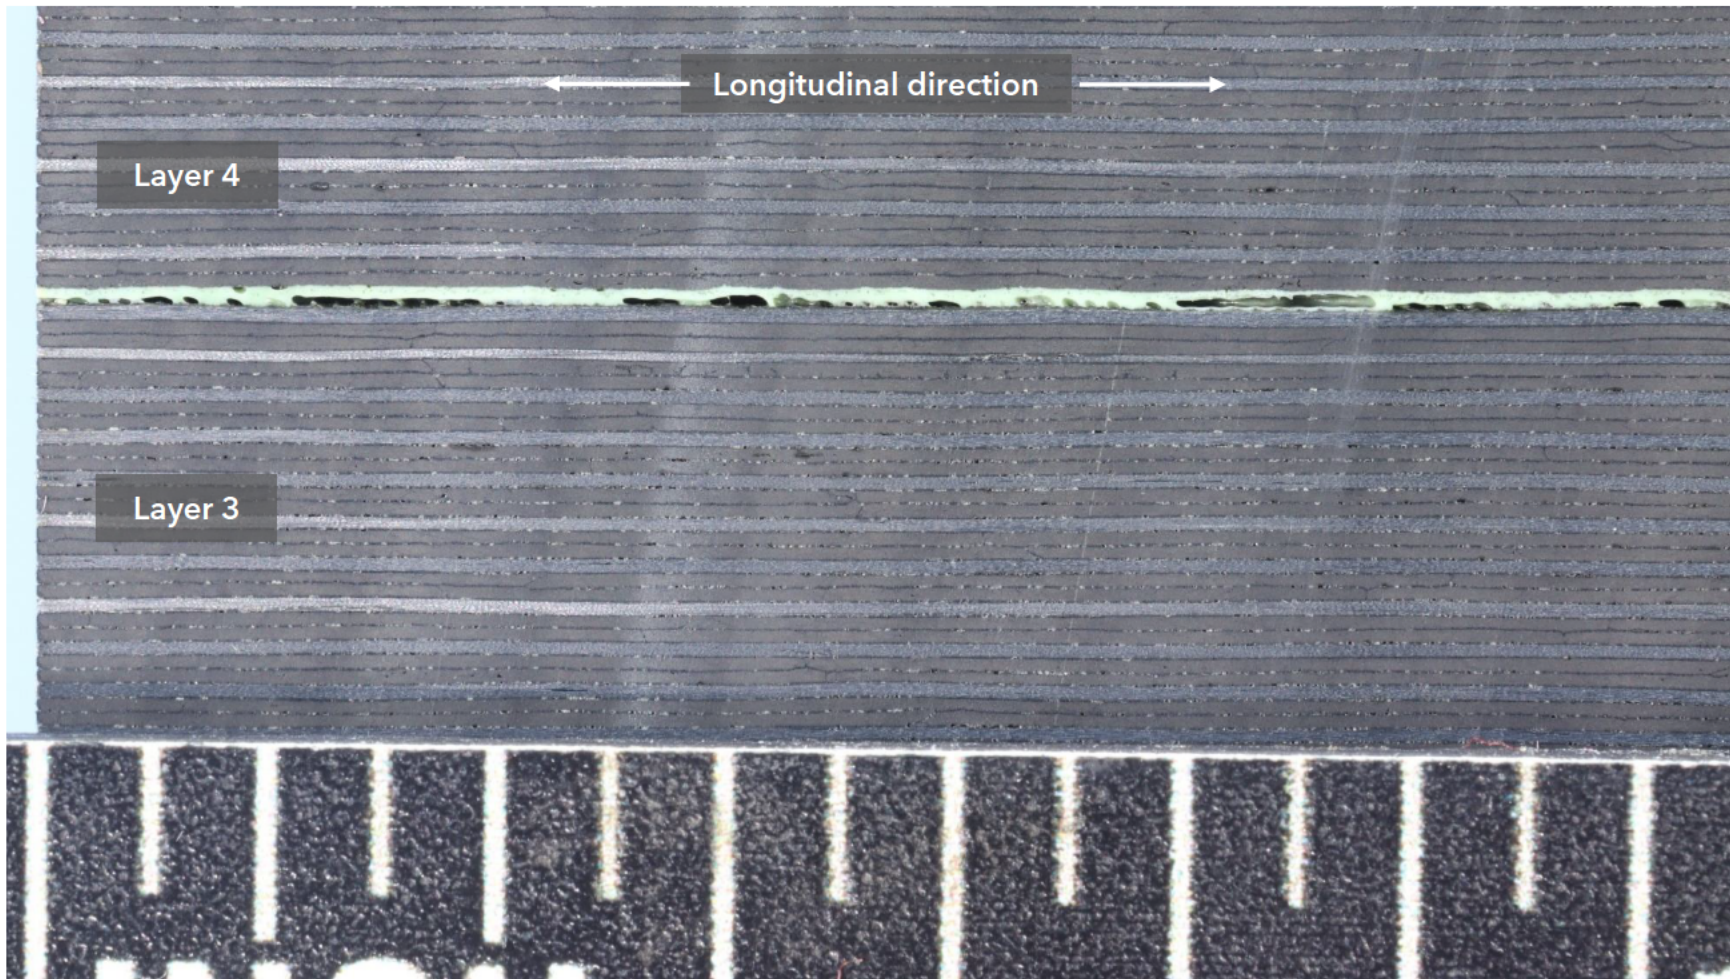
**Figure 36.** Closer image of the adhesive between layers 3 and 4 showing voids at the layer 3/4 adhesive interface.
