# National Transportation Safety Board

DCA23FM036

Factual Report 24-011

Location: Atlantic Ocean  
Date: June 18, 2023  
Vehicle: OceanGate Experimental Submersible Titan  
Investigator: Marcel Muise, MS-10

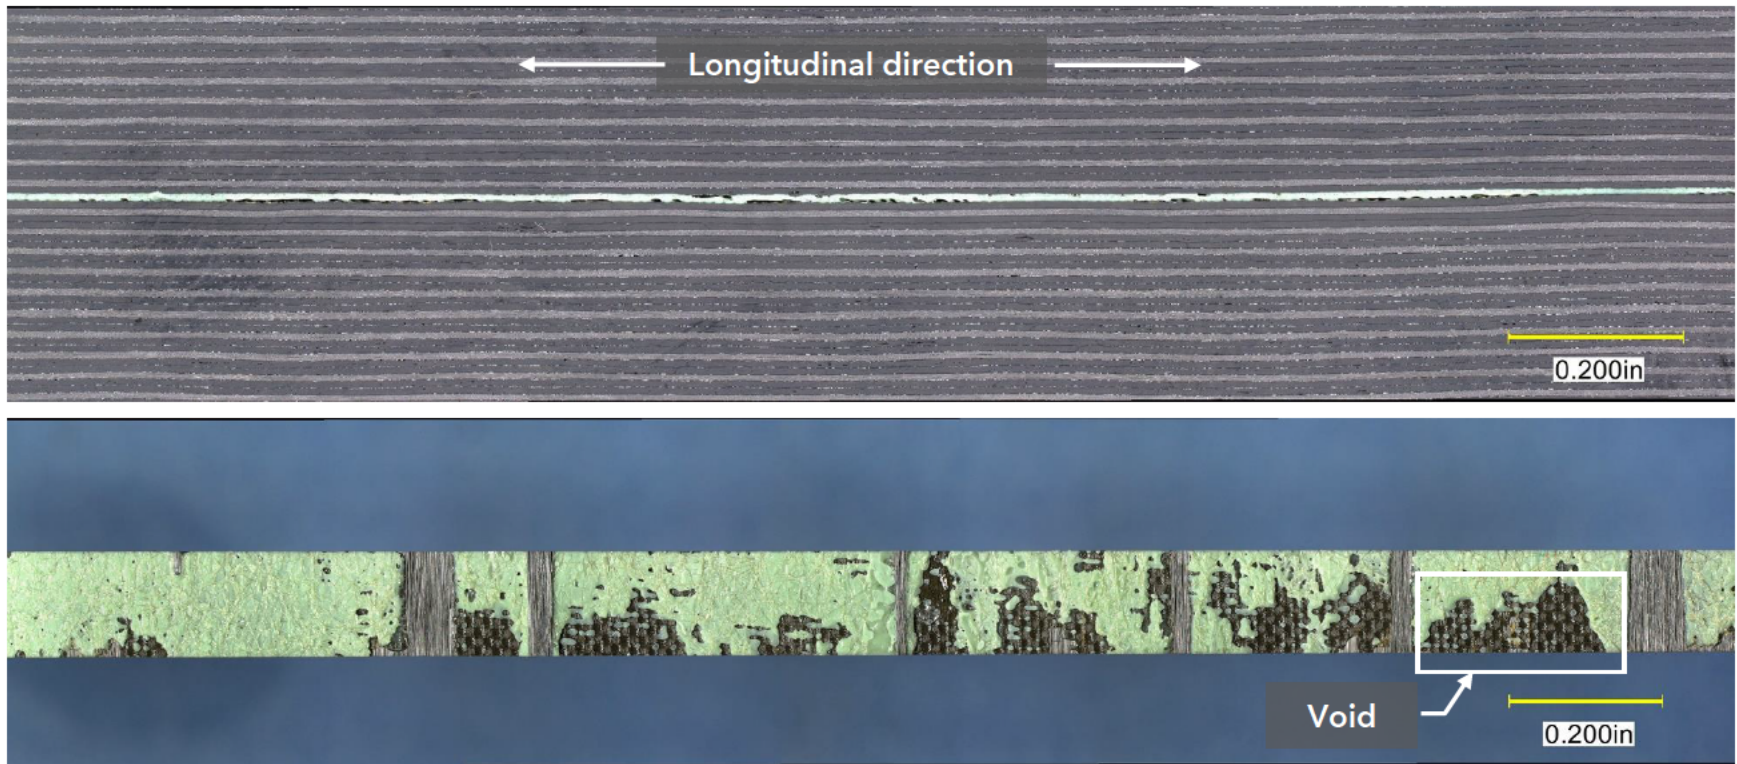
**Figure 37.** Top image: Cross section image of the adhesive between layers 1 and 2. Similar to previous images, areas of voids are present at the layer 1/2 interface. Lower image: plan view of the adhesive layer after lab fracture.

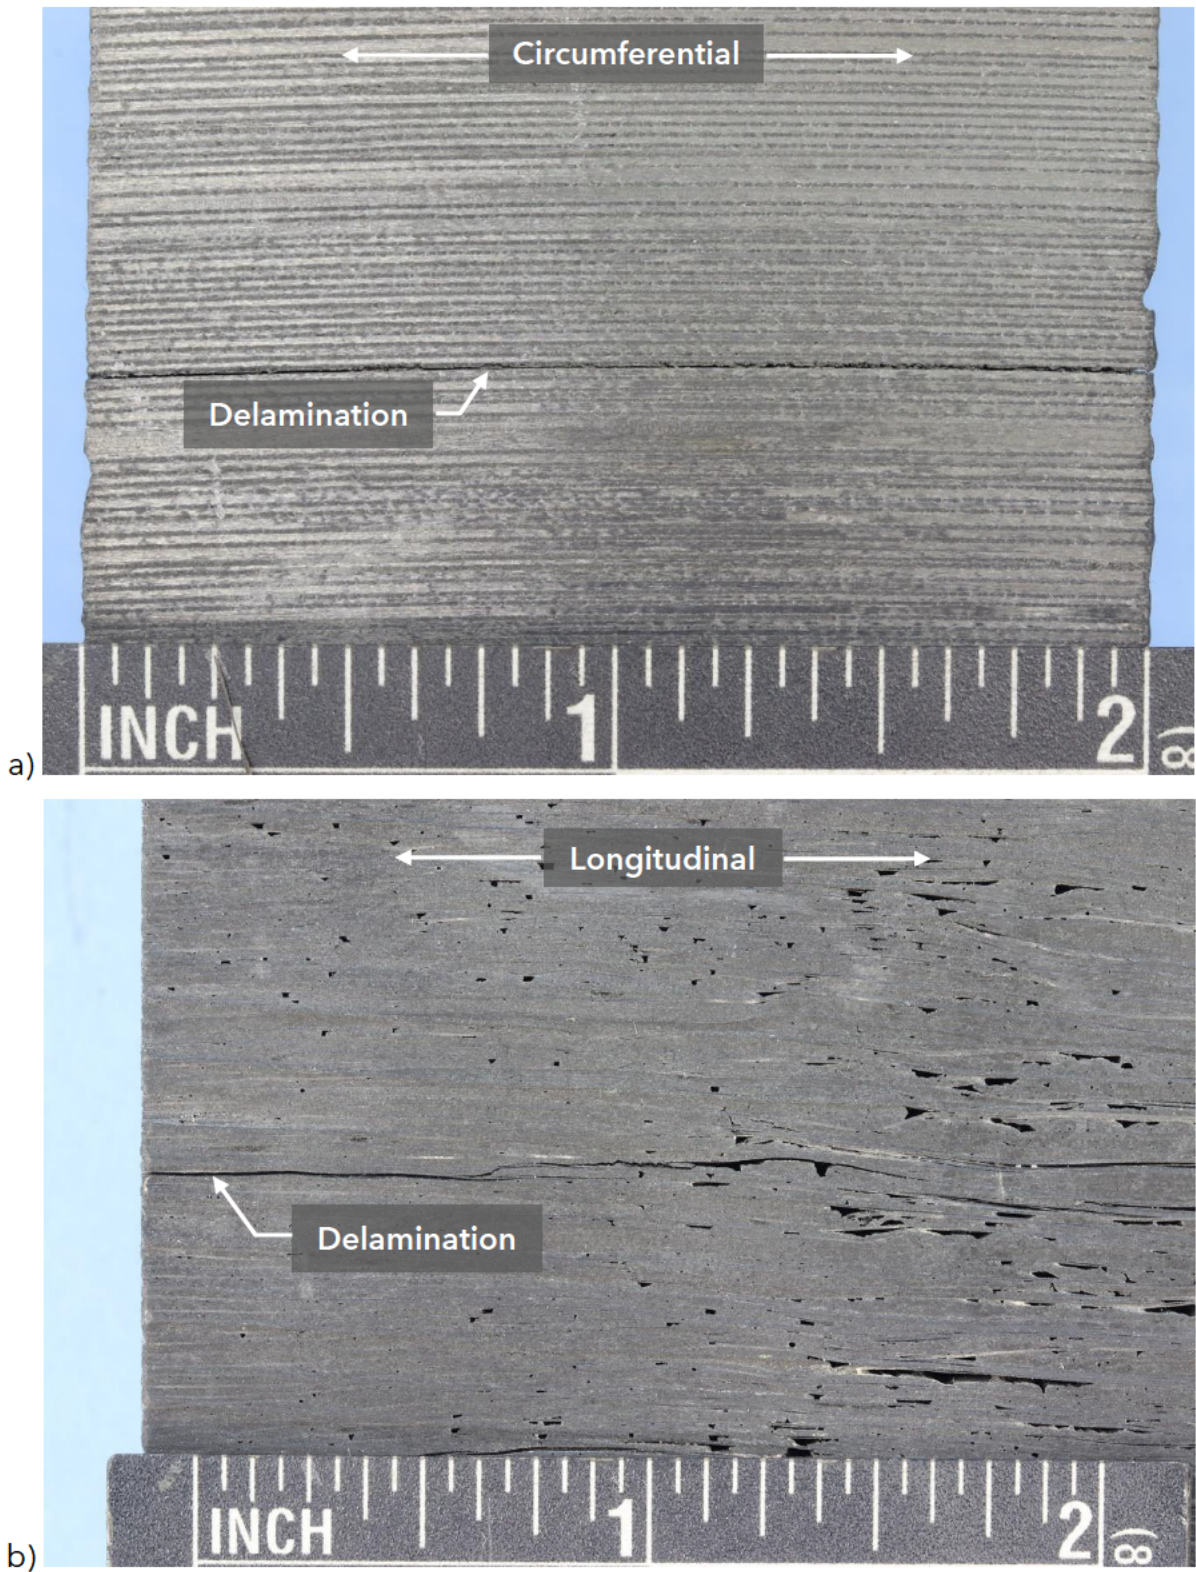
**Figure 40.** Images of the centerline delamination in the first full-scale Titan hull trimmed end piece: a) circumferential cross section and b) longitudinal cross section.

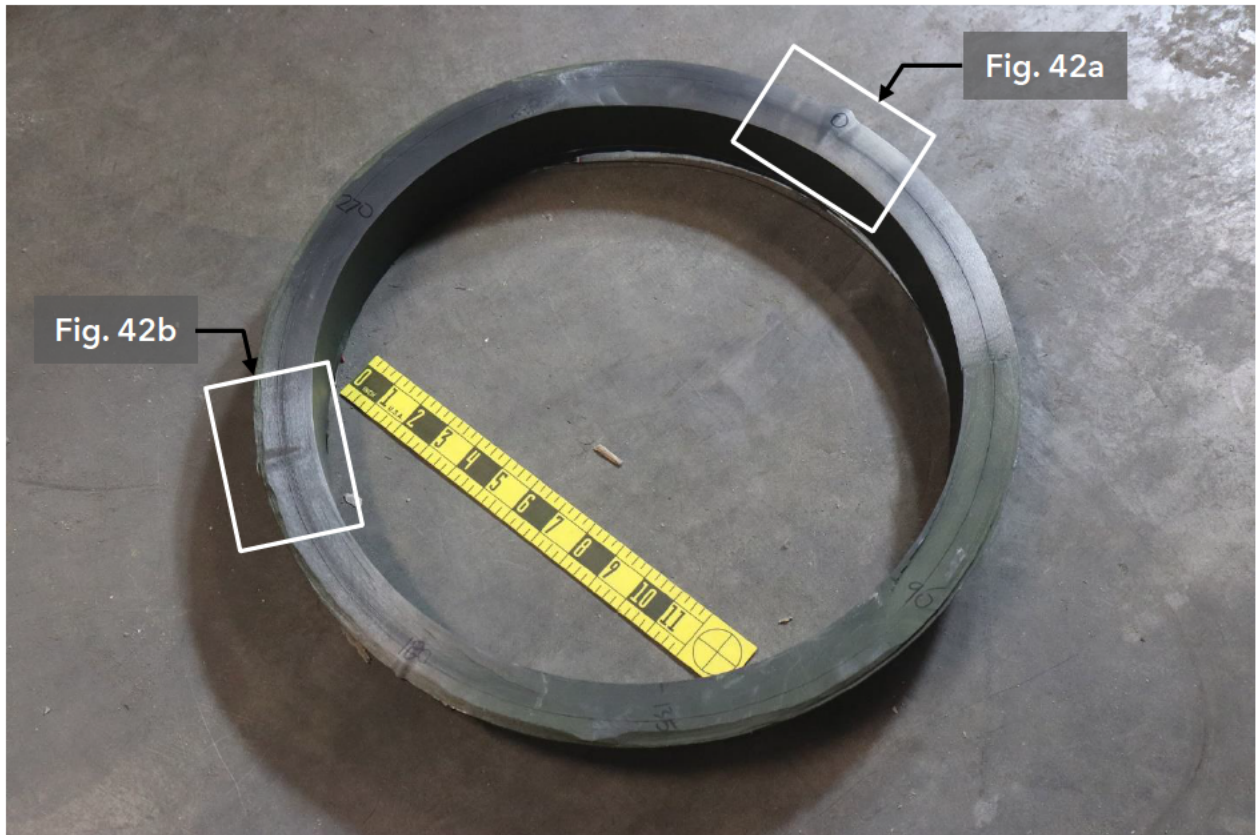
Prior to manufacturing the second full-scale hull, OceanGate manufactured two one-third-scale test articles. A trimmed end piece from the first test article is shown in figure 41. The piece had two notable wrinkles that are indicated in the figure and are shown in figures 42a and b. A mid-thickness delamination was observed around nearly the entire perimeter, only terminating on either side of the dominant wrinkle. The two ends of the delamination are just visible at the edges of figure 42a and a typical appearance for the delamination is shown in the image of the secondary wrinkle in figure 42b. The second test article (not shown) contained similar wrinkle and delamination features.

**Figure 41.** Trimmed end from the first of two one-third-scale test articles manufactured from prepreg carbon fiber after the retirement of the first Titan hull. The locations of two wrinkles are indicated and are shown below in figures 42a and b.

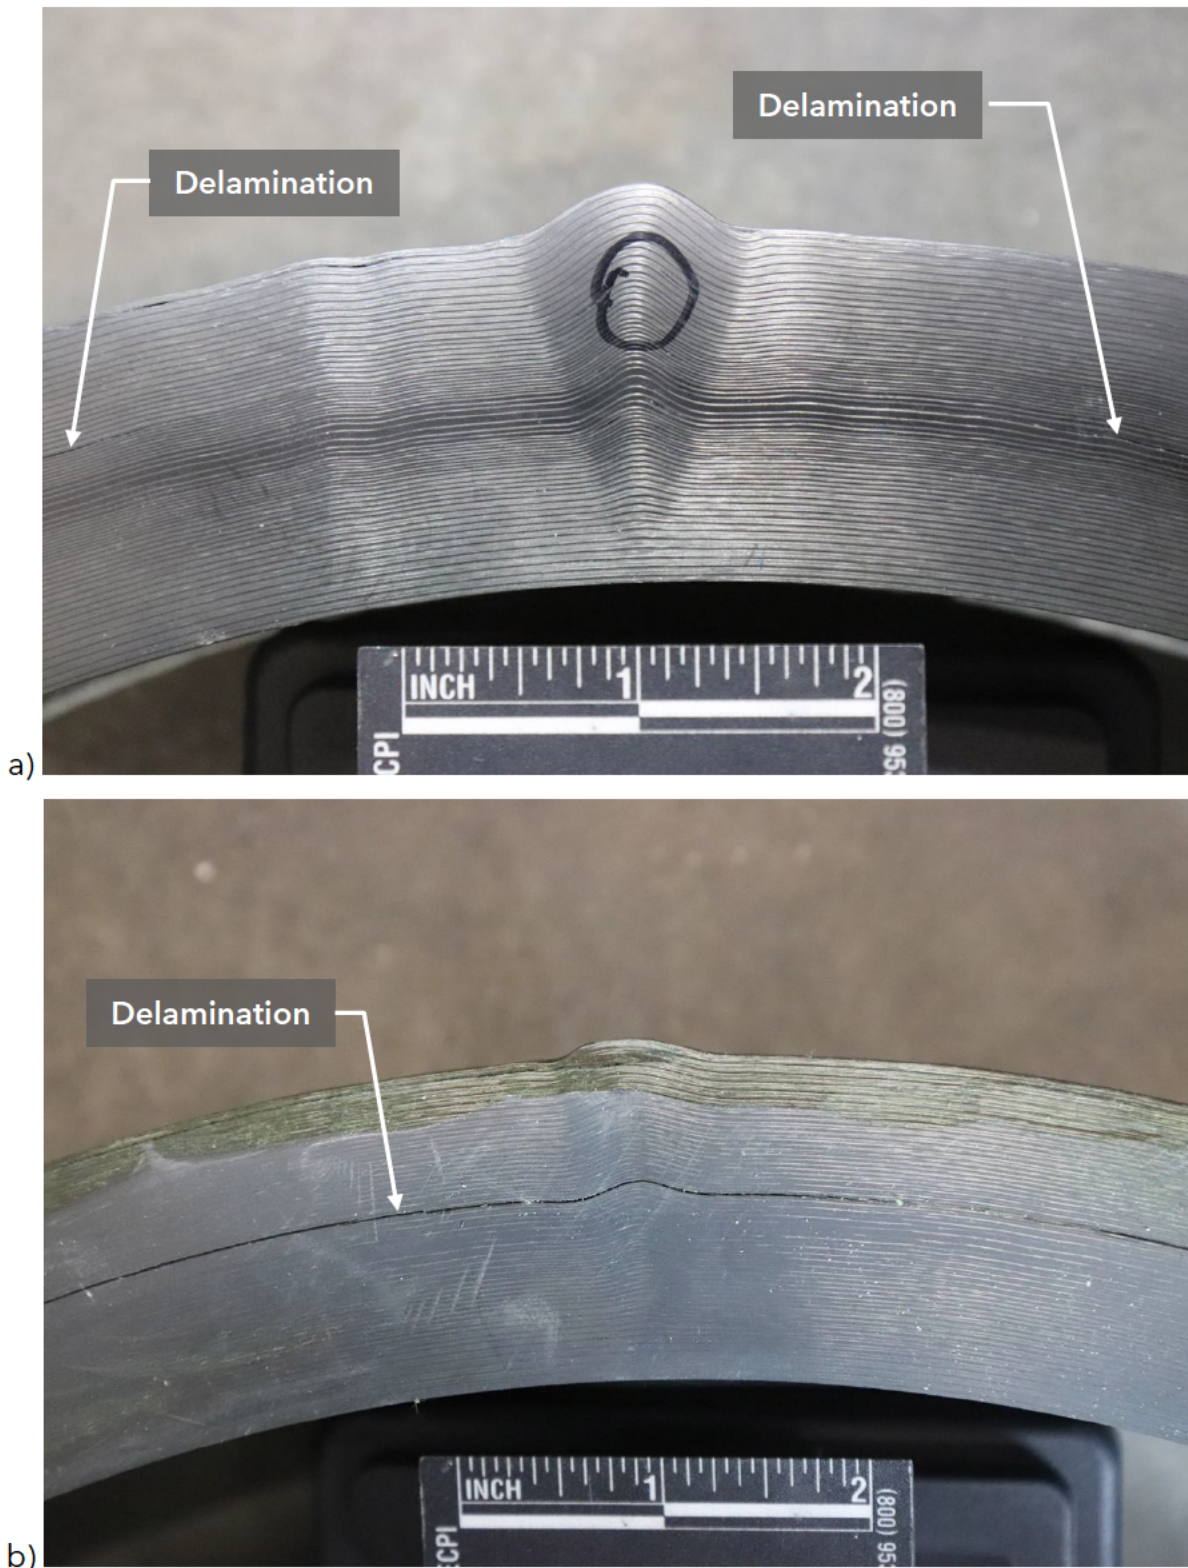
**Figure 42.** Images of wrinkles in the third-scale test article trimmed end piece: a) primary wrinkle and b) secondary wrinkle with a near-centerline delamination also present.

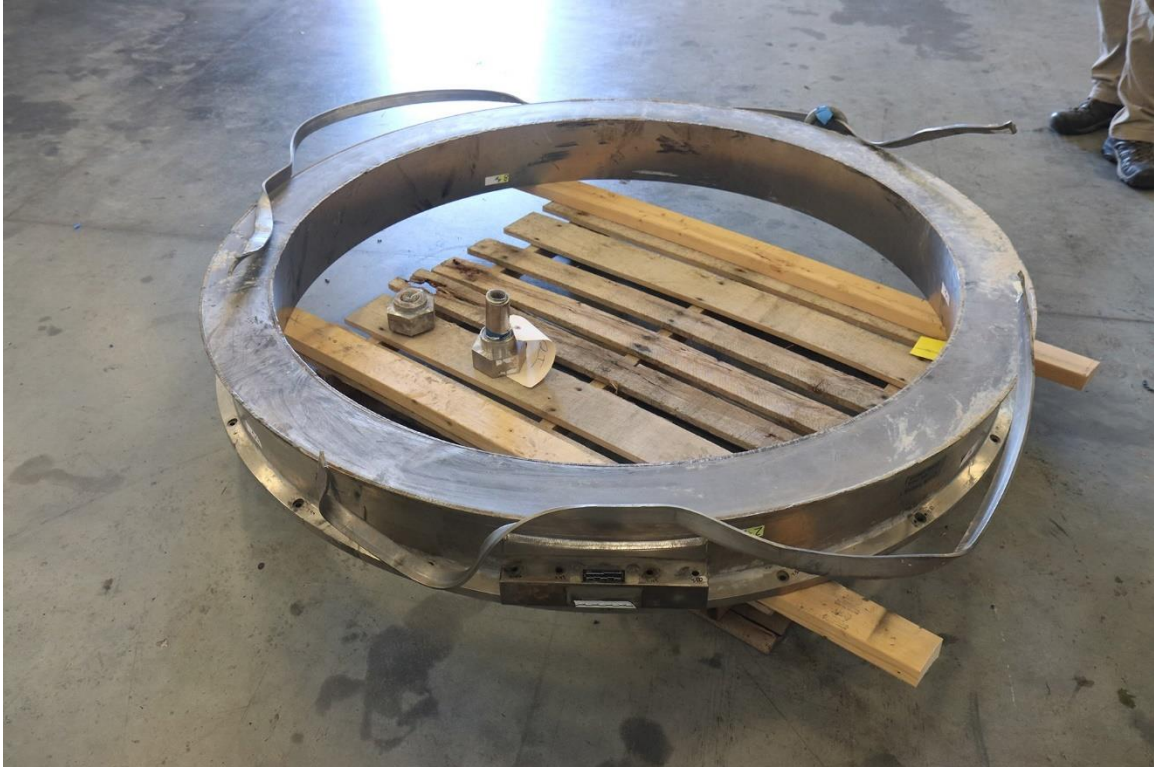
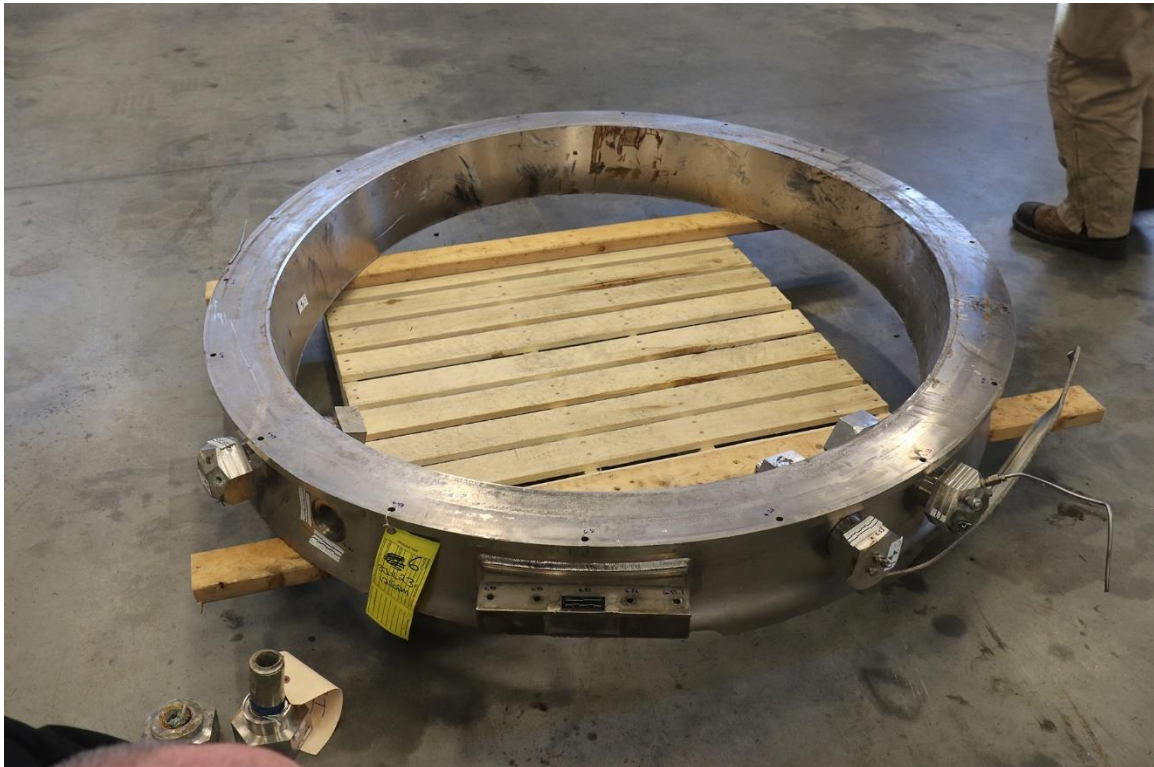
The titanium segments and domes were examined in Newport, RI. The forward and aft segments are shown in figures 43a and b, respectively. The segments were slightly ovalized. The top and bottom of each segment had deformed radially outward and the port and starboard sides had deformed radially inward. The inner rims on the C-channels were completely separated and the outer rims were mostly separated, remaining attached by one or two shorter ligaments on the order of 6 to 12 inches. The rim fractures were examined using a binocular magnifier. A typical section of the forward segment C-channel is shown in figure 44. The inner rim fractures all exhibited flat smeared surfaces with shear marks pointing radially inward and a shear deformation lip along the edge of the inner surface, consistent with inward shear fractures. The outer flange fractures were rough by comparison with fracture features progressing radially outward with either plastic damage or a plastic hinge along the edge of the outer surface, consistent with bending / tensile fracture. There were no features indicative of metal fatigue.

**Figure 43.** a) Overview image of forward segment and b) overview image of aft segment.

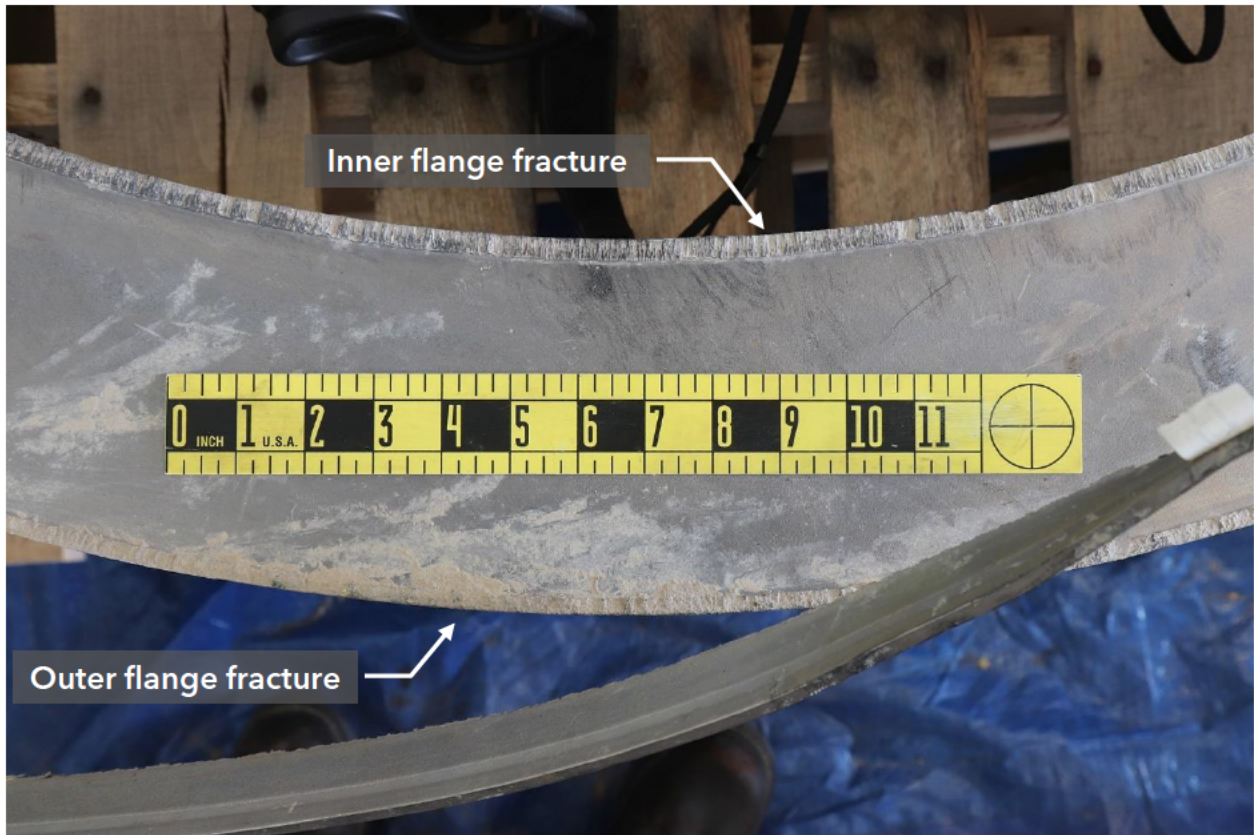
**Figure 44.** Image from the forward segment bonding C-channel showing the shear fracture of the inner rim, bending/tensile fracture of the outer rim, and disbondment of the adhesive.

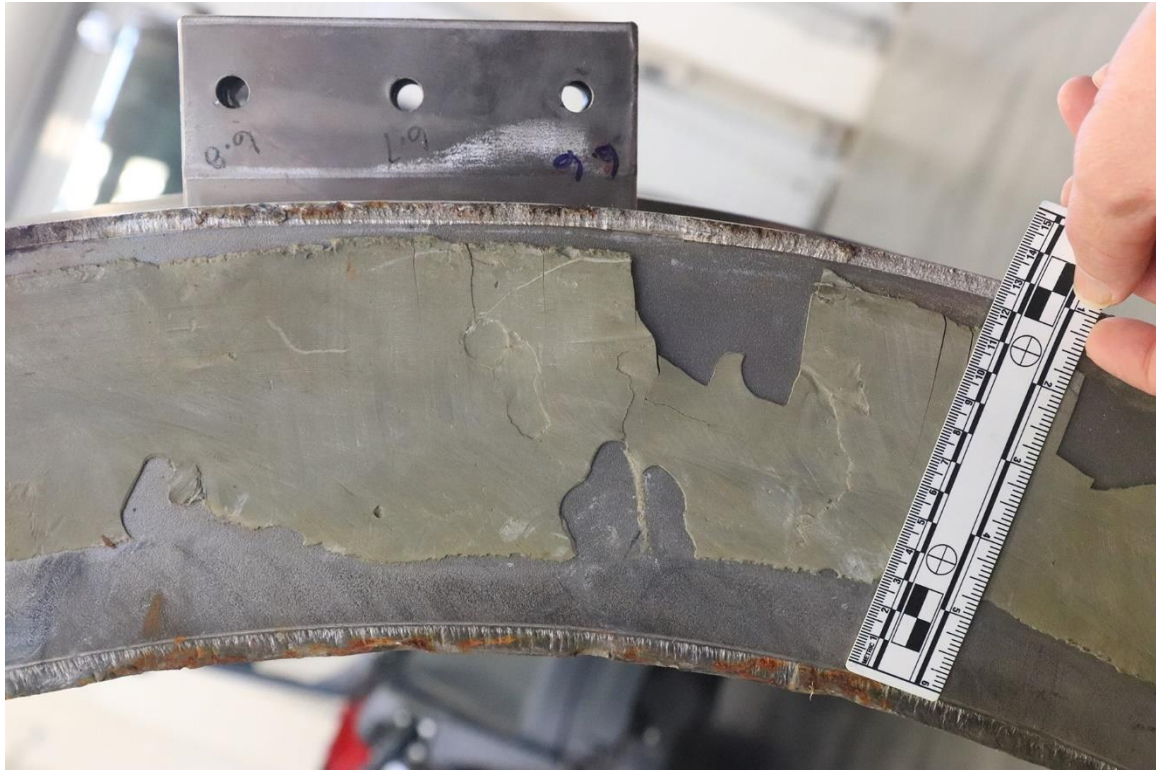
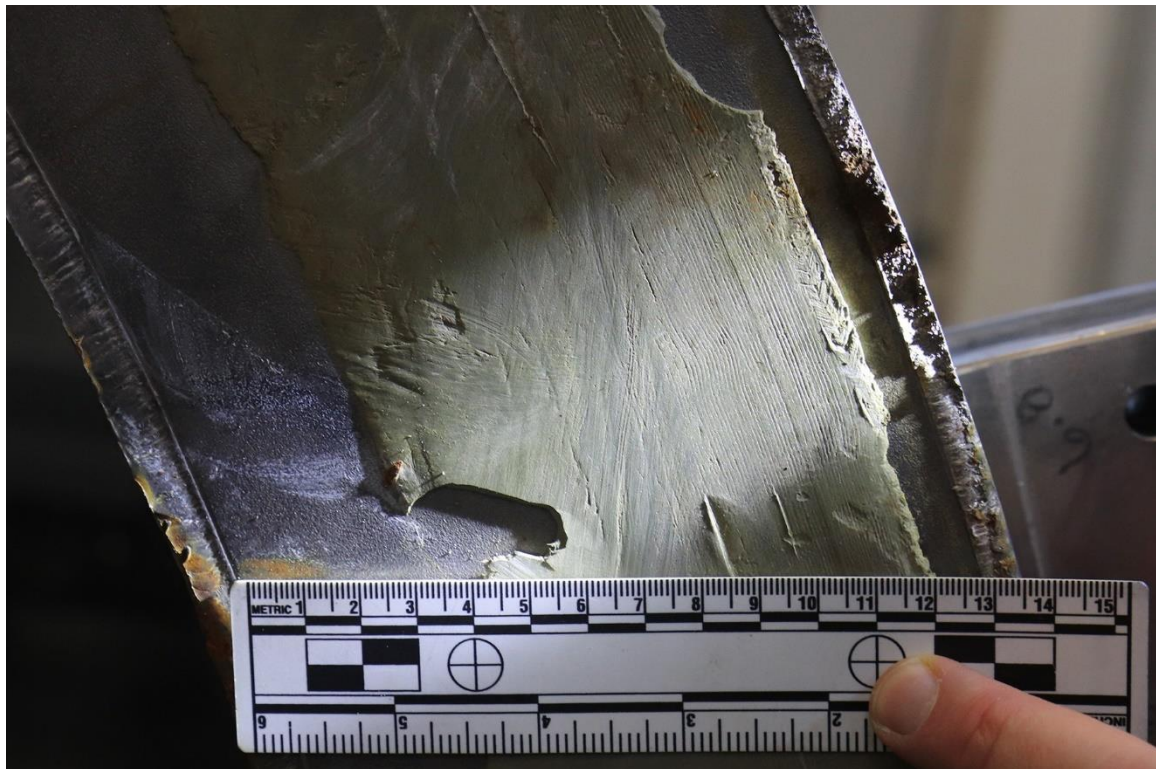
**Figure 45.** Images from the aft segment bonding C-channel near the top (12:00 position) where an approximately 90° arc of adhesive remained bonded to the segment: a) general lighting conditions and b) oblique lighting conditions showing the disappearance of the hull end machining marks towards the inner surface.

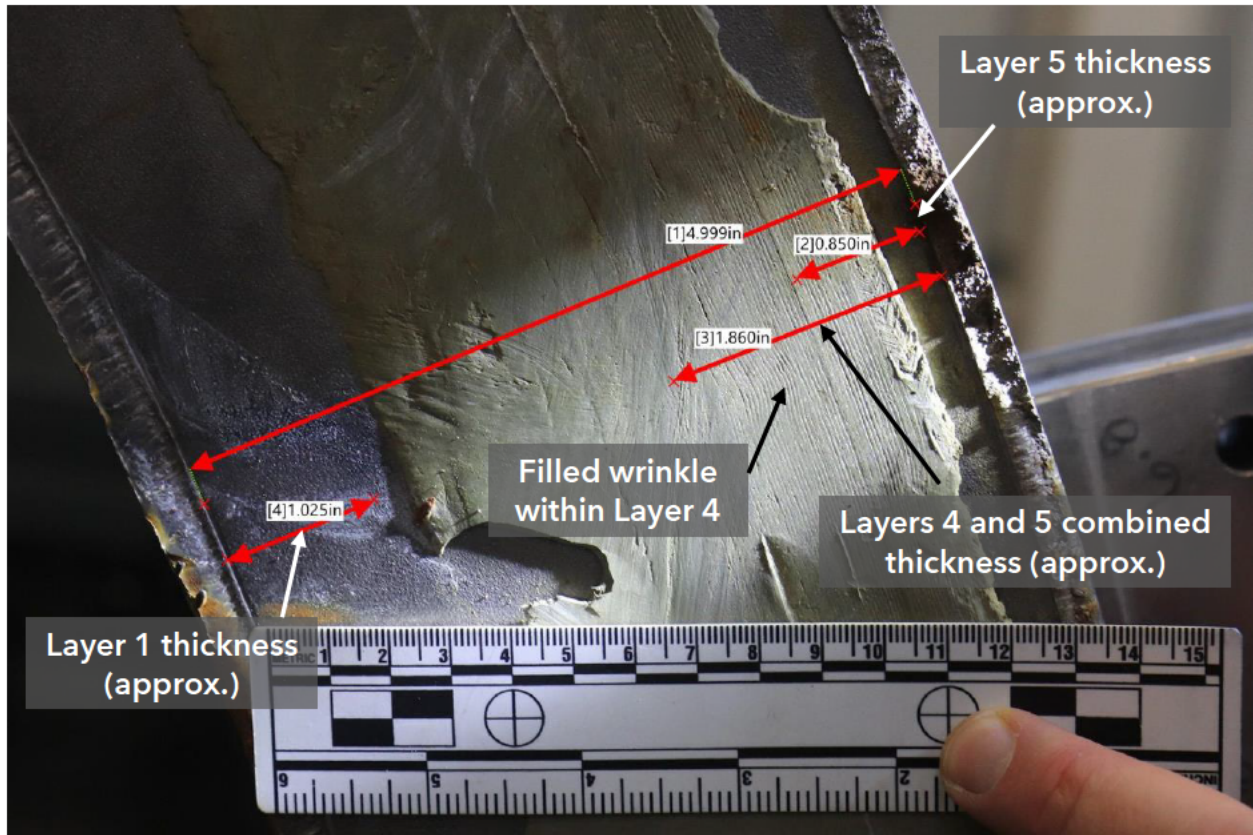
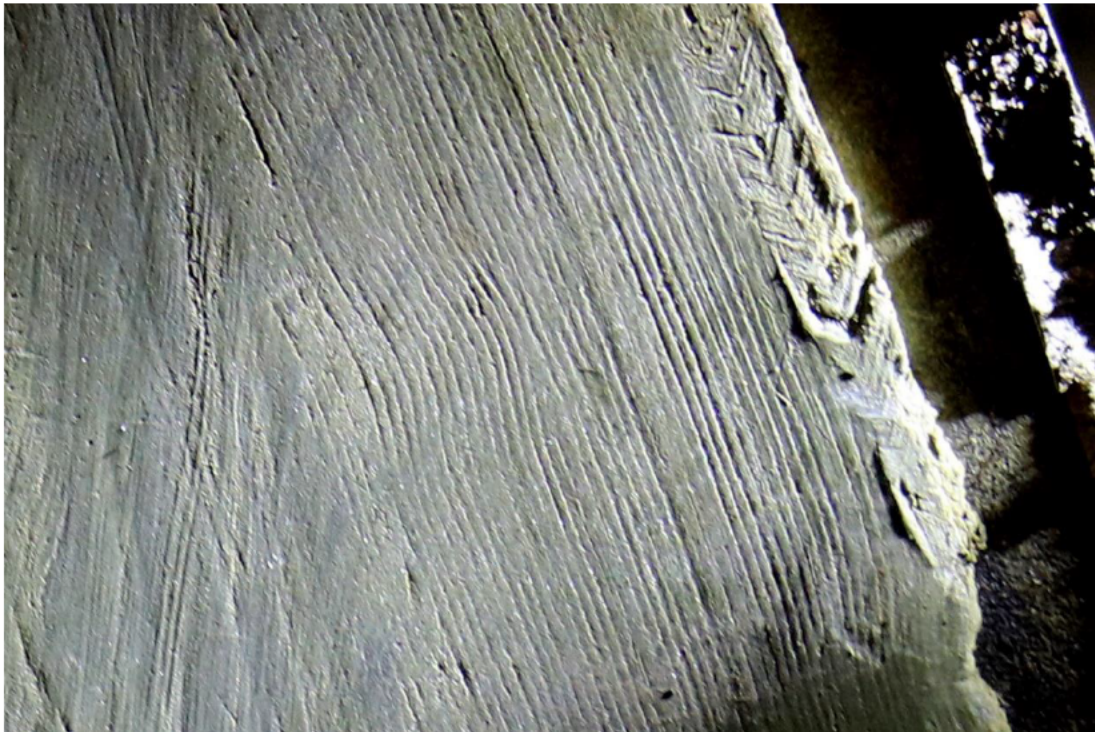
**Figure 46.** Top image: Annotated image showing the approximate location of co-cured layer interfaces and the location of a filled wrinkle. Bottom image: closer image of the filled wrinkle.

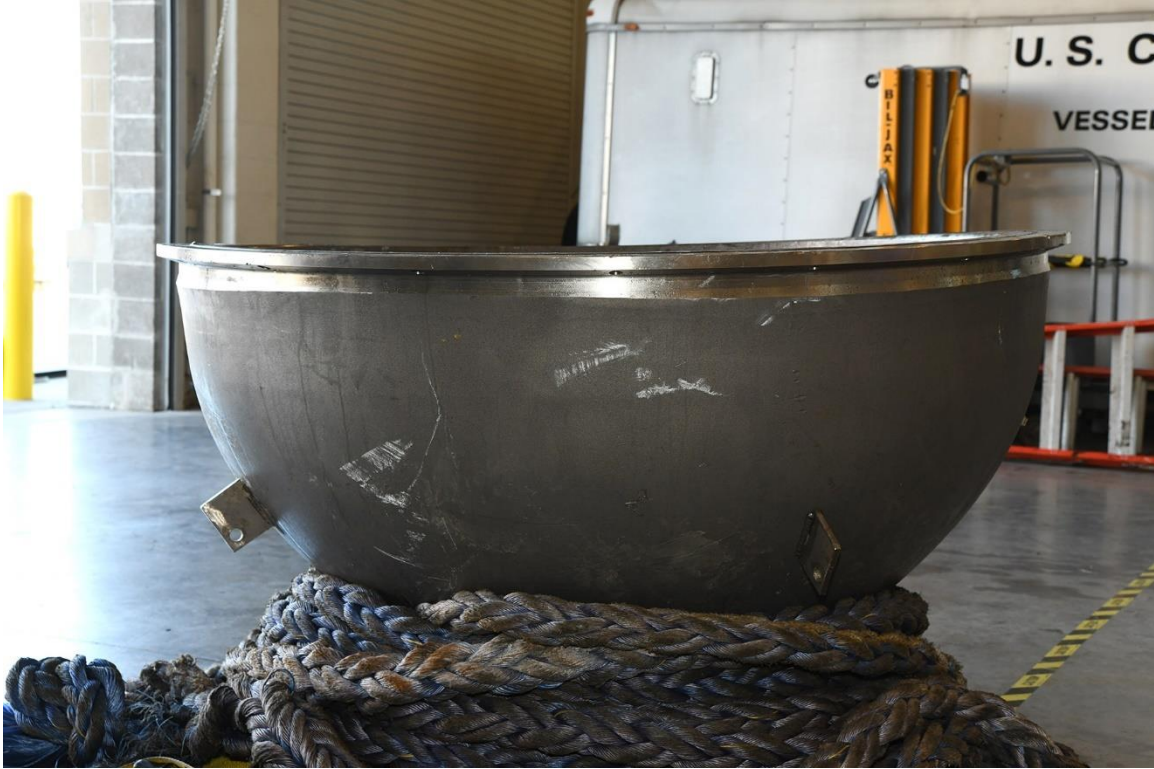
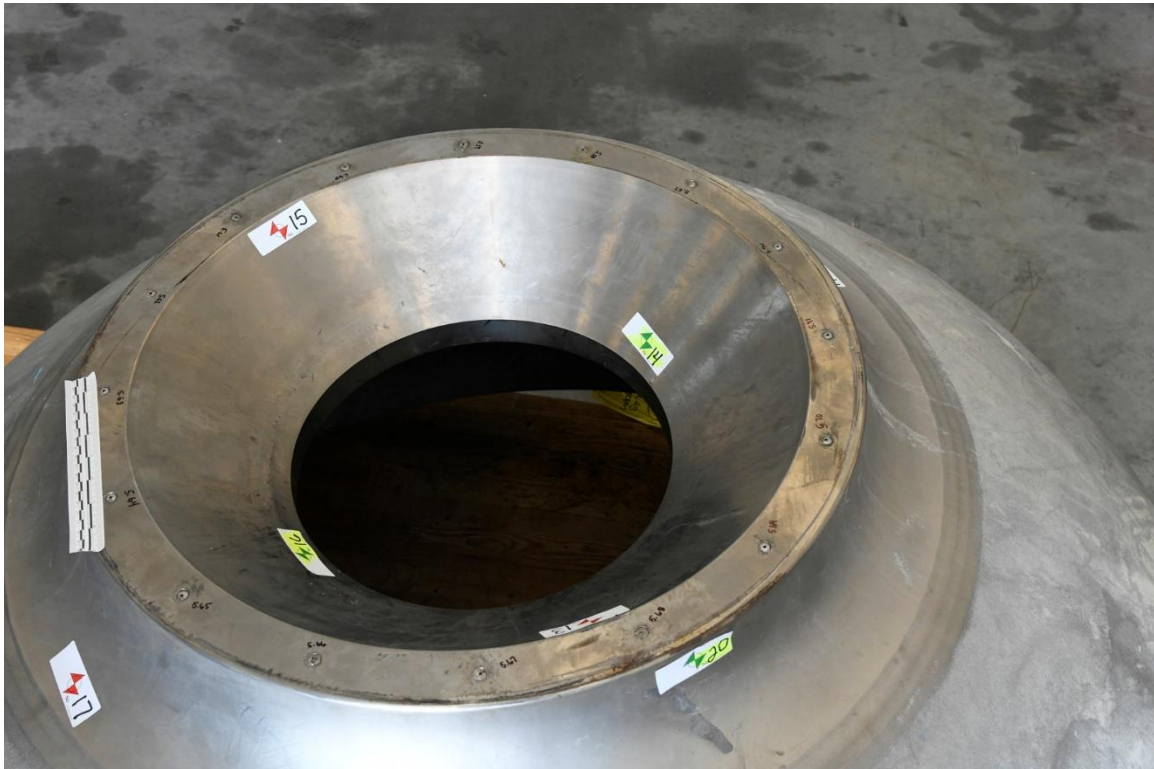
A photo of the aft dome and the viewport seat on the forward dome are shown in figures 47a and b, respectively. The domes were ovalized, similar to the segments, and the mating flanges were warped. The retaining ring used to hold the viewport in place had separated. The bolts used to secure the retaining ring all had flat fractures that originated at thread roots, consistent with tensile fractures (Note: the bolts were through-drilled).

**Figure 47.** a) Image of aft dome and b) image of viewport seat on forward dome.

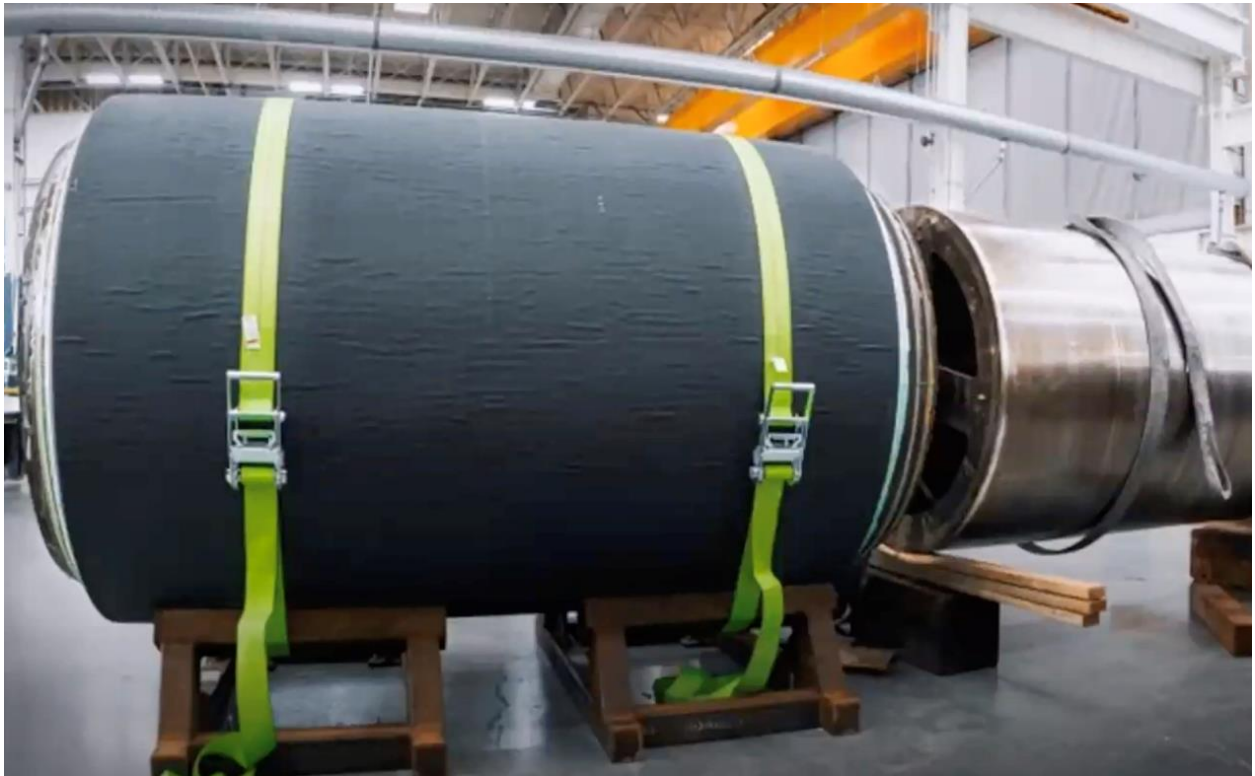
**Figure 49.** Images showing waviness on the outer surface of the hull: Upper image: retrieved hull piece. Lower image: Rough hull post-curing with mandrel removed.

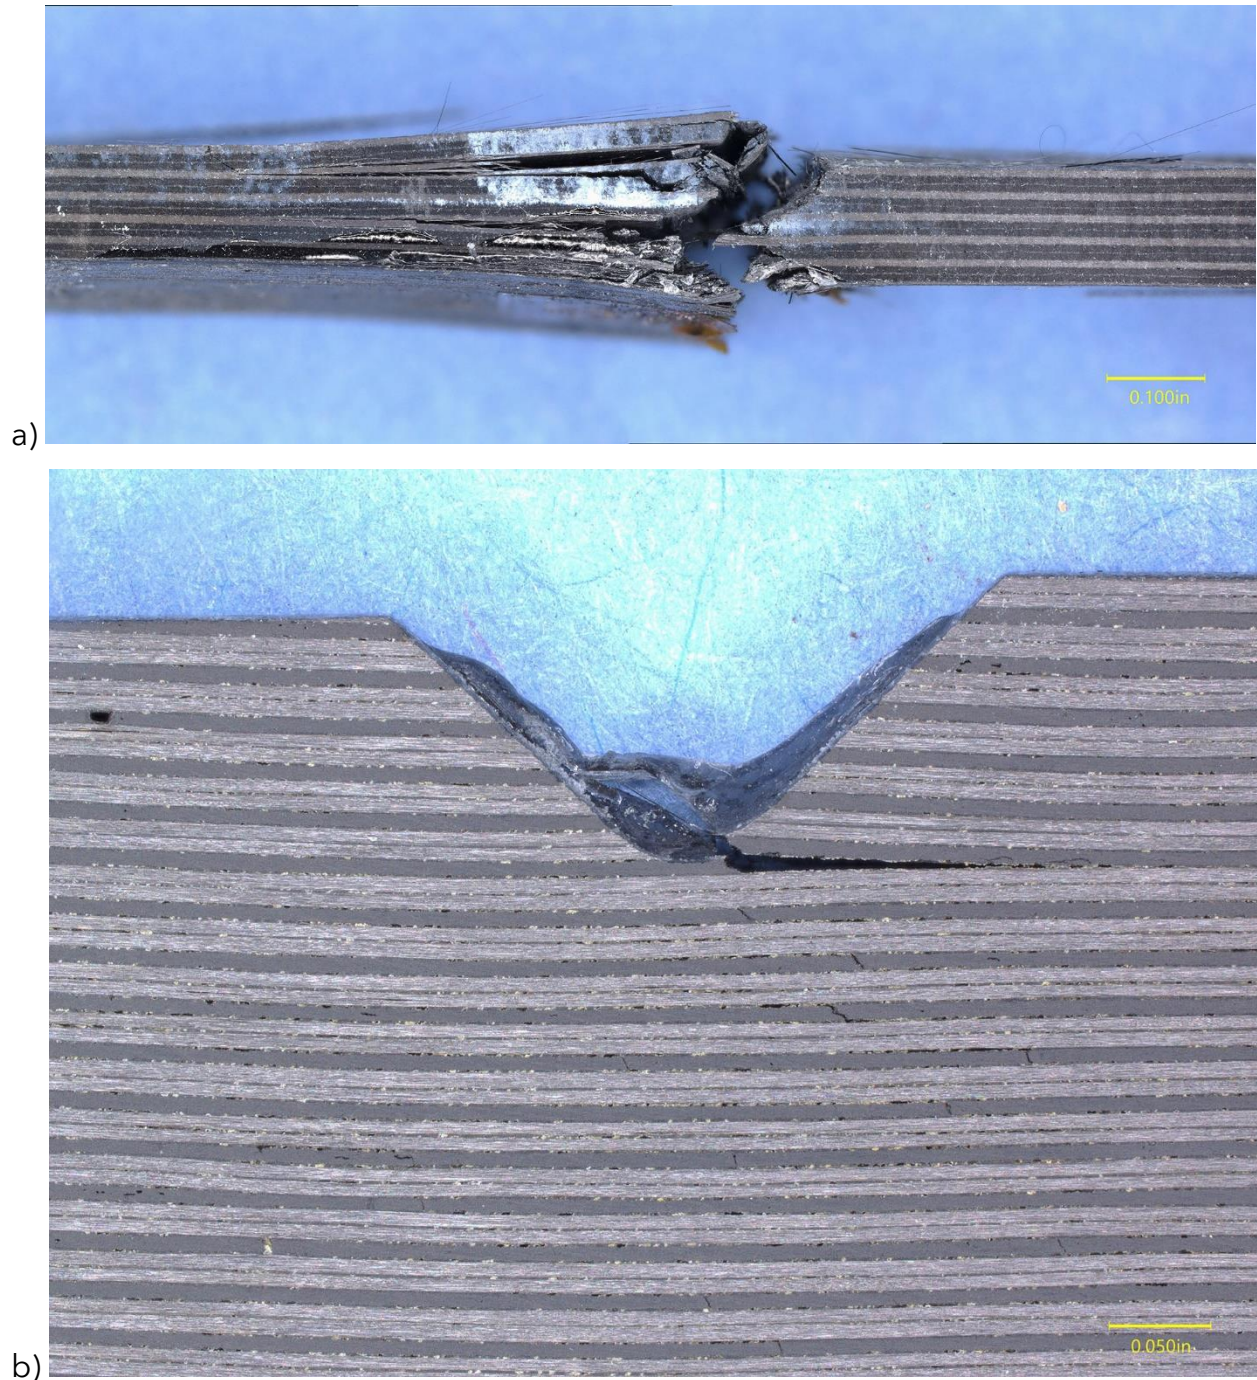
Examples of a typical post-failure compression and V-notch specimen are shown in figures 51a and b, respectively. The compression test sample exhibited brooming and slant fractures. The shear test specimen exhibited horizontal cracking along the interface between a radial ply and a circumferential ply and inclined cracks in the radial plies.

**Figure 51.** Images of fractured test specimens: a) compression specimen and b) shear specimen.
