National Transportation Safety Board

MATERIALS LABORATORY

Factual Report 24-012

Location: Atlantic Ocean
Date: June 18, 2023
Vehicle: OceanGate Experimental Submersible Titan
Investigator: Marcel Muise, MS-10

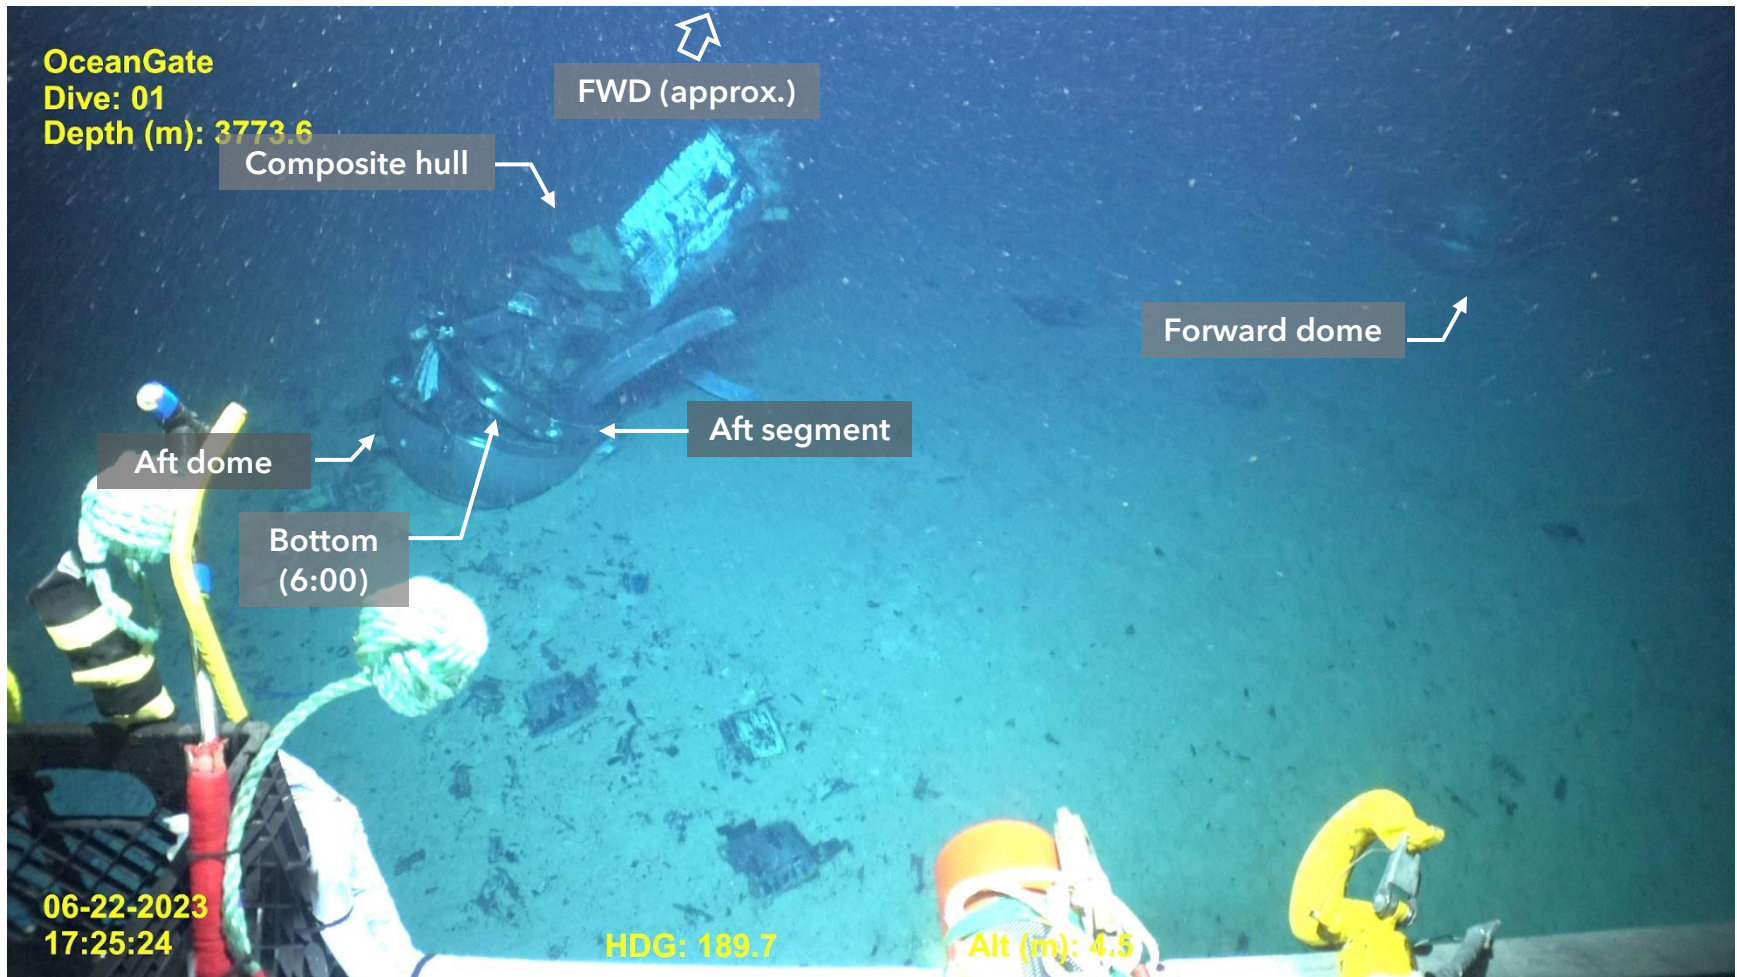
Figure 1 shows the Titan main wreckage as discovered on the ocean floor. The aft dome, aft segment, aft portions of the hull, and rails were located together in a comingled mass. The forward dome was located by itself (figures 1 and 2). The forward segment and tail section were also located by themselves (figures 3 and 4, respectively). Other hull fragments, likely from the middle or forward portion of the hull were scattered about the ocean floor. Four views of the main wreckage from port side, bottom side, starboard side, and top side are shown in figures 5 - 8, respectively. A view from the forward end / top side is shown in figure 9. A nearly full-length segment of the hull was located near the top of the vessel (possibly offset toward the port side). There were few, if any, full thickness hull pieces. All of the visible hull pieces had delaminated, and multiple pieces had green surfaces, consistent with separation within or adjacent to the co-bonded adhesive layers. Many adhesive surfaces exhibited light/dark color patterns like that documented in

Figure 1. Titan main wreckage as discovered on the ocean floor.

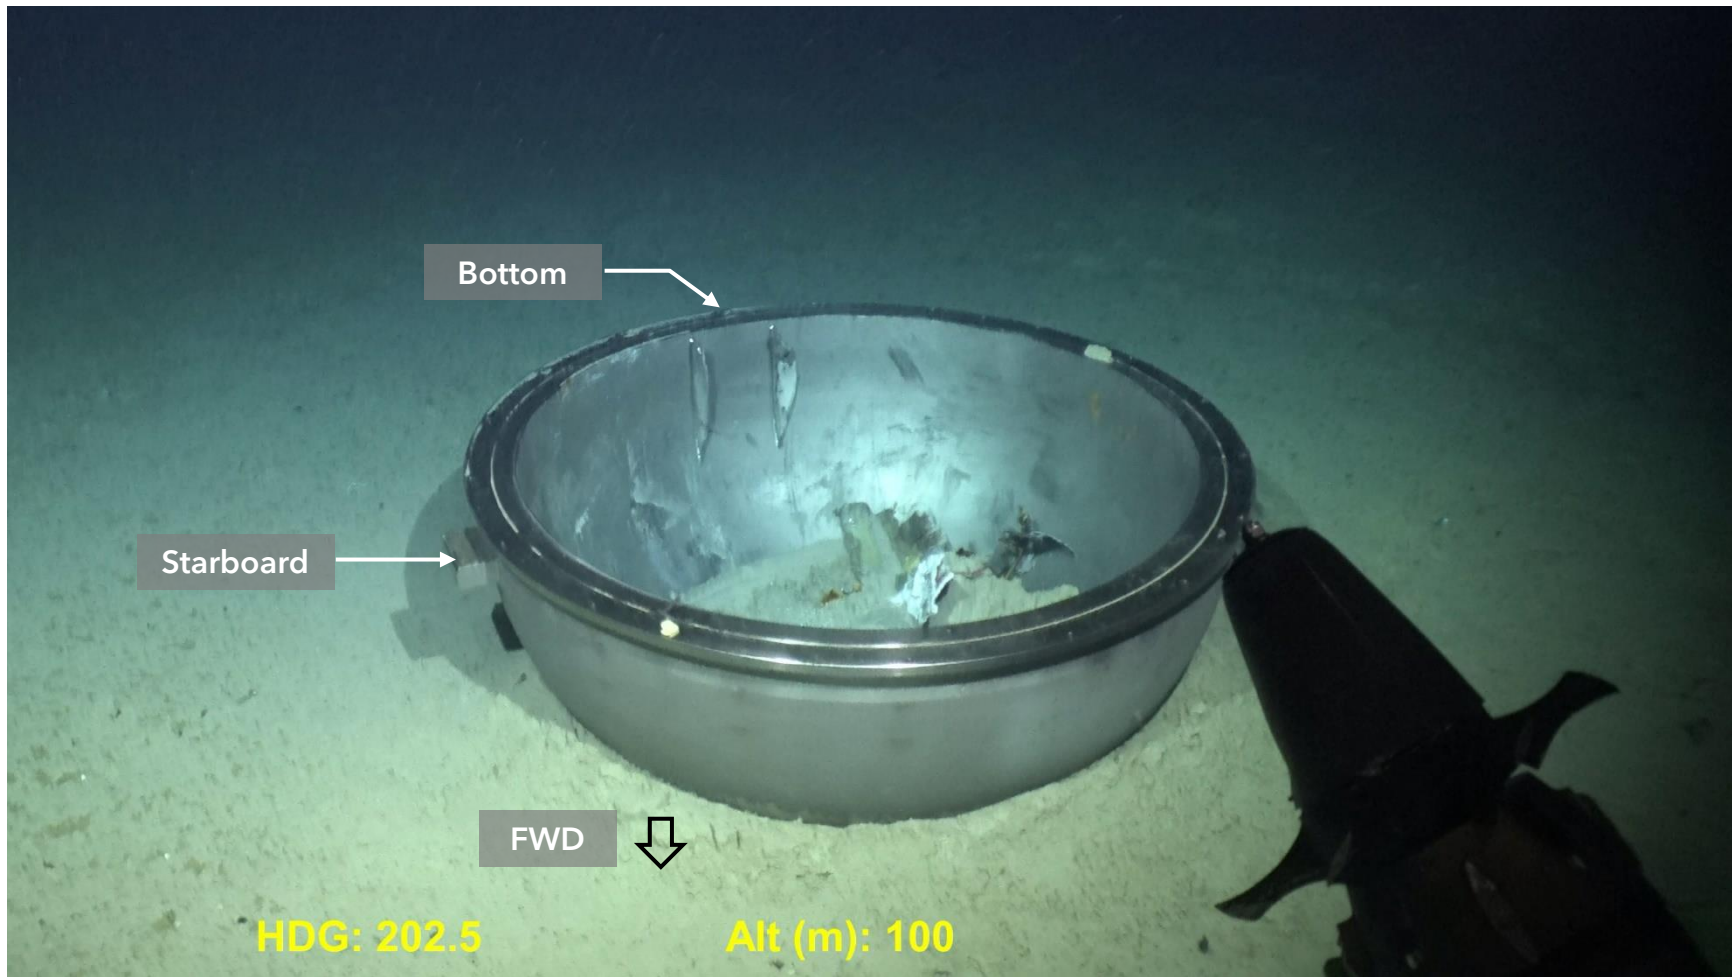
Figure 2. Forward dome, discovered with forward end down.

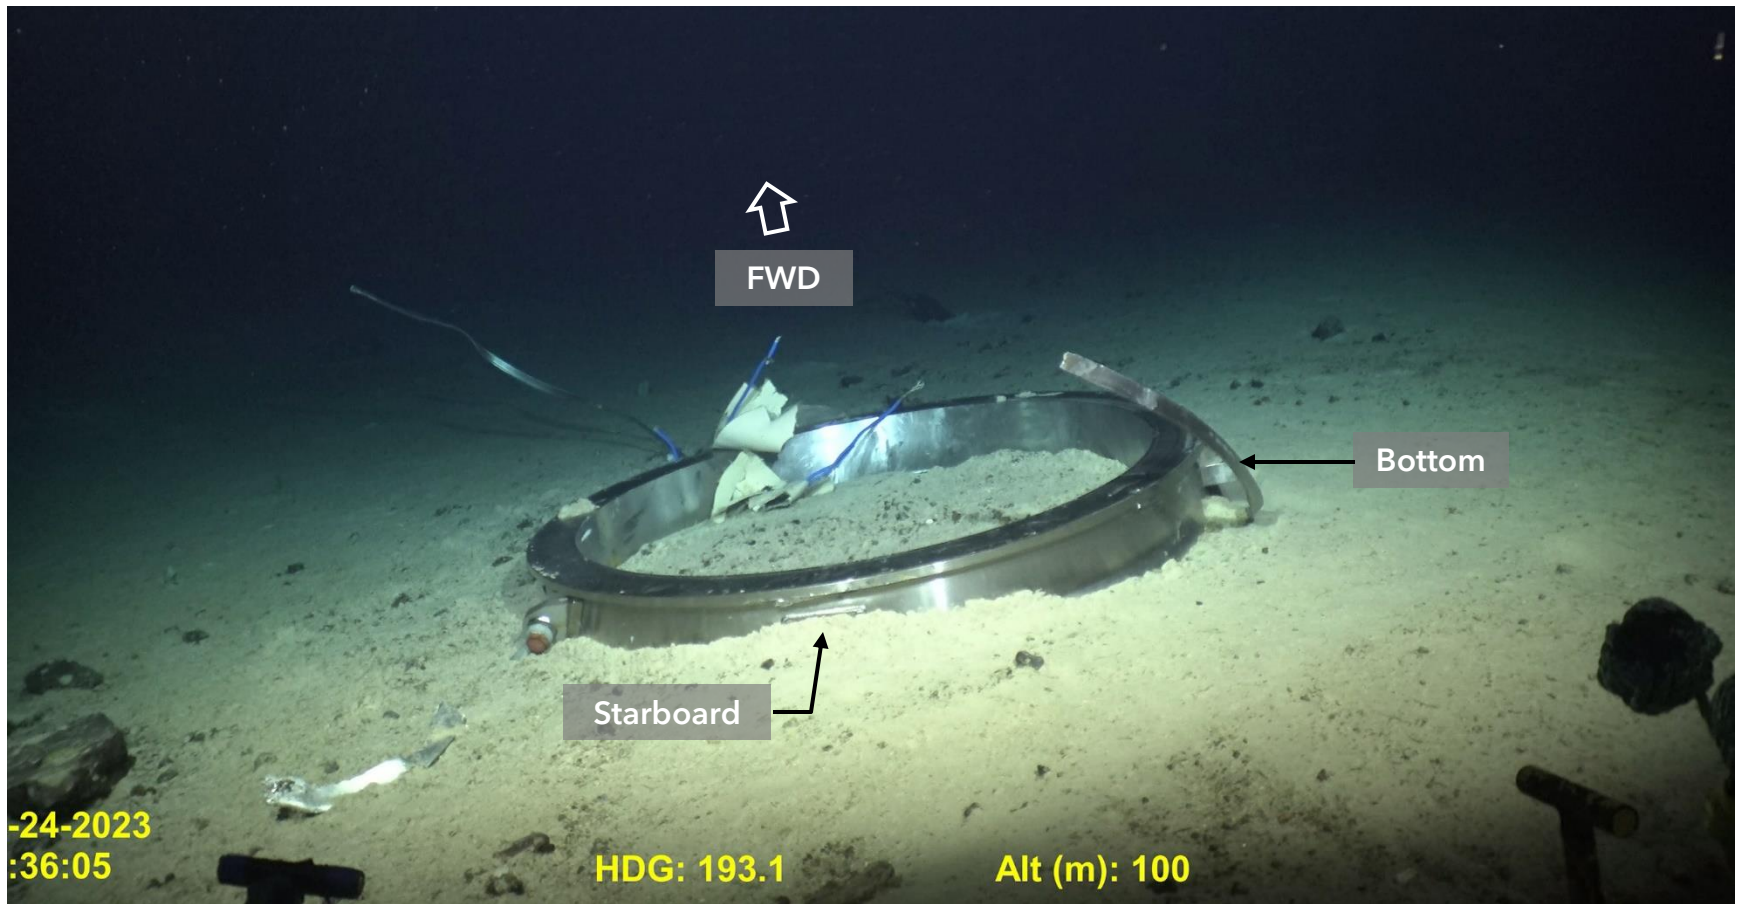
Figure 3. Forward segment, discovered with forward end up.

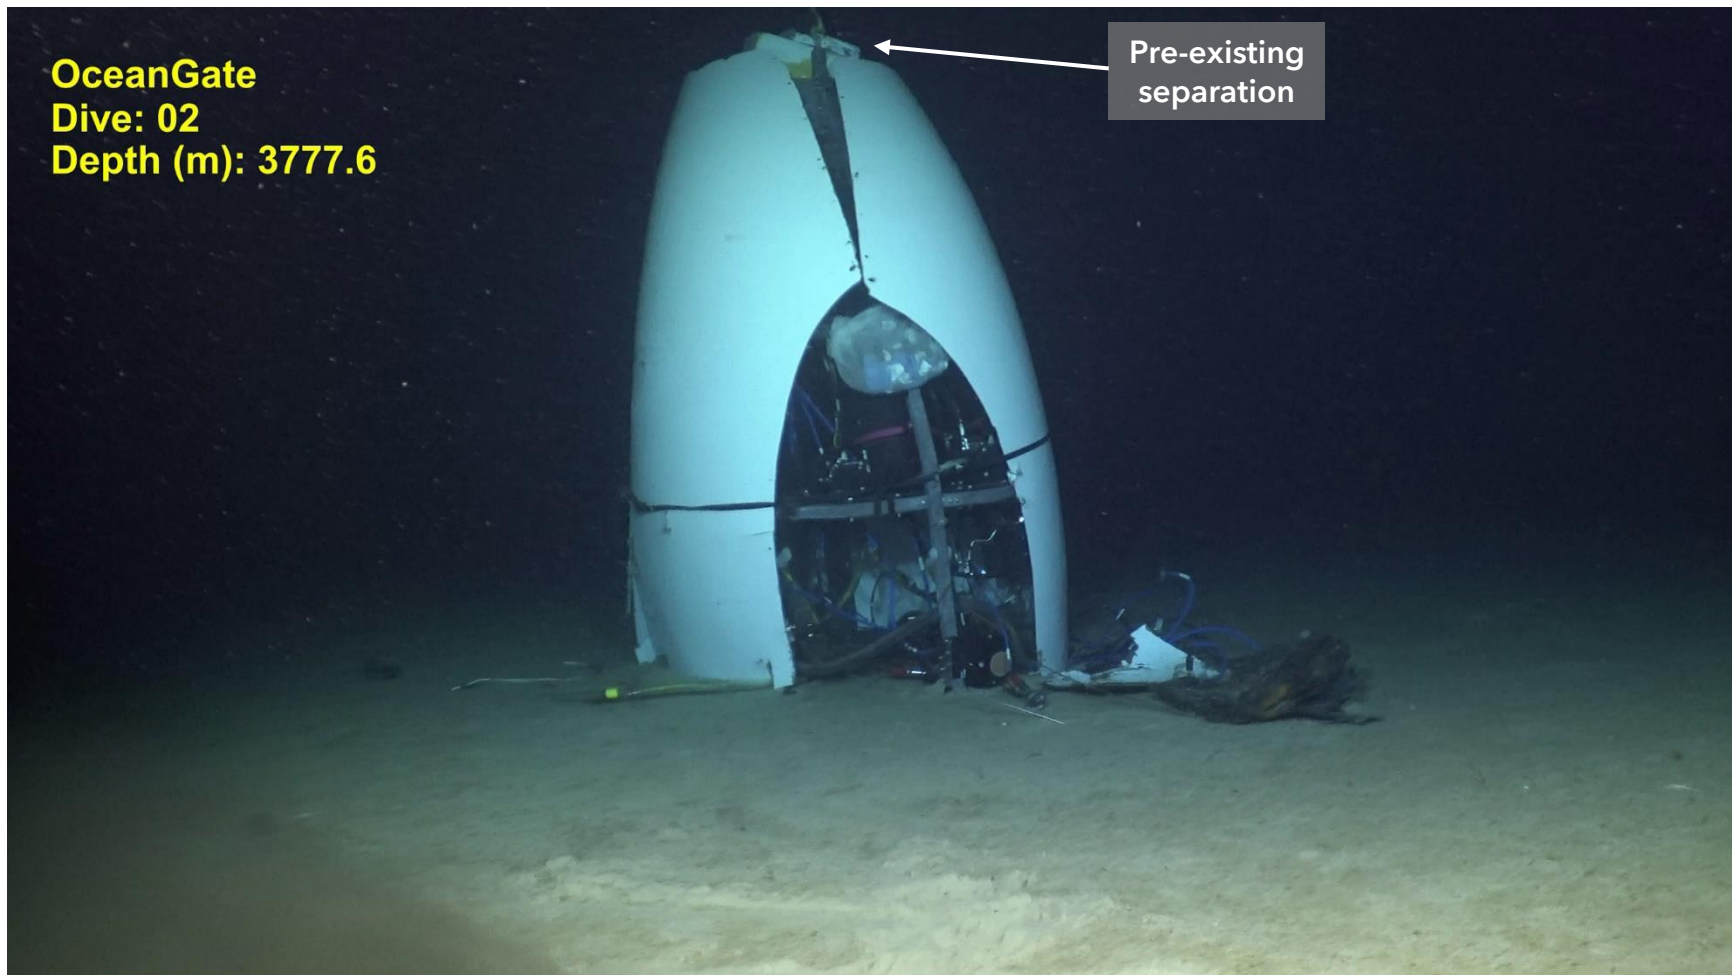
Figure 4. Tail section, originally attached to the aft end of the hull, as discovered. Note: The aftmost portion of the tail section separated prior to the dive.

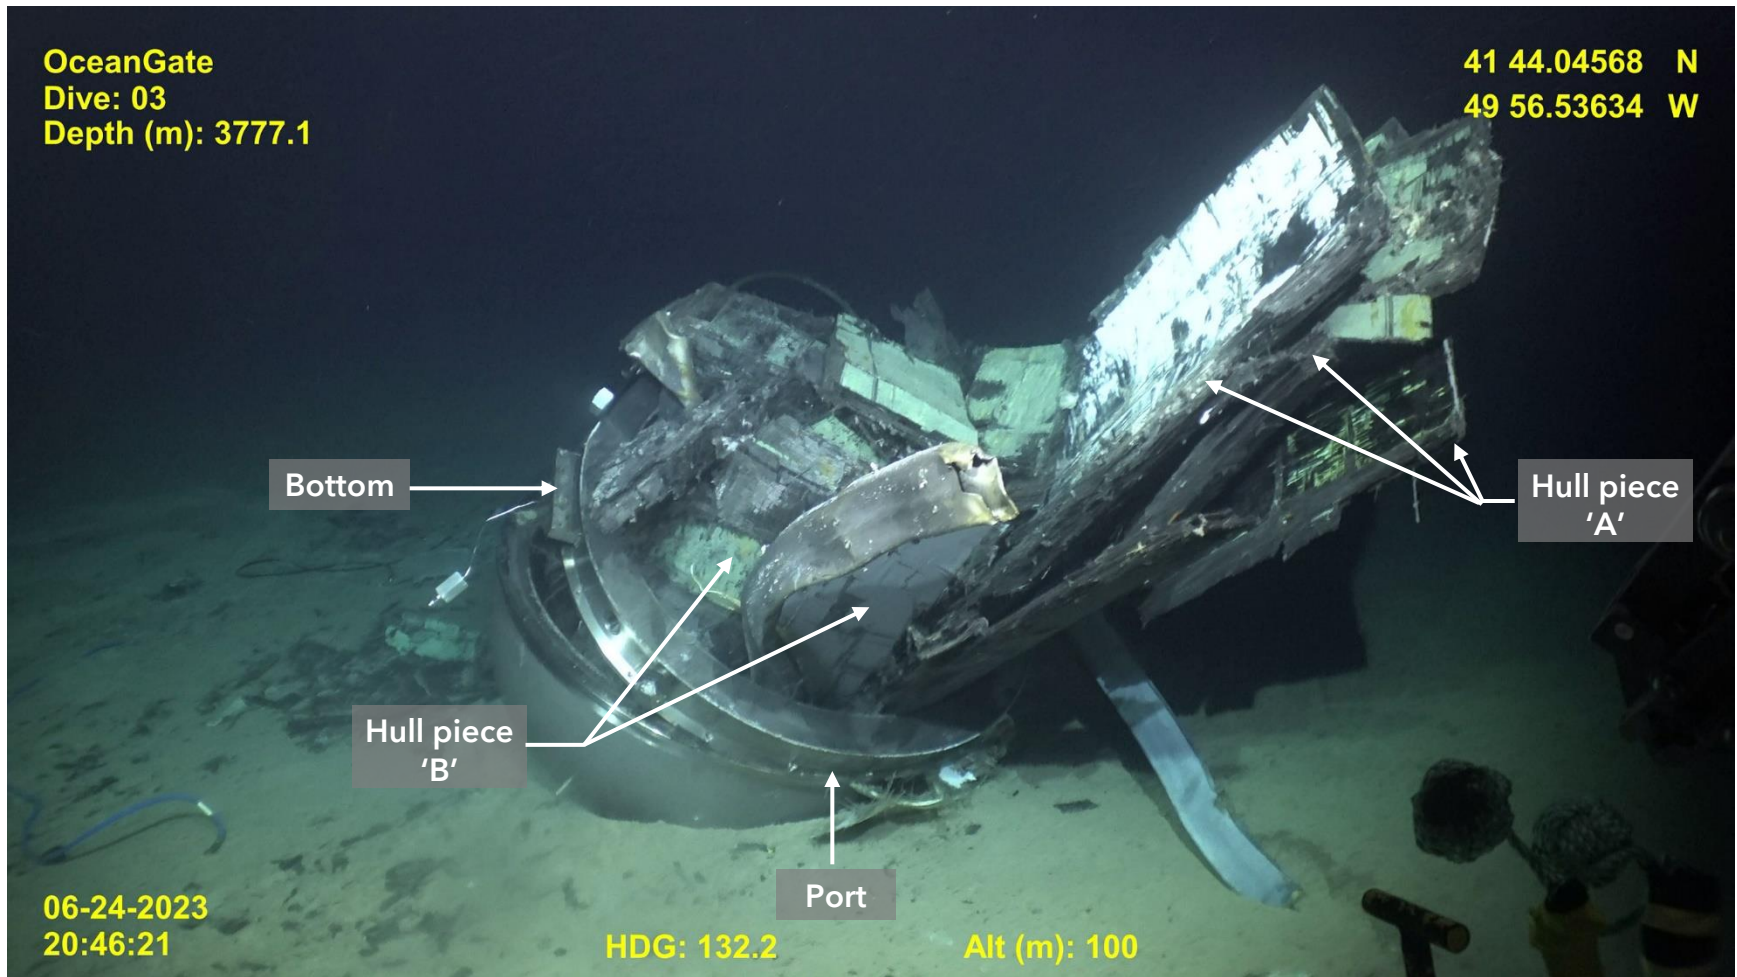
As found, piece 'B' was located on the port side of the wreckage (figure 5). Images of 'B' are shown in figures 13 and 15 - 21. The dimensions of the piece could not be precisely established but based on the size of 'A' it was likely between 60 inch and 72 inch long (between 5 and 6 feet), over half the length of the hull (full length is 100 inch). The aft end of the piece is labelled in figure 15. As with 'A', the piece had delaminated into multiple layers: layer 1, layers 2/3, and layers 4/5. The delamination at the layer 1/2 interface resided within the adhesive as did much of the delamination at the layer 3/4 interface.

Figure 5. Main wreckage viewed port side.

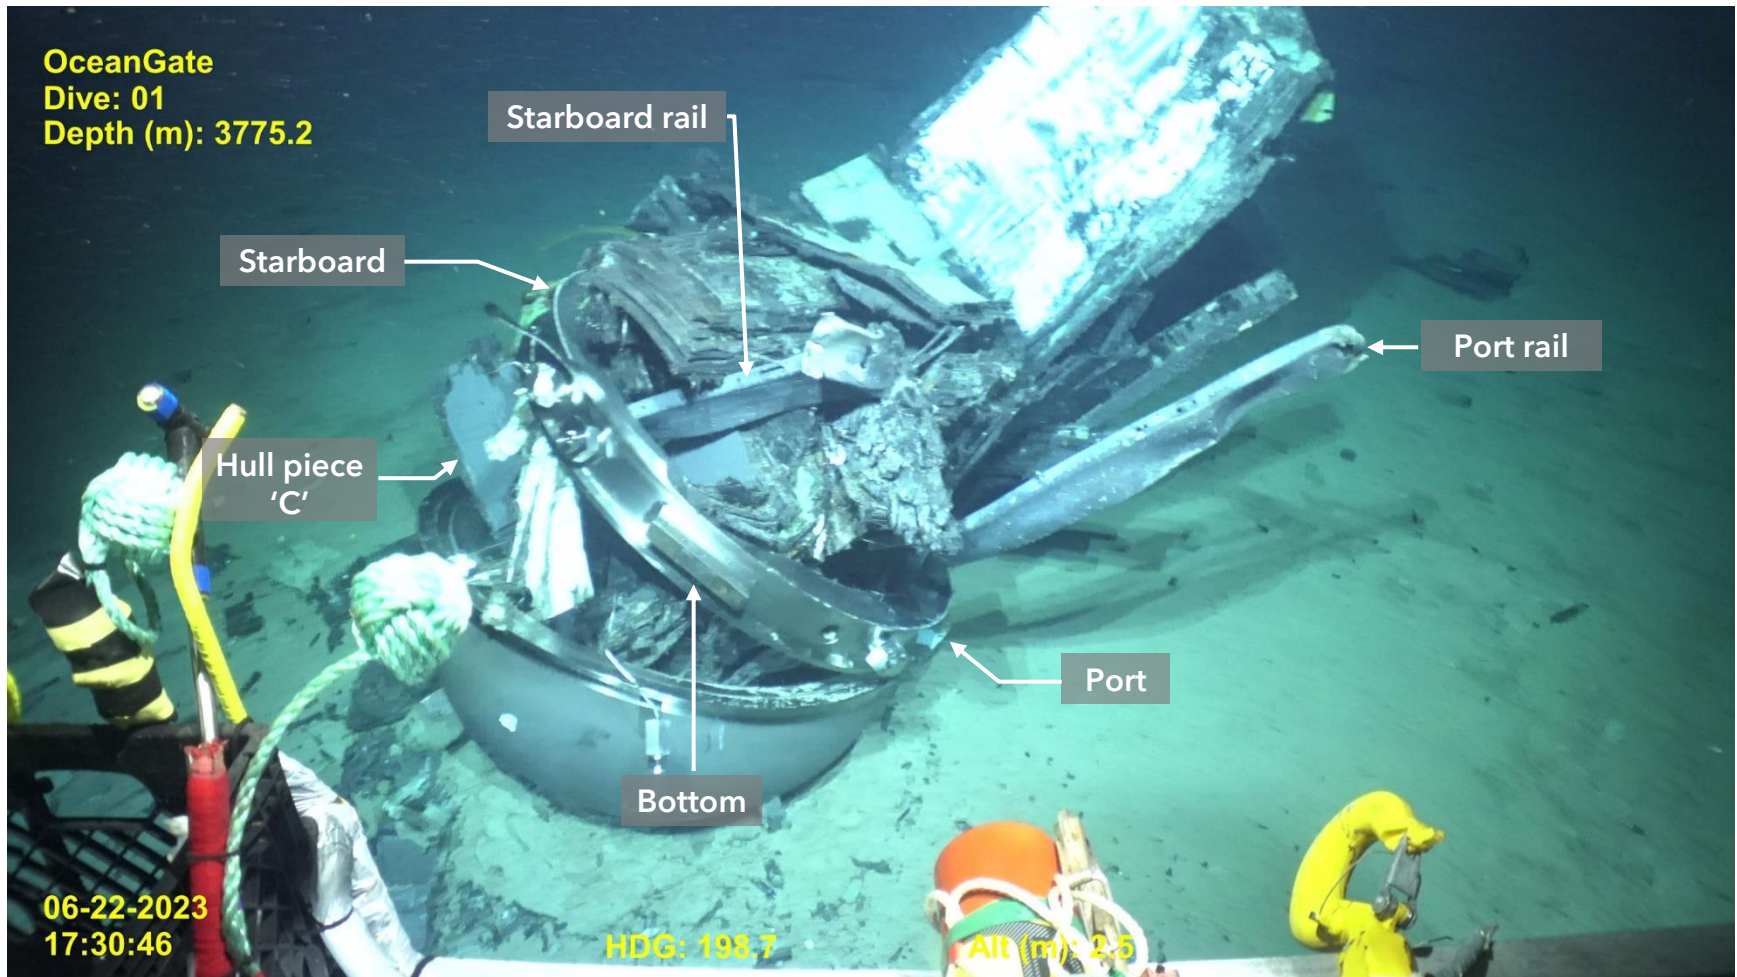
Piece 'C' was found between the bottom and starboard sides of the wreckage (figure 6). Additional images of 'C' are shown in figures 10 - 12. Its dimensions could not be determined. As with 'A', the piece had delaminated into multiple layers: layer 1, layers 2/3, and layers 4/5. The layer 3/4 interface had a dark appearance with occasional patches of green, consistent with separation near the 3/4 interface but predominantly through the carbon fiber composite.

Figure 6. Main wreckage viewed from bottom side.

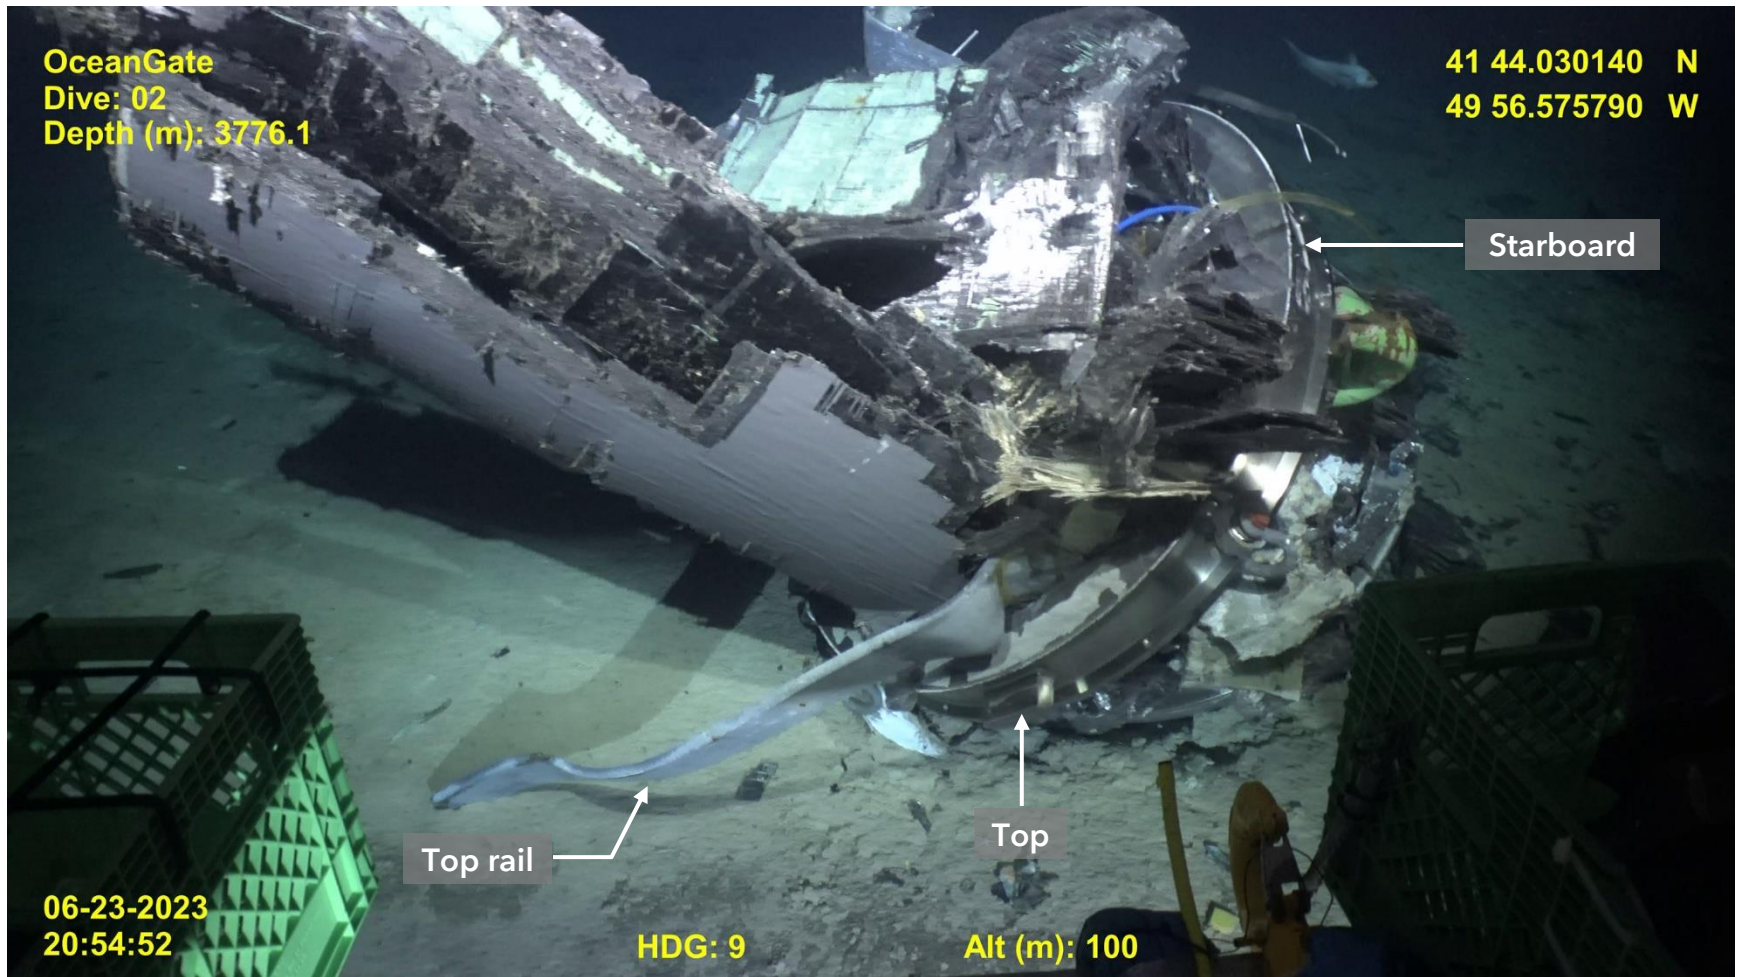
The top, port, and starboard rails were bent and/or fractured. The top rail, shown in figure 8 contained sigmoidal buckles at the forward and aft ends. The port and starboard rails are shown in figure 24. The ends of the rails were fractured and the forward end of the starboard rail was bent. The starboard rail was also bent mid-span. The port rail exhibited a counterclockwise twist.

Figure 8. Main wreckage viewed from top side.

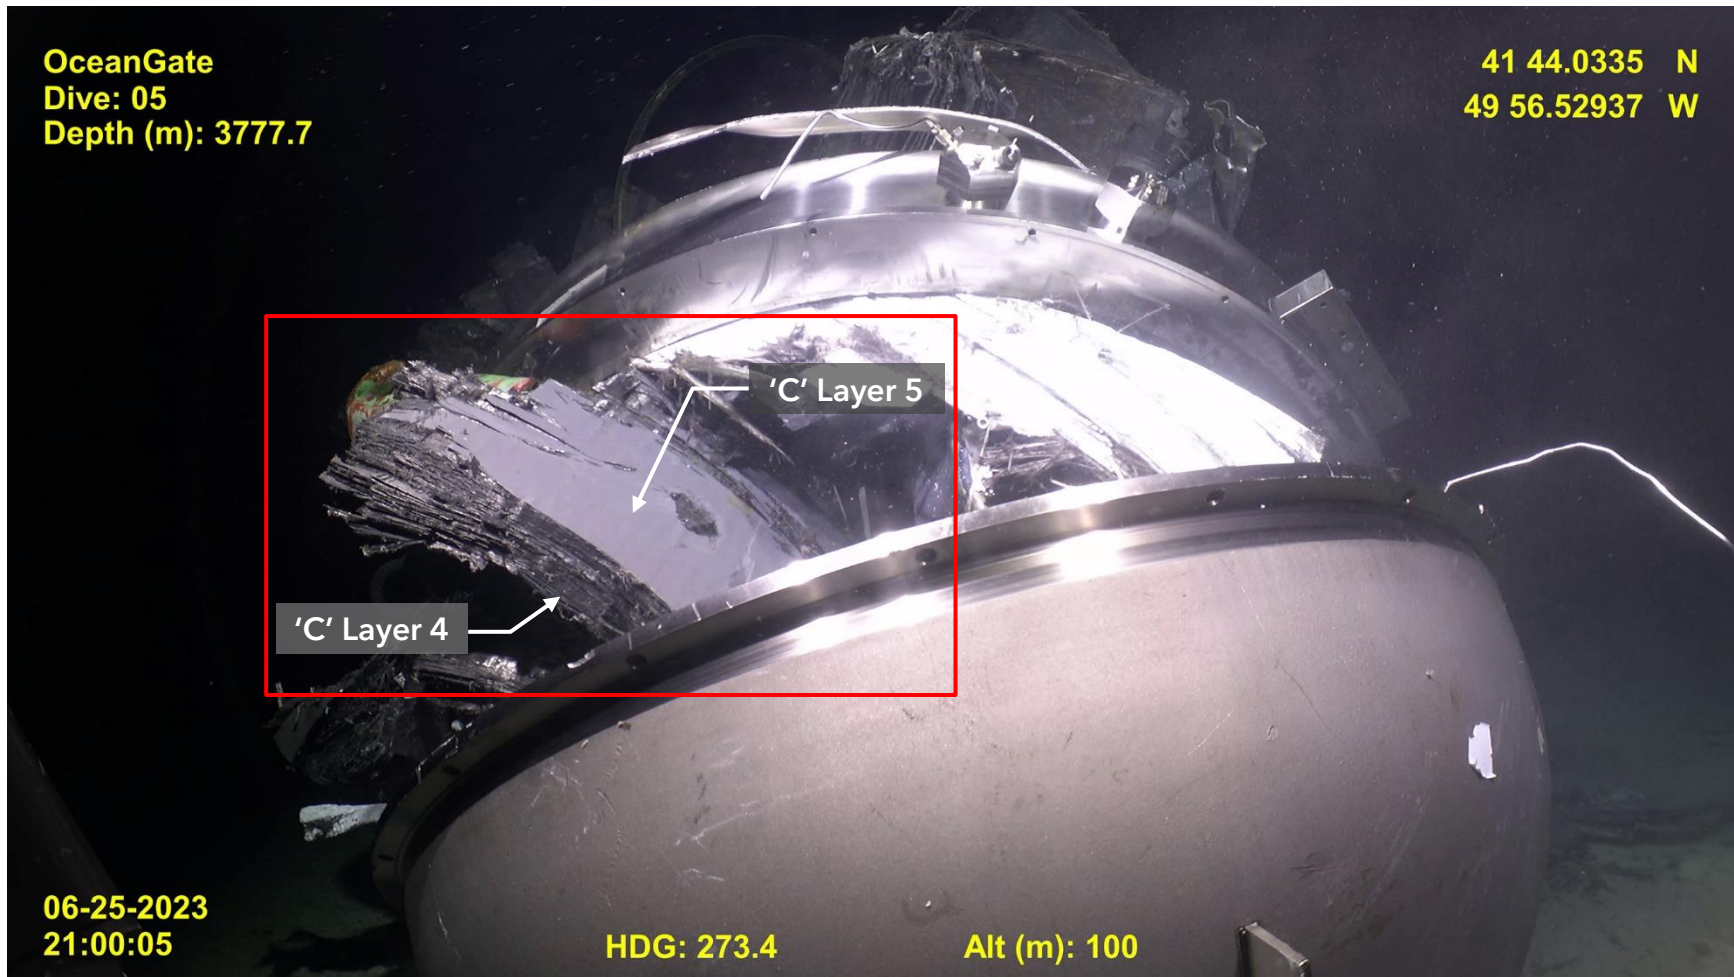
Figure 10. Piece of hull with rubber coating on the outside and the thickness of two co-bonded layers, consistent with layers 4 and 5.

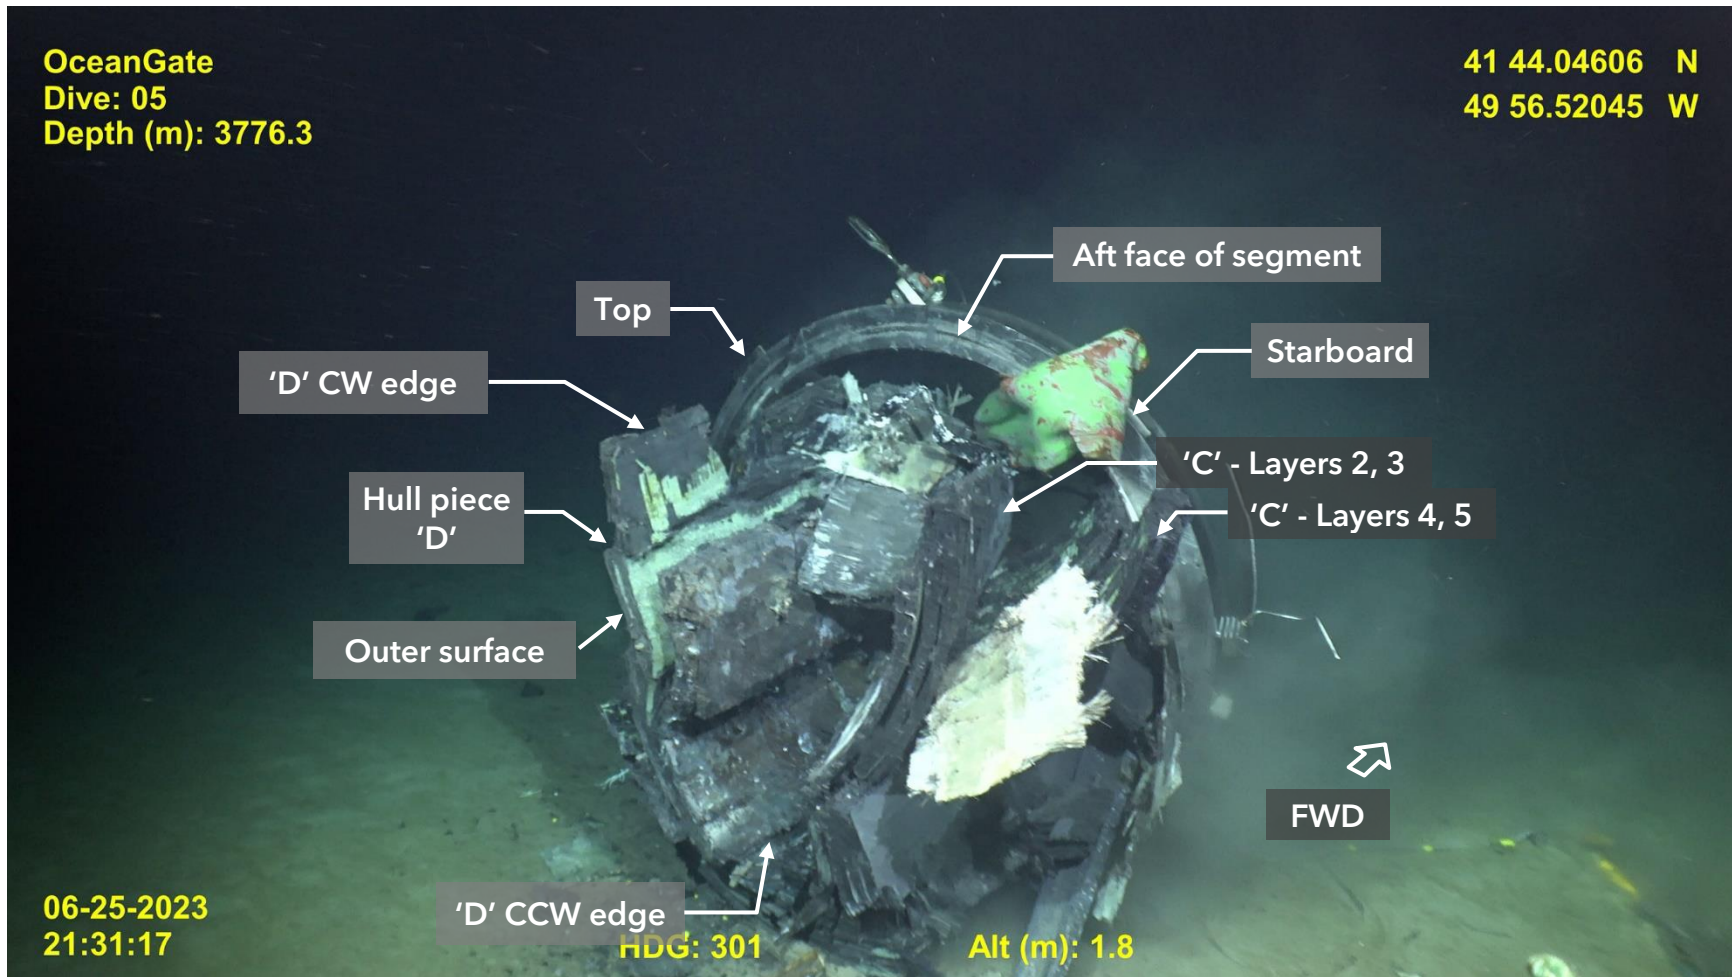
Several notable hull pieces were identified and given labels: 'A', 'B', etc. The pieces all contained delaminations within or adjacent to the co-bonded adhesive interfaces and so pieces were also identified by layer. The nearly full-length piece from the top of the hull was labelled 'A'. A piece viewable from the port side of the wreckage, indicated in figure 5, was labelled 'B'. A piece viewable from the starboard / bottom sides was labelled 'C' as indicated in figures 6, 10 and 11. Finally, a piece that was hidden from view until the aft segment was separated from the aft dome was labelled 'D', as indicated in figure 11.

Piece 'D' was not originally visible from outside of the wreckage. The aft end of the piece was revealed after the segment was separated from the aft dome (figure 11). 'D' appeared to have been sandwiched between 'B' and 'C'. Additional photos are shown in figures 22 and 23. 'D' was a partial piece. Layer 1 was missing (the inner surface of the hull was painted white and no painted surface was seen). Along the CW side, the piece was delaminated through the adhesive. 'D' exhibited a sigmoidal buckle as indicated by the yellow dashed line in figure 22, with an inward bend and an adjacent outward bend. Between the bends, the separation within the adhesive layer transitioned into the adjoining composite material.

Figure 11. Aft segment and aft end of aft hull pieces after the segment was removed from the aft dome.

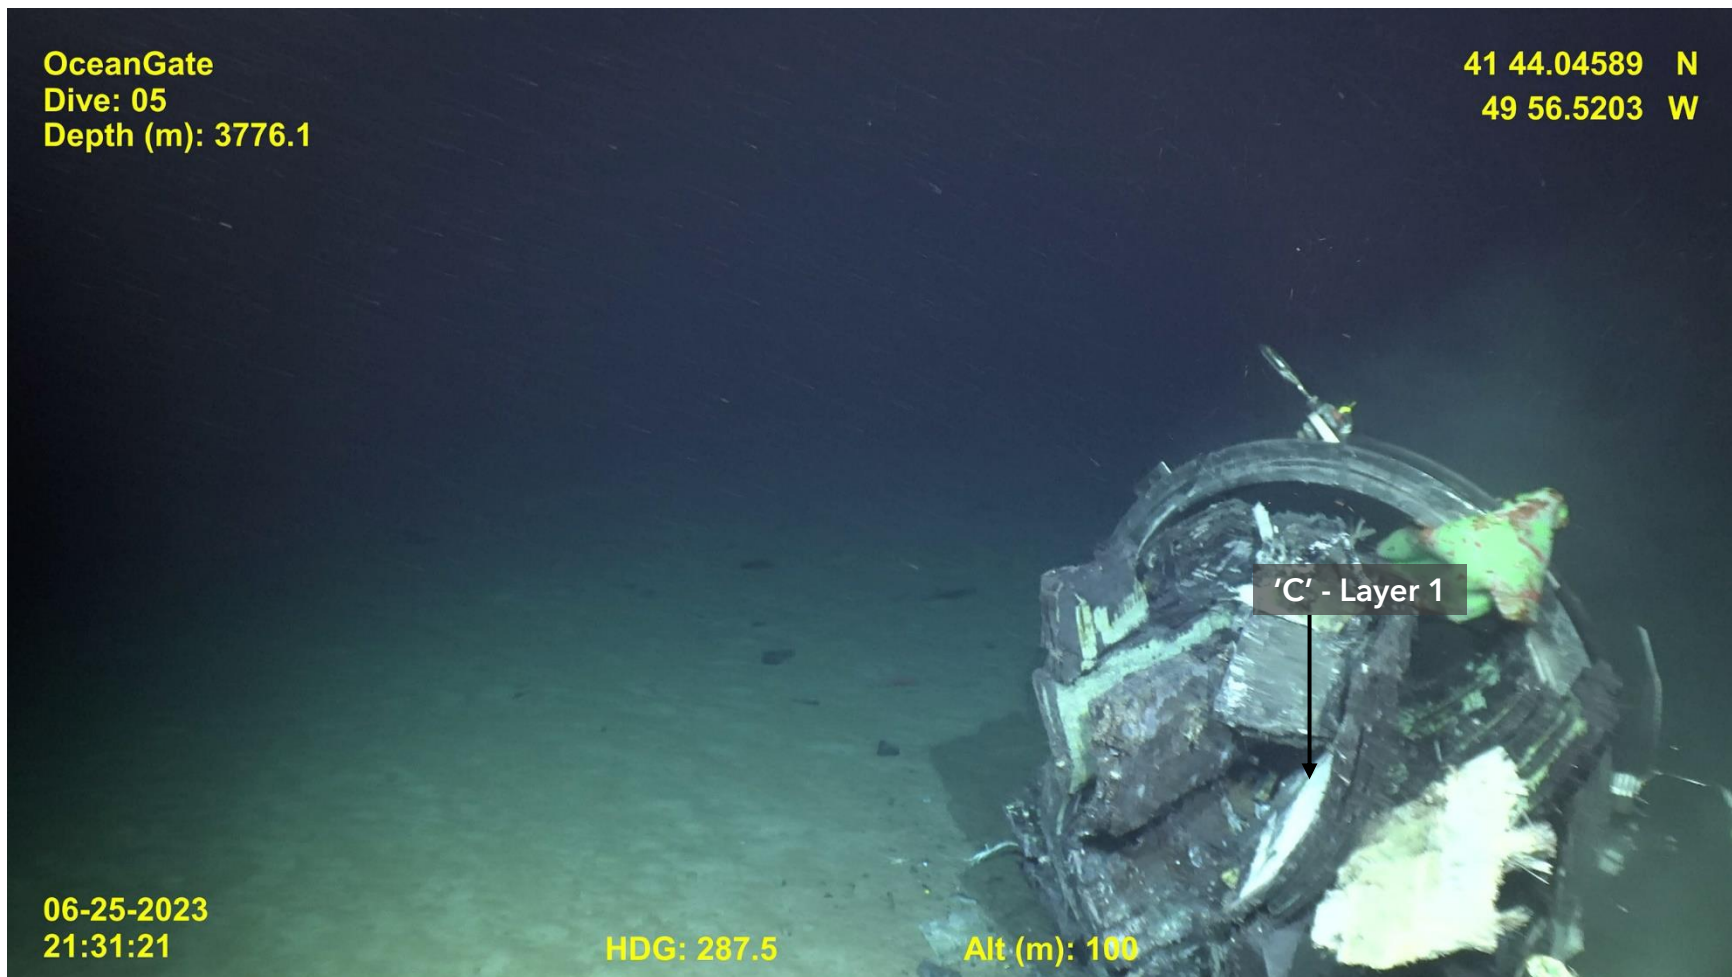
Figure 12. Similar image as figure 11 but at a slightly different angle to show the white paint on the inner surface hull piece 'C' layer 1.

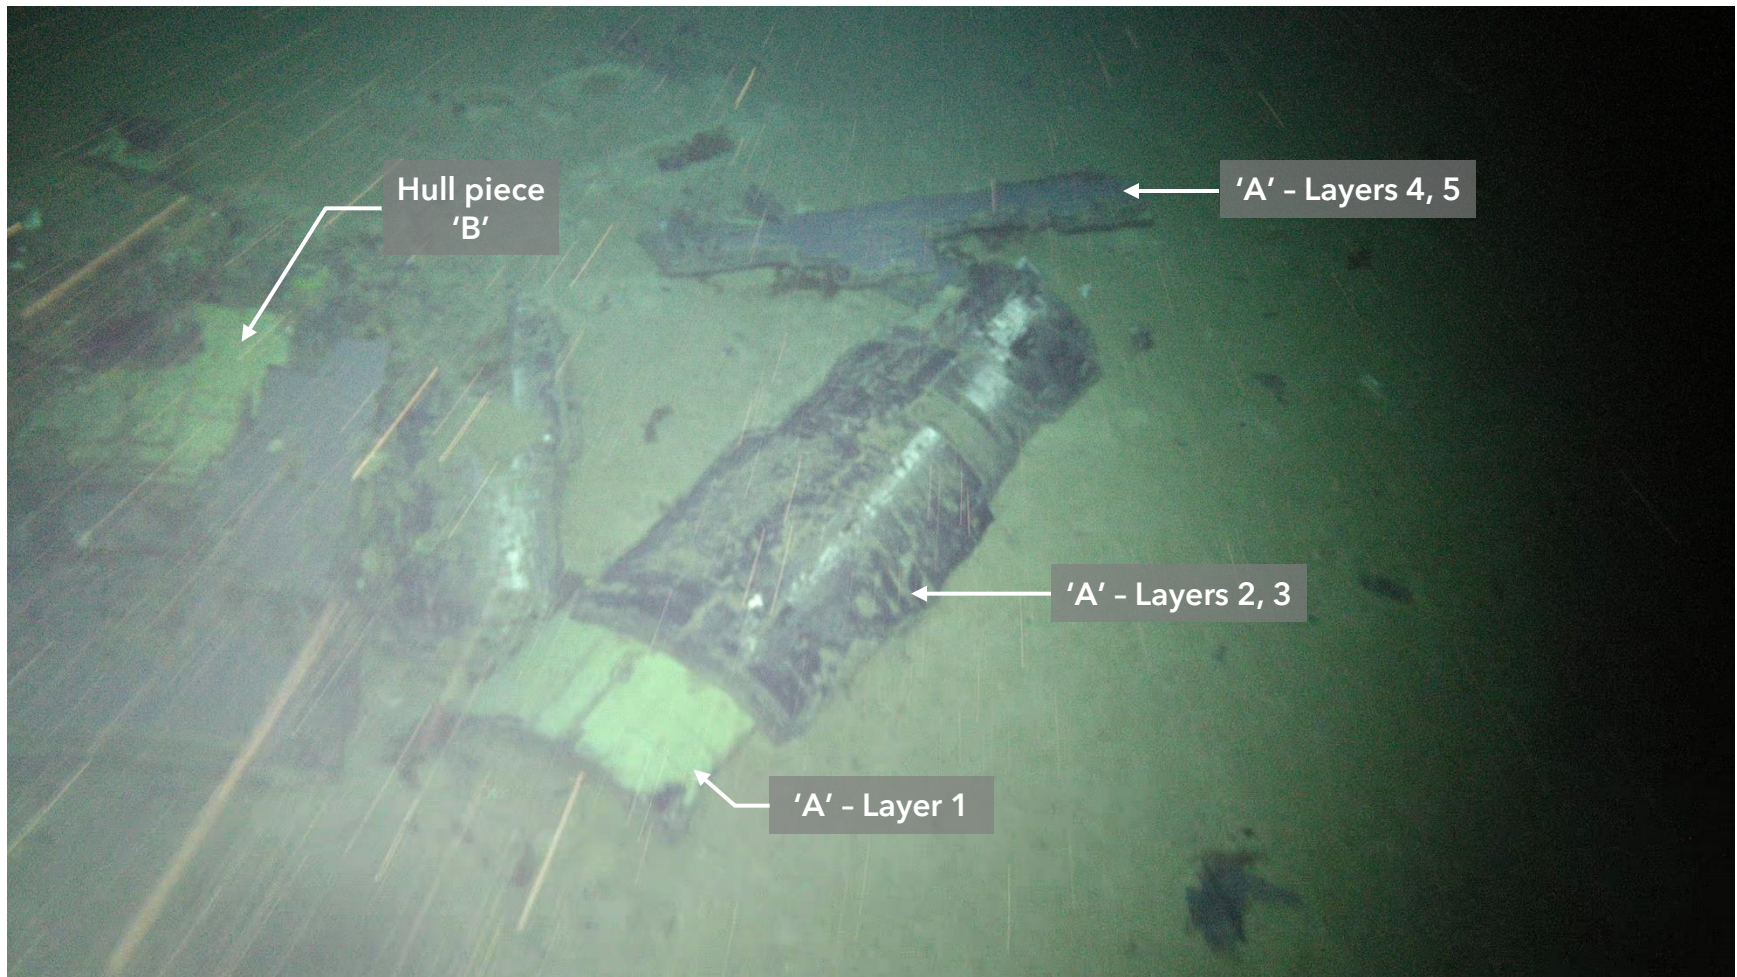
Figure 13. Image of hull piece 'A' after disentanglement from the aft segment.

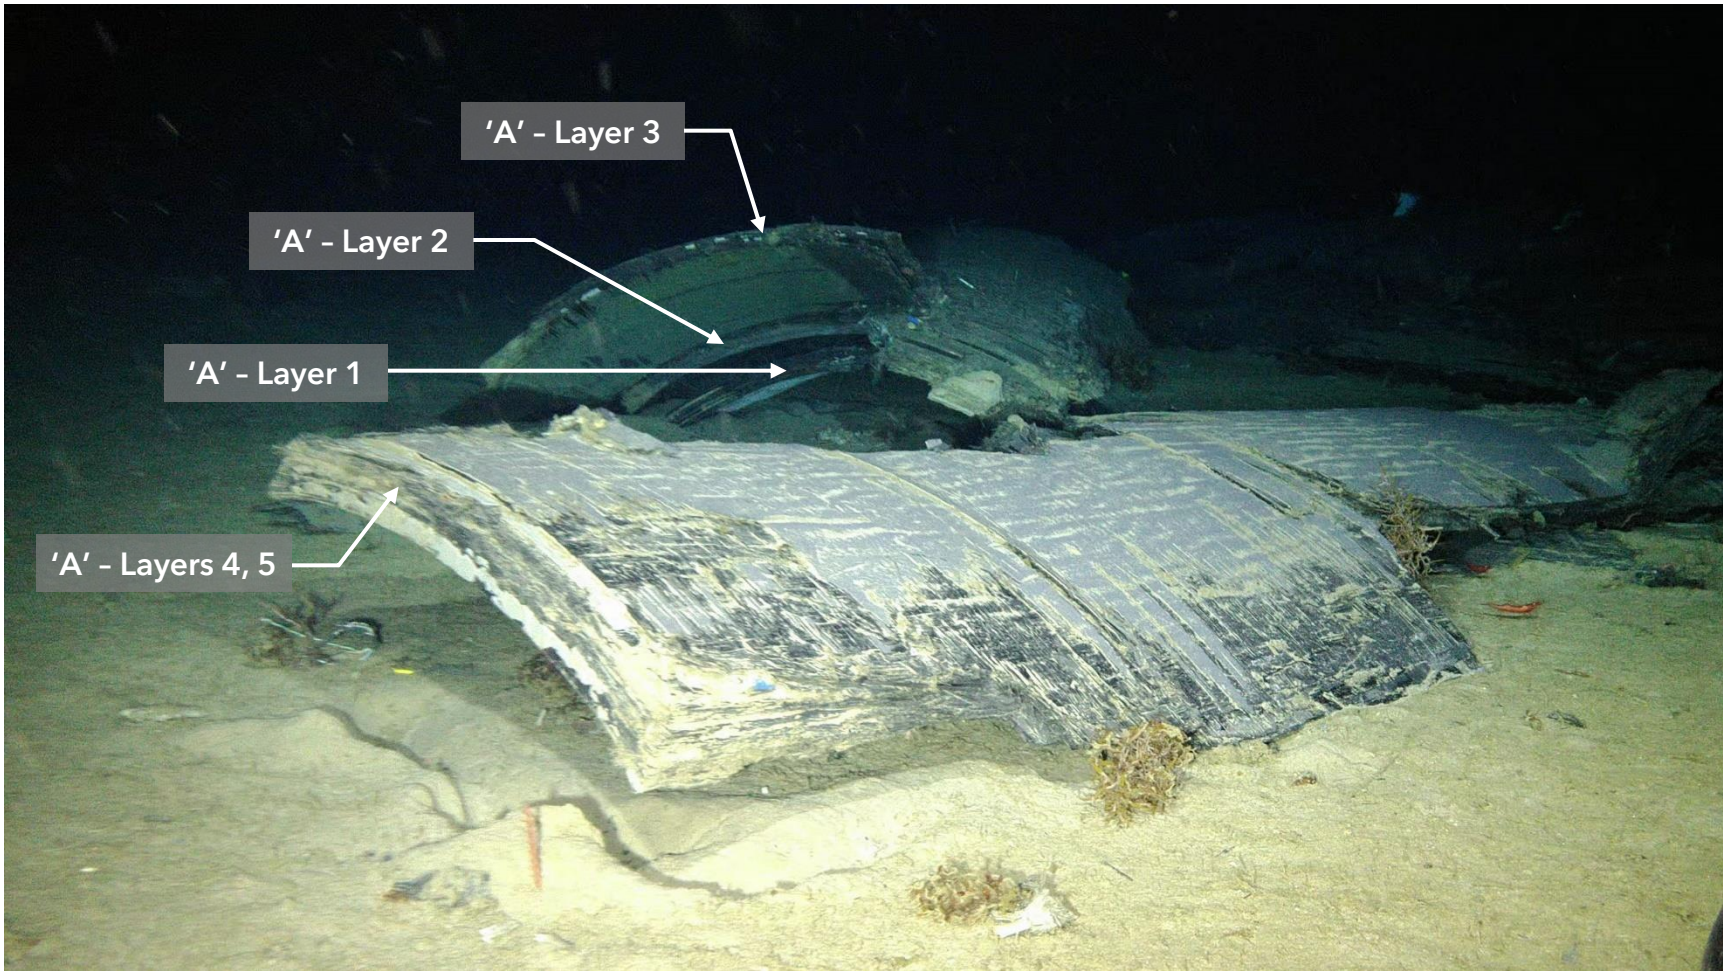
Piece 'A' spanned nearly the full length of the hull (Layers 4 and 5 from 'A' were recovered from the ocean floor and later examined at the U.S. Coast Guard facility in Newport, RI. That piece was 97 inch long). As found, 'A' was located near the top of the hull, possibly offset toward the port side. Several of the layers at the forward end had a machined appearance and bits of attached adhesive were observed. Images of 'A' during the second salvage mission are shown in figures 13 - 16. 'A' had delaminated into three layered pieces. The outer piece consisted of layers 4 and 5. The inner piece consisted solely of layer 1. The middle piece consisted of layers 2 and 3. As seen in figure 14, there was an additional delamination at the forward end between layers 2 and 3 and a fragment of layer 2 had separated from the rest of the piece. It could not be determined how far along the interface the layer 2/3 delamination extended. The outer surface of 'A' - layer 1 was green, consistent with separation within the adhesive layer. The layer 4 and 5 sub-piece examined at the U.S. Coast Guard facility had separated from the top of layer 3 adjacent to the layer 3/4 interface, primarily within the carbon fiber laminate.

Figure 14. View of the forward ends of hull piece 'A' with the individual co-bonded layer labelled.
