National Transportation Safety Board

MATERIALS LABORATORY

Factual Report 24-012

Location: Atlantic Ocean
Date: June 18, 2023
Vehicle: OceanGate Experimental Submersible Titan
Investigator: Marcel Muise, MS-10

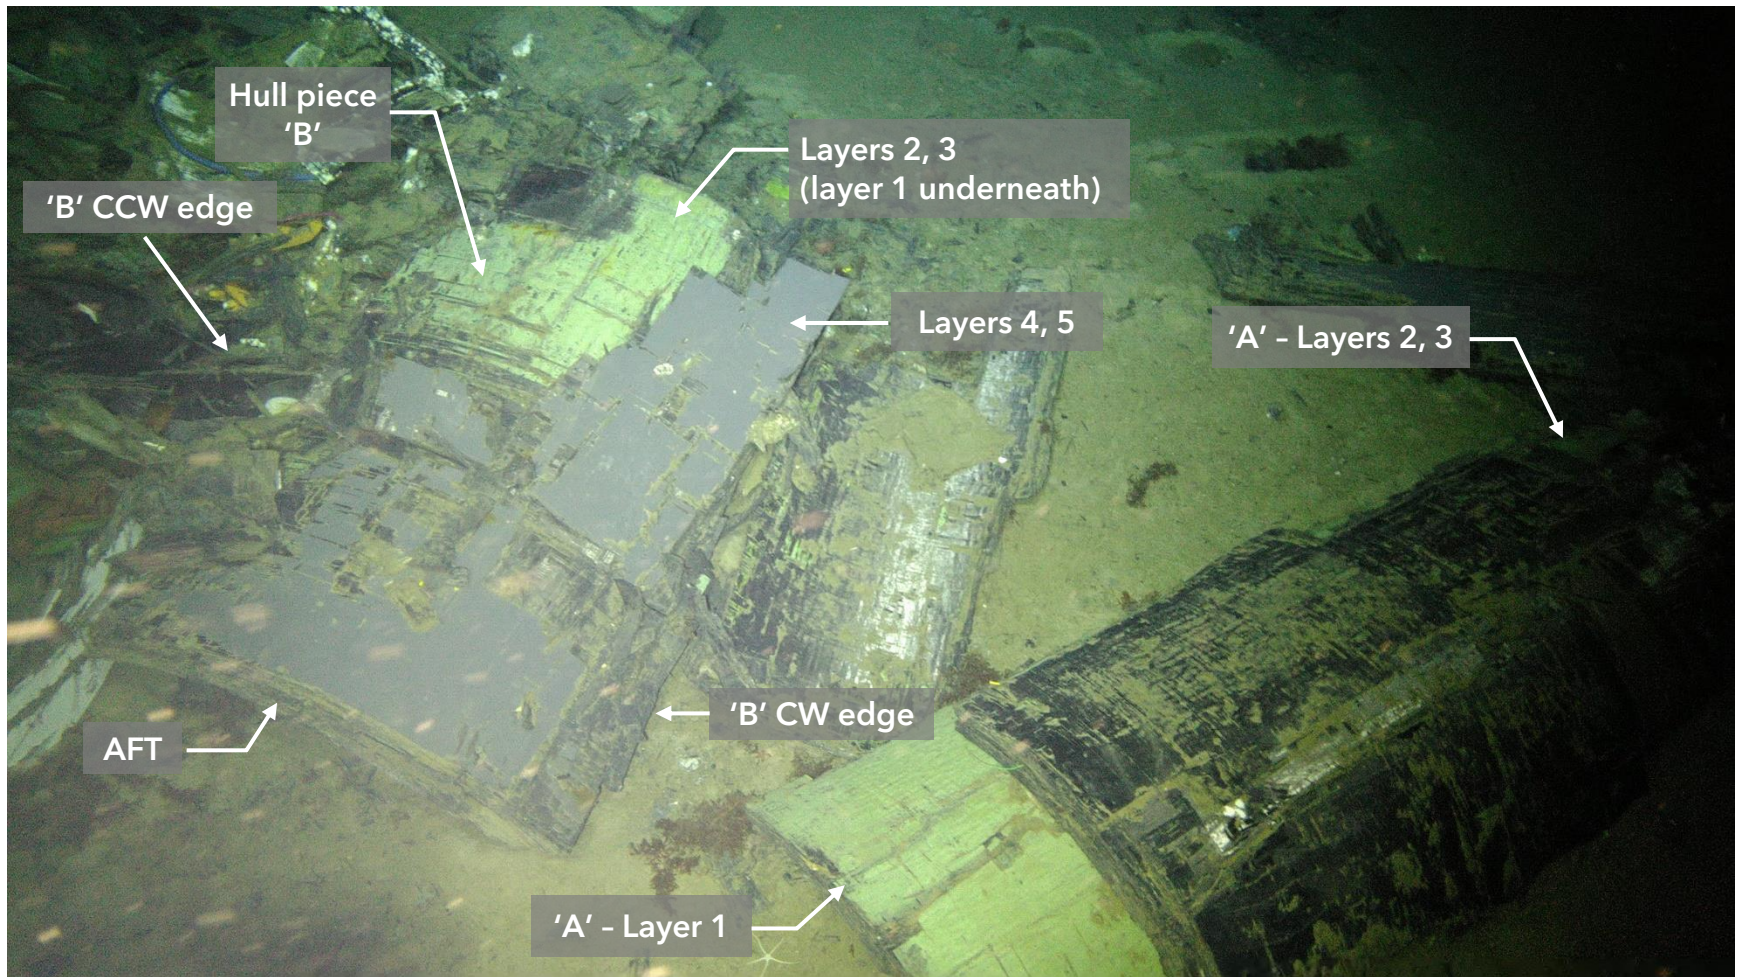
Figure 15. View of hull piece 'B' with the layers labelled. Portions of piece 'A' visible on the right side of the image.

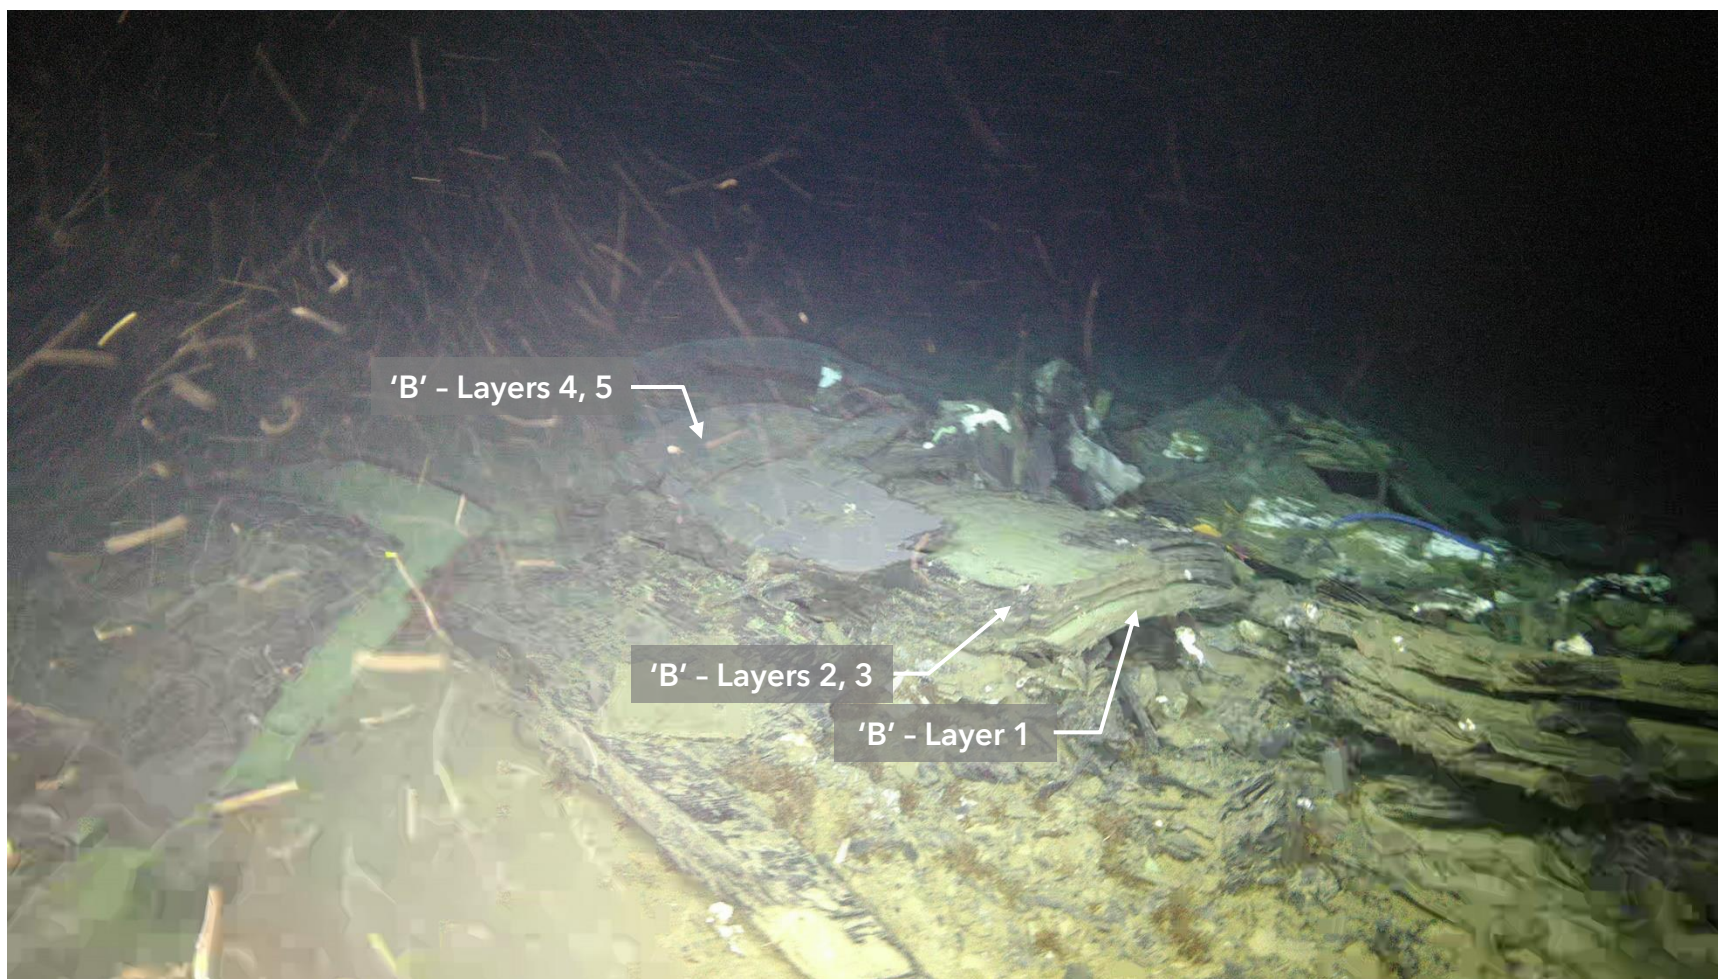
Figure 17. Image of piece 'B' with the layer pieces labelled.

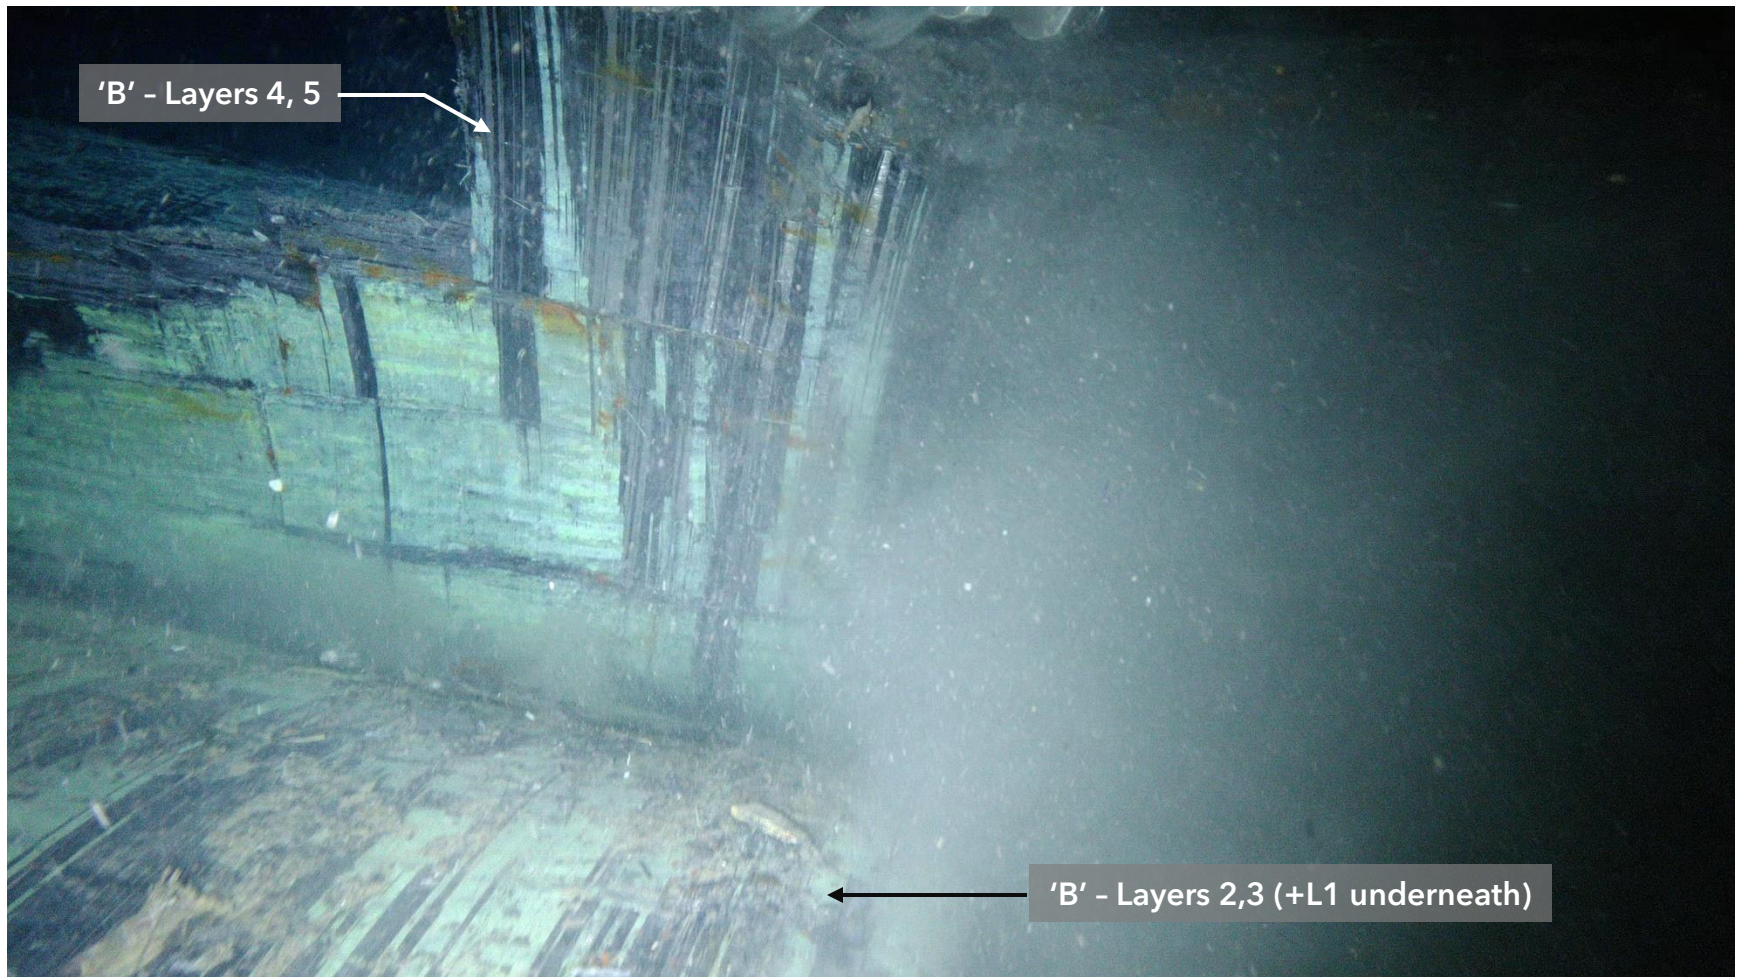
robotic arm (see figure 18), the underside exhibited multiple longitudinal cracks. The adhesive surface also exhibited a light/dark pattern, like that documented in Materials Laboratory Factual Report 24-011. Features consistent with voids were present on the surface of layer 1, but due to the layup sequence at the layer 3/4 interface, it could not be determined if some features at that interface were voids or longitudinal fiber fragments. The longitudinal through-thickness fracture on the clockwise (CW) edge of the piece appeared relatively straight, whereas the through-thickness fracture on the counterclockwise (CCW) edge was irregular (see figure 20).

Figure 18. Piece 'B' layer 3/4 interface showing period light dark pattern in the adhesive.

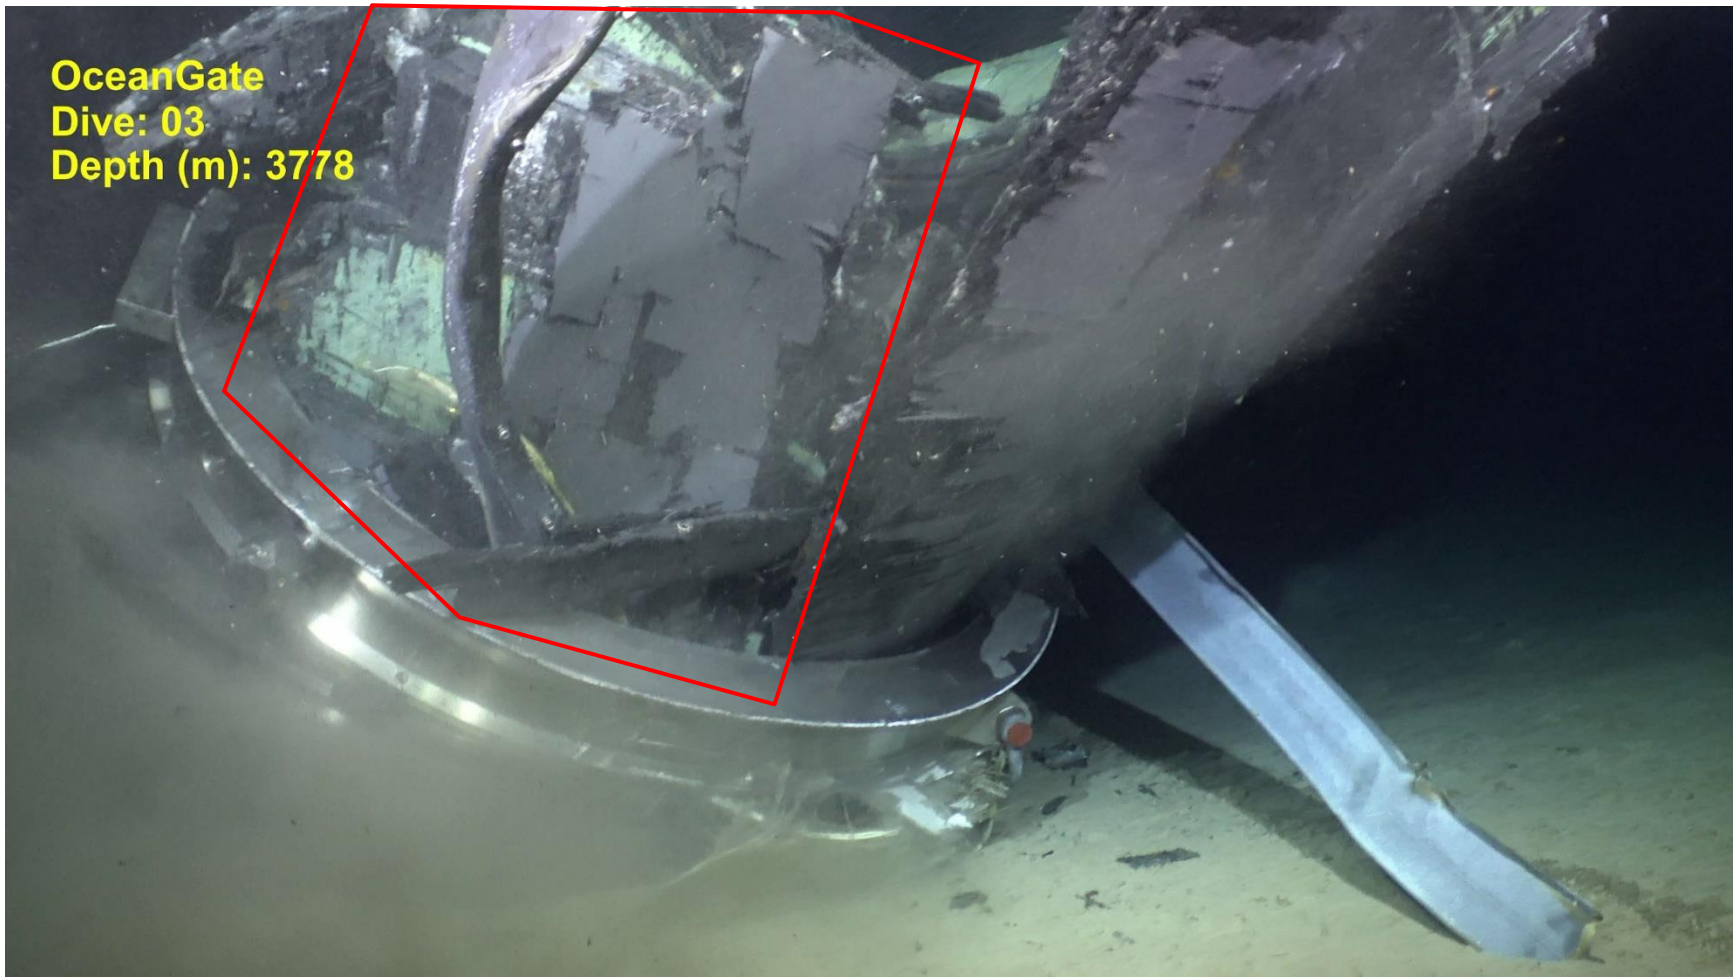
The outermost piece (layers 4/5) was fractured and cracked in additional locations. Part of its forward end was missing, allowing line-of-sight visibility of the adhesive on top of layer 3. When the layer 4/5 piece was lifted and set aside by

Figure 19. Image of piece 'B' showing cracking on the surface.

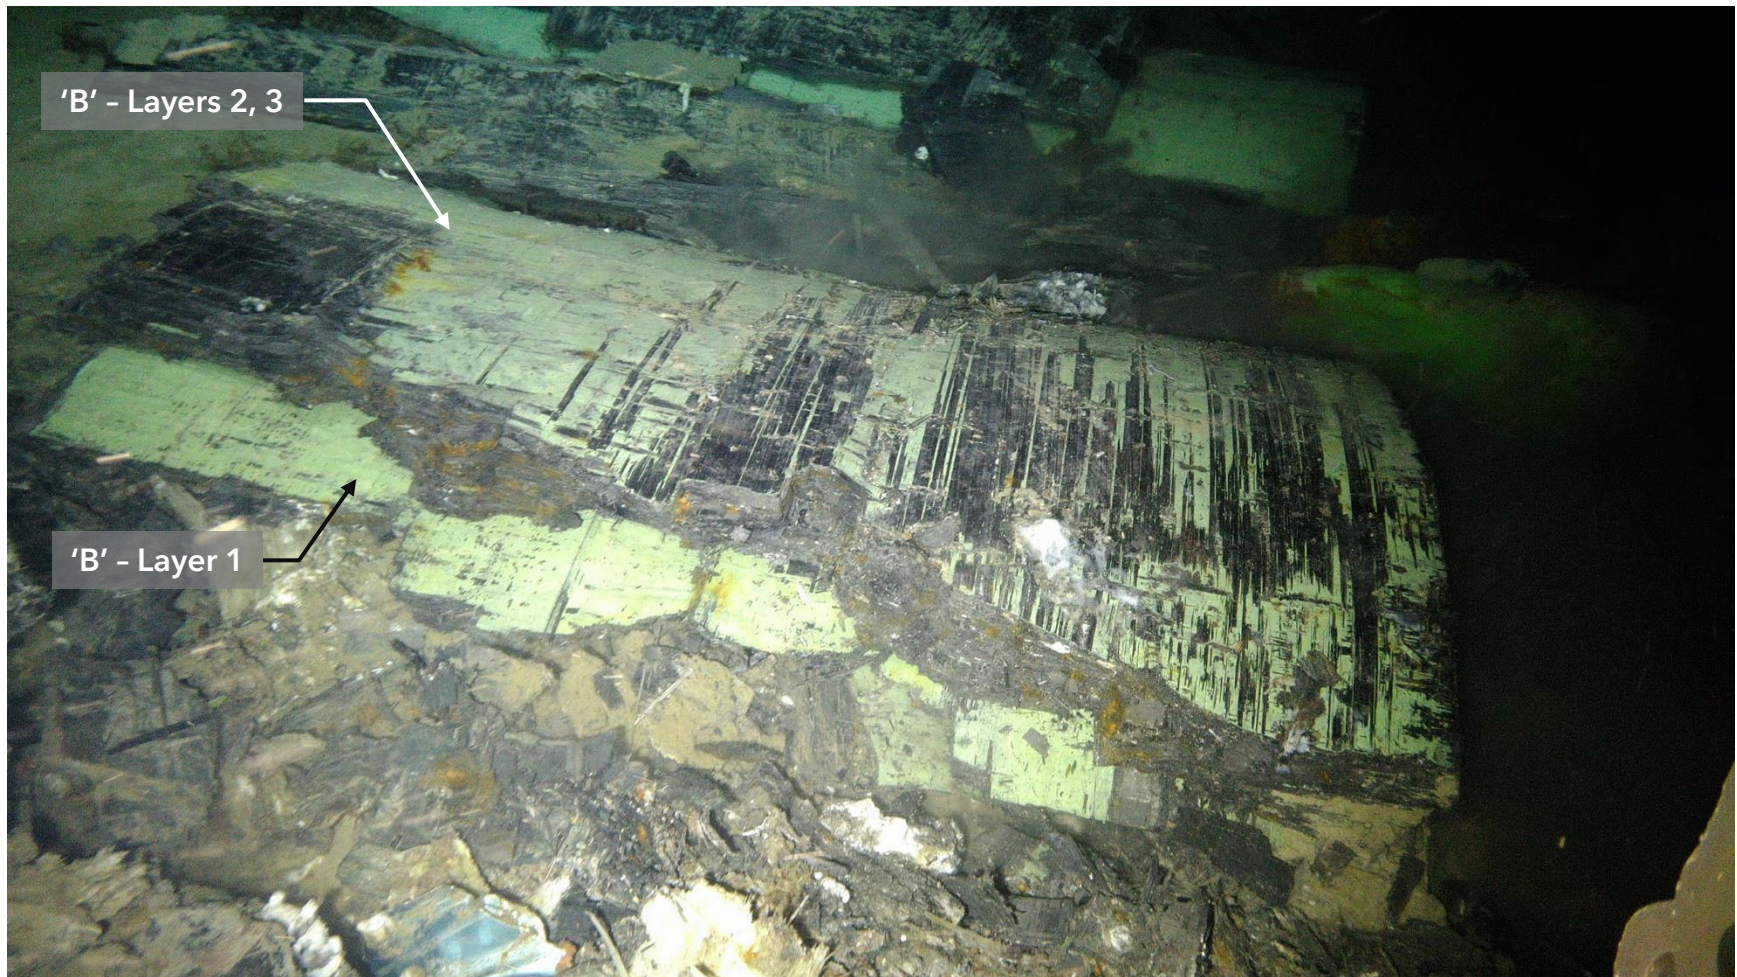
Figure 20. View of piece 'B' after removal of layers 4 and 5. The fracture along the CCW edge was irregular.

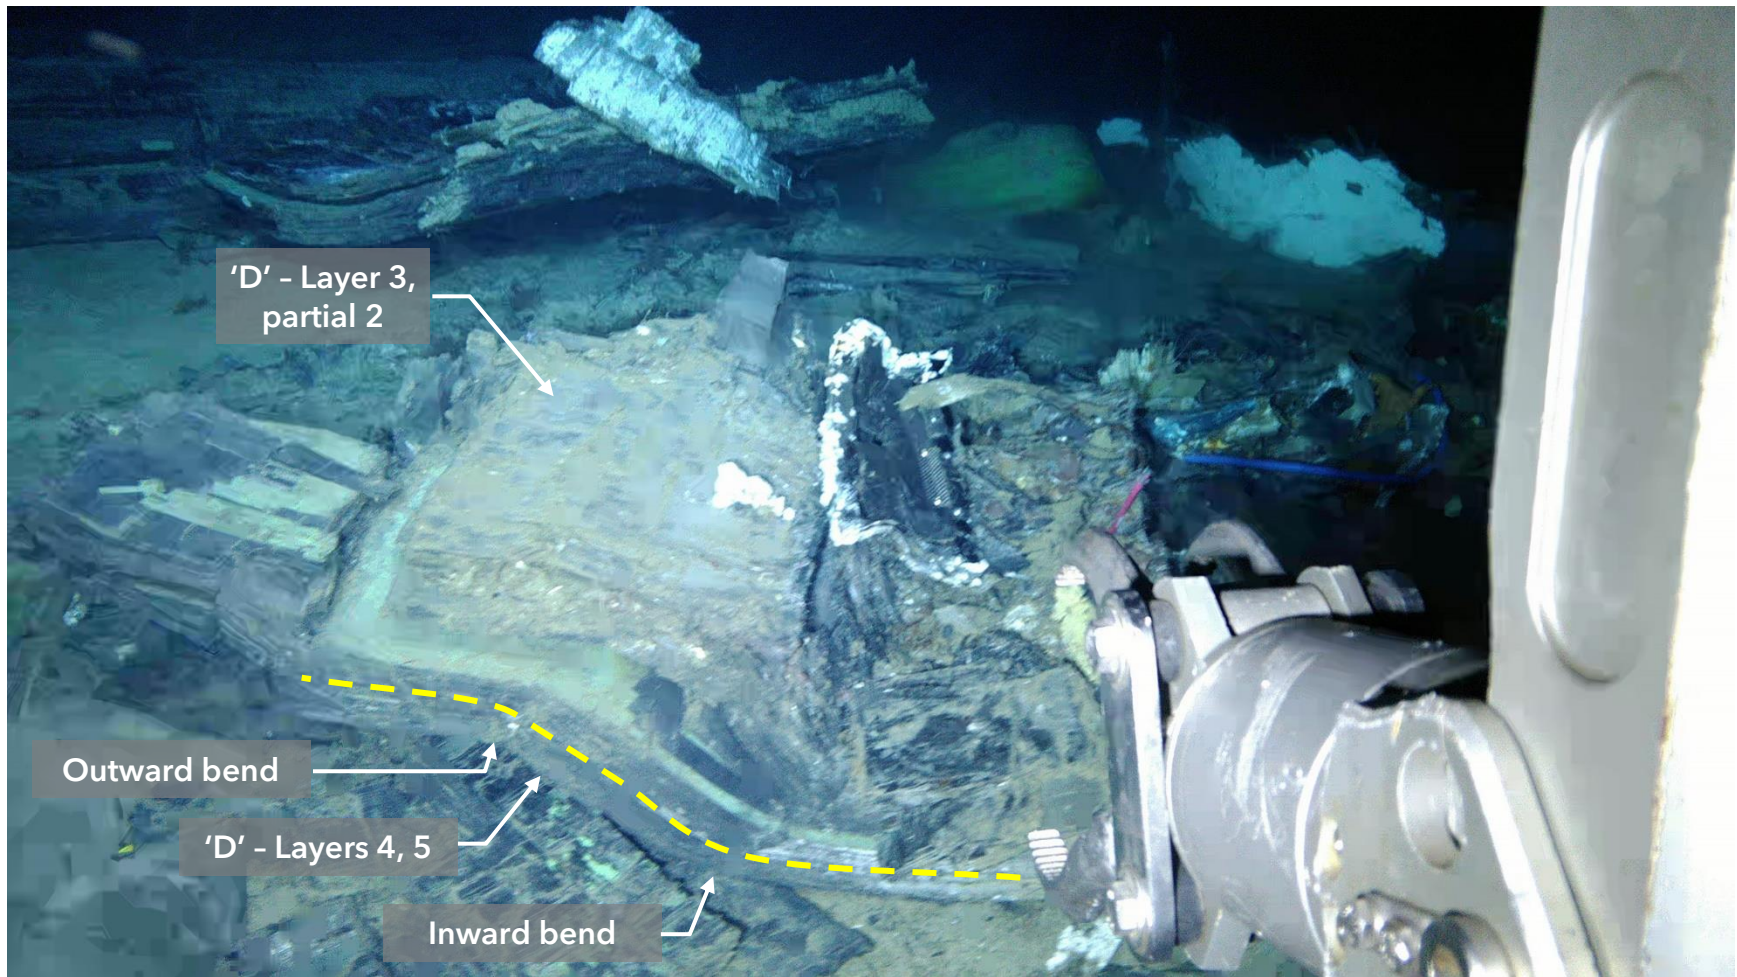
Figure 22. Image of piece 'D' showing the sigmoidal buckle as a yellow dashed line.

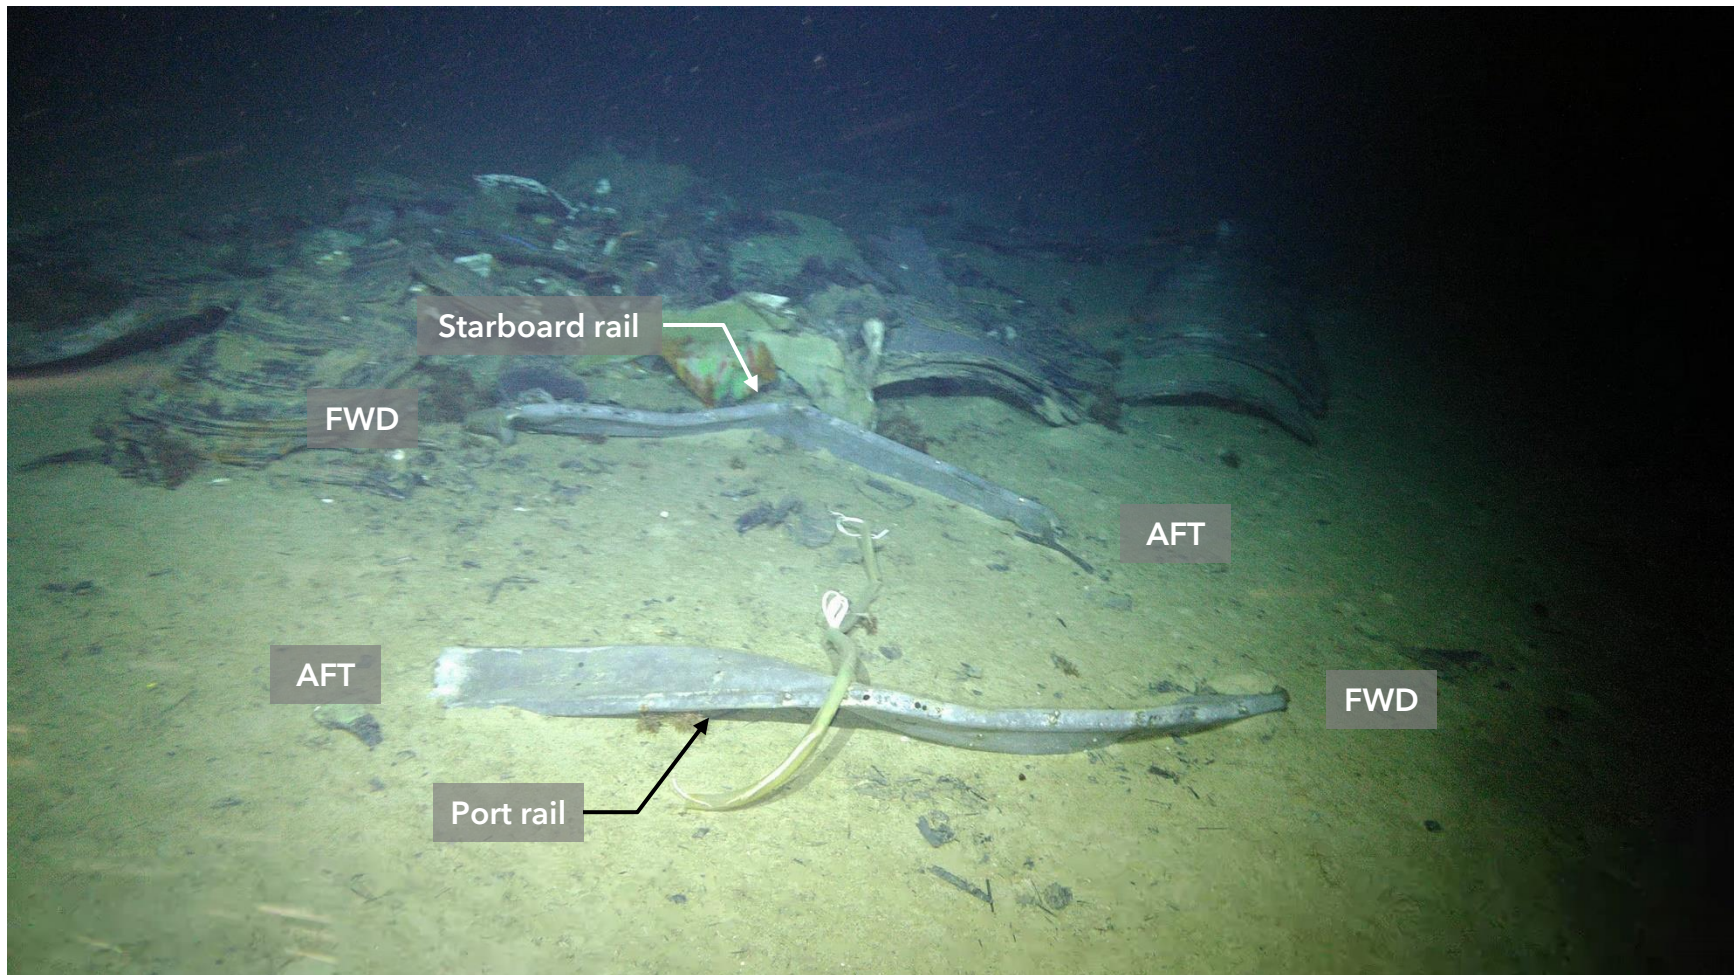
Figure 24. Port and starboard rails. The short sides of the rails in view are most likely the lower sides, based on residual marks left by the drop weight assembly attachment brackets.

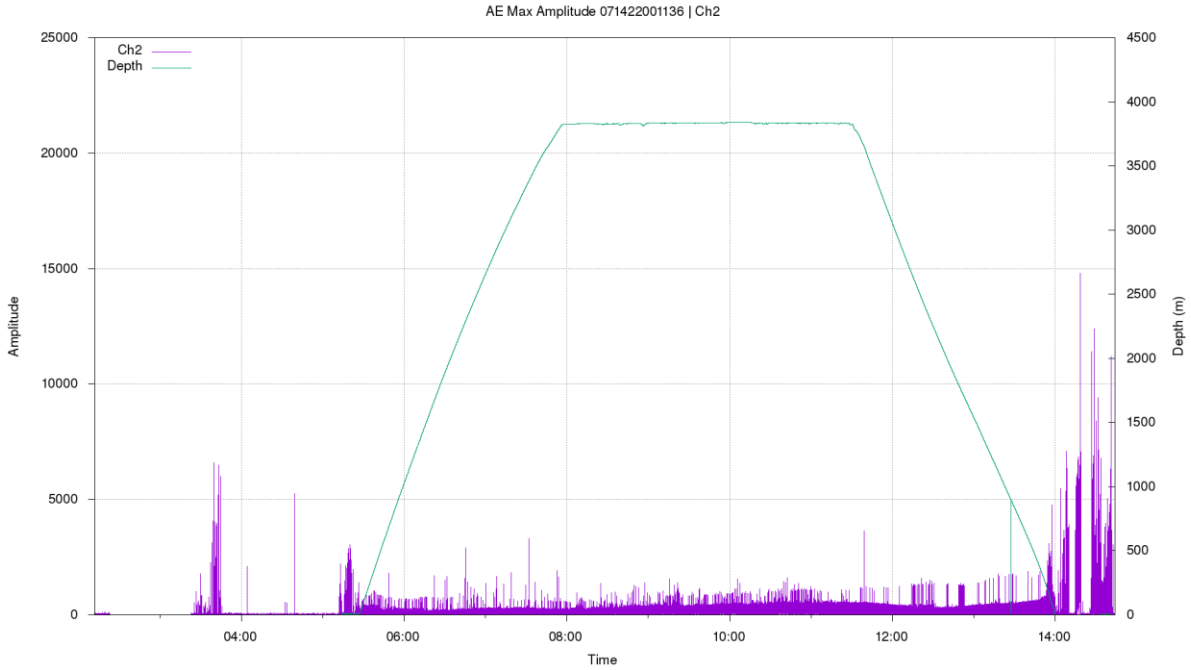
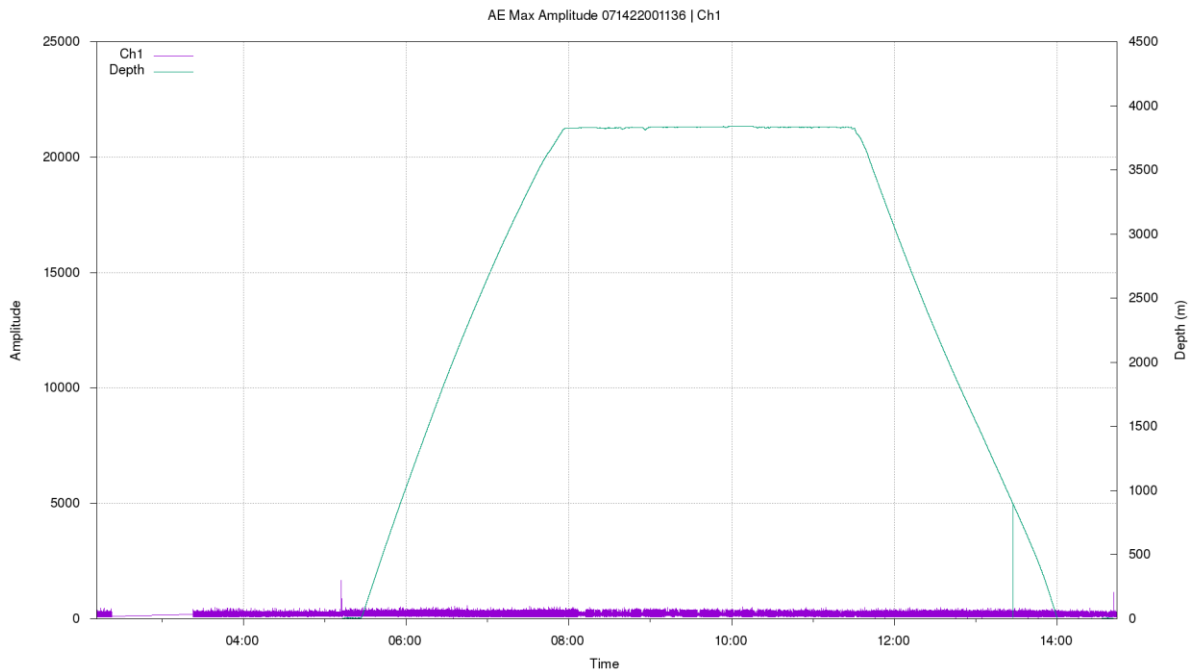
OceanGate staff produced time-based plots of acoustic activity and strain gage output for each dive. Complete dives, correlated with the vessel's ocean depth, were available for dives 75, 76, and 79 - 83. Dive 75 took place on July 3, 2022.¹ Dive 83 took place on July 23, 2022, but at a different dive location and to a depth of only 2,954 m. The other dives all descended to approximately 3,840 m. Three of the eight sensors did not register acoustic events for any of the 2022 dives. Typical outputs for an active and inactive sensor are shown in figures 25a and b, respectively. Figure 25a shows acoustic events captured by channel 2. Figure 25b shows that no analogous

events were captured by channel 1. Channels 1, 3, and 5 did not capture any apparent acoustic events for the 2022 dives.²

Figure 25. Time plots of acoustic events detected by acoustic emission detector for Dive 76: a) Channel 2 showing detected event and b) channel 1 showing no indication of event detection.

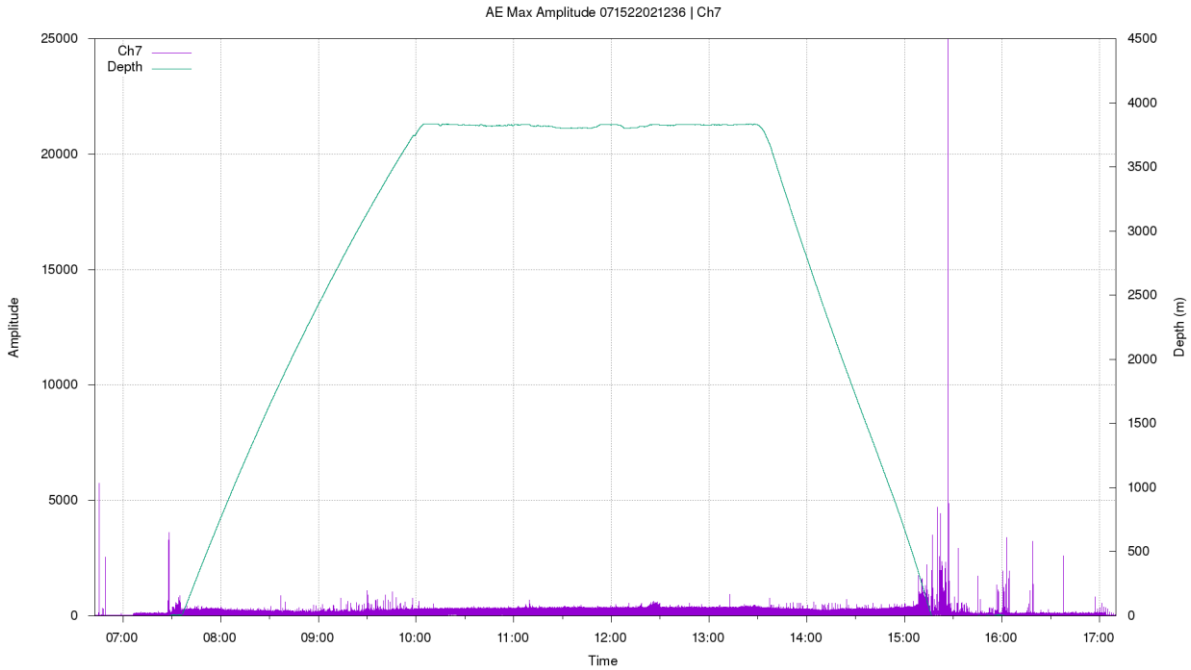
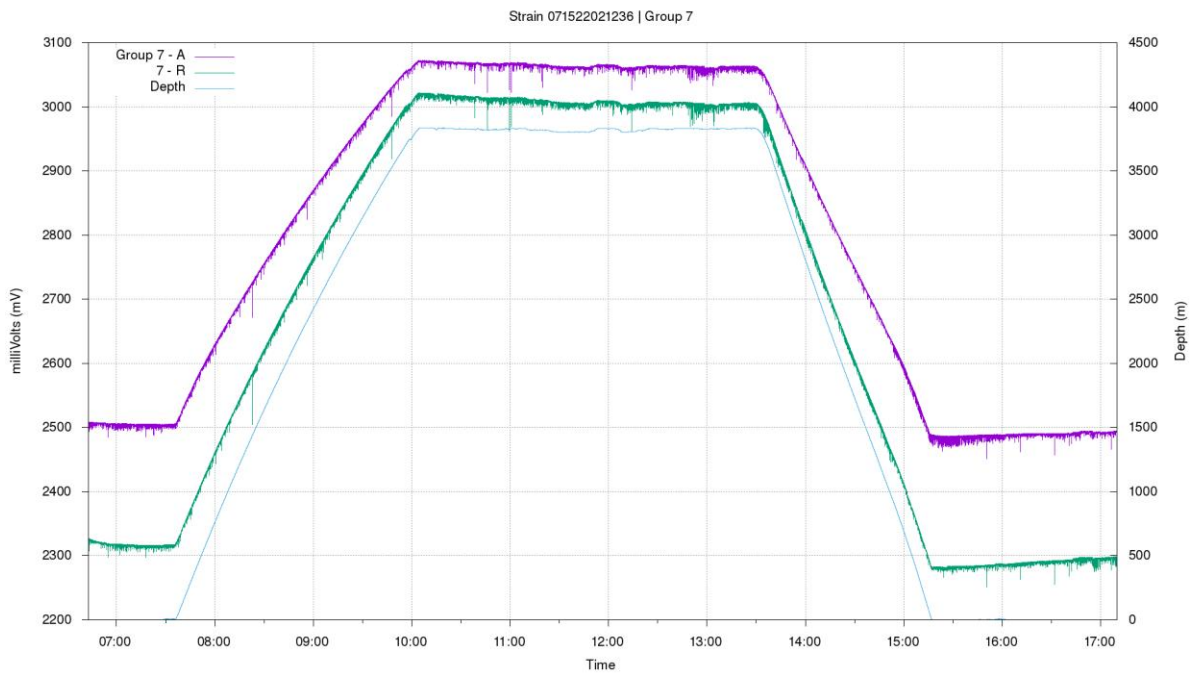
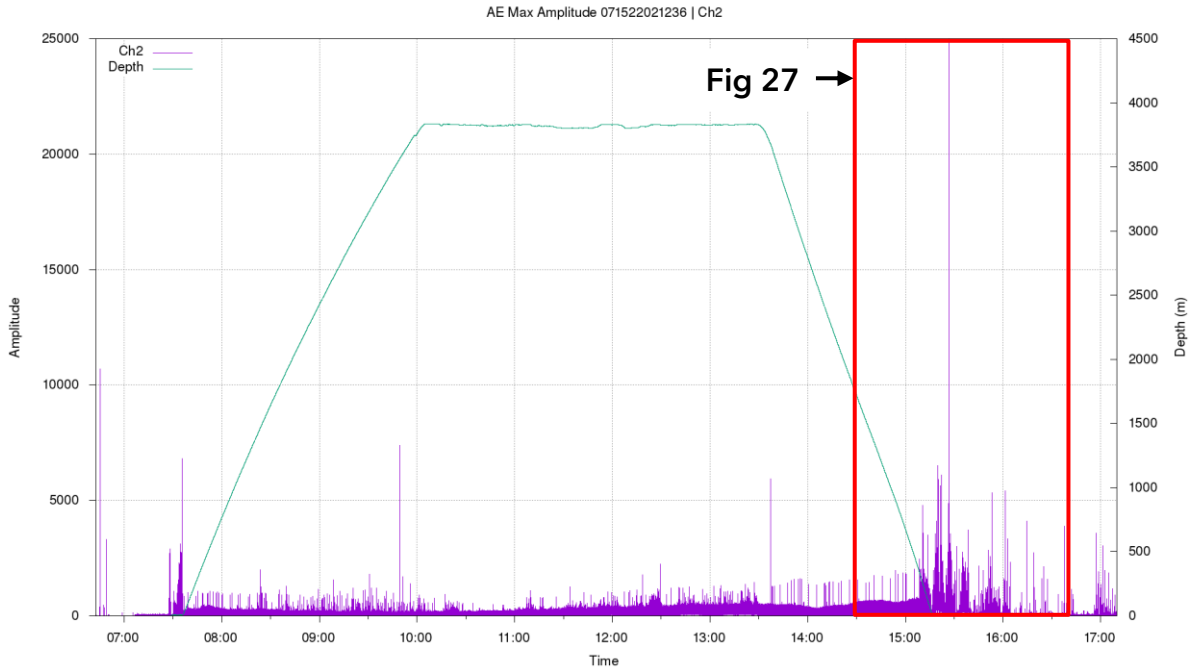
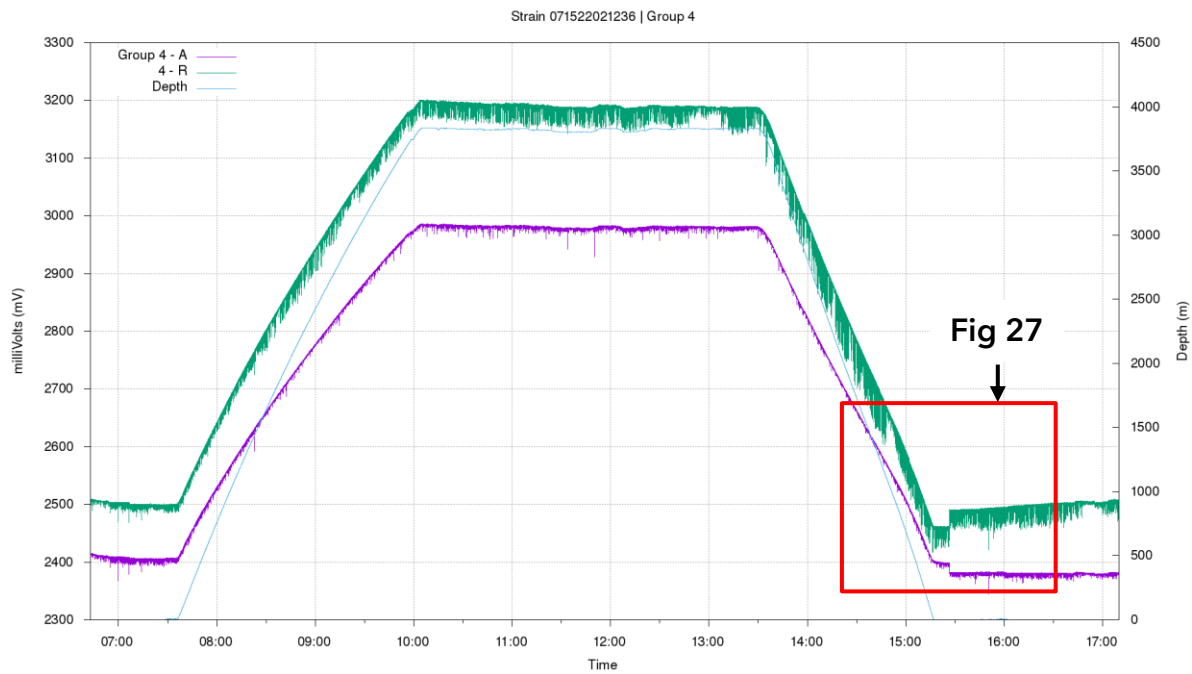
On July 15, 2022, the Titan dove to the Titanic, reaching a depth of 3,840 m (Dive 80). Shortly after surfacing, an audible “loud bang” was heard, according to the dive log. Acoustic emission and strain data, collected by the real-time monitoring system, were processed by OceanGate personnel after the dive, which was their typical procedure. Plots for acoustic activity and strain as a function of time for Dive 80, prepared by OceanGate, are shown for acoustic emission channel 7 and strain gage group 7 in figures 26a and b, respectively. The strain plots in figure 26b include hoop strain (R) and longitudinal strain (A). While at maximum depth, there was time-dependent reduction in hoop and longitudinal strain gage output.³ When the vessel returned to the surface, the strain gage voltage outputs were lower than they were at the start of the dive. There was a burst of acoustic activity shortly after surfacing, between approximately 15:15 and 15:30 (Newfoundland Daylight Time). Plots for acoustic channel 2 and strain gage group 4 are shown in figures 26c and d. Channel 2 shows additional acoustic activity compared to channel 7 after the vessel surfaced. In addition, between 15:15 and 15:30 there was an abrupt increase in hoop strain (R) readout and reduction in longitudinal strain (A) readout. The acoustic signal and the strain gage outputs are shown together in figure 27, plotted in UTC. The large amplitude acoustic event coincided with the change in hoop and longitudinal strain gage output.

Figure 26. Time plots from Dive 80. Time of day is reported in Newfoundland Daylight Time (UTC - 2:30): a) acoustic activity from channel 7; b) strain gage output from group 7 showing hoop strain (R) and longitudinal strain (A);

Figure 26 (cont.). c) acoustic activity from channel 2 and d) strain gage output from group 4 showing hoop strain (R) and longitudinal strain (A).

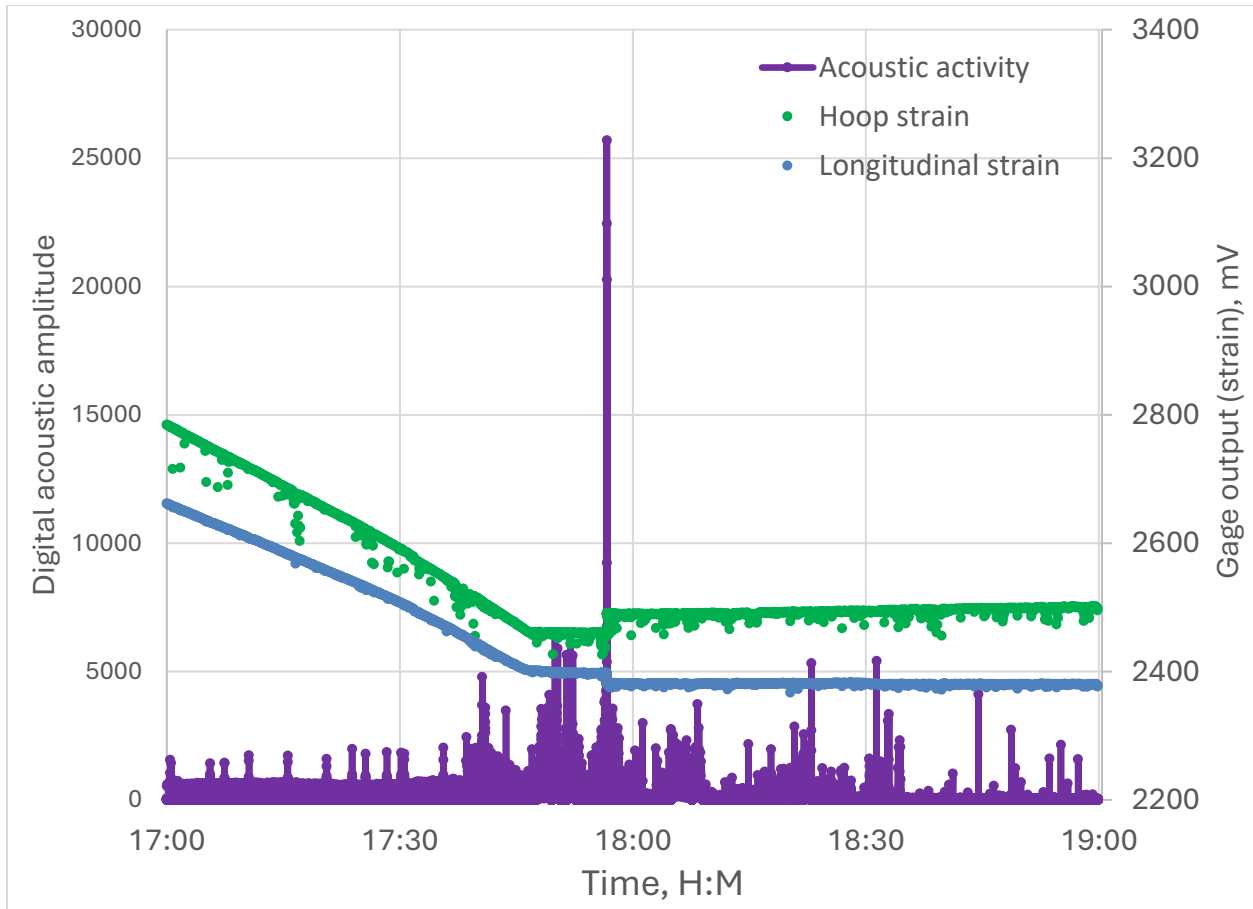
Figure 27. Time plot of channel 2 acoustic activity, hoop strain, and longitudinal strain from group 4 for the Dive 80 2-hour interval after surfacing. Time is reported in UTC.

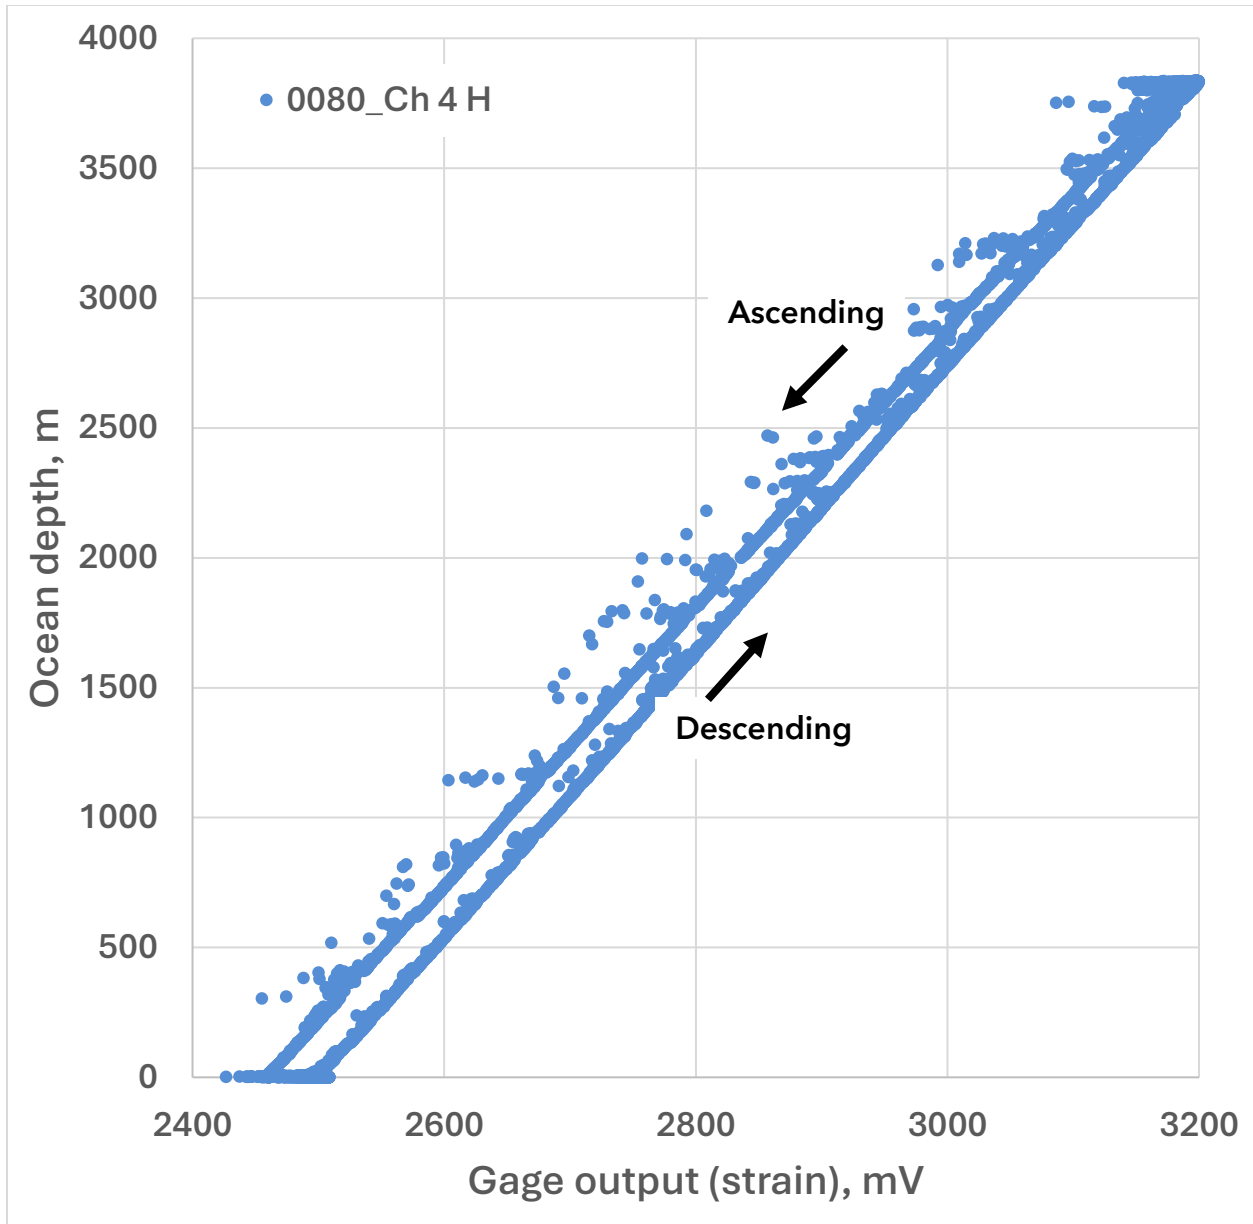
Changes were observed in the initial strain response of the hull following Dive 80. Figure 28 shows the variation in hoop strain gage output with ocean depth for group 4 on Dive 80 (prior to the audible event, which occurred after surfacing). For visualization purposes, strain gage output is plotted on the abscissa (horizontal axis) and ocean depth is plotted on the ordinate (vertical axis). Because of the strain reduction at depth, the ascent curve is at a lower strain value than the descent curve. Both descending and ascending curves appeared to be linear. A comparison with Dive 75 is shown in figure 29. Both dives showed the same linear response (as did Dives 76 and 79, which are not shown). Figure 30 shows a comparison with Dive 81, the first dive after the audible event. The strain response at low depth was non-linear after the event. The same non-linear response was observed for Dives 82 and 83. Figure 31 shows the strain/depth plots for Dives 75 and 80 - 83, focused on 0 m to 1000 m of ocean depth. Dives 81 - 83 all showed the same non-linear response between approximately 0 m and 500 m ocean depth. To illustrate the change in initial strain response, the slope of the depth/strain plots was calculated using a linear least squares fit to dive data between 15 m and 150 m of ocean depth. The slopes for

Figure 28. Plot of dive depth as a function of strain gage output for Dive 80 - Gage group 4 - hoop strain gage. The reduction of gage output while at the ocean bottom results in lower gage output for the ascent phase of the trip.

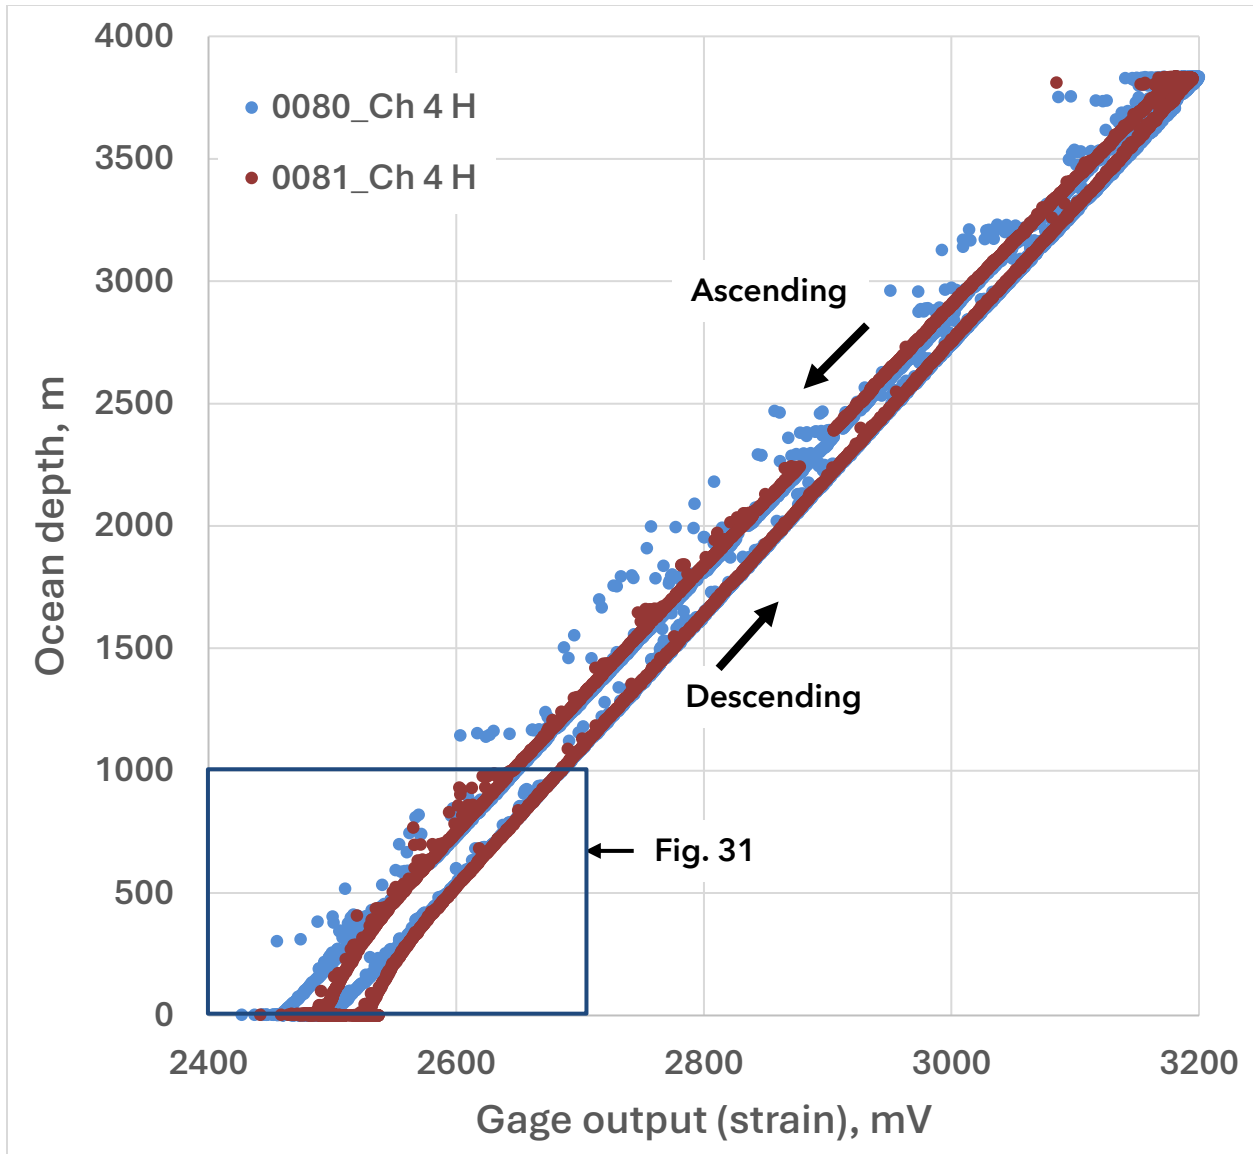
Figure 30. Plot of dive depth as a function of strain gage output for Dives 80 and 81 - Gage group 4 - hoop strain gage. The curves have been aligned using the linear portion of the descent phase of the trip. The strain for Dive 81 shows non-linear behavior between 0 m and 500 m dive depth.
