National Transportation Safety Board

MATERIALS LABORATORY

Factual Report 24-012

Location: Atlantic Ocean
Date: June 18, 2023
Vehicle: OceanGate Experimental Submersible Titan
Investigator: Marcel Muise, MS-10

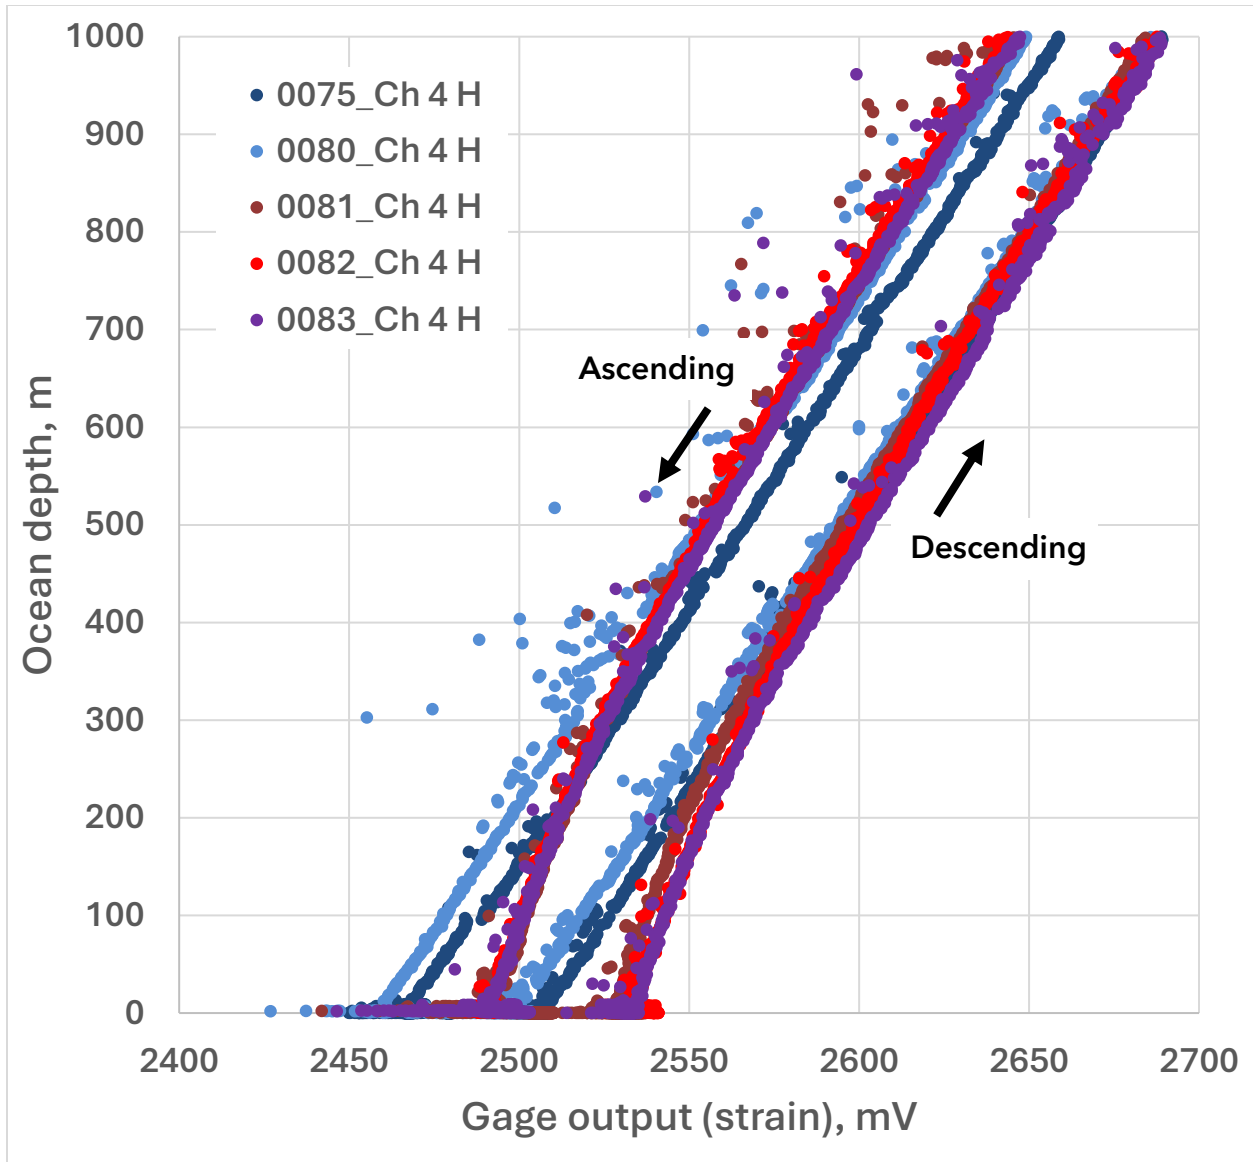
Dives 75 and 80, prior to the event, were 5.00 m/mV and 4.74 m/mV, respectively. After the event, the slopes for Dives 81, 82, and 83 were 8.76 m/mV, 8.09 m/mV, and 8.77 m/mV, respectively.

Figure 31. First and last 1000 m of dive depth for Dives 75 and 80 - 83 - Gage group 4 - hoop strain gage. The curves have been aligned using the linear portion of the descent phase of the trip. The strain for Dives 81, 82, and 83 show non-linear behavior between 0 m and 500 m dive depth.

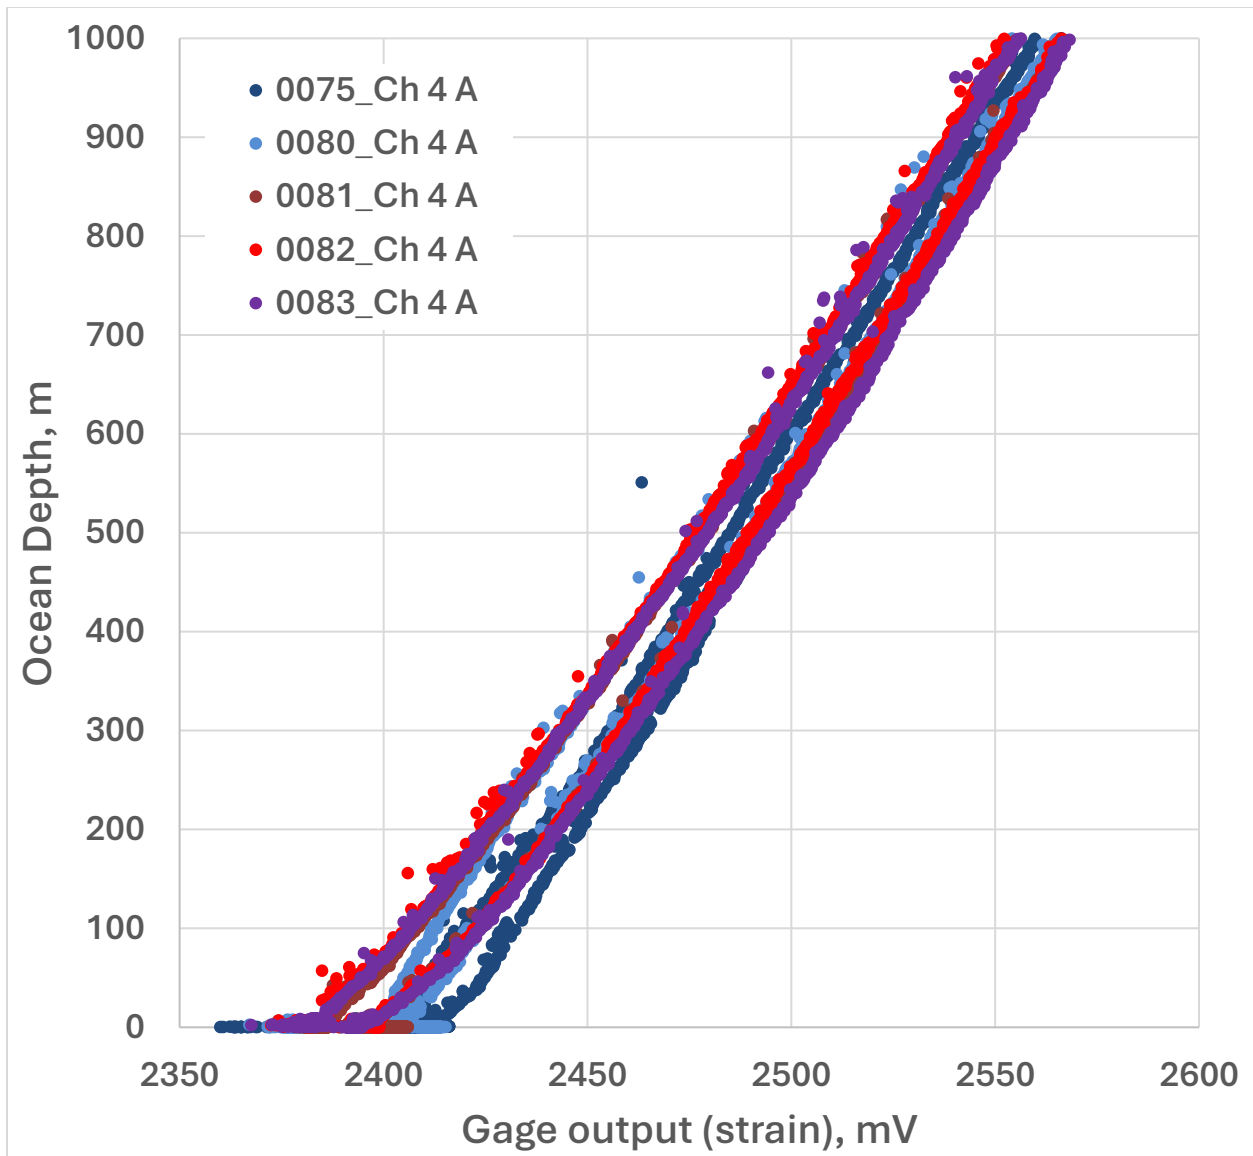
Changes in strain response were observed for other strain gages as well. Figure 32 shows the low-depth hull response for the group 4 longitudinal-oriented strain gage. After the audible event, the initial slope of the curve decreased. Figure 33 shows a discontinuity in the group 5 hoop-oriented strain gage during the ascent phase of the dive. There was an approximately 6 minute and 27 second gap in the recorded data between 2389.7 m and 2242.5 m ocean depth. When the gage readout resumed, the data had shifted to a lower gage output voltage and there was an initial change in the slope of the ascent curve (During the same event, the group 6 longitudinal gage stopped recording data and never resumed).⁴ Group 5 hoop and longitudinal gage plots for the first and last 1000 m are shown in figures 34 and 35, respectively. There was a visible change in the longitudinal strain response below approximately 800 m, but no affirmative change in the hoop strain response. Gage group 8 hoop and longitudinal plots for the first and last 1000 m are shown in figures 36 and 37, respectively. There was a change in the hoop strain response below approximately 400 m. Groups 3 and 7 (the other two gage groups on the composite hull) did not show a significant change in strain response before or after Dive 80. For example, see the group 3 hoop strain response in figure 38. Additional strain response curves for the Ti dome and segment are included in Appendix A.

Figure 32. First and last 1000 m of dive depth for Dives 75 and 80 - 83 - Gage group 4 - longitudinal strain gage. The curves have been aligned using the linear portion of the descent phase of the trip. The strain for Dives 81, 82, and 83 show non-linear behavior and reduced apparent stiffness between 0 m and 500 m dive depth.

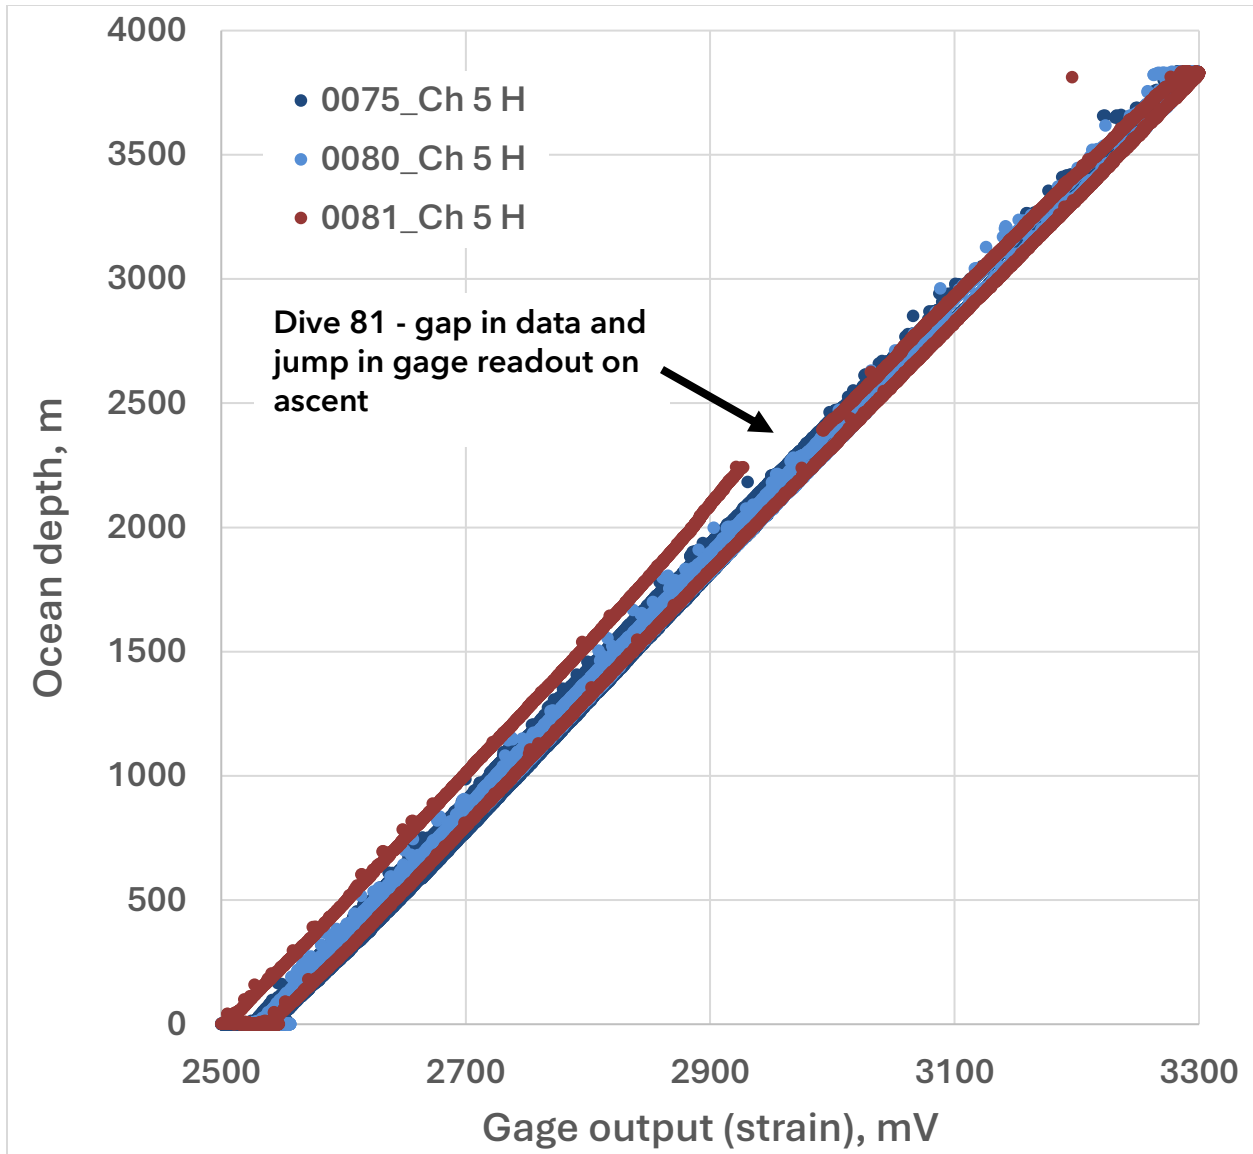
Figure 33. Plot of dive depth as a function of strain gage output for Dives 75, 80 and 81 - Gage group 5 - hoop strain gage. The curves have been aligned using the linear portion of the descent phase of the trip. On the ascent phase of the trip there is an approximately 6 minute and 27 second gap in recorded data between 2389.7 m and 2242.5 m. When recording resumes, the gage output has shifted to a lower voltage.

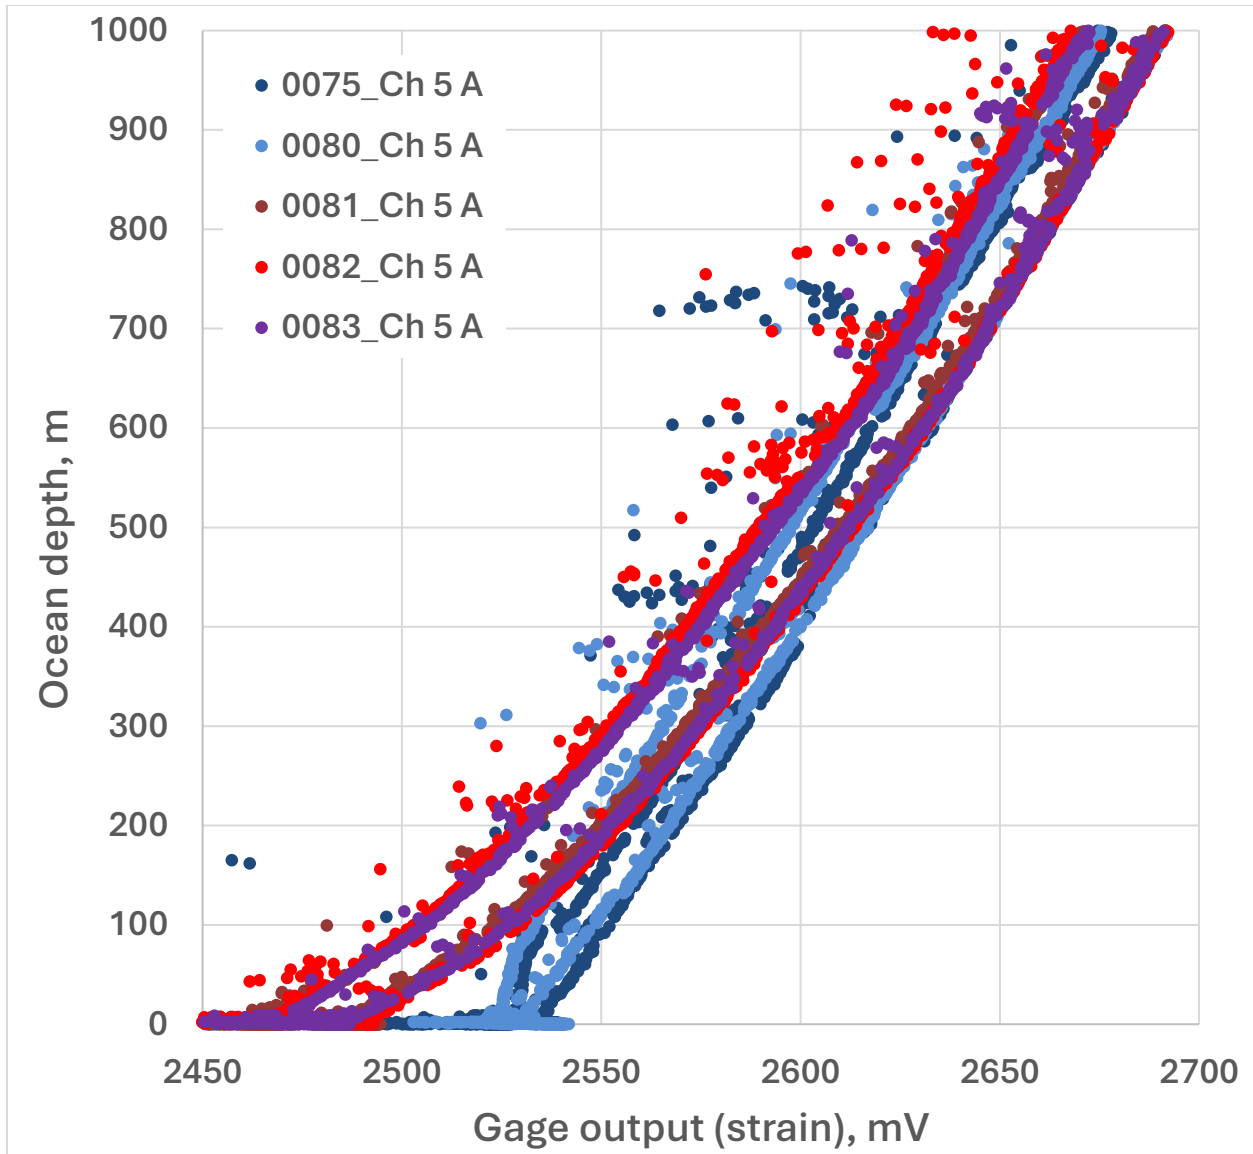
Figure 35. First and last 1000 m of dive depth for Dives 75 and 80 - 83 - Gage group 5 - longitudinal strain gage. The curves have been aligned using the linear portion of the descent phase of the trip. The strain for Dives 81, 82, and 83 show non-linear behavior and reduced apparent stiffness between 0 m and 800 m dive depth.

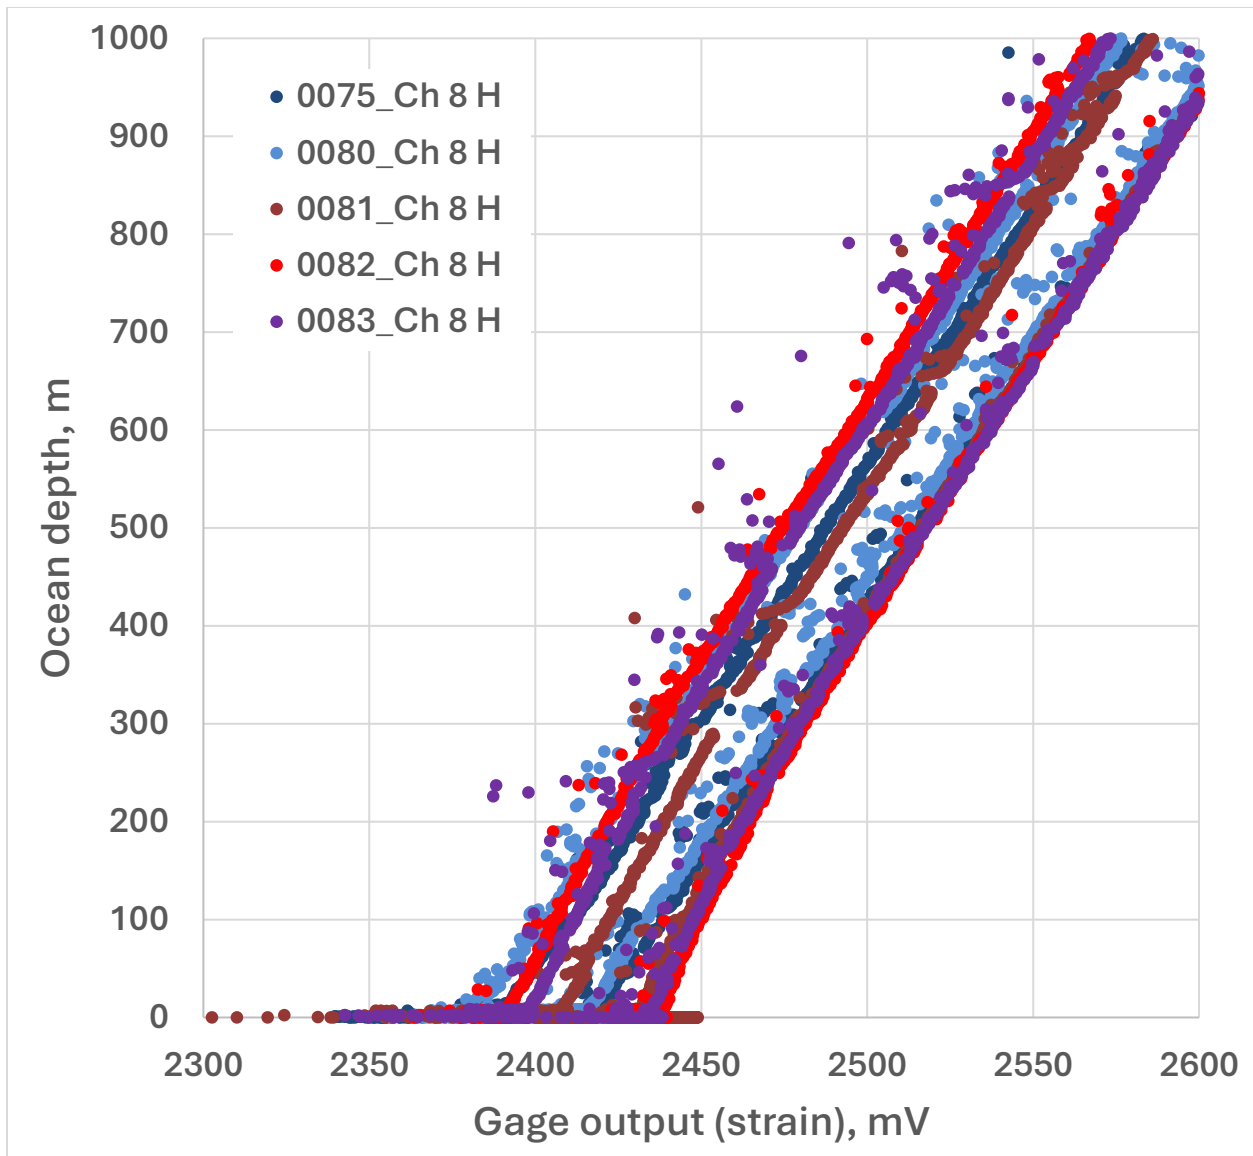
Figure 36. First and last 1000 m of dive depth for Dives 75 and 80 - 83 - Gage group 8 - hoop strain gage. The curves have been aligned using the linear portion of the descent phase of the trip. The strain for Dives 81, 82, and 83 show non-linear behavior between 0 m and 400 m dive depth.

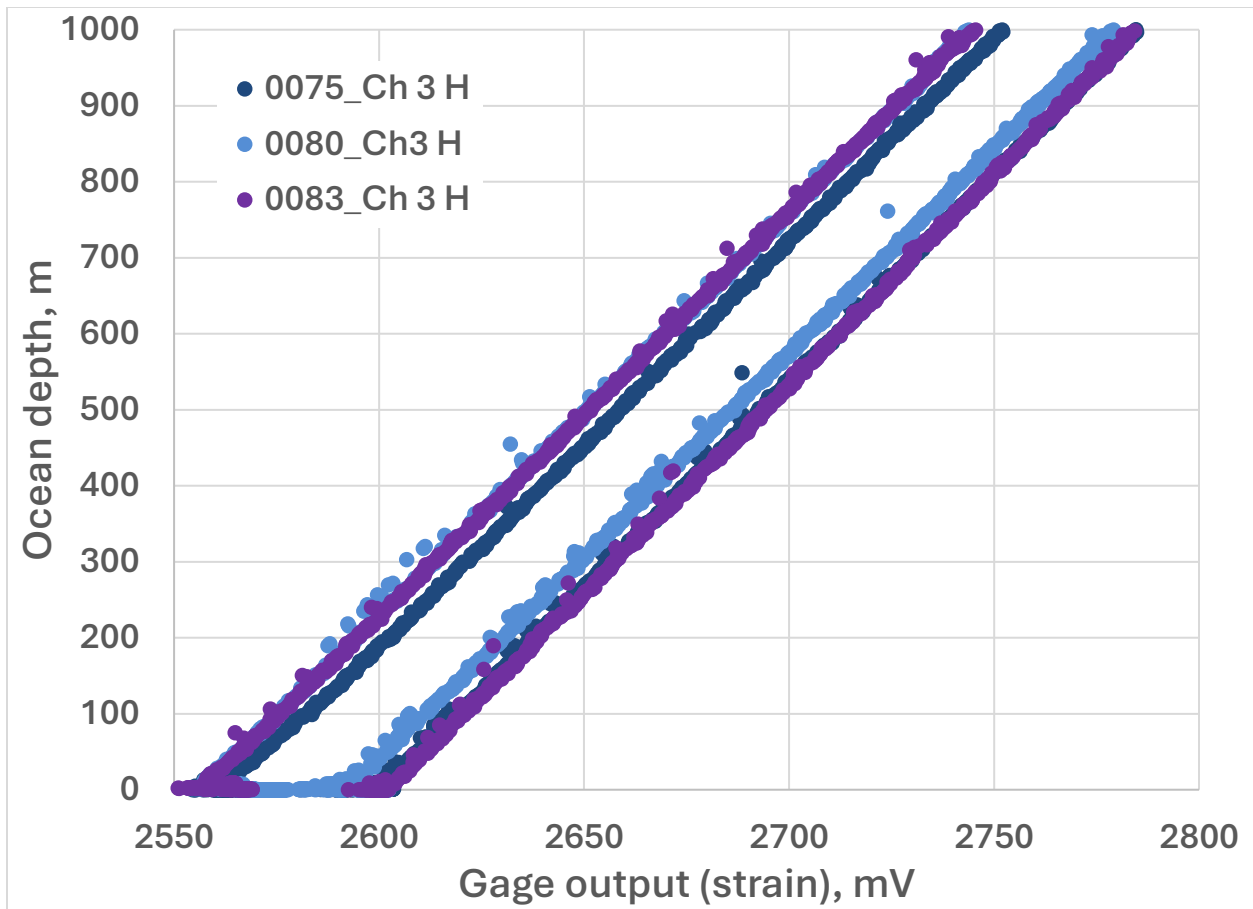
Figure 38. First and last 1000 m of dive depth for Dives 75, 80, and 83 - Gage group 3 - hoop strain gage. The curves have been aligned using the linear portion of the descent phase of the trip. The strain response was linear for all dives.

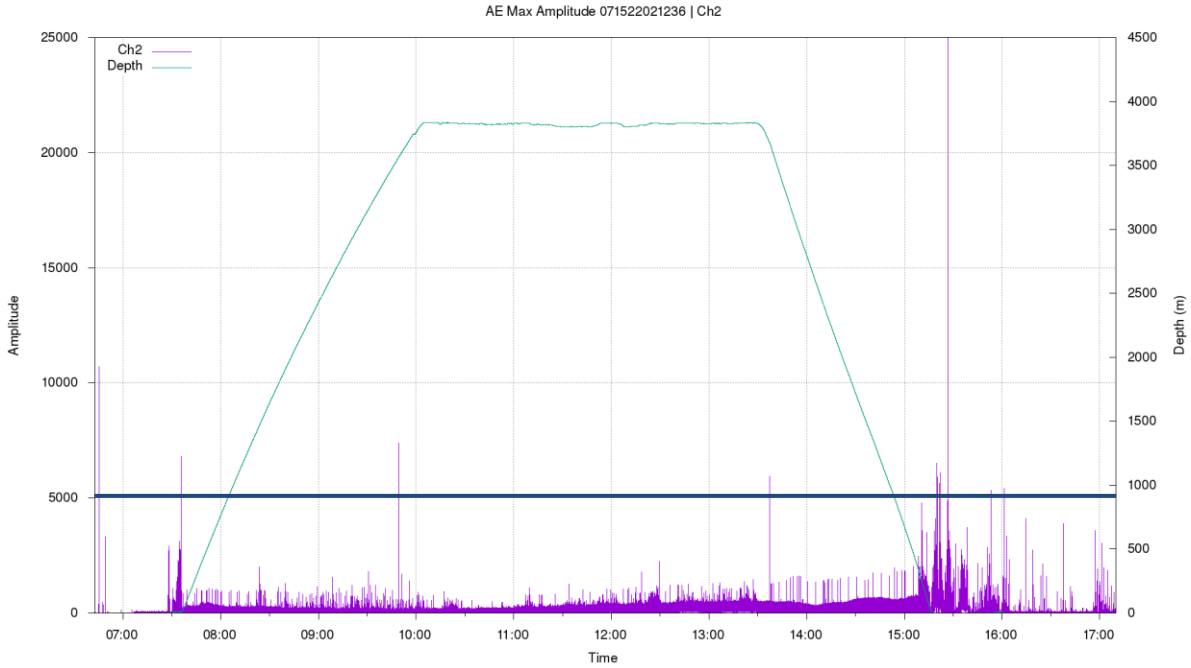
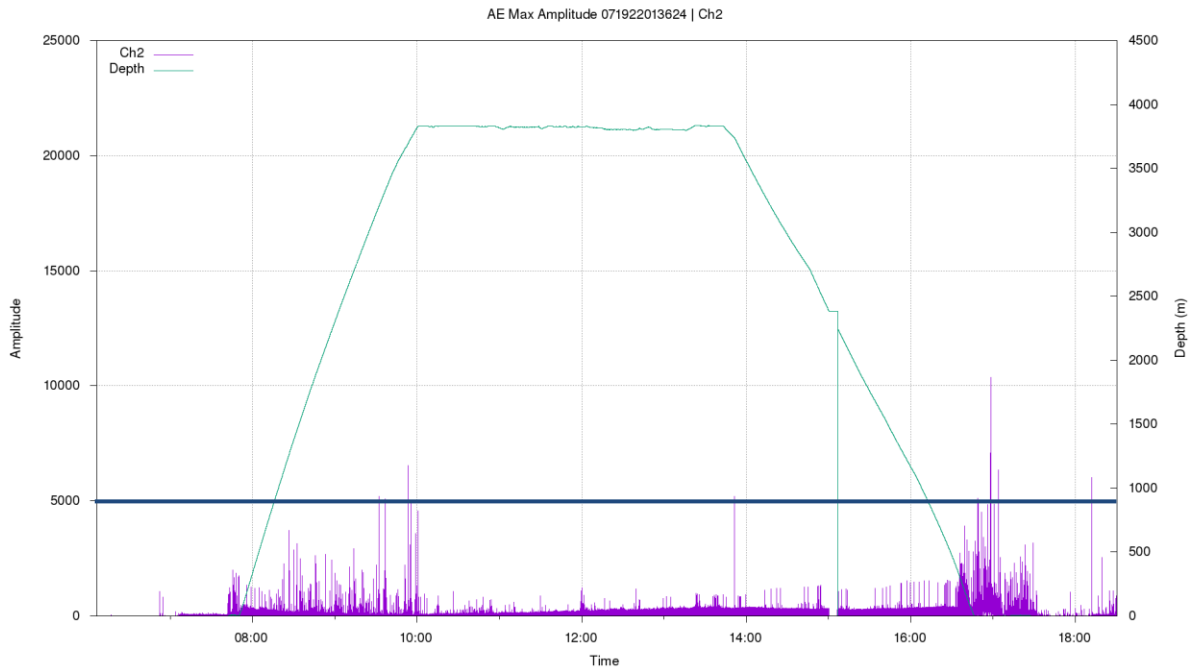
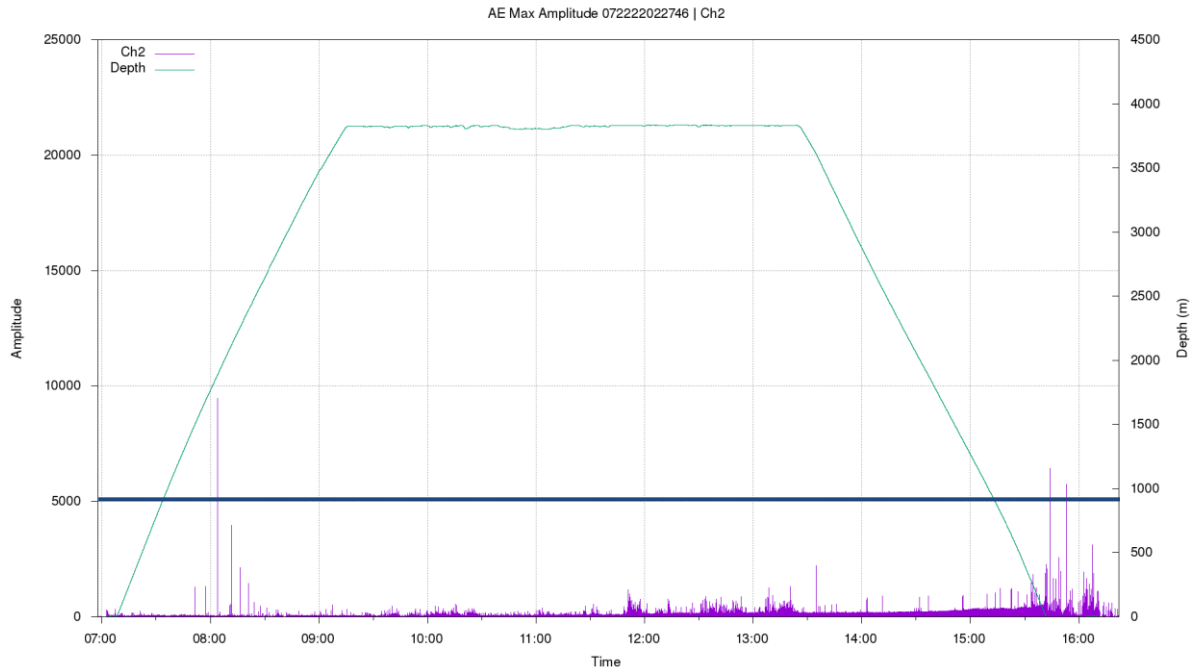
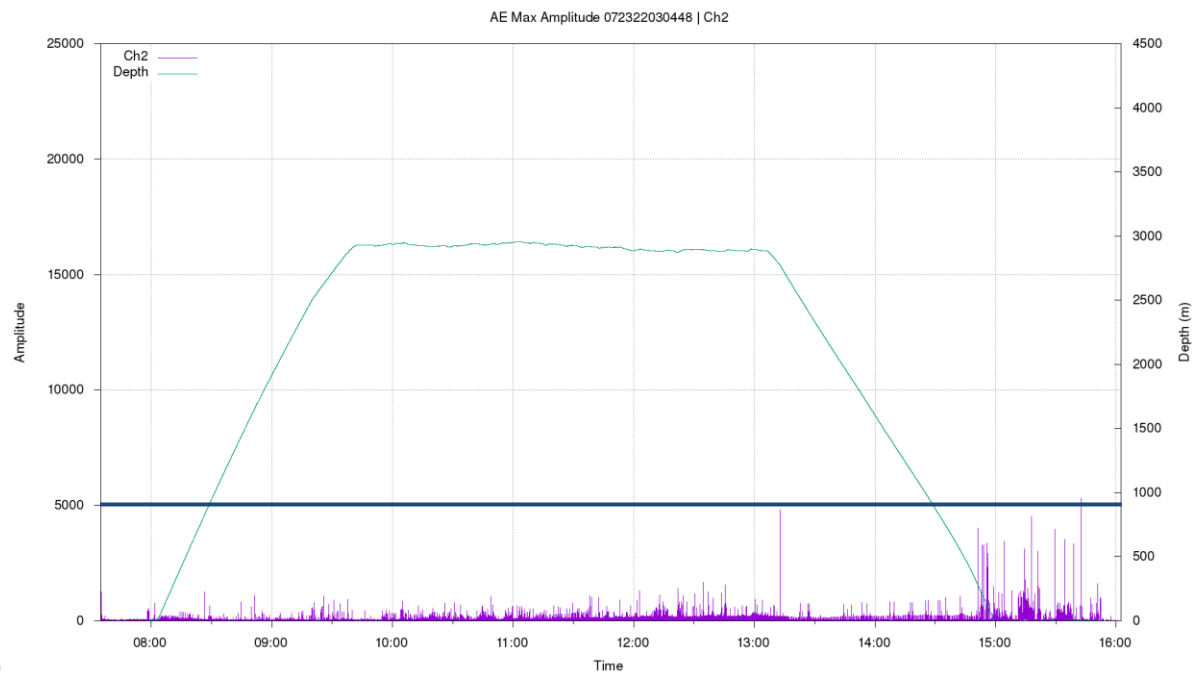
The amplitude of acoustic activity marginally increased for channel 2 during the descent phase of Dive 81 compared to Dive 80 (figures 39a and b). Four acoustic events during the descent qualified as a “hit”. None of the other channels registered hits during this phase of the dive. The acoustic activity for channel 2 generally decreased for Dives 82 and 83 relative to Dive 81 (figures 39c and d), except for one notable hit registered during the descent phase of Dive 81.

Figure 39. Comparison of acoustic sensor channel 2 activity (forward port side sensor) for: a) Dive 80 and b) Dive 81. The hit threshold is indicated by a horizontal line.

Figure 39 (cont.). c) Channel 2 activity for Dive 82; and d) activity for Dive 83.

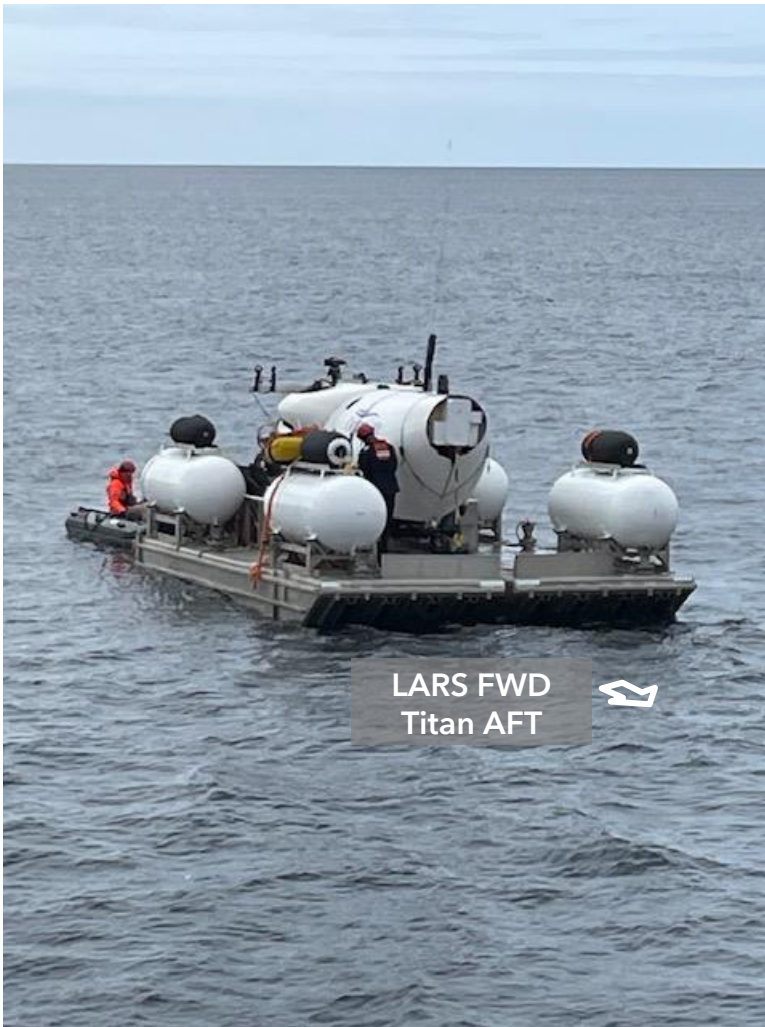
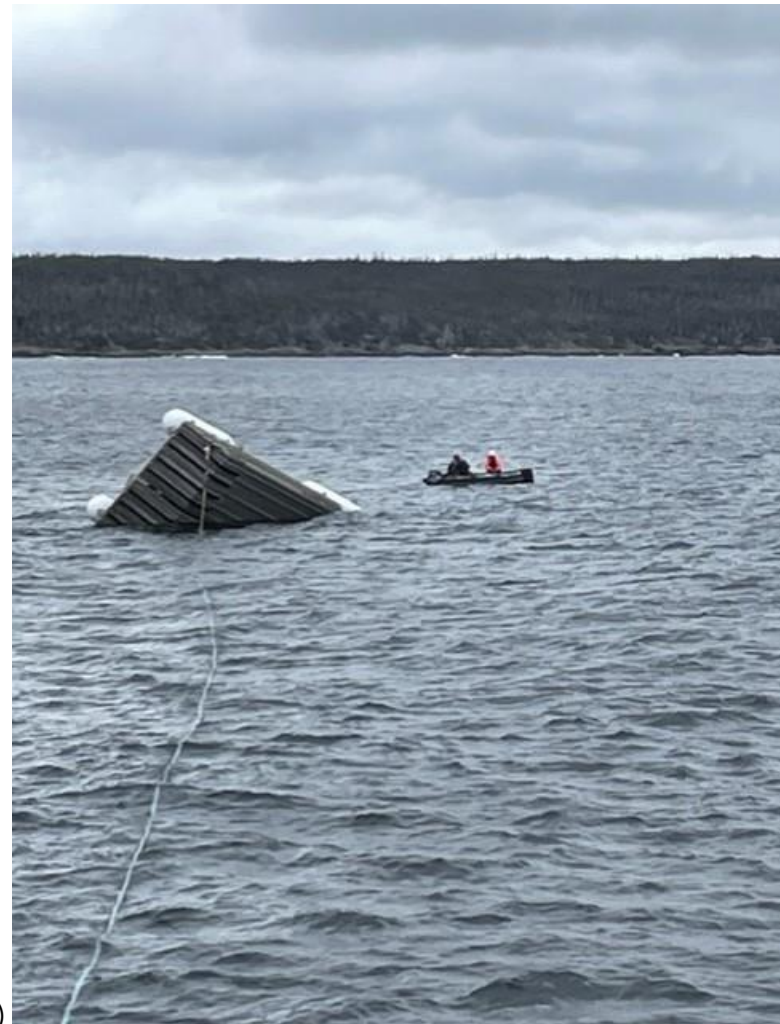
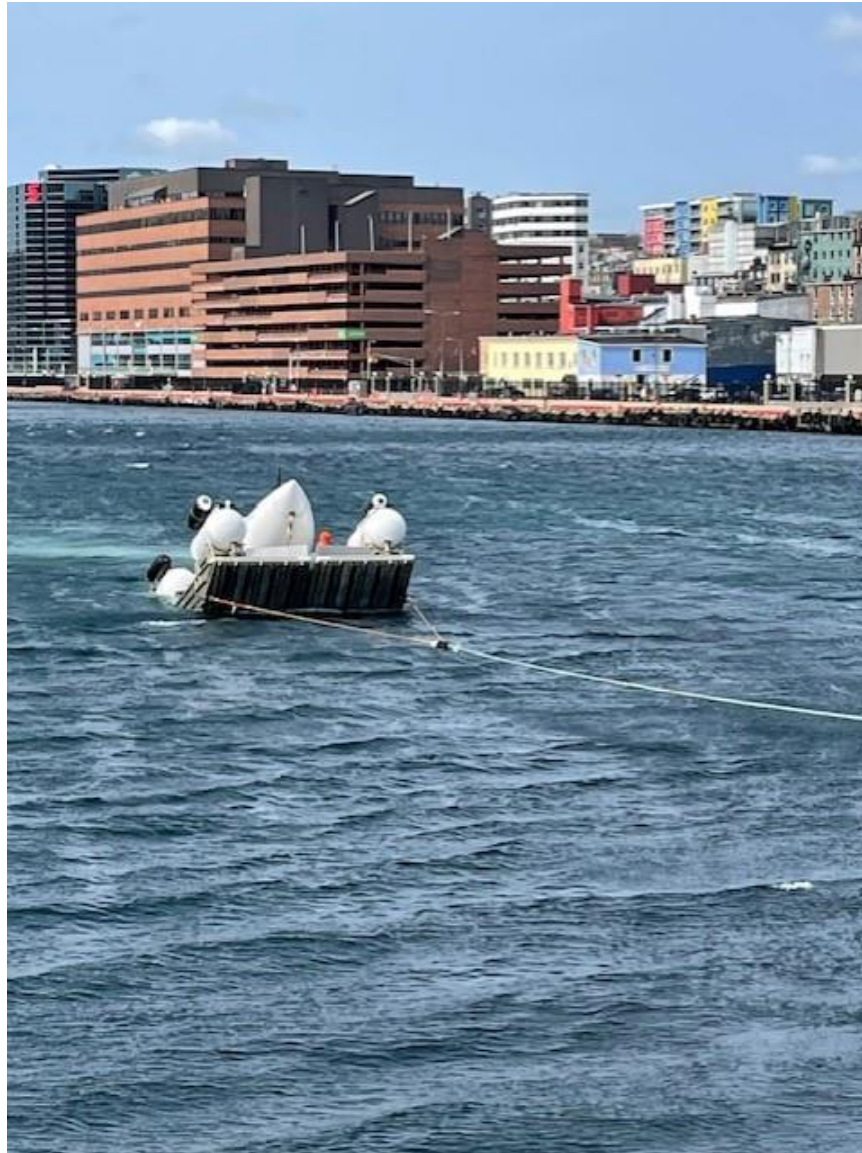
shown in figures 40a - c. The first image shows the vessel after recovery from a known mishap. The bow of the LARS had tipped downward, causing damage to the tail cone (figure 40a). The vessels underwent unspecified inspections and repairs. Two additional tipping events are shown in figures 40b and c.

Figure 40. Images of tipping/upset events during 2023 expedition (Source: Steven Taragel): a) Post recovery after the forward end of the LARS (aft end of Titan) tipped downward. The tail cone separated as a result of the mishap; b) tipping event with the aft starboard corner of the LARS tipped downward; and

Figure 40 (cont.). c) aft end of LARS tipped downward in St. John's.

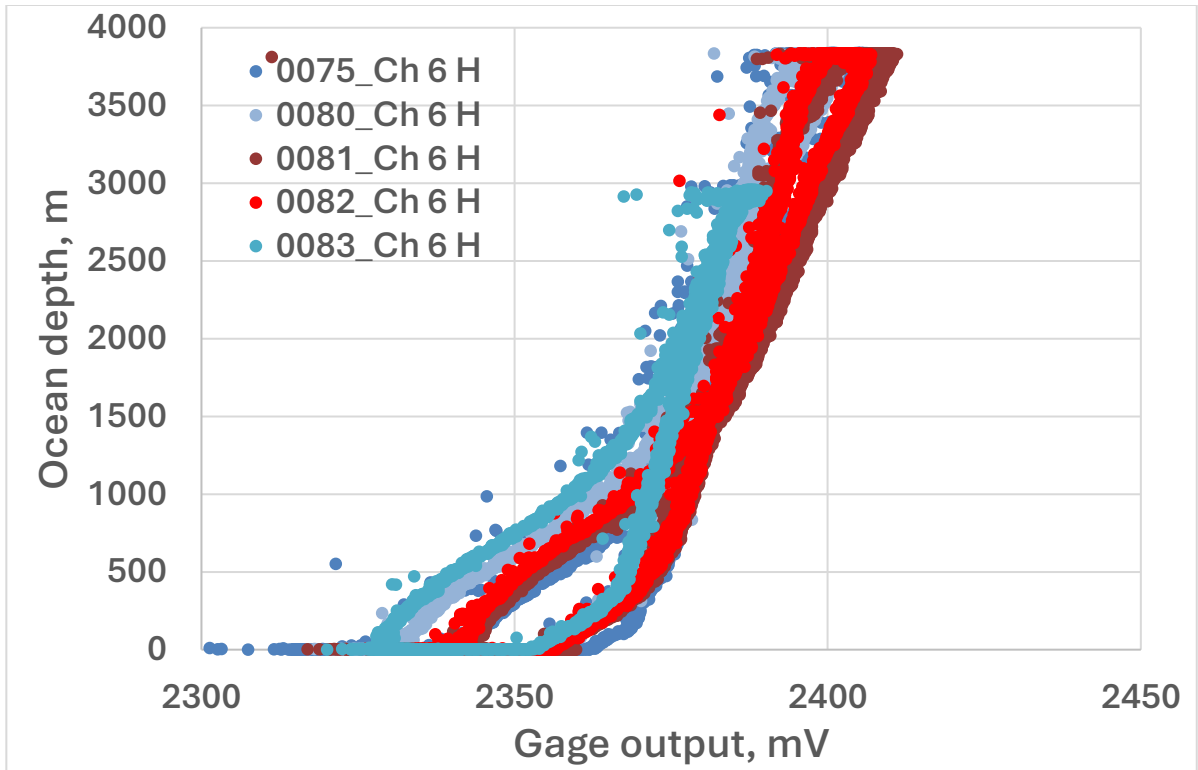
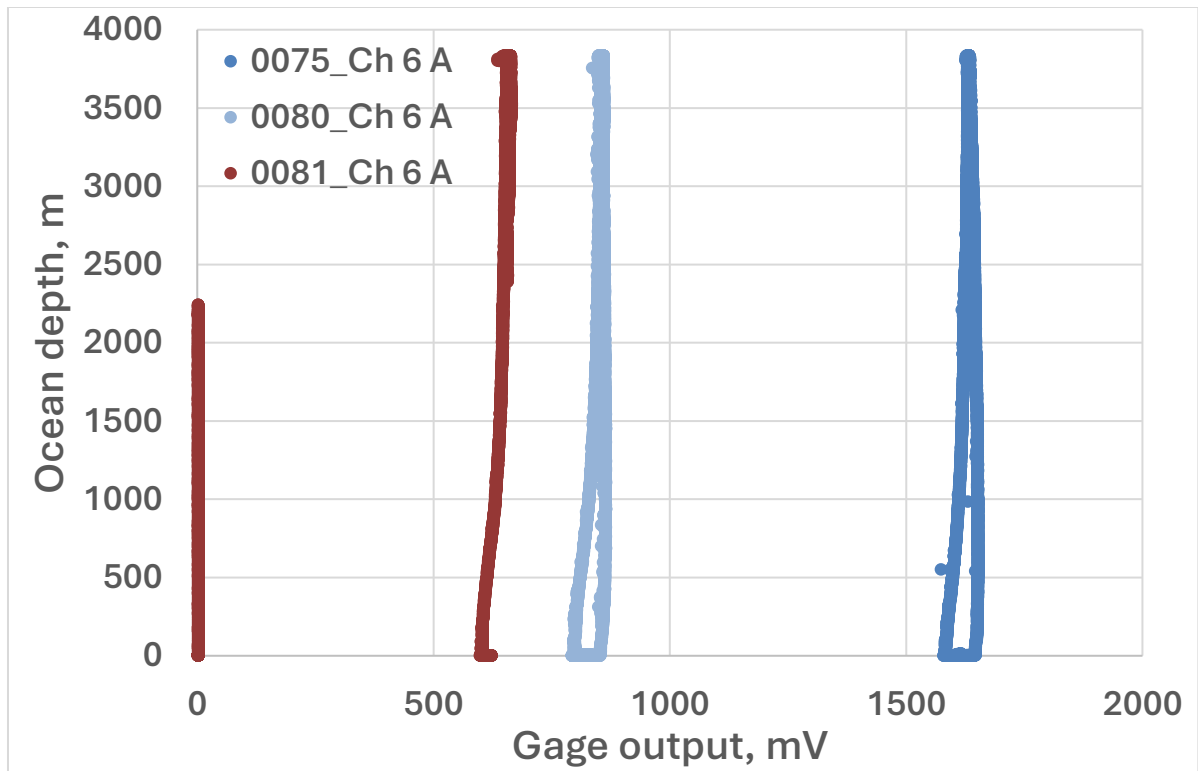
The strain response of the aft titanium segment is shown in figures A2a and A2b for the hoop and longitudinal directions, respectively. Both gages exhibited a non-linear response. The longitudinal gage showed drift from Dives 75 to 80 and from 80 to 81. During the Dive 81 ascent, the longitudinal gage stopped exhibiting a strain response and did not show a strain response on subsequent dives.

Figure A2. a) Plot of dive depth as a function of strain gage output for Dives 75 and 80 through 83 - Gage group 6 - "H" and b) Plot of dive depth as a function of strain gage output for Dives 75, 80, and 81- Gage group 6 - "A".

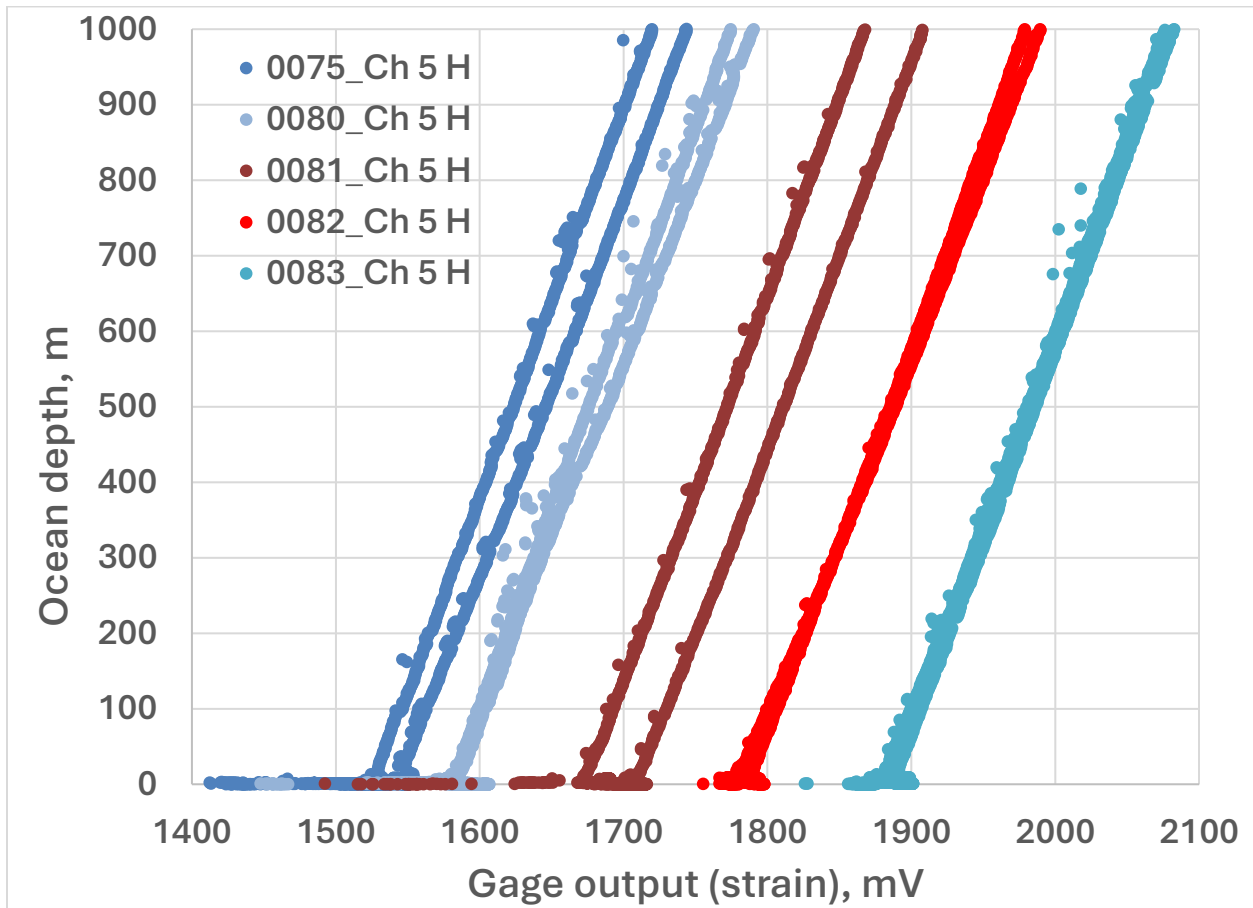
The group 5 hoop gage output drifted between dives as shown in figure A3. None of the other gages attached to the composite hull showed similar drift from dive to dive.

Figure A3. First and last 1000 m of dive depth for Dives 75 and 80 - 83 - Gage group 5 - hoop strain gage. The curves have not been aligned, showing the drift in gage output from dive to dive.
