# National Transportation Safety Board

## **MATERIALS LABORATORY**

Factual Report 23-094

Location: Lindenhurst, NY  
Date: 3/5/2023  
Vehicle: Piper PA28-161  
Investigator: Brian Rayner

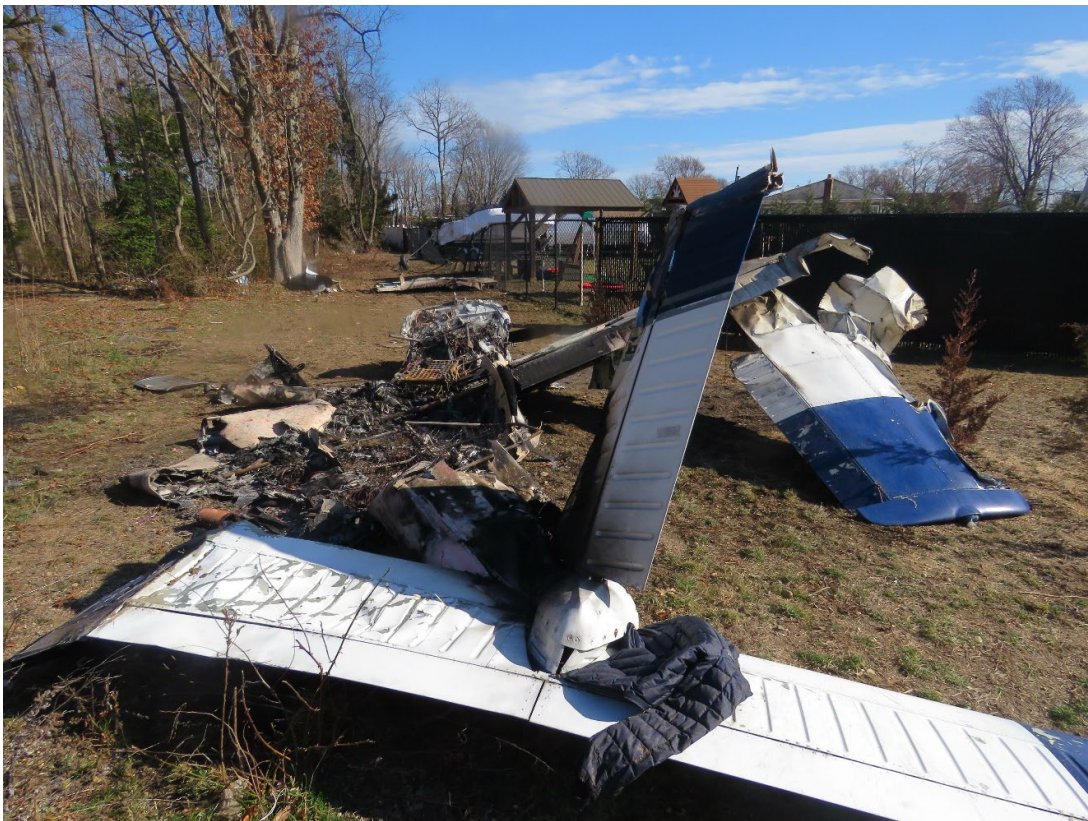
The aircraft had impacted trees while on descent after reporting an in-flight fire. The impacts with trees resulted in a path of debris leading up to the main portion of the wreckage (Figure 1). Some portions of the aircraft burned after coming to rest. The post-crash fire was fueled by gasoline released from the impact damaged wing tanks. A portion of the left wing, upstream of the main wreckage, in the debris field exhibited fire damage (Figure 2). This portion of left wing included the landing gear and part of the fuel tank. Further upstream, inside a fenced in lot, some personal watercraft resting on trailers exhibited fire damage on their covers. A portion of the engine cowling was also found upstream of the main wreckage near the portion of left wing (Figure 2). The fuselage and forward portion of the cockpit had been almost entirely consumed and melted during the fire (Figures 3, 4).

**Figure 1.** Resting position of the aircraft at the accident site. The aircraft spun around and was facing opposite the direction of travel.

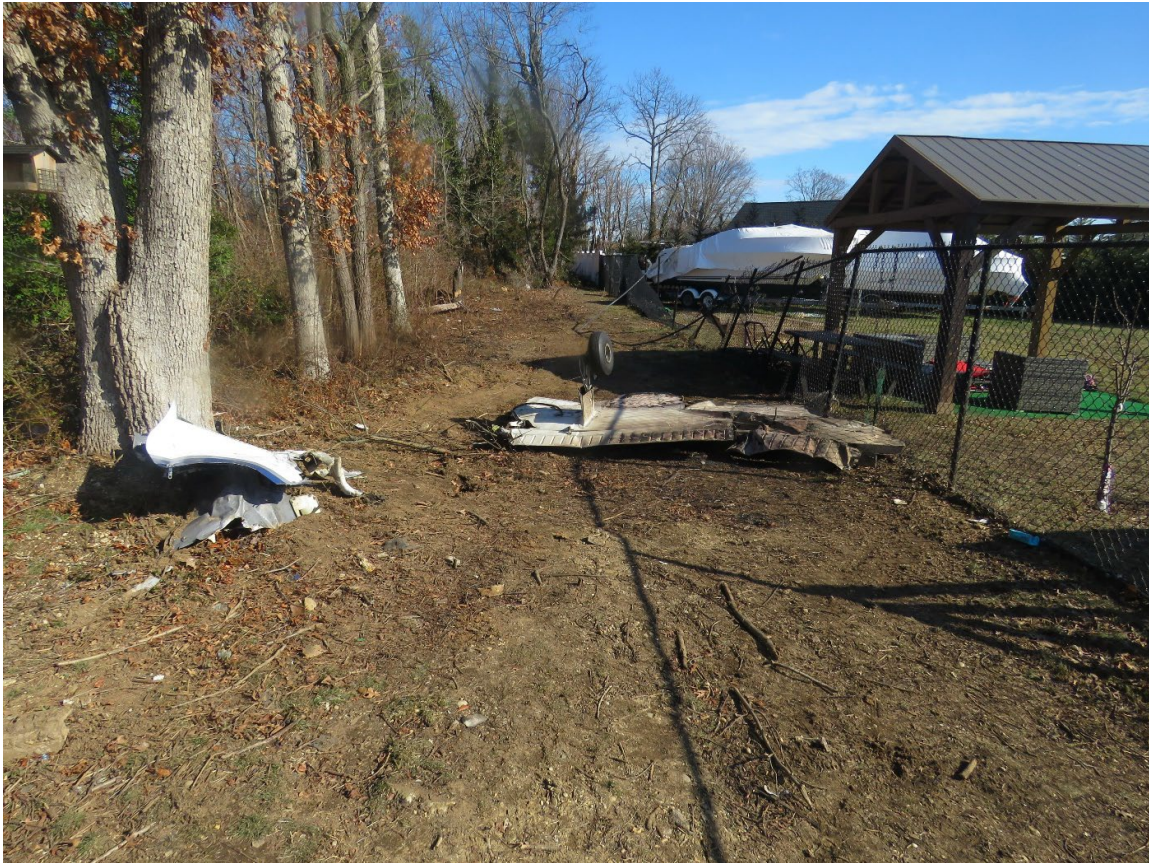
**Figure 2.** A portion of left wing with main landing gear attached. A portion of the engine cowling can be seen at the base of a tree.

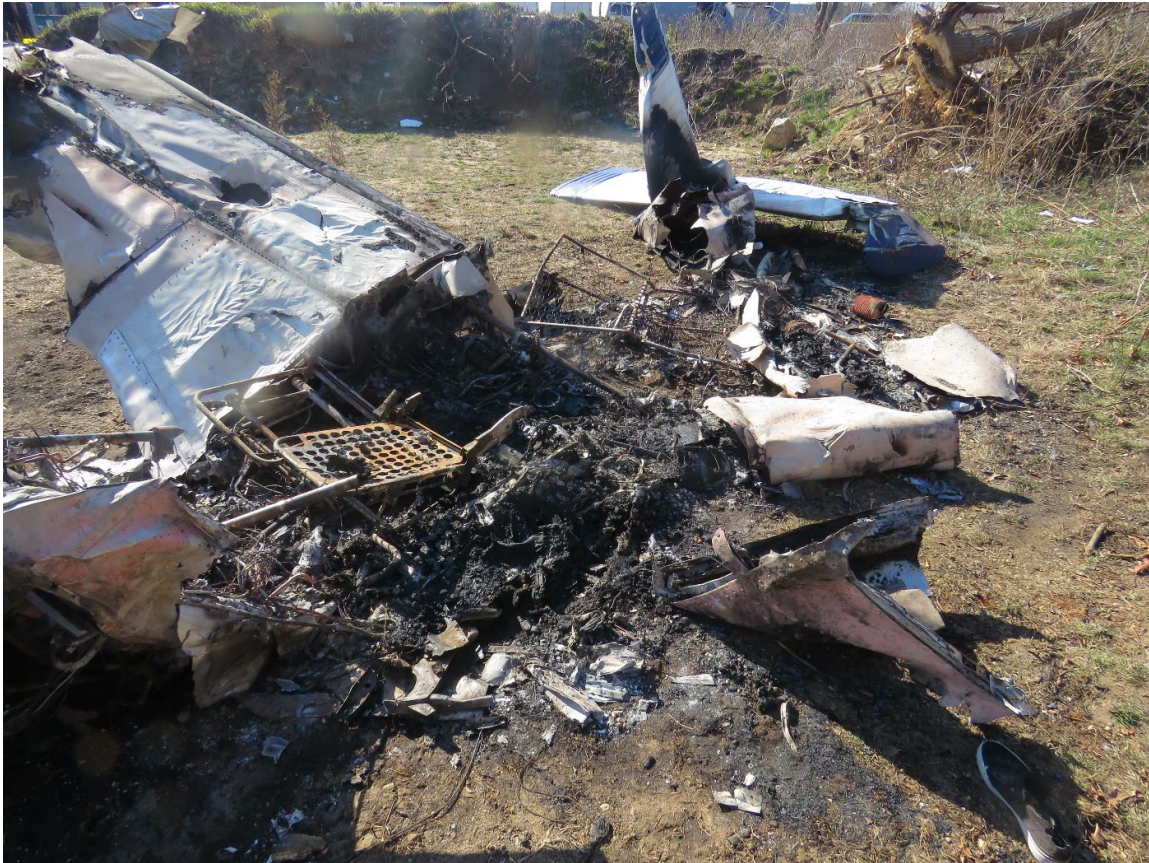
**Figure 3.** Remaining portions of the aircraft fuselage.

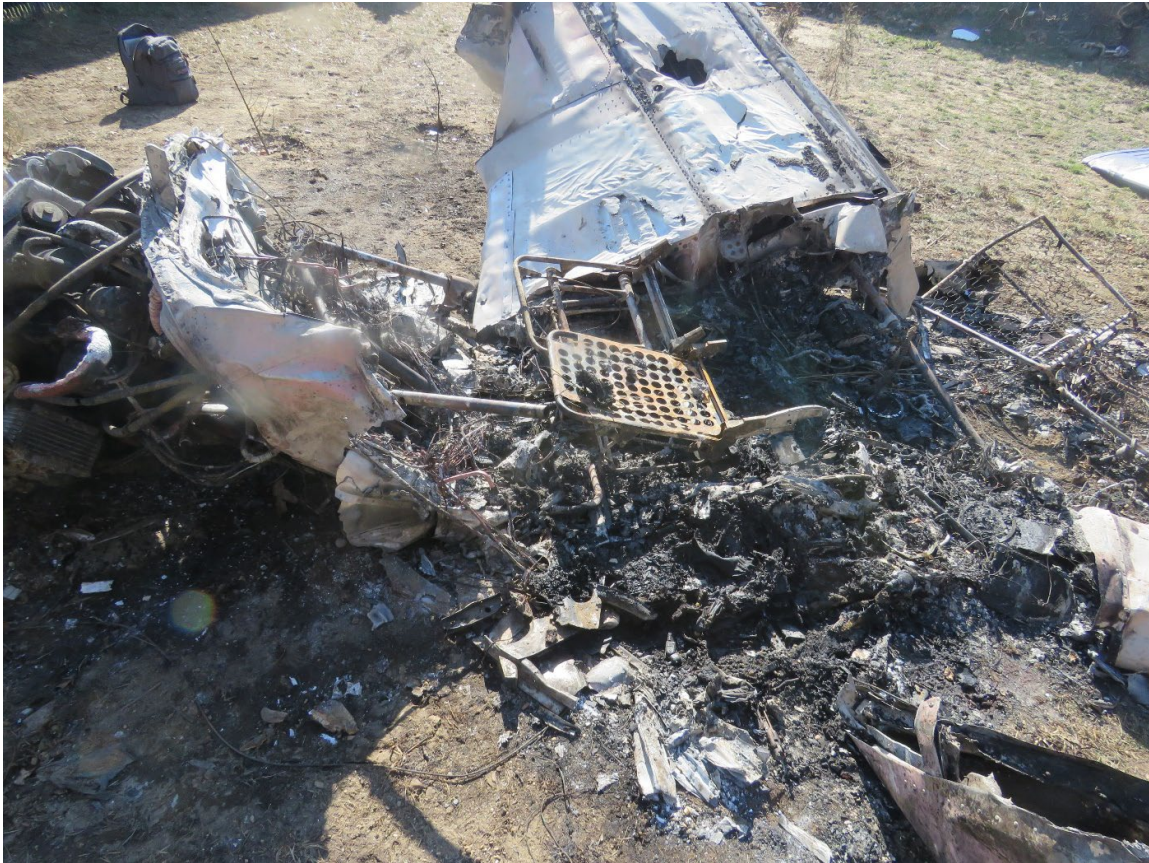
**Figure 4.** Cockpit portion of fuselage.

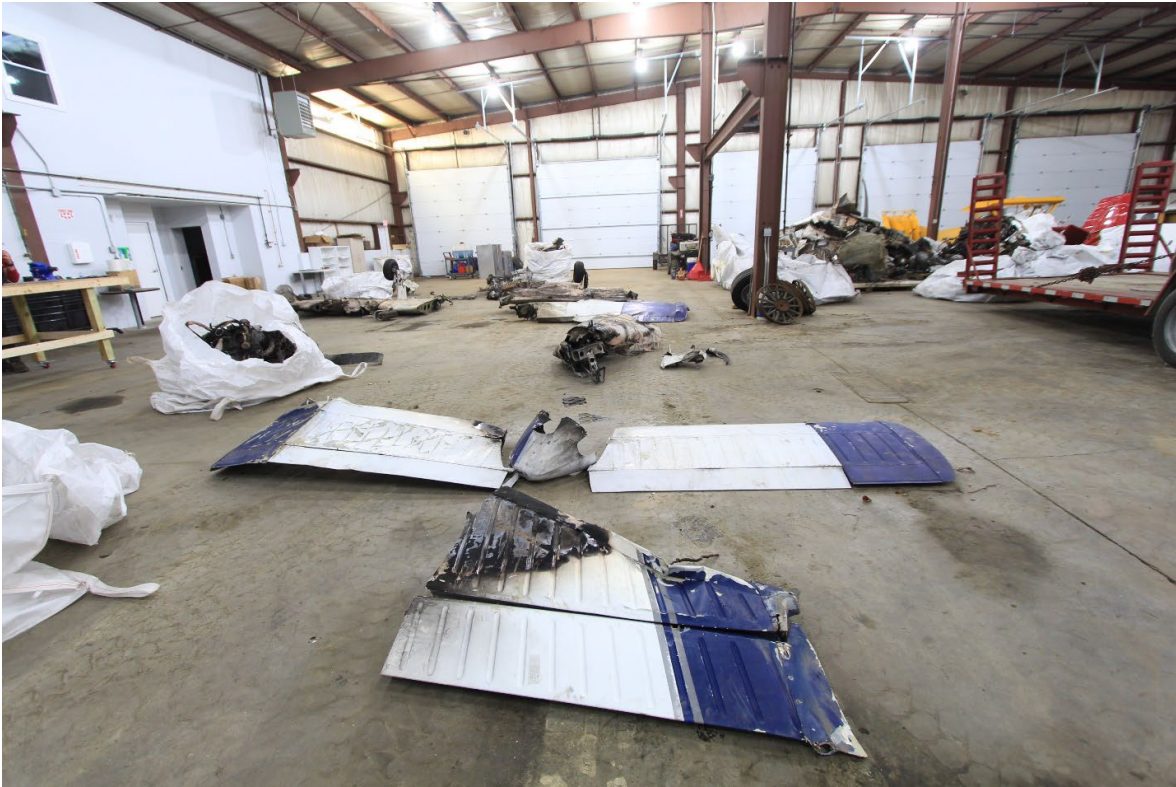
laid out and arranged in their relative positions to the extent possible. Examination of the portion of empennage and the vertical and horizontal stabilizers of the tail section did not reveal any burn patterns or soot deposition patterns on the surfaces that could be attributed to an in-flight fire (Figure 5). The fire damage on the empennage and its associated flight control surfaces was consistent with exposure to a fire while on the ground and at rest. Portions of the left (Figure 6) and right (Figure 7) wings were examined for burn patterns and soot deposition consistent with in-flight fire. No evidence of fire damage or sooting consistent with an in-flight fire was observed on the portions of the left and right wings. The fire damage to the portions of the left and right wings was consistent with burning while on the ground and at rest. A portion of the engine cowling consisting mostly of the top and left sides of the cowling was examined for evidence of fire. Neither the exterior (Figure 8) or interior (Figure 9) surfaces exhibited any thermal damage or soot deposition.

**Figure 5.** Portion of the empennage and tail section components.

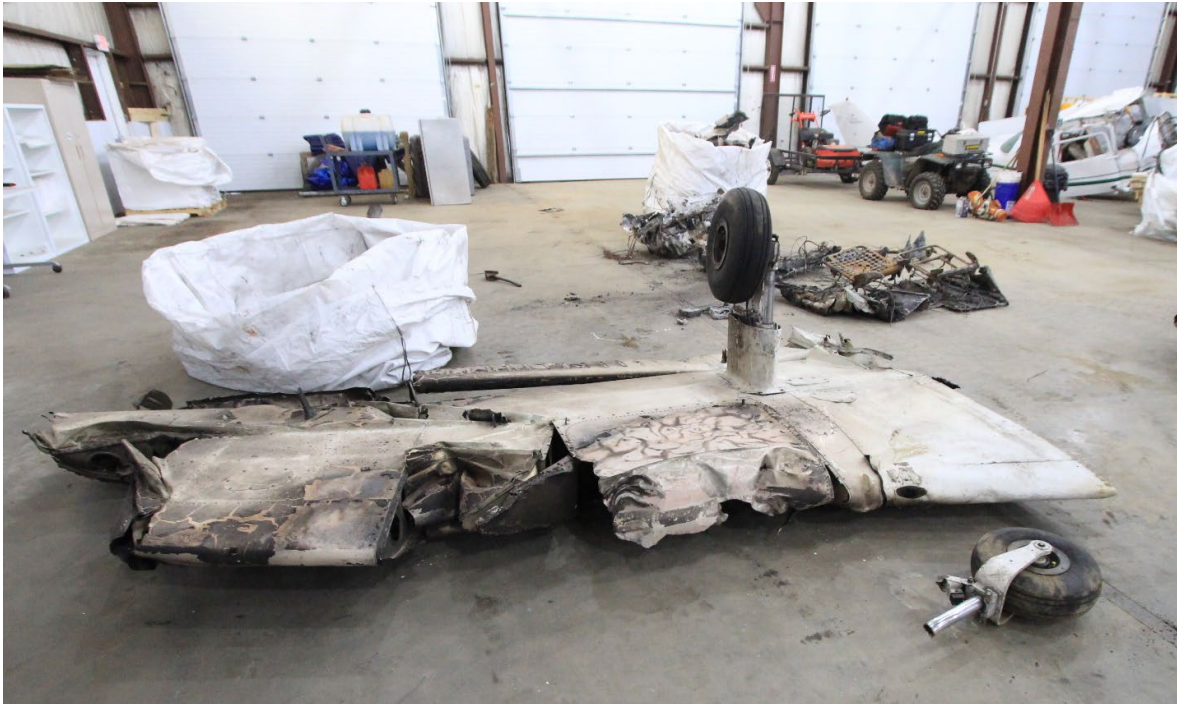
**Figure 6.** Portion of the left wing.

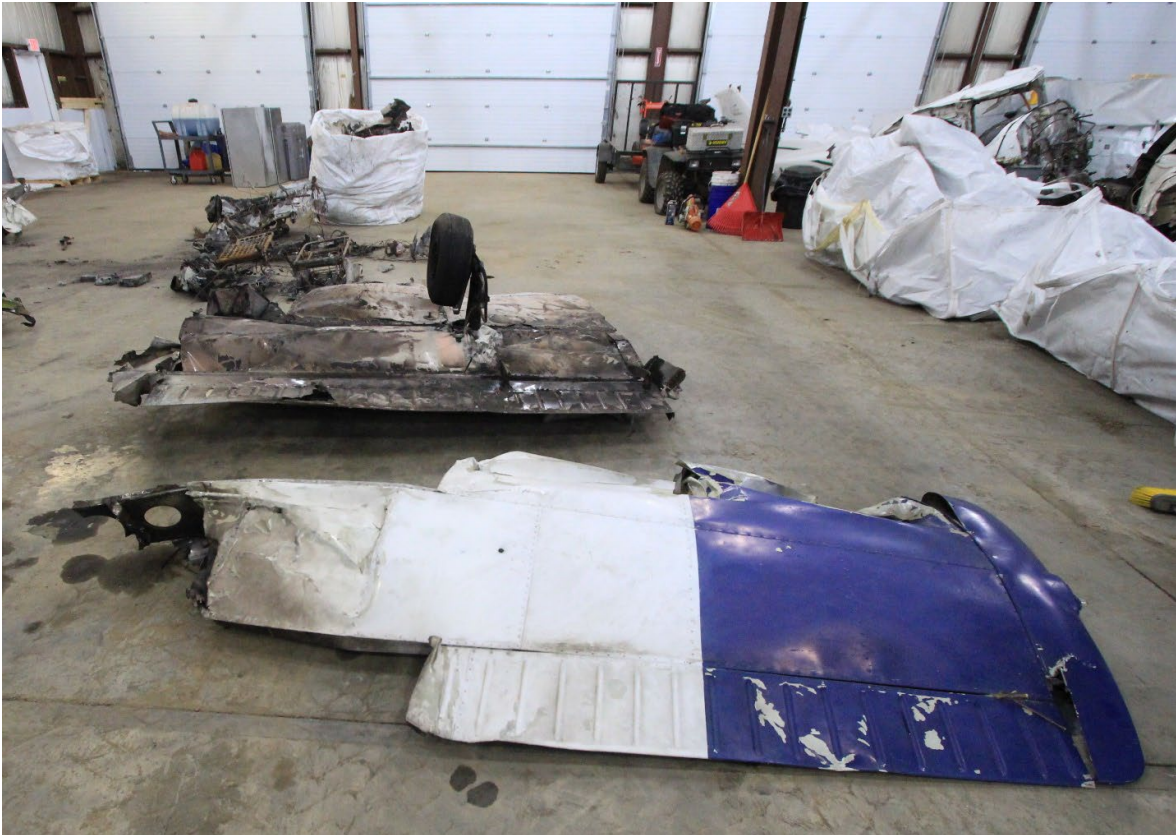
**Figure 7.** Portions of the right wing.

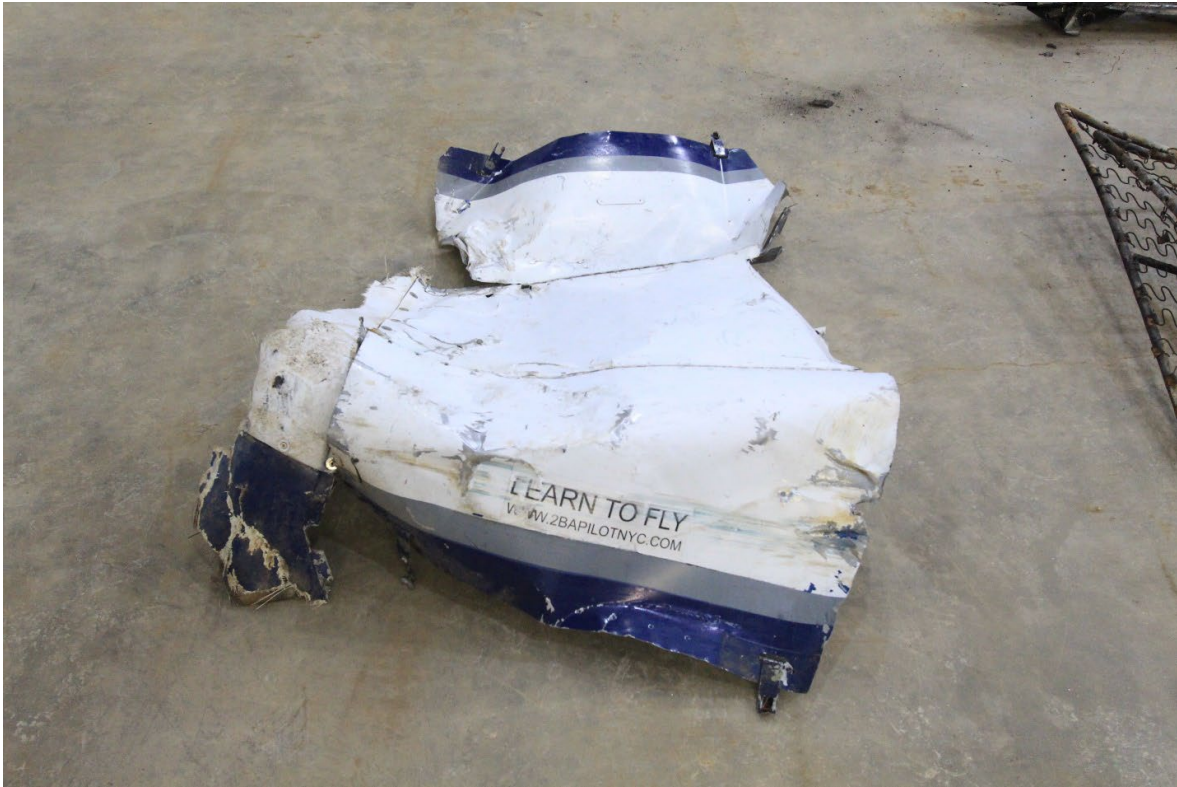
**Figure 8.** Exterior surface of the portion of engine cowling.

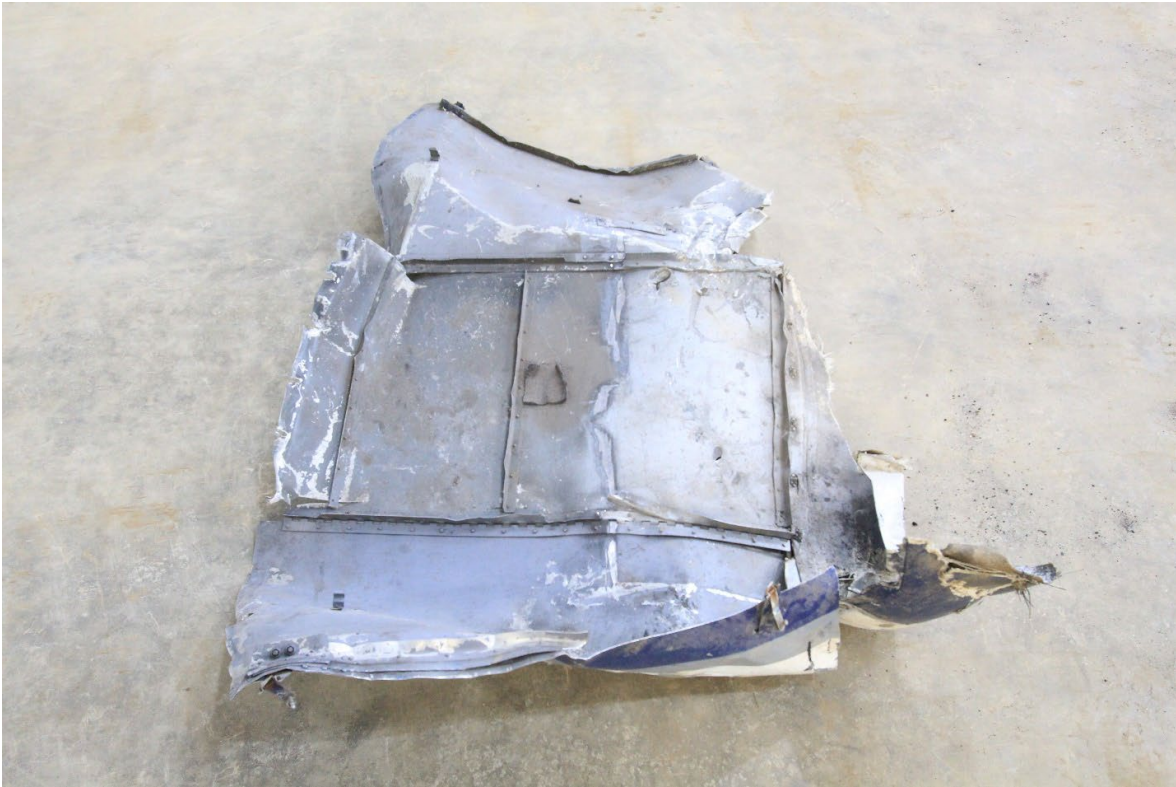
**Figure 9.** Interior surface of the portion of engine cowling.

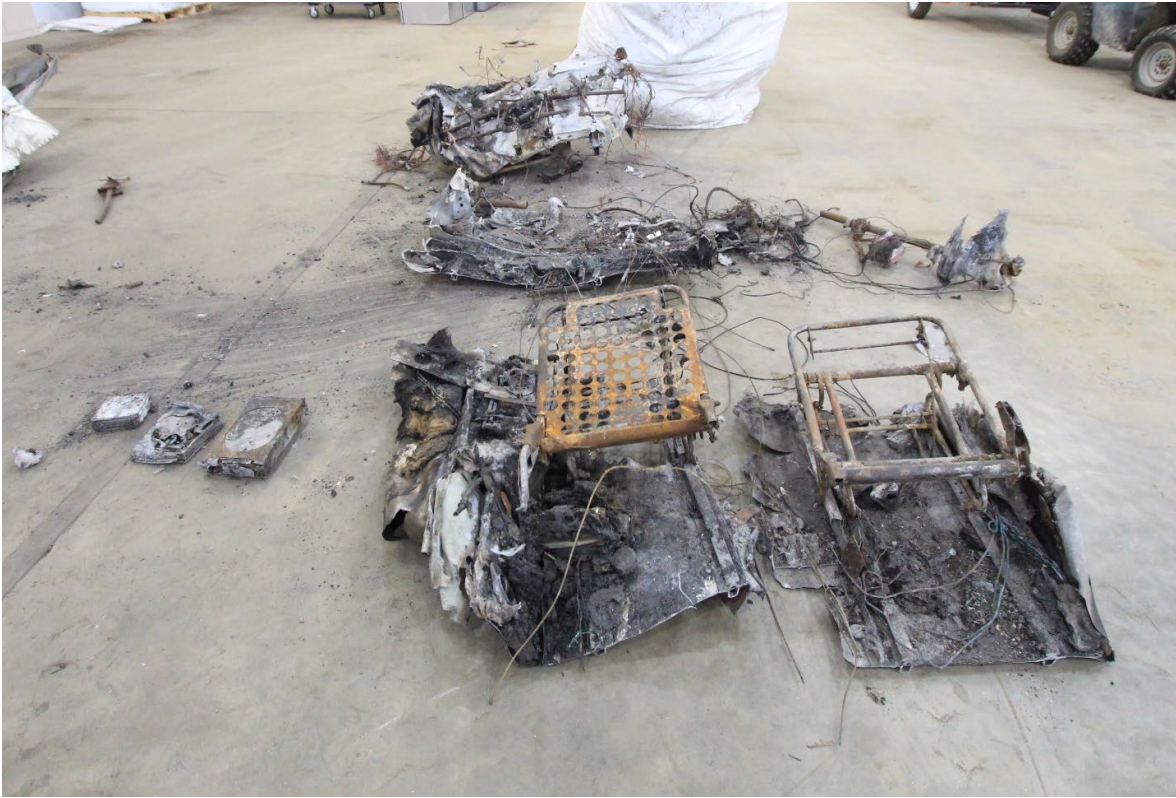
Very little material remained from the fuselage and cockpit area of the aircraft. The parts that could be identified from the cockpit area consisted mostly of the steel seat frames, some electronic components from the instrument panel, control cables, and portions of aircraft skin under the seat frames (Figure 10). Examination of these components did not reveal any clues as to the cause and origin of the reported in-flight fire.

**Figure 10.** Cockpit portion of the fuselage.

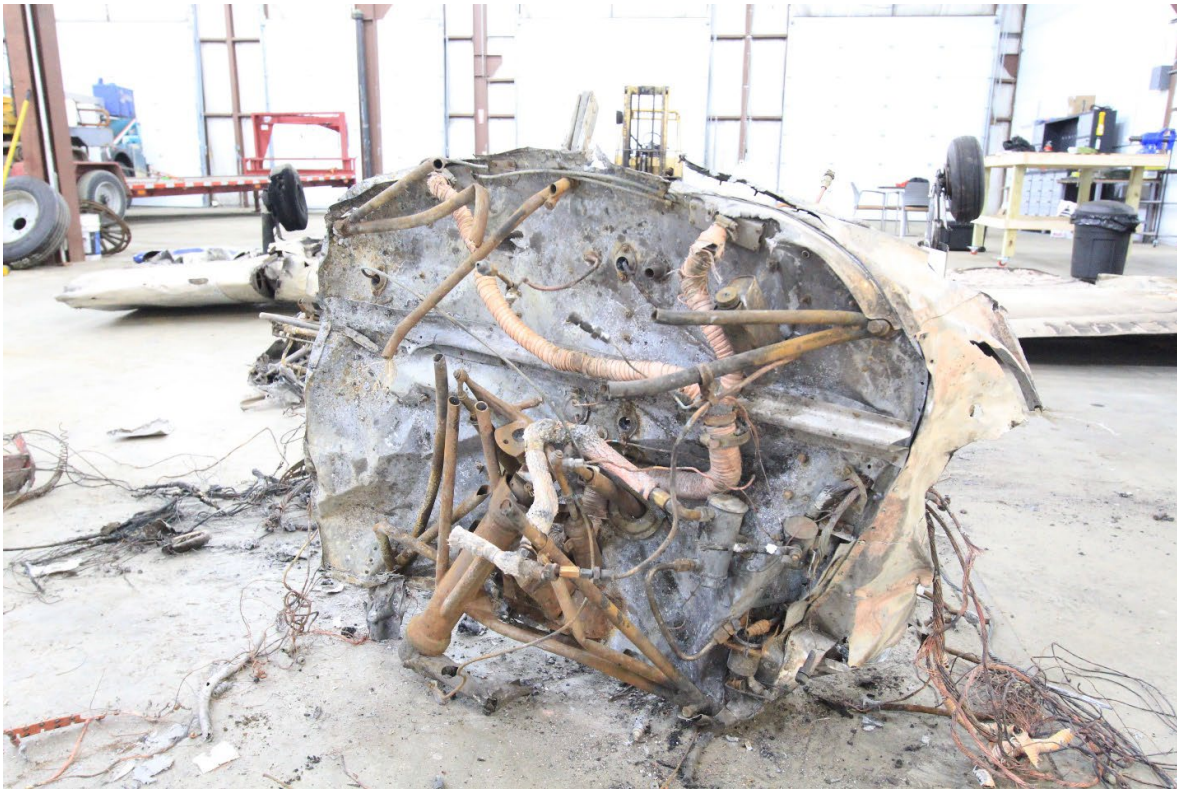
The firewall between the engine compartment and fuselage interior had been exposed to fire and exhibited thermal damage on both sides (Figures 11, 12). Although the firewall panel was composed of sheet steel and remained intact it exhibited deformation and thermal discoloration. The thermal damage to the firewall and the attached components was relatively uniform and consistent on both sides. Examination of the firewall and components remaining attached to the engine side of the firewall did not reveal any discernable evidence of concentrated thermal damage beyond the overall thermal exposure exhibited by all the materials in the area. Examination of the firewall and components remaining attached to the cockpit side of the firewall did not reveal any concentrated thermal damage on the firewall panel but did identify two copper tubes (associated with the fuel priming pump) and a fitting on a copper tube (oil pressure line) that exhibited localized areas of melting (Figure 13). These components exhibited a sharp demarcation between the melted area and the adjacent material. The fuel priming lines were standard equipment consistent with the aircraft design. The fitting on the oil pressure line was not standard equipment and was not consistent with the design of the original oil pressure line. Both the fuel primer lines (Figure 14) and the fitting on the oil pressure line (Figure 15) were retained for further examination.

**Figure 11.** Engine side of the firewall.

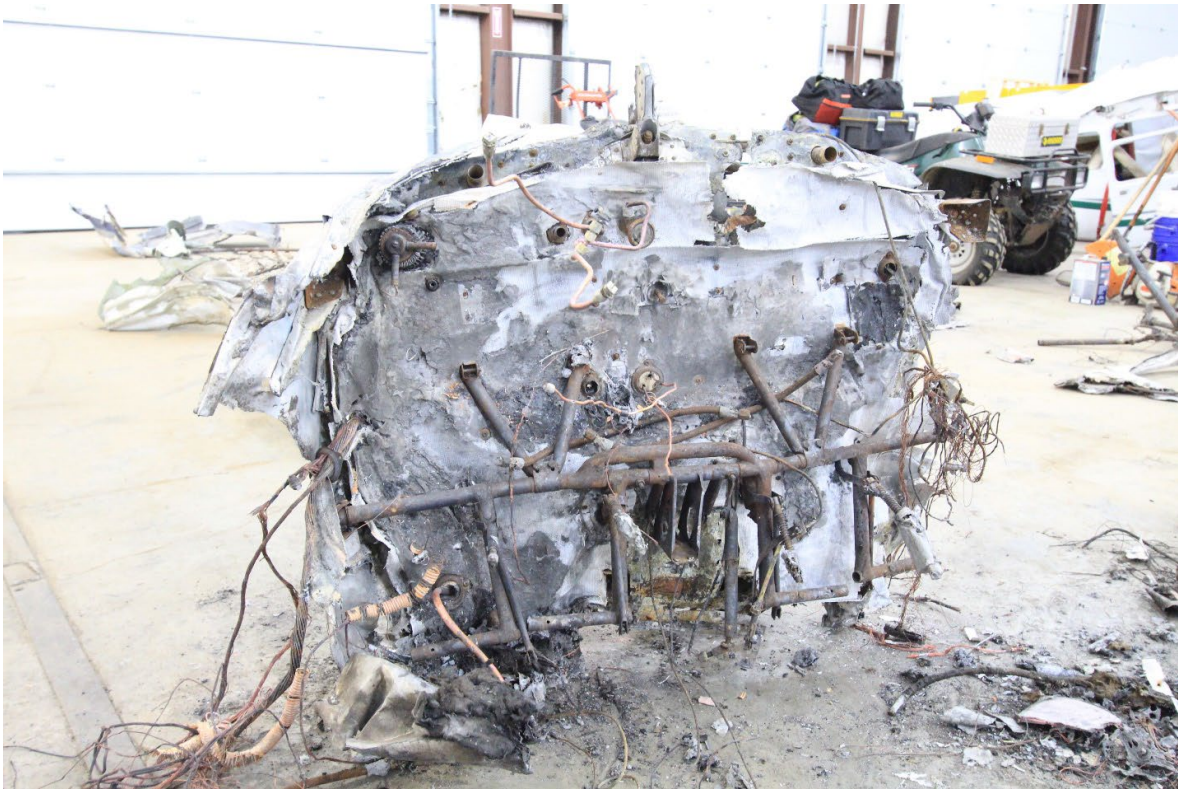
**Figure 12.** Cockpit side of the firewall.

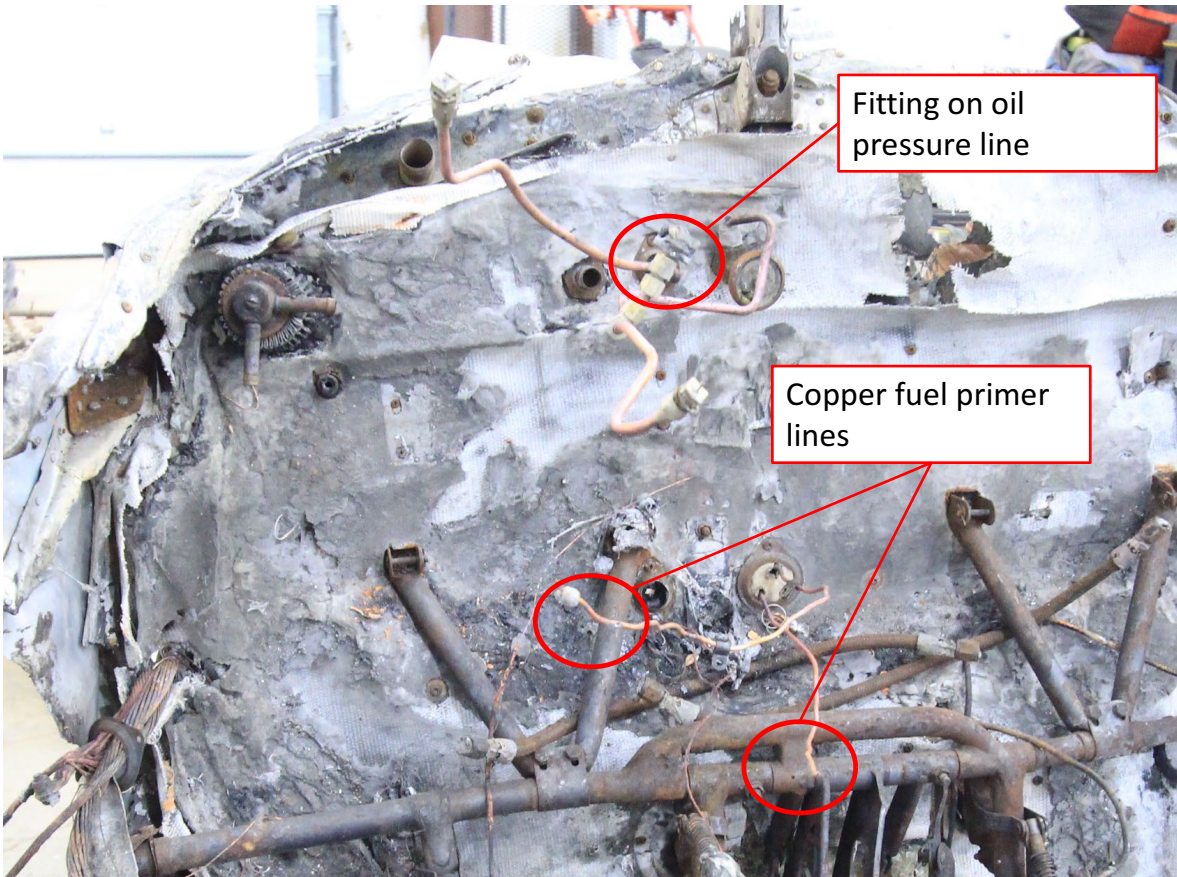
**Figure 13.** Components exhibiting localized melting on cockpit side of the firewall.

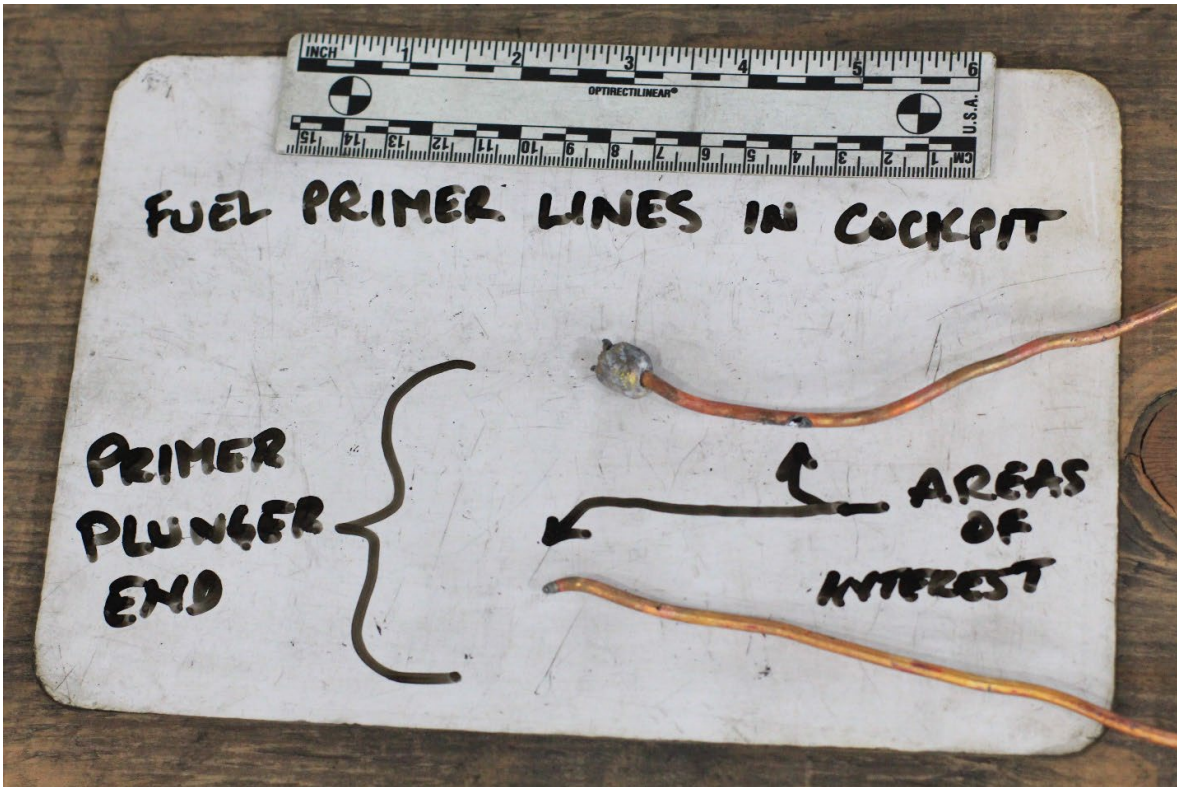
**Figure 14.** Portions of the fuel primer lines.

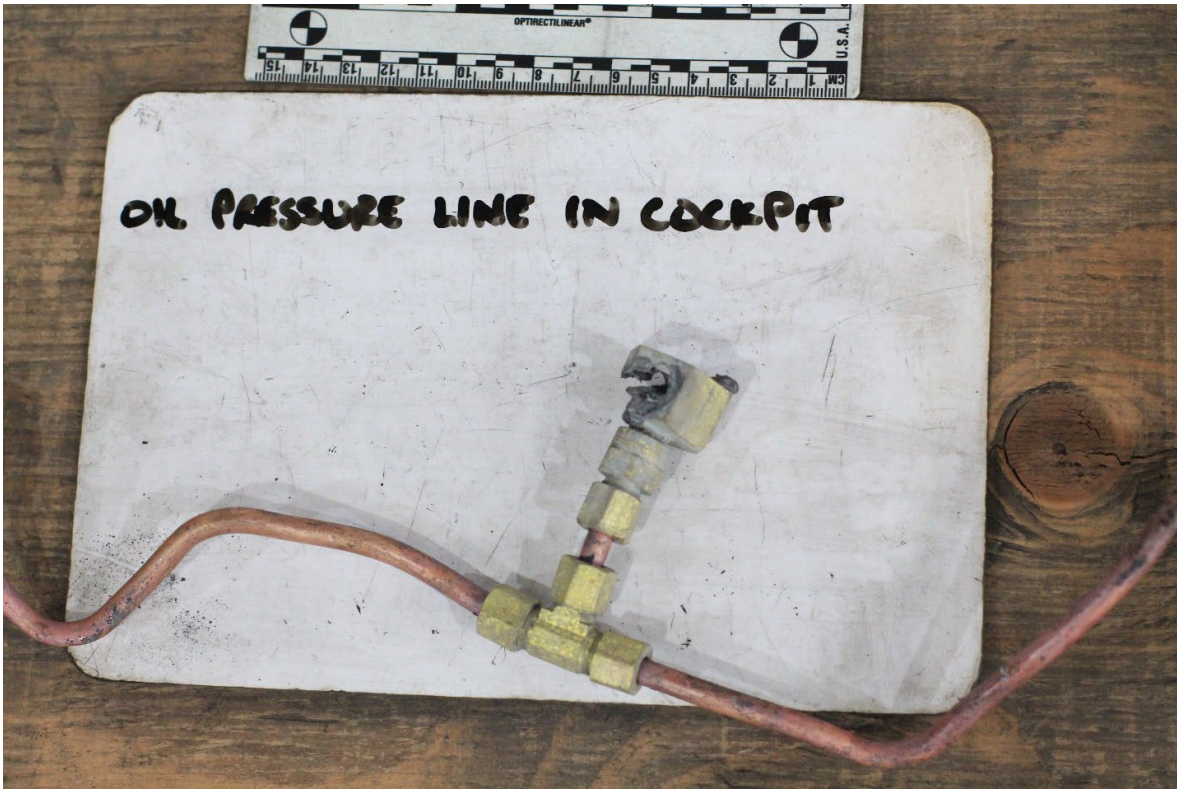
**Figure 15.** Portion of oil pressure line with fitting.

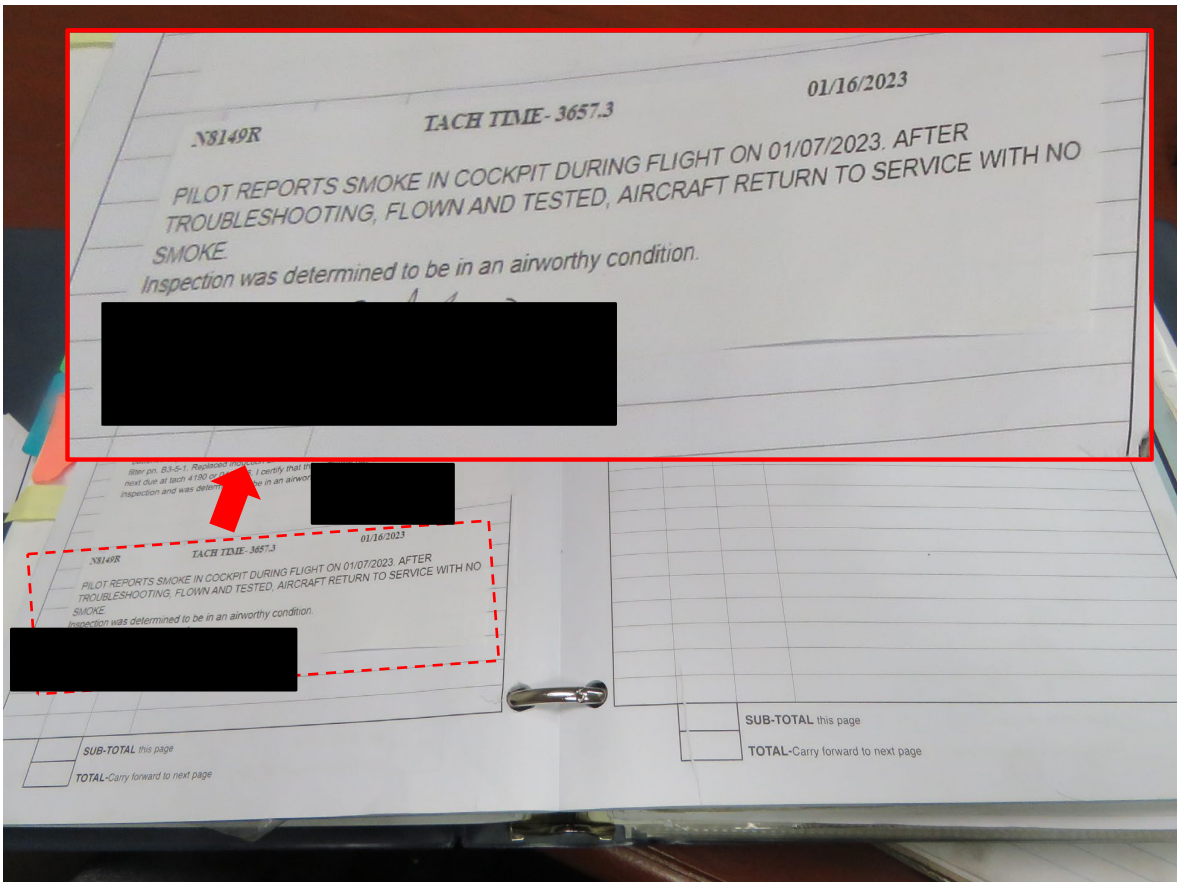
The aircraft's maintenance logs contained an entry dated 1/16/2023 describing a pilot's report of smoke in the cockpit during a flight on 1/7/2023 (Figure 16). The entry did not indicate that a source of the smoke was found during trouble shooting or that any repairs were made before returning the aircraft to service.

**Figure 16.** Logbook entry describing previous issue with smoke in the cockpit.
