National Transportation Safety Board

DCA22FM022

Fire Factual Report 22-101

Location: Norfolk, VA
Date: June 7, 2022
Vehicle: Spirit of Norfolk
Investigator: Michael Karr

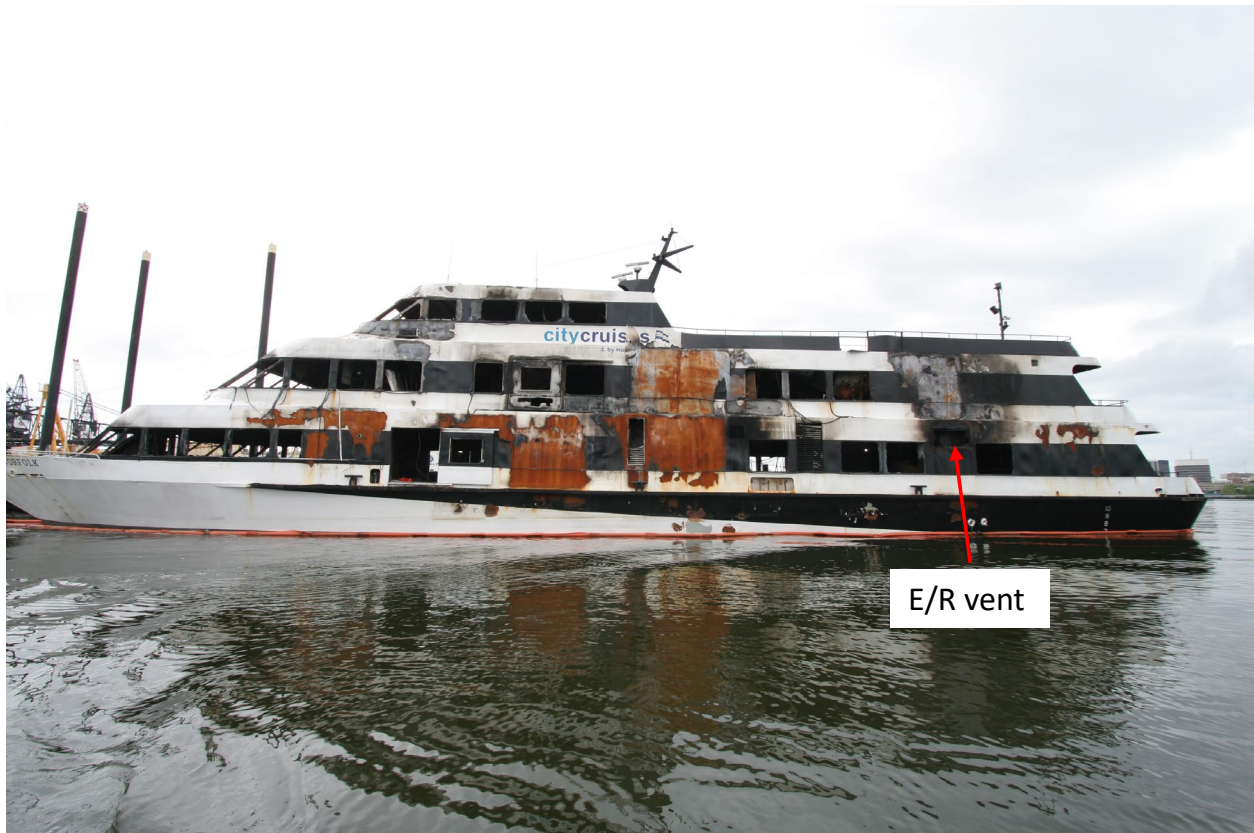
Overall, the entire vessel sustained fire damage throughout all the decks. As witnessed from the exterior there appeared to be more thermal discoloration and charring of the exterior paint on the starboard side than on the port side (Figures 1, 2). This was likely a consequence of the prevailing winds while the ship was burning at the pier. From the exterior, the engine room exhaust vents were visible. These vents exhibited soot around the vent outlets and patches of charred and burned off paint above the vent outlets (Figures 3, 4). On the port side exterior there was an area of charred/burned-off paint at the height of the engine room vent inlet. A similar area was not observed on the starboard side.

Figure 1. Port side exterior.

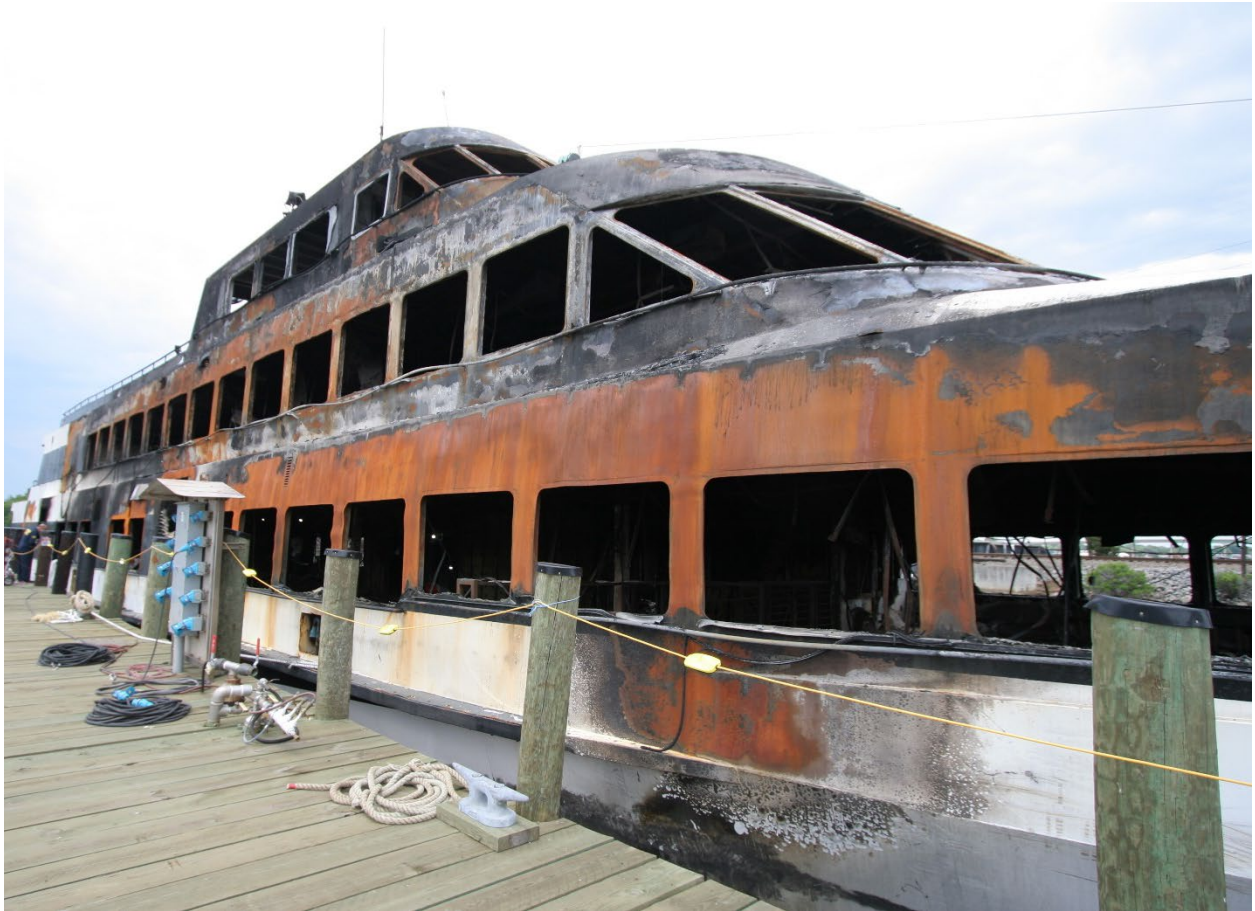
Figure 2. Starboard side exterior.

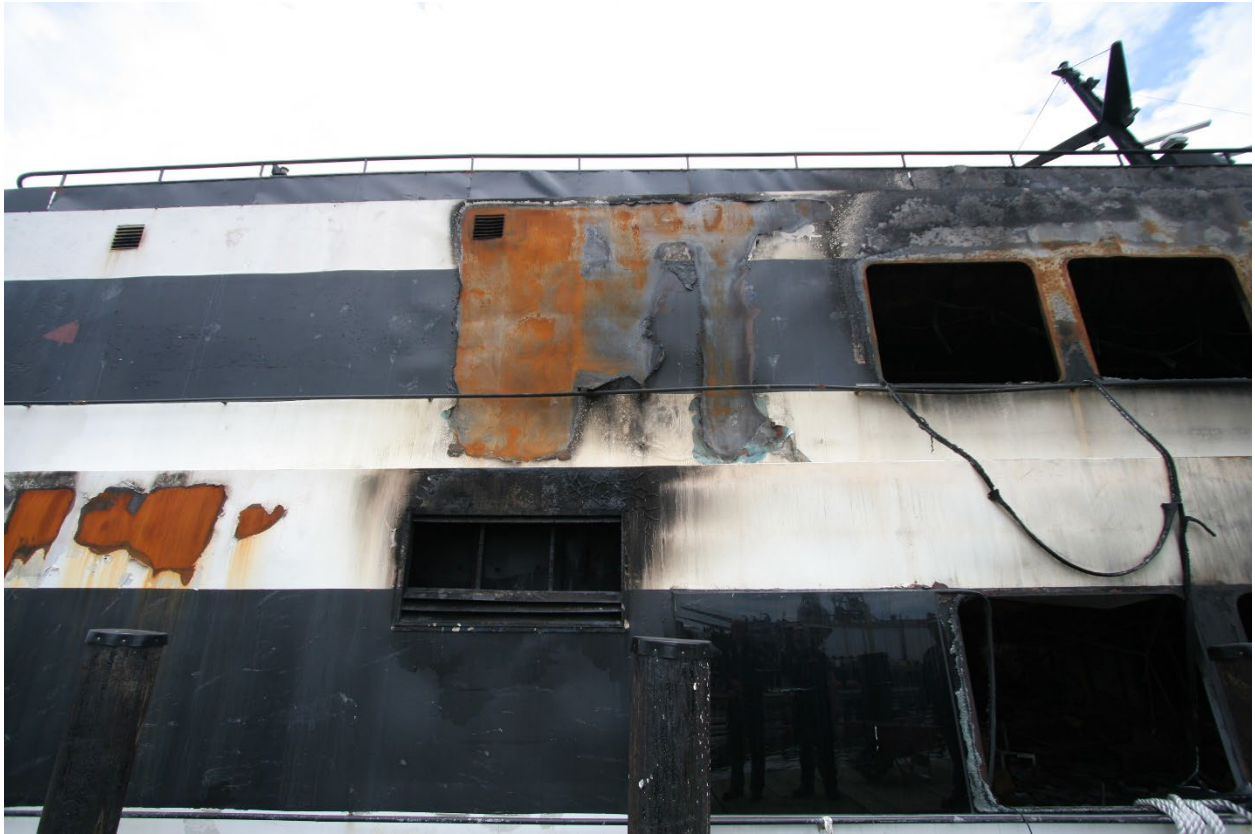
Figure 3. Starboard side engine room vent outlet.

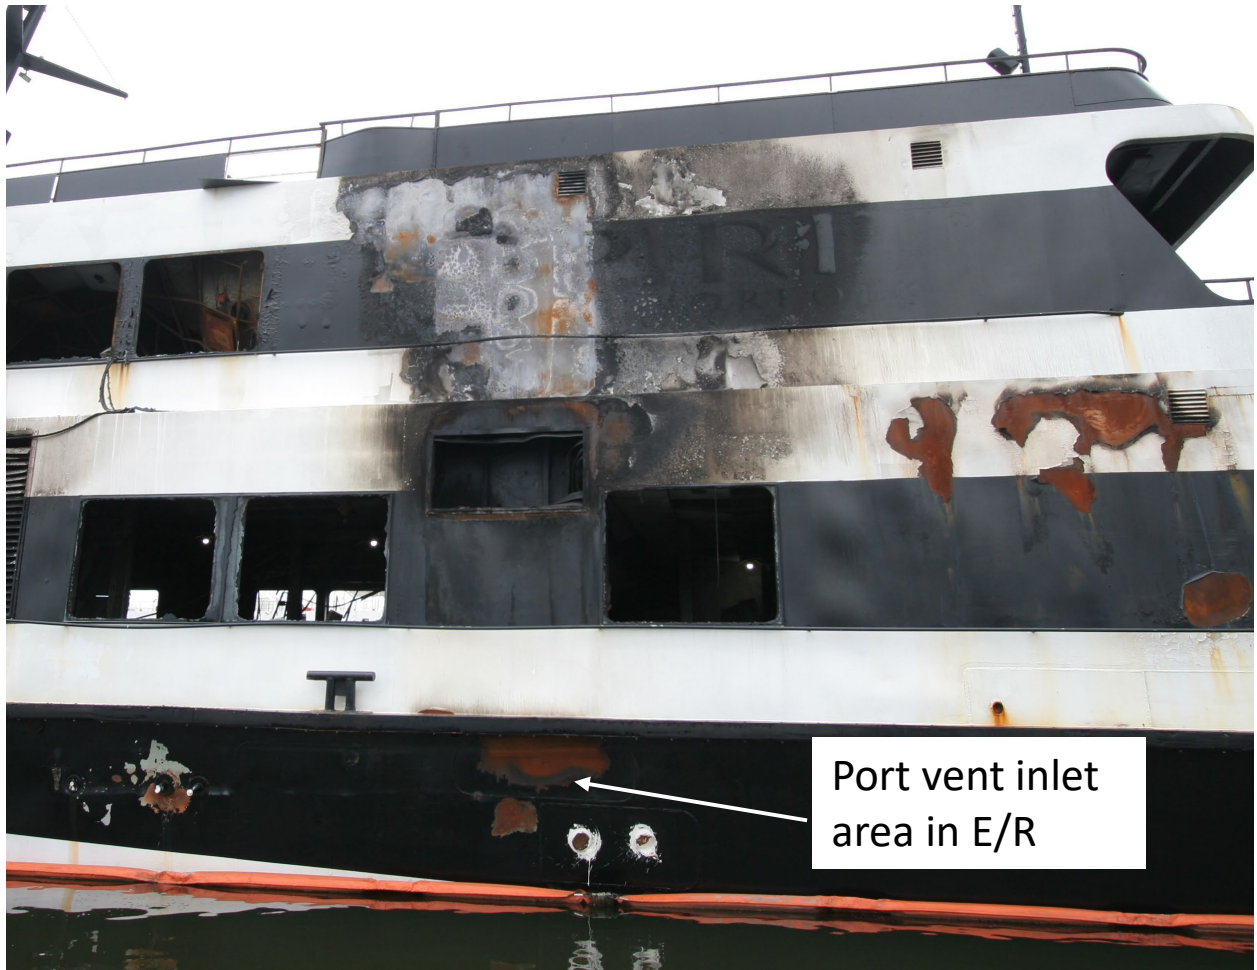
Port vent inlet
area in E/R

Figure 4. Port side engine room vent outlet.

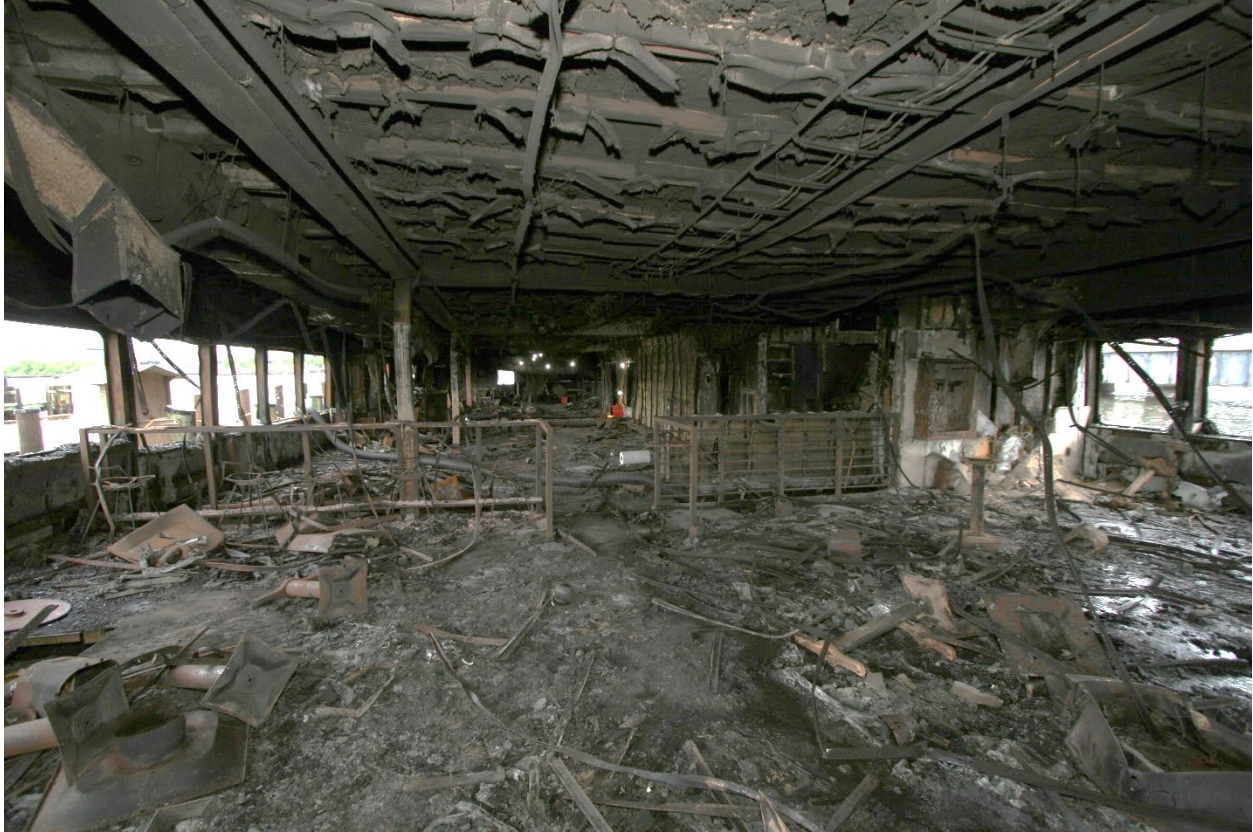
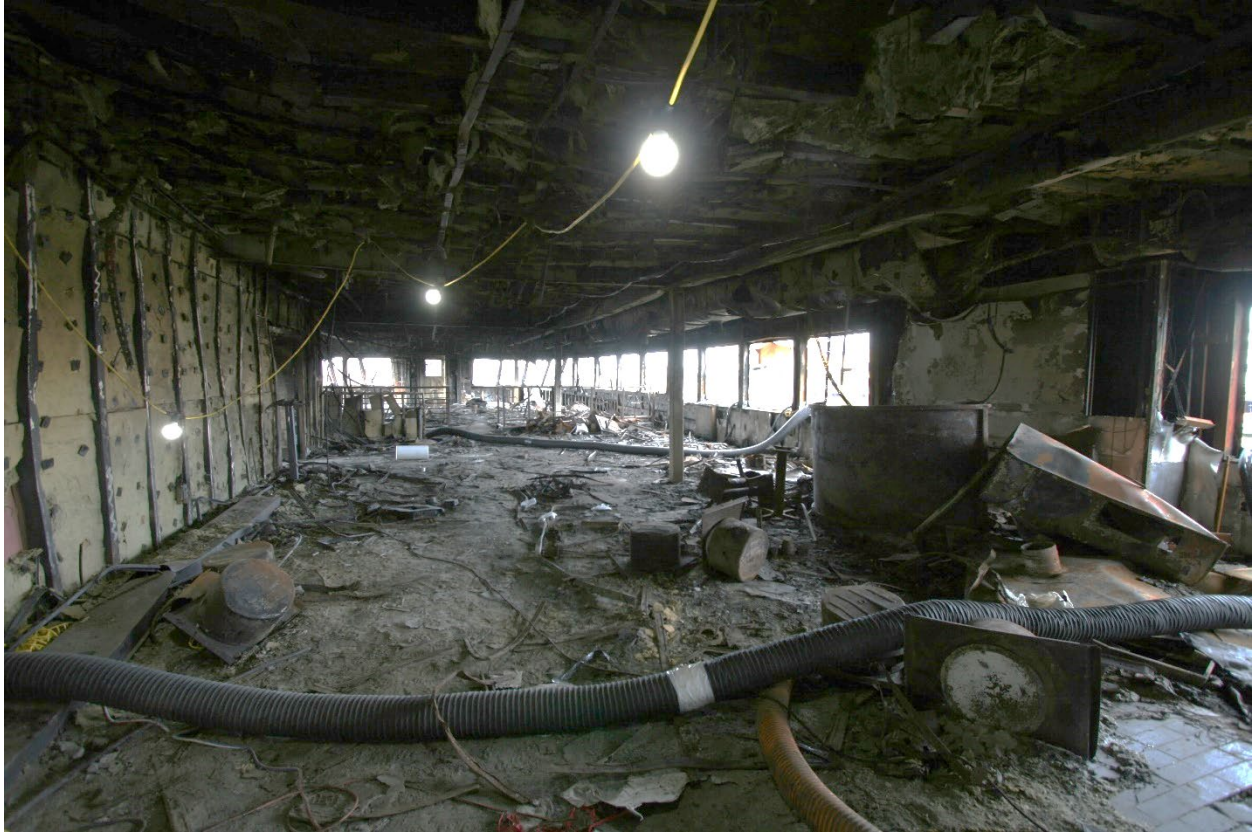
The forward portion of the main deck was completely consumed on the interior (Figures 5, 6). There were portions of the aft section of the interior main deck with less damage than the forward section but did exhibit some sooting. Exterior areas on the stern of the main deck were not fire damaged but did exhibit some sooting.

Figure 5. Main deck interior looking aft.

Figure 6. Main deck interior looking forward.

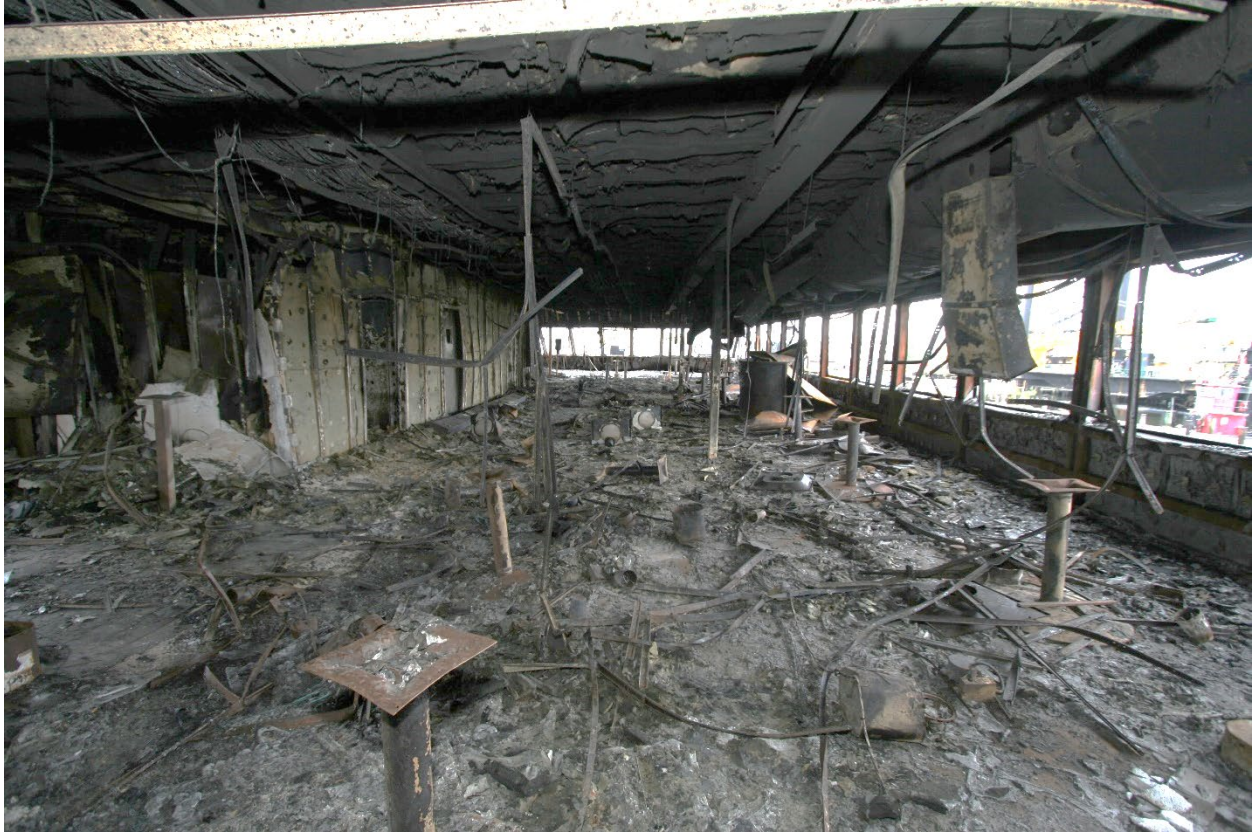
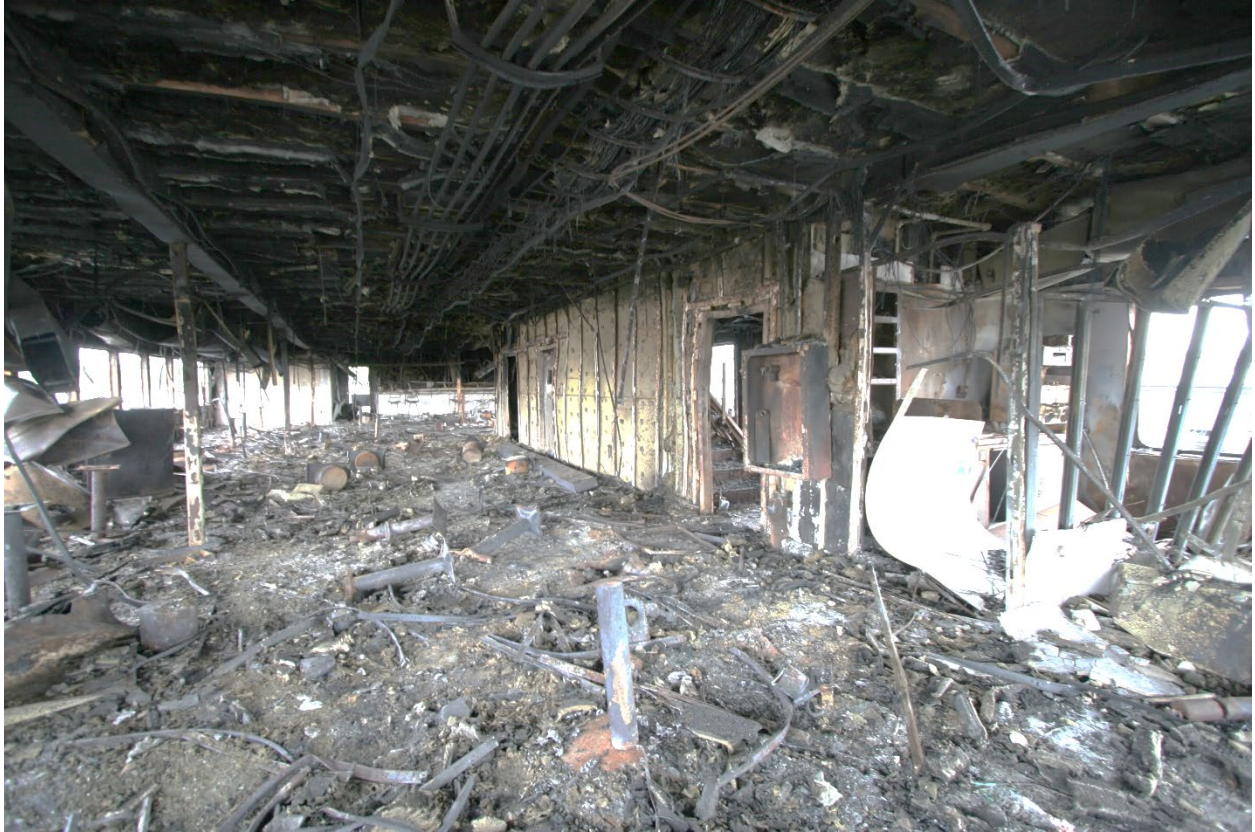
The second deck in a similar manner to the main deck was consumed on the interior from bow to stern (Figures 7, 8). Exterior areas on the stern of the second deck were not fire damaged but did exhibit some sooting.

Figure 7. Second deck interior looking forward.

Figure 8. Second deck interior looking aft.

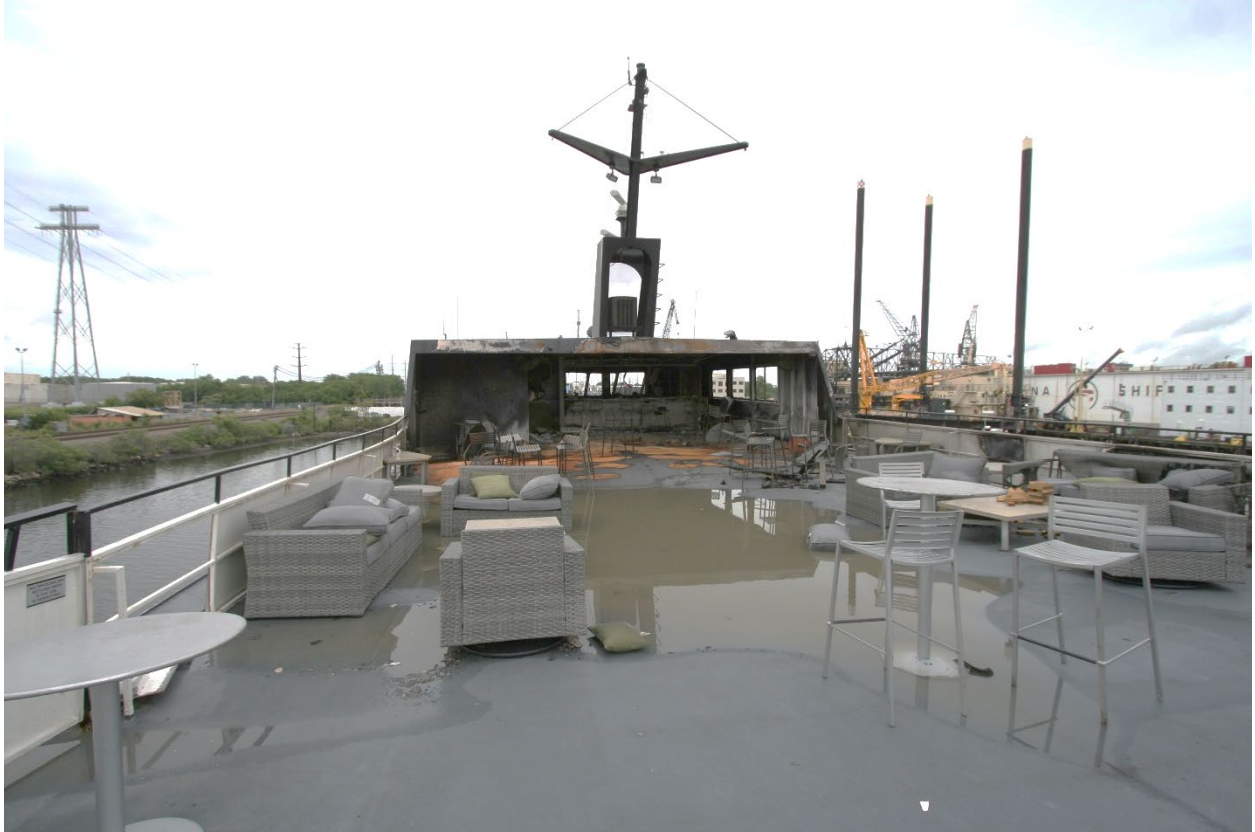
The third deck consisted of an open seating area on the aft portion, a partially enclosed bar area in the middle and a wheelhouse at the forward portion. The open seating area of the third deck was mostly undamaged by fire except for buckling of the decking from the effect of the fire inside the second deck compartment (Figure 9). The bar area was consumed by fire, the decking was buckled with the paint burned off (Figure 10). The wheelhouse was completely consumed by fire (Figure 11).

Figure 9. Third deck open seating area looking forward.

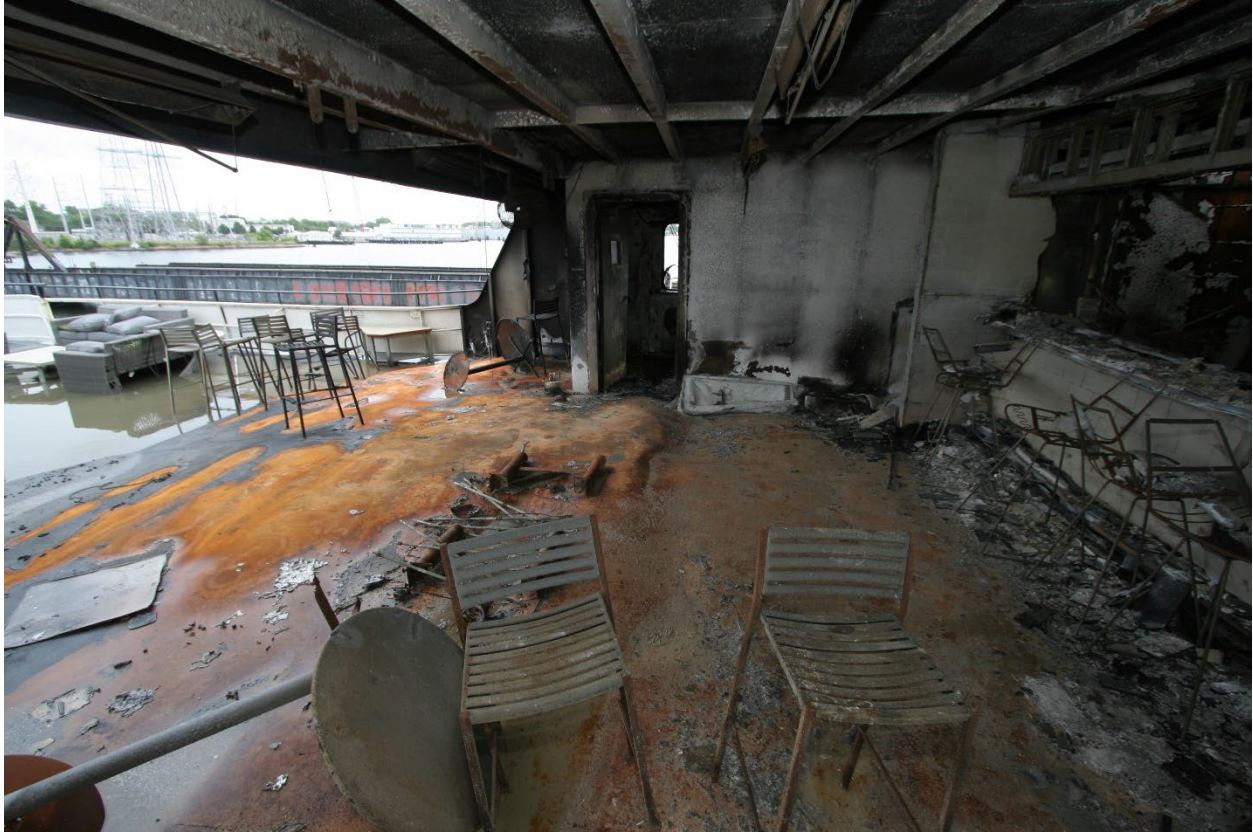
Figure 10. Third deck bar area.

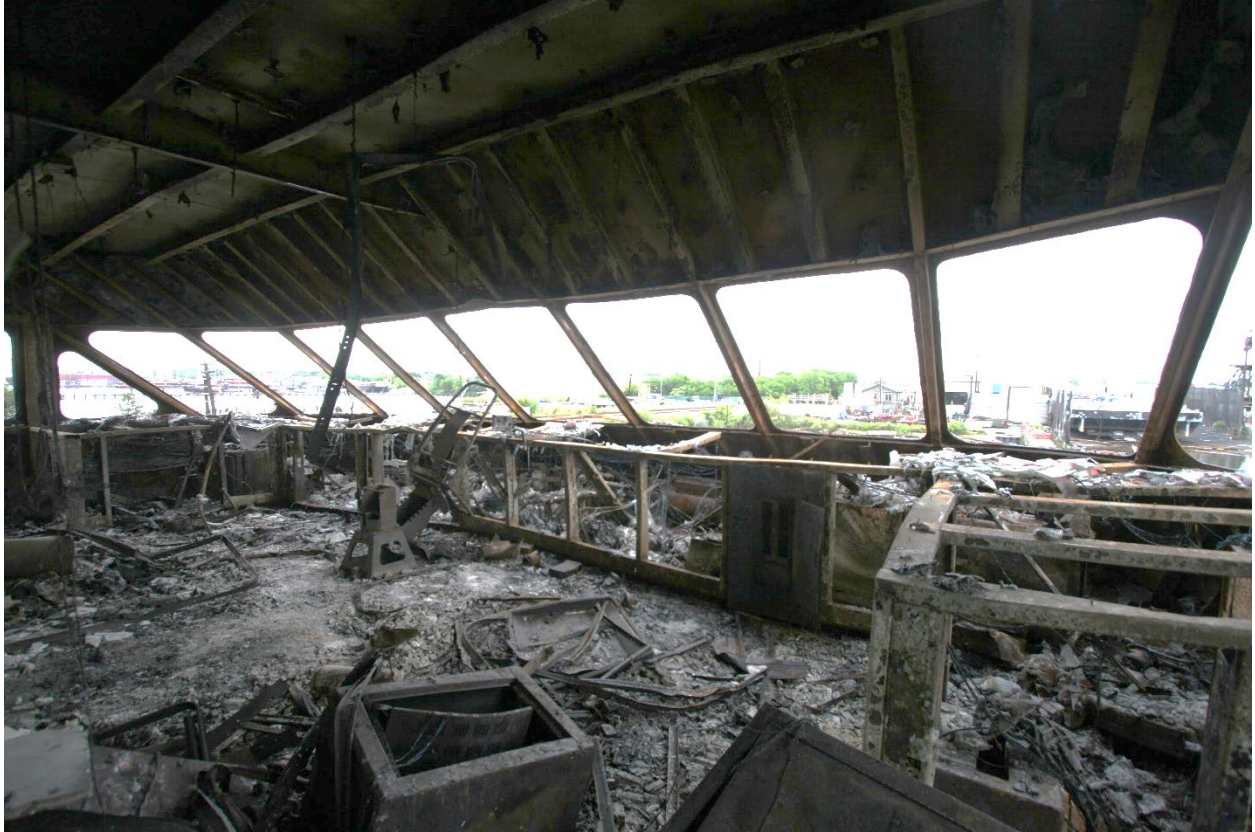
Figure 11. Wheelhouse interior.

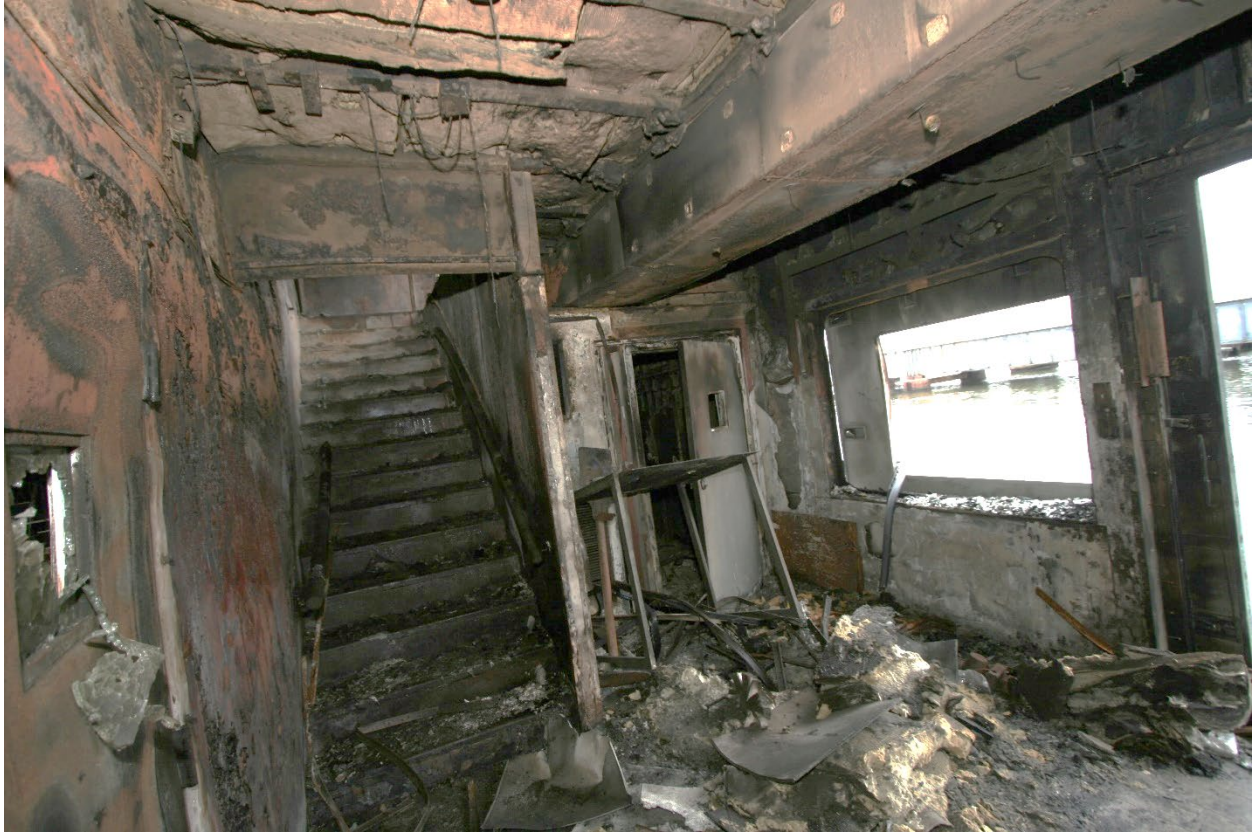
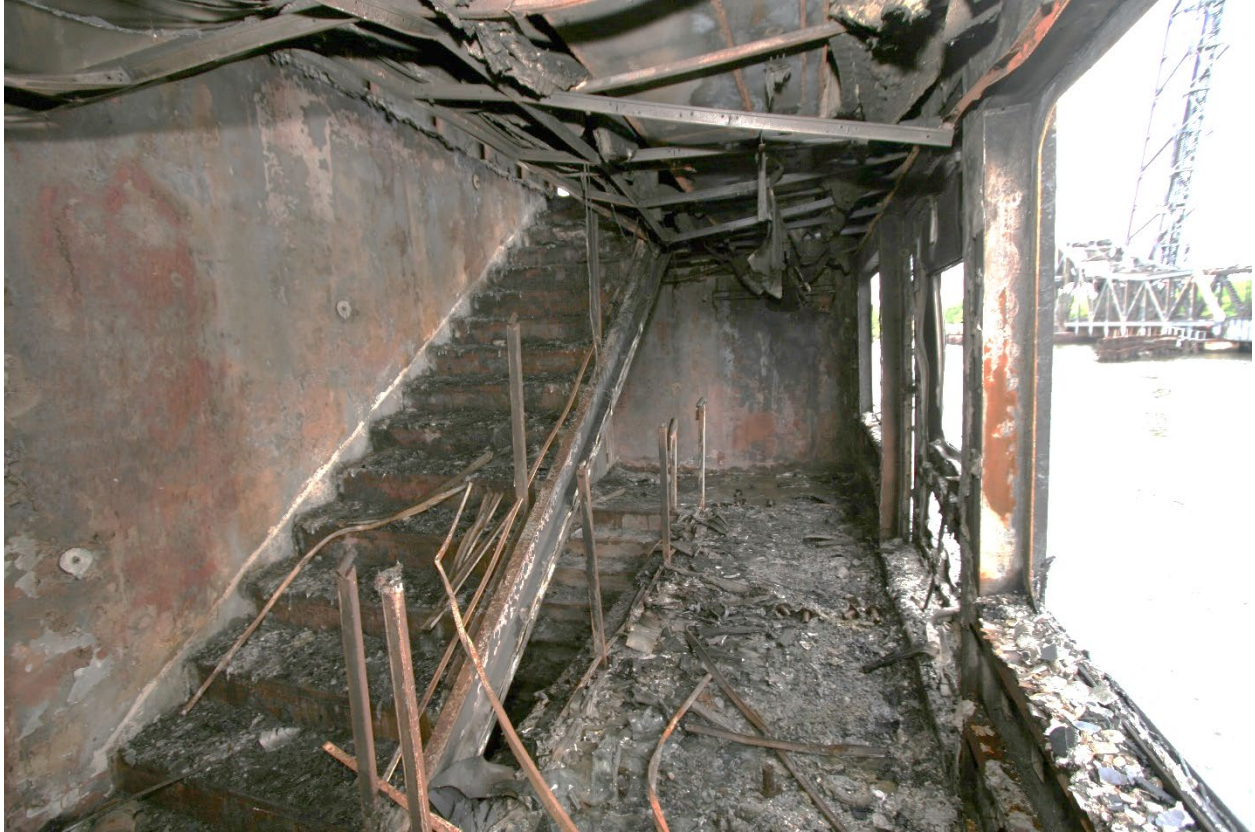
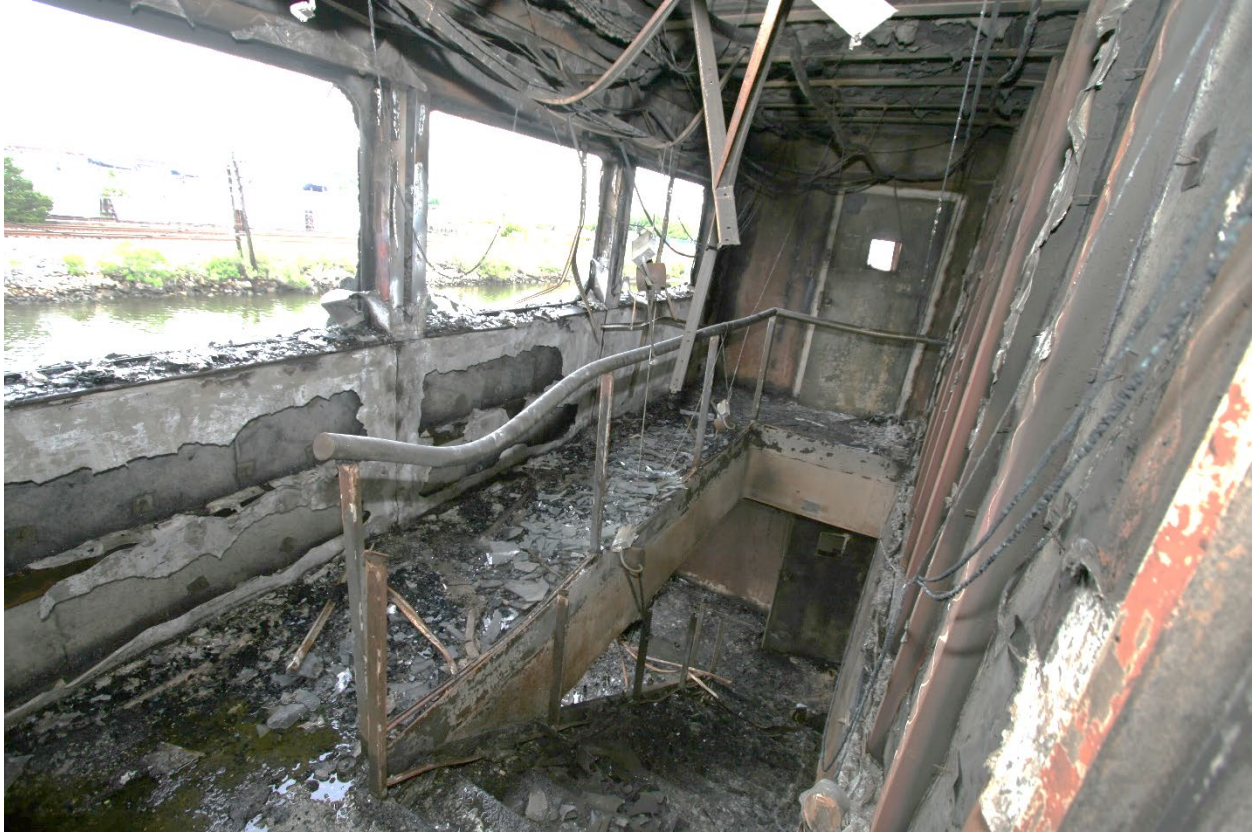
The interior stairwells connecting the decks were also entirely consumed by the fire (Figures 12, 13, 14)

Figure 12. Stairwell from main deck to second deck including passenger boarding area.

Figure 13. Stairwell from second deck to the third deck.

Figure 14. Stairwell on the third deck looking forward towards wheelhouse door.

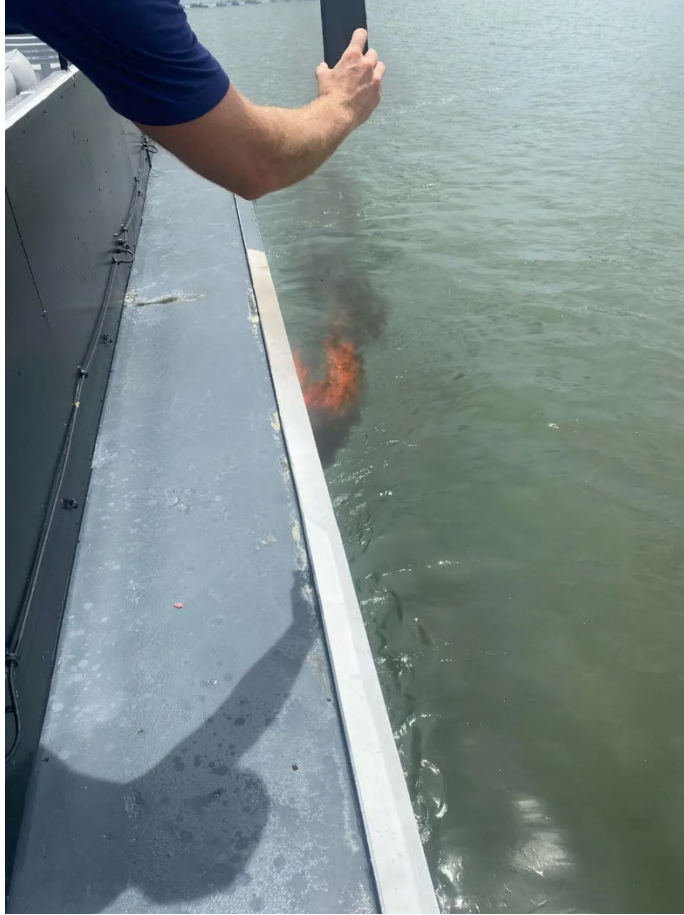
Figure 15. Photo of smoke and flame exiting port side engine room vent. (Source: Passenger Jason Sleeth).

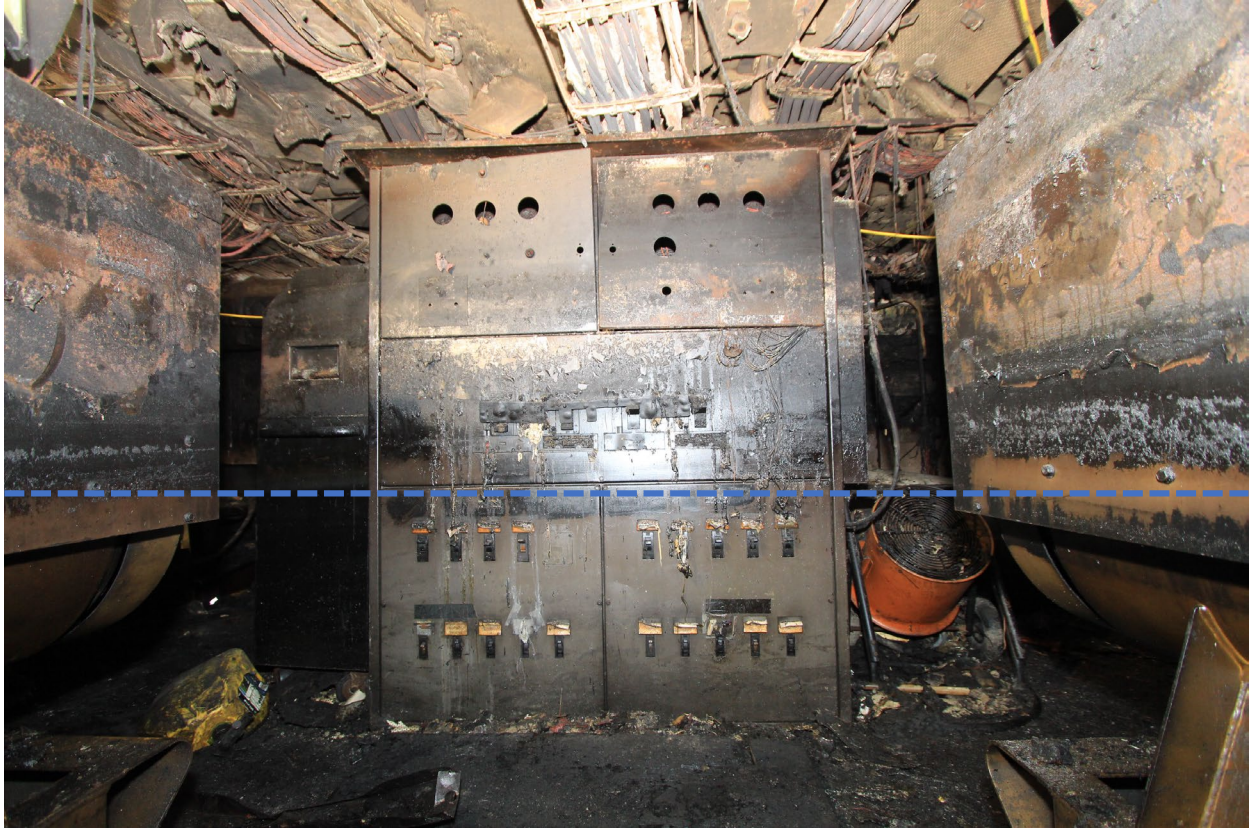
Figure 17. Electrical Cabinet with demarcation line.

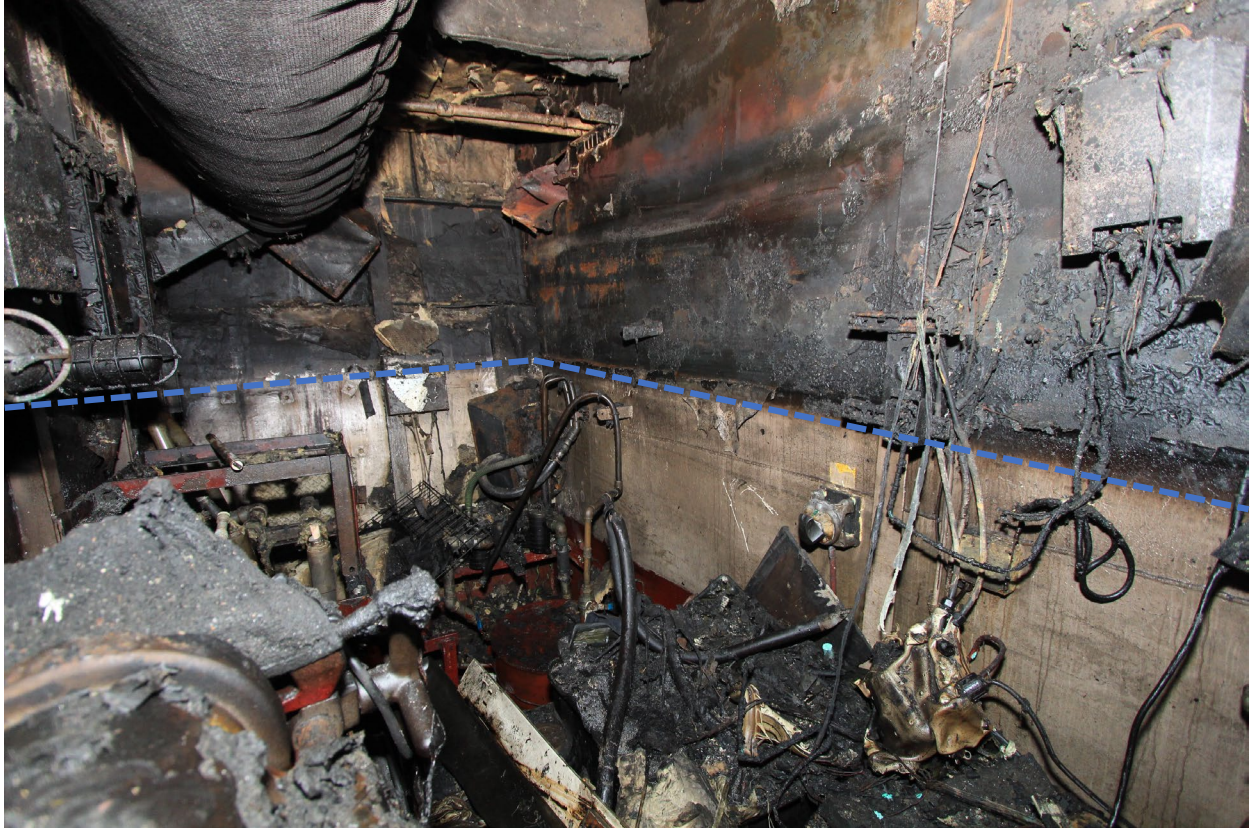
Figure 18. Alcove forward of port main engine exhibiting demarcation between thermally damaged and undamaged area.

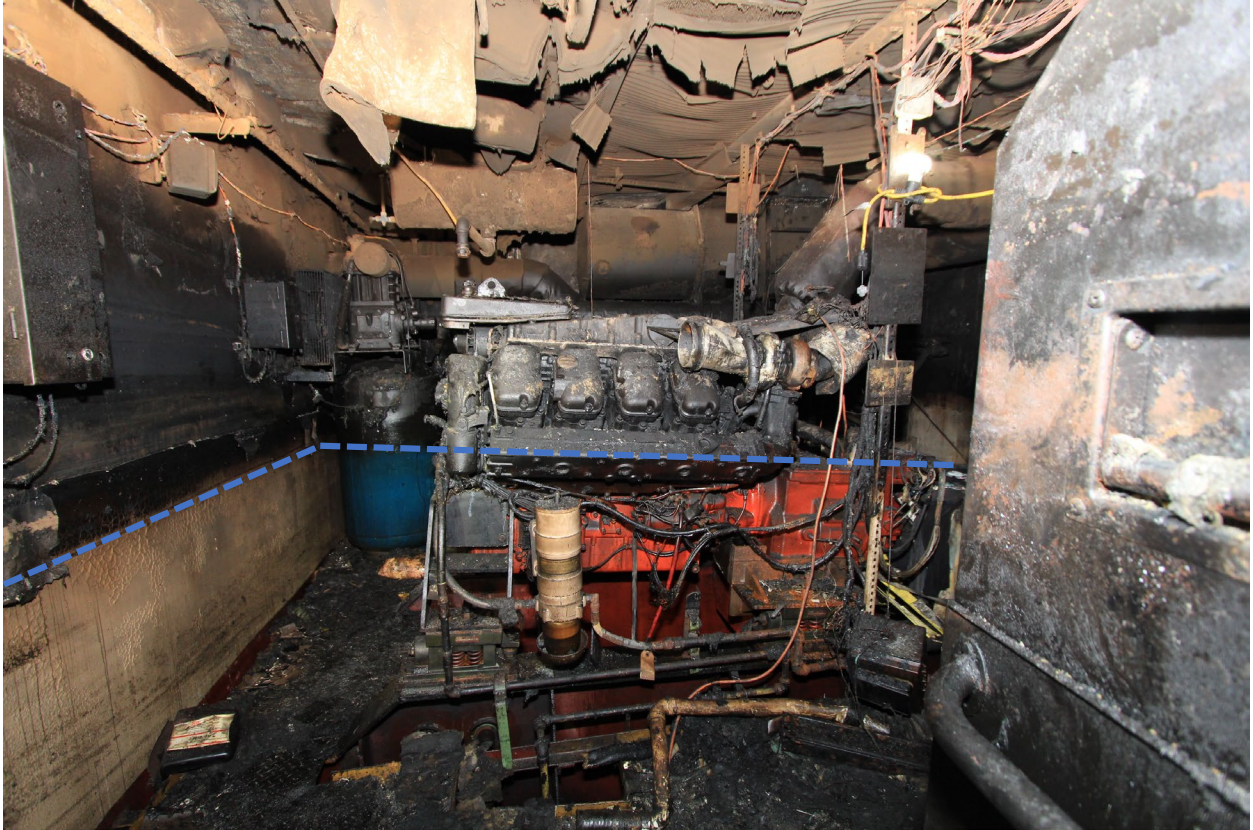
Figure 19. Starboard main engine exhibiting demarcation between thermally damaged and undamaged area.

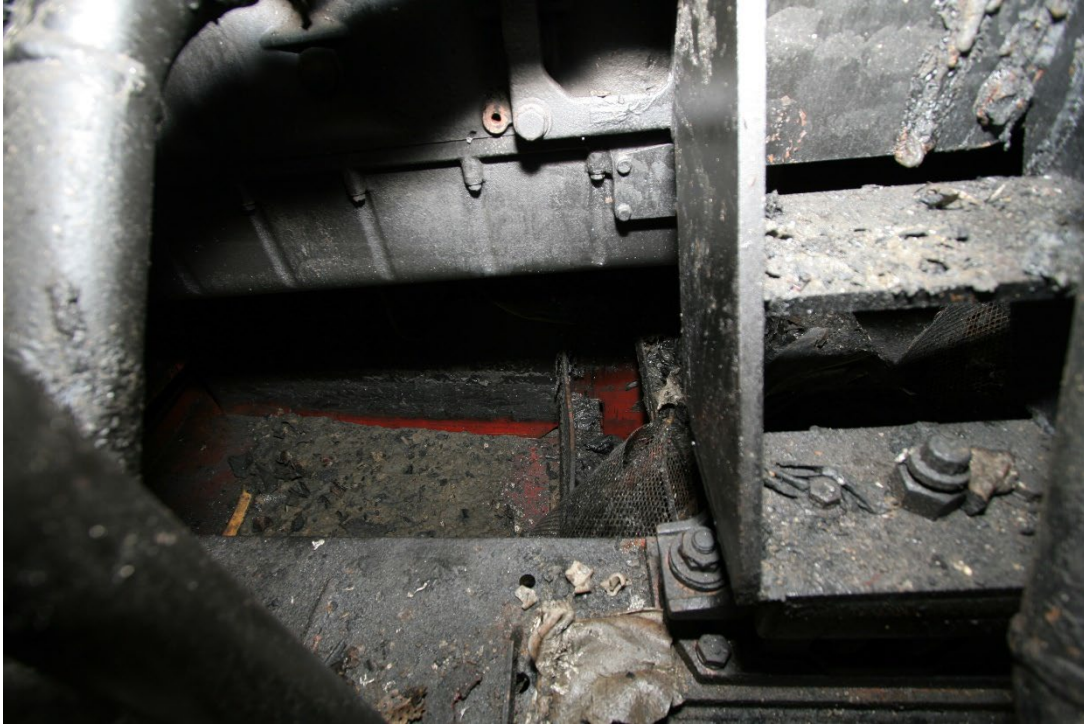
Figure 20. Bilge area below port main engine with some charring on the red paint.

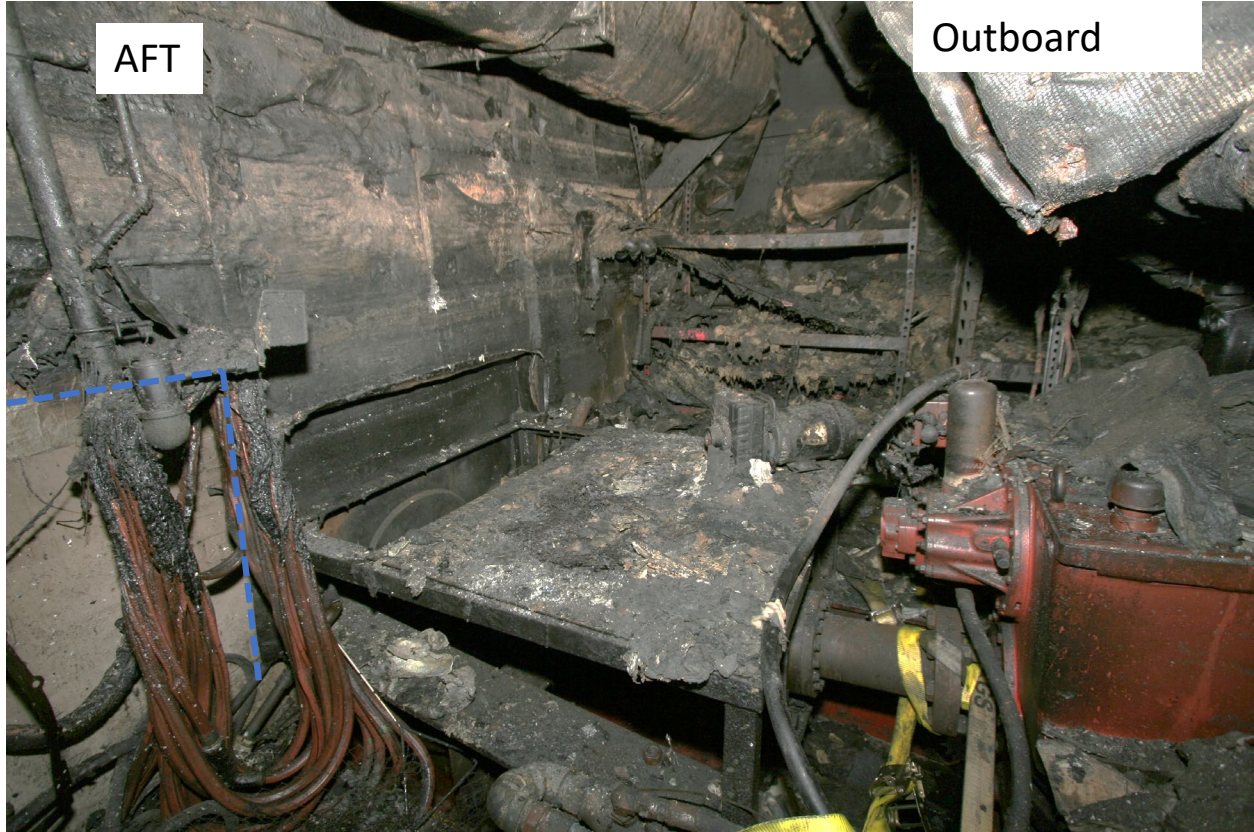
Figure 22. Bulkheads aft and outboard of port main engine.

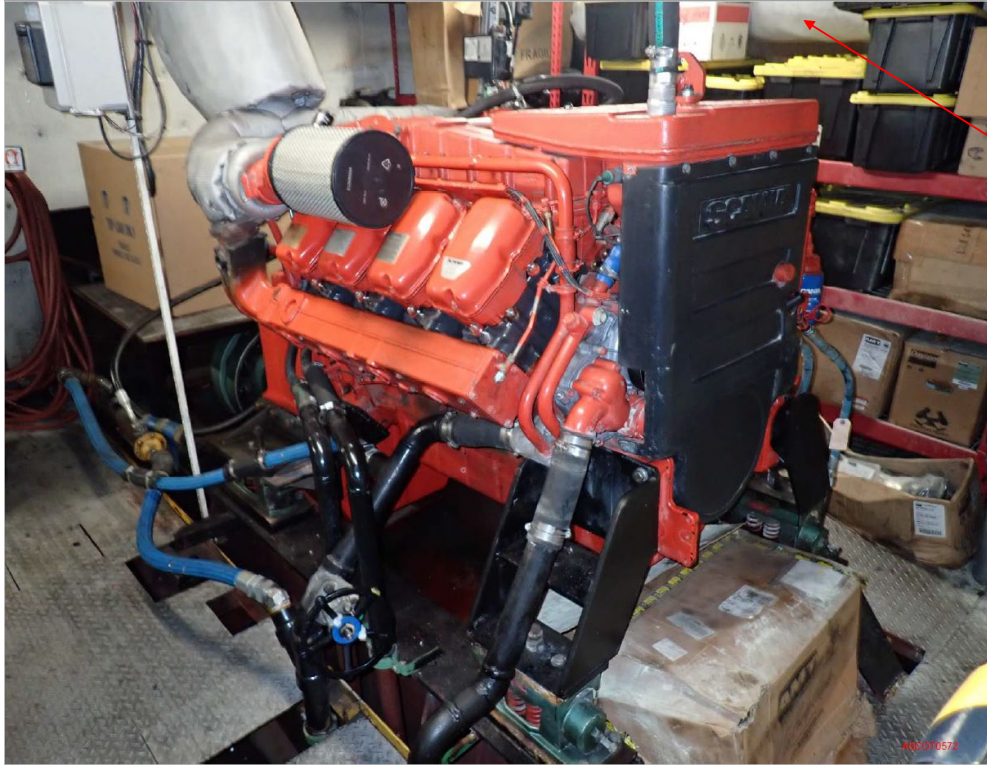
Port generator
exhaust

Figure 23. Photo from survey on 6/2/2022 showing storage shelf and port generator exhaust.

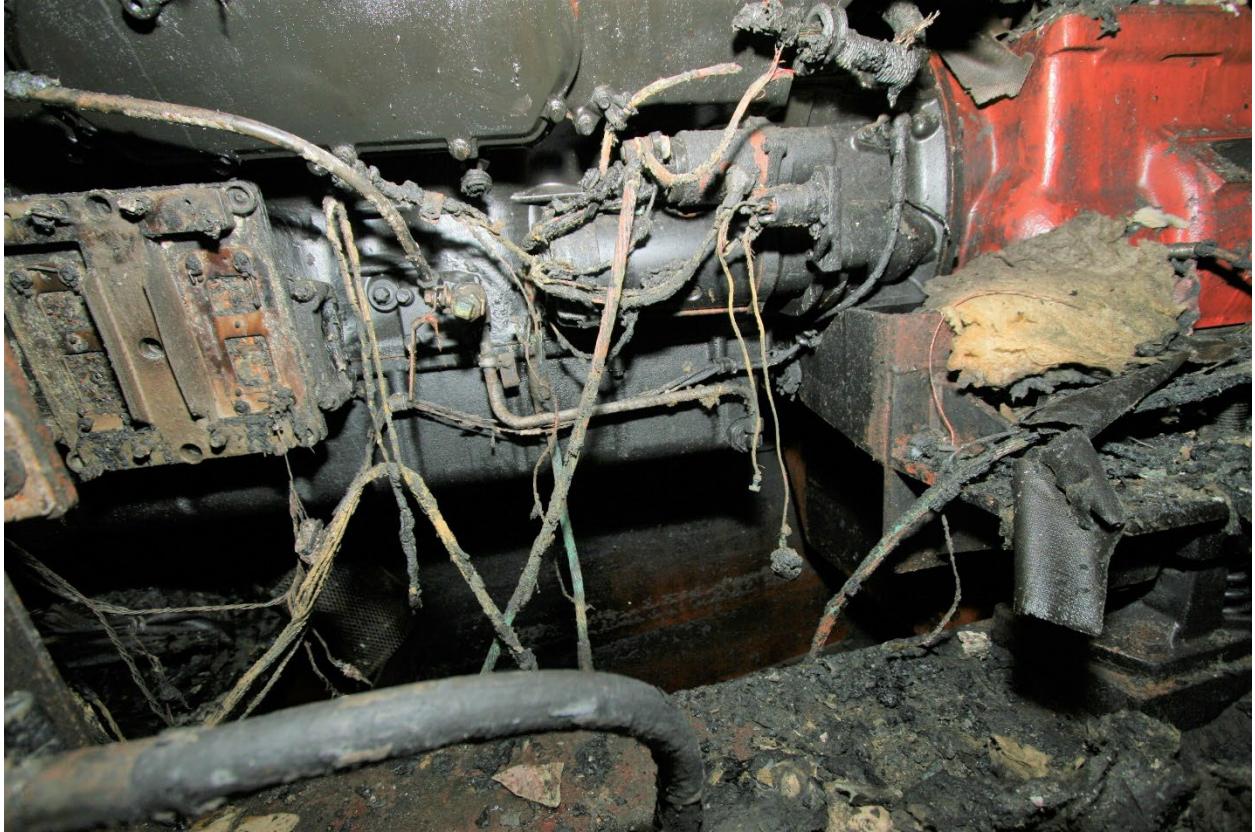
Figure 24. Gear box aft of port main engine with intact paint.
