National Transportation Safety Board

DCA22FM022

Fire Factual Report 22-101

Location: Norfolk, VA
Date: June 7, 2022
Vehicle: Spirit of Norfolk
Investigator: Michael Karr

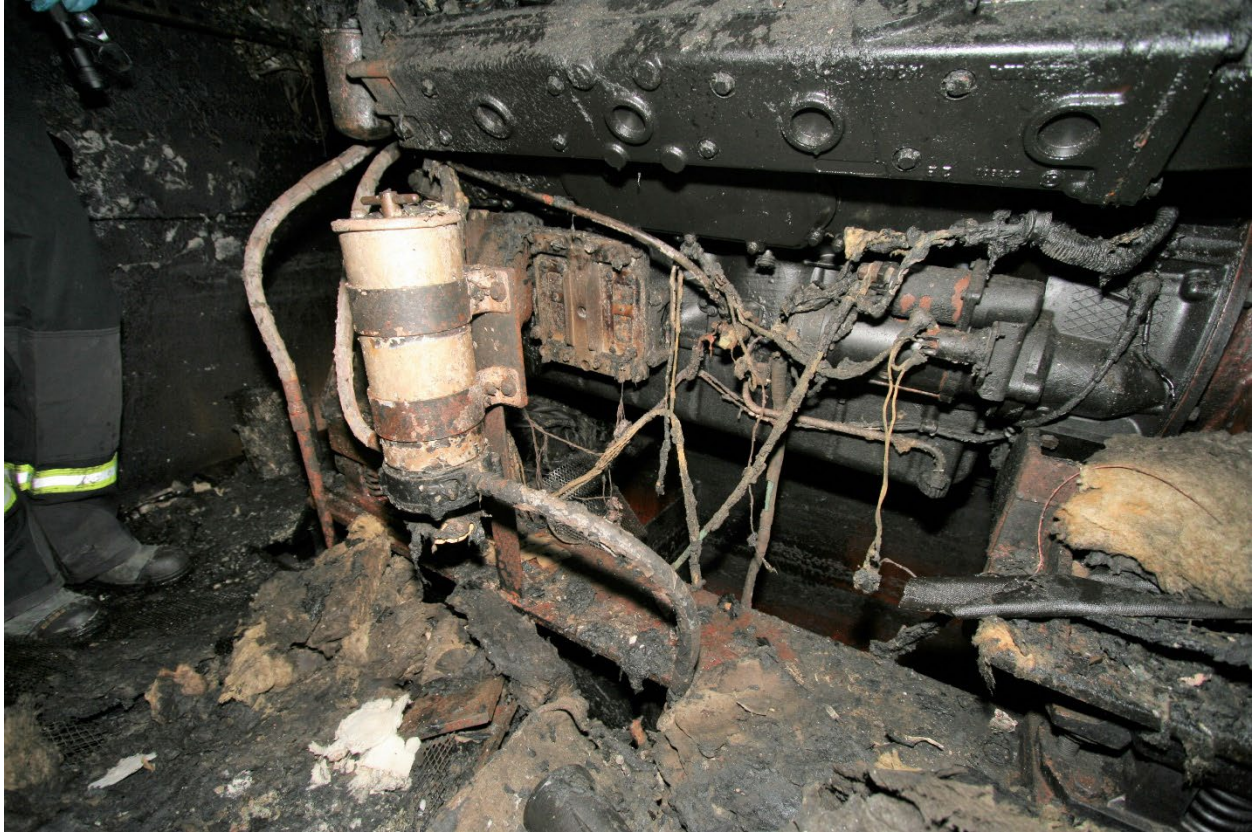
Figure 25. Outboard side of port main engine. Consumed fuel/water strainer bowl and low-lying charring to the deck level and below.

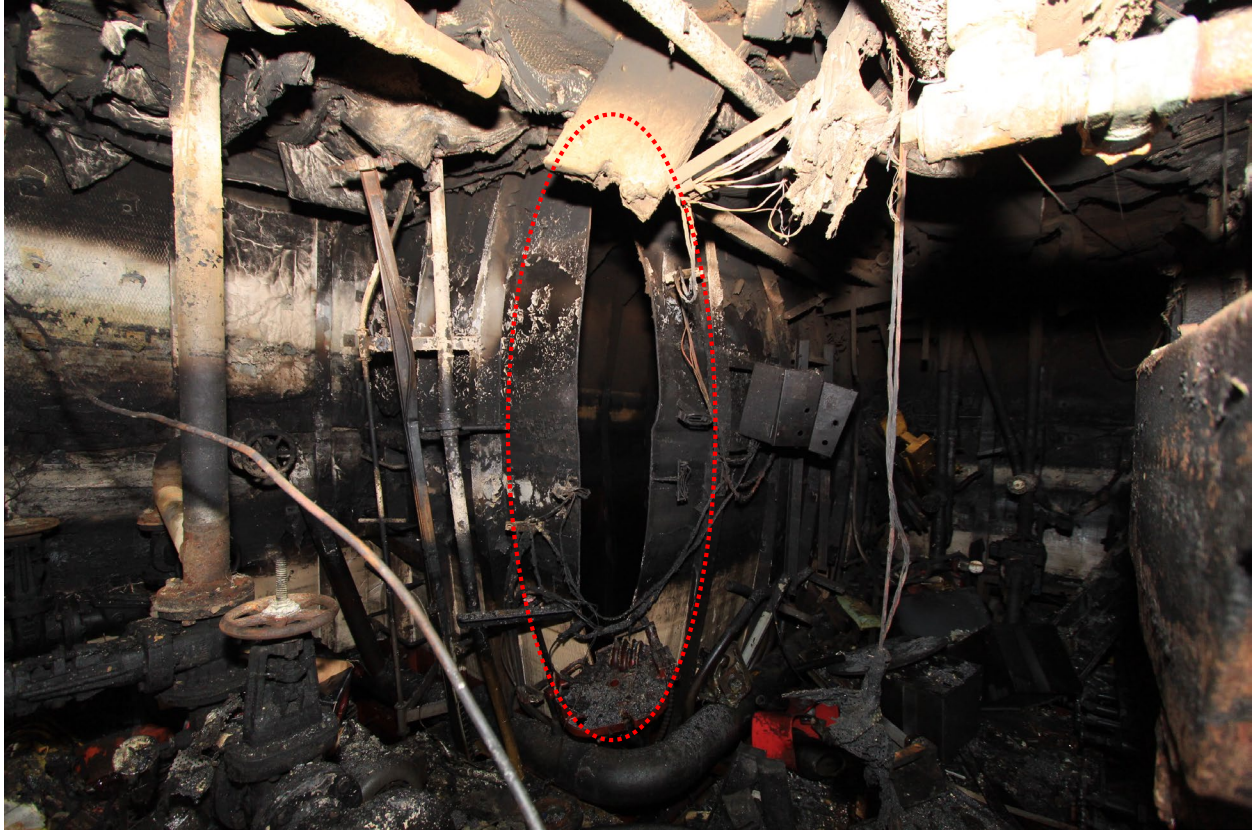
The two fuel tanks in port and starboard forward corners of the engine room exhibited evidence of having sustained overpressure conditions. The port fuel tank walls were bowed outwards but appeared to remain intact. The starboard fuel tank exhibited outward bowing as well a tear along one of the seams that extended from the ceiling down to the deck (Figure 26). The damage to both fuel tanks was consistent with the ignition of ullage space fuel vapors.

Figure 26. Starboard fuel tank fracture.

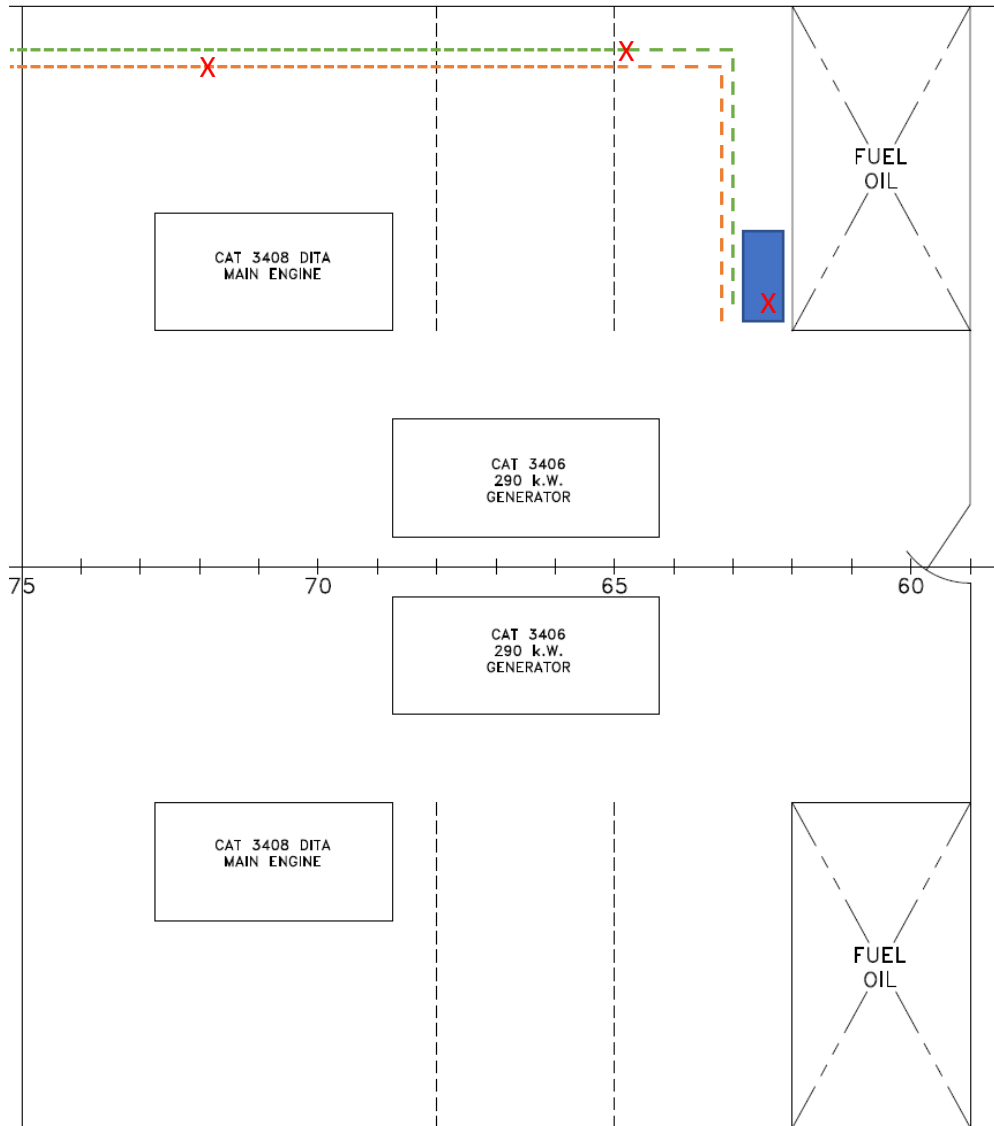
Examination of the hydraulic steering system revealed three failure points in the hydraulic oil distribution system (Figure 27). One of the failures was associated with the high-pressure hose from the hydraulic pump (Figure 28) and the other two were associated with the iron pipes leading to the hydraulic rams in the steering gear compartment aft of the engine room. One fractured iron pipe was located at ceiling height outboard of the port main engine (Figure 29). The other fracture was also located at ceiling height but in the area near the hydraulic power unit as shown in Figure 30. The fractured hose and sections of the pipes containing the fractures were retained for laboratory examination. The details of these examinations are contained in the accident docket².

Figure 27. Locations of hydraulic system failures.

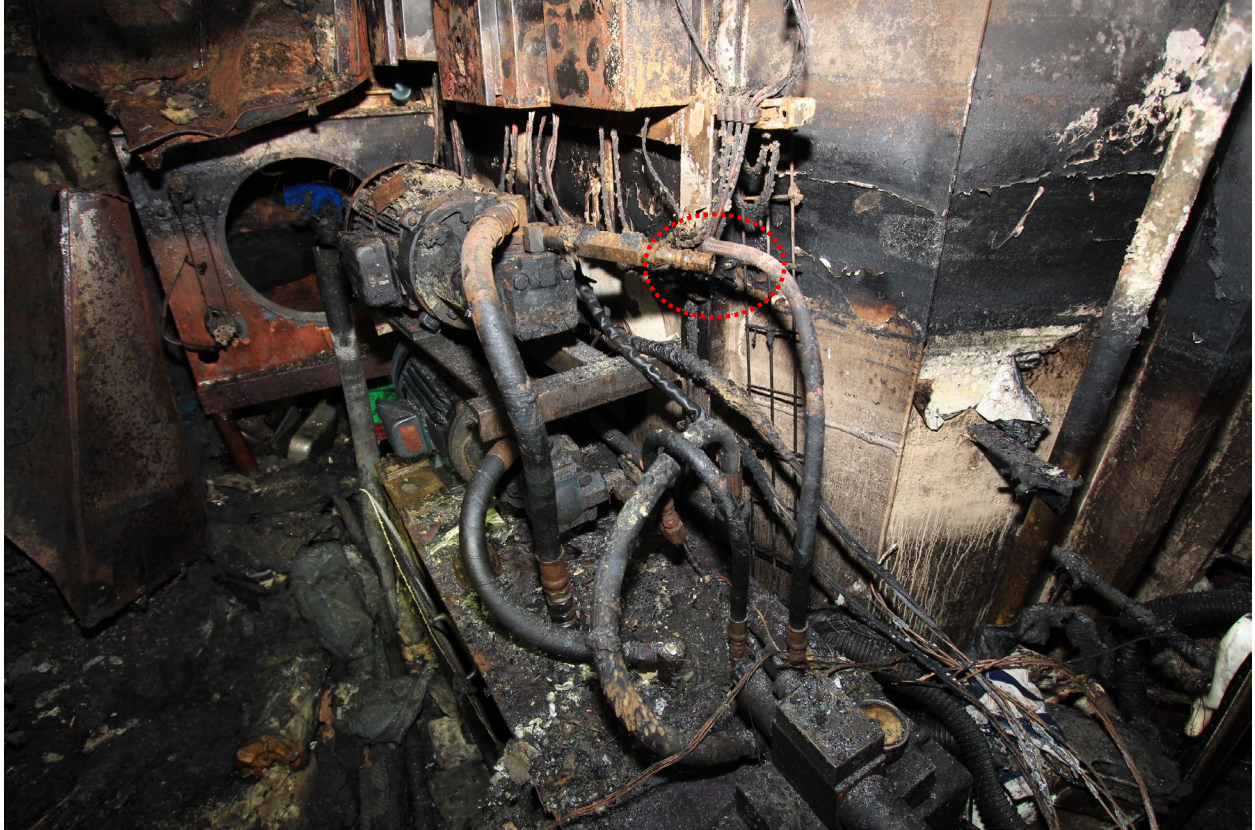
Figure 28. Hydraulic hose failure at pump outlet.

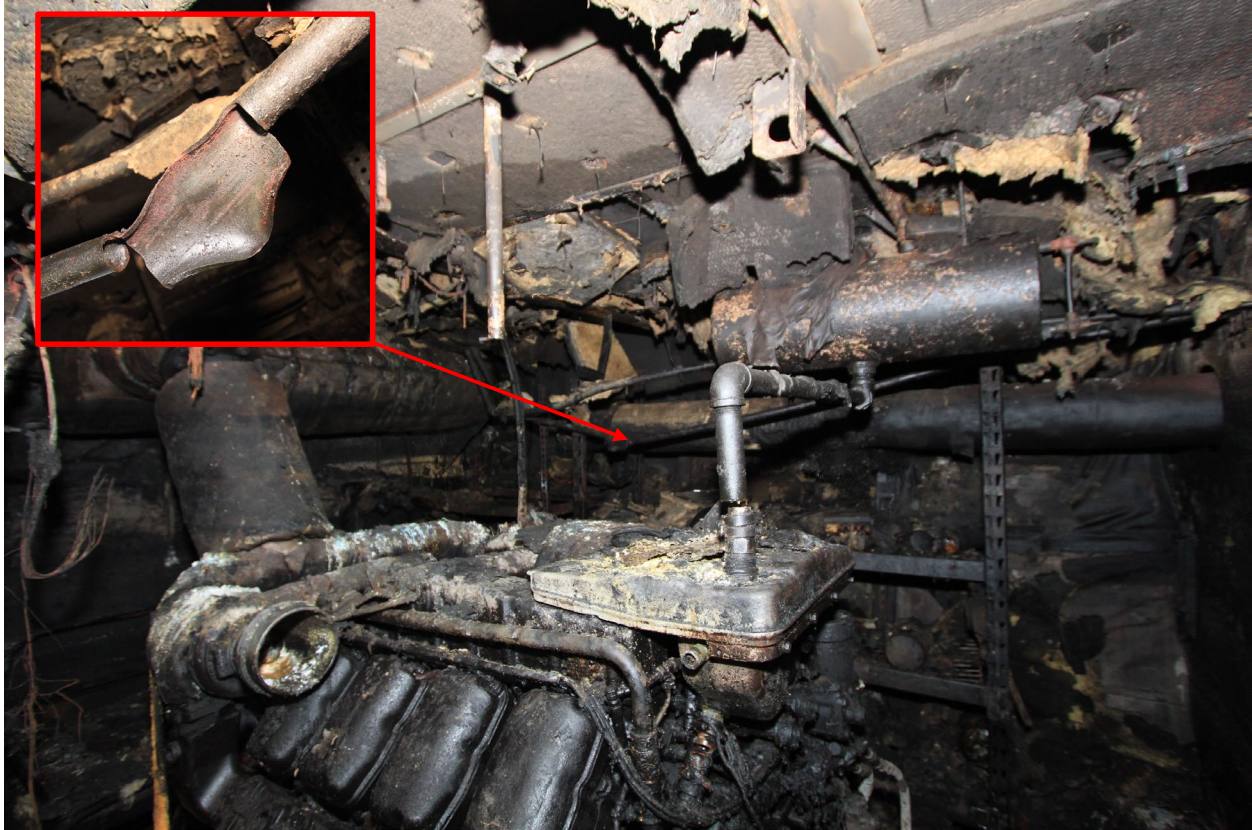
Figure 29. Hydraulic pipe fracture at ceiling height near port main engine.

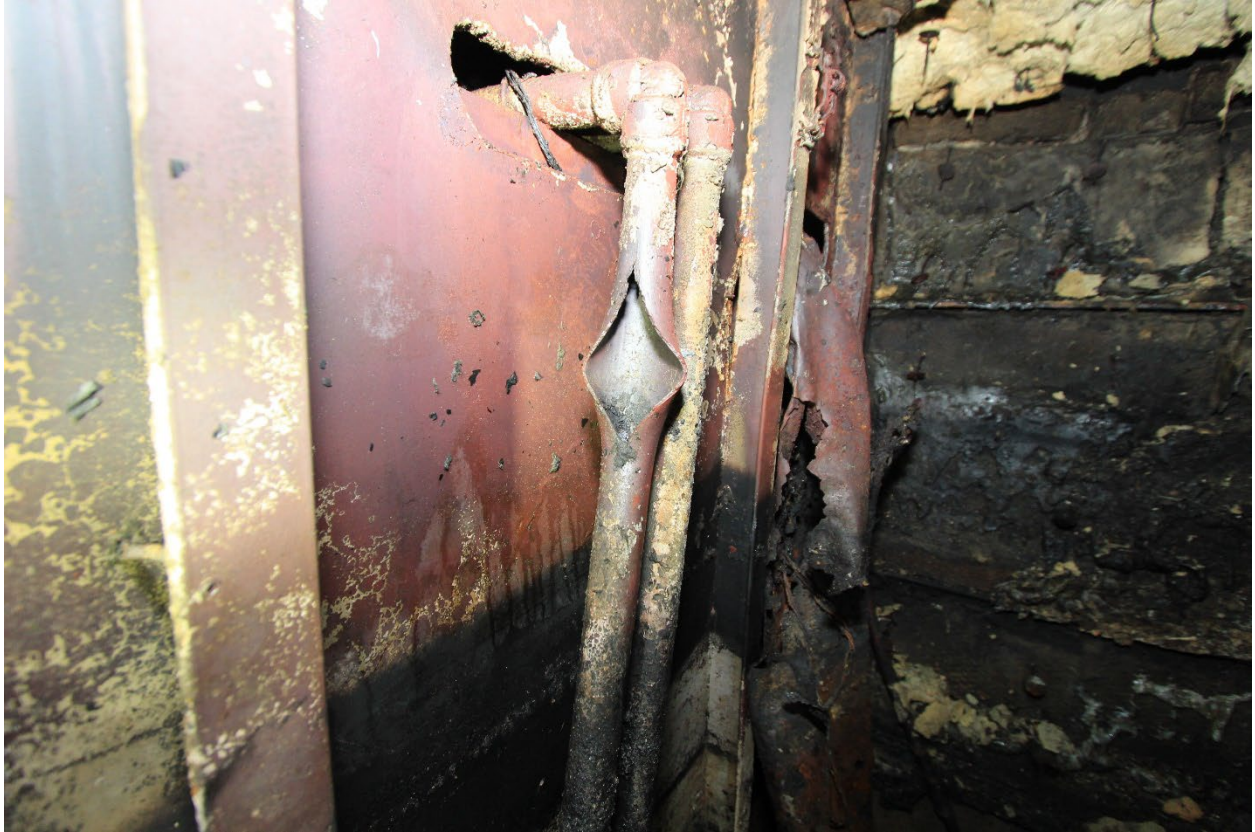
Figure 30. Hydraulic pipe fracture at ceiling near hydraulic power unit.
